Patsaouras Plaza Revisited

- Unique brickwork of roadway is restored to original pattern following extensive repairs.

(Nov. 4, 2004) A repaired and reconstructed Patsaouras Plaza reopened to traffic Nov. 2, following extensive improvements to the pedestrian, automobile and bus areas of the plaza's roadway.

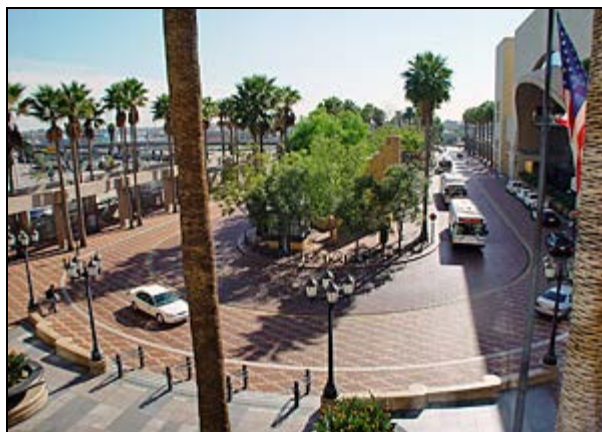
Patsaouras Plaza
re-opened to traffic
Nov. 2.

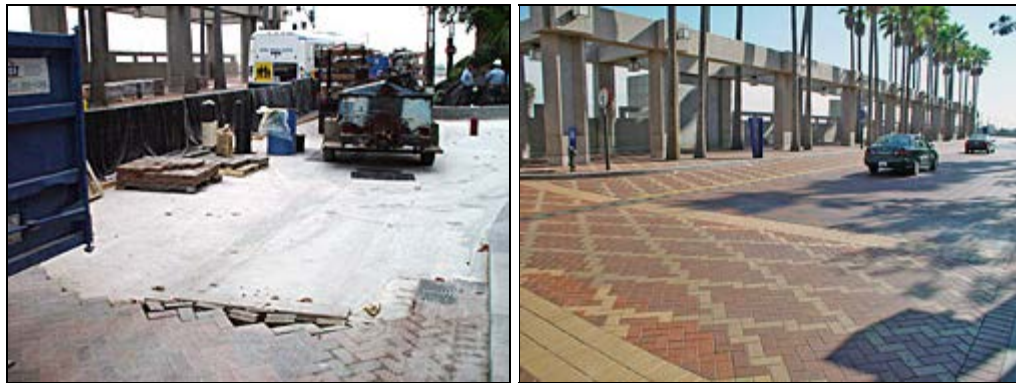
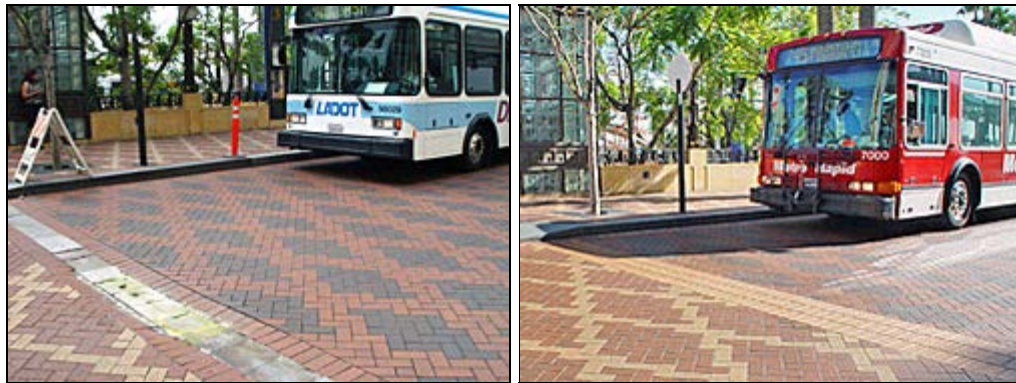
Since the Transit Plaza first opened in 1995, the constant passage of heavy buses had displaced and cracked the brick pavers and granite blocks of the pedestrian crosswalks.

At the south turn of the busway, water seeping from the landscaped park undermined the layer of sand supporting the bricks, and the weight and movement of the buses caused them to buckle, said Noonan.

Before and after: Above, workmen replaced paver bricks from the deck of the south end of the roadway that had buckled under the weight of buses. Below, workers removed damaged granite and replaced it with colored brick to mark pedestrian walkways.

The area at the top of the Vignes Street ramp also was damaged by bus movement. New bedding sand was placed and the pavers reinstalled.
