## Wayside Systems' 36-Hour Effort Restores Green Line Service

By BILL HEARD, Editor

(Dec. 3, 2004) Metro Green Line service is back to normal, today, following a 36-hour effort by Light Rail Wayside Systems employees who repaired damage caused by a train that ripped out a 450-foot section of electrical wire.

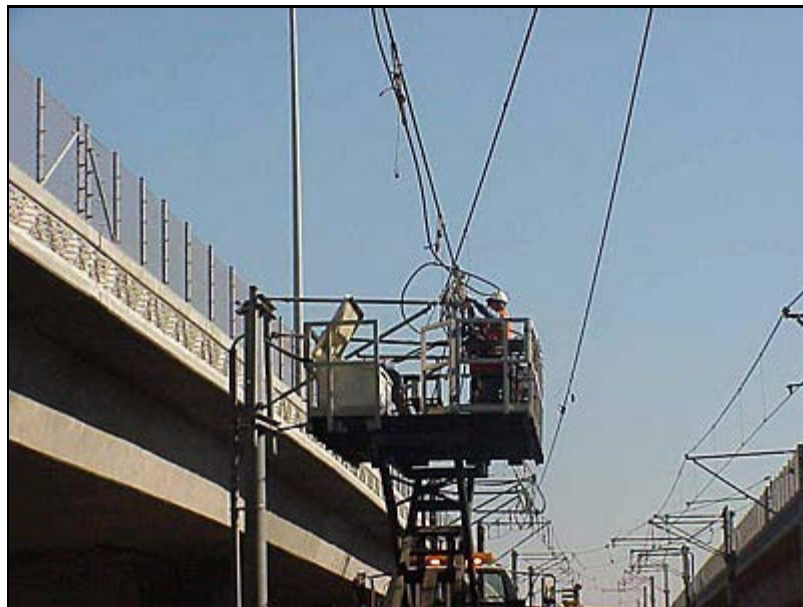
Traction  
Power  
Inspectors  
Tobe  
Cowden and  
Frank  
Hernandez  
work to  
repair the  
downed  
catenary  
wire on the  
Metro Green  
Line east of  
the Aviation  
station.

The incident happened at 5:30 p.m., Nov. 30, when the train's pantograph, a metal rod that draws power from the overhead catenary wire, somehow became entangled in the wire as the westbound train approached the Aviation station.

The electrical wire, under 8,000 pounds tension, snapped, but the train – hurtling along at 50 to 55 mph – continued forward carrying the wire with it and tearing steel arms off six or more catenary poles. No one was hurt in the incident.

Working in bone-chilling overnight temperatures, Metro Rail crews de-energized the catenary wire, cut it and spliced it and replaced all the damaged hardware on the poles. They then re-strung the wire to the original 8,000 pounds tension. After testing, the repaired stretch was again deemed safe for operation.
