Metro Gold Line
Eastside Extension

UPDATE

Photos by Ned Racine
4/15/2005

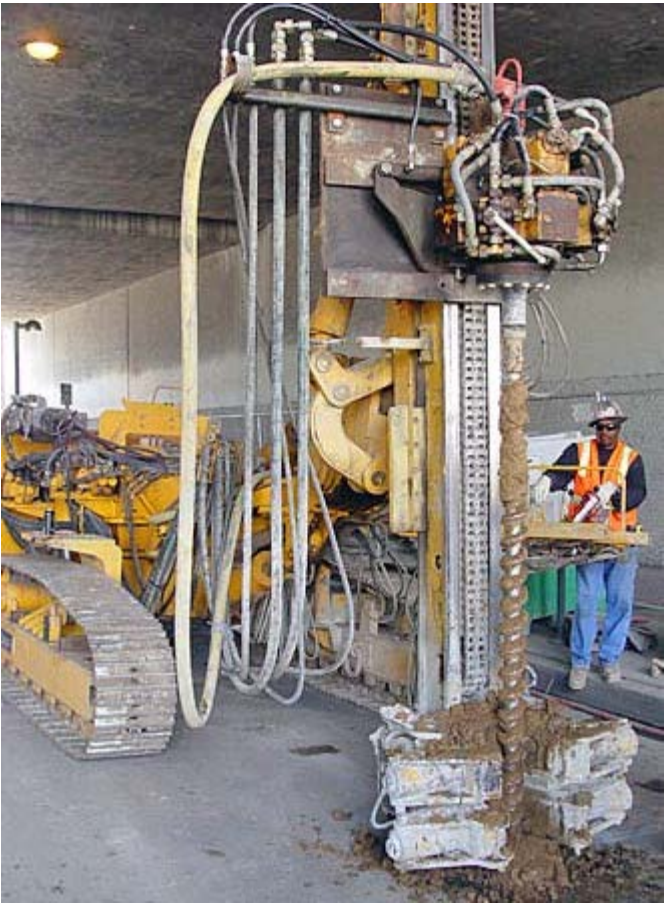
Photos, taken April 7, show workers boring holes in First Street, just west of Cummings Street, in preparation for chemical grouting. CalTrans required that grouting be injected under the U.S. 101 overpass to reduce any potential settling that might be caused by the tunnel boring machine working under First Street. When they are done, workers will have drilled approximately 250 holes under the overpass. Holes range from a depth of 47 to 52 feet.
