Master Mechanic Slows Avalanche of Engine Problems

(Aug. 14, 2008) An exhaust manifold is one of the simpler pieces of a modern bus. It removes the scalding gases from the combustion chambers and sends the gases on their way to the tail pipe. Not too complicated—unless the manifold begins failing.

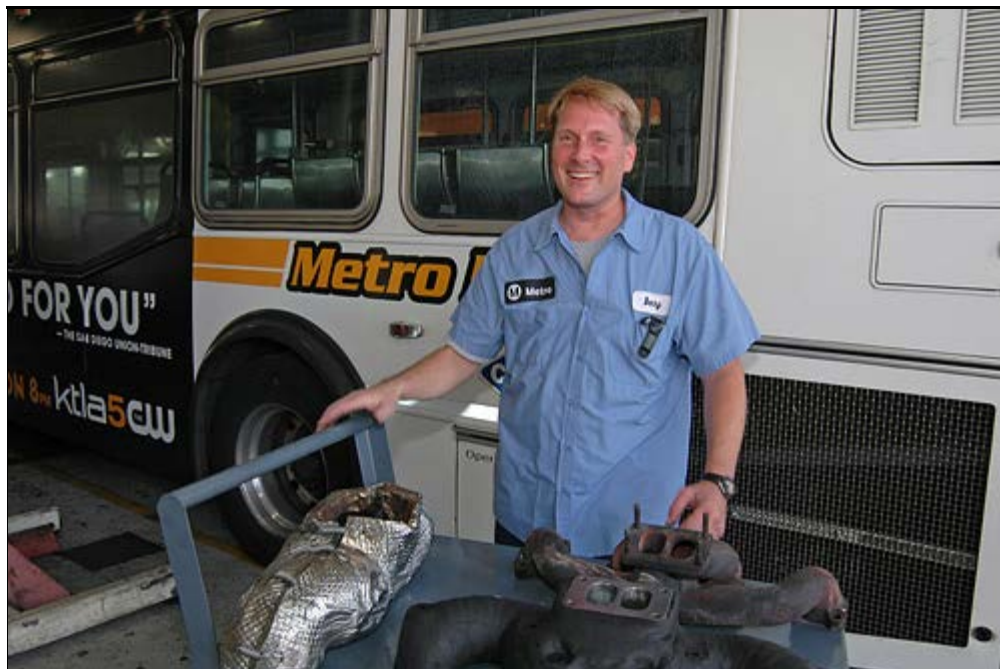
Barry Richter, San Gabriel Valley Division 9 master mechanic leader, discovered a replacement for cracked manifolds. His two-piece solution included a clam-shell insulator and a manifold developed for diesel engines. *Photo by Ned Racine*

Richter, who has worked for Metro for 16 years, researched the misbehaving manifold and discovered Detroit Diesel offered an identical part, made for diesel engines. Metro even had some in stock. Richter began testing the part with good results.

Using the M3 system, Richter found a Metro vendor who made an insulating wrap for coach exhaust pipes. That vendor agreed to produce a clam-shell-shaped insulator needed for the new manifold.

By December 2007, insulator in hand, Richter had a two-piece solution, a solution that saved the agency over \$1,000 from the cost of the original manifold.

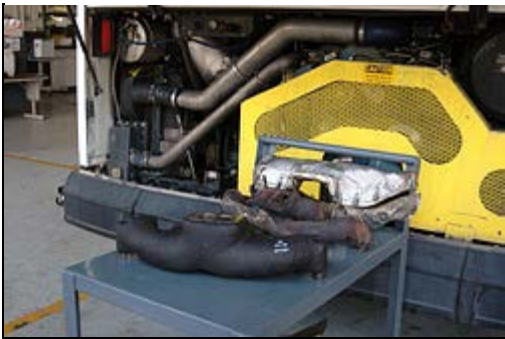
Richter needed to find a way to insulate the heat of the manifold from the rest of the engine.

Another problem remained, however. He needed to find a way to insulate the heat of the manifold from the rest of the engine because the manifold reaches 1,000 degrees when it idles; 1,200 degrees when it runs.
