Wayside Systems Team Races the Clock in Rebuilding Blue Line Crossings

(Oct. 8, 2008) When Jeff Root and his team rebuilt the Metro Blue Line crossing near 41st Street and Alameda Street, there was no giant clock hanging over their heads, but there might well have been. Root and his crew are all about efficiency and quick turnaround time.

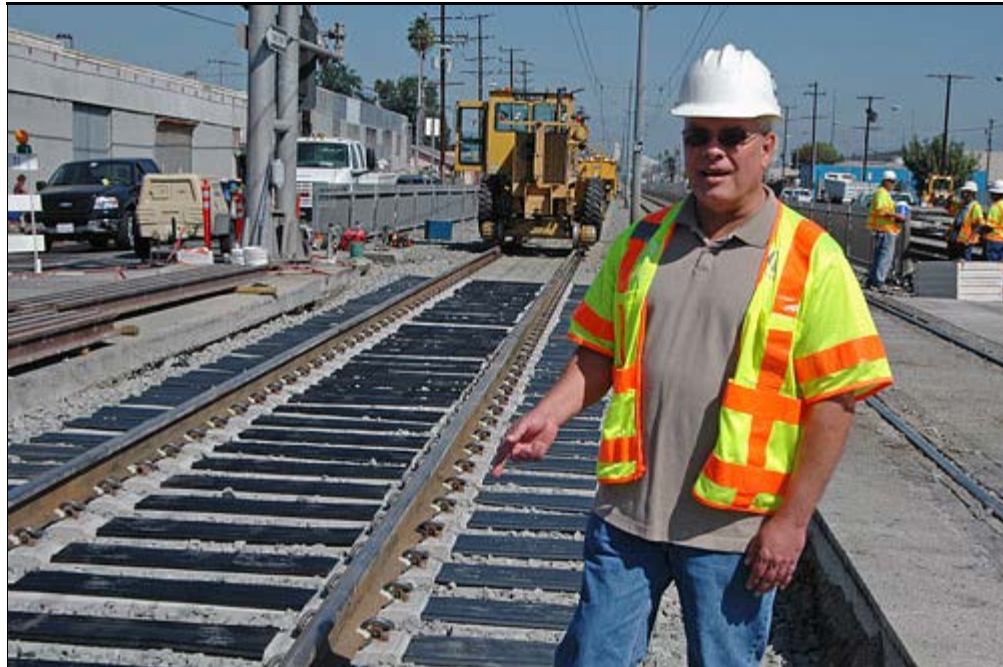
JWayside Systems Manager Jeff Root explains that the concrete grade-crossing panels—replacing the asphalt surface and wood headers installed when the Blue Line was built—will make servicing the rail crossing faster. *Photos by Ned Racine*

much as a small car—will bring the wayside service team a big advantage. Unlike the asphalt-and-wood sections placed when the Blue Line was built in 1989, which need to be dug out before the rail can be serviced, Root and crew will be able to snap out the concrete panels, service the rail, and snap the panels back in place, as if they were giant Lego pieces.

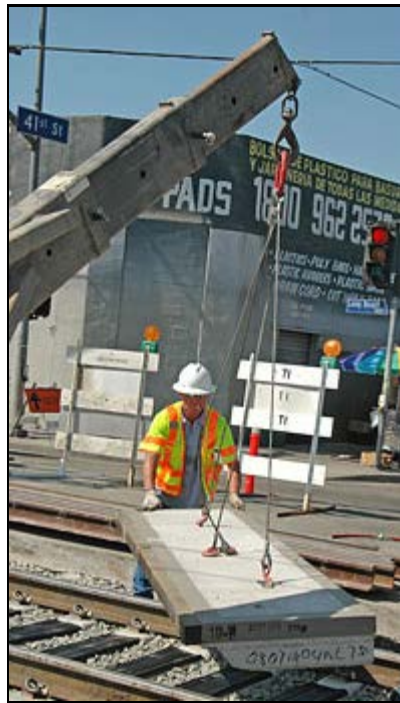
Concrete panels, weighing approximately 7,000 pounds per pair, will be placed over the black rubber mats.

Workers then “hand dressed” the ballast to ensure its proper placement. Rubber “crossing pads” were placed on the concrete ties to prevent concrete-to-concrete friction (and protect against dirt).

Then the concrete grade-crossing panels were lowered and tweaked into place. The rail was welded together and reconnected to the Blue Line's electronic monitoring system.

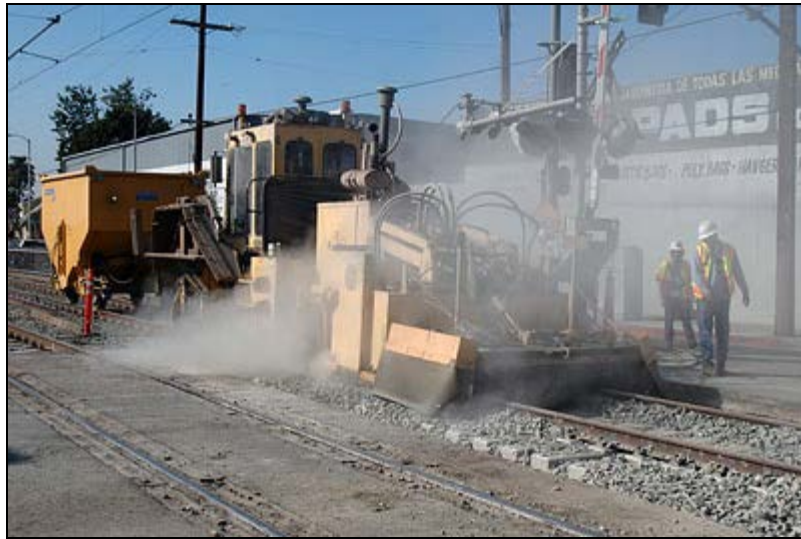
Tamper-regulator unit passes over the rails to ensure their alignment is correct.

On Saturday morning, after the permanent rail was reinstalled, the tamper-regulator ran over the rail, using its laser to ensure the rail met the computer's measurements. (If the rail is not aligned, the tamper feet nudge the rail into place.)
