SHRP 2 Renewal Project R06G

Mapping Voids, Debonding, Delaminations, Moisture, and Other Defects Behind or Within Tunnel Linings

This final report documents the work conducted under Phase II of Strategic Highway Research Program (SHRP 2) Project R06(G), Mapping Voids, Debonding, Delaminations, Moisture, and Other Defects behind or within Tunnel Linings.

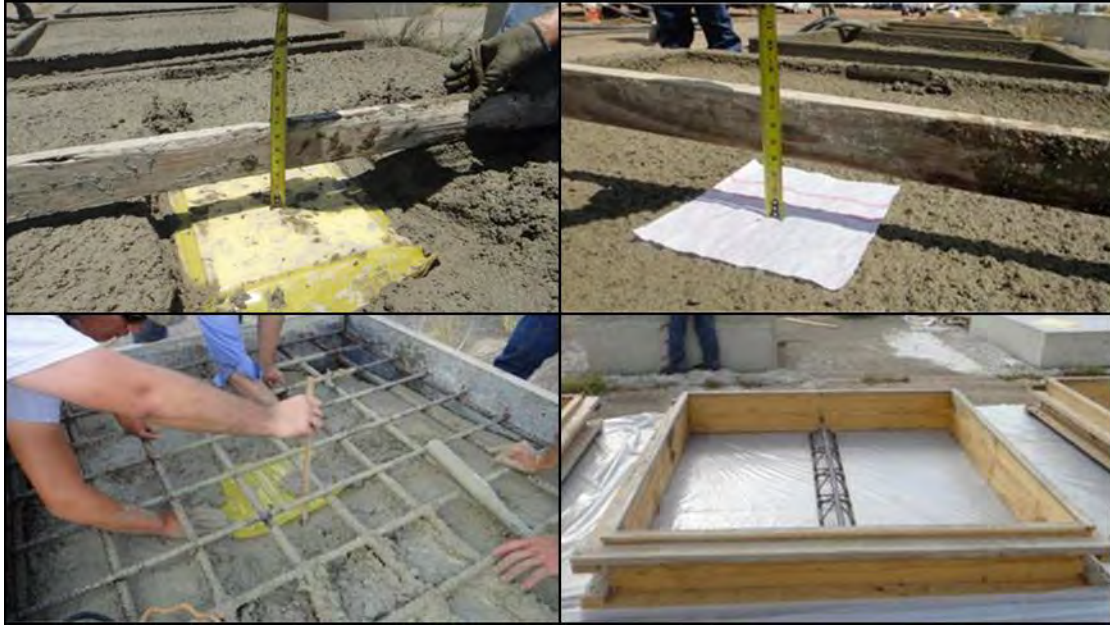
Figure 1. Construction of slabs with simulated defects.

Eleven normal-weight concrete slabs and 13 shotcrete slabs were constructed to mock various defects. The concrete slabs were used to mimic typical concrete tunnel linings with and without reinforcing steel. The shotcrete slabs were constructed to mimic applications in which shotcrete is sprayed on as a finished layer, as typically found in tunnel linings. A specially designed lattice girder, also typical in tunnel wall construction, was used as reinforcement in the shotcrete slabs (Figure 1, bottom right).

The simulated delaminations in these slabs were constructed from three types of material. Delaminations were imitated by using 0.05 mm (0.002-inch) plastic square sheets and 0.25 mm (0.01-inch) cloth squares (Figure 1, top right). Air-filled voids (Figure 1, top left) were constructed by inserting 13 mm (0.5-inch) thick foam squares in vacuum-sealed plastic bags. Water-filled voids (Figure 1, bottom left) were constructed in a similar manner by placing water-filled Ziploc bags within vacuum-sealed plastic bags and carefully padding the defect with concrete/shotcrete during construction so as not to puncture the plastic. Table 1 is a summary of the specimen details.

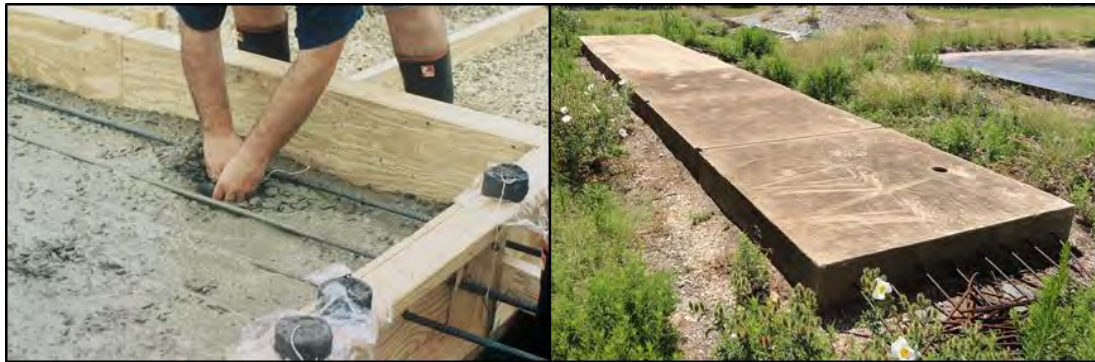
Figure 2. Clay lump slab construction.

In addition to the concrete and shotcrete slabs, six concrete slabs were tested that were constructed in the 1990s by the Texas Transportation Institute as part of a previous research project. These slabs contain manufactured clay lumps of different diameters. The clay lumps are a high-plasticity clay, classified as Burleson Clay CH (American Association of State Highway and Transportation Officials [AASHTO] A-7-6) with a plasticity index (PI) range of 35-45. The slabs and lumps are shown in Figure 2 and are summarized in Table 2 (Specimens A2-F2). These six specimens consist of two sets of three slabs: one set with steel reinforcement and one set without. In each set, one slab was designated as the control with no clay lump contaminations. The remaining two had various levels of lumps of documented sizes corresponding to three regions of interest: (1) lumps below the reinforcement that represent typical lumps dense enough not to be quickly displaced toward the surface via vibration, (2) those that are caught in the reinforcing steel layer on their path toward the surface, and (3) those that are dispersed between the reinforcement and the top surface. The depth of the slabs is nominally 305 mm (12 inches), but all measurements are taken as approximate since neither ground truth data were retrieved nor any accurate pictures were taken to confidently support documented placement.

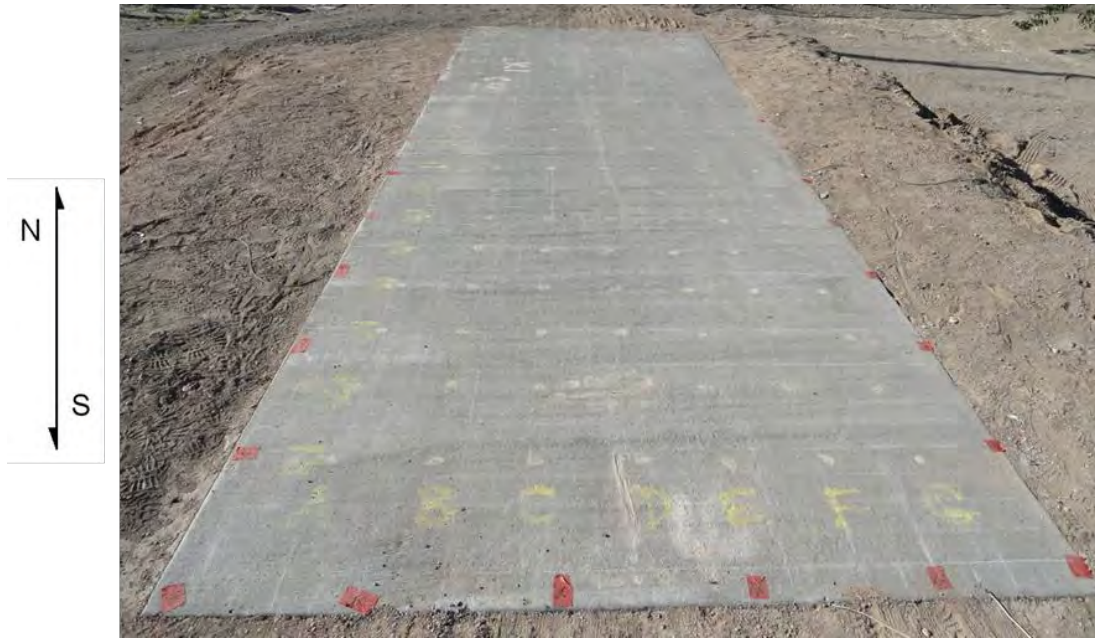
Figure 3. Simulated bridge deck at UTEP in El Paso, Texas.

In addition to the above-mentioned slabs, a bridge deck constructed by the University of Texas at El Paso (UTEP) was available for blind testing. The bridge deck was constructed with known artificial delaminations, cracks, and corroded reinforcement. Several parameters were considered in the construction of the artificial delaminations including stacked delaminations, delaminations of various thicknesses (ranging from 0.3 mm [0.01-inch] to 2.0 mm [0.08-inch] thickness), sizes (ranging from 305 mm x 305 mm to 610 mm x 1220 mm [12 inch x 12 inch to 24 inch x 48 inch]), depths (above reinforcing steel at 64 mm [2.5 inches] below surface, and below two layers of reinforcing steel at 152 mm [6 inches]), with some located above prestressed girders supporting the slab. The deck, pictured in Figures 3 and 4, measures 2.4 m x 6.1 m x 0.2 m (8 ft x 20 ft x 8-3/4 inches), and rests on three prestressed concrete girders. Simulated defects constructed in the deck consist of nine artificial delaminations, five cracks, and two corroded reinforcement mats, which are all summarized in Table 3.

In constructing the deck, 27.6 MPa (4000 psi) concrete was used, and two layers of No. 5 longitudinal and transverse steel were placed at 254 mm and 203 mm (10 inches and 8 inches) on center, respectively, at centroid depths of 83 mm and 184 mm (3.25 inches and 7.25 inches) from the surface. The 28-day strength and modulus exceeded 34.5 MPa (5000 psi) and 27.6 MPa (4000 ksi), respectively. A 0.25 mm (0.01-inch) polyester fabric was used to mock an ultra-thin horizontal delamination. The vertical cracks were constructed from both thick and thin cardboard sheets. The No. 5 corroded steel mats were electrically merged and attached to the normal reinforcement. The corrosion depth was measured to be 1-2 mm (0.04-0.08 inch) prior to pouring the concrete.

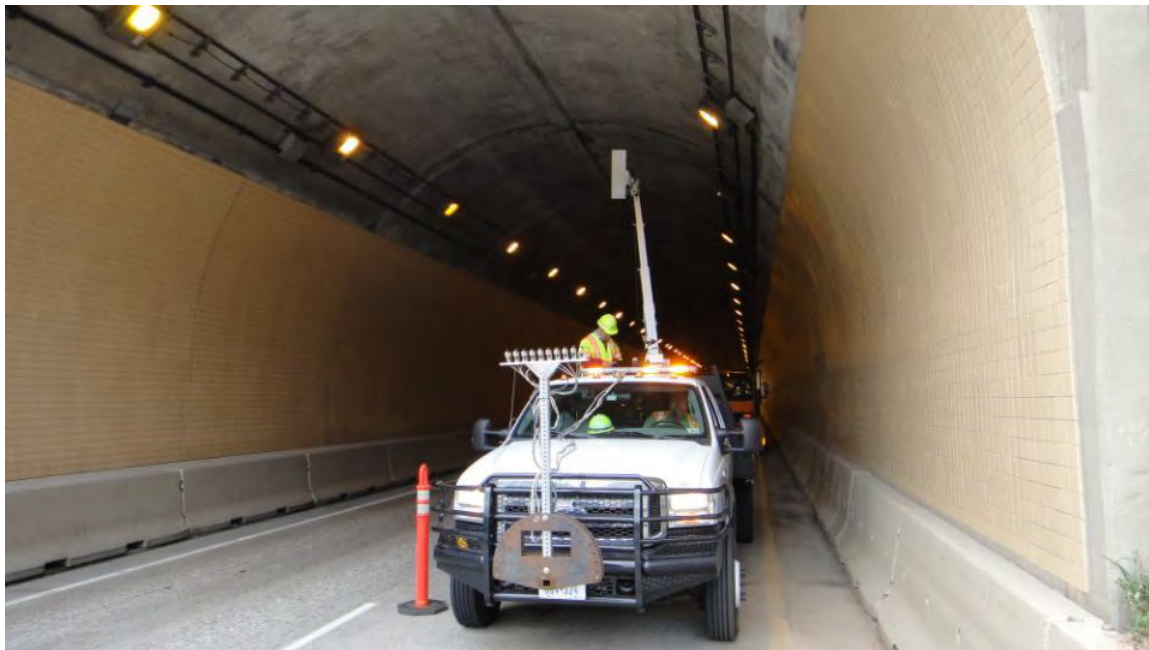
Figure 9. TTI air-coupled GPR system collecting data in the No Name Tunnel.

The No Name tunnel was constructed in 1965 and is located approximately 7.5 miles west of the Hanging Lake Tunnel. The team collected air coupled ground penetrating radar data and infrared images only in the westbound bore, which is approximately 1,000 feet long. The upper portion of this tunnel consists of a concrete surface; the sides are tiled. Figure 9 shows the TTI air coupled GPR system collecting data in this tunnel. Plan sets were not available for this tunnel.

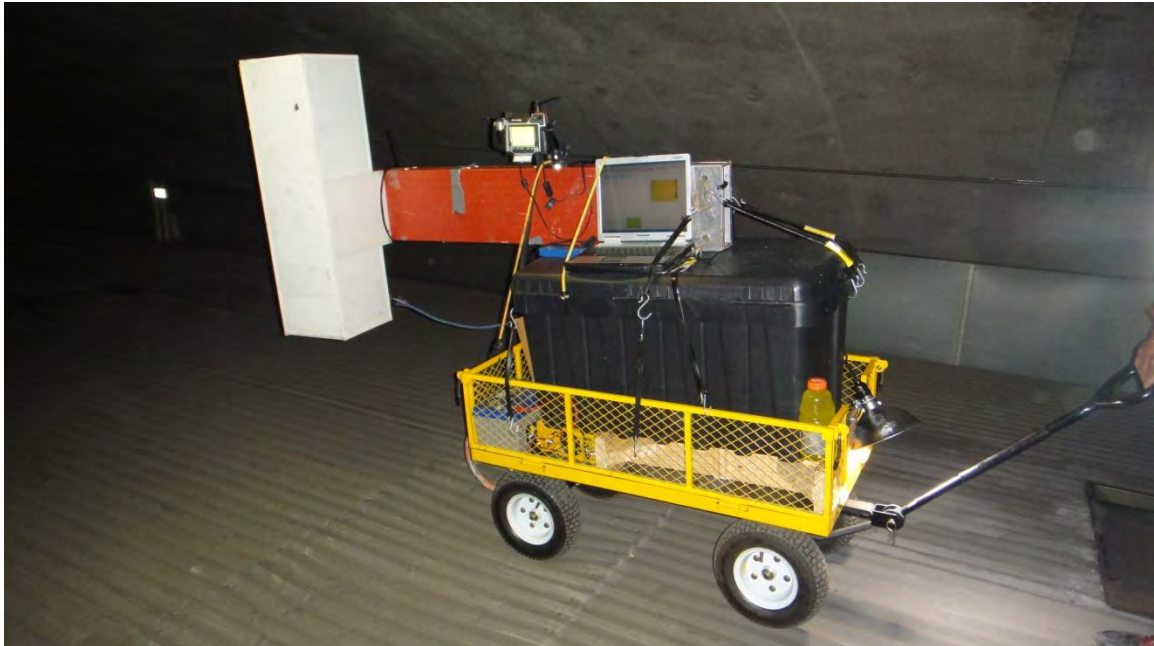
Figure 11. TTI air-coupled GPR system collecting tunnel roof lining data in Colorado.

The system used by TTI in collecting tunnel lining data includes a Wavebounce 1-GHz central frequency GPR antenna with distance measuring indicator (DMI) equipment. The system uses data collection software developed by TTI. Researchers used the Pavecheck and Colormap programs, also developed by TTI, to analyze the data. The researchers slightly modified Pavecheck and renamed it Tunnelcheck. This software is available for free download; the user's manual is provided in a separate publication. The researchers also mounted a FLIR T-300 camera on the GPR boom; the TTI data collection system collected images from this camera along with the GPR data.

Since such air-coupled systems (Figures 10 and 11) are not in contact with the structure, data collection can theoretically happen at full traffic speeds, although this is not practical for tunnel lining data collection. Currently, air-coupled antenna systems are manufactured by GSSI, Penetradar, Pulse Radar, and Wavebounce, all from the United States; butterfly dipole systems are manufactured by Radar Team Sweden Ab.

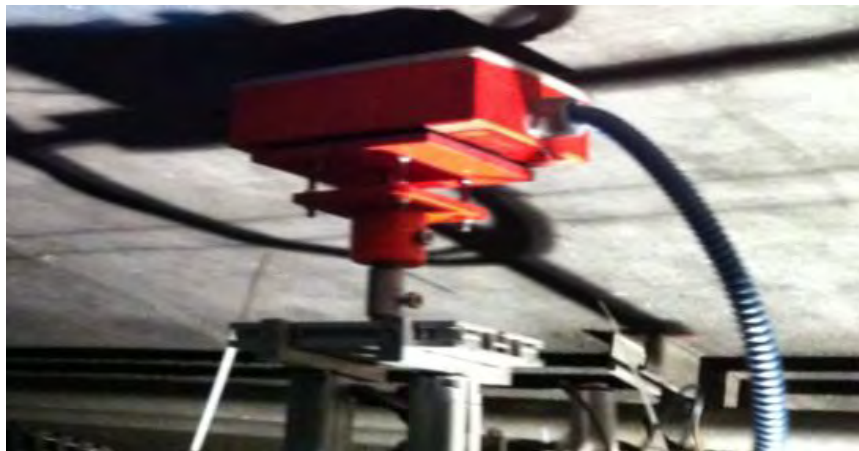
Figure 12. GCGPR equipment.

Ground-coupled ground-penetrating radar (GCGPR) needs to be either in contact or very close to the lining surface when collecting data (Figure 12). The operating principles are the same as ACGPR; GCGPR cannot detect defects in concrete unless significant air pockets or significant moisture is within the defects. However, GCGPR can detect defects that ACGPR cannot. GCGPR can also detect reinforcing steel. Researchers used the GSSI 1.5-GHz central frequency GPR antenna during the tunnel tests because shallow defects were found during those tests; researchers used a 900-MHz central frequency GPR antenna during the TTI specimen tests since the researchers were trying to determine if GCGPR can detect deep defects.

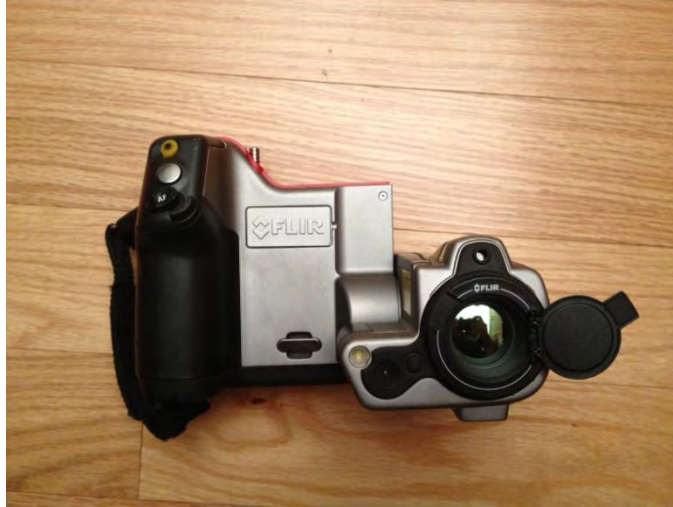
Figure 13. FLIR T300 thermal camera used in the study.

Handheld thermal cameras (Figure 13) have improved significantly over the past decade, with consistently higher image resolutions and improved temperature accuracy occurring over time. The research team used the FLIR T-300 thermal camera for this study. The researchers analyzed the images for changes in tunnel lining temperature, which could indicate possible defects within or behind the lining. The research team believes that the images from such cameras can be used to determine where to conduct testing with in-depth nondestructive testing devices and techniques.

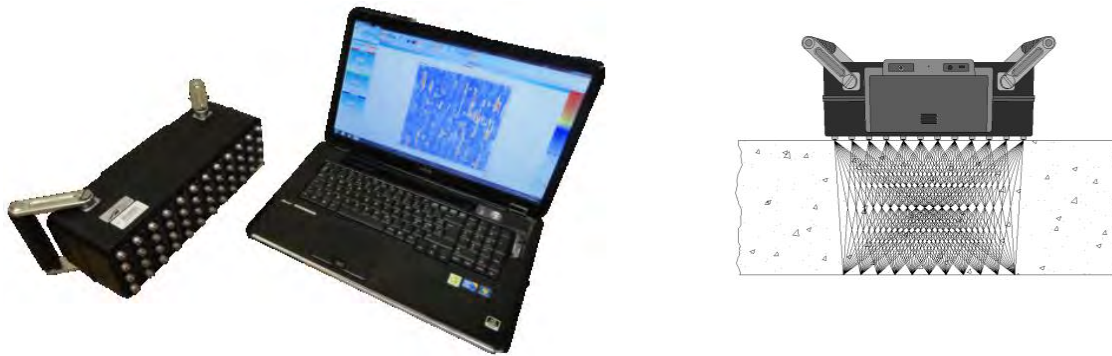
The ultrasonic tomography (UST) system used in this study is a device that uses an array of ultrasonic transducers to transmit and receive acoustic stress waves for the inspection of concrete structures. The system used here, the A1040 MIRA, is produced by Acoustic Control Systems (Figure 14).

Figure 14. The A1040 MIRA system (left) and the transmission/reception of acoustic waves and corresponding echo intensity (right)

The tomograph, shown in Figure 14 (left), uses a 4 by 12 grid of mechanically isolated and dampened transducers that can fit the profile of a rough concrete testing surface with a variance of approximately 10 mm (0.4 inches). Each row of four transducers transmits stress waves sequentially while the remaining rows act as receivers. In this manner, there is a wide

With the help of a digitally focused algorithm, a three-dimensional (3D) volume is presented with each point of possible reflection in half-space represented by a color scheme, scaled according to reflecting power. This 3D image can also be dissected into each of the three planes representing its volume: the B-scan, C-scan, and D-scan (Figure 15). The B-scan is an image slice showing the depth of the specimen on the vertical (or z) axis versus the width of scan on the horizontal (or x) axis. This slice is a plane perpendicular to the scanning surface and parallel to the length of the device. The C-scan is an image slice showing the plan view of the tested area, with the vertical (or y) axis of the scan depicting the width parallel to the scanning direction and the horizontal (or x) axis of the scan representing the length perpendicular to the scanning direction. Note that the scanning direction is always defined as the y-axis as seen in Figure 6. The D-scan is like the B-scan in that it images a plane perpendicular to the testing surface, but it is oriented parallel to the scanning direction. On each of the scans, the various intensities reported by the returned waves are color-coded from light blue to deep red, representing low reflectivity (typically sound concrete) and high reflectivity (any type of impedance), respectively. With this intensity scaling, it is easy to see any discontinuities with distinctly different wave speeds, such as voids, delaminations, cracks, and other abnormalities..

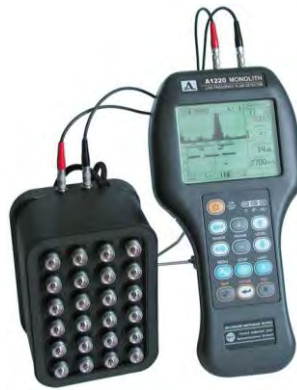
Figure 16. Ultrasonic echo equipment A1220 Monolith by ACSYS.

The handheld ultrasonic transducer used by the German Federal Institute for Materials Research and Testing (BAM) for field testing together with the corresponding data acquisition/analyzer unit is shown in Figure 16. In tunnel testing applications, the ultrasonic echo technique can be used to estimate the thickness of the tunnel lining and to detect delamination and voids within the lining.

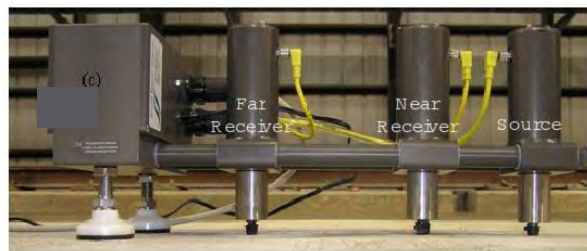
(a) Traditional device

USW and IE measurements can be performed with these two methods simultaneously with the PSPA shown in Figure 18. The traditional PSPA is a box containing a solenoid-type impact hammer and two high-frequency accelerometers (Figure 18a). All controls and data acquisition are in a computer that is connected to the box. The two receivers allow the calculation V_p using the USW method. The test at a single point is simple and takes less than 30 s. The impact duration (contact time) is about 60 μ s, and the data acquisition system has a sampling frequency of 390 kHz.

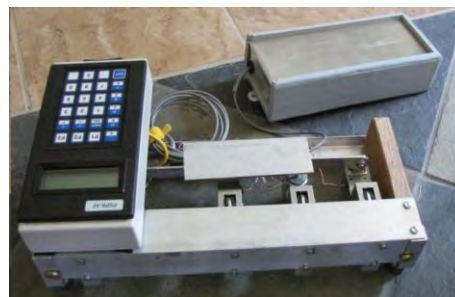
(b) New version

As shown in Figure 18b, the PSPA has been redesigned to make it more user friendly and compact for tunnel work. The new PSPA is self-contained, and there is no need for an external computer to collect data. The waveforms collected in the field are stored in a removable flash memory. The new PSPA is also lighter as compared with the traditional PSPA (8 lb versus 16 lb). Data collection with the new PSPA is a two-hand operation, which can accommodate the curvature within the tunnel more easily. Data acquisition with the new PSPA is on average two to three times faster than the traditional one. Also the new PSPA is equipped with three receivers to better optimize the data collection for the combined IE-USW methods. The power source for the device is six AAA battery placed in a container that can be carried by the operator on her or his belt. Typical signals collected with the PSPA are shown in Figure 19. These signals are used to develop USW dispersion curves and the IE amplitude spectra. The advantage of combining USW and IE methods in a single device is that once the test is performed, the variations in the modulus (an indication of the quality of concrete) and return resonance frequency (an indication of the full thickness or depth of delamination) of a slab can be assessed concurrently.

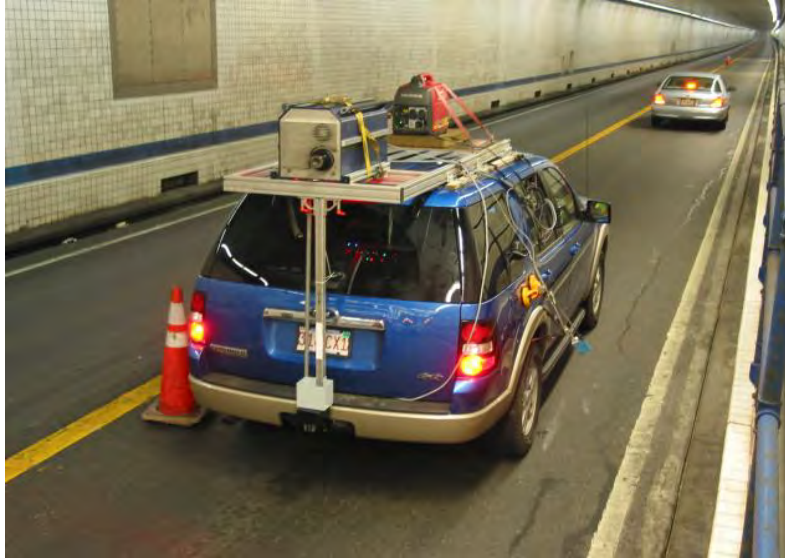
Figure 22. SPACETEC scanner in the Chesapeake Bay Tunnel.

The SPACETEC scanner (Figure 22) is a mature system developed for the inspection of railway and roadway tunnels. Therefore, employing this technology of this project requires no additional hardware/software development. The scanner has been already used to survey many miles of railway and roadway tunnels (in many different countries), but it has never been used in the United States prior to

The SPACETEC TS3 scanner records three different measurement

- Surveying the cross-sectional tunnel profile.
- Full-surface visual recording of the tunnel lining.
- Full-surface thermographic recording (thermal imaging) of the tunnel surface.

The measurements are processed and can be viewed individually or together to detect and locate tunnel surface and near-surface anomalies. The high-resolution visual recording allows a thorough inspection of the tunnel surface and, combined with the profiling, the location of surface defects. The cold spots in the thermal images are usually indications of near-surface moisture. Superimposing the thermal images on the visual recordings allows such moist zones to be easily identified. Monitoring the changes in the tunnel profile over time presents another potential application of this system.

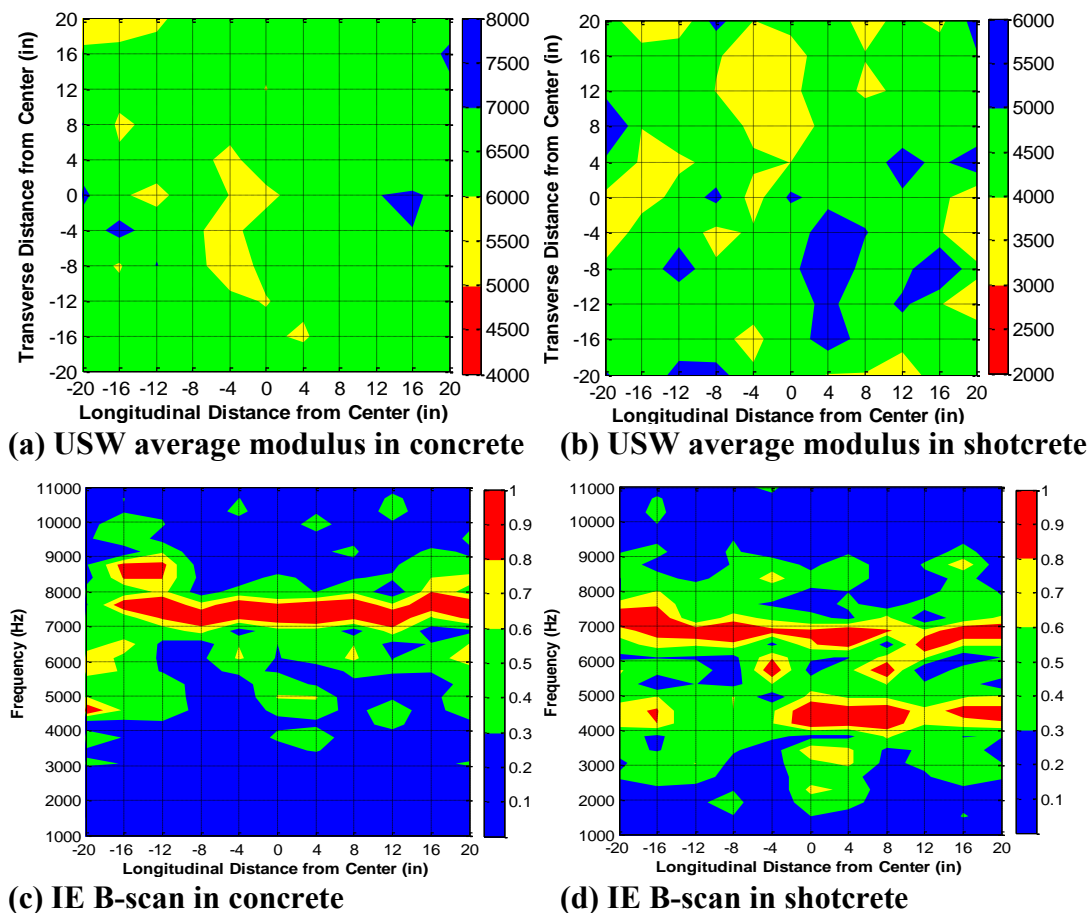
The IE and USW results on the TTI specimens are shown in Appendix U. As an example, a USW planar contour map and an IE spectral B-scan on selected intact concrete and shotcrete slabs are shown in Figure 23. In spite of the heterogeneity of shotcrete slabs, the contour maps of the variations in average USW modulus and dominant IE frequency exhibited reasonable uniformity for intact slabs (both concrete and shotcrete). In most cases the variation in modulus with depth was quite small. The reported thicknesses from spectral B-scan agreed well with the actual slab thicknesses. However, the peak frequency along the centerline of shotcrete slab varies more significantly than the concrete slab, mostly due to the heterogeneity of shotcrete. In spite of the effectiveness of the IE method in estimating the slab thickness, this method, as configured in the PSPA, cannot estimate the thickness of slabs that are thicker than 18 inches or thinner than 6 inches.

Figure 23. PSPA results on 12-inch-thick intact concrete and shotcrete slabs.

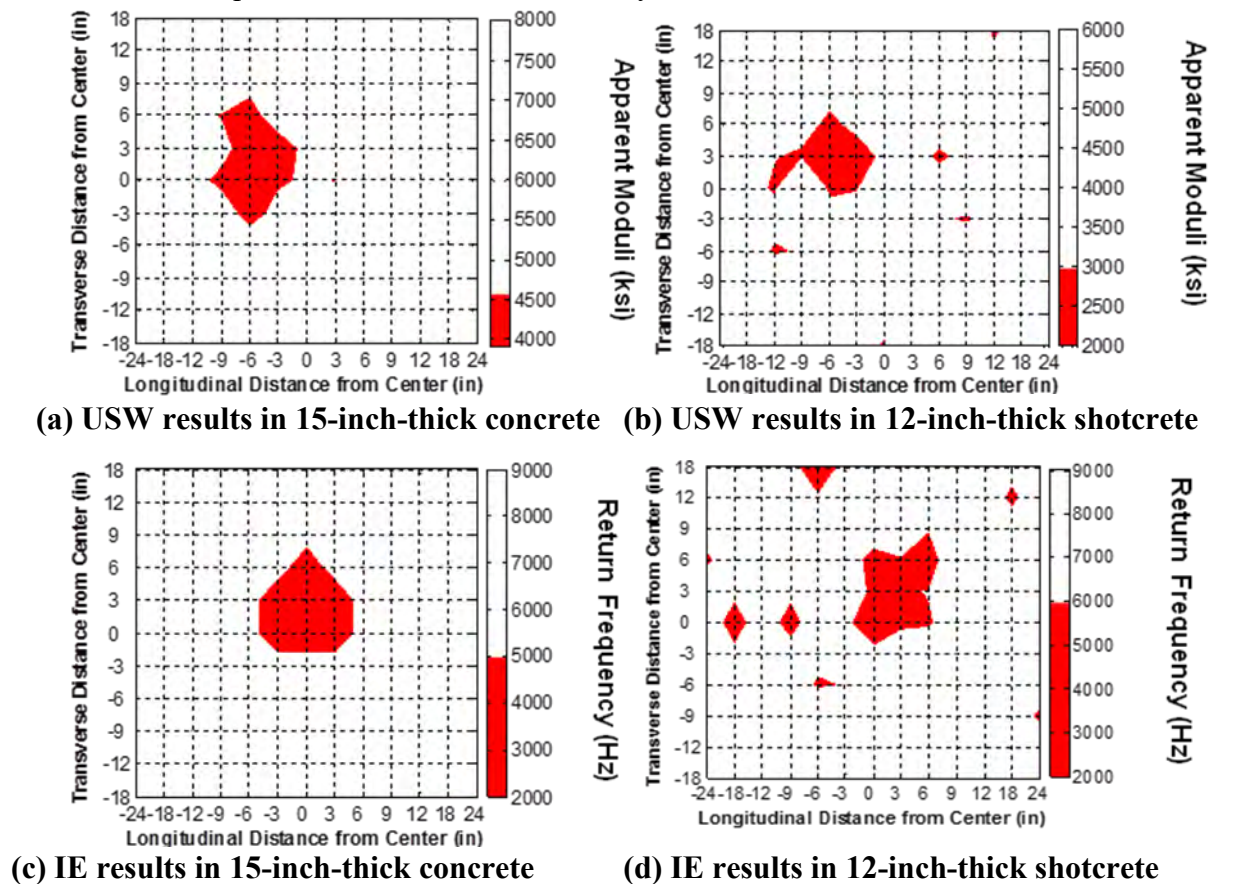
Due to the size of the specimens, reflections from the vertical boundaries sometimes affect the frequency content of the signal. The PSPA software contains appropriate filters to minimize the impact of these reflections as long as the slab is not very thick and the PSPA is located at an adequate distance from the boundary.

Figure 24. Contour maps of USW average modulus and IE dominant frequency in concrete and shotcrete slabs with embedded delamination at 3 inches from top surface.

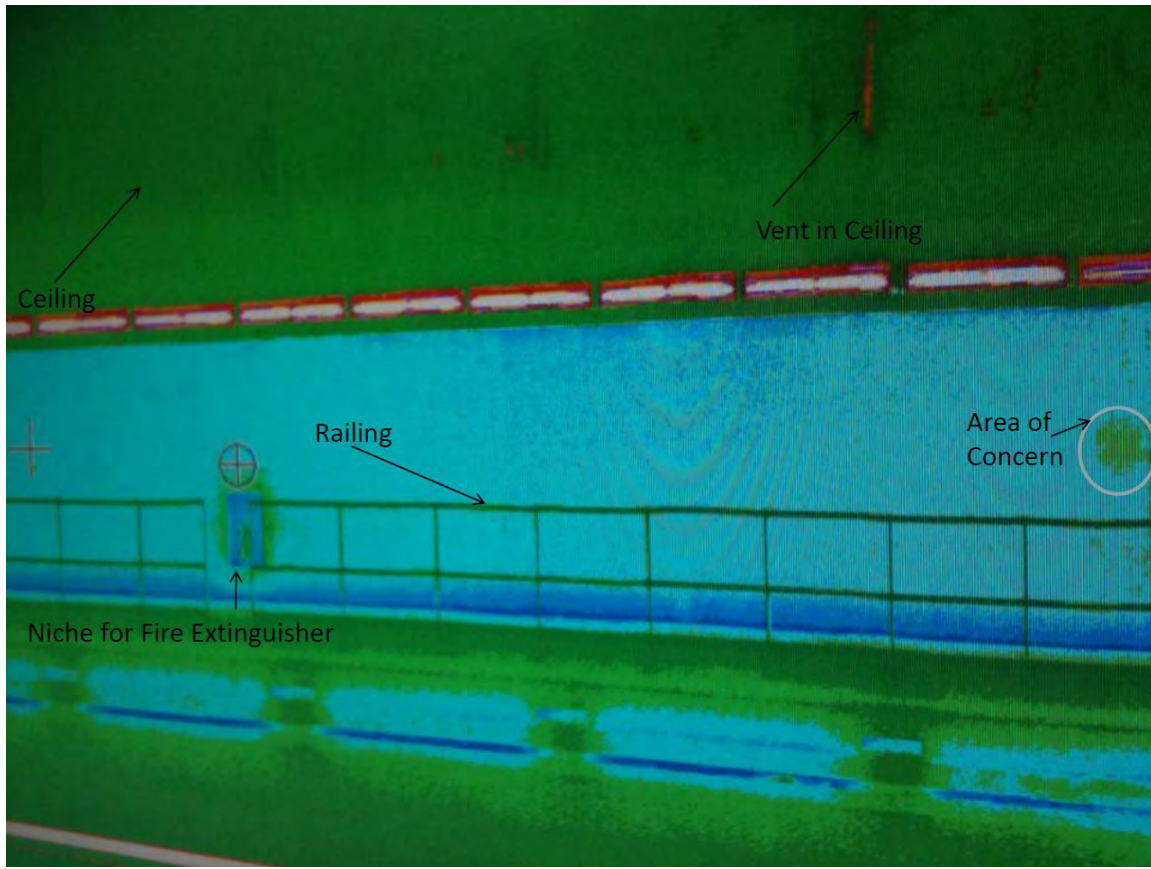
In addition, the SPACETEC equipment operator reviewed the infrared images immediately after data collection in April 2011. He noticed an area on the tunnel wall that appeared to have a defect according to the infrared image. This image is shown in Figure 25.

Figure 25. Infrared image from SPACETEC indicating an area of concern.

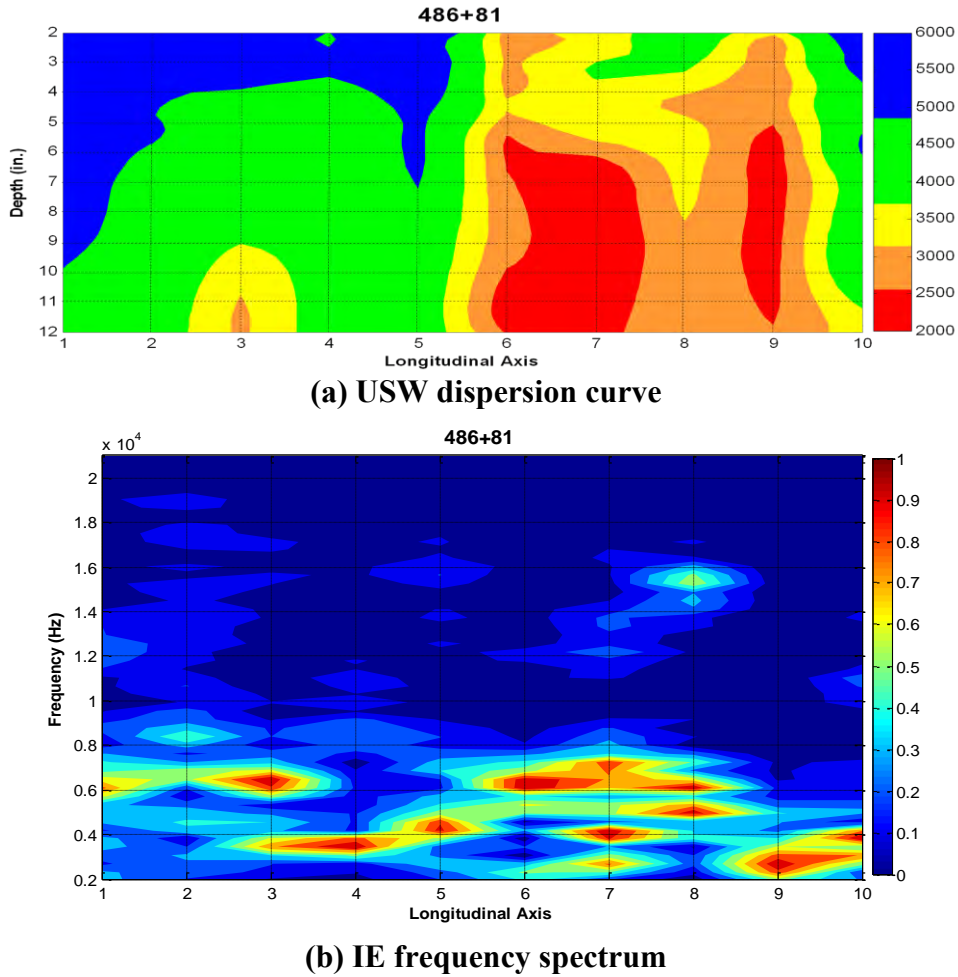
Figure 31. PSPA results on a defective area in the Chesapeake Tunnel.

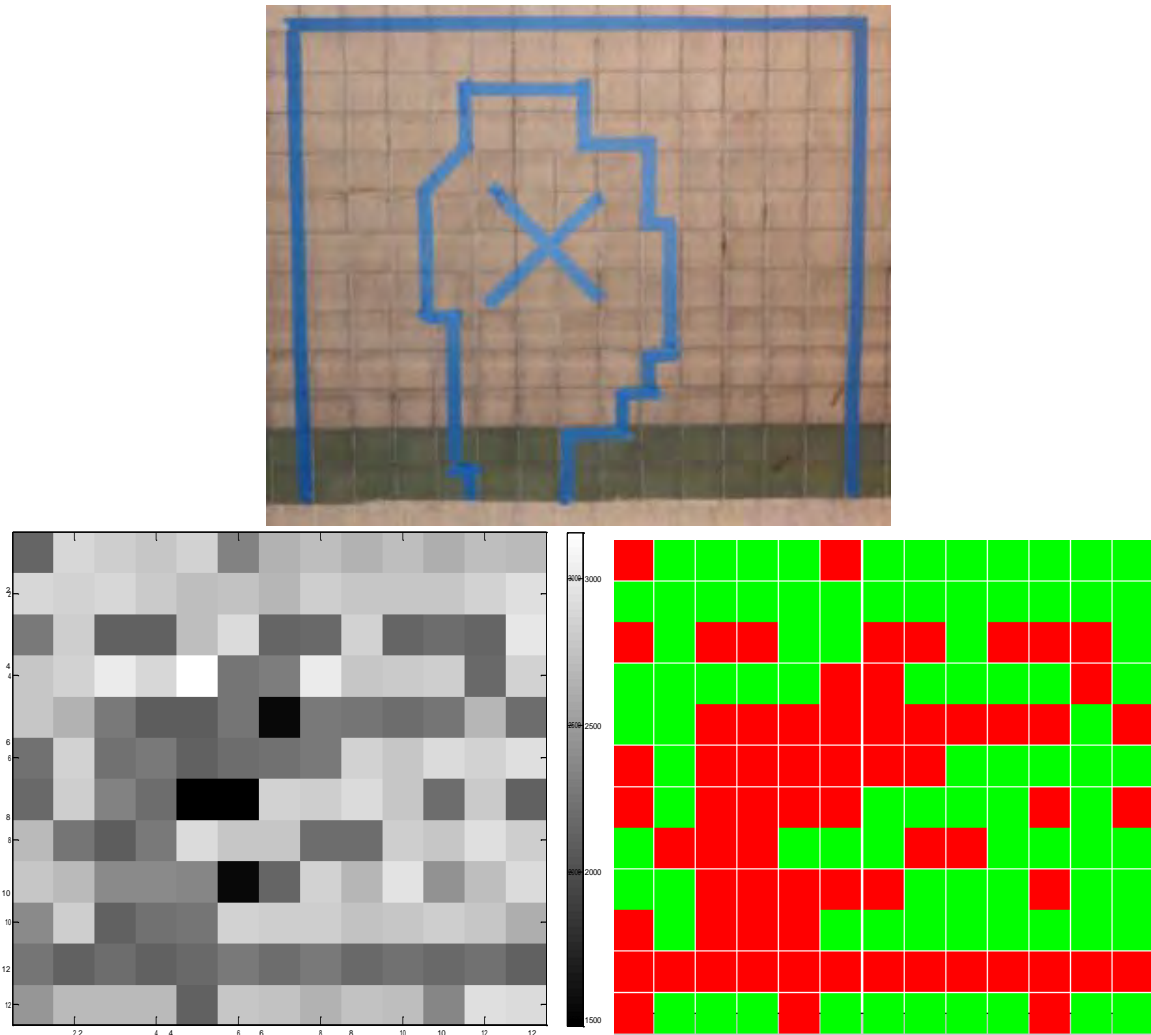
Figure G-2. Debonded regions of tile (top) paired with the acoustic sounding results (bottom).

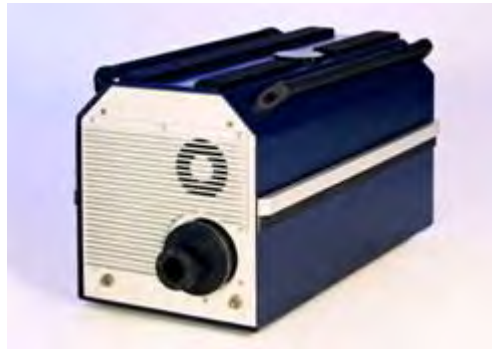
Figure I-1. TS3 scanner.

Since 1982, SPACETEC has offered a scanner system to monitor disruptions and conditions of tunnel linings (Figure I-1). With this tool, it is possible to validate the effects of degradation, like crack developments, cavities beneath the surface, changes in material composition, and water intrusions, over time.

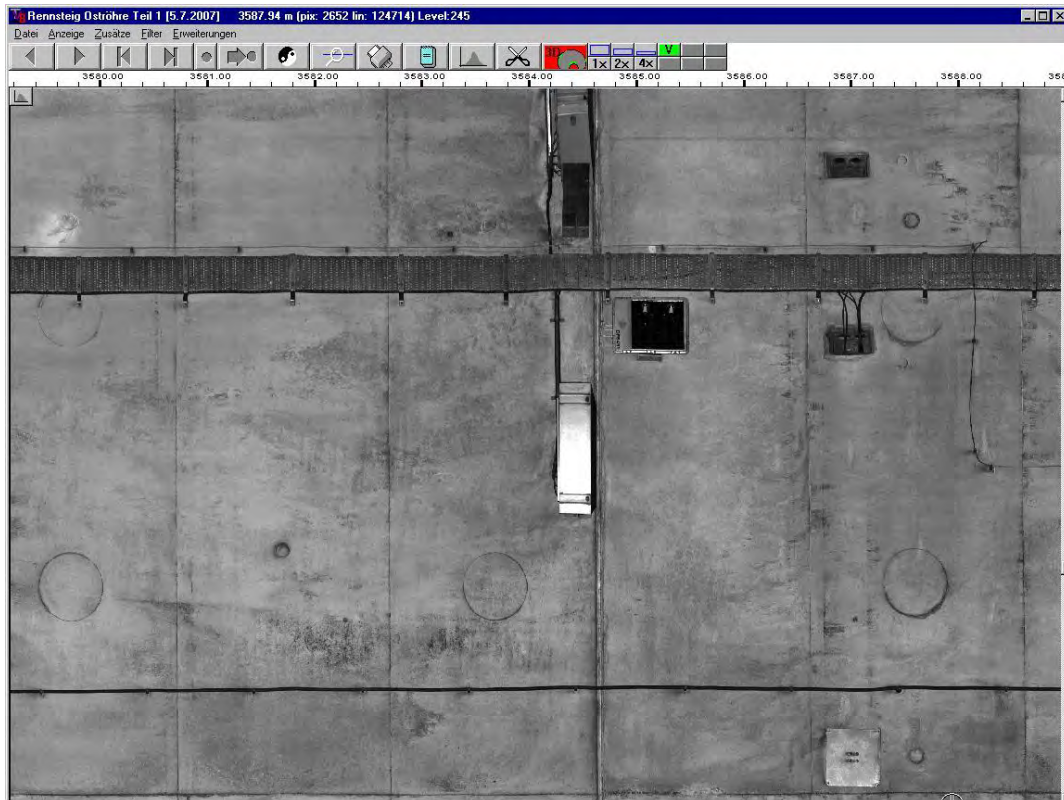
Visual images (Figure I-3) are most frequently used for general documentation and maintenance purposes. They show the condition of the lining as far as visible phenomena are concerned. At any time, later data may be consulted to look for changes in these conditions.

Figure I-3. Visual image showing the conditions of a shotcrete lining in a motorway tunnel.

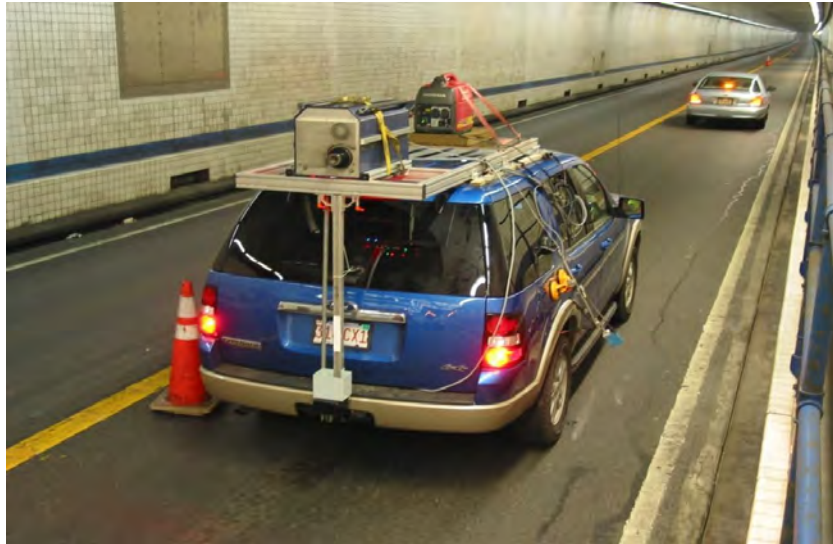
Figure I-7. Inspection vehicle in the Chesapeake Tunnel.

The survey was performed during the night between April 11 and 12, 2011. During the measurement, a sufficient temperature difference for a quasi-stationary heat flow was obtained. The TS3 scanner was installed on the roof in the rear part of the inspection vehicle (Figure I-7). This provided an undisturbed 360-degree measurement. The highest resolution of 10,000 pixels was used for an appropriate imaging of fine-scale features.

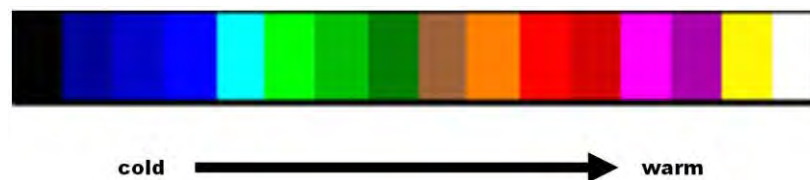
Figure I-9. Color scale for thermographic images.

Every thermographic surface point corresponded to a color-coded temperature interval with a temperature resolution of 0.1 °C (Figure I-9) and 16 colors from black, blue, green, red, yellow, and white. This color palette gave an intuitive physiological impression of cold (dark to blue) and warm (red to white) temperatures.

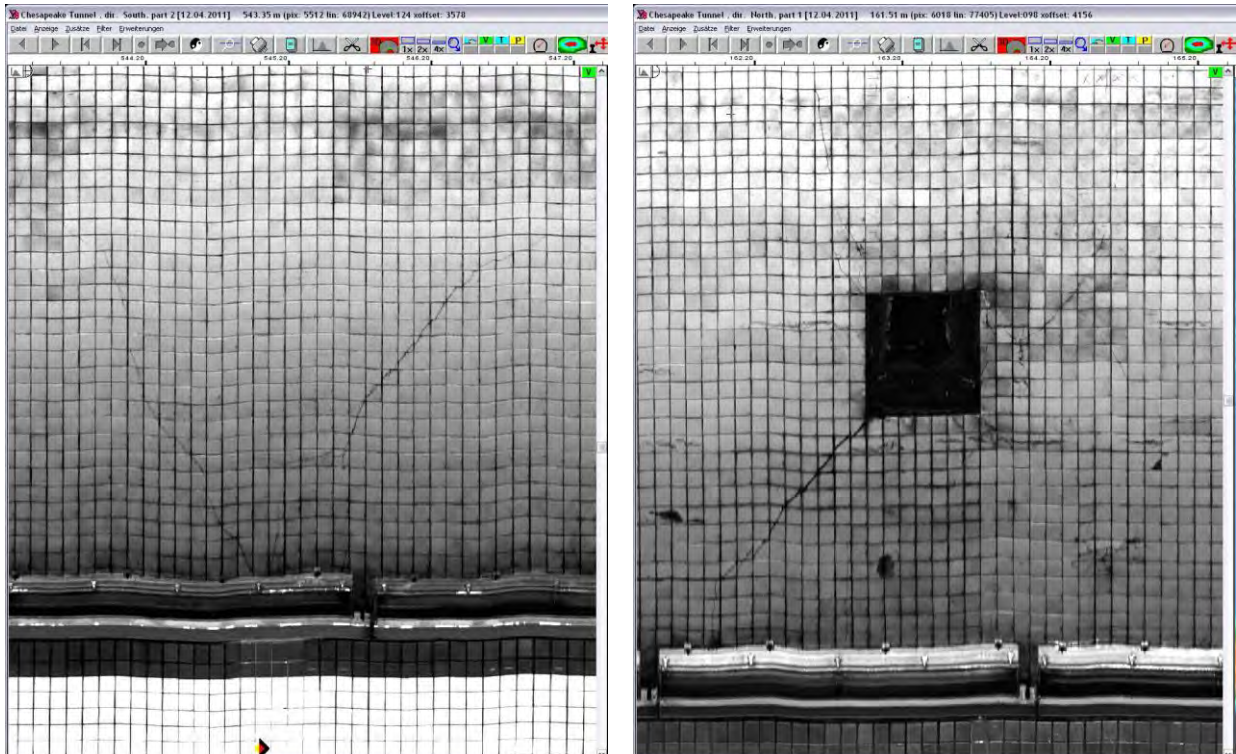
Since opening in 1964, the tunnel has been exposed to a strong environmental impact through exhaust gases from traffic, corrosion, and water intrusion. In general, the visual damages are easy to identify and self-explanatory. Figure I-10 displays split and dirty ceramic tiles, which are the main concern of disruption.

Figure I-10. Development of split ceramic tiles (south, 544 m; north, 163 m).

The loose and broken tiles are mainly located on the ceiling of the tunnel (Figures I-10 and I-11).

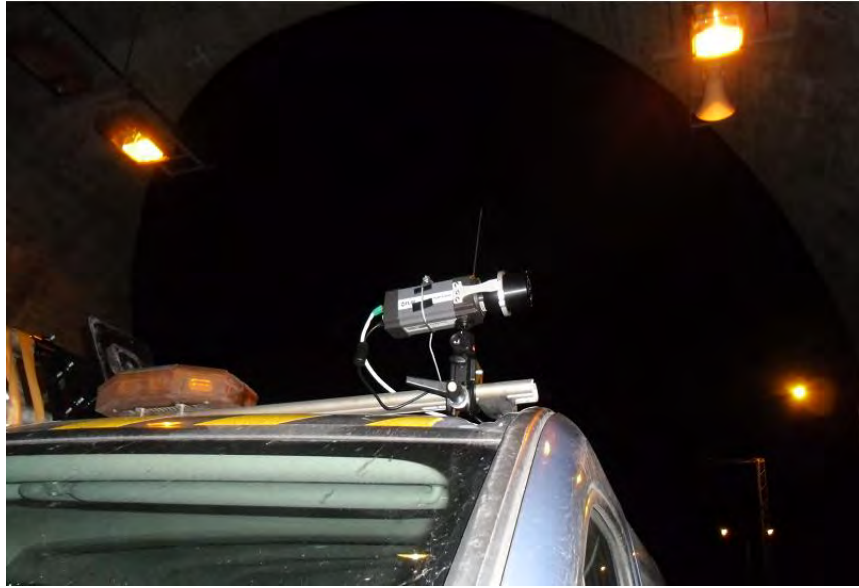
The thermal videos were collected using Road Doctor™ CamLink video equipment by Roadscanners Oy. In addition to the digital thermal videos, normal digital videos were also recorded. All the collected data were linked to the distance information using CamLink's software synchronization file. In the collected thermal video, the resolution was 320 x 240, and thermal videos were collected using a 60 Hz image frame rate. The device manufacturer declares a ± 2 °C or ± 2 percent accuracy for the thermal camera. Figures J-4 and J-5 present examples of FLIR thermal camera mounting systems used on the survey van. The mounting system presented in Figure J-5 was judged to be better because an analysis of the data indicated that it reduced the thermal reflection of the van, which was causing noise in the data.

Figure J-4. Thermal camera installed on the roof of the van in the first measurement.

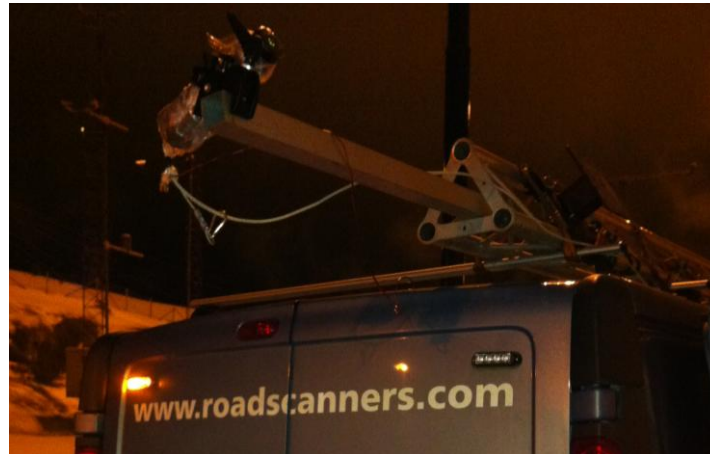
Figure J-5. Thermal camera installed on the end of the boom behind the van.

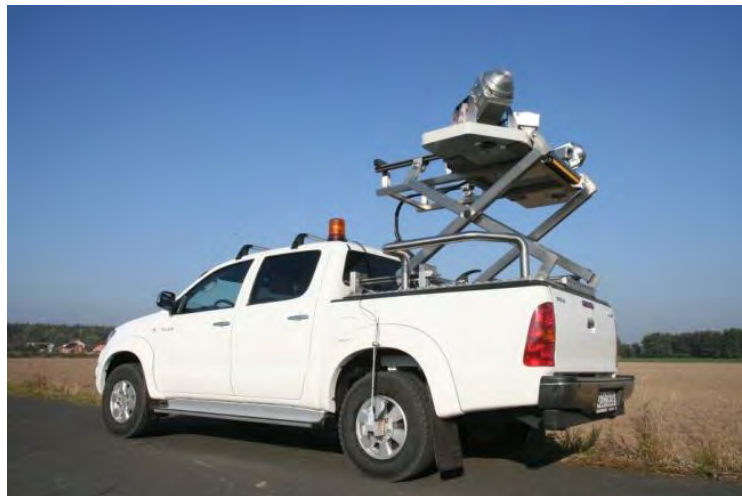
The goal in the laser scanner tunnel tests was to test if the method could provide valuable information concerning the tunnel lining condition and shape. The Category A laser scanner data were collected by GEOVAP Ltd, from the Czech Republic, using their quantum three-dimensional technique based on Lynx laser scanner hardware. The GEOVAP survey vehicle is presented in Figure J-6. Data analysis and all the presentations were made by GEOVAP using their software packages. The Category B laser scanner data were collected by Roadscanners Oy using a model SICK LMS151 laser scanner. The survey van is presented in Figure J-7. The data analysis was made with a new Road Doctor™ Laser Scanner (R LS) module, which is an additional module for the Road Doctor™ Pro software. The module facilitates integrated analysis of the laser scanner data and other survey data in Road Doctor™ Pro software.

Figure J-6. Category A laser scanner survey system used in this research.

When the laser beam angle is known, as in the setups shown above, and beams are sent in different directions from a moving vehicle with a known position, it is possible to make a three-dimensional surface image—a point cloud—of the road and its surroundings. A point cloud can have billions of points with accurate x, y, z coordinates and reflection or remission characteristics. Since all points have coordinates, it is possible to measure distances between points and changes between these distances. This gives extra value to tunnel management tasks, for instance, changes in the position of a tunnel lining after an earthquake. For these high-accuracy x, y, z tasks, Category A laser scanner systems are needed. An example of a point cloud view of the Vuosaari Tunnel mouth area is shown in Figure J-8. The accuracy of the laser scanner survey can be reduced by different factors that affect visibility, such as dust, rain, fog, or snow.

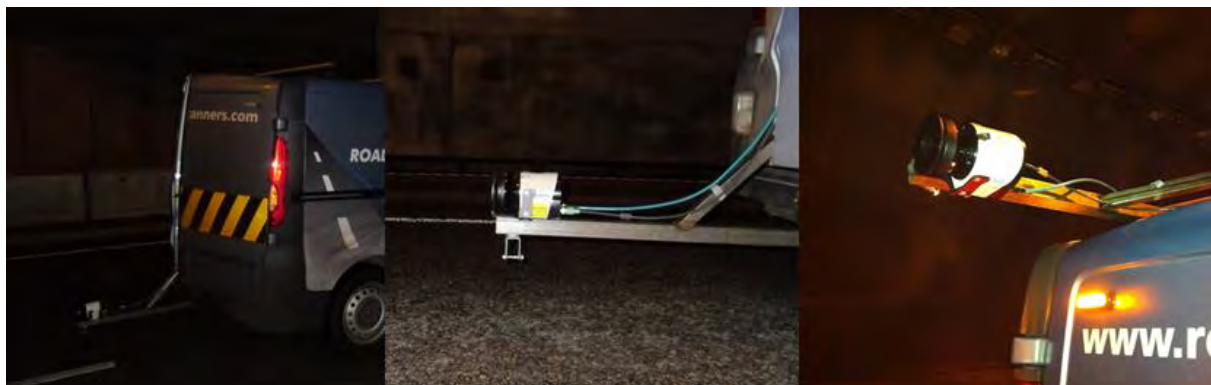
J-7. Category B laser scanner mounting systems used in the trials.

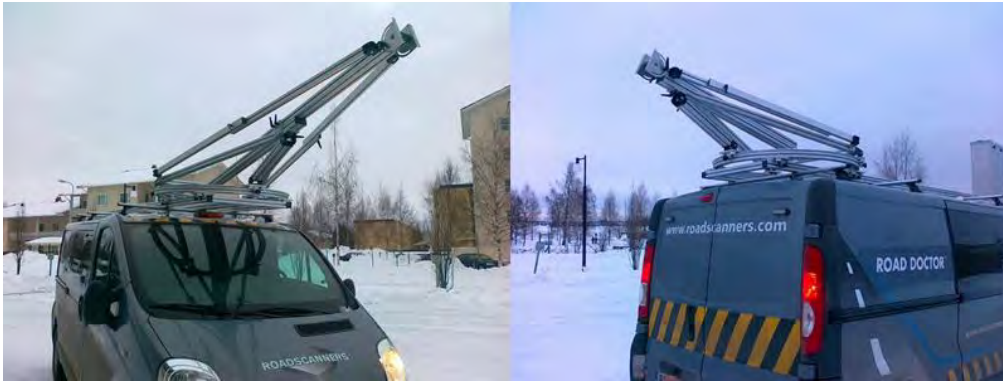
Figure J-17. New Roadscanners van roof-mounted rack system for laser scanner and thermal camera data collection.

For future surveys, Roadscanners has been developing a new rack system for thermal cameras and laser scanners. This new rack system is mounted on a van roof. The rotating rack system can be slid back and forth on the roof. Device angles can be modified to be optimal for different tasks. These rack features make measurement practice easier and thus improve data quality. The rack system is presented in Figure J-17.

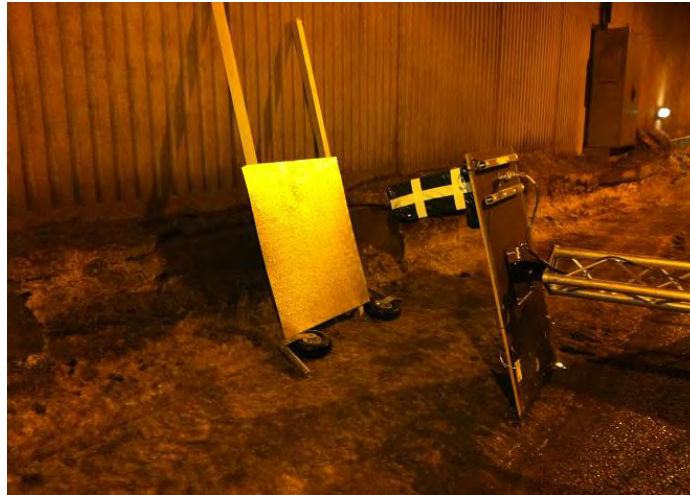
Figure J-32. GPR metal reflection data collection during winter tests in 2011.

In further tests, metal plate reflections were also measured using two other test distances, but the size, 1 m by 1 m, of the metal plate was observed to be too small at distances of 1 and 1.5 m (Figure J-32). The GPR signal did not reflect from the metal as expected, and signal loss was too high. From a distance of 1.0 m, the signal was 20 percent weaker, and from a distance of 1.5 m, it was 50 percent weaker compared to the signal received from the 0.5 m distance.

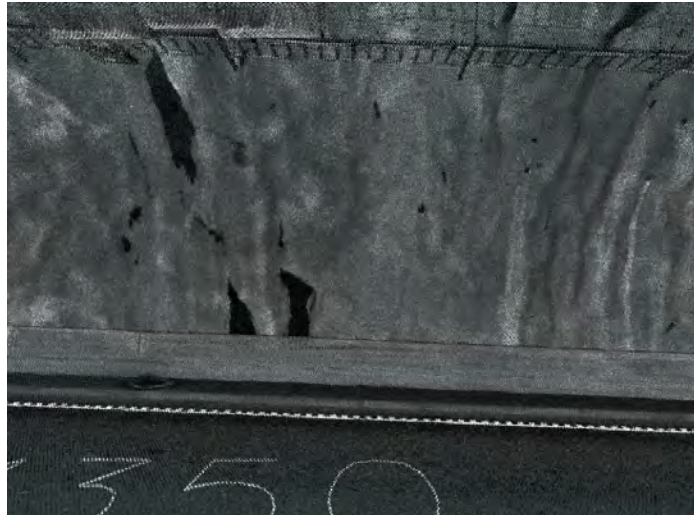
Figure J-39. Category A laser scanner detailed view from the side wall at 1350 m (also see Figure J-38). See the small wet spots on the right side of the figure and white areas beneath them indicating salt.
