SHRP 2 Renewal Project R06G

Mapping Voids, Debonding, Delaminations, Moisture, and Other Defects Behind or Within Tunnel Linings

This final report documents the work conducted under Phase II of Strategic Highway Research Program (SHRP 2) Project R06(G), Mapping Voids, Debonding, Delaminations, Moisture, and Other Defects behind or within Tunnel Linings.

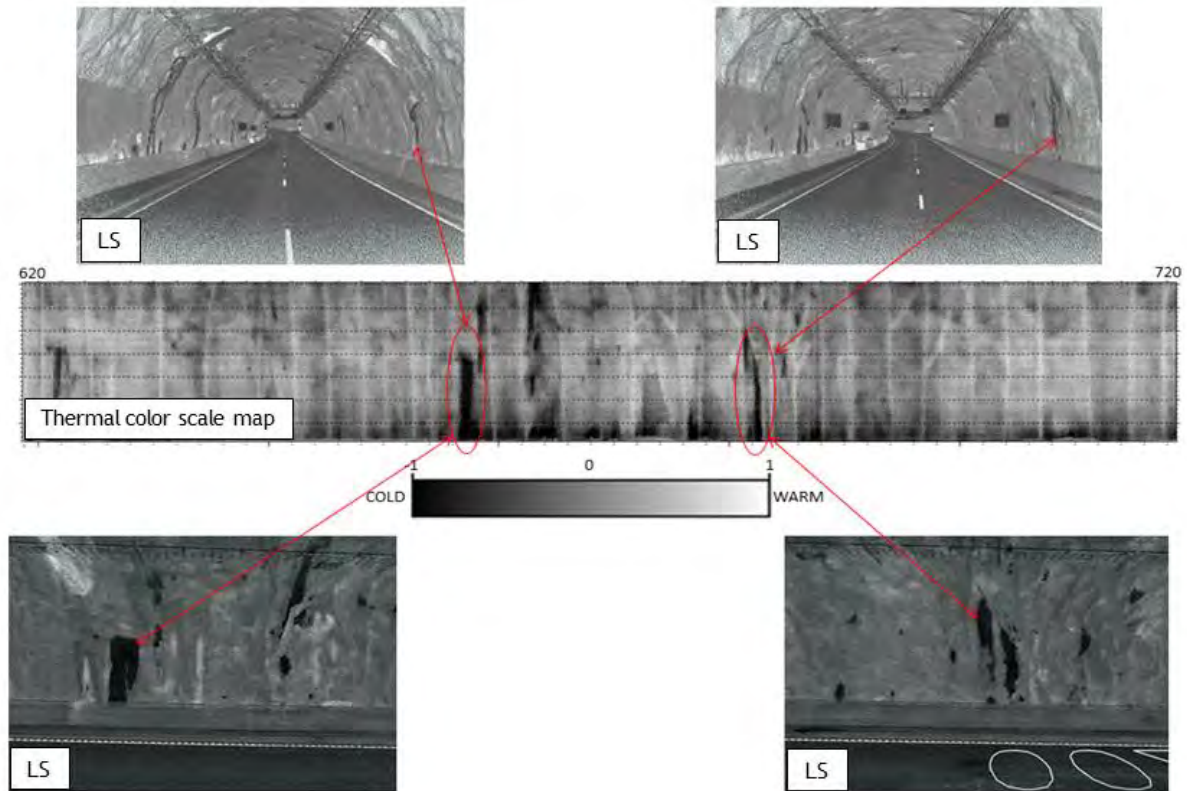
data, these areas with higher water content could be seen as colder anomalies and, with proper color scale, as dark spots. In both data sets, the darkest areas indicated water existence in the tunnel structure. Analysis of multiple points showed that the correlation between these points was really good.

Figure J-43. Thermal color-scale map anomalies' connection to the Category A laser scanning video results on Vuosaari Tunnel right wall.

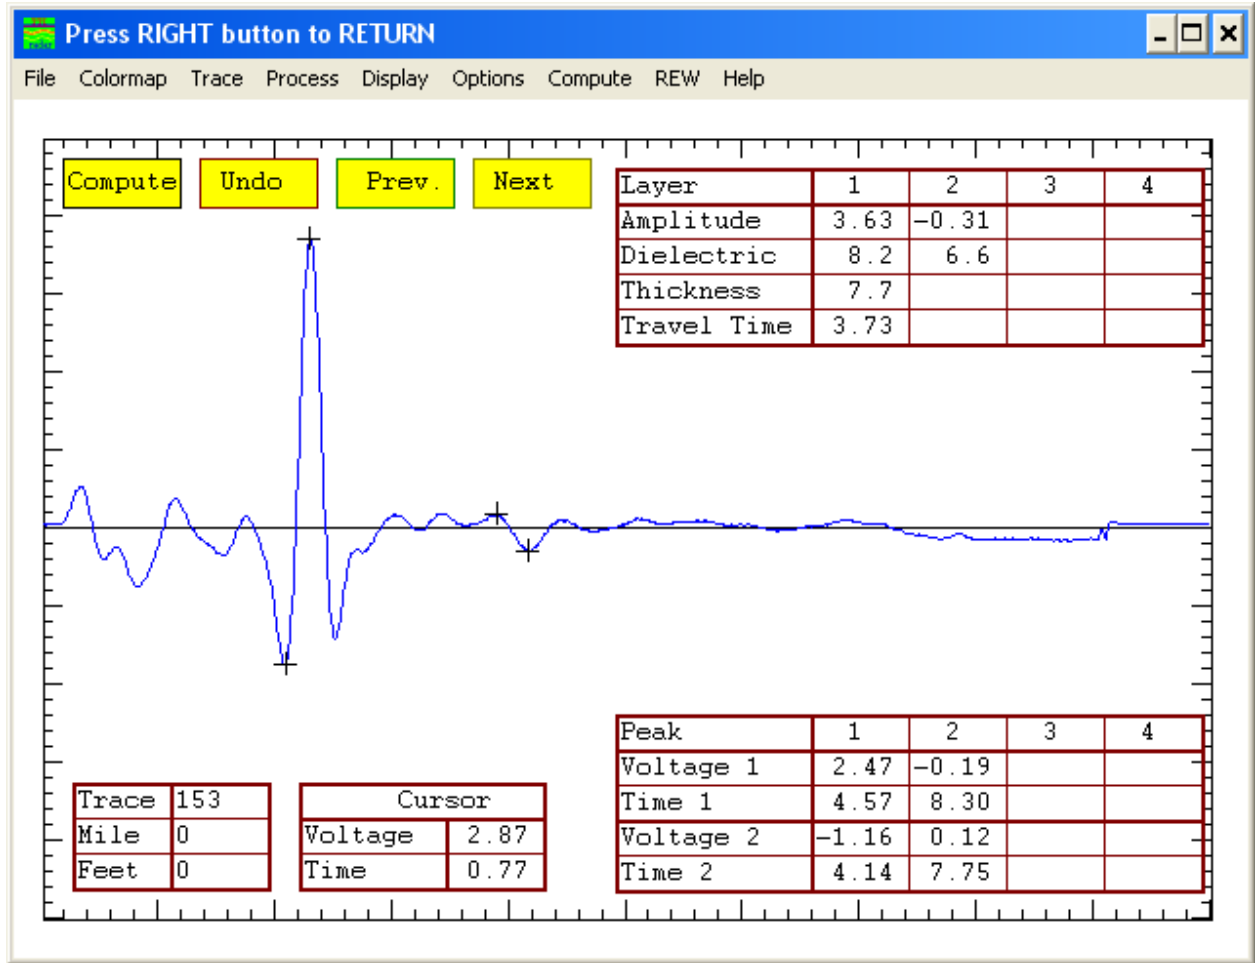
Figure K-2 shows the analysis of the GPR data on specimen D using the COLORMAP program. The program indicated that the depth to the defect was 7.7 inches. The program calculated a surface dielectric of 8.2 and a void dielectric of 6.6. If an air-filled void exists, the calculated dielectric of the void is less than the surface dielectric.

Figure K-2. Air-coupled GPR data on specimen D.

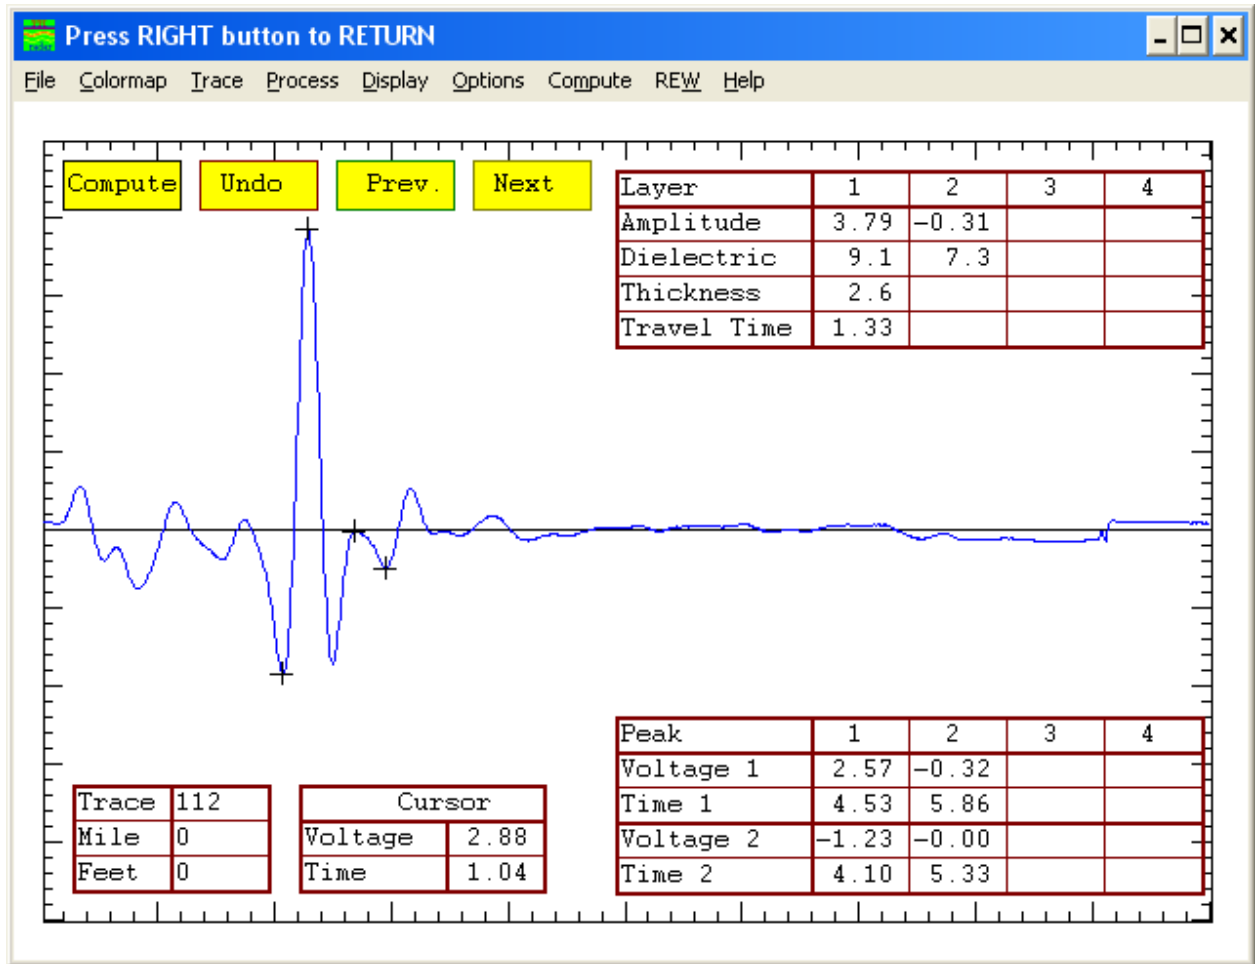
Figure K-3 shows the analysis of the GPR data on specimen F using the COLORMAP program. The program indicated that the depth to the defect was 2.6 inches. The program calculated a surface dielectric of 9.1 and a void dielectric of 7.3. If an air-filled void exists, the calculated dielectric of the void is less than the surface dielectric.

Figure K-3. Air-coupled GPR data on specimen F.

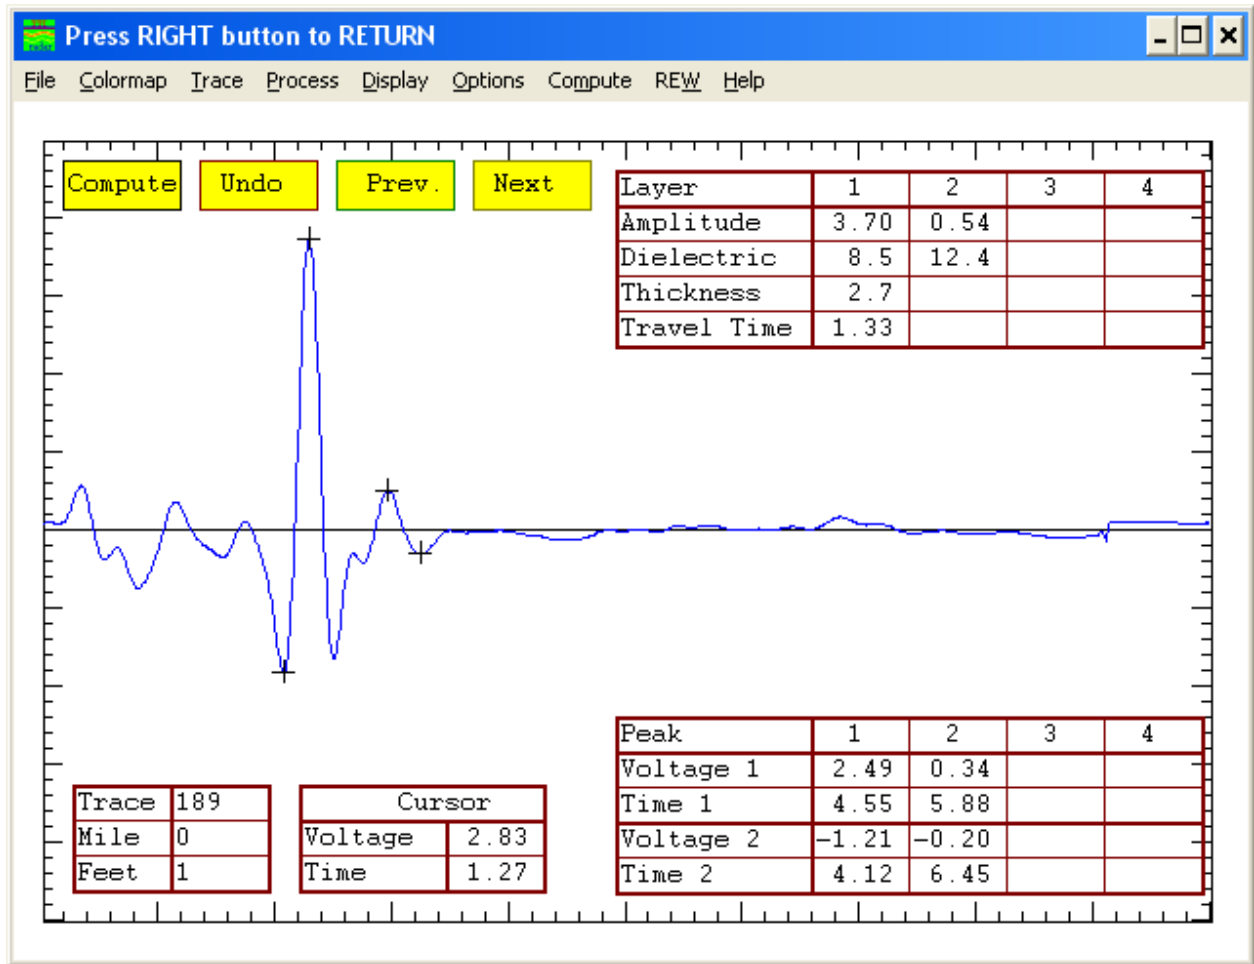
Figure K-4 shows the analysis of the GPR data on specimen G using the COLORMAP program. The program indicated that the depth to the defect was 2.7 inches. The program calculated a surface dielectric of 8.5 and a void dielectric of 12.4. If a water-filled void exists, the calculated dielectric of the void is greater than the surface dielectric.

Figure K-4. Air-coupled GPR data on specimen G.

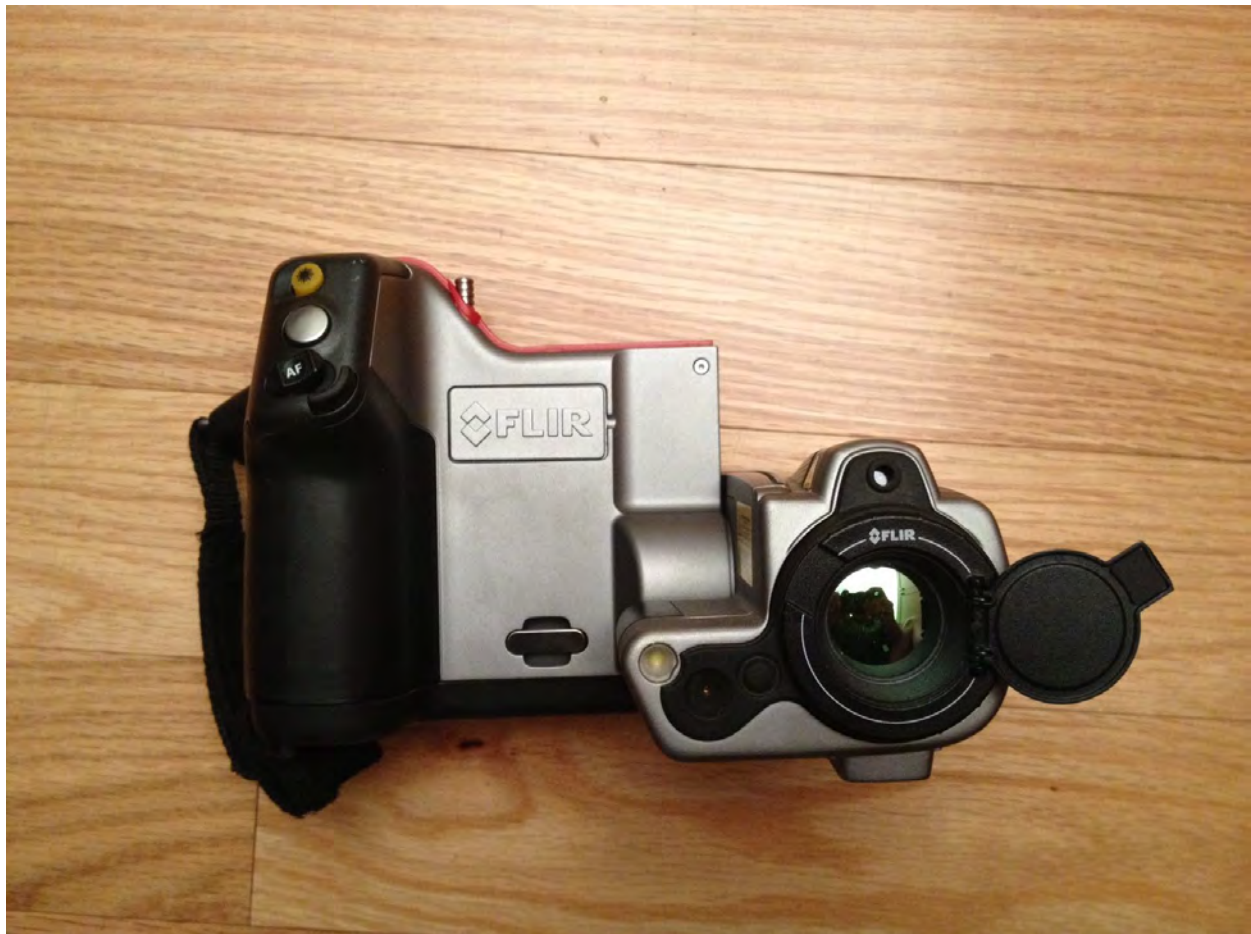
Figure L-1. FLIR T-300 infrared camera.

The Texas A&M Transportation Institute (TTI) purchased a FLIR T-300 handheld infrared camera for this project. The cost of the camera was approximately \$9,000. Figure L-1 is a photo of this camera.

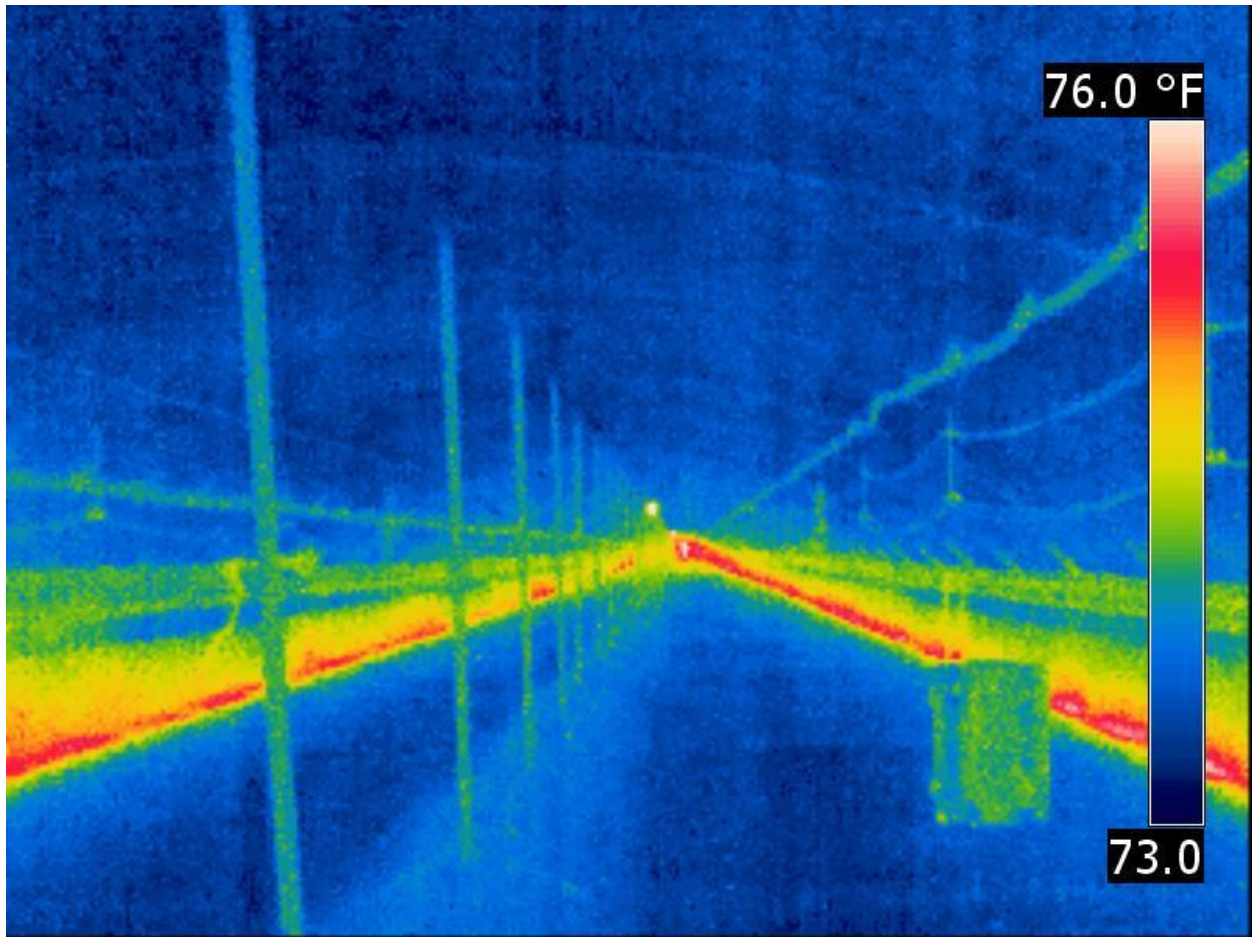
Figure L-5. FLIR T-300 infrared image of the top of the Chesapeake Bay Tunnel. The areas in red are air vents.

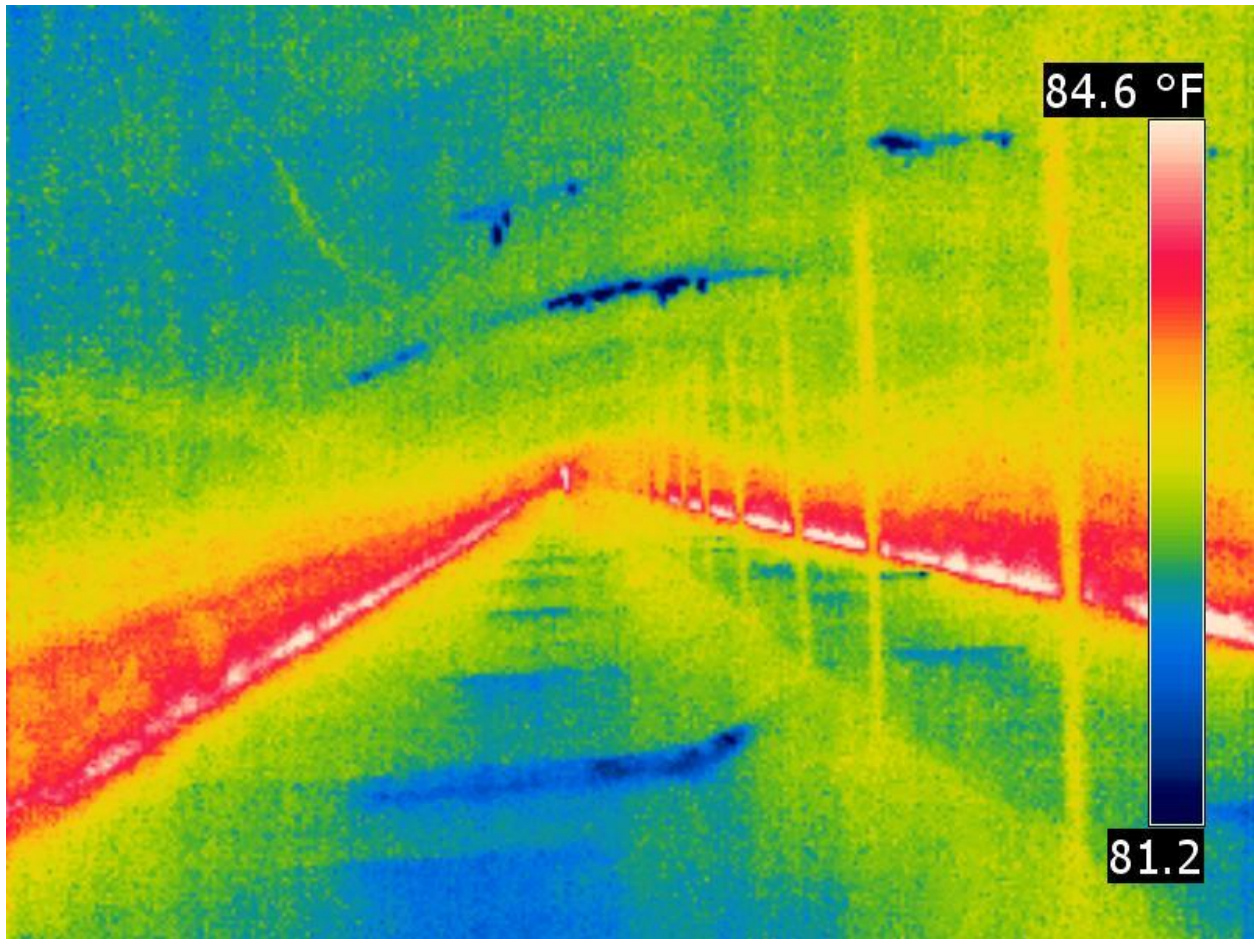
Figure L-7. FLIR T-300 infrared image of the top of the Chesapeake Bay Tunnel. The areas in blue at the top of the tunnel are cracks with moisture.

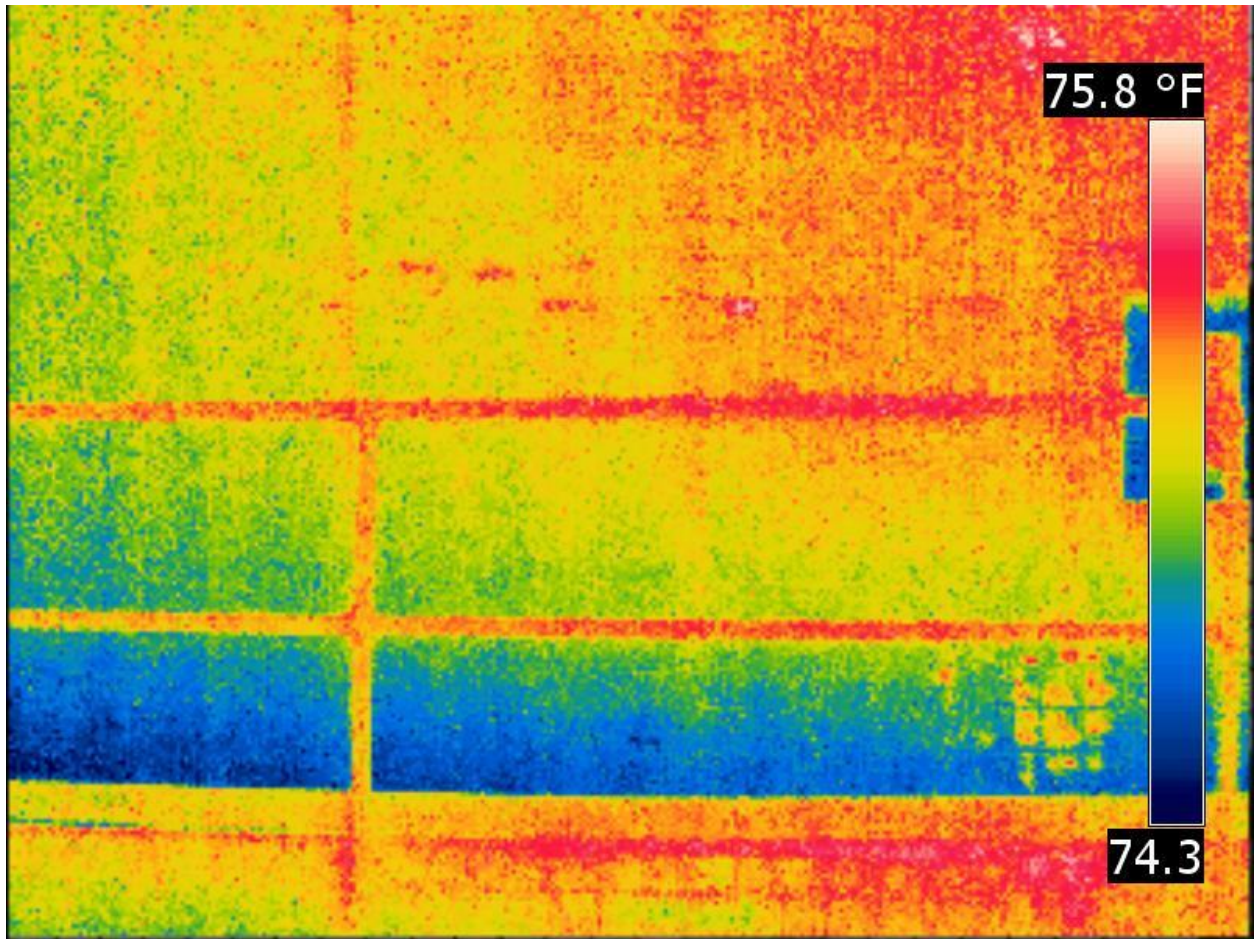
Figure L-8. FLIR T-300 infrared image of the tiled lining in the Chesapeake Bay Tunnel.

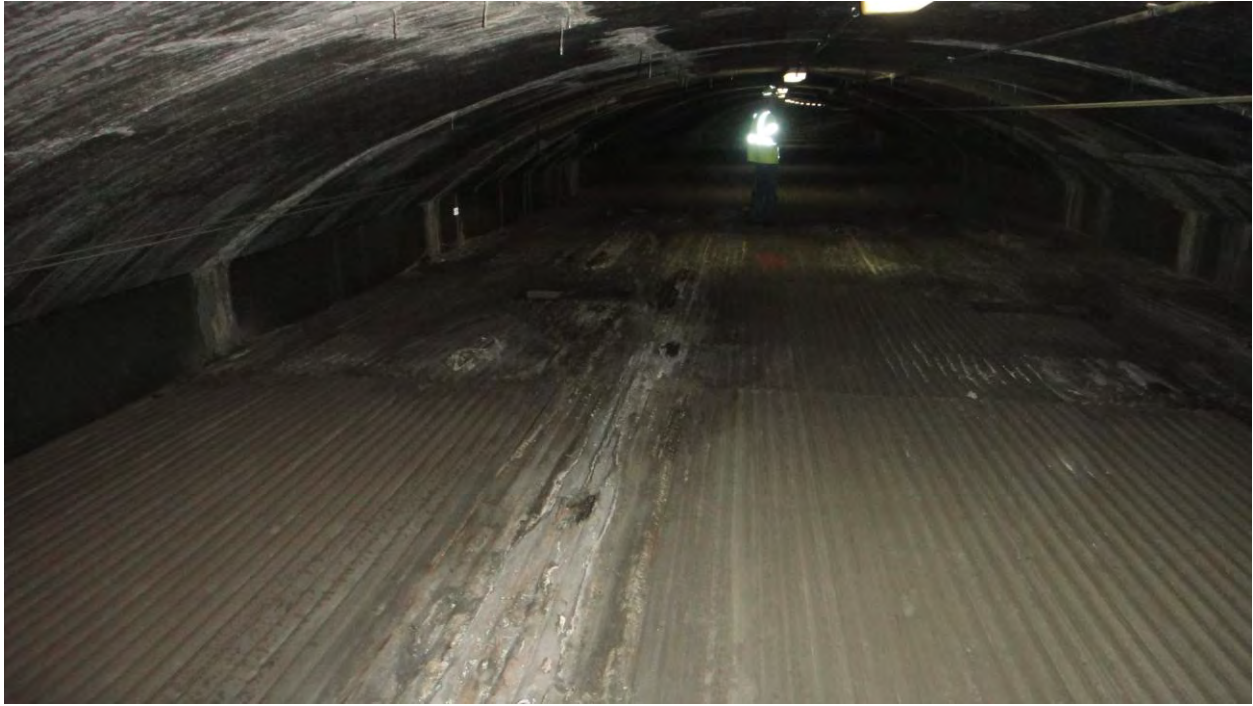
Figure L-25. Visual image of the top of the Hanging Lake Tunnel. Notice the staining around cracks.

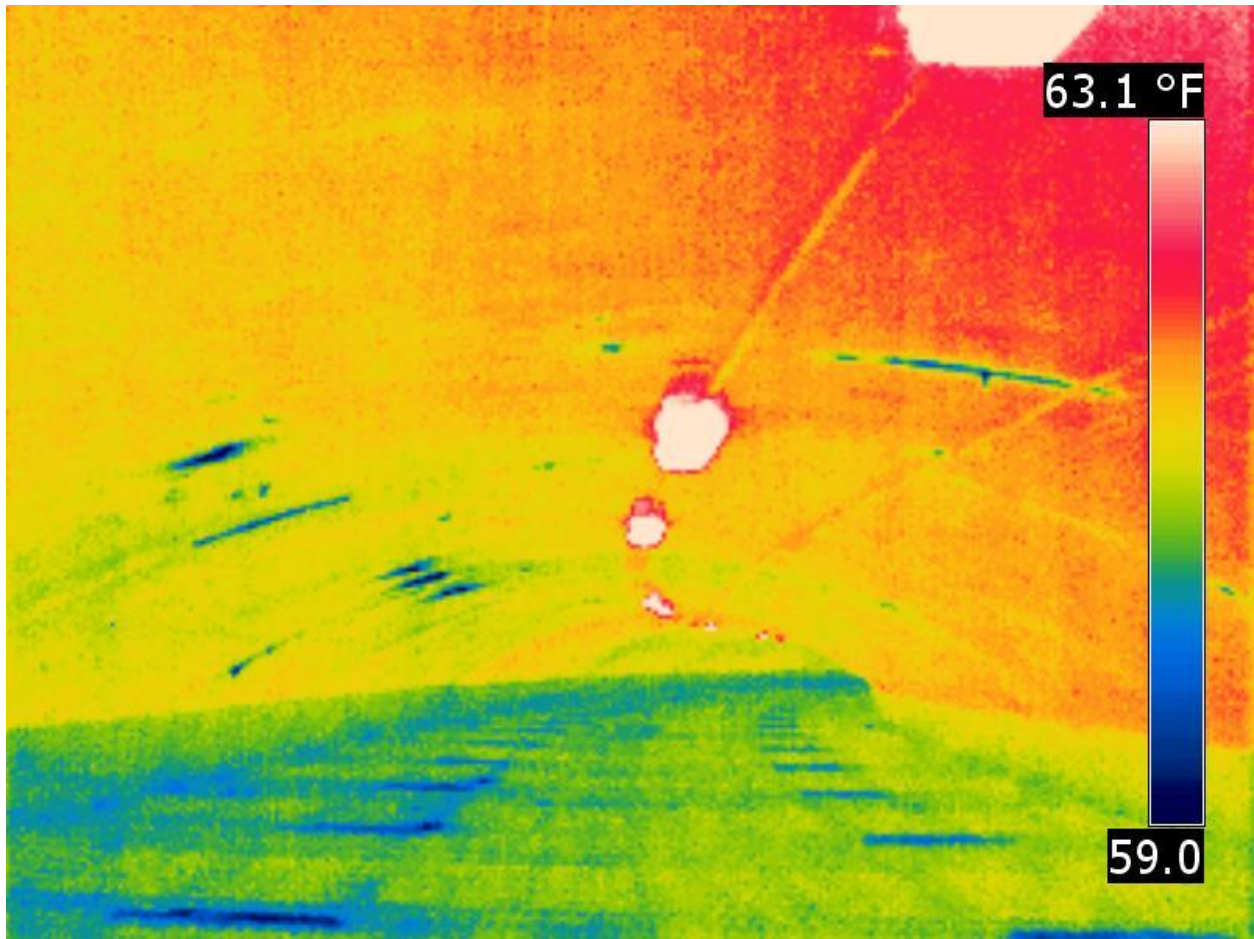
Figure L-26. FLIR T-300 infrared image of the top of the Hanging Lake Tunnel. The areas in blue along the tunnel ceiling are cracks with moisture according to visual observations. The areas in blue at the bottom are air vents.

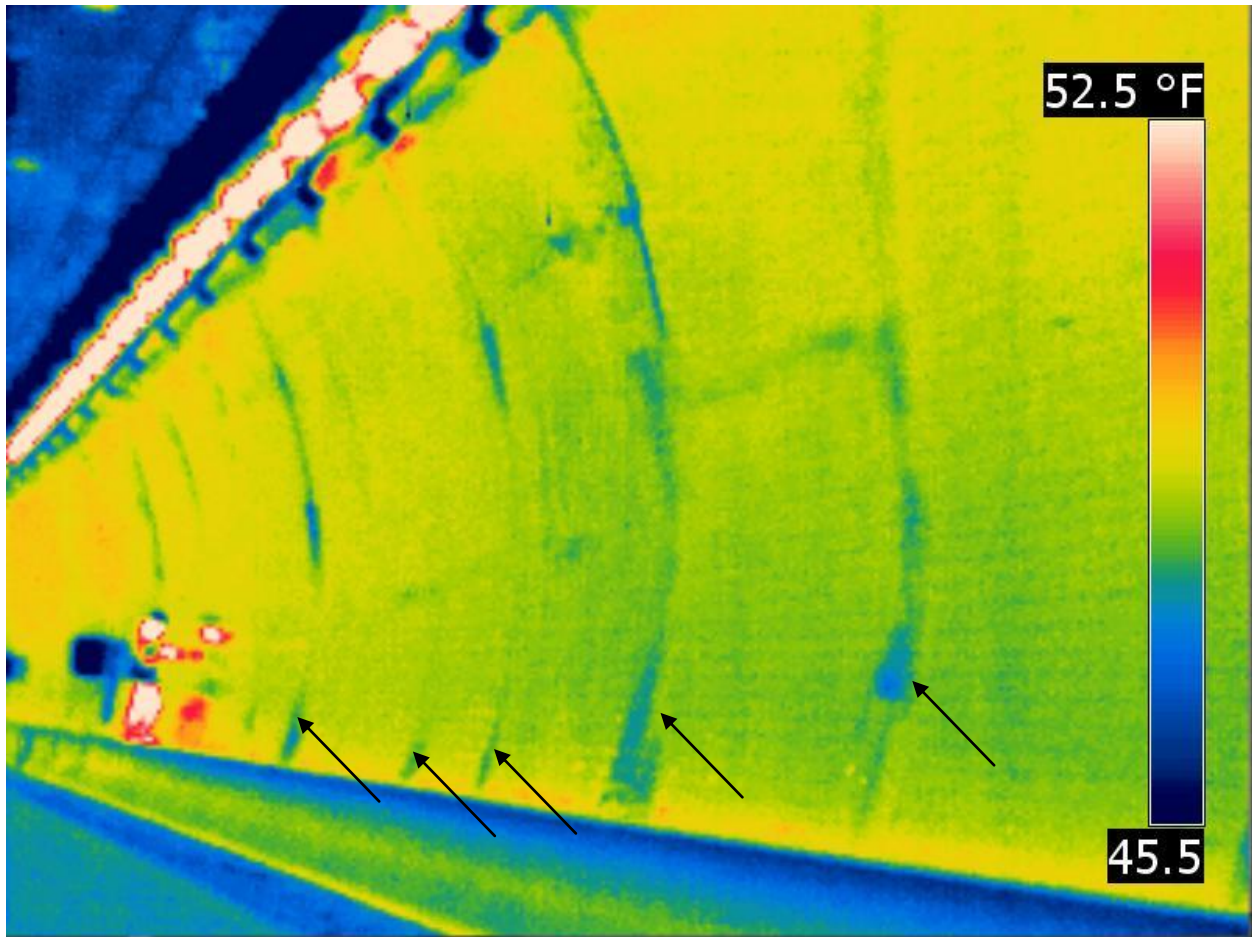
Figure L-27. FLIR T-300 infrared image of the tiled tunnel wall in the roadway section (eastbound). The areas in blue appear to be areas of debonded tiles according to limited sounding tests.

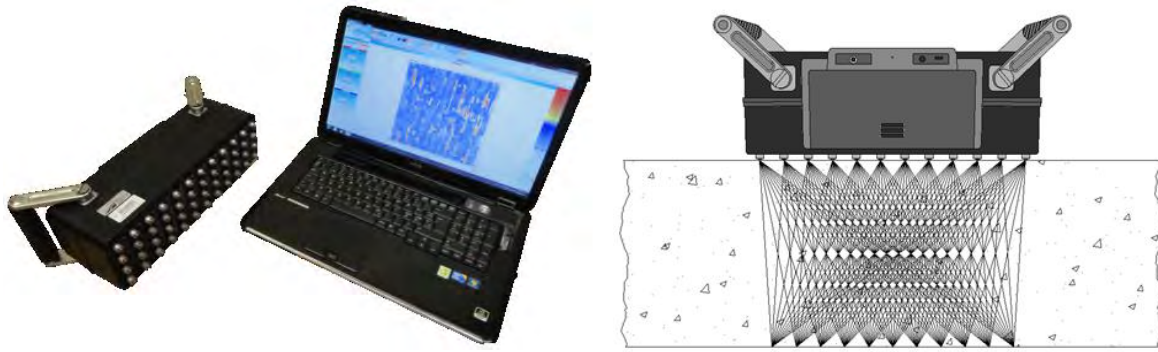
Figure M-1. The A1040 MIRA system (left), and the transmission/reception of acoustic waves (right).

The tomograph, shown in Figure M-1 (left), uses a 4 x 12 grid of mechanically isolated and dampened transducers that can fit the profile of a rough concrete testing surface with a variance of approximately 10 mm (0.4 inch). Each row of four transducers transmits stress waves sequentially while the remaining rows act as receivers. In this manner, there is a wide coverage of shear wave pulses that reflect at internal interfaces where the material impedance changes (Figure M-1, right). With the help of a digitally focused algorithm (an alteration of the Synthetic Aperture Focusing Technique (SAFT; Schickert 1995 and Schickert et al. 2003), a three-dimensional volume is presented with each point of possible reflection in half-space represented by a color scheme, scaled according to reflecting power. This three-dimensional image can also be dissected into each of the three planes representing its volume: the B-scan, C-scan, and D-scan (Figure M-2). The B-scan is an image slice showing the depth of the specimen on the vertical (or z) axis versus the width of the scan on the horizontal (or x) axis. This slice is a plane perpendicular to the scanning surface and parallel to the length of the device. The C-scan is an image slice showing the plan view of the tested area, with the vertical (or y) axis of the scan depicting width parallel to the scanning direction and the horizontal (or x) axis of the scan representing the length perpendicular to the scanning direction. The scanning direction is always defined as the z -axis, as seen in Figure M-2. The D-scan is like the B-scan in that it images a plane perpendicular to the testing surface, but it is oriented parallel to the scanning direction.

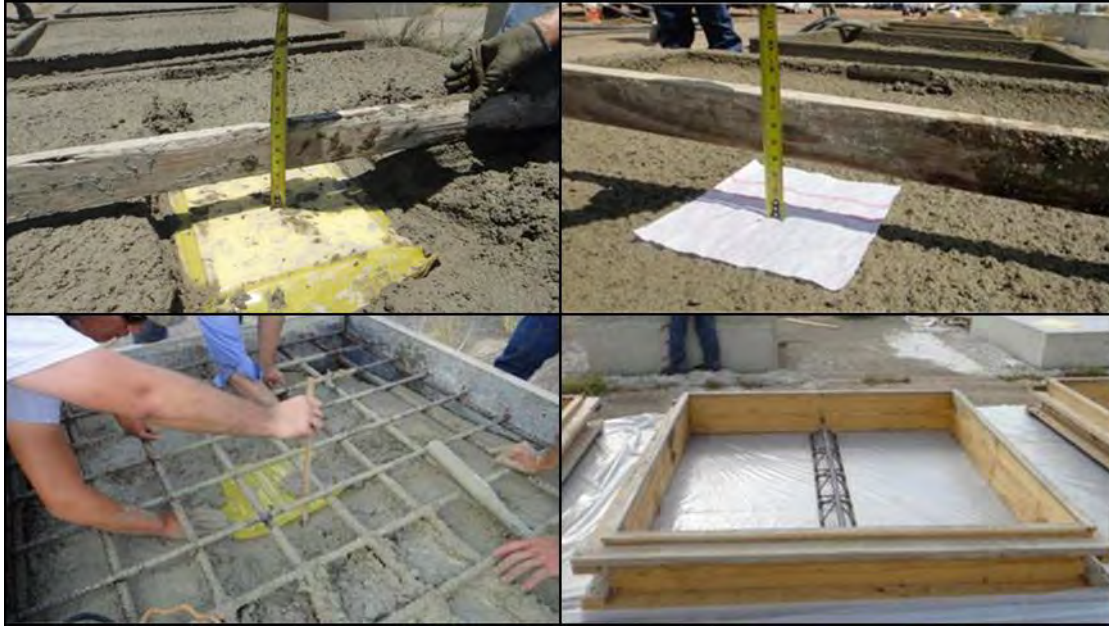
Figure M-3. Construction of slabs with simulated defects.

The simulated delaminations in these slabs were constructed from three types of material. Delaminations were imitated by using 0.05 mm (0.002-inch) plastic square sheets and 0.25 mm (0.01-inch) cloth squares (Figure M-3, top right). Air-filled voids (Figure M-3, top left) were constructed by inserting 13 mm (0.5-inch) thick foam squares in vacuum-sealed plastic bags. Water-filled voids (Figure M-3, bottom left) were constructed in a similar manner by placing water-filled Ziploc bags within vacuum-sealed plastic bags and carefully padding the defect with concrete/shotcrete during construction so as not to puncture the plastic.

Eleven normal-weight concrete slabs and 13 shotcrete slabs were constructed to mock various defects. The concrete slabs were used to mimic typical concrete tunnel linings with and without reinforcing steel. The shotcrete slabs were constructed to mimic applications in which shotcrete is sprayed on as a finished layer, as typically found in tunnel linings. A specially designed lattice girder, also typical in tunnel wall construction, was used as reinforcement in the shotcrete slabs (Figure M-3, bottom right).

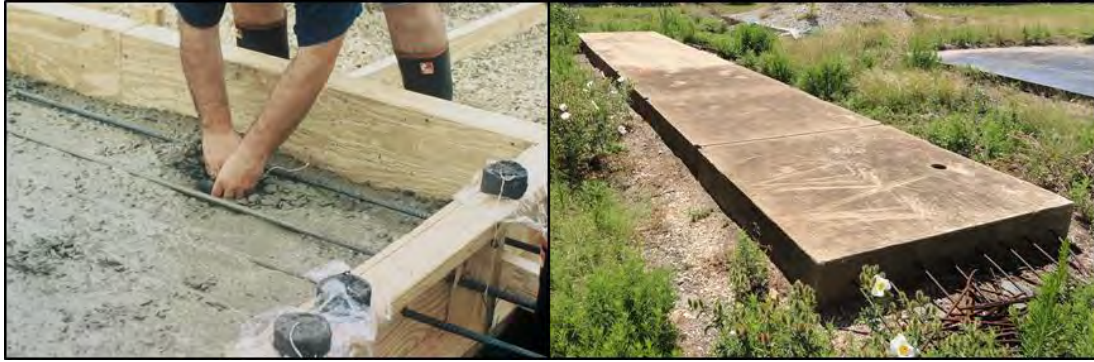
Figure M-7. Clay lump slab construction.

Similar to the concrete and shotcrete slab specimens discussed previously, the simulated specimens with clay lumps were tested using a 50 mm x 150 mm (2 inch x 6 inch) scanning grid. Since the type of discontinuity under inspection was known beforehand, scanning only took place in one direction, although all of these specimens were fully scanned twice to judge repeatability. The scans took place in only one direction because the objects under inspection had a cross-sectional surface area (parallel to the scanning surface) greater than 50 mm (2 inches) in the -scanning direction (more on the topic of device polarity and increment sizes can be found in the Conclusions section). Repeatability was necessary in order to confirm the detection of each lump. In both sets of measurements taken for repeatability, the clay lumps found in all slabs were precisely in the same location, indicating remarkable repeatability.

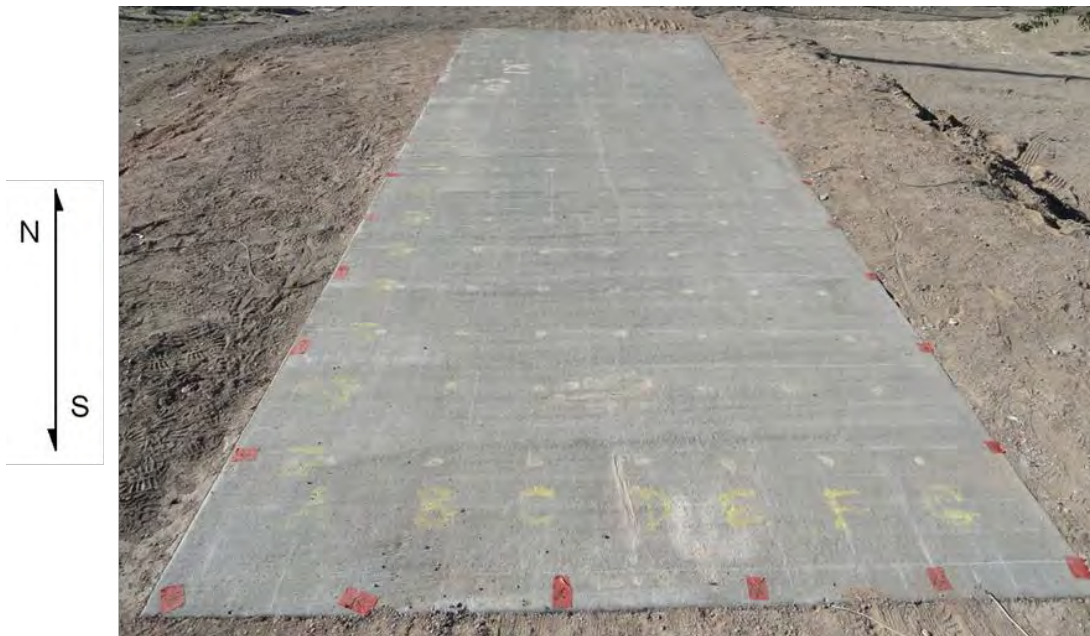
In constructing the deck, 27.6 MPa (4000 psi) concrete was used, and two layers of No. 5 longitudinal and transverse steel were placed at 254 mm and 203 mm (10 inches and 8 inches) on center, respectively, at centroid depths of 83 mm and 184 mm (3.25 inches and 7.25 inches) from the surface. The 28-day strength and modulus exceeded 34.5 MPa (5000 psi) and 27.6 MPa (4000 ksi), respectively. A 0.25 mm (0.01-inch) polyester fabric was used to mock an ultra-thin horizontal delamination. The vertical cracks were constructed from both thick and thin cardboard sheets. The No. 5 corroded steel mats were electrically merged and attached to the normal reinforcement. The corrosion depth was measured to be 1-2 mm (0.04-0.08 inch) prior to pouring the concrete.

Figure M-10. Simulated bridge deck at UTEP in El Paso, Texas.

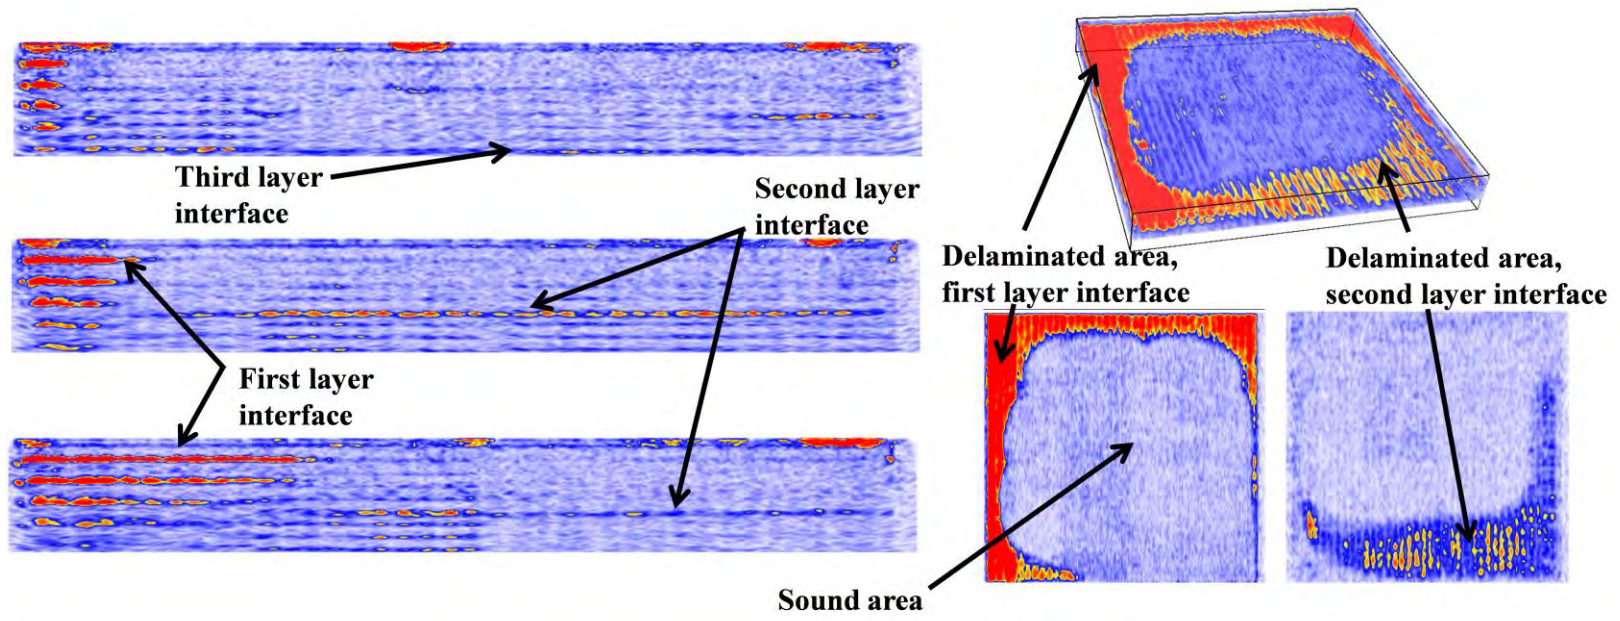
Figure M-14. Second segment tested at IAH: B-scans (left), Volume-scan (top right), and C-scans (bottom right).

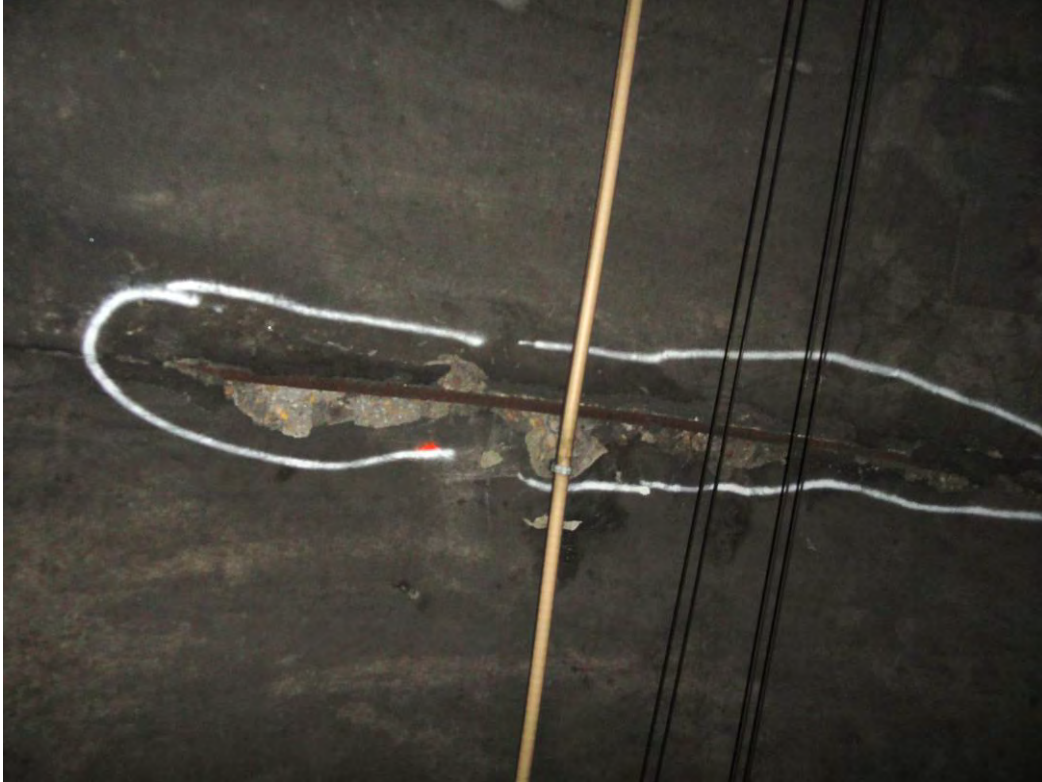
Figure M-47. Typical spalling and corrosion.

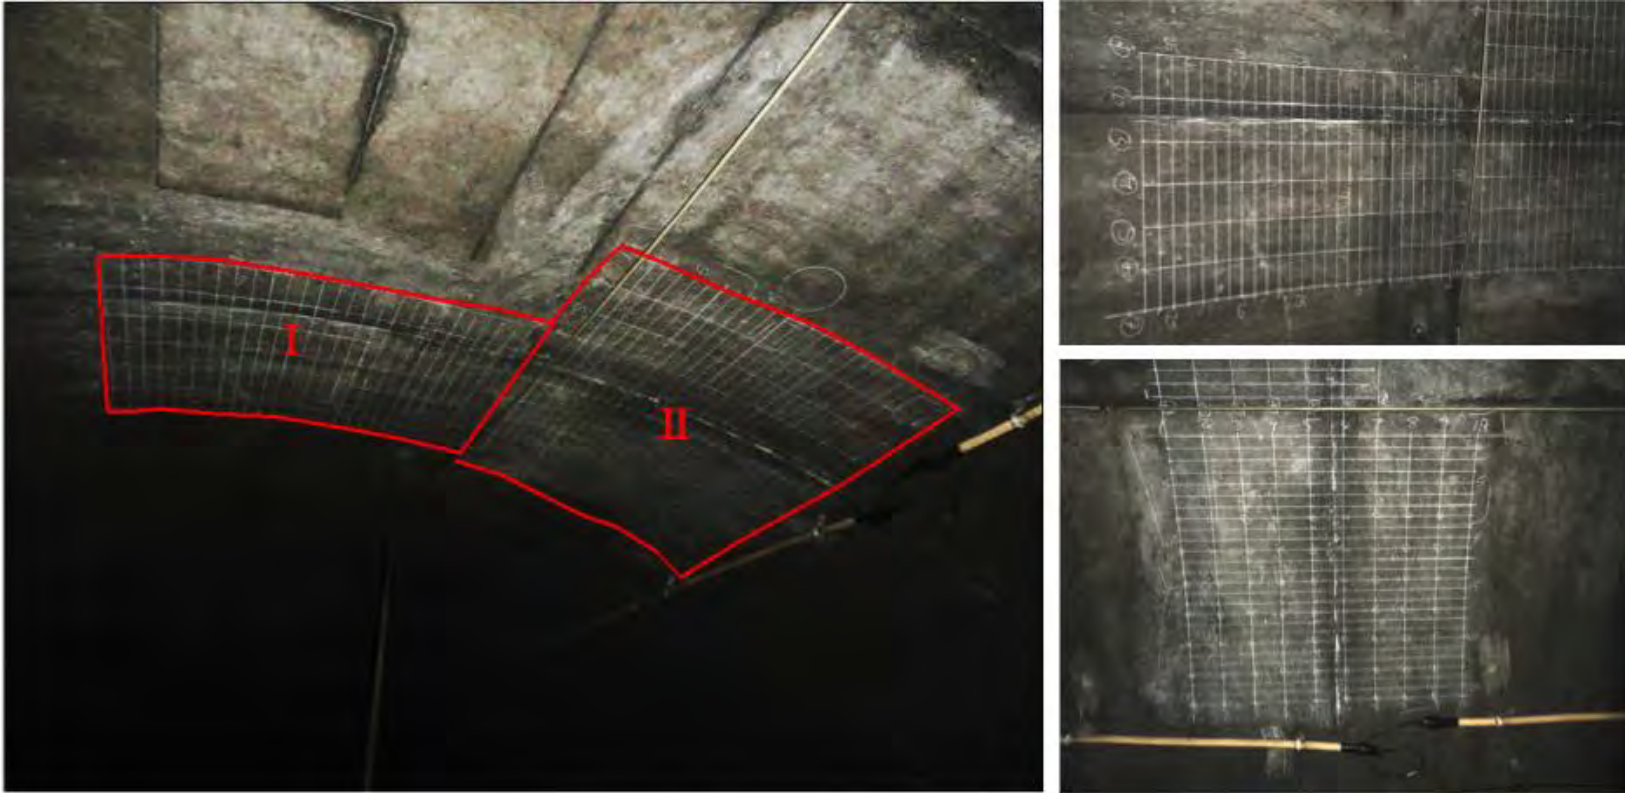
Figure M-51. Images depicting Region I (top right) and Region II (bottom right).

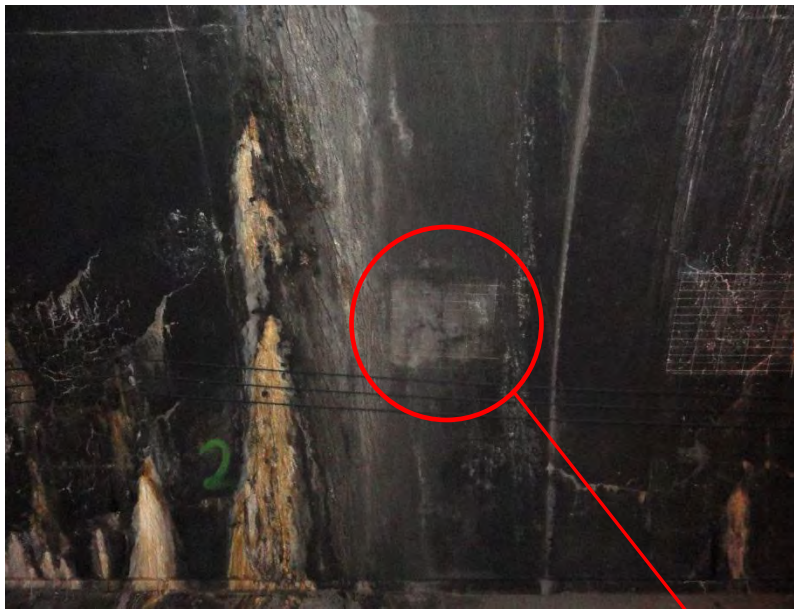
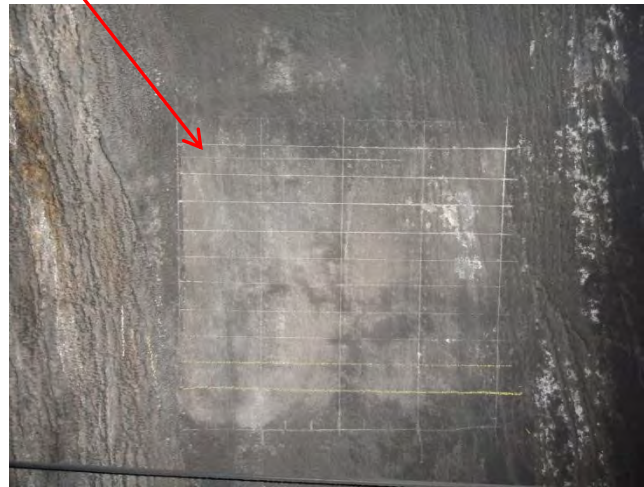
Figure N-1. Images of test site ET 10.4-1, 2.

Defects	Notes	Reinf. Detail	
No significant defect noticed, except for strip of area (~9.4" wide, 16.2" deep) consistently found in other maps. Possibly structural steel reinforcement.	Backsurface not discernible. Area tested as representative of sound concrete.	Hoop reinf: ~4.2" deep @ ~9.9" on center. Longitudinal reinf: below hoop reinforcement.	$V_{\text{shear}} = 2751 \text{ m/s}$ X-step: 150 mm Y-step: 50 mm Max Depth: 1000 mm Frequency: 50 kHz
			Dillon, CO Eisenhower Tunnel ET 10.4-1, 2 Segment 8 TAMU/TII 10/2011

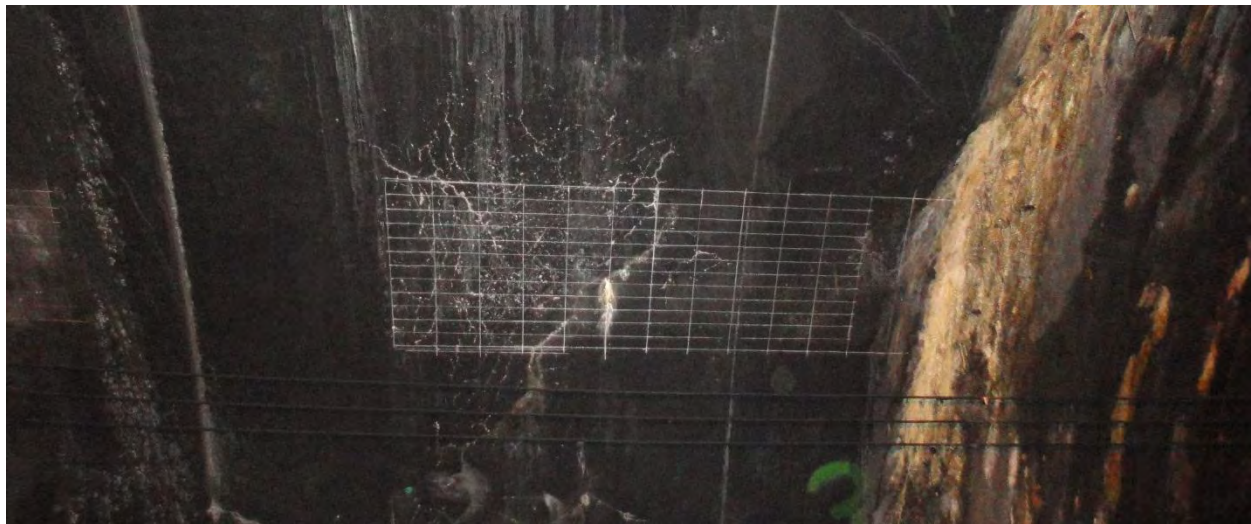
Figure N-3. Image of test site 10.4-3.

Defects	Notes	Reinf. Detail	
<p>No significant defect noticed, except for strip of area (~12.2" wide, 17.2" deep) consistently found in other maps. Possibly steel structural reinforcement.</p>	<p>Backsurface not discernible. Area tested because of surface cracking and crazing, nearby stalactite formation. Could not test over stalactite crack due to obtrusions.</p>	<p>Hoop reinf: ~3.7"-5.1" deep @ ~10.1" on center. Longitudinal reinf: below hoop reinforcement.</p>	<p>$V_{\text{shear}} = 2751 \text{ m/s}$ X-step: 150 mm Y-step: 50 mm Max Depth: 750 mm Frequency: 50 kHz Dillon, CO Eisenhower Tunnel ET 10.4-3 Segment 8 TAMU/TII 10/2011</p>

Defects	Notes	Reinf. Detail	$V_{\text{shear}} = 2751 \text{ m/s}$ X-step: 150 mm Y-step: 50 mm Max Depth: 750 mm Frequency: 50 kHz Dillon, CO Eisenhower Tunnel ET 10.4-3 Segment 8 TAMU/TII 10/2011
No significant defect noticed, except for strip of area (~12.2" wide, 17.2" deep) consistently found in other maps. Possibly steel structural reinforcement.	Backsurface not discernible. Area tested because of surface cracking and crazing, nearby stalactite formation. Could not test over stalactite crack due to obtrusions.	Hoop reinf: ~3.7"-5.1" deep @ ~10.1" on center. Longitudinal reinf: below hoop reinforcement.

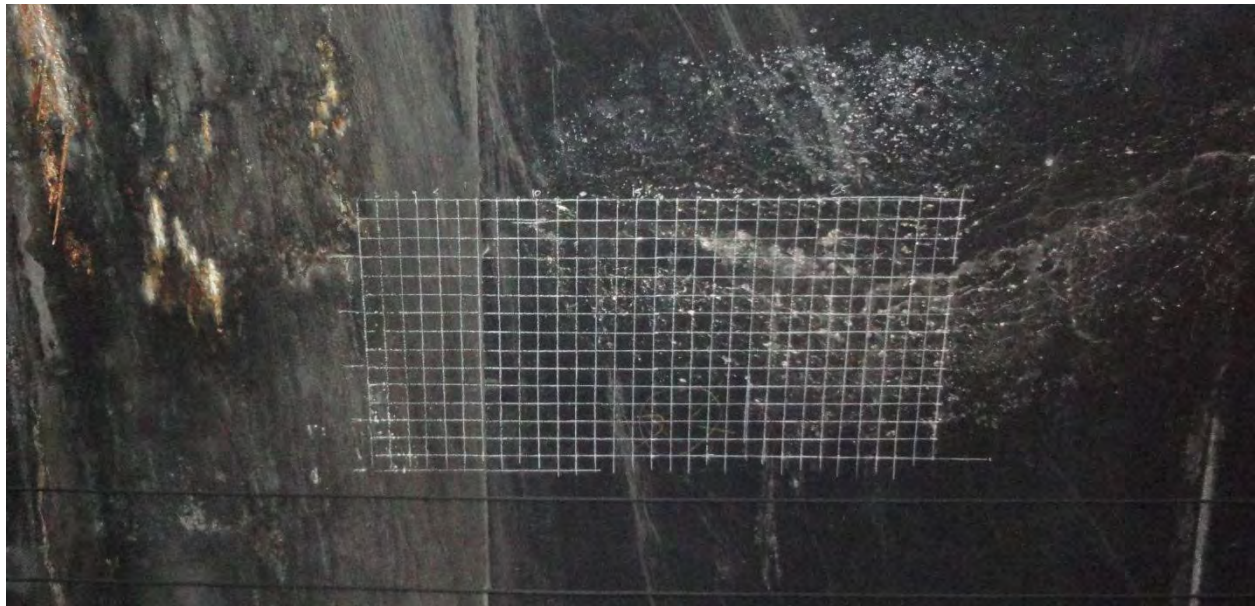
Figure N-5. Image of test site ET 10.4-4, 5.

Defects	Notes	Reinf. Detail	$V_{\text{shear}} = 2751 \text{ m/s}$ X-step: 150 mm Y-step: 50 mm Max Depth: 750 mm Frequency: 50 kHz
No significant defect noticed, except for strip of area (~13.5" wide, 16.1" deep) consistently found in other maps. Possibly steel structural reinforcement.	Backsurface not discernible. Area tested because of surface cracking and crazing and nearby joint.	Hoop reinf: ~4.1" deep @ ~10.1" on center. Longitudinal reinf: below hoop reinforcement.	Dillon, CO Eisenhower Tunnel ET 10.4-4, 5 Segment 10 TAMU/TII 10/2011

Defects	Notes	Reinf. Detail	$V_{\text{shear}} = 2751 \text{ m/s}$ X-step: 150 mm Y-step: 50 mm Max Depth: 750 mm Frequency: 50 kHz Dillon, CO Eisenhower Tunnel ET 10.4-4, 5 Segment 10 TAMU/TII 10/2011
No significant defect noticed, except for strip of area (~13.5" wide, 16.1" deep) consistently found in other maps. Possibly steel structural reinforcement.	Backsurface not discernible. Area tested because of surface cracking and crazing and nearby joint.	Hoop reinf: ~4.1" deep @ ~10.1" on center. Longitudinal reinf: below hoop reinforcement.
