SHRP 2 Renewal Project R06G

Mapping Voids, Debonding, Delaminations, Moisture, and Other Defects Behind or Within Tunnel Linings

This final report documents the work conducted under Phase II of Strategic Highway Research Program (SHRP 2) Project R06(G), Mapping Voids, Debonding, Delaminations, Moisture, and Other Defects behind or within Tunnel Linings.

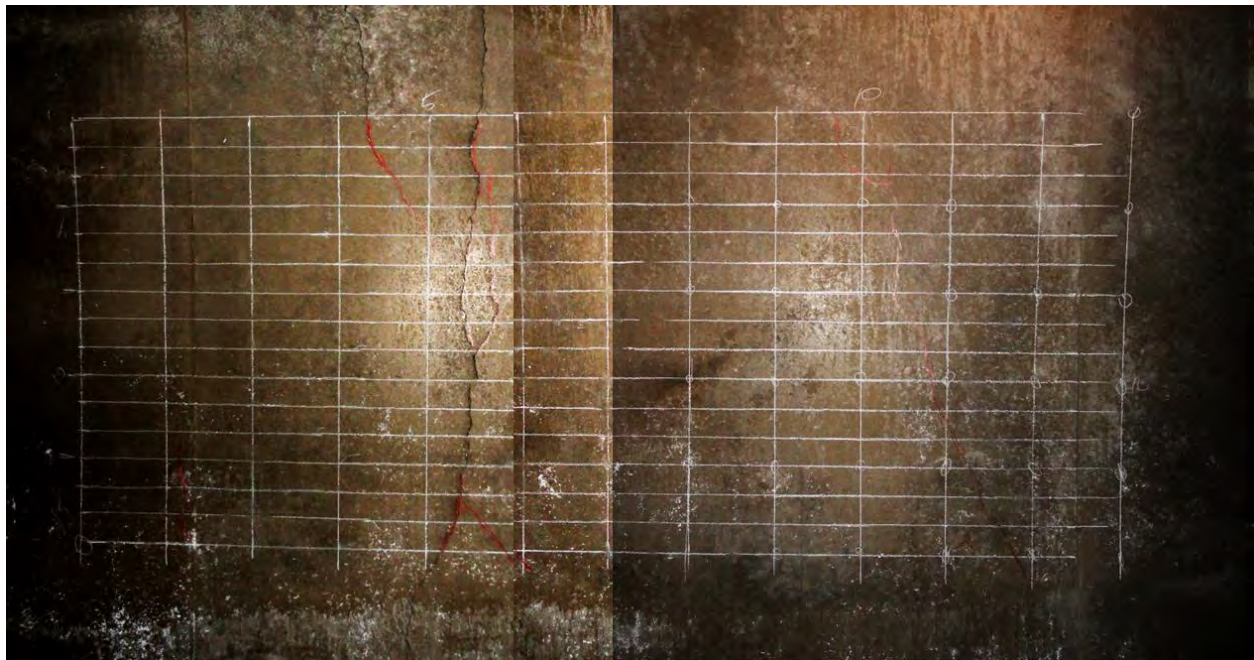
Figure N-7. Image of test site HLT 10.5-1, 2, 3.

Defects	Notes	Reinf. Detail	
Apparent delamination extending 12.3" deep, originating from surface crack; possibly connecting to another crack located approximately 35" to the right of surface crack	Backsurface possibly seen at 27.6" in depth. Severe cracking. Area also tested by BAM.	Hoop reinf: 4.6"- 6.2" deep @ 15.7" on center. Longitudinal reinf: above and possibly below hoop reinforcement @ 14.1" on center.	Vshear = 2159 m/s X-step: 150 mm Y-step: 50 mm Max Depth: 2500 mm Frequency: 50 kHz
			Glenwood Springs, CO Hanging Lake Tunnel HLT 10.5-1, 2, 3 Segment 57 + 3.4 TAMU/TII 10/2011

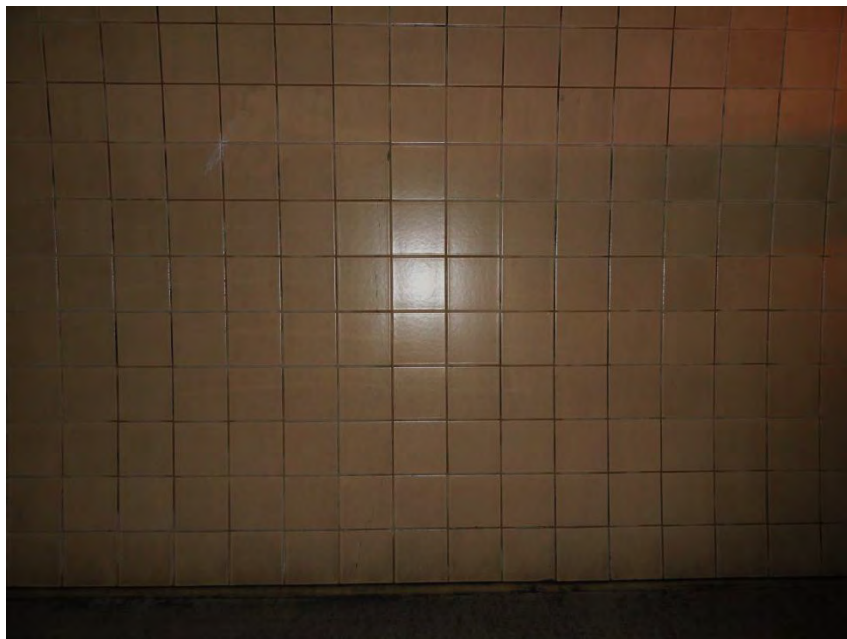
Figure N-17. Images of test site HLT 10.5-13.

Defects	Notes	Reinf. Detail	Vshear = 2159 m/s X-step: 150 mm Y-step: 50 mm Max Depth: 1000 mm Frequency: 50 kHz
No significant defect noticed.	Backsurface not discernible. Area tested on surface of tile. Hair-line crack present.	Hoop reinf: ~5.1" deep @ ~16.3" on center. Longitudinal reinf: below and possible above hoop reinforcement @ ~14.0" on center.	Glenwood Springs, CO Hanging Lake Tunnel HLT 10.5-13 Interior Tile Lining TAMU/TII 10/2011

Defects	Notes	Reinf. Detail	
No significant defect noticed.	Backsurface not discernible. Area tested on surface of tile. Hair-line crack present.	Hoop reinf: ~5.1" deep @ ~16.3" on center. Longitudinal reinf: below and possible above hoop reinforcement @ ~14.0" on center.	Vshear = 2159 m/s X-step: 150 mm Y-step: 50 mm Max Depth: 1000 mm Frequency: 50 kHz
			Glenwood Springs, CO Hanging Lake Tunnel HLT 10.5-13 Interior Tile Lining TAMU/TII 10/2011

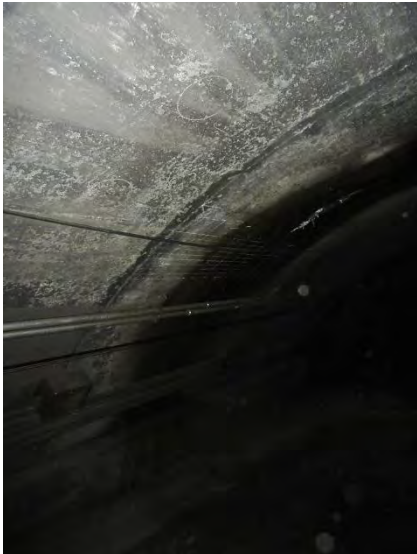
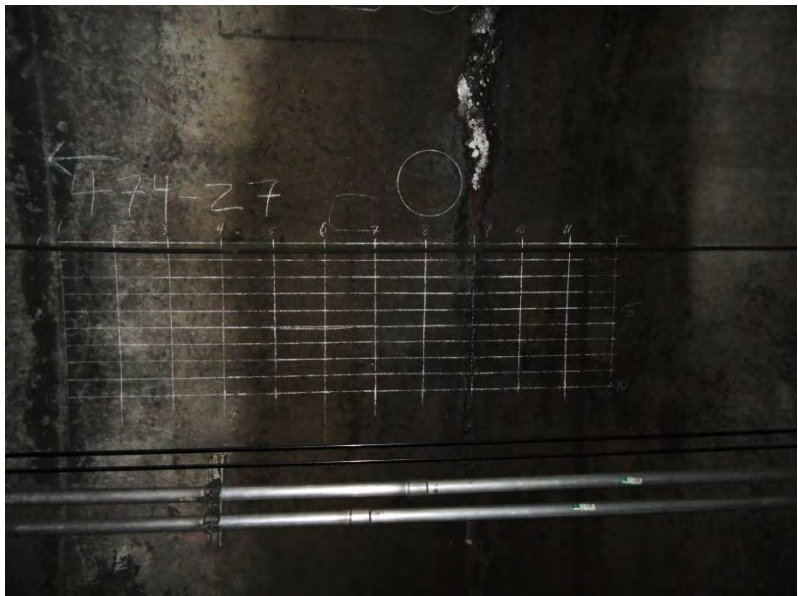
Figure N-23. Images of test site CBBT 10.11-5.

Defects	Notes	Reinf. Detail	
Significant shallow defects, such as shallow cracks (~9" deep) and possibly shallow delaminations (~2" deep), which seem to produce the ringing.	Backsurface at ~24.1" deep. Area tested because of live crack. Significant ringing may suggest debonding of longitudinal reinforcement.	Hoop reinf: ~2.0"-2.6" deep @ ~12.0" on center. Longitudinal reinf: below hoop reinforcement.	Vshear = 2710 m/s X-step: 150 mm Y-step: 50 mm Max Depth: 1000 mm Frequency: 50 kHz
			Norfolk, VA Chesapeake Tunnel CBBT 10.11-5 Sta. 474+27 TAMU/TII 10/2011

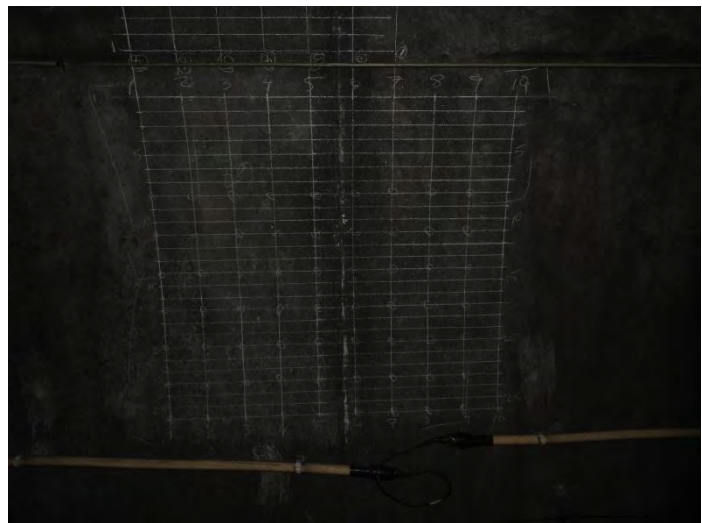
Figure N-25. Images of test site CBBT 10.11-7, 8.

Defects	Notes	Reinf. Detail	
Hammer tapping revealed hollow region as shown by shallow reflective region in the C- and B-scans. Significant cupped-shaped delaminations as deep as 19.2"	Backsurface at 24.1"-26.0" deep. Area tested because of high dielectric reading from GPR scan. No significant visual distress noticeable, but hammer sounding revealed shallow delamination in Region II.	Hoop reinf: ~2.2" deep @ ~12.1" on center. Longitudinal reinf: below hoop reinforcement @ 16.2" on center.	Vshear = 2710 m/s X-step: 150 mm Y-step: 50 mm Max Depth: 1000 mm Frequency: 50 kHz
			Norfolk, VA Chesapeake Tunnel CBBT 10.11-7, 8 (Region II) Sta. 486+67 TAMU/TII 10/2011

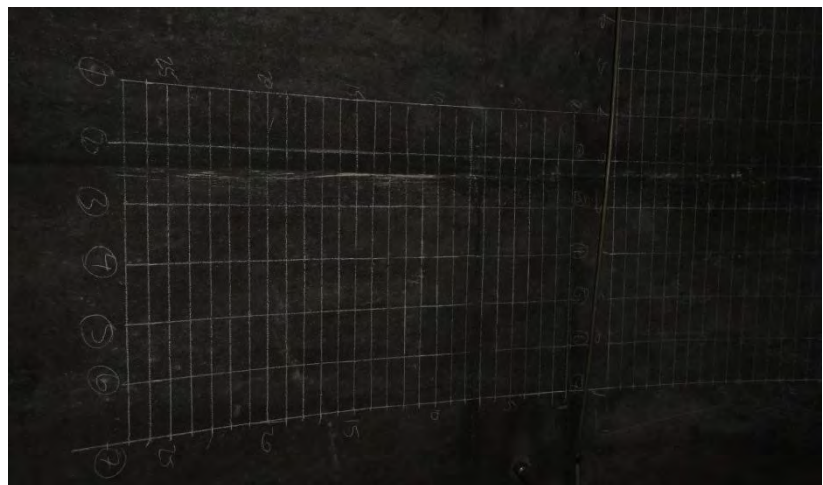
Figure N-27. Images of test site CBBT 10.11-9.

Defects	Notes	Reinf. Detail	
Significant cracks up to 8.6" deep.	Backsurface at 24.3"-26.0" deep. Area tested because of high dielectric reading from GPR scan. No significant visual distress noticeable.	Hoop reinf: ~2.0"-3.0" deep @ ~12.2" on center. Longitudinal reinf: below hoop reinforcement @ 19.8" on center.	Vshear = 2710 m/s X-step: 150 mm Y-step: 50 mm Max Depth: 1000 mm Frequency: 50 kHz
			Norfolk, VA Chesapeake Tunnel CBBT 10.11-9 (Region I) Sta. 486+67 TAMU/TII 10/2011

Defects	Notes	Reinf. Detail	Vshear = 2710 m/s X-step: 150 mm Y-step: 50 mm Max Depth: 1000 mm Frequency: 50 kHz Norfolk, VA Chesapeake Tunnel CBBT 10.11-9 (Region I) Sta. 486+67 TAMU/TII 10/2011
Significant cracks up to 8.6" deep.	Backsurface at 24.3"-26.0" deep. Area tested because of high dielectric reading from GPR scan. No significant visual distress noticeable.	Hoop reinf: ~2.0"-3.0" deep @ ~12.2" on center. Longitudinal reinf: below hoop reinforcement @ 19.8" on center.

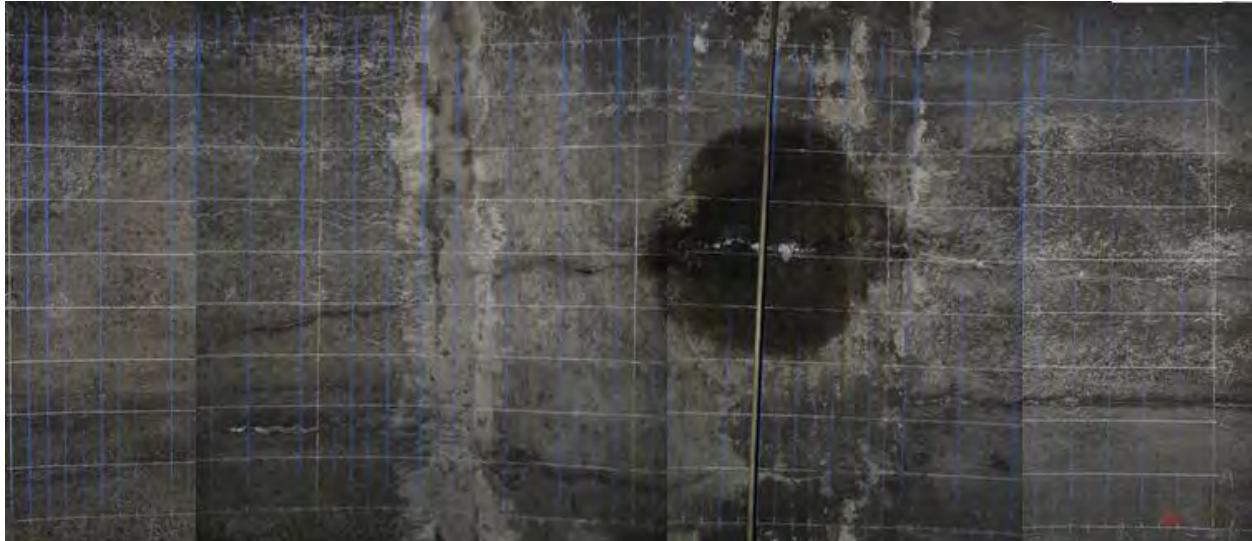
Figure N-29. Images of test site CBBT 10.11-10.

Defects	Notes	Reinf. Detail	
Heavy ringing made internal inspection difficult. Possible deep delamination (~17.7" deep and possibly 19" wide) and evidence of surface crack extending ~9.8" deep.	Backsurface at 22.7"-25.9" deep. Area tested because of large surface crack and small area of water intrusion.	Hoop reinf: ~2.7"-3.2" deep @ ~11.7"-12.4" on center. Second layer of hoop reinf. directly beneath top layer. Longitudinal reinf. below first layer of hoop reinforcement @ ~17.1" on center.	Vshear = 2710 m/s
			X-step: 150 mm Y-step: 50 mm Max Depth: 1000 mm Frequency: 50 kHz
			Norfolk, VA Chesapeake Tunnel CBBT 10.11-10 Sta. 491+25 TAMU/TII 10/2011

Defects	Notes	Reinf. Detail	
Heavy ringing made internal inspection difficult. Possible deep delamination (~17.7" deep and possibly 19" wide) and evidence of surface crack extending ~9.8" deep.	Backsurface at 22.7"-25.9" deep. Area tested because of large surface crack and small area of water intrusion.	Hoop reinf: ~2.7"-3.2" deep @ ~11.7"-12.4" on center. Second layer of hoop reinf. directly beneath top layer. Longitudinal reinf. below first layer of hoop reinforcement @ ~17.1" on center.	Vshear = 2710 m/s X-step: 150 mm Y-step: 50 mm Max Depth: 1000 mm Frequency: 50 kHz
			Norfolk, VA Chesapeake Tunnel CBBT 10.11-10 Sta. 491+25 TAMU/TII 10/2011

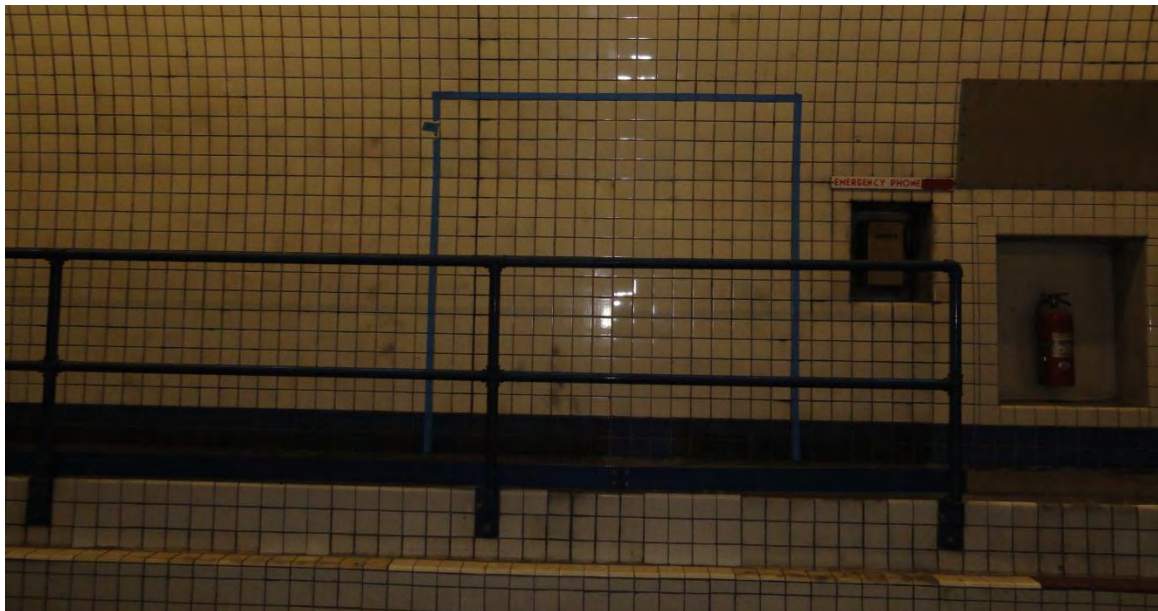
Figure N-31. Images of test site CBBT TILE 10.11-11.

Defects	Notes	Reinf. Detail	
Heavy ringing made internal inspection difficult. Possible deep delamination (~15.7" deep and 20.3" wide).	Backsurface at 25.0"-30.0" deep. Area tested was tiled lining over a joint where tile has debonded. Determined area via hammer sounding.	Hoop reinf: ~4.3"-7.7" deep @ ~12.1" on center. Second layer of hoop reinf. seen beneath top layer in one location-possibly splice area. Longitudinal reinf: below hoop reinforcement @ ~13.0" on center.	Vshear = 2710 m/s X-step: 110 mm Y-step: 110 mm Max Depth: 750 mm Frequency: 50 kHz
			Norfolk, VA Chesapeake Tunnel CBBT TILE 10.11-11 Approx. Sta. 488 TAMU/TII 10/2011

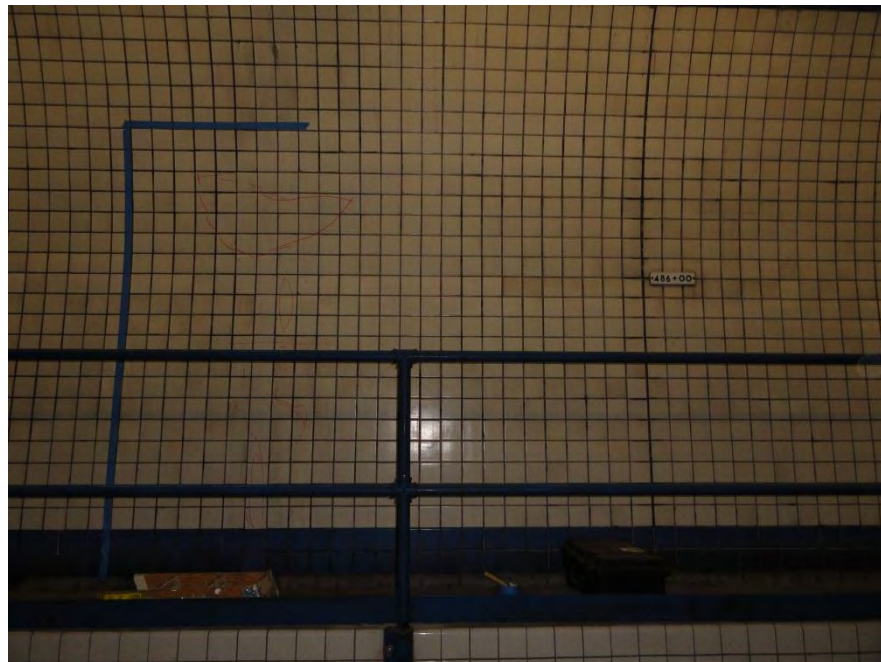
Figure N-33. Images of test site CBBT TILE 10.11-12.

Defects	Notes	Reinf. Detail	
Heavy ringing made internal inspection difficult. Possibly multiple cracks as deep as 8.6".	Backsurface at 28.1"-31.0" deep. Area tested was tiled lining. Hammer sounding did not indicate debonding, but SPACETEC infrared scans showed area of question..	Hoop reinf: ~4.8"-9.4" deep @ ~11.7" on center. Longitudinal reinf: below and possibly above hoop reinforcement.	Vshear = 2710 m/s X-step: 110 mm Y-step: 110 mm Max Depth: 1000 mm Frequency: 50 kHz
			Norfolk, VA Chesapeake Tunnel CBBT TILE 10.11-12 Sta. 486-09 TAMU/TTI 10/2011

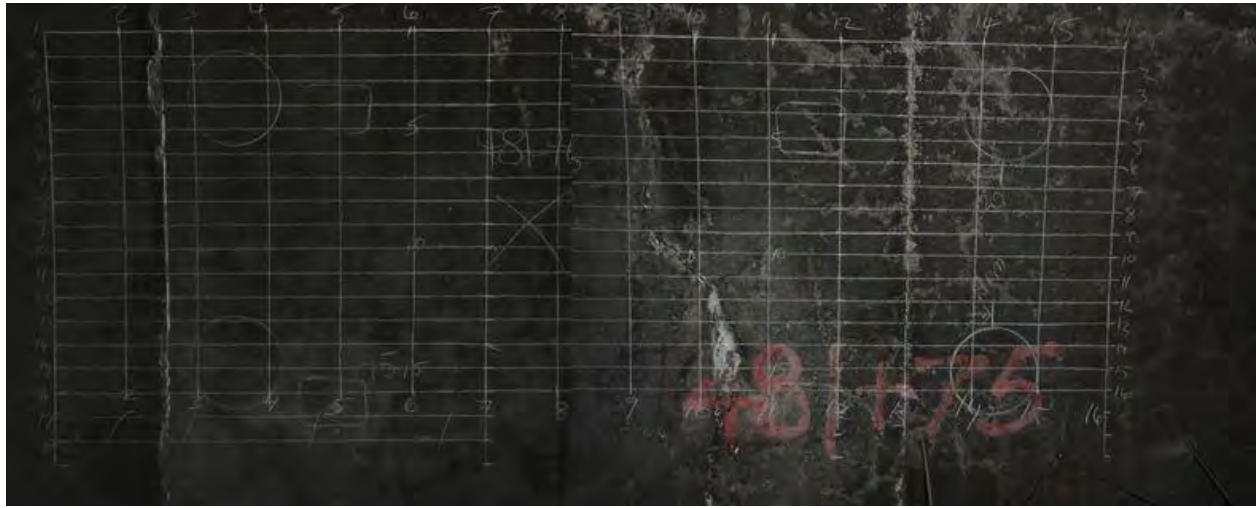
Figure N-35. Images of test site CBBT 10.11-13.

Defects	Notes	Reinf. Detail	
Apparent delamination 20.2" deep and 27.4" wide.	Backsurface at 26.6"-28.4" deep. Area tested because of surface crack and varying backwall reflections from single-point evaluations.	Hoop reinf: ~2.0"-3.6" deep @ 12.1" on center. Longitudinal reinf: below hoop reinforcement.	Vshear = 2710 m/s X-step: 150 mm Y-step: 50 mm Max Depth: 1000 mm Frequency: 50 kHz
			Norfolk, VA Chesapeake Tunnel CBBT 10.13 Sta. 481+76 TAMU/TTI 10/2011

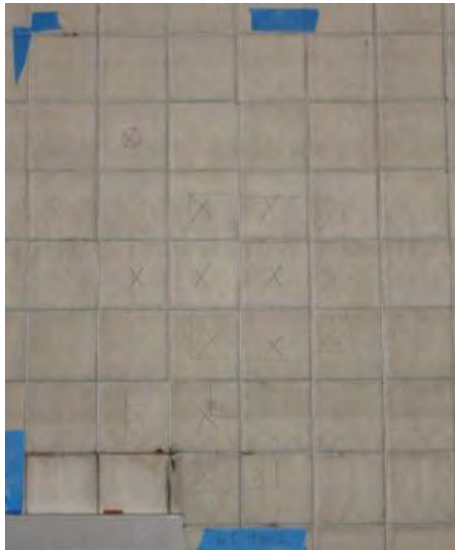
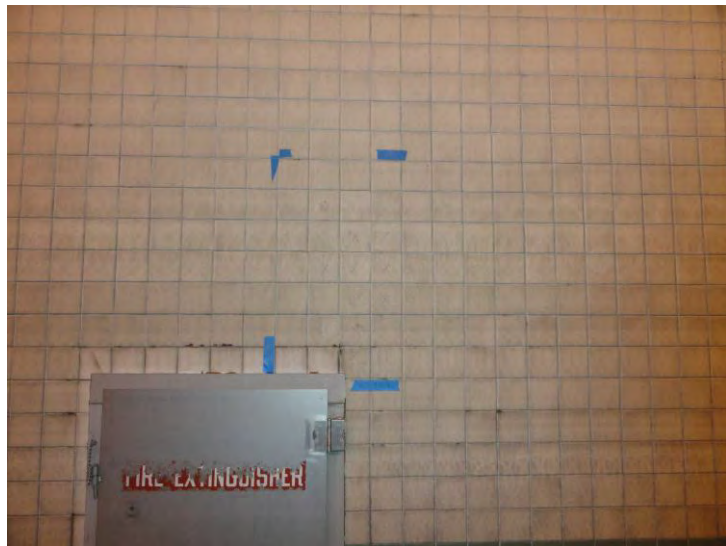
Figure N-37. Images of test site WT 9.16-1.

Defects	Notes	Reinf. Detail	
Significant shallow debonding/delamination . Deep delamination approximately 13" deep (B-scan image).	Backsurface not discernible. Area tested because of debonding located via hammer sounding.	Hoop reinf: ~6.8" deep.	Vshear = 2710 m/s X-step: 110 mm Y-step: 110 mm Max Depth: 500 mm Frequency: 50 kHz
			Houston, TX Washburn Tunnel WT 9.16-1 West Side TAMU/TTI 9/2011

Defects	Notes	Reinf. Detail	
Significant shallow debonding/delamination . Deep delamination approximately 13" deep (B-scan image).	Backsurface not discernible. Area tested because of debonding located via hammer sounding.	Hoop reinf: ~6.8" deep.	Vshear = 2710 m/s
			X-step: 110 mm
			Y-step: 110 mm
			Max Depth: 500 mm
			Frequency: 50 kHz
			Houston, TX
			Washburn Tunnel
			WT 9.16-1
			West Side
			TAMU/TTI 9/2011

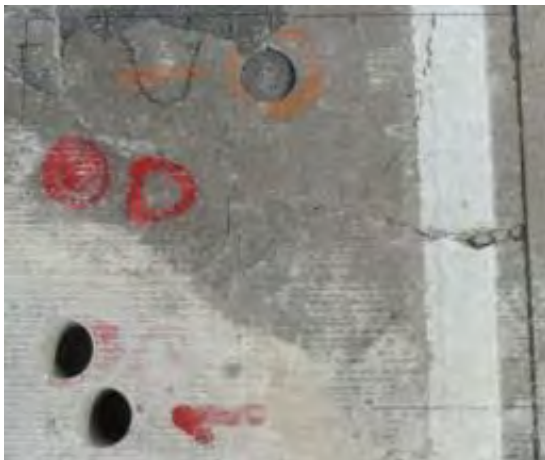
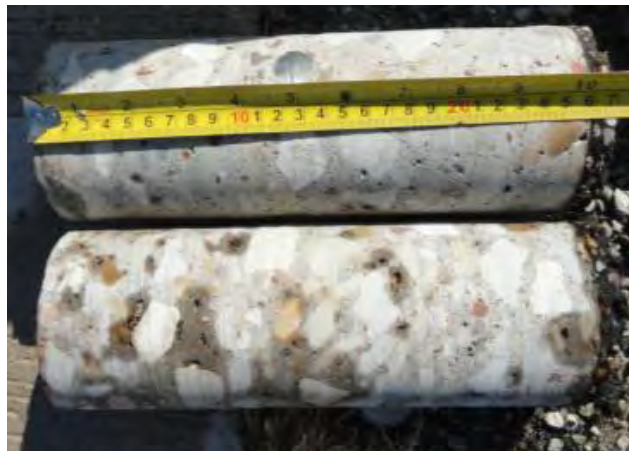
Figure N-45. Images of test site IH20 9.27-1.

Defects	Notes	Reinf. Detail	
Significant delamination on both sides of surface crack, ranging from 4.2"-5.0" from top surface.	Top layer of pavement 10.2" below surface. Area tested because of transverse surface cracking. Pavement depth confirmed by 2 cores, both indicating 10.2" thickness and one indicating 5.0" reinf.	Longitudinal reinf.: ~4.6"- 5.0" deep @ 5.6" on center. No transverse reinforcement located in this area.	Vshear = 2770 m/s X-step: 150 mm Y-step: 50 mm Max Depth: 500 mm Frequency: 50 kHz
			Ft. Worth, TX I-20 IH20 9.27-1 MP 426 + 0.5, RM 2871 TAMU/TTI 9/2011

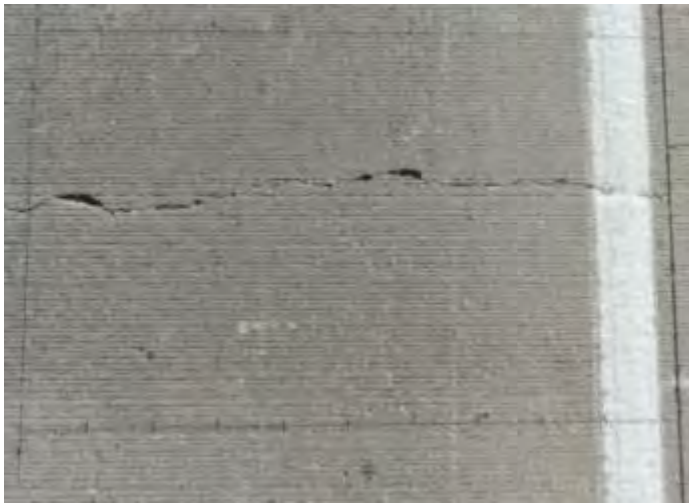
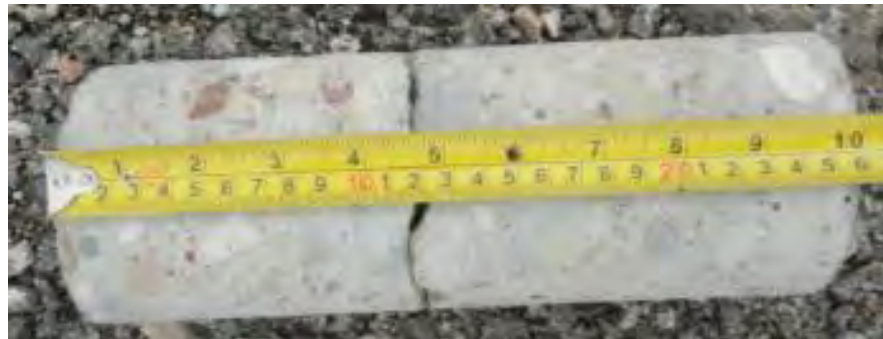
Figure N-47. Images of test site IH20 9.27-2.

Defects	Notes	Reinf. Detail	
Significant delamination on both sides of surface crack, ranging from 4.5"-5.3" from top surface.	Top layer of pavement 10.4" below surface. Area tested because of transverse surface cracking. Pavement depth confirmed by 2 cores, indicating 9.4"-10.4" thickness.	Longitudinal reinf.: ~4.5"- 5.2" deep @ 7.1" on center. No transverse reinforcement located in this area.	Vshear = 2770 m/s
			X-step: 150 mm Y-step: 50 mm Max Depth: 500 mm Frequency: 50 kHz
			Ft. Worth, TX I-20 IH20 9.27-2 MP 426 + 0.5, RM 2871 TAMU/TTI 9/2011

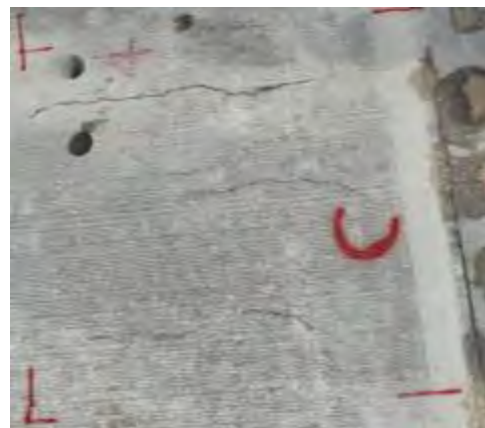
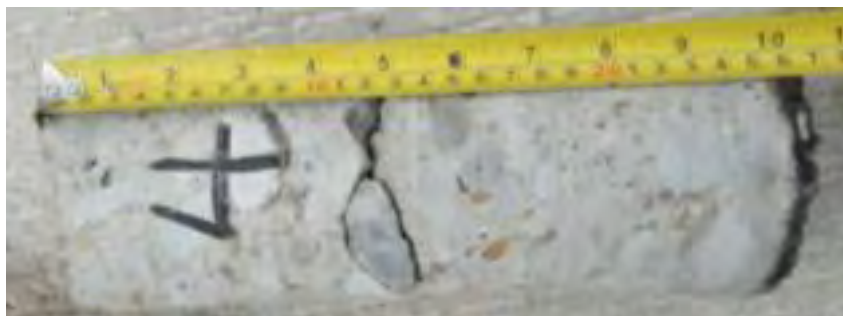
Figure N-49. Images of test site IH20 9.27-3.

Defects	Notes	Reinf. Detail	
Significant delamination on both sides of surface crack, ranging from 4.6"-5.1" from top surface.	Top layer of pavement approximately 10.2" below surface. Area tested because of transverse surface cracking. Pavement depth confirmed by 2 cores, indicating 10.2" thickness.	Longitudinal reinf.: ~4.8"- 5.0" deep @ 7.2" on center. No transverse reinforcement located in this area.	Vshear = 2770 m/s X-step: 150 mm Y-step: 50 mm Max Depth: 500 mm Frequency: 50 kHz
			Ft. Worth, TX I-20 IH20 9.27-3 MP 426 + 0.5, RM 2871 TAMU/TTI 9/2011

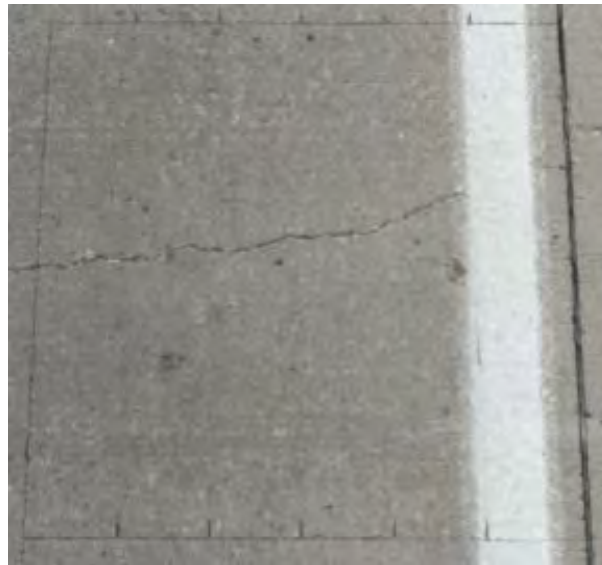
Figure N-51. Images of test site IH20 9.27-5.

Defects	Notes	Reinf. Detail	
Significant delamination on both sides of surface crack, approximately 5.0" from top surface.	Top layer of pavement approximately 10.1" below surface. Area tested because of transverse surface cracking. No cores taken in this location.	Longitudinal reinf.: ~4.6"- 5.2" deep @ 7.0" on center. No transverse reinforcement located in this area.	Vshear = 2770 m/s X-step: 150 mm Y-step: 50 mm Max Depth: 500 mm Frequency: 50 kHz
			Ft. Worth, TX I-20 IH20 9.27-5 MP 426 + 0.5, RM 2871 TAMU/TTI 9/2011

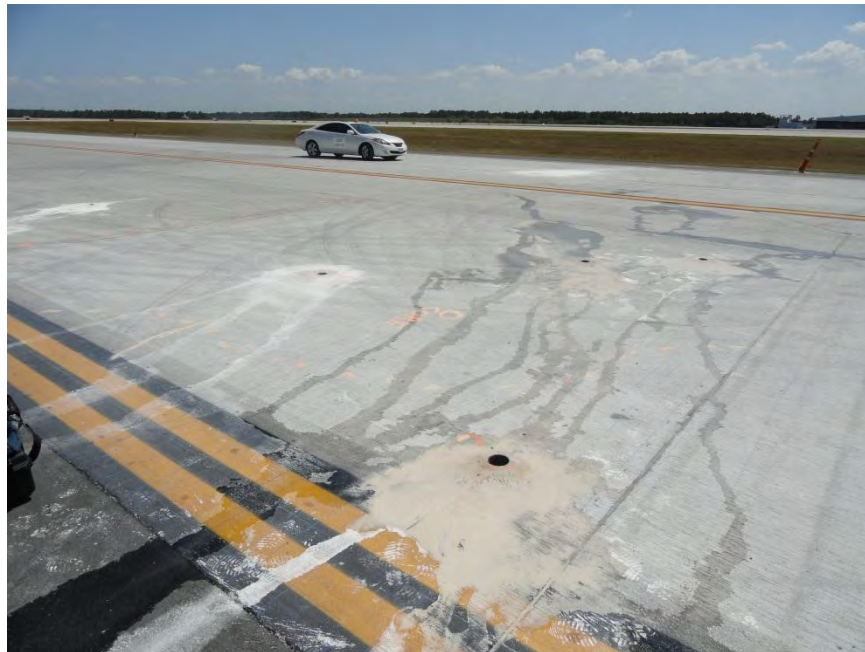
Figure N-53. Images of test site IAH 6.9-1.

Defects	Notes	Reinf. Detail	
Significant debonding at at runway/subbase (7.6"-8.1" deep) and verified by coring. Possible further debonding in deeper layers (26.9" and 37.7" deep).	Top layer of pavement approximately 7.6"-8.1" below surface; second layer 26.9" below surface; third layer 37.7" below surface. Area tested because of surface cracking and hammer sounding revealing possible debonding. Image is of typical runway segment.	None.	Vshear = 2885 m/s X-step: 200 mm Y-step: 100 mm Max Depth: 1000 mm Frequency: 50 kHz
			Houston, TX IAH IAH 6.9-1 Sta 83+00 T/W WA E TAMU/TTI 6/2011

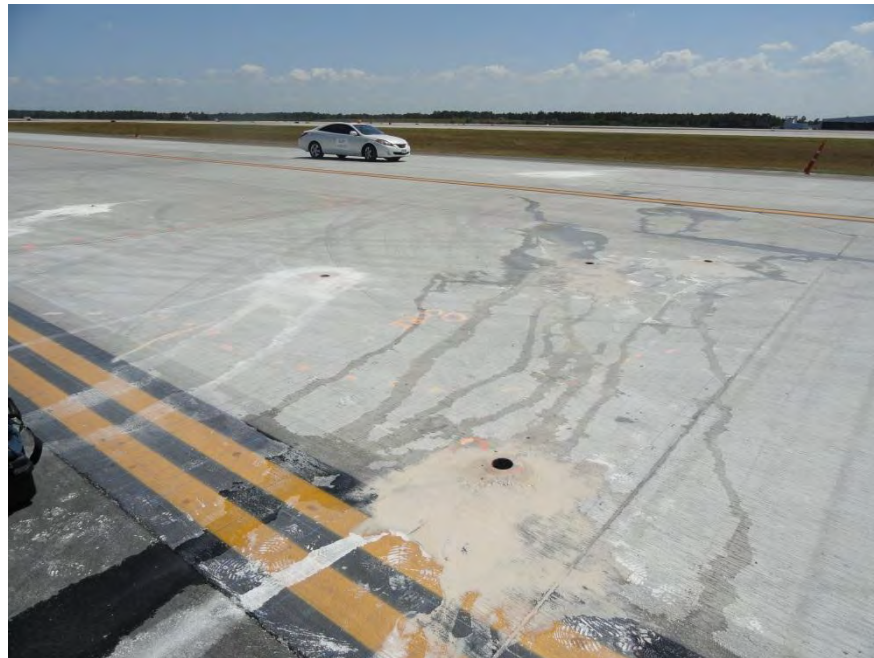
Figure N-55. Images of test site IAH 6.9-2.

Defects	Notes	Reinf. Detail	
Significant debonding at at runway/subbase (7.1" deep) and verified by coring. Possible further debonding in deeper layers (25.6" and 37.5" deep).	Top layer of pavement approximately 7.1" below surface; second layer 25.6" below surface; third layer 37.5" below surface. Area tested because of surface cracking and hammer sounding revealing possible delaminations. Image is of typical runway segment.	None.	<p>Vshear = 2885 m/s X-step: 200 mm Y-step: 100 mm Max Depth: 1000 mm Frequency: 50 kHz</p> <hr/> <p>Houston, TX IAH IAH 6.9-2 Sta 82+75 T/W WA E TAMU/TTI 6/2011</p>

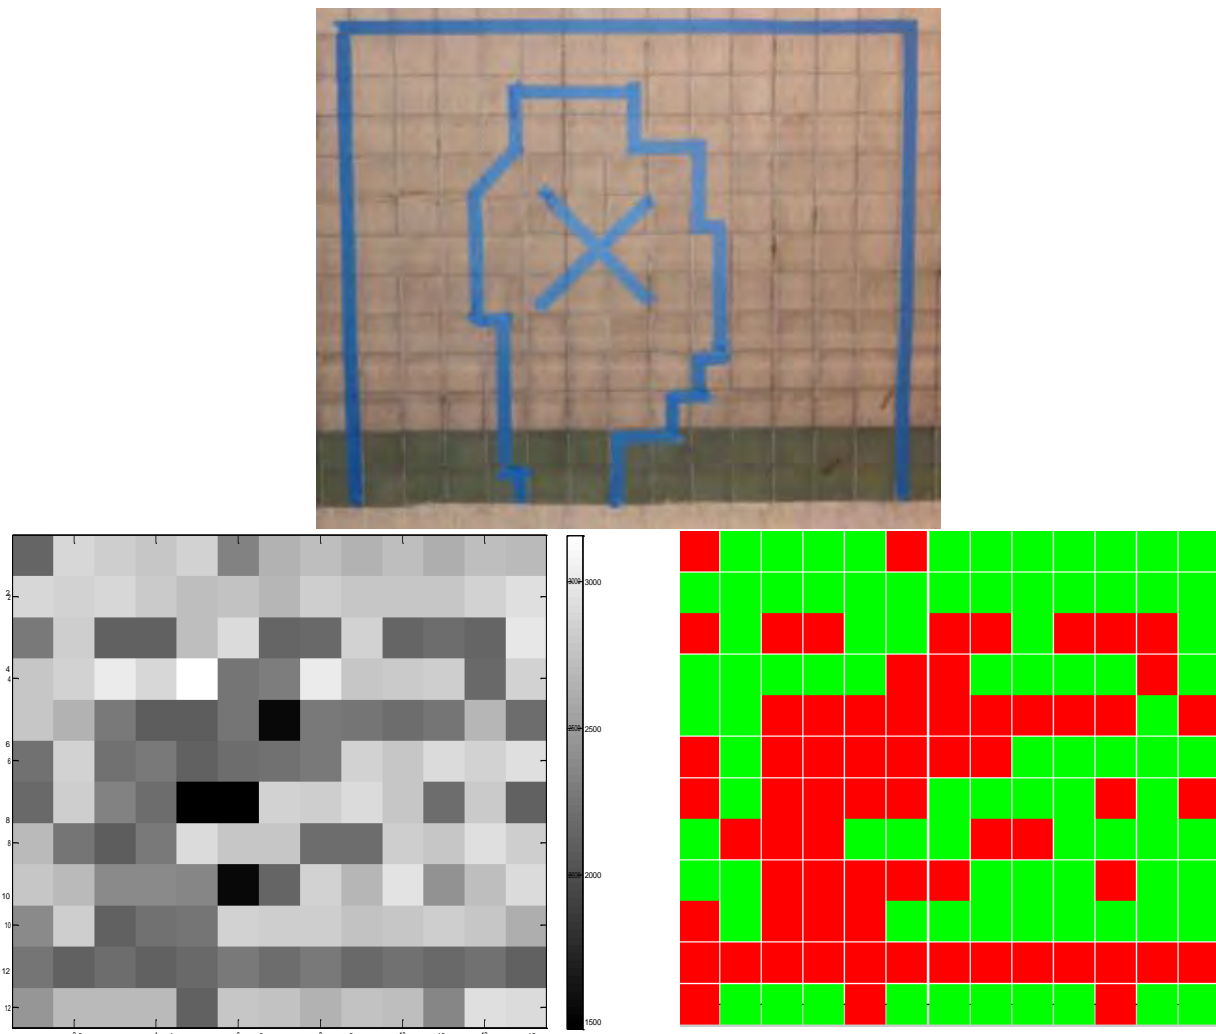
Figure O-3. Debonded regions of tile (top) paired with the acoustic sounding results (bottom).

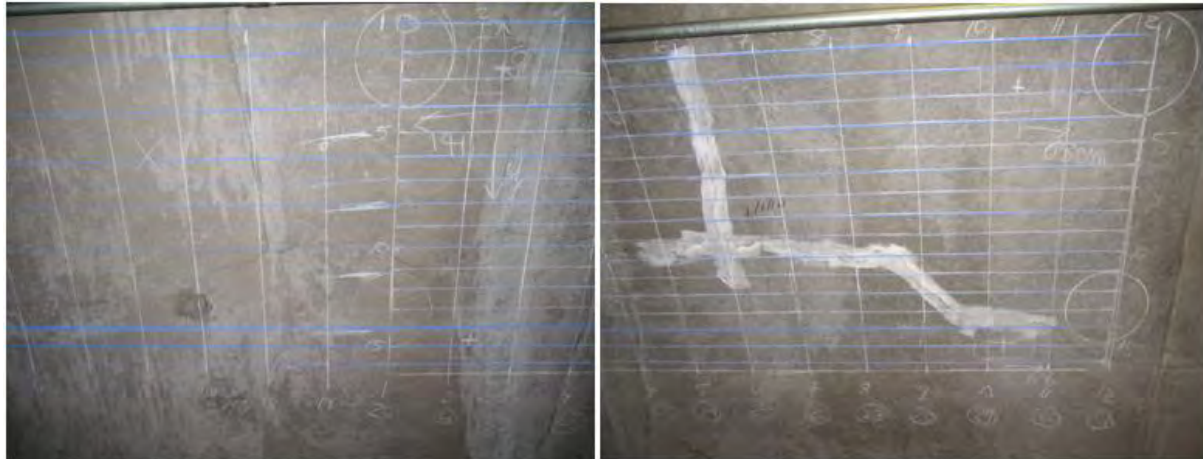
(a) The actual photograph

Figure P-5. The tested blocks with denser grid measurement in Hanging Lake Tunnel.

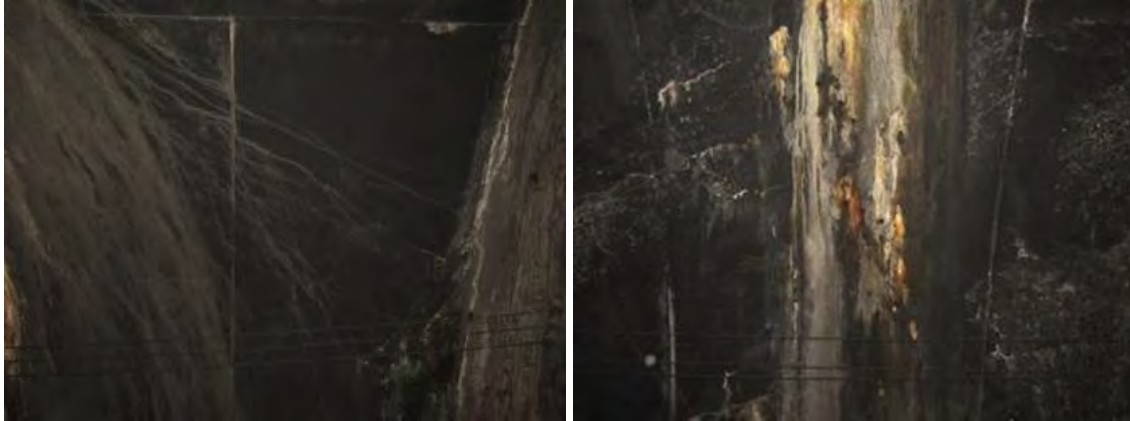
(a) Intact location

(b) Defective location

Figure P-8 shows a typical USW dispersion curve for an intact area and a defective point along with their actual photograph. The dispersion curve shifts to lower moduli where severe flaws are present.

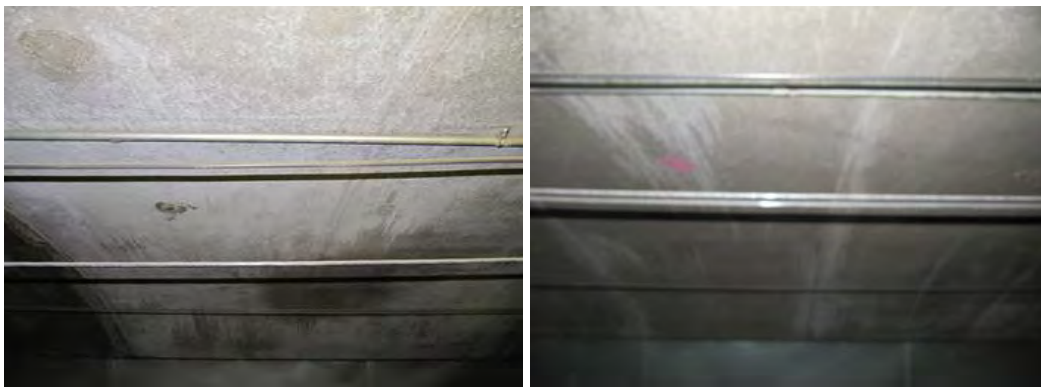
(a) Intact location

(b) Defective location

The actual condition of liners at the time of testing is shown in Figures P-10a and P-10b. The amplitude spectra for selected intact and defective points are also shown in Figure P-10c. Based on an average compression wave velocity of about 14,000 ft/s measured for the concrete, the dominant frequency corresponding to the tunnel thickness (15 inches) is around 5.4 kHz. As compared to the intact point, higher peak frequencies mostly control the response at the defective points.

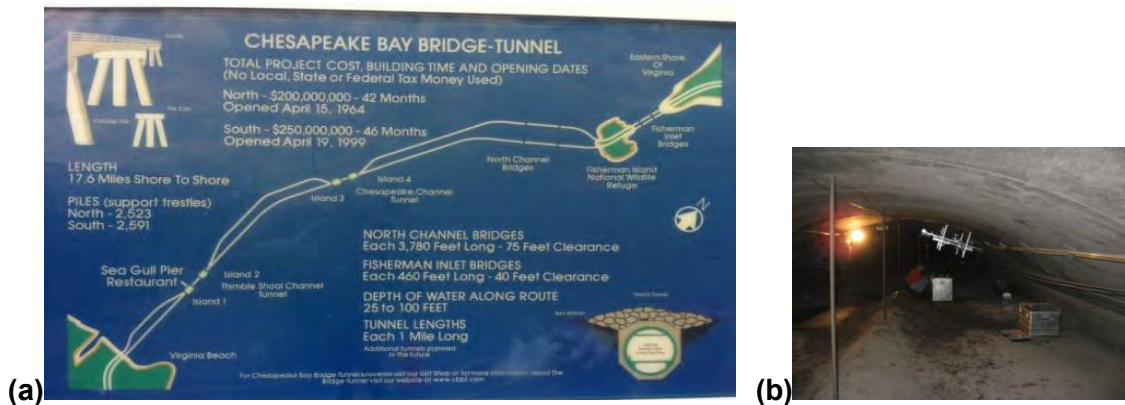
Figure Q-3. Construction information on the Chesapeake Bay Bridge-Tunnel (a) and supply air duct where most measurements took place (b).

The Chesapeake Bay Tunnel is a part of a bridge-tunnel construct connecting Virginia’s eastern shore with its mainland. The tunnel itself is 1 mi long going under the Atlantic Ocean. Construction started in November 1960, and the first part was opened in April 1964. Figure Q-4 shows a bulletin from the side and a view of the supply air duct, where most measurements were taken.

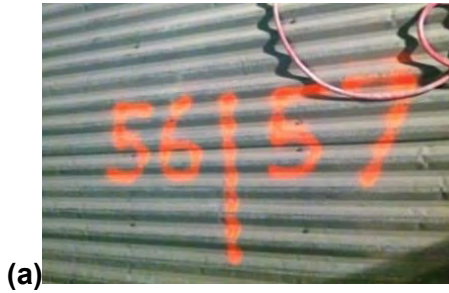
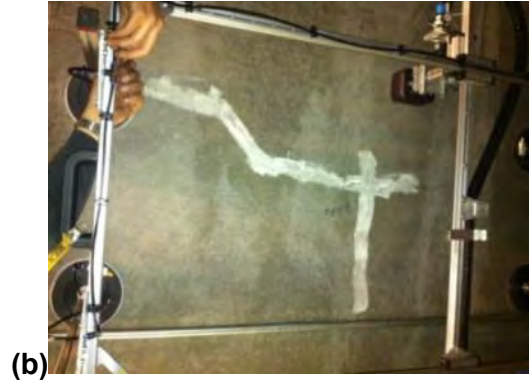
Figure Q-23. (a) Mark on the tunnel vent floor of HL1 used as a reference to identify the Sections). (b) The location of the repaired crack across the test field in relation to the scanner aperture.

Testing in the HL Tunnel took place on October 5, 2011, and October 6, 2011. As noted in Figure Q-23, three test areas were measured with GPR, US, and IE.

The first test area was situated in Section 56 of the tunnel and is hereinafter referred to as HL1. We did not find any referencing system for this tunnel. The test area was believed to be within Section 56 because 56/57 was marked with spray on the floor, looking south on the right-hand side of the test location (see Figure Q-23[a]). On the left-hand side, E16 was written. A repaired crack ran across the selected test area (see Figure Q-23[b]). As shown schematically in Figure Q-24, the 48 inch x 24 inch test area was located between two joints at a distance of 27 inches from the north joint and 56 inches from the south joint. The scanning started at the point closest to the center line. It then moved away from the center line and farther south, toward the tunnel entrance. The grid spacing was 1 inch for US and IE testing and 5 inches for GPR testing. The length (larger dimension) of the US, IE, and GPR transducer was parallel to the center line of the tunnel.

The second test area at Hanging Lake Tunnel (HL2) took place in Segment 57 (segment number was assumed based on the marking on the ground as shown in Figure Q-23[a]). The 48 inch x 24 inch test area was located 52 inches north of the joint dividing segments 56 and 57. Its upper (toward the tunnel crest) edge was at a distance of about 100 inches to the center line. Figure Q-33 shows a sketch of HL2. An unrepaired crack ran across the test area, as shown in Figure Q-34(a). Figure Q-34(a) and (b) show the ZFP Scanner. The scanning started at the point closest to the center line, first moving down away from the

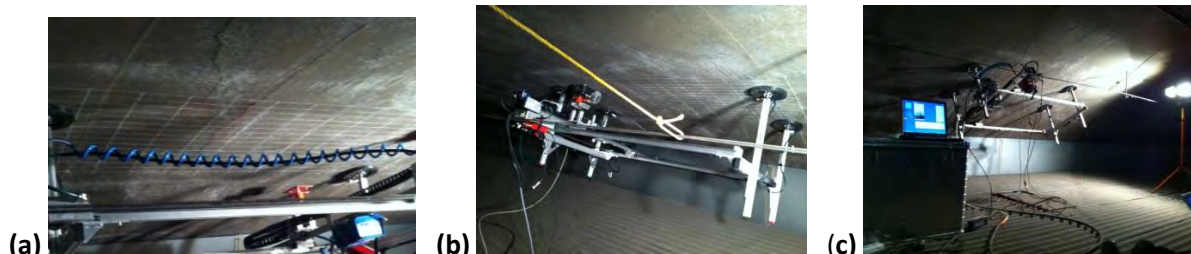
Figure Q-34. HL2: (a) crack running across the test area, (b) NDT scanner mounted on the tunnel ceiling, and (c) scanning of the test area.

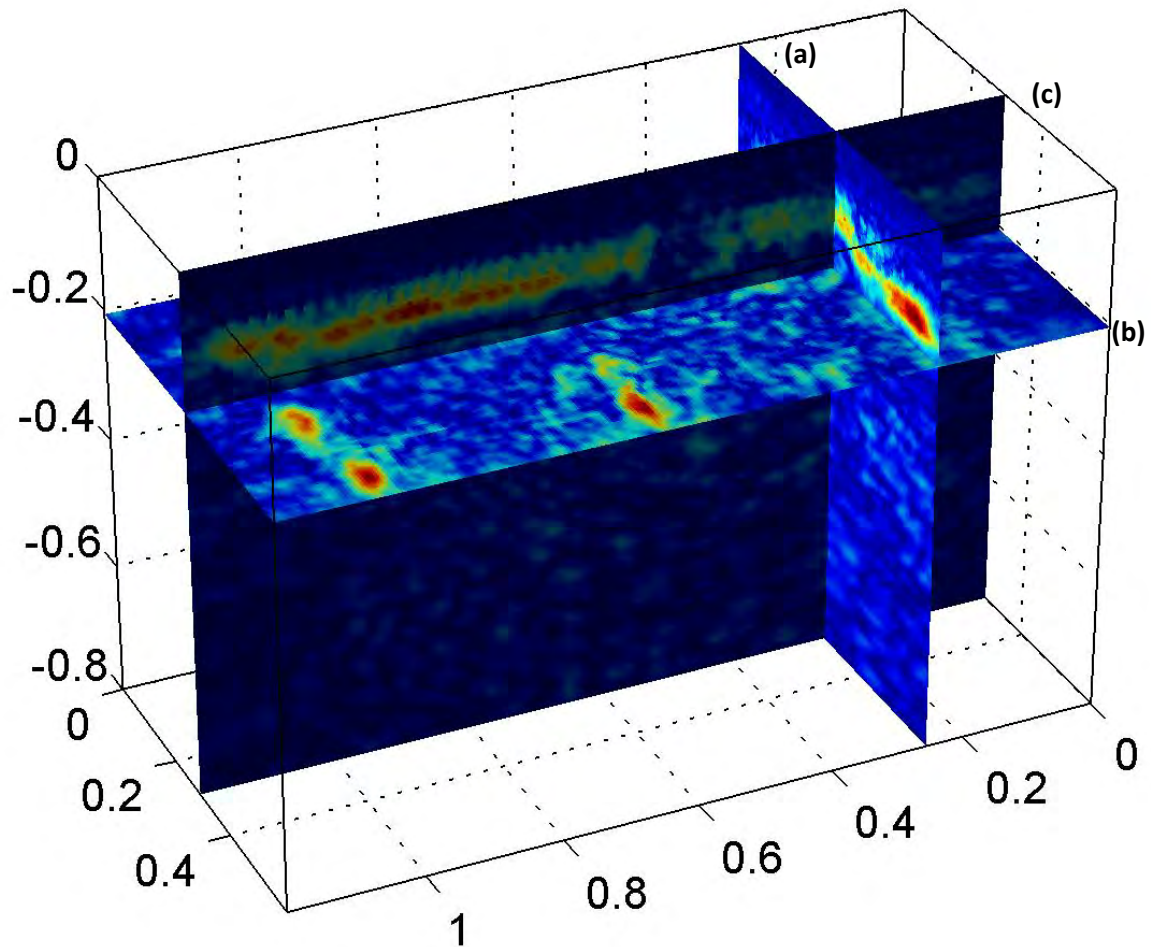
Figure Q-42. HL2, US: three-dimensional image of the volume positioned to reveal the reinforcing elements, with the B-Scan (a) positioned at $x = 10.5$ inches, the C-Scan (b) at $z = 8$ inches, and the D-Scan (c) at $y = 12$ inches. The missing reinforcement due to the crack is also seen in the D-Scan.

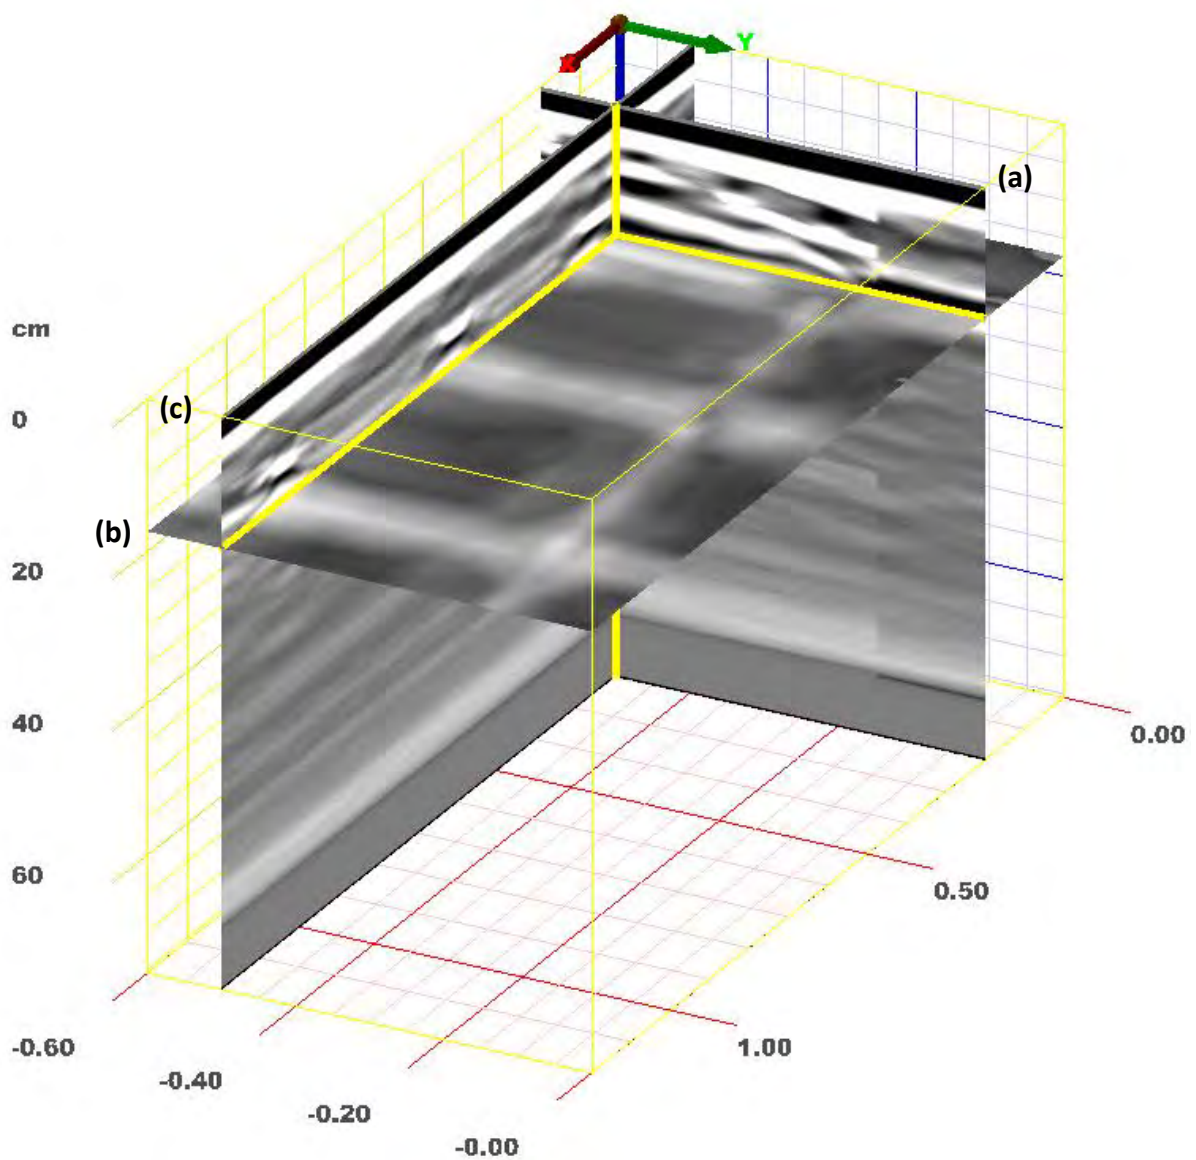
Figure Q-49. HL3, GPR: three-dimensional image of the volume positioned to reveal the reinforcing elements, with the B-Scan (a) positioned at $x = 8$ inches, the C-Scan (b) at $z = 7$ inches, 1-inch width, and the D-Scan (c) at $y = 16$ inches.

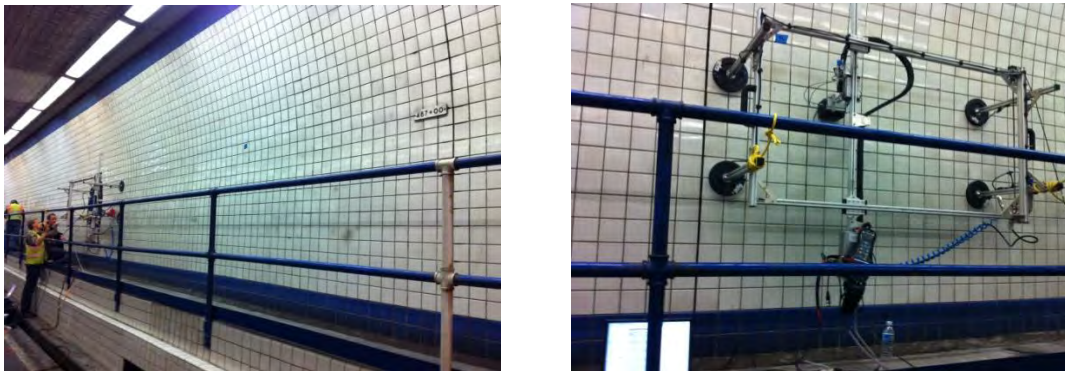
Figure Q-88. CPB4 near Sta. 486+28.

The test area CPB4 was located between Sta. 486+28 and Sta. 487, close to the north end of the tunnel, where an anomaly was previously detected in SPACETEC thermal images. As seen in Figure Q-88, the scanner's feet were mounted on the wall near the joint. The test field was larger here, covering a 48 inch x 36 inch area. The spacing for US and IE was chosen as 1 inch, and that for GPR was 2 inches. During the testing, the GPR, US, and IE transducers were oriented such that their length was parallel to the center line of the tunnel. The measurement started in the lower right corner of the test field. The scanner moved upwards and then left (south). Figure Q-88 shows snapshots of the test area and measurement system.

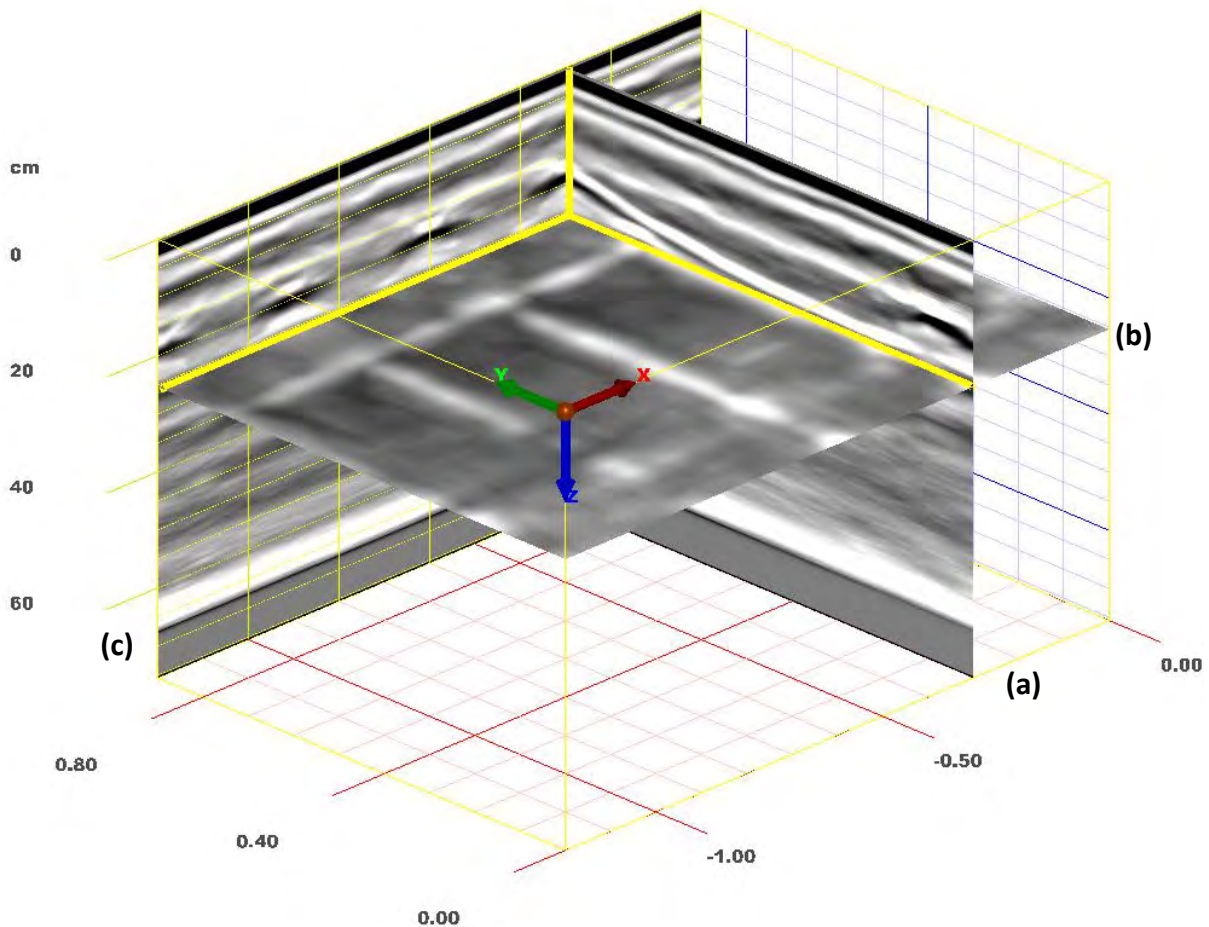
Figure Q-89. CPB4, GPR: three-dimensional image of the volume positioned to reveal the reinforcement, with the B-Scan (a) positioned at $x = 11$ inches, the C-Scan (b) at $z = 10$ inches, 4-in. width, and the D-Scan (c) at $y = 4$ inches.

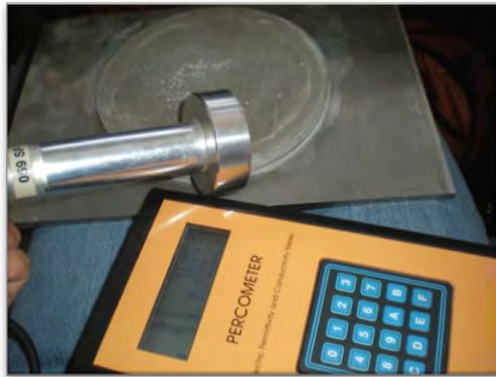
Figure S-4. Determination of percometer penetration depth with cement paste cast on stainless steel at different thicknesses. The probe of the percometer uses a frequency of 40-50 MHz.

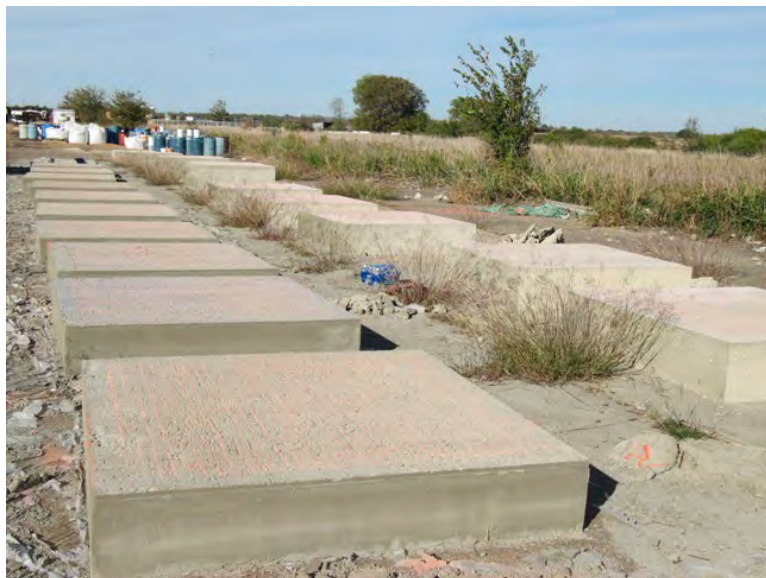
Figure U-2. Overall view of TTI slabs.

An overall view of the test slabs is shown in Figure U-2, and their characteristics are summarized in Table U-1. Two sets of slabs were tested in this study. Each slab was 6 ft by 6 ft in dimension. The first set of specimens included six intact concrete slabs with thicknesses of 12, 15, 18, and 24 inches, and three defective 15-inch-thick slabs with embedded 1 ft by 1 ft delaminated zones in the center of the slabs. The last three slabs contained defects at depths of 1, 2, and 3 inches from the top surface. Two other concrete slabs in this set were 15 inches thick with embedded air voids and water voids at a depth of 8 inches.

The second set of slabs was shotcrete slabs that included four intact slabs with thicknesses of 4, 6, 8, and 12 inches and five 12-inch-thick delaminated slabs. The 1 ft by 1 ft delaminated areas were embedded at the center of each slab at depths of 1, 2, 3, 4, and 8 inches from the top surface. Four other shotcrete slabs contained air voids and water voids with different sizes at different depths.
