SHRP 2 Renewal Project R06G

Mapping Voids, Debonding, Delaminations, Moisture, and Other Defects Behind or Within Tunnel Linings

This final report documents the work conducted under Phase II of Strategic Highway Research Program (SHRP 2) Project R06(G), Mapping Voids, Debonding, Delaminations, Moisture, and Other Defects behind or within Tunnel Linings.

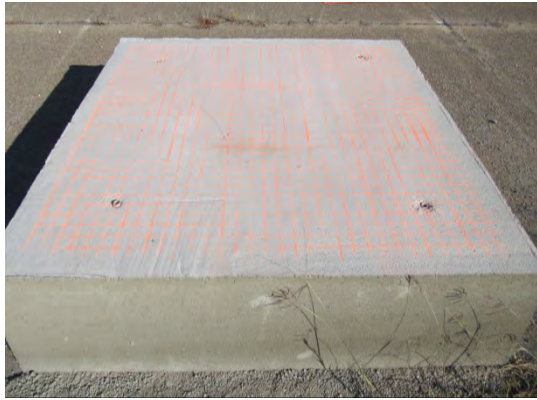
(a) Slab #2

Figure U-5. Contour maps of the acquired results from USW and IE tests for concrete slab #2 (18-inch-thick intact slab).

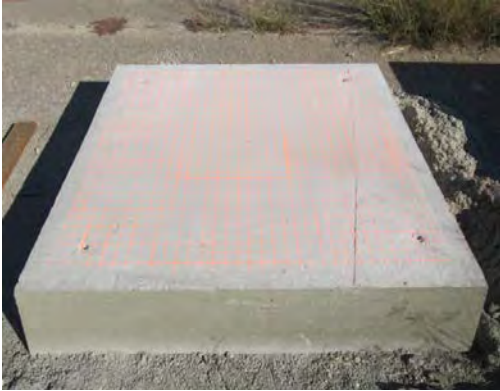
(a) Slab #3

Figure U-6. Contour maps of the acquired results from USW and IE tests for concrete slab #3 (12-inch-thick intact slab).

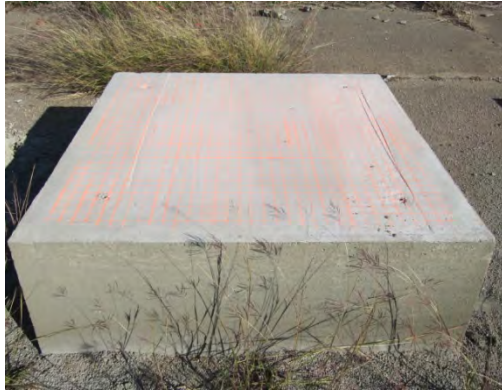
(a) Slab #4

Figure U-7. Contour maps of the acquired results from USW and IE tests for concrete slab #4 (24-inch-thick intact slab).

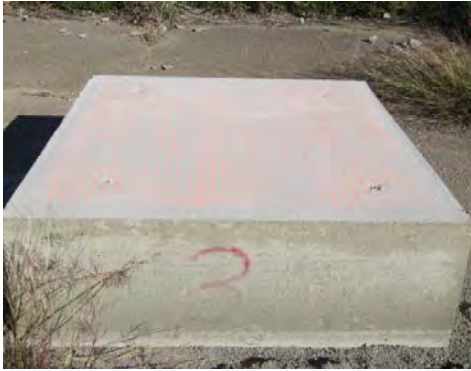
(a) Slab #5

Figure U-8. Contour maps of the acquired results from USW and IE tests for concrete slab #5 (24-inch-thick intact slab).

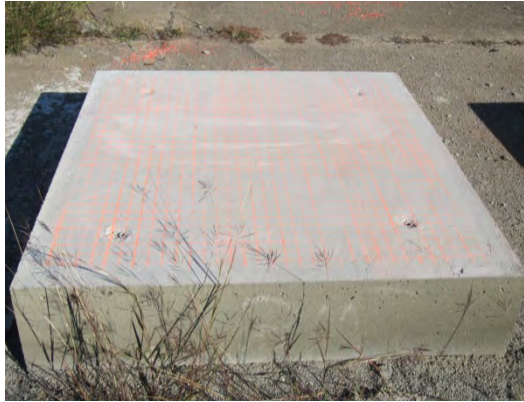
(a) Slab #6

Figure U-9. Contour maps of the acquired results from USW and IE tests for concrete slab #6 (15-inch-thick intact slab).

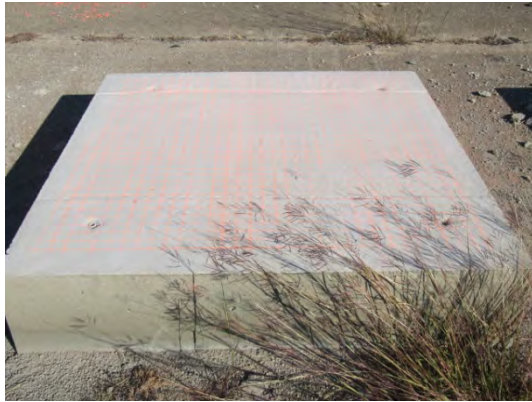
(a) Slab #7

Figure U-10. Contour maps of the acquired results from USW and IE tests for concrete slab #7 (15-inch-thick delaminated at 2 inches).

The same statements can be made for the results from Slabs 8 and 9 (Figures U-11 and U-12) where the delaminated zones were at nominal depths of 3 inches and 1 inch. By comparing the amplitudes of the waveforms in Figures U-10b, U-11b, and U-12b, one can roughly estimate that the delamination in Slab 7 is shallower than the one in Slab 8 but deeper than the defect in Slab 9. The delamination in Slab 8 is readily approximated in both the USW results and IE results in Figures U-11c and U-11d. It seems that the inserted delamination in Slabs 7 and 8 moved slightly in the construction phase.

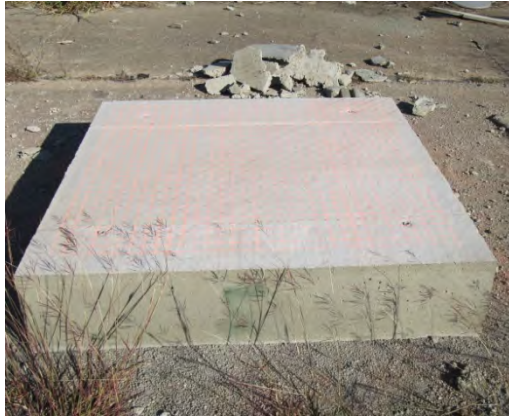
(a) Slab #8

Figure U-11. Contour maps of the acquired results from USW and IE tests for concrete slab #8 (15-inch-thick delaminated at 3 inches).

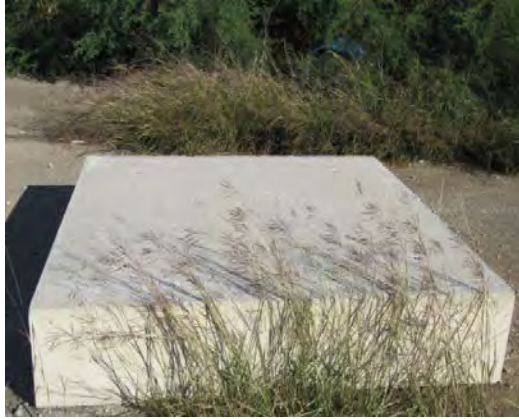
(a) Slab #11

Figure U-14. Contour maps of the acquired results from USW and IE tests for concrete slab #11 (15-inch-thick slab with water void at 8-inch depth).

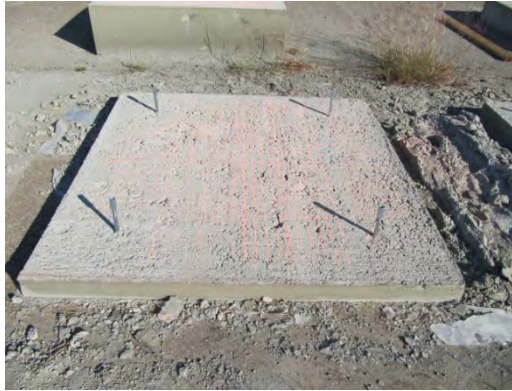
(a) Slab #1

Figure U-15. Contour maps of the acquired results from USW and IE tests for shotcrete slab #1 (4-inch-thick intact slab).

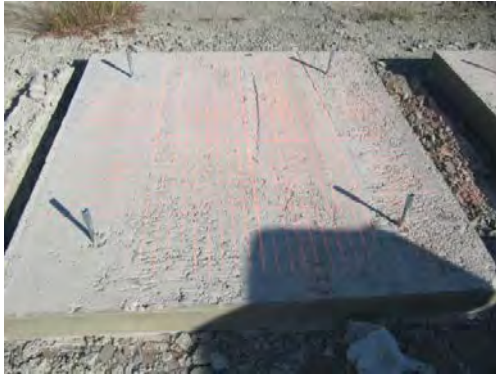
(a) Slab #2

Figure U-16. Contour maps of the acquired results from USW and IE tests for shotcrete slab #2 (6-inch-thick intact slab).

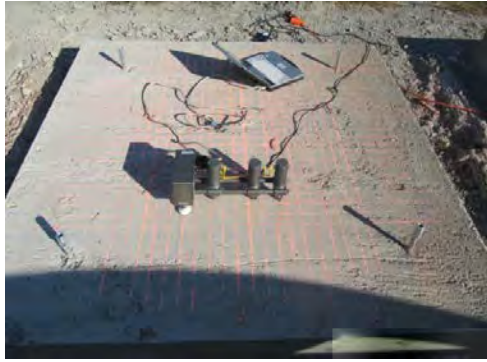
(a) Slab #3

Figure U-17. Contour maps of the acquired results from USW and IE tests for shotcrete slab #3 (8-inch-thick intact slab).

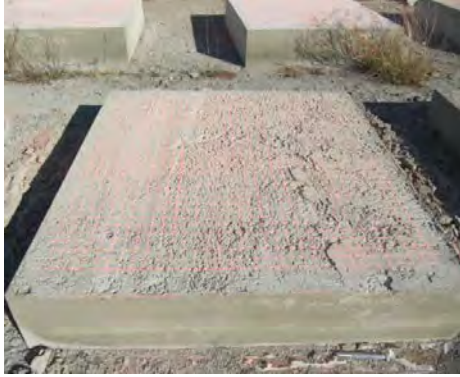
(a) Slab #8

Figure U-19. Contour maps of the acquired results from USW and IE tests for shotcrete slab #8 (12-inch-thick delaminated at 8-inch depth).

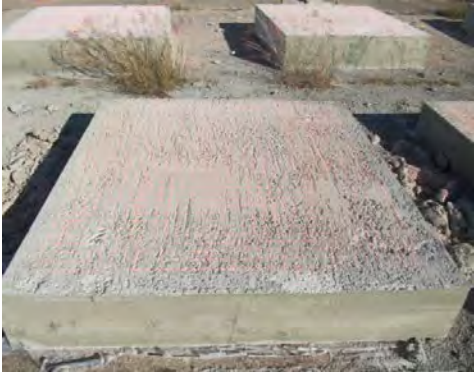
(a) Slab #9

Figure U-20. Contour maps of the acquired results from USW and IE tests for shotcrete slab #9 (12-inch-thick delaminated at 4-inch depth).

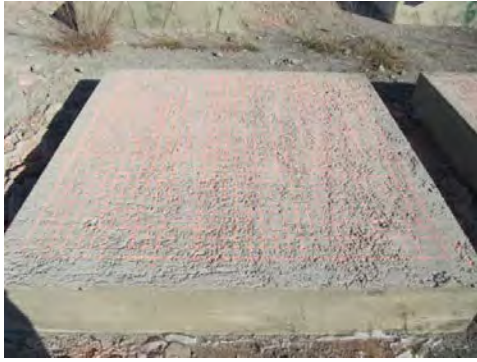
(a) Slab #10

Figure U-21. Contour maps of the acquired results from USW and IE tests for shotcrete slab #10 (12-inch-thick delaminated at 3-inch depth).

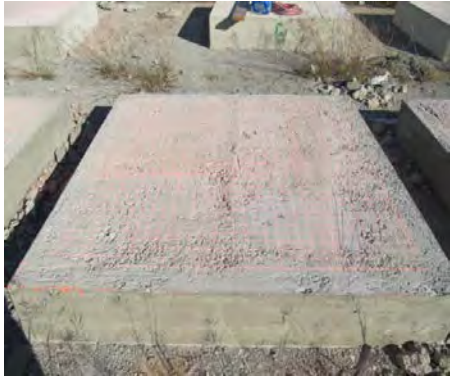
(a) Slab #11

Figure U-22. Contour maps of the acquired results from USW and IE tests for shotcrete slab #11 (12-inch-thick delaminated at 2-inch depth).

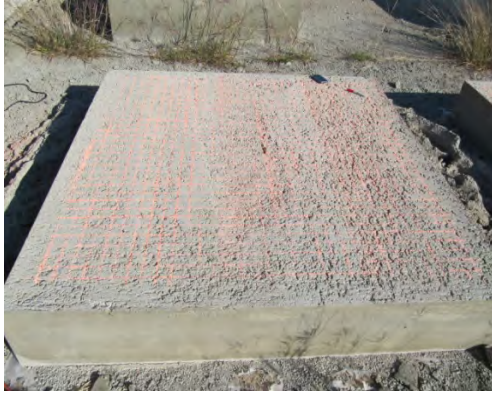
(a) Slab #4

Figure U-24. Contour maps of the acquired results from USW and IE tests for shotcrete slab #4 (12-inch-thick slab with air void at 7.5-inch depth).

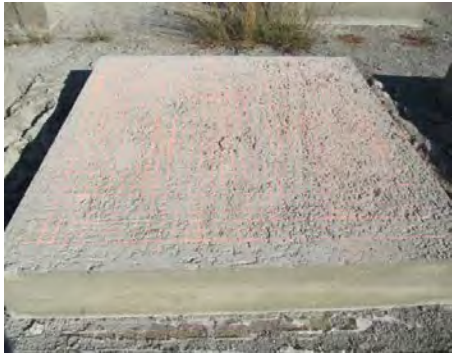
(a) Slab #5

Figure U-25. Contour maps of the acquired results from USW and IE tests for shotcrete slab #5 (12-inch-thick slab with water void at 7.5-inch depth).

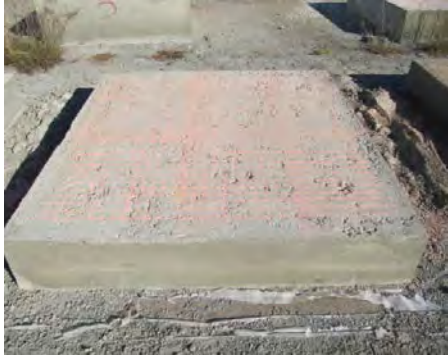
(a) Slab #6

Figure U-26. Contour maps of the acquired results from USW and IE tests for shotcrete slab #6 (12-inch-thick slab with air void at 3-inch depth).

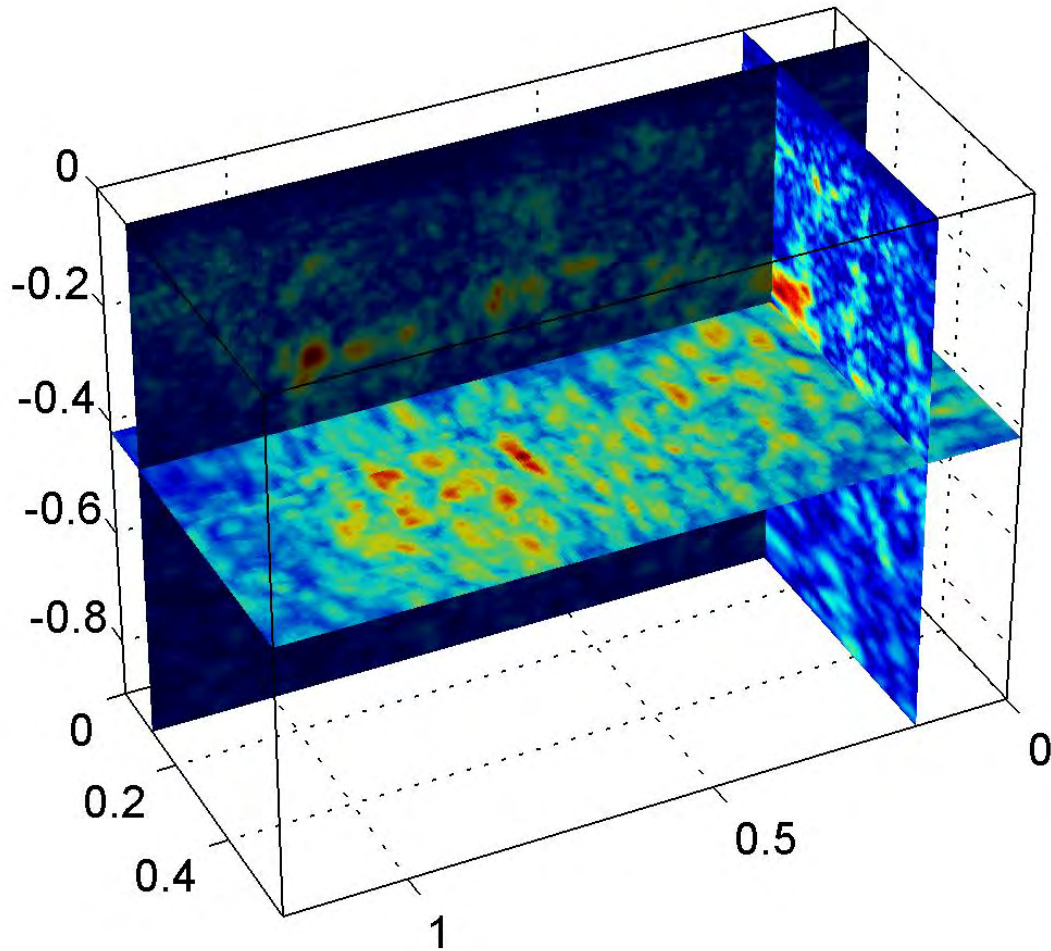
Figure W.5 BAM-HL1, US: three-dimensional image of the volume positioned to reveal the anomaly, with the B-Scan positioned at $x = 6$ inches, the C-Scan at $z = 21$ inches (4 inches thick), and the D-Scan at $y = 6$ inches.

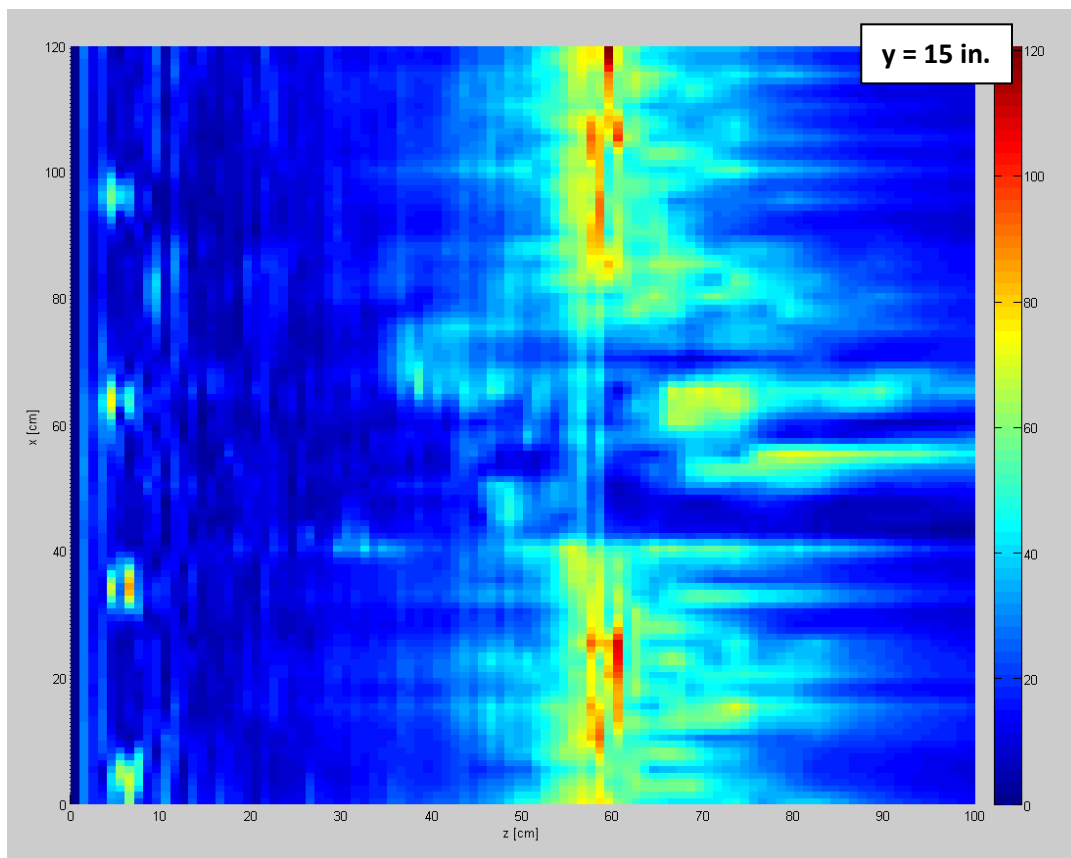
Figure W.14 BAM-CPB3: the combined IE-US-GPR D-Scan at $y = 15$ inches.

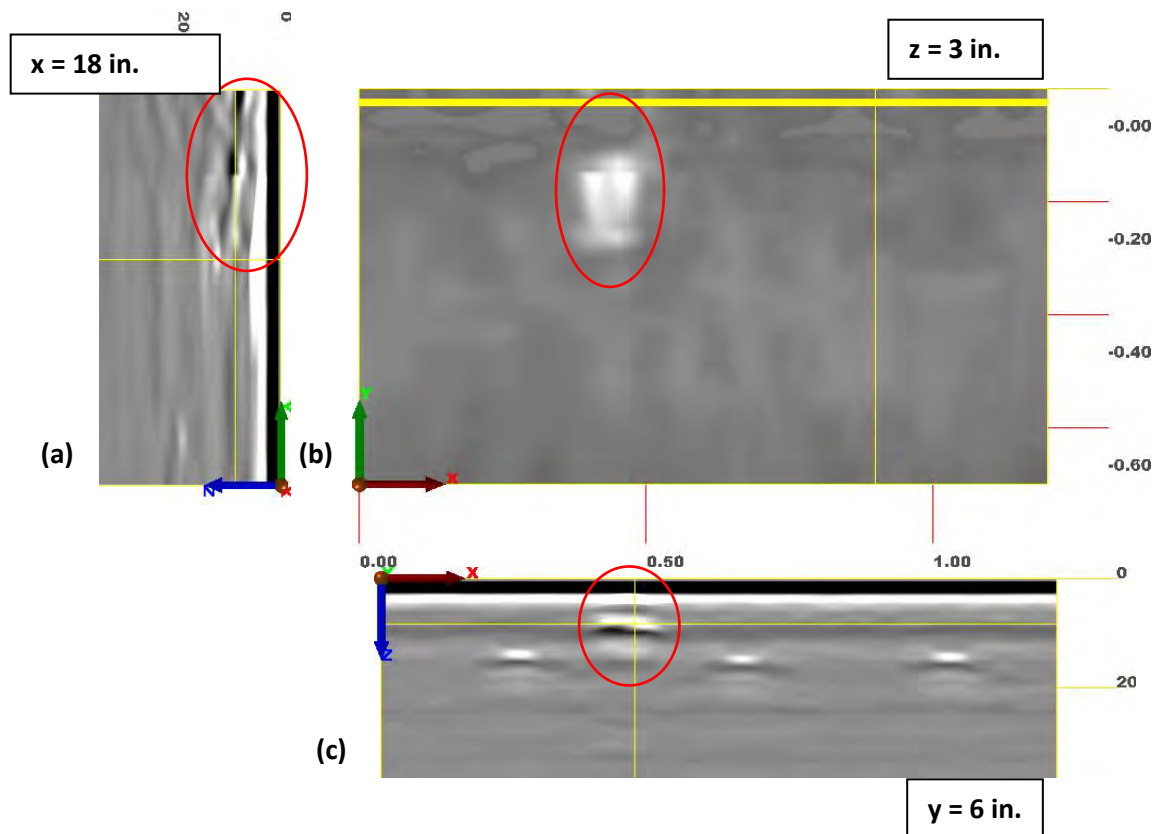
Figure W.15 BAM-HL2, GPR: C-, D-, and B-Scans showing reflections caused by the presence of a surface crack.

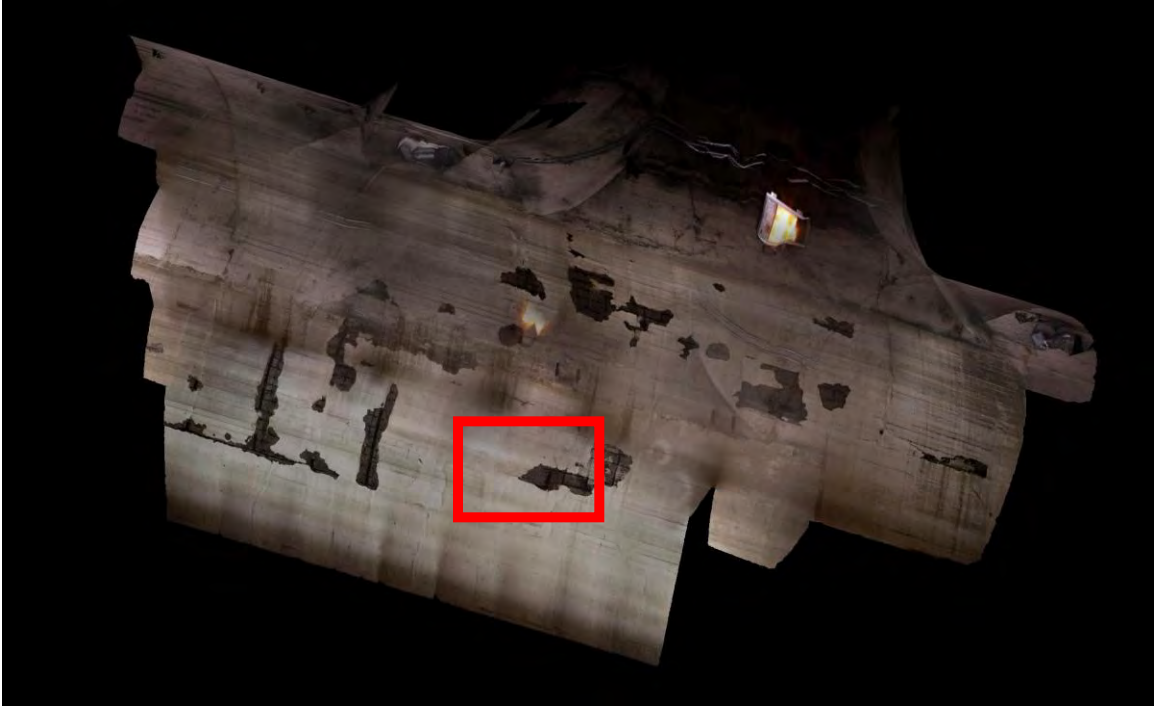
Figure X-2. Three-dimensional model of Liberty Tunnel inbound tube by the ventilation shaft.

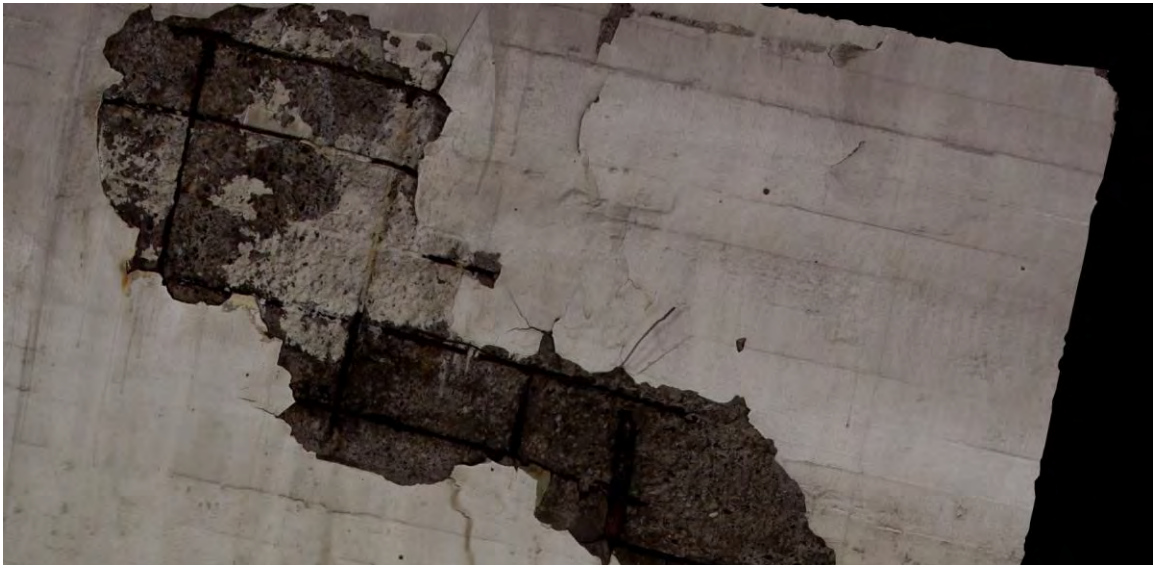
Figure X-3. Detail of spalling by the ventilation shaft.

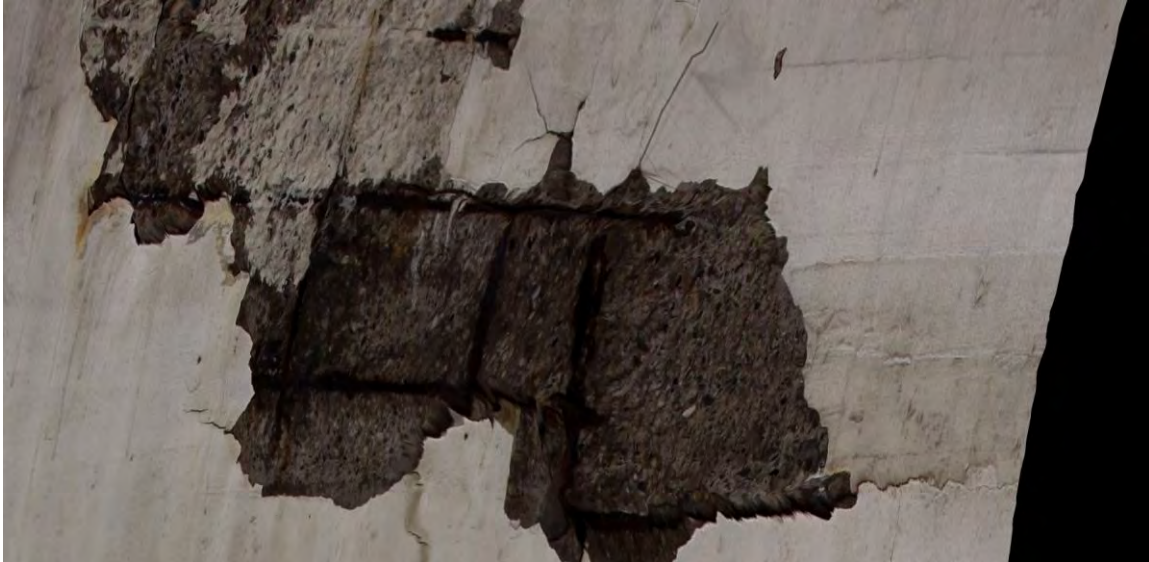
Figure X-4. Foreshortened view of spalling by the ventilation shaft.

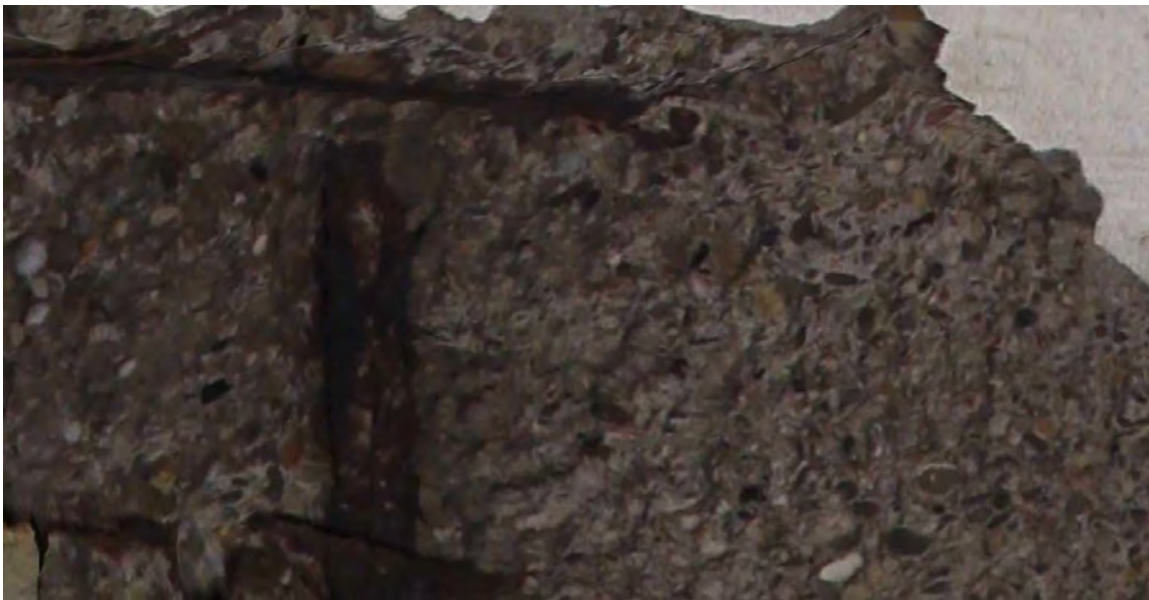
Figure X-5. Detail of exposed aggregate and rebar by the ventilation shaft.

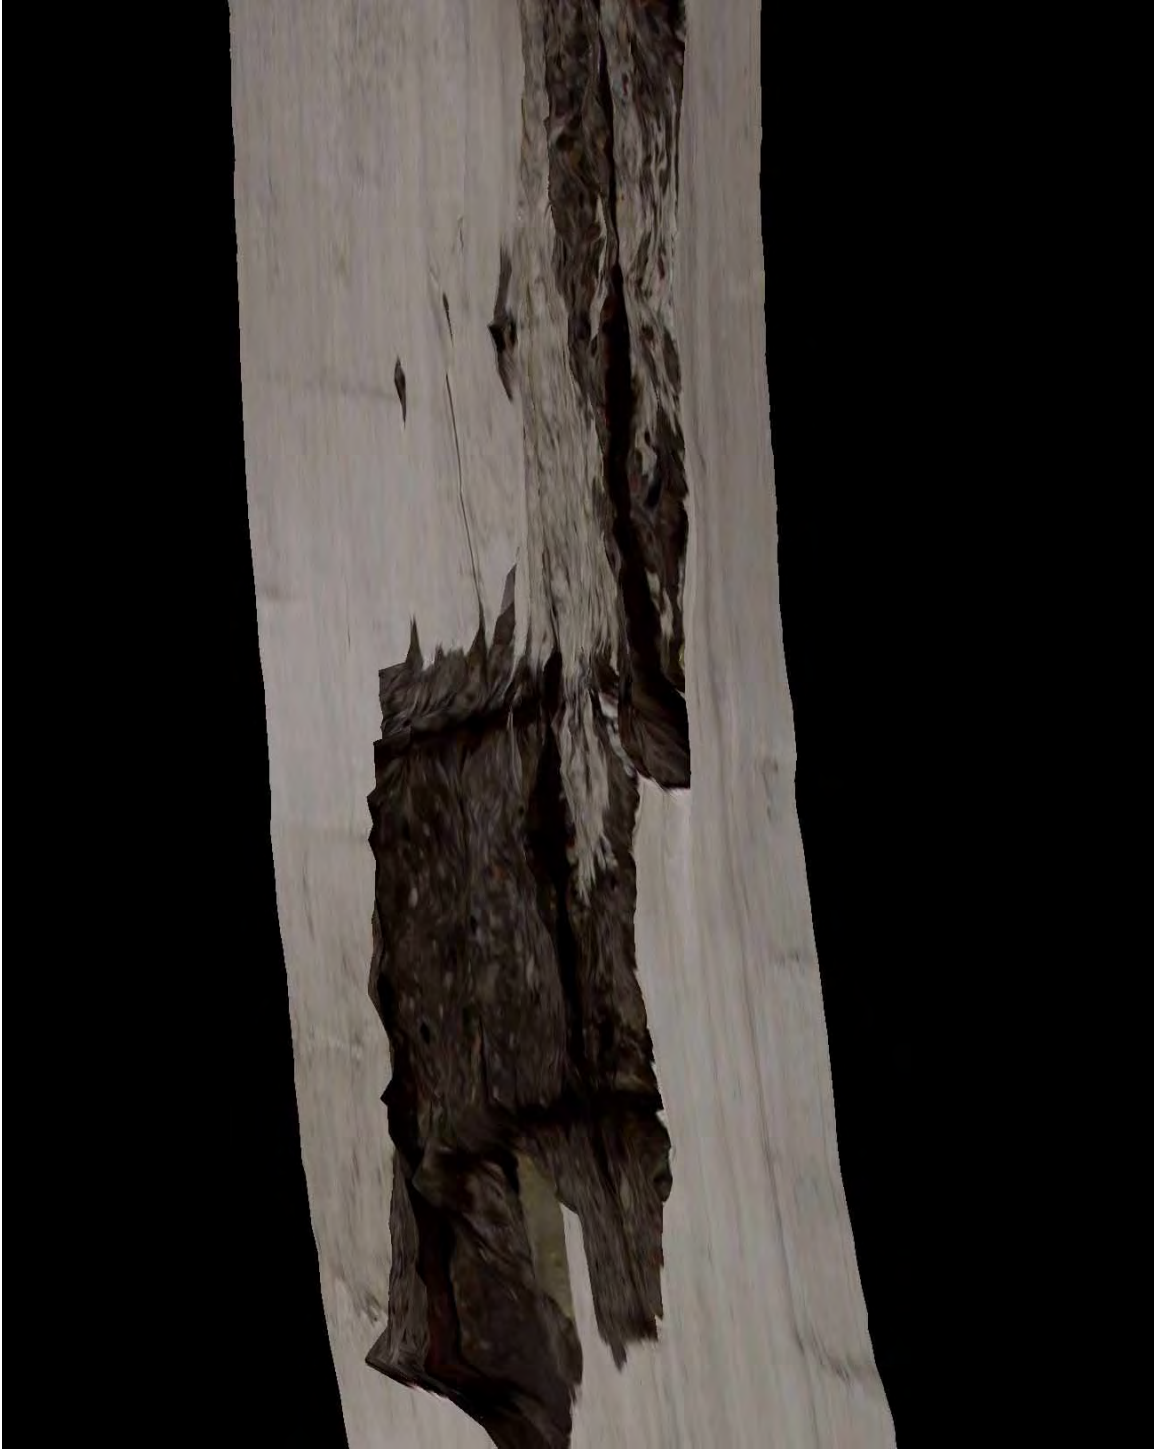
Figure X-6. Backside view of spalling by the ventilation shaft to better appreciate spalling depth and extent.

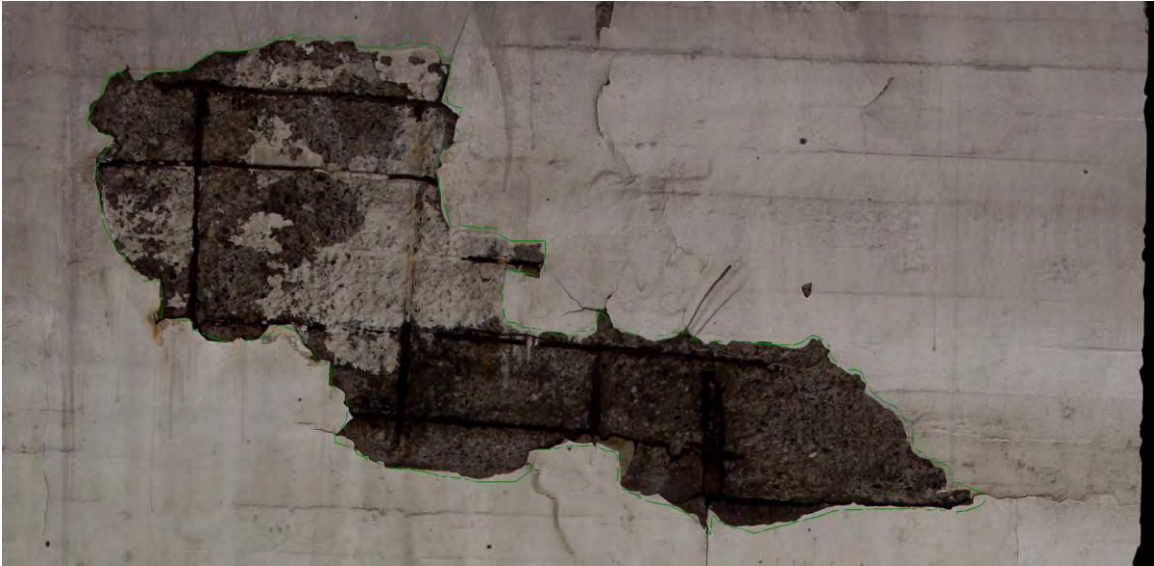
Figure X-7. Closed polyline to determine area of spalling by the ventilation shaft.

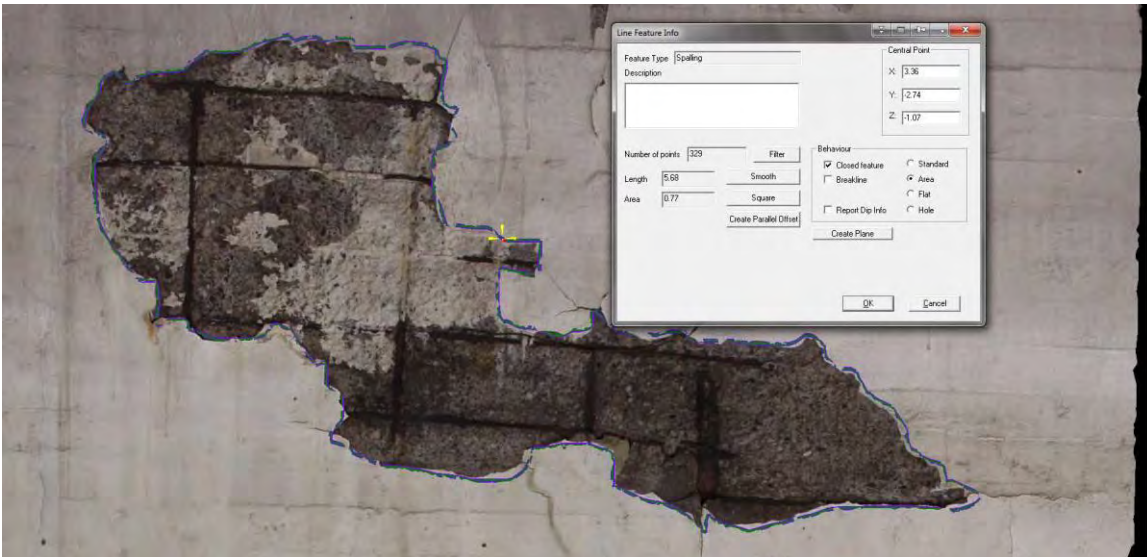
Figure X-8. Information on spalling by the ventilation shaft: coordinates of center point and area.

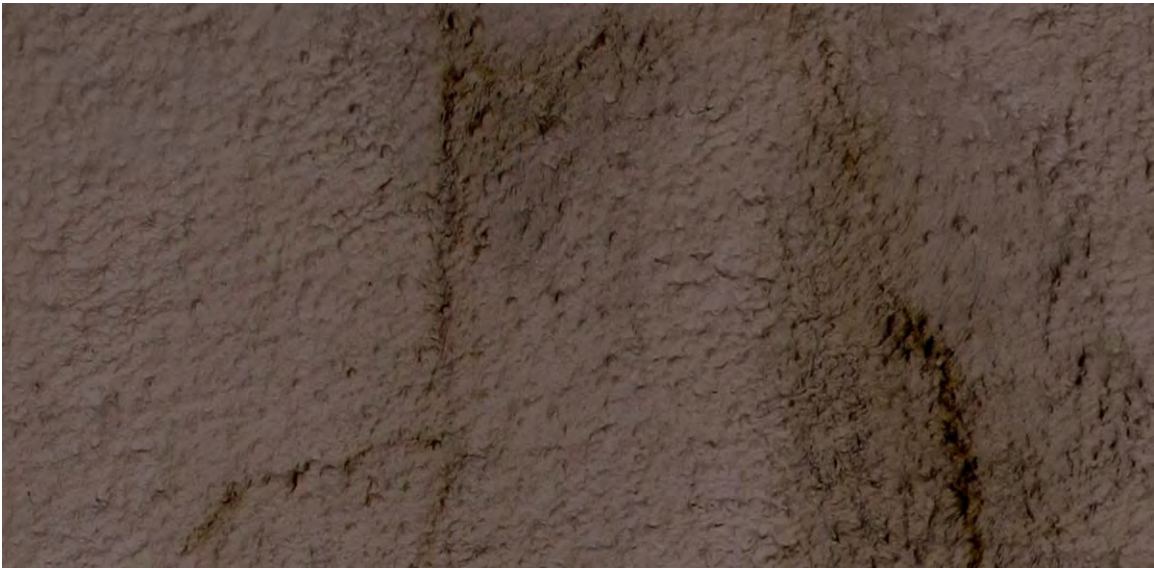
Figure X-12. Detail of shotcrete cracks on left wall by the southern portal with digitized cracks toggled off.

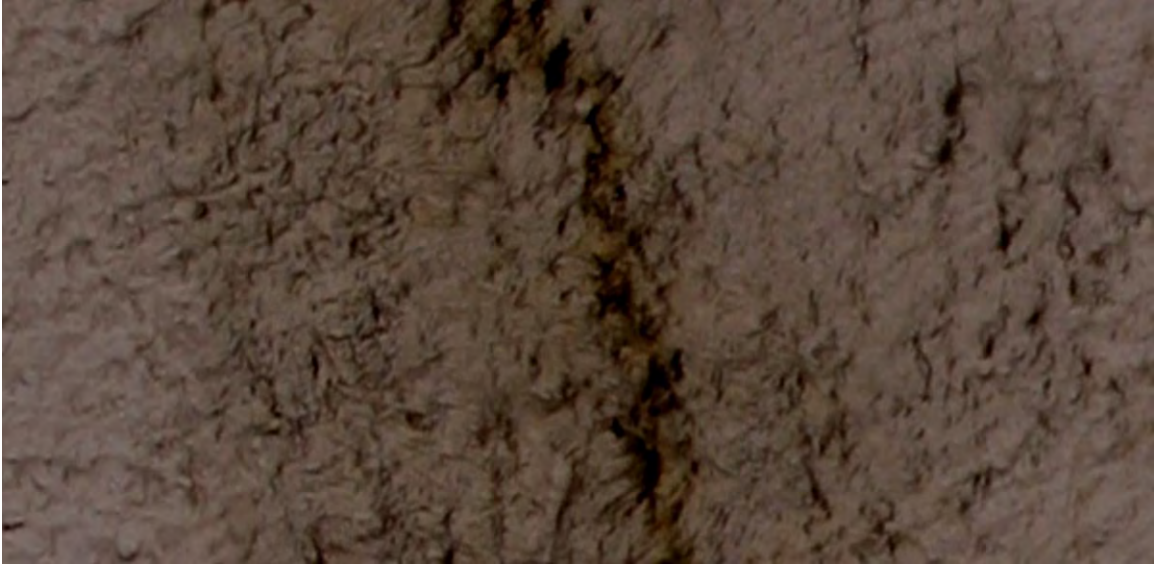
Figure X-13. Close-up view of shotcrete crack on left wall by the southern portal: detail of surface roughness.

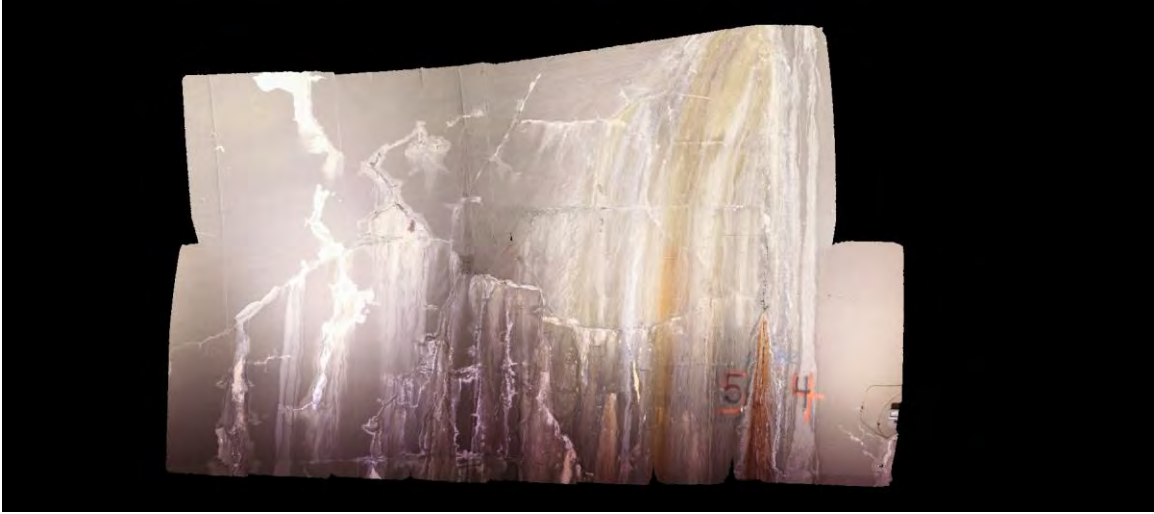
Figure X-19. Eisenhower-Johnson Tunnel: clean air supply duct south-west ventilation building: view of the south lining wall from within the duct.

Figure X-16 through Figure X-21 illustrate the three-dimensional model of the clean air supply duct at the Eisenhower-Johnson Tunnel. In this research, special lighting systems have been devised to evenly illuminate the lining even in dark situations, such as air ducts, and to ensure that the colors of the lining are reliably reproduced. The pipes attached to the divider wall have not been reproduced satisfactorily in three dimensions: this is due to the fact that pattern is needed in photogrammetry to find relative-only points, and steel pipes have very little, if any, pattern. In any case, one of the objectives of this application was to check the use of photogrammetry in surveying a divider wall with embedded steel hangers that cannot be examined by any nondestructive technique. Details of the divider walls are given in Figure X-17 and Figure X-18, and a global accuracy of 1 mm was achieved; this ensures that progressive yielding of a hanger (or hangers) may be detected if surveys of this kind are carried out systematically. Figure X-19 and Figure X-20 depict the model of the south wall as seen from the inside of the tunnel, where several cracks are evident. Some of the cracks have been digitized in Figure X-20: one is a typical construction (pour) joint, but the others are not, and their orientation allows one to infer the causes of distress in a specific area of the lining. Such inferences are very difficult to make while inspecting the tunnel and mapping the cracks by hand. Finally, Figure X-21 provides a detail of a cracked area of the lining.

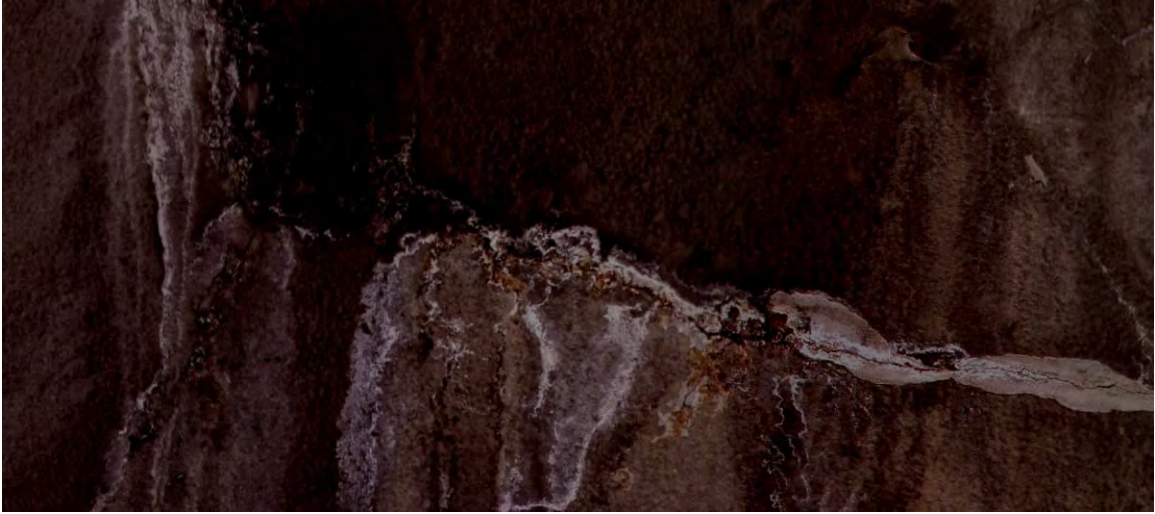
Figure X-21. Eisenhower-Johnson Tunnel: clean air supply duct south-west ventilation building: detail of the south lining wall from within the duct.
