# **REPORT TO CONGRESS**

## **School Bus Safety: Crashworthiness Research**

**April 2002**

**Research and Development  
National Highway Traffic Safety Administration**

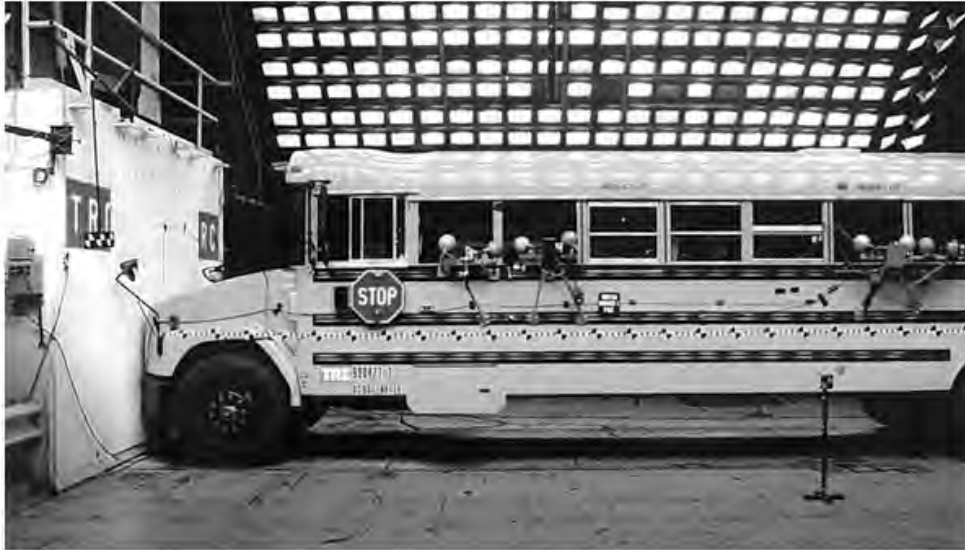
**Figure 1. Pre-Crash Photograph of Frontal School Bus Test.**

Figure 1 shows the pre-impact conditions for the test. Figure 2 presents the final resting position of the bus after the impact with the rigid wall.

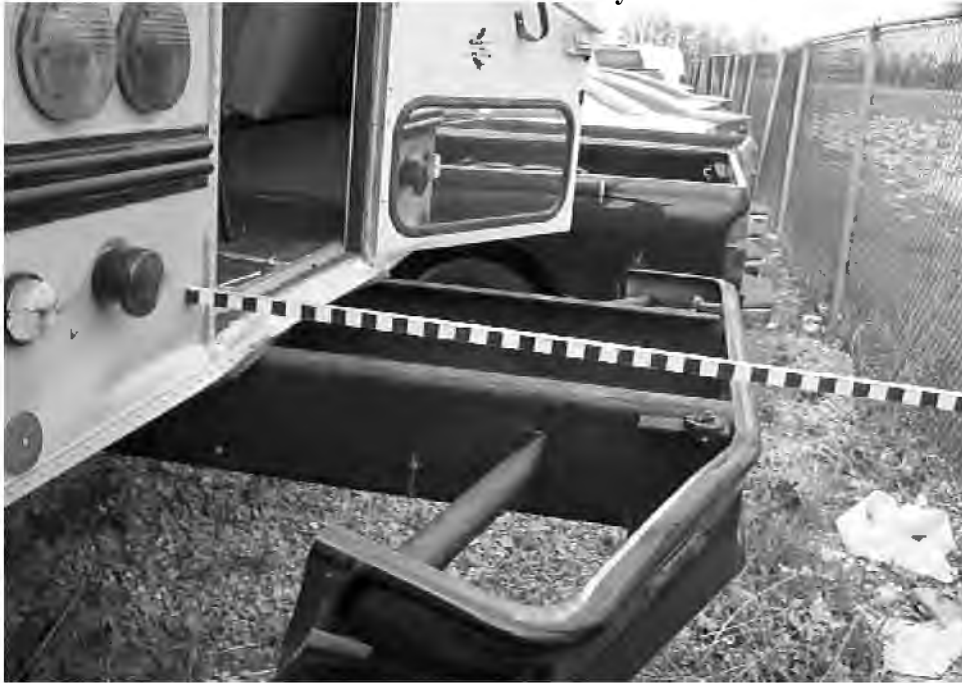
As typical of large school bus manufacture, the body of the bus is mounted to the frame rails of the chassis by a series of clips or clamps. As shown in Figure 3, this non-rigid mounting feature allowed the bus body to slide forward approximately 36 inches (92 cm) during impact. This dissipation of impact energy over a longer time duration acted to reduce the interior contact speeds and resulting acceleration levels on the vehicle's occupants.

Figure 3. Post-Test Photograph of Frontal Test Showing Body to Frame Movement

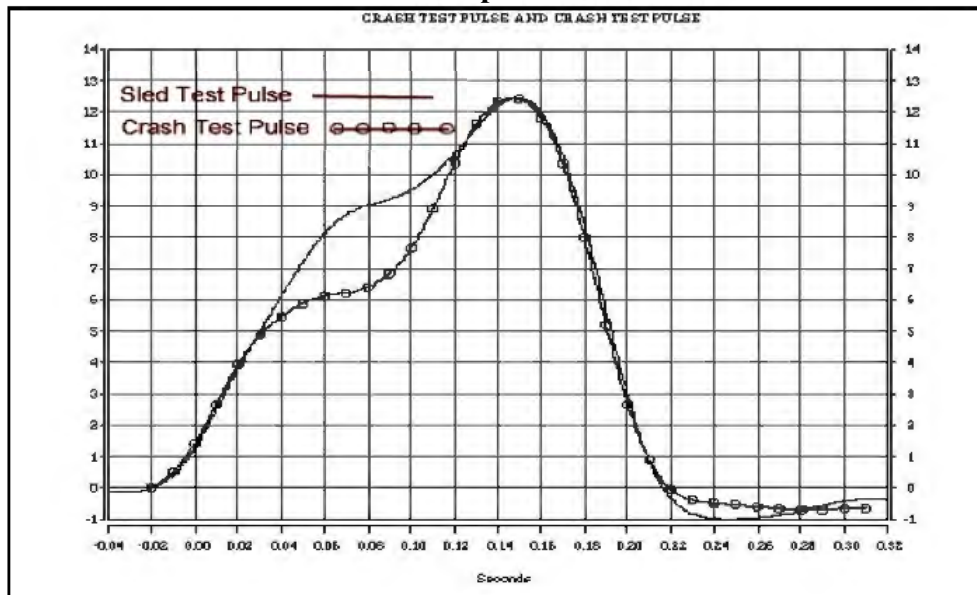
The leveling off of the acceleration pulse of the crash test from about 40-90 milliseconds is a result of the bus body sliding along the chassis. The sled’s “metering pin” did not exactly replicate this plateau, producing somewhat higher acceleration in this zone. This resulted in a slightly higher velocity change (delta-V). Delta-Vs for the sled tests were about 35 to 37 mph.

**Figure 6. Crash Test Deceleration Pulse with Sled Pulse Overlay**

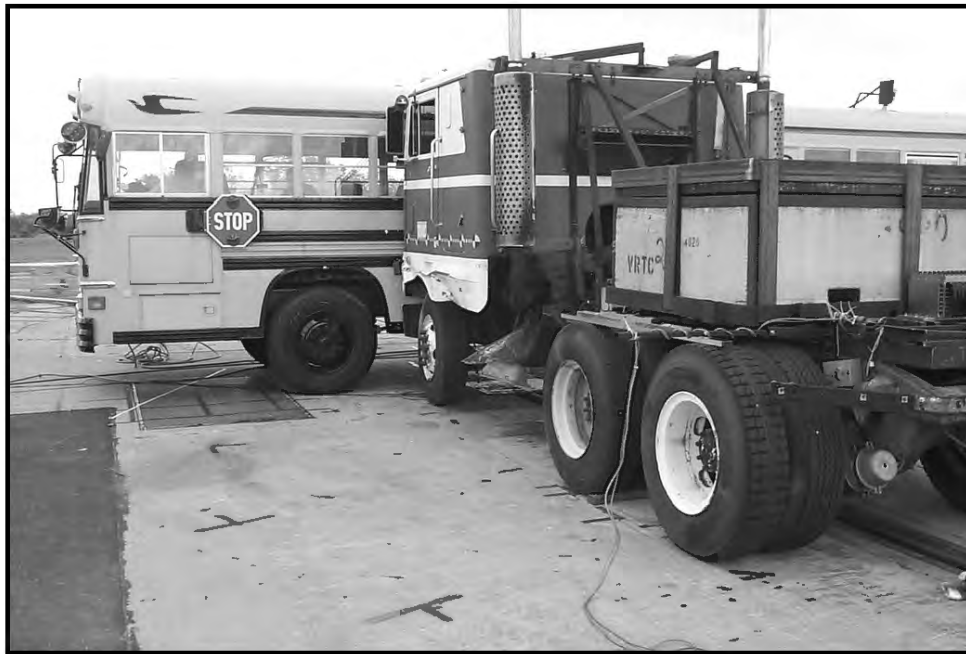
**Figure 7. Pre-Test Photograph of Side Impact School Bus Crash Showing Bullet Truck**

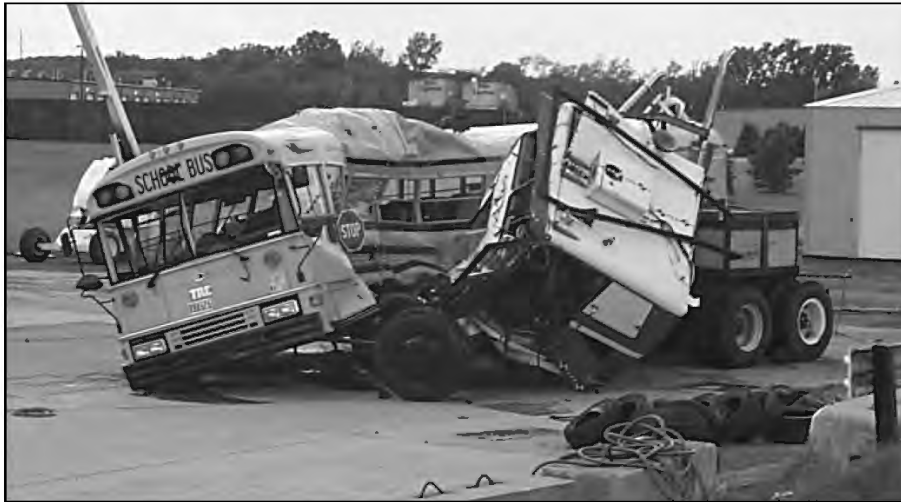
A post-impact photograph showing the post-crash positions of the school bus and truck is contained in Figure 8. During impact, the truck penetrated the bus side approximately half way into the compartment, and remained engaged while rotating 180 degrees before coming to a stop. The front axles were severed from both vehicles as seen in Figure 8.

**Figure 8. Post-Test Photograph Showing Final Resting Positions**

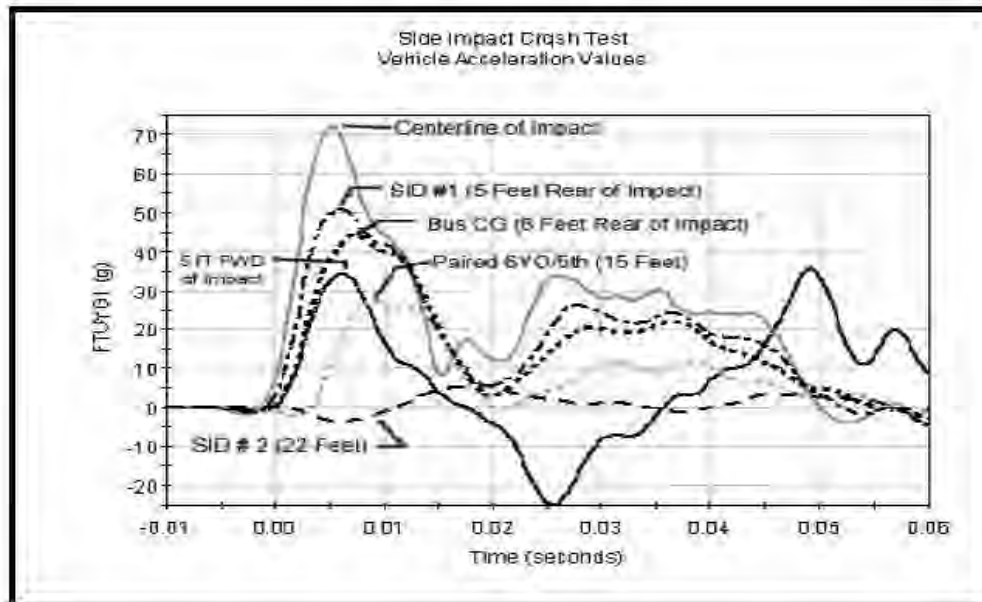
Accelerometers were positioned along the length of the school bus. Figure 10 shows the acceleration time histories overlaid for this test. At the center of impact, the peak lateral acceleration was 72 g's. Acceleration levels drop significantly away from the point of impact. This is largely due to the amount of deformation that occurred at the point of impact. This deformation acted to absorb/dissipate much of the energy that would otherwise have been transmitted to the occupants of the bus.

Figure 10. Side Impact School Bus Acceleration at Various Locations in the Bus

Unlike the frontal crash, no single pulse is fully representative of the range of vehicle responses observed in the side impact crash. Generally, all accelerometers measured an increasing level of acceleration with the peak occurring in the 50 to 75 milliseconds range. The magnitude of the peak acceleration was directly related to the proximity of the accelerometer to the impact point, with the accelerometer directly in line with the impacting vehicle's centerline registering the highest.

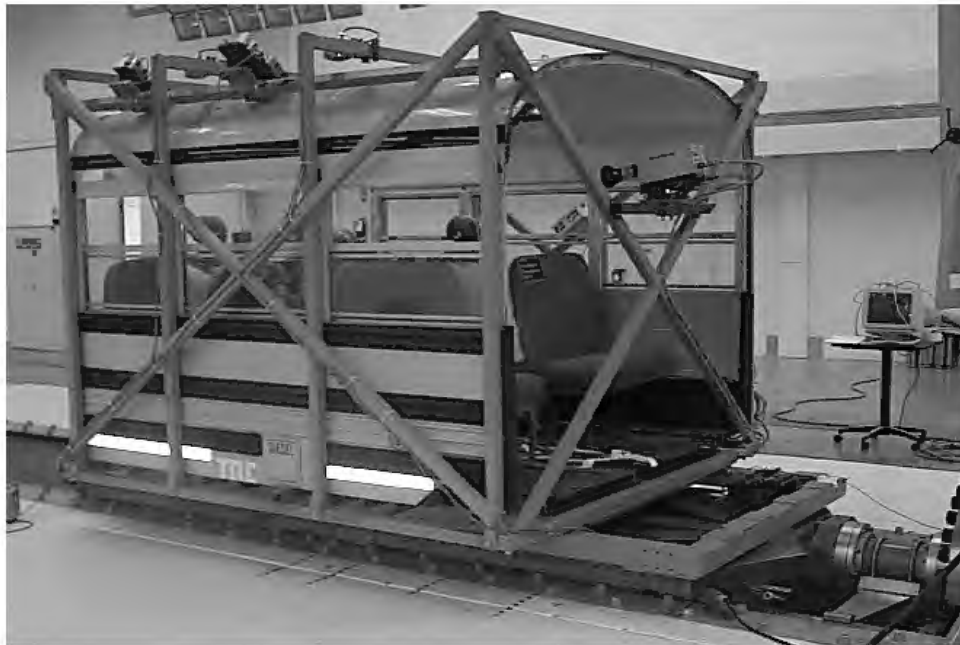
Sled tests were conducted using two different test bucks to evaluate bus safety restraint systems. The first test buck was fabricated by mounting a section from the body of the school bus on the sled. This was done to assess the degree of deformation/energy absorption by the bus floor and its interaction with the seats, and to assess any potential for occupant interaction with portions of the interior other than the seats themselves. The finished test buck is shown in Figure 11. The bus body section contained three rows of seats on both the right and left side of the center aisle. This allowed for testing a maximum of 2 rows of dummies per test.

**Figure 11. First Sled Buck used in Simulating Frontal Crashes**

Testing with the first sled buck showed that there was no significant interaction between the dummies and the walls or ceiling of the bus shell; but there was some incremental damage to the

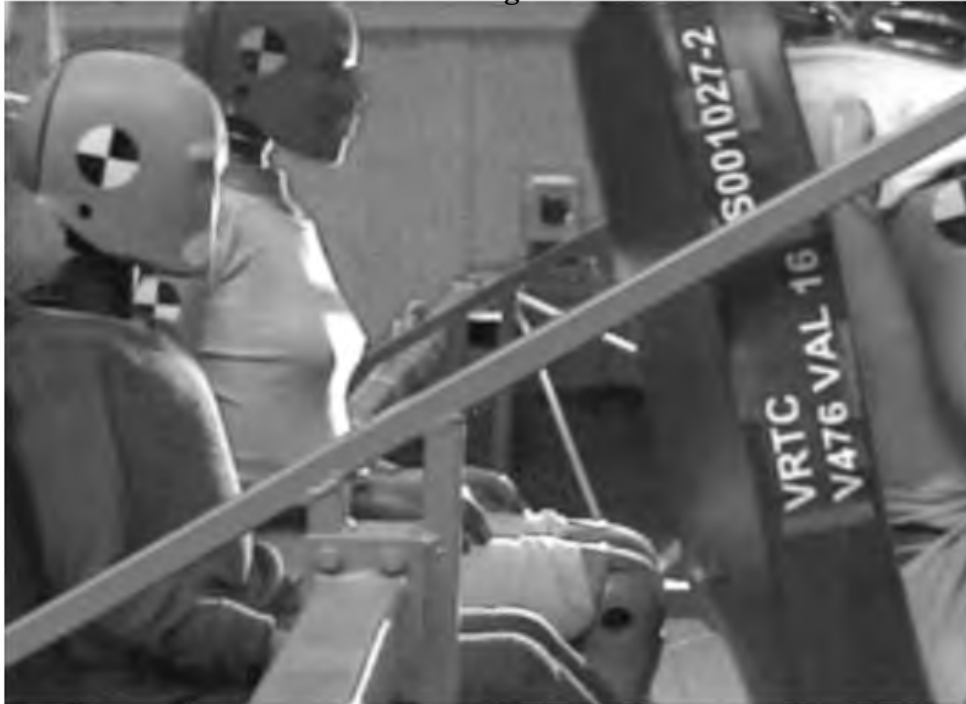
Figure 16. Initial Position of the 6-year-old and 5th Percentile Female Dummies

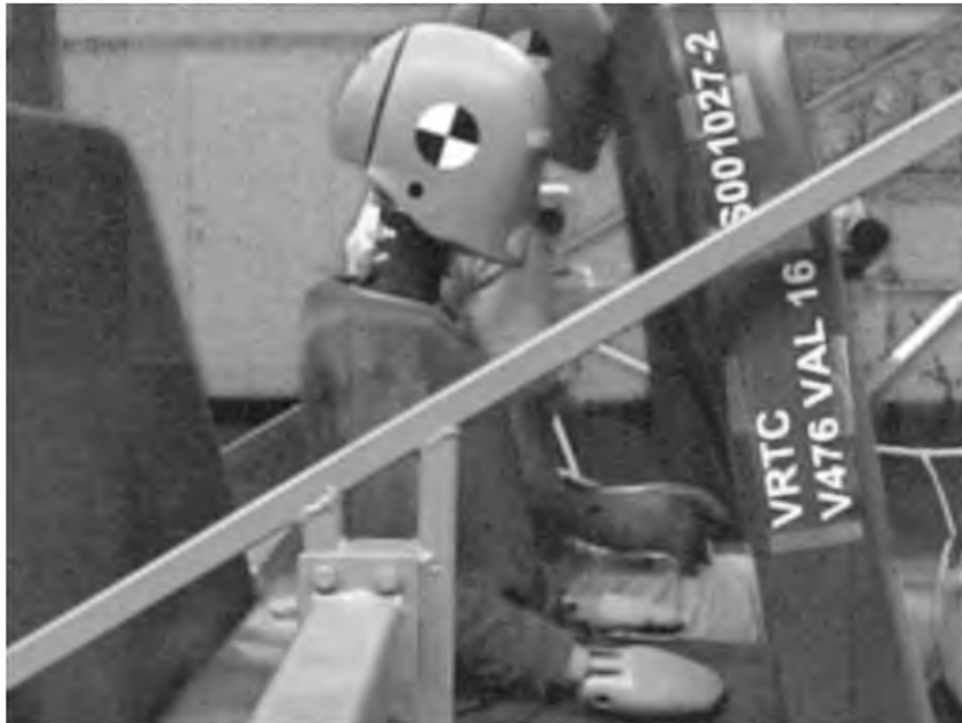
With the onset of the test, the dummy slides forward on the bench seat. The dummy remains in an upright-seated position until the knees of the dummy strike the seat back in front of it. At this point the upper torso begins to rotate forward and downward. The dummy's head strikes the seat back, pushing the head backward which bends the neck. Figure 17 is an image taken at 100 milliseconds into the crash event at the point of knee contact.

Figure 17. Compartmentalization Test, Knees make Contact with Seat Back at 100 msec

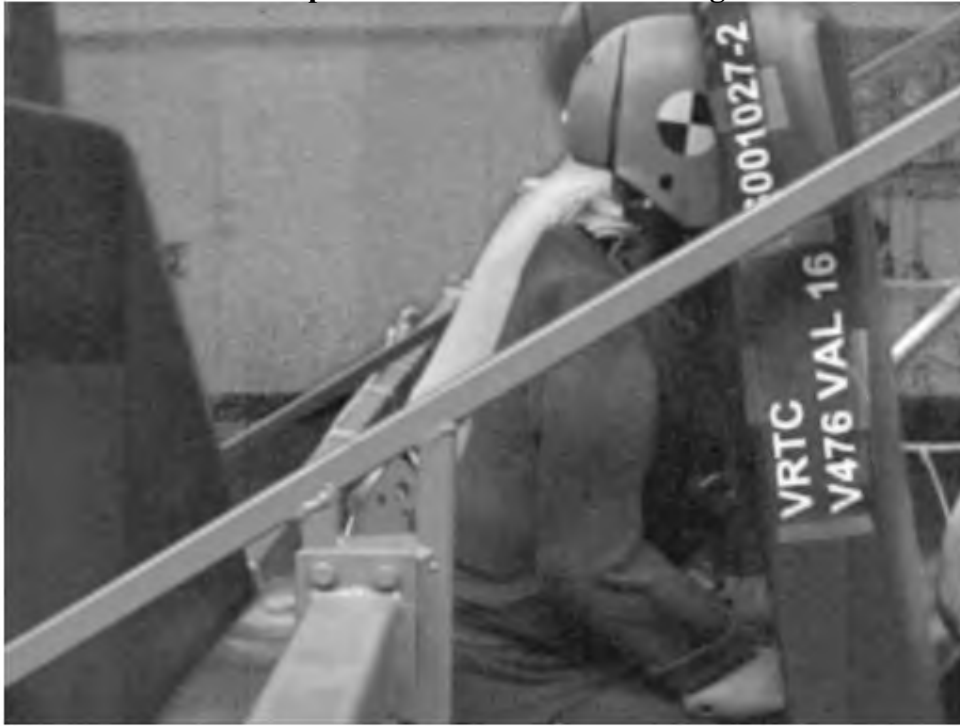
As the dummy continues to slide forward the head and neck are driven rearward in extension. This continues until the shoulders and upper torso of the dummy reach the seat back and reduce loading on the head and neck. During this portion of the event, the knees and legs of the dummy generally slide below the bench of the impacted seat. Figure 18 is an image taken at 150 milliseconds into the event at the point of maximum extension of the neck. The neck injury criterion typically reached its maximum value either shortly after the head impact, or near the point of maximum neck extension. This point of maximum Nij varies from test to test.

Figure 18. Compartmentalization Test, Upper Body Pivots and Head Contacts at 150 msec

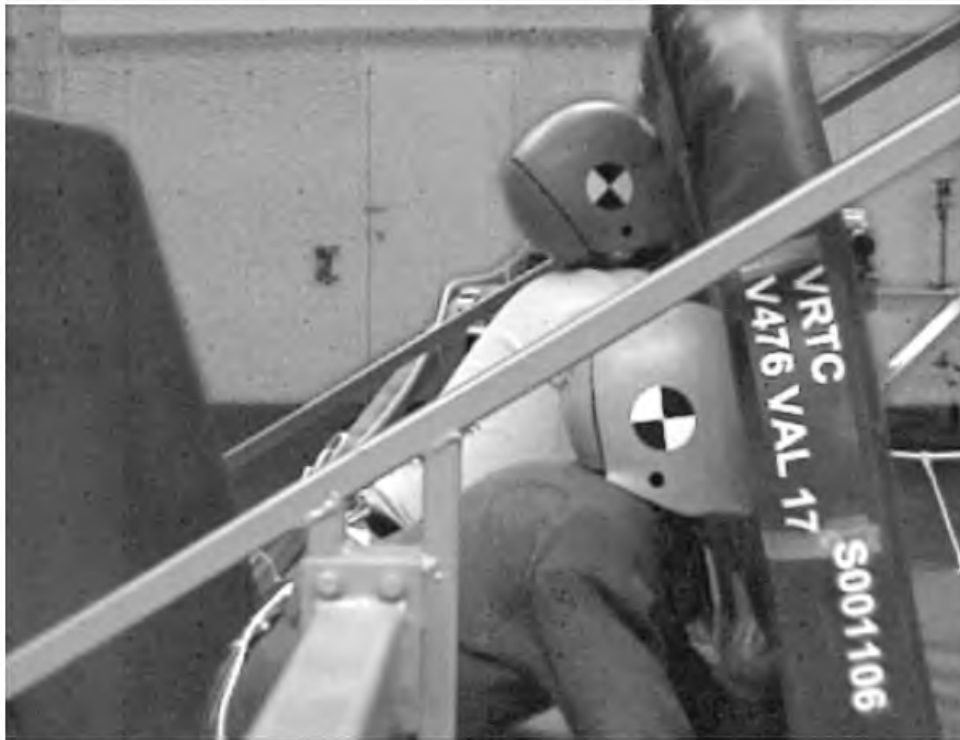
A notable difference between the motion of the unbelted and the lap belted dummies is the point at which the forward motion of the dummy stops and torso rotation begins. For the unbelted dummy, this occurs when the knees impact the seat back. For the lap belted dummy, this occurs when the belt becomes taut. This determines when, or if, the upper torso comes into contact with the seat back. For the small 6-year-old dummy, this did not occur in any of the lap belted tests. For the larger 5<sup>th</sup> percentile female and 50<sup>th</sup> percentile male dummies, the degree of upper torso involvement, which could have a profound effect on the neck loading, was dictated by seat spacing.

Figure 20. Lap Belt Test at Maximum Neck Extension, 150 msec

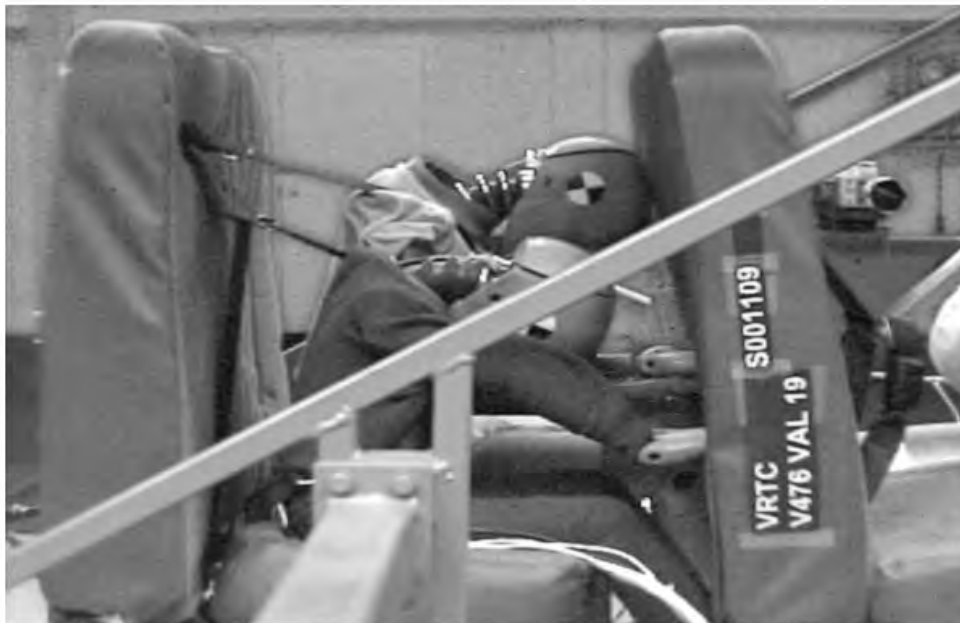
The lap/shoulder belt restraint systems typically prevented head impact into the seat back. The few exceptions with the 50<sup>th</sup> percentile male dummy resulted in very minor impacts with low resulting injury criteria values. As seen in Figure 21, a 5<sup>th</sup> percentile female and 6-year-old dummy were restrained properly with the lap/shoulder belt systems. The injury criteria values observed were the results of inertial loading on the head and neck as they snapped forward when the torso was restrained by the restraint system.

Figure 21. Lap/Shoulder Belt Test at Maximum Neck Flexion

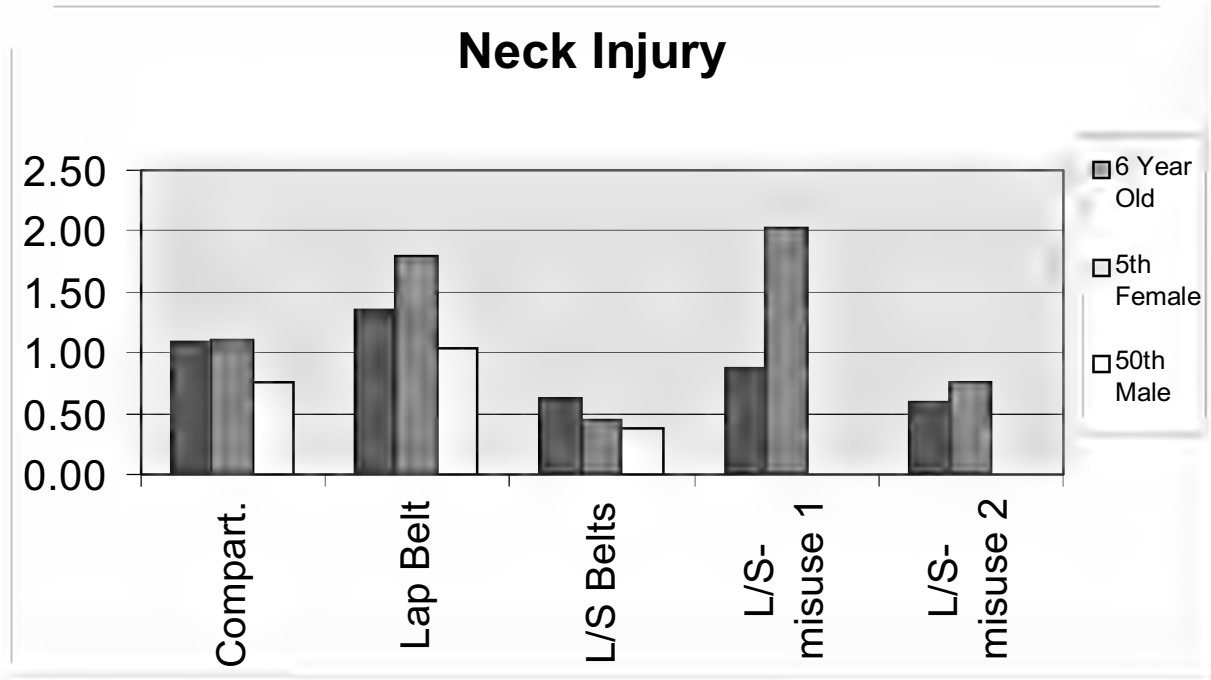
The average neck injury scores (denoted using Nij data) are presented in Figure 23. Here dummy readings are above and below the reference value, indicating some conditions have a much higher risk of neck injury than others. For neck injury, a Nij of 1 equates to a 22 percent risk of a serious neck injury while a Nij of 2 equates to a 67 percent risk of serious neck injury.

**Figure 23. Summary of Average Nij Scores Sled Tests Simulating Frontal Crashes**

**5<sup>th</sup> Percentile Female Dummy:** The average  $N_{ij}$  response value for the 5<sup>th</sup> percentile female dummy was higher (See Figure 23) and had a much greater range of responses ( $N_{ij} = 0.48$  to 2.85) than for either the 6-year-old or the 50<sup>th</sup> percentile male dummies. The highest  $N_{ij}$  values observed for this test program occurred with the lap belt tests for this dummy size.

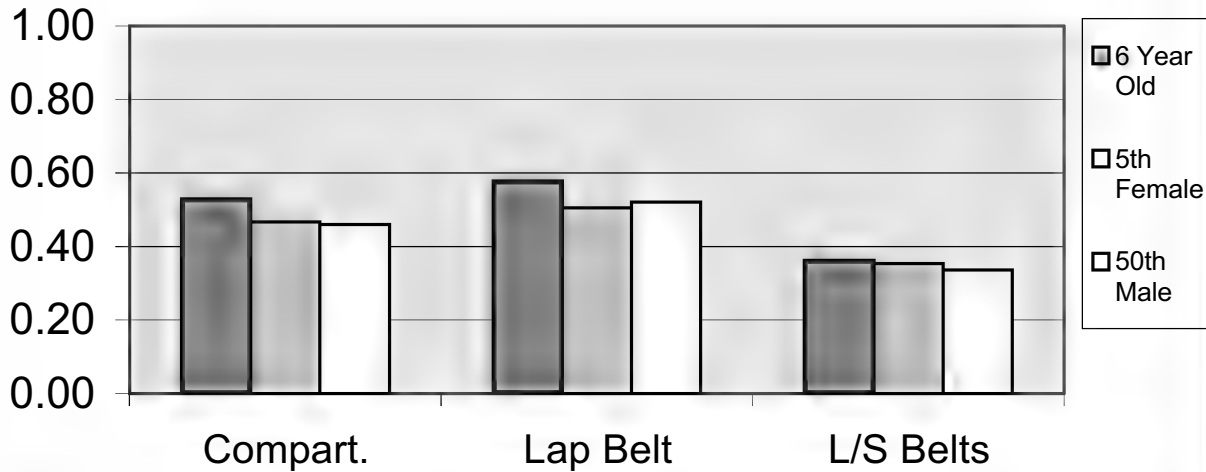
The primary injury criterion used for evaluating chest injury potential is the 3-millisecond Chest Acceleration as specified in FMVSS 208. The reference value for this criterion is 60 g's for all three of the dummy sizes used in these tests. Figure 24 summarizes the normalized average results of the testing. None of the test results showed any significant threat to injury for any of the restraint systems tested.

Figure 24. Normalized 3-msec Chest Acceleration for Frontal Sled Tests

The general kinematics along with the closely spaced and padded seat backs provided good protection to the chest for the unbelted occupant in the compartmentalized seat. The lap belt prevented the upper torso from making significant contact with the padded seat back therefore minimizing any potential loading on the chest. The shoulder portion of the lap/shoulder belt restraint system did potentially apply a load to the chest through the shoulder belt portion of the restraint system. However, the relatively low peak acceleration loads within the passenger compartment kept loading on the chest to very low levels.
