# CALIFORNIA

## HIGHWAYS AND PUBLIC WORKS

MAY  
1942

## Table of Contents

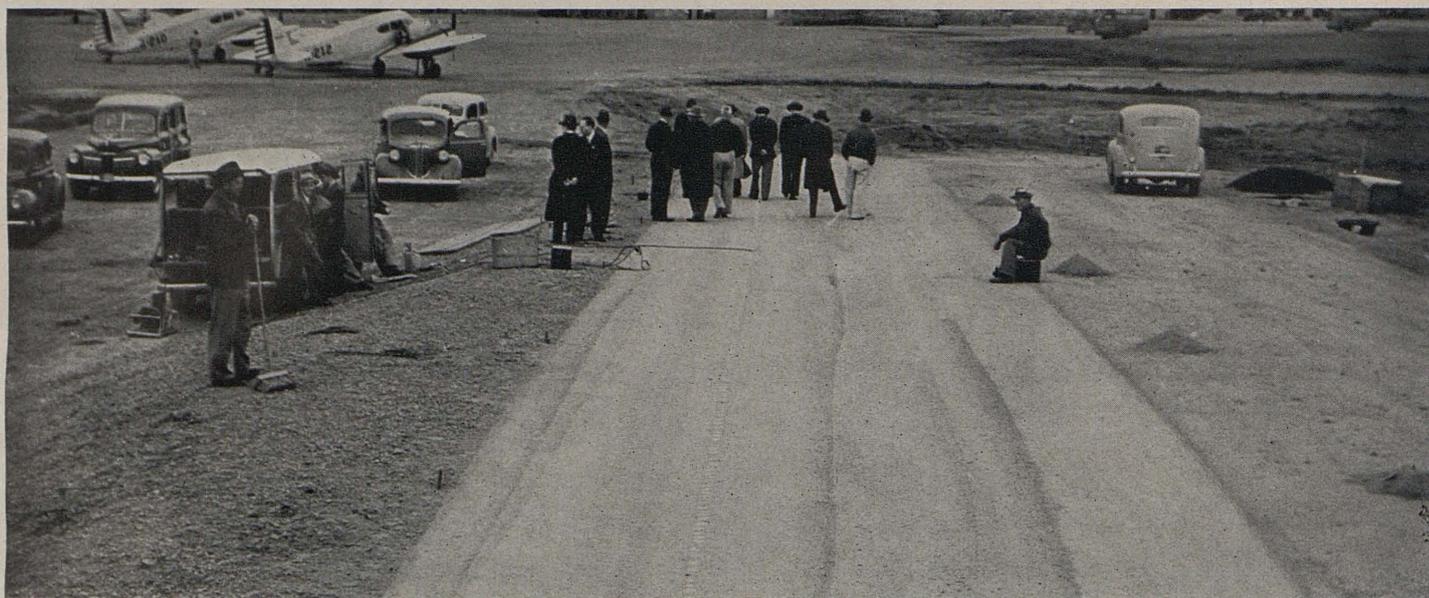
Army engineers inspect runway test pavement at Stockton field. Electric recording equipment for measuring subgrade pressure and pavement deflection under heavy wheel loads is mounted in station wagon at left

The tests recently made for the Army Engineers on the Stockton Runway Test Section with wheel loads duplicating the footprint and contact pressure of heavy bombers were presented, together with a tentative criteria for the design of foundations for flexible pavements. The necessity of drainage and the proper use of thick layers of imported fill material and substantial base courses to carry heavy bombers over weak soils was clearly developed during this session.

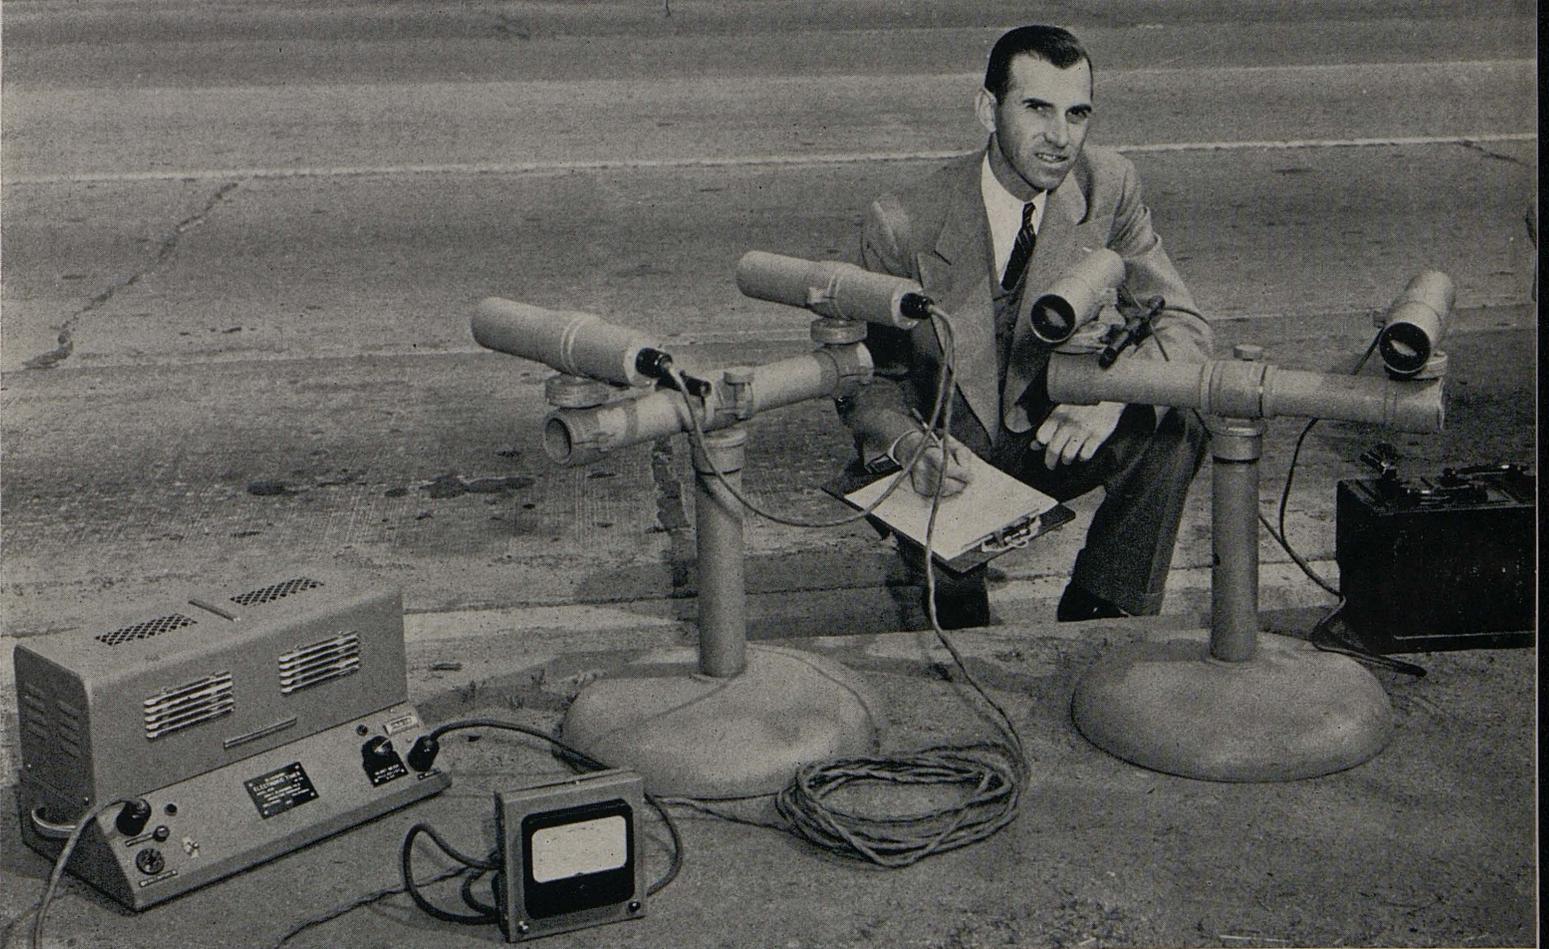
Views of new photo-electric roadside speed timer in action at top. Units of the apparatus are shown below with District Traffic Engineer W. M. Rieth who supervised its development

After the instrument has been set up, and the switch turned on, it takes about one minute for the tubes to warm up. The meter needle moves to the speed at which a vehicle is traveling as it passes through the beam and remains at that point until the reading is cleared by pressing a button. Other passing vehicles do not affect the reading until the meter is cleared. If the meter fails to operate, it is because the light beams are not properly focused upon the photo-cells.

Continuous transporting of the unit in a car may cause the telescopes to get out of alinement. The instrument, however, is fairly rugged and will stand about the same amount of vibration and jarring as a radio.

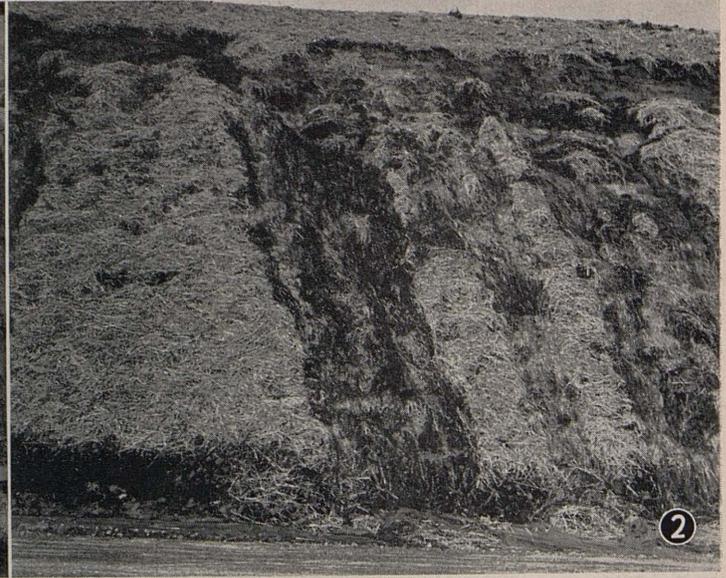
(1) Erosion gullies formed on a top soiled cut slope by 2.13 inches of rain. Note no intercepting drain ditches. (2) Result of 3 days rain, 3.95 inches in 24 hours, on newly treated slopes. Failure due to lack of bond of top soil to subsoil

On December 14, 1941, approximately 12 acres of cut slope had been treated. During the 24-hour period on this date, 3.95 inches of rain fell. The heaviest intensity was 1½ inches per hour for a 30-minute period,

The greatest loss was caused by overflowing water. Broad and shallow intercepting ditches were then constructed and run on flat contours to drain into the natural undisturbed ground. The slipouts were repaired and the gullies packed with straw and seeded.

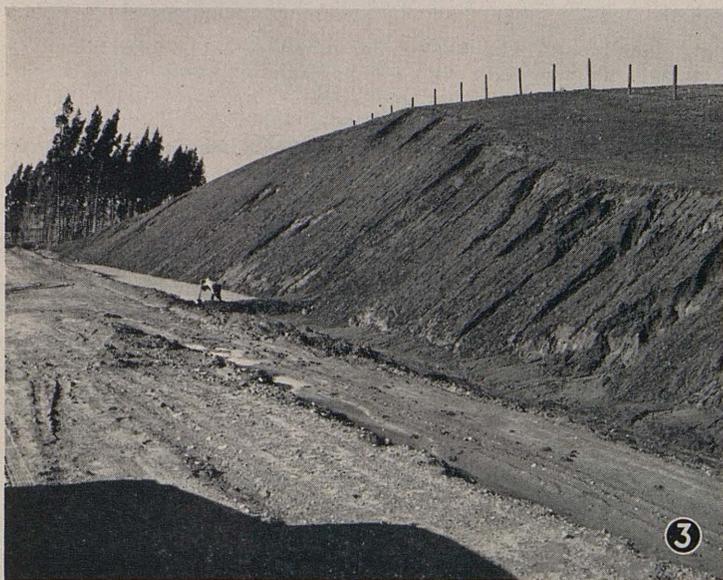
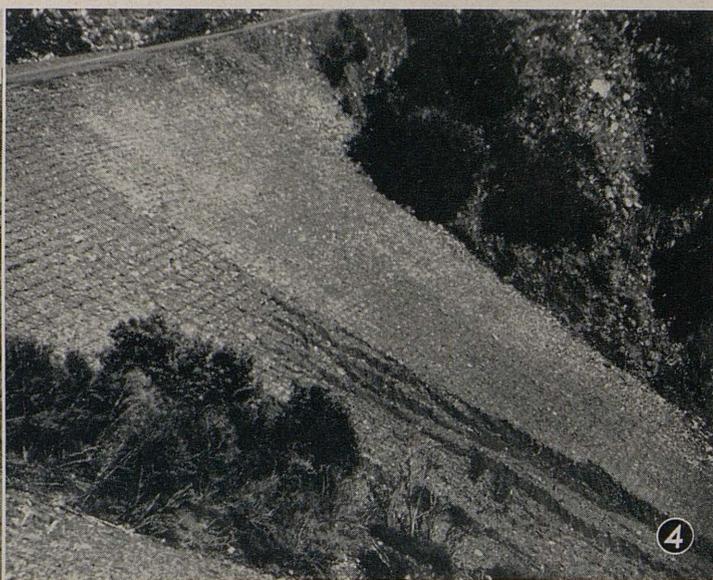
(3) Loss of top soil caused by first rain. No additional loss from subsequent rains has occurred. Soil is clay loam. (4) Fill slope protected by wattle method. On far half wattles were placed approximately 2 feet apart; on near half 4 feet apart. Note effects of erosion

5. To reduce loss of top soil or other applied protection during the first heavy rains a complete bond of the top soil to the subsoil is necessary. Usually the first gentle rains of the season will accomplish this. In the event of heavy down pour, however, the surface application becomes saturated and slips down over the subsoil unless the subsoil is of such character as to absorb the moisture. To prevent this loss, where conditions warrant the cost, a bond may be effected by artificial watering during application.

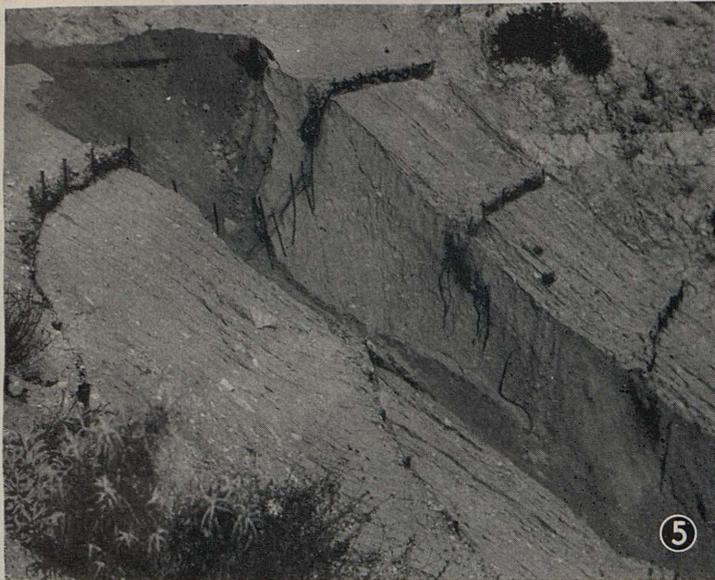
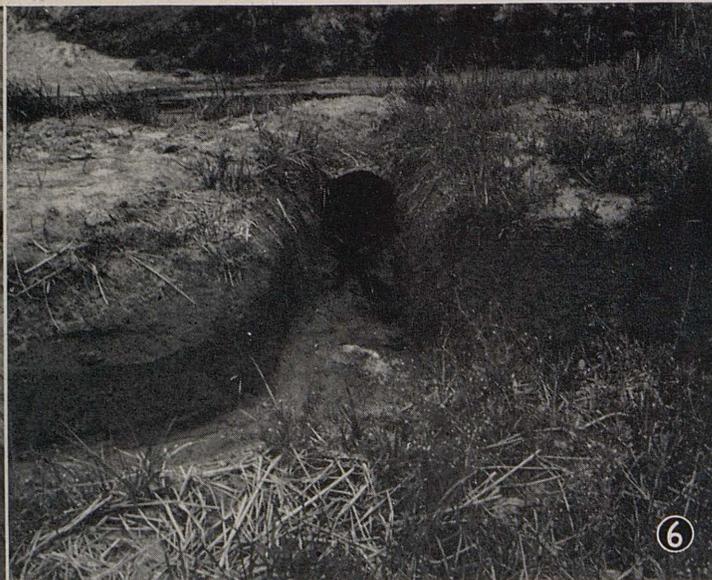
(5) Barriers that retard the flow of water are not successful. Note deep slip out. Highly erodible soils must not be allowed to move. (6) A down drain poorly installed. Water flows under pipe. Flattened and blanketed with humus material would promote grass growth over which water would flow without scouring

The northerly section of the project is still under construction and on which no erosion control work has been done. Severe erosion has taken place on both cut and fill causing slough material to encroach on private property. The extreme erodible condition of the soil can be fully appreciated by the fact that the damage to the new work has occurred since the heavy rainfall of December, 1941. Photo No. 6 illustrates the erosion experienced on this section.

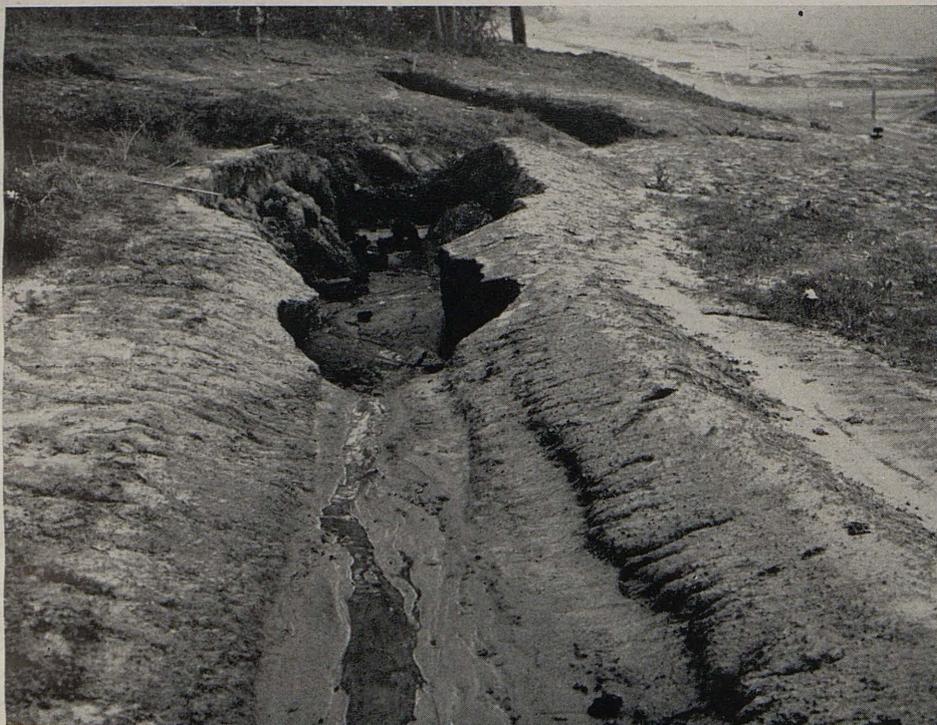
Intercepting drain ditches at top of slope like above also need vegetative protection

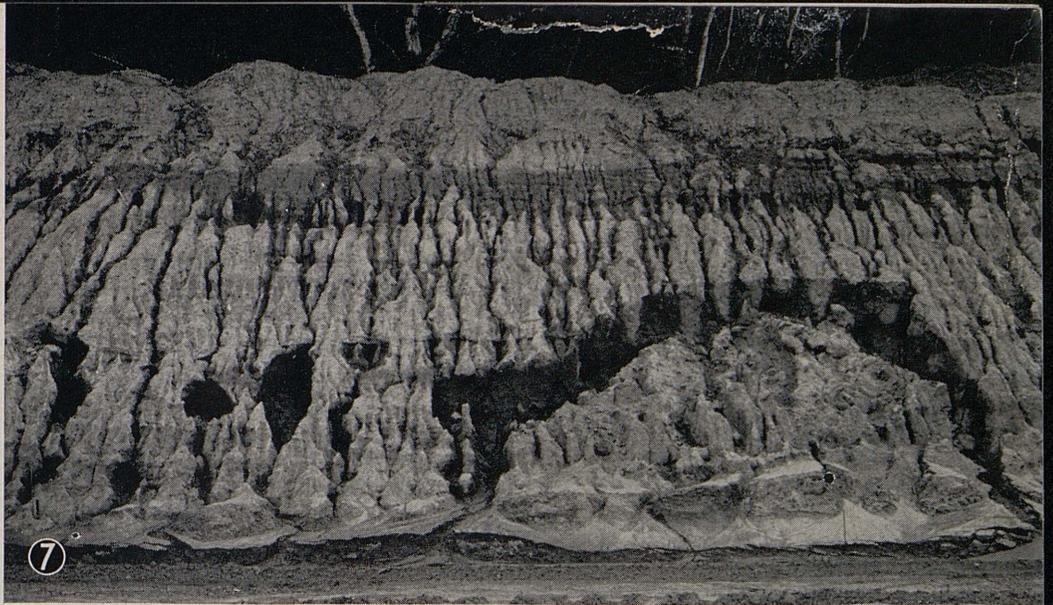
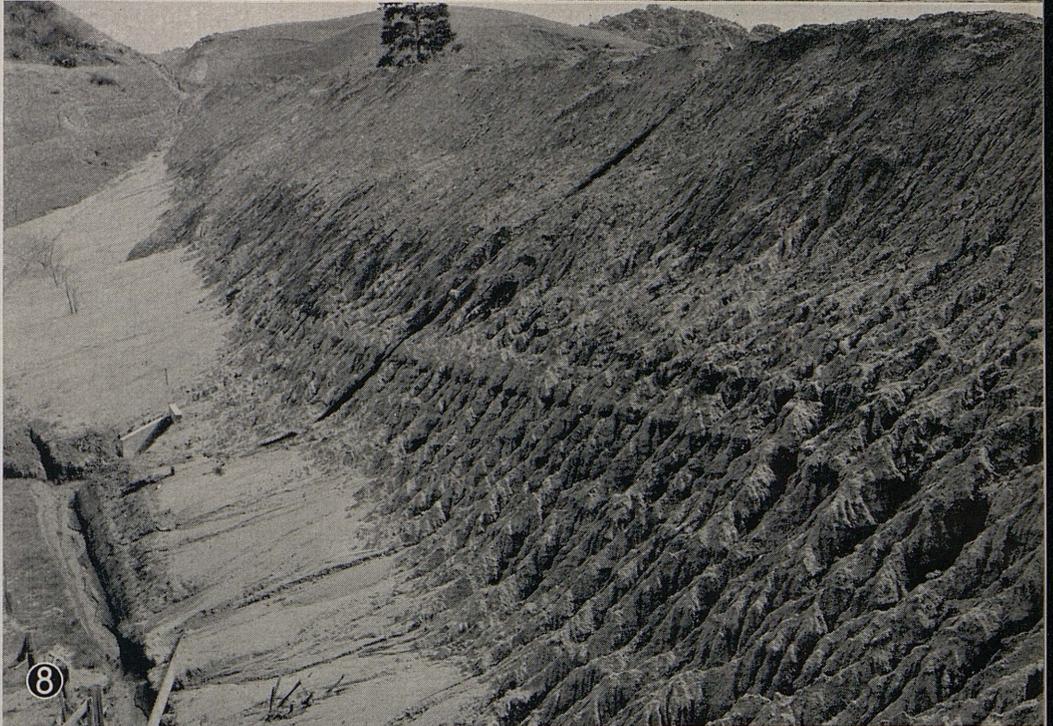
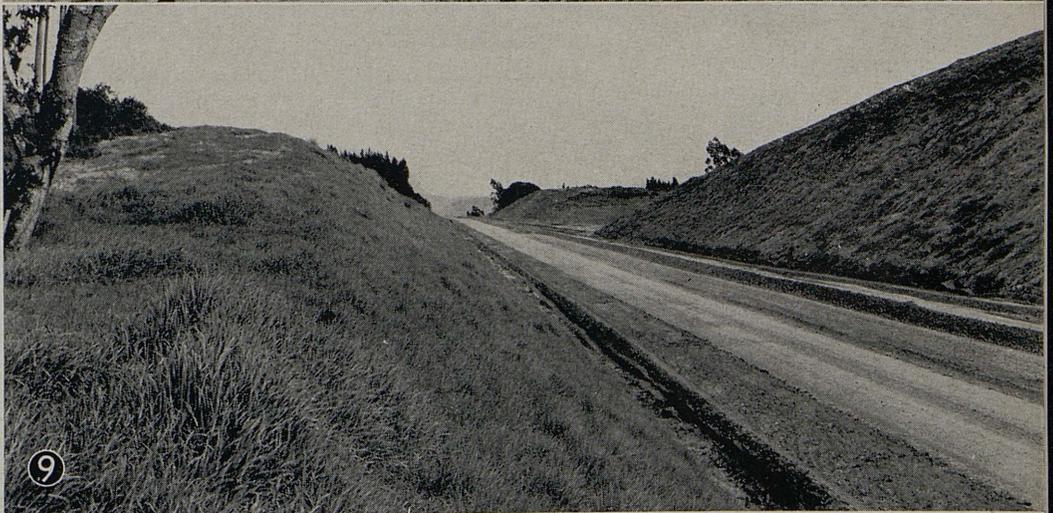
Typical erosion occurring on cut slopes during construction are shown in Nos. 7 and 8. On the same job and same soil  $1\frac{1}{2}$ :1 cut slopes are shown in No. 9 that were stabilized with top soil, rye grass and straw

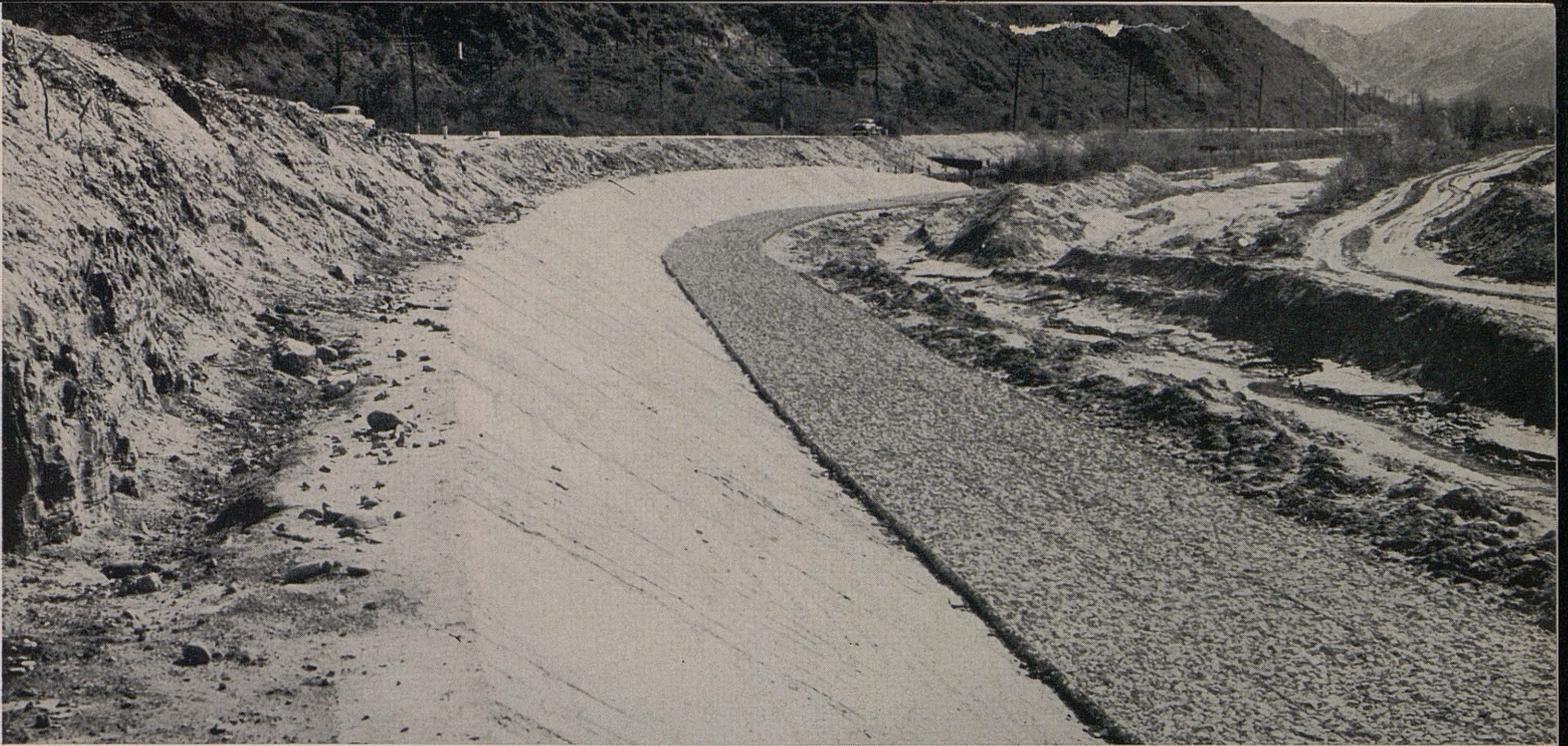
Portland cement concrete revetment on 1½:1 slope 10 inches thick with rock and wire mattress 14 feet 6 inches wide

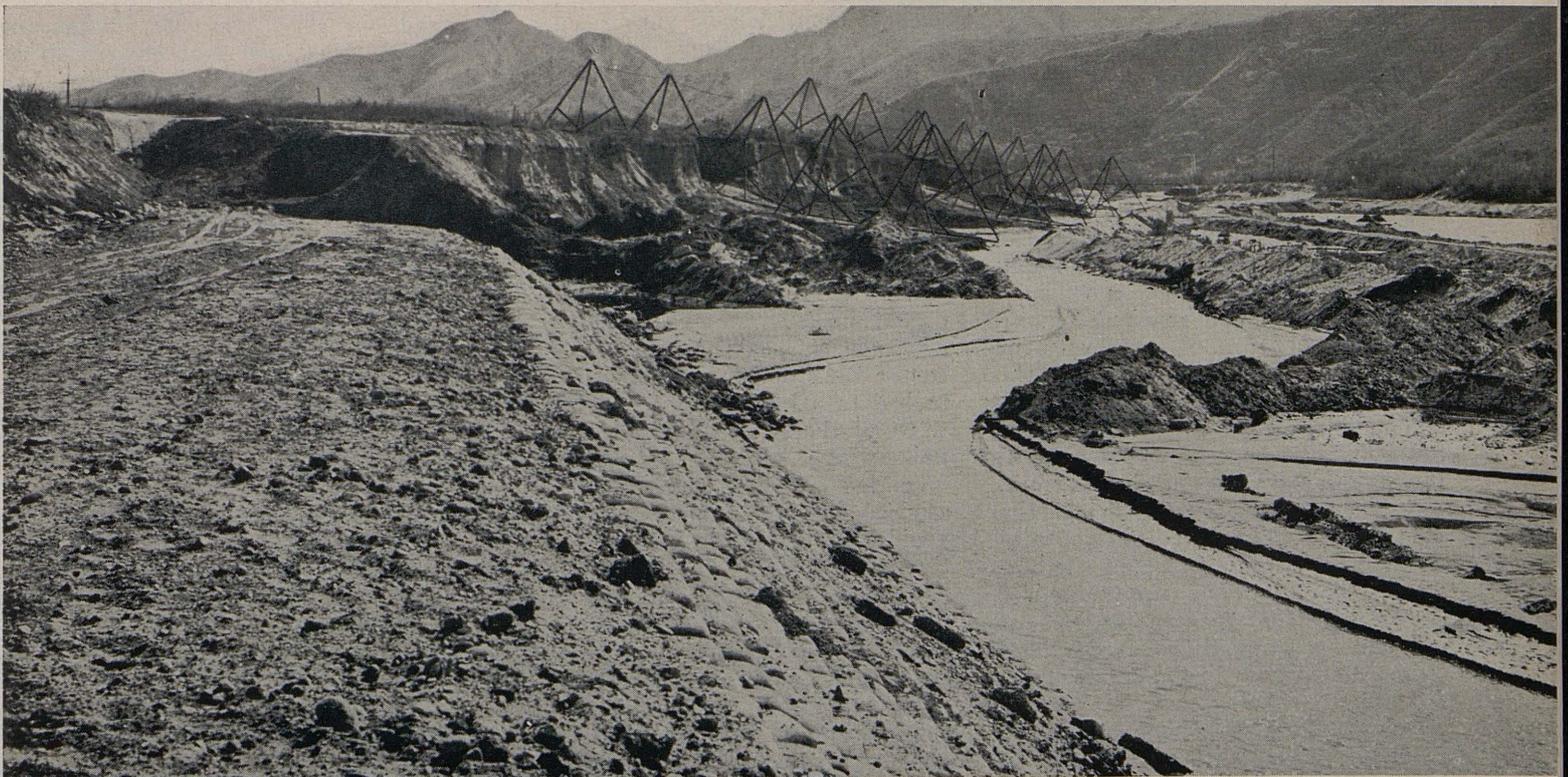
Thirty-foot steel rail tetrahedrons, shown in middle ground, and sacked concrete riprap installation in foreground

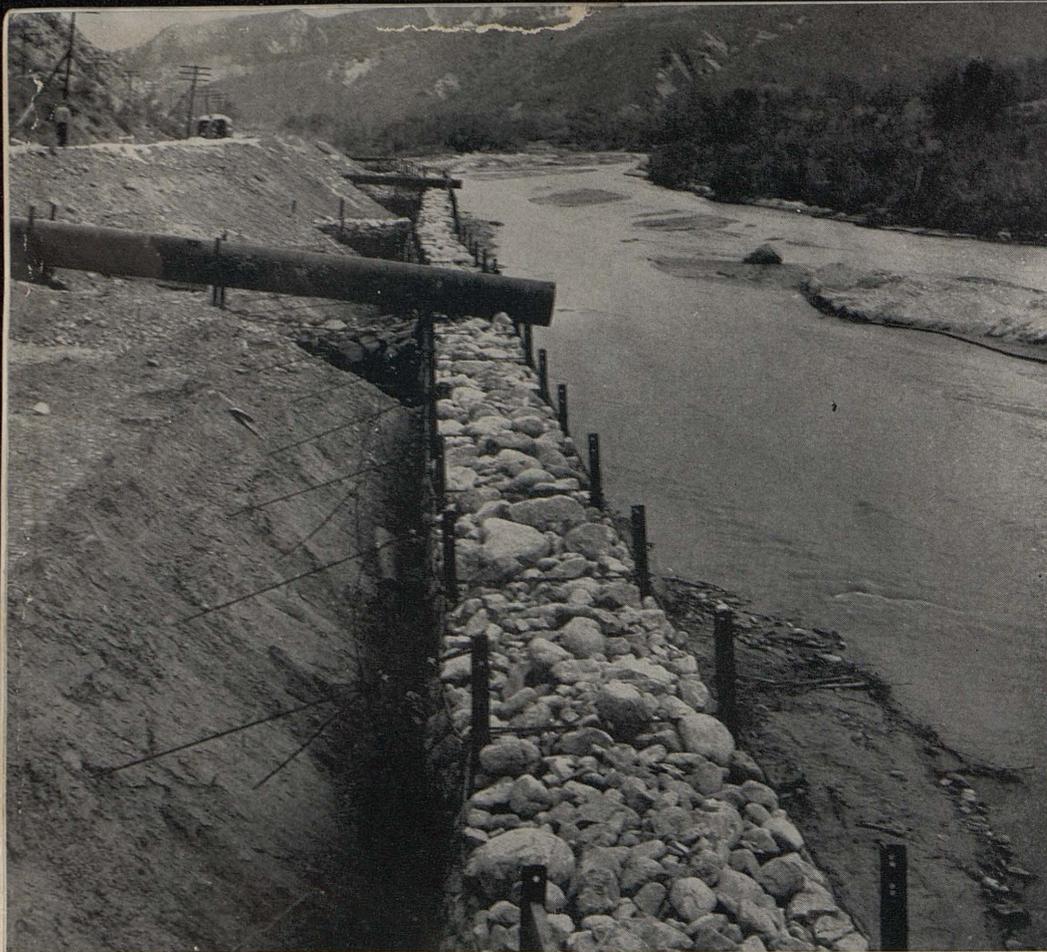
Steel rail and cable and rock-fill double fence bank protection

The first type to be installed was the steel rail and cable and rock-fill double fence, constructed in 1938-1939 shortly after the disastrous March, 1938, floods. One thousand fifty-one feet of double fence was built at a vulnerable point where the Santa Clara River overtopped and washed out the State highway roadbed a short distance east of the town of Piru. With no solid foundation available,

Each fence consists of 60 pound steel rails, 30 feet long, spaced 12 feet center to center and driven 23 feet into the streambed, the rails being connected longitudinally with  $\frac{3}{4}$ -inch steel wire cables. Both the inner and outer rail fence is lined on the outside with 9 feet 8 inches of 58-inch galvanized woven wire fencing. Inside the steel rail fences spaced 5 feet apart, an adjustable basket of galvanized woven wire fencing is fixed to the outer fence, and filled with alternate layers of brush and rock cobbles. When scour under the fence occurs, the rock and brush filler is free to drop into the scoured area.

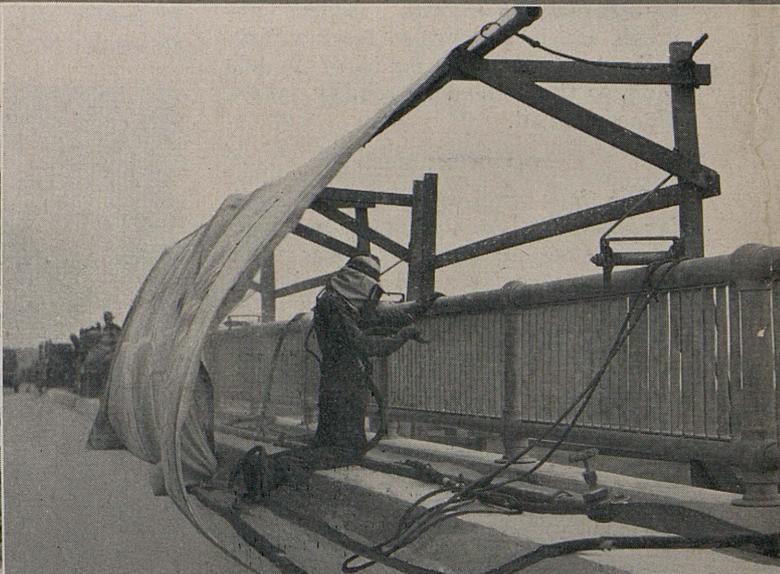
Top picture shows typical set-up of bridge painting equipment and camp. Center (left) painting superstructure from catwalks; (right) sandblaster at work on bridge railing. Canvas screen protects passing vehicles. Bottom—Raising catwalks on steel span over river

Catwalks used above deck on truss-type bridges are built somewhat less than panel length in order to clear the plumb posts and sway-bracing. They are raised or lowered by double-sheaved block and tackle suspended from chains attached to the top laterals at the panel-points and hooked up below with a triangular hanger at the end of the catwalk. Triangular hangers with an eye at the apex are recommended, since there is less likelihood that the hook on the blocks will disengage from the hanger.

width; 3 x 6-inch stringers are suitable for a 35-foot length. They are supported by means of needle beams hung from the bottom chord by adjustable steel hangers or straps with holes that match, providing a 24-inch extension. The angle where the hanger rests on the top of the bottom chord of the bridge structure is heavily reinforced to prevent the hanger from straightening. Above this reinforcing is a handle by which the hanger can be moved. Where catwalks can be suspended from a pipe rail, the hanger is made of 2-inch pipe, so that it can be readily rolled along the rail.
