ASSESSMENT OF THE PHASE I MORGANTOWN
PEOPLE MOVER SYSTEM

N.D. LEA & ASSOCIATES, INC.
Washington, D.C. U.S.A.

FINAL REPORT

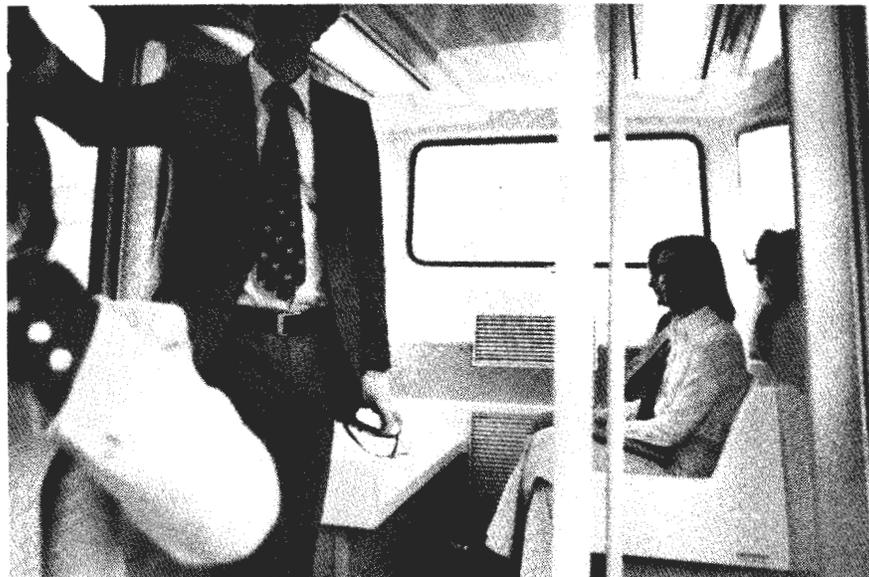
FIGURE 2.2 : VEHICLE

STEERING ARM

INTERIOR

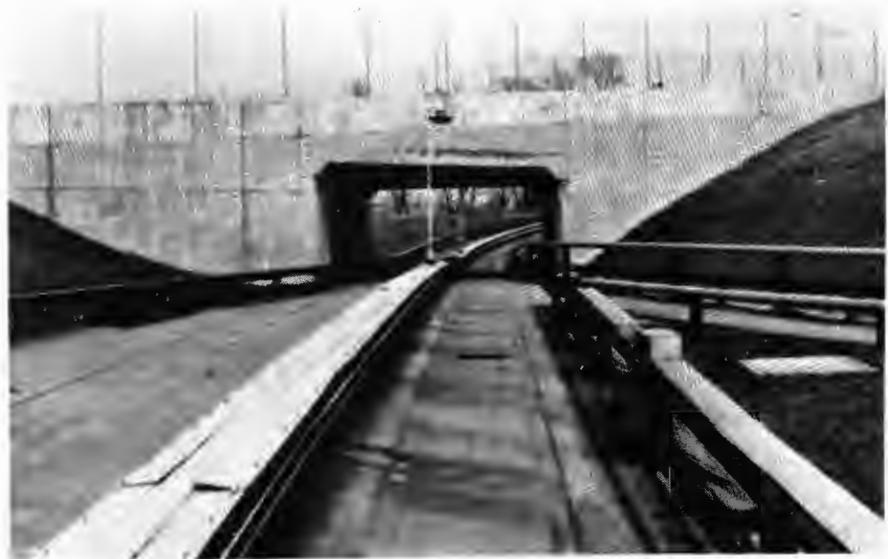
FIGURE 2.3 : GUIDEWAYS

The general arrangement and type of construction used for the guideways is shown in Figure 2.3. The running surface is reinforced concrete. It is supported in elevated sections by a steel superstructure mounted on sturdy concrete piers. The at-grade guideways blend in well with the existing terrain and are relatively unobtrusive. This is not the case with the elevated structures, which tend to be rather massive. However, most elevated sections are located in an industrial area along a railroad right-of-way, so that the visual impact is not objectionable.

AT-GRADE GUIDEWAY

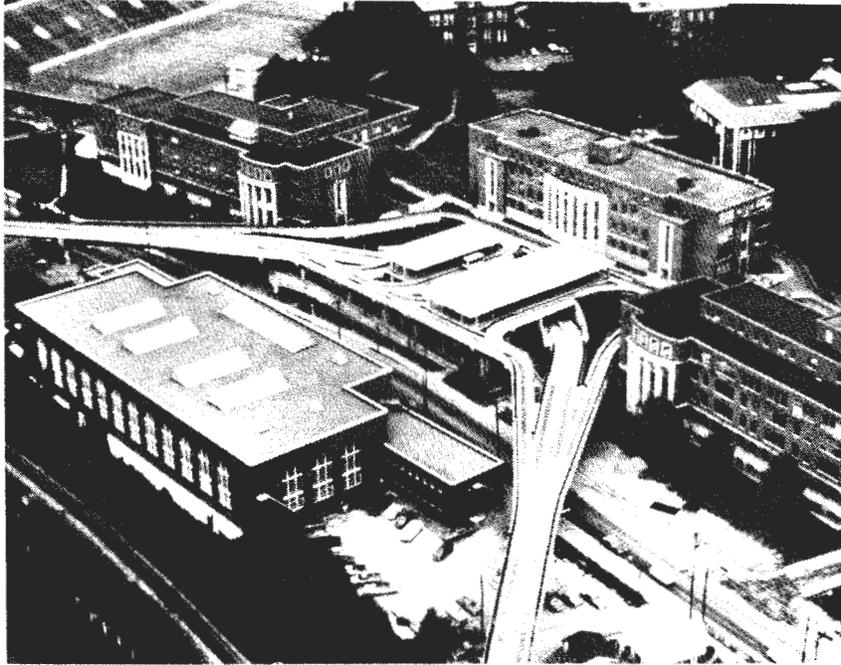
FIGURE 2.5 : BEECHURST STATION

Of the three Phase I stations at Morgantown, Beechurst, which serves the downtown campus, was the largest and the most complex. As shown in Figure 2.5, this station has the following unique features.

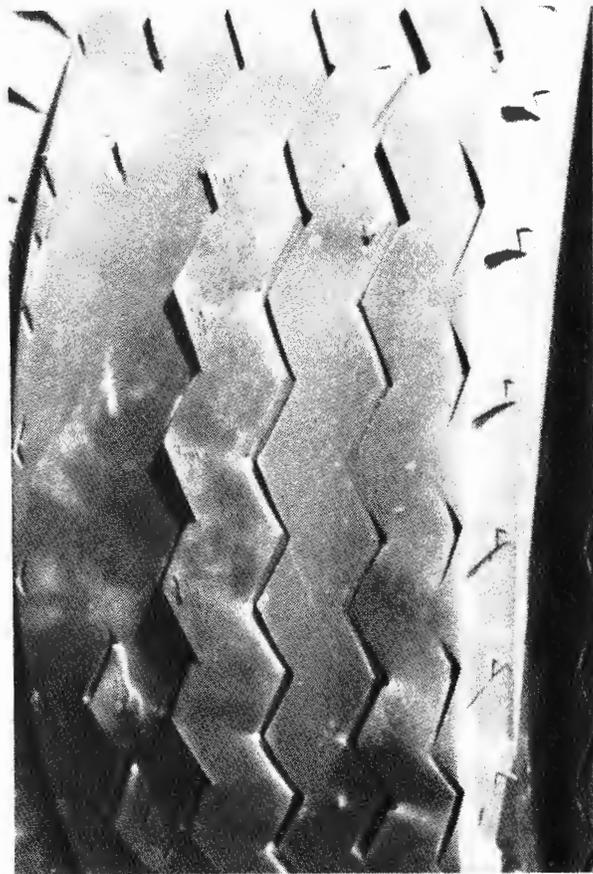
FIGURE 3.26: TIRE WEAR

- o The Morgantown vehicle runs on four rubber tires, mounted on axles suspended from the vehicle by four air-bag springs.
- o Tire wear was initially quite rapid, but careful attention to wheel alignment and the use of recapped tires have solved the problem. Present tire life is up to 50,000 miles.

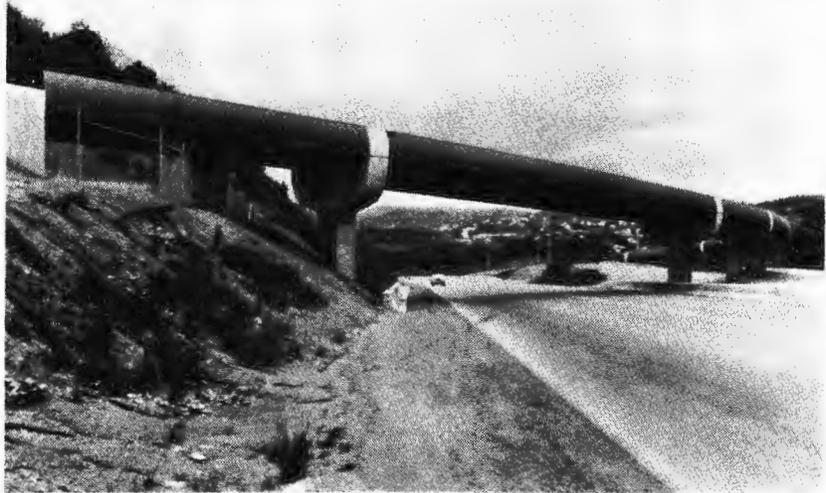
FIGURE 3.29 : ELEVATED GUIDEWAY OVER MONONGAHELA BLVD. -- AWARD OF MERIT BRIDGE, 1973 BY THE AMERICAN INSTITUTE OF STEEL CONSTRUCTION

In an automated guideway transit installation, the guideway system constitutes the most extensive and the most visible feature. It is also generally the most expensive single component of the entire system. Morgantown is no exception. The guideways have been the subject of considerable comment both locally and nationally. The existing design has been criticized as unnecessarily massive and ponderous. It has also been singled out for special praise. In 1973, for example, the guideway crossing over Monongahela Boulevard shown in Figure 3.29 was cited as one of the most beautiful new steel bridges by the American Institute of Steel Construction.

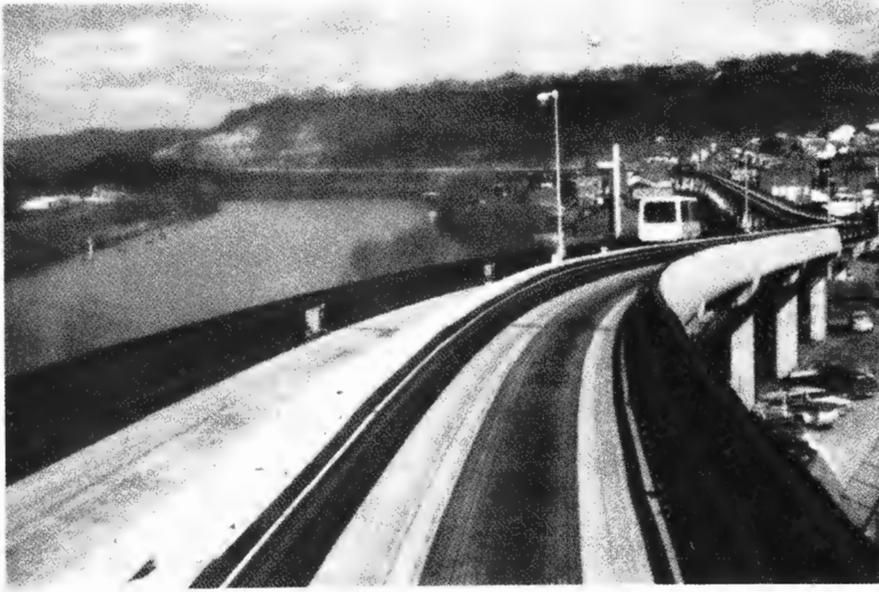
FIGURE 3.31 : PLEASANT VIEW OF THE RIVER FOR PASSENGERS

At the very outset of planning for the MPM system, the guideway routing was the subject of considerable study. The very hilly topography of Morgantown and the location of the activity centers to be served in relation to streets, buildings and readily available real estate established the present alignment along the riverside on the edge of the railroad right-of-way as clearly the most logical choice. Figure 3.30 shows that this routing of the guideway very effectively avoids built-up and residential property. However, the structure is high enough to afford the passengers a very pleasant view of the river (Figure 3.31).

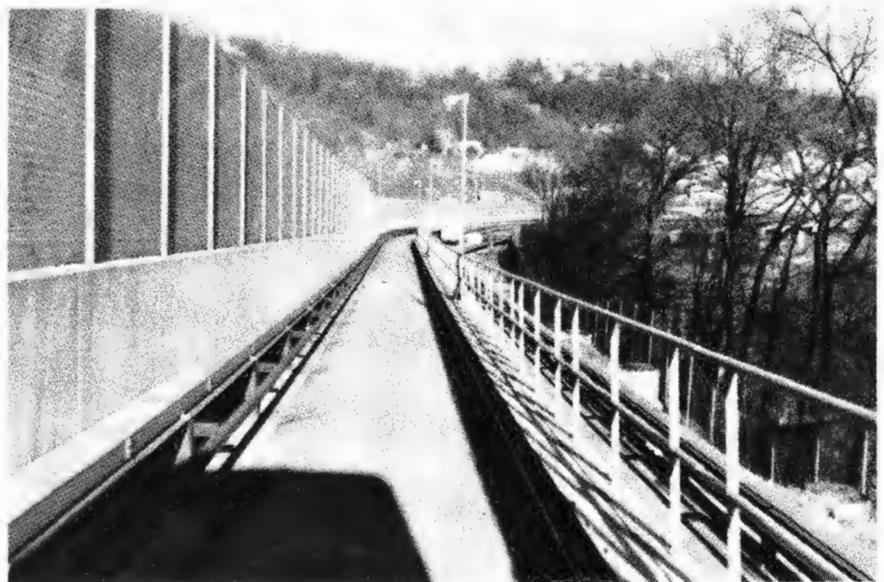
FIGURE 3.32 : STEPPED DESIGN OF AT-GRADE GUIDEWAY

Where the guideway follows the highway, up the hill toward the Engineering Campus, it is constructed at grade on two different levels, as shown in Figure 3.32. This is an aesthetically pleasing design which follows the natural terrain unobtrusively.

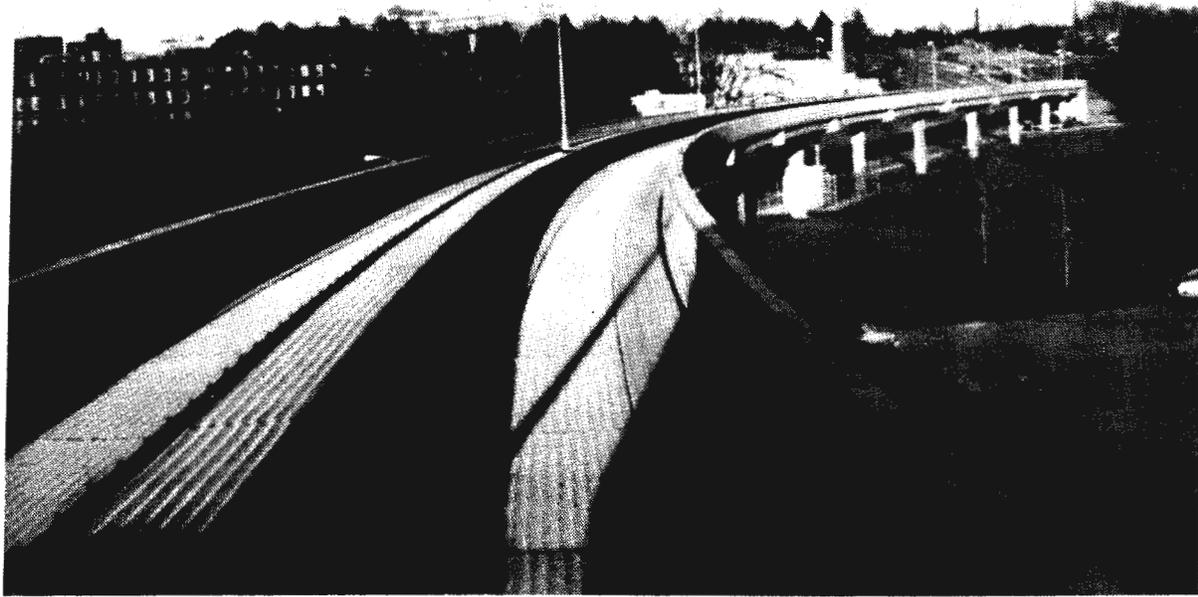
FIGURE 3.33: PHASE II ELEVATED GUIDEWAY

In contrast to the crash program which characterized the design and construction of the initial Phase I guideways, design of the extension to the system was conducted in an orderly manner. As a result a much cleaner design for elevated guideways evolved, as indicated in Figure 3.33.

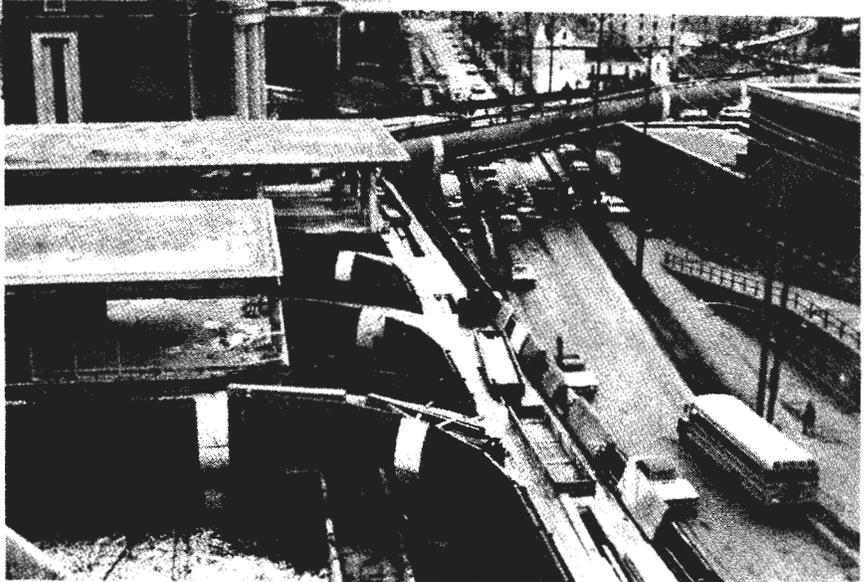
FIGURE 3.36

(c) PARTIALLY COMPLETED GUIDEWAY AT BEECHURST STATION

Most of the Phase I guideway system (60 percent) consists of elevated structures supported by substantial concrete pedestals. The structural members are steel beams which in turn support eight-inch thick running surfaces or pads, as illustrated in Figure 3.35. Figure 3.36 presents several views of guideways under construction. Figure 3.35 indicates the arrangement of the running surfaces, and the guiderail and power rail assembly, as well as the safety barrier on either side of the structure. As indicated, a cover plate has been provided above the power and guiderail assembly on the left side of the guideway in the direction of travel, to facilitate exit from the vehicles should emergency conditions so dictate. Where these rails are on the outside of the guideway, as illustrated in Figure 3.37, safety railings have been provided.

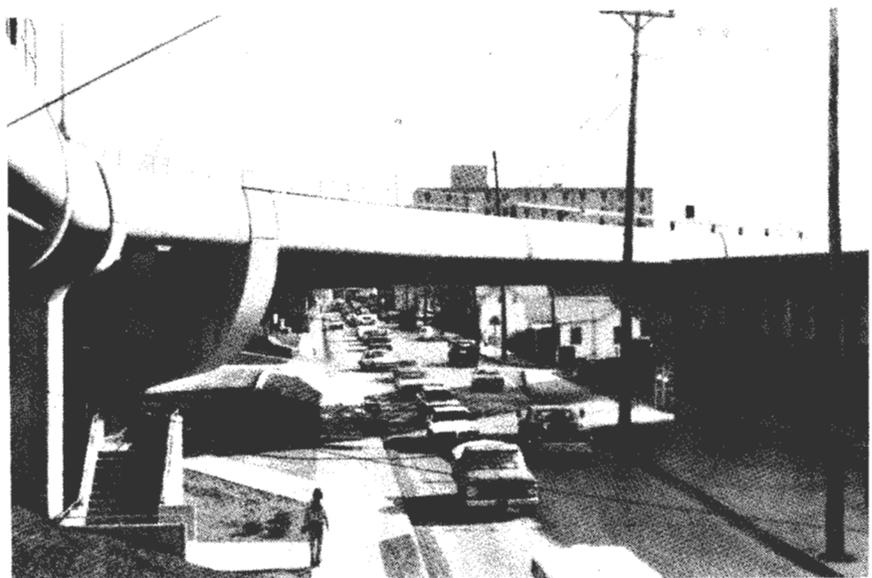
FIGURE 3.39 : SOUTHERN LARGE SPAN CROSSING BEECHURST AVENUE

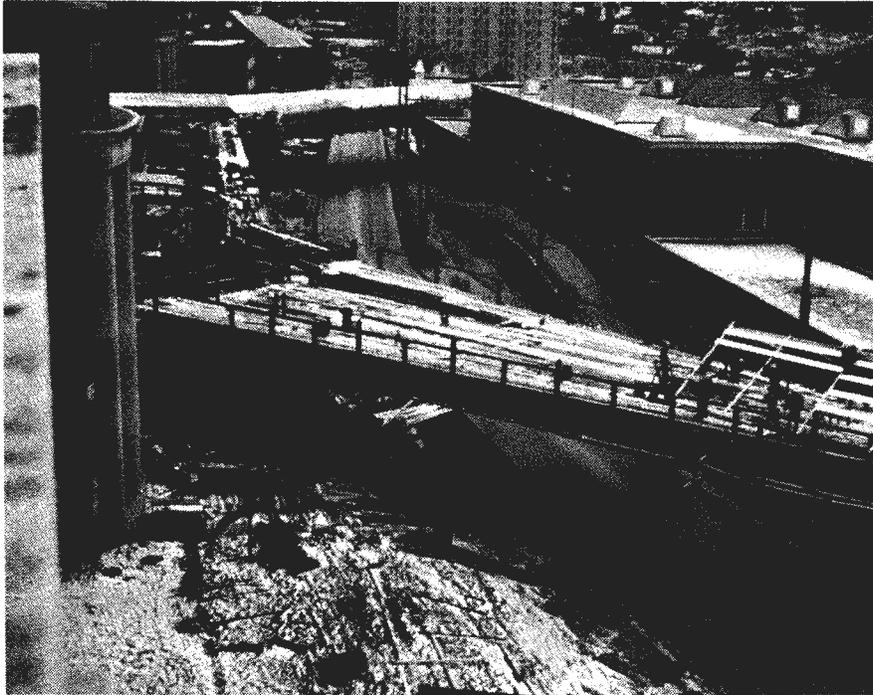
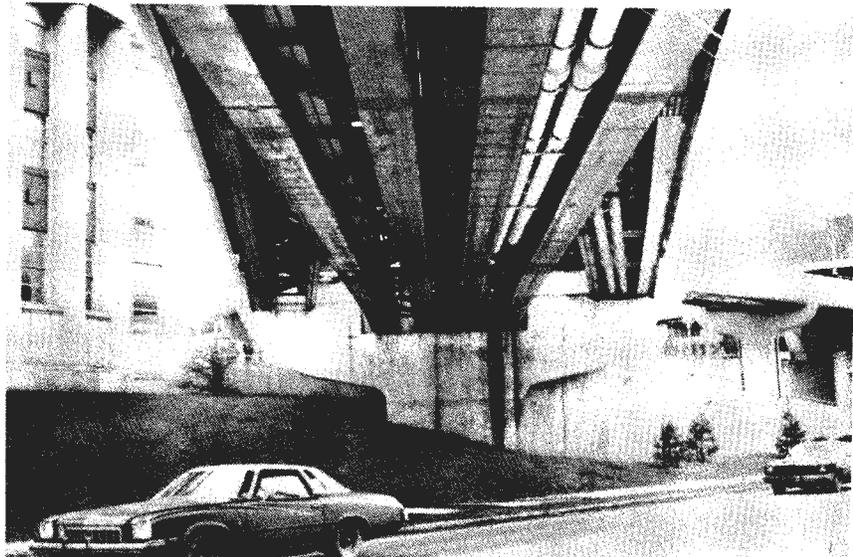
(a) SPANS OVER BEECHURST AVENUE

(b) GUIDEWAY UNDERSIDE

FIGURE 3.40 : MASSIVE CONSTRUCTION OF LARGE SPANS

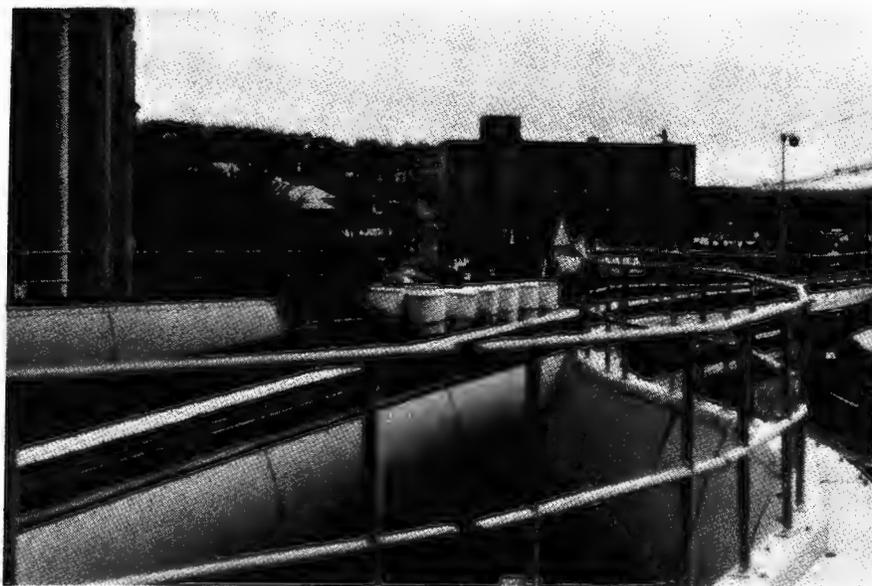
FIGURE 3.42 : SAND FILLED PLASTIC DRUMS AT TURNOUTS

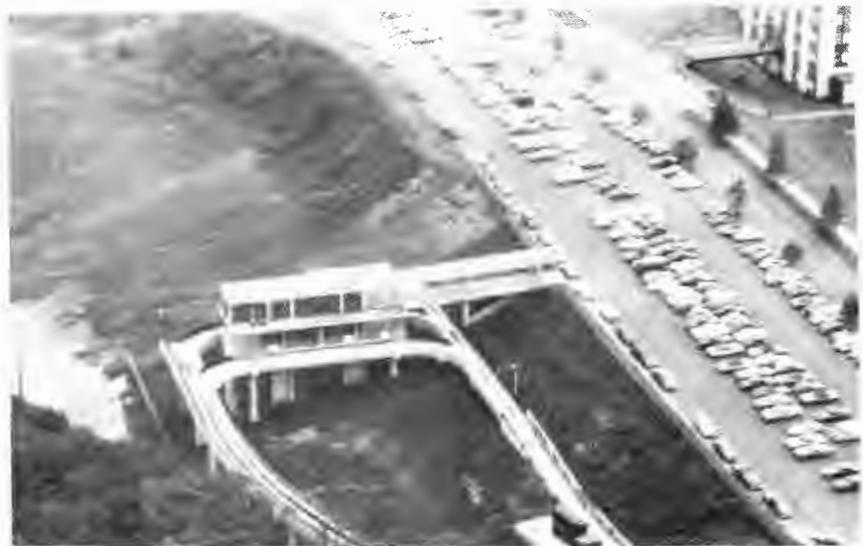
FIGURE 3.55 : ENGINEERING
STATION

As constructed for Phase I, Engineering was equivalent to only one-half of a Beechurst-type station. It had one platform which was served by two turn-back channels, as indicated in Figure 3.55. As completed for Phase II, Engineering now has three turn-around channels "facing" Beechurst and one "facing" the new Towers station.

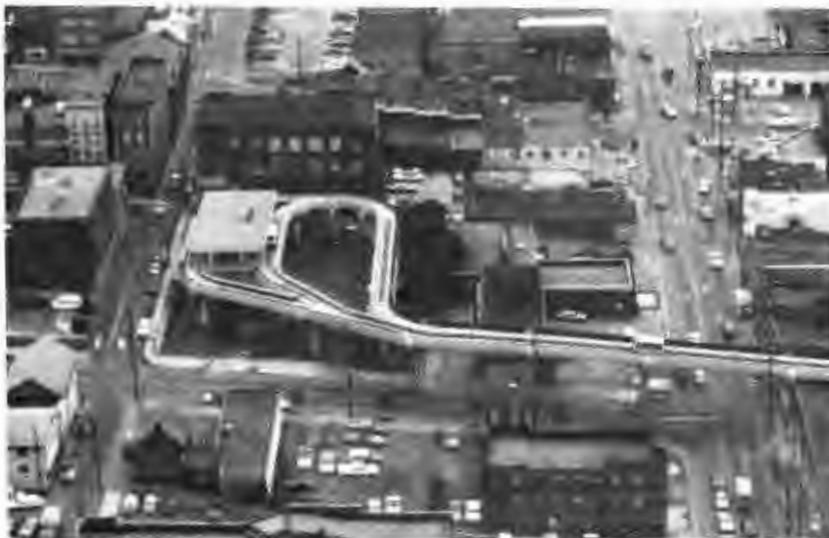
FIGURE 3.56 : WALNUT
STATION

Walnut (Figure 3.56) is a terminal station with two channels for receiving and dispatching vehicles. Since a lower volume of traffic is anticipated to and from this station, its capacity is considered ample.

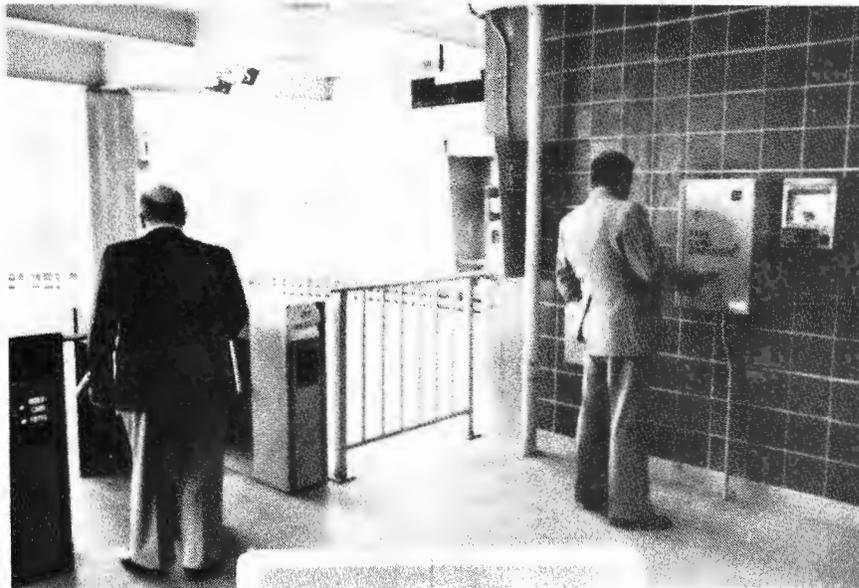
FIGURE 3.59 : STATION UNPAID AREA

Figures 3.57 and 3.58 are plan views of Platforms "A" and "B" of the Beechurst station, respectively. Platform "B" is typical of the platform arrangements at Walnut and Engineering stations. Passengers enter the stations at the street level and reach the platforms via stairways. There were provisions for elevators for the handicapped, but these were not installed until Phase II. An automatic ticket dispenser was located in the unpaid area (Figure 3.59). Exact change was required

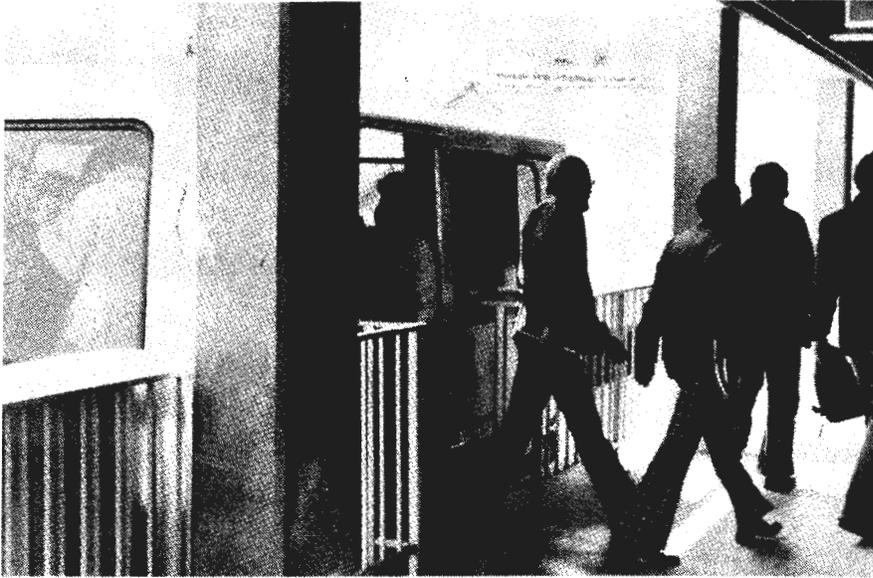
FIGURE 3.62 : PASSENGERS EXIT VEHICLES AT SEPARATE DEBOARDING BERTHS

Passengers deboard vehicles at one of three berths (turnaround channel) or two berths (passthrough channel) and leave the paid area through manually operated turnstile exit gates (Figures 3.62 and 3.63). These gates are located on the opposite side from the entrance gates, separating entering and leaving passenger streams.

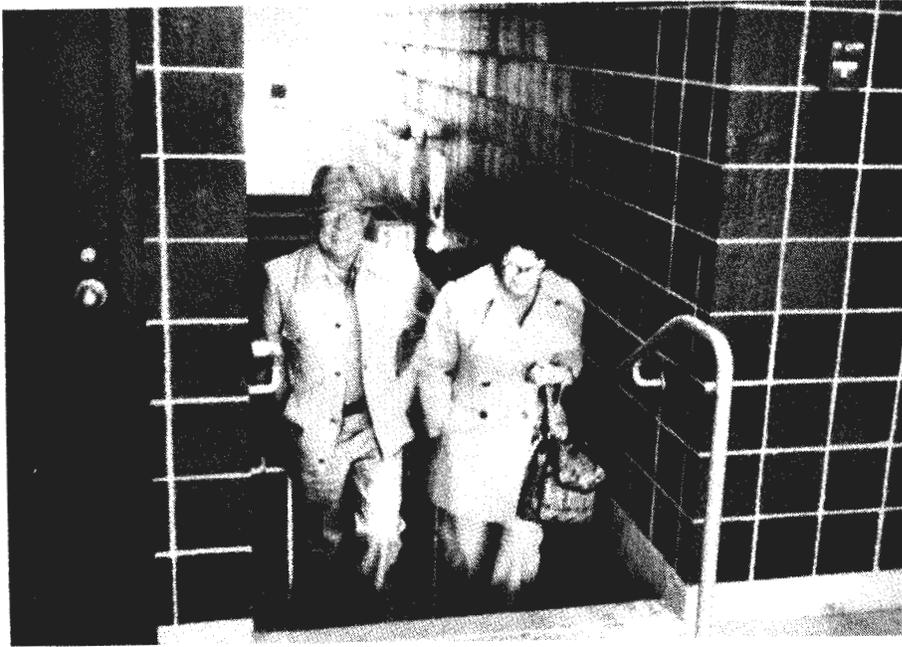
(a) STAIRWAYS ARE SINGLE LANE ONLY

Stairways in Morgantown stations are found to follow the recommended building code standard of 22-inch lane increments with the clear distance between handrails dimensioned at 44 inches for the typical two-lane stairs. In practice, it has been found that this minimum stair-lane width does not function well in urban transit stations, particularly where two-way traffic occurs (Figure 4.17a). As discussed in a subsequent section, the larger male shoulder width exceeds 22 inches. With consideration of additional heavy clothing, the natural swaying that occurs during locomotion, hand carried packages and the traffic frictions of opposing pedestrian flows, center to center handrail dimensions of 30 inches (762 mm) are being recommended for transit stairs. Adherence to the building code in Morgantown has led to the narrowing of an otherwise functionally well dimensioned stair at the Beechurst Station by the insertion of a double handrail (Figure 4.17b).

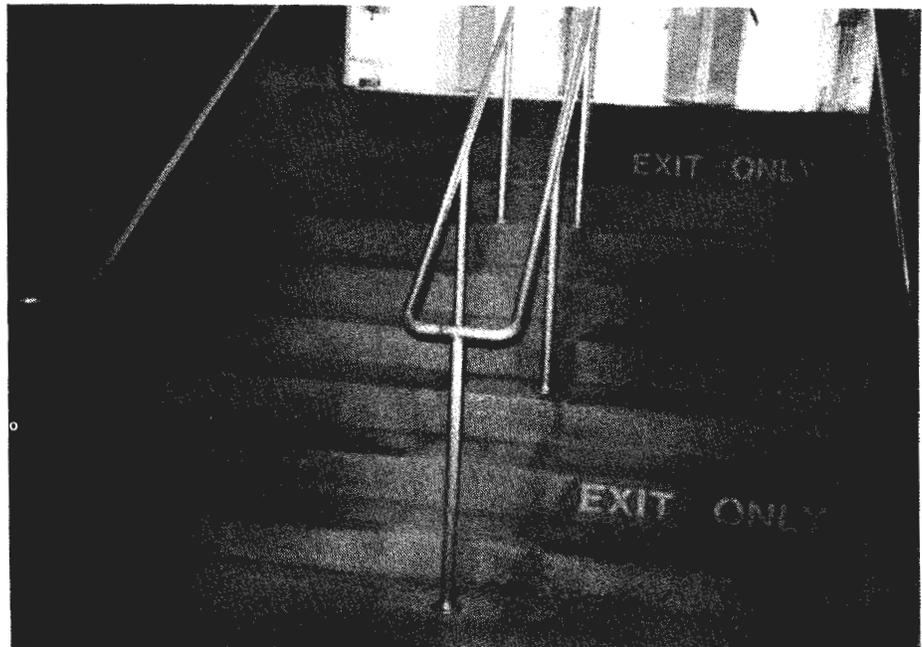
(b) EFFECTIVE STAIRWAY WIDTH REDUCED BY DOUBLE HANDRAIL

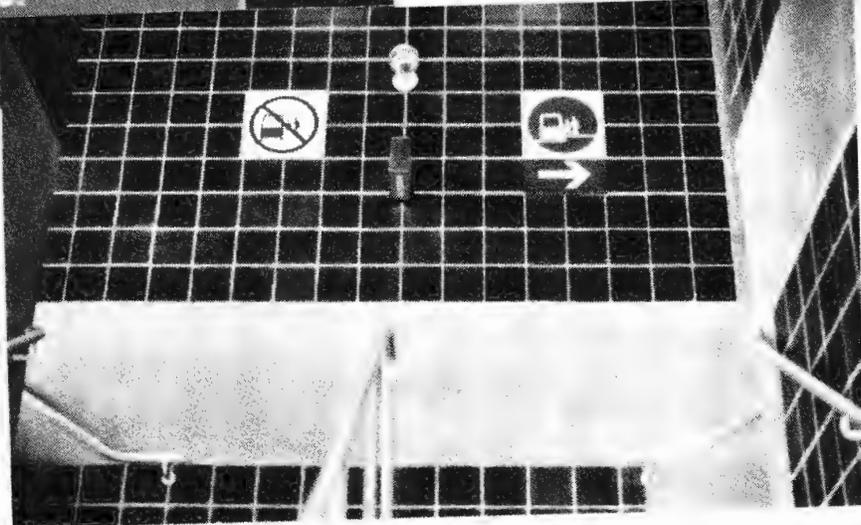
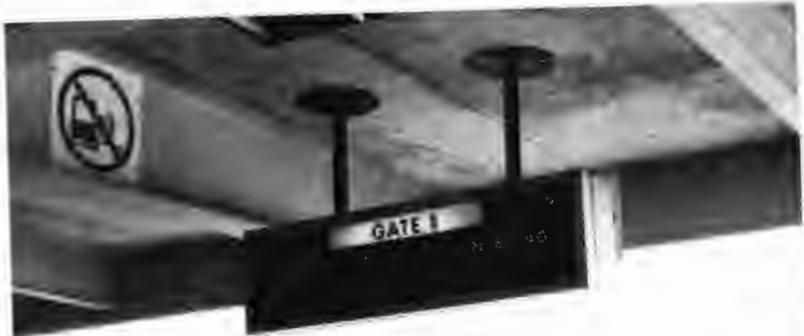
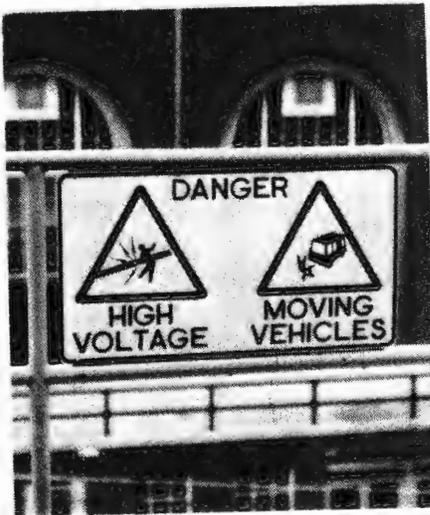
Operating Hours
Monday thru Friday
7:30 AM to 8:30 PM
Saturday and Sunday
9:30 AM to 3:00 PM
If amber light is flashing,
the station is temporarily
out of service.

FIGURE 4.18 b : PASSENGER INFORMATION IN STATIONS

Information aids in the Morgantown stations were intended primarily for the college population which is familiar with campus locations. Visitors experience minor problems locating the Walnut station in Morgantown because there are no directional signs from the town's main street. The system maps in stations (Figure 4.18a) for Phase I were too complicated with conflicting colors and were covered by a reflecting surface causing a glare which made them difficult to read. Figure 4.18b shows other signing used in the stations, including the active boarding sign.

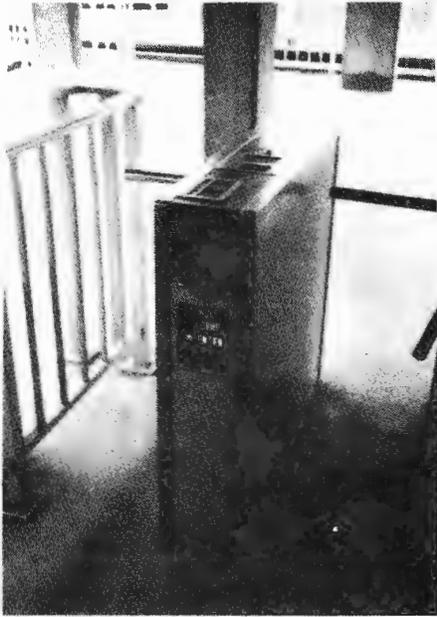
FIGURE 4.19 : TURNSTILE

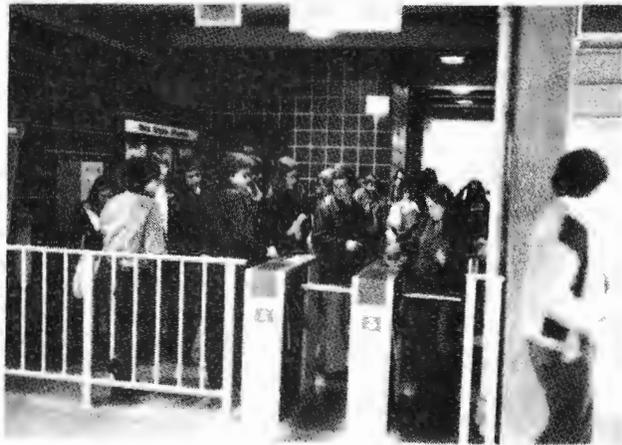
FIGURE 4.22 : PASSENGER QUEUE CAUSED BY ONE TURNSTILE OUT OF SERVICE

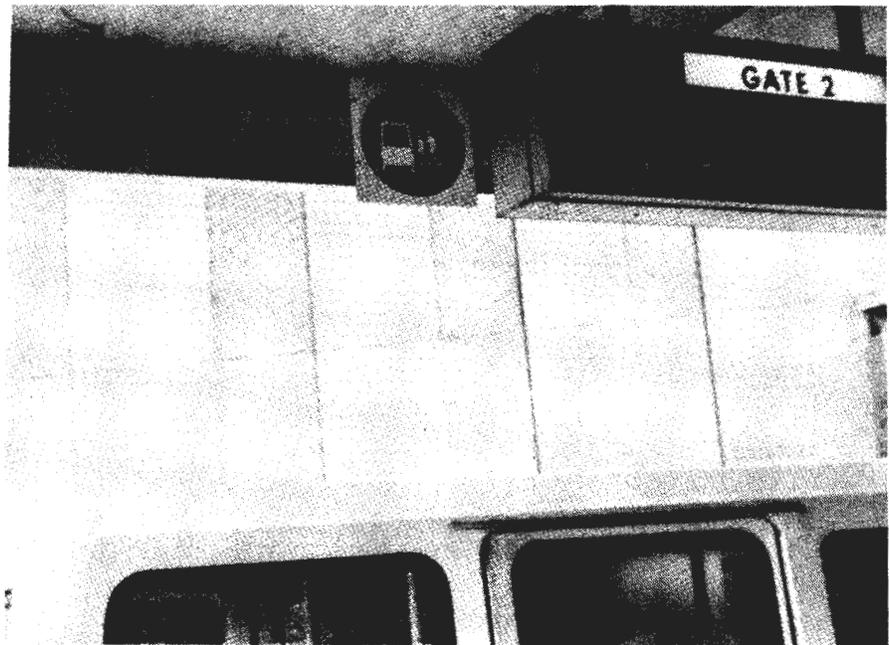
FIGURE 4.41 : HARD TO READ BOARDING SIGN

Audible signals and announcements for the arrival and departure of vehicles, as well as for the opening and closing of doors, would be an aid to the blind and probably for others, as well. WVU has added chimes to the boarding signs. The lighted boarding and destination signs (Figure 4.41) are barely adequate for MPM system users because they are relatively dim against a frequently bright background. Their placement high above departure gates, instead of at eye level, means that some new users may not even realize they exist. The need to continually monitor departure signs on opposite sides of the platform is also irksome.

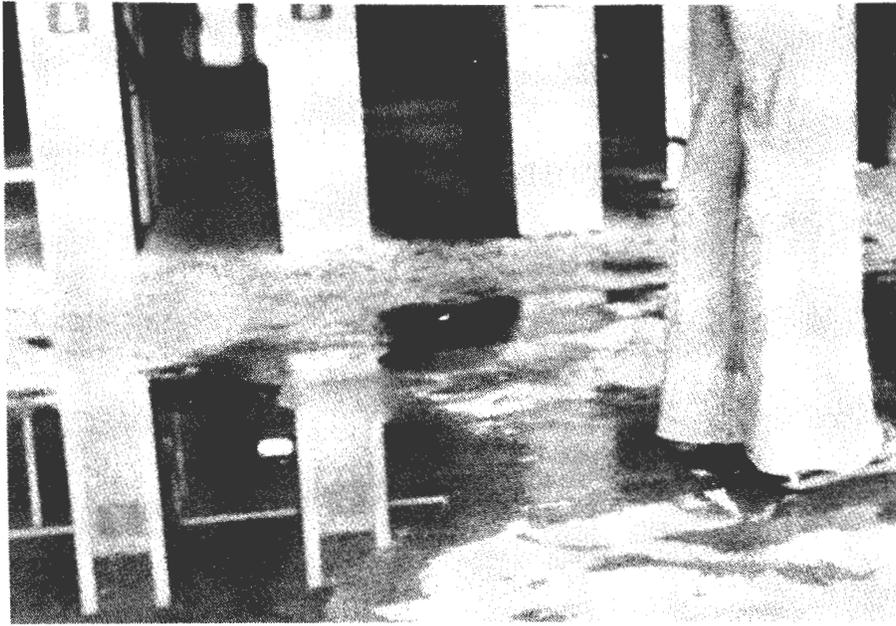
FIGURE 4.48 : WATER PUDDLES ON PLATFORMS

In Phase I, stairs were the only means of passage within stations to and from the platforms. Phase II provides elevators for use by the elderly and handicapped. Due to the geographical location of Morgantown, ice and snow can cause approach difficulties if walkways and stairs are not maintained properly. The station platforms which are neither enclosed nor climatized are subject to the same problems. Although provided with roofs (and wind screens in Phase II) platforms are exposed to wind-blown rain and snow as illustrated in Figure 4.48. If not cleared adequately, ice on the platforms can be a safety problem and can impair access and egress to and from vehicles.

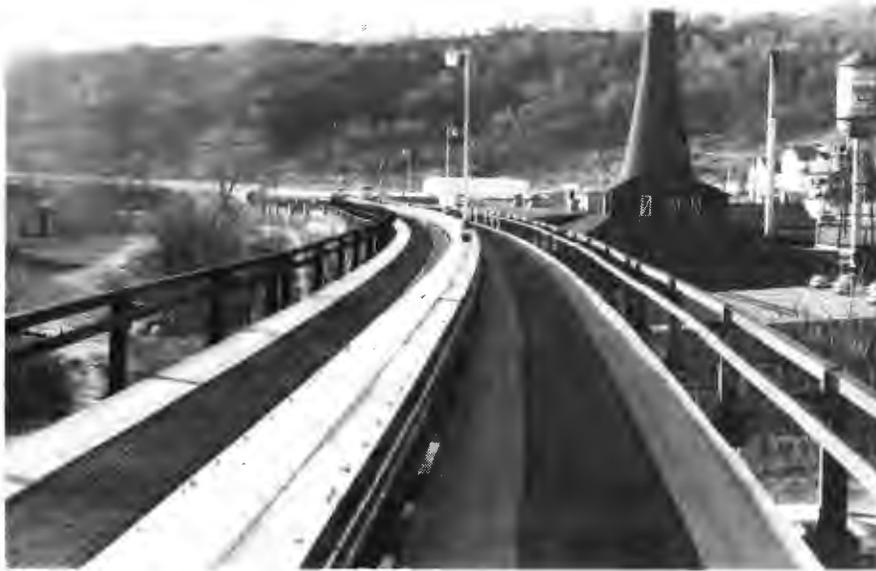
FIGURE 4.50 : GUARD RAILS AT SIDES OF GUIDEWAY

AGT systems, with their grade-separated guideways, afford the general public excellent protection from collisions with vehicles. However, this protection depends upon public adherence to warning signs and restrictions imposed by protective rails and fences, as used at Morgantown (Figure 4.50 and 4.51).

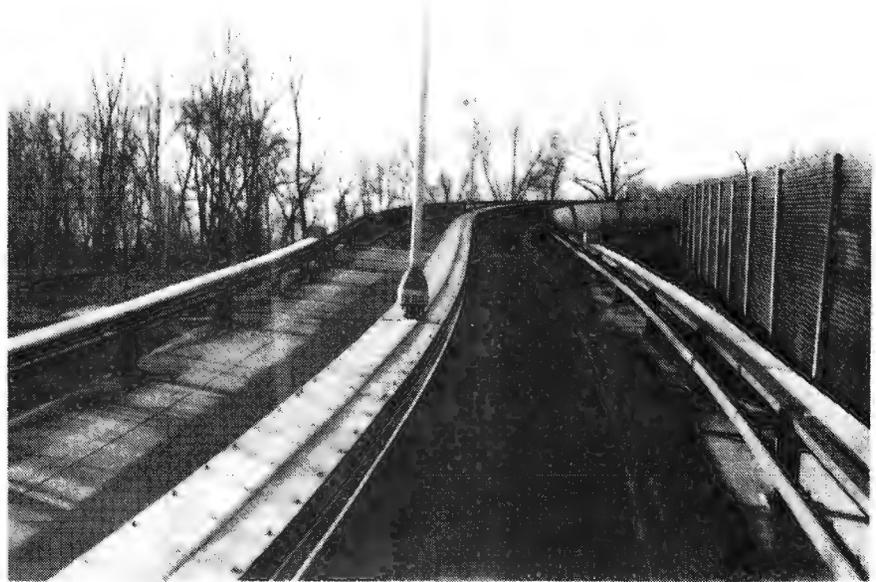
FIGURE 4.51 : FENCED IN AT-GRADE GUIDEWAY
