CRENSHAW/LAX PHOTOGRAPHIC UPDATE

October 15, 2020

Crenshaw/LAX Transit Project

- 8.5 miles Light Rail
- 8 Stations
- \$2,058.0 Million
(Board approved revised LOP)

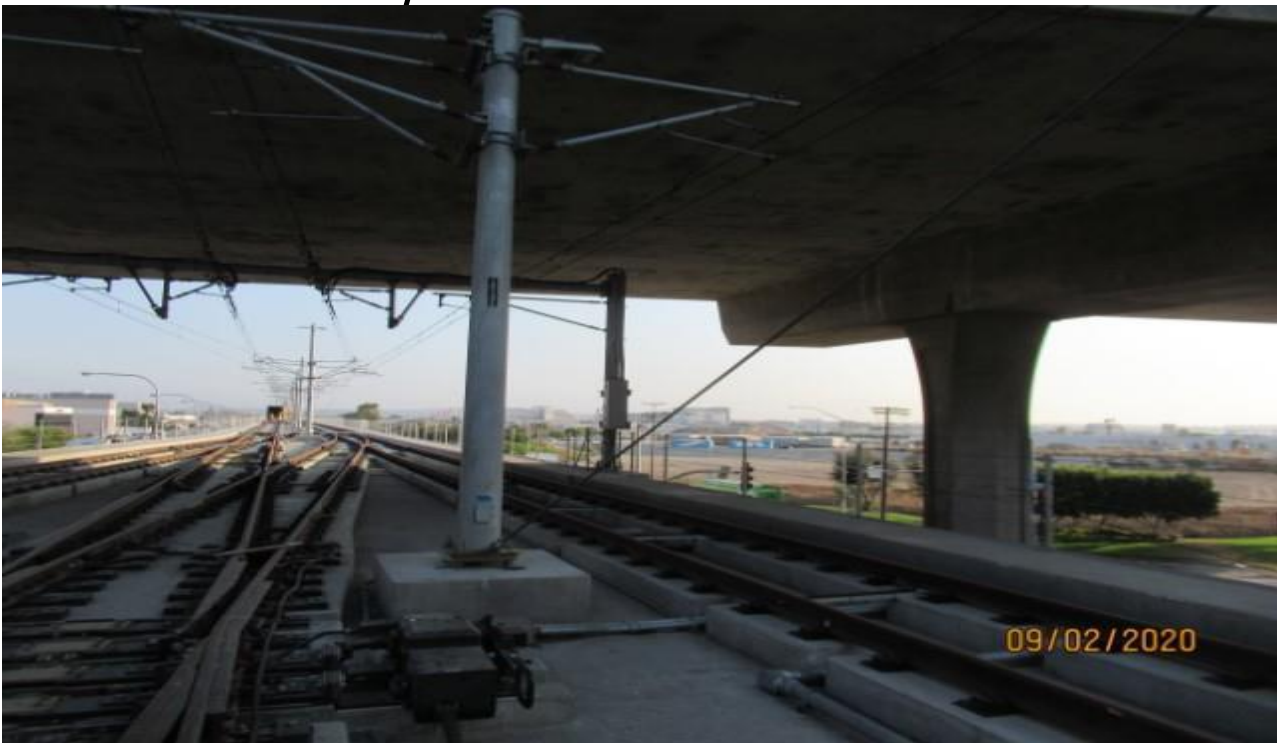
Guideway- OCS pole 1014E at GL Wye Down guy wire still in place over Switch Machine for MPF 3X-ING (looking northeast)

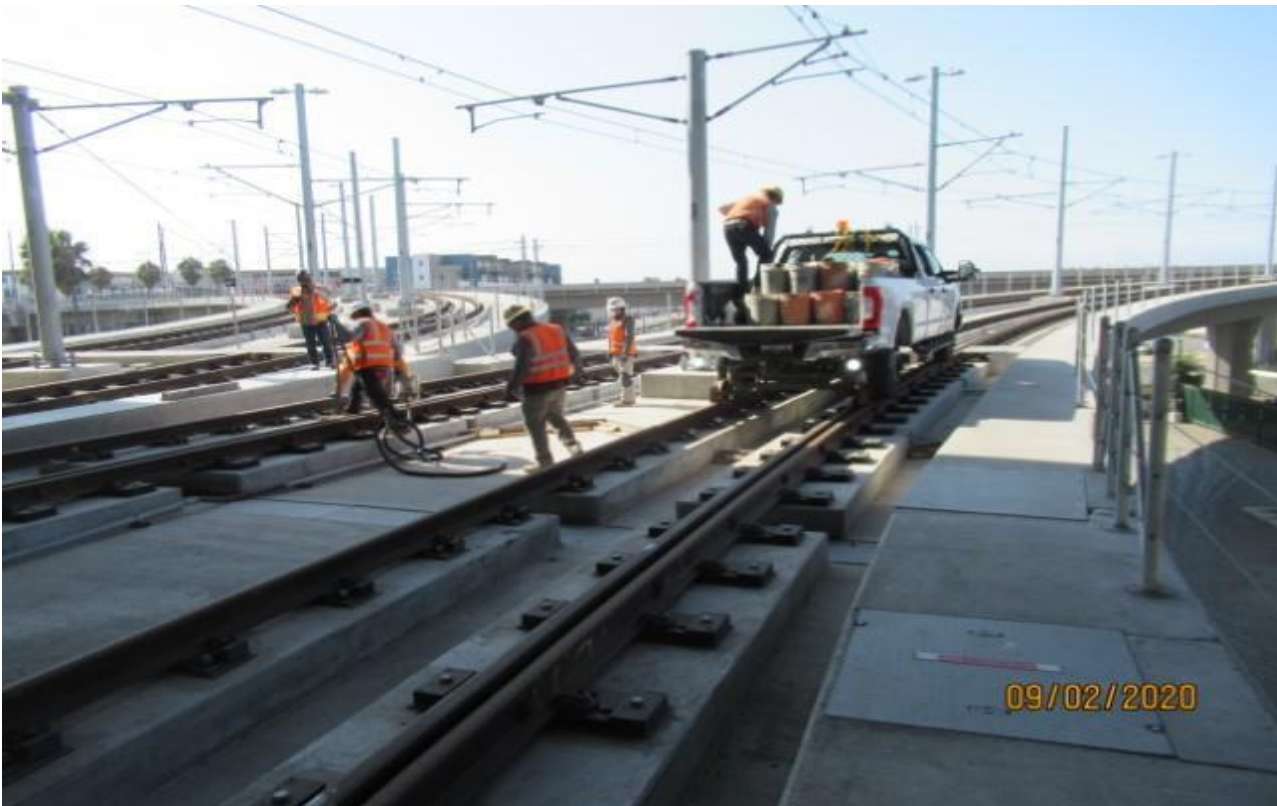
Guideway- LKC & HCC installing & adjusting connecting rods for 10ERH XO at GL Wye (switch point repair) (looking northeast) Rework

Replacement of damaged switch points continues throughout Segments B1, B2, and C.

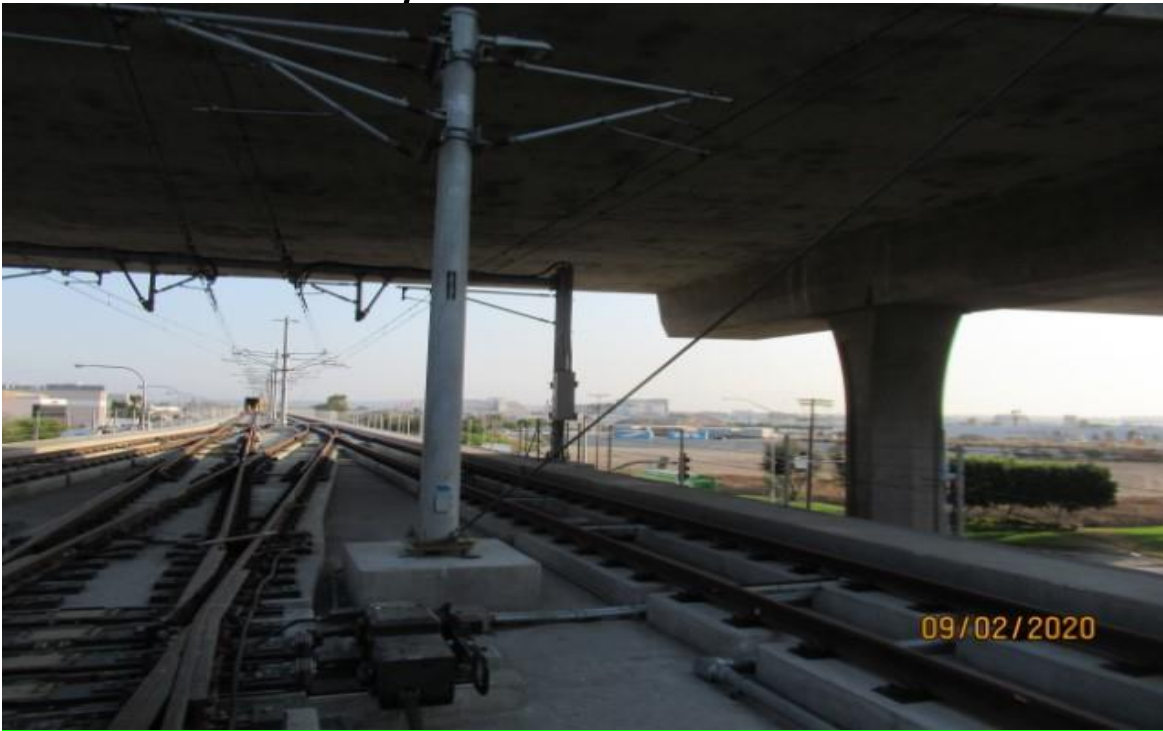
Guideway- OCS pole 1014E at GL Wye Down guy wire still in place over Switch Machine for MPF 3X-ING (looking northeast)

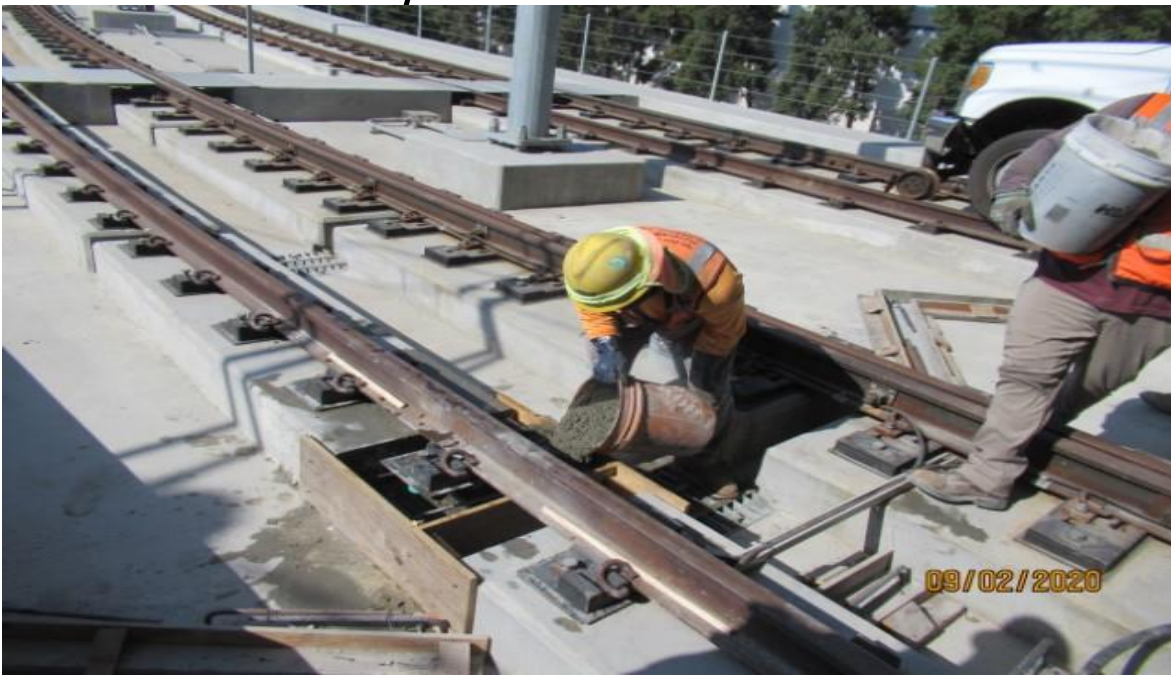
Guideway- WSCC using 5-gal. buckets to place concrete into end of plinth on NBW track
GL Wye, Rework for NCR-A 111-B case 4

Repair of plinth gap to invert continues at the Green Line Bridge, Century Bridge, I-405 Bridge, UG3, and UG4 per NCR-A-111 B. The remaining work for this NCR is adding the joint sealant in all locations.

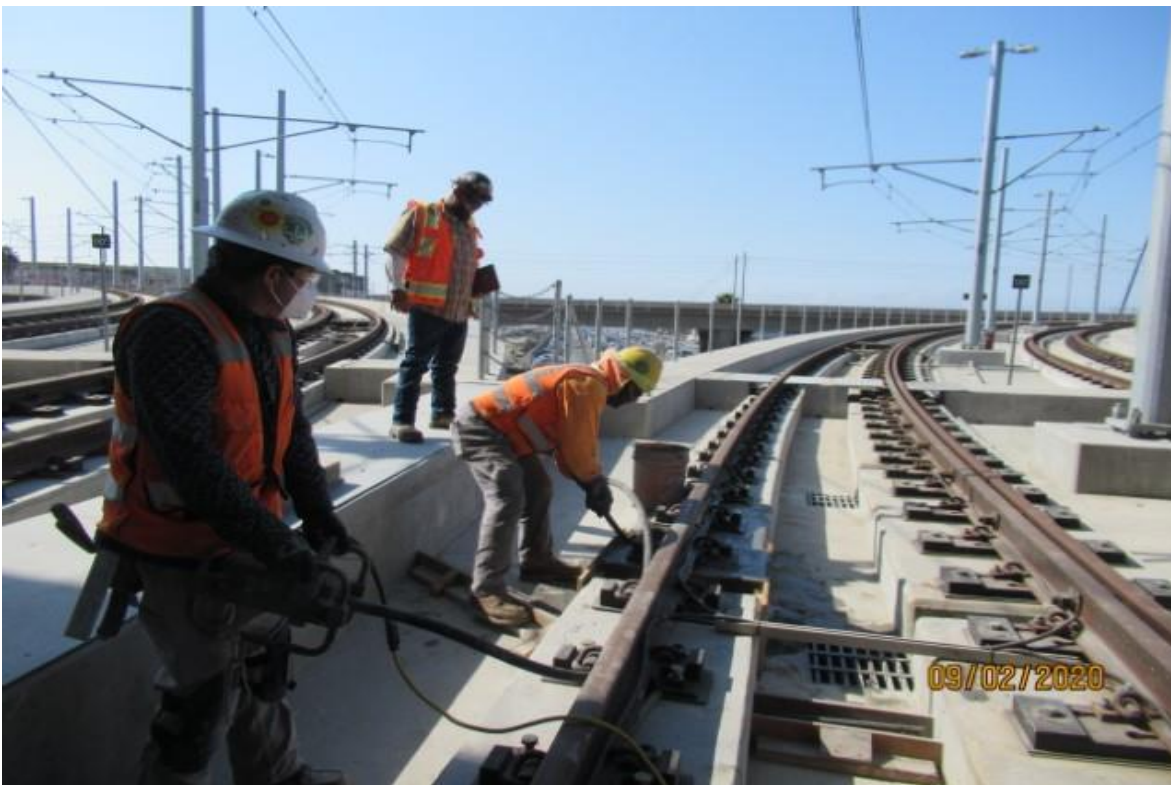
Guideway- WSCC vibrating concrete in repaired plinth on NBW at GL Wye (looking south)
Rework for NCR-A 111-B case 4

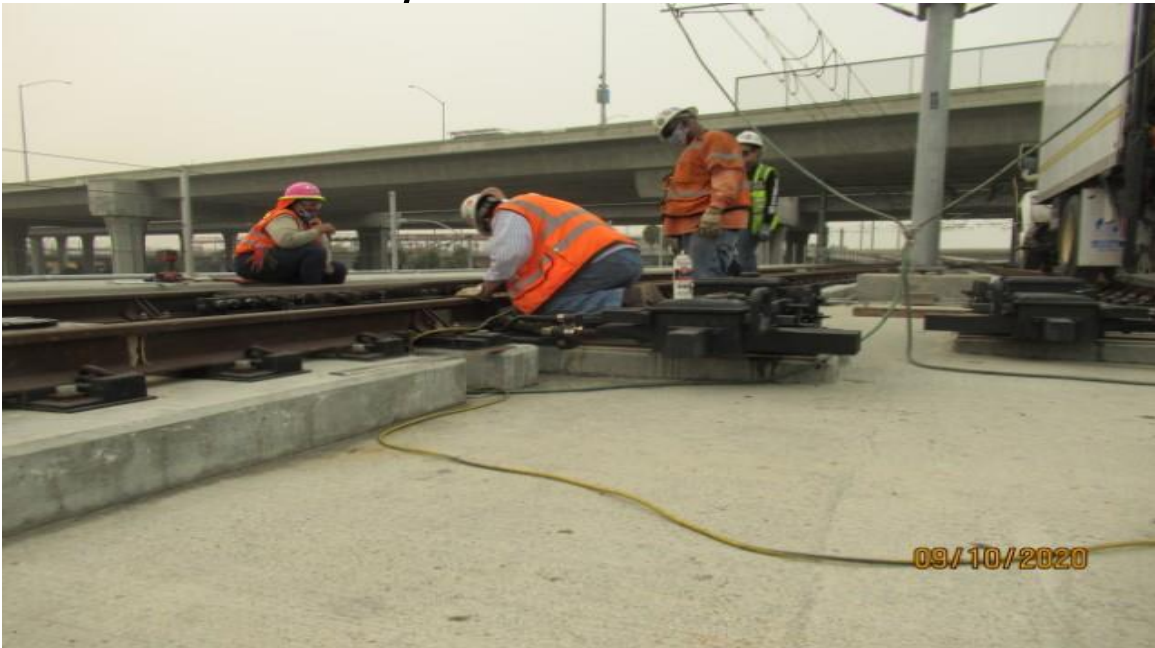
Guideway- HCC Foreman evaluating condition of right (straight) side Switch Point on 0FRHXO NBW track POS STA 15+98 GL Wye (looking southeast) Rework for damaged Switch Point repair

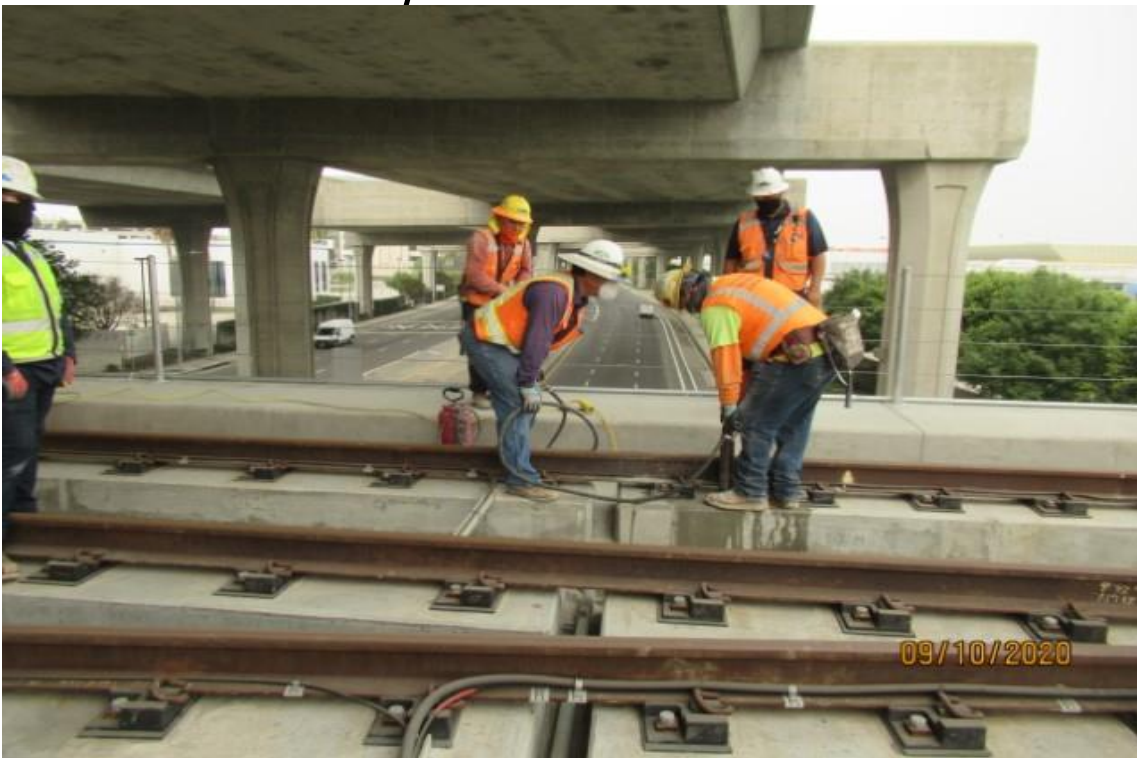
Guideway- WSCC on SBW track at GL Wye left side plinth core drilling concrete sample for re-testing break strength (looking west) Rework

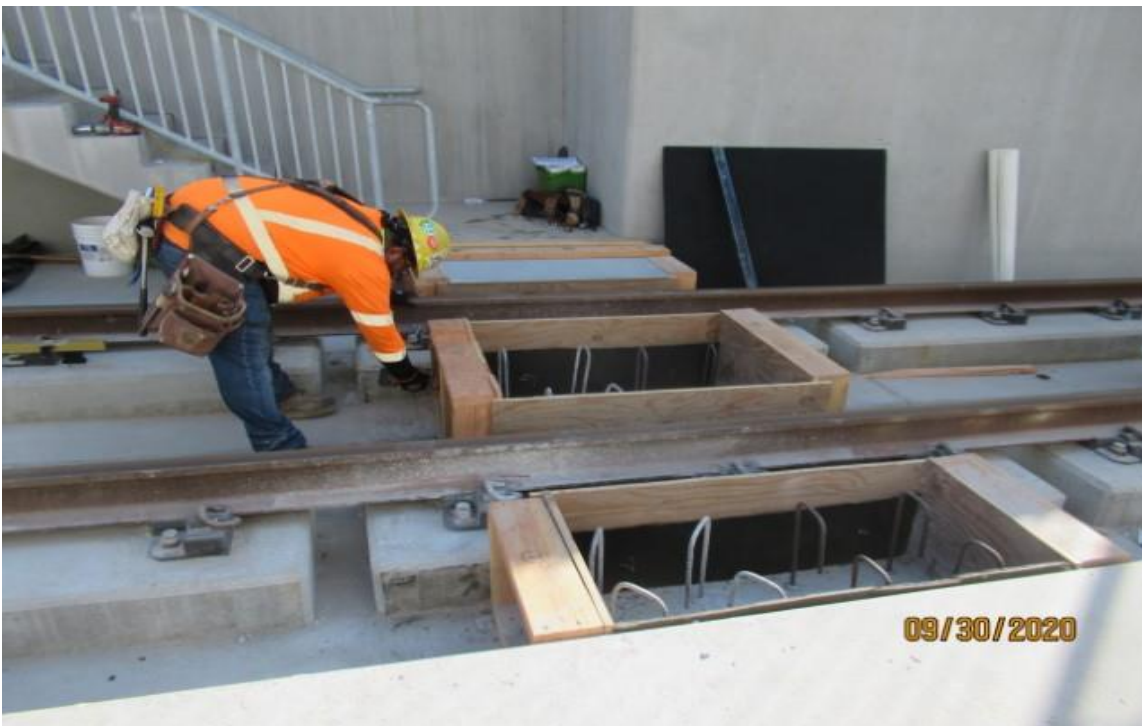
UG1- WSCC carpenter adjusting concrete foundation forms for Emergency Walkway Crossings at UG1 NB track STA 56+50 Rework

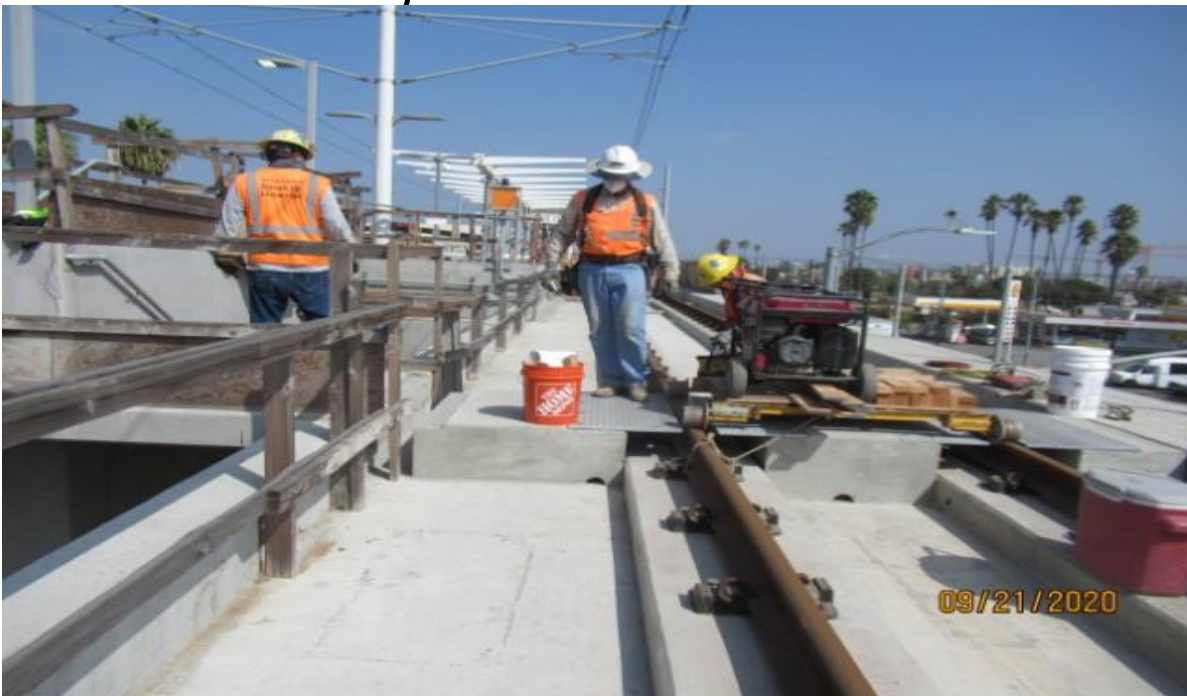
AVIATION/CENTURY- Century/Aviation Bridge NB track STA 66+28 WSCC repair work on Emergency Walkway Crossing plates (looking north)

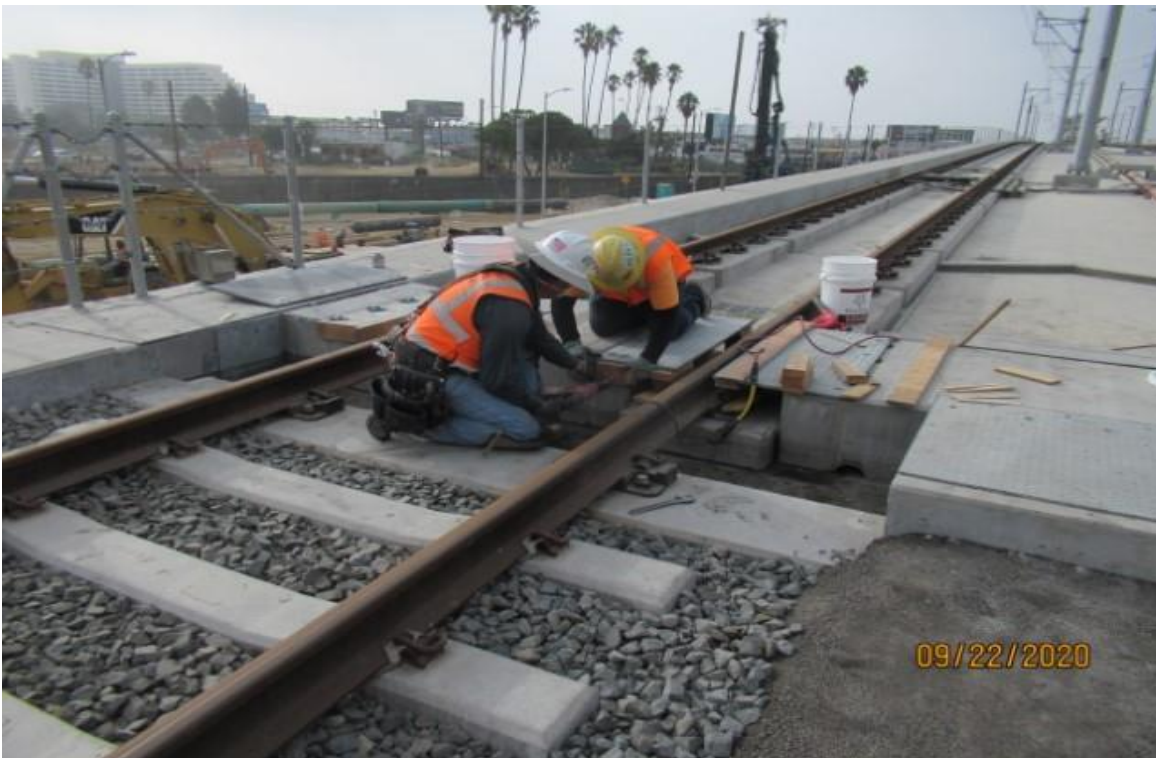
AVIATION/CENTURY- WSCC setting grout forms on Emergency Walkway Crossing foundations NB track Century/Aviation Bridge STA 74+65

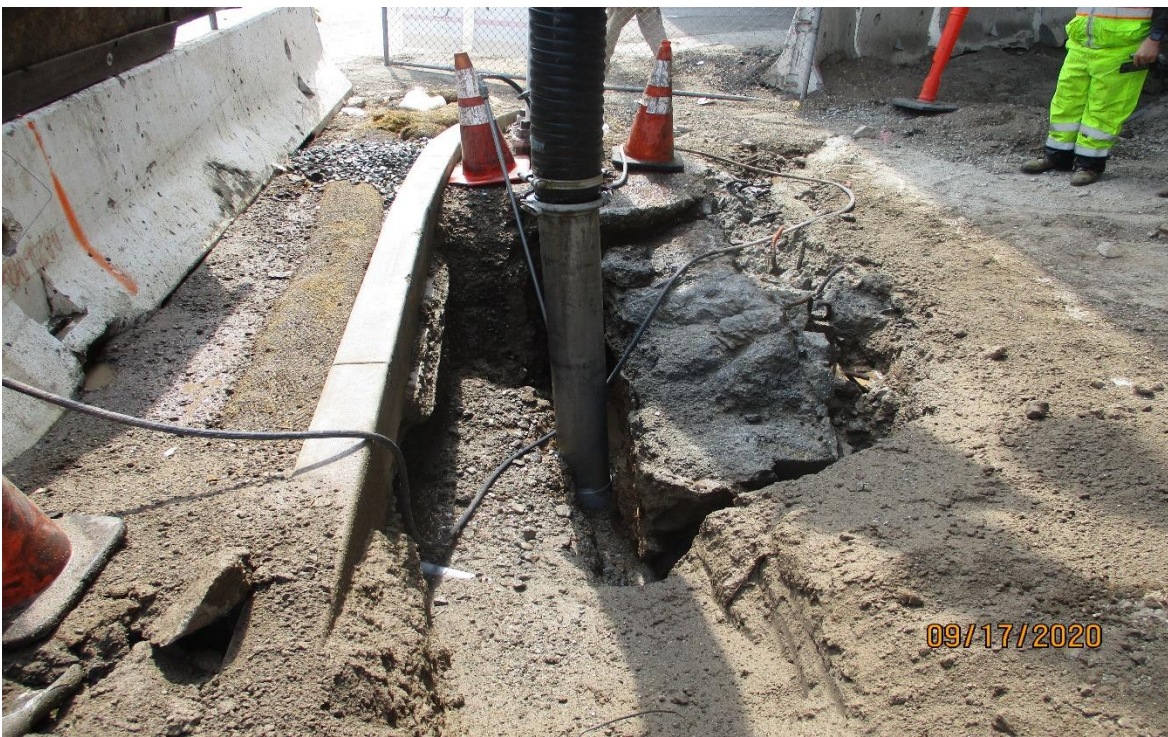
104th street- Obstruction found during traffic signal conduit installation at the NW corner of Aviation and Century

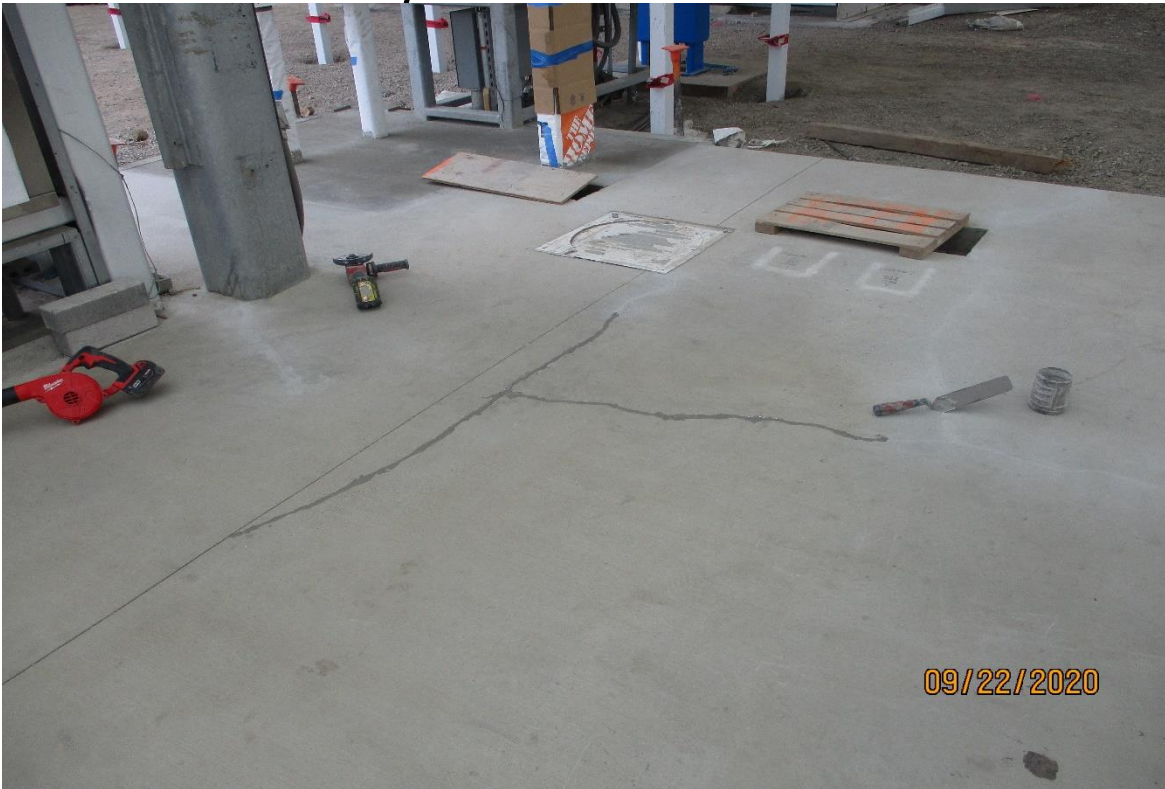
104th street- Crack repair at the Aviation Station ticket kiosk slab.

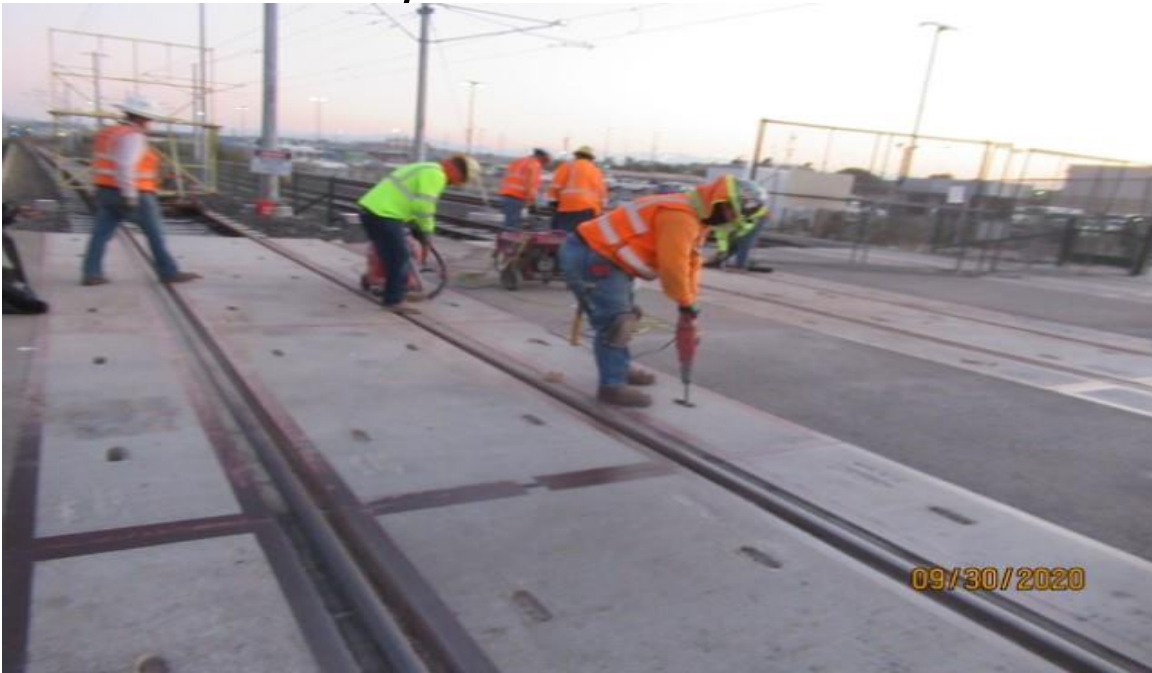
Arbor Vitae- WSCC preparing grade crossing panels to be removed at Arbor Vitae for damaged rail replacement (looking northeast) Rework RFI-01499

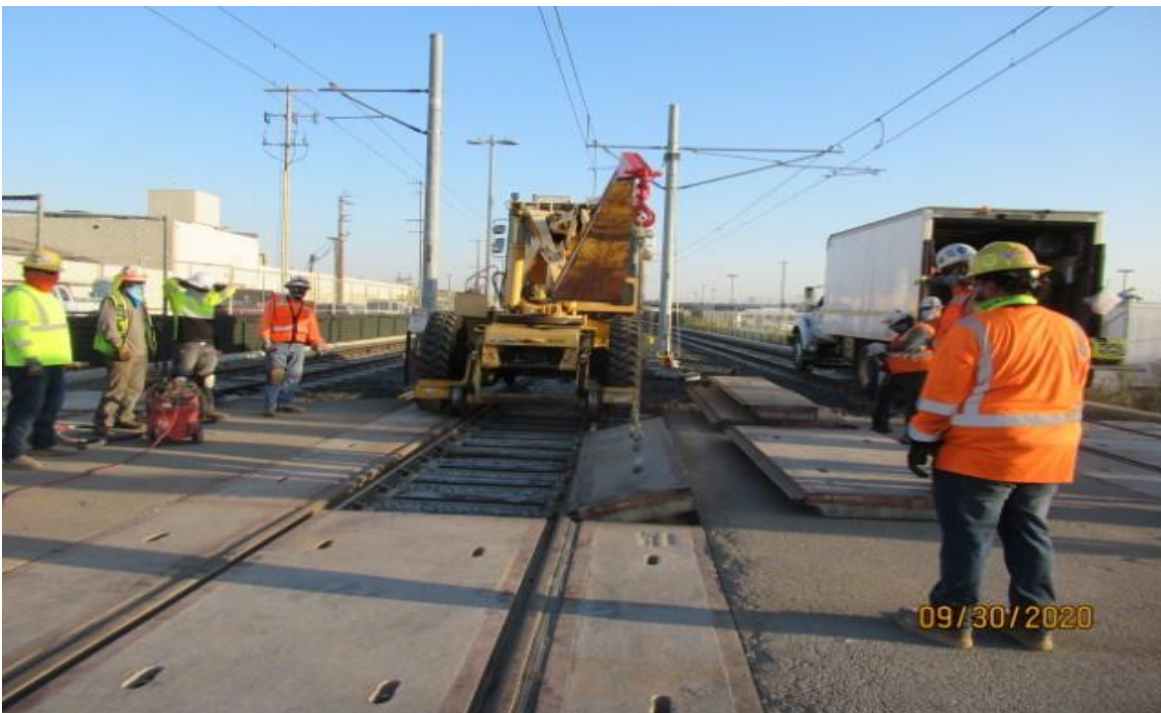
Arbor Vitae- HCC using Speed Swing to remove grade crossing panels at Arbor Vitae for damaged rail replacement (looking north) Rework

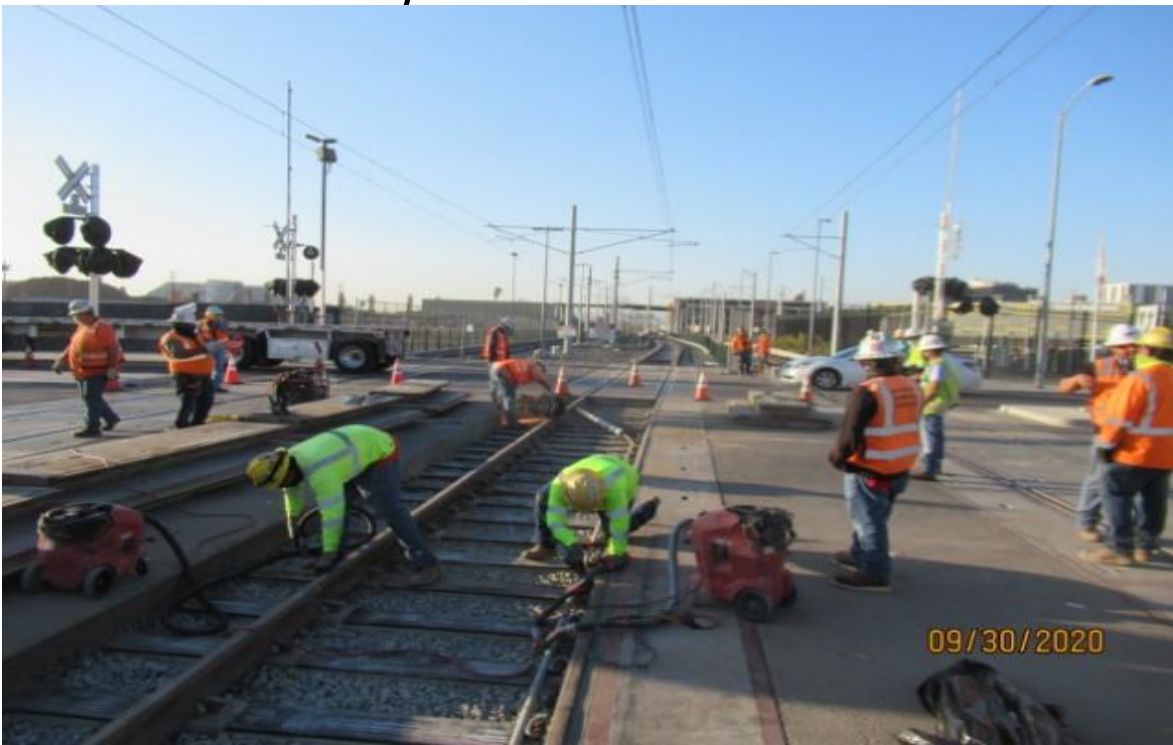
Arbor Vitae- LKC removing system loop O-bonds inside Arbor Vitae grade crossing SB track between STA 93+77 & 94+33 (looking south) Rework RFI-01499

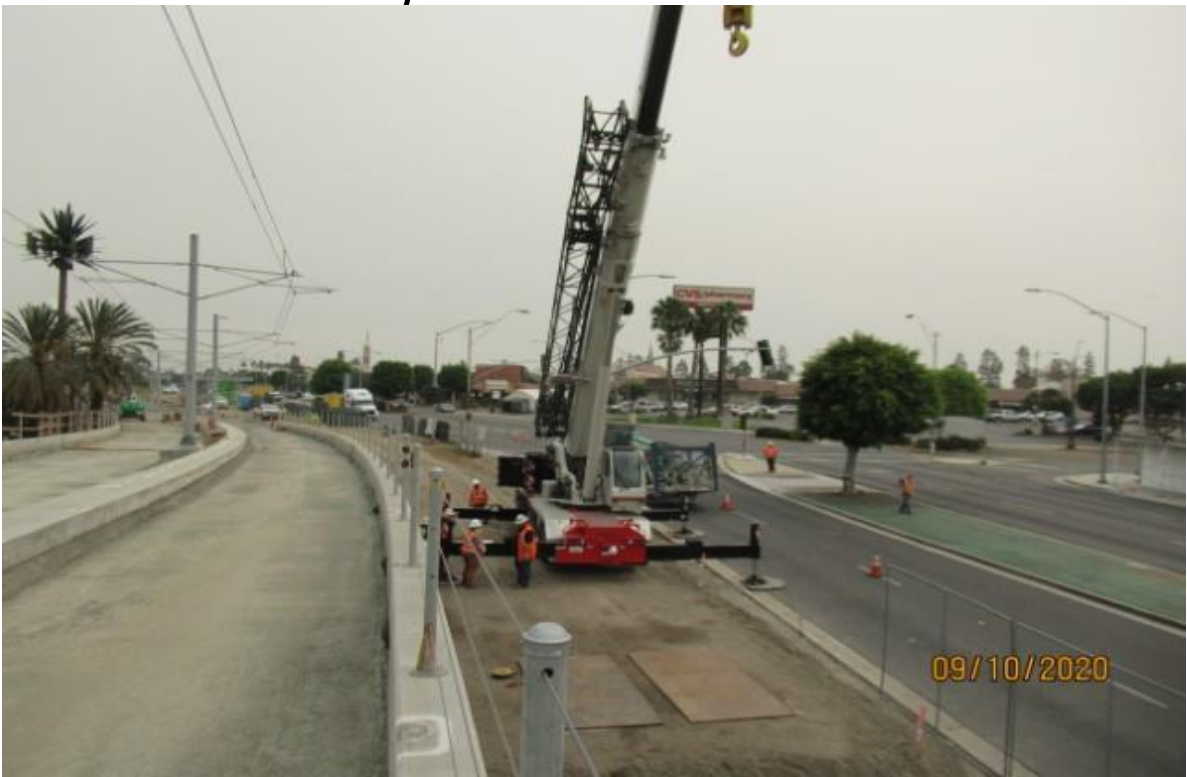
La Brea – La Brea wall 202 WSCC sub-contractor mobilizing & setting up Crain for repair work to be done (looking north) Rework

Jet Grouting of Wall #202 has begun for grout test samples only.

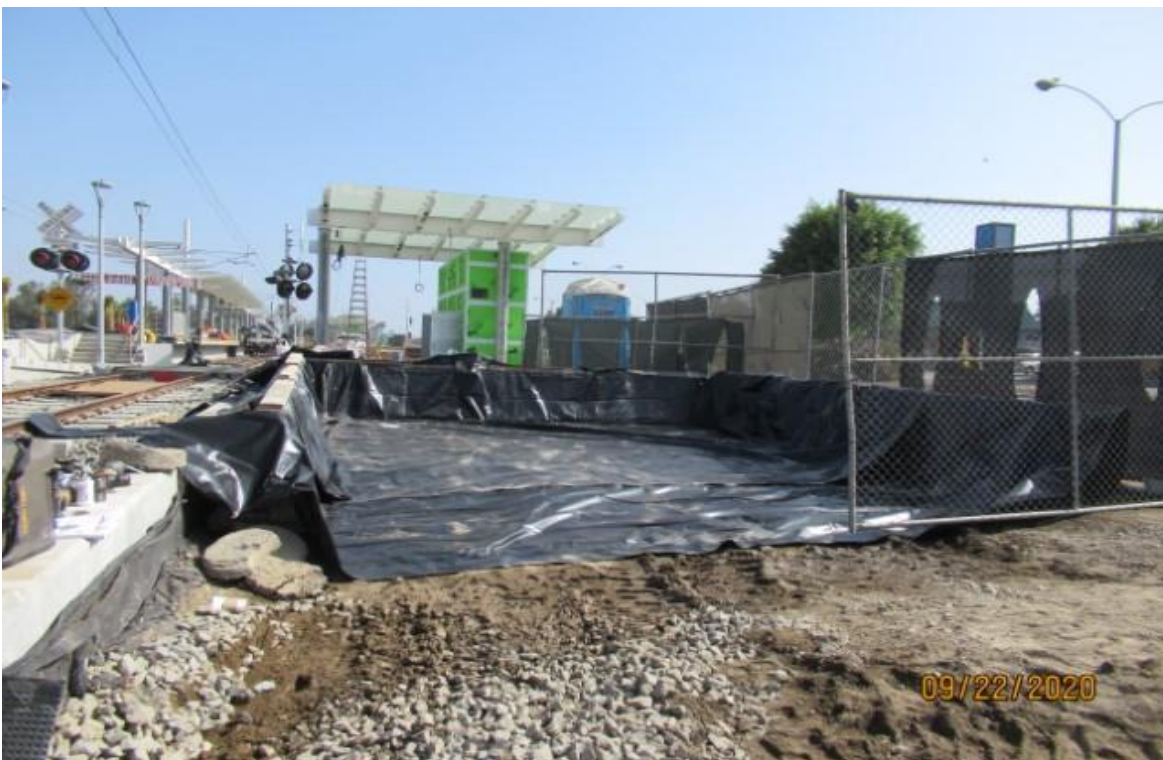
La Brea – La Brea wall 202 off NB track at approximate STA 208+25 WSCC assembling pit for Vacuum truck dump area Rework NCR B-089

- Disturbed ballast due to systems electrical conduit relocations continues to be repaired and re-dressed.
- WSCC submitted the Stability Calculations and the CWP for Wall 202 Jet Grouting for review.
- WSCC has completed the removal of SB rails, ballast, and ties above Wall 202 and excavated to expose the AC cap.
- WSCC has completed the removal of NB rails, ballast and ties above Wall 202 and excavate to expose the AC cap.
- Investigation of rail flaws continues.
