PATSAOURAS PLAZA

WATERPROOFING & LANDSCAPE RENOVATION

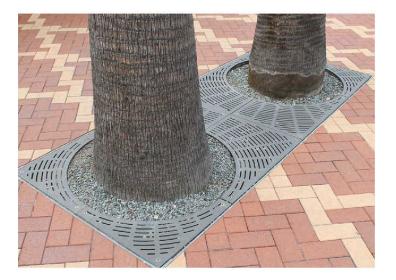
HARDSCAPE

Uplifted paving due to root-bound planters Unused phone booths

Replace uneven tree grates with DG paving Remove and recycle phone booths to reduce visual clutter

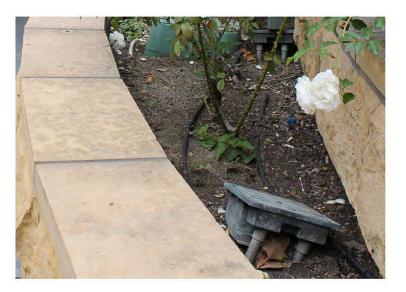
LANDSCAPE LIGHTING

Broken ballast housings, conduits, junction boxes Broken or missing fixtures Missing or burned-out lamps

Repair / replace lighting infrastructure Replace with in-grade fixtures Replace burned-out lamps as required

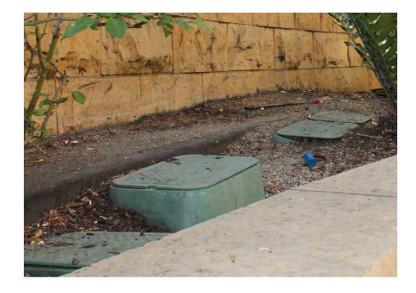
IRRIGATION

Drip and sprinkler heads need repair Valves and boxes need repair, replacement, or removal

Install new subterranean drip throughout planters Reinstall valve boxes

Central control software will allow remote control Weather station can be repaired and made operational

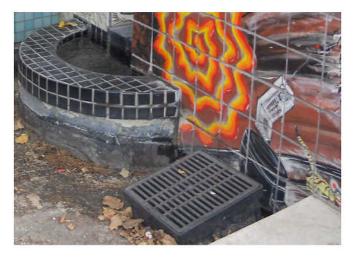
WATERPROOFING AND DRAINAGE

Blocked drainage (roots, debris)

Exposed and damaged waterproofing

Dislodged surface drains

Water damage on paving at spherical concrete planters

Manually clean drain, install a clean-out chimney Repair waterproofing, add flashing at top edge Replace with vandal-resistant grate and risers Seal drain hole, install a chimney and gravel drainage layer

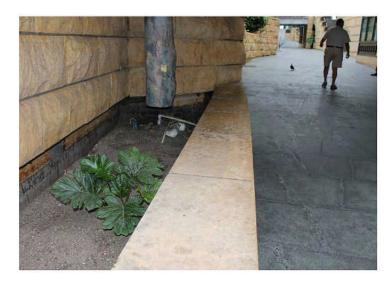
PLANTS

Bare, unplanted areas

Unhealthy plants Root-bound planters Unnecessary tree supports

Replant with plants appropriate for specific conditions

Remove unhealthy plants Root-prune existing trees to remain Remove unnecessary tree supports
