HIGHWAYS AND PUBLIC WORKS

APRIL
1940

State Speeds Program to Restore Damaged Levees and Aid Work of Farm Land Rehabilitation

New Survey of Flood Control Project Needed

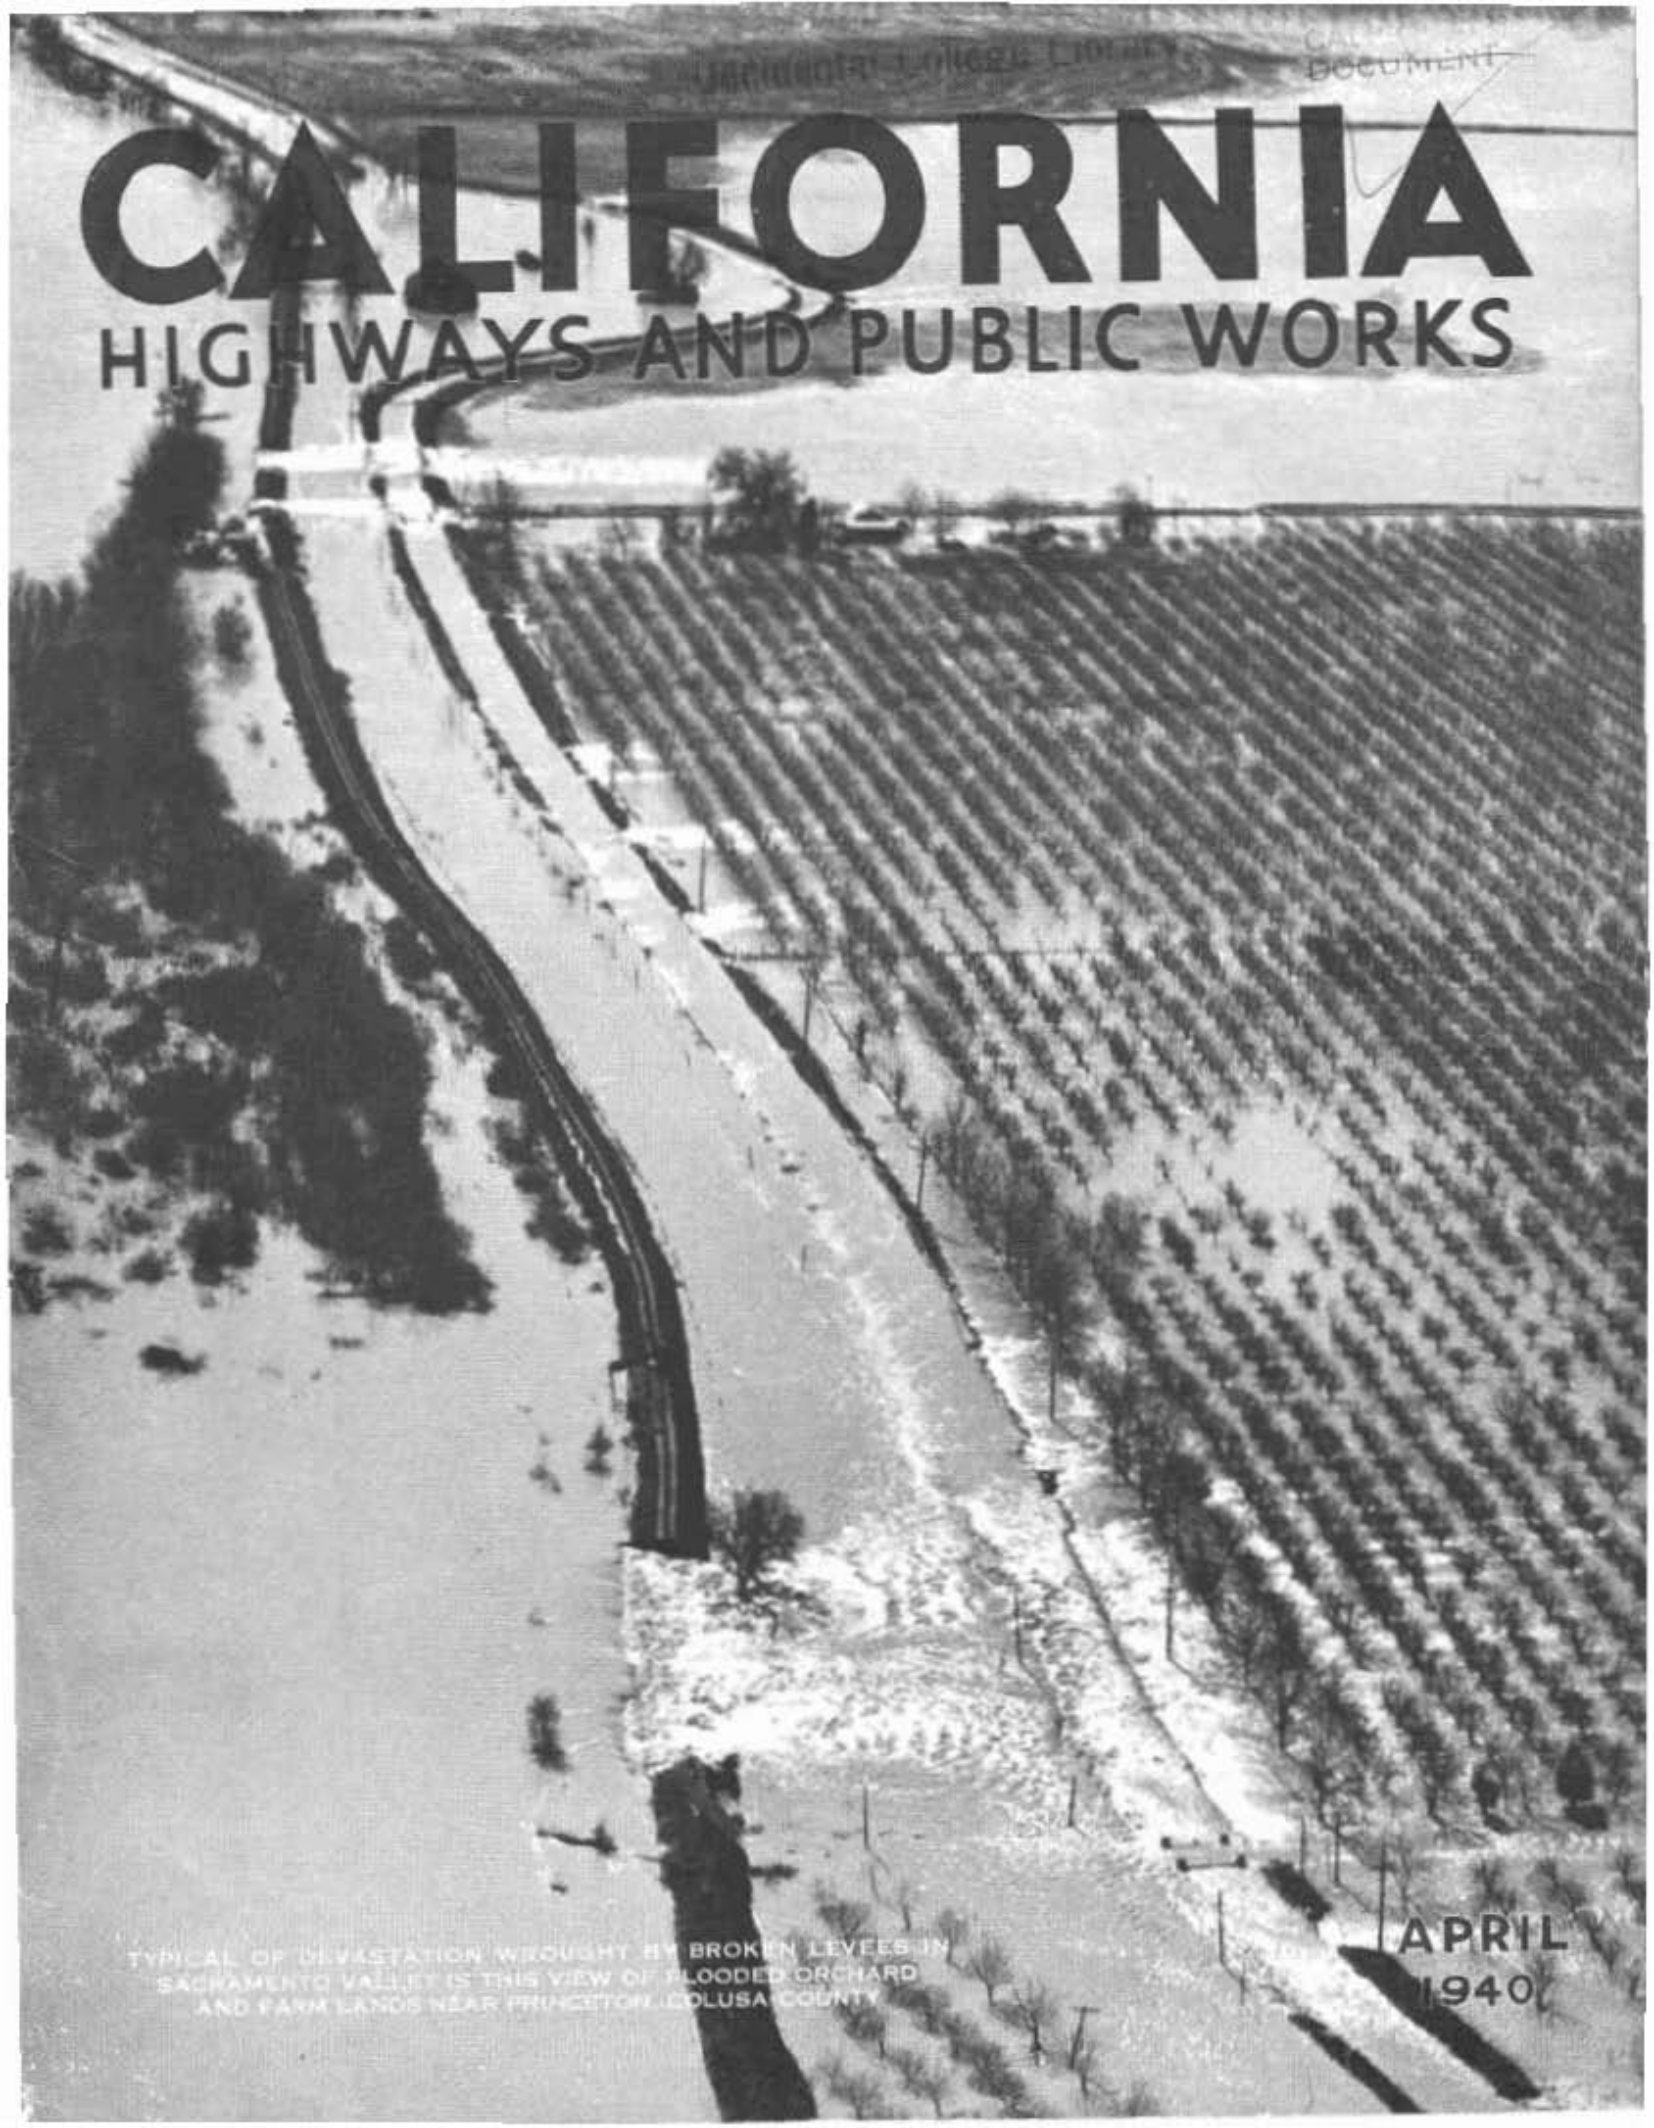
TYPICAL OF DESTRUCTION WROUGHT BY BROKEN LEVEES IN SACRAMENTO VALLEY IS THIS VIEW OF FLOODED ORCHARD AND FARM LANDS NEAR PRINCETON, COLUSA COUNTY

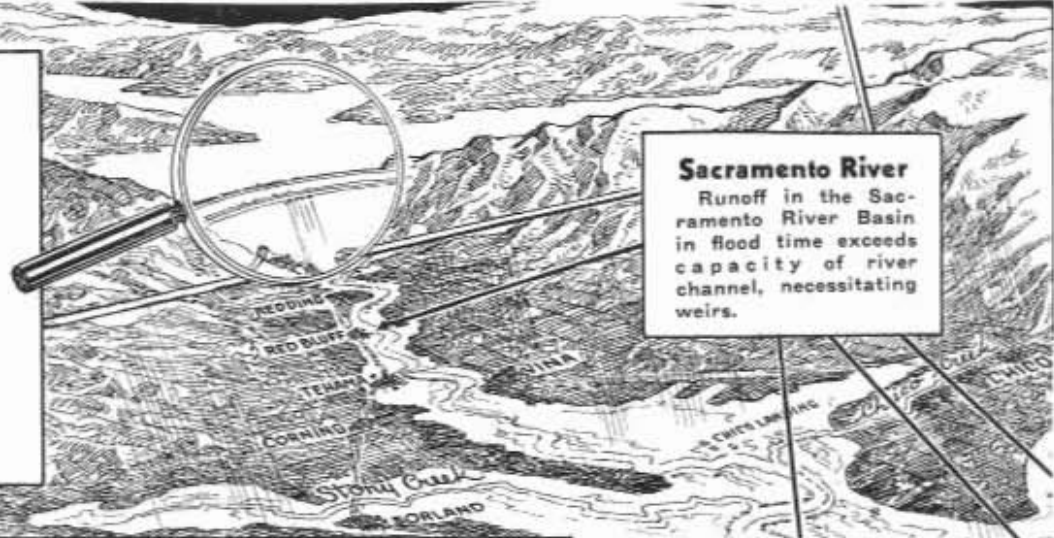
Analysis made of flow of Sacramento River at Kennett and Red Bluff during the February-March flood shows that had Shasta Dam been in operation it would have checked flood on upper reaches of the Sacramento River by reducing the peak flow at Red Bluff from 291,000 second feet to 125,000 second feet.

Runoff in the Sacramento River Basin in flood time exceeds capacity of river channel, necessitating weirs.

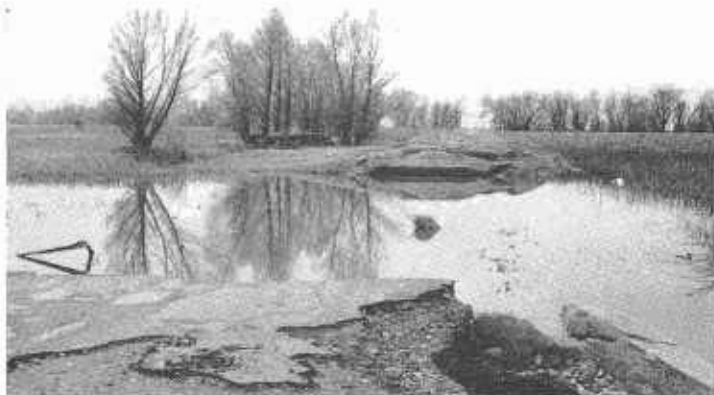
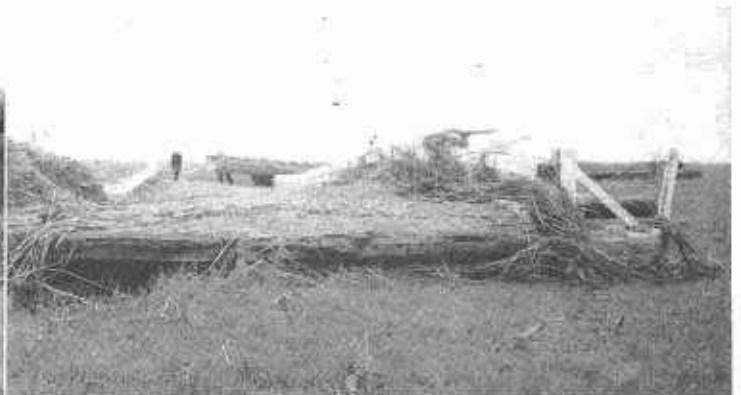
Left—Site of Big Butte Creek Overflow Bridge on State Highway between Butte City and Biggs. Right—Ruins of deck of bridge carried down stream 1000 feet.

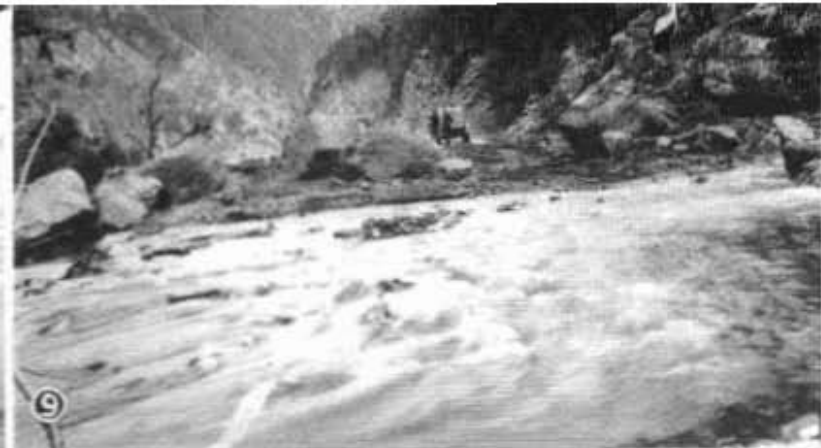
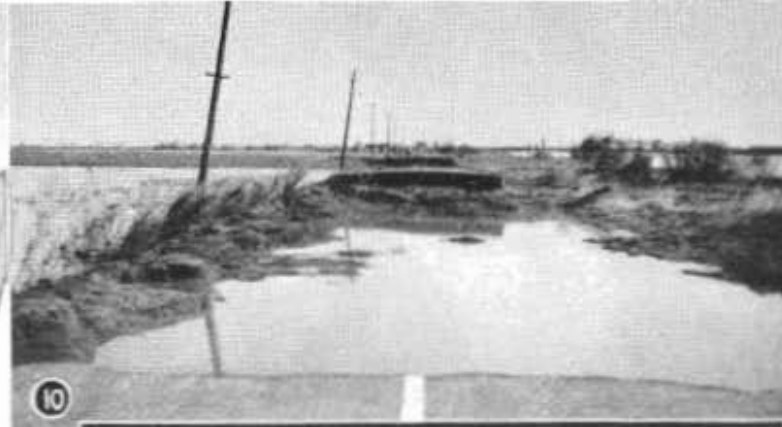
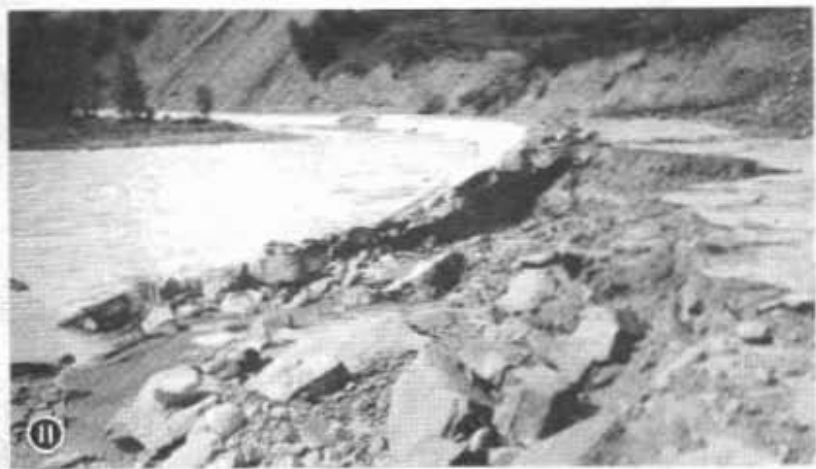
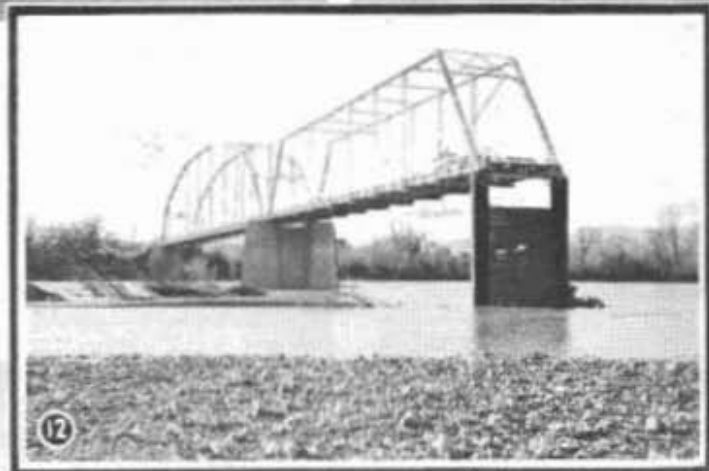
9. Pattles Creek overflows the Feather River State Sign Route 24 in Butte County.

10. Section of State Highway 99 destroyed by flood, in Solano County.

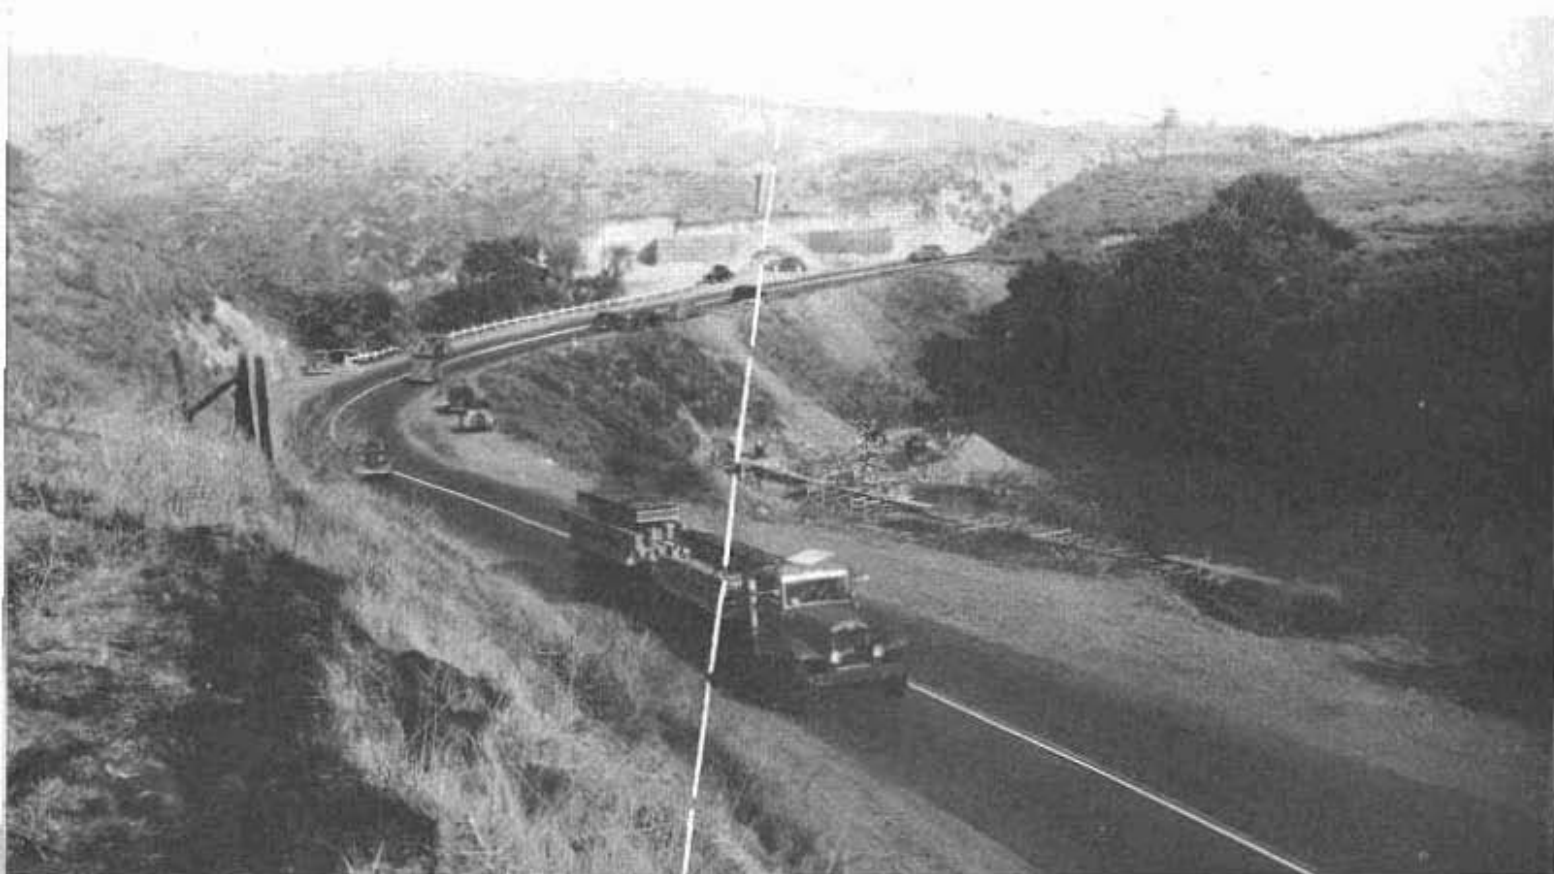
This view of Roosevelt Highway improvement project was taken at Escondido Creek looking easterly.

Work was started on this contract October 30, 1939, and is progressing according to schedule. The contract calls for some 400,000 cubic yards of roadway excavation, the major portion of which has already been made. The black adobe surface was removed and wasted but the remainder of the excavated material after being tested was found to be satisfactory for placing in the embankments. Modern, specially built, dirt moving equipment is being used on this job to make the large cuts which are found at Latigo Point and Ramirez Hill. For this purpose, Woolridge scrapers of 15- and 18-cubic yards capacity are being drawn by 105- and 110-horsepower tractors respectively.

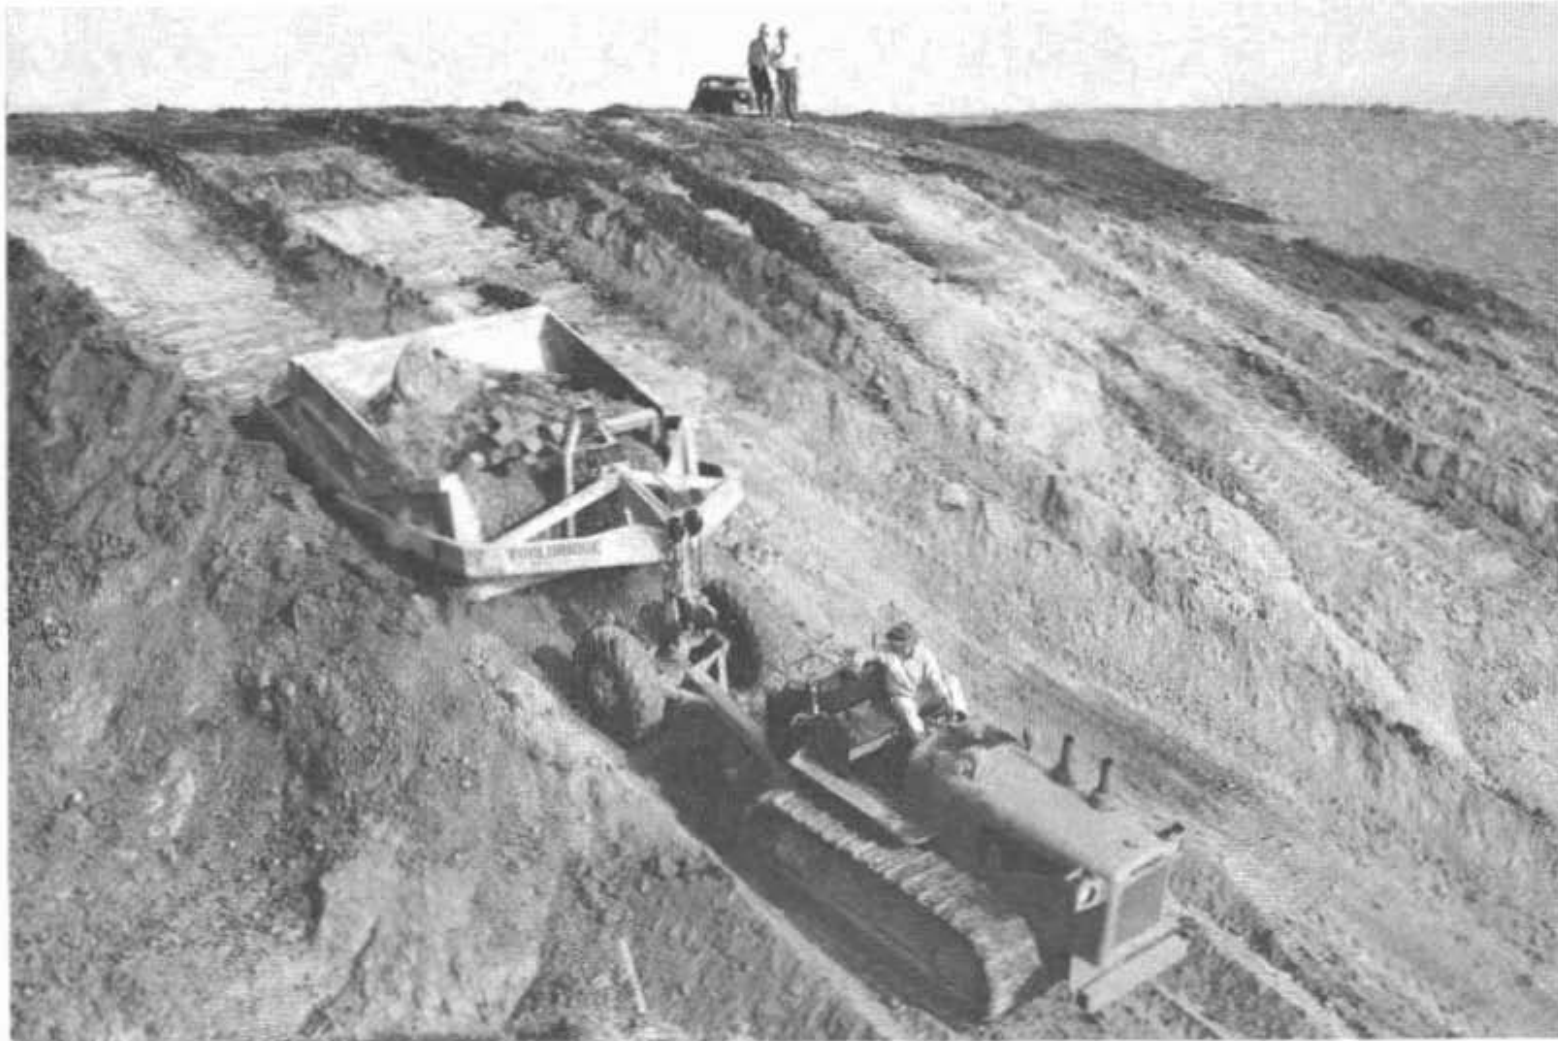
New type six-cylinder Diesel tractor pulling 15-cubic yard scraper on Roosevelt Highway construction.

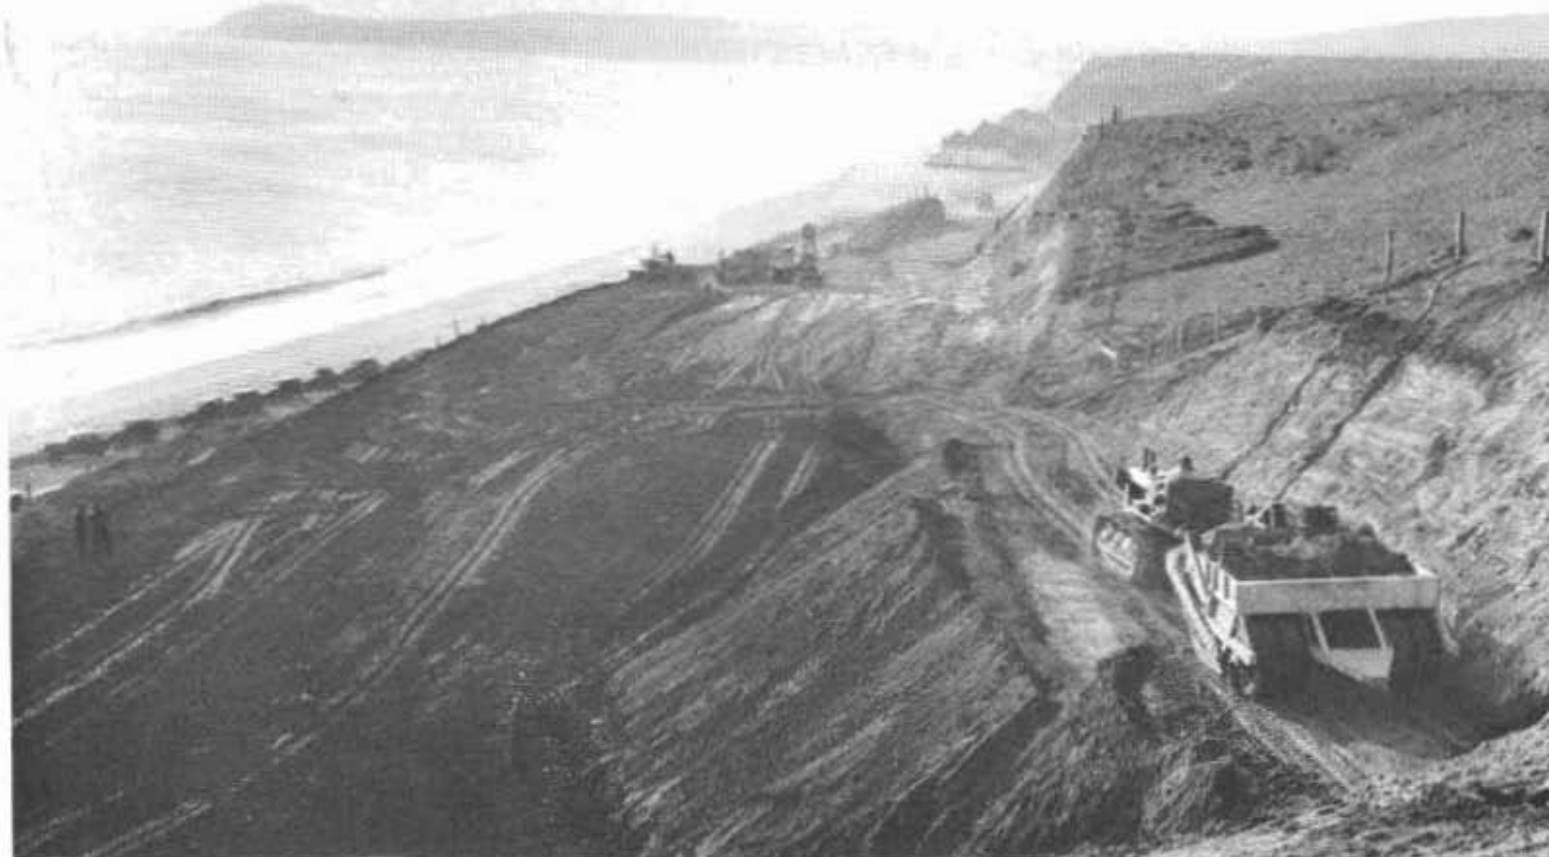
Line change at Latigo Canyon road. New center line shown along right edge of picture eliminates sharp curve around point.

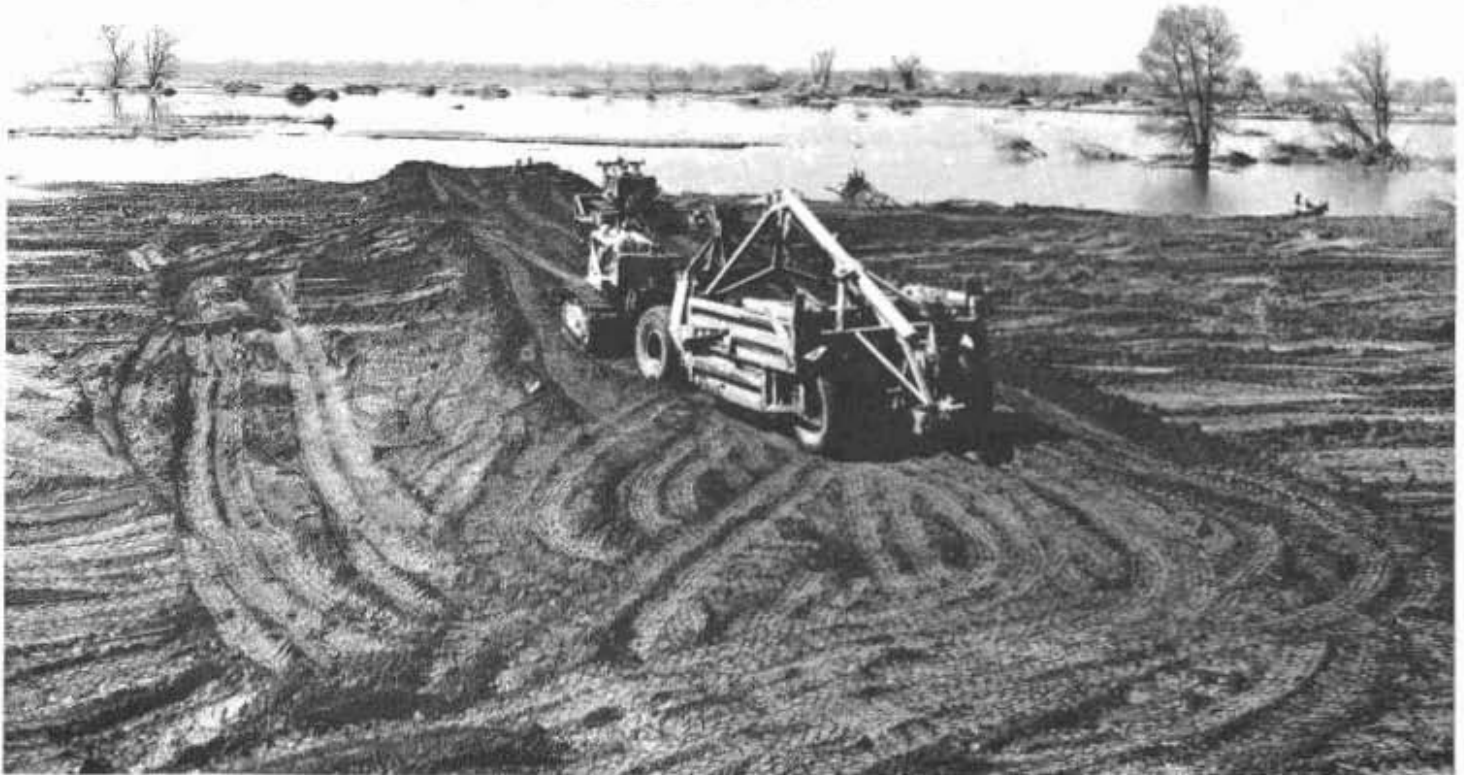
Equipment engaged in repairing levee break along Sutter By-pass near Meridian.

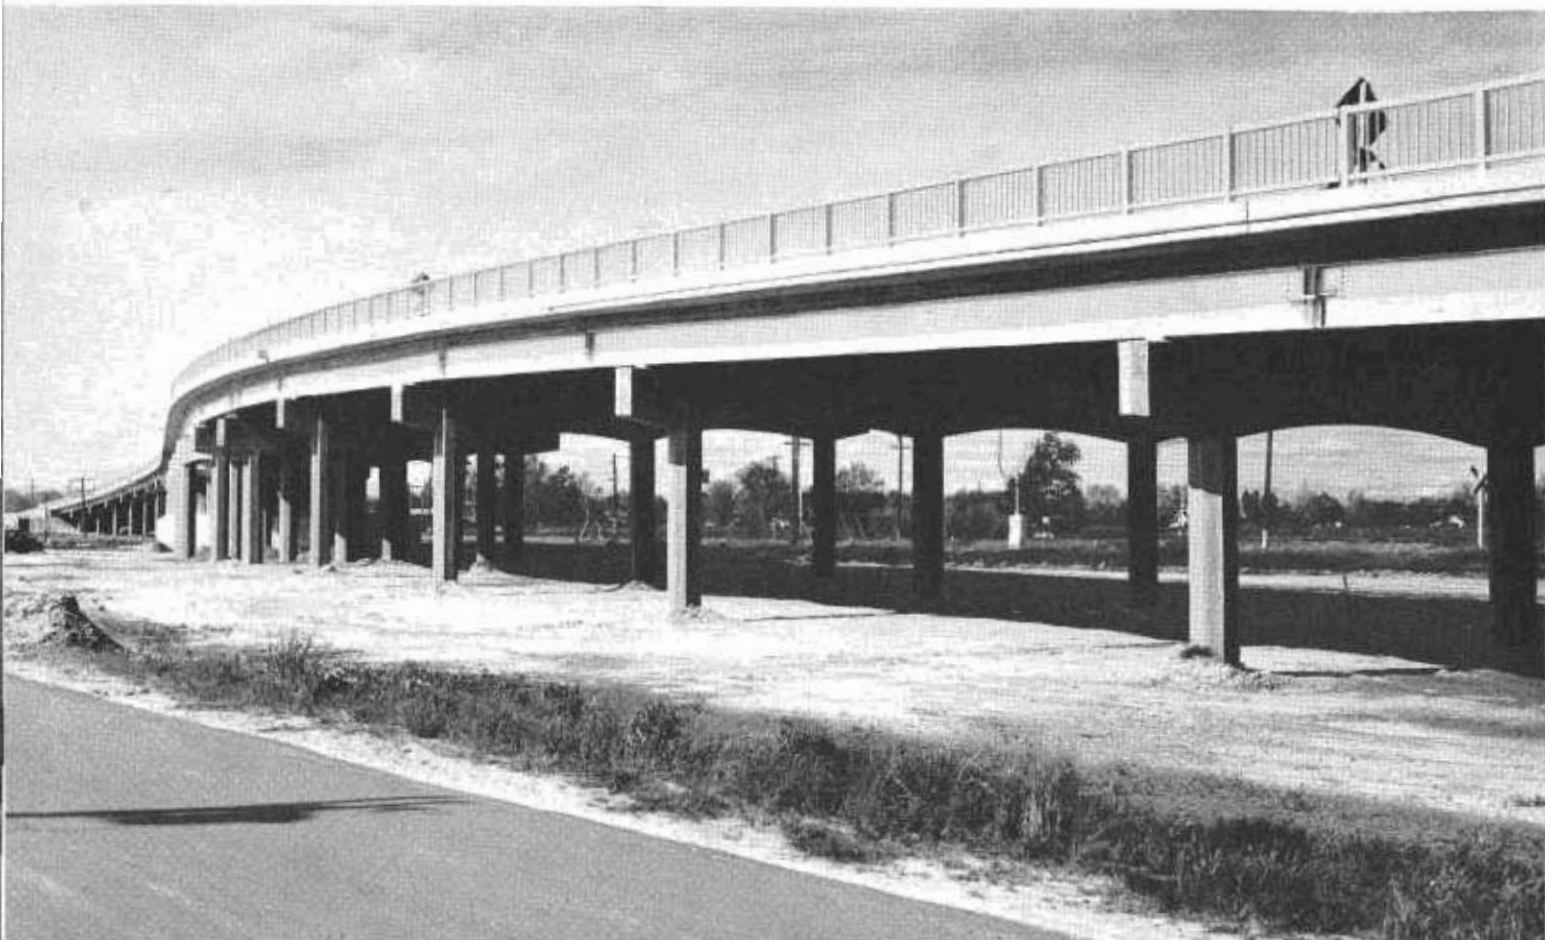
View of new Turlock grade crossing overpass which was officially dedicated on April 5.

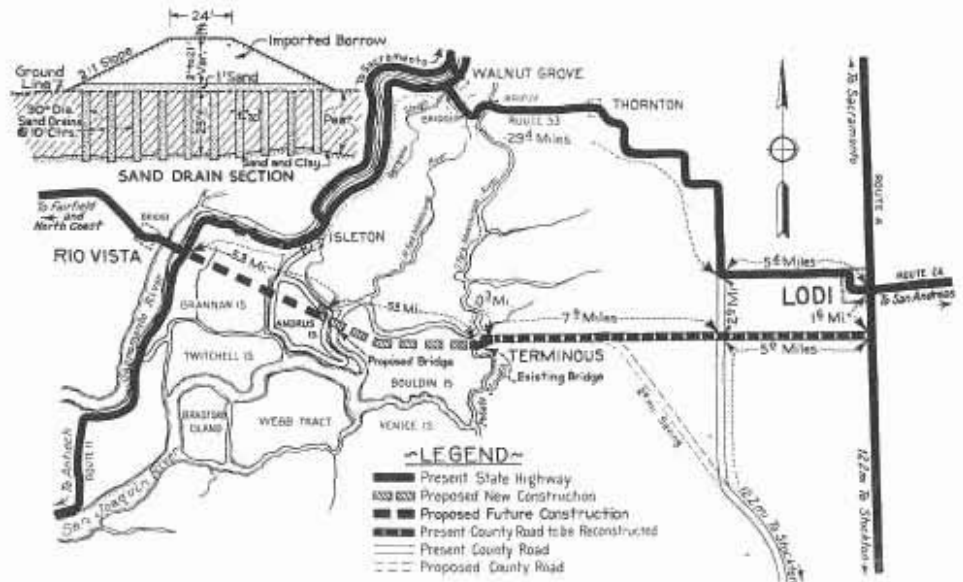
Sketch map shows proposed Rio Vista-Lodi cut-off.

county road known as the Kettleman-Terminus Road from Terminus to Route 4, south of Lodi. From Terminus to Rio Vista it was planned to run by a very direct route across Bouldin, Andrus, and Brannan Islands. During the 1935-37 biennium the first unit on the new location, a drawbridge across Potato Slough at Terminus and the east approach was constructed. This eliminated a county operated ferry here, but due to there being nothing but a few miles of indifferent county road along the levee on Bouldin Island, its use was limited to local traffic.

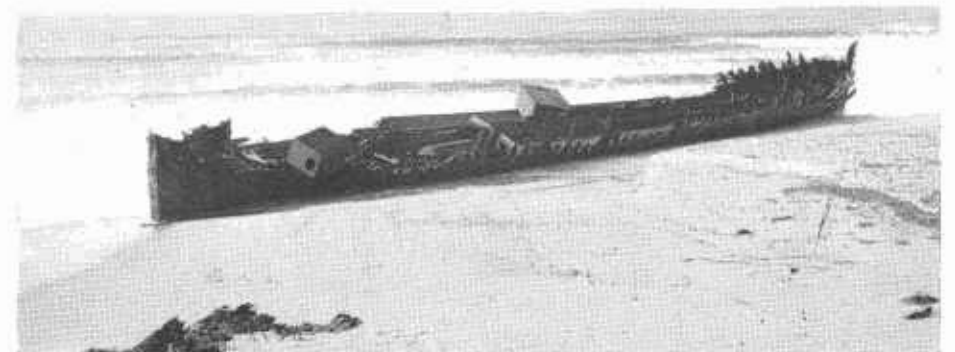
All that remained of "Minnie A. Caine" after burning

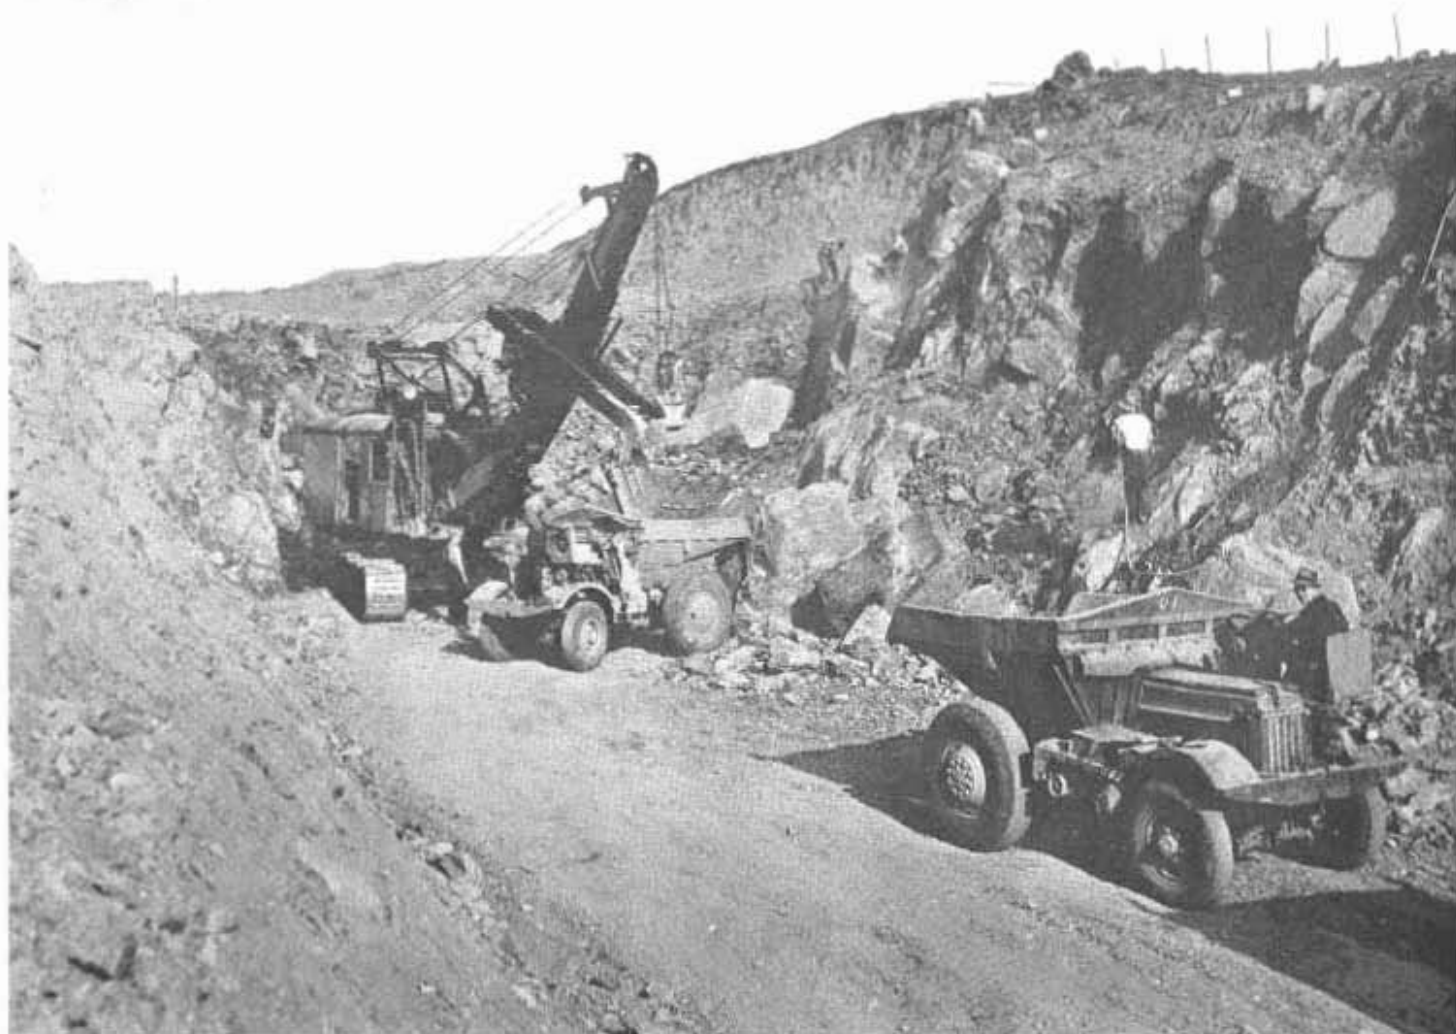
Shovel engaged in heavy excavation work in rock cut on realignment east of Folsom.

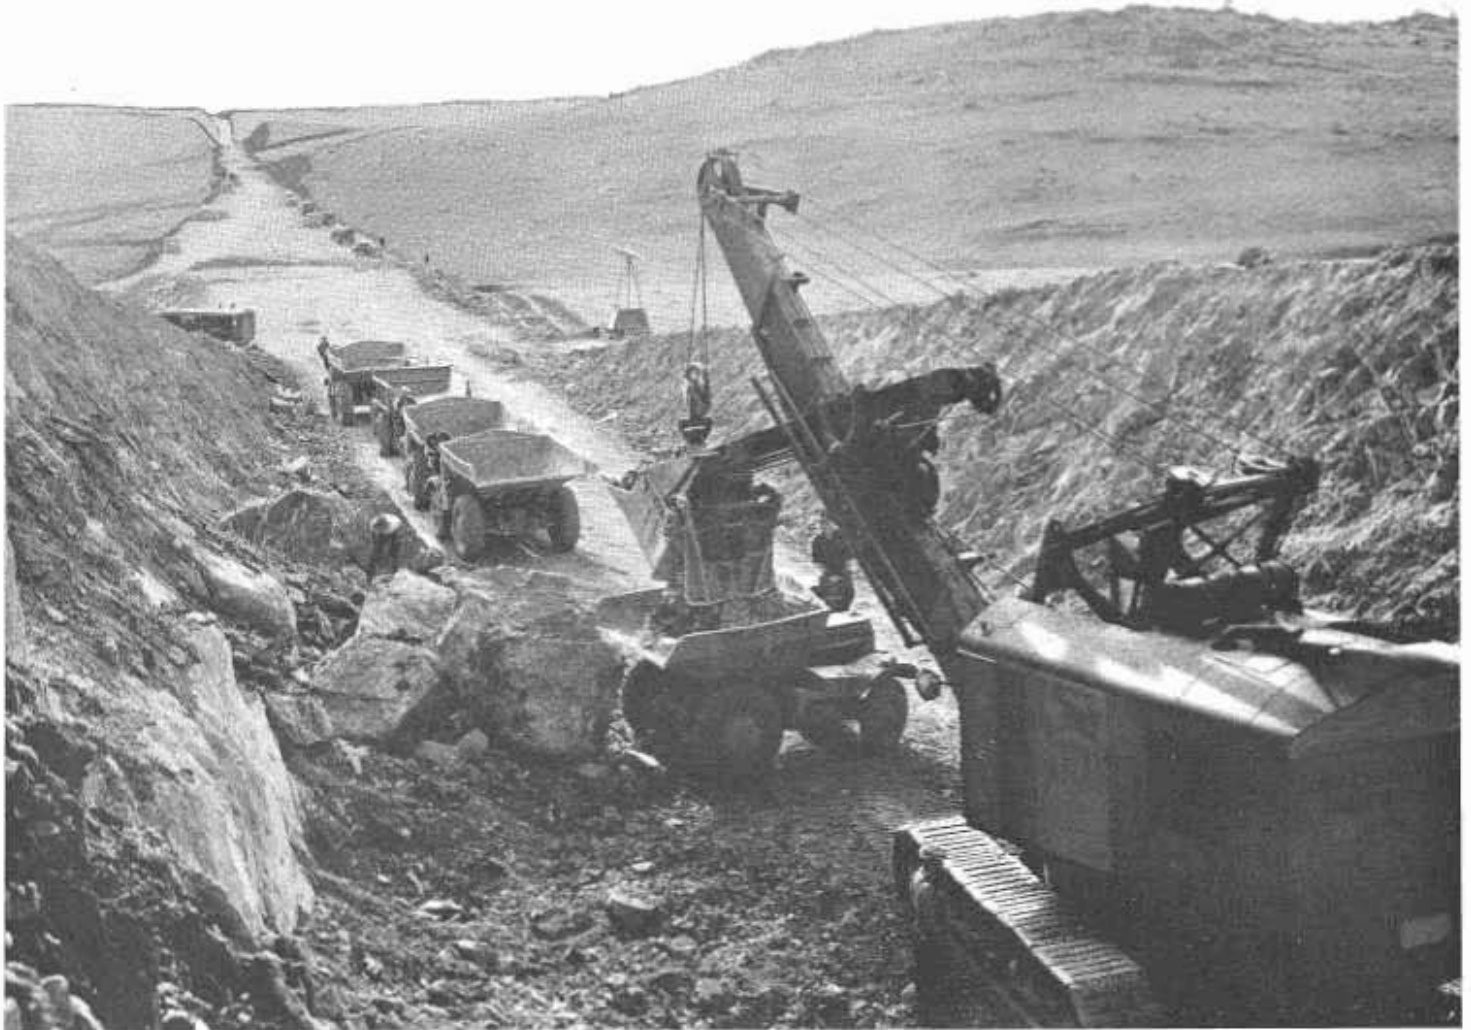
This is another view of construction on U. S. 50 between Folsom and Clarksville in El Dorado County.

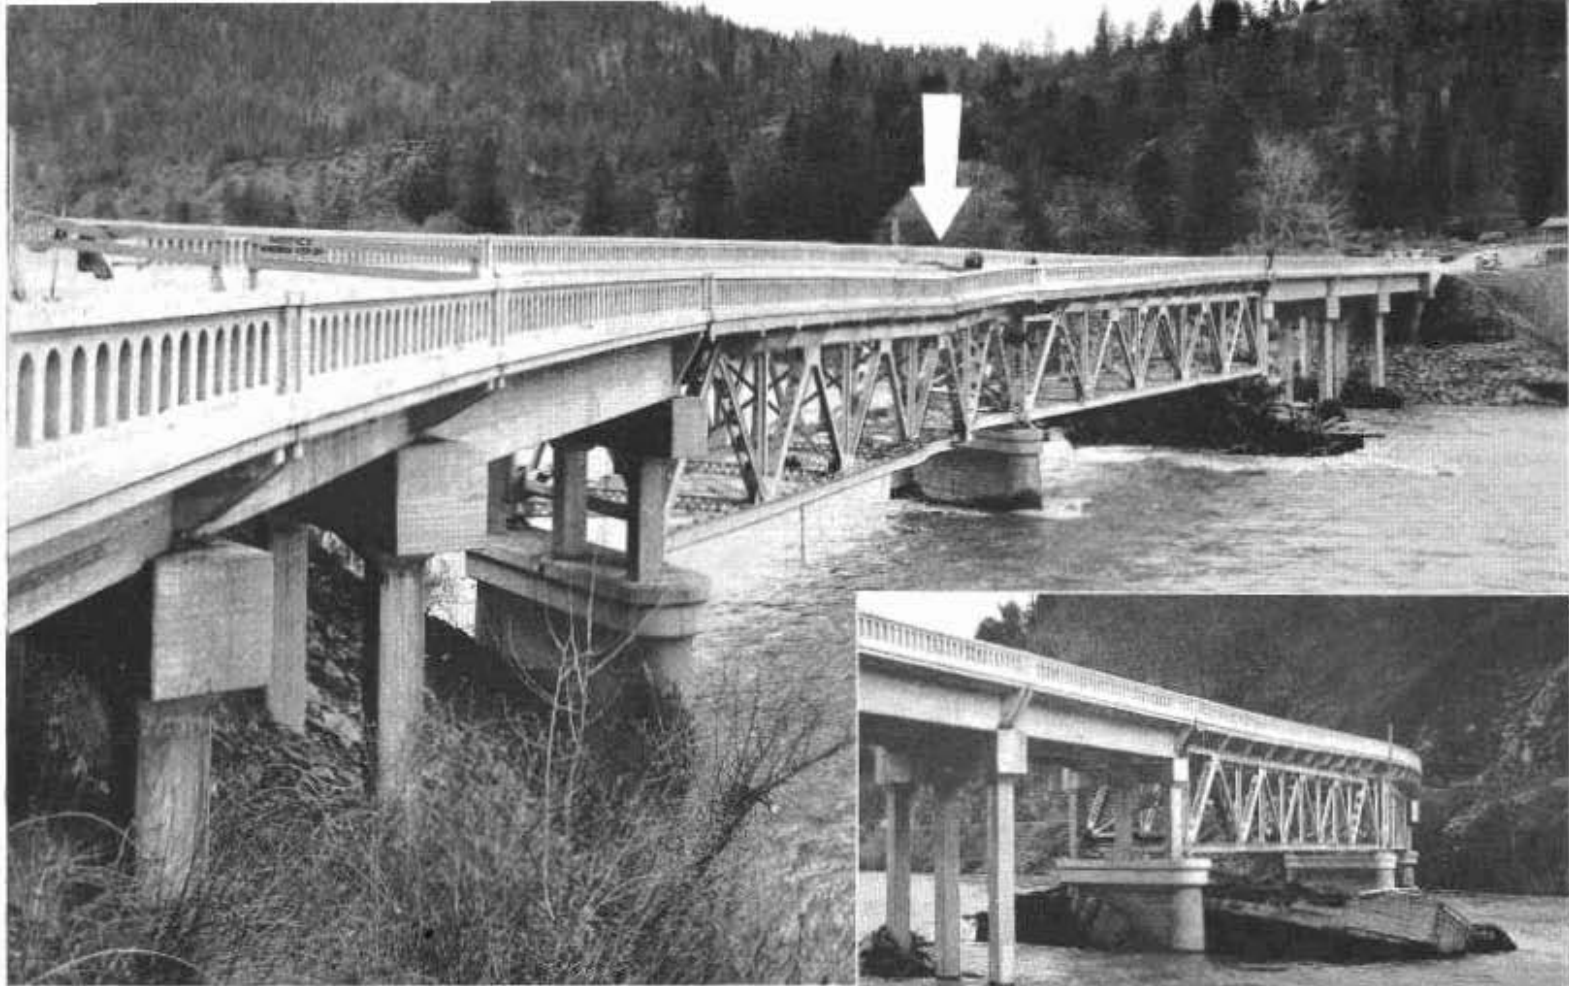
Flood-Damaged Highway Bridge across Trinity River near Douglas City. Arrow points to weakened section.

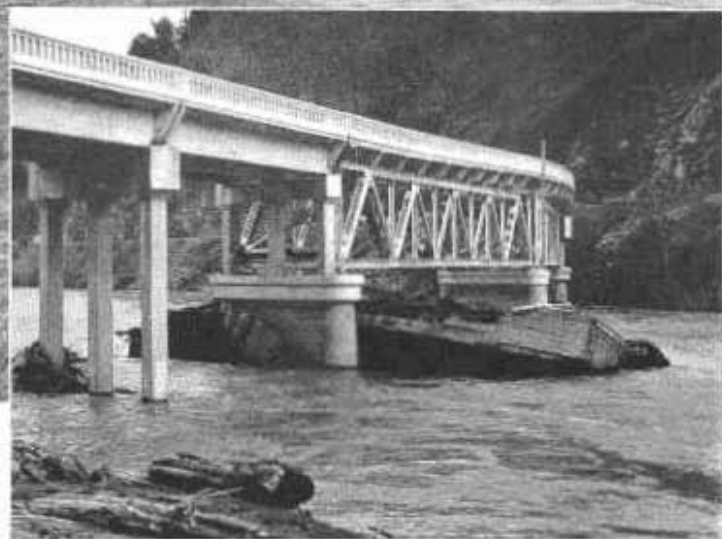
This view shows wrecked dredger washed against bridge piers.

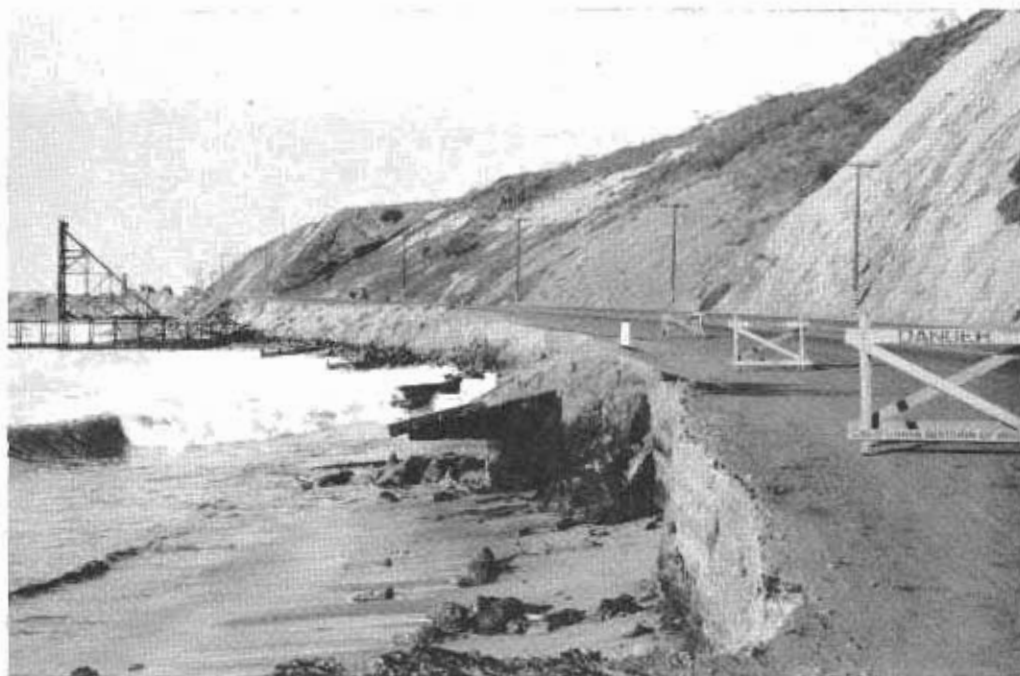
While "Minnie A. Caine" was forming sand bar, tidal currents threatened highway.

It was decided that the most satisfactory way to dispose of the boat under the circumstances was by burning. The matter was discussed with Captain Olson. His approval was secured, and he offered to cooperate with the Division of Highways maintenance forces. As soon as abandonment papers had been filed by Captain Olson, and the necessary permits secured from several agencies, final arrangements were made for the conflagration.

Weather service bureaus were consulted, and they advised that conditions would be most favorable for burning on the night of December 21, 1939, when an off shore breeze would be blowing. Plans were therefore laid for the burning at that time, and during the evening six hundred gallons of fuel oil and gasoline were

spread over the boat. By 1 a.m. everything was in readiness for the blaze. All cars and onlookers were cleared from the highway for a distance of two hundred yards each way, and a gasoline soaked rope which had been laid over the deck and out across the sand bar was ignited. There was no explosion, and the flames spread over the boat very slowly. By daylight the deck and a portion of the stern had burned, but the hull was not much more than charred.

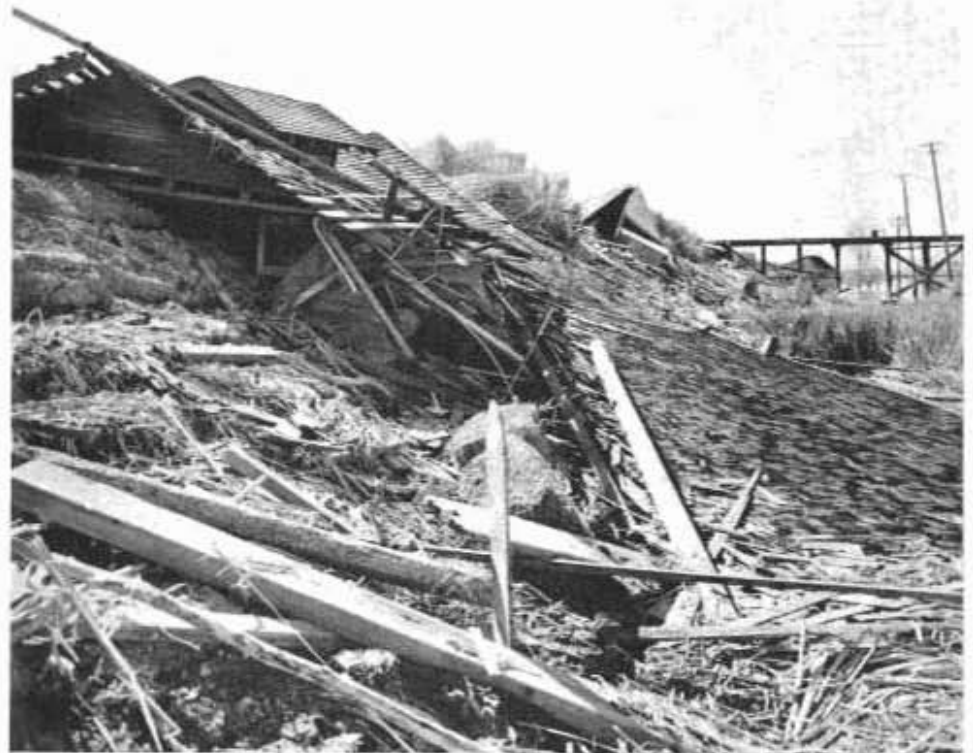
This debris, washed up against Sutter By-pass levee, is all that remained of several farm structures after February floods.
