CALIFORNIA  
**Highways**  
and Public Works

**JULY-AUGUST 1961**

# California Highways and Public Works

Official Journal of the Division of Highways, Department of Public Works, State of California

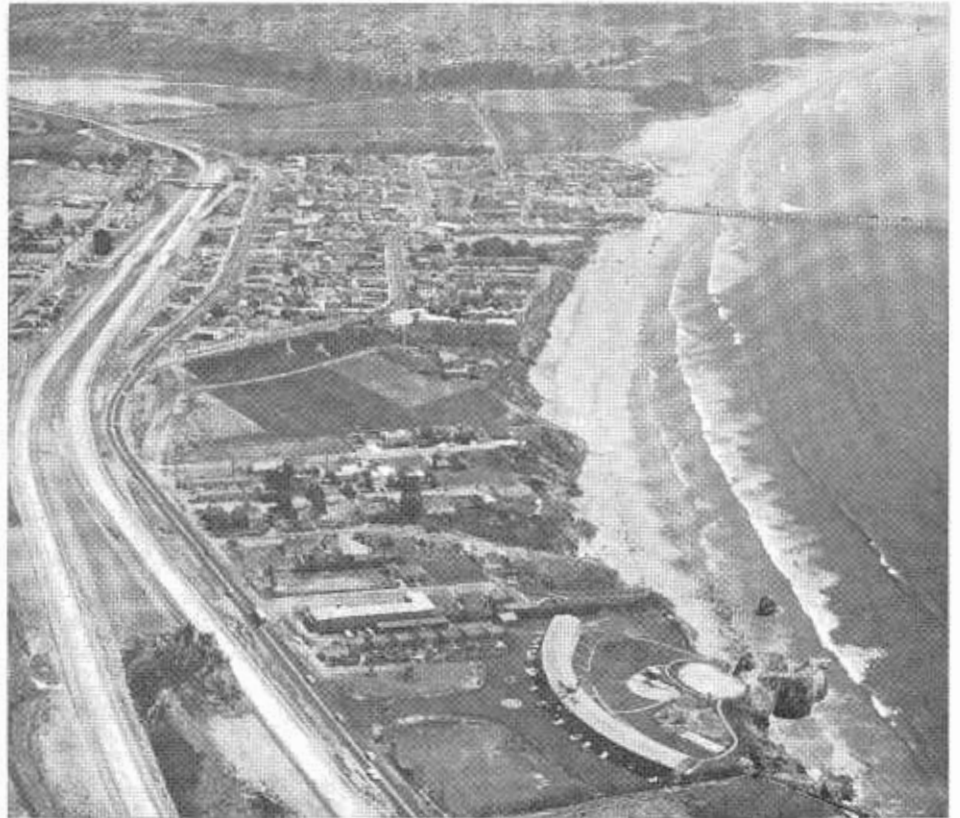
*A southward view of the Pismo Beach Freeway under construction with traffic still using the old highway which parallels the southbound freeway lanes.*

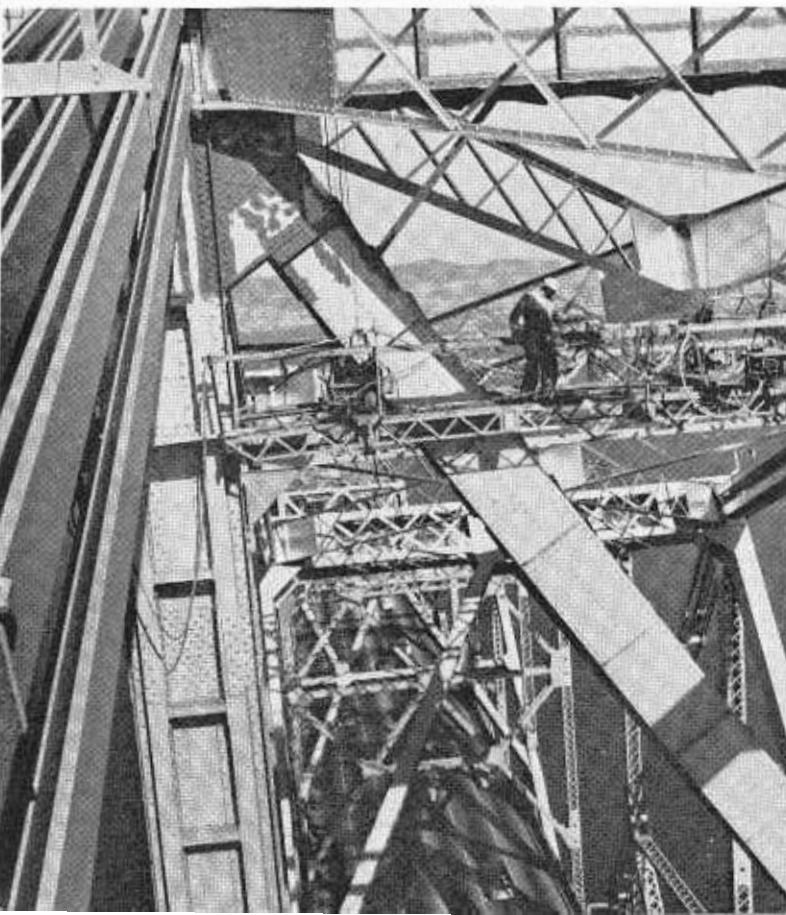
*The first spot coat painting is applied on one of the towers of the East Bay cantilever section using air-powered hoists on trussed aluminum scaffolds designed by members of the Bay Bridge staff. The view is eastward with the Berkeley hills in the distance.*

It was soon found that this was not practical, and the system was changed to be a first spot coat of lead, a second spot coat of lead, and a solid coat of aluminum. This also was found to be impractical because of the mottled appearance of the finish in a few weeks after completion. Another change was made, making the first coat of lead a spot coat, the second coat a solid coat, and the finish coat a solid coat of aluminum. This gave a good appearing finish to the structure, and the solid coat of lead immediately before the finish coat of aluminum has been continued since late in 1939.

1. Steam clean all surfaces that can be reached and where it does not interfere with traffic.
2. Rust removal, that is, spot sandblasting, power brush buffing, hand cleaning, and phosphoric acid crack treatment and caulking where required.
3. First spot coat red lead on all seams, edges, rivet heads, and sandblasted areas.
4. Second spot coat red lead on all seams, edges, rivet heads, and sandblasted areas.
5. Third coat red lead, a solid coat.
6. Finish coat aluminum.

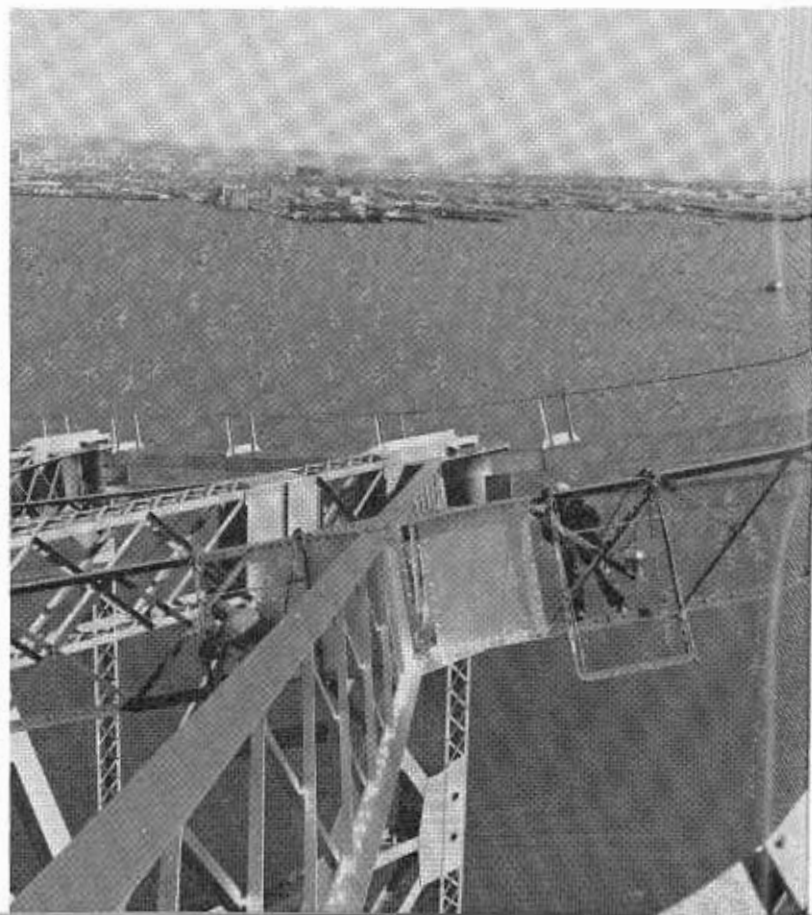
*Painting the aluminum finish coat on top of the lateral bracing in the cantilever structure.*

applied to the bridge, changes were made from black because of civic pressure, and aluminum was used for the finish coat. The aluminum originally used was a long oil varnish using tung oil. Two and one-quarter pounds of aluminum paste were used per gallon of varnish.

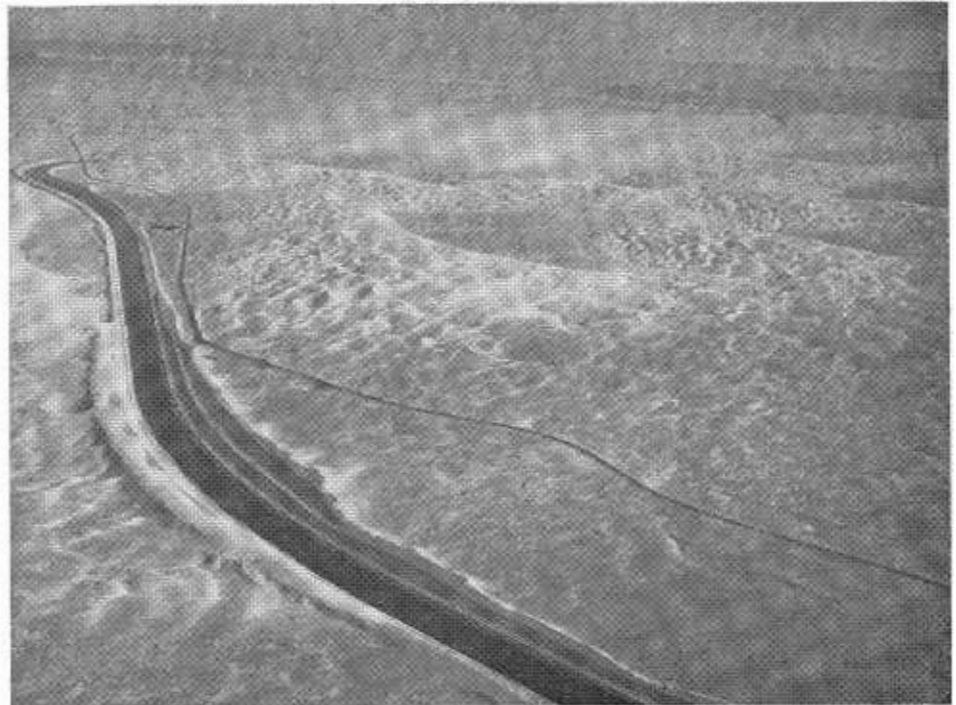
This 1956 aerial of the dunes area shows U.S. 80 (thin line right) and the All American Canal (broad ribbon).

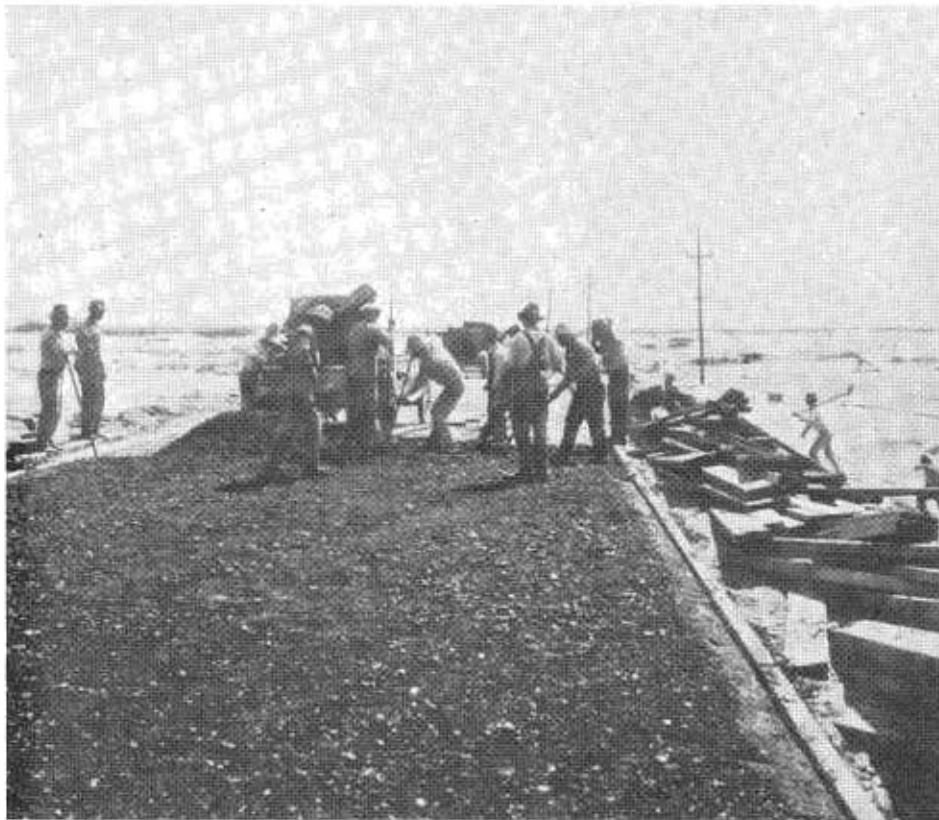
This 1925 photo shows a crew laying pavement on U.S. 80. The planks on the right laid crossways to support trucks carrying asphalt to the construction area.

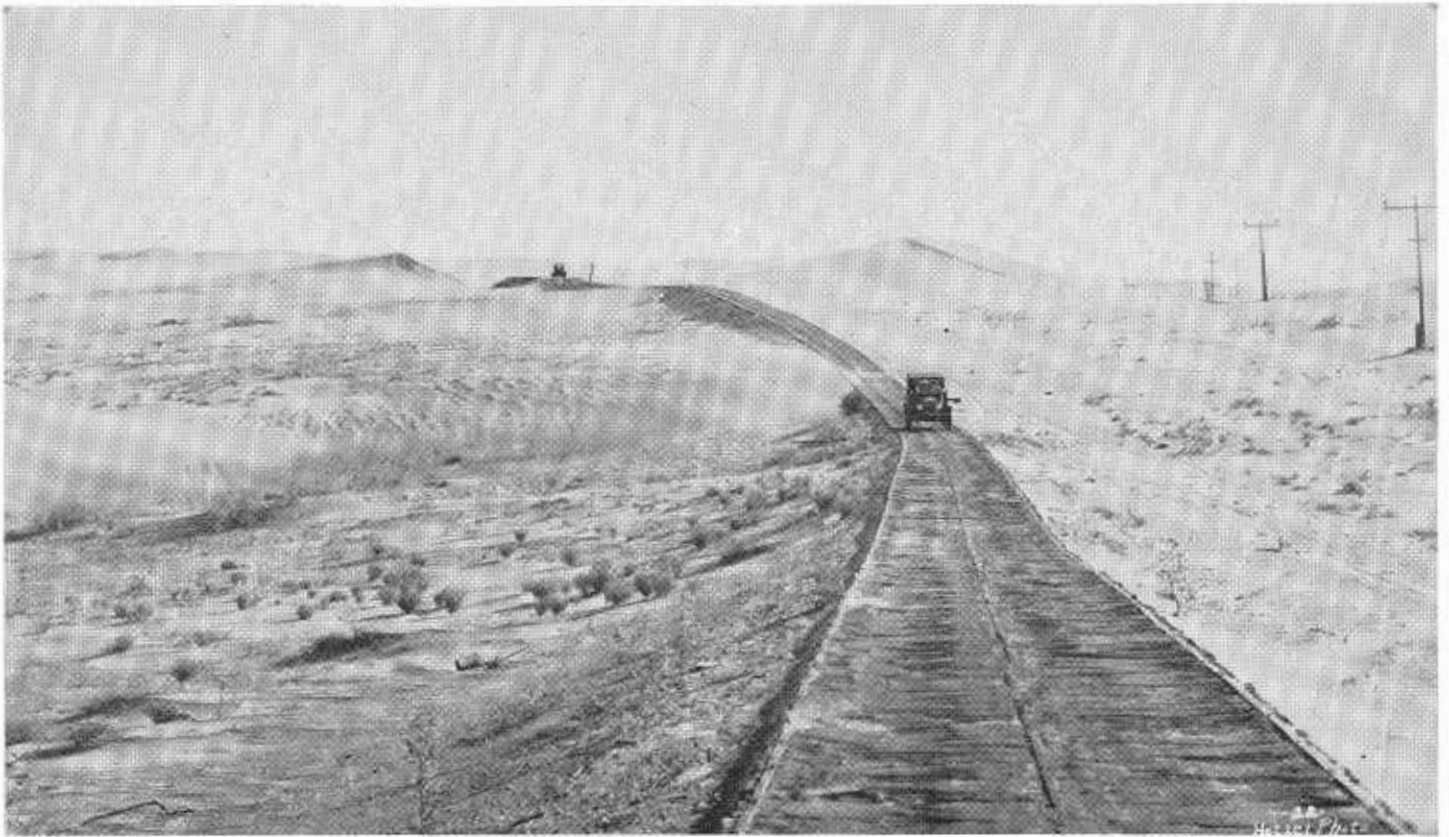
*A section of the improved plank road constructed by the California Highway Commission across the Sand Hills in 1916.*

In 1912, a group of San Diego businessmen, endeavoring to attract motorists from the East, built a crude but successful road across the Sand Hills. Thirty-six carloads of 12-inch planks were used. Two planks, laid parallel to each other and connected with cross boards, formed a section. Sections laid end to end constituted the road. When the traveler found his path blocked by drifting sand, he pulled sections from under their sand blanket and relaid the sections. The 60-mile trip from Yuma to El Centro generally required 12 grueling hours. A few traces of this road still exist as a remnant of the historical past.

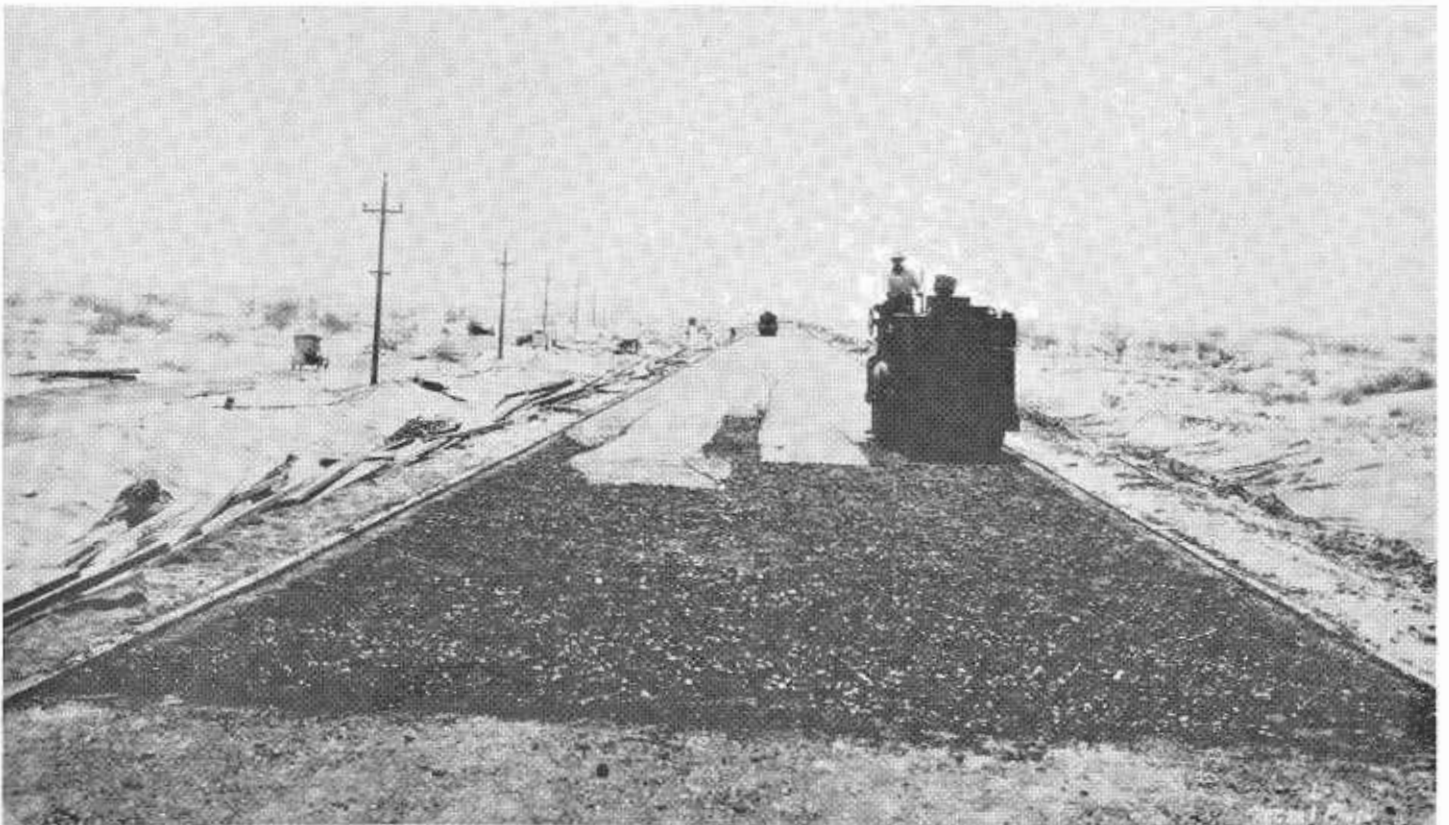
*This photo was taken during construction of the 20-foot wide asphalt concrete road built in 1925.*

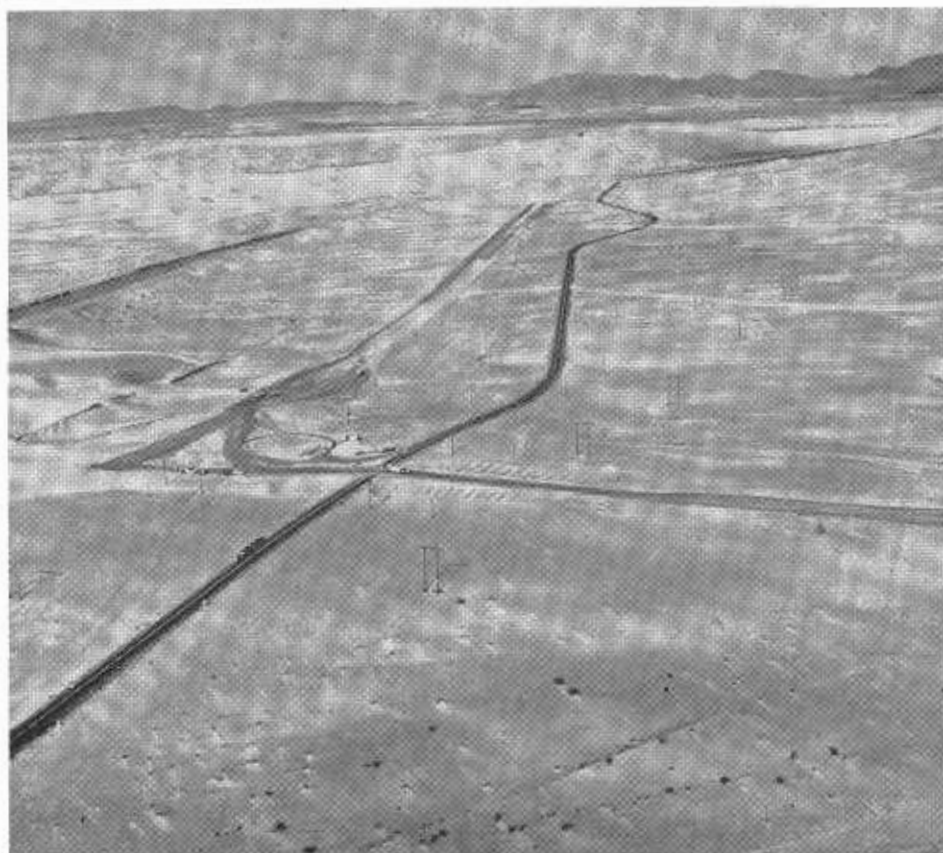
*An aerial view of the haul road for construction equipment crossing the present highway.*

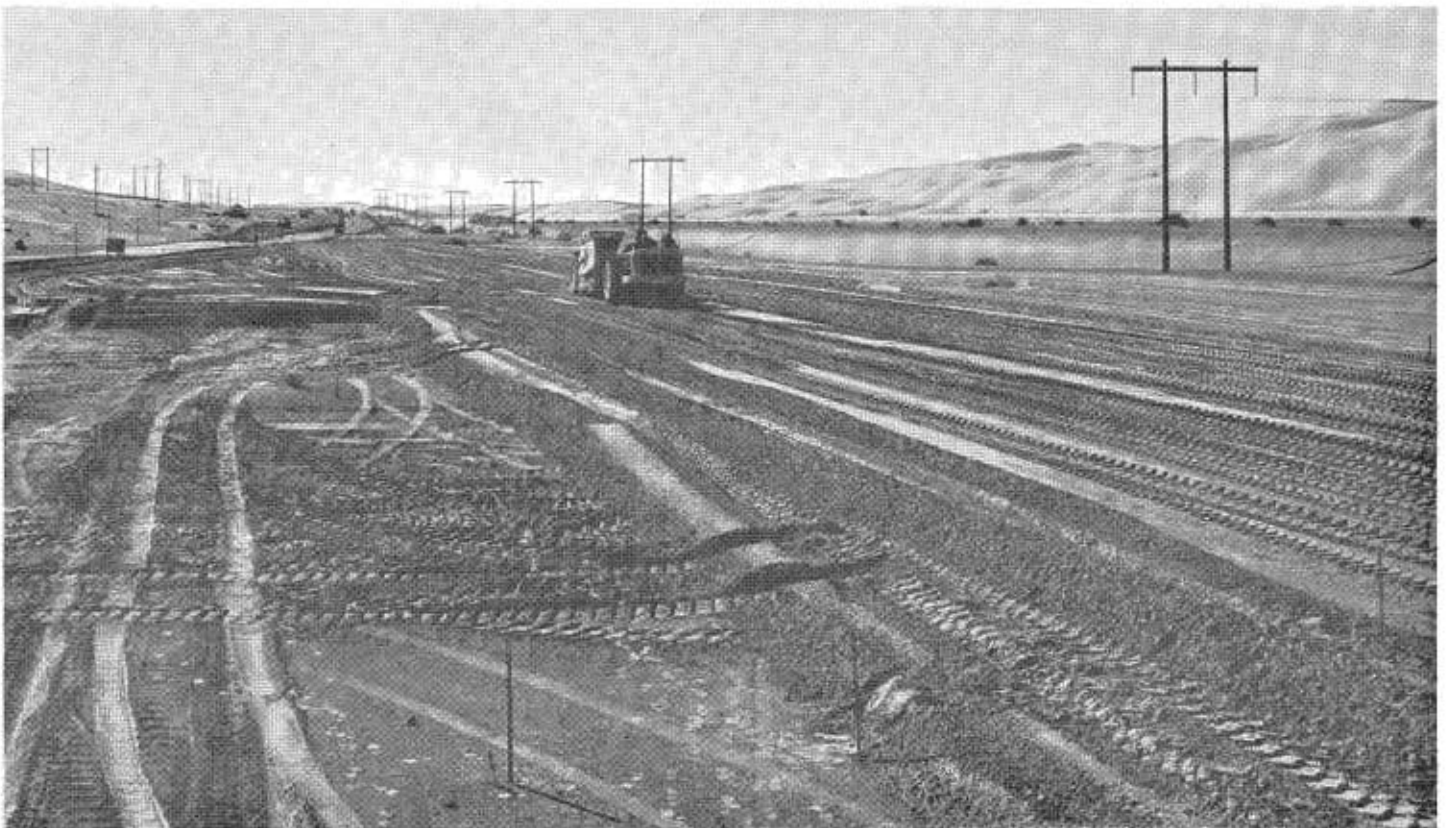
Grading operations on the current reconstruction of U.S. 80 through the Sand Hills. The present highway is on the left.

Embankments are constructed of blow sand obtained from sites located approximately 1000 to 2000 feet south of the project. Average haul length is about 45 stations. A total of 2½ million cu. yds. of borrow is being

placed and paid for by the cubic yard in completed embankment.

The contractor attempted to move rubber-tired scrapers into the borrow pit areas without success. The scrapers were virtually unable to move in dry sand and little more success was found even when the area was saturated with water. It appeared that track laying equipment, only, would negotiate this type of material. Various measures such as lowering scraper tire pressure and filling tires with water or water solutions aided movement, but it was still necessary to push the scrapers with track laying equipment from the pit to the fill.

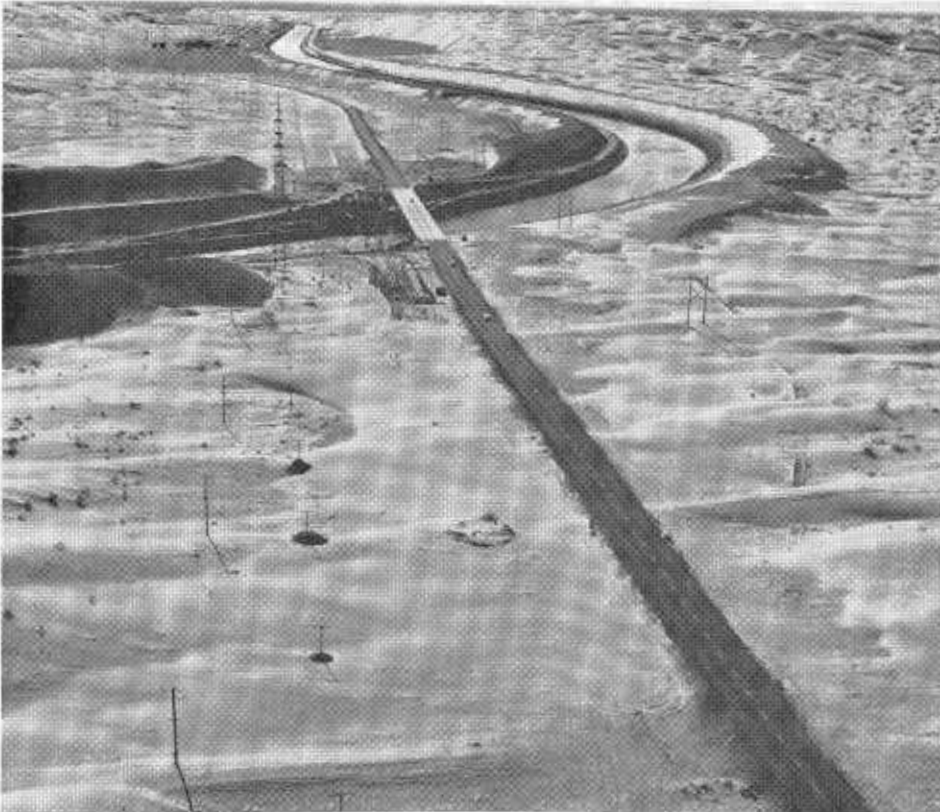
A westward view of construction on U.S. 80 showing the bridge across the All American Canal. A second bridge is being built to the left of the existing one.

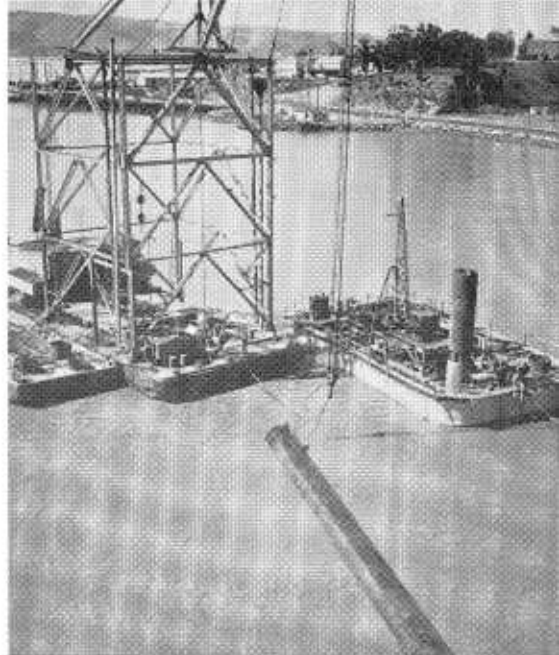
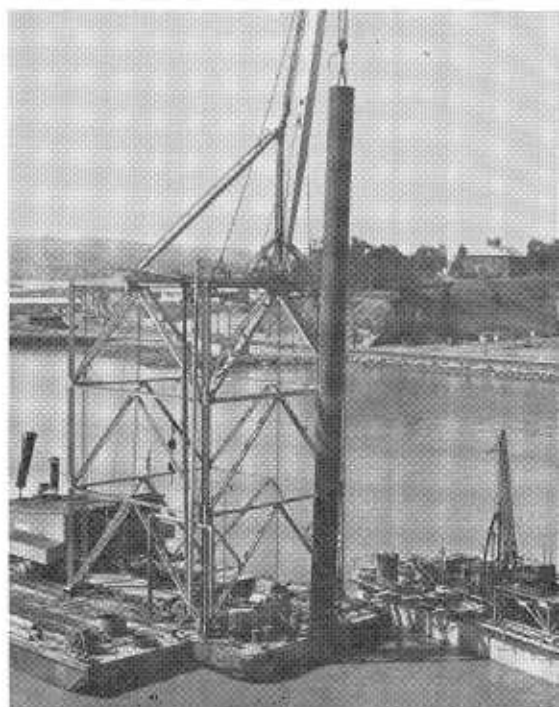
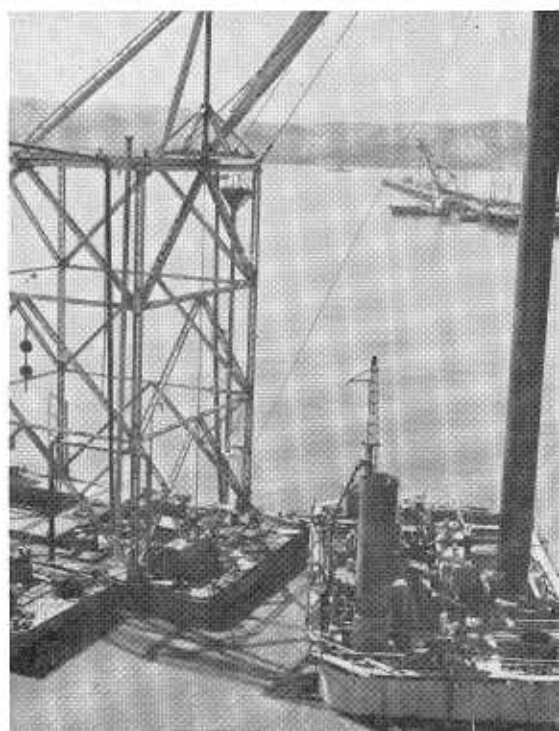
*PHOTOS RIGHT—The 6-foot-diameter steel caissons were fabricated at the Benicia plant of the Yuba Consolidated Industries and floated to the pier site (top) where they were picked up by the "Judy Ann," a floating crane (center) and placed in one of the pier cells (bottom).*

At the second parallel Carquinez Bridge (1955-58), an improved method was used which cost much less and still incorporates adequate safety features. This time the bottom 31 feet of the pier with its cutting edges was built in a dry dock and then floated into position where it was anchored. The concrete walls of the piers were then extended upward and as weight was added the pier sank through the water until it entered the mud line. At this point the timber bottoms to some of the 18 cells which had been constructed in the caisson would be removed and the mud excavated from under the caisson. Excavation and con-

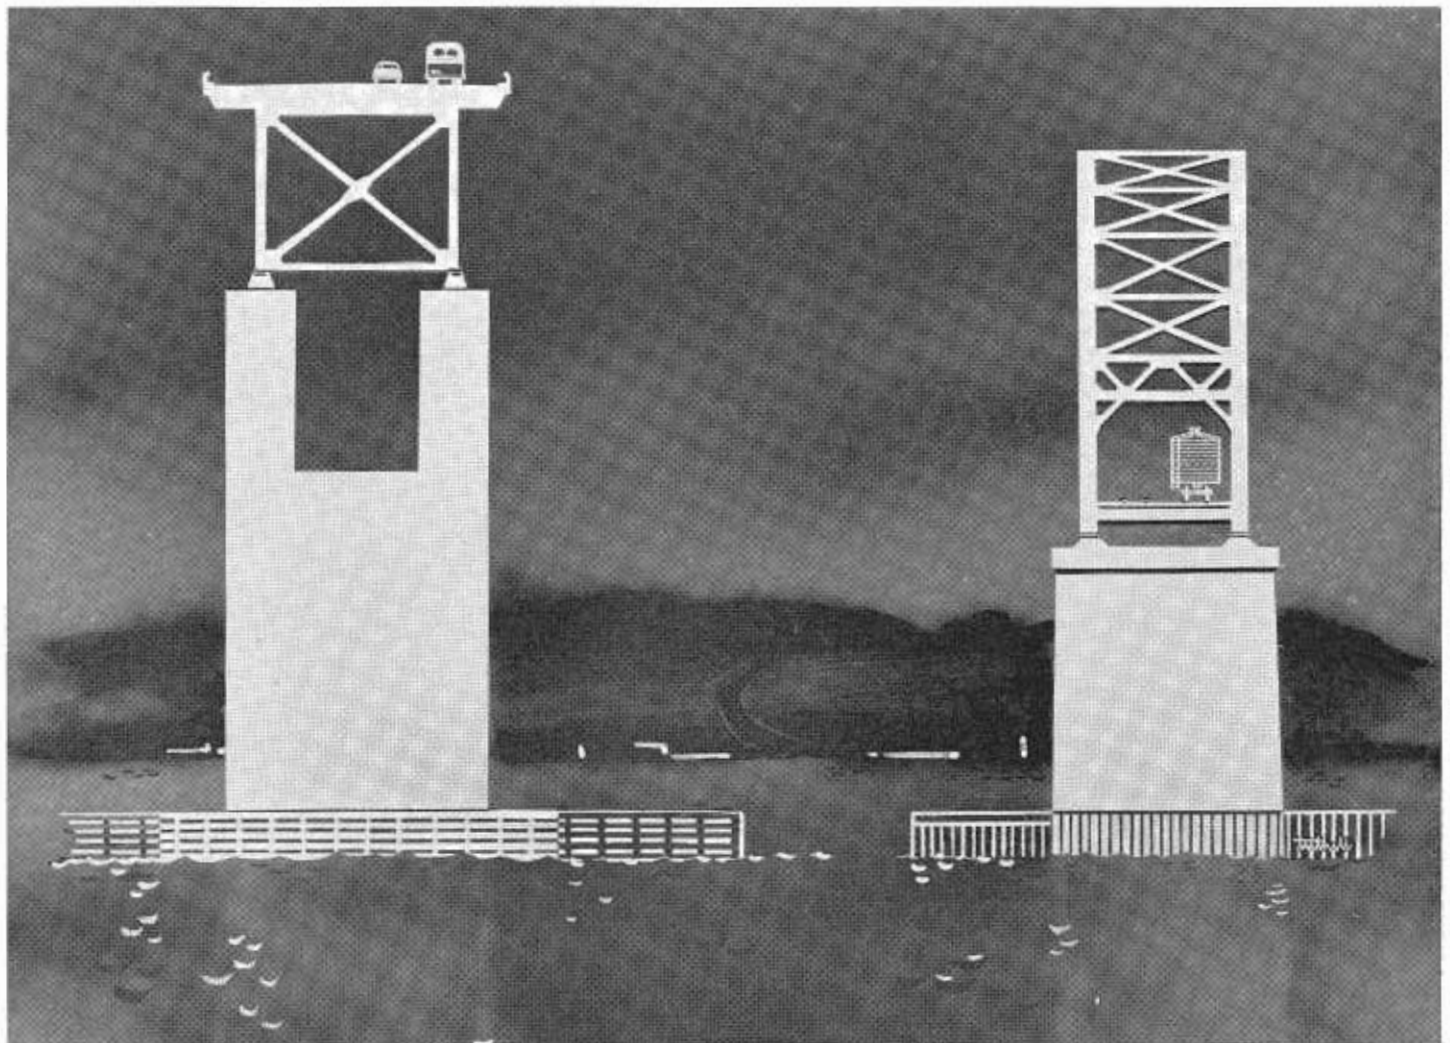
This sketch shows the relation of the new highway structure to the existing Southern Pacific Co. Bridge and the relative height of the highway deck above the water level. Maximum vertical clearance at the navigation channel between low steel and water is 138 feet on the highway bridge and 70 feet on the railroad bridge. The railroad bridge requires a vertical lift span for the passage of river traffic. Highway traffic will be about 178 feet above water at the highest point.

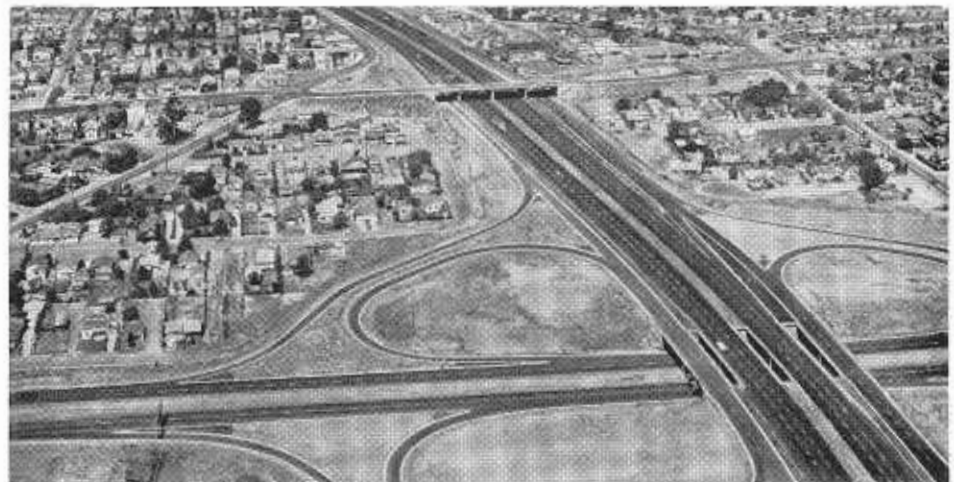
AFTER—An aerial of the State Route 74 Separation (foreground) and Benicia Road Overcrossing (background) following construction of the freeway.

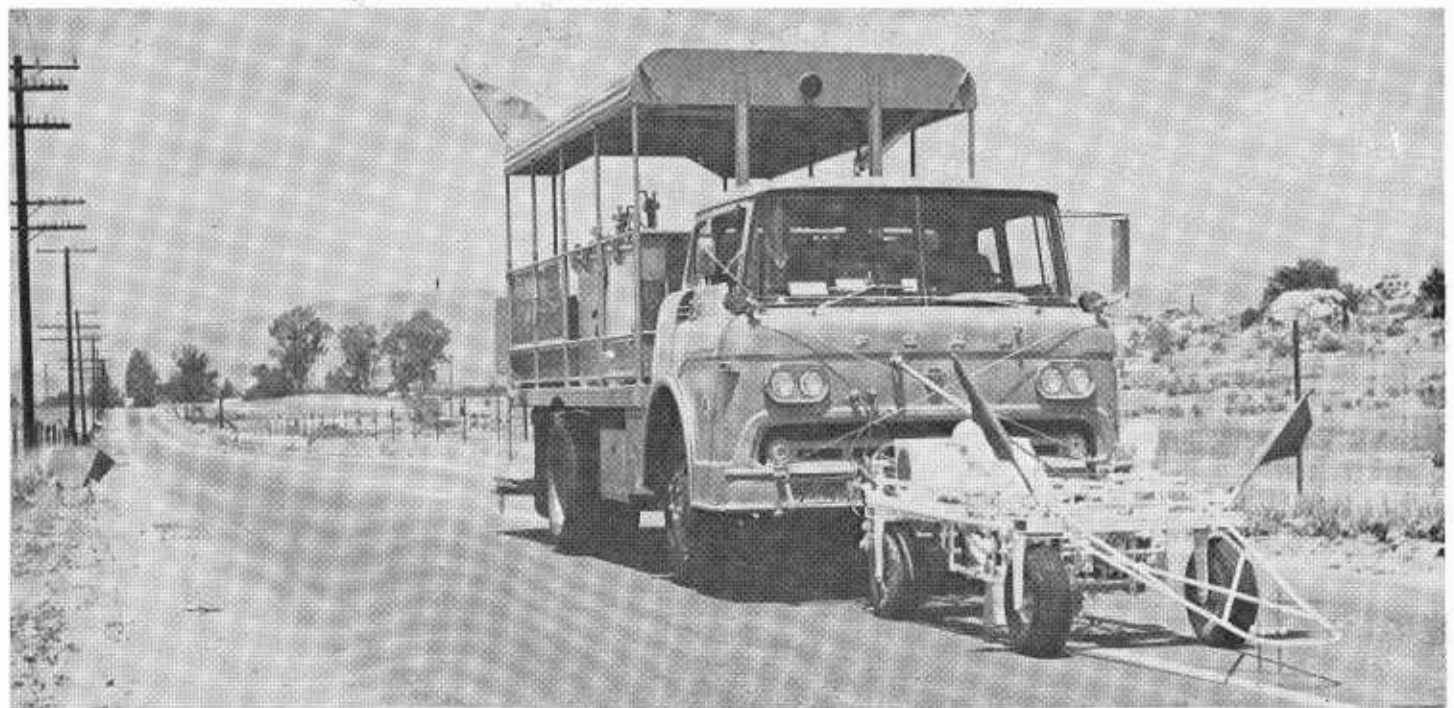
*This high crown secondary road presents no problem to the new striper with its narrower tread.*

The needs of the Division for traffic striping have been under constant study with the idea of developing better machines that would accommodate themselves to all of the various types of roadways that make up our highway system. Two years ago, in cooperation with the Maintenance Department, work was undertaken on a new model that would place the operator in the truck cab, and paint more miles of stripe at a lower cost per mile. An article published in the January-February 1960 issue of *California Highways and Public Works* described the prototype of this machine.

Since then, testing and improving of the original model have progressed to the stage where we now have in service a machine that embodies all the basic features originally planned, plus some additional improvements which add to the flexibility and ease of control.

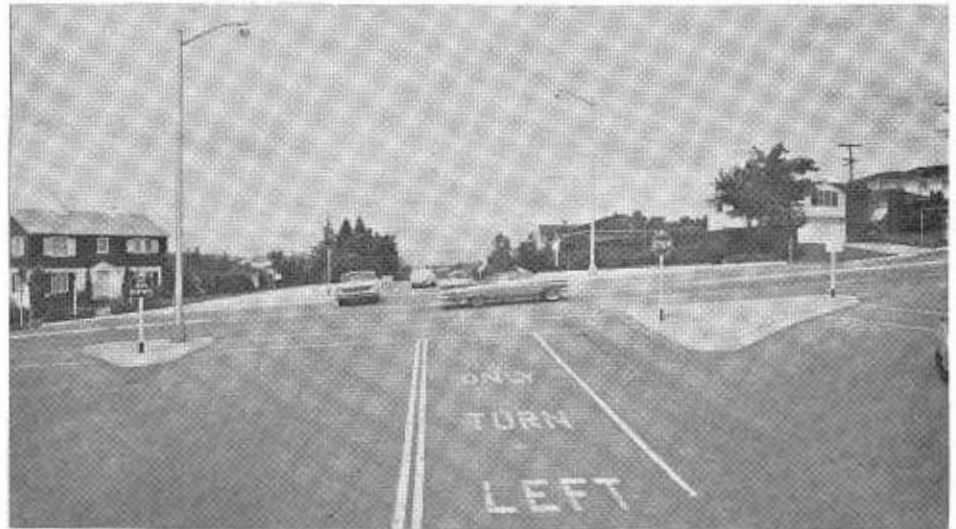
Channelization of the intersection of Parrott Drive and Alameda De Las Pulgas in San Mateo was designed with provision for future traffic signals when needed.

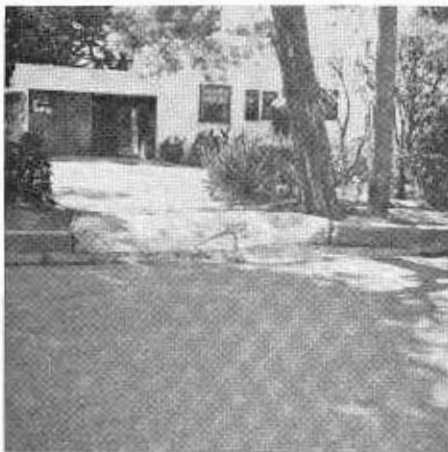
BEFORE—A broken curb, gutter and driveway prior to reconstruction.

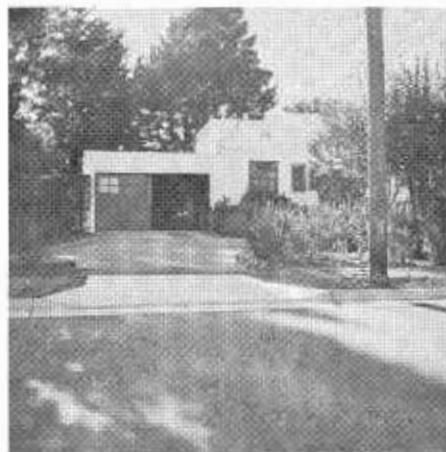
AFTER—The curb, gutter and driveway following reconstruction and resurfacing of the street.

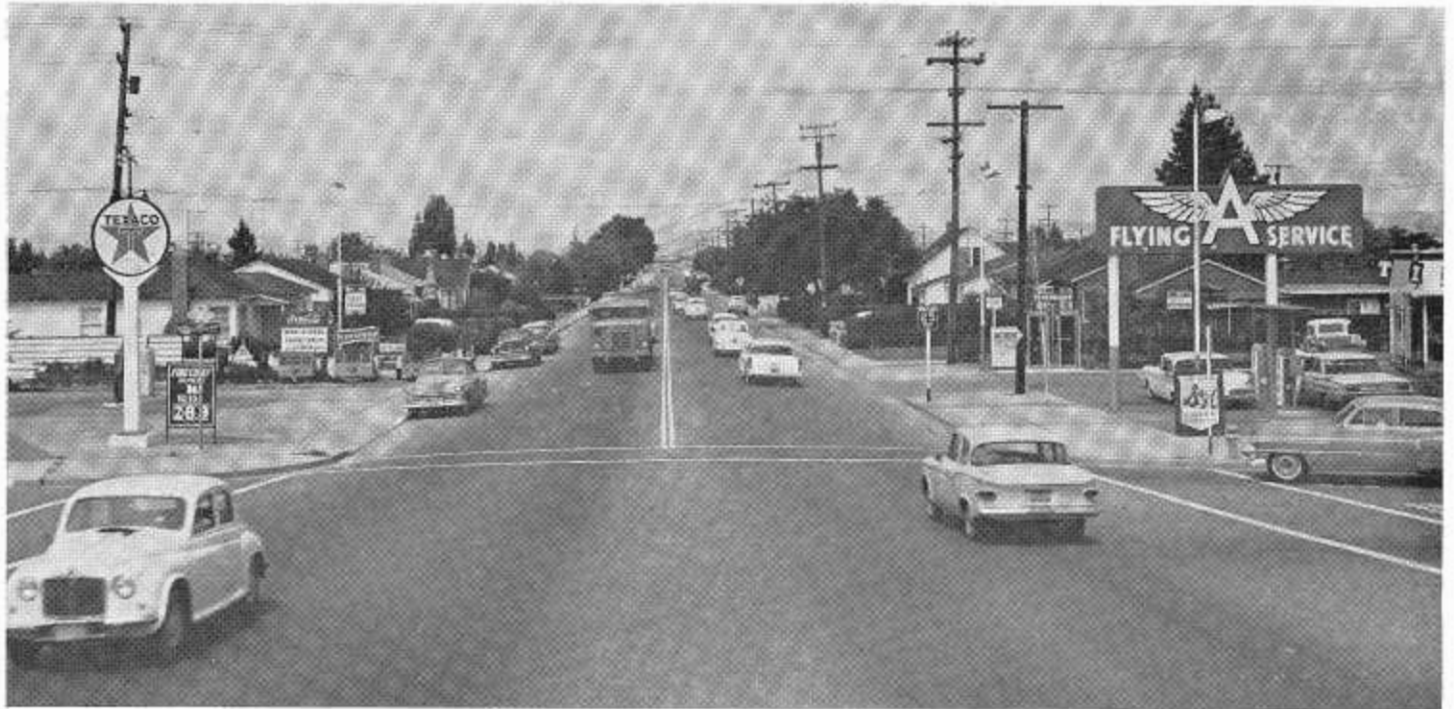
East Hillsdale Boulevard, recently resurfaced, serves as San Mateo's major traffic connection between El Camino Real (U.S. 101) and the Bayshore Freeway (U.S. 101 Bypass).

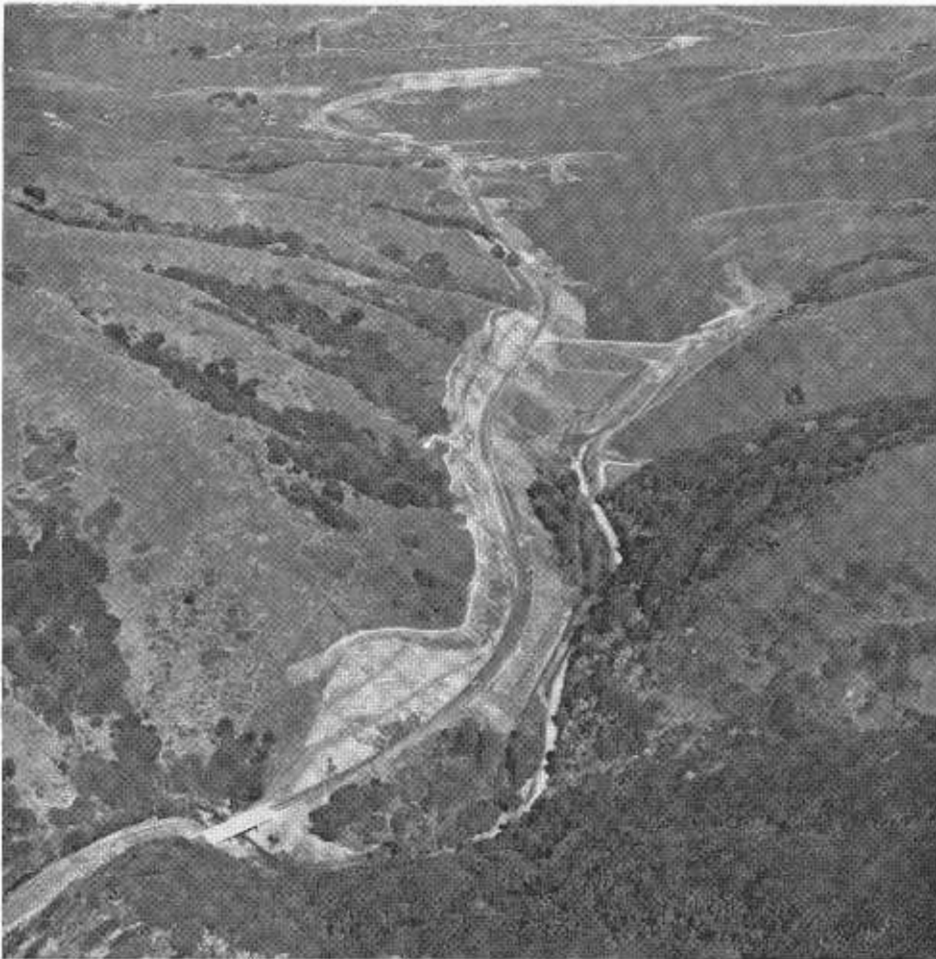
A northerly view of the Marin Water District's Nicasio Dam and rerouted section of Nicasio Road (FAS Route 879). The reservoir behind the dam is not yet full.

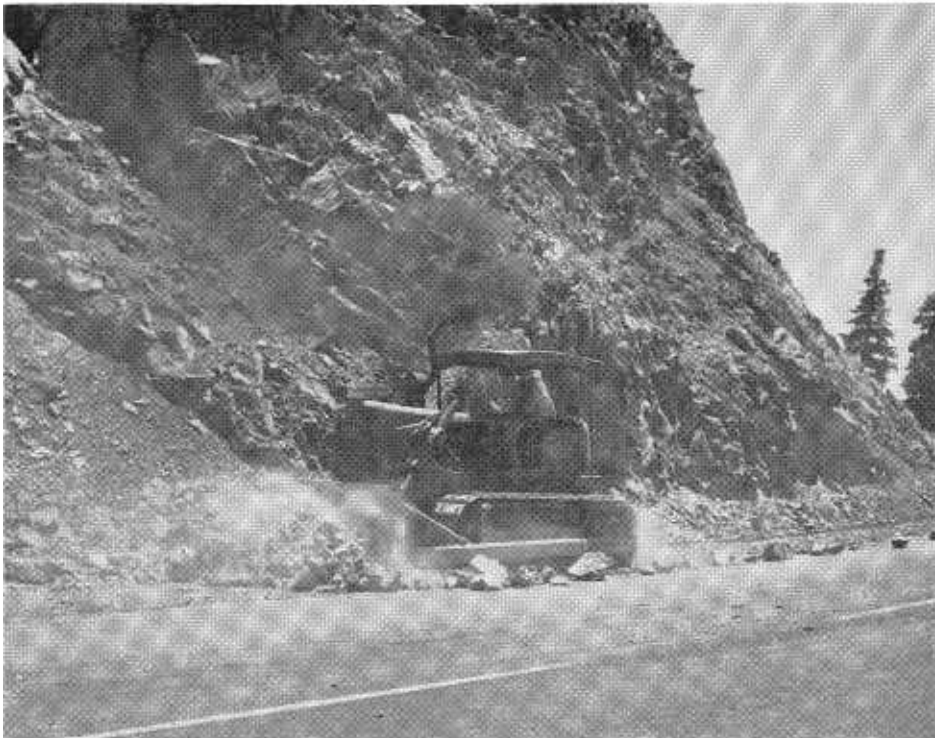
Slide Removal Operations. A bulldozer gathers the loose rock into piles.

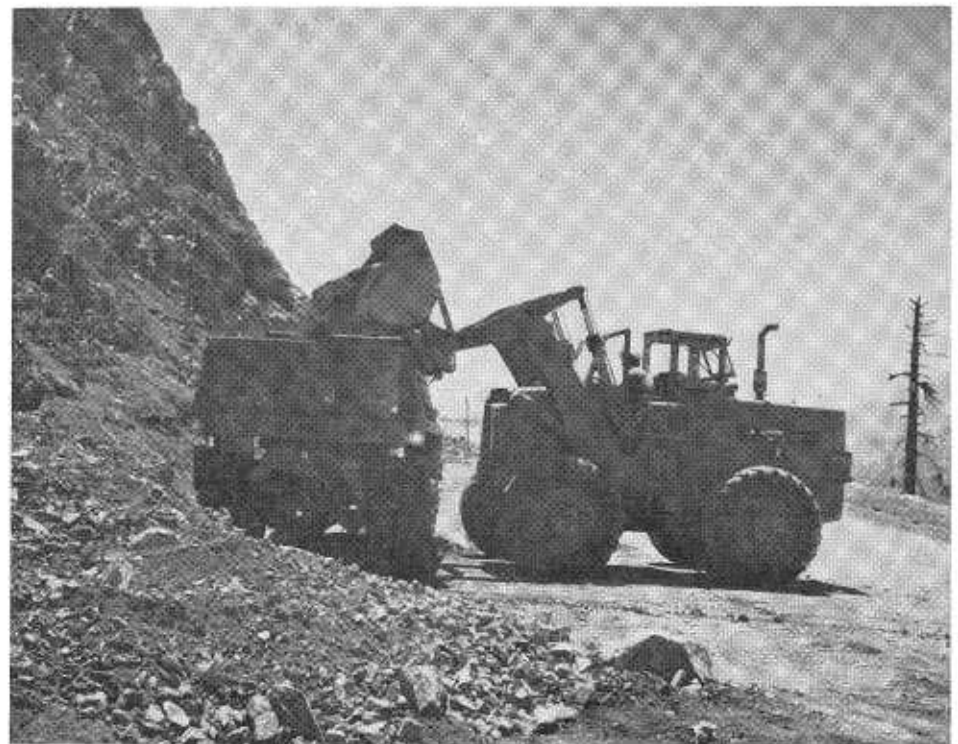
Slide Removal Operation. The rock is then loaded into trucks for removal from the site.

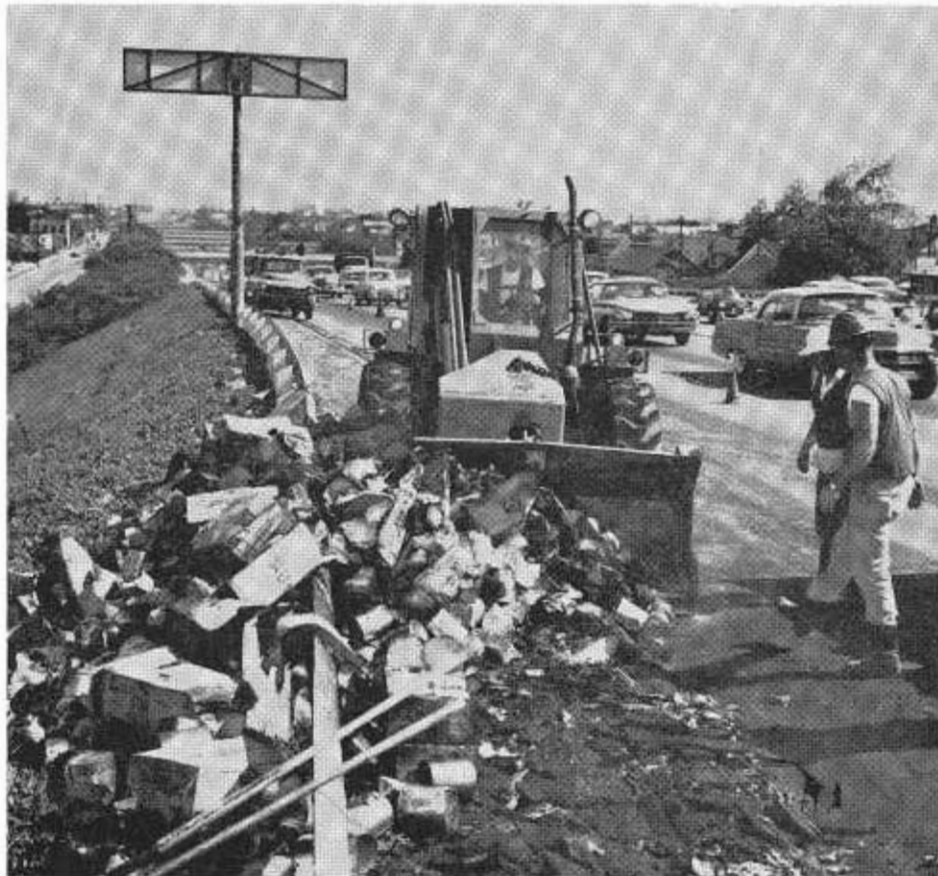
*A highway maintenance crew removes debris from an overturned truck on a freeway.*

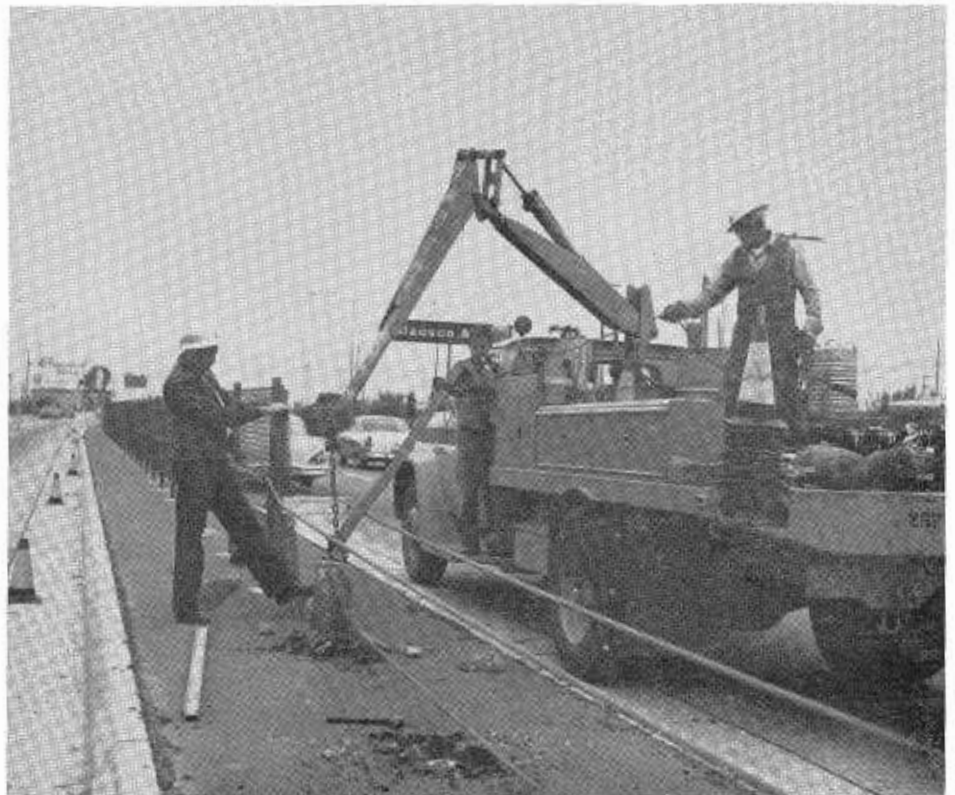
*A crew removes a damaged post prior to replacement of a new section of fence.*

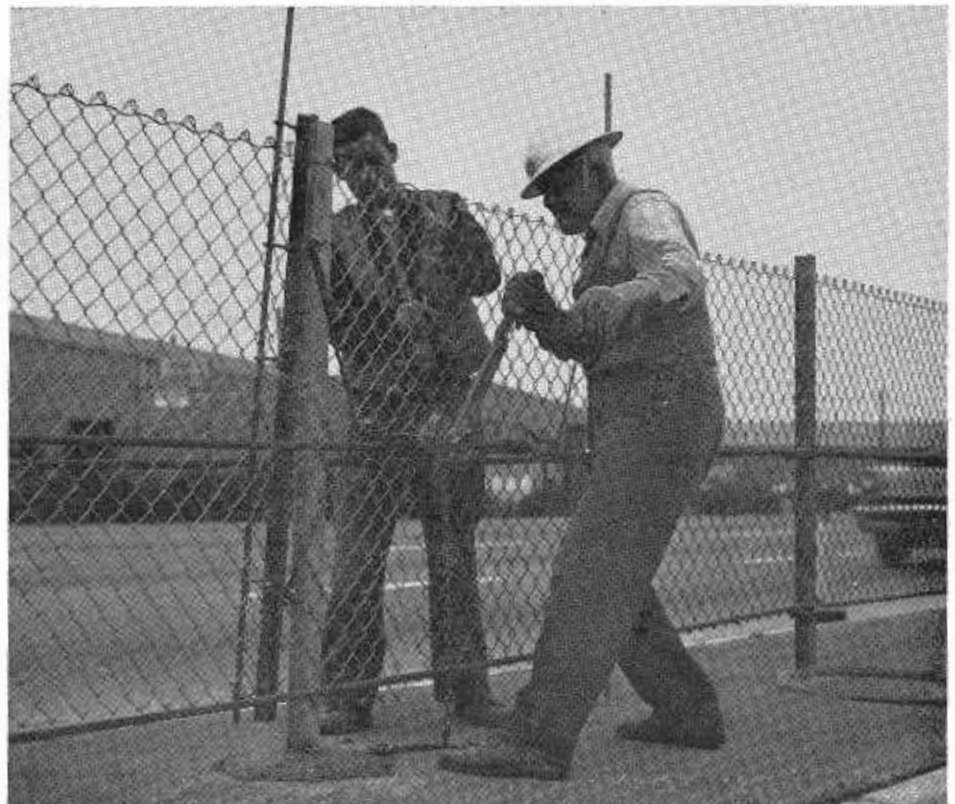
*Members of the maintenance crew tighten up the reinforcing cable in the replaced section of fence.*

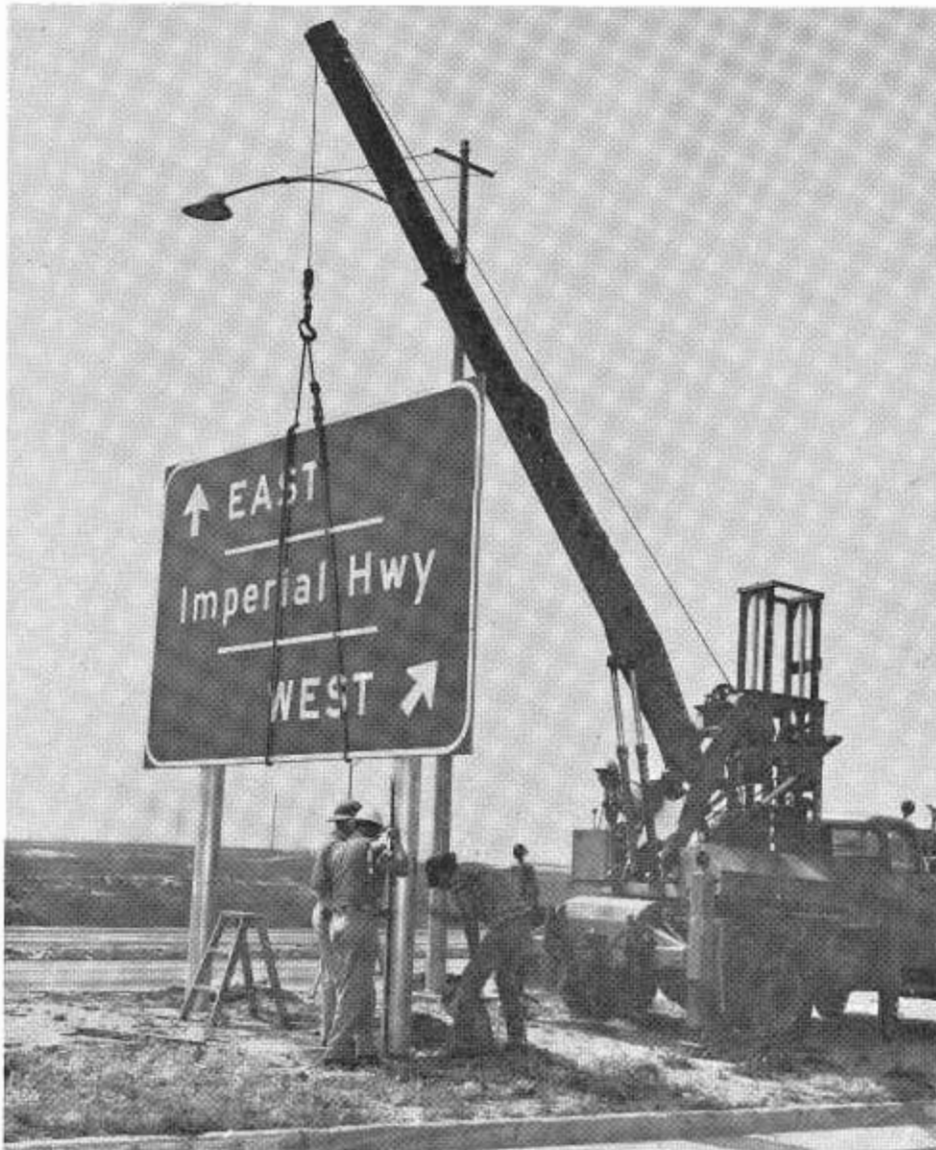
*Following assembly, the crew raises the sign and secures the posts in the ground.*
