CALIFORNIA  
**Highways**  
and Public Works

**JULY-AUGUST 1961**

# California Highways and Public Works

Official Journal of the Division of Highways, Department of Public Works, State of California

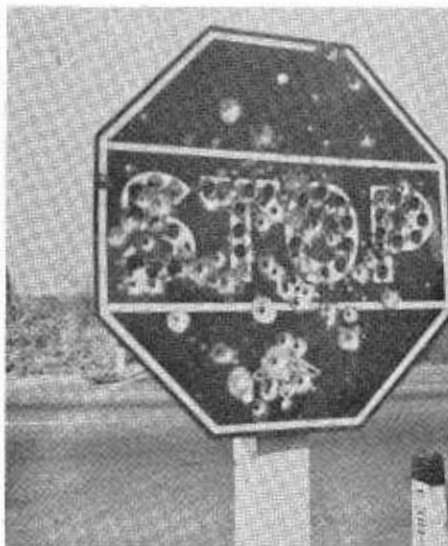
One Highway District says of this sign, which had been in place less than two months, and was found with 85 bullet holes in it: "Many of the bullets passed clear through the sign in such a way that they crossed busy Highway 41 from Fresno to Yosemite at a point about 30 feet beyond the end of a high cut. The shooter had to have stood in the position where he could not possibly see traffic approaching this point through the cut. Thus it appears possible, by considering reaction time, that a car could have driven into the line of fire between the time the shooter squeezed the trigger and the time the bullets crossed the road."

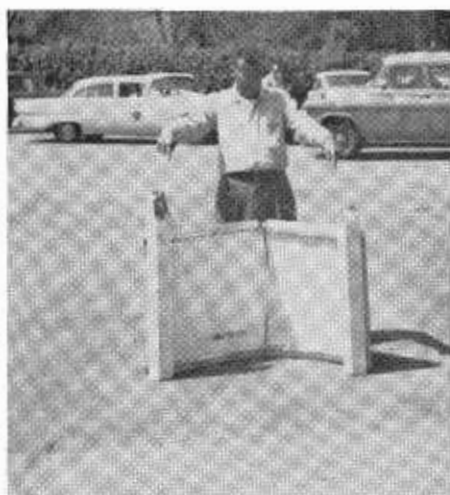
About \$75 is needed to replace this two-post city limit sign carelessly destroyed by "muscle men."

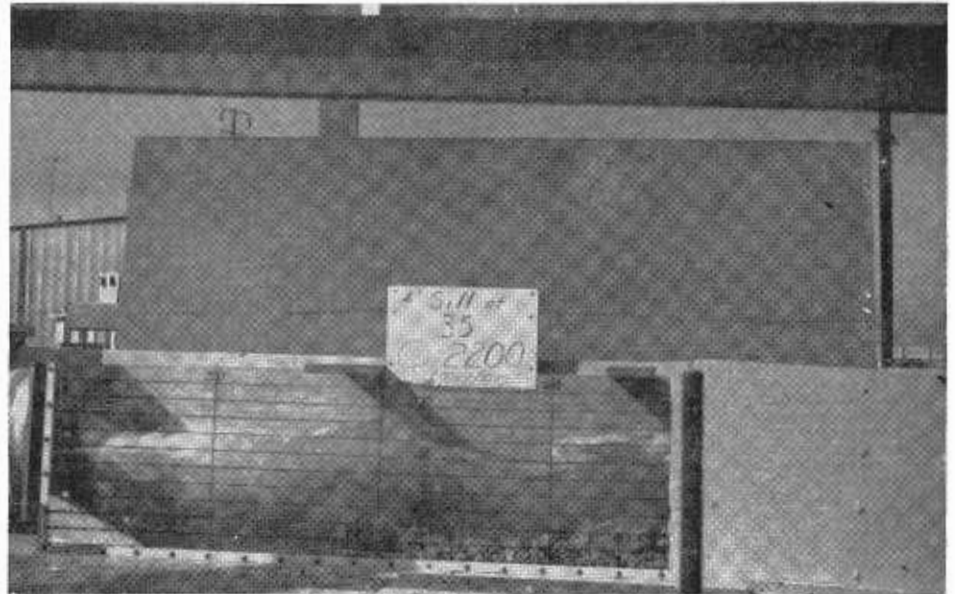
The above photos show some of the different combinations of lengths and arrangements of appurtenances which were tested. Some 20 test runs were conducted with various quantities of flow and different dissipator lengths.

During the design of the Santa Paula Freeway (State Sign Route 126), it became apparent that the design of a Hydraulic Energy Dissipator should be considered for the culvert to be constructed under the freeway at Harmon Barranca, which is about three miles east of the City of Ventura. Studies indicated the fourteen-foot diameter field assembled plate structure would carry the flow that was expected to occur once in one hundred years, but velocities higher than the natural stream velocities could be expected to occur at the culvert outlet during times of high flow. The Barranca is an uncontrolled natural stream about fifty feet deep and has nearly vertical side slopes in the vicinity of the freeway crossing. Because the soil

in the Barranca is an easily erodible, fine, sandy loam, it was decided that a Hydraulic Energy Dissipator should be designed to reduce the culvert outlet velocity to the velocity of flow expected in the natural stream.
