October 31, 2008
Project No. 92666-4F

Subject: Hazardous Materials Corridor Study

**Project: Perris Valley Line Project
Riverside County, California**

**HAZARDOUS MATERIALS CORRIDOR STUDY
PERRIS VALLEY LINE PROJECT
RIVERSIDE COUNTY, CALIFORNIA**

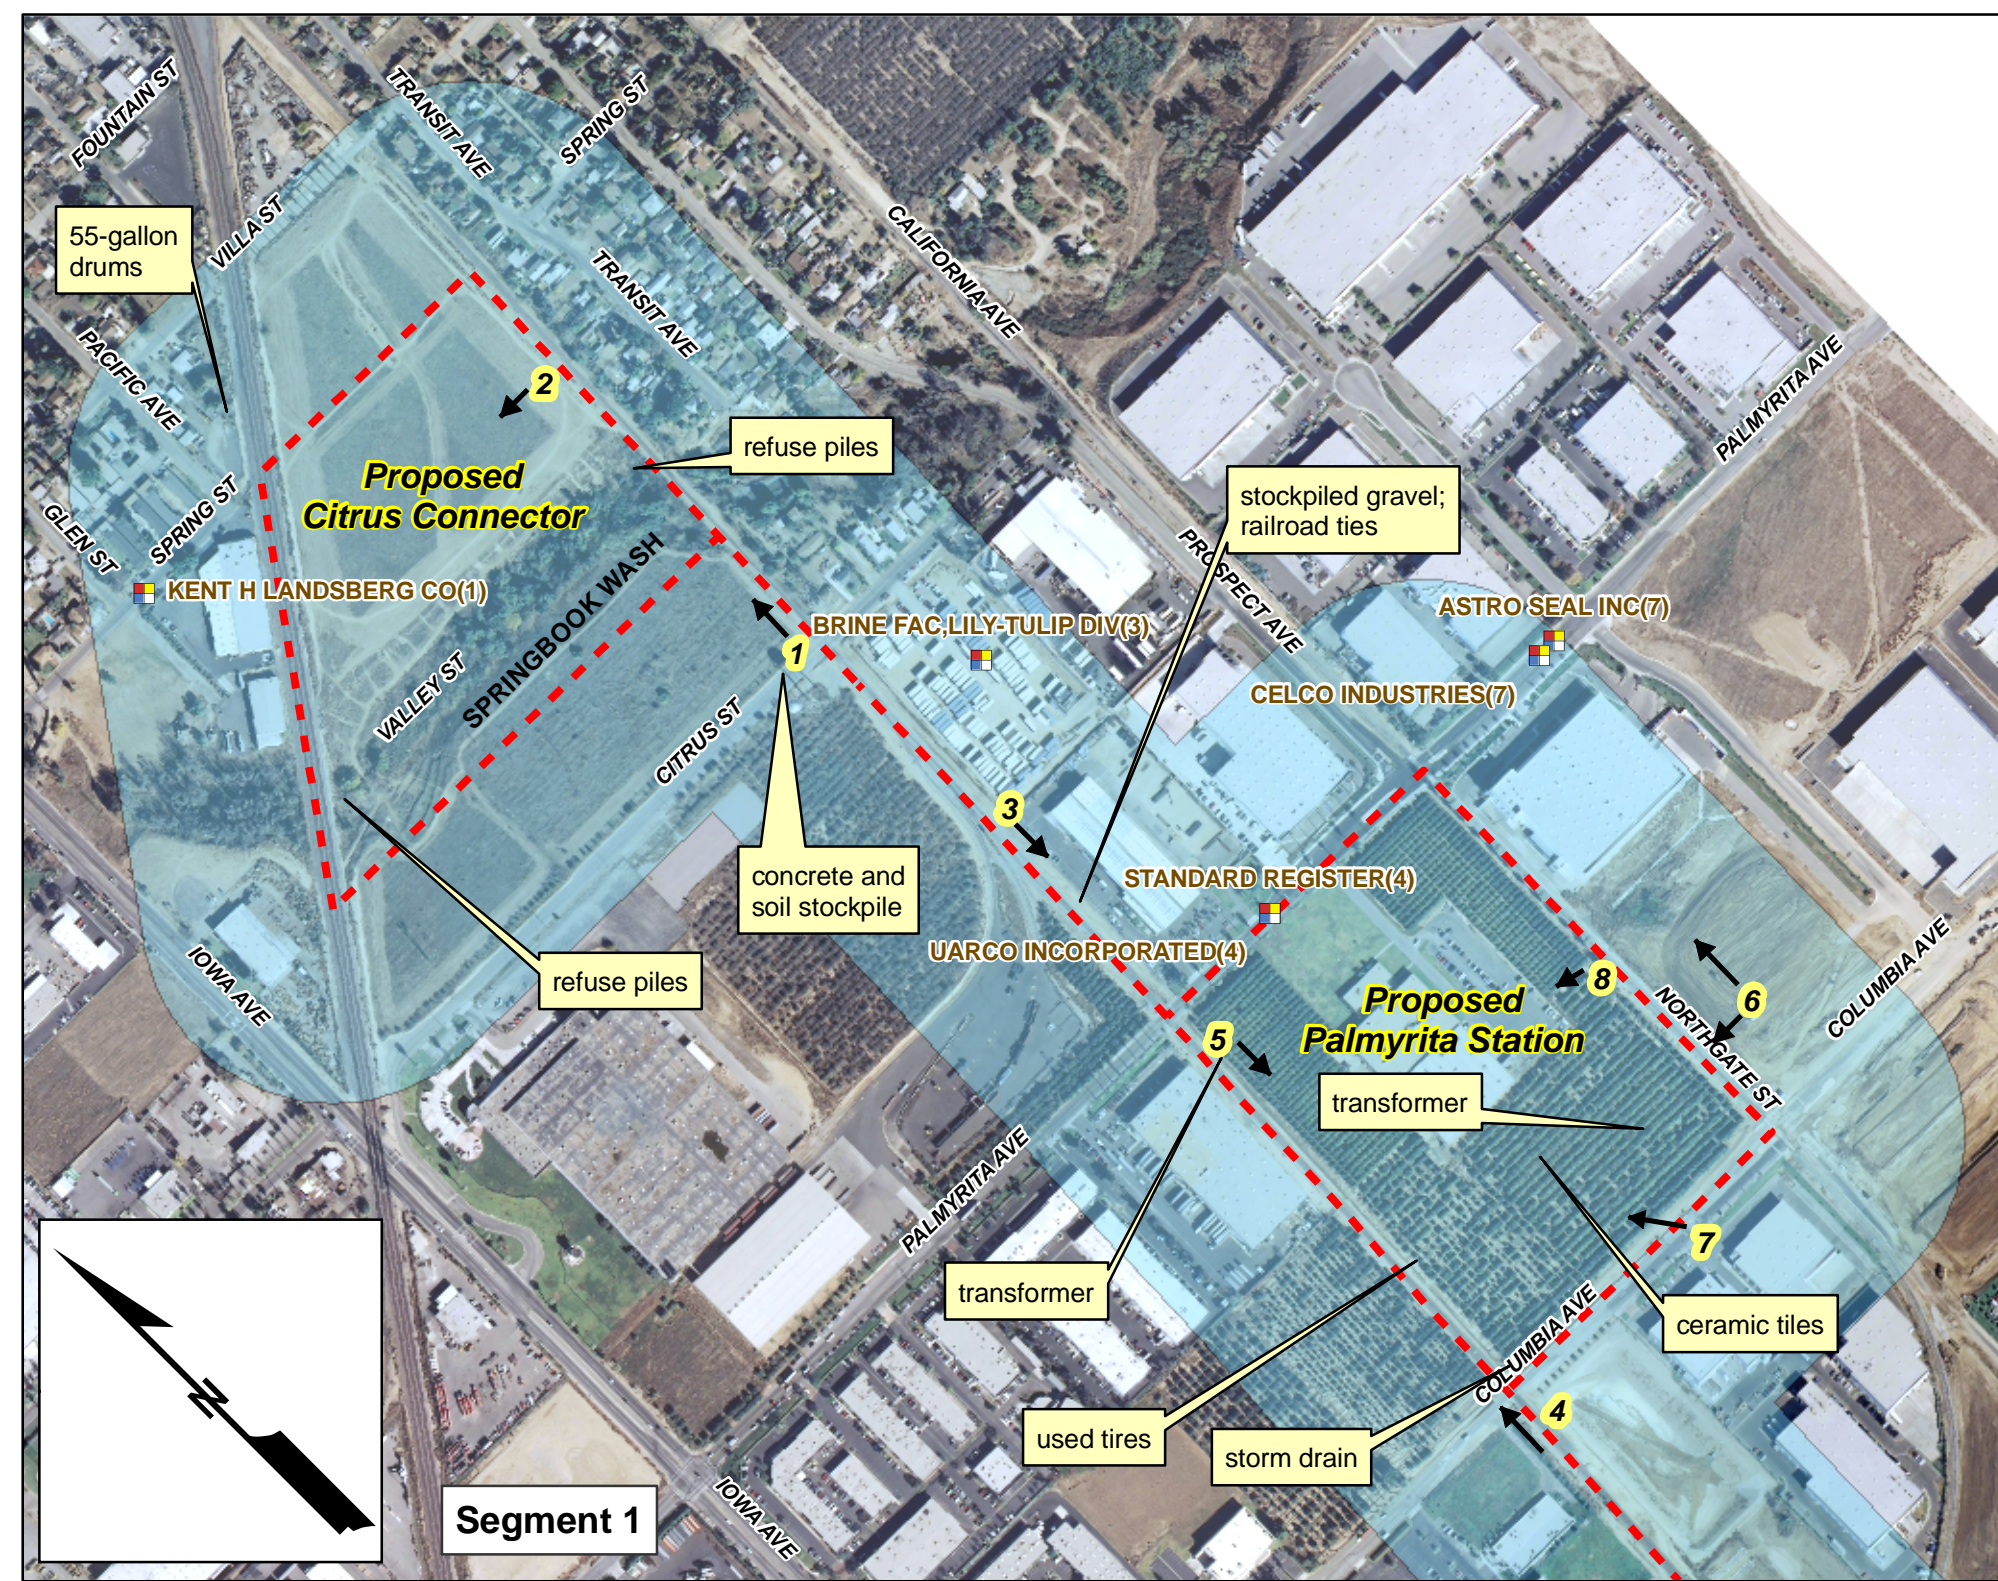
Segment, Appendix B Photo, and Plate Reference	Observations
Segment 1 – Spring Street to Columbia Avenue (Photos 1 – 8)	
Corridor Photos 1, 3, and 4 Plate 2	<p>Refuse was observed at various locations along the railroad alignment between the proposed Citrus Connection and the proposed Palmyrita Station. The majority of the refuse was observed east of the proposed Citrus Connection and west of the proposed Palmyrita Station. The refuse included household trash east of the proposed Citrus Connection, and ceramic tiles and old tires west of the proposed Palmyrita Station. No evidence of hazardous materials was observed. A stockpile of gravel and rail ties was observed along the Corridor to the north of Palmyrita Avenue. A pole-mounted transformer was observed on the Corridor near the northwestern portion of the proposed Palmyrita Station. No evidence of leaking or staining was observed in the vicinity of the transformer. A polyvinyl chloride (PVC) pipe was observed within Segment 1 and appeared to originate from the adjoining proposed Palmyrita Station parcel to the east. No evidence of staining was observed beneath the outfall of this pipe. A storm drain was observed at the southwest corner of Segment 1.</p>

Proposed Citrus Connection Photo 2 Plate 2	<p>The proposed Citrus Connection is located on one parcel consisting of vacant land covered with vegetation. A creek was observed at the southern portion and is situated at a lower elevation than the remaining areas. Unimproved roads were observed at the northern and southern portions of the proposed Citrus Connection. Refuse piles were observed throughout the creek area, with a concentration of trash located within the creek areas near the railroad tracks to the east and west. No evidence of hazardous substances or hazardous wastes was observed in the refuse piles.</p> <p>Evidence of discolored soil or water, stressed vegetation, ASTs, underground storage tanks (USTs), pits, ponds, or lagoons were not observed at the proposed Citrus Connection parcel.</p>
Proposed Palmyrita Station Photos 5 – 8 Plates 2 and 5	<p>The proposed Palmyrita Station consists of vacant land covered with vegetation. Evidence that the proposed Palmyrita Station was formerly used for agricultural purposes (i.e., rows and stockpiles of organic material) was observed. A row of orange trees was observed around the perimeter of the proposed Palmyrita Station parcel with two rows branching into the interior at the northern end. A concrete stand pipe associated with the irrigation of the former orange groves was observed on the northern portion of the parcel between the orange trees.</p> <p>A building is located on the parcel and is divided into a northern portion, with an adjoining office to the north, and a southern portion. The northern portion of the building consisted of an open warehouse area. A “TCL Powder Coating” room was observed at the northwestern corner of this portion of the building. Two openings leading to a basement were observed within the concrete floor of this room. A small room located in the northeastern corner of this portion of the building contained a sign labeled “waste ink”.</p> <p>The southern portion of the building consisted of a warehouse area. Two pieces of equipment, (one of which was a press, the other unknown), was observed in the northern end of this portion of the building. Standing liquid, less than an inch deep was observed in the vicinity of the press. A placard labeled</p>

Segment, Appendix B Photo, and Plate Reference	Observations
Segment 2 – Columbia Avenue to Mount Vernon Avenue (Photos 9 – 12)	
Corridor Photos 9 and 10 Plate 2	<p>Segment 2 begins at Columbia Avenue (immediately south of the proposed Palmyrita Station) and includes the Corridor south to, and including, the proposed UCR Station, terminating at Mount Vernon Avenue. Several stockpiles were observed along the railroad between Columbia Avenue and Marlborough Avenue. The stockpiles consisted of gravel, ballasts, wood, and railroad ties. Ballasts and railroad ties are typically impacted by petroleum products or other hazardous materials. Numerous drainage structures (such as culverts) were observed crossing the Corridor between Columbia Avenue and Marlborough Avenue. Kinder Morgan petroleum pipeline markers were observed along the railroad alignment to the north of Spruce Street, which indicated the petroleum pipeline was located within the Corridor, parallel to the east side of the railroad tracks.</p> <p>Evidence of discolored soil or water, stressed vegetation, ASTs, USTs, pits, ponds, or lagoons were not observed along the Segment 2 alignment. A description of the remaining Segment 2 observations is included in the proposed UCR Station description below.</p>

Proposed UCR Station Photos 11 and 12 Plate 2	<p>The proposed UCR station consists of a narrow strip of vacant land from West Blaine Street at the western end to Mount Vernon at the eastern end. Kinder Morgan petroleum pipeline markers were observed along the northern portion of the proposed UCR Station to Valencia Hill Drive, where the pipeline appears to be redirected south of the alignment. The neighboring residences were encroaching onto the northern portion of the proposed UCR Station and included garden areas, a basketball court, and storage of abandoned vehicles. At least five, pole-mounted transformers were observed along the northern portion of the proposed UCR Station. Evidence of staining or leaking was not observed on or beneath the transformers. A Santa Ana Valley Water Test Station and a 9-inch high-pressure water pipeline are located near the intersection of the alignment and Valencia Hill Drive. A flood control channel is located along the southern portion of the proposed UCR Station from Valencia Hill Drive to Mount Vernon Avenue.</p> <p>Evidence of discolored soil or water, stressed vegetation, ASTs, USTs, pits, ponds, or lagoons were not observed on the proposed UCR Station site at the time of the Site reconnaissance.</p>

Proposed Fair Isle Station Photo 15 Plate 2	<p>The proposed Fair Isle Station is situated in an undeveloped area at the base of hills near the existing railroad tracks. Outcrops of rocks and areas of alluvial deposits were observed. A stream was observed immediately west of the alignment at the proposed Fair Isle Station.</p> <p>Evidence of discolored soil or water, stressed vegetation, ASTs, USTs, pits, ponds, or lagoons were not observed at the proposed Fair Isle Station at the time of the Site reconnaissance.</p>

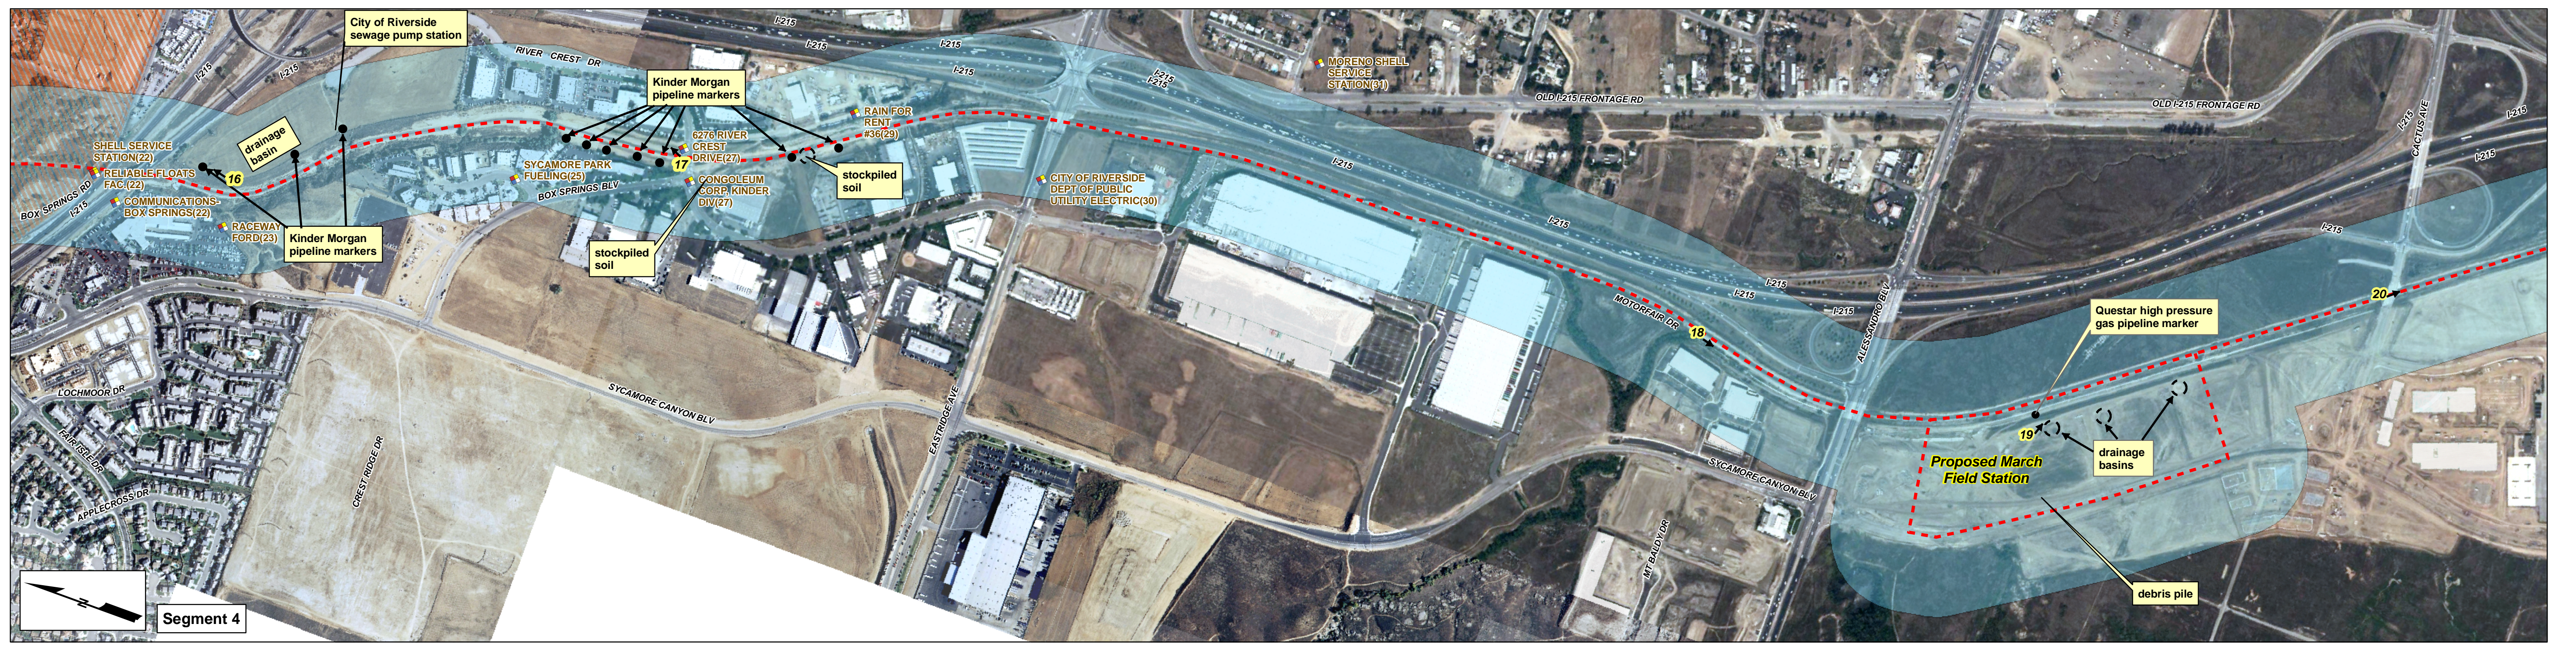
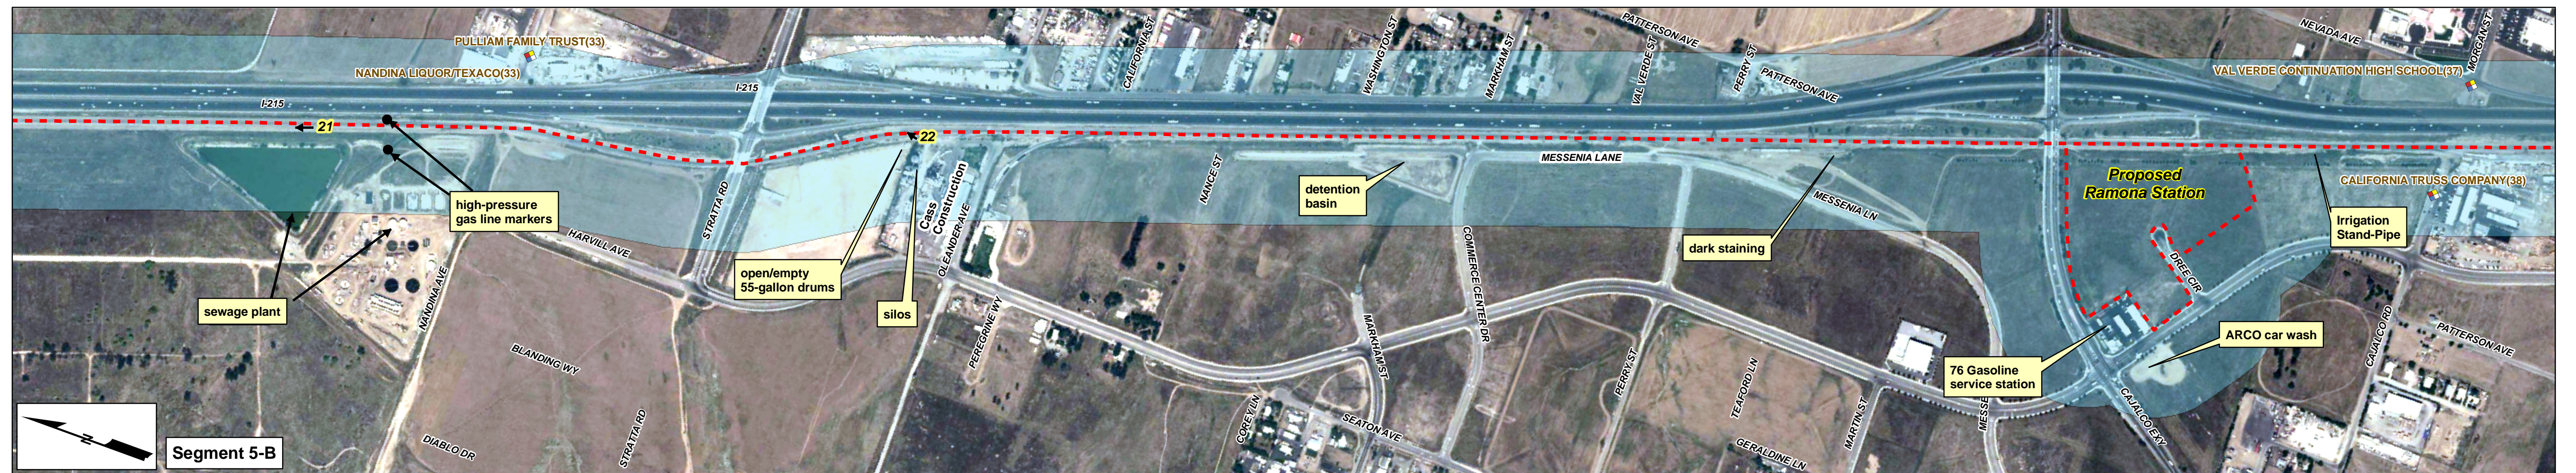
Project No.	92666
Drawn By:	R. Alvarez
Checked by:	
Date:	08/01/2008
File Name:	PVL_plate3_080108

Segment, Appendix B Photo, and Plate Reference	Observations
Segment 4 – Box Springs Road (Fair Isle Drive) to Cactus Avenue (Photos 16 – 19)	
Corridor Photos 16 – 18 Plate 3	<p>Segment 4 begins at Fair Isle Drive and continues south, crossing the freeway, and continuing south up to, and including, the proposed March Field Station and terminating at Cactus Avenue. The northern portion of Segment 4 crosses Highway 60 and I-215 to the south and continues south along the west side of I-215. Drainage structures (such as culverts) were observed at various locations crossing Segment 4 from east to west. Kinder Morgan petroleum pipeline markers were observed along the east side of the railroad tracks and on the west side of the railroad tracks immediately north of River Crest Drive. A pad-mounted transformer was observed along the railroad, immediately adjacent to the west the alignment's intersection with I-215 and River Crest Drive, south of a drainage basin. The transformer was labeled as containing non-PCB oil. Adjacent to the transformer was a City of Riverside sewage pump station. General household trash was observed at various locations along the Corridor. Stockpiled soil was observed along the railroad alignment, west of the railroad tracks, and immediately south of River Crest Drive.</p> <p>Evidence of discolored soil or water, stressed vegetation, ASTs, USTs, pits, ponds or lagoons were not observed along Segment 4 at the time of the Site reconnaissance. A summary of the observations of the proposed March Field Station is below.</p>

Proposed Moreno Valley/March Field Station Photo 19 Plate 3	<p>The proposed Moreno Valley/March Field Station parcels consist of vacant, graded land, with some shrubs. A debris pile was observed at the northwestern portion of the station and included ceramic tiles, broken concrete pieces, ballasts, paper, and asphalt. Ballasts may be impacted with petroleum hydrocarbons or other hazardous materials. Three drainage areas were observed along the eastern portion of the parcels. A road was observed leading eastward. A flood control channel was observed immediately east of the proposed March Field Station, followed by the Corridor within Segment 4. A Questar pipeline marker was observed near the railroad tracks indicating that a high-pressure gas pipeline was located in the vicinity of the Corridor.</p> <p>Evidence of discolored soil or water, stressed vegetation, ASTs, USTs, pits, ponds or lagoons were not observed at the proposed March Field Station at the time of the Site reconnaissance.</p>

Segment, Appendix B Photo, and Plate Reference	Observations
Segment 5 – Cactus Avenue to Cajalco Road (Photo 20 – 22)	
Corridor Photos 20 – 22 Plate 3	<p>Segment 5 begins at Cactus Avenue and continues south encompassing the proposed Ramona Station to Cajalco Road. General household trash was observed at various locations along the Corridor. Drainage channels were also observed at various locations along Segment 5. An approximate 10-foot square area of dark staining was observed north of the Cajalco Expressway on the west side of the railroad tracks and immediately south of a siding. An irrigation standpipe was observed south of the Cajalco Expressway and south of the proposed Ramona Station. Rail cars were observed on a railroad spur that was branching from the main railroad tracks within the Corridor to the south of an existing construction facility. Stockpiled soil was observed along the Corridor south of Oleander Avenue.</p> <p>A high-pressure gas line (evidenced by pipeline markers) was shown in Segment 5 at the approximate location of the adjacent sewage plant north of Oleander Avenue. Another high-pressure gas line was shown crossing the Corridor immediately north of Van Buren Boulevard. In this same area the March Air Field Museum was observed east of I-215.</p> <p>With the exception of the dark stained soil described above, evidence of discolored soil or water, stressed vegetation, ASTs, USTs, pits, ponds or lagoons were not observed along Segment 5 at the time of the Site reconnaissance.</p>

Proposed Ramona Station Plate 3	<p>The proposed Ramona Station consists of vacant land with low shrubs. Evidence of discolored soil or water, stressed vegetation, ASTs, USTs, pits, ponds, or lagoons were not observed at the proposed Ramona Station during the Site reconnaissance.</p>

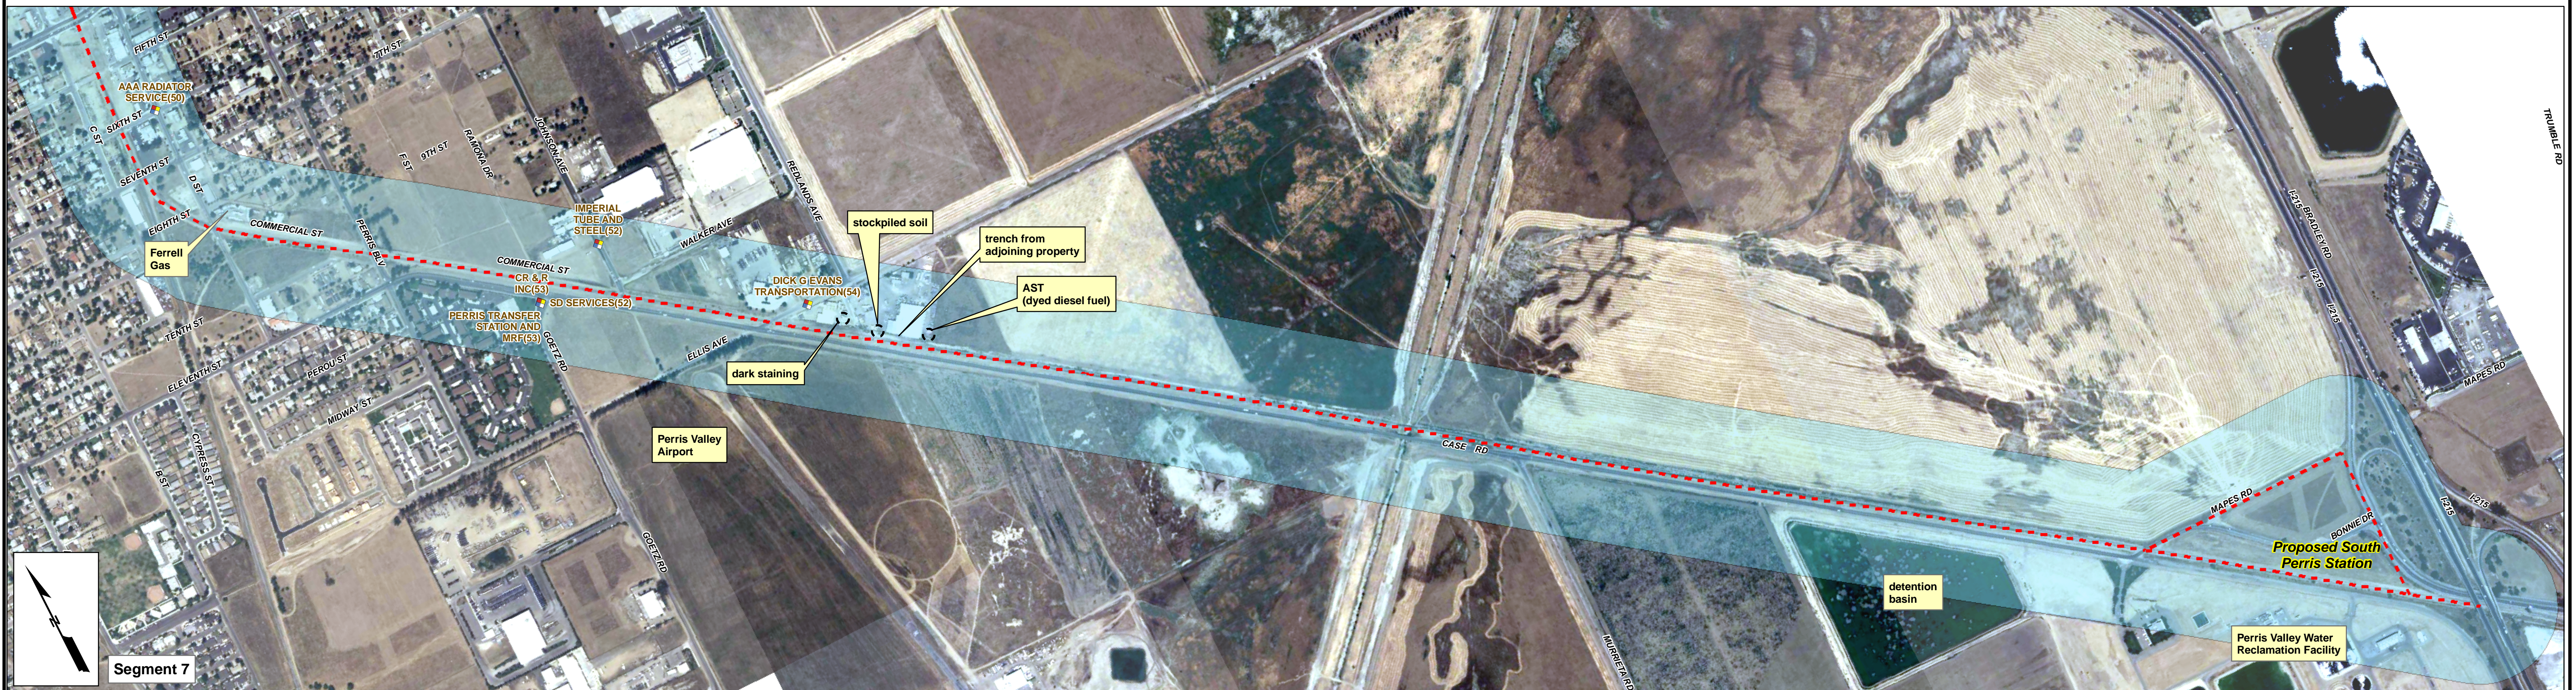
Project No.	92666
Drawn By:	R. Alvarez
Checked by:	
Date:	08/01/2008
File Name:	PVL_plate4_080108

Segment, Appendix B Photo, and Plate Reference	Observations
Segment 6 – Cajalco Road to 4th Street (Highway 74) (Photo 23 –30)	
Corridor Photos 23 – 30 Plate 4	<p>Segment 6 begins at Cajalco Road, continues south to 4th Street (Highway 74), and includes the proposed Downtown Perris Station. General household trash was observed at various locations along the segment. Drainage channels were also observed at various locations along Segment 6. A railroad car was observed on the railroad tracks to the north of Orange Avenue. Three pole-mounted transformers were observed along the west side of the segment immediately north of Orange Avenue. No leaking or staining was observed on or beneath the transformers. Stockpiled soil, which appeared to be associated with adjacent construction activities, was observed along the west side of the segment north of Nuevo Road.</p> <p>Evidence of discolored soil or water, stressed vegetation, ASTs, USTs, pits, ponds, or lagoons were not observed along the Segment 6 alignment during the Site reconnaissance. Observations of the proposed Downtown Perris Station are summarized below.</p>

Proposed Downtown Perris Station Photo 31 Plate 4	<p>The proposed Downtown Perris Station is situated on four parcels of land that are owned by the Riverside County Transportation Commission (RCTC). Two vacant structures were observed on the southwestern parcel. Only a portion of the southernmost structure appears to be located on this southwestern parcel of the proposed Downtown Perris Station, and the building was labeled as a hardware store. The interior of this building was not accessible at the time of the Site reconnaissance. A second building was observed north of the hardware store. A rail spur traversed the southwestern parcel along the east side of this building.</p> <p>An area of lower elevation (appears as drainage) was observed on the northwestern parcel of the proposed Downtown Perris Station. The northeastern parcel was vacant. The southeastern parcel was vacant. A railroad spur and three stockpiles of soil were observed on the southeastern parcel of the proposed Downtown Perris Station. No evidence of staining was observed and no odors noted in the stockpiled soil. The origin of the soil is unknown to Kleinfelder.</p> <p>Evidence of discolored soil or water, stressed vegetation, ASTs, USTs, pits, ponds, or lagoons were not observed at the proposed Downtown Perris Station during the Site reconnaissance.</p>

Segment, Appendix B Photo, and Plate Reference	Observations
Segment 7 – 4th Street (Highway 74) to Interstate 215 (Photos 31 –38)	
Corridor Photos 32 – 35 and 38 Plate 4	<p>Segment 7 begins at Highway 74 and continues south to 8th Street, where it continues southeast to I-215. General household trash was observed at various locations along the Corridor. Drainage channels were also observed at various locations along the Segment 7 alignment. Dark staining was observed on a wall to an adjoining facility immediately east of Ellis Avenue. The staining also appeared on the ground, consisting of an area of approximately 3 by 5 feet, within the segment near the base of the wall. A little further east of this staining was a stockpile of soil and a trench. The trench appeared to be a deliberately made trench that originated from the adjoining property to the north (Global Plastics), and extended onto the railroad alignment toward the east. The soil within the trench appeared to be grayish in color and different from the surrounding soil. Broken plastic was observed in this area of the Corridor. An AST was observed as containing dyed-diesel fuel; no staining was observed on the ground around the AST. Open land to the south of this area is part of the airfield associated with Perris Valley Airport.</p> <p>With the exception of the staining in the soil and one AST described above, evidence of discolored water, stressed vegetation, USTs, other ASTs, pits, ponds, or lagoons were not observed along the Segment 7 alignment during the site reconnaissance. Observations of the proposed South Perris Station are summarized below.</p>

Proposed South Perris Station Photos 36 – 37 Plate 4	<p>The proposed South Perris Station consists of vacant land covered with vegetation. Evidence of discolored soil or water, stressed vegetation, hazardous materials, ASTs, USTs, pits, ponds, or lagoons were not observed at the segment during the Site reconnaissance.</p>
