Archaeological Resources Survey: Phase 3 Los Angeles Downtown People Mover Program

by JULIA G. COSTELLO for the Downtown People Mover Authority, City of Los Angeles

MARCH 1981

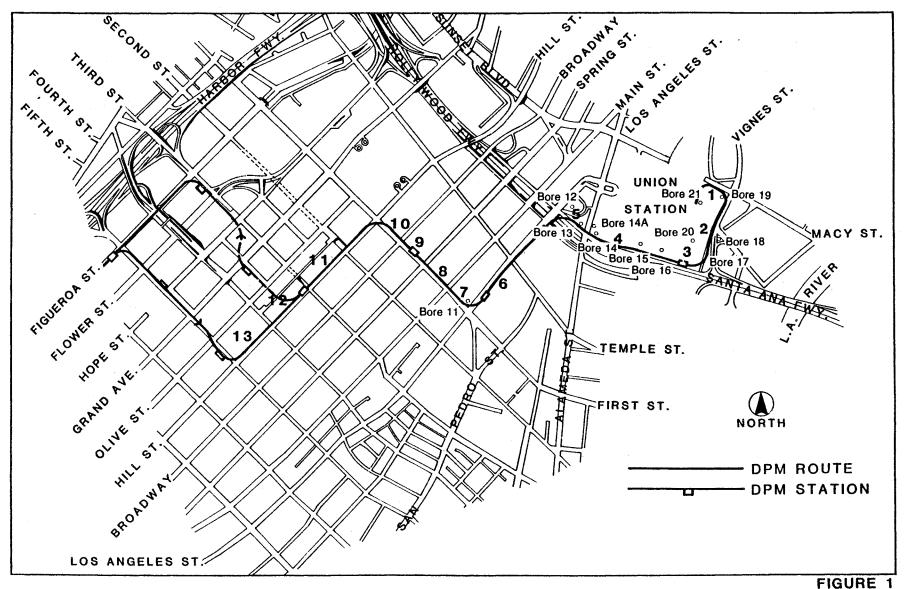
Location of Bore Holes
ARCHEOLOGICAL RESOURCES SURVEY: PHASE 3
LOS ANGELES DOWNTOWN PEOPLE MOVER PROGRAM
Julia G. Costello

technical investigations of subsurface soil conditions along the DPM route. Core borings planned in or near sensitive areas identified during Phase 2 were monitored by archaeologists to determine the presence and nature of buried cultural deposits. The locations of the bores are shown on Figure 1.

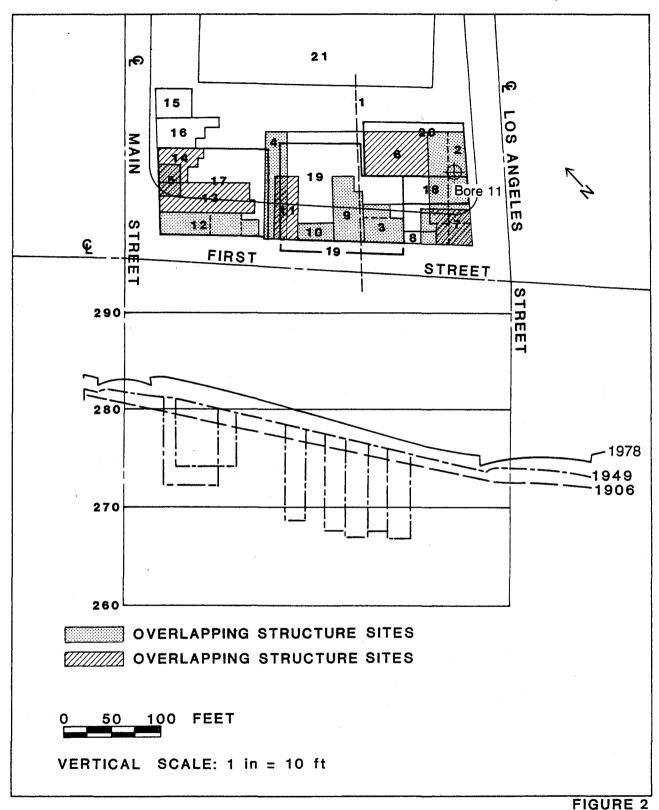
Block # 7

BLOCK 7 HISTORIC PLAN VIEW AND PROFILE
ARCHEOLOGICAL RESOURCES SURVEY: PHASE 3
LOS ANGELES DOWNTOWN PEOPLE MOVER PROGRAM
Julia G. Costello

Boring 11 was located on the northeast corner of Los Angeles Street and First Street on the grass lawn area of the present City Hall South. (Figure 2) Historically this area lay just south of the central plaza of the pueblo and, by 1840, contained some structures of the spreading urban center. Few changes occurred on the block until the 1880s when the area began to be developed commercially. Small shops predominated although several of these were replaced by hotels in the early part of the twentieth century. In 1949 the City widened First Street and the buildings fronting that street were removed. The construction of the City Health Building in 1953 produced the landscaped setting present today.

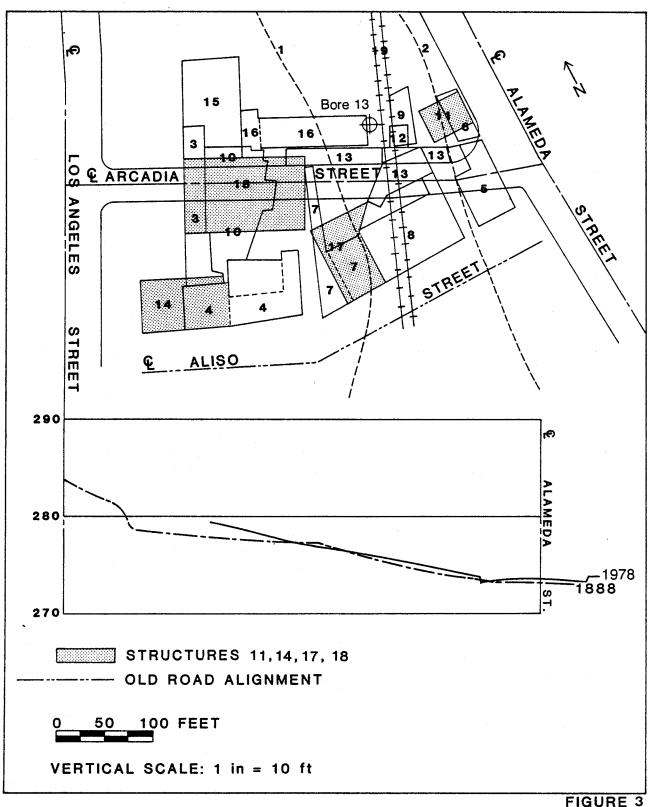
BLOCK 5 HISTORIC PLAN VIEW AND PROFILE
ARCHEOLOGICAL RESOURCES SURVEY: PHASE 3
LOS ANGELES DOWNTOWN PEOPLE MOVER PROGRAM
Julia G. Costello

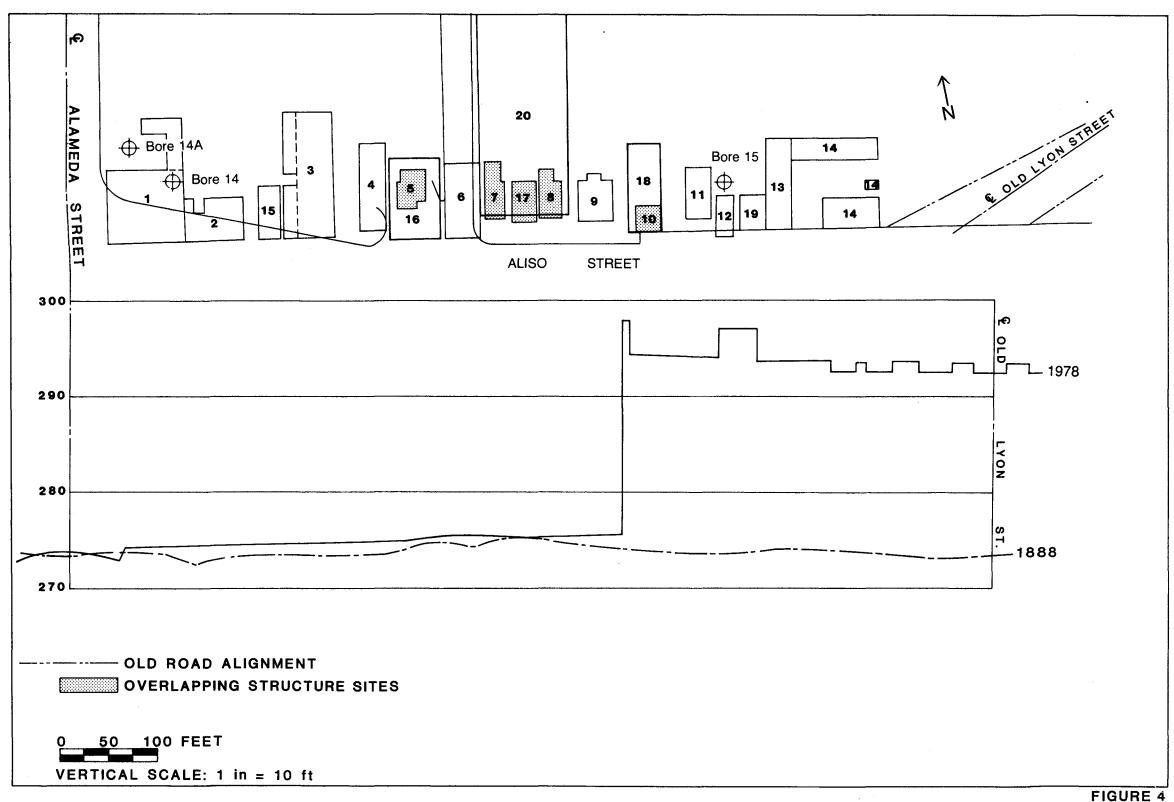
BLOCK 4 HISTORIC PLAN VIEW AND PROFILE
ARCHEOLOGICAL RESOURCES SURVEY: PHASE 3
LOS ANGELES DOWNTOWN PEOPLE MOVER PROGRAM
Julia G. Costello

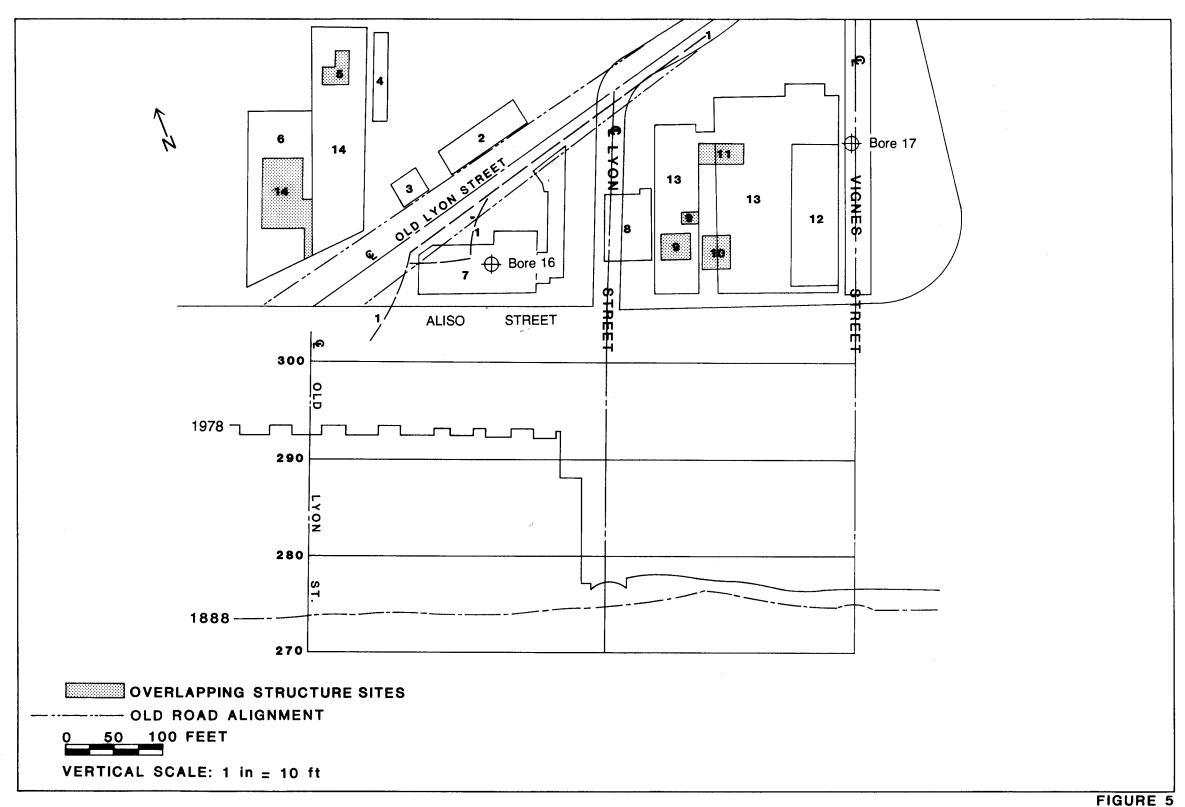
BLOCK 3 HISTORIC PLAN VIEW AND PROFILE
ARCHEOLOGICAL RESOURCES SURVEY: PHASE 3
LOS ANGELES DOWNTOWN PEOPLE MOVER PROGRAM
Julia G. Costello

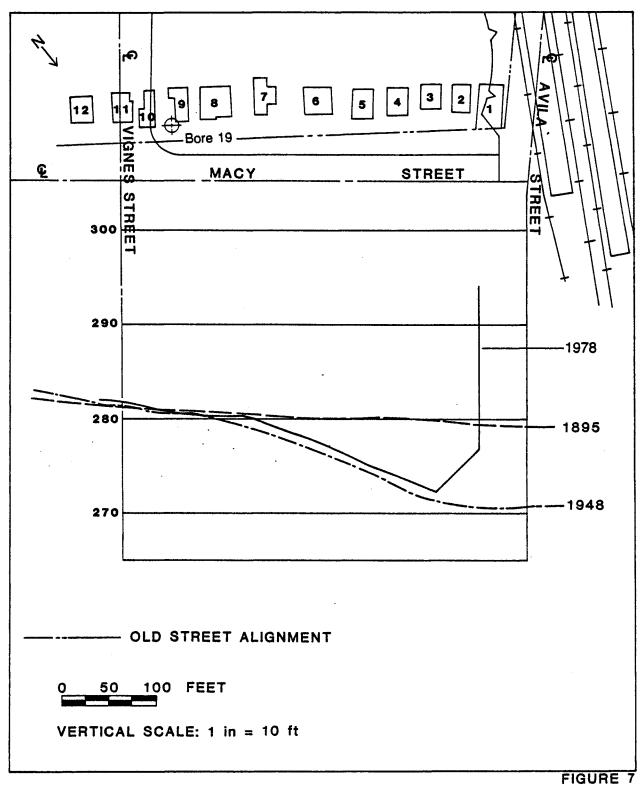
BLOCK 1 HISTORIC PLAN VIEW AND PROFILE ARCHEOLOGICAL RESOURCES SURVEY: PHASE 3 LOS ANGELES DOWNTOWN PEOPLE MOVER PROGRAM Julia G. Costello

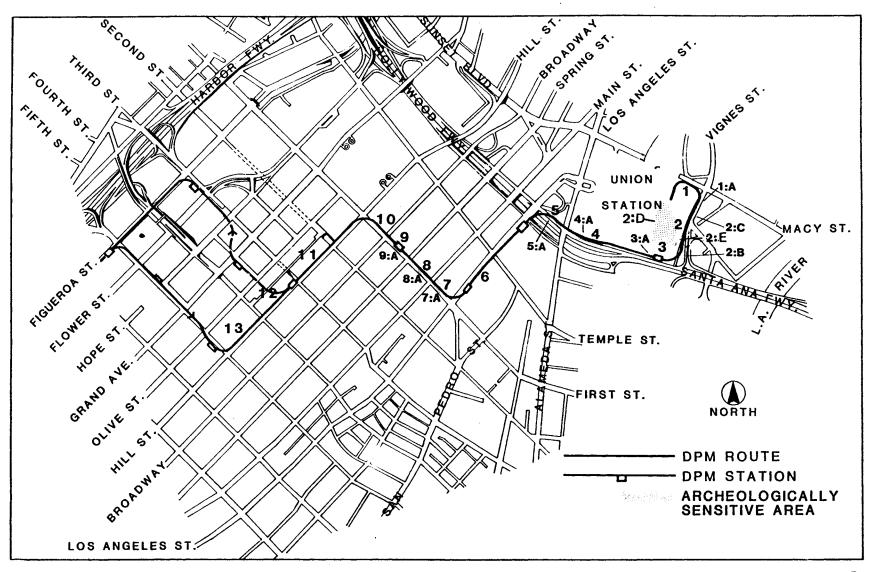
IDENTIFICATION OF SENSITIVE AREAS

As a result of information obtained by these test bores, Phase 2 Sensitive Areas were reassessed: Three areas have been eliminated (2:A, 6:A, and 13:A); one area reduced considerably (5:A); and two new areas added (2:D and 2:E). The revised Sensitive Areas are designated on the figure below and are shown in detail on the blueprints accompanying this report.
