HISTOIC PROPERTIES SURVEY AND EFFECTS REPORT

Gold Line Phase II Project

(Pasadena to Montclair)

Los Angeles and San Bernardino Counties, California

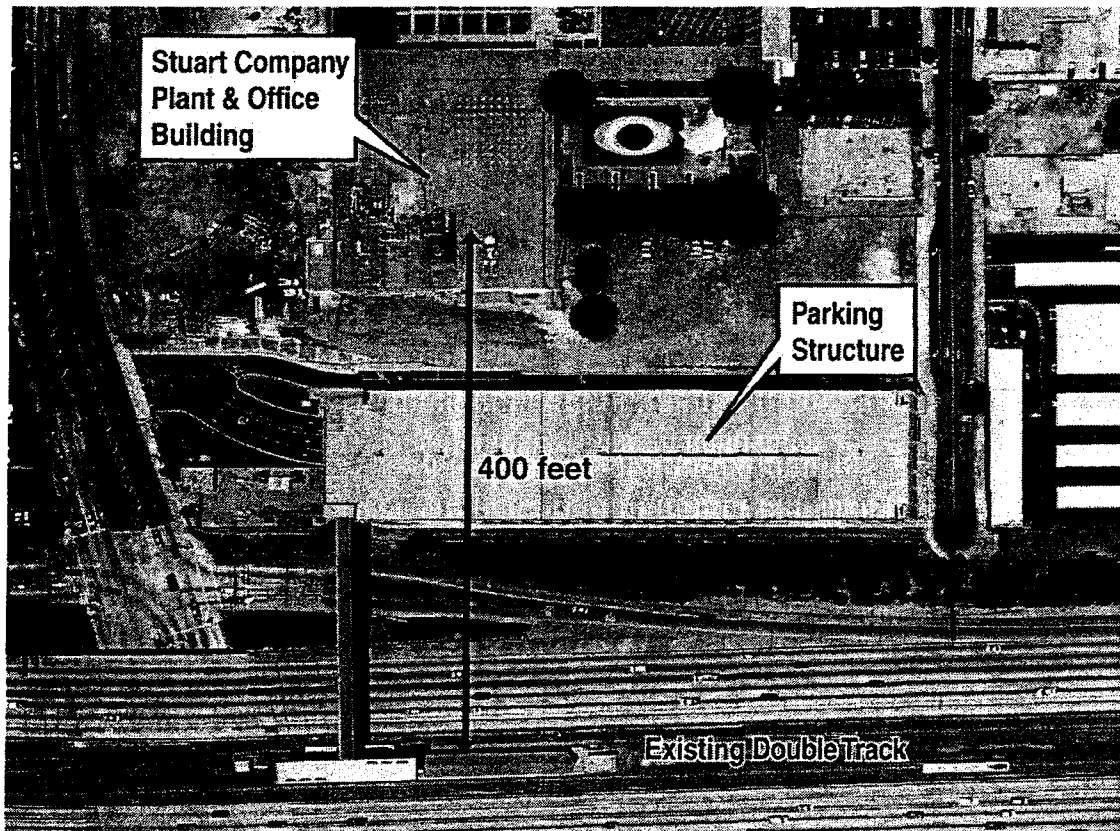
FIGURE 1

The proposed project's double track would be located within the existing railroad ROW between the east and westbound lanes of the 210 Freeway, approximately 400 feet to the south of the southern elevation of the Stuart Company Plant Office Building. The existing 5-level parking structure for the Sierra Madre Villa station is located immediately north of the 210 Freeway, between the proposed double track alignment and the Stuart Company Plant Office Building. Because of this relatively great distance, and because the existing parking structure blocks views to and from the Stuart Company Plant Office Building, there would be no visual change to this historic property or its setting. Therefore, there would be no effect under Section 106 *criteria example (v)*. (see Figure 1)

(Proposed project in relation to The Stuart Company Plant and Office Building)

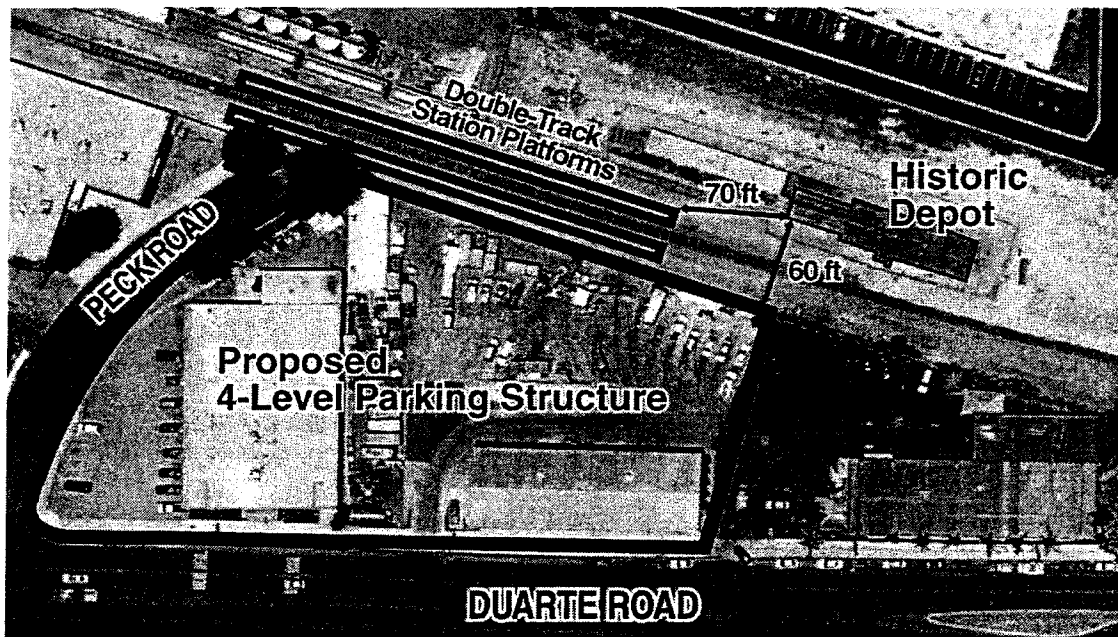
FIGURE 2

The Monrovia Santa Fe Depot is currently being restored and will be incorporated into development plans.

(Proposed project in relation to Monrovia Depot)

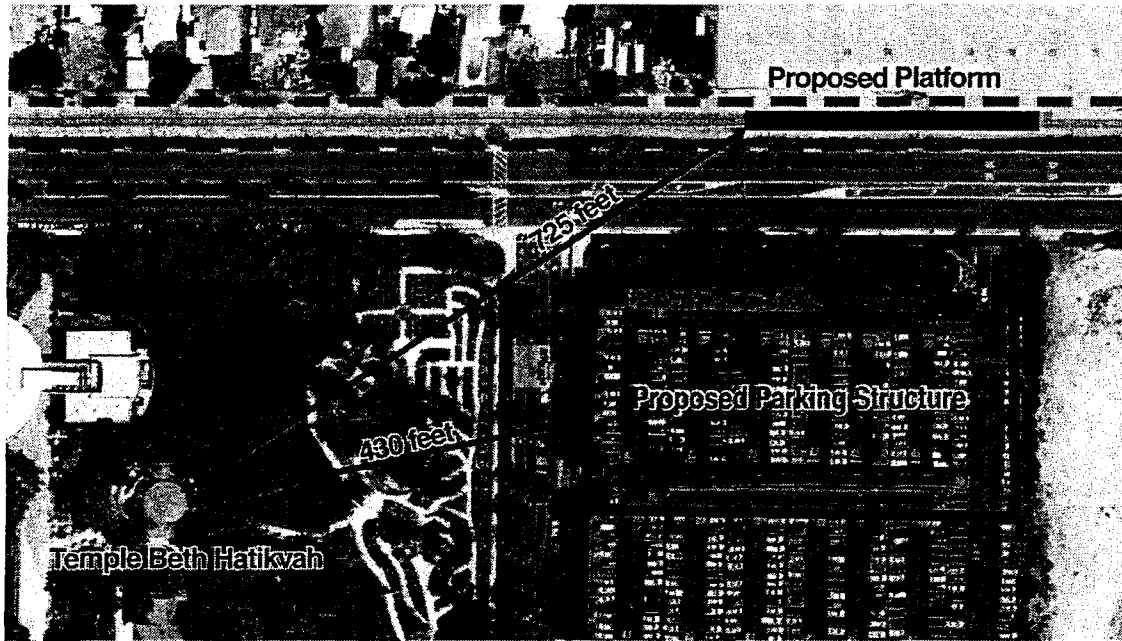
FIGURE 3

The proposed project's station platform would be located approximately 725 feet to the northeast of the Temple Beth Hatikvah, and the parking structure would be located approximately 430 feet to the east. Because of this great distance both proposed structures would not introduce any visual, atmospheric or audible elements, and therefore would not diminish the integrity of the property's significant historic features. Therefore there would be no effect for the proposed project under Section 106 *criteria example (v)* (see *Figure 3*)

(Proposed project in relation to Temple Beth Hatikvah)

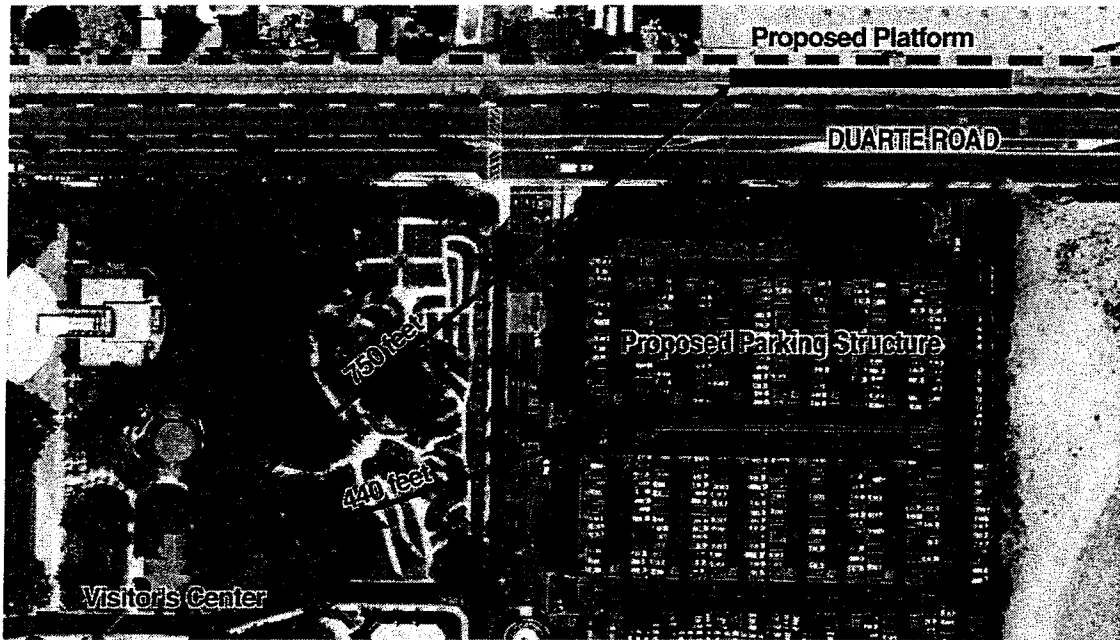
FIGURE 4

The proposed project's station platform would be located approximately 750 feet to the northeast of the Visitor's Center, and the parking structure would be located approximately 440 feet to the east. Because of this great distance both proposed structures would not introduce any visual, atmospheric or audible elements, and therefore would not diminish the integrity of the property's significant historic features. Therefore there would be no effect for the proposed project under Section 106 *criteria example (v)* (see Figure 4)

(Proposed project in relation to The Visitors Center)

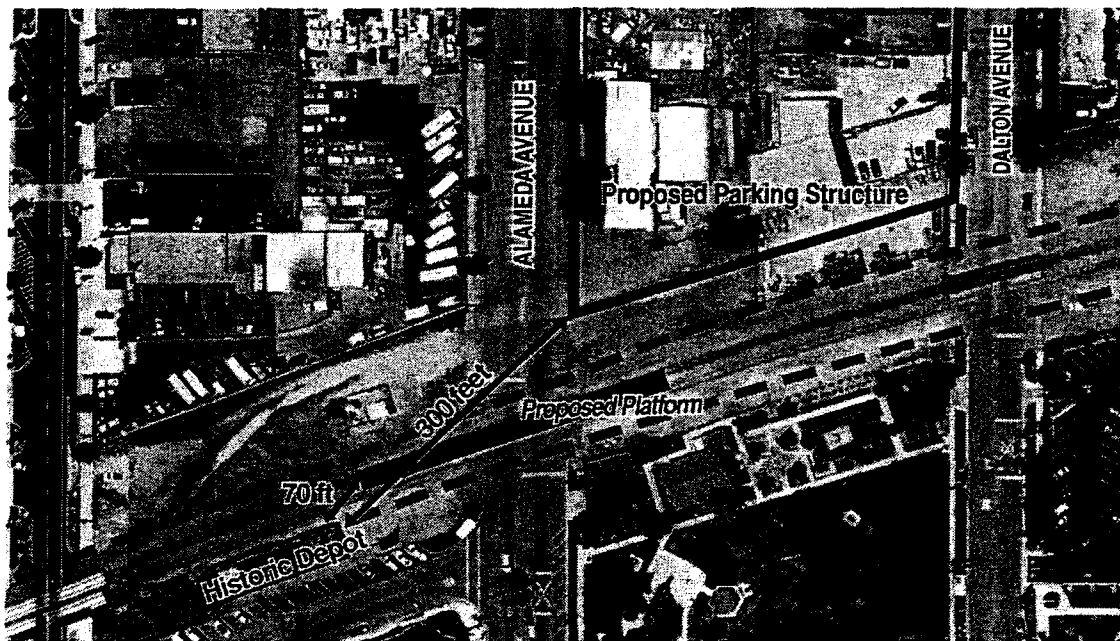
FIGURE 5

The proposed project's station platform under the triple track alternative would be located approximately 70 feet to the northeast of the historic AT&SF depot, and the two station platforms under the double track alternative would be located approximately 40 feet to the northeast. The proposed project's station platforms, for either alternative would be approximately 3-4 feet in height and constructed with a waiting shelter/canopy, waiting benches, ticket kiosks and centenary wire support poles. While the construction of the new platforms for either alternative would introduce a visual element it would be of a scale and size that would not diminish the historic integrity of the historic Azusa AT&SF depot building and would be compatible with its historic use and setting as a passenger railroad depot. The 2-level parking structure would be located approximately 300 feet to the northeast on a site that is currently occupied by light industrial warehouse type buildings, with two or three residential type structures located at the northern end. Because of its height and its proposed location in a light industrial setting, the proposed parking structure would not be introducing a visual element that would diminish the integrity of the significant historic features of the Azusa AT& SF depot building. Therefore there would be no effect for the proposed project under Section 106 *criteria example (v)* (see Figure 5)

(Proposed project in relation to The Azusa AT&SF Railroad Depot)

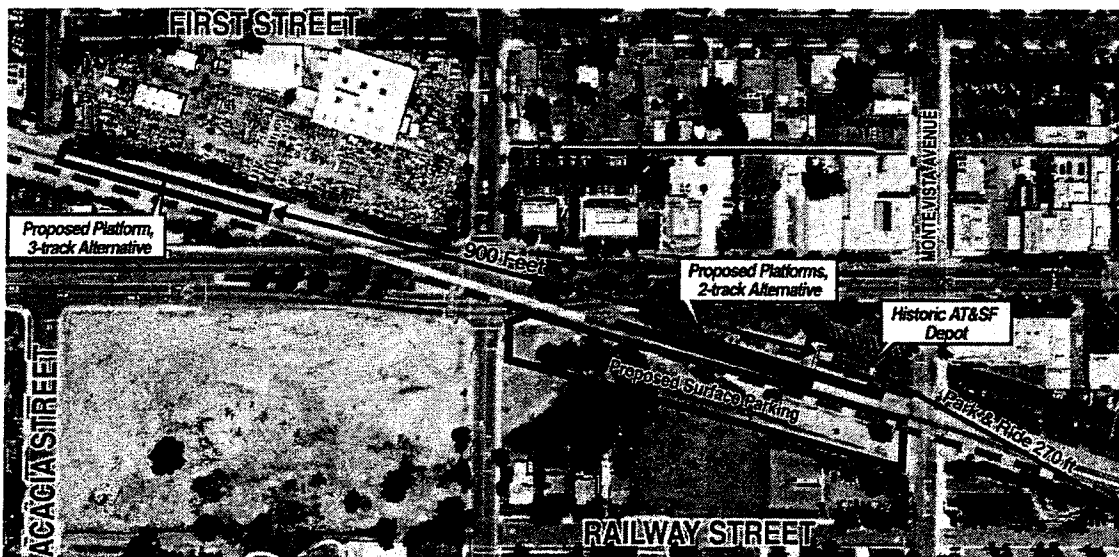
FIGURE 6

For the proposed triple-track alternative, the station platform would be approximately 900 feet to the west in the ROW and possible surface parking would be located approximately 50 feet to the southwest across the ROW. Parking would also be located at the existing Park and Ride lot, which is approximately 270 feet to the southeast. Because the proposed platform would be at such an extreme distance from the historic depot building and because the possible surface parking would be constructed on a vacant site south of the ROW, there would be no potential to diminish the integrity of the historic depot building. For the proposed double-track alternative, platforms would be located close to the historic depot building, with the westbound platform being located approximately 5 feet to the south of its southern elevation (The platform would be limited to a 3'-3" height concrete platform with a waiting shelter/canopy, waiting benches, ticket kiosks and centenary wire support poles.) Because of this close proximity, the double-track alternative would introduce a visual element to the setting of the historic depot, however the platforms would be compatible with the historic railroad setting of the San Dimas AT&SF Depot and would not diminish the integrity of its significant historic features. Therefore under the double track alternative the proposed project would have no adverse effect on the San Dimas AT&SF Depot under Section 106 *criteria example (v)* (see Figure 6)

(Proposed project in relation to San Dimas Train Station)

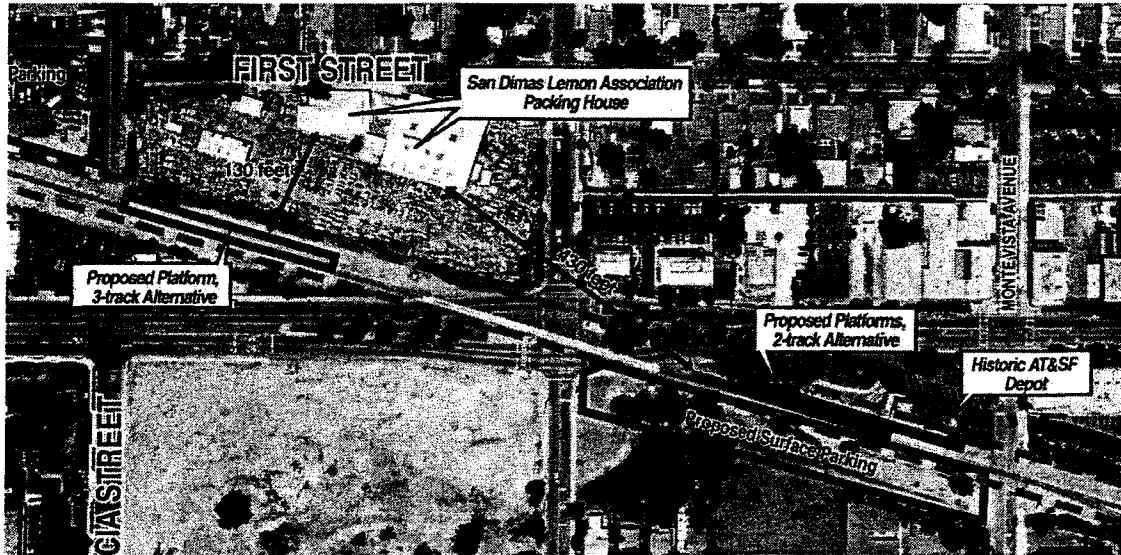
FIGURE 7

The proposed project's station platform, for the triple-track alternative, would be located approximately 130 feet to the southwest in the ROW. For the proposed 2-track alternative, platforms would be approximately 430 feet to the southeast. Because of the great distance from the historic Lemon Association Packing House the proposed project under the triple track alternative would result in a finding of no effect under Section 106 *criteria example (v)* (see *Figure 7*)

(Proposed project in relation to San Dimas Lemon Association Packing House)

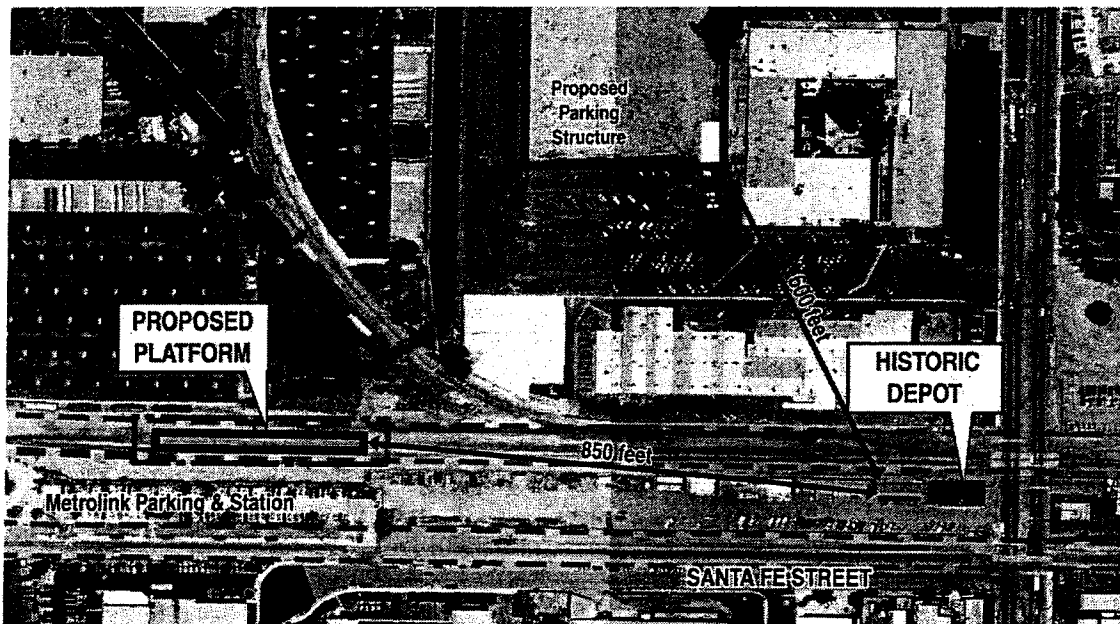
FIGURE 8

The proposed Pomona station platform would be approximately 850 feet to the west, in the ROW, and a 3-level parking structure would be located approximately 600 feet to the northwest. The proposed platform would be constructed at a great distance from the historic Southern Pacific depot building and would not have the potential to impact the historic property. The proposed parking structure would also be constructed at great distance from the historic depot building and would be visually separated from it by a large existing warehouse building and parking lot. Therefore the proposed project would result in a finding of no effect under Section 106 *criteria example (v)* (see Figure 8)

(Proposed project in relation to the Pomona Southern Pacific Station)

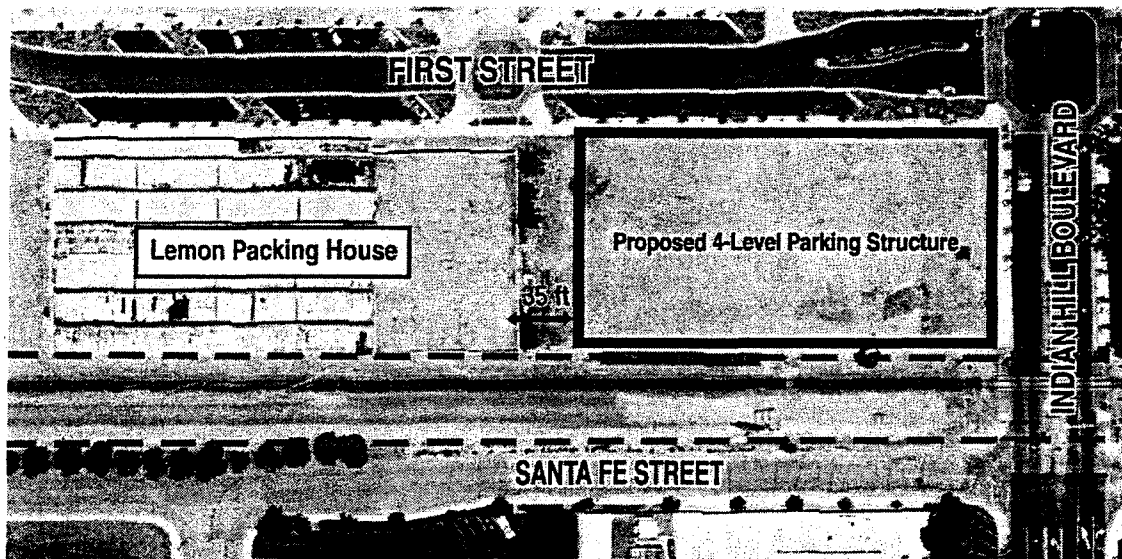
FIGURE 9

The proposed project's 4-level parking structure would be located 35 feet east of the east elevation of the historic Corona College Heights Lemon Packing House. The building's east façade has been extensively altered and features no distinctive architectural details. While the construction of the parking structure would result in the introduction of a new visual element it would not be adverse due to the fact that it does not obscure views of the building's primary elevations. The proposed 4-level parking structure's design, scale, and landscaping should be constructed as to not diminish the integrity of the Corona College Heights Lemon Packing House setting, feeling, and association. Therefore the construction of the 4-level parking structure would result in a finding of no adverse effect on this historic property under Section 106 *criteria example (v)* (see Figure 9)

(Proposed project in relation to the Corona College Heights Lemon Packing House)

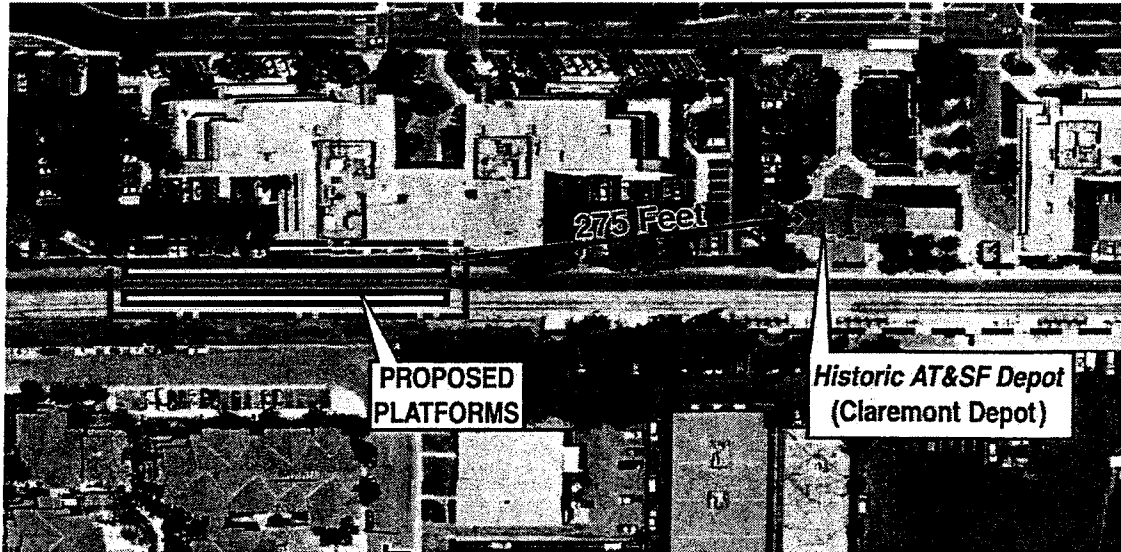
FIGURE 10

The proposed Claremont station platform would be located approximately 275 feet to the west of the historic Atchison Topeka & Santa Fe Railroad Station. A two level parking structure would be constructed approximately 930 feet to the east of the Claremont Depot. Both the proposed station platform and parking structure would be sufficiently distanced from the historic depot building as to not visually impact it in any way. Therefore the proposed project would result in a finding of no effect under Section 106 *criteria example (v)* (see Figure 10)

(Proposed project in relation to the Claremont AT&SF Depot)

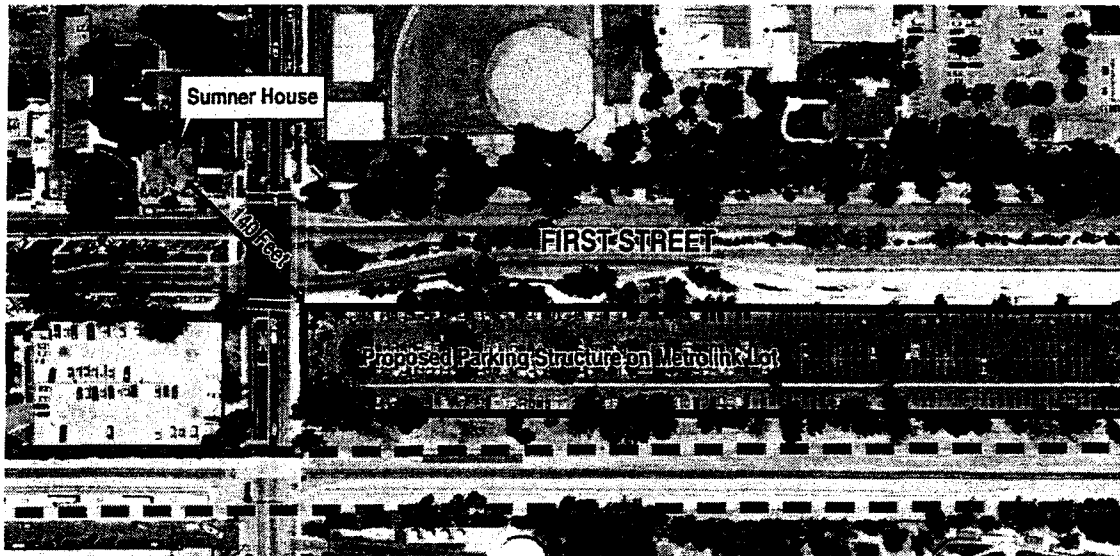
FIGURE 11

The proposed Claremont station platform would be located over 600 feet to the west of the Sumner House, and would be visually separated from it by First Street and a large commercial building. A two level parking structure would be constructed on an existing surface parking lot located at the southeast corner of College Avenue and First Street, approximately 140 feet from the Sumner House. The proposed parking structure would only be two stories in height, would be located within the boundaries of an existing surface parking lot, and would be separated from the Sumner House by the intersection of College Avenue and First Street, and would therefore not visually impact it in any way. Therefore the proposed project would result in a finding of no effect under Section 106 *criteria example (v)* (see Figure 11)

(Proposed project in relation to the Sumner House)

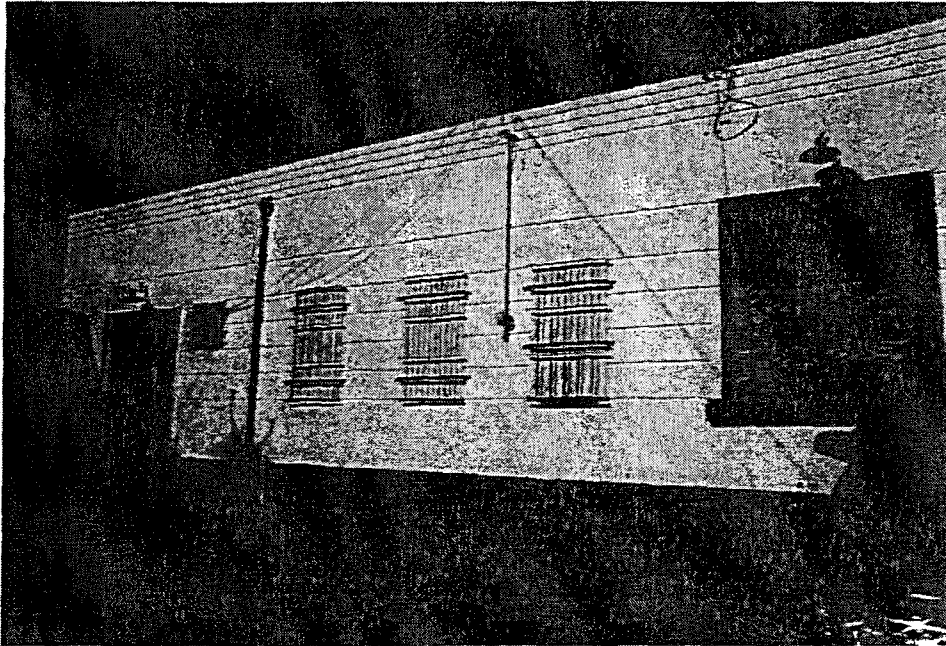
-Picture Attachments-
800 North Azusa (Santa Fe Station)

Side view facing South.

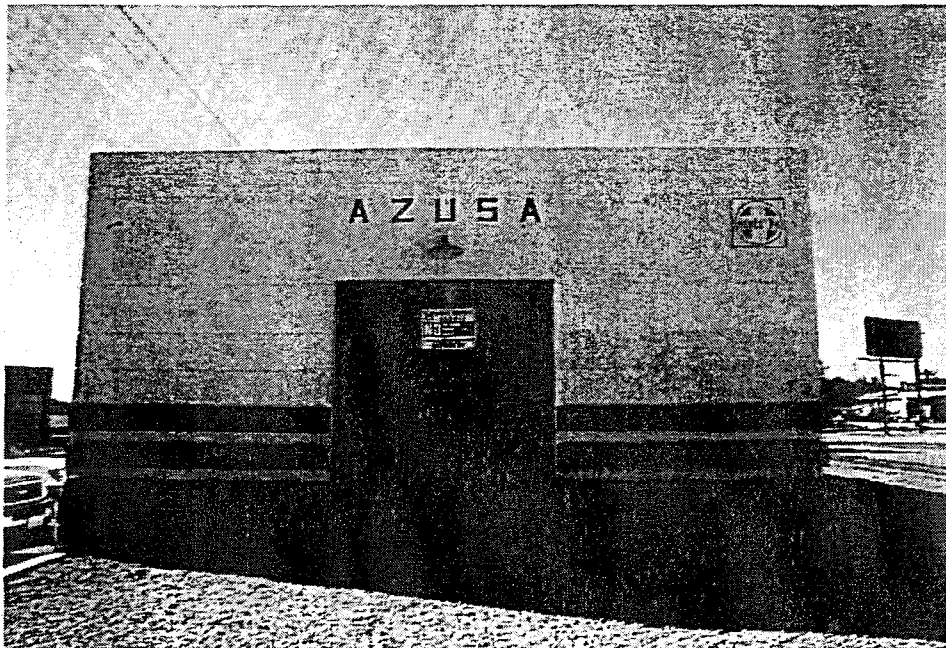
View facing North-East.

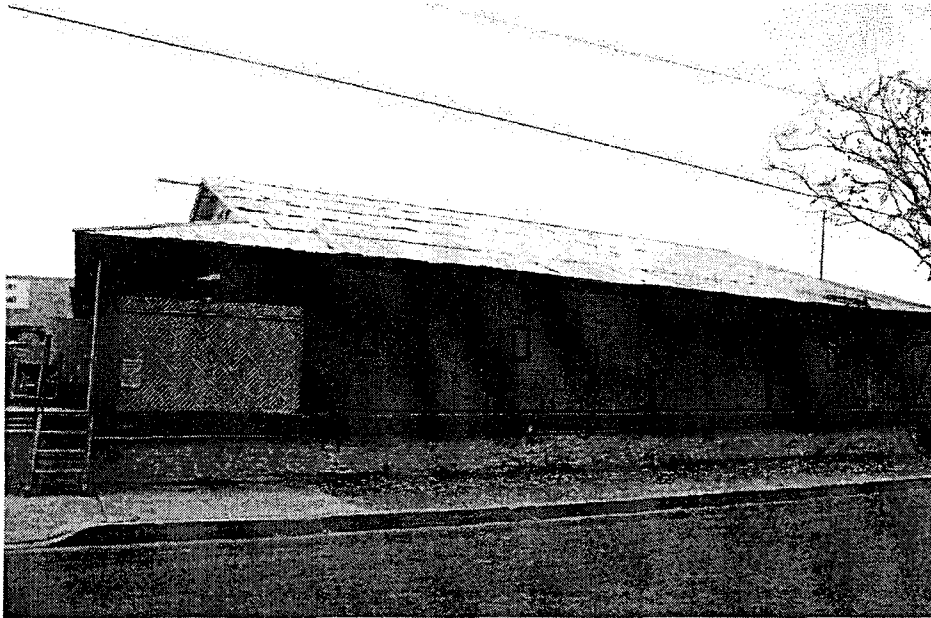
Packing house located in the northwest portion of parcel number 8386-016-002.

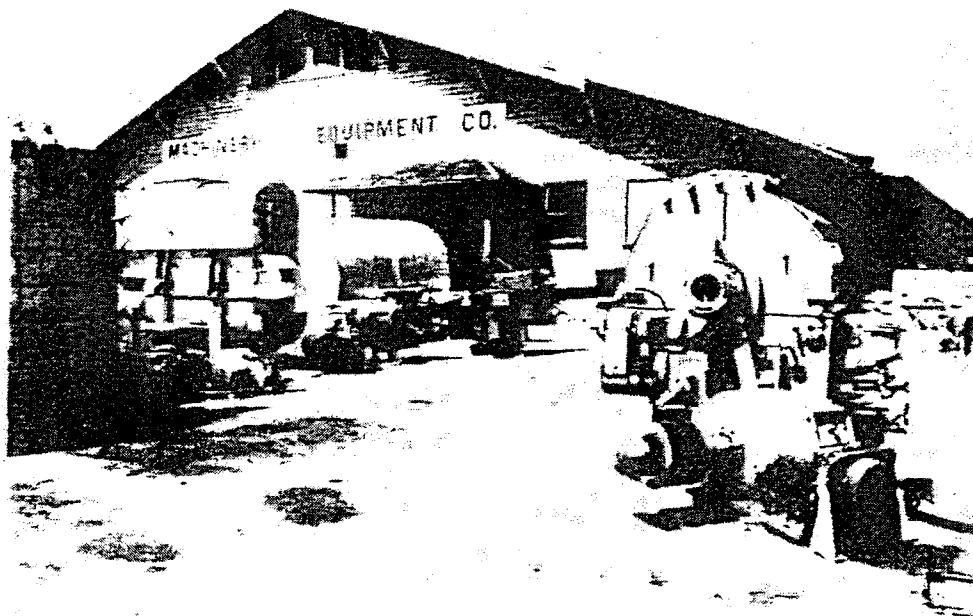
Located on a 2.79 acre lot adjacent to the railroad tracks at the southwest corner of Cataract Avenue and First Street, the building faces Cataract Avenue. The large rectangular shaped building has a medium gable roof with broad eaves supported by knee brackets. Under the gable peak are four connecting vent windows that have been covered. The raised front entry is covered by a hip roof supported by square wood posts. Adjacent to the entry are a row of wood sash windows, one over one with flat wood moldings. The building is covered with medium horizontal board siding and is in good condition. The large lot contains additional buildings, loading platforms and railroad tracks once used in the citrus industry.

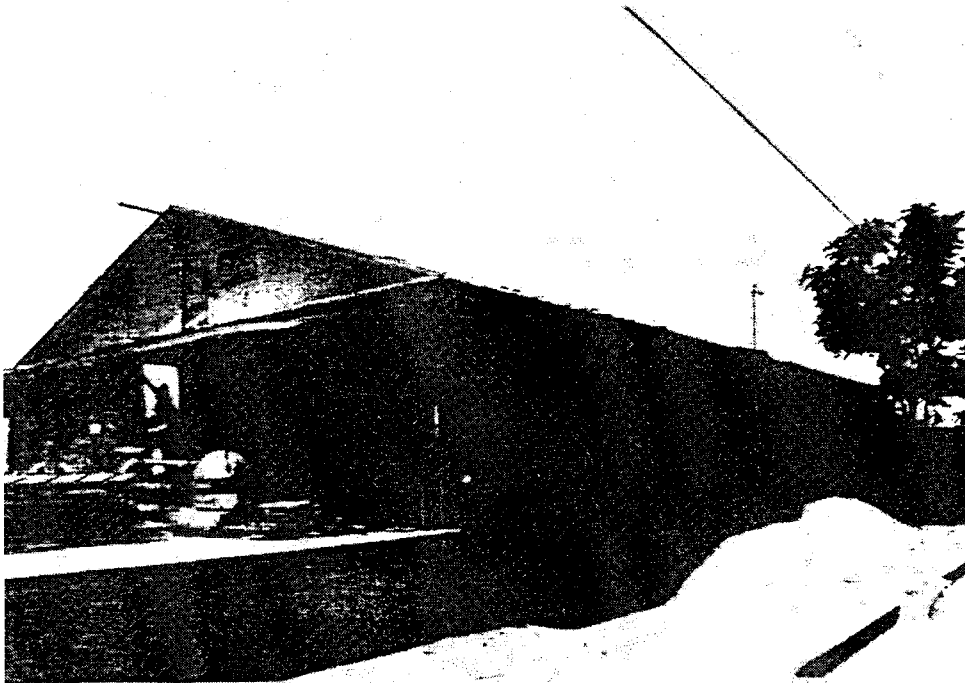
This long rectangular shaped 1 1/2 story building has a medium pitched gable roof. The building is constructed of reinforced concrete and is raised with a basement underneath. The basement is divided into small rooms. There are several windows and doors on all sides of the building. A second floor entrance is found under the peak of the front gable. There have been modifications to the windows and doors. The stairway to the upstairs entrance has been removed. The building is in fair condition.

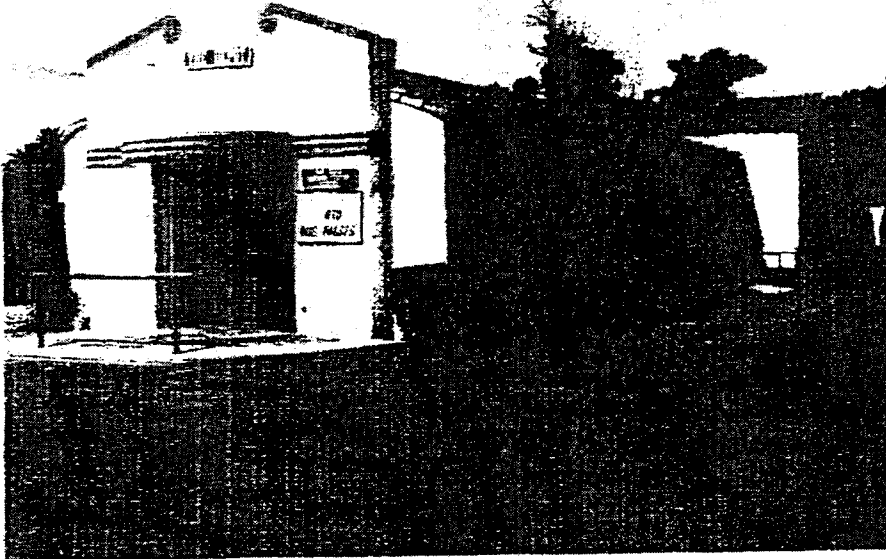
The prominent feature of this one story building is the Mission style parapet above the entrance. Built in a modified t-shape, the building has a low pitched gable roof with a slightly taller intersecting gabled roof wing in the rear. Windows are wood frame sash except for some changes to aluminum sliders. The windows have plain wood casings. The slightly recessed front entrance has a double paneled door with a flat semi-circular roof. A fluted band extends across the front of the building and across the front of the flat roof. This element is typical of the Moderne style of the 1930s. The building is covered with a smooth stucco finish and has a clay tile roof. It is in good condition. The building lies adjacent to the railroad tracks and is surrounded by an asphalt parking lot. A few foundation plantings lie adjacent to the building. In front of the building is a Mission style fountain.

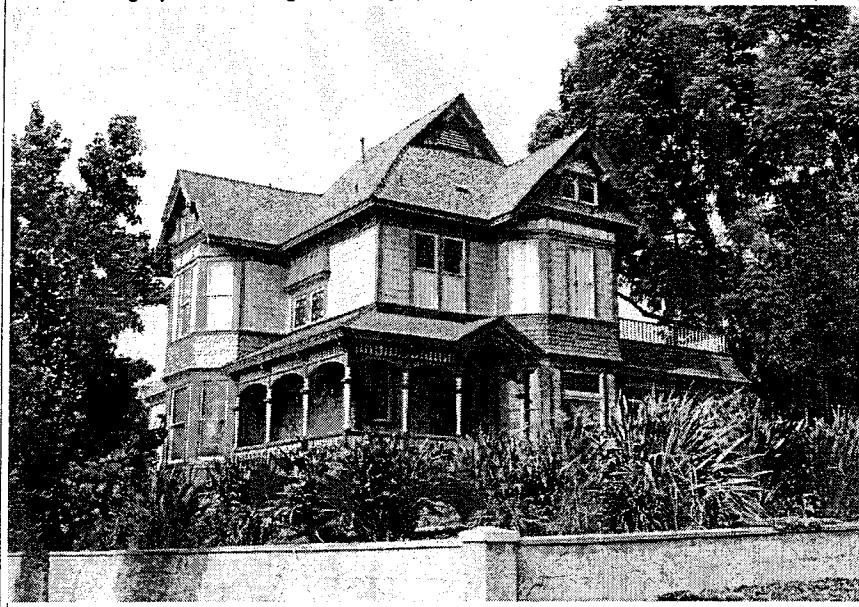
P5a. Photograph or Drawing (Photograph required for buildings, structures, and objects)

Looking northwest, 10/29/03, Photo#
DCP_0116

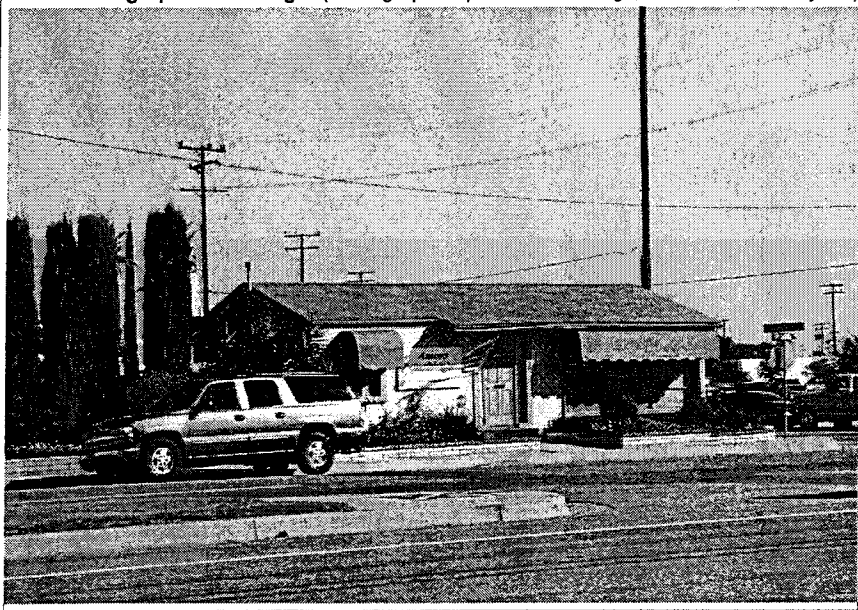
P5a. Photograph or Drawing (Photograph required for buildings, structures, and objects)

Looking south east, 11/07/03, Photo#

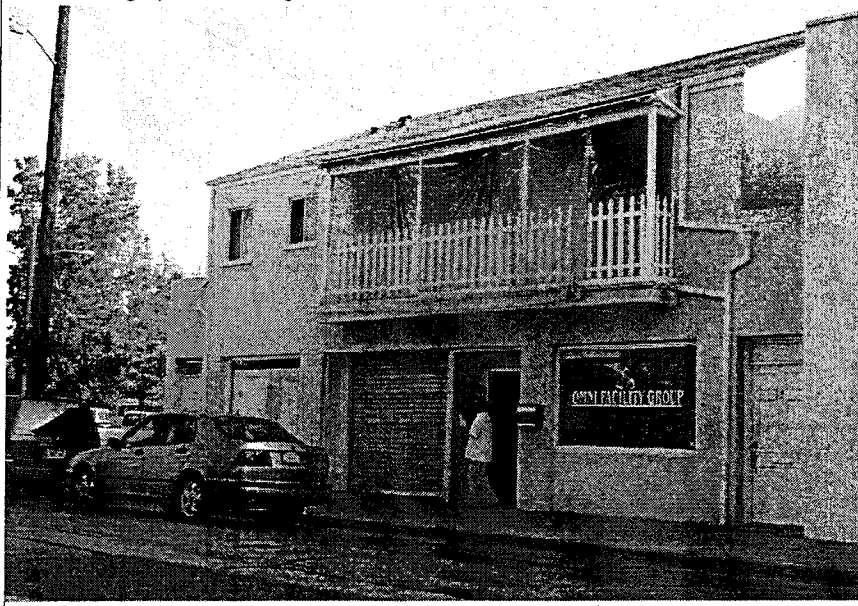
P5a. Photograph or Drawing (Photograph required for buildings, structures, and objects)

Looking southeast, 11/7/03, Photo#
DCP 0415

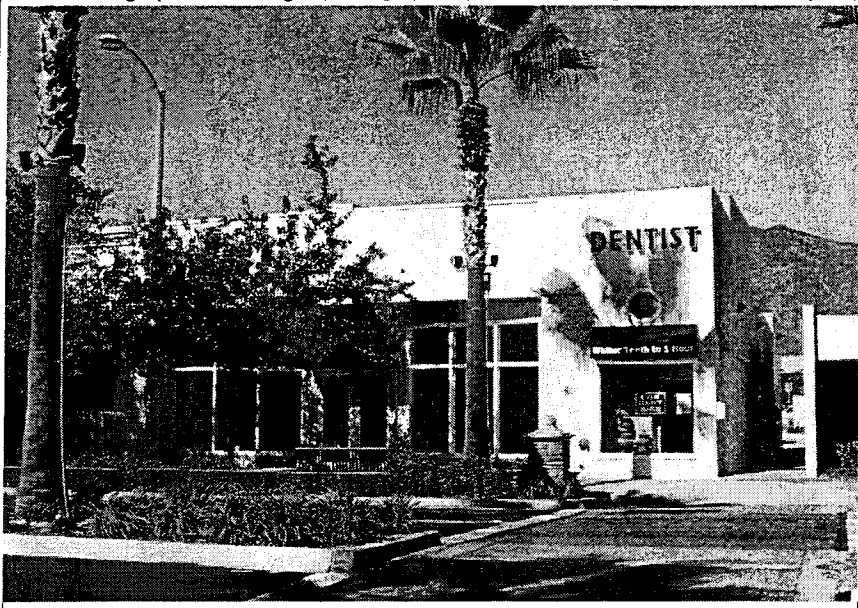
P5a. Photograph or Drawing (Photograph required for buildings, structures, and objects)

Looking north, 11/07/03, Photo#

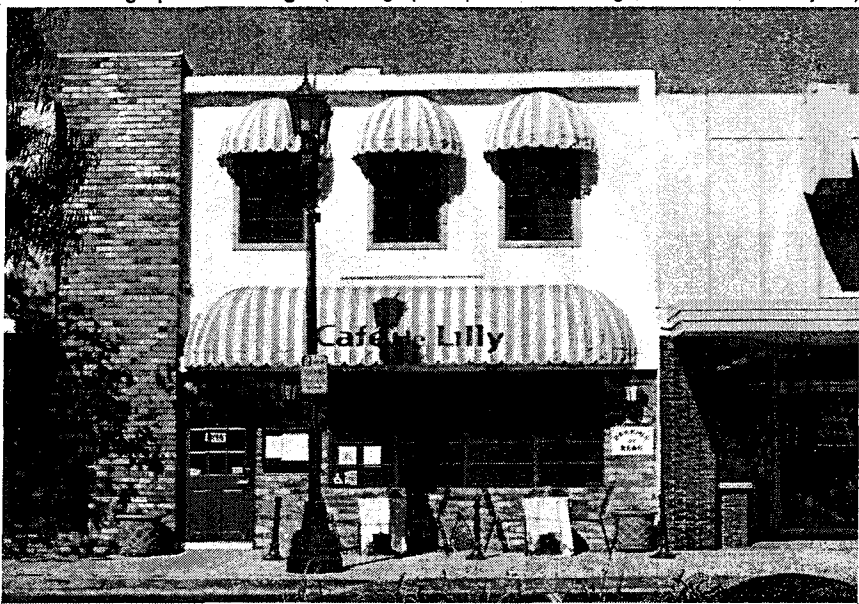
P5a. Photograph or Drawing (Photograph required for buildings, structures, and objects)

Looking north, 10/21/03, Photo#

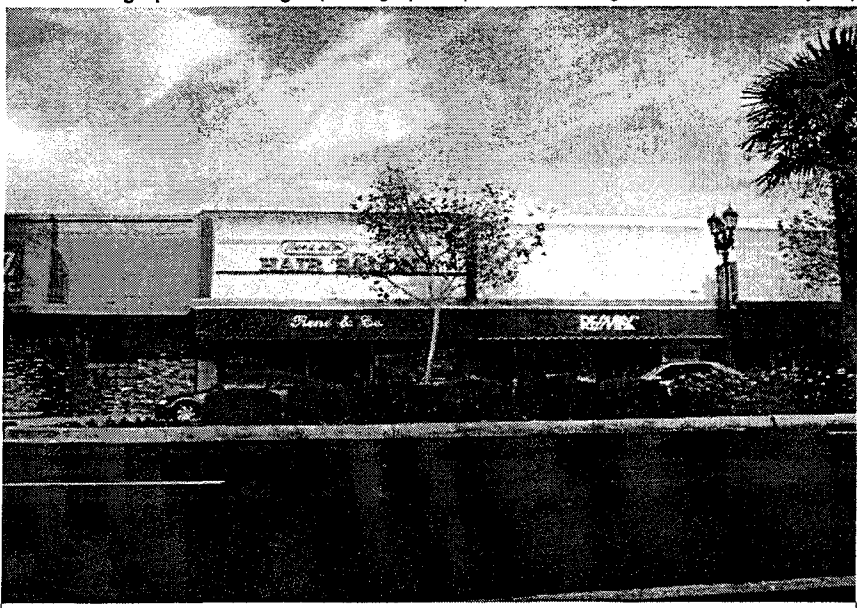
P5a. Photograph or Drawing (Photograph required for buildings, structures, and objects)

Photographer facing north, Photo#

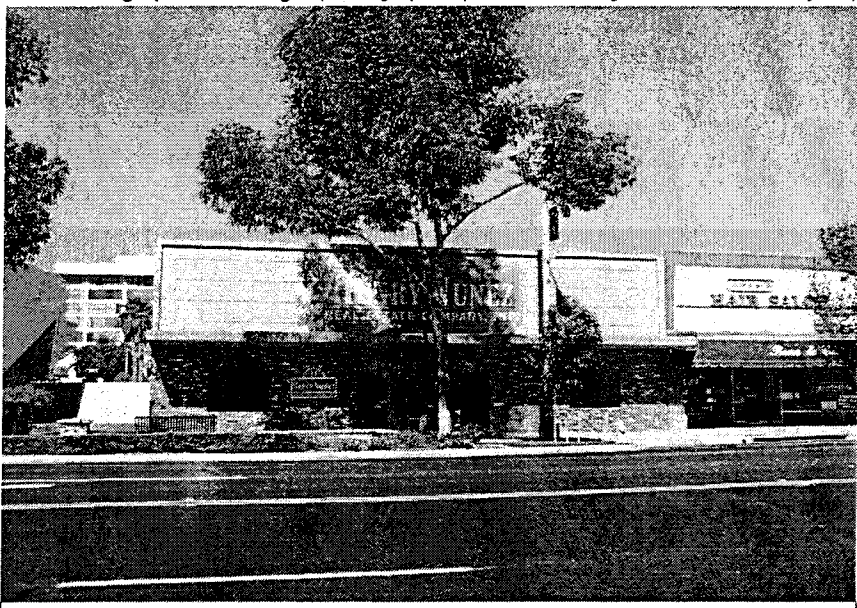
P5a. Photograph or Drawing (Photograph required for buildings, structures, and objects)

Looking north, Photo# DCP_3692

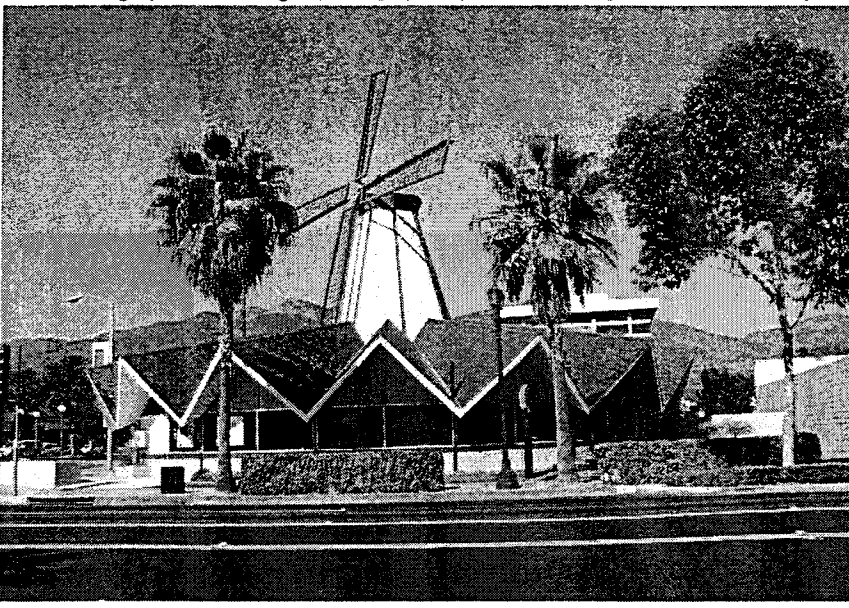
P5a. Photograph or Drawing (Photograph required for buildings, structures, and objects)

Photographer looking north;

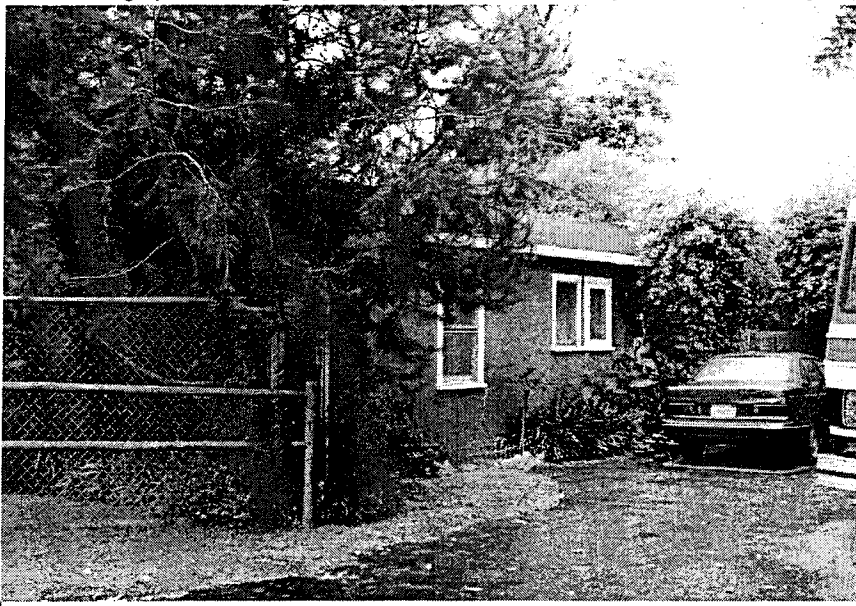
P5a. Photograph or Drawing (Photograph required for buildings, structures, and objects)

Looking southwest, Photo# DCP_0170

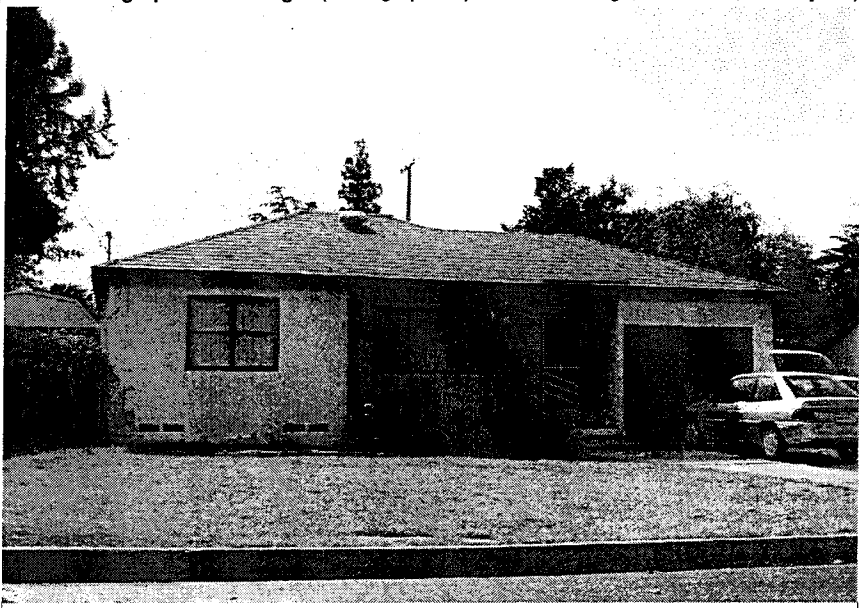
P5a. Photograph or Drawing (Photograph required for buildings, structures, and objects)

Looking south, 10/31/03, Photo#

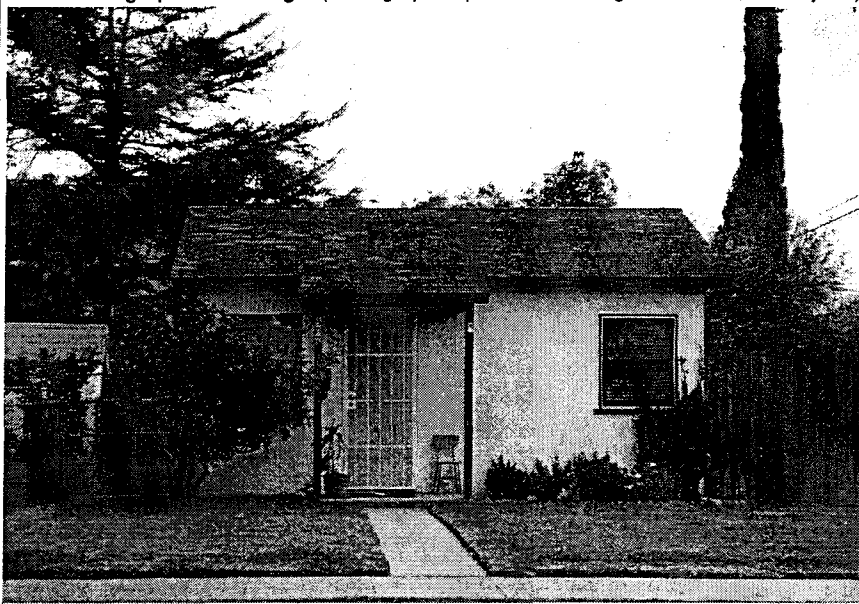
P5a. Photograph or Drawing (Photograph required for buildings, structures, and objects)

Looking east, 10/31/03, Photo#

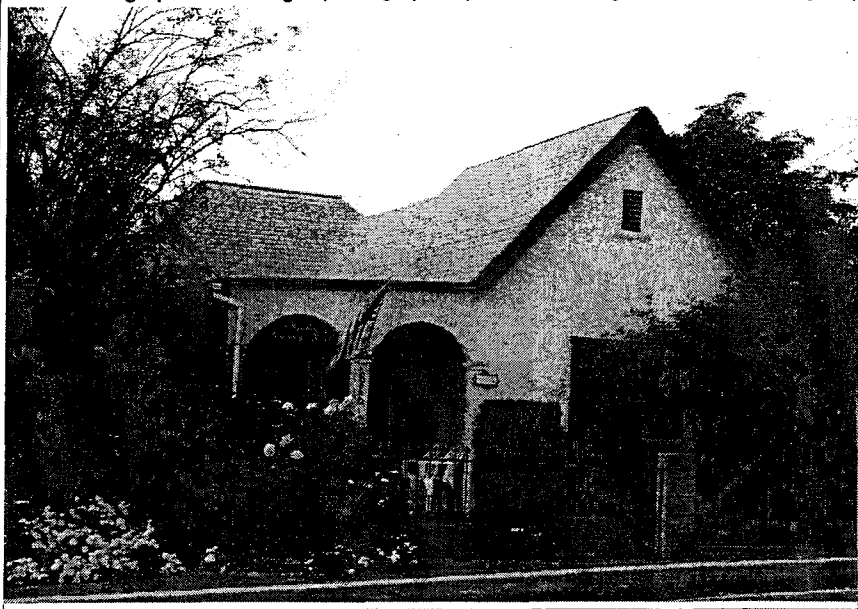
P5a. Photograph or Drawing (Photograph required for buildings, structures, and objects)

Looking west, 10/31/03, Photo#
DCP 0196
