**THE ARCHAEOLOGY AND HISTORY  
OF THE  
ZANJA MADRE BELOW BROADWAY,  
CITY OF LOS ANGELES, CALIFORNIA**

**Submitted to:**  
Carl Ripaldi  
Metropolitan Transportation Authority  
One Gateway Plaza  
Los Angeles, CA

**April 2007**

*Type of Study:* Archaeological Phase II and Phase III (testing and monitoring)

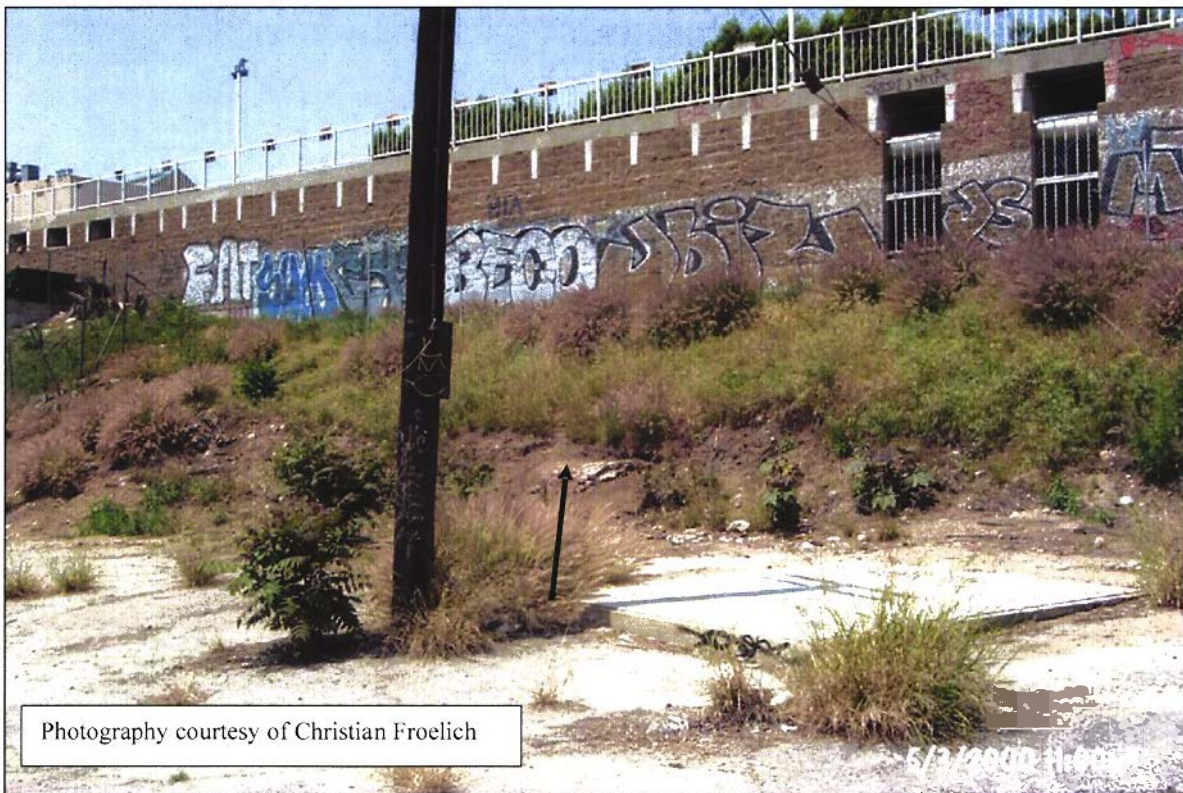
**Figure 2.1. Zanja segment on private property, as observed in 2000**

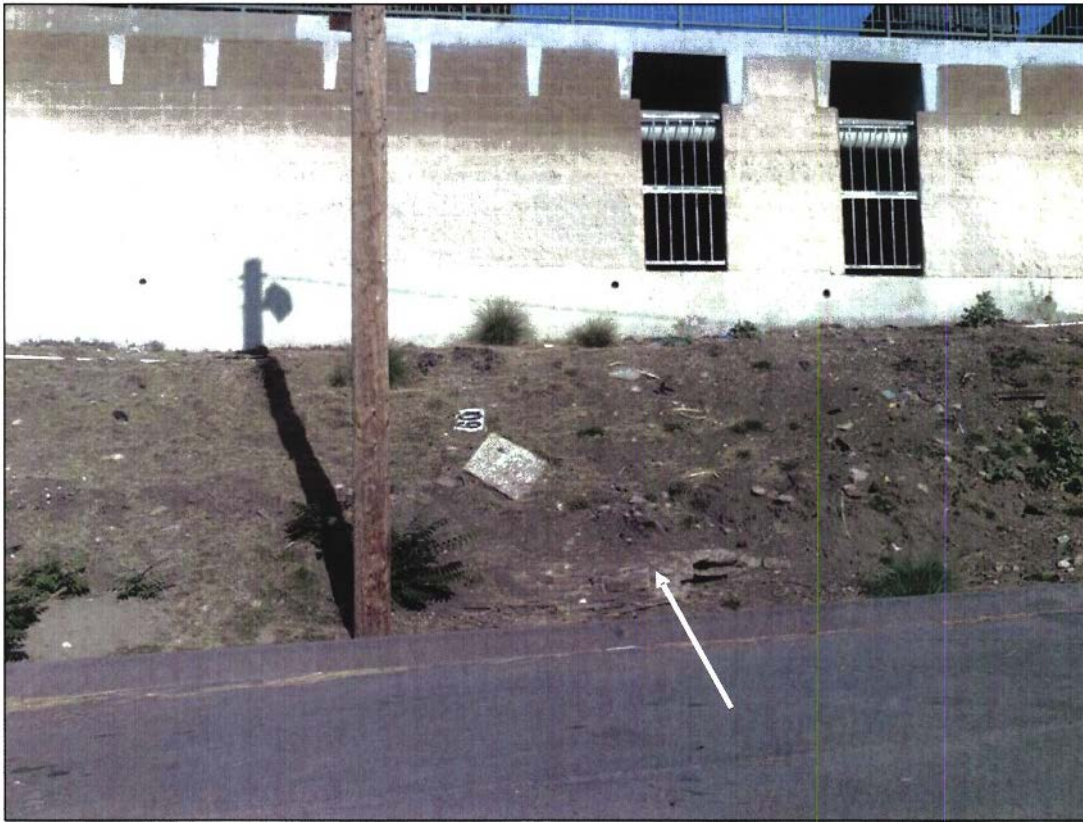
No features related to the Zanja Madre were observed on Metro property during the survey. Cogstone relocated the segment of the Zanja Madre discovered on private property in 2000 south of the parking garage on Broadway at Bernard. We obtained a photo taken of the segment in 2000 (Figure 2.1). Comparison to a 2005 photograph of the same segment shows installation of pavement and curb and relocation of a power pole (Figure 2.2).

**Figure 2.2. Zanja segment on private property, as observed in 2005**

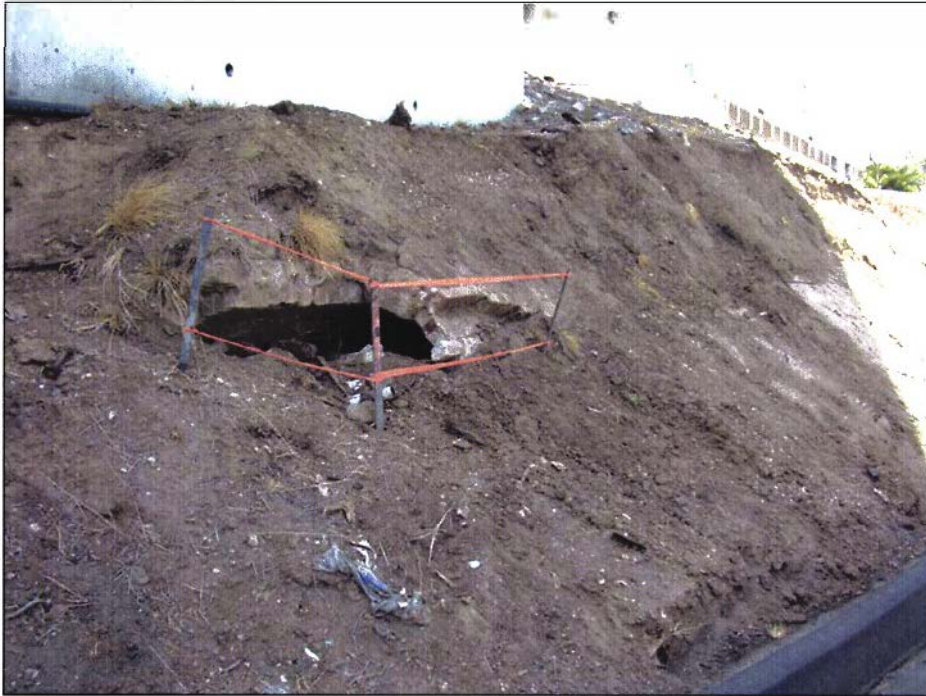
We found that two additional segments had been exposed sometime in 2003 or early 2004 adjacent to the original segment during weed removal associated with paving a new parking lot (Figure 2.3, 2.4). Both are located by following the slight curve of the hillside southwest from the 2000 segment (Figure 2.5).

**Figure 2.3. Easterly 2004 segment of Zanja on private property**

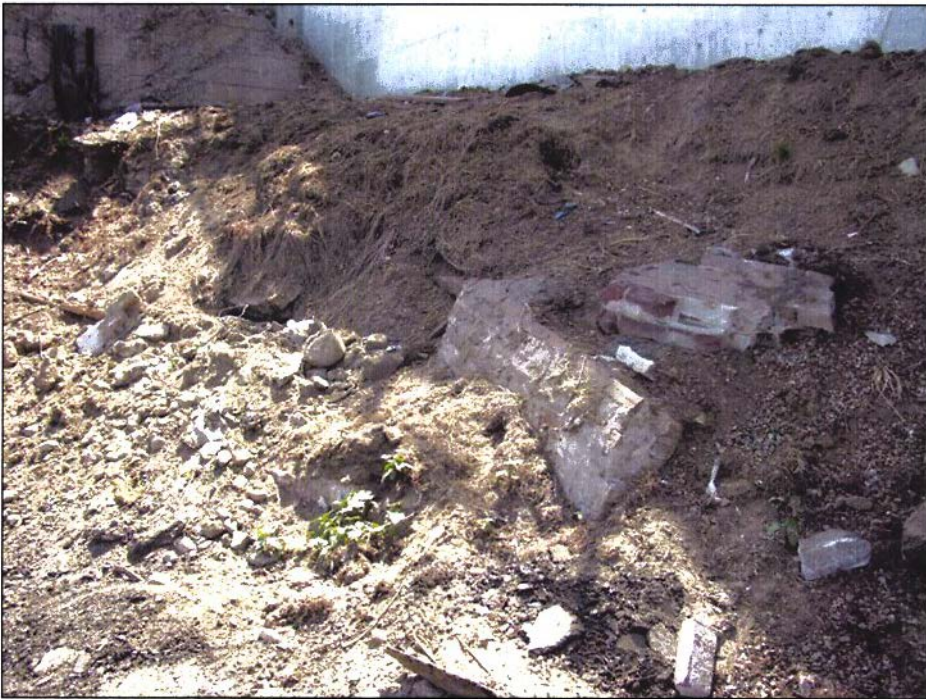
**Figure 2.4. Westerly 2004 segment of Zanja on private property**

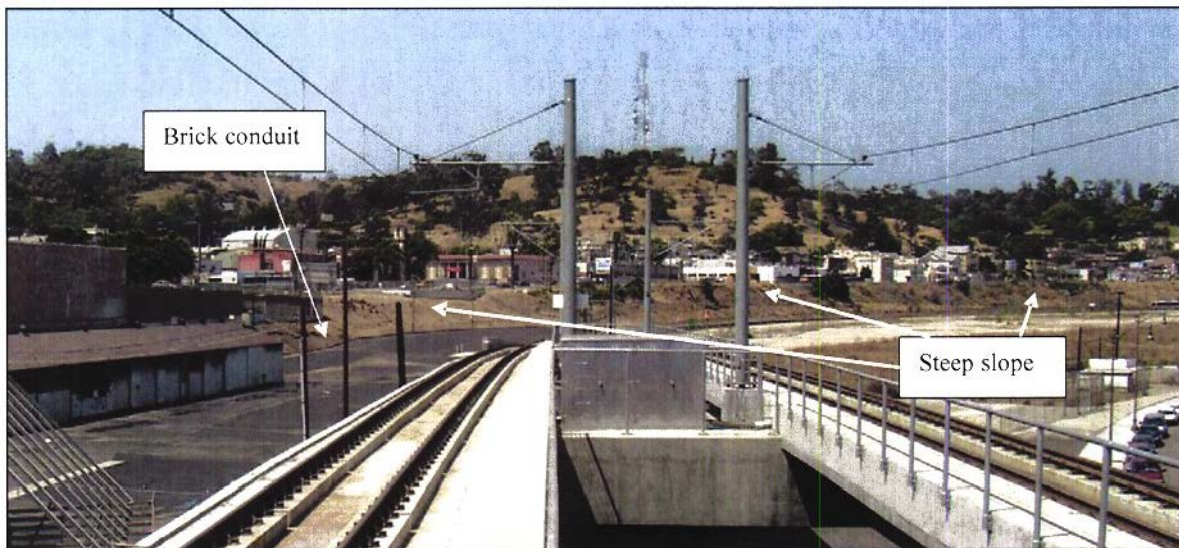
Cogstone concluded, based on the locations of the exposed segments of Zanja Madre on the private property hillside and the corresponding historical information, that more segments of intact Zanja Madre might exist in the steep slope below Broadway (Figure 2.5; Gust and Parker 2004).

**Figure 2.5. Location of exposed brick conduit (2000 segment) on private property northeast of Gold Line platform**

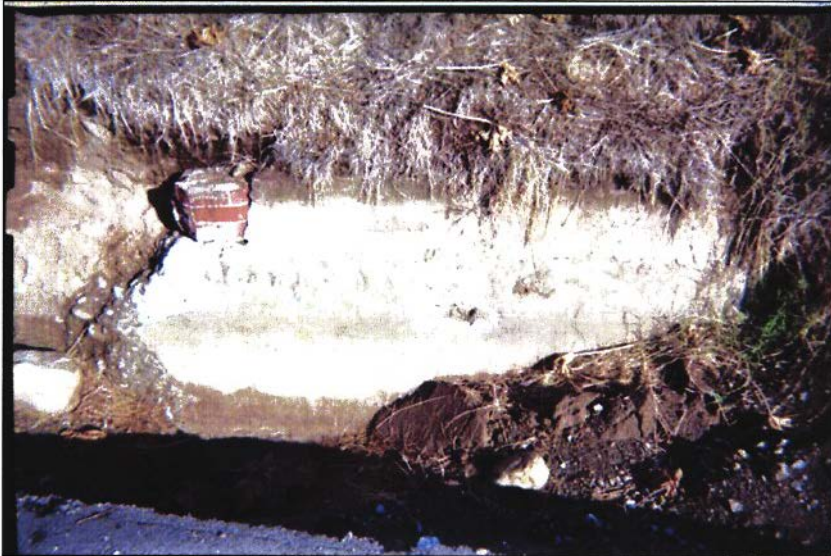
The most northerly feature exposed was a curved section of concrete with finished top edge partially of cement and partially of brick (Figure 2.6, 2.7). Several historic artifacts, including a cork bottle stopper, a horseshoe and several pieces of glass were recovered from the interior debris.

Figure 2.6. Feature 1 as first observed, view to west

Feature 1 was thoroughly mapped, measured, photographed and studied. Exploration of this feature and the surrounding area revealed it was isolated and had been impacted at both ends and bisected vertically during past construction activities, probably by Southern Pacific. This feature had low integrity and was eventually removed by backhoe as part of retaining wall construction.

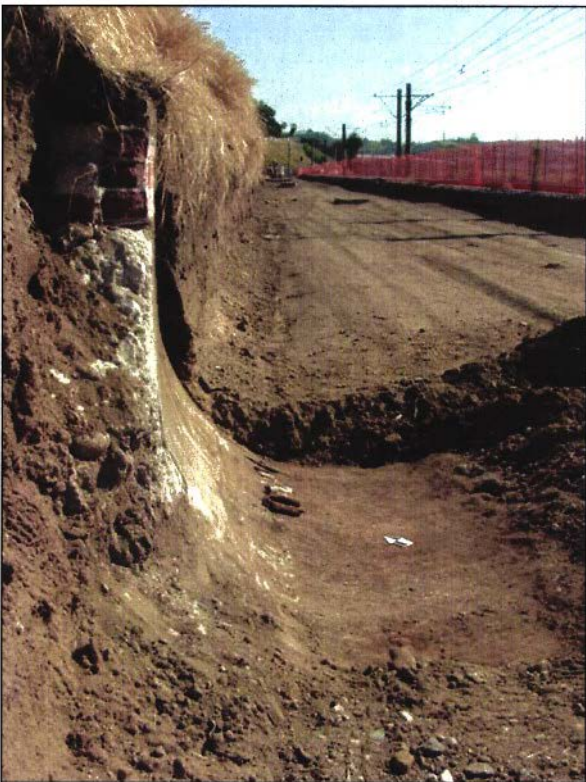
Figure 2.7. Feature 1, view to northwest, after clearing sediment

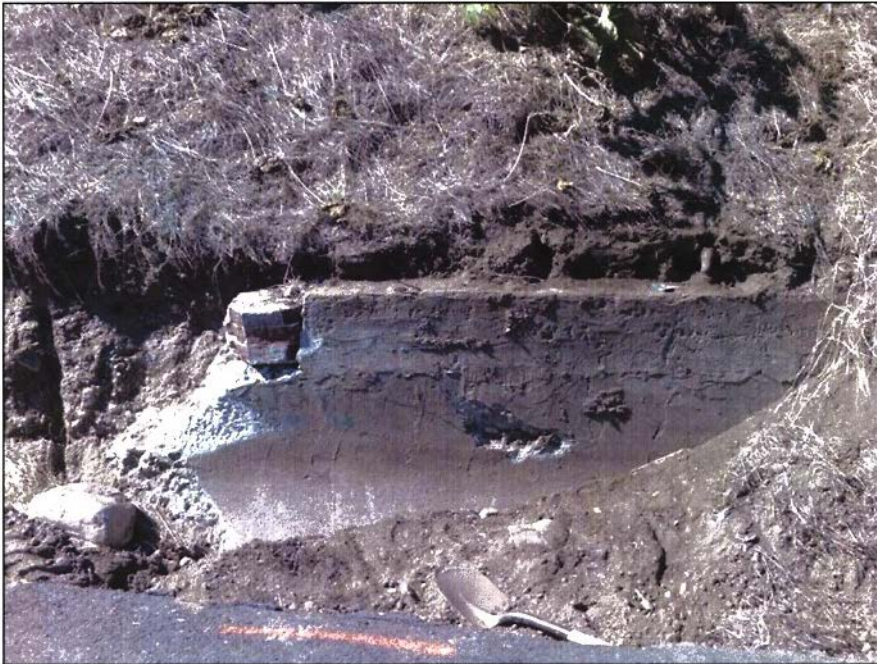
Feature 1 measured 1.7 meters high and 2.4 meters long (Figure 2.8). The south end of the top edge was comprised of 8 bricks mortared together into 2 stacks and inset into the concrete with the long edge of the brick parallel to the surface of the wall (figure 2.9). After clearing the top of the cement portion of the wall of sediment it was discovered to consist of 8 bricks laid with the short end parallel to the surface of the wall (perpendicular to the previous bricks) and skinned with cement (Figure 2.10). Only from the top view are the mortar lines between the bricks visible. In addition, a badly decomposed piece of wood about 3.75 inches wide, 1 inch deep, and 24 inches long was found on top of these bricks (Figure 2.10).

Figure 2.9. Feature 1 after rim cleanup, view to west

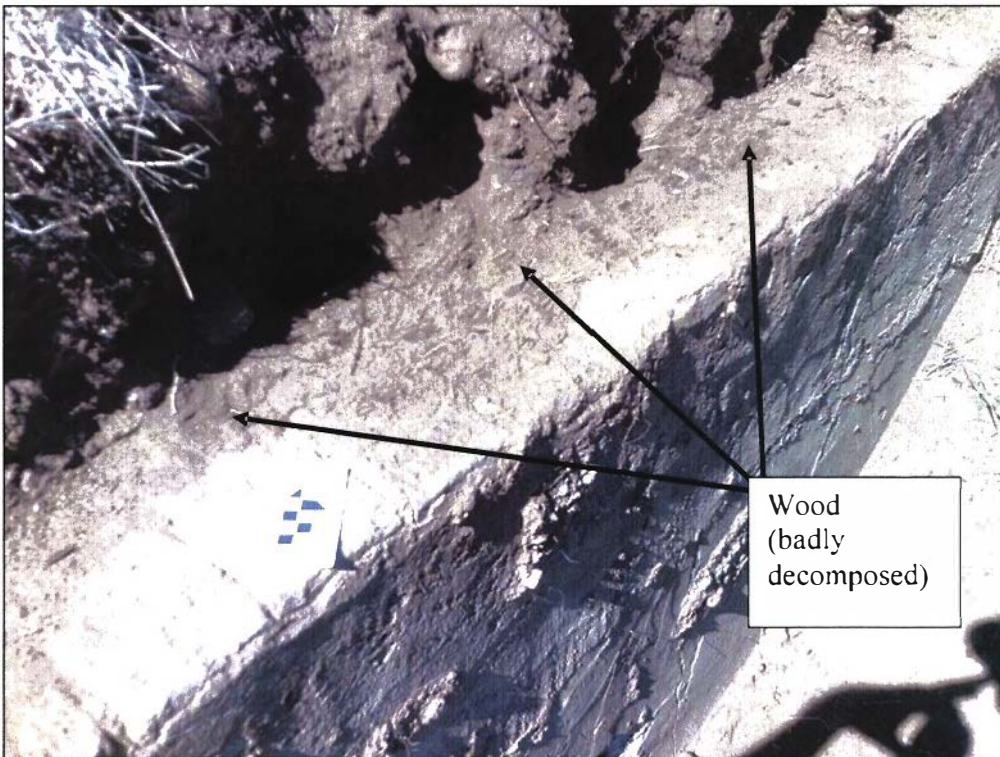
Figure 2.10. Feature 1 rim closeup, view to north

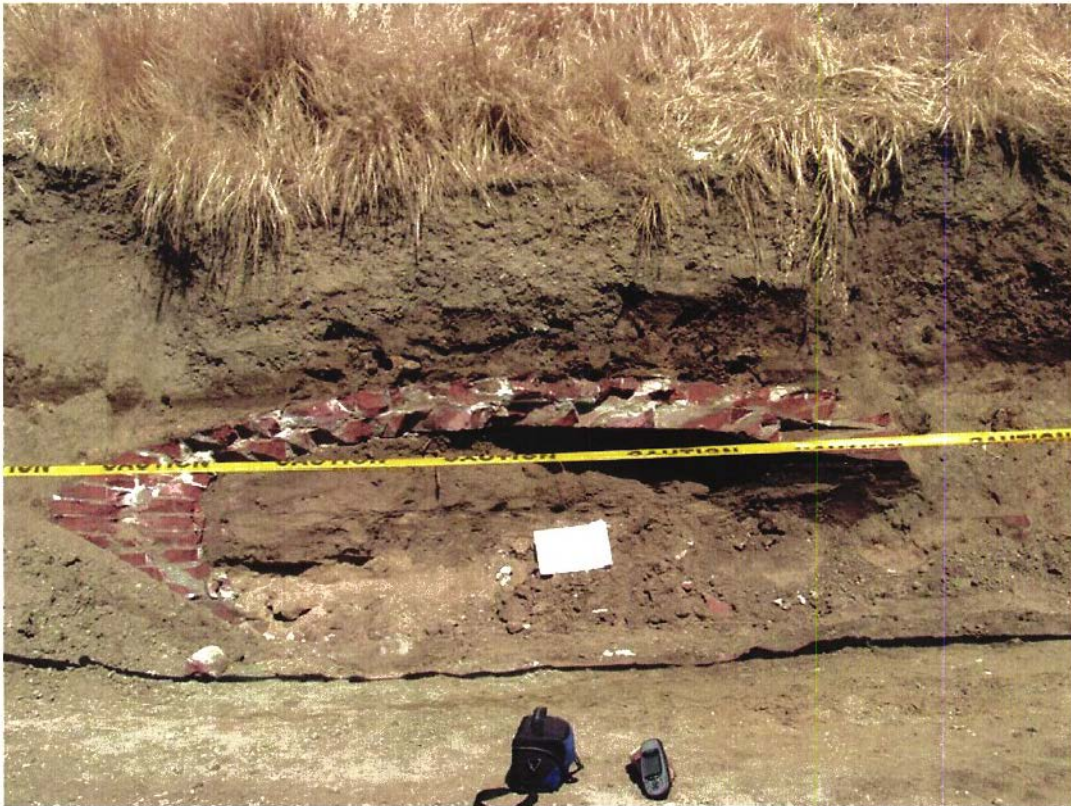
Feature 2 consisted of an oblique cross-section of brick conduit of two courses of brick (Figure 2.11, 2.12). The current project activities grazed the surface of these bricks which has been impacted by historic construction activities. Note brick “shavings” in dirt below feature. It was located at the base of the hillside and was completely filled with sediment.

Figure 2.11. Feature 2, view to west, as first observed

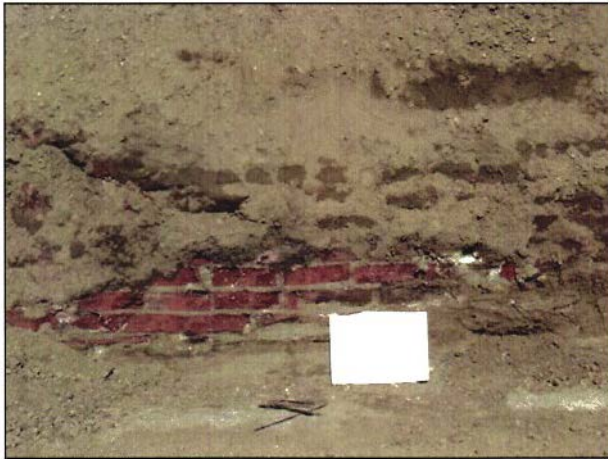
Feature 3, when first observed (Figure 2.13) consisted of a panel of mortared brick. Cogstone archaeologists directed a backhoe to remove the sediment over and behind about 1.5 meters of the feature which revealed an intact tube of brick conduit (Figure 2.14, 2.15).

**Figure 2.13. Feature 3 as first observed, view to west**

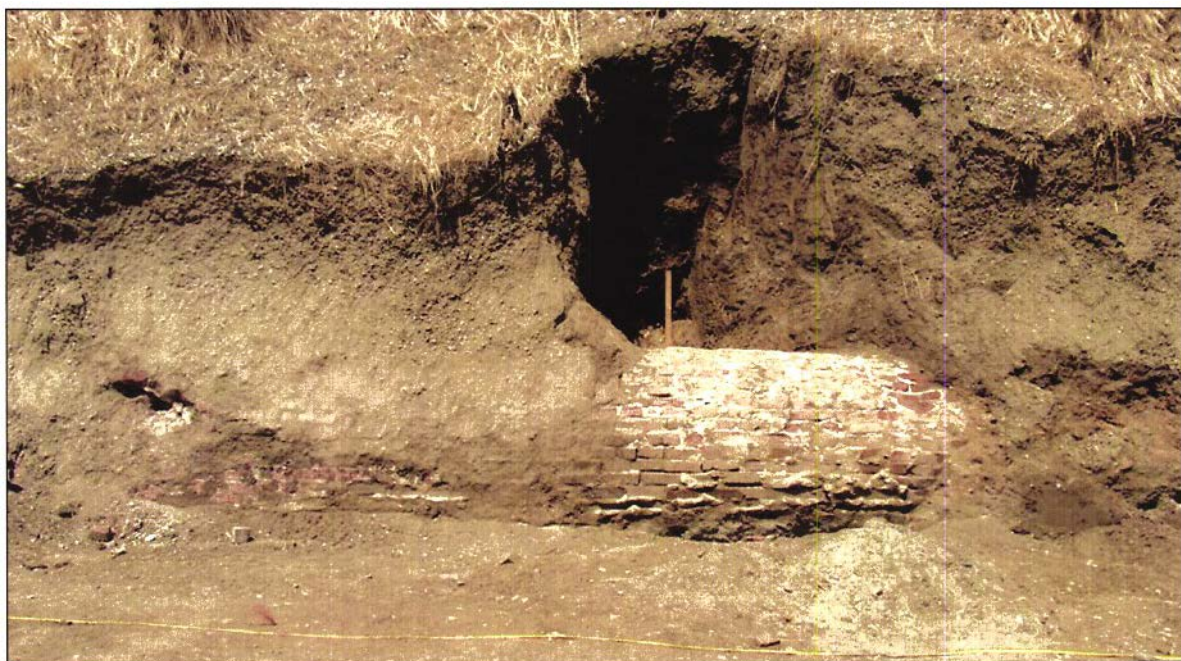
**Figure 2.14. Feature 3 after initial sediment removal, view to west**

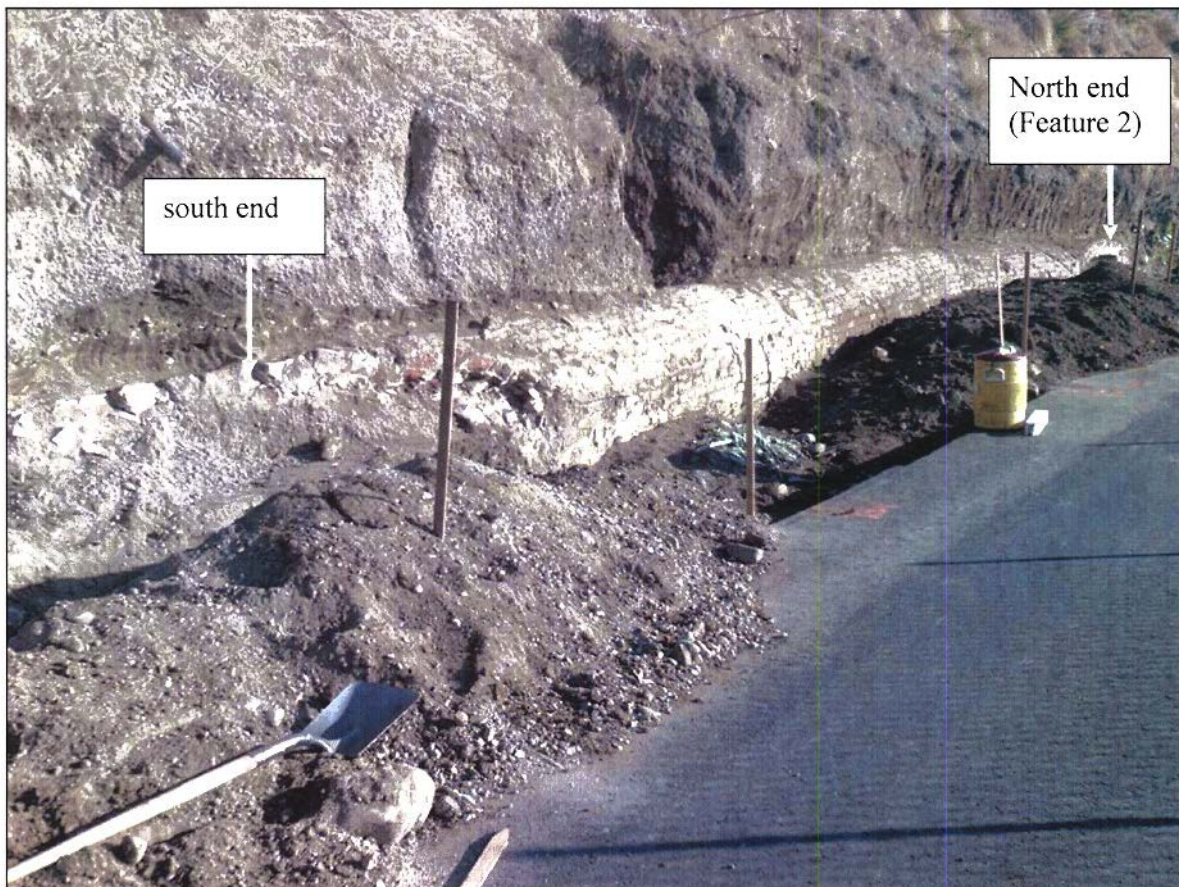
Further exploration eventually revealed that Features 2 and 3 were continuous with one another and had a total length of about 75 feet (Figure 2.16). Both the north (Feature 2) and south end of the tube of brick conduit had been obliquely impacted in the past (Figure 2.17). Historic iron pipe was associated with the cut southern end of the brick conduit.

**Figure 2.16. Zanja Madre segment of 75 feet, Features 2 & 3, view to northwest**

This large segment of the Zanja Madre was built on a cradle of pale greenish gray, layered sand visible at the base. This distinct sand is the native sand of the Los Angeles River and was found one of many flood plain elements the Zanja site shared with the neighboring Los Angeles State Historic Park (revealed as it was graded; J. Newland, personal communication, 2006).

The brick conduit segment represented by the conjoined Features 2 and 3 measured 63 feet in length across the top and 90 feet in length across the bottom from one obliquely cut point to the other. These “tails” of bottom-only brick conduit were carefully cut and removed as part of the process of building the retaining wall to protect the Zanja Madre. The bricks have been stockpiled in Midway Yard for potential future repairs of the Zanja Madre. Testing of brick and mortar by professional conservators to determine their constituents and provide recommendations to assist with preservation of the Zanja Madre were performed on samples from the “tails” taken on October 10, 2005. The conservators recommended a retaining wall to protect the Zanja Madre from landslides, an engineered drainage plan to prevent water pooling which might damage the bricks or mortar and no plants within six feet of the brick conduit for similar reason (Appendix B).

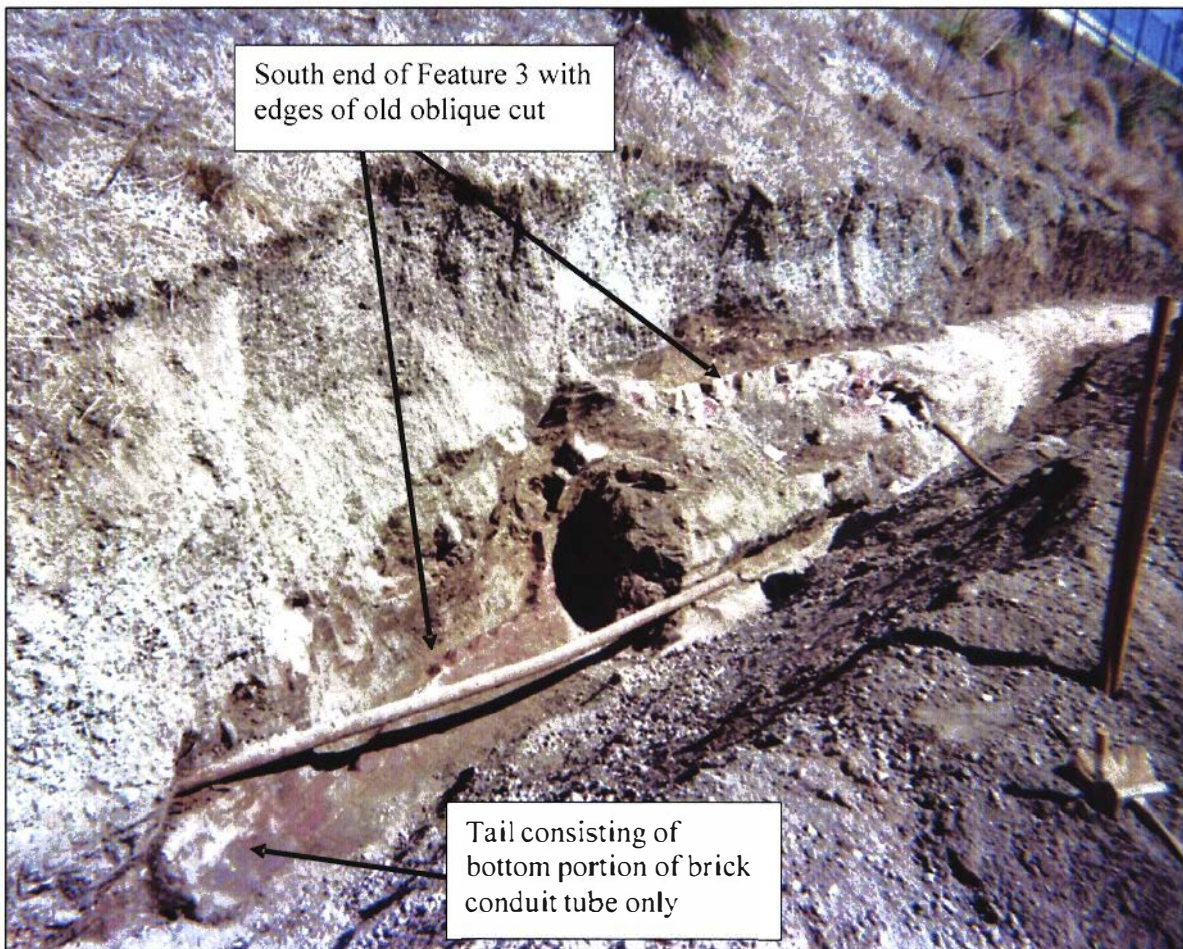
At both obliquely cut ends (Features 2 & 3), excavation of sediment revealed “tails” consisting of the bottom portion of the brick conduit only (Figure 2.17). Thus previous impacts were related to construction of specific elements, not destruction of the Zanja Madre.

**Figure 2.17. South end of Feature 3 showing old oblique cut and historic iron pipe, view to northwest**

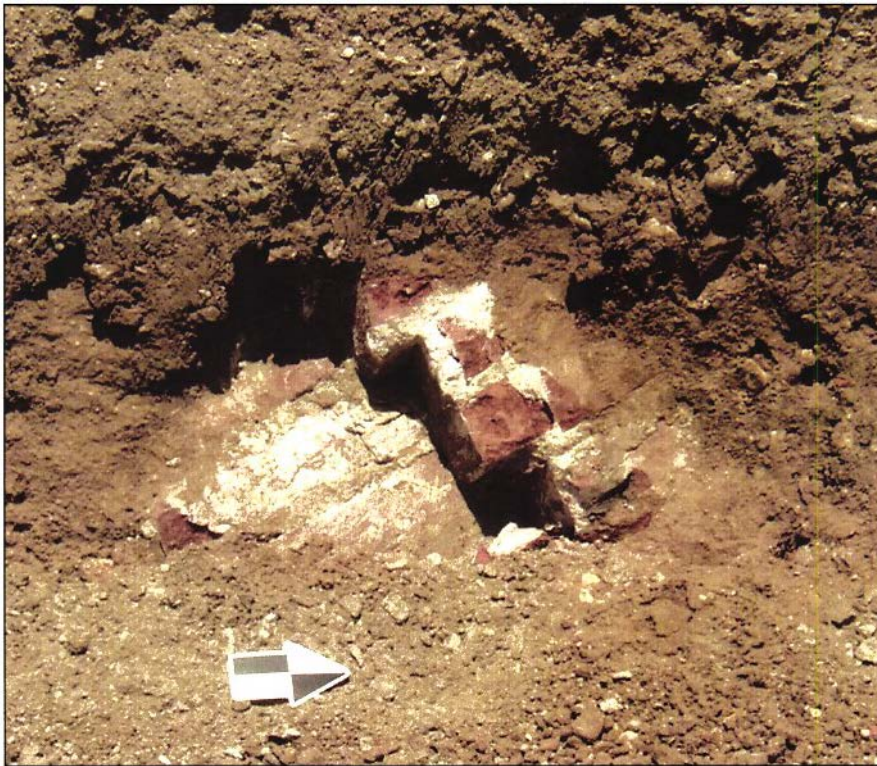
Feature 5, as first observed south of Feature 3, consisted of several bricks joined by mortar sitting at an oblique angle as though slumped (Figure 2.18). Exploration revealed that this was a small piece of brick conduit Zanja Madre, consisting of about 9 partial bricks, displaced during historic construction activities.

**Figure 2.18. Feature 5 as first observed, view to west**

Feature 5 was determined to be a small block of brick conduit that had been displaced and isolated from its original context by past construction activities. The block was comprised of damaged, partial bricks and was discarded.

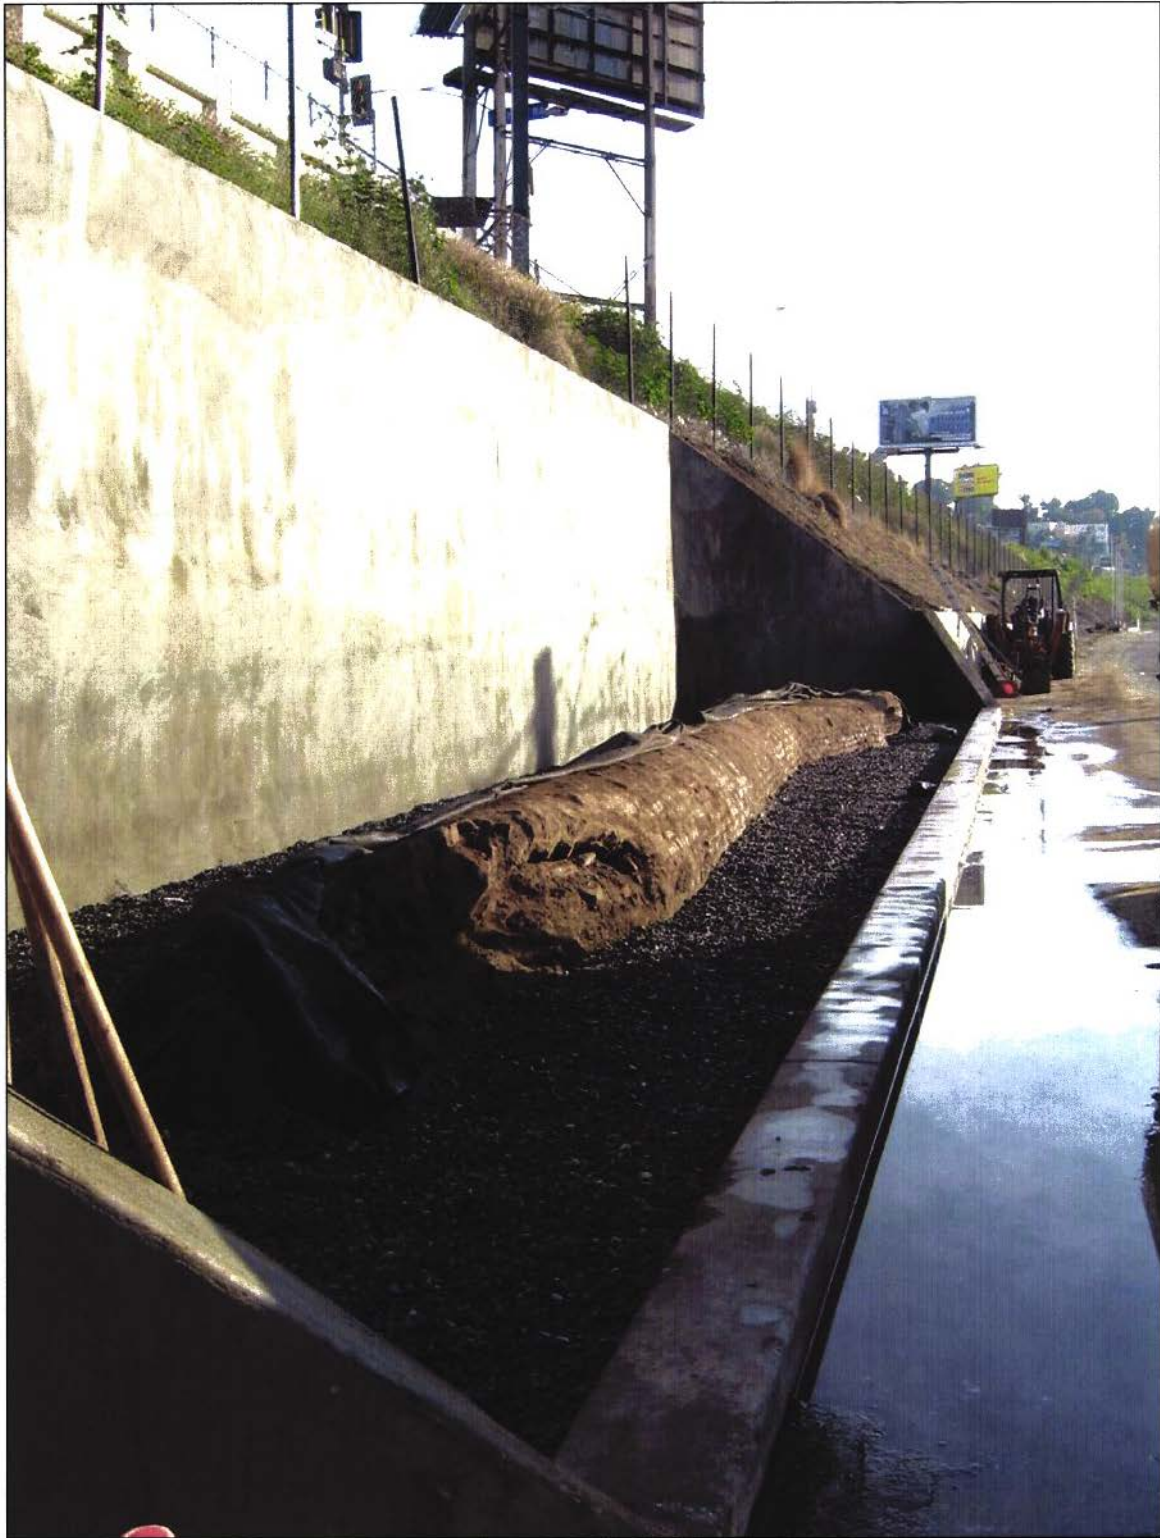
**Figure 2.20. Zanja Madre with retaining wall & gravel, view to north**

The remaining preserved segment of the Zanja Madre is 75 feet (23 meters) long (Figure 2.19). During construction of the retaining wall the Zanja Madre was entirely covered with black plastic and sediment, outlined with flagging tape and monitored by Cogstone archaeologists for protection of the resource. After completion of the retaining wall, the sediment was removed under the supervision of the archaeologists and gravel installed around the base for drainage (Figure 2.20). Sand and decorative boulders were then added to finish the project in April of 2006 (Figure 2.21).

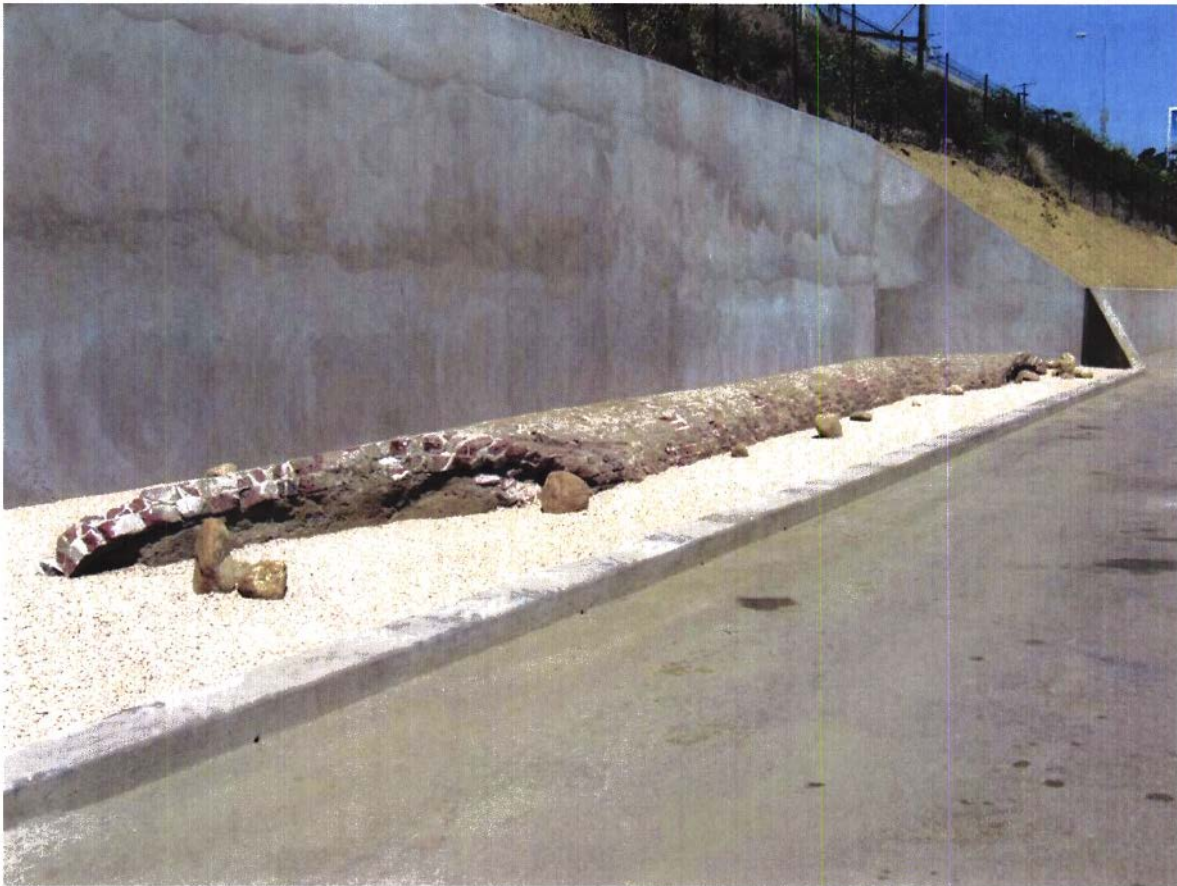
**Figure 2.21. Zanja Madre final appearance, view to northwest**

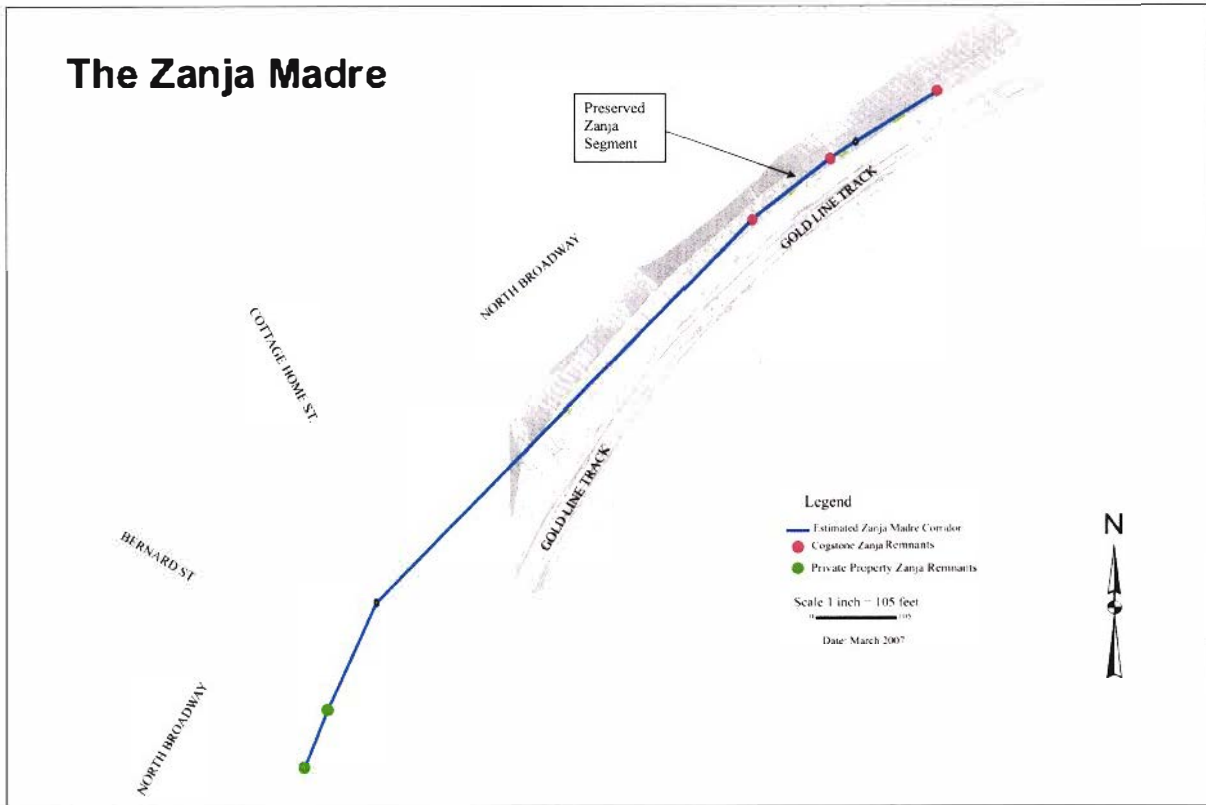
The first Zanja Madre segment found on adjoining private property in 2000 is only about 5 feet long. However, the segments discovered to the south by Cogstone archaeologists in 2004 appear to represent another intact segment of brick conduit of about the same length as the one preserved by Metro on their property (Figure 2.22).

Figure 2.22. Zanja Madre segments below Broadway

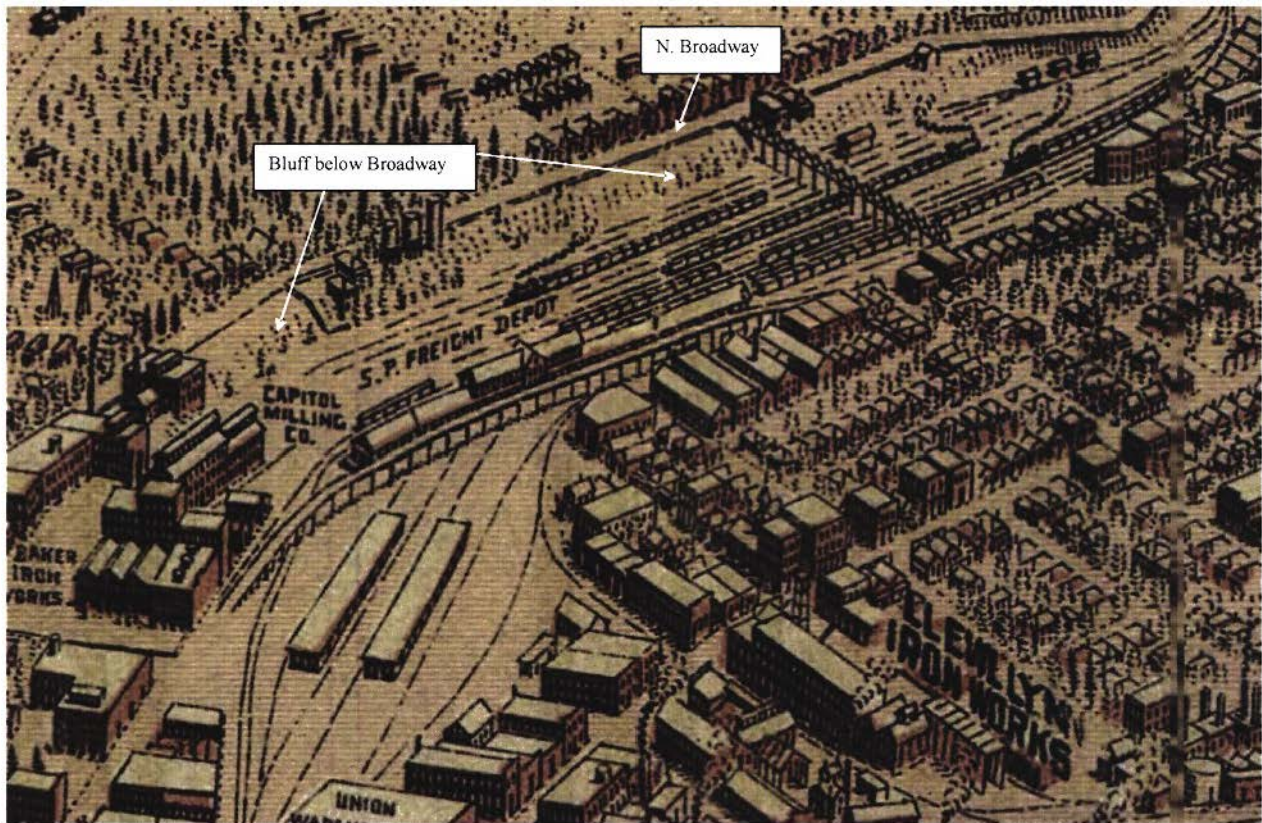
A 1909 map (Gates) shows that the roundhouse present in 1894 has been removed, along with the other maintenance buildings (Figure 3.8). Several small building appear at the base of the bluff between Solano Ave. and Bishops Rd. that also appear likely to have damaged the Zanja Madre.

Figure 3.8. 1909 map of River Station Yard looking north (Gates 1909)

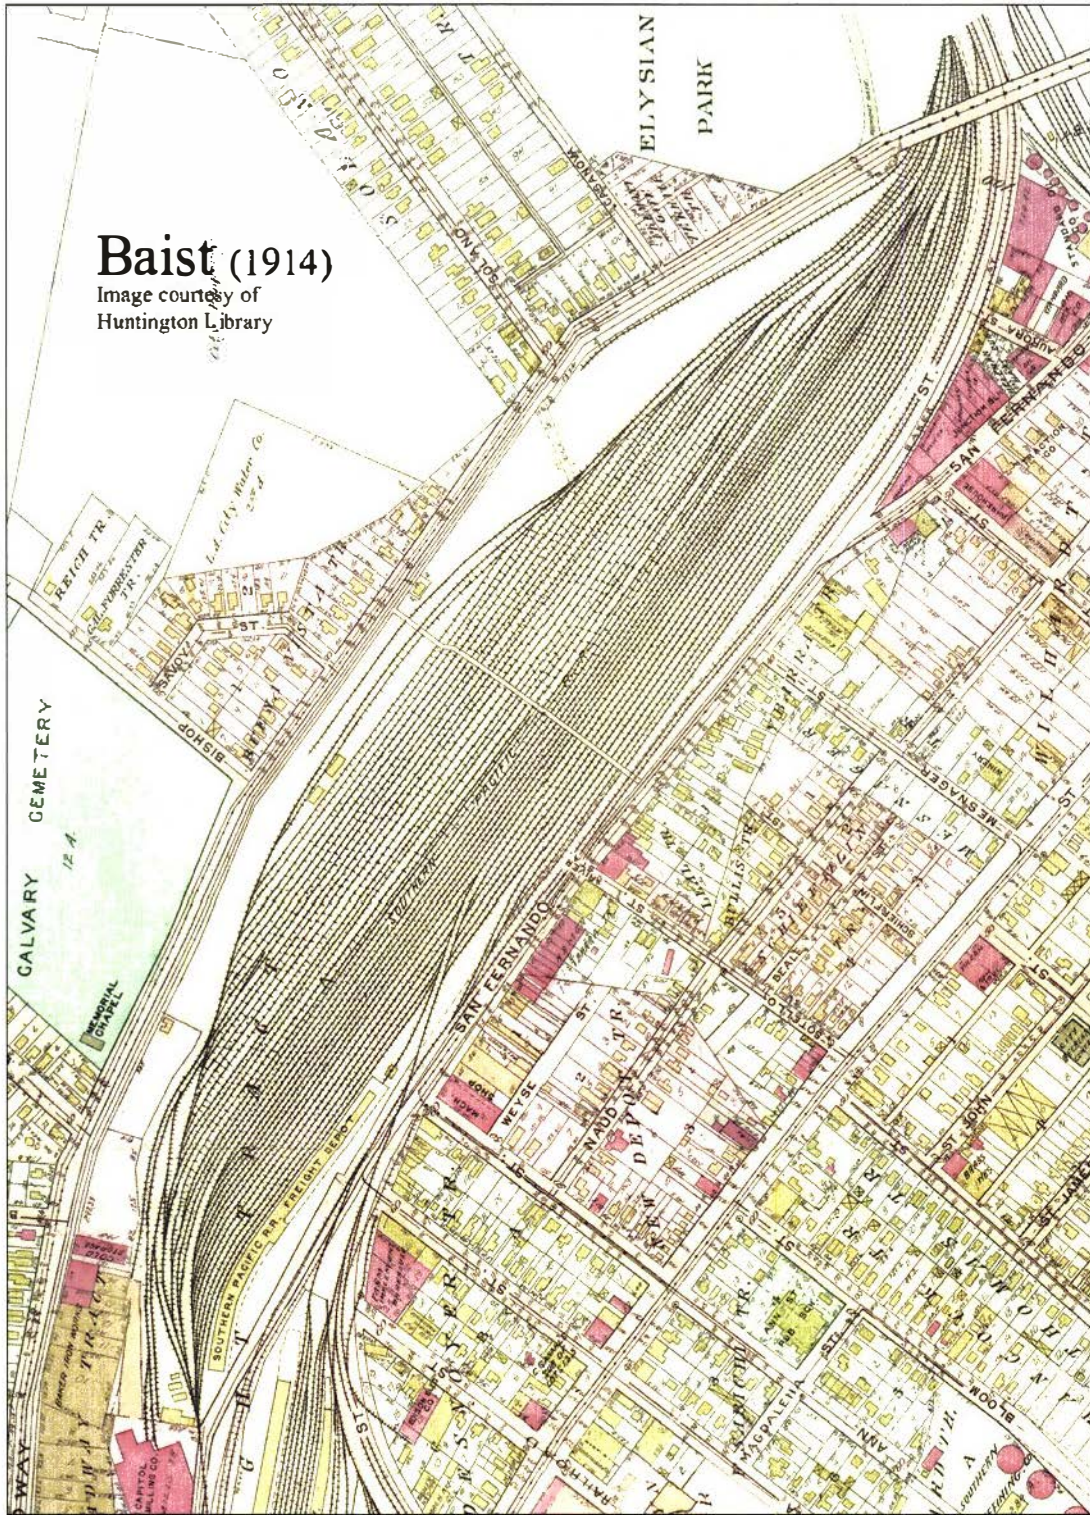
This is accentuated by 1914 where a new spur track appears overlying the position of the brick conduit Zanja Madre north of Bishops Rd. (Figure 3.9; Baist 1914).

Figure 3.9. 1914 map of River Station Yard looking northeast
