Determination of Eligibility for Section 106 and CEQA Initial Study  
Cultural Resources Section for Metro Division 2 Bus Repair Garage

#### **Determination of Eligibility for Section 106 and CEQA Initial Study, Cultural Resources Section for Metro Division 2, Bus Repair Garage: An Exploration of the Potential Historic Nature of Division 2 Should the Agency Contemplate Alterations to the Property in the Future.**

*A Survey Report of the LARy 16<sup>th</sup> Street Bus Repair Garage and a Brief Reconnaissance and History of the Site*

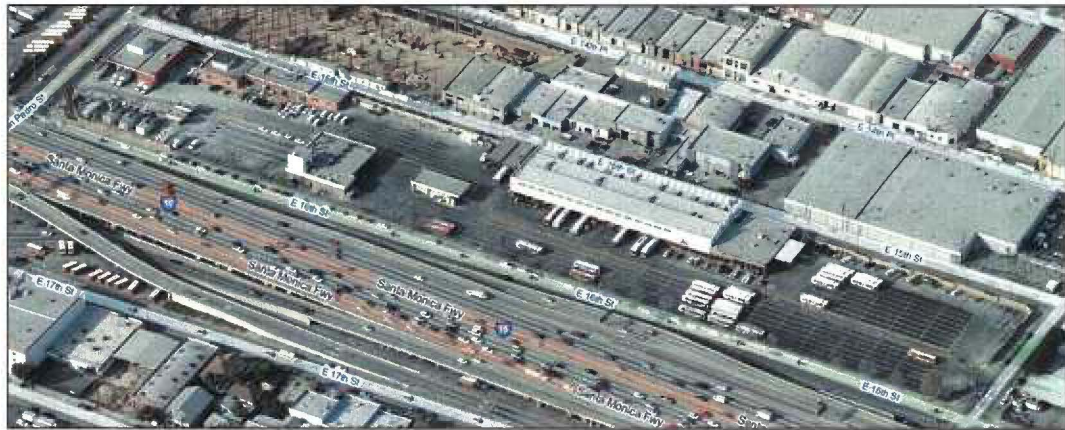
**Figure 1. Satellite Photo: Division 2 in 2006 or 2007<sup>4</sup>**

The site is bounded by San Pedro Street on the west, Griffith Avenue on the east, E. 15<sup>th</sup> Street on the north, and E. 16<sup>th</sup> Street on the south (see Figure 1).

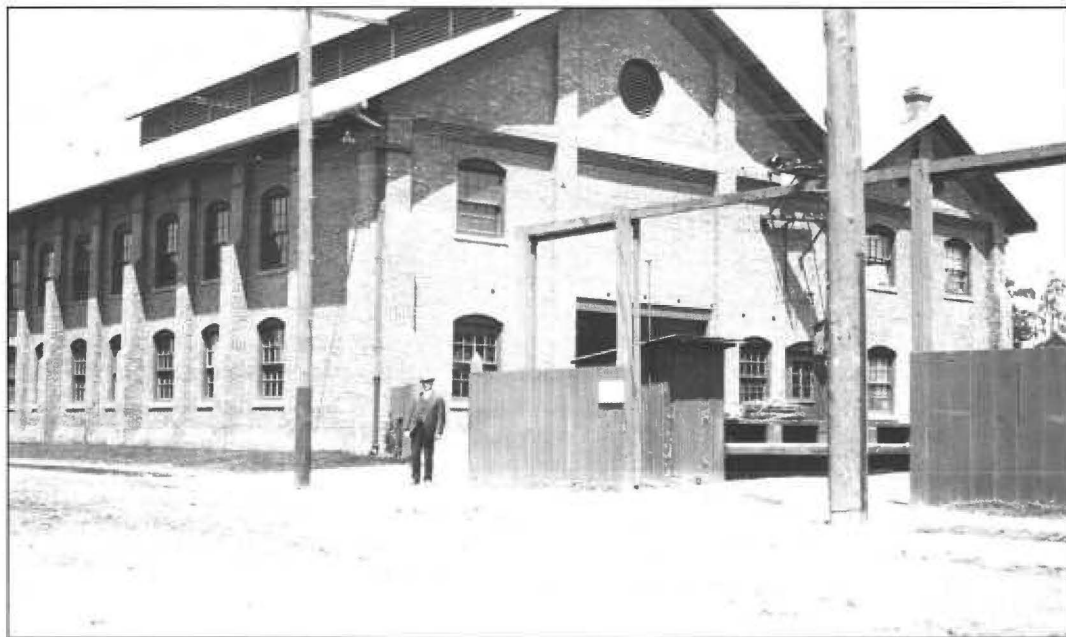
Figure 5. LARy 16<sup>th</sup> Street Substation, demolished by RTD in the 1970s<sup>12</sup>

A 1912 LARy company site plan (Figure 4) shows a substantial number of buildings to have been built fronting 16<sup>th</sup> Street across the street from the horse barn. The most important building on the site was the large brick 16<sup>th</sup> Street substation, built at a cost of \$20,790 and equipped with \$96,180 worth of substation equipment to convert high-voltage AC power purchased from Pacific Light & Power to 600v DC used by the electric trolleys (see Figure 5).<sup>10</sup>

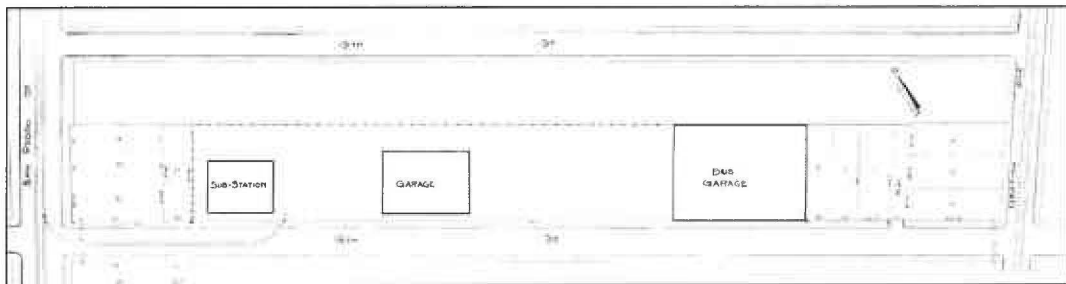
**Figure 6. LARy site plan (c. 1923) was found among legal papers in the Metro Library. It shows the new bus garage, an automotive garage, the substation, streetcar tracks on San Pedro and Griffith, as well a section of non-revenue track on E. 16<sup>th</sup> Street<sup>15</sup>**

On October 10, 1923, LARy opened the 16<sup>th</sup> Street garage, and on January 29, 1929, the 16<sup>th</sup> Street garage was officially designated a coach division (see Figure 6).<sup>14</sup> On July 31, 1932, LARy's Rail Division 2 at 54<sup>th</sup> and Avalon Streets closed, and soon after, company officials renamed the 16<sup>th</sup> Street garage "Division 2."

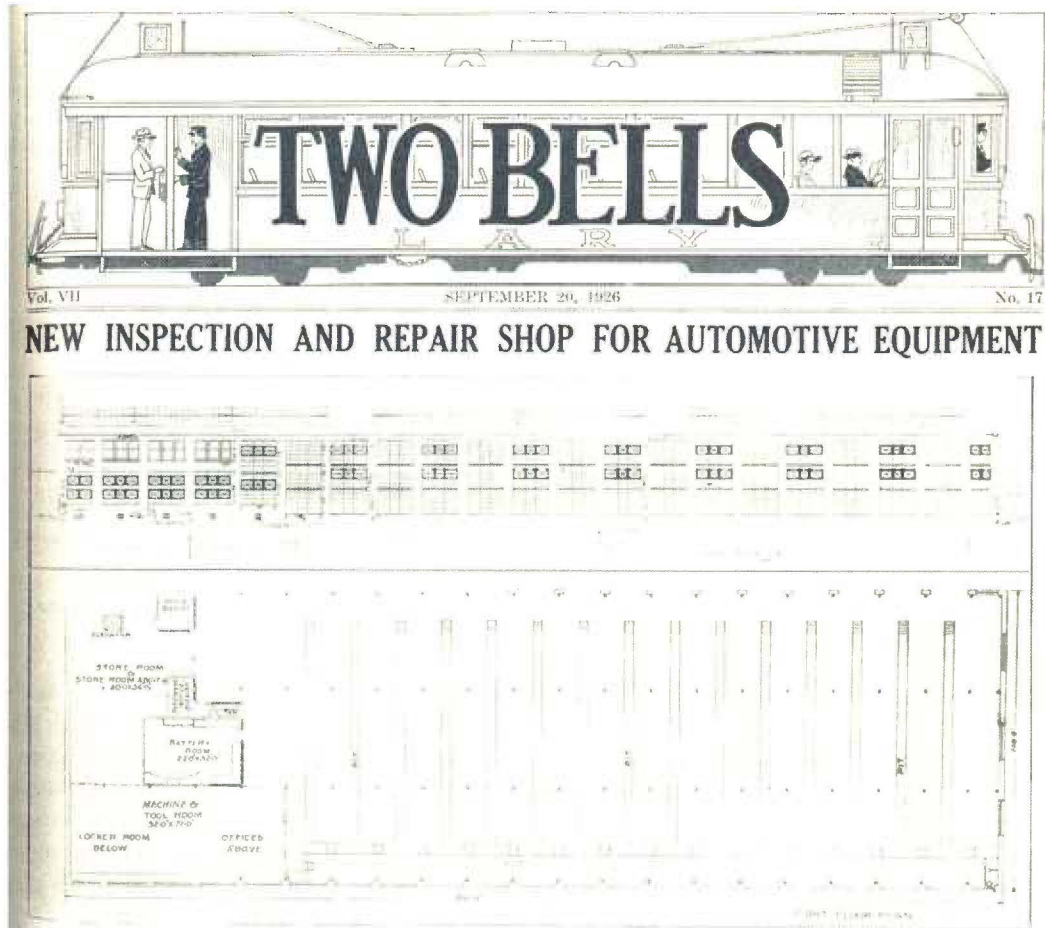
Figure 7. *Two Bells* Describes Features of the New Shop

The September 20, 1926, issue of the LARY magazine *Two Bells* featured the new repair shop on its cover.

Above: North elevation of building to be erected on the 15th St. frontage of the L. A. Railway Property known as the Sixteenth Street Yard

The Los Angeles Railway Company has just given a contract to the Willard Bond Company for the erection of a modern brick, reinforced concrete and steel structure to be used as a general bus, truck and auto inspection and repair shop.

*The Los Angeles Railway Company has just given a contract to the Willard Brent Company for the erection of a modern, brick, reinforced concrete and steel structure to be used as a general bus, truck, and auto inspection and repair shop.*

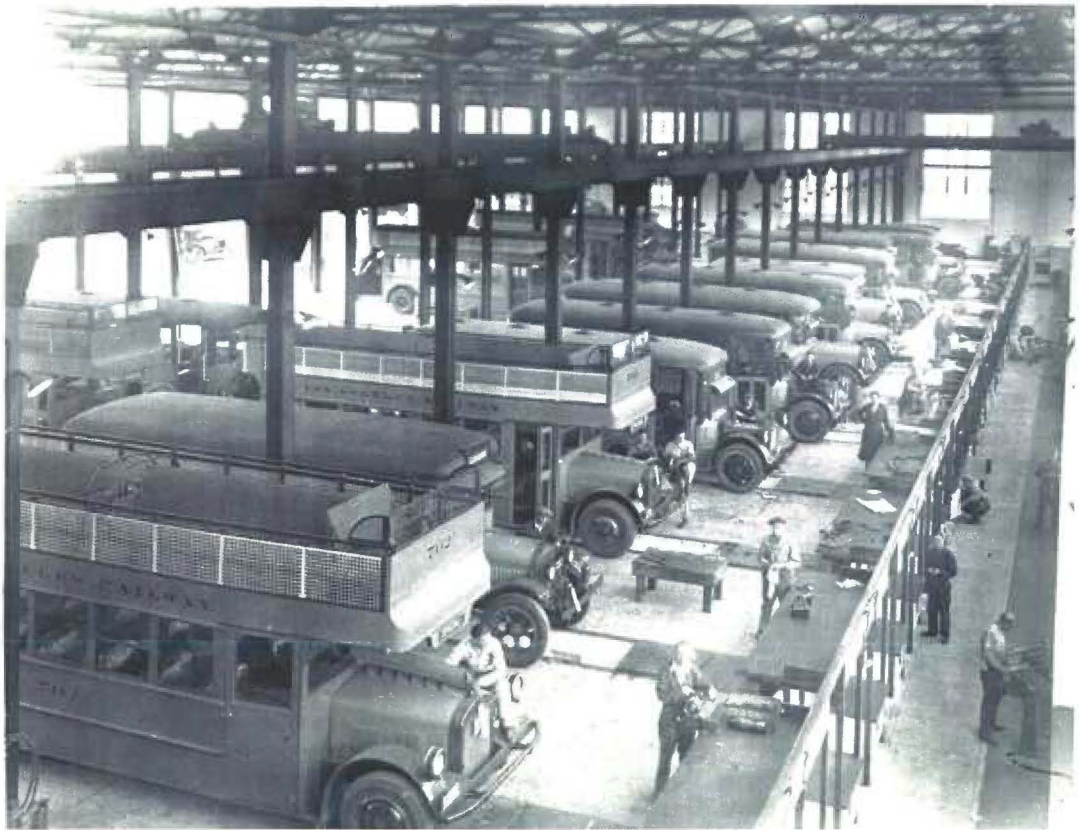
Figure 8. Inside the Bus Maintenance Garage Soon after the Building Was Opened<sup>17</sup>

*The stores department will have quarters both on the ground and the mezzanine floors. The two floors will be connected by a hydraulic elevator. The machine shop and battery room are to be located immediately below the mezzanine floor.*

*Repair facilities are contained in the large fire-proof repair shop built in 1927. Nearly all of the first floor area is occupied by a series of pits for repair work, served by overhead cranes, and is a most modern layout in every respect. The remainder of the first floor is occupied partly by the machine shop for unit overhaul (motors, transmissions, differential carriers, etc.) and partly by a storeroom. On the mezzanine floor, the sub-store of the store department handling coach parts is located together with the general foreman's office. The second floor provides space for the superintendent of automotive equipment and his staff. Part of the storeroom also occupies this floor.*

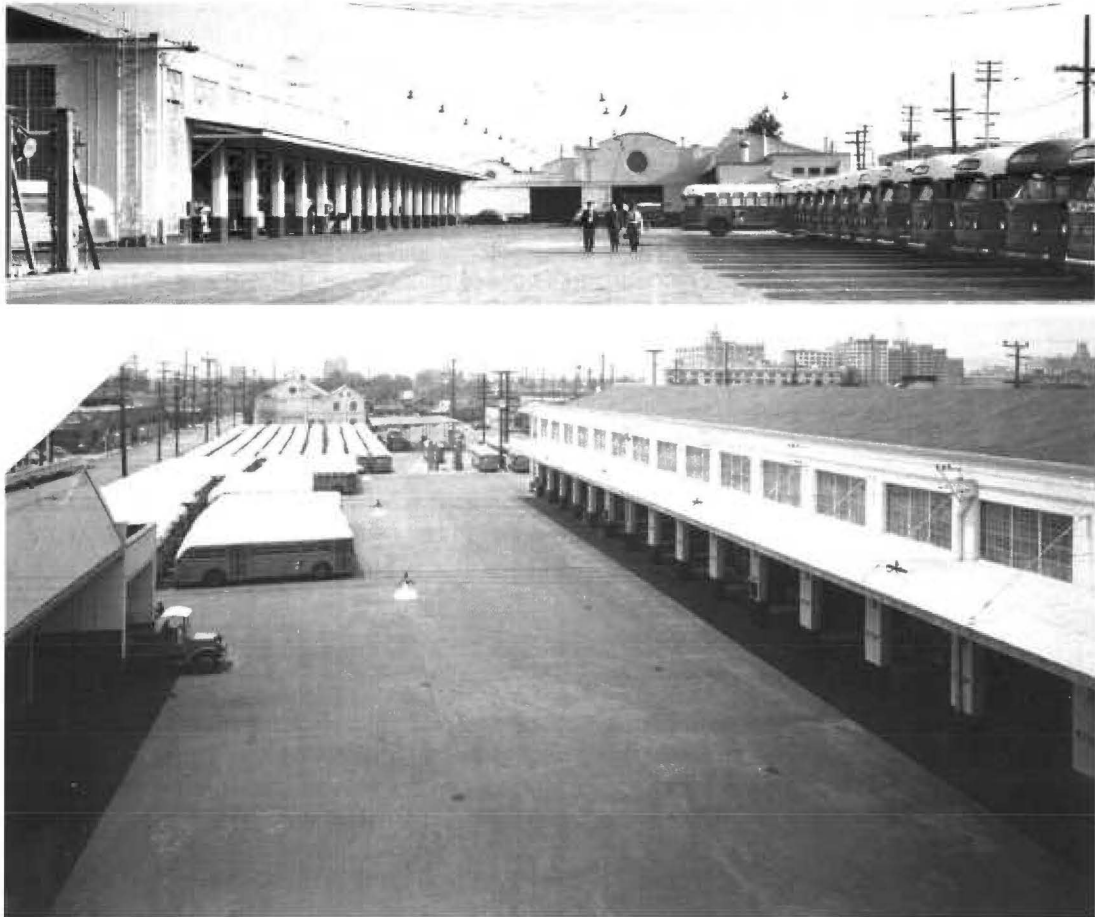
**Figure 11. Two Views of Division 2 and the Bus Repair Garage in 1945<sup>23</sup>**

The only alterations to have occurred to Division 2 since the Southern California Rapid Transit District became the Los Angeles County Metropolitan Transportation Authority have to do with light building maintenance. Two buildings on-site meet the 50-year age threshold to be potentially eligible as historic resources: the 1926 bus repair garage and the 1935 automotive repair garage (see Figure 10). It will be approximately 10 years before the next-oldest buildings, the dispatcher's building and the money counting building, will meet this same criterion. It is possible to make exceptions to the 50-year rule under certain circumstances.

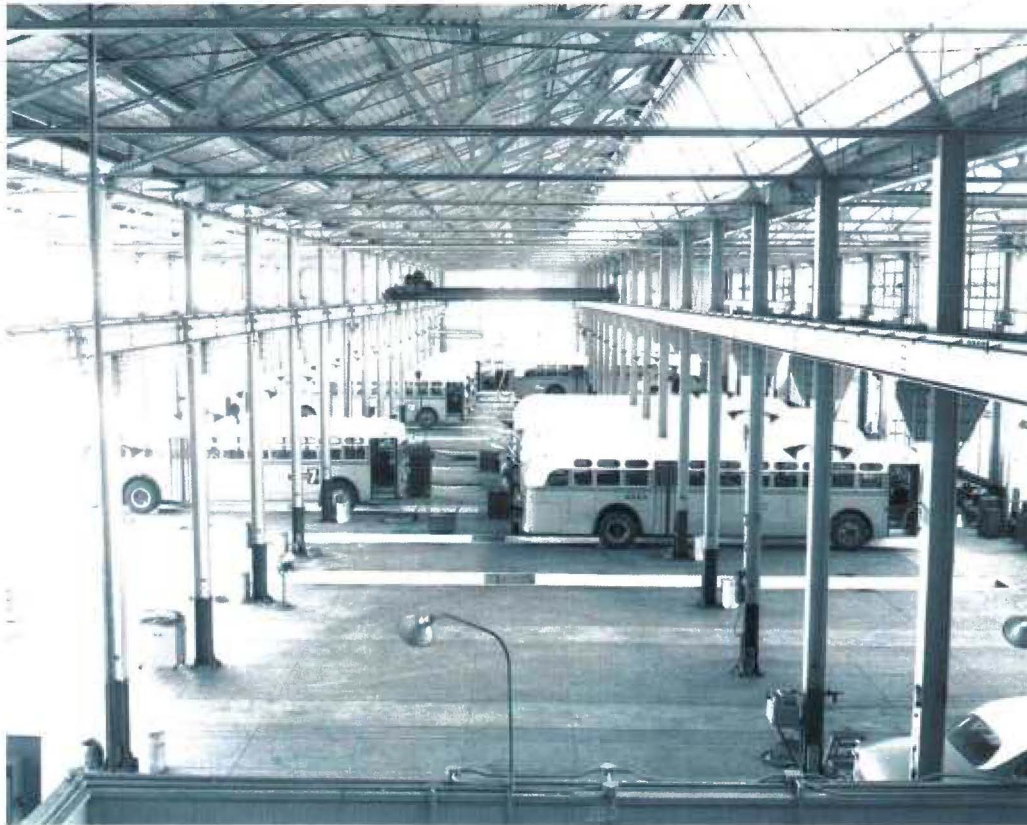
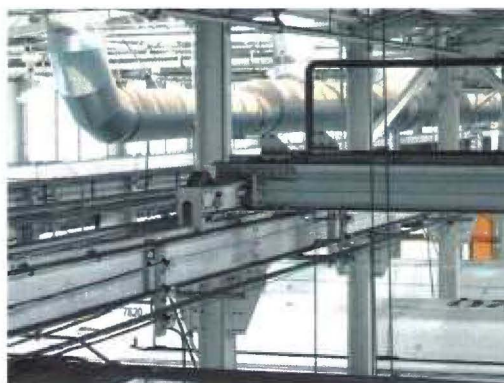
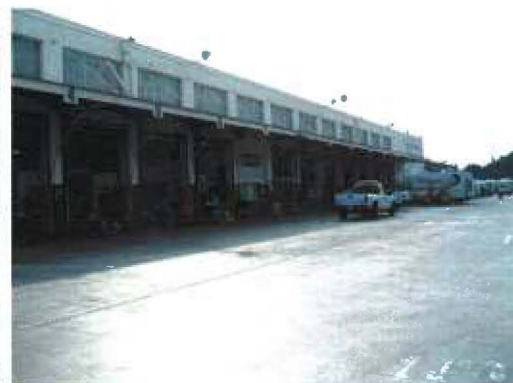
Figure 12. Inside the bus repair garage in the 1950s, showing how little modified it was from new; it remains largely unchanged today<sup>24</sup>

Designed in-house by the LARy engineering department, the bus repair garage contains a number of innovative features unique to this use. The building is of fireproof concrete construction; even the roof is made of cast-in-place concrete. As a testament to the designers, the transit agency still repairs its buses in the building, and very few modifications have been made after 80 years of use.

- unadorned board-formed concrete, exposed steel and brick walls, and structure;
- exposed purpose-designed steel truss roof system with concrete ceilings, north-facing monitor windows, and natural daylighting;
- in-floor repair pits with built-in lighting and niches for tools (some pits have been altered);
- three-level arrangement of locker rooms, offices, and parts depot with elevator and original stairs and railings; and
- built-in gantry cranes running the length of the main space.

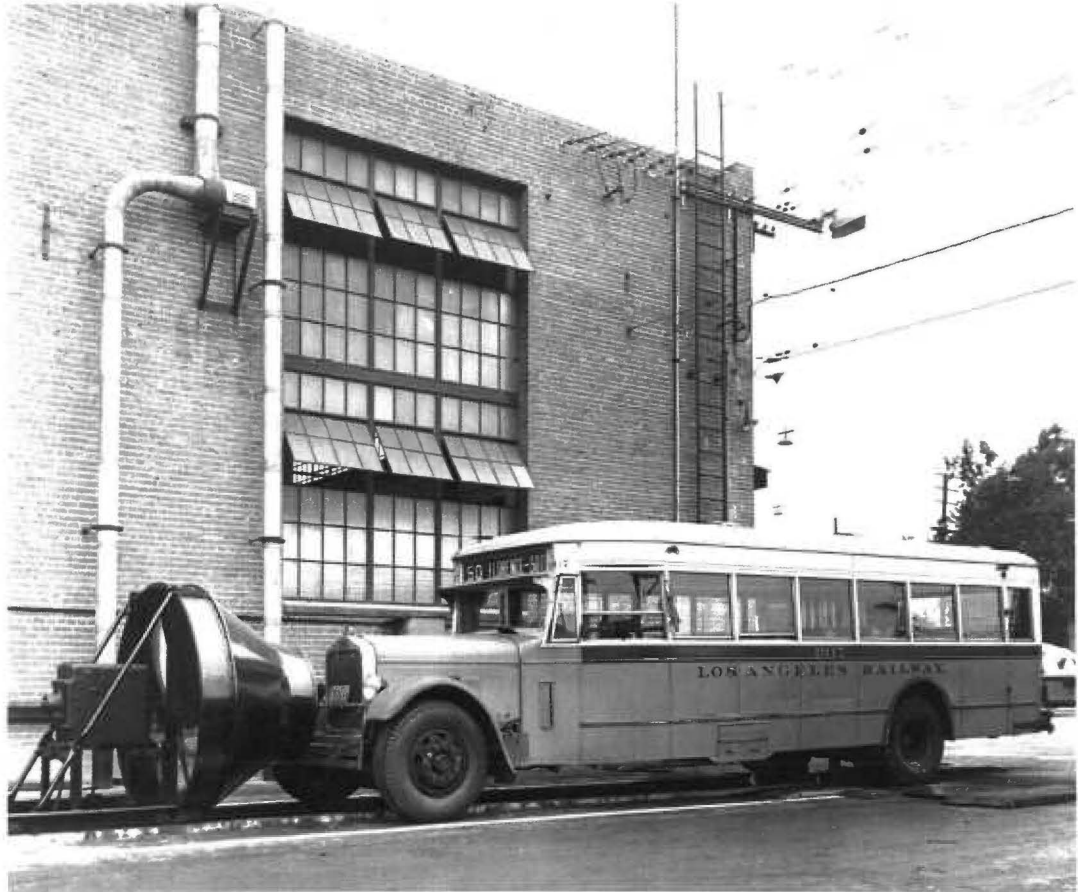
Figure 13. LARy was very proud of this bus dynamometer, taking many photos of the installation. This view from the 1930s shows clearly the west window arrangement, which was filled in during the 1982 remodeling<sup>25</sup>

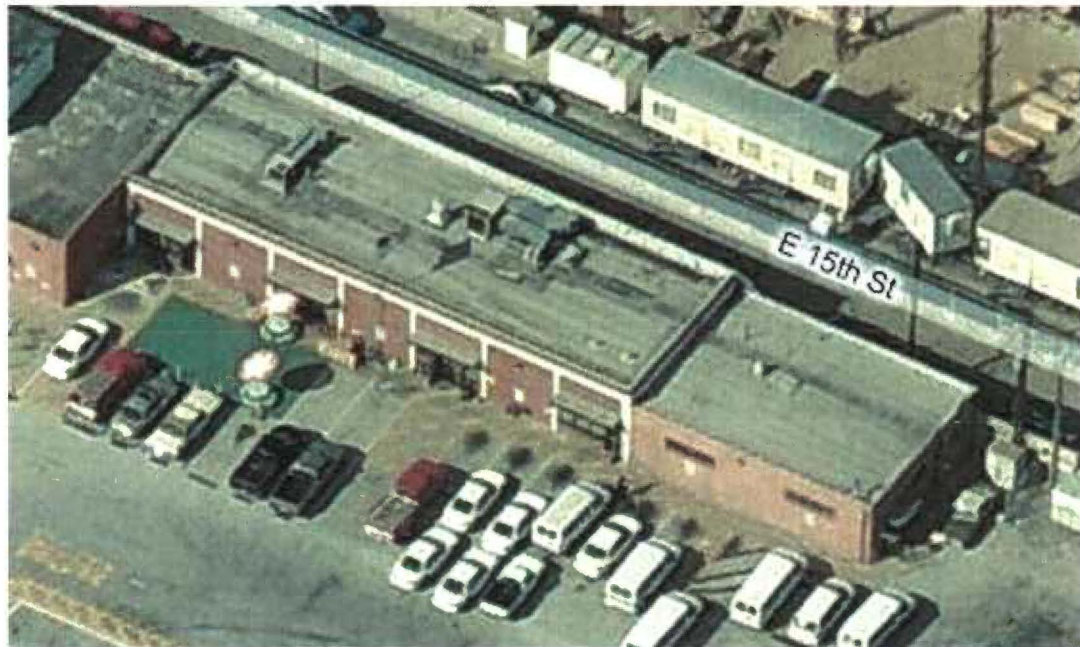
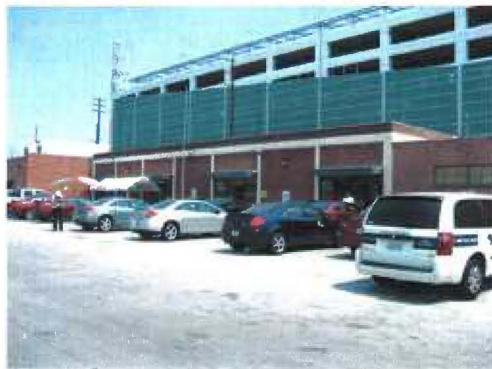
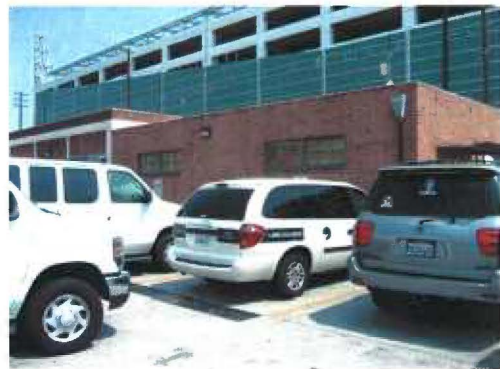
Figure 14. Automotive Garage/Metro Police Headquarters<sup>26</sup>

These two buildings are more than 50 years old but lack integrity of design and materials due to extensive interior and exterior alterations.

The LARy 16<sup>th</sup> Street bus repair garage appears to be the only historical resource remaining on the site. Two other buildings over 50 years of age have been found ineligible for listing at the national or state levels due to extensive interior and exterior alterations.
