SAN FERNANDO VALLEY EAST-WEST TRANSIT CORRIDOR

**DMJM-HARRIS AND
R. ALEMAN & ASSOCIATES, INC.,
SOUTH MIAMI-DADE BUSWAY SAFETY STUDY
FOR METRO-DADE TRANSIT, AUGUST 13, 2001**

SOUTH MIAMI-DADE BUSWAY SAFETY STUDY

FINAL REPORT

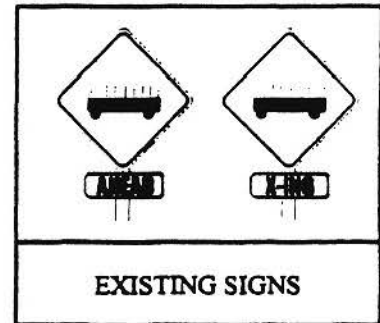
The typical signage on the cross-streets at the busway intersections include a Busway Crossing sign and a Busway Ahead Sign. The signs include a symbol representing the busway that is currently a non-standard design. The signs were installed with the approval of the Federal Highway Administration (FHWA) following a request submitted by the Florida Department of Transportation.

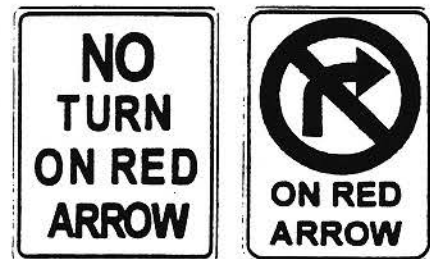
In the existing condition, the southbound right turn lane at the typical US 1/Busway intersection has three posted NO TURN ON RED signs. The existing signs are located: (1) at the entry point to the exclusive southbound right turn lane; (2) at the stop line for the exclusive southbound right turn movement and (3) on the mast arm facing the southbound right turn movement (see condition diagrams, Appendix A).

This countermeasure would involve replacing the existing NO TURN ON RED signs with either of the signs shown in caption. The sign using the international symbol would be preferred since it more directly addresses the right turn movement and it is symbolic. Use of the international symbol should improve the visual impact of the sign and promote wider understanding, given the multilingual Miami-Dade community.

2. Installation of NO RIGHT TURN ON RED ARROW signs for the southbound right turn movement on US 1. This countermeasure involves replacing the existing NO TURN ON RED signs with NO RIGHT TURN ON RED ARROW sign (international symbol recommended). This improvement is expected to clarify any misunderstanding with regards to the red arrow signal displays and reduce right turn on red violations. This recommendation is discussed in detail under Countermeasure # 17 on page 39 of the report.
