Canoga Transportation Corridor

Draft Environmental Impact Report

Hazardous Materials - Environmental Site Assessment

**PHASE I ENVIRONMENTAL SITE ASSESSMENT
NORTHERN/CANOGA EXTENSION OF THE METRO ORANGE LINE
LOS ANGELES COUNTY, CALIFORNIA**

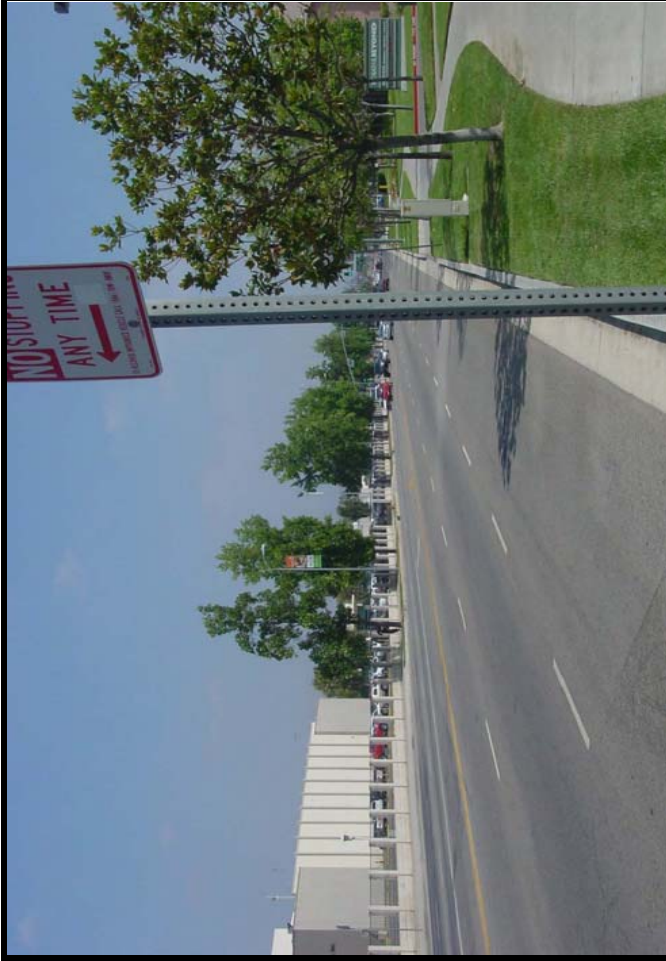
Photo 1:
View north on Canoga Avenue at intersection with Victory Boulevard. South of Project limits. Existing Rocketdyne facility on the left. Former Rocketdyne property now a commercial center on the right.

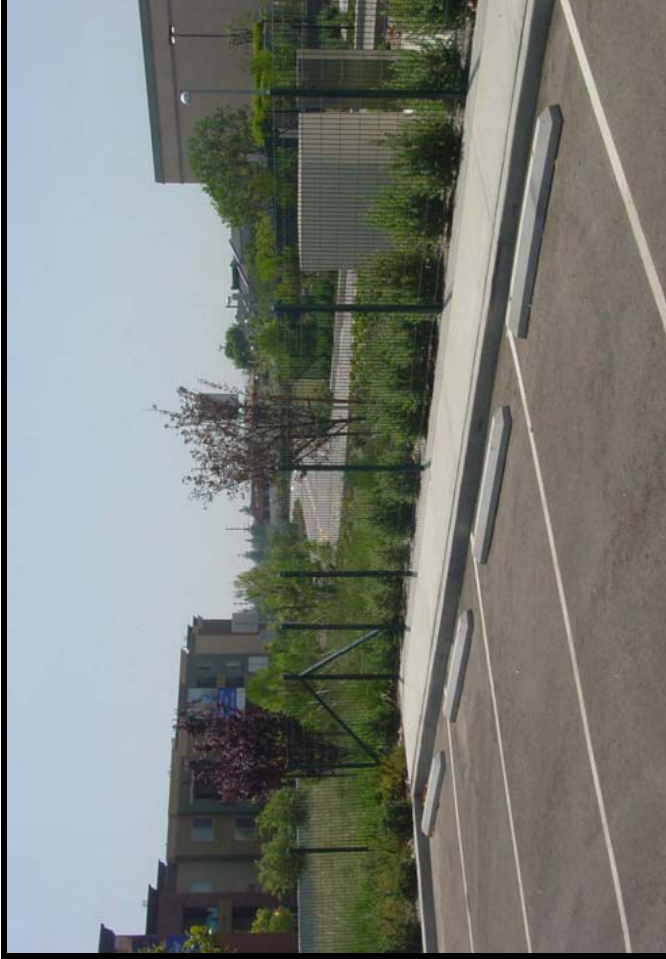
Photo 2:
View southeast at Metro Canoga Park and Ride facility north of intersection with Canoga Avenue and Victory Boulevard. Southern end of Project. New residential units east of former railroad right-of-way (ROW).

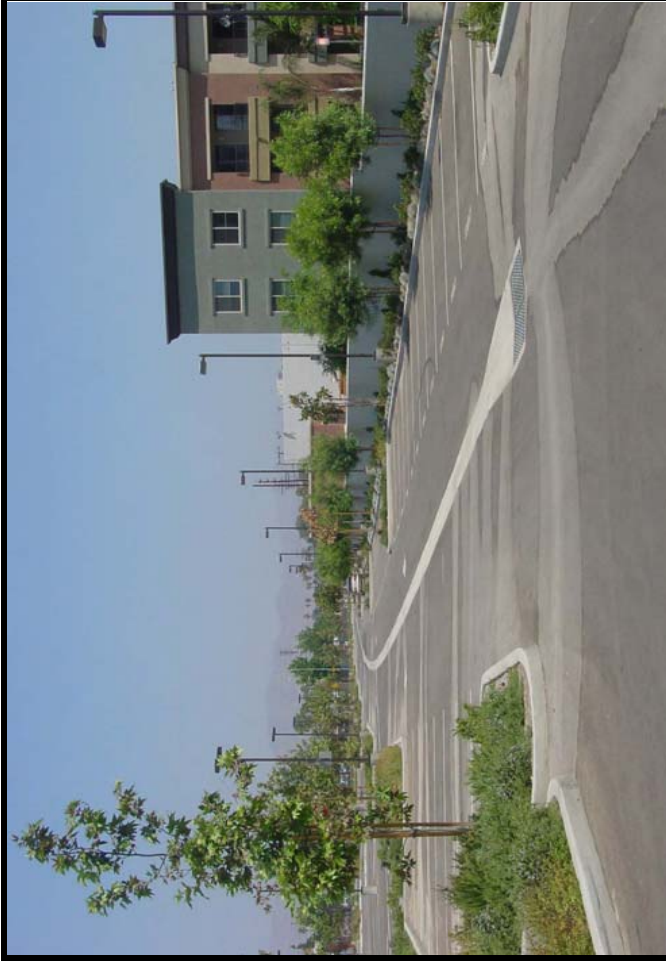
Photo 4:

View north at Metro Canoga Park and Ride facility north of intersection with Canoga Avenue and Victory Boulevard. Southern end of Project. Former railroad ROW paved with asphalt concrete (AC) and used as parking lot.

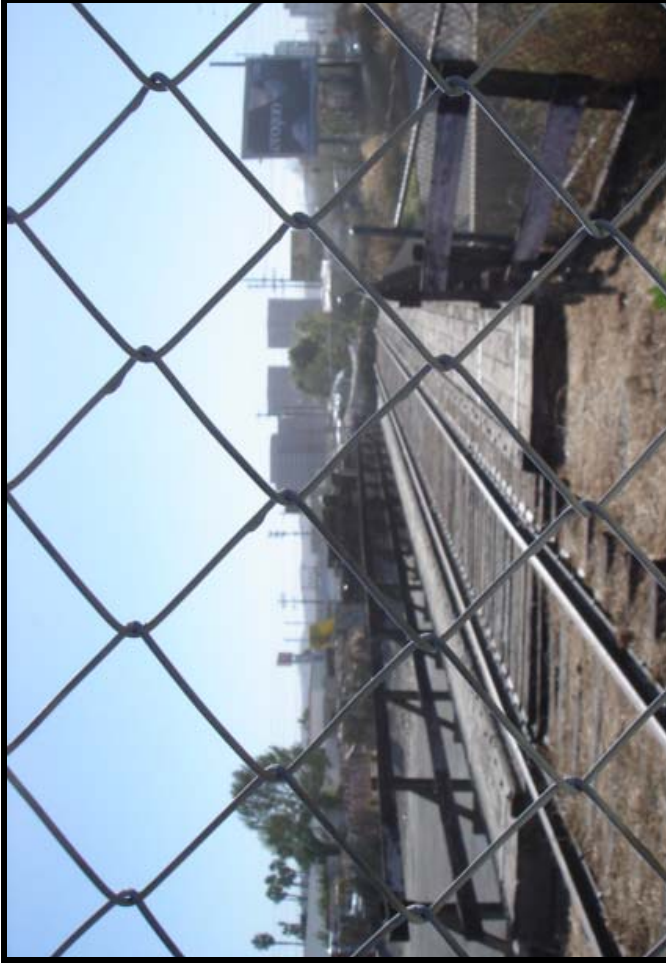
Photo 7:

View south on former railroad ROW at Santa Ana River. Existing railroad bridge to be replaced.

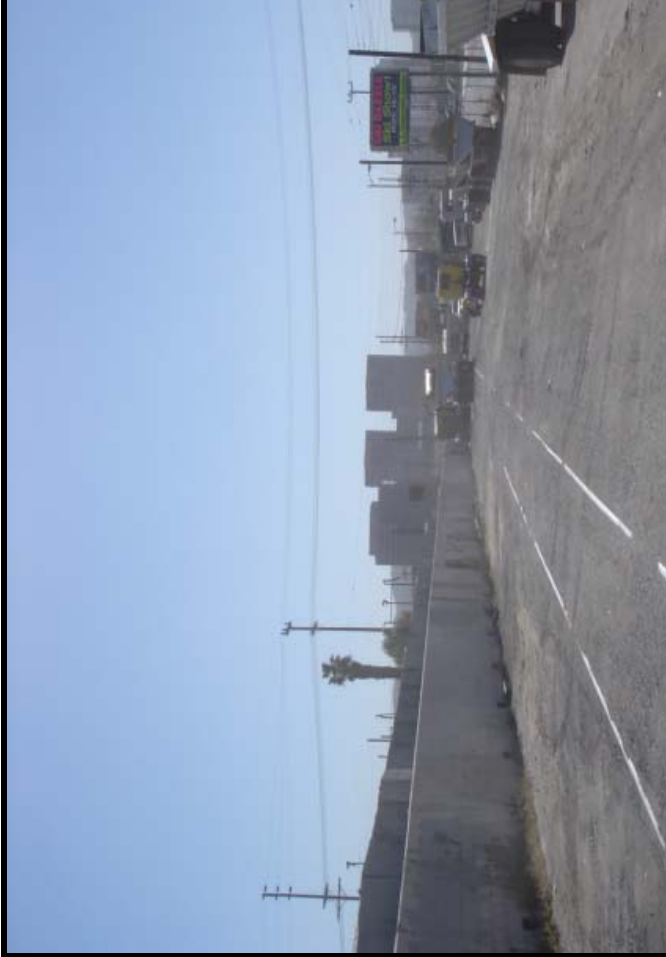
Photo 8:

View south on old railroad ROW approximately at Hart Street. Portland cement concrete (PCC) plant on the left adjacent to Project ROW. Metro ROW used to store vehicles.

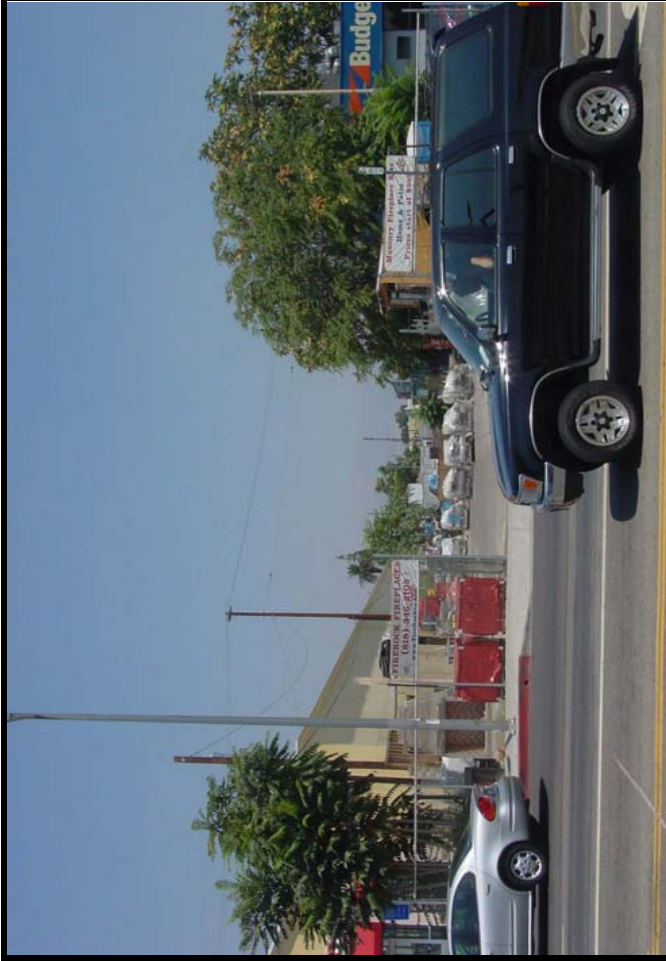
<p>Photo 10: View north on former railroad ROW at Sherman Way. Former railroad ROW paved with AC and used to construction materials.</p>	<p>Photo 11: View north on former railroad ROW at Roscoe Boulevard. Existing building located on Project ROW. Canoga Avenue on the left.</p>
<p>Photo 12: View north on old railroad ROW approximately 200 feet north of Schoenborn Street.</p>	<p>Northern/Canoga Extension Metro Orange Line Los Angeles County, CA DYA Project No. 2007-018 Photos dated 8-6-07</p>

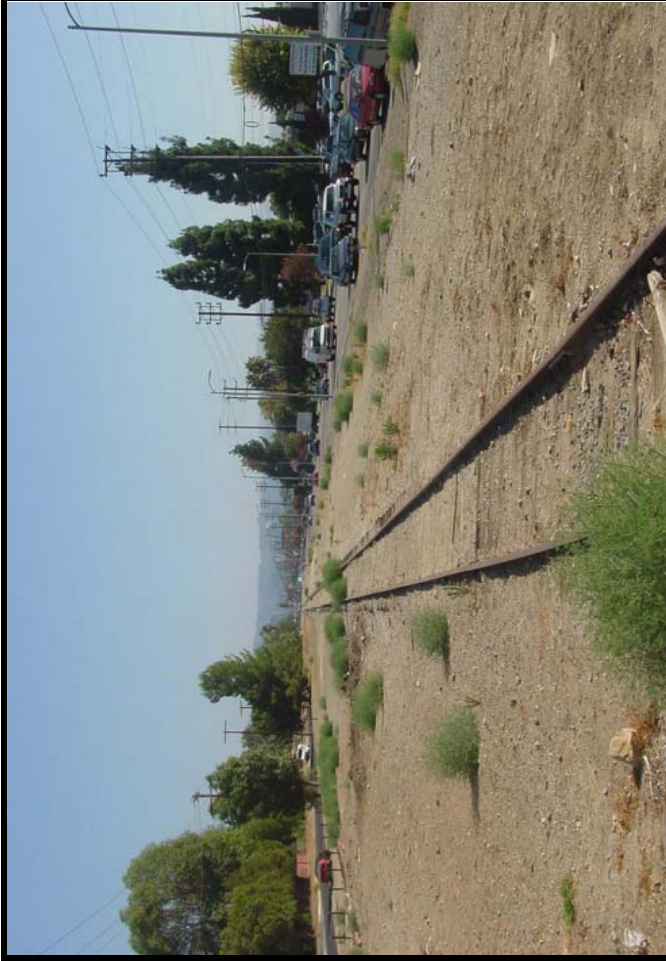
Photo 13:
View south of Parthena Street on former railroad ROW. Canoga Avenue on right side.

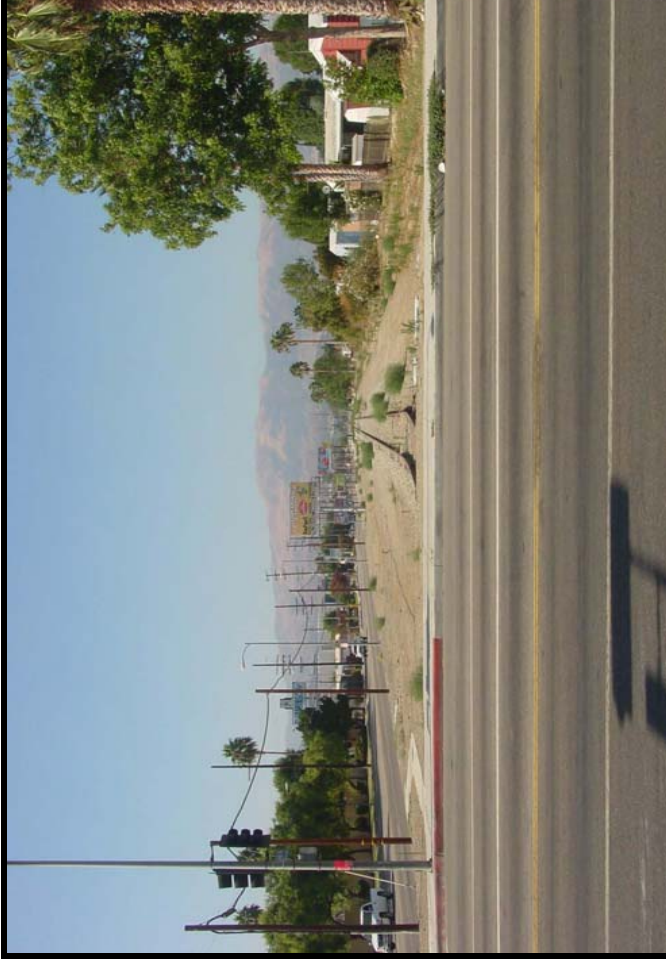
Photo 15:
View east on Canoga Avenue at Santa Susana Wash. Existing railroad bridge to be replaced.

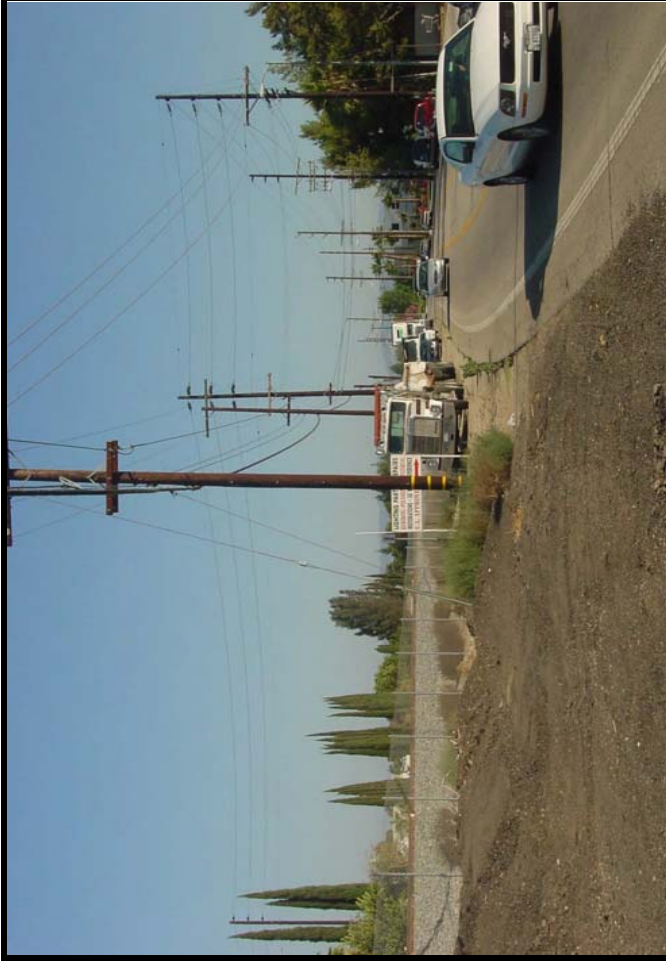
Photo 16:
View south on Canoga Avenue. Former railroad merges with existing Metrolink railroad track. Metro ROW between Canoga Avenue and Metrolink fence. Stock pile of AC cuttings adjacent to fence.

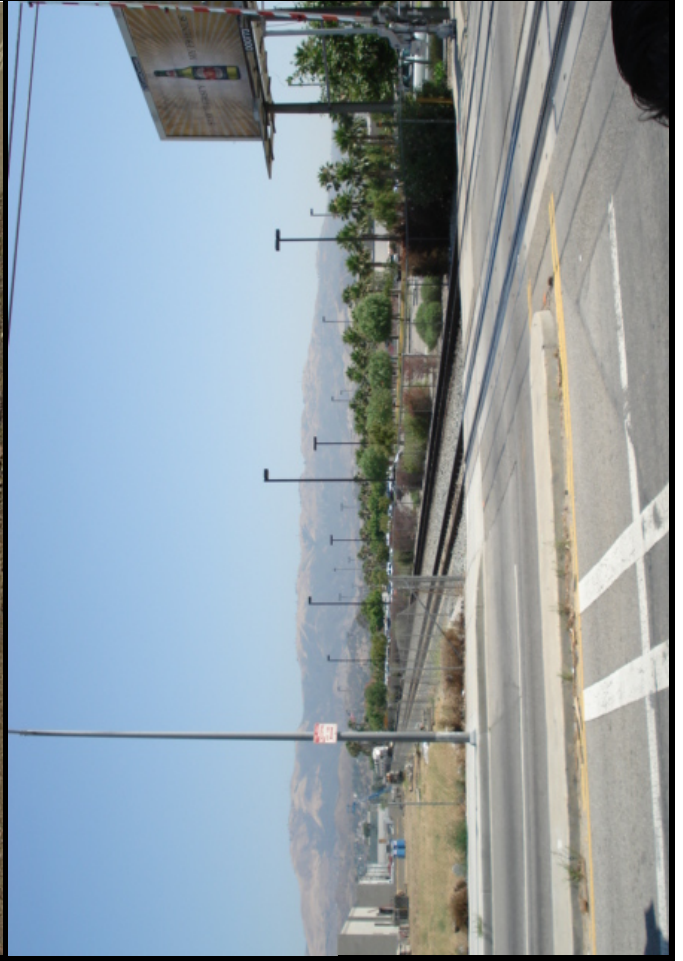
Photo 17:
View north on Canoga Avenue. Metrolink railroad track on the right. Metro ROW used for storage of vehicles.

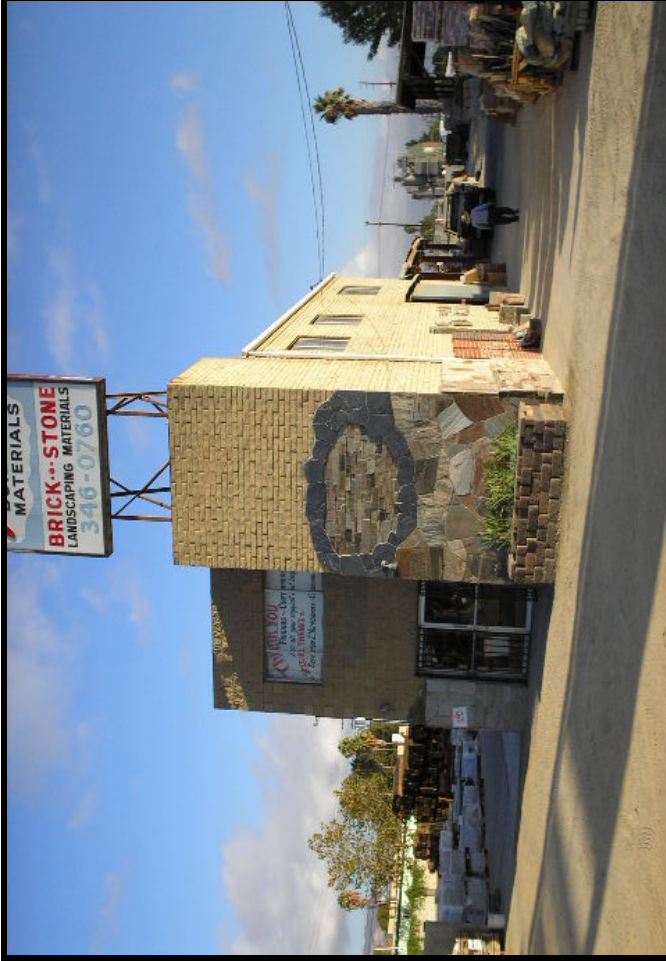
Photo 19:
 Building and stone building materials on ROW, Jacobi Building Materials, 21341 Vanowen Street.

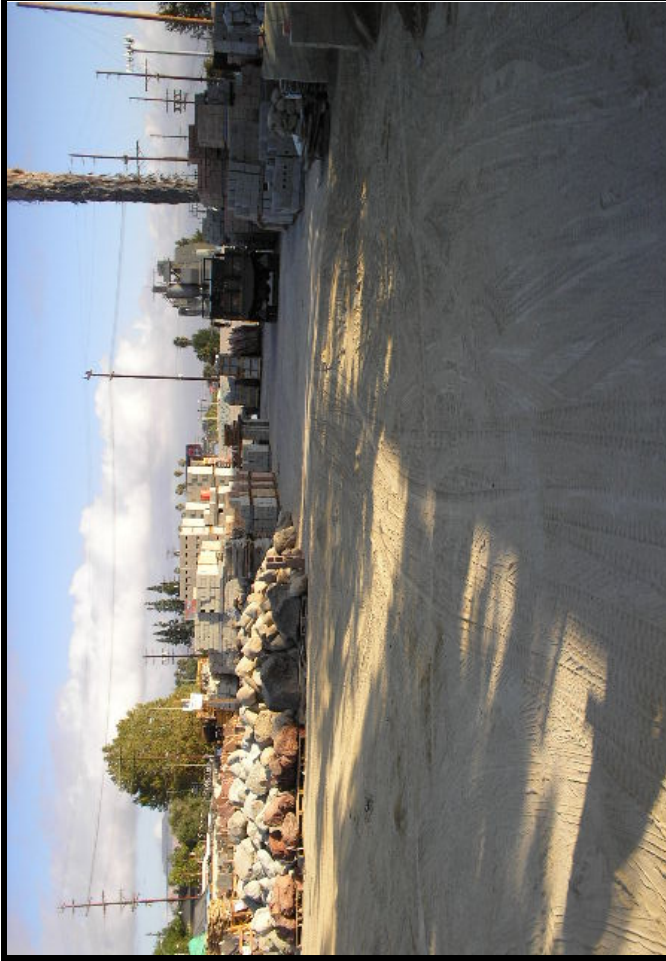
Photo 20:
 Stone and brick building materials on ROW, Jacobi Building Materials, 21341 Vanowen Street.

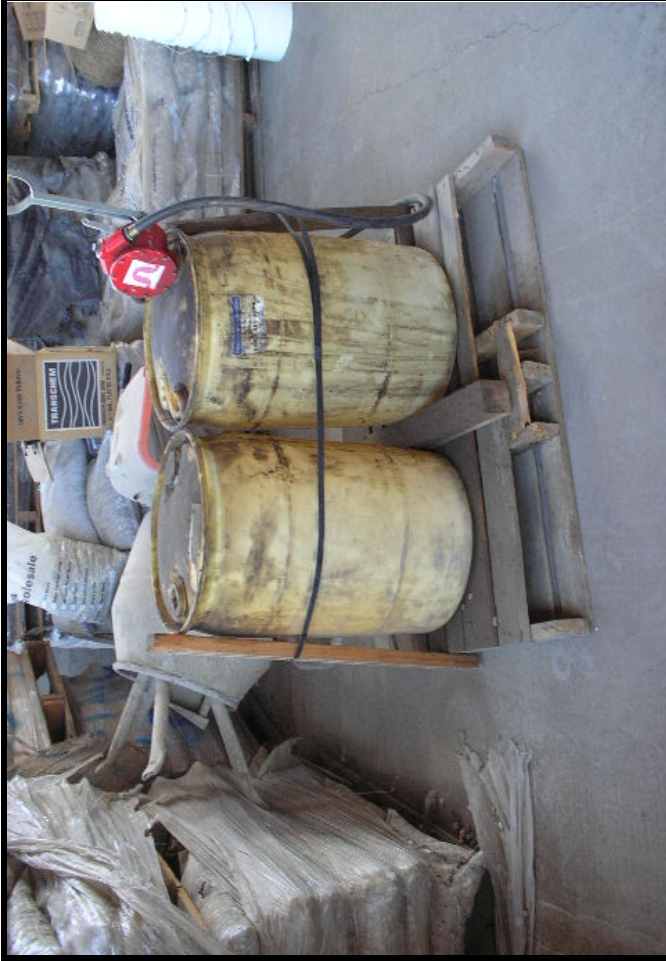
Photo 22:
Diesel fuel containers, Masonry Club, 7000 Canoga Ave.. No secondary containment, inadequate labeling

- Masonry Club, stone and brick building materials, 7000 Canoga Avenue: this facility has two 55-gallon diesel fuel containers (per discussion with tenant) in a shed in the northeastern corner on a pallet on a concrete floor; the drums have no secondary containment or labeling and there are oil stains on the parcel. There are also used, treated railroad ties within the facility.

- Mr. Eddie Martin (818-887-1684), Masonry Club, stone and brick building materials, 7000 Canoga Avenue. This facility has two 55-gallon diesel fuel containers in a shed in the northeastern corner of the site. The containers are on a pallet on concrete floor; the drums have no secondary containment or labeling but there was no evidence of recent spills in the area. There are at least 200 5-gallon buckets of masonry grout products on the site sold as a product, but they are not labeled as hazardous, with the exception of a few waterproofing products marked “flammable.” There are also used, treated railroad ties sold for landscaping. No other known RECs were observed onsite.

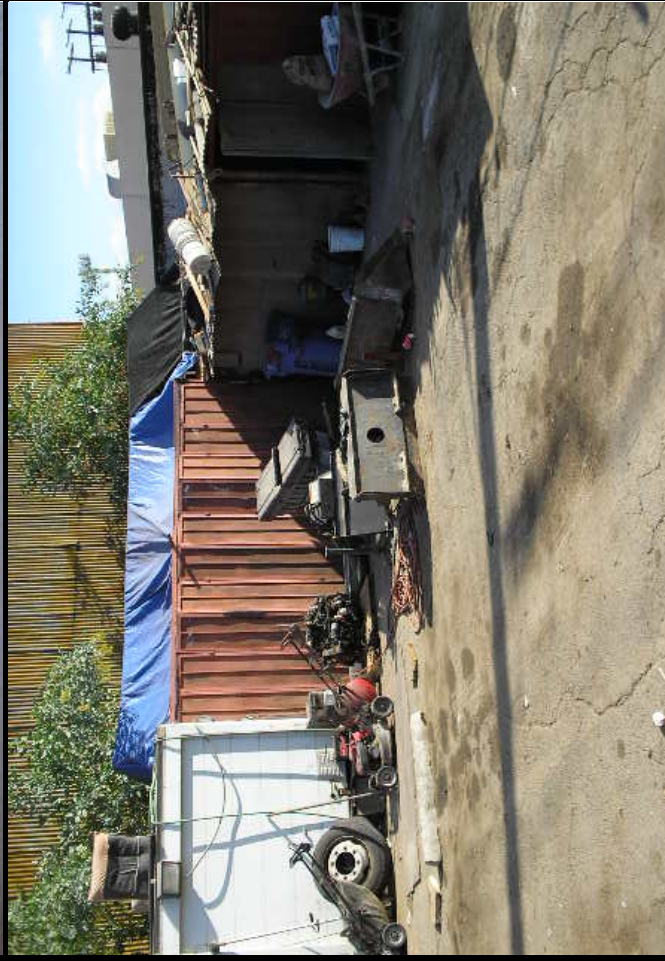
Photo 23:
Storage shed with diesel fuel containers, Masonry Club, 7000 Canoga Ave.

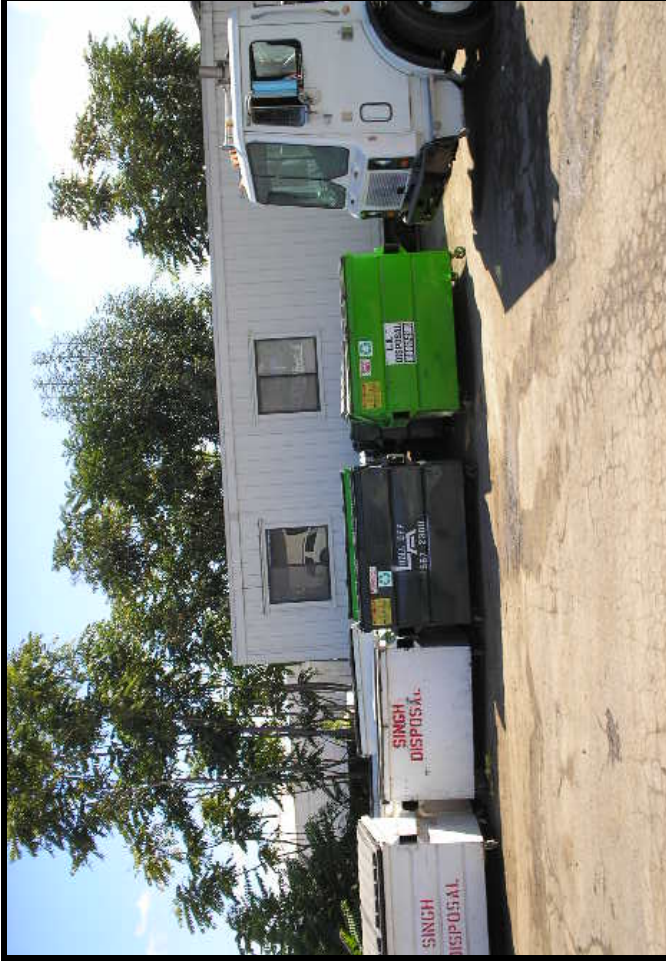
Photo 25:
Waste transfer facility on west side of ROW between Sherman Way and Vanowen Street (7100? Canoga Ave.).
View of office trailer at entrance

- An unidentified solid waste transfer facility (no address available, assumed to be +/- 7100 Canoga Avenue) on a narrow strip on the east side of Canoga Avenue approximately halfway between Vanowen Street and Sherman Way. Phase II sampling in shallow soils at the vehicle maintenance areas, areas of stained soils, and stained pavement areas is recommended. Evidence of regulatory compliance for operation of a waste transfer facility is also recommended for the waste facility, including verification that no hazardous materials have been stored or disposed.

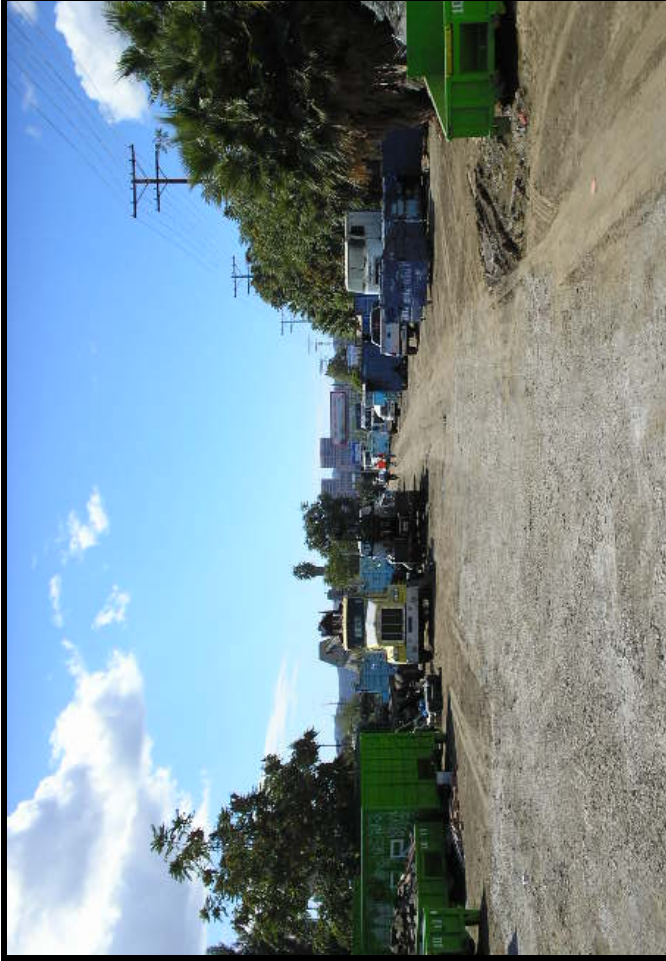
Photo 26:
Waste transfer facility on west side of ROW between Sherman Way and Vanowen Street (7100? Canoga Ave.).
View south from entrance.

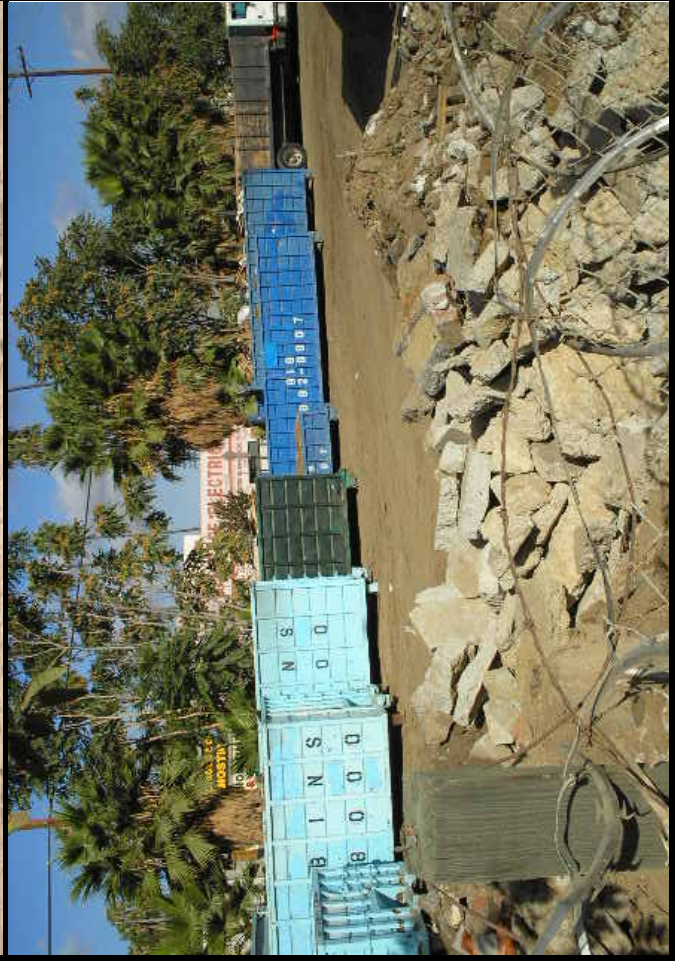
Photo 27:
Waste transfer facility on west side of ROW between Sherman Way and Vanowen Street (7100? Canoga Ave.).
Roll-off bins

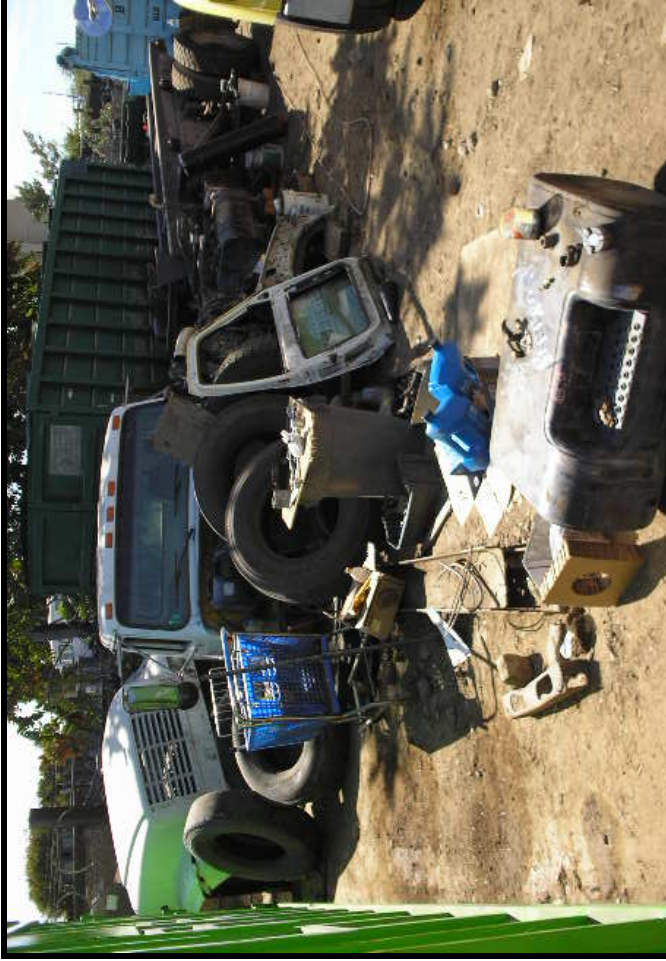
Photo 28:
 Waste transfer facility on west side of ROW between Sherman Way and Vanowen Street (7100? Canoga Ave.). Vehicle maintenance area in central portion.

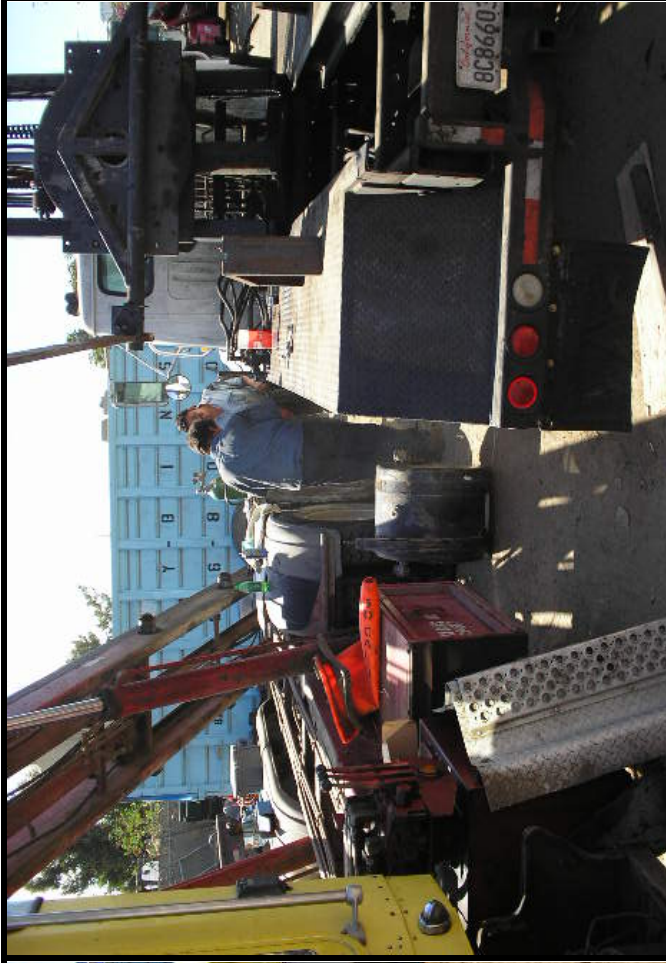
Photo 29:
 Waste transfer facility on west side of ROW between Sherman Way and Vanowen Street (7100? Canoga Ave.). Vehicle maintenance activity in central portion.

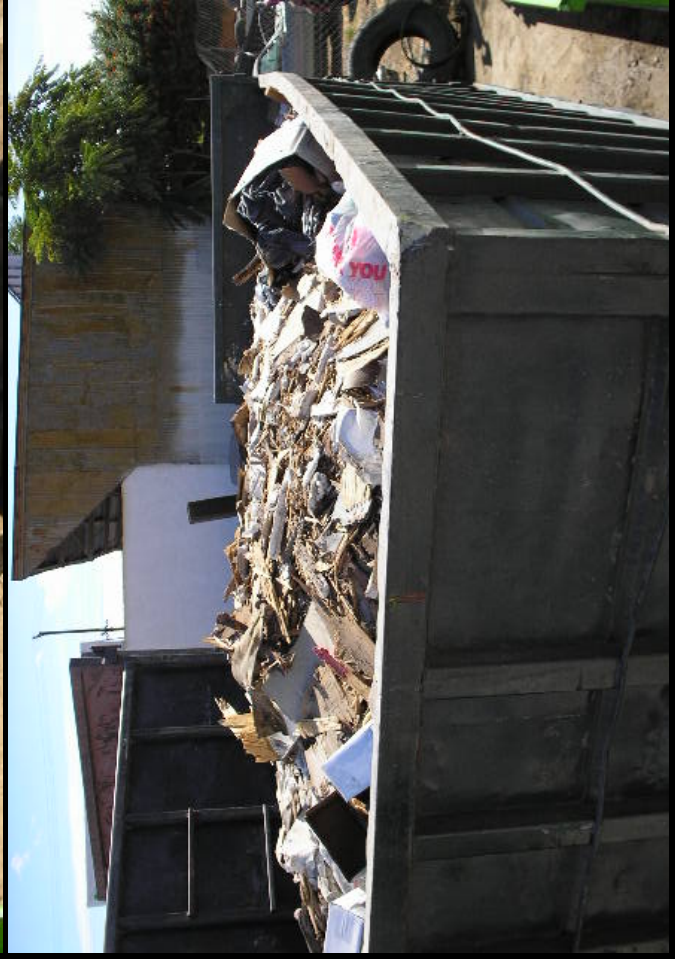
Photo 30:
 Waste transfer facility on west side of ROW between Sherman Way and Vanowen Street (7100? Canoga Ave.). Building demolition debris

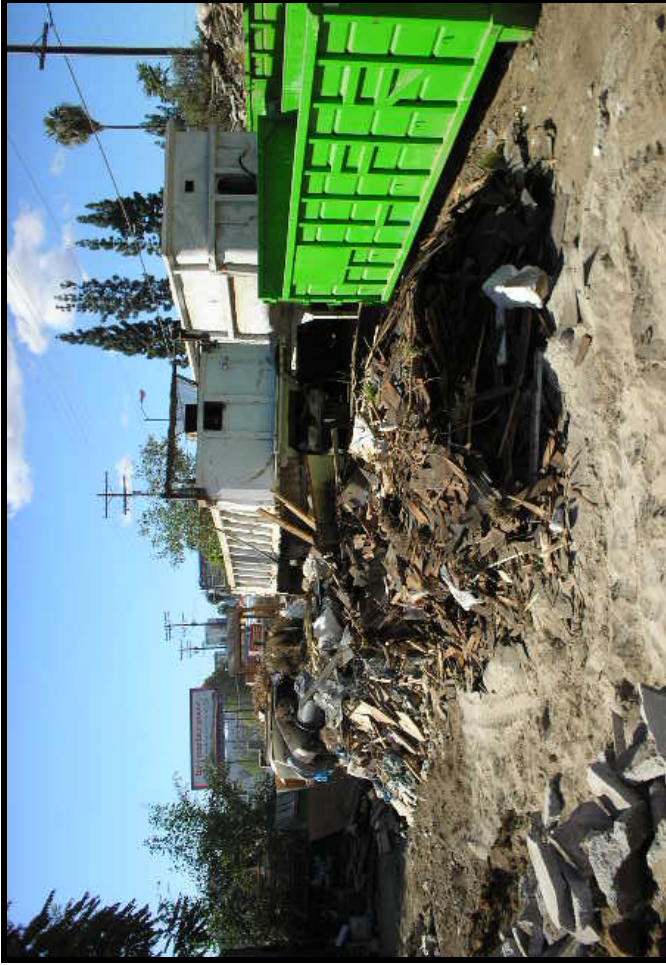
Photo 31:

Waste transfer facility on west side of ROW between Sherman Way and Vanowen Street (7100? Canoga Ave.). Waste piles on unpaved ground, southern end

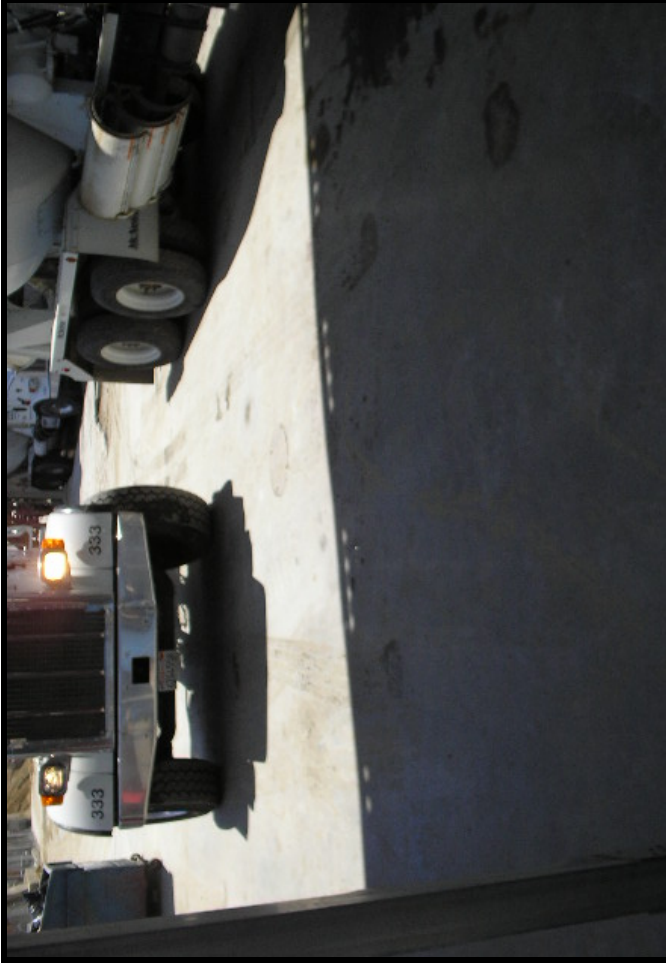
Photo 34:
 Underground Diesel fuel tank, Northeast corner of National Ready Mix, 6969 Deering Ave.

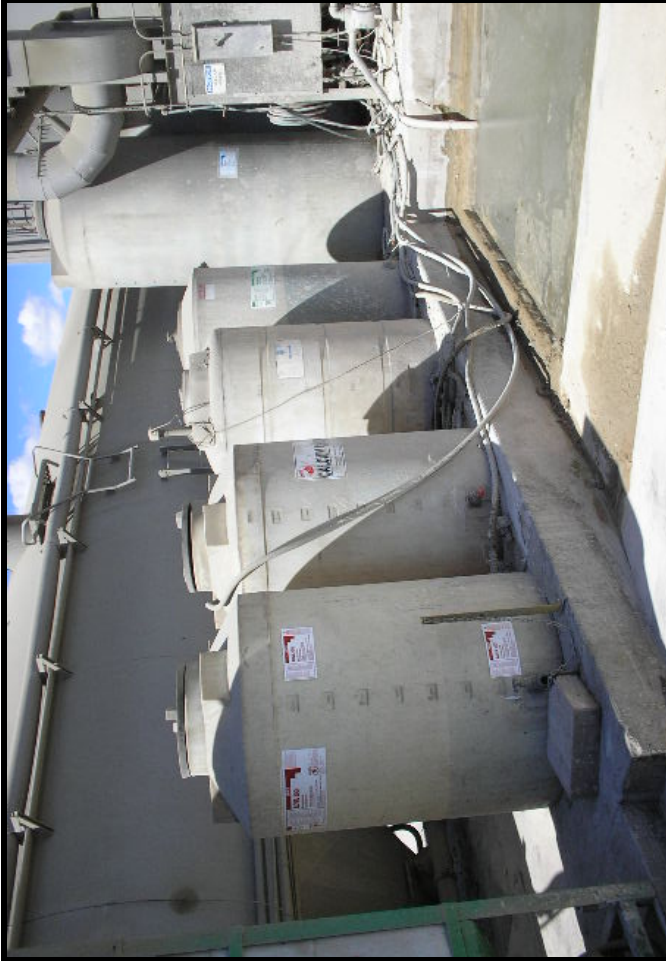
Photo 35:
 Component mixing ASTs for National Ready Mix, 6969 Deering Avenue.

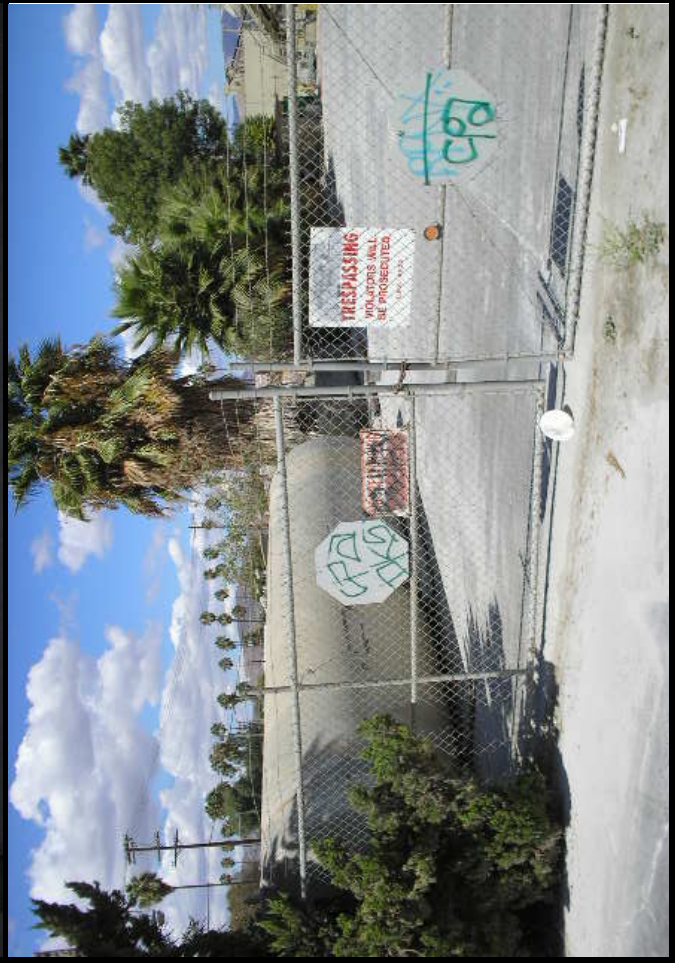
Photo 36:
 Empty (?) AST on Southwest corner of Catalina Pacific ready mix facility (7001 Deering Avenue). Site was not operating and vacant, no access provided at the time of the 9-20-07 site visit.

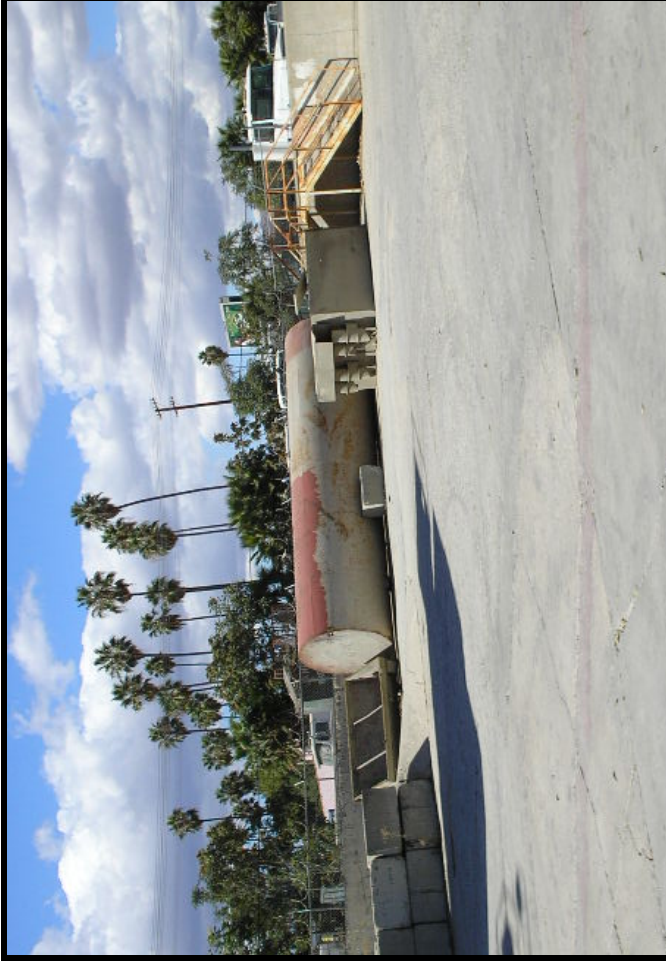
Photo 37:
 Empty (?) AST on Northwest corner of Catalina Pacific ready mix facility (7001 Deering Avenue). Site was not operating and vacant, no access provided at the time of the 9-20-07 site visit.

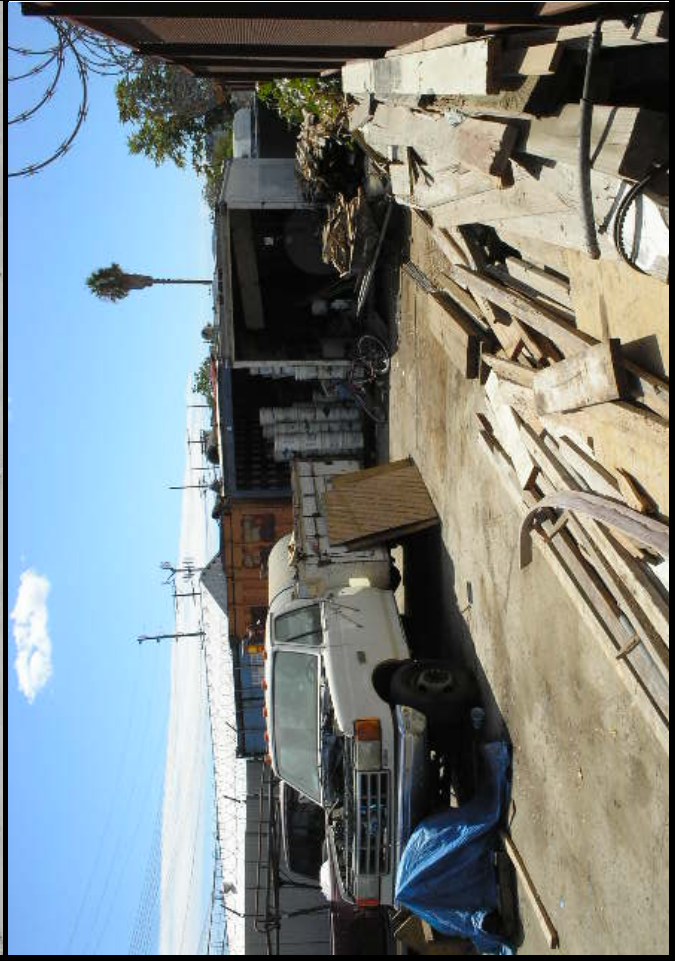
Photo 38:
 Central Valley Lumber (7119 Deering Avenue), left of photo, on east side of ROW south of Sherman Way; Autos parked in central area of ROW on the right.

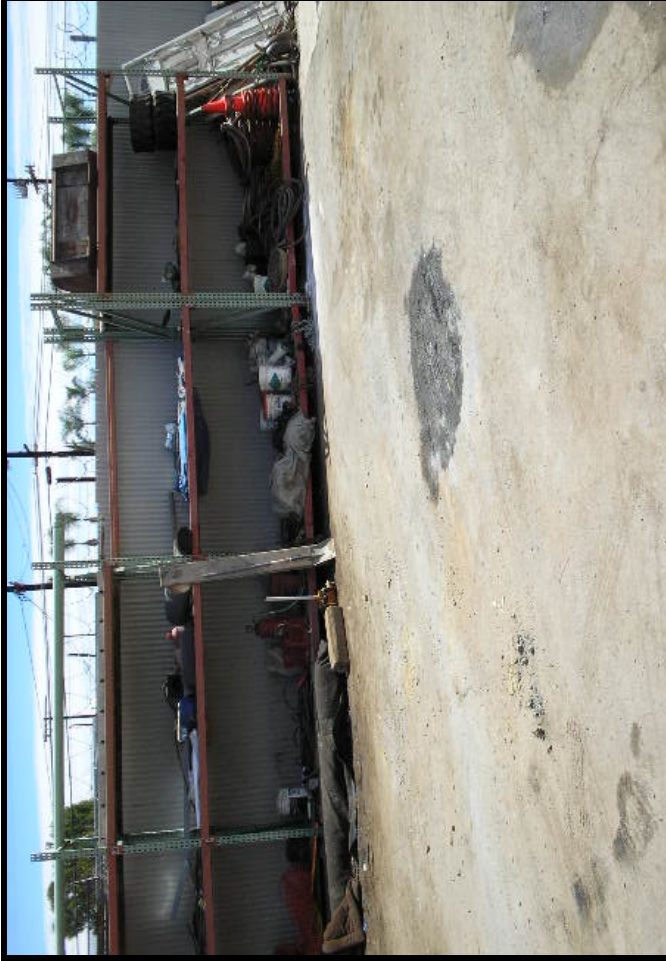
Photo 40:

Oil stains, central area of Star Construction, 7320? Canoga Ave.

- The eastern side of the Project ROW facing Canoga Avenue, Wyandote Street to Valerio Street is occupied by Star Construction contractor yard (7320 Canoga Avenue). The Star Construction parcel was observed to have unlabeled 55-gallon drums stored, scattered oil stains, and fueling trailers. Phase II sampling of shallow soils is recommended in the stained areas of this parcel.

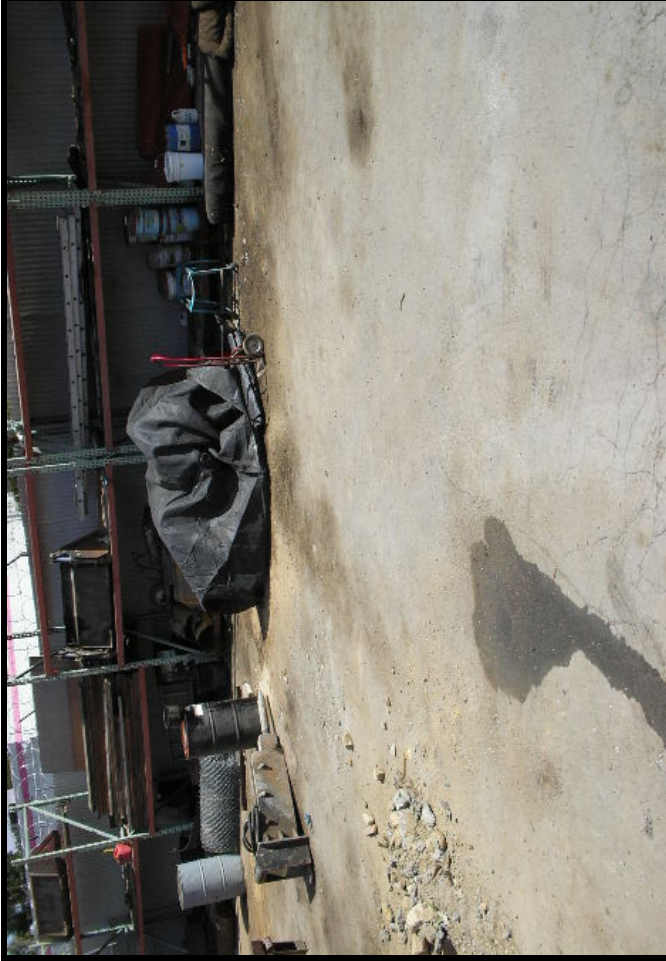
Photo 41:

Oil stains, drums, containers maintenance activity, central area of Star Construction, 7320? Canoga Ave.

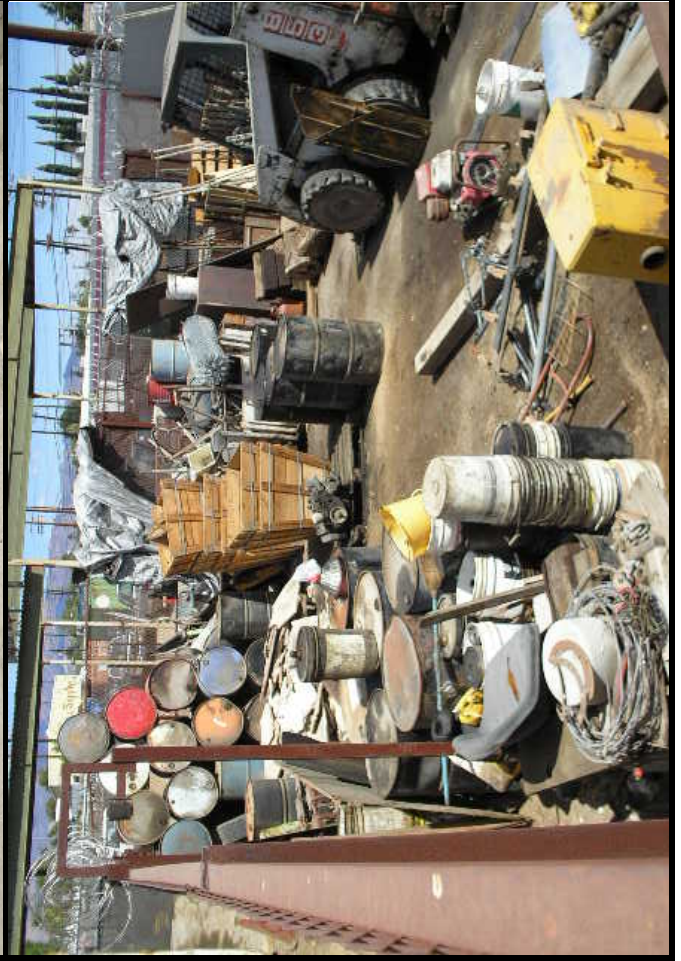
Photo 42:

55-gallon drums, miscellaneous containers, oil stains north end of Star Construction, 7320? Canoga Ave.

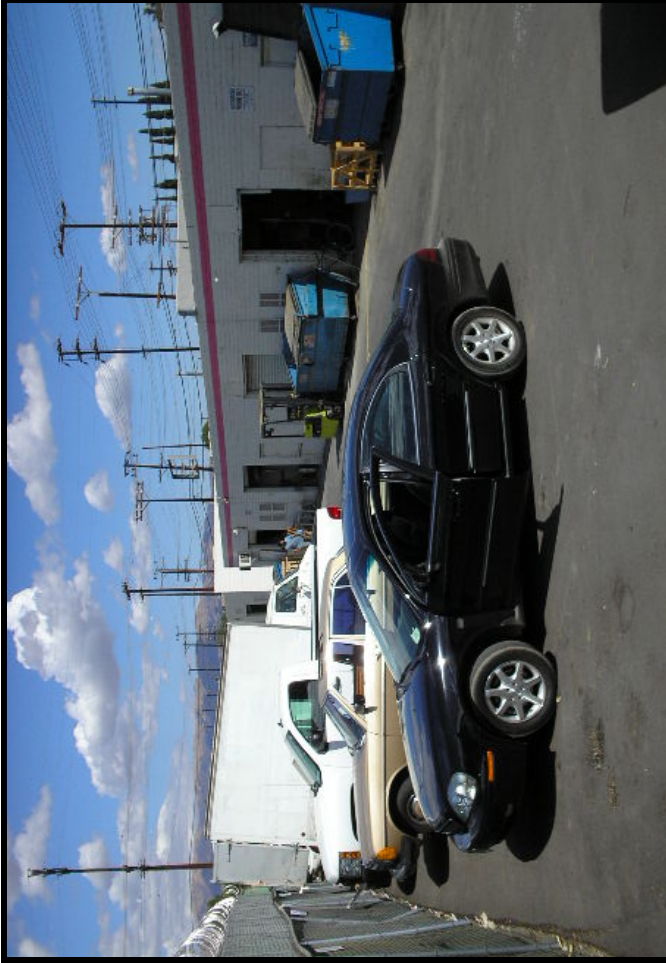
Photo 43:

Rear access to neighboring small industrial shops on Deering Avenue next to east side of ROW south of Valerio Street. Pavement slopes to the east away from ROW

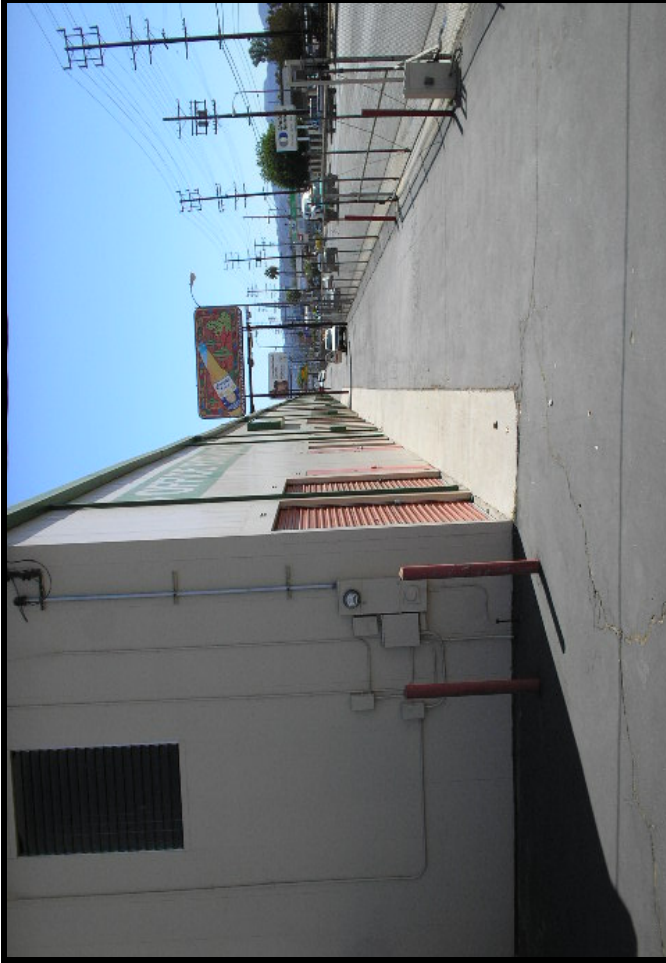
Photo 46:
Long narrow self-storage building on east side of ROW next to Canoga Ave., between Ingomar Street & Saticoy Street.

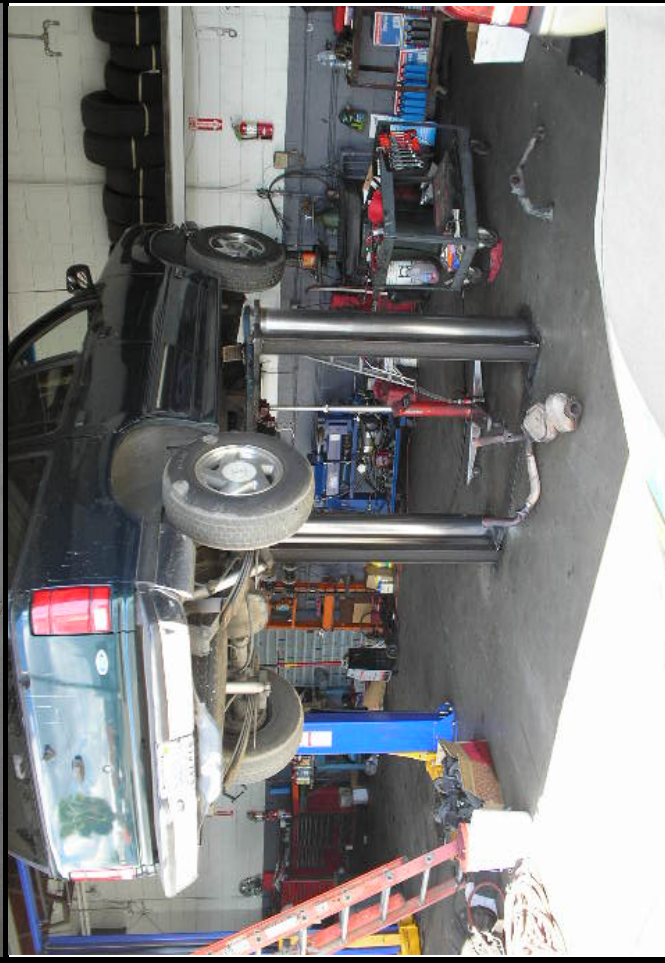
Photo 47:
Auto repair garage on west side of ROW, 7800 Canoga Ave.

- “Ovidios,” an operating auto repair garage, 7800 Canoga Avenue, is within the Project ROW north of Ingomar Street, which includes a concrete block garage with approximately six bays with at least five underground hydraulic lifts. There is also a waste oil and waste oil filter storage area on the south side of the building using five 55-gallon drums for storage; the waste oil materials are reportedly recycled by a service. The area has oil stains on the concrete surface. A clarifier was also shown south of the building on a 1998 Metropolitan Transportation Authority report. According to a previous UST closure report, as much as 1,000 milligrams per kilogram (mg/kg) total petroleum hydrocarbons (TPH) remained in soil beneath the auto service garage building. Phase II soil sampling is recommended for the waste oil and clarifier area south of the building, within the south side of the building, and beneath the hydraulic lifts.

- "Clark," CPS Auto Sales, and Mr. Ovidios, Proprietor (818-992-6952), 7800 Canoga Avenue, CPS Auto Sales and Ovidios auto repair garage. This parcel includes a concrete block wall garage with approximately six bays, with at least five underground hydraulic lifts. There is also a waste oil and waste oil filter storage area on the south side of the building using five 55-gallon drums for storage. The waste oil materials are recycled by a service. The area has oil stains on the concrete surface.
