Canoga Transportation Corridor

Draft Environmental Impact Report

Hazardous Materials - Environmental Site Assessment

**PHASE I ENVIRONMENTAL SITE ASSESSMENT
NORTHERN/CANOGA EXTENSION OF THE METRO ORANGE LINE
LOS ANGELES COUNTY, CALIFORNIA**

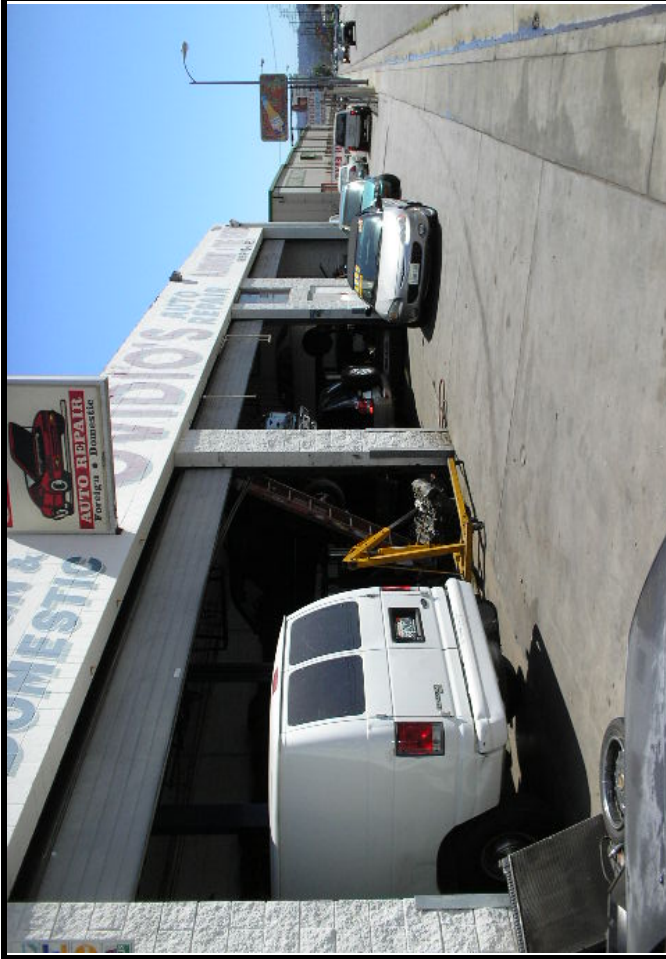
Photo 48:
Five hydraulic lifts in bays, 7800 Canoga Ave.

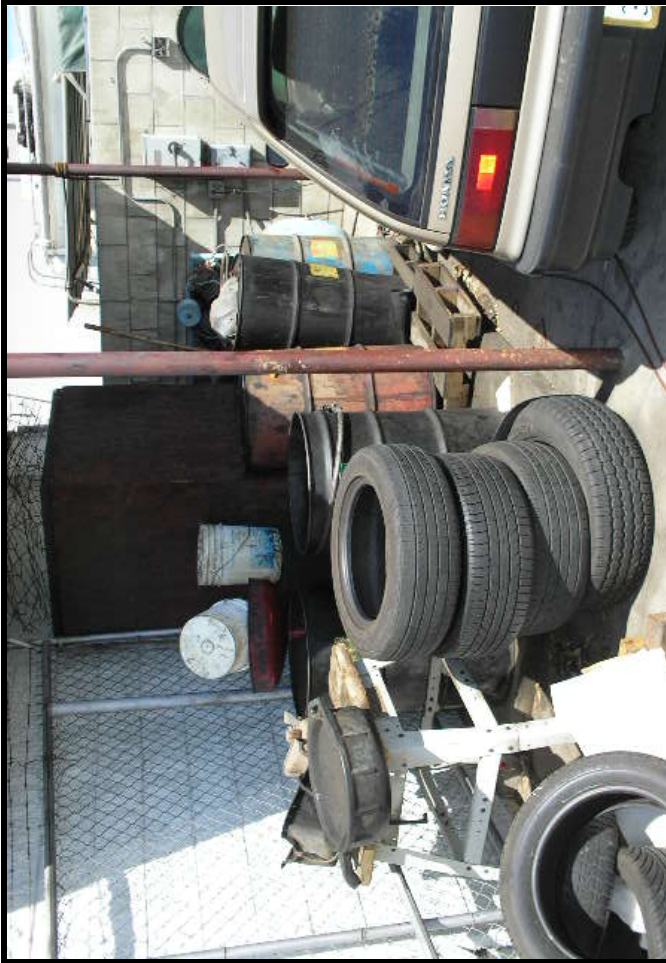
Photo 49:

Waste oil storage area, south end of building, 7800 Canoga Ave. Formerly a UST that was removed, soil with oil remained under building.

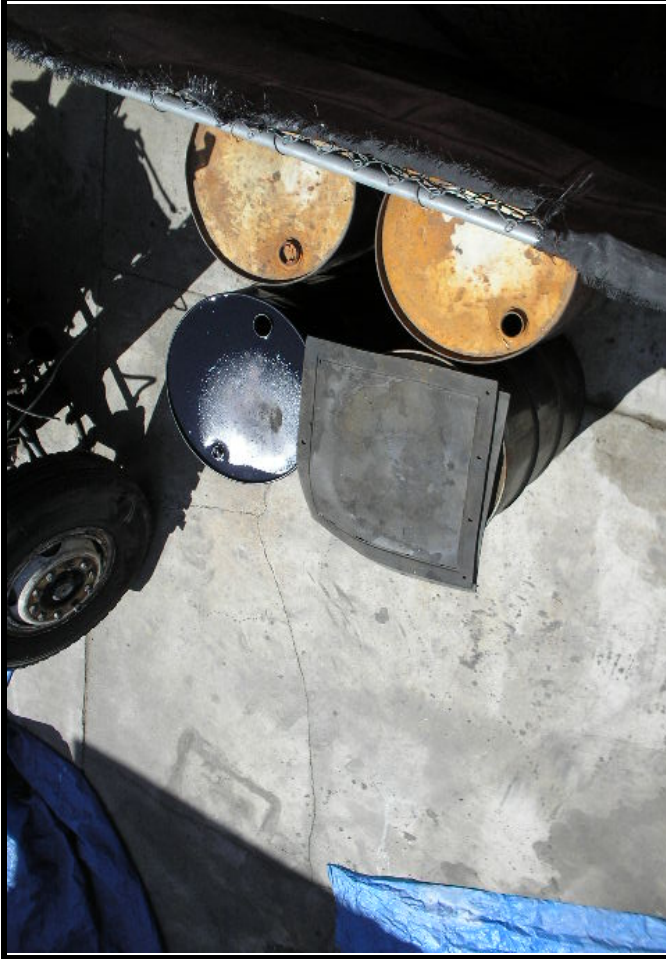
Waste oil UST, oily waste and parts washing, Valley Truck Repair office, 7900 Canoga Ave.

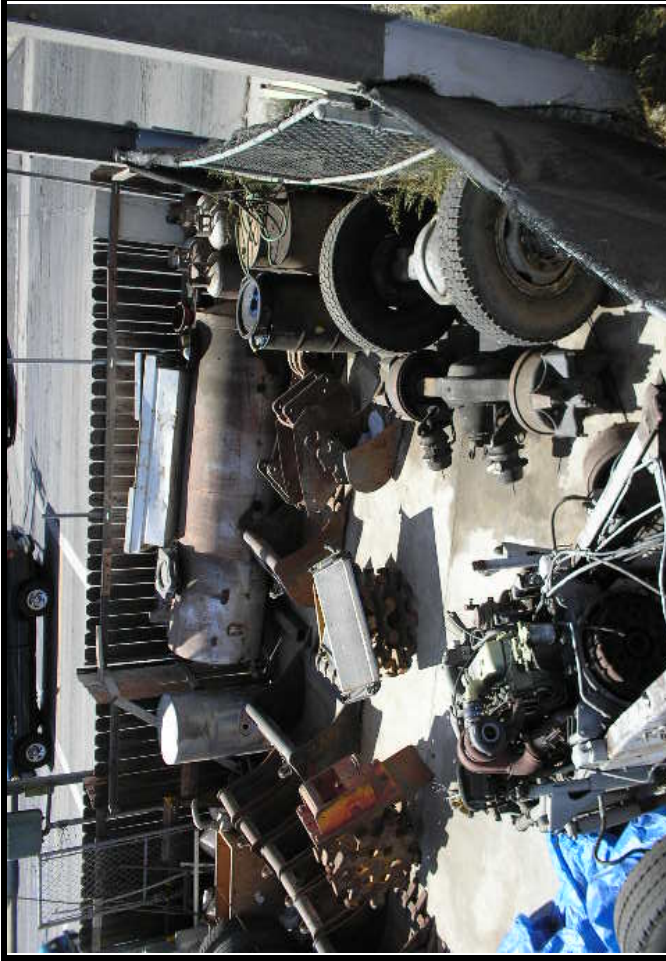
Photo 52:

55-gallon drums on contractor storage yard, across from Strathern Street intersection on Canoga Avenue (7994?-8050?); Parcel locked no occupants present and no access at time of site visit; Photo from neighboring driveway at north end of parcel.

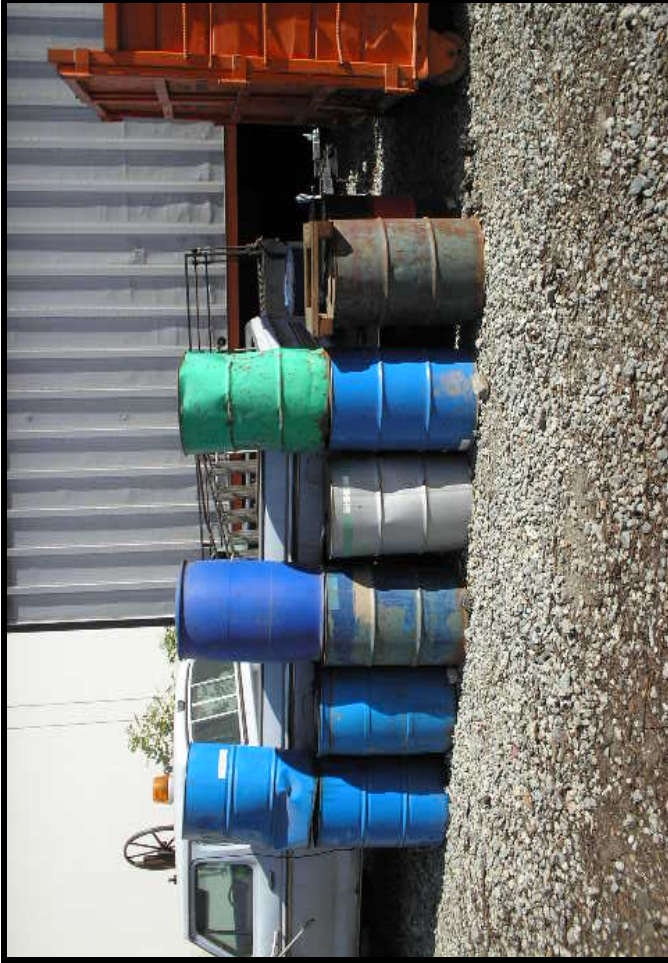
Photo 55:

Unlabeled drums in used railroad tie facility in ROW, south of Plummer St.
