# Appendix A NES Figures

SR 710 North Study  
 Project Location

SR 710 North Study  
 Biological Study Area  
 07-LA-710 (SR 710)  
 EA 187900  
 EFIS 0700000191

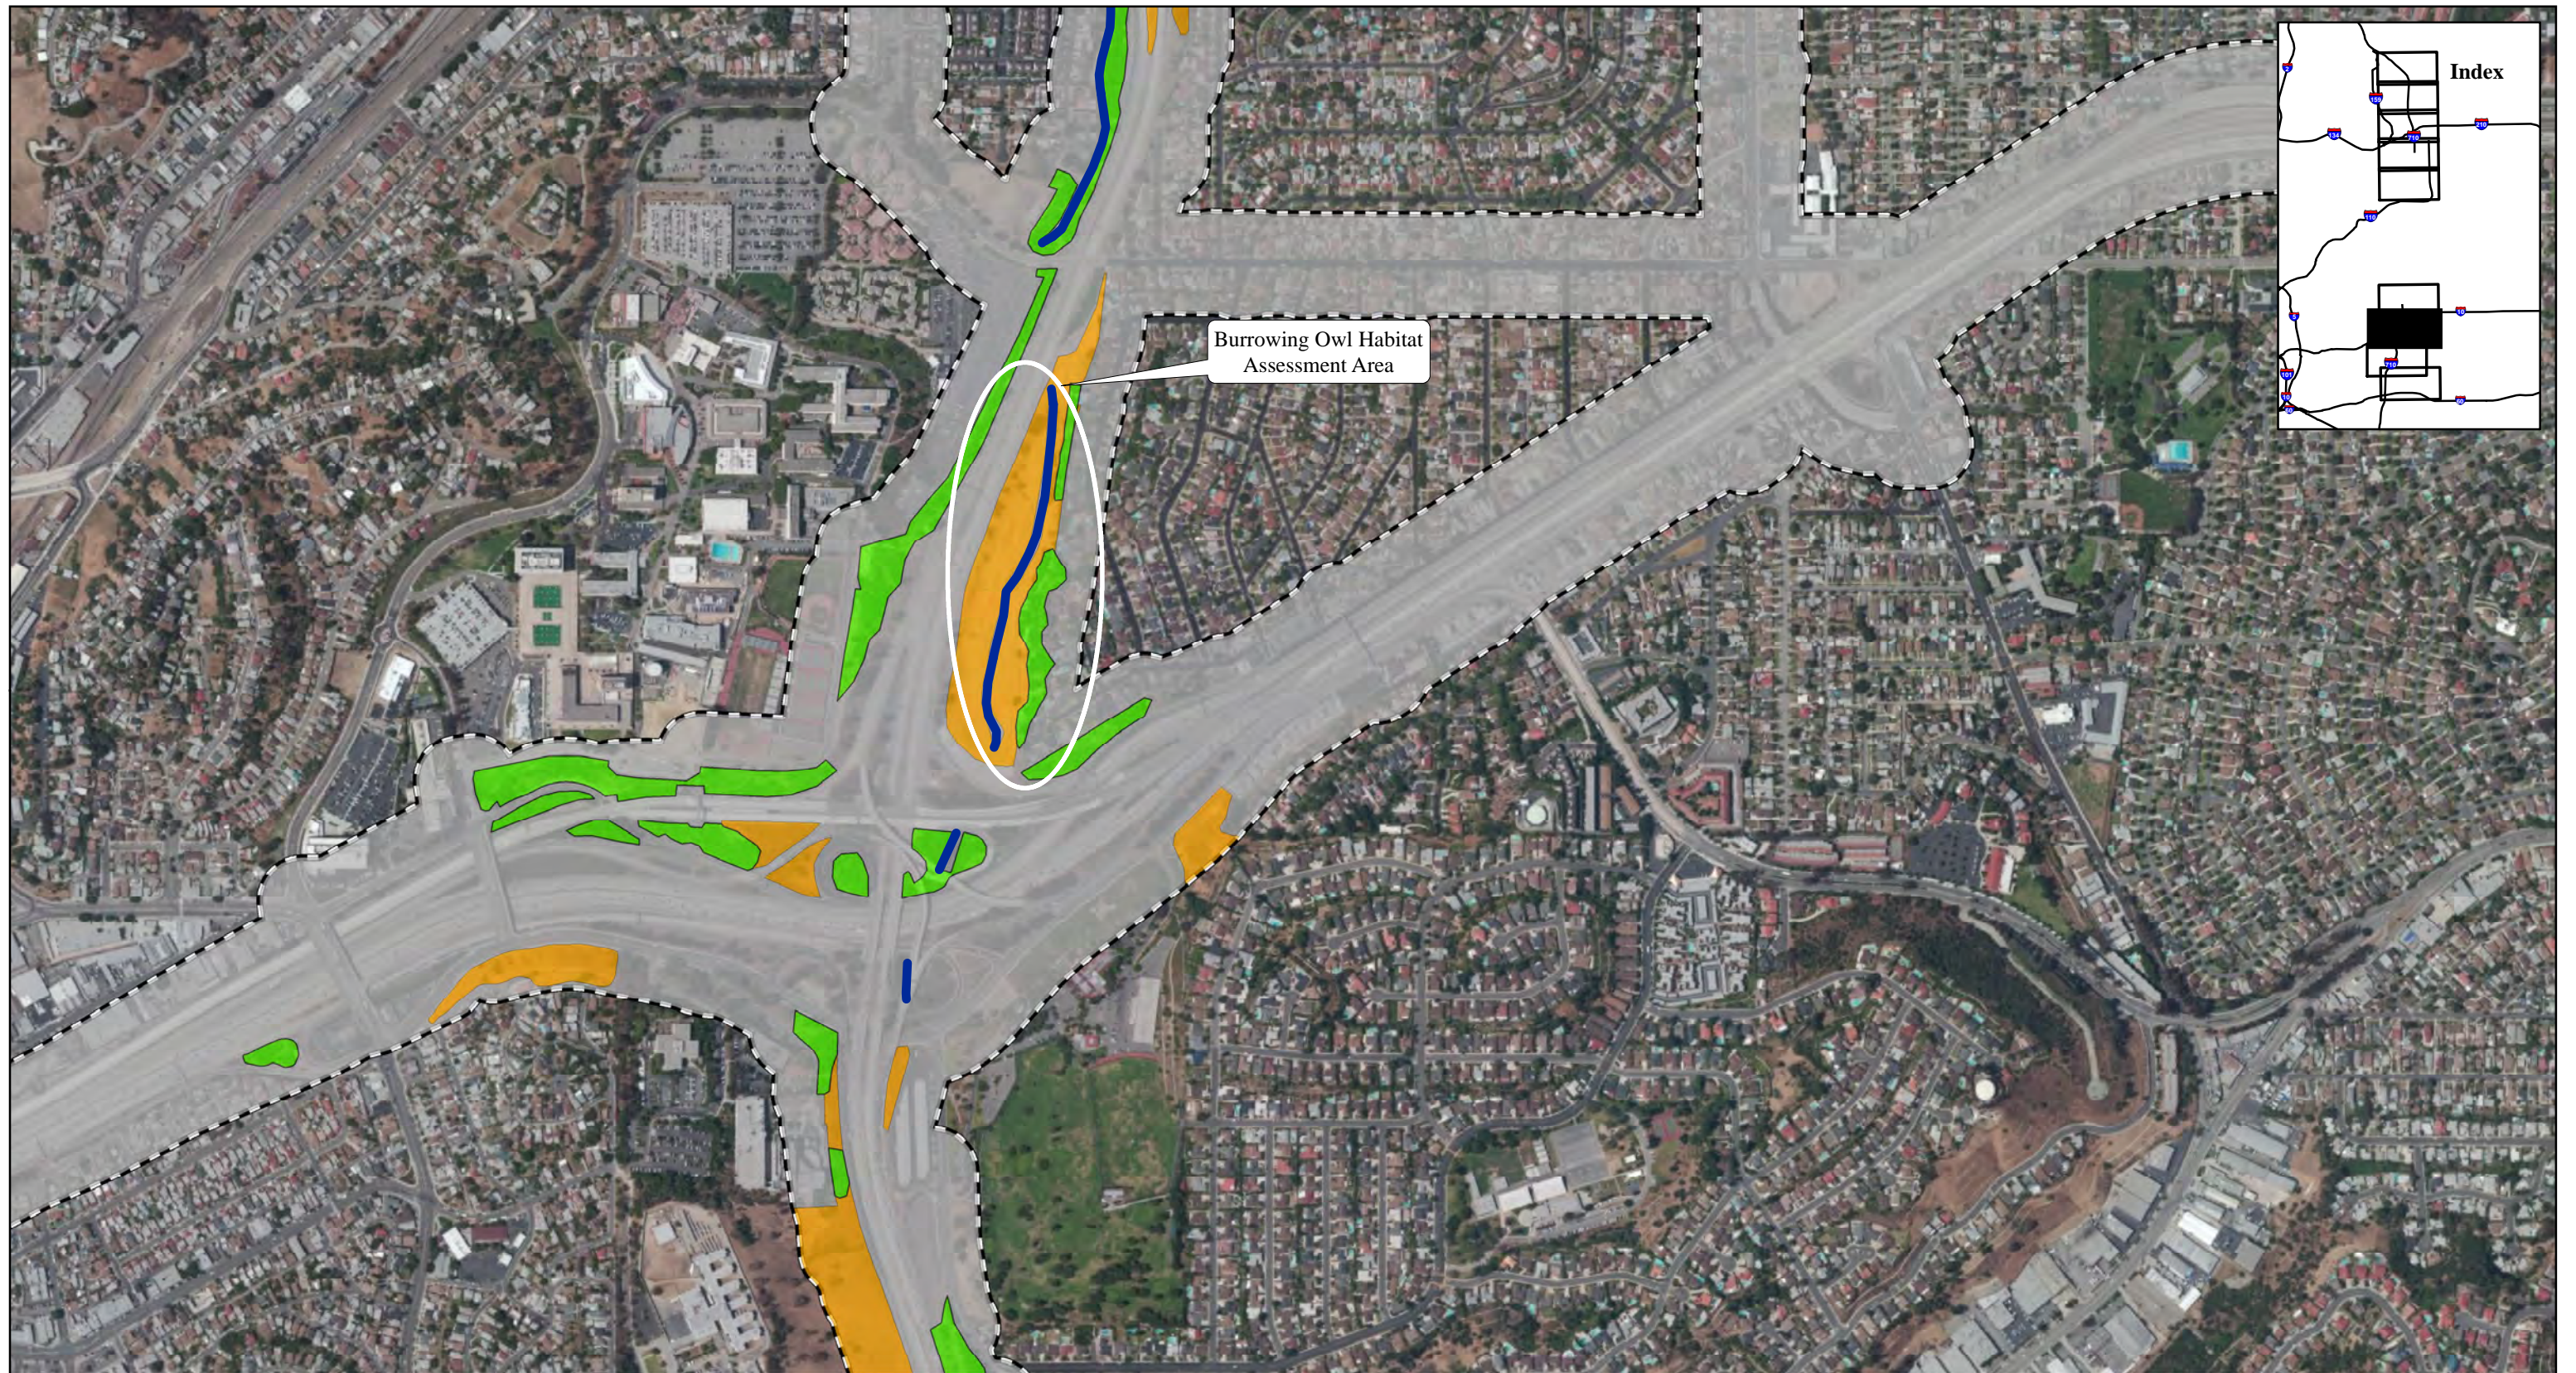
FIGURE 9.6

Burrowing Owl Habitat Assessment Area

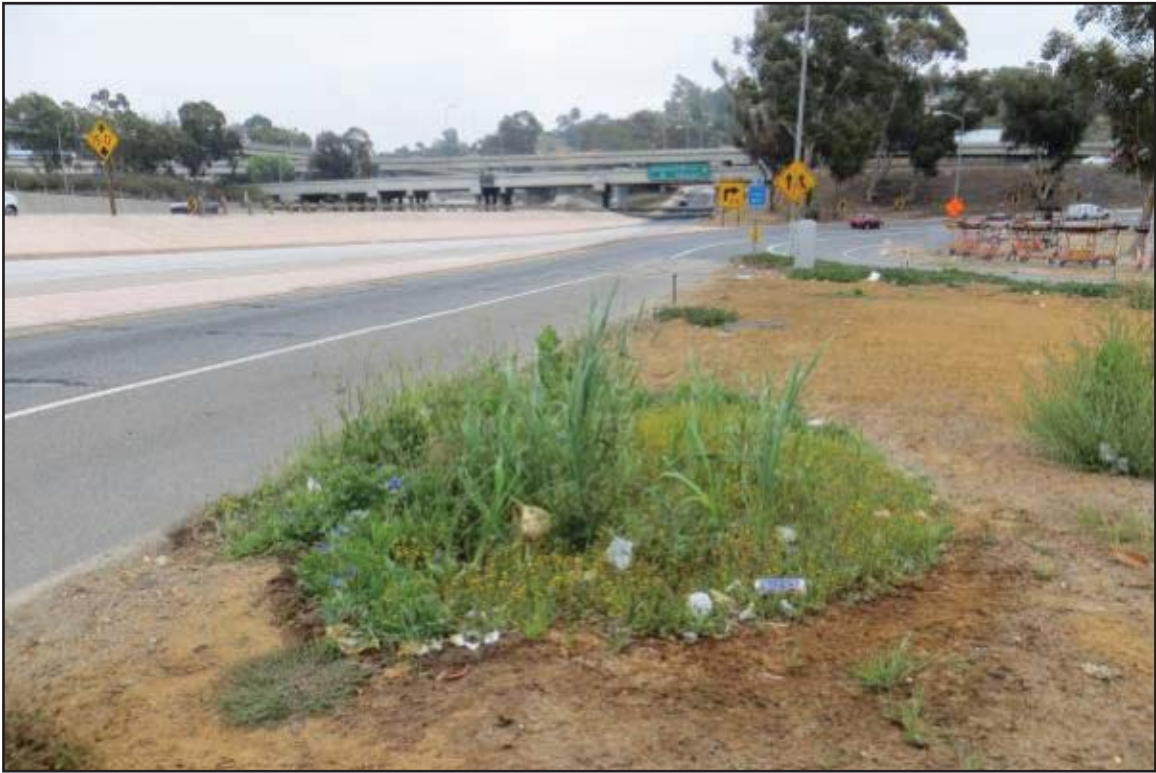
**PHOTO 2**  
Habitat view of the Coulter's goldfields found along the Interstate 10 East to SR 710 South ramp (July 31, 2013).

Botanical surveys conducted throughout the entire BSA in 2013 resulted in the identification of a small population of Coulter's goldfields within a freeway edge along the I-10 freeway near the SR 710 / I-10 interchange in Monterey Park (Figure 4; Attachment B, Photos 2–3). This species was found to be blooming out of season with other spring annuals near a leaking irrigation system in an area that appeared to have been recently hydro-seeded, most likely during road maintenance activities. Coulter's goldfields is known to occasionally be found outside of its typical habitat due to its inclusion in native wildflower seed mixes distributed by certain seed suppliers. This also appears to be the case for its presence within the BSA.

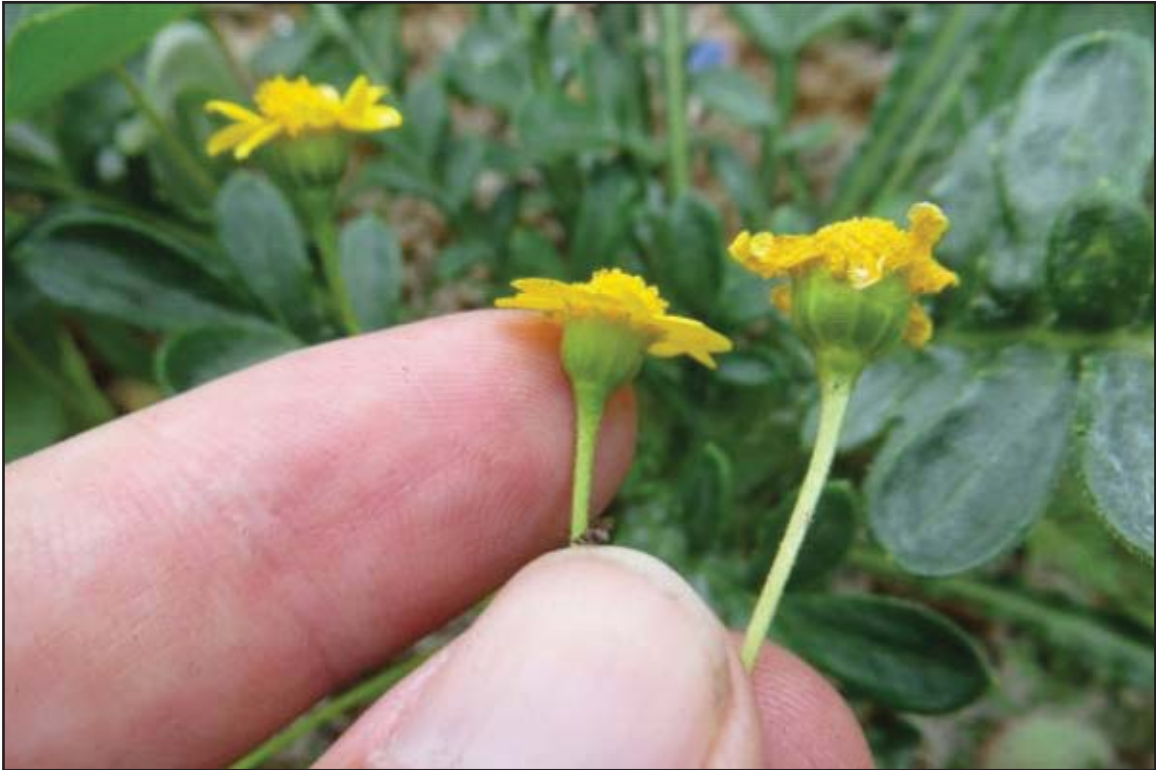
**PHOTO 3**  
Close-up view of the Coulter's goldfields found along the Interstate 10 East to SR 710 South ramp (July 31, 2013).

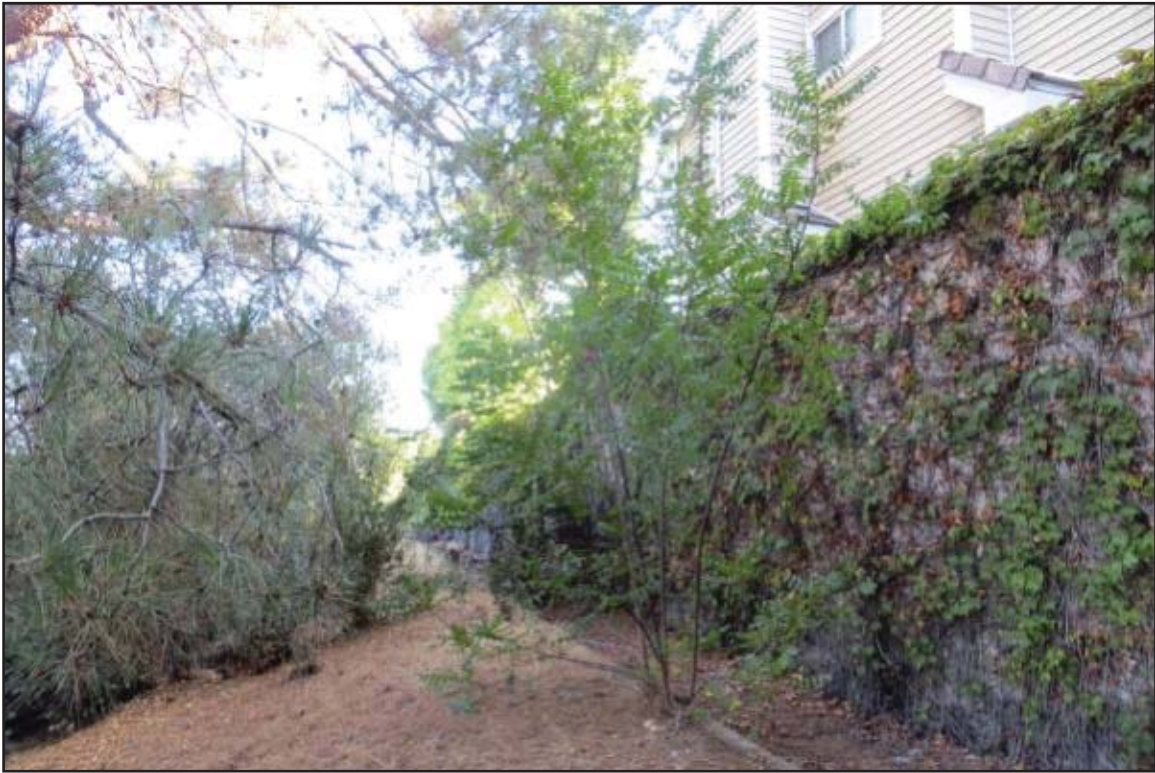
**PHOTO 4**  
Habitat view of a Southern California walnut upslope from the 210 freeway  
(August 6, 2013).

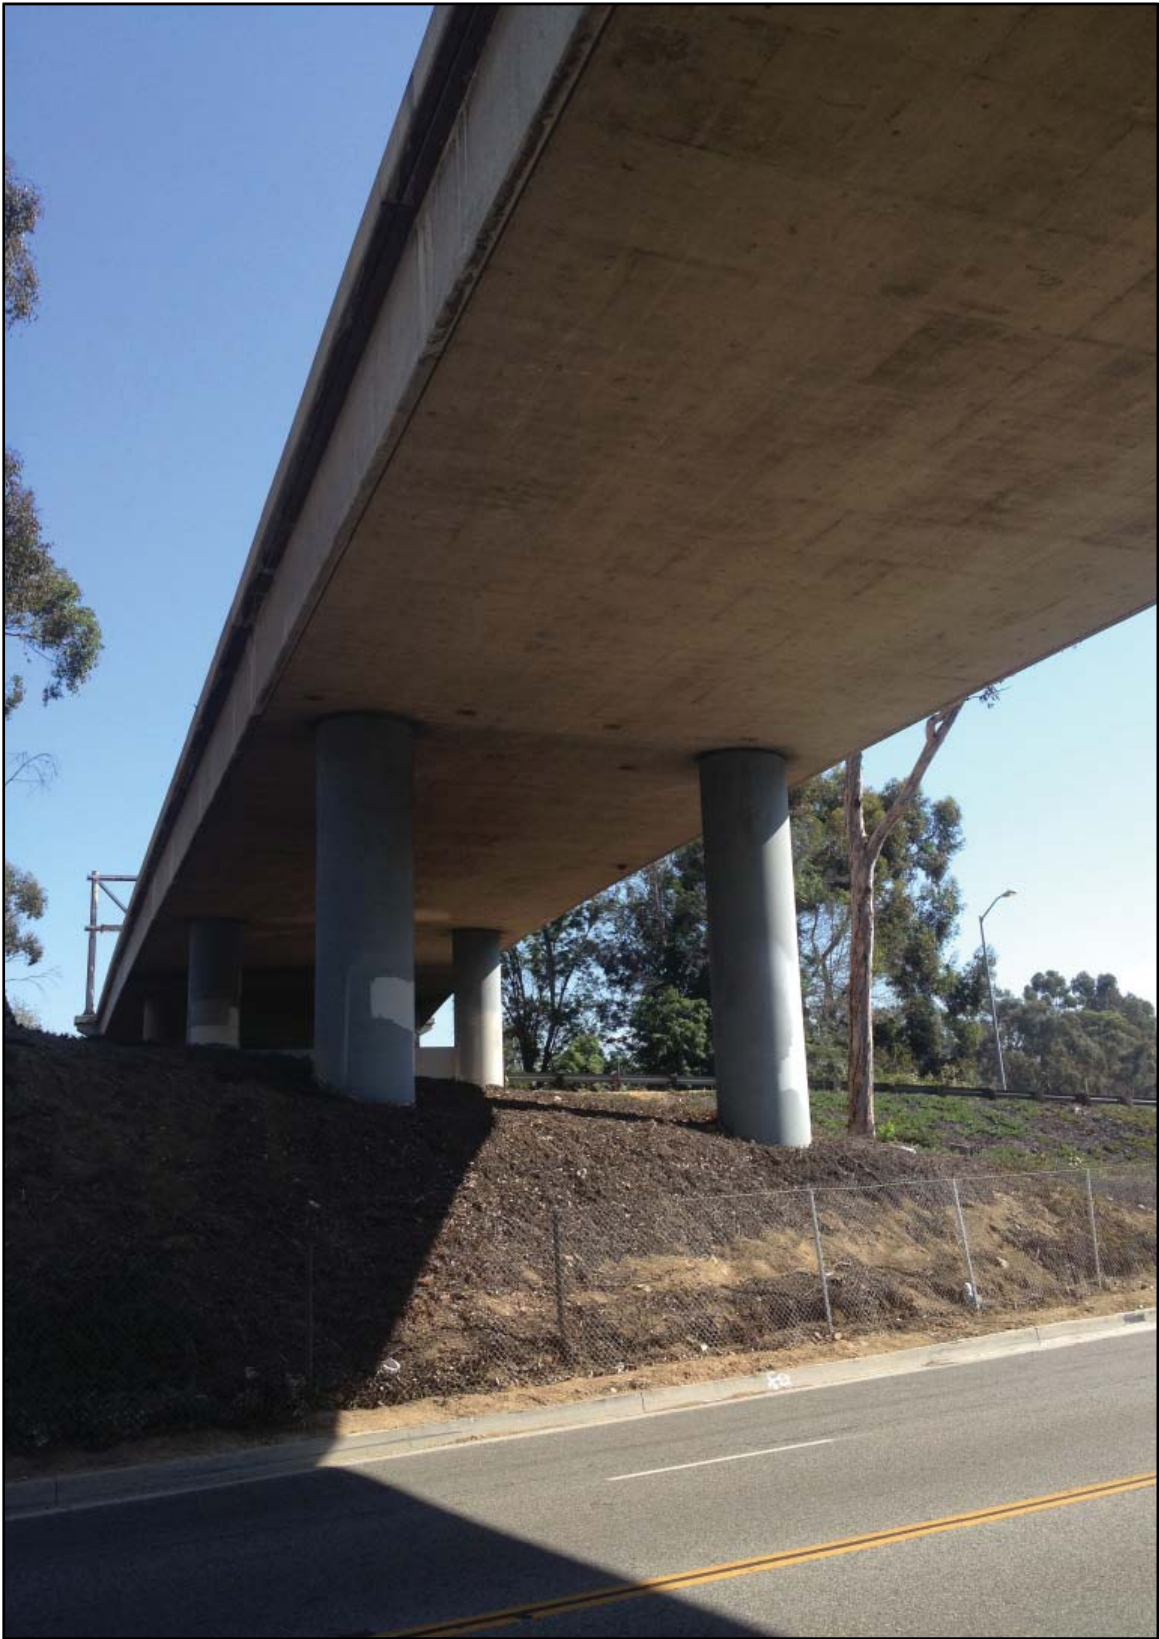
**PHOTO 1**

**Notes:** Drainage holes & crevices along edges possible roosting locations, stains (likely bird) present but bat use unlikely. Golf course within 0.25 miles may provide foraging/roosting habitat. No other open water available nearby.

N710-E & W10 Connector OC Bridge, facing north: (August 29, 2013)

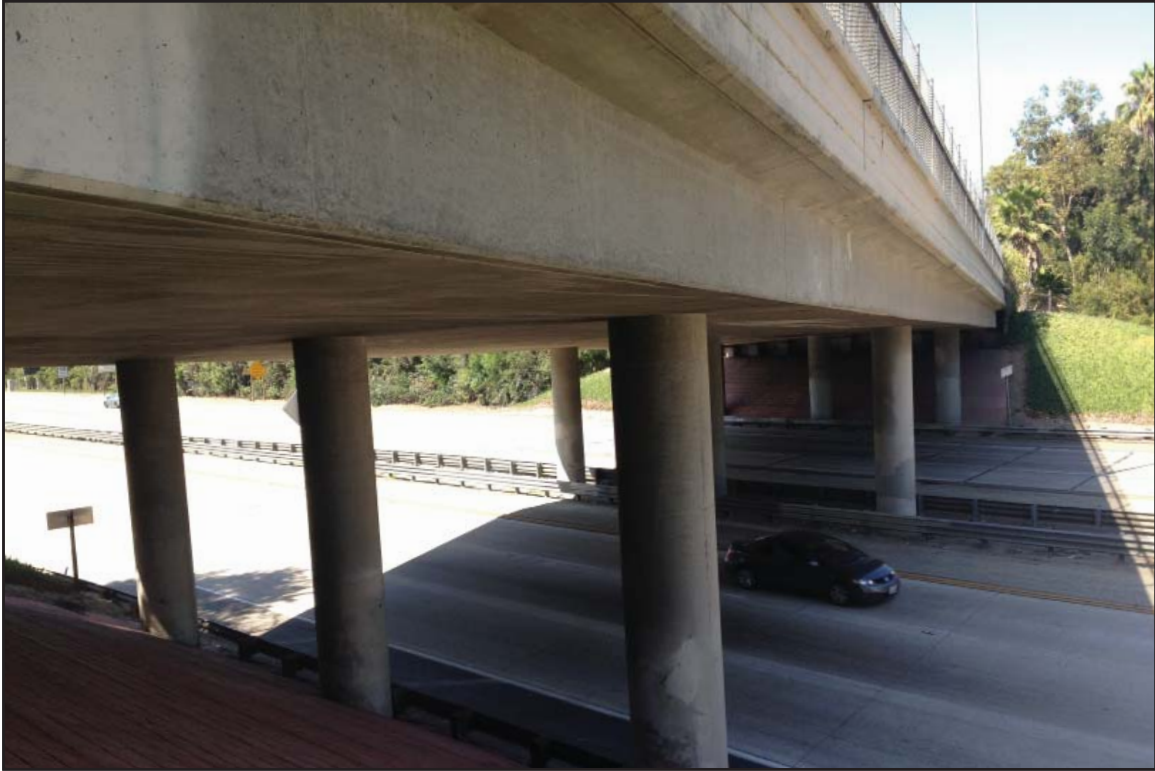
**PHOTO 12**

**Notes:** Drainage holes present, possible roosting availability in crevices but unlikely, very clean bridge, very few stains, crevices are not deep enough for bats. Above ground portion of Laguna Channel nearby (~0.15 miles away) may provide foraging habitat.

Hellman Avenue OC Bridge, facing west: (August 28, 2013)

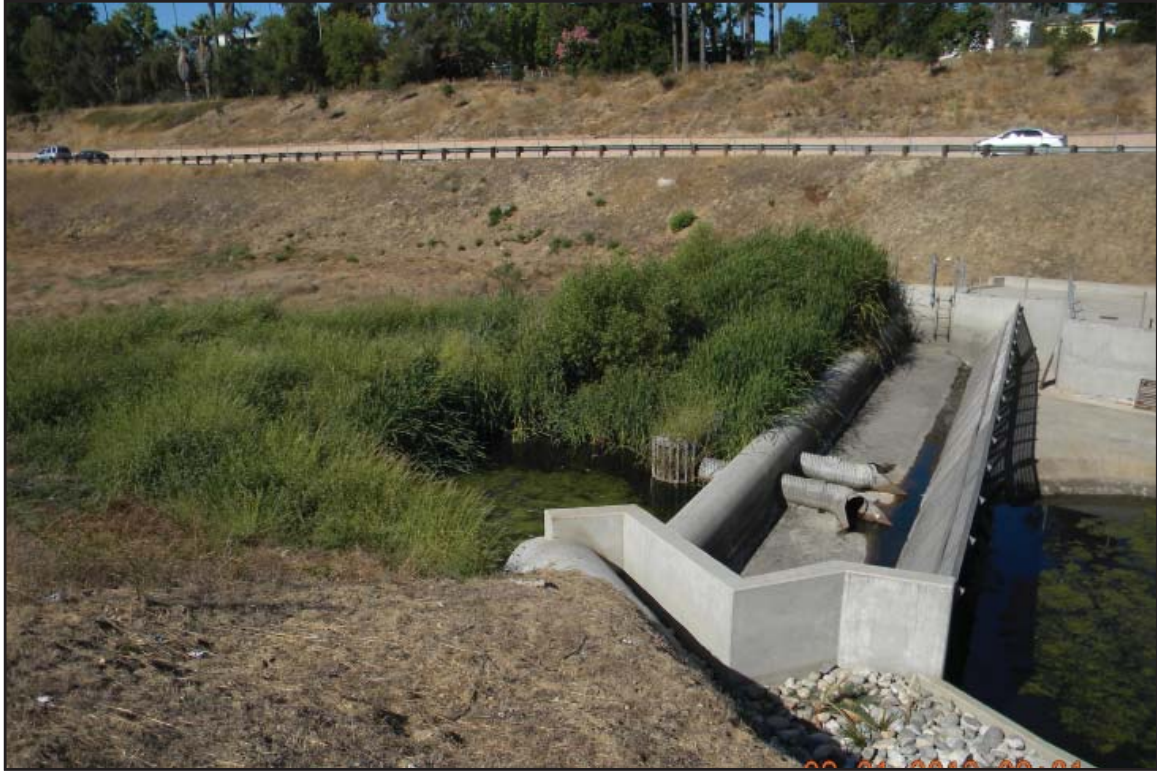
**PHOTO 21**

Del Mar Pump Station, suitable foraging habitat: (August 21, 2013)
