METROPOLITAN TRANSPORTATION AUTHORITY

WATER TREATMENT REPORT

AQUATEC CHEMICAL SERVICES

Water Treatment Services
Environmental Assessment

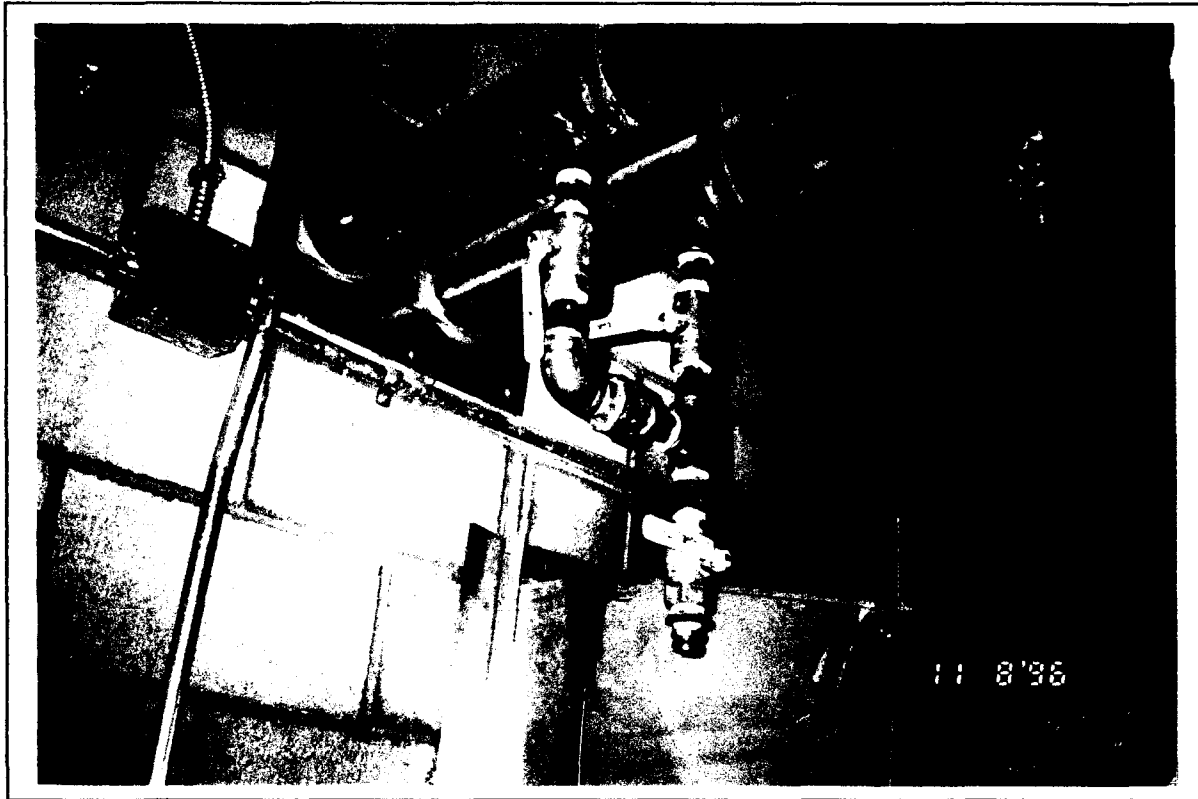
CLOSED CONDENSER - POC

These two cleaning programs will cause the pH of the system to fluctuate and promote the formation of sludge. This sludge will build up in the areas of low flow and must be removed from the system.

The samples of debris that were removed with the Lakos bag filter are indicative of this type of sludge formation. Continue to use the filtration system and maintain the nitrite levels of corrosion inhibitor.

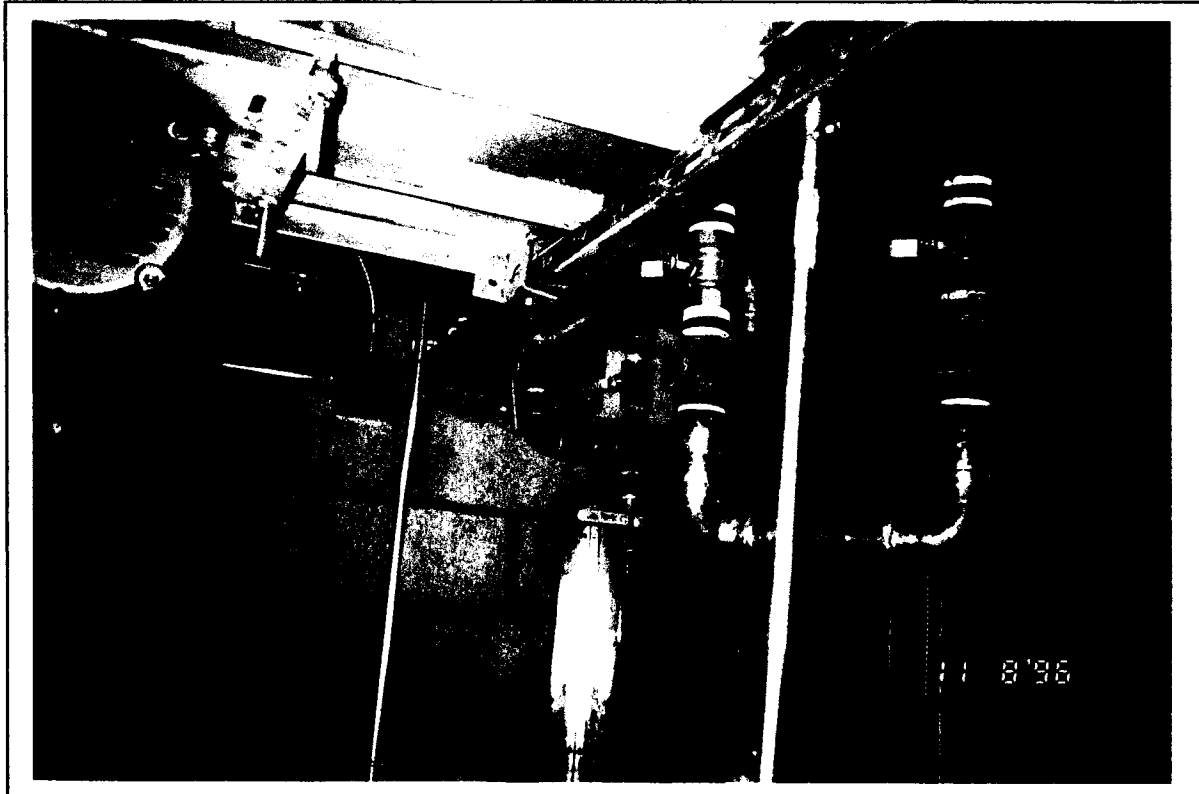
CLOSED CONDENSER - POC

The bypass size for the 4" recirculating line is 1" in diameter. This piping configuration could be used as a loop to promote recirculation during the cleaning process.

The flow through the 1" bypass is not adequate to achieve the desired flow velocity for a chemical cleaning.

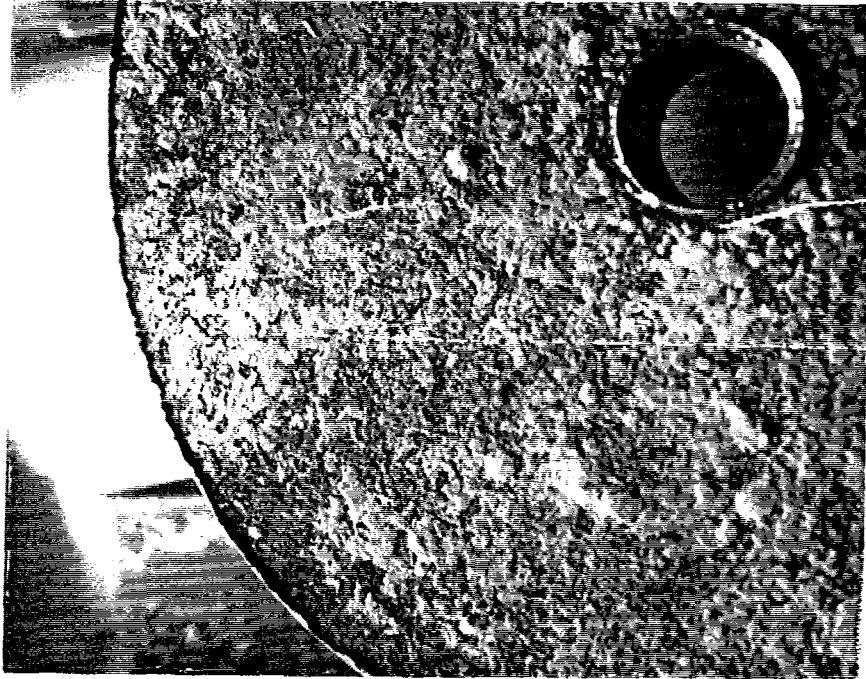
Figure 1- Photograph showing the corroded surface of the steel plug sample as received.

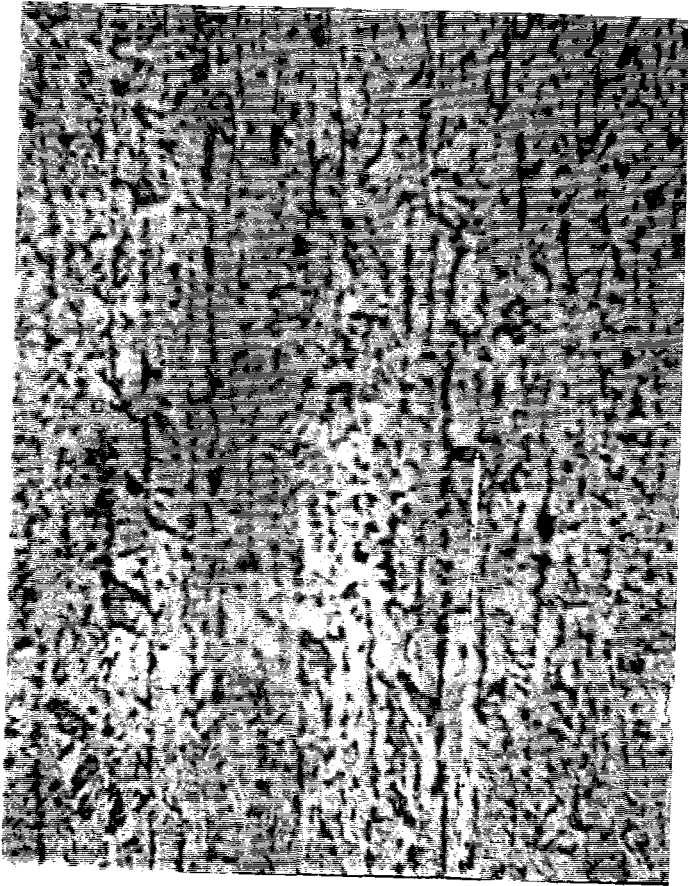
(a)Mid-section-Magnification 200X (b)Edge-Magnification 200X

Figure 2- (a) The structure at the center had very fine ferrite grains and pearlite banding.
(b) Corroded surface profile showed grain dissolution and general pitting.

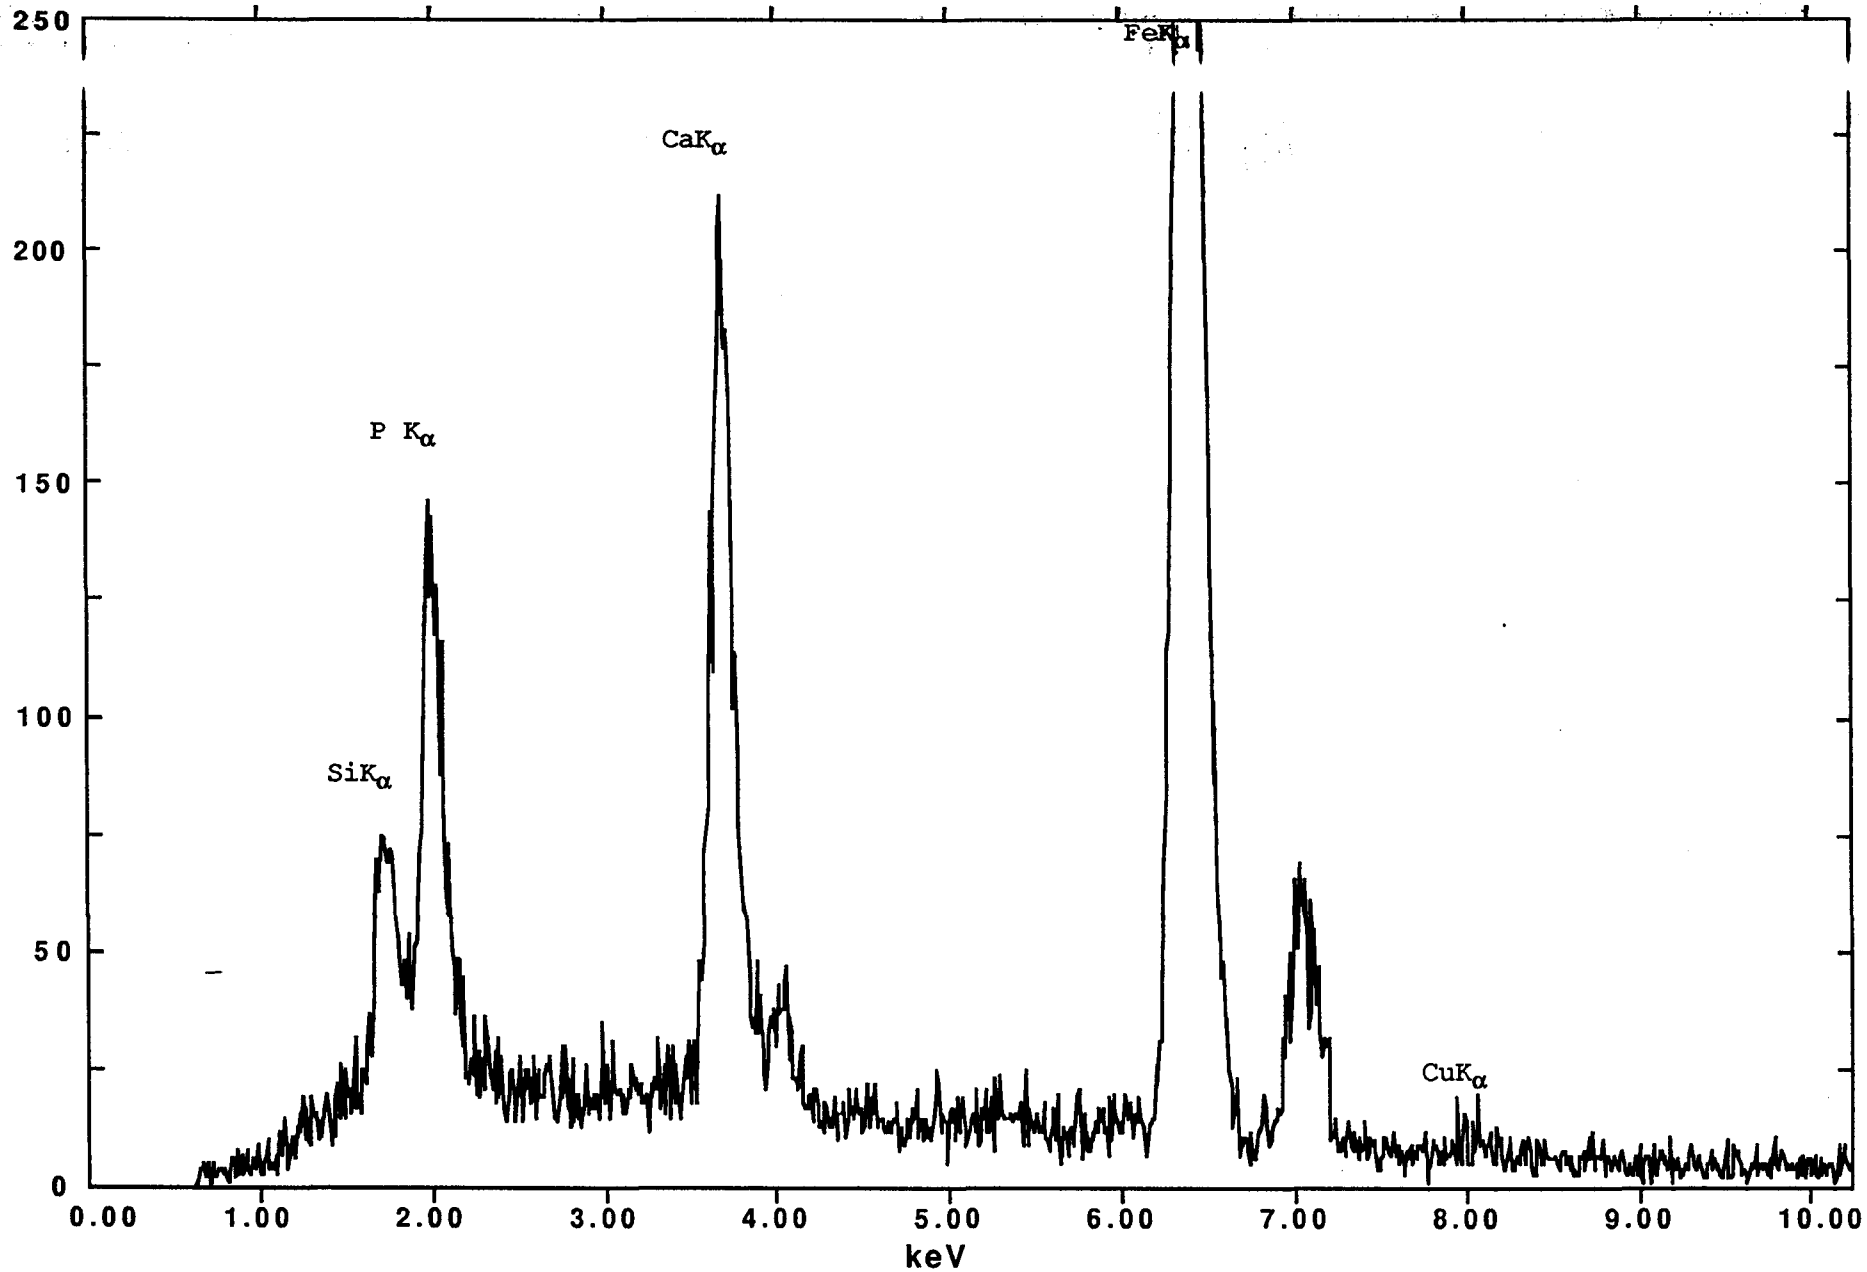
STEEL PLUG SCALE #1

Elem & Line	k-Value	Conc.	AtNo Fact.	Absorp Fact	Fluor Fact.
SiKA1	0.0001	0.0225	0.9006	0.5341	0.0037
P KA1	0.0002	0.0537	0.9323	0.6346	0.0035
CaKA1	0.0004	0.0947	0.9271	0.9301	0.0341
FeKA1	0.0031	0.8141	1.0201	0.9900	0.0014
CuKA1	0.0001	0.0150	1.0563	0.9369	0.0000
