Improved multi-lane roundabout designs for urban areas

May 2012

Campbell, D¹, I Jurisich² and R Dunn³ (2012) Improved multi-lane roundabout designs for urban areas. *NZ Transport Agency research report 476*. 284pp.

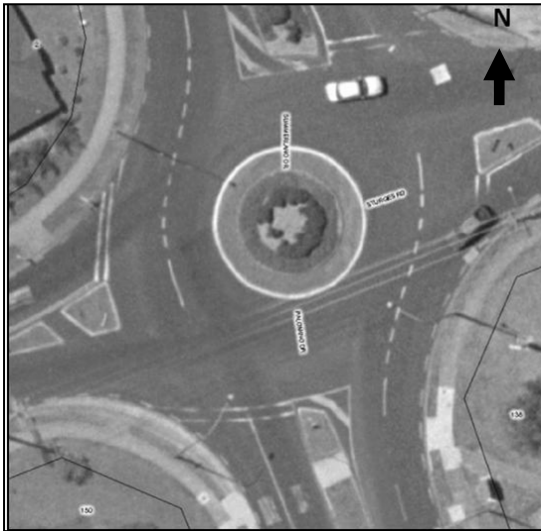
Figure 2.5 Aerial photo of the Palomino Drive–Sturges Road roundabout in Waitakere City, Auckland, prior to reconstruction

A new type of multi-lane roundabout design called the C-roundabout was developed in New Zealand specifically to improve safety for cyclists (Campbell et al 2006). To date, several of these have been constructed in Waitakere City, Auckland (an example is shown in figures 2.5 and 2.6). Justification for the works were to improve cyclist and pedestrian safety, and to address a history of high-speed single-vehicle crashes at that location. The C-roundabout uses confined geometry as a means of reducing vehicle speed to around 30km/h or lower, and consequently requires large trucks to straddle traffic lanes as they negotiate the roundabout. On-road cyclists are expected to benefit both from the reduced speed environment and also the narrow traffic lanes, which dissuade car drivers from overtaking them. Currently, the C-roundabout is being comprehensively evaluated as part of an NZTA research project; the results to date indicate that it is successful in reducing driver speeds and has been favourably received by cyclists.

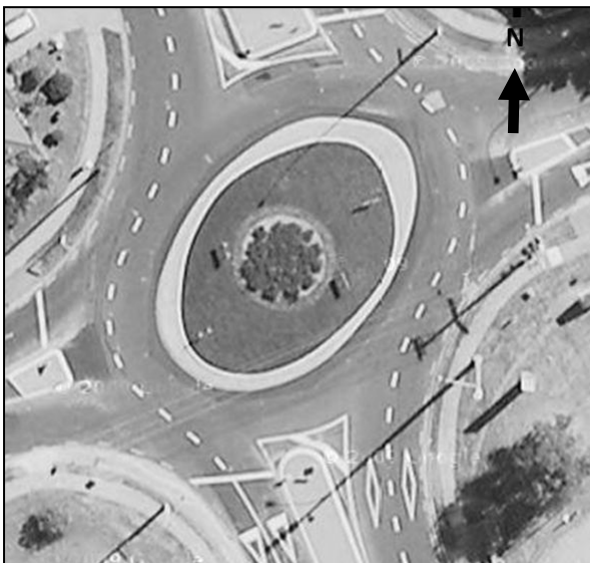
Figure 2.6 Aerial photo of the Palomino Drive–Sturges Road roundabout in Waitakere City, Auckland, after a C-roundabout configuration was installed in 2009

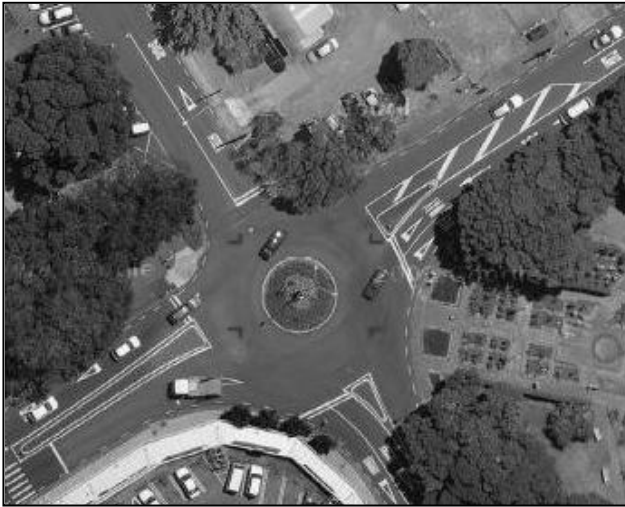
Figure 3.9 Example of a roundabout built with minimal regard for speed control: Lake Road and Taharoto Road in the North Shore, Auckland (photo courtesy of Google Maps)

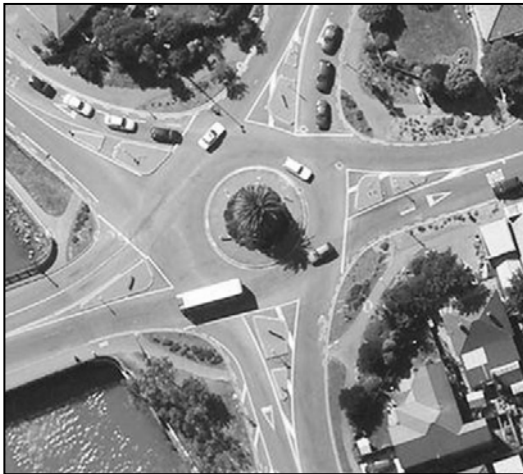
Figure 3.10 Example of a roundabout built with minimal regard for speed control: Pages Road, New Brighton Road, Owles Terrace and Seaview Road in Christchurch (photos courtesy of Google Maps)

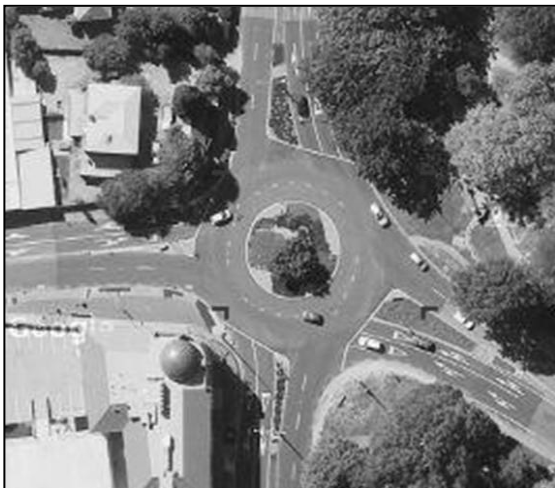
Figure 3.11 Example of a roundabout built with minimal regard for speed control: Riccarton Road and Deans Avenue in Christchurch (photos courtesy of Google Maps)

- The example in figure 3.8 at the Glenfield Road–Coronation Road intersection has a substantial crash history, experiencing 37 crashes, including six injury crashes for the five-year period 2004–2008.
- The example in figure 3.11 at the intersection of Riccarton Road and Deans Avenue has a particularly significant crash history with 45 reported crashes during 2004–2008, including seven minor injury crashes.

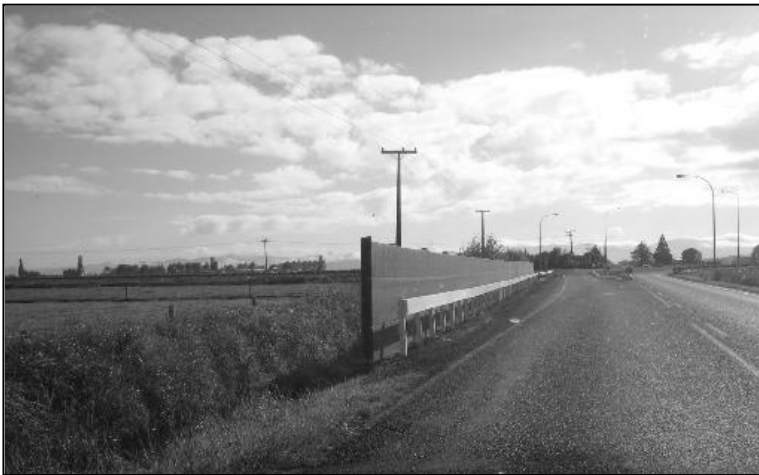
Figure 4.4 The minor road eastbound approach showing the hessian screen at the Paeroa-Tahuna Road-State Highway 27 intersection (photo taken in 2008)

In February 2001, a large (~100m) hessian screen was installed on the eastbound approach (figure 4.4), and was still there until a roundabout was installed in 2010. The screen terminated 25m prior to the limit line and disrupted the previously open view of oncoming vehicles to the left. A before/after study was undertaken that compared approaching vehicle speeds and also made an assessment of driver recognition of main road vehicles. It was determined that the hessian screen conclusively resulted in a substantial, immediate and long-term reduction of approach speeds, and also increased the rate at which drivers on the minor road identified traffic on the main road. A conclusion of the researchers was that visibility

At that time, the screen was not envisaged as a long-term solution, but rather as an interim measure until a more permanent solution could be installed. The crash history for the eight years since installation (2001–2008) shows a total of eight reported crashes including two fatality, two serious injury and three minor injury crashes involving eastbound vehicles colliding with main highway traffic. This would appear to indicate that although the visibility screening may have led to a reduction in driver approach speeds and be an improved situation compared to previously, the junction was still a significant crash location.

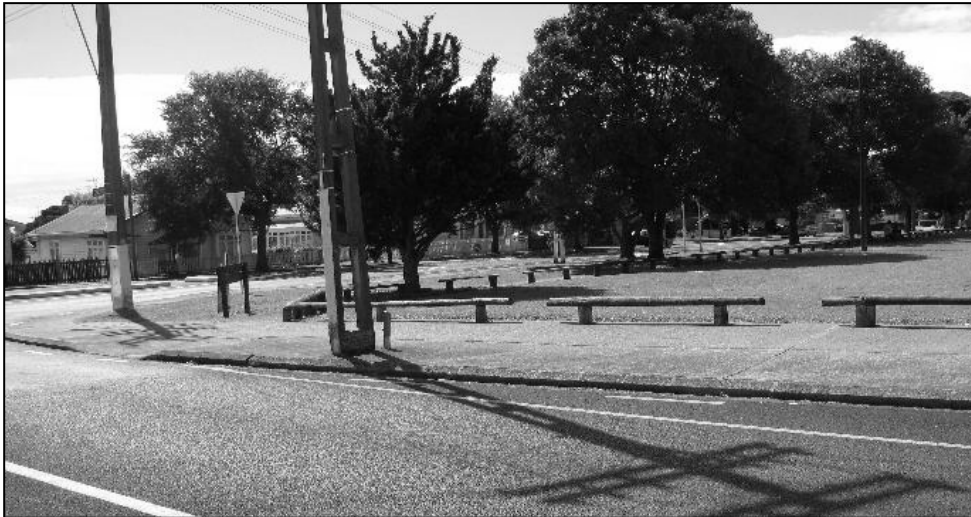
Figure 4.11 View taken on approach A at a point 25m from the roundabout limit line, showing the almost unimpeded visibility of opposing vehicles coming from approach D to the right

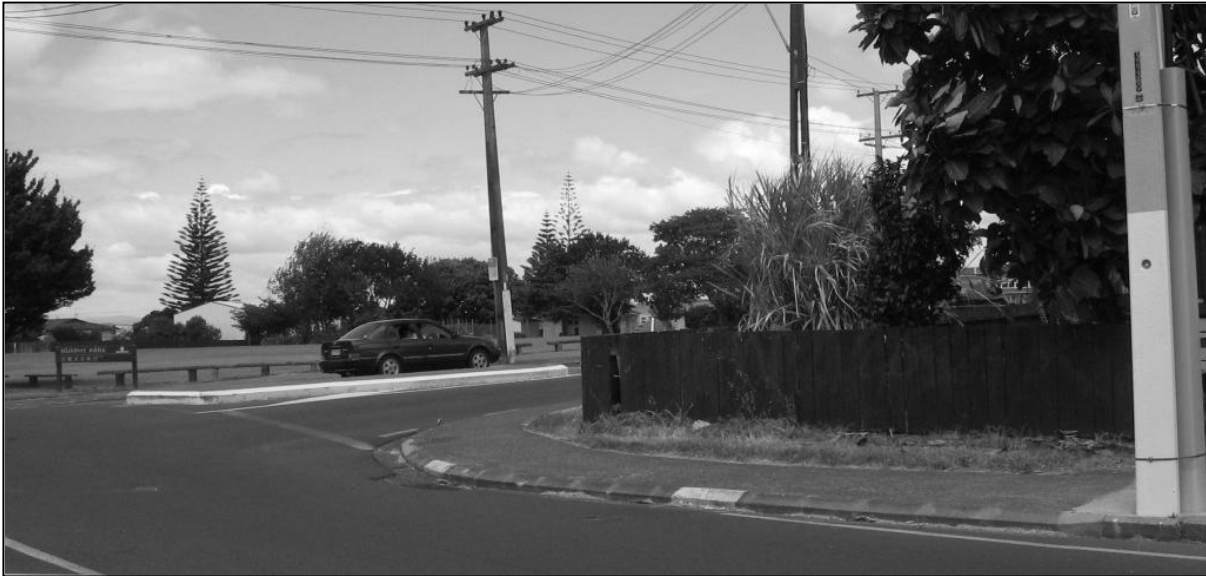
Figure 4.12 View taken on approach B at a point 10 m from the roundabout limit line, showing the corner boundary fence which severely restricts visibility of vehicles coming from approach A to the right

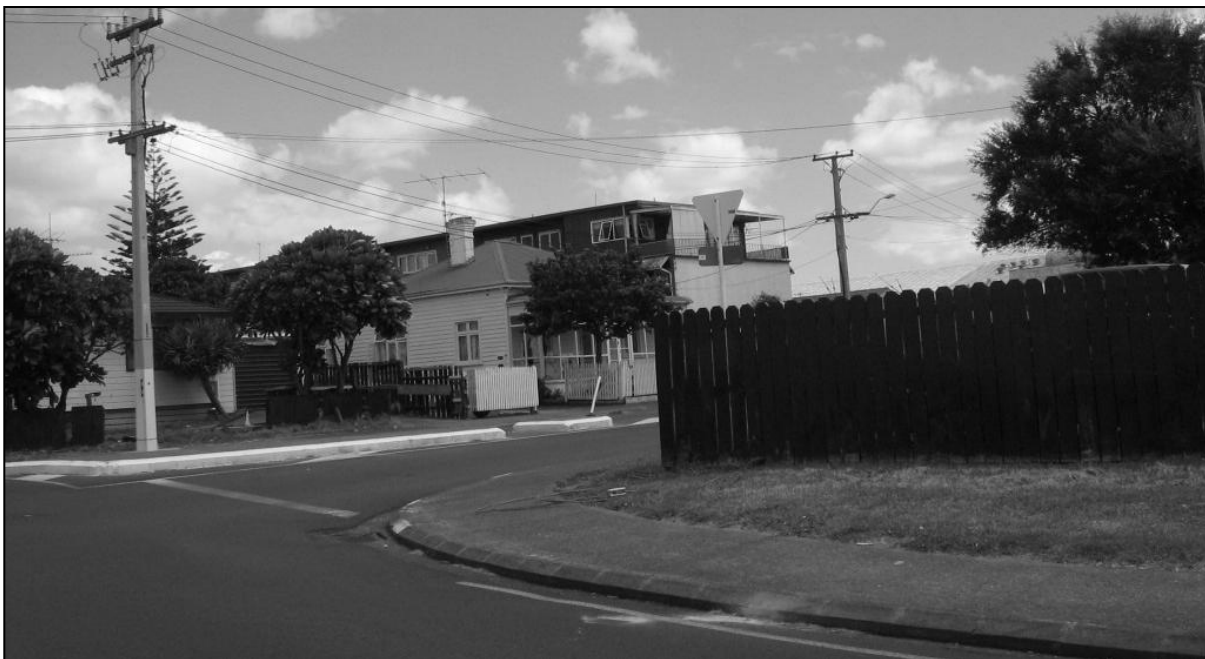
Figure 4.13 View taken on approach C at a point 10m from the roundabout limit line, showing the corner boundary fence which severely restricts visibility of opposing vehicles coming from approach B to the right

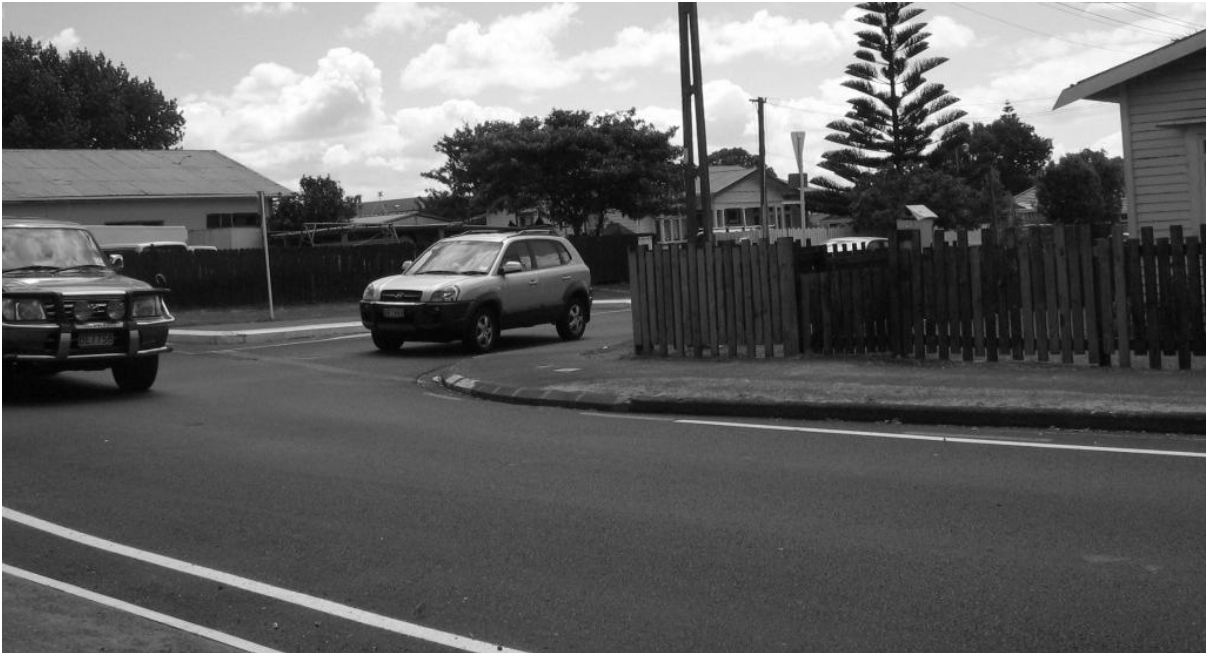
Figure 4.14 View taken on approach D at a point 10m from the roundabout limit line, showing the corner boundary fence which severely restricts visibility of opposing vehicles coming from approach C to the right

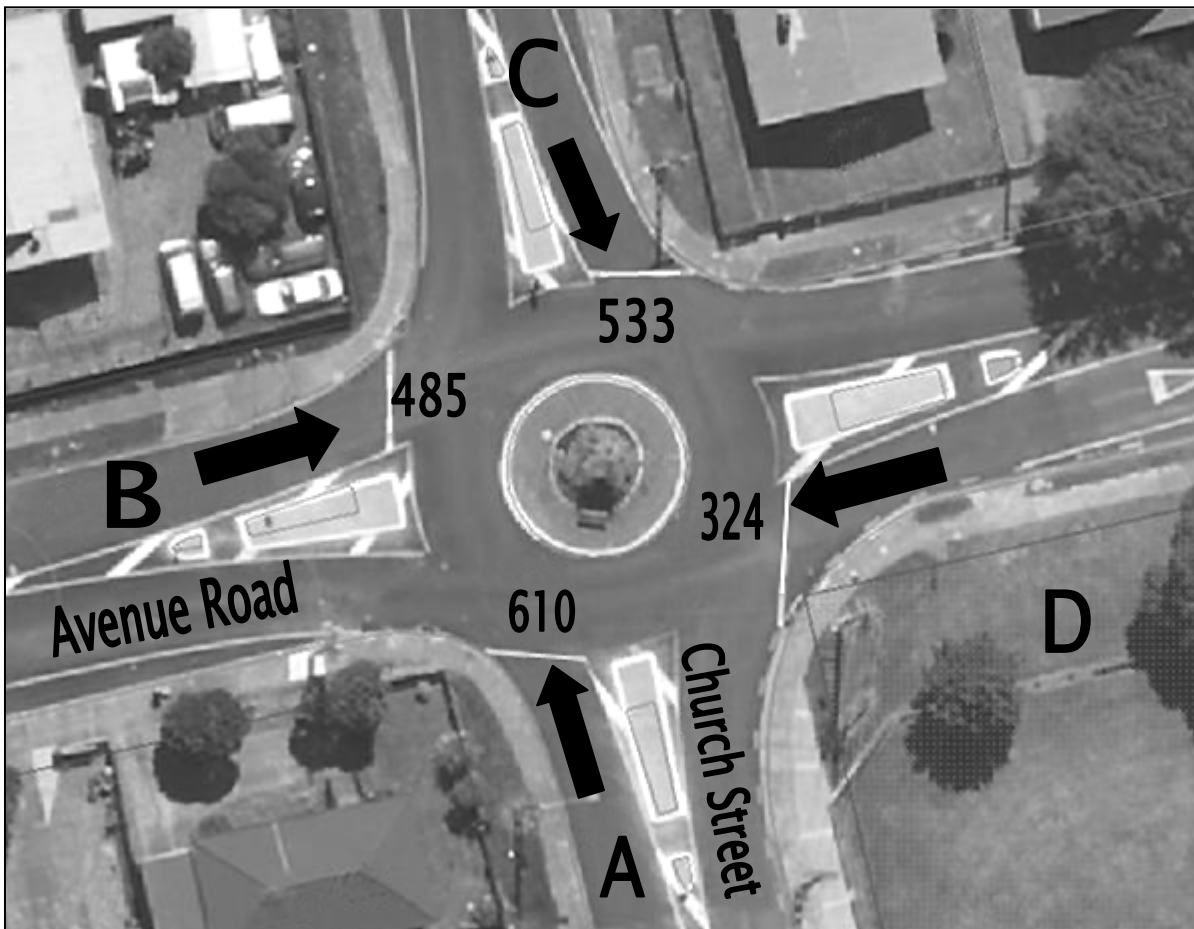
Figure 4.15 Diagram showing counted total traffic volumes between 9:30am and 3:00pm on one sample weekday

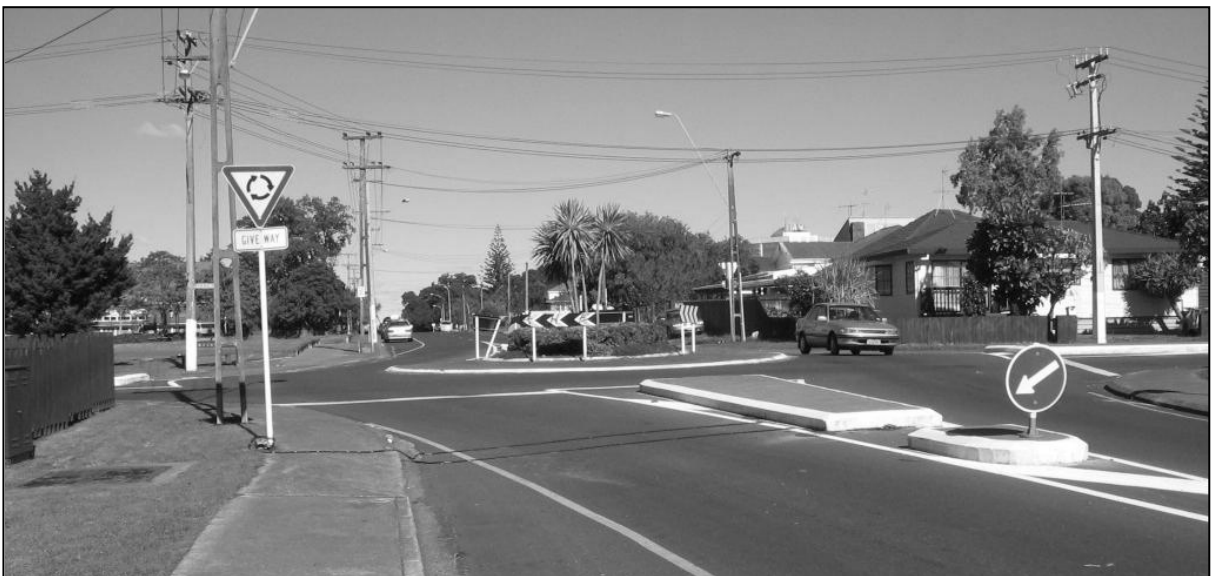
Figure 4.18 One of the tube counters around 10m from the limit line on approach C

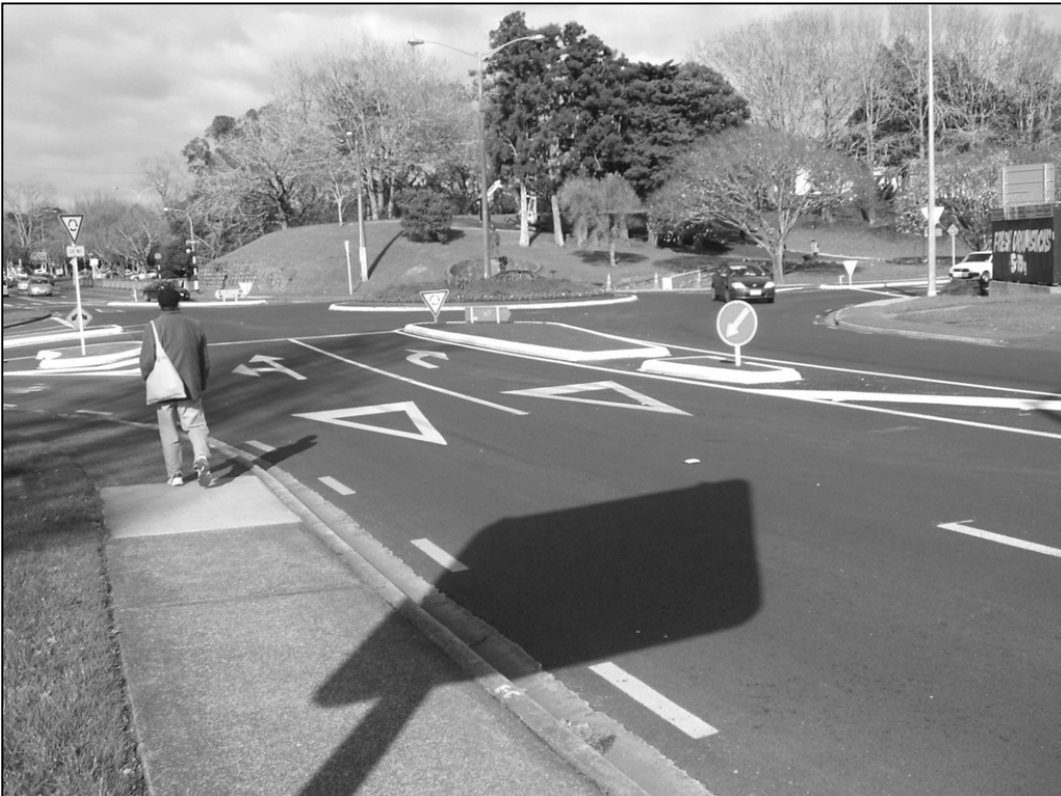
Figure 5.1 A pedestrian refuge island by the Sel Peacock Drive–Alderman Drive roundabout in Waitakere, Auckland

Pedestrian refuge islands (figure 5.1) are commonly installed at roundabouts where pedestrian volumes are low and do not justify installation of a zebra crossing or traffic signal facility. As the priority of way is with vehicle traffic it is assumed that pedestrians will use due caution before crossing, although at busy vehicle locations, refuge islands can be much less amenable than zebra crossings.

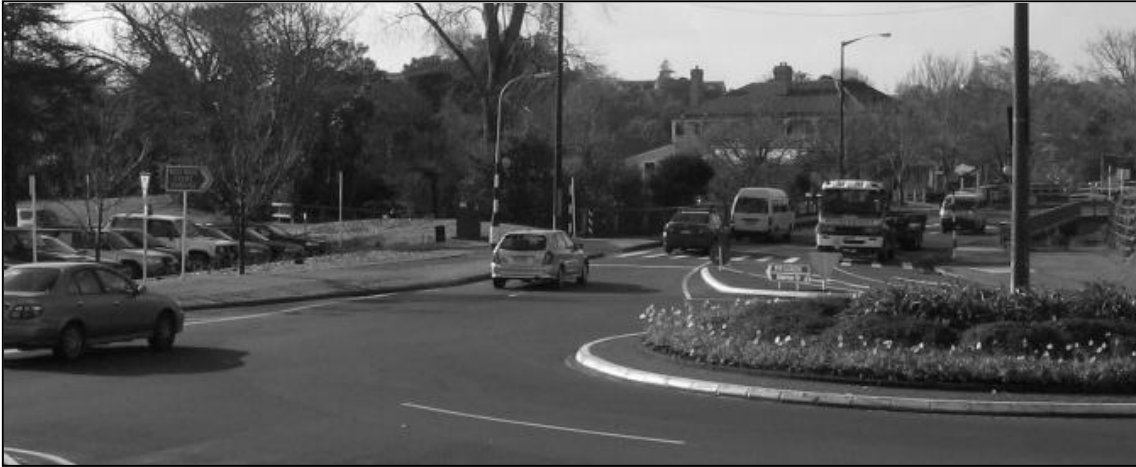
Figure 5.2 Zebra crossing facility at a roundabout in Waitakere, Auckland

Note: Here, both the standard 300mm Belisha beacons as well as 400mm orange Belisha discs have been installed, but both are relatively small and inconspicuous.

Zebra crossings (figures 5.2 and 5.3) are some of the most common facilities at roundabouts in New Zealand that cater for substantial volumes of pedestrians. Pedestrians have legal priority of way, although, according to the New Zealand *Road code* (NZTA 2010b), they are not supposed to step out if any vehicles are so close to the crossing that they cannot stop.

Standard signage for zebra crossings in New Zealand is illuminated Belisha beacons and/or reflective Belisha discs (refer to figure 5.2). It is the authors’ opinion that for busy arterial road applications, these are relatively inconspicuous and should be increased in size from the current standard of 400mm diameter to 750mm, which would be comparable to some overseas practice (refer to figure 5.3). It is recommended that the *Manual of traffic signs and markings* (MOTSAM) (NZTA 2010c) be amended on this basis.

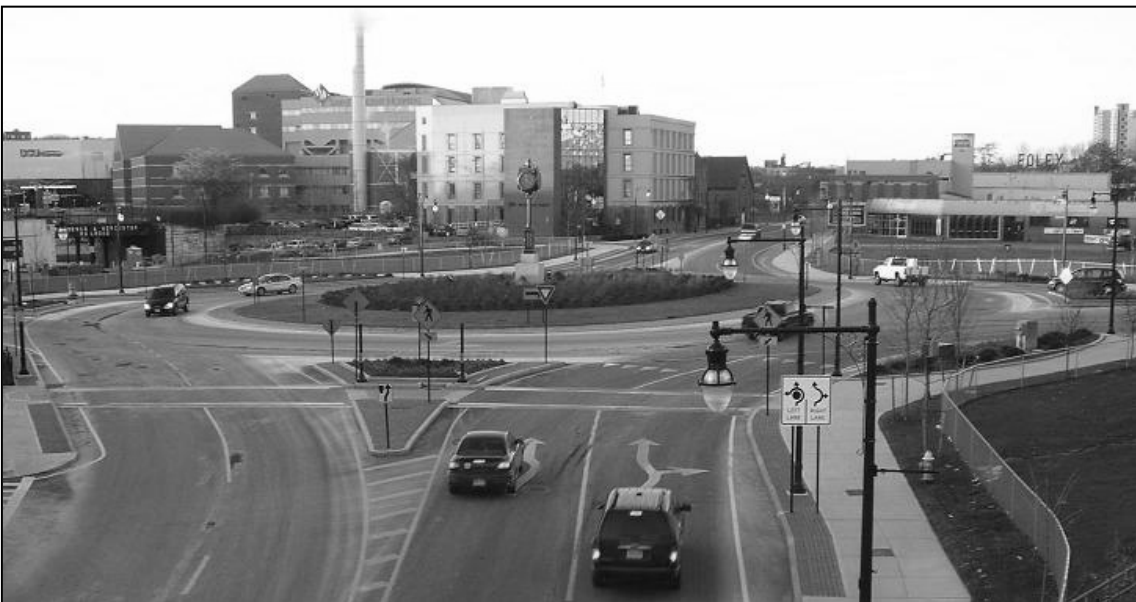
Figure 5.3 Photo of a roundabout in the US with zebra crossing type facilities (where drivers are supposed to yield to pedestrians) with associated signage* and slightly raised red paver treatments

* In the US, these facilities are not required to be marked with white stripes as they are in New Zealand. Note the much larger signs used at the crossing compared to the Belisha discs and/or beacons used in New Zealand.

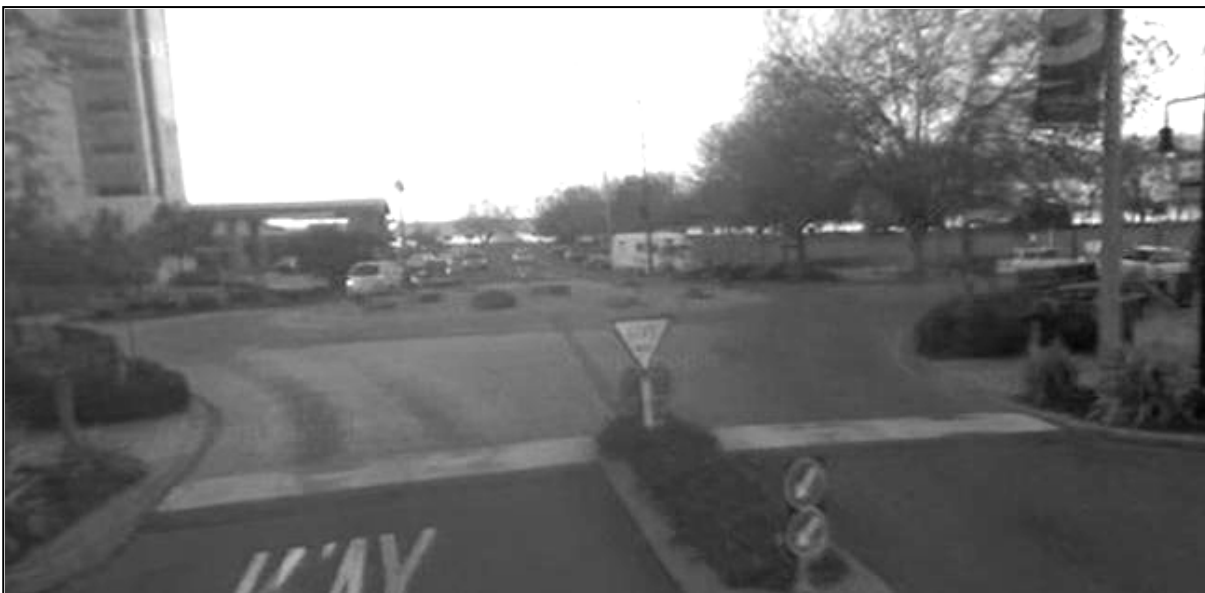
Figure 5.4 Whakahue Street–Tutanekai Street intersection in the Rotorua Central Business District (CBD), where the entire roundabout (single-lane) is constructed as a raised platform, giving a low-speed environment that is conducive to pedestrians

Raised platforms (figure 5.4) have occasionally been used to improve pedestrian safety at designated crossing points near roundabouts, and they do so by virtue of the fact that they provide a reduced traffic speed environment (provided that the platform is of sufficient height to have this effect). However, speed platforms potentially have some adverse effects on vehicle traffic and this subject is researched in more detail in chapter 7.

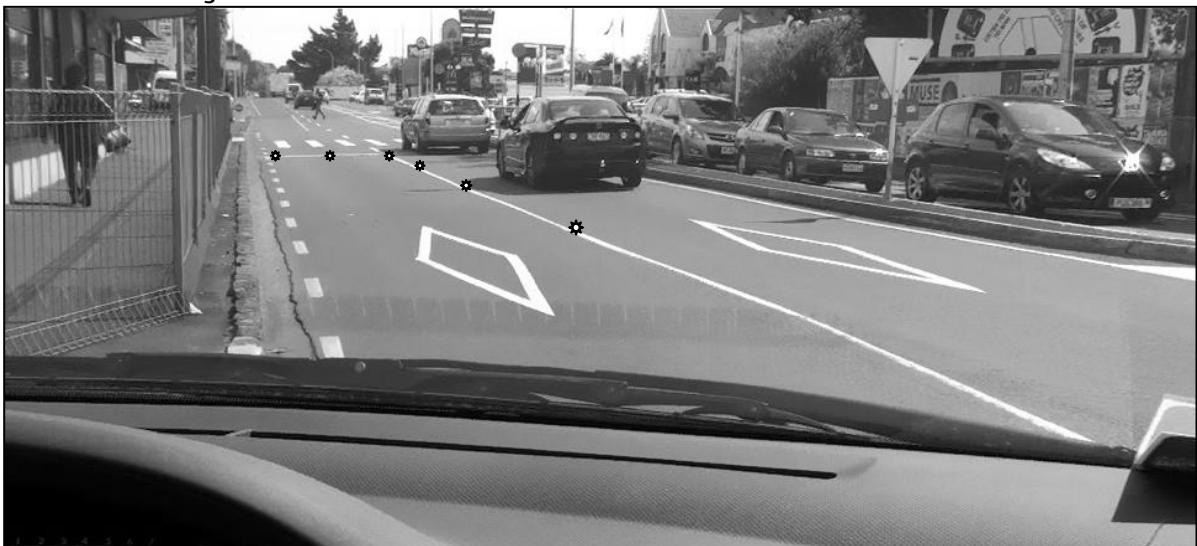
Figure 5.5 Driver view when exiting the Royal Oak roundabout of the Mt Albert Road zebra crossing fitted with amber flashing road studs

Note: the approximate stud locations have been added for additional emphasis, as they are less discernible in sunny conditions, such as when this photo was taken. The studs were installed in 2006, and it is entirely likely that with improved light-emitting diode (LED) technology, their visibility in daytime conditions would improve.

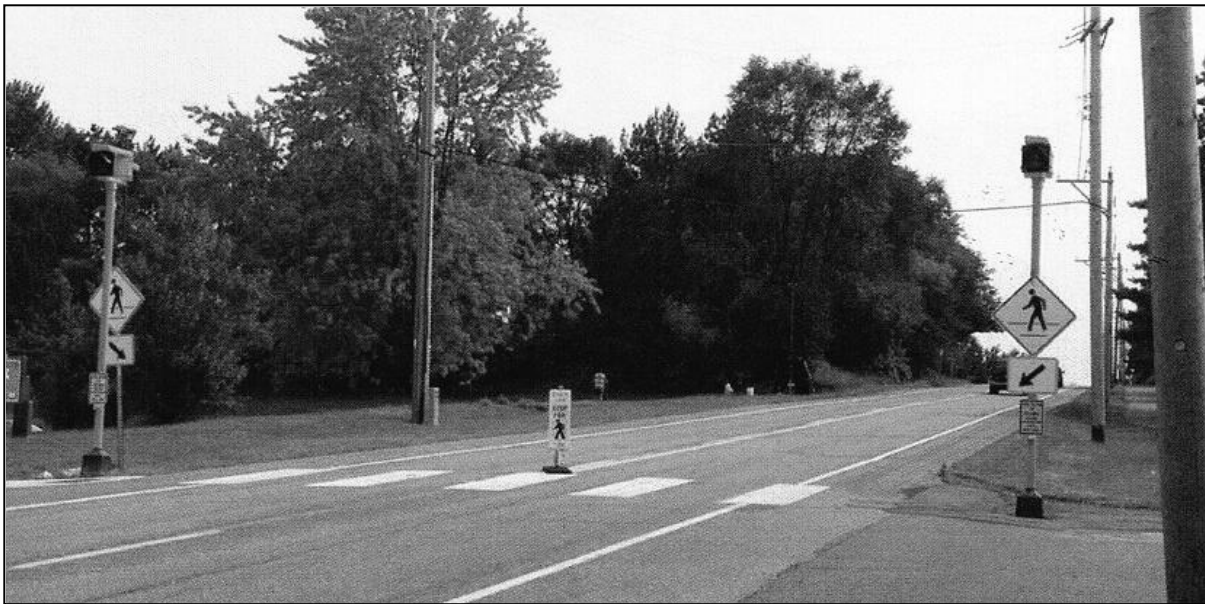
Figure 5.6 An example of an active warning sign with push-button call-up installed at a pedestrian crossing site in the US

A US study (Department of Transportation Minnesota 2009) was not absolutely definitive as to the benefits of flashing sign devices at sites where they are activated by a push-button, and recommended that if flashing signals were installed, an automated detection system of pedestrians be used because a proportion of users do not bother to activate the warning signs, which was considered to be a shortcoming.

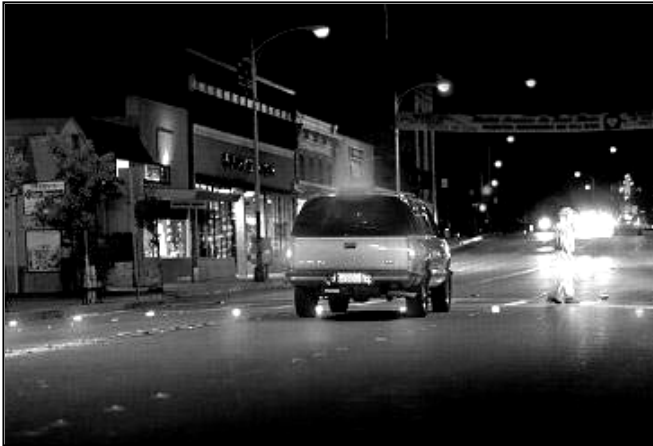
Figure 4.7 Flashing road studs used at a zebra crossing in the US (Malek 2001)

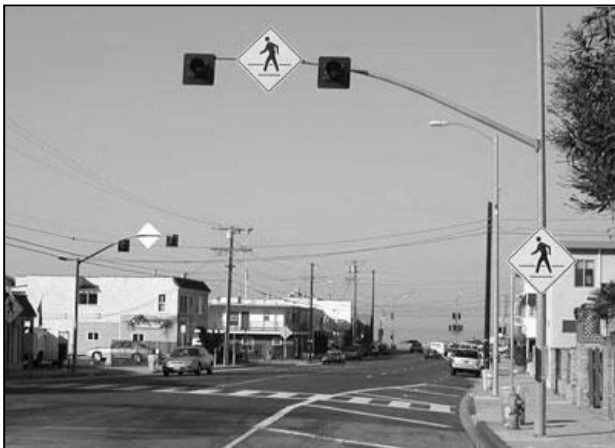
Figure 4.8 Overhead yellow flashing lights used at a zebra crossing in the US (Malek 2001)

A 2001 study from California (Malek 2001) compared effectiveness of flashing road studs (figure 4.7) and overhead yellow flashing lights (figure 4.8), both using identical infra-red systems for detecting pedestrians. The pavement lights were found to be substantially more effective in alerting drivers to the presence of pedestrians in both daytime and night conditions. It was acknowledged that road studs may be liable to additional maintenance costs. However, more recently, RRFBs have been used at pedestrian crossing facilities with some success and have also been measured as having superior performance to overhead yellow flashing light systems (Federal Highway Administration 2010). It is considered by the authors of this present report that RRFBs might be a more practical solution.

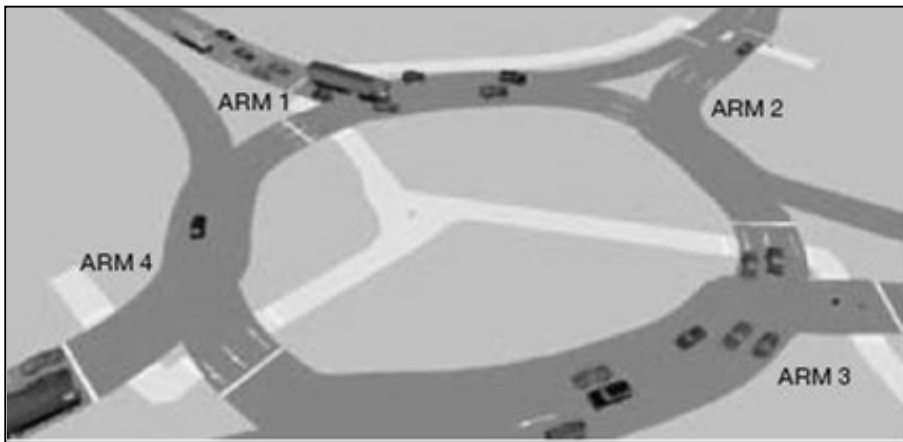
Figure 5.9 A full-time signalised pedestrian crossing at a multi-lane roundabout using the central island as a walking route (DfT 2009) (pale grey indicates the pedestrians' paths)

Signalised roundabouts as commonly used in the UK can satisfactorily accommodate pedestrians via signalised crossing points either on roundabout approaches or using the central island as a walking route (see figures 5.9 to 5.11), and they have demonstrable safety benefits for cyclists as well (Lines 1995; DfT 2009).

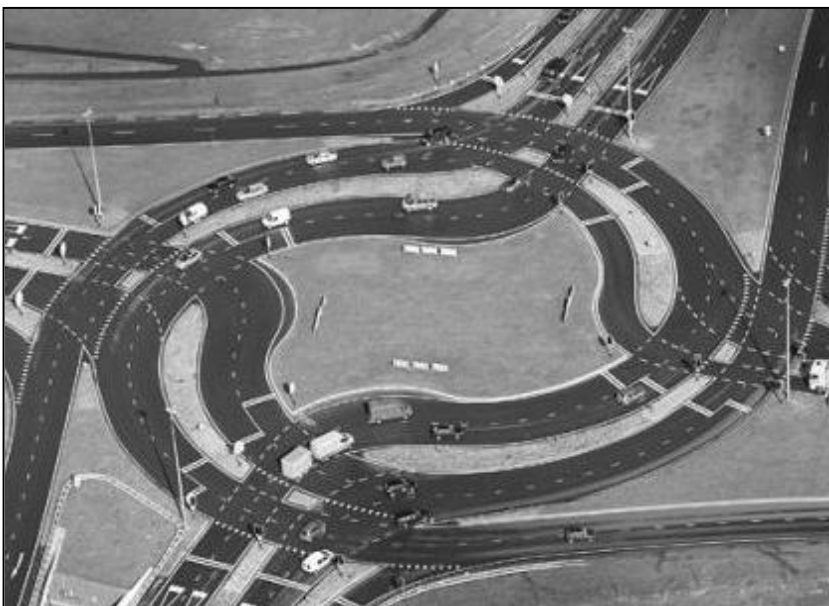
Figure 5.11 Model of a signalised turbo-roundabout (see chapter 8) currently operating in The Netherlands

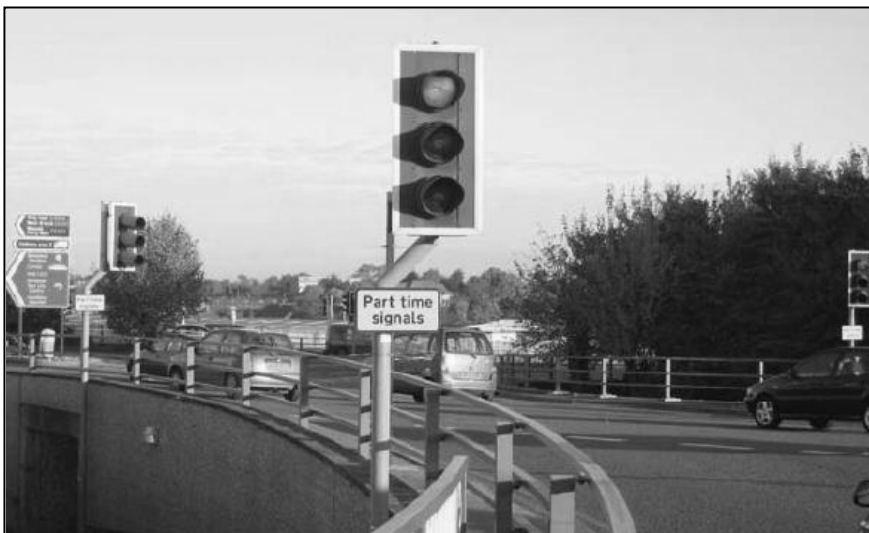
Figure 5.12 Part-time signals in the UK at a motorway junction (DfT 2009)

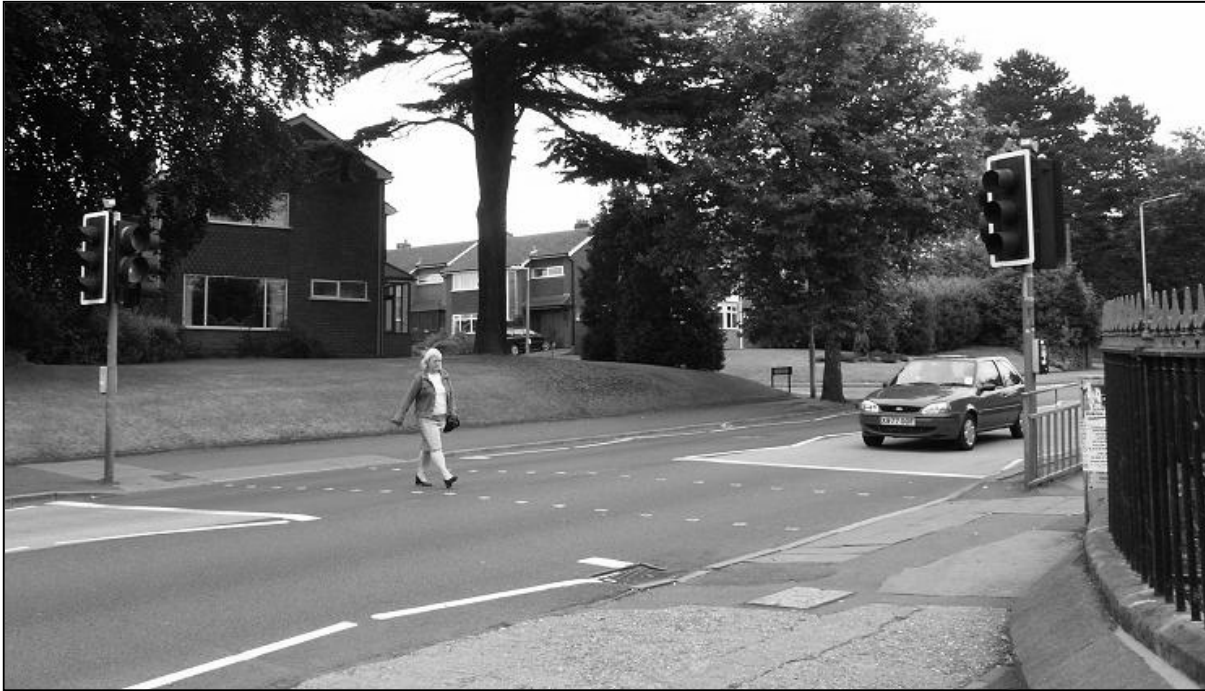
Figure 5.13 A British Pelican crossing, which is a full-time signal arrangement using three-aspect displays facing drivers. This particular example is fitted with nearside displays for pedestrians similar to those used by Puffin crossings (photo from Dudley Metropolitan Borough Council)

operations. It is based on the Pelican crossing (figure 5.13), which has been used since 1968 in the UK (Kennedy and Sexton 2009) and is also a standard configuration used in Australia.

Pelican crossings have a short period of displaying a fixed green walking figure for 4–9 seconds, during which vehicles are shown a red signal. This is followed by a clearance period with a flashing green figure for pedestrians and flashing amber lights to drivers, who may proceed if the crossing is clear (DfT 1995a). Australian studies have shown that vehicle delays at Pelican crossings are approximately half those at conventional pedestrian-activated crossings (Austroads 2009a).

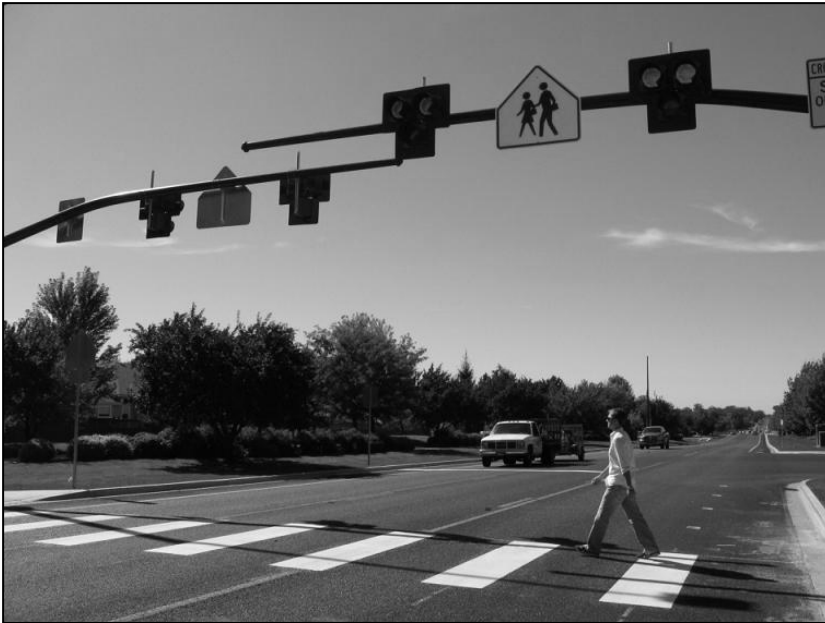
Figure 5.14 Hawk hybrid pedestrian signal in the United States (photo from Ada County Highways Department)

The Hawk system, as used in the US (see figure 5.14 and table 5.3), is very similar in practice to the Pelican. However, at roundabouts, it offers an option of blanking out the displays unless the Hawk is activated, so pedestrians confident enough to cross without using the lights can choose not to use the push-button at all. This is the main difference between the Hawk and the British Pelican – the Hawk has the flexibility to function as a regular zebra crossing facility when not activated by pedestrians, while the Pelican is a full-time signal arrangement. In addition, the Hawk uses only amber and red displays facing vehicles, but the Pelican also uses a green display.

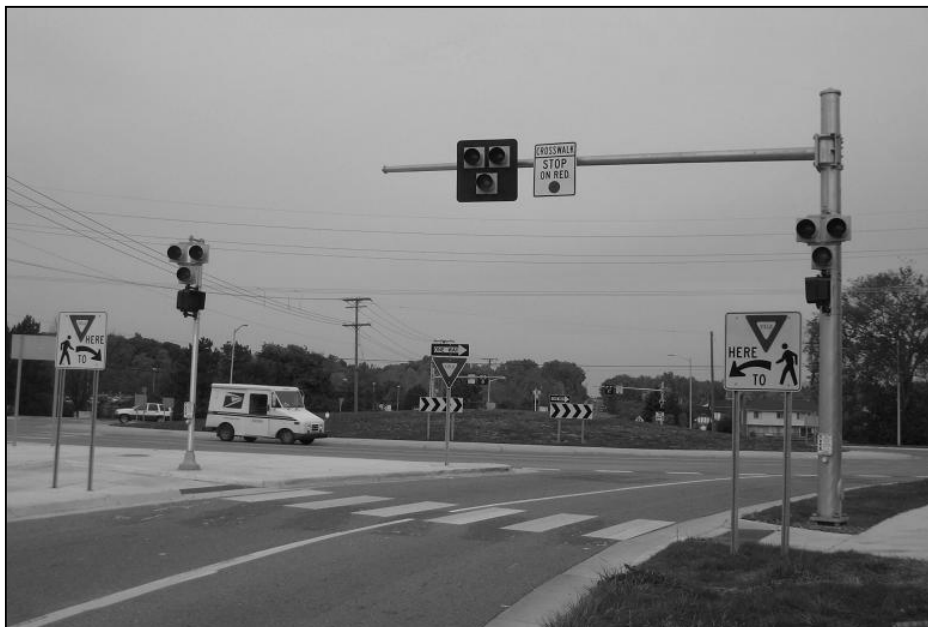
Figure 5.15 A Hawk signal at a two-lane entry to a roundabout in Michigan in the US

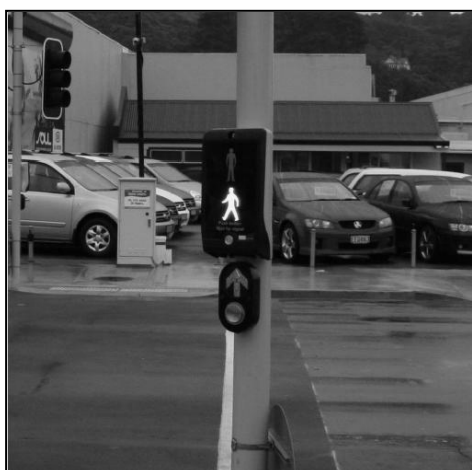
Figure 5.16 The nearside pedestrian displays that are a feature of the Puffin crossing recently trialled in Lower Hutt (King 2010)

Puffin crossings have recently been trialled by Lower Hutt City Council in New Zealand (King 2010; see figure 5.16), although pedestrian detection equipment was not used to reduce pedestrian walk time. The nearside displays associated with Puffin crossings apparently improved pedestrian compliance by around 60% compared to the previous standard signal arrangement, and this was considered by Lower Hutt City Council to be a worthwhile improvement for the roughly \$6,000 it cost to upgrade.

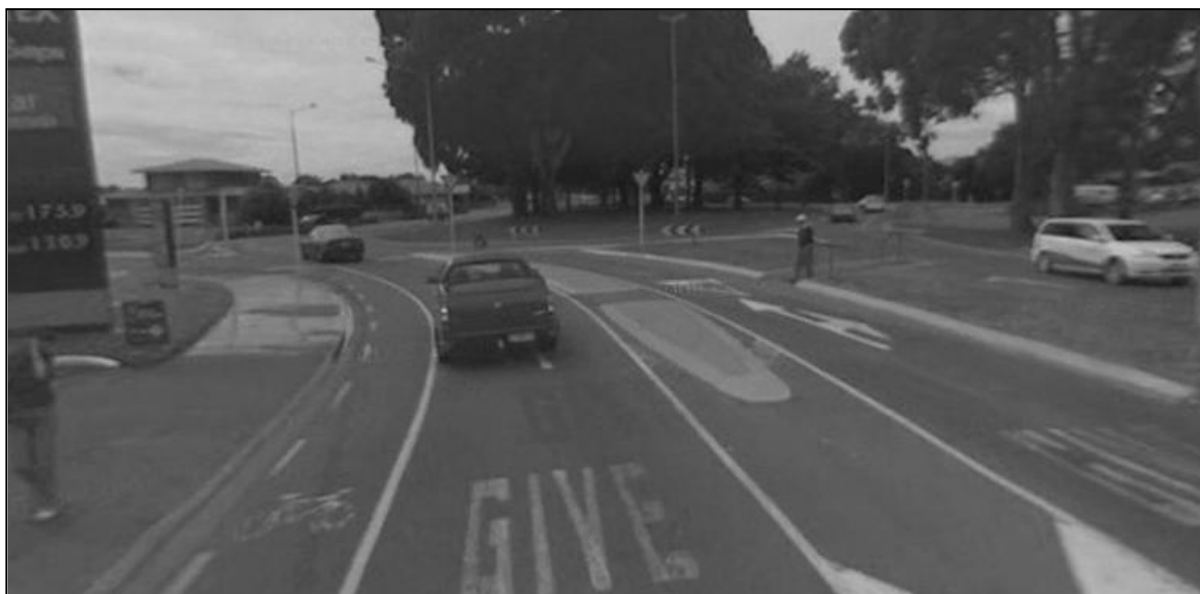
Figure 5.19 Harewood Road eastbound approach to a double-lane roundabout at its intersection with Highsted Road in Christchurch.

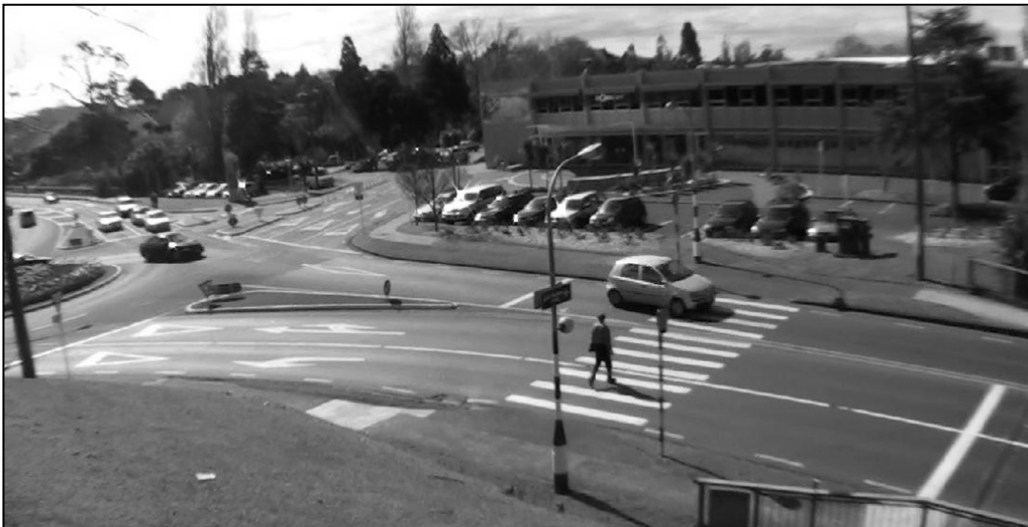
Figure 6.2 Photo showing the full width of the zebra crossing on the Alderman Drive arm of the roundabout. This shows the only time a vehicle was observed driving past when a pedestrian coming from the south side was on the crossing

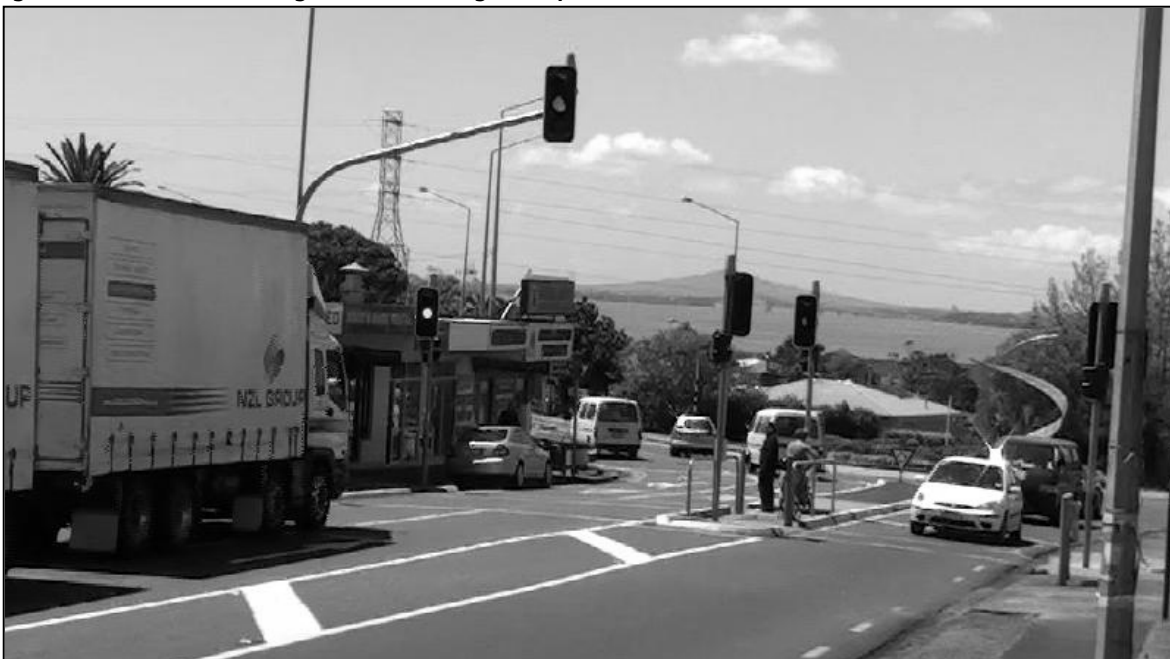
Figure 6.4 View of the signalised crossing facility across Edmonton Road

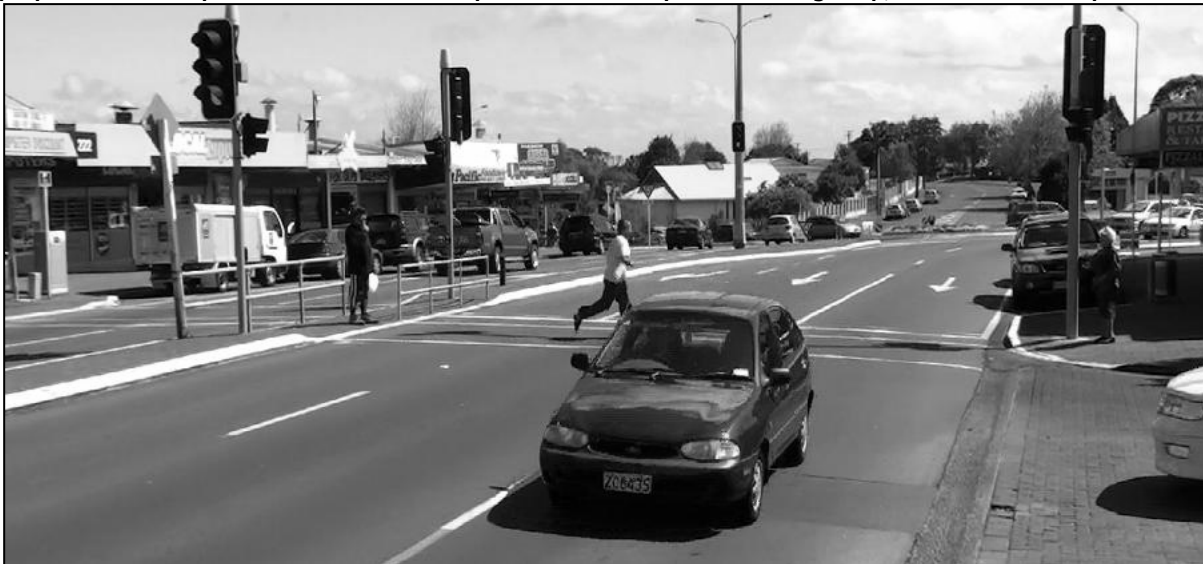
Figure 6.8 This photo at the Great North Road signalised crossing shows that while some pedestrians are prepared to wait up to a minute before the pedestrian cross phase is brought up, others are not so patient

This location was videoed for two hours on a weekday off-peak period in October 2009 (see figure 6.8), and 77 pedestrians were observed crossing Great North Road in the vicinity of the signalised crossing point. Thirty-four pedestrians used the signals to cross either the full width or one stage of the crossing, with only 18 using it to cross the two stages (23% of total pedestrians). Twenty-nine pedestrians (38%) did not use the signals at all to cross, and 45 (58%) crossed the road for one stage or more without using the signals. No pedestrian-vehicle conflicts or near-conflicts were observed.

The substantial proportion of pedestrians crossing heedless of the pedestrian phase is probably because of the signal timing arrangement. Pedestrians wishing to use the staggered signals arrangement have a crossing time of around two minutes from first pressing the push-button to stepping off the kerb at the other side, comprising around one minute's wait from the first call-up to the pedestrian phase when crossing the first stage, 30 seconds' wait upon pressing the button on the central island for the second stage, and the remainder being walking time. Over the two-hour observation period, 10 false call-ups for the pedestrian phase were triggered by pedestrians that crossed before the pedestrian crossing phase was called up. Although the pedestrian wait times here are most probably set up to minimise delays to Great North Road traffic (ie to give more time to accumulate pedestrians on the footpath before crossing phases are called up), it is a compromise to pedestrian convenience and, consequently, a potentially adverse impact on pedestrian safety.

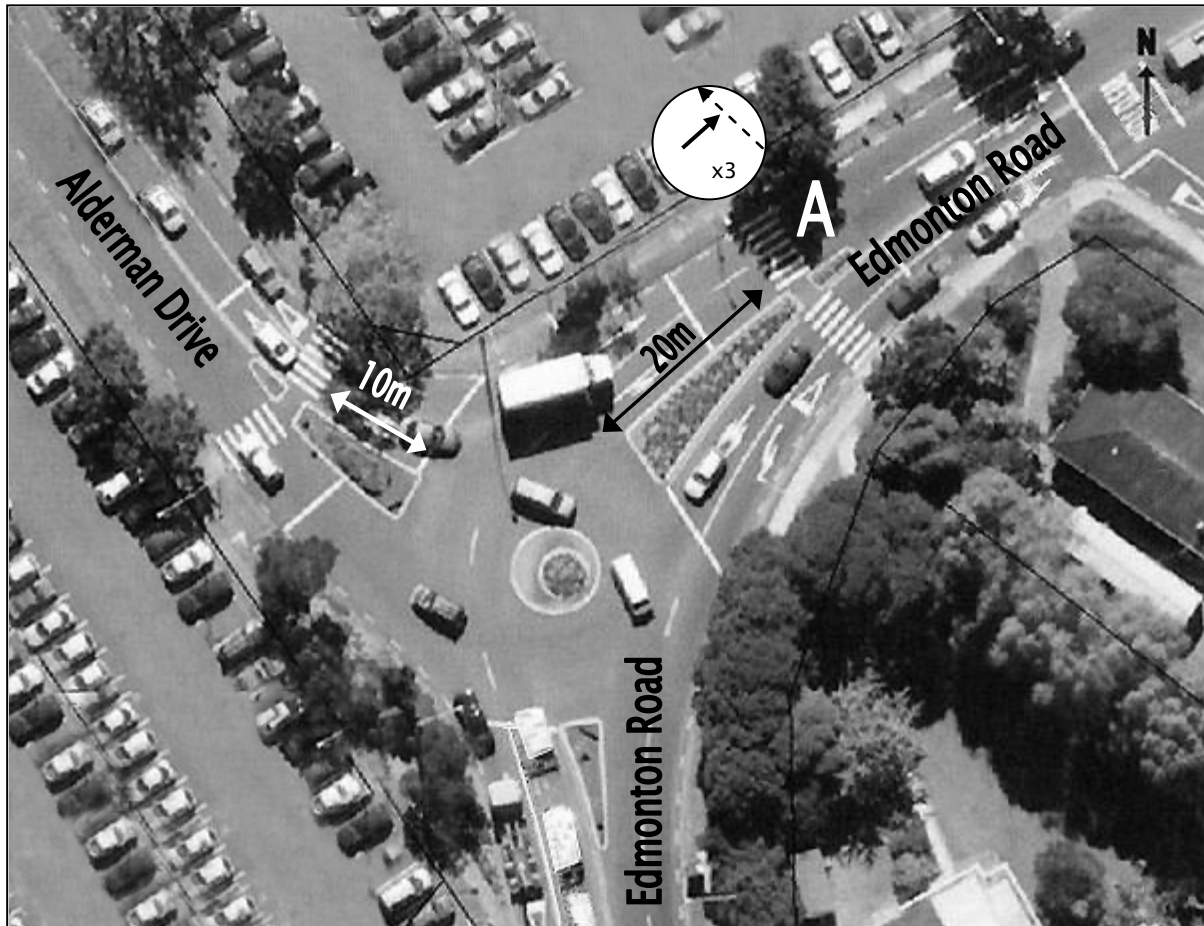
Figure 6.9 Aerial view of Alderman Drive–Edmonton Road, showing crash locations

The zebra crossing on the Edmonton Road arm (location A in figure 6.9) has dual lanes in both directions and is approximately 20m from the roundabout. The exit side has had three reported pedestrian crashes (table 6.5), one which involved one vehicle passing another in queued conditions.
