Improved multi-lane roundabout designs for urban areas

May 2012

Campbell, D¹, I Jurisich² and R Dunn³ (2012) Improved multi-lane roundabout designs for urban areas. *NZ Transport Agency research report 476*. 284pp.

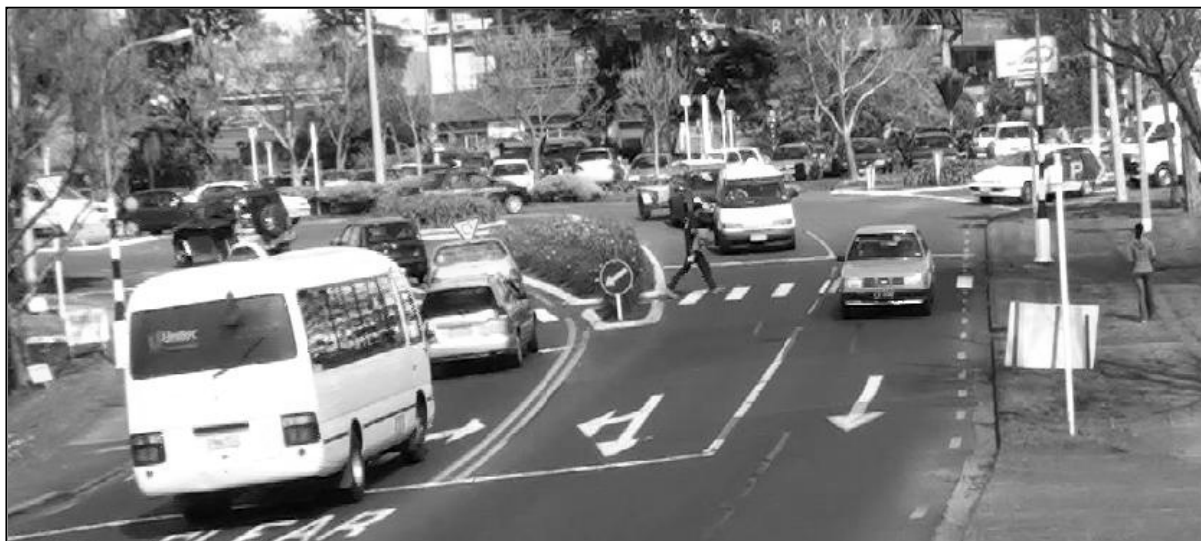
Figure 6.10 Photo at the Edmonton Road crossing, showing vehicles driving through while a pedestrian is using the crossing

During two hours of video observation undertaken during a weekday from approximately 9:00am to 11:00am, 4 (24%) out of the observed 17 pedestrians crossing from the south side had exiting vehicles from the roundabout drive through while they were stepping out onto the zebra crossing from the central island (figure 6.10). This demonstrates a similar circumstance to one of the reported pedestrian injuries at this crossing in 2001, where a van in the nearside lane had stopped to let an 11-year-old girl walk across from the east side, who was then struck by a vehicle in the adjacent lane that had failed to see her crossing in time. The remaining 13 pedestrians during the video period had exiting vehicles stop for them prior to their reaching the crossing on that side. This observation highlights that drivers are likely to be accelerating once they have left the roundabout and might be less prepared to stop for pedestrians. No pedestrian-vehicle conflicts or near-conflicts were observed.

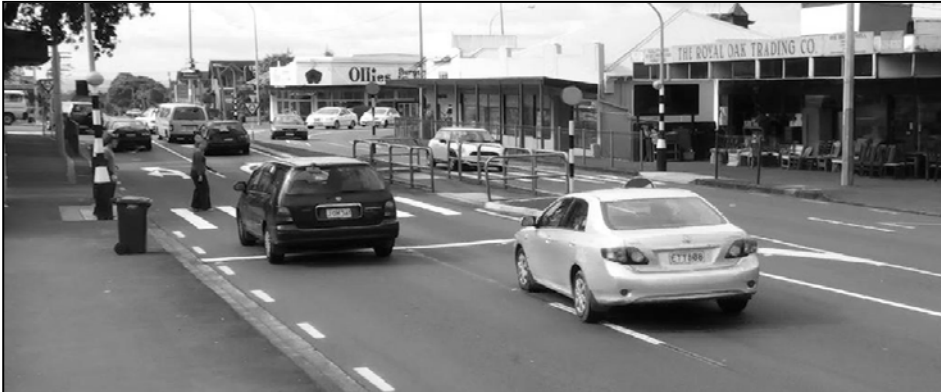
Figure 6.13 The first near-conflict incident at the Mt Albert Road zebra crossing

Two pedestrian near-conflict situations were observed which, if either the pedestrian or driver had not taken evasive action, would have resulted in a collision (figures 6.13 and 6.14). In the first scenario (figure 6.13), a following vehicle (the light-coloured sedan) in the kerbside traffic lane decided to shift lanes after the vehicle ahead (the darker station-wagon) stopped to let two pedestrians cross. In this instance, the pedestrians were alert to the situation, and the vehicle managed to undertake an emergency stop before reaching the zebra crossing markings. The flashing road studs possibly contributed towards alerting the driver. In the second (figure 6.14), the pedestrian was not hidden by queued vehicles, but the kerbside vehicle (the light grey station-wagon) was approaching at speed and only just managed to perform an emergency stop prior to the pedestrian stepping out onto the zebra crossing. Again, it is possible that the flashing road studs contributed towards alerting the driver. Figure 6.15 also shows a scenario that illustrates a potential safety issue, especially for younger pedestrians, at multi-lane crossing points such as these. Thirty-seven percent of pedestrians observed during the survey crossed in circumstances where stopped vehicles in the nearside lane would be restricting how visible they are to

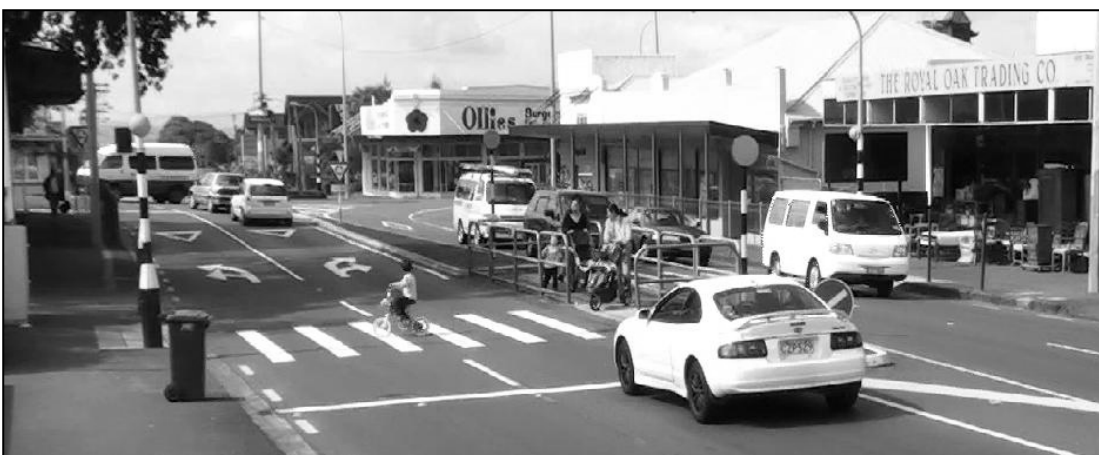
Figure 6.15 A recorded incident demonstrating the particular vulnerability of younger pedestrians, who are even more likely to be hidden from view by queued vehicles

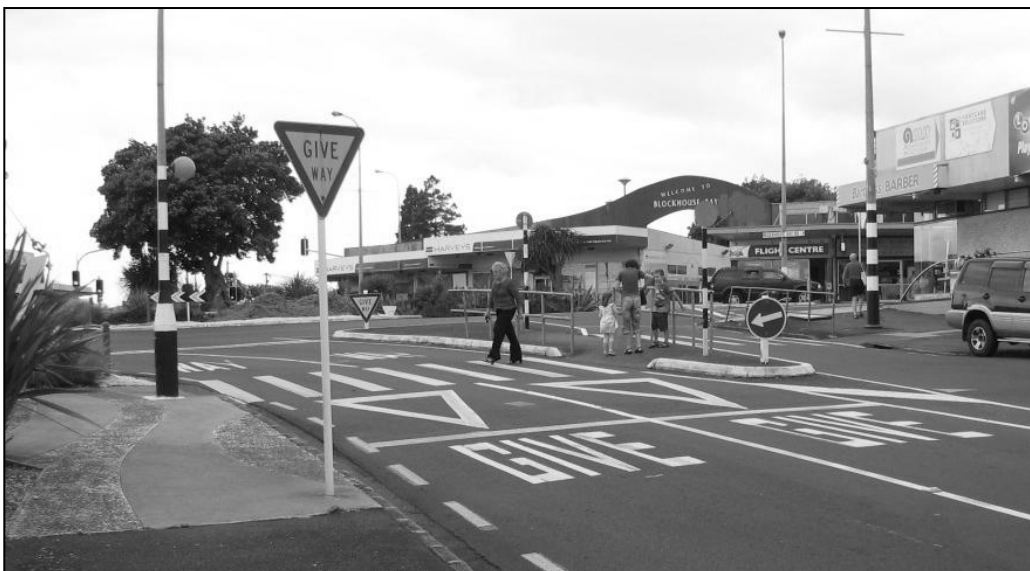
Figure 6.19 Photo of the staggered pedestrian zebra crossing on the Kinross Street approach to the Blockhouse Bay roundabout

At the zebra crossing on Kinross Street (location D), which is located approximately 10m from the roundabout with a staggered island arrangement (see figure 6.19), two pedestrian crashes and one rear-end crash have been reported (table 6.9). Both pedestrians were quite elderly (80 and 81 years old). The single-lane exit has experienced two rear-end crashes.

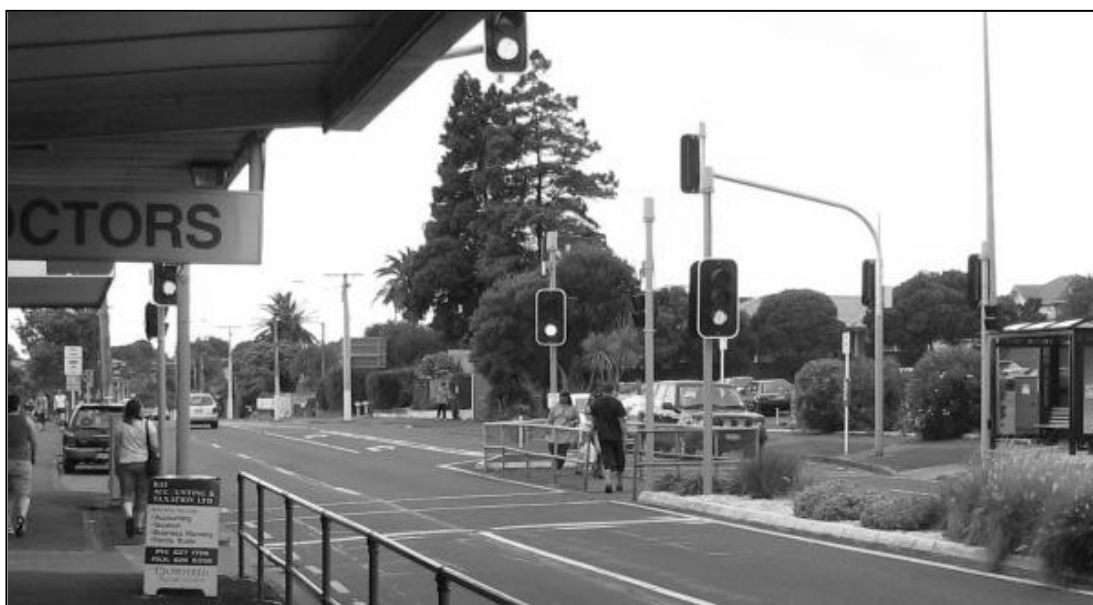
Figure 6.20 Photo of the staggered pedestrian signal arrangement on Donovan Street at the Blockhouse Bay roundabout

The staggered pedestrian signals on Donovan Street (figure 6.20) approximately 25m from the roundabout (locations B and C) have experienced two pedestrian crashes, both involving pedestrians crossing heedless of a vehicle green light display.

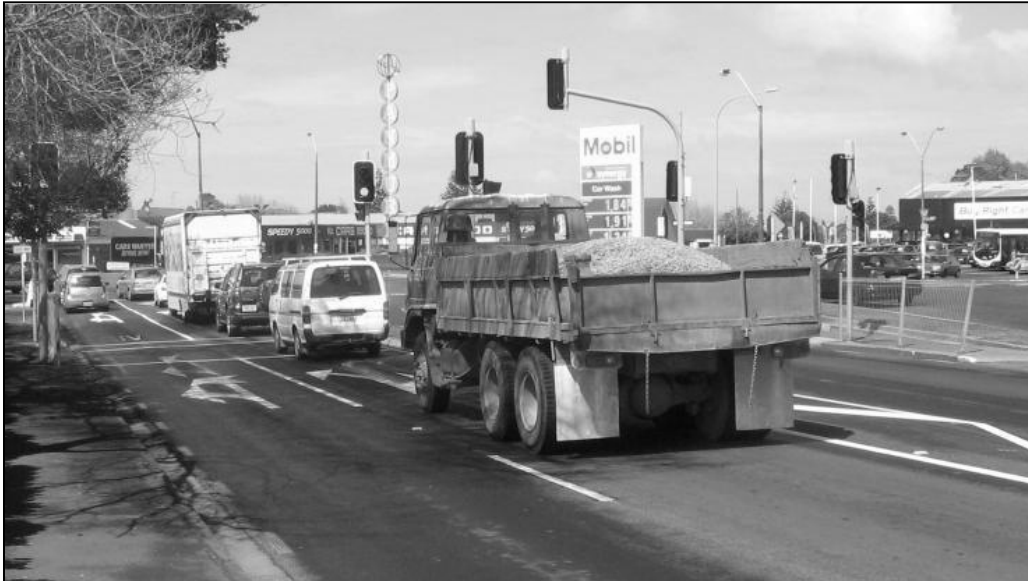
Figure 6.25 Photo showing southbound queues on Jellicoe Road past the signalised pedestrian crossing

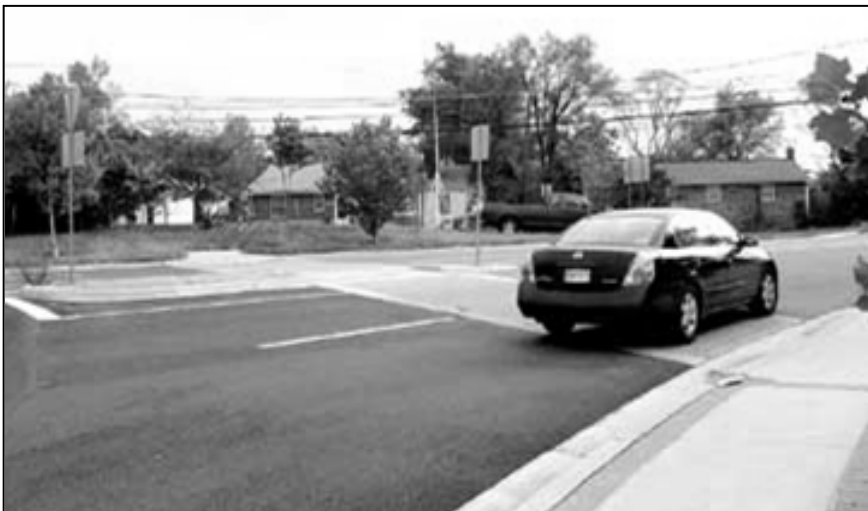
Figure 7.1 A low raised speed platform on a two-lane roundabout exit in the US

Vertical deflection devices (figure 7.1) are an effective means of vehicle speed control, and potentially are viable for use in the proximity of roundabouts for the benefit of cyclists and pedestrians in particular. Recent research undertaken by Campbell et al (2006) identified that the reduction of vehicle speeds on roundabout approaches is a principal factor in reducing cyclist crashes at roundabouts. Vertical deflection devices (speed humps, speed tables or speed cushions) offer one of the most economic methods of retrofitting existing roundabouts to achieve this. These devices can also be used at pedestrian crossing facilities, and may be particularly useful at multi-lane crossings where safety might be an issue (refer to chapters 5 and 6).

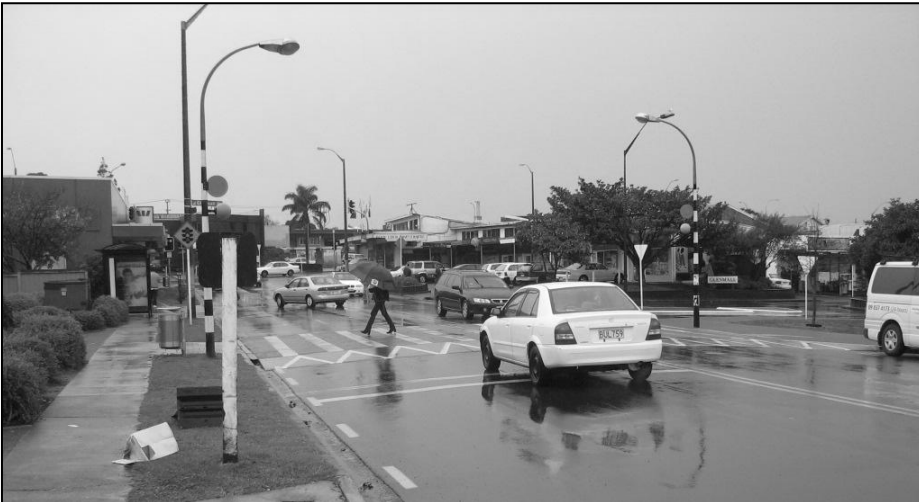
Figure 7.2 A typical speed platform with a zebra crossing installed in Glen Eden town centre, Waitakere

In New Zealand, raised platforms can be used in town centres, local area or liveable street schemes. They are built with cobblestone or coloured concrete effects, and are often used in conjunction with pedestrian crossing points (figures 7.2 and 7.3). Ramp lengths and platform heights can vary, but generally are around 100mm high with ramps at 1 in 10 or 1 in 15 gradients for bus routes.

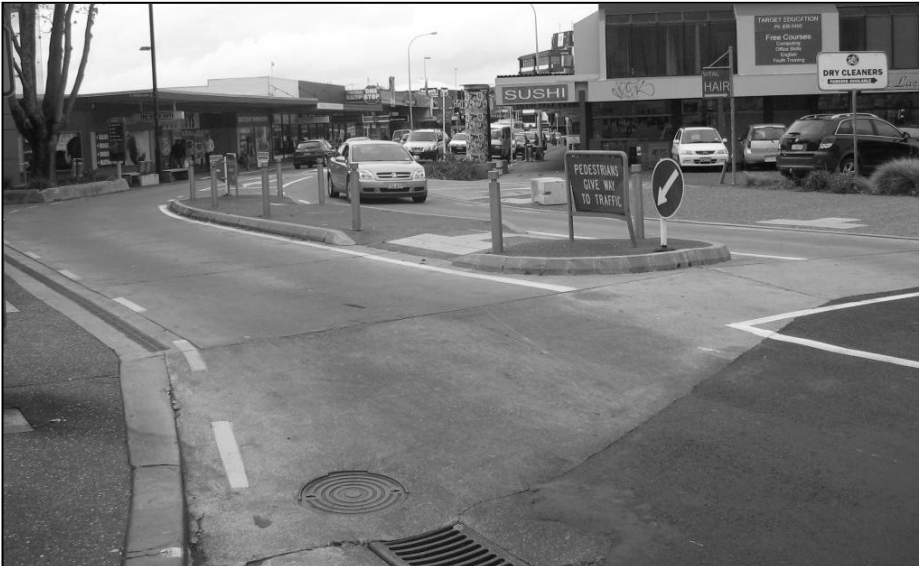
Figure 7.3 A platform arrangement at an informal crossing point in Henderson town centre, Waitakere

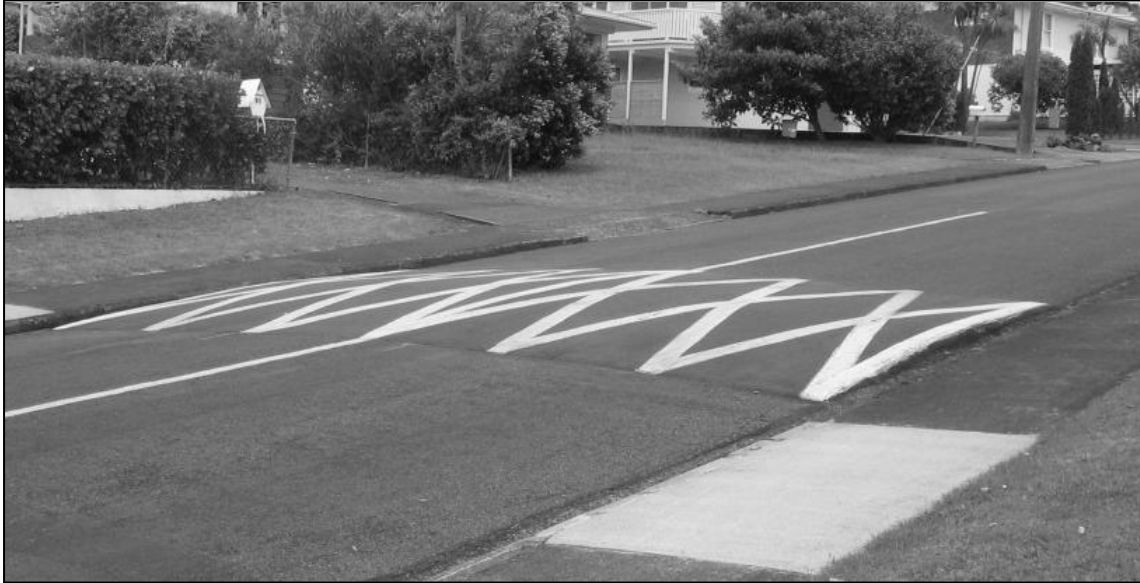
Figure 7.4 A MWP speed hump in a local street, as commonly installed by many New Zealand jurisdictions

Round-top humps are the most common devices installed in New Zealand residential streets, and the profile generally used is the Watts profile or Modified Watts profile (MWP) as shown in figure 7.4. The MWP is 5m long in the direction of travel and is specially designed to be more forgiving to heavy vehicles than the standard Watts profile, which is 3.7m long. Compared to speed platforms and cushions, they are generally the least expensive vertical deflection option by a significant margin.

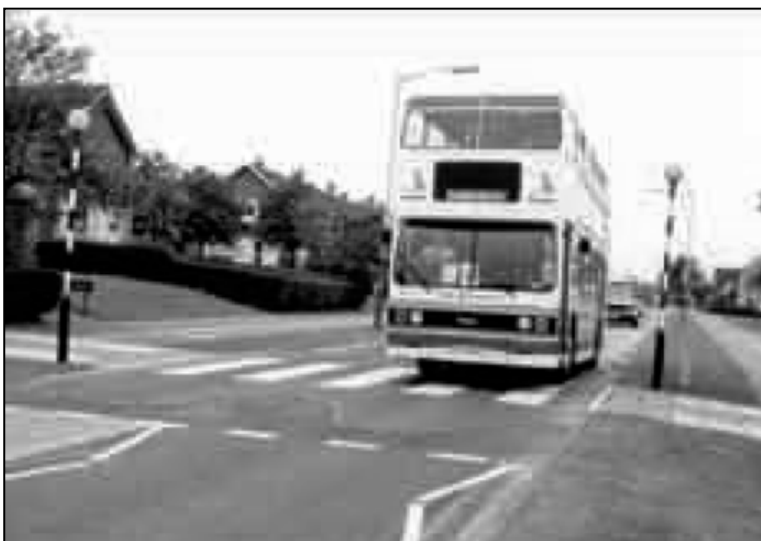
Figure 7.11 An S speed hump installed in the UK (DfT 2007c)

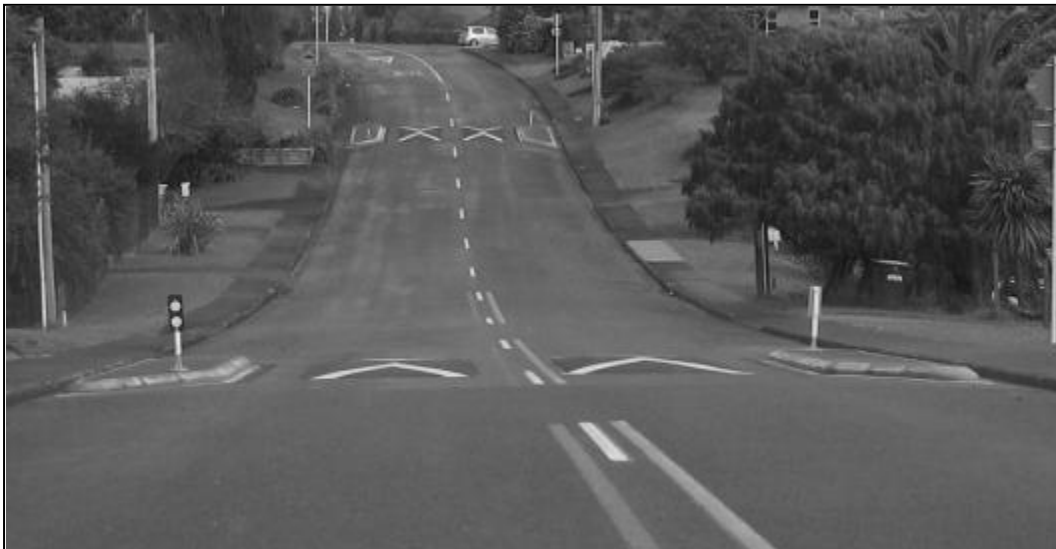
Figure 7.12 Photo of a speed cushion scheme installed on Wattle Street, a local road in Waitakere City (these particular examples are constructed of asphalt based on a North American profile of 1.8m wide × ~5m long × 90mm high)

Speed cushions were originally used in the UK in the 1990s and have been increasingly used by some New Zealand local authorities over the past decade (figures 7.12 and 7.13). Although they are generally used only on local roads, Rotorua District Council has installed them on an arterial route where speeding was identified as a significant problem in a residential area with high pedestrian activity.

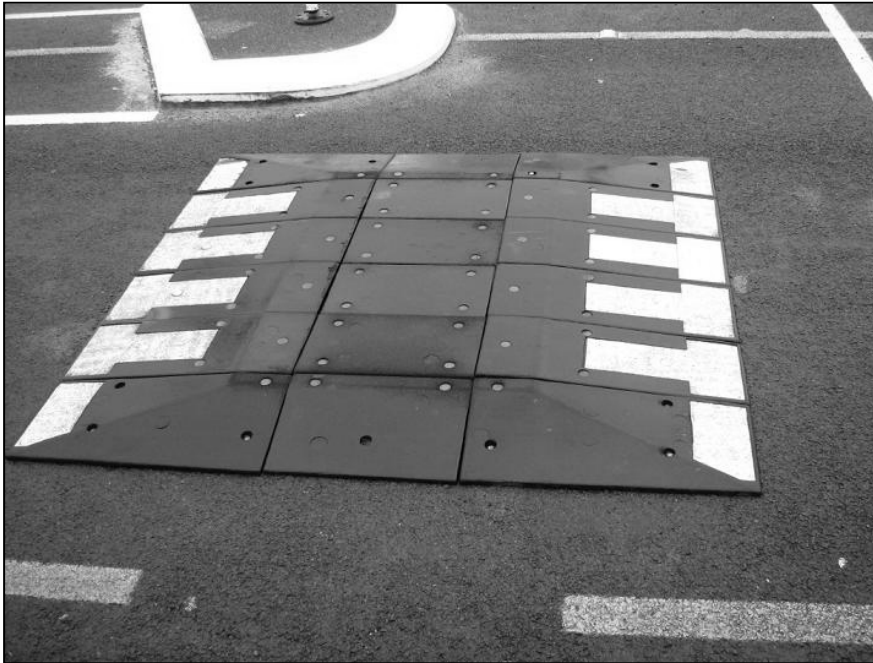
Figure 7.13 Photo of a 1.8m wide speed cushion installed on Pooks Road in Waitakere City (this 75mm high example is made of recycled rubber, which means it can be installed quickly and with minimum traffic management)

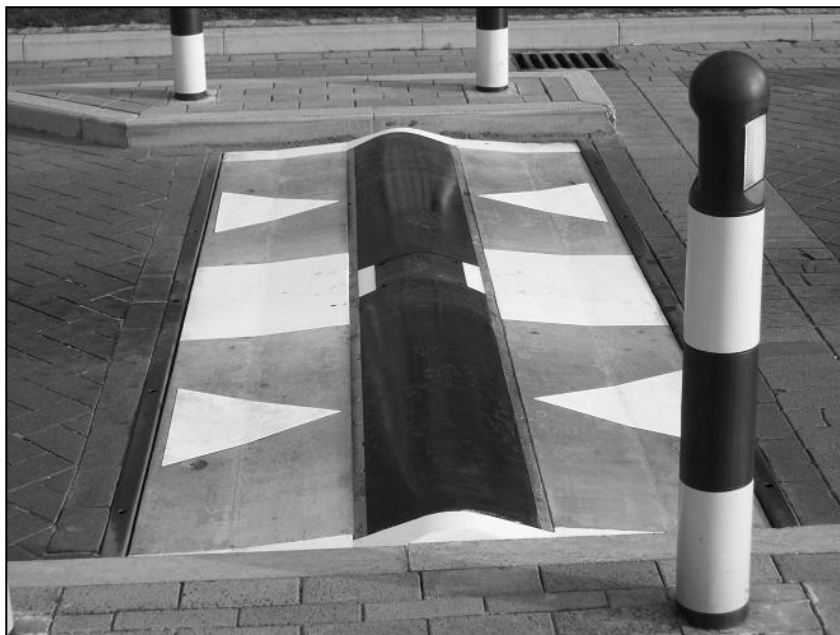
Figure 7.14 Typical example of a Transcalm device (photo supplied by Dunlop Transcalm Ltd)

The Dunlop Transcalm responsive speed hump is a device just recently developed. It is an air-filled rubber device especially designed to reduce vehicle speeds to around 30km/h or less, and also to have a minimal effect on heavy vehicles such as buses or larger emergency vehicles, or any vehicle over ~3000kg (figures 7.14 and 7.15). It comprises an air filled rubber reservoir fitted atop a specially installed concrete mount. Dunlop has indicated that it would be uneconomic to consider shipping these to New Zealand currently (at least \$7000 for each device plus freight), but a surface-mounted unit is being developed for export at the time of writing. Motorbikes do not get the same benefits as car drivers because of their lower weight but, according to the manufacturers, they apparently still prefer Transcalm-type devices to conventional road humps.

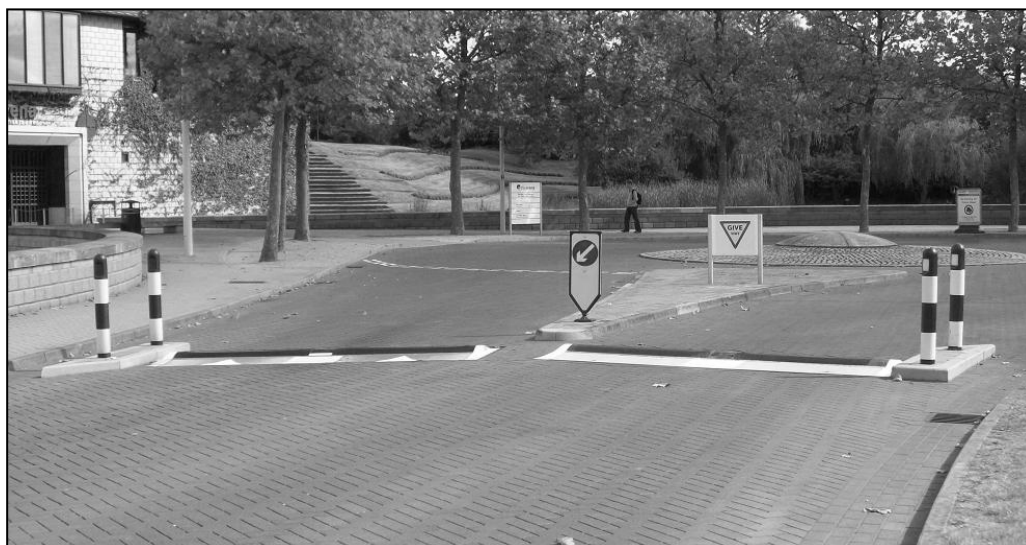
Figure 7.15 Example of a Transcalm in the UK installed near a single-lane roundabout on a busy bus route (photo supplied by Dunlop Transcalm Ltd)

In the context of roundabouts, Transcalm-type devices could feasibly be installed on roundabout approaches or departures, and appear to be a viable means of speed control while minimising adverse effects to buses and emergency vehicles. They would be an expensive option to install, however, and their long-term maintenance requirements are still uncertain.

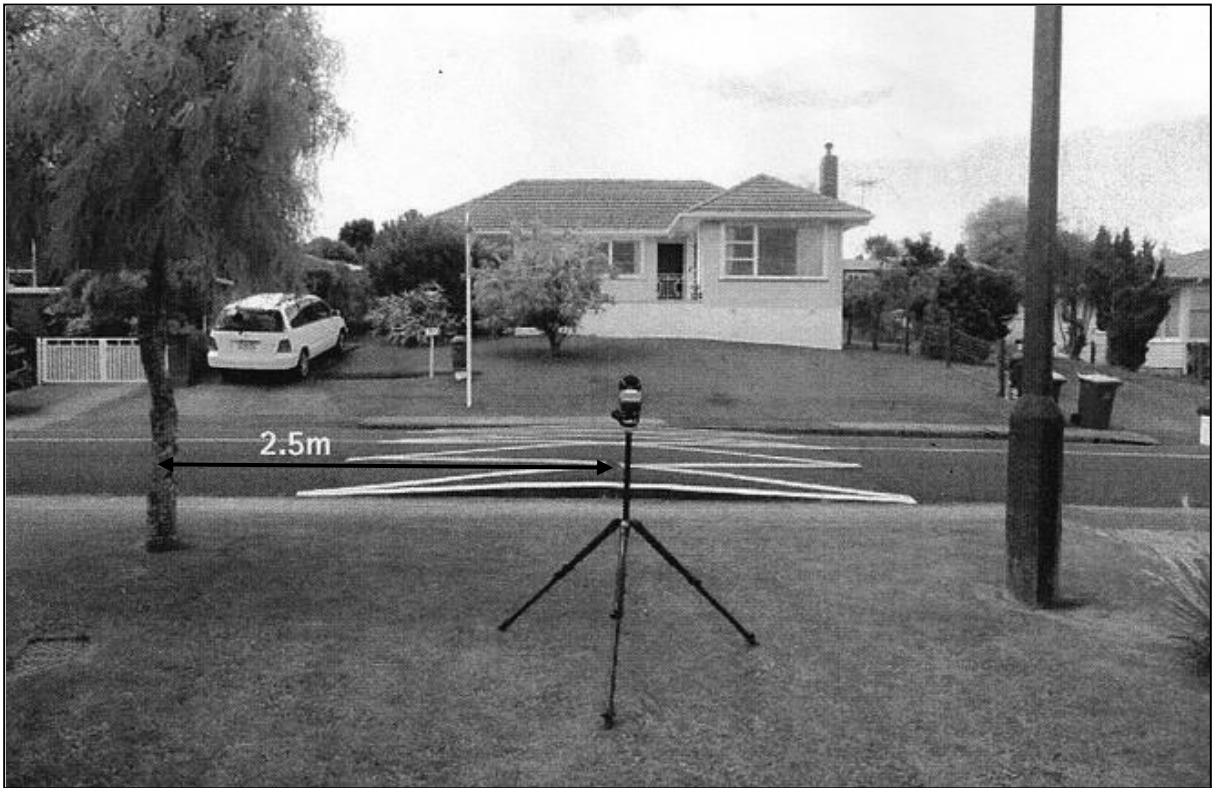
Figure 7.18 Photo showing the assessment site at Waitaki Street, Waitakere. The MWP speed hump is 5m long by 100mm high, and spacing was approximately 100m between each device

In 2008, an acoustic study was undertaken by Marshall Day Acoustics for Waitakere City, in order to compare traffic noise before and after a 100mm high MWP speed hump was installed on a residential street (figure 7.18). Residents sometimes perceive that such devices increase street noise, and this study was instigated as a means of addressing future queries. A full copy of this study is attached in appendix G.

The same rental truck and model of bus were used for before/after measurements, and the sound level meter was located 4.4m back from the road kerb edge in line with the centre of the speed hump.

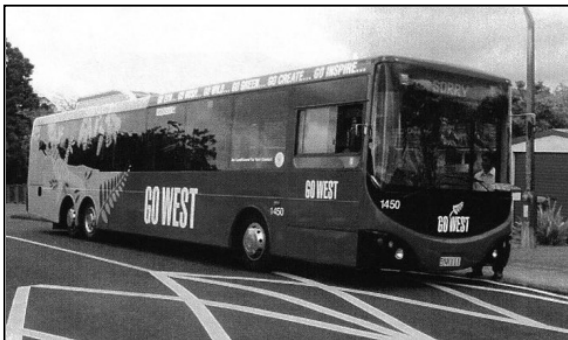
Figure 7.19 The bus used for the acoustic study

- local vehicles (mostly cars) using Waitaki Street
- a test bus supplied by Go West buses (figure 7.19)
- a test rental truck (figure 7.20).

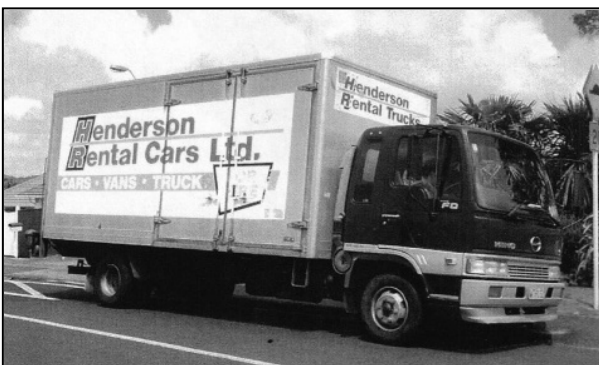
Figure 7.20 The truck used for the acoustic study

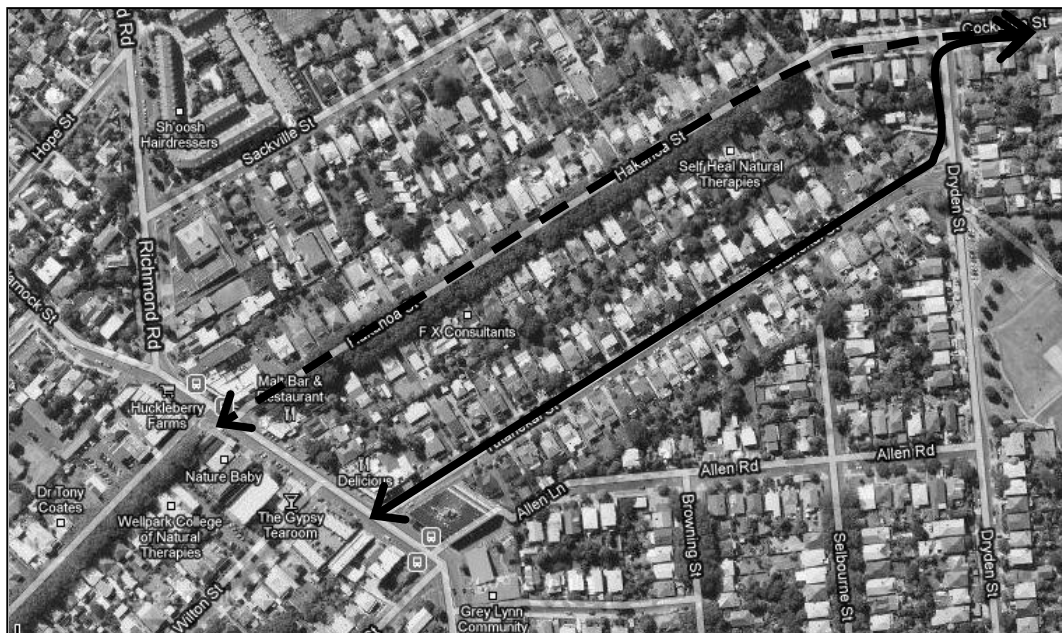
Figure 7.23 Hakanoa Street (dashed line) and the alternate Tutanekei Street route (solid line); both routes now have speed humps (photo courtesy of Google Maps)

- Nine raised speed platforms were installed on Ireland Road (figure 7.21) in the 1990s, which had the effect of diverting previously substantial heavy vehicle traffic onto the adjacent Mt Wellington Highway, which, although not too dissimilar in length, has five signalised intersections.
- After several speed humps were installed on Walworth Avenue (figure 7.22) in the 1990s, regular traffic which was using the route to access Marvon Downs Avenue overwhelmingly began to use the longer route on Archmillen Avenue.
- When four speed humps were installed on Hakanoa Street (figure 7.23) in the 1990s, substantial traffic diverted onto adjacent Tutanekei Street until speed humps were installed on that route the subsequent year or so.

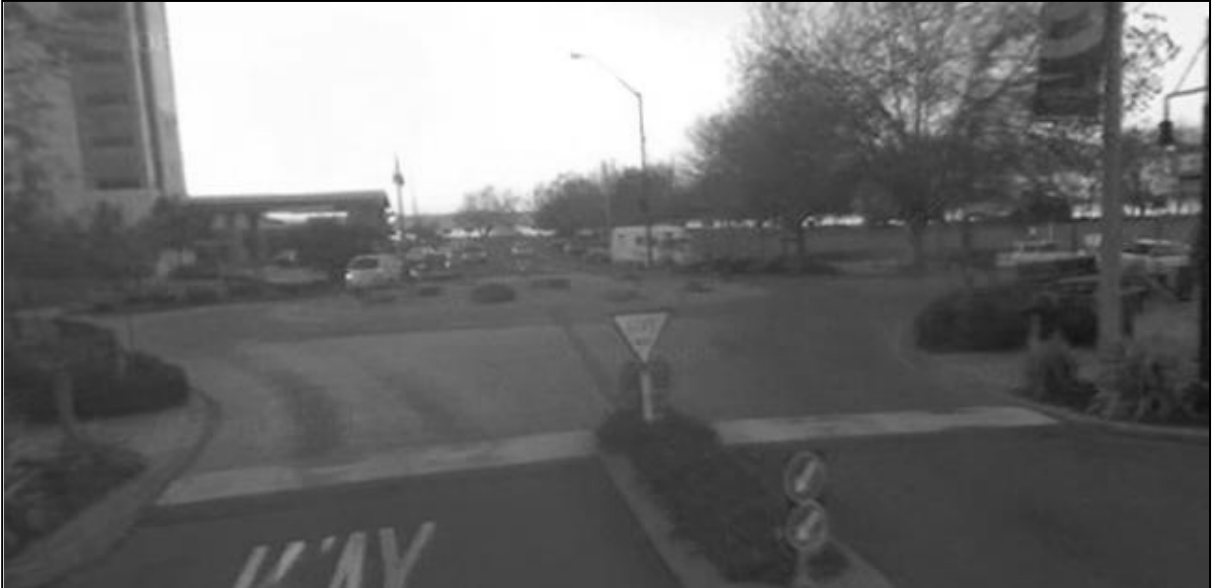
Figure 7.24 Whakahue Street–Tutanekai Street intersection in the Rotorua CBD: here, the entire roundabout (single-lane) is constructed as a raised platform, giving a low-speed environment that is conducive for pedestrians (photo courtesy of Google Maps)

order of 1 in 50 (2%). Compared to a raised intersection (see figures 7.24 and 7.25), this would appear to be a relatively cost-effective method of achieving a similar result. Most examples so far have been received well by residents of Malmö, although one of these examples is located within 100m of residential housing. However, one installation on a main street did receive complaints regarding noise and vibration – the design engineer related this particular instance to an insufficient gradient on the approach ramp about 1 in 20 or 5%), which was resulting in higher than desirable heavy vehicle speeds when these hit the platform.

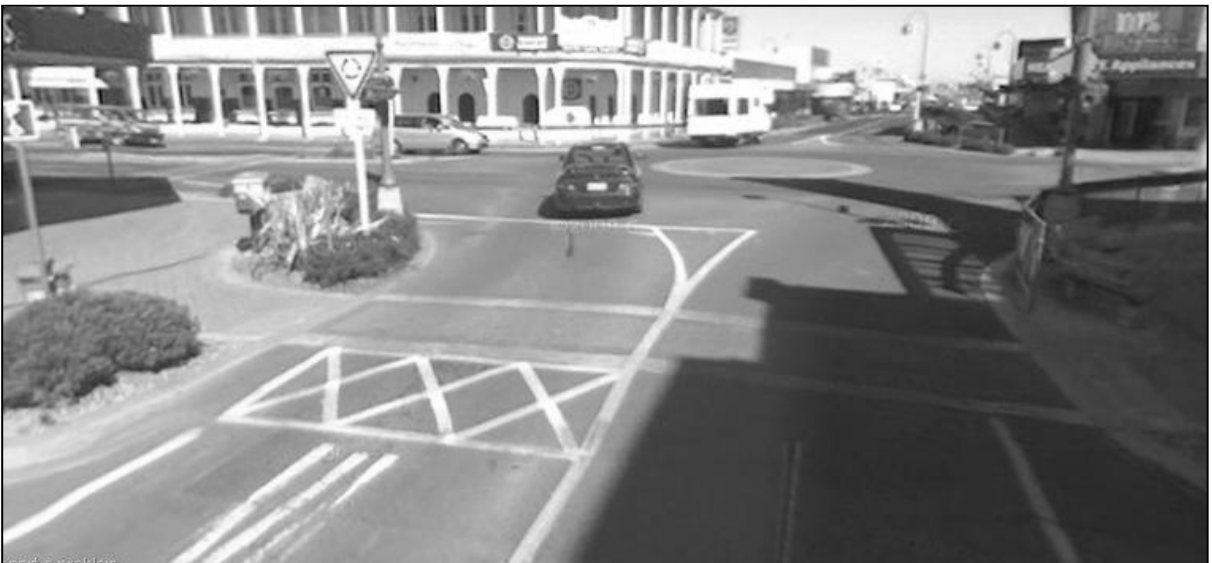
Figure 7.25 The Studholme Street–Thames Street intersection in Morrinsville, Waikato: a single-lane roundabout in the main street of a small town that is effectively at a raised level with ramps on each approach (photo courtesy of Google Maps)

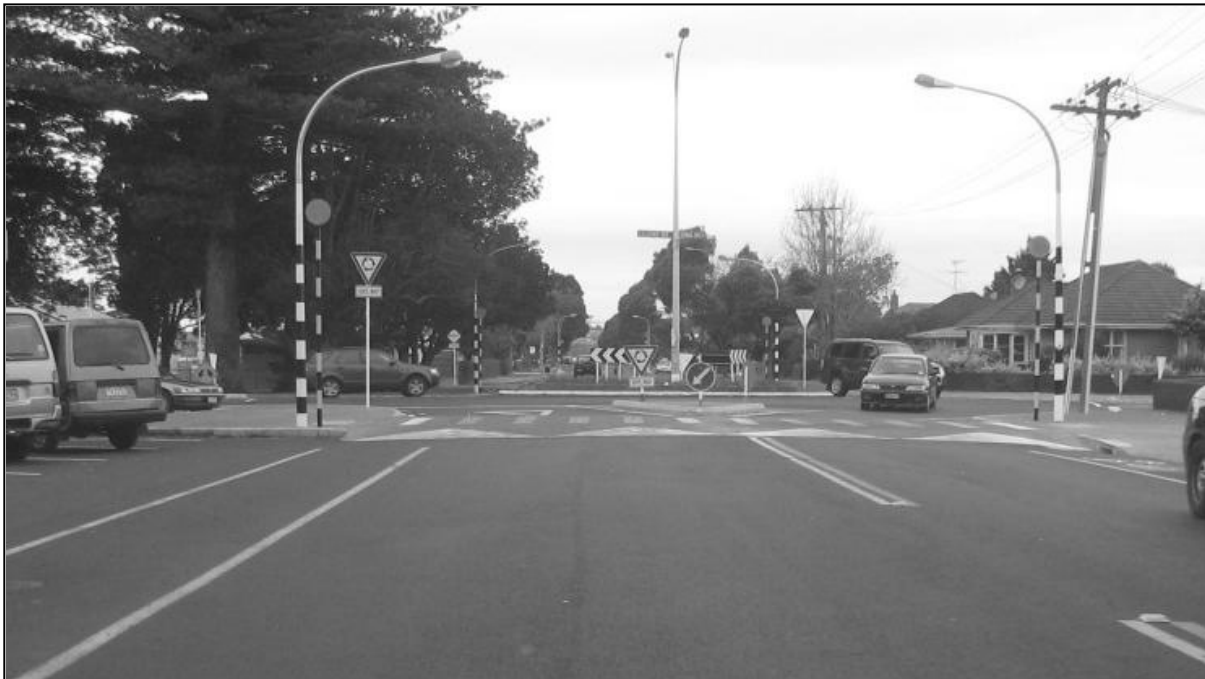
Figure 7.26 The Point England Road-Erima Avenue roundabout in Glen Innes, Auckland, which had raised speed platforms installed on the approaches to improve pedestrian safety in 2009

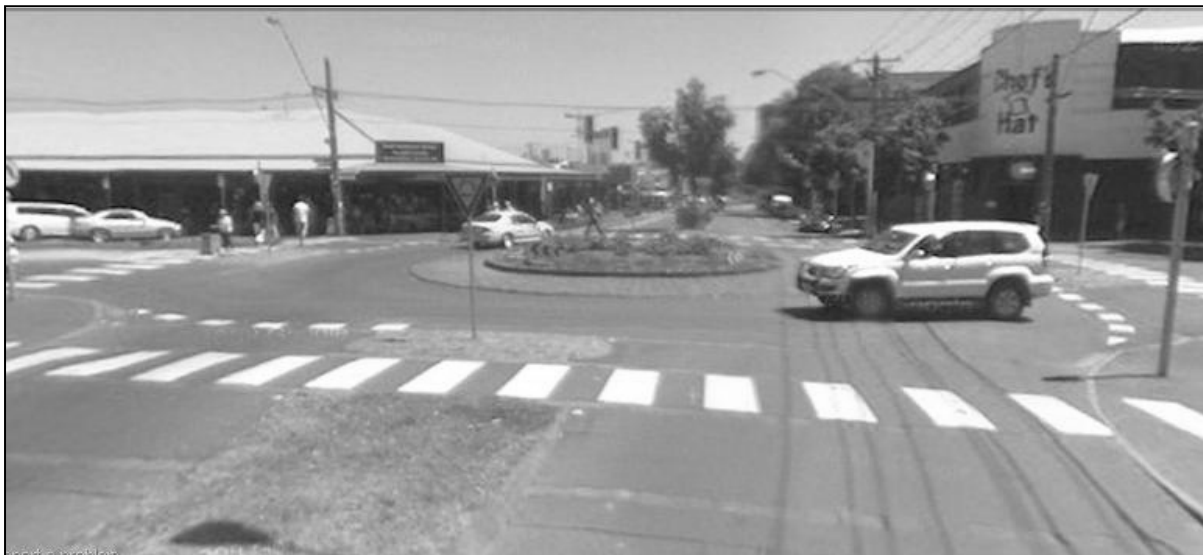
Figure 7.27 The Cecil Street-Coventry Street roundabout in Port Phillip, Melbourne, Australia: conventional raised platforms with zebra crossings on each of the four arms (photo courtesy of Google Maps)

Note: This site was evaluated before and after the platforms were installed, the overall result being decreased vehicle speeds and a presumed improvement in pedestrian safety (Candappa et al 2008).

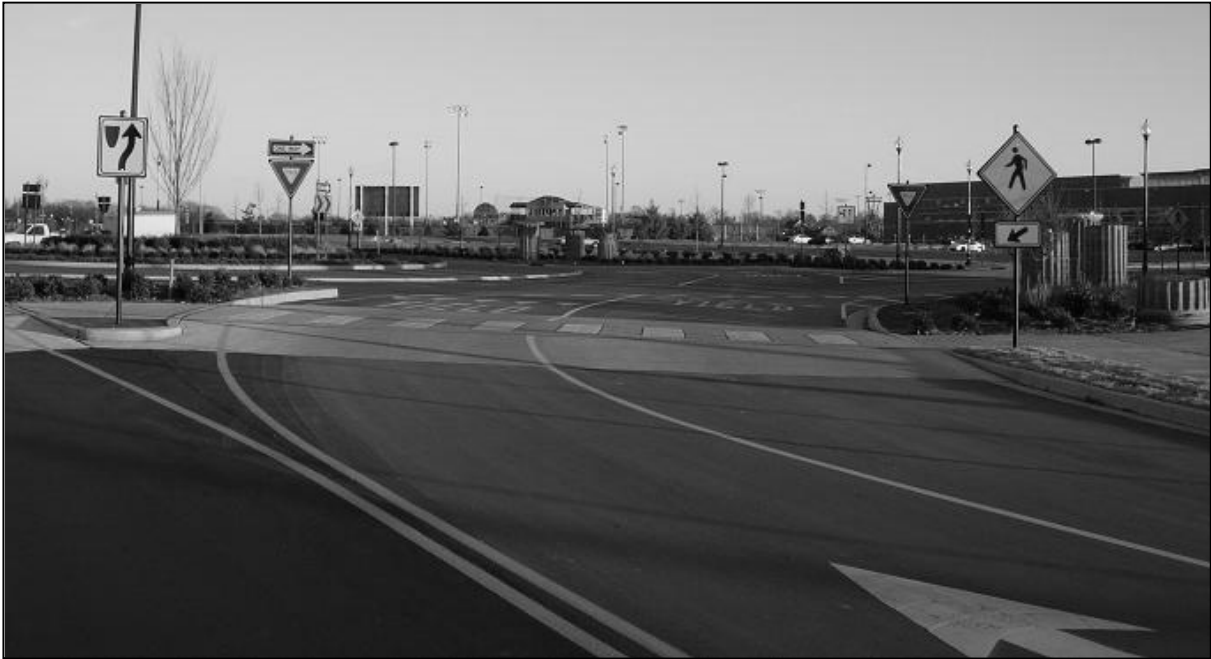
Figure 7.28 A multi-lane zebra crossing on a short raised platform at an unidentified roundabout in the US

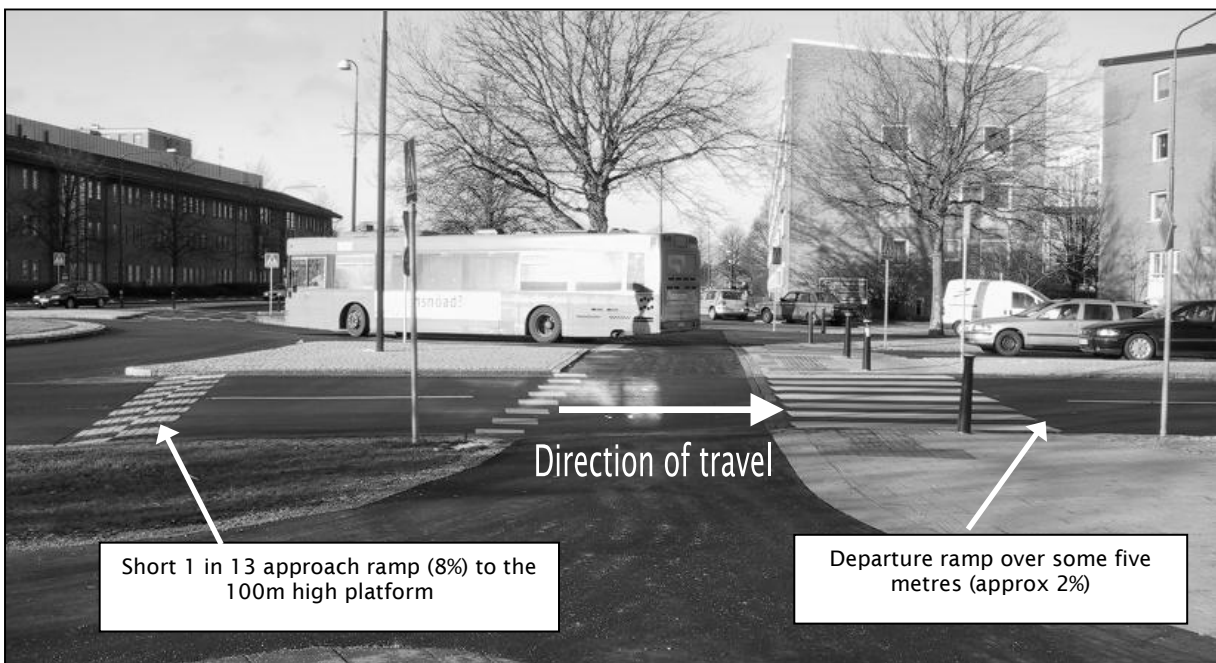
Figure 7.31 Side view of a platform from the Swedish city of Malmö with roundabout exit lanes in the foreground. For entry lanes in the background, this profile is in the opposite direction of vehicle travel. A median island of some length is required to allow for the differing carriageway levels in each direction (photo provided by Transport Department, City of Malmö)

The Swedish city of Malmö has recently constructed several multi-lane roundabouts with raised platform treatments for pedestrian and/or cyclist crossing points. An interesting difference here, though, is that they have used short ramps on the approach direction to each crossing point; and for the departure direction, the platform is ramped off at a slight gradient (see figures 7.30–7.35). This method of construction achieves a similar effect to that of a raised intersection treatment, in that it minimises the discomfort to road users (particularly bus passengers) while still maintaining a measure of speed control. This concept is considered to hold great potential for application in New Zealand.

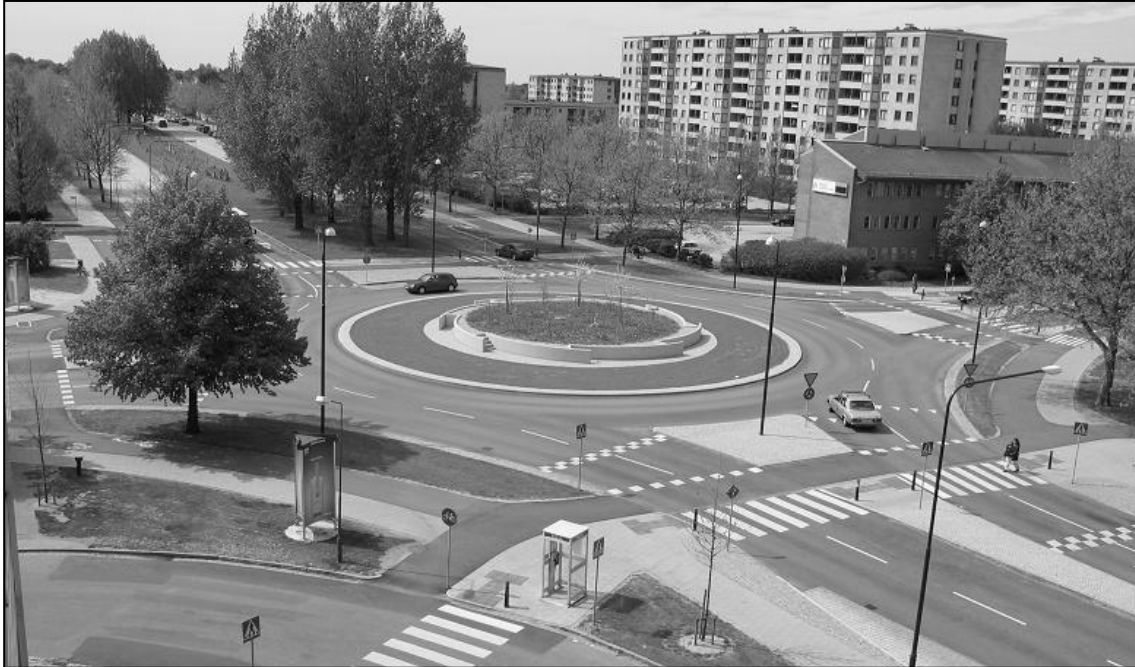
Figure 7.32 The Lorensborgsgatan–Stadiongatan roundabout in Malmö, Sweden (left-hand drive): 100mm high raised platforms are provided on each arm to facilitate the pedestrian and cycle path crossing points around the perimeter of the roundabout (photo provided by Transport Department, City of Malmö)

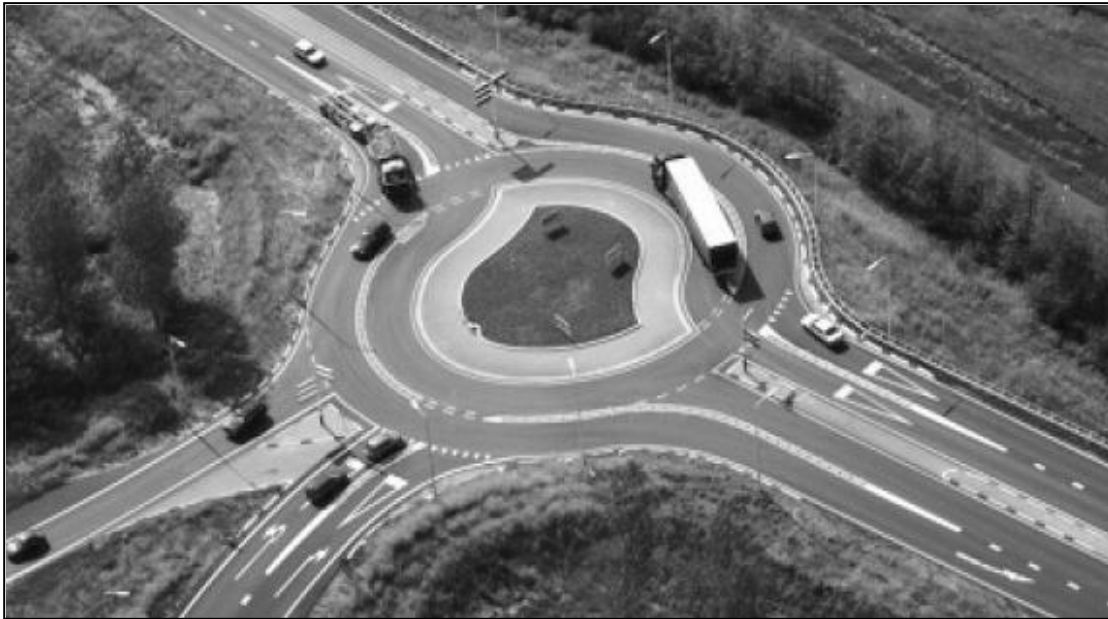
Figure 8.1 A turbo-roundabout in The Netherlands, showing the typical layout (CROW 2008)

The turbo-roundabout (figure 8.1) was developed in 1996 by Mr LGH Fortuijn, a lecturer at the Delft University of Technology in The Netherlands. It is a generic spiral-type design with radial entry roads where drivers do not have to change lanes inside the roundabout, and are physically discouraged from doing so via solid lane dividers placed between the approach and circulating lanes. This type of design came about because of concerns in The Netherlands regarding the high vehicle speeds through multi-lane roundabouts, and the sideswipe crashes that can occur between vehicles changing lanes inappropriately on the roundabout. The turbo-roundabout appears to address these safety concerns satisfactorily, and can apparently achieve a substantially higher capacity than conventional multi-lane designs. In the province of South Holland, turbo-roundabouts are apparently considered at intersections where a single-lane roundabout would not provide sufficient capacity, following which a signalised intersection or signalised roundabout is considered (in that order of priority) (V Inman and G Davis 2007).

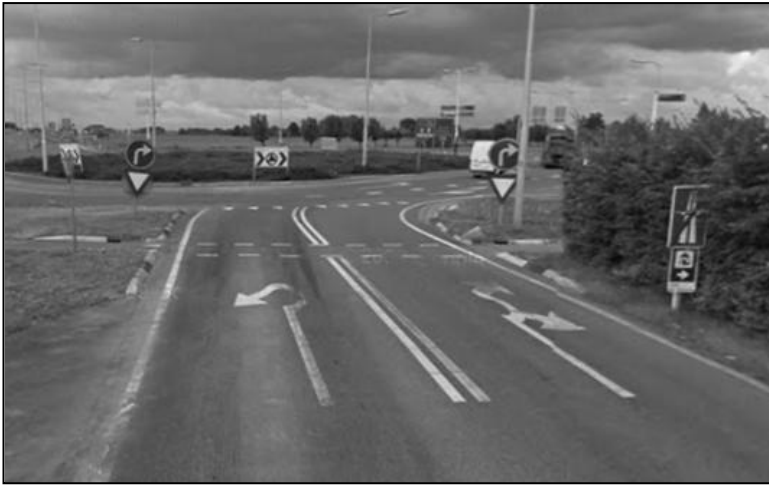
Figure 8.16 Street view of the Rien Cock Ovonde-Provinciale Weg intersection: this five-arm junction is best described as a partial turbo-roundabout, as not every approach has lane dividers – a minor road approach with paint markings only is shown (photo courtesy of Google Maps)

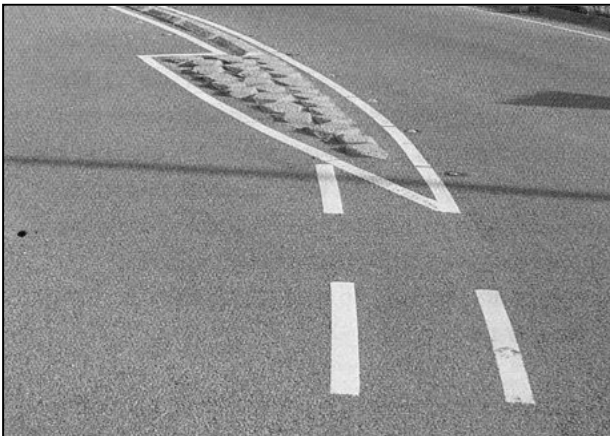
Figure 8.20 Pointed end treatment applied to the lane dividers (CROW 2008)

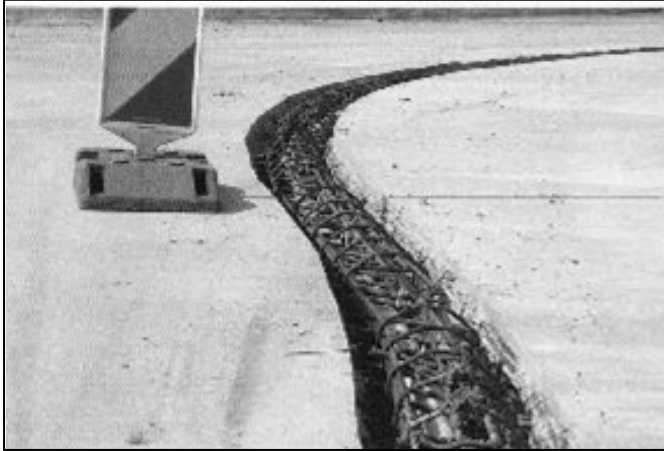
Figure 8.21 In situ construction of the mountable lane dividers: note the steel reinforcement (CROW 2008)

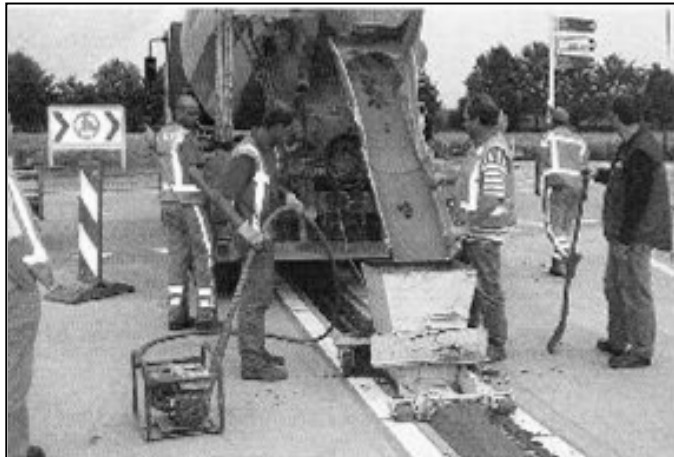
Figure 8.22 In situ construction of the mountable lane dividers: pouring the concrete (CROW 2008)

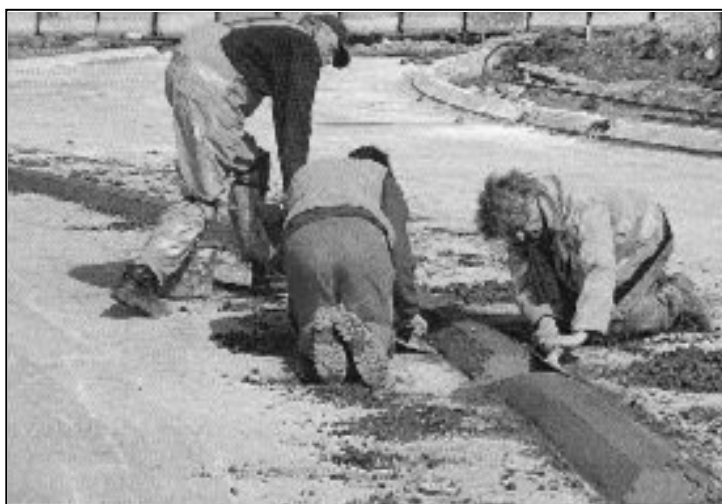
Figure 8.23 In situ construction of the mountable lane dividers: shaping the dividers (CROW 2008)

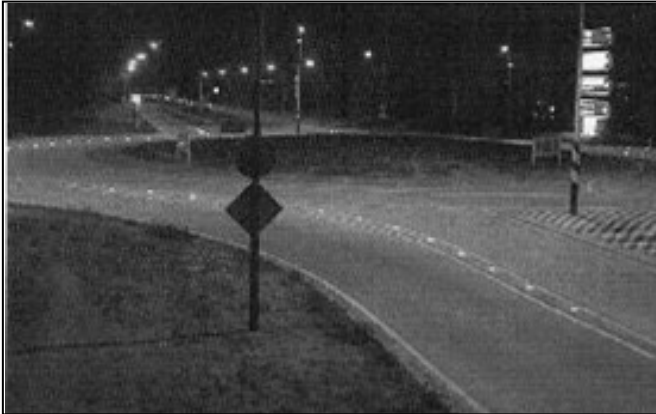
Figure 8.24 Wide-angle view of a typical lighting arrangement on the mountable lane dividers at a turbo-roundabout (CROW 2008)

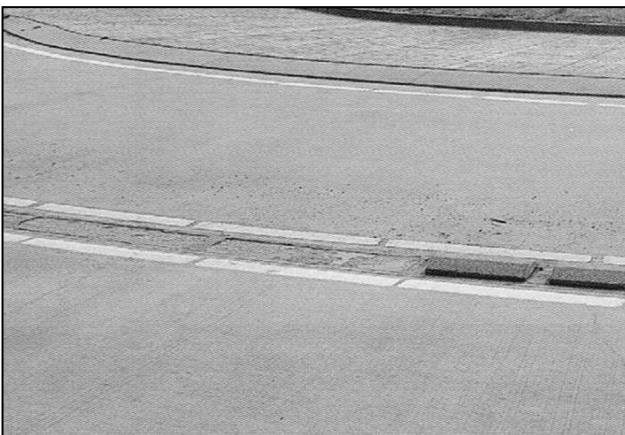
Figure 8.26 Photo of the damage that can occur if lane dividers are glued onto the roadway instead of cast in situ (CROW 2008)
