Improved multi-lane roundabout designs for urban areas

May 2012

Campbell, D¹, I Jurisich² and R Dunn³ (2012) Improved multi-lane roundabout designs for urban areas. *NZ Transport Agency research report 476*. 284pp.

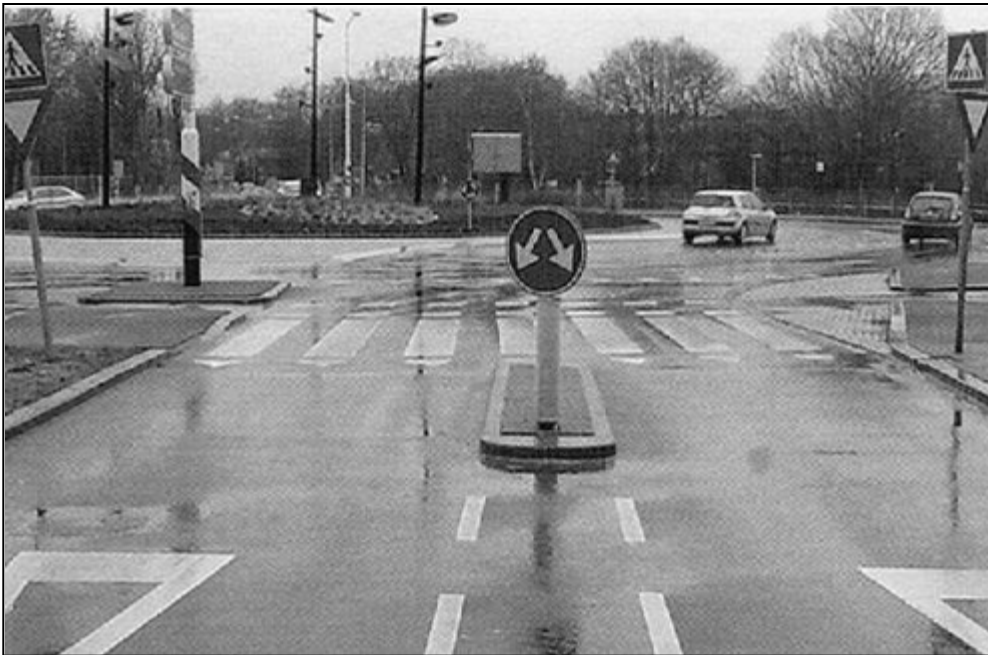
Figure 8.30 Example of a turbo-roundabout with at-grade perimeter paths for cyclists and pedestrians, who have priority over vehicles, much like zebra crossings for pedestrians in New Zealand (CROW 2008)

Design guides for The Netherlands recommend against providing for on-road cyclists at multi-lane roundabouts (CROW 2008), so turbo-roundabouts are expected to be provided with off-road perimeter paths for these users (see figures 8.28–8.32).

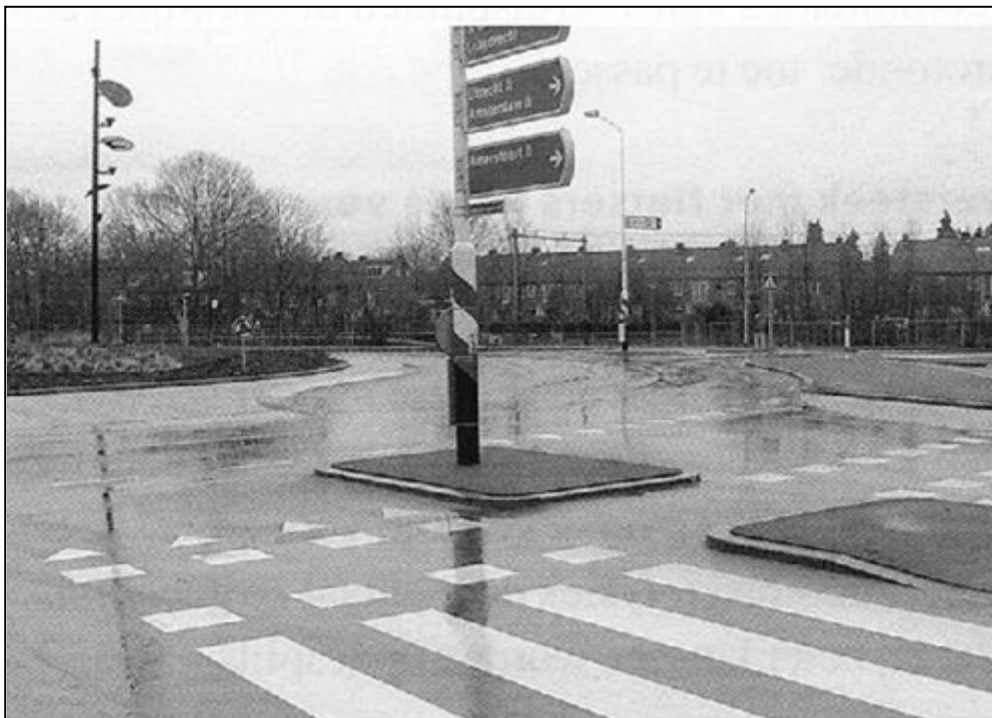
Figure 8.31 Closer view of the markings of the at-grade perimeter paths for cyclists and pedestrians at a Dutch turbo-roundabout - note the small white triangle markings that denote who has priority of way in The Netherlands (CROW 2008)

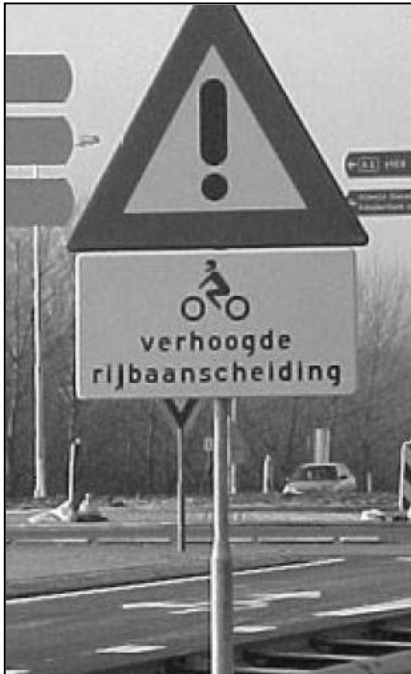
Figure 8.33 Advance warning sign for motorcyclists that reads 'Raised lane dividers' (Royal Haskoning 2009)

Two-wheeled users such as motorcyclists could potentially be at greater risk at a turbo-roundabout, owing to the presence of the lane dividers, which present a hazard if ridden over. Advance warning signage is duly recommended as shown in figure 8.33 below. Anecdotal evidence from The Netherlands suggests that motorcyclists prefer a turbo-roundabout, as the lane dividers reduce the lane changing behaviour of motorists, which is otherwise a concern at conventional designs (W Brilon, pers. comm. April 2010).

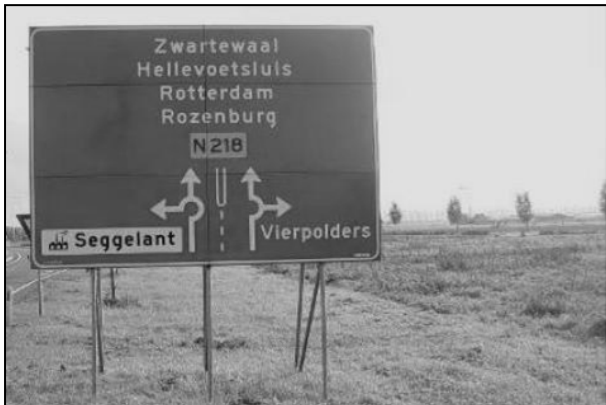
Figure 8.34 Signage to be installed 400m in advance of the turbo-roundabout (CROW 2008)

Because of the presence of the raised lane dividers in particular, some emphasis is put on good advance warning signage and road marking to let drivers know which lane they need to be in well before they reach the roundabout. Some examples of recommended signage are shown in figures 8.34–8.36.

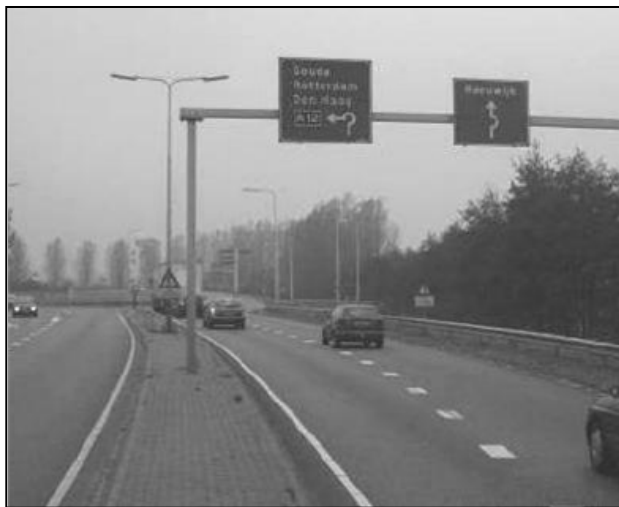
Figure 8.35 Optional overhead signage to be installed 100m in advance of the turbo-roundabout (CROW 2008)

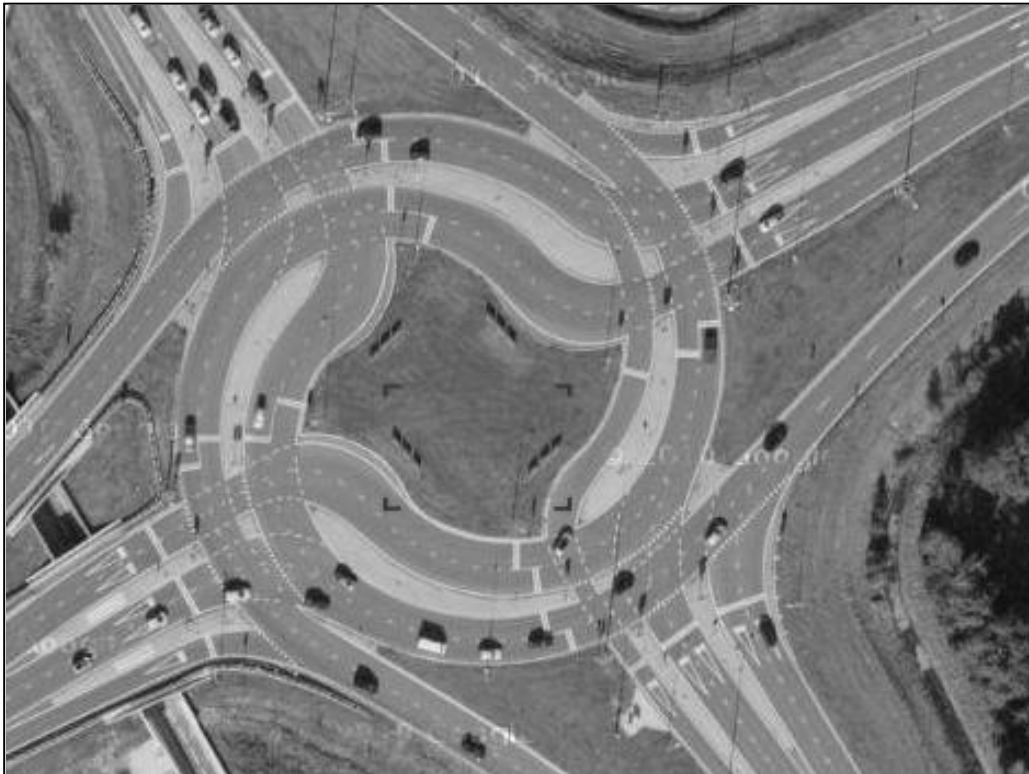
Figure 8.42 Aerial view of the Doenkadeplein signalised turbo-roundabout in The Netherlands at the intersection of roads N209 and N471 (the outside diameter of the roundabout is approximately 110m; photo courtesy of Google Maps)

Currently, two signalised roundabouts are installed in the province of Zuid-Holland in The Netherlands, both within approximately two kilometres of one another at Doenkadeplein (constructed 2006; figure 8.42 below) and Tolhekeplein (constructed 2007). The estimated capacity for signalised roundabouts like these is around 11,000–12,000 vehicles per hour (CROW 2008). No design layout is standard for this type of intersection.

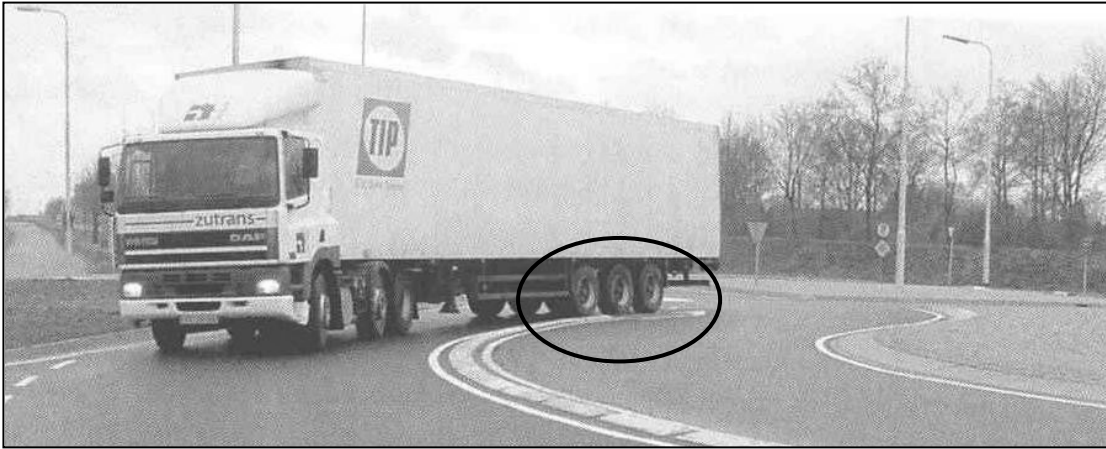
Figure 8.45 Photo showing a semi-trailer in The Netherlands negotiating a turbo-roundabout (CROW 2008). Note the mountable lane dividers between traffic lanes which the rear tyres are driving over (circled)

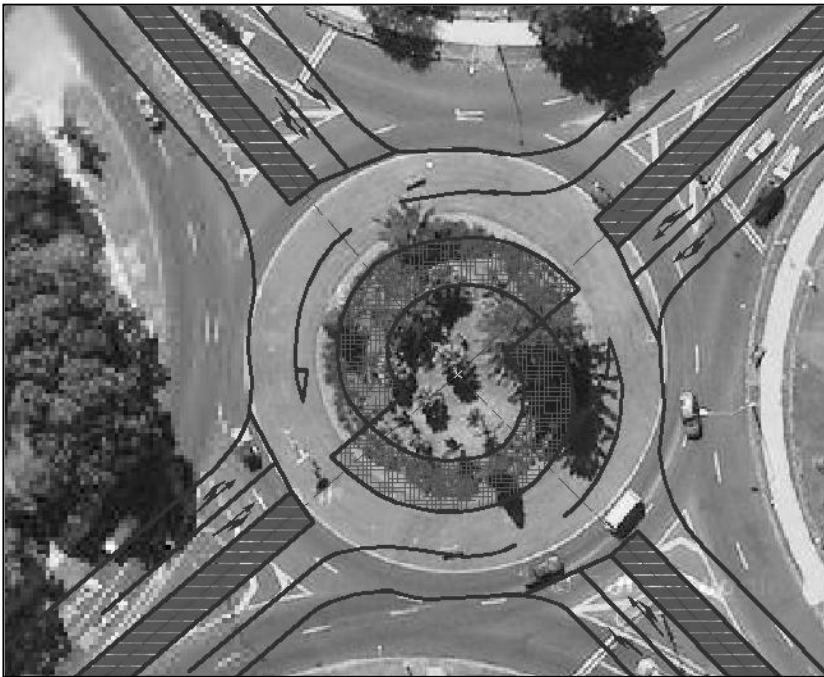
Figure 8.51 A turbo-roundabout layout as per Dutch specifications atop the Robertson Road-Bader Drive roundabout in Mangere, Auckland

Figure 8.51 shows a basic turbo-roundabout overlaid atop the Robertson Road–Bader Drive roundabout in Mangere, Auckland. Existing traffic volumes at this roundabout are in the order of 25,000 vehicles per day, which is within the assumed capacity of a basic turbo-roundabout. Although this roundabout was part of some proposed cyclist route improvements being studied by Manukau City Council in 2004, no substantial work was undertaken at this location. A turbo-roundabout here could be a worthwhile improvement on the basis that it would achieve a safer low-speed environment for these users and potentially improve capacity, and could easily be accommodated within the existing road reserve.

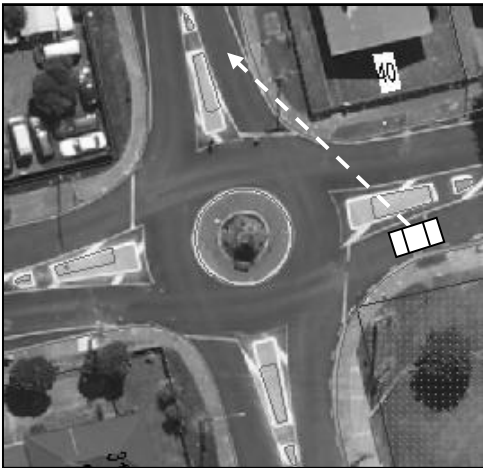
Figure D1 Birds-eye view of the Church Street–Avenue Road roundabout in Otahuhu, Auckland, showing how sightlines are restricted from one approach

However, if sightlines to the right are restricted too much relative to the speed of circulating vehicles, then entering v circulating vehicle crashes may eventuate. This can happen if entering drivers are still travelling too fast to react and come to a stop for an opposing vehicle that comes into view.

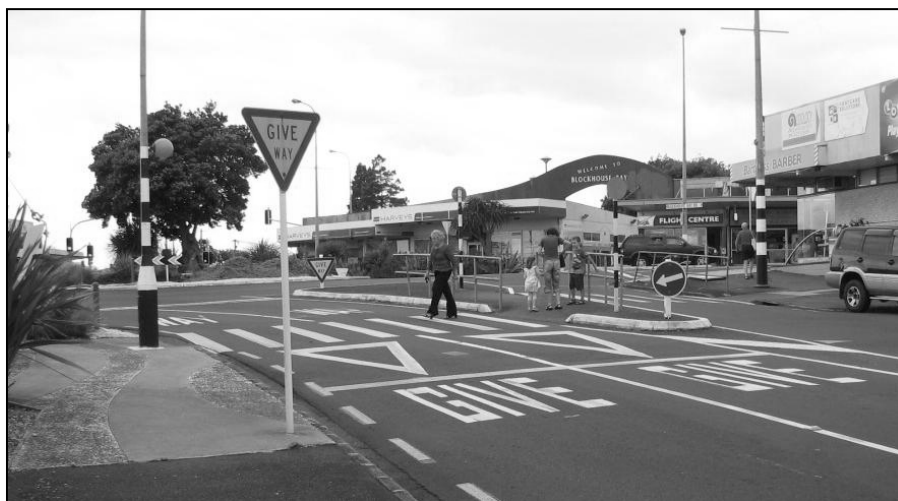
Figure F1 Zebra crossing facilities at a roundabout near a shopping centre, showing elderly pedestrians and children using these facilities

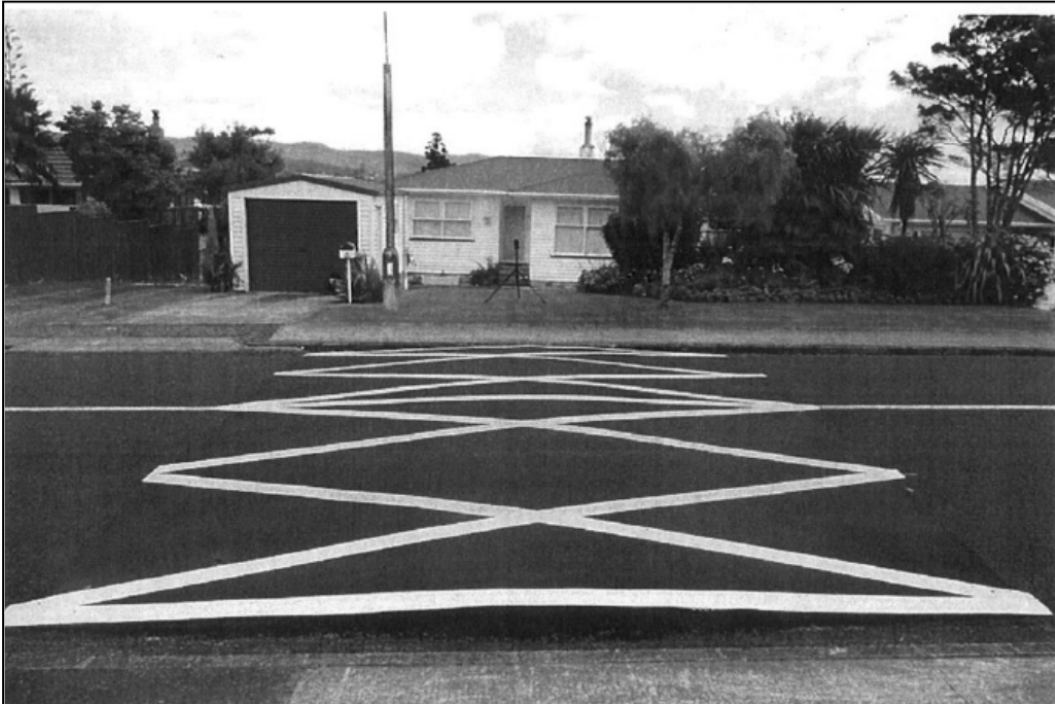
Figure G10 Speed hump outside 18 Waitaki Street (30/10/08)

While carrying out attended measurements with the speed humps in place, it was observed that most cars typically cruised over the speed hump located outside 18 Waitaki Street without any significant engine revving or noise from suspension or tyres.

During test measurements of the bus and truck with the speed humps in place, it was observed that the bus and truck braked (decelerated) before each speed hump, coasted over the hump until the rear wheels reached the downhill side of the speed hump, and then accelerated away back up to speed. This pattern was typically repeated for each speed hump. Some brake squeal was audible during braking.

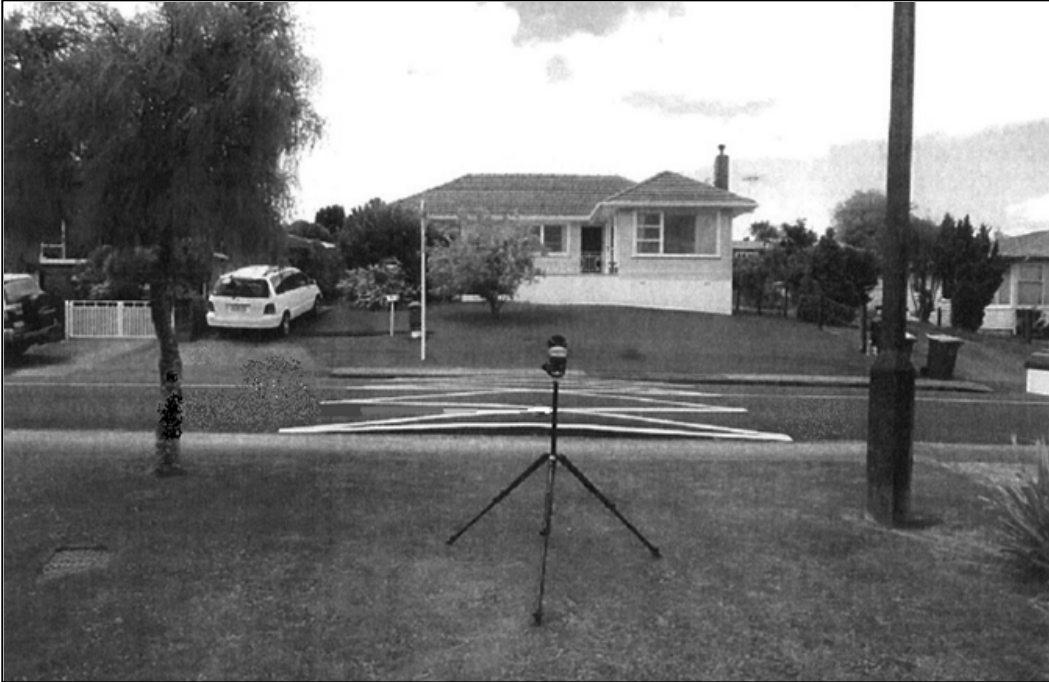
Figure G11 Speed hump viewed from 18 Waitaki Street, showing attended measurement position (30/10/08)

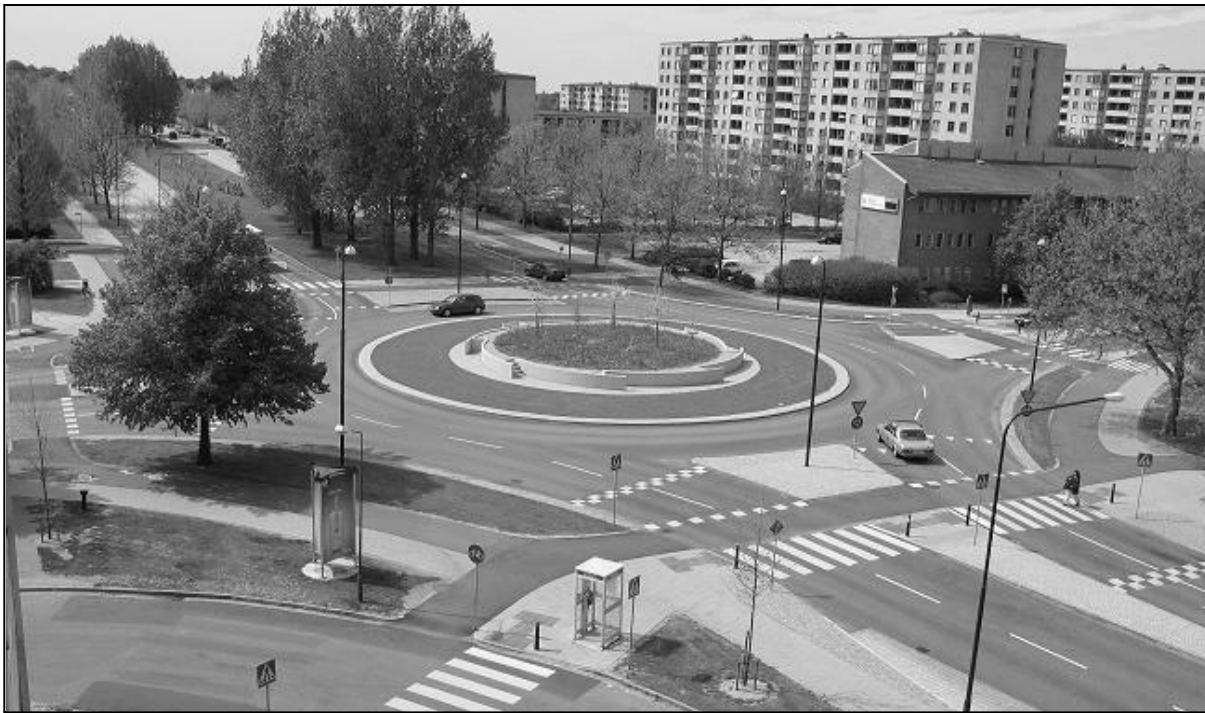
Figure H1 The Lorensborgsgatan–Stadiongatan roundabout in Malmö, Sweden (left-hand drive) which uses 100mm-high raised platforms on each entry and exit arm to facilitate pedestrian and cycle path crossing points around the perimeter of the roundabout (photo provided by Transport Department, City of Malmö)

25–30km/h immediately adjacent to six 100mm-high speed tables with ramps that ranged from 1:10 to 1:15 gradients (Auckland City Council 2001).

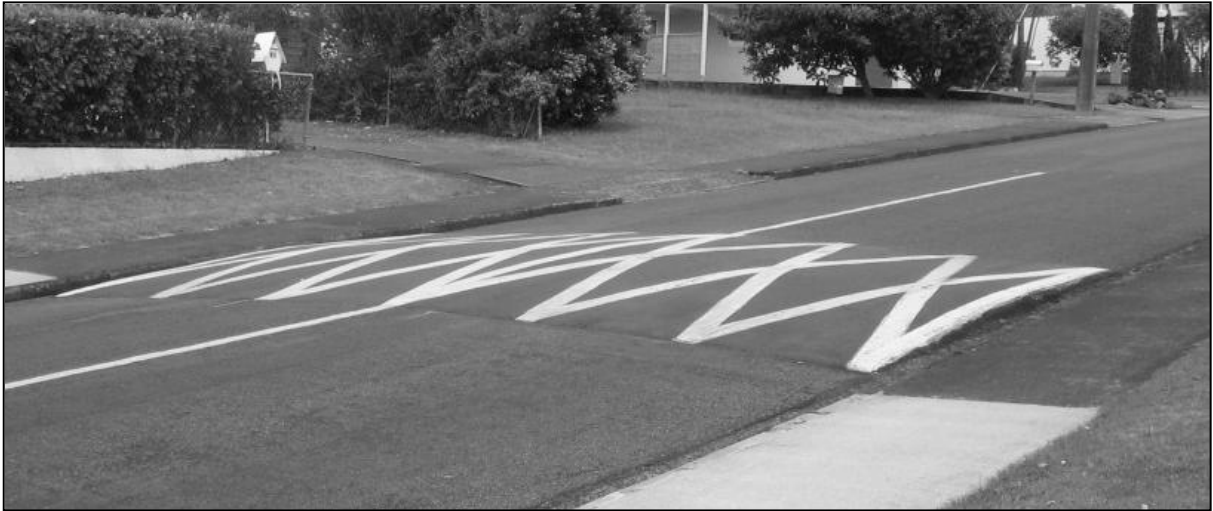
Figure H3 Photo of a MWP speed hump, as commonly installed in some New Zealand jurisdictions

The 100mm high Watts Profile or Modified Watts Profile (MWP; figure H3) can achieve similar vehicle speed control to platforms and are usually the cheapest devices to install. MWPs are 5m long (along the direction of travel) and are specially designed to be more forgiving to heavy vehicles than the standard Watts profile, which is 3.7m long. However, they can result in discomfort to bus passengers if drivers are not considerate. Tube counters immediately adjacent to three MWP speed humps on local roads in Waitakere City, Auckland, demonstrated 85% speeds of 35–40km/h (Waitakere City Council 2010). In addition, a study from the United Kingdom measured 85% crossing speeds of around 50km/h at seven local road sites with round-top speed humps 50mm high and 900mm long (Department for Transport 1994).

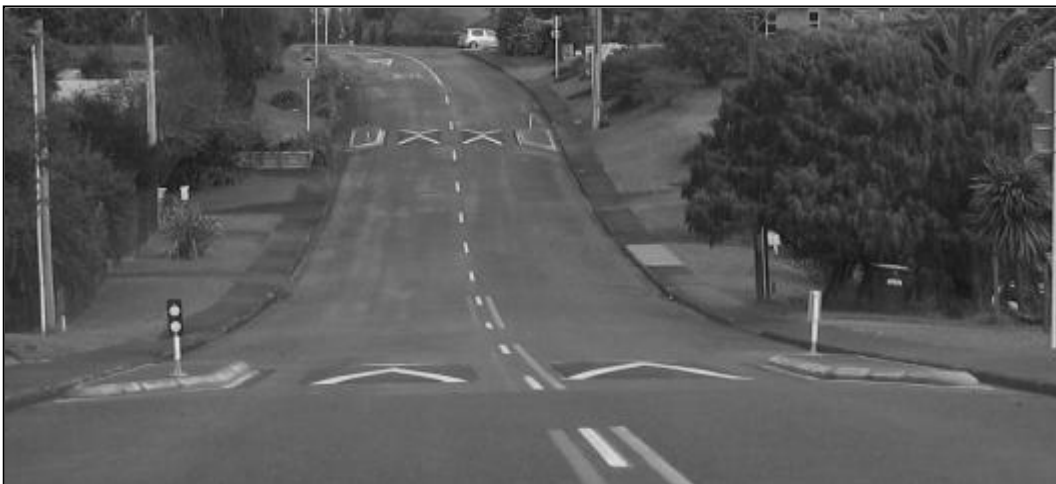
Figure H4 Photo of a speed cushion scheme installed in Waitakere City, Auckland

A variety of profiles for speed cushions (figure H4) are available. In the United Kingdom, speed cushions 75mm high and 1.6m wide are preferred to platforms or humps for bus or ambulance routes on local roads (Department for Transport 2007). Some guidance from the United Kingdom for expected vehicle crossing speeds at speed cushions on local roads is given in figure H5.

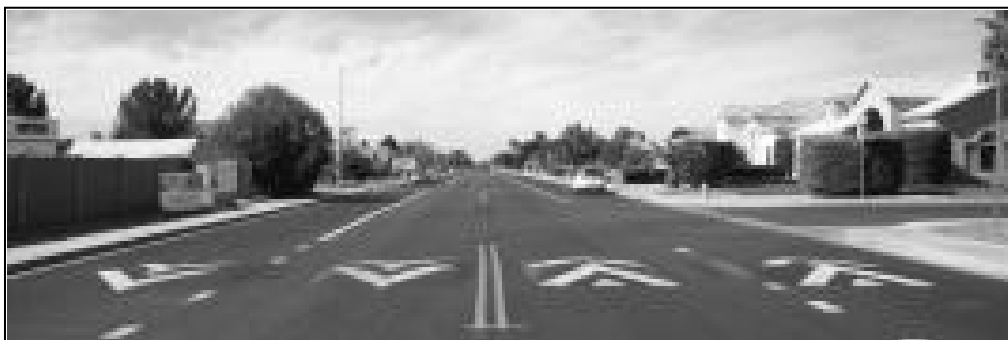
Figure H6 Example of speed cushion layout that could be used at a multi-lane situation

Although, as far as the authors are aware, it has not been tried before, speed cushions also might feasibly be used at multi-lane approaches to roundabouts as per figure H6. In general, the wider the cushion, the lower the speeds.

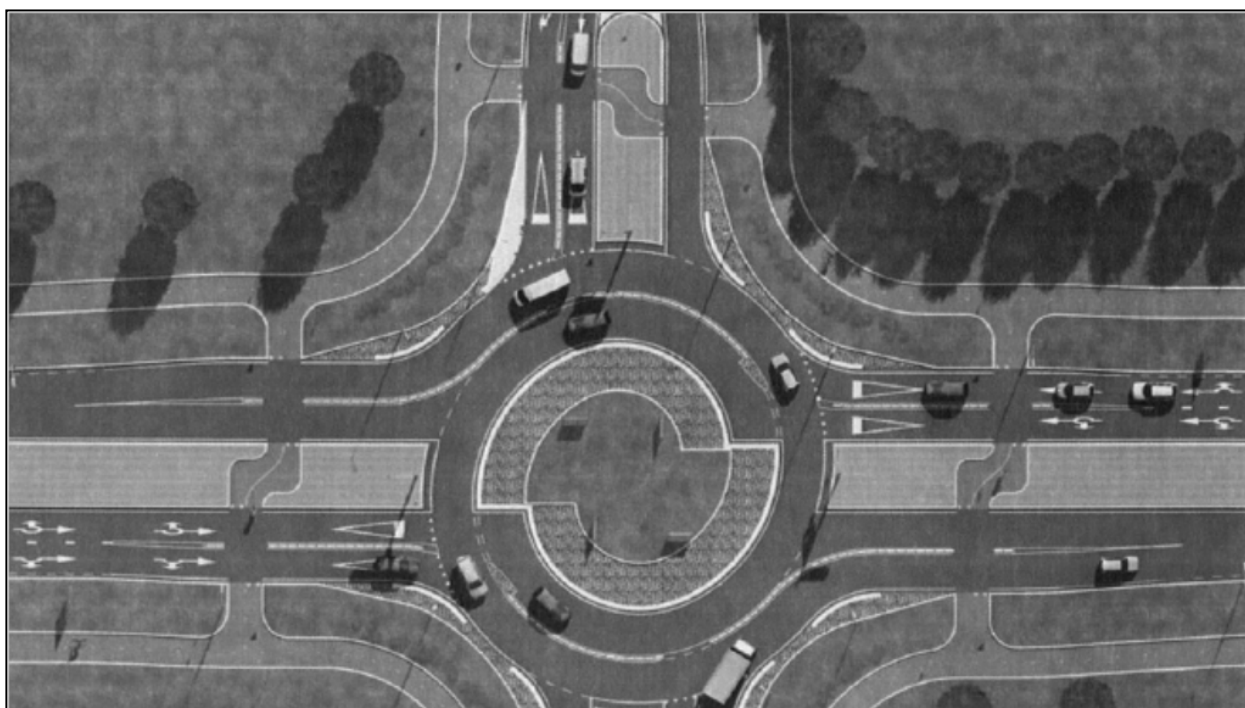
Figure 11 Standard layout of a turbo roundabout

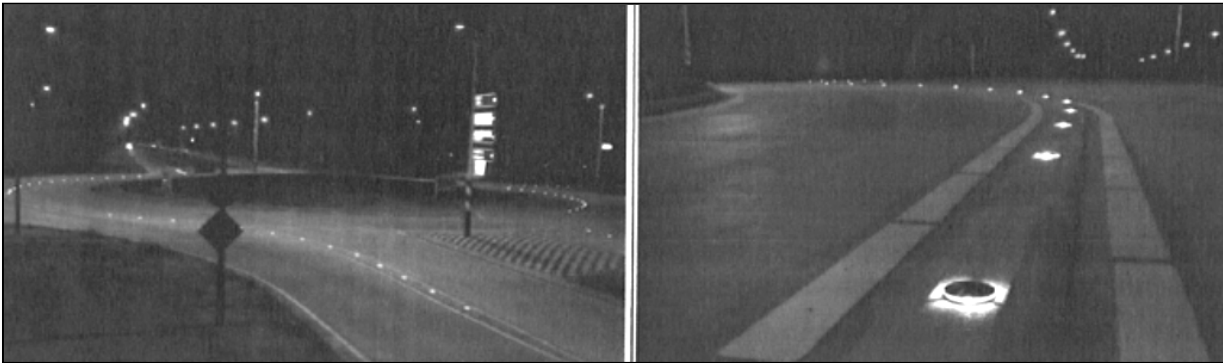
Figure I29 Example of road lighting (LED) to improve visibility of the lane dividers

The aim of public lighting on turbo roundabouts is drivers. Of course the visibility of the intersection and the alignment of the lanes have to be assured. Specifically for turbo roundabouts, public lighting should be used to improve visibility of the middle island and the lane dividers, (see figure I29). It can also be used to pay extra attention to conflict points or specific elements of the turbo roundabout.

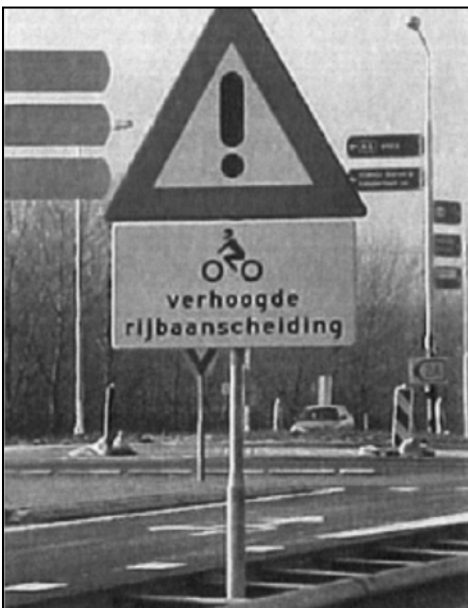
Figure I30 Warning sign 'raised lane dividers' for motor cyclists

Lane dividers create a risk for powered two wheelers, which can easily fall when driving over a lane divider. Nevertheless, experience in The Netherlands shows that motor cyclists prefer turbo roundabouts to multi lane roundabouts because they do not have to fear cars changing lanes on the roundabout. For the safety of the motor cyclists, it is essential to put clear signs to warn them about the lane dividers (see figure I30; 'verhoogde rijbaanscheiding' = raised lane divider).

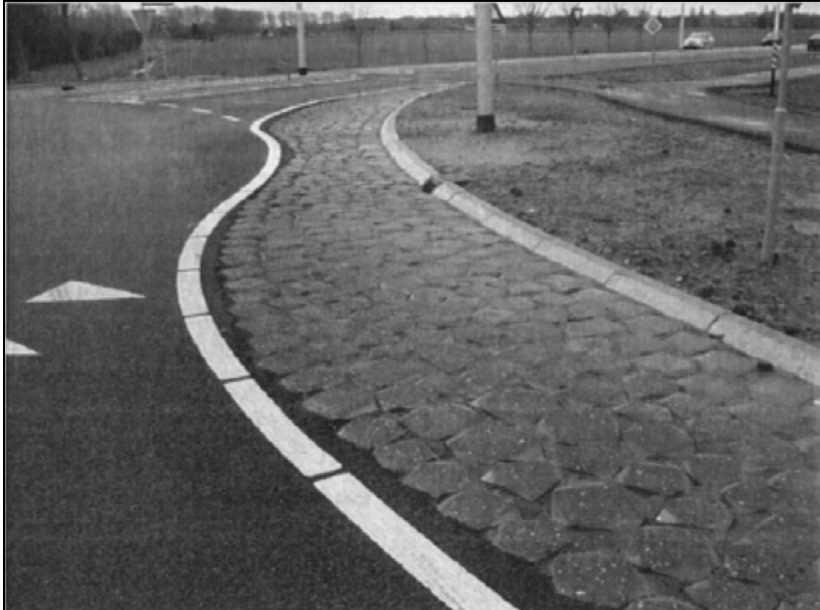
Figure I31 Rumble area for articulated vehicles
