NCHRP Synthesis 220

**Waterproofing Membranes for
Concrete Bridge Decks**

A Synthesis of Highway Practice

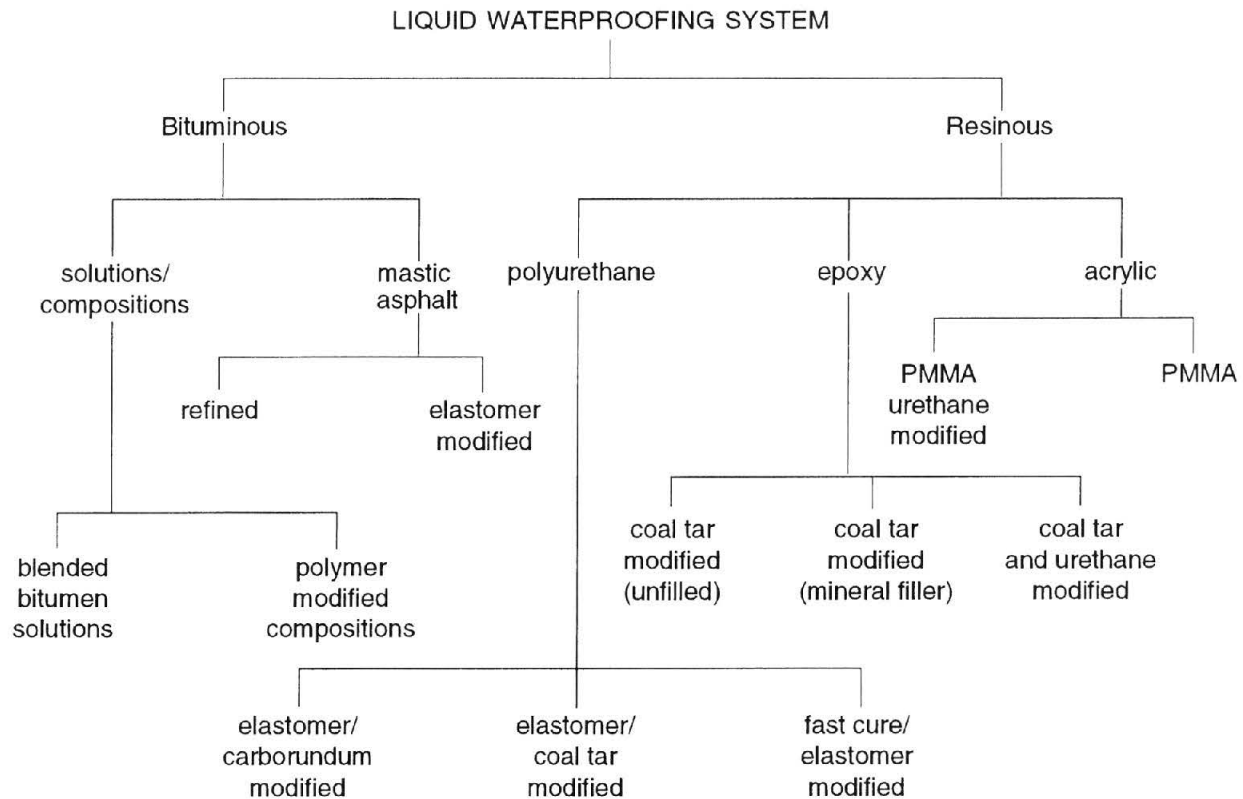
FIGURE 7 Liquid waterproofing systems (adapted from 9).

The resin-based systems were either one or two part mois-

ture curing or two part chemical curing, based on either urethane, epoxy, or acrylic resins.

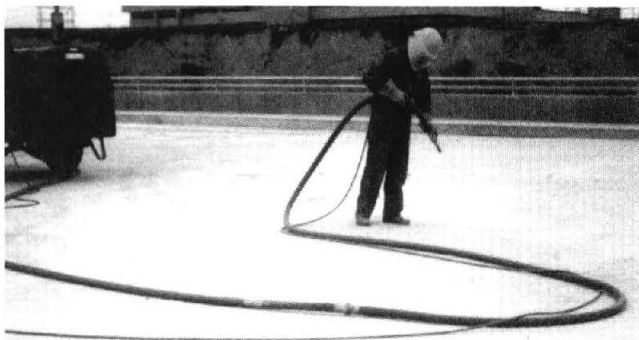
FIGURE 13 Sand blasting a bridge deck prior to waterproofing.

Where a curing compound was used on the concrete surface, it must be removed completely (66). This can only be done adequately by water or abrasive blasting. During field trials undertaken in California in the early 1970s, problems were experienced with two different systems because of reactions with

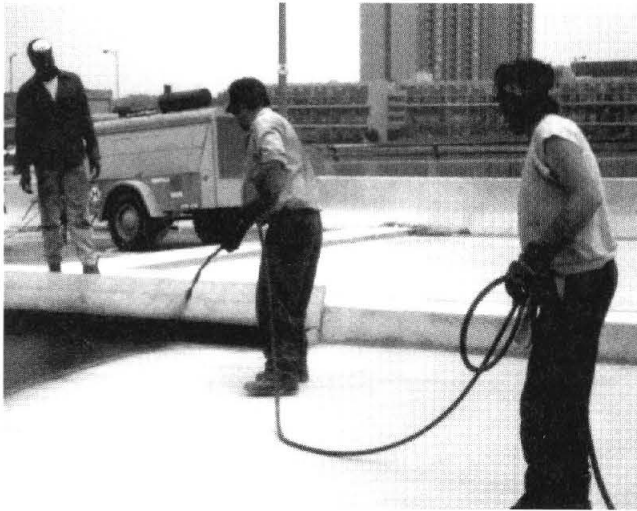
FIGURE 14 Application of an asphalt emulsion primer using a spray.

The membranes should be applied soon after the prime coat has cured. Long exposure results in deterioration of the primer, often accompanied by contamination of the primed surface. In such cases, the surface must be cleaned and an additional primer coat applied. Specifications typically prohibit equipment and foot traffic on the primed surface until the primer has cured completely.

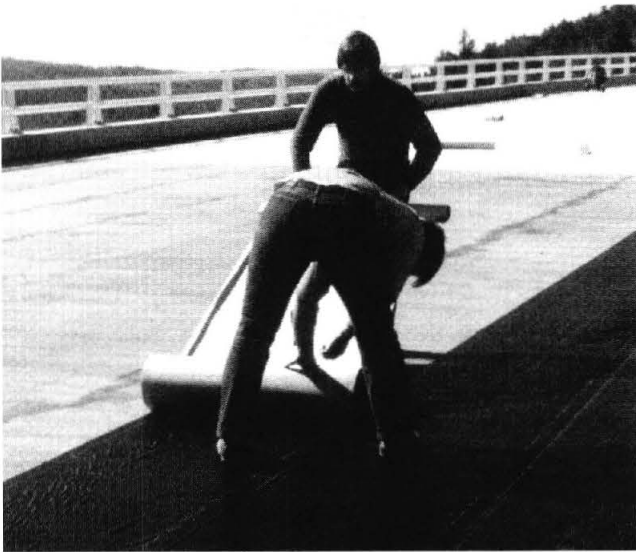
FIGURE 18 Application of a self-adhesive preformed membrane. (Courtesy of Vermont Agency of Transportation)

Most of the sheet membranes used in North America have a self-adhesive backing. The membranes are unrolled to cover

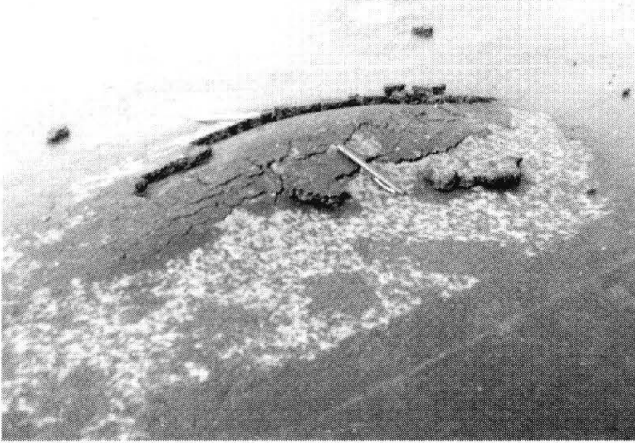
FIGURE 23 Blisters in membrane and base course. (Courtesy of Vermont Agency of Transportation)

The rapid expansion of vapor during placement of the hot mix can also result in blister formation. Unless the asphalt cracks, these blisters are difficult to detect and even more difficult to repair. Air pockets trapped beneath a protection layer will also have the same effect.

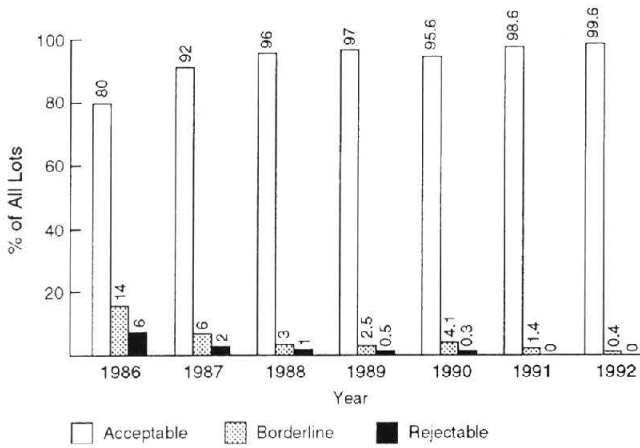
FIGURE 25 Annual thickness compliance for liquid membranes.

Figure 25 shows improvement in compliance with the thickness requirements from the introduction of the specification in 1986 to 1992. In 1986, only 80 percent of the lots were accept-

able, and 6 percent were rejectable. In 1992, a total of 94 890 m² (1,021,000 ft²) was installed by eight contractors. Of the 257 lots reported, there was only one borderline lot and no rejectable lot. The borderline lot received a price adjustment factor of 0.93.

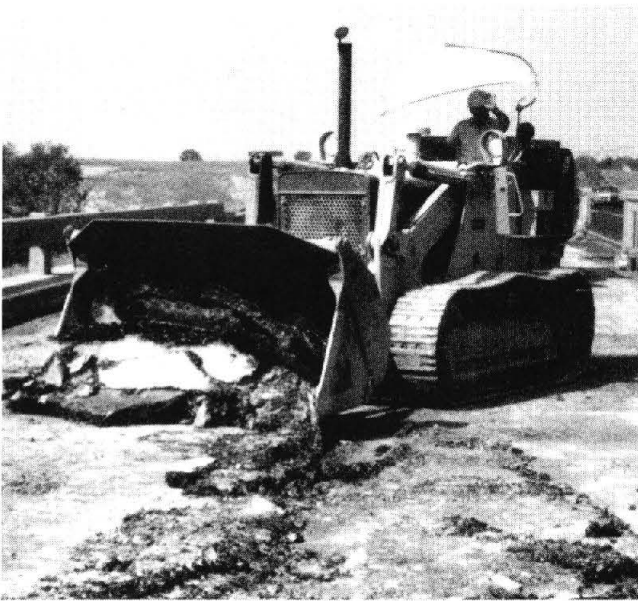
FIGURE 29 Use of a bucket to remove surfacing and poorly bonded membrane.

Where there is an existing membrane on the deck, the difficulty of removal is a function of the bond to the deck. If the bond is weak, the membrane can be planed, sometimes in the same operation as removing the asphalt surfacing as illustrated in Figure 29. In situations where the membrane is tightly adhered to the concrete, removal can be very difficult. Eleven responding agencies reported that they had experienced difficulties in removing existing membranes and eight agencies reported experiencing no difficulties. Other agencies reported no experience because it had not been necessary to remove membranes. The methods of removal varied, although planing or scraping, often followed by abrasive or water blasting, were most common. Some agencies use milling equipment, and Colorado reported using heat to soften the membrane so that it

can be removed by scraping. The softer, liquid membranes are especially difficult to remove because they remain tacky; they are also not easily removed by blasting. Recognizing these difficulties, several agencies reported that the contractor is allowed to leave remnants of membrane in place provided that they are tightly bonded to the deck surface. This does not appear to have caused problems in North America because of the limited range of membranes used. The issue of compatibility of materials is much larger in Europe because of the greater diversity of materials used in waterproofing systems. Where a bituminous system is being replaced by a resinous waterproofing system, very thorough preparation is necessary because of the incompatibility of many bitumens and resins (22). The deck also needs to be examined for evidence of applications of a sealer. Some silane treatments have been found to reduce the adhesion of membranes (66).
