1. Report No. FHWA/TX-01/1879-2		2. Government Accession No.		3. Recipient's Catalog No.	
4. Title and Subtitle EVALUATION OF TRAFFIC CONTROL DEVICES FOR RURAL HIGH-SPEED MAINTENANCE WORK ZONES: SECOND YEAR ACTIVITIES AND FINAL RECOMMENDATIONS				5. Report Date October 2000

6. Performing Organization Code	
7. Author(s) Michael D. Fontaine, Paul J. Carlson, and H. Gene Hawkins, Jr.				8. Performing Organization Report No. Report 1879-2

**EVALUATION OF TRAFFIC CONTROL DEVICES FOR RURAL HIGH-  
SPEED MAINTENANCE WORK ZONES:  
SECOND YEAR ACTIVITIES AND FINAL RECOMMENDATIONS**

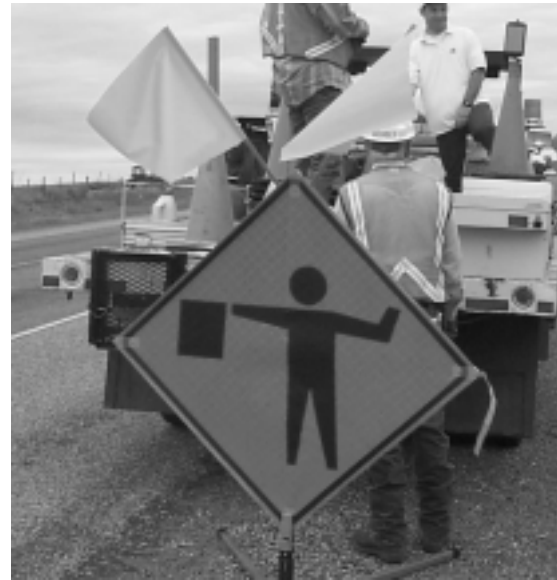
**Figure 1. Fluorescent Orange Sign.**

- The main advantage of fluorescent signing occurs during periods of low light. The advantages of fluorescence are especially noticeable on cloudy days, in the morning, in the evening, or in shady areas. A secondary advantage to fluorescent orange signing is that most are made of prismatic retroreflective sheeting. Consequently, if work crews used the signs during nighttime conditions, they would appear brighter than the beaded retroreflective material normally used.

- Maintenance crew opinions were positive concerning use of fluorescent orange signing.
- The main advantage of fluorescent signing occurs during periods of low light. The advantages of fluorescence are especially noticeable on cloudy days, in the morning, in the evening, or in shady areas. A secondary advantage to fluorescent orange signing is that most are made of prismatic retroreflective sheeting. Consequently, if crews used the signs during nighttime conditions, they would appear brighter than the beaded retroreflective material normally used.

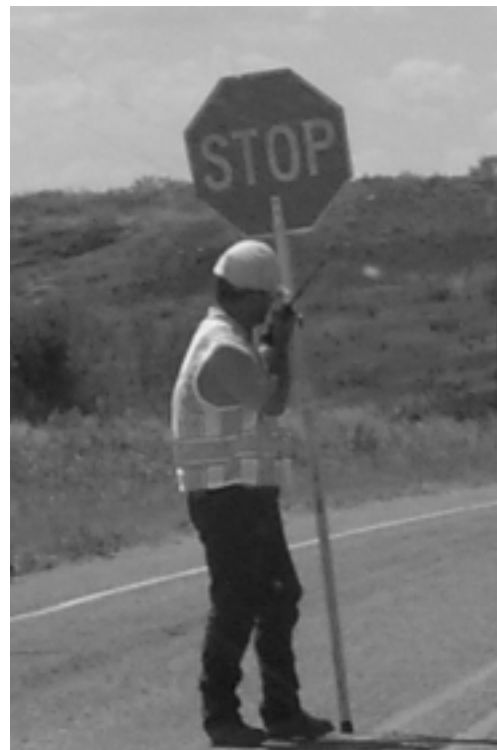
**Figure 2. Fluorescent Yellow-Green Vests and Hard Hat**

**Fluorescent yellow-green worker vests**  
(Figure 2)

**Fluorescent yellow-green hard hat covers**  
(Figure 2)

- The maintenance crews responded favorably to the fluorescent yellow-green vests.
- The vests were more conspicuous than the standard orange vests that TxDOT personnel normally wear. The fluorescent yellow-green vests provide a distinct contrast between the highway workers and the orange traffic control devices, which can sometimes act as camouflage for highway workers.
- Testing showed that the fluorescent yellow-green vests with solid fabric panels provided the best luminance and contrast ratios.
- The TxDOT fluorescent yellow-green vests were the best performing mesh vests evaluated.

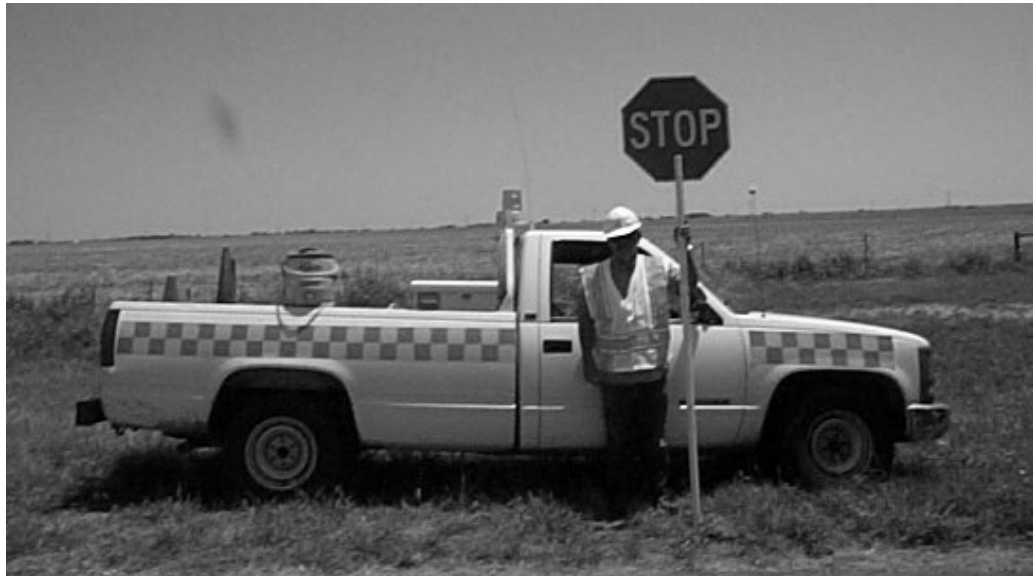
**Figure 3. Vehicle Visibility Improvements.**

**Retroreflective magnetic strips on work vehicles**  
(Figure 3)

- While these devices added some obvious conspicuity to the vehicles, there were no direct measures of their benefit. However, the fluorescence of the strips would provide a significant increase in conspicuity during low-light conditions.

- Being retroreflective, the strips' main benefit would occur at night.

- While these devices added some obvious conspicuity to the vehicles, there were no direct measures of their benefit. However, the fluorescence of the strips would provide a significant increase in conspicuity during low-light conditions.
- Being retroreflective, the strips' main benefit would occur at night.

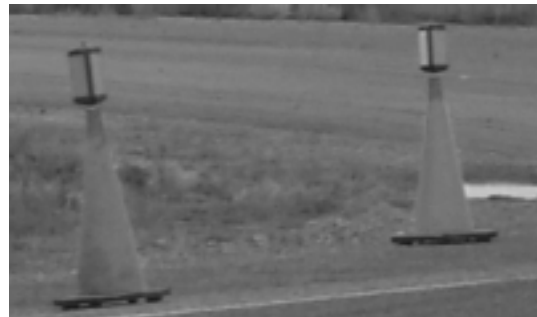
**Figure 4. Safe-T-Spins.**

- When used on the multilane highways where lane closures were used, the devices appeared to have a negative effect. With vehicles, especially trucks, passing so close to the devices and at speeds near highway operating speeds, the devices caused the cones to blow over. They required constant attention from the maintenance personnel in order to keep them in an upright position.

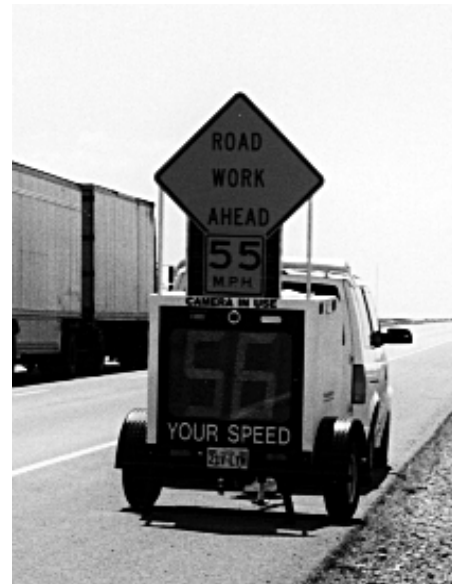
**Figure 5. Speed Display.**

### Speed display (Figure 5)

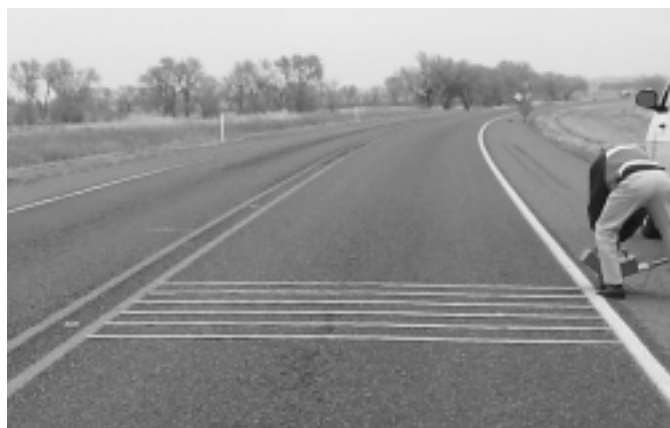
**Figure 6. Portable Rumble Strips.**

#### **Portable rumble strips (Figure 6)**

- The portable rumble strips had little impact on passenger car speeds but reduced truck speed by 3-5 mph.
- The percentage of vehicles exceeding the speed limit tends to be reduced following the rumble strip installations.
- Installation time for the rumble strips was probably too lengthy to justify their use at rural maintenance work zones.

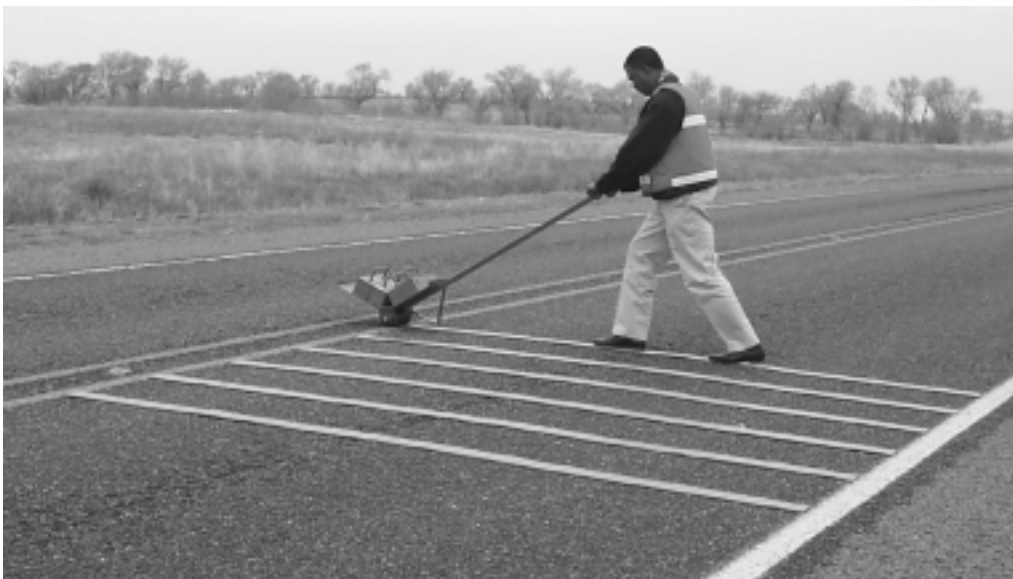
**Figure 7. Portable Rumble Strips Installation.**

Researchers tested two sets of rumble strips at each data collection site. Since the Kansas study showed that the initial 0.125 inch thickness produced minimal speed reductions, the thickness of the strips was doubled by adhering one strip to the face of another. Each set was composed of six individual rumble strips that were placed at 18 inch intervals parallel to one another. The adhesive backing was simply peeled from the back of the strip, and the strip was placed on the pavement. A tamping cart was used to ensure that there was good adhesion between the strip and the road surface. [Figure 7](#) shows an example of the tamping process.

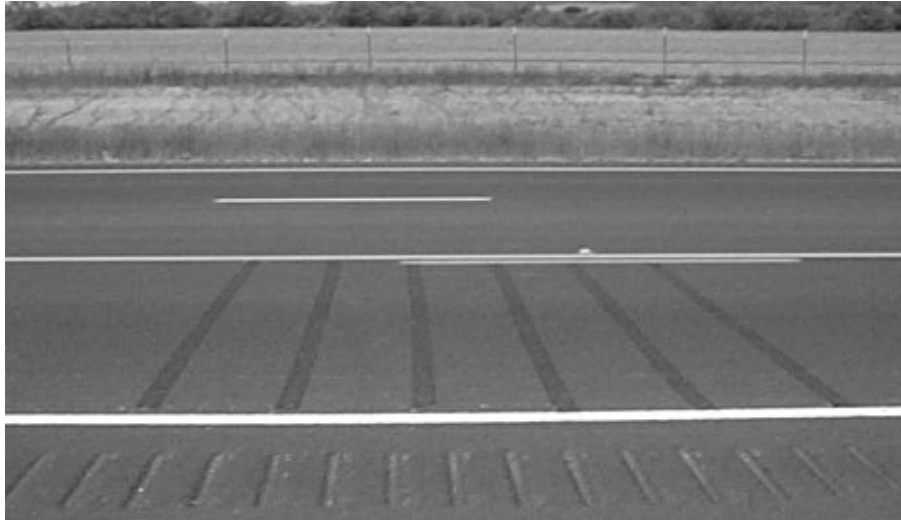
**Figure 8. Removal of Rumble Strips.**

Removal of the rumble strips was accomplished by simply peeling them off the road surface. If the surface of the road was not clean, or was composed of loose pavement, some debris could still be attached to the back of the rumble strip. In these cases, the rumble strips were not reusable. Figure 8 shows the aftermath of removing the rumble strips from the pavement.

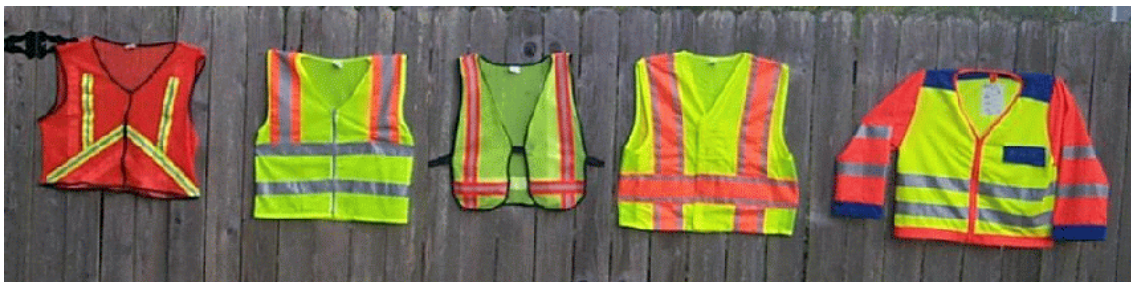
**Figure 9. Worker Garments Evaluated.**

- TxDOT orange mesh vest,
- TxDOT yellow-green mesh vest,
- mesh yellow-green vest,
- solid panel yellow-green vest, and
- yellow-green garment with sleeves.

These garments were evaluated based on their visual performance and the wearer's anticipated comfort level. In order to determine an acceptable procedure for objectively determining a garment's visibility, a great deal of research was conducted into how humans process visual information and requirements for worker garments. This research is described below.

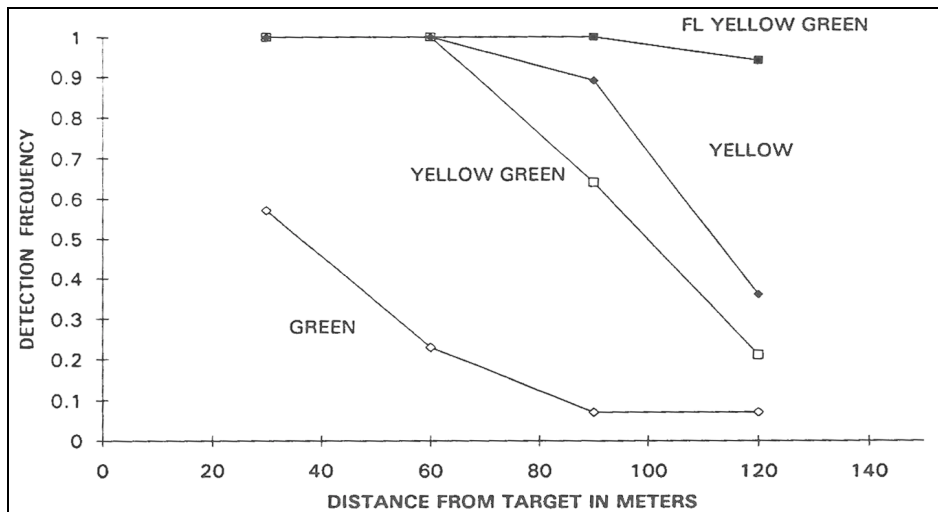
**Figure 10. Detection (10).**

In 1995, Burns and Pavelka evaluated the daytime visibility of fluorescence for signing applications (10). Although the main intent of their research was for signing, their research results apply to fluorescent worker garments as well. In field studies, Burns et al. looked at detection and recognition of fluorescent and non-fluorescent colors. Figure 10 shows how much more detectable fluorescent yellow-green is over similar non-fluorescent colors. The background material was a camouflage made up of 23 percent light green, 34 percent green, 25 percent brown, and 18 percent black. Similar findings, not shown here, were obtained for fluorescent orange versus standard orange.

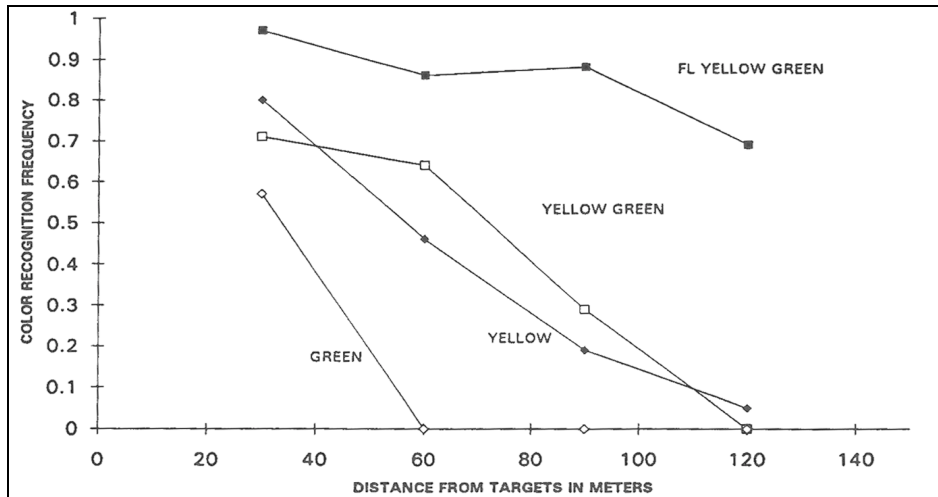
**Figure 11. Color Recognition (10).**

Figure 11 shows similar results for color recognition of fluorescent versus non-fluorescent colors. Again, the findings comparing fluorescent orange and non-fluorescent orange showed similar results.

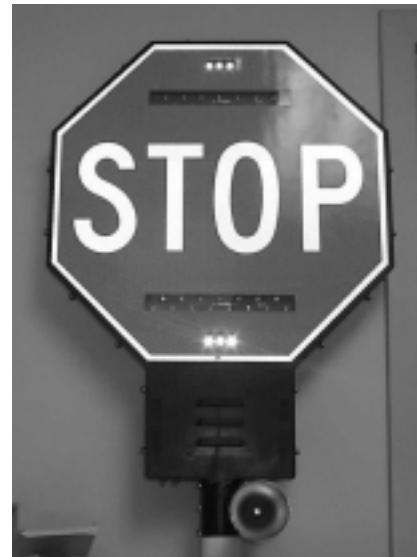
**Figure 14. Radar-Activated Flagger Paddle.**

A prototype radar-activated flashing flagger paddle was developed by the Texas Transportation Institute for this project. The existing device is currently very fragile and is not suitable for extended field use. The paddle consists of an 18 inch stop and slow sign made of prismatic sheeting mounted on a 5 feet tall plastic pipe. [Figure 14](#) shows the front of the paddle.

There are three white and 15 red light emitting diodes (LEDs) above and below the legend of the stop sign. These LEDs are extremely bright, but also very directional. If the flagger points the stop paddle directly at an oncoming vehicle, the LEDs can be seen from quite a distance during the day. The battery is included in the sign face and is rechargeable. The radar and LEDs can operate for more than a day on a single battery charge.

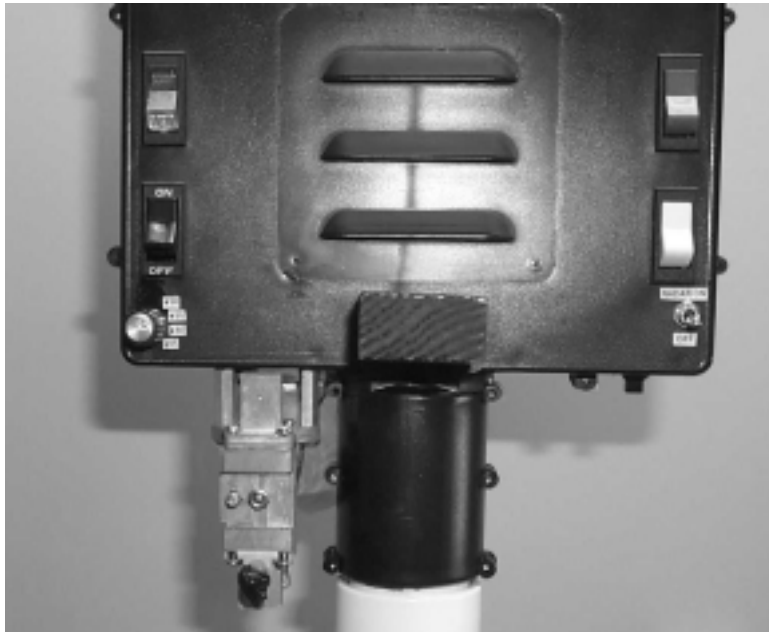
**Figure 16. Flagger Paddle Controls.**

When the radar is active, the LEDs in the face of the sign will blink when a vehicle is detected traveling over a set speed threshold. The speed threshold can be set at 50, 55, 60, or 65 mph. When the radar detects a vehicle above the speed threshold, the red and white LEDs blink alternatively. The radar can only detect speeds when the stop legend is facing traffic. An indicator is located on the face of the slow sign that will provide the flagger with an indication as to how fast oncoming traffic is traveling. LEDs can still be activated manually without being triggered by the radar gun should the flagger desire additional visibility. Figure 16 shows the controls used to operate the sign.

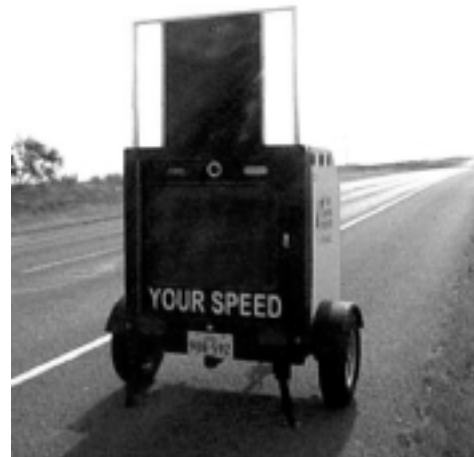
**Figure 17. Speed Display (Front View).**

This evaluation utilized a trailer-mounted speed display provided by TxDOT. [Figure 17](#) shows the front of the speed display, and [Figure 18](#) shows the profile of the display. The unit features a 24 inch LED display and uses Ka-band radar to detect oncoming vehicles. The display has a strobe lamp that flashes when a vehicle is detected traveling over a preset speed threshold. This feature is intended to simulate the operation of photo enforcement, possibly decreasing speeds through the threat of automated enforcement. During this evaluation, the speed threshold for the strobe light was set at 75 mph. The display also has a 130 decibel siren that can be activated by vehicles traveling over a preset speed. This option is intended to warn workers when an extremely high-speed vehicle is approaching but was not used in this evaluation due to concerns about battery drain. [Figure 19](#) shows the controls for the speed display.

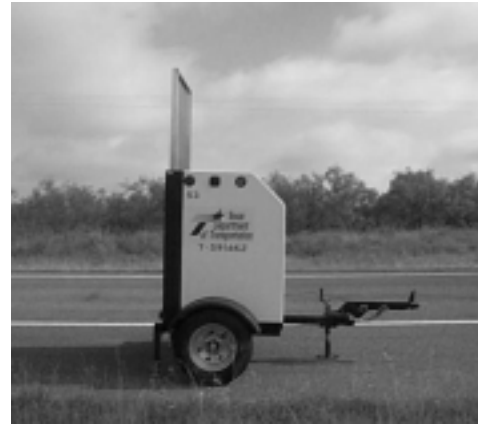
**Figure 18. Speed Display (Side View).**

The set up and removal of the sign could be accomplished in under 10 minutes. A towing vehicle brought the sign to the desired location. The display was disconnected from the towing vehicle and placed perpendicular to traffic. Workers leveled the display by adjusting the legs attached to the trailer. The front of the display was then opened, and the power was turned on. Speed thresholds for the strobe light and siren could be set by simply dialing the correct speed. The display was then closed, and the speeds were verified using Light Detection and Ranging (LIDAR) guns. Removal of the display involved turning the power off and connecting the display to the towing vehicle.

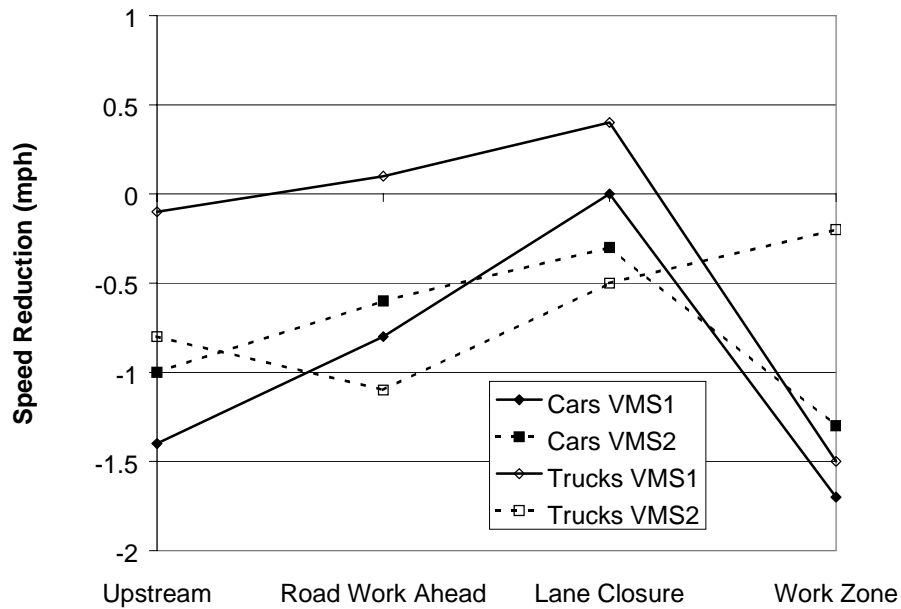
**Figure 21. Speed Reductions at VMS1 and VMS2.**

**Counter Data.** [Figures D-4 and D-5](#) show the speeds collected at VMS1 and VMS2. [Figure 21](#) shows the speed reductions achieved with the VMS. Very small speed changes were observed at the sites.

Passenger car speeds were usually lower at all of the data collection stations at both sites, with speed reductions of no more than 2 mph. These speed reductions were found to be significant for cars upstream of the work zone and within the work zone at both sites. The percentage of cars speeding was also significantly reduced within the work zone at both sites.

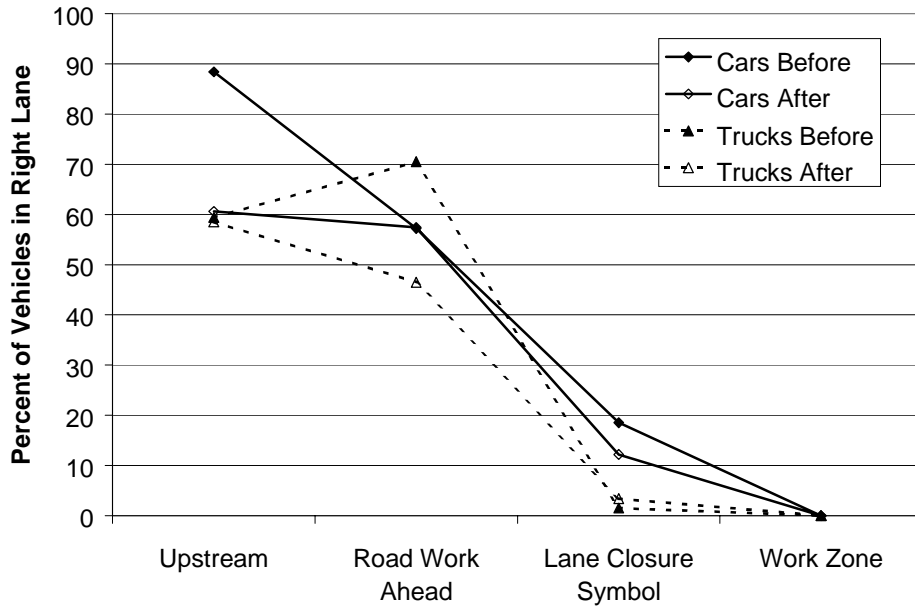
**Figure 22. Percentage of Vehicles in Closed Lane at VMS1.**

vehicles in the closed lane was consistently lower when the VMS was operational. Typically, 20 to 30 percent fewer vehicles were in the closed lane at VMS2 at each of the data collection points. The impact of the VMS on the lane distribution of traffic was less consistent at VMS1, with the percent of traffic in the closed lane sometimes increasing when the VMS was operational.

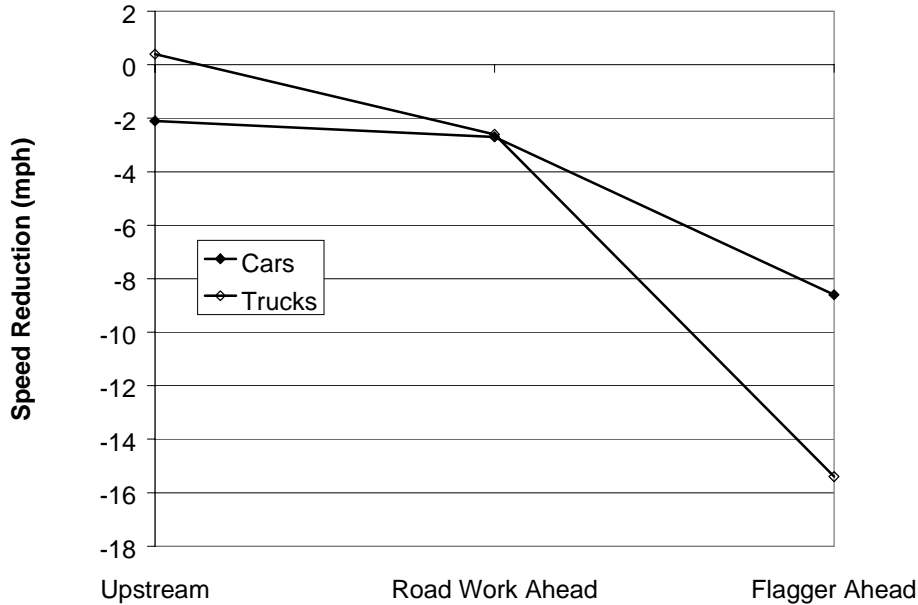
**Figure 24. Speed Reduction at RD1.**

magnitudes of the speed reductions observed may not be representative of what could be expected with these devices.

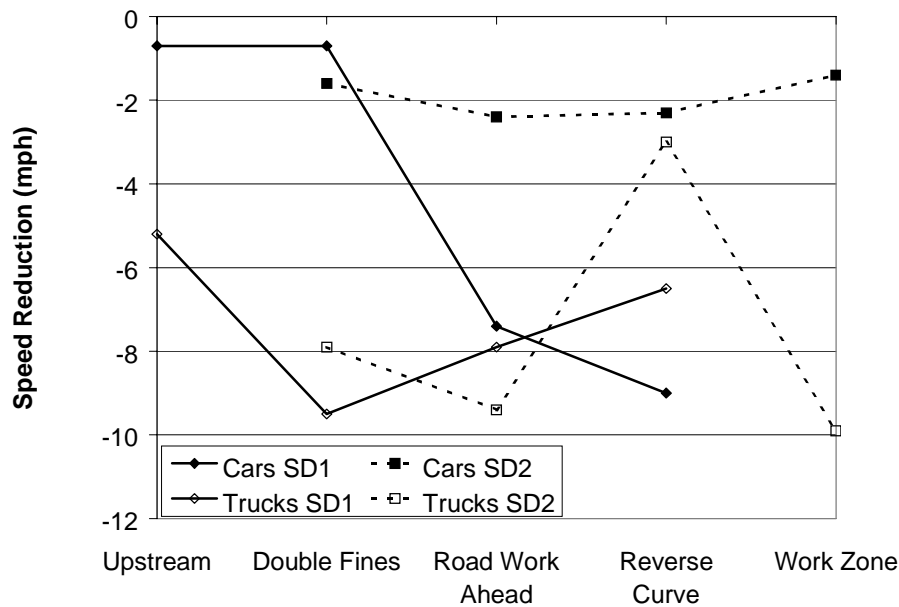
**Figure 25. Speed Reductions at SD1 and SD2.**

**Counter Data.** Figures D-7 and D-8 show the speed data collected with the counters at SD1 and SD2. Figure 25 shows the speed reductions observed when the speed display was set up at SD1 and SD2. At all data collection locations, the speeds were reduced when the display was operating. Speeds at SD2 tended to be reduced less than the speeds at SD1.

Average speeds for both cars and trucks were consistently lower when the speed display was active. Passenger car speeds were reduced by 7 to 9 mph approaching the work zone at SD1 and by about 2 mph at SD2. SD1 also showed a significant reduction in the percent of cars exceeding the speed limit at SD1. Trucks generally experienced larger speed reductions than cars at both sites. Trucks at SD1 slowed 7-8 mph, and trucks at SD2 slowed by as much as 10 mph.

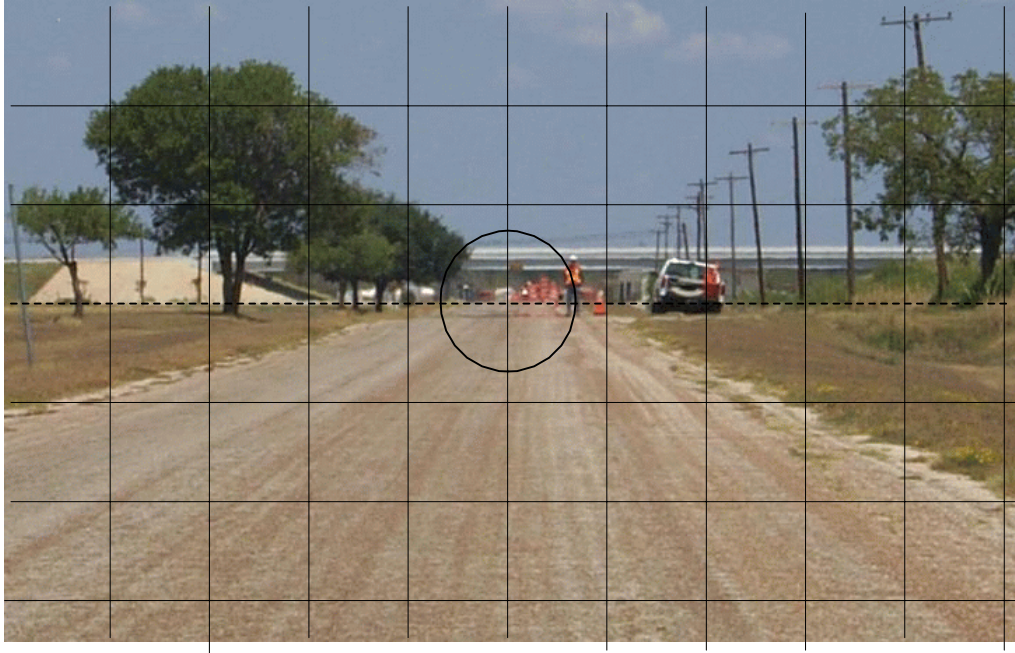
**Figure 27. Area Covered by Foveal Vision.**

The fovea area is limited to approximately a 2 degree visual arc. This rather narrow field of vision, combined with the relatively poor visibility performance characteristics of the peripheral area, is critical when assessing the conspicuity of highway workers under photopic and mesopic conditions. Figure 27 shows a picture taken of a typical rural high-speed maintenance work zone with flagger operations. The circle in the middle of Figure 27 represents the approximate area covered by foveal vision. Mostly because of the limited size of the foveal area, object detection usually occurs in the periphery. As such, the foveal area is shifted to the area of interest in order to determine recognition of the object. However, in order for an object to be detected in the periphery, it must have certain characteristics that make its attention-getting ability substantial enough for peripheral detection. Furthermore, as demonstrated in Figure 26, the farther an object is from the foveal area, the less likely it is to be detected. In this case, which is perhaps the best-case scenario, the flagger is on the edge of the foveal vision area and is in a good spot for detection. However, not all real-world situations can be set up as nicely as shown in Figure 27, and the flagger often ends up being in an area of the visual field where detection is less likely.

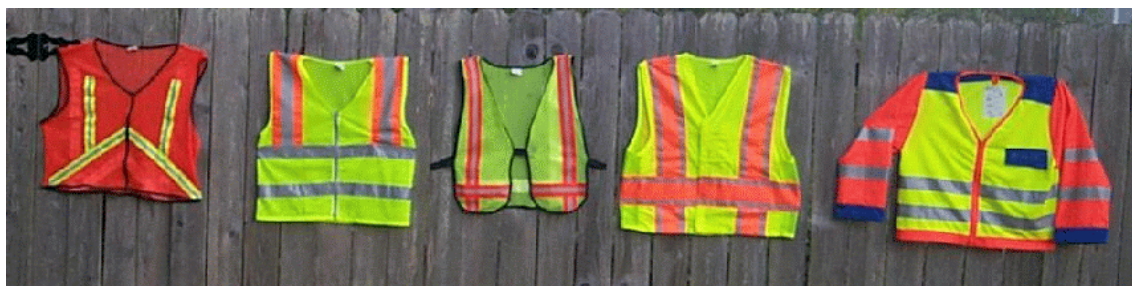
**Figure 28. Worker Garments Evaluated.**

The researchers evaluated both worker garments and hard hats. Five different garments and three different hard hat designs were evaluated. Table 15 provides a summary of these targets and Figures 28 and 29 show pictures of the worker garments and hard hats used.

<b>Worker Garments</b>	
TxDOT Fluor. Orange	mesh vest
TxDOT Fluor. Yellow-Green	mesh vest
Alternative Fluor. Yellow-Green	mesh vest
Fluor. Yellow-Green	solid vest with mesh sides
Fluor. Yellow-Green	solid jacket
<b>Hard Hats</b>	
TxDOT White	TxDOT hard hat
Silver and Fluor. Yellow-Green	alternative
Solid Fluor. Yellow-Green	alternative (pull-over cap)

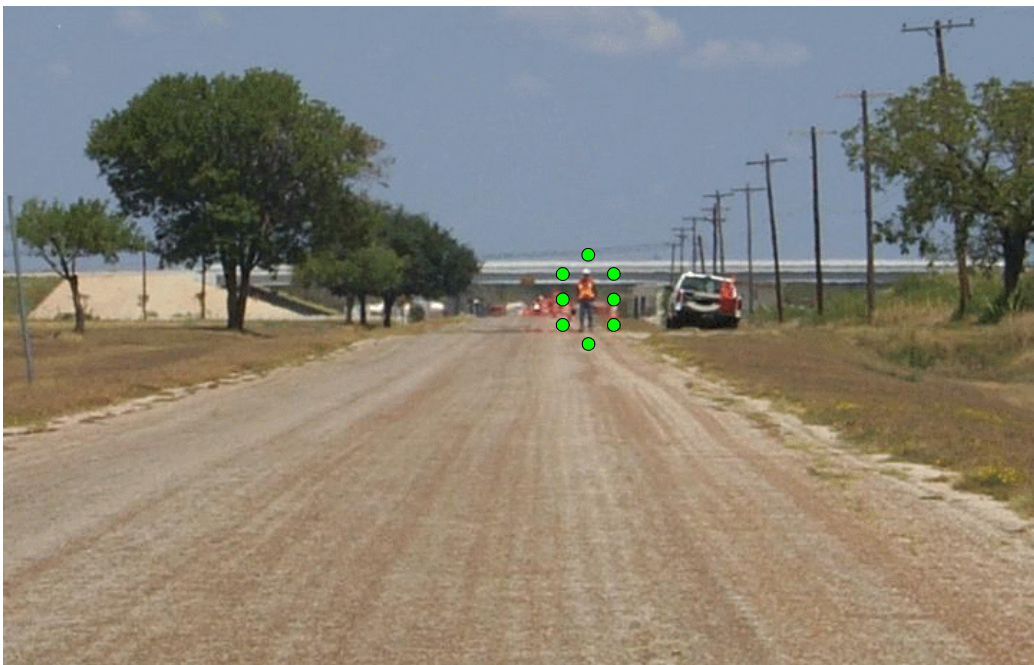
**Figure 30. Background Luminance Measurement Locations.**

Luminance values were taken through the windshield at 500 feet for all garments and hard hats, as shown in [Figure 30](#). Chromaticity data were recorded through the windshield at approximately 40 feet because of the restrictive viewing aperture of the PR-650.

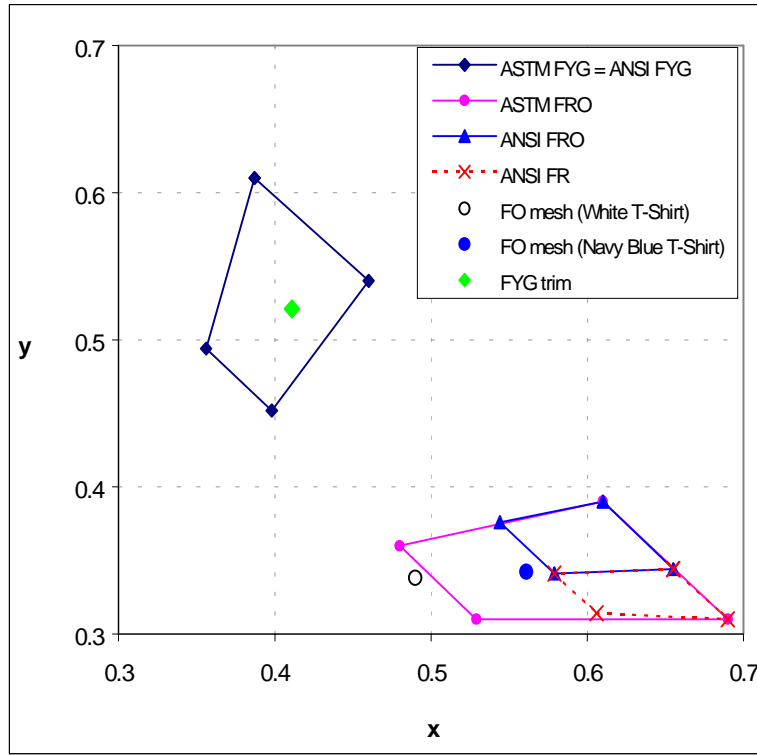
Figure 32. TxDOT Fluorescent Orange Mesh Vest.

Outdoor color measurements of worker vests and hard hats are shown in Figures 32 through 37. Each figure contains recommended color limits from the ANSI and ASTM (18, 33). The recommended color limits are to be evaluated in a laboratory setting with controlled lighting and geometry. The field results shown here are based on practical criteria. The color boxes are shown for reference and later comparison. Researchers in the profession are increasingly recognizing that test methods do not always simulate practical field conditions and that test methods may need to be modified to better correlate them to field observations (34).

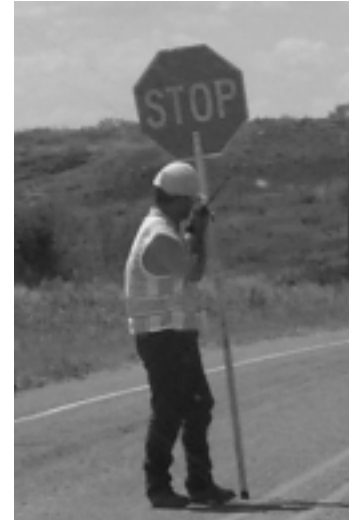
**Figure 39. Fluorescent Yellow-Green Vests and Hard Hat Covers.**

**Usability:** The yellow-green vests and hard hat covers can be easily implemented and require no additional effort on the part of the worker.

**Evaluation:** The evaluation was based on both the closed course testing and the field testing of the garments.

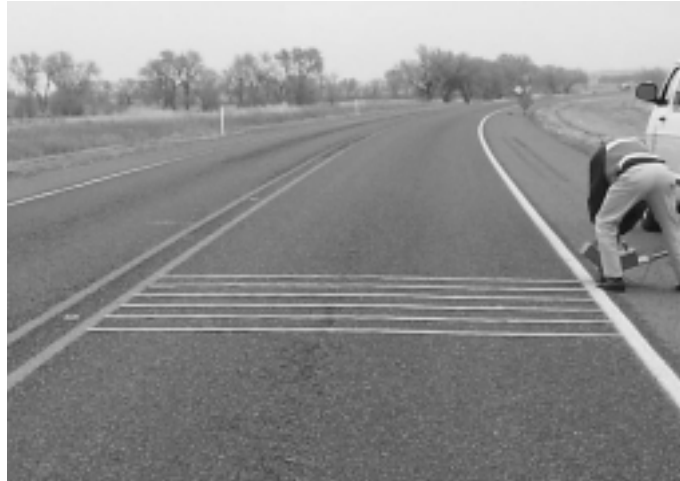
**Figure 40. Portable Rumble Strips.**

**Description:** The portable rumble strips used were manufactured by Advance Traffic Markings. The rumble strips were shipped as individual 12 feet long strips that are 4 inches wide and 0.125 inch thick. The strip thickness was doubled to 0.25 inches for this study. The strips were colored bright orange and had an adhesive backing. When these strips are placed perpendicular to the direction of traffic, they create an auditory and vibratory warning to drivers

**Application:** Portable rumble strips were tested only on two-lane roads. If they are to be used on four-lane roads, the strips may be more difficult to install.

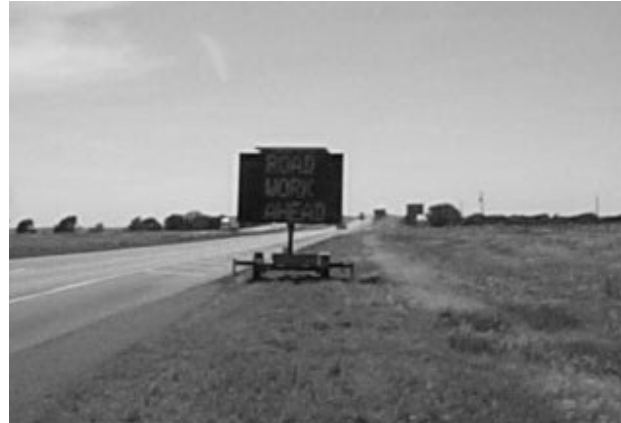
**Figure 41. Portable Variable Message Sign.**

**Usability:** The device was set up in under 10 minutes. The VMS was solar assisted, so the unit required little day-to-day maintenance.

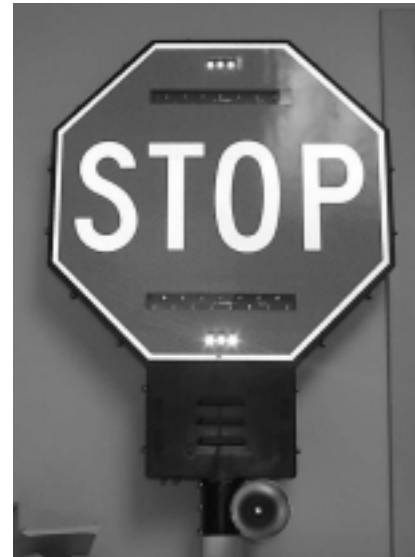
**Figure 42. Radar-Activated Flagger Paddle.**

**Usability:** The device is a prototype and has several obvious usability issues. First, the battery for the unit is located within the face of the sign, making the unit rather top-heavy. Also, the wiring for the radar is exposed to the elements and is very fragile. Users of the prototype must be very careful in order to ensure that the radar is not damaged. Should a commercial version of this device be made available, it is quite likely that these issues could be resolved.

**Evaluation:** The evaluation of this device is based solely on subjective observations of the device. Some field testing should be performed to determine if the device holds promise in the field.

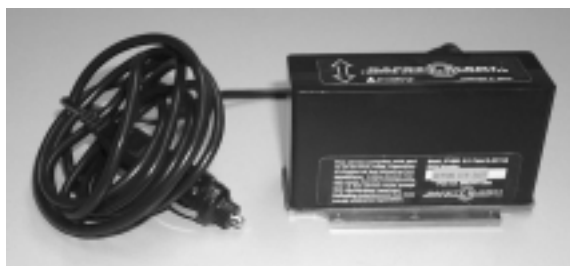
**Figure 43. Radar Drone.**

**Description:** This evaluation utilized a commercially available radar drone. The radar drone emits a K-band radar signal that can be detected up to a mile away. The radar signal will activate radar detectors, potentially decreasing vehicles speeds as they approach the drone site.

**Application:** The radar drone was tested at both two-lane and four-lane work zones.

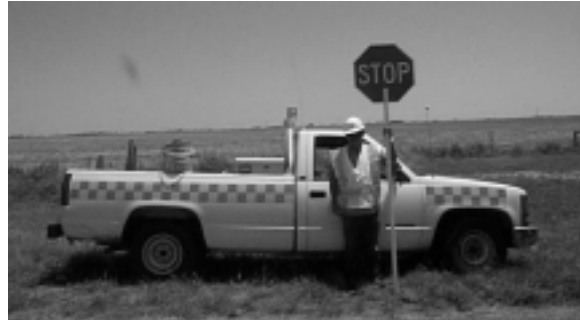
**Figure 44. Vehicle Visibility Improvements.**

**Description:** The vehicle visibility treatment tested consisted of an 8-inch wide strip of sheeting on a magnetic backing. The strips were produced in lengths of 3 feet. Square blocks with 4-inch sides were alternated along the strip to produce a checkerboard pattern. The blocks were composed of microprismatic sheeting in orange and fluorescent orange colors. The magnetic strips were manufactured specifically for this project

**Application:** The strips were evaluated on both two-lane and four-lane roads.

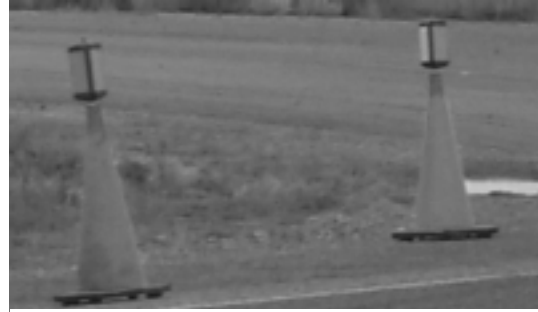
**Figure 45. Safe-T-Spins.**

**Description:** Safe-T-Spins are reflective three-sided warning devices that can be placed on top of a traffic cone. The three sides of the Safe-T-Spin are covered with 4 inch by 6 inch strips of either orange or white prismatic sheeting. The Safe-T-Spin rotates when hit by wind. The purpose of the Safe-T-Spin is to draw further attention to traffic control devices.

**Application:** The Safe-T-Spins were tested on both two-lane and four-lane roads.

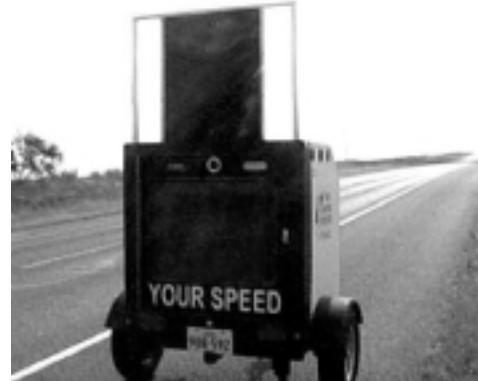
**Figure 46. Speed Display Trailer.**

**Description:** This evaluation utilized a trailer-mounted speed display provided by TxDOT. The features a 24-inch LED display and uses Ka-band radar to detect oncoming vehicles. The display has a strobe lamp that flashes when a vehicle is detected traveling over a preset speed threshold. This feature is intended to simulate the operation of photo radar, possibly decreasing speeds through the threat of automated enforcement. During this evaluation, the speed threshold for the strobe light was set at 75 mph. The display also has a 130 dB siren that can be activated by vehicles traveling over a preset speed. This option is intended to warn workers when an extremely high-speed vehicle is approaching.

**Application:** The speed display was tested at both two-lane and four-lane roads.
