AN ASSESSMENT OF EXISTING AND PROJECTED
NOISE AND VIBRATION LEVELS NEAR STUDIOS
AND OTHER SENSITIVE FACILITIES
ON SUNSET BOULEVARD

SOUTHERN CALIFORNIA RAPID TRANSIT DISTRICT

DRAFT REPORT
OCTOBER 1987

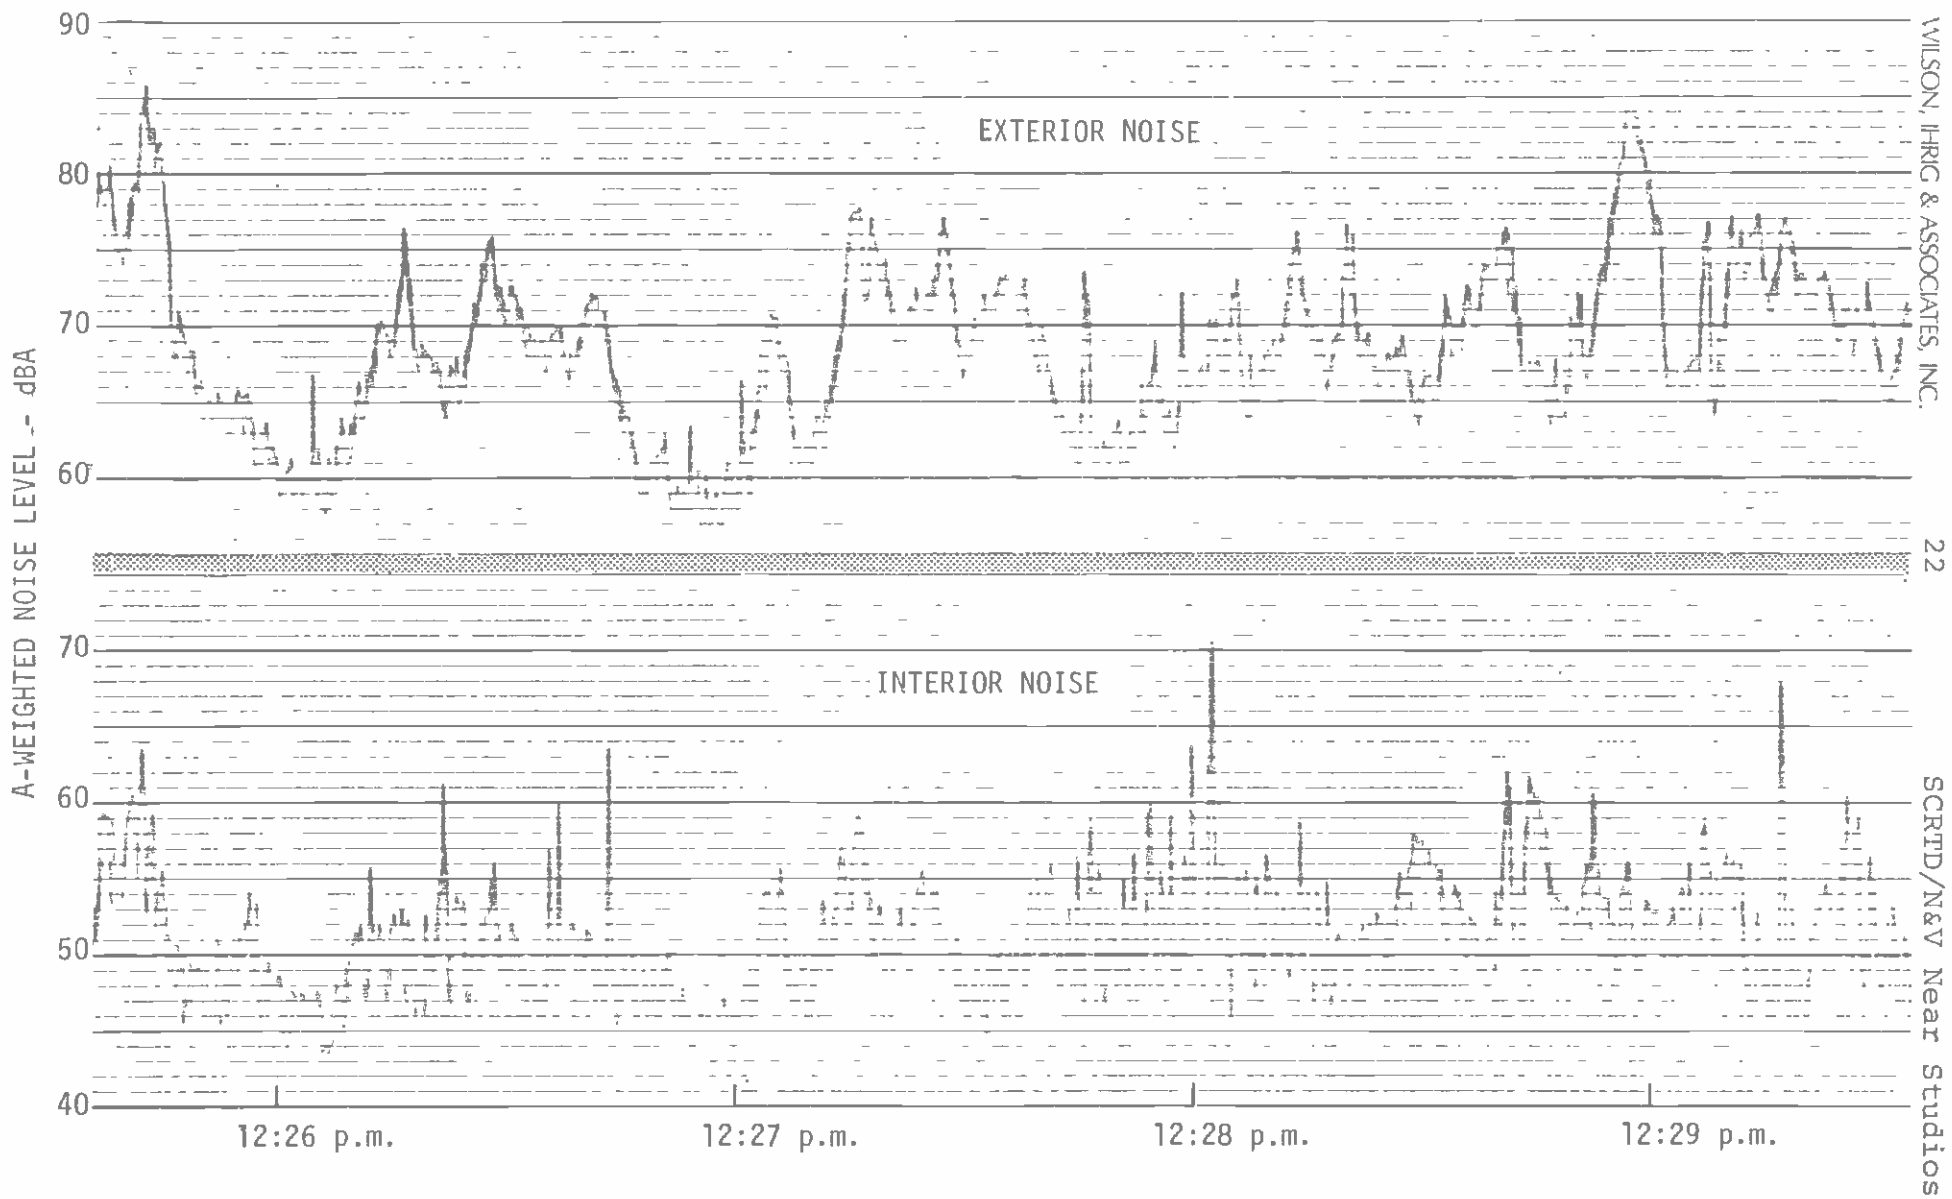
FIGURE 4 A-WEIGHTED EXTERIOR AND INTERIOR L10 NOISE LEVELS (LEVELS EXCEEDED 10% OF THE TIME) MEASURED AT KTTV CHANNEL 11 ON TUESDAY, 8 SEPTEMBER, 1987

Figures 3 and 4 show the A-weighted exterior and interior octave band noise levels that were exceeded 1% and 10% of the time (L_1 and L_{10} , respectively). (A discussion of the significance of statistical levels, including L_1 and L_{10} , is provided in Appendix B.) The spectra have been A-weighted to show the relative contributions of the octave band levels to the overall A-weighted noise levels (which are shown on the right hand axis of each graph). Also shown are the estimated A-weighted octave band levels from a six-car train, at 40 ft distance, travelling at 55 mph on an aerial structure incorporating sound barrier walls.

The estimated train noise is less than the L_1 traffic noise level, but comparable with the L_{10} traffic noise. Thus, the maximum train passby noise will be less than that from existing noisy vehicles, such as trucks, buses and motorcycles. In addition, the A-weighted octave band spectra in Figures 3 and 4 show that the traffic noise levels at 63, 125, and 250 Hz are significantly higher than the estimated train passby noise levels in those octave bands. Because the airborne sound insulation provided by building structures is typically far greater in the higher frequency octave bands, this means that the overall exterior to interior noise reduction in dBA will be somewhat higher for train noise than for traffic noise. Thus, we expect that train movements will be inaudible inside Stages 6 and 7 at KTTV Channel 11.

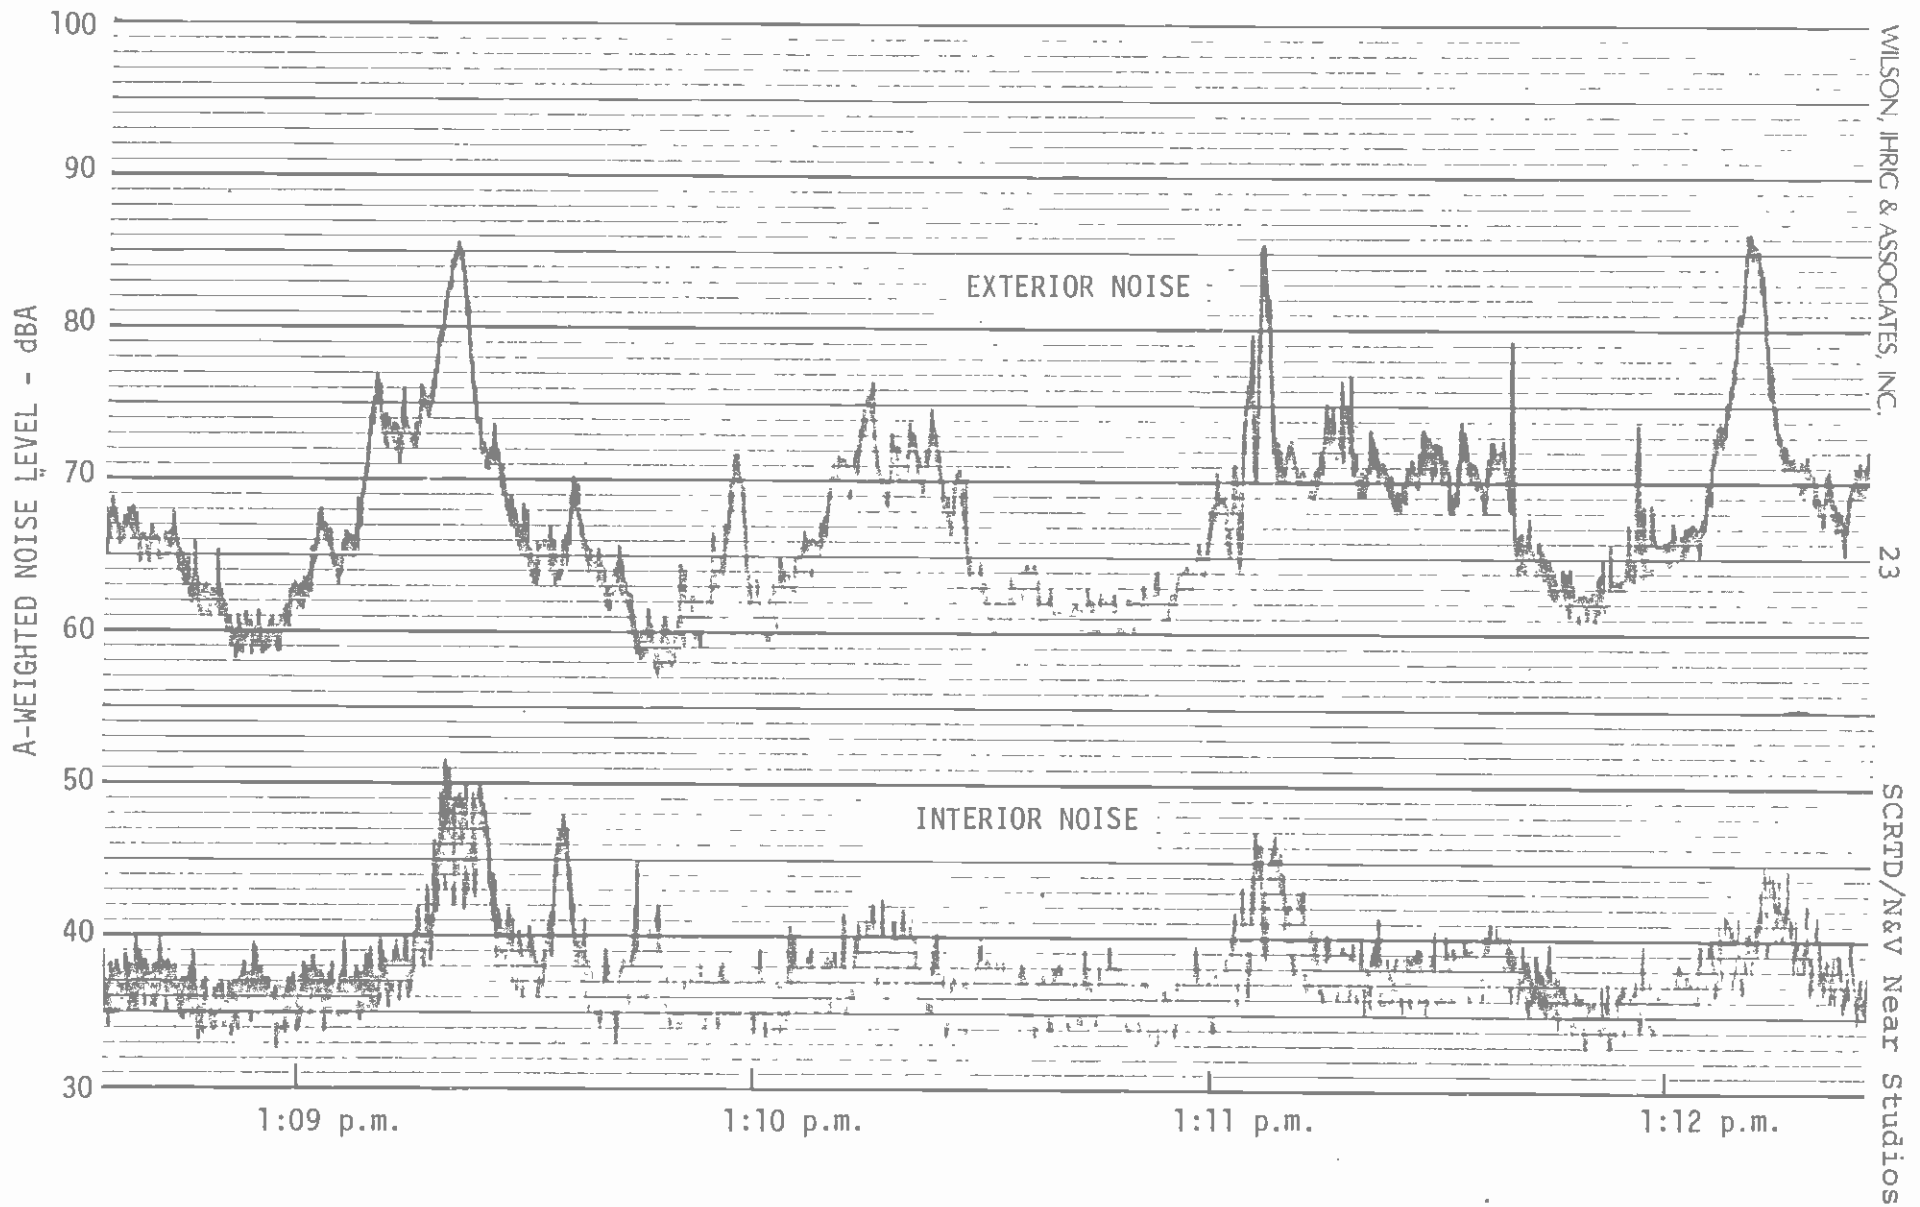
FIGURE 5 SECTION OF THE TIME HISTORY OF THE A-WEIGHTED NOISE LEVEL INSIDE AND OUTSIDE THE SELF REALIZATION FELLOWSHIP MEETING AREA, MEASURED ON TUESDAY, 8 SEPTEMBER 1987.

Figures 5 and 6 show representative sections of the A-weighted time histories of both the exterior and interior noise and Figures 7 and 8 show the L_1 and L_{10} exterior and interior noise levels, in terms of the A-weighted octave band spectra. The estimated train passby noise levels are also shown in Figures 7 and 8.

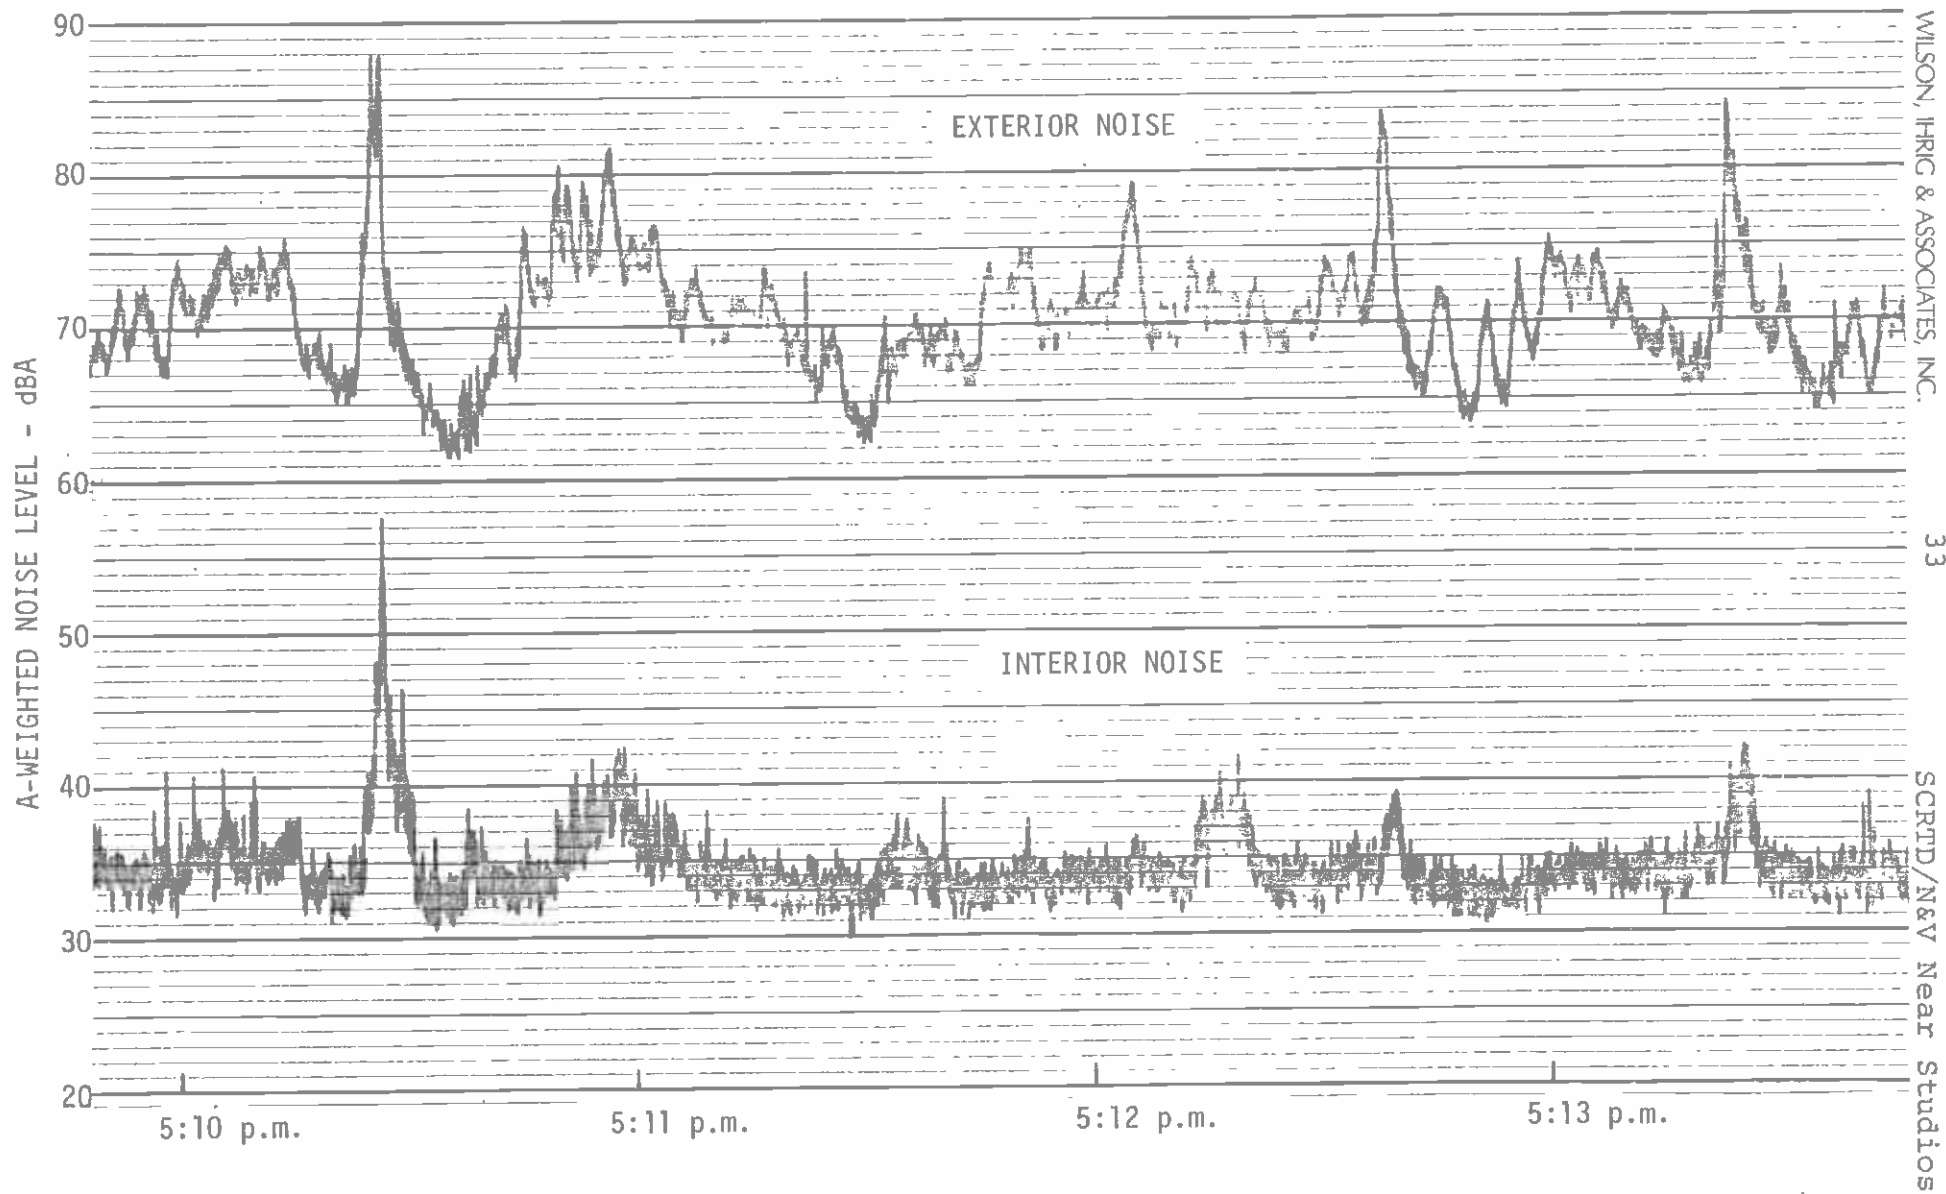
FIGURE 15 SECTION OF THE TIME HISTORY OF THE A-WEIGHTED NOISE LEVEL INSIDE AND OUTSIDE THE KWHY CHANNEL 22 STUDIOS (STUDIO B), MEASURED ON TUESDAY, 8 SEPTEMBER 1987.

The results, shown in Figures 15 through 18, confirm our subjective findings that traffic noise was at times audible in both studios, due to their close proximity to Sunset Boulevard and the inadequate sound isolation provided by the existing building construction. The A-weighted time-histories, shown in Figures 15 and 16, show that there is some correlation between the exterior and interior noise levels, particularly in Studio A. Thus, we expect that train movements may be just audible in both studios, although interior noise from train passbys will be less than from existing noisy vehicles.

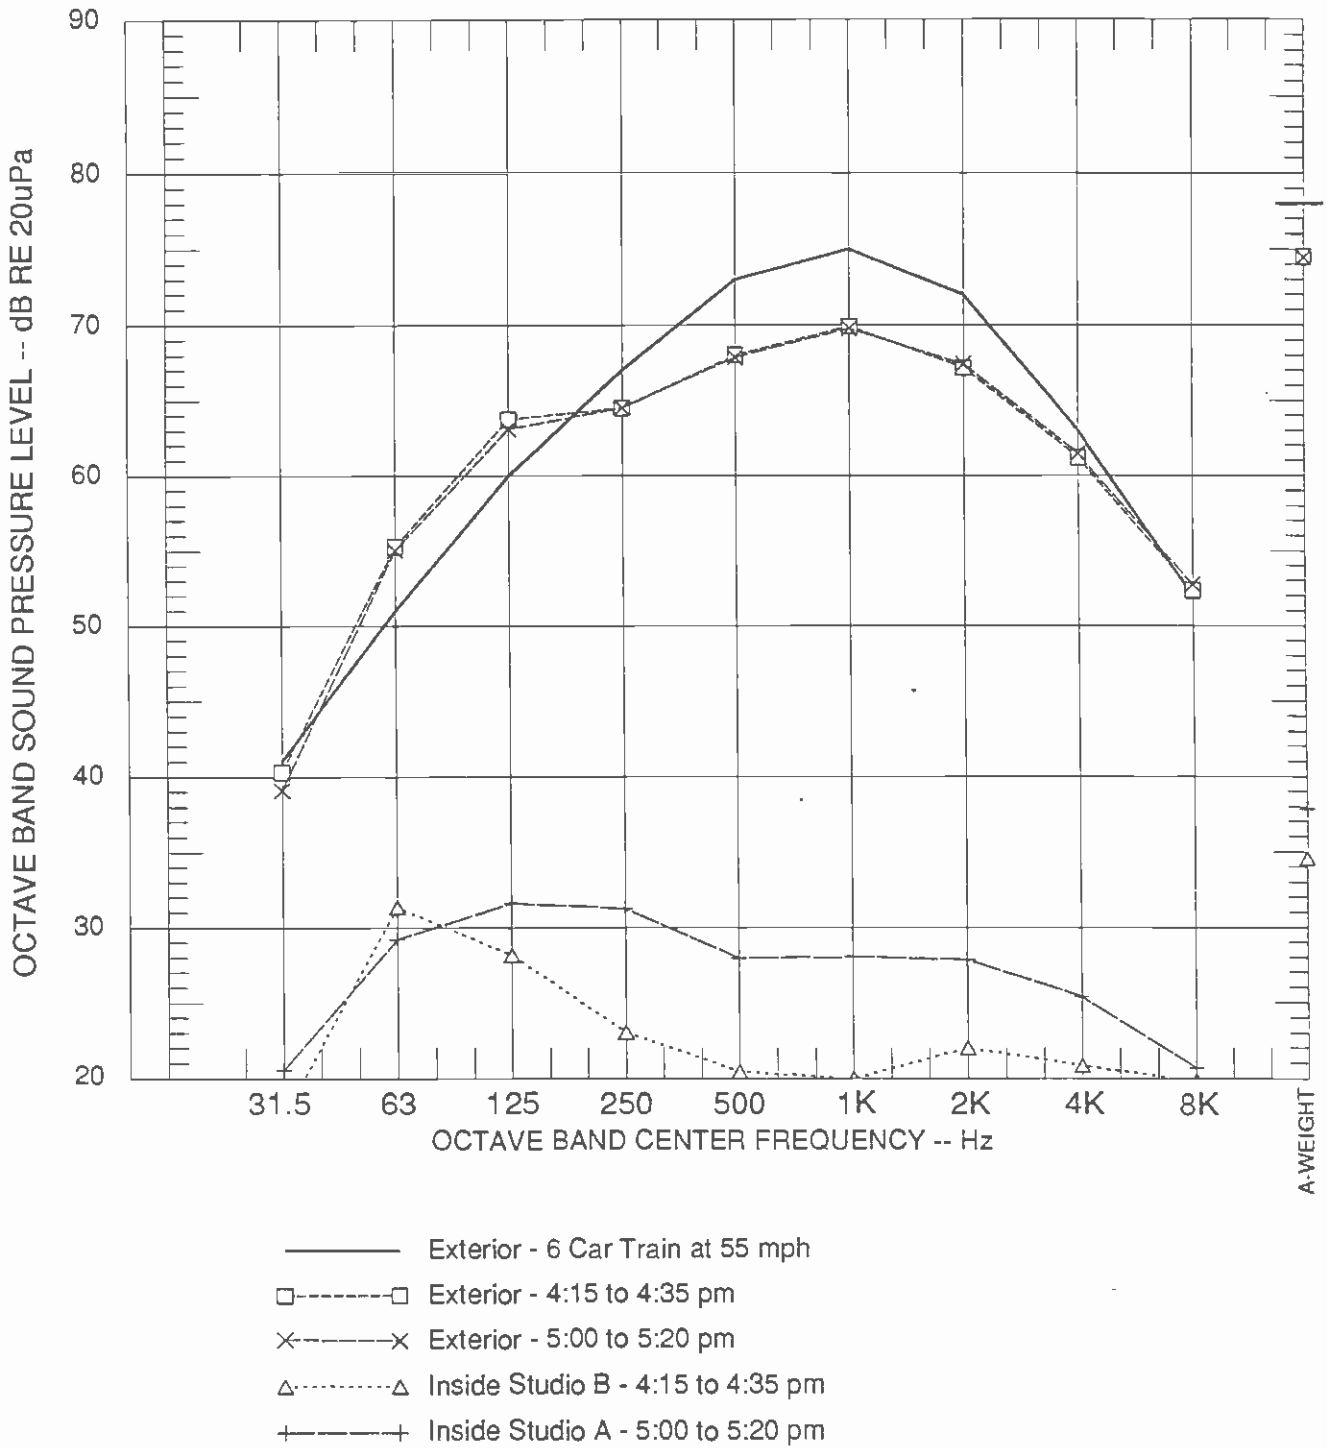
FIGURE 17

A-WEIGHTED EXTERIOR AND INTERIOR L1 NOISE LEVELS (LEVELS EXCEEDED 1% OF THE TIME) MEASURED AT KWHY CHANNEL 22 ON TUESDAY, 8 SEPTEMBER, 1987
