Use of Left Turn Gates at Highway Railroad Grade Crossings on the Los Angeles Metro Blue Line

December 31, 2002

FTA-CA-26-7010-02

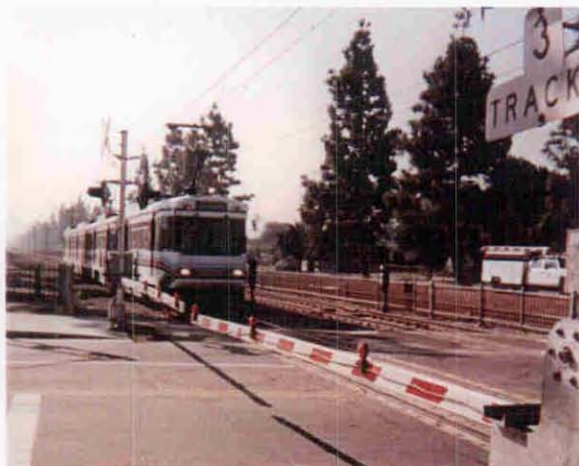
Figure 1-1
FOUR QUADRANT GATES DOWN FOR
NORTHBOUND METRO BLUE LINE
TRAIN AT 124TH STREET

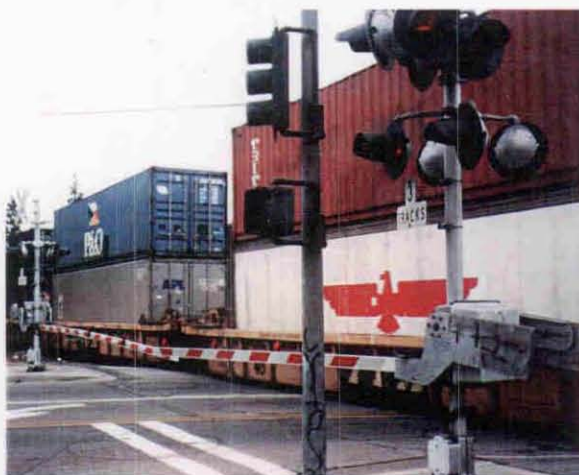
Figure 1-2
FOUR QUADRANT GATES DOWN FOR
UPRR FREIGHT TRAIN

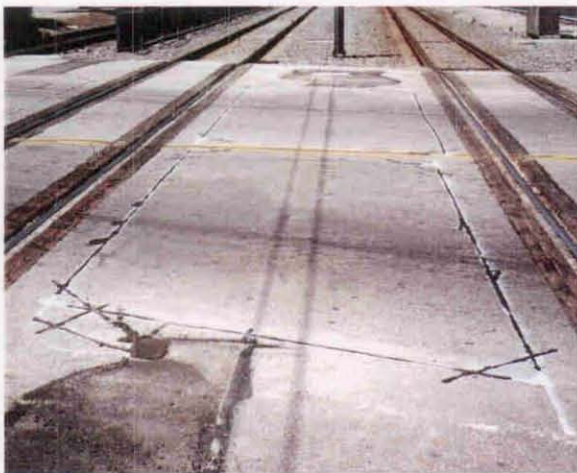
A series of inductive loop detectors, similar to those widely employed throughout North America for traffic signal control applications but incorporating a unique design that provides for the verification of the track area loop detectors each time that a train approaches the crossing, are installed in the track area and used to detect vehicle presence.

Figure 1-3
TRACK AREA VEHICLE DETECTION
LOOPS BETWEEN METRO BLUE LINE
TRACKS

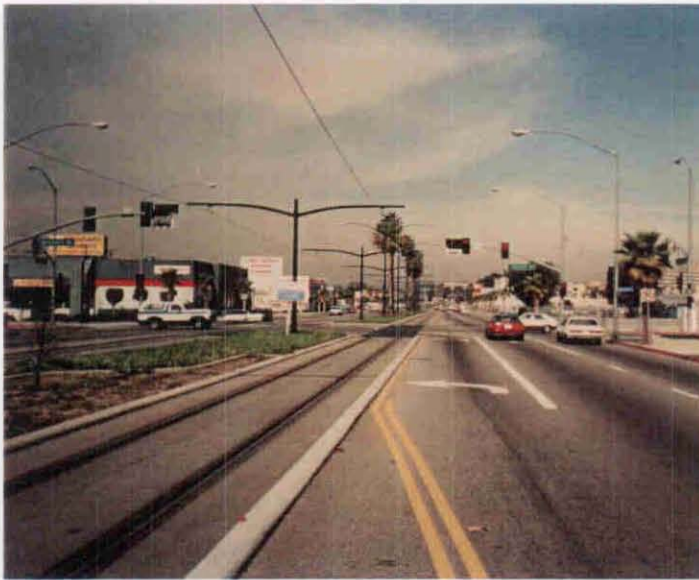
**Figure 3-1
SEPARATE TRAFFIC LANE AND
SIGNAL PHASE FOR TRAFFIC
TURNING LEFT FROM STREET
RUNNING PARALLEL TO LRT
TRACKS**

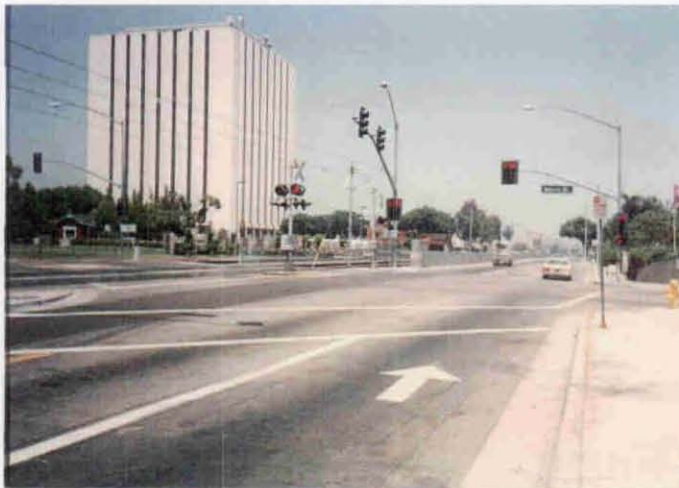
**Figure 3-2
RAILROAD FLASHING LIGHTS AND
RED LEFT TURN ARROW FOR
TRAFFIC TURNING LEFT FROM
STREET RUNNING PARALLEL TO LRT
TRACKS**

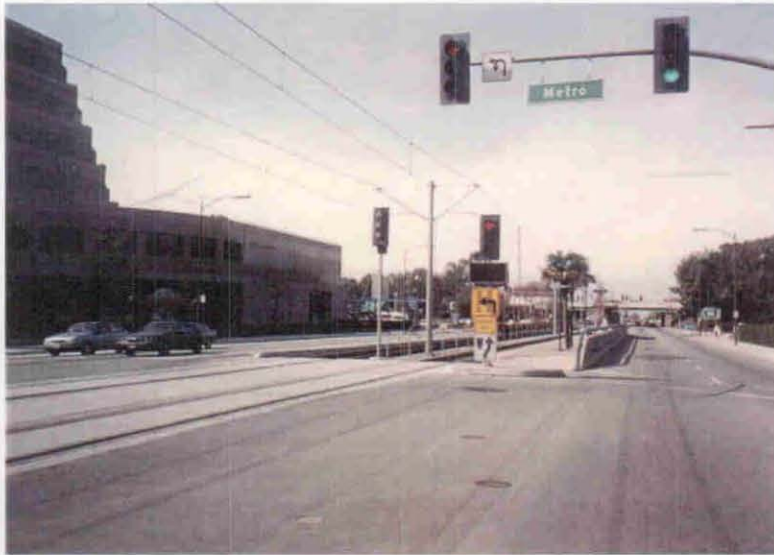
Figure 3-3
TRAIN-ACTIVATED WARNING
SIGN FOR TRAFFIC TURNING
LEFT FROM STREET
RUNNING PARALLEL TO LRT
TRACKS

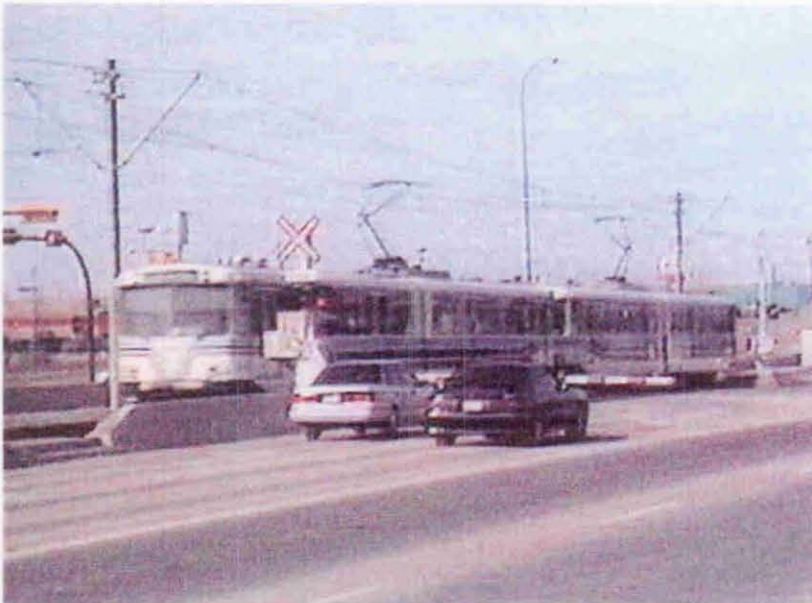
Calgary Transit has installed left turn gates in this configuration at one of its LRT crossings (see Figure 3-4). When lowered, the left turn gates extend across the two dedicated left turn lanes of a major one-way street running parallel to LRT tracks. These gates are installed at Calgary Transit's 12th Avenue NE grade crossing. Note the concrete barriers installed between the LRT track and left turn traffic lanes.

Figure 3-4
LEFT TURN GATES AT
CALGARY TRANSIT 12TH
AVENUE NE CROSSING

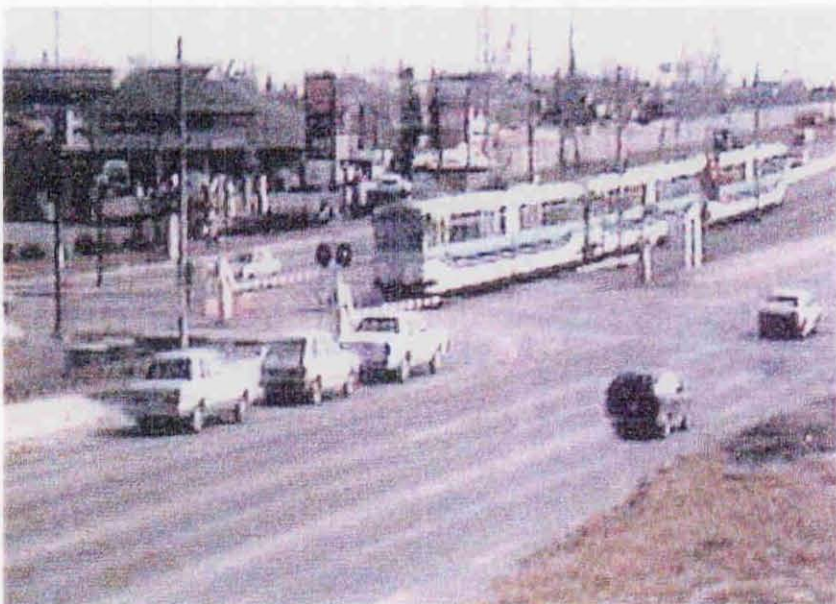
Calgary Transit has installed left turn gates in this configuration at its 20th Avenue NE LRT crossing. A view of this crossing, with the left turn gates lowered, is shown in Figure 3-6. Note the large gap between the lowered gate arms. These gates were initially installed in the same configuration as described above for the 12th Avenue NE crossing, with the gates at 90 degrees to the left turn lane. The gates were turned parallel to the left turn lanes and LRT tracks due to problems with the gate arms hitting vehicles in the left turn lane as they were lowered.

**Figure 3-6
LEFT TURN GATES
AT CALGARY
TRANSIT 20TH
AVENUE NE
CROSSING**

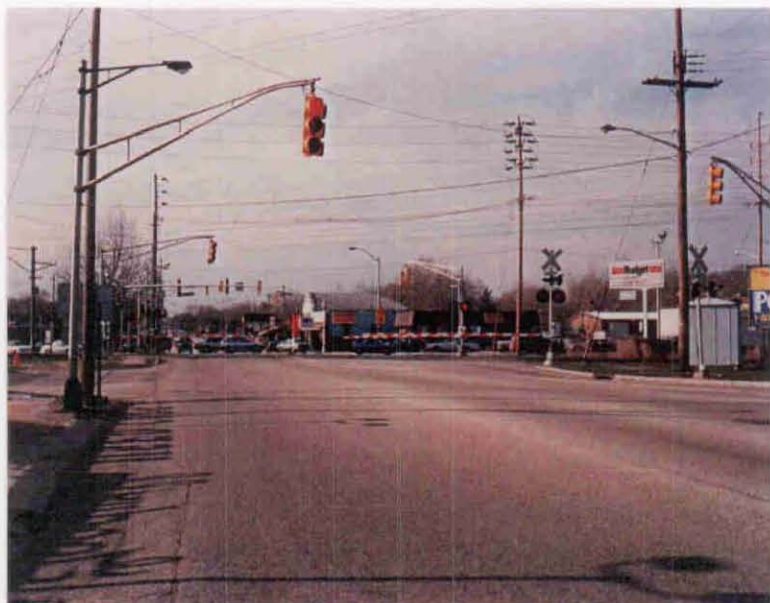
Crossing gates are installed in this configuration at the Broad Street crossing on NJ Transit's North Jersey Coast line in Red Bank, New Jersey. In Figure 3-8, views of the crossing gates at the Broad Street crossing are shown. Note that there is a gap of approximately 20 feet between the tips of the gates when they are lowered. Traffic volumes at this crossing are heavy and there is frequent commuter train service on two tracks. The crossing is protected with traffic signals as well as automatic gates, flashing lights, and bells. Left turns into the track area may be made from Newman Springs Road which runs parallel to the tracks on the south side of the tracks. There is two-way traffic on Newman Springs Road.

Figure 3-8
VIEW OF LEFT TURN GATES
AT NEW JERSEY TRANSIT
BROAD STREET CROSSING

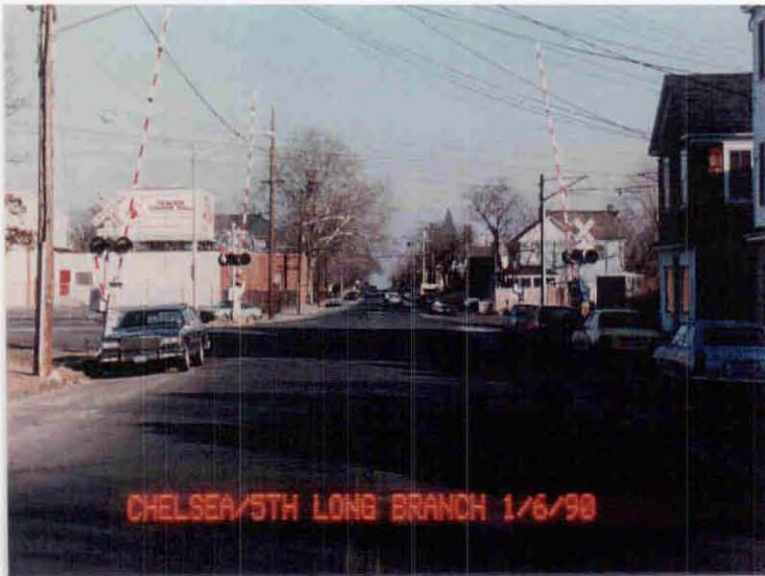
Figure 3-11
VIEW OF LEFT TURN GATE AT NEW
JERSEY TRANSIT FIFTH
STREET/CHELSEA STREET
CROSSING

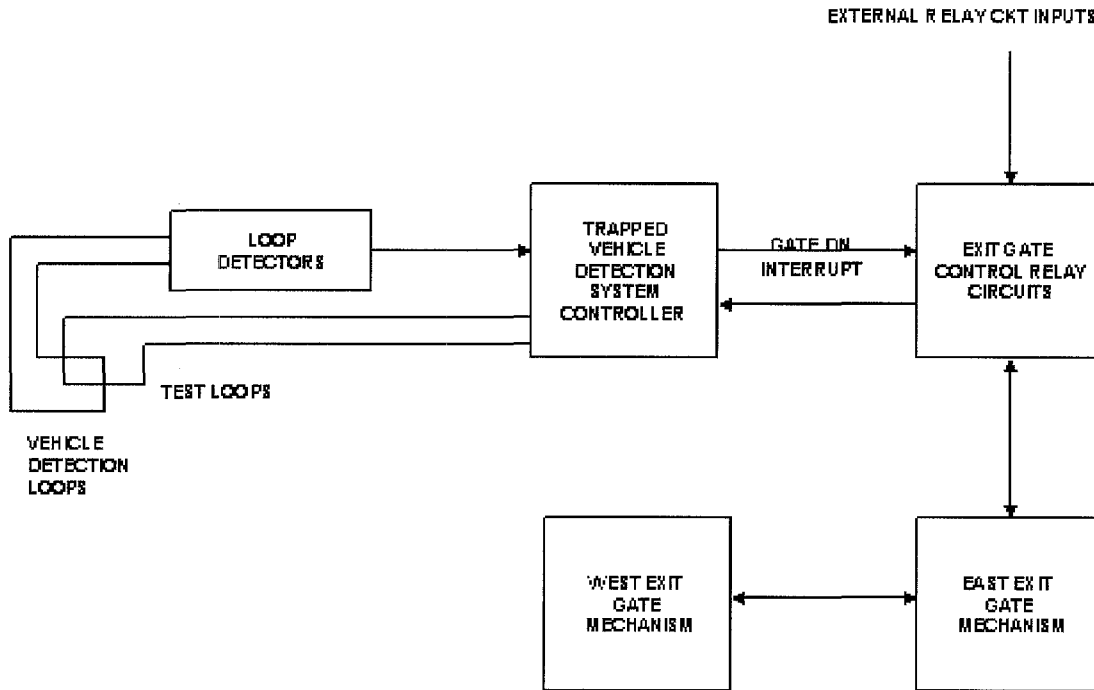
- **Vehicle Detection Loops.** Eight loops have been installed in the track area to provide as much coverage of the track area as possible. The loops are large and rectangular in shape, varying in size from 60 square feet to 200 square feet. Each loop consists of three turns of Caltrans-standard loop wire. The loop corners are cut at an angle to minimize the loss of detection at the loop corners.

Figure 4-1
FULL CLOSURE CROSSING GATE SYSTEM SCHEMATIC

The loops are offset by one foot, or nearly so, from the crossing surface timber to allow room for the re-cutting of the loop without affecting the loop coverage area, should that be required in the future. The loops are offset by approximately one foot from the edge of pavement on both sides of the street.

The loop-to-loop distance, measured at right angles to each track and across each track, is 8'-10" for all loop pairs. The angled configuration of the crossing assists for vehicle detection, as the front left corner and right rear corner of vehicles are detected at distances less than the loop-to-loop distance measured at right angles to the tracks. The ends of the loop wires for each of the eight loops are spliced at pullboxes located at the side of the roadway to detector lead-in cables, which run in conduits to the control case.

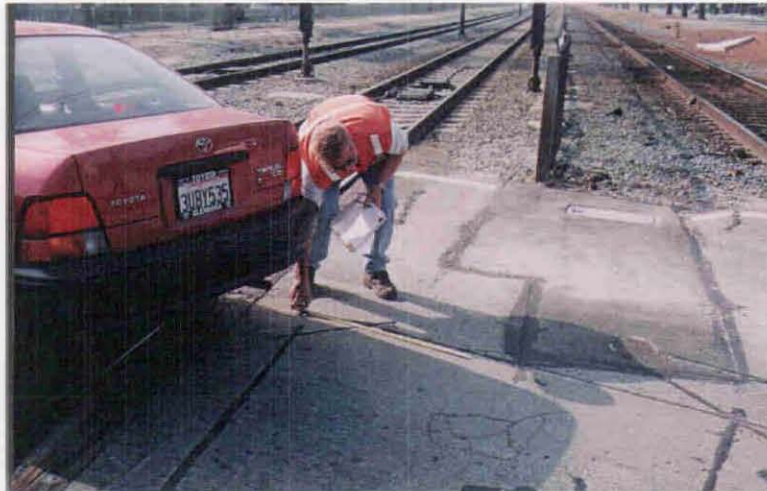
The vehicle detection loops were tested in advance of system operation. A motor vehicle, 12'-5" long and 5'-0" wide, was used to verify continuous detection in the track area. It was required that there is continuous detection of the test motor vehicle along three alignments through the track area – one alignment centered on the through traffic lanes in each direction; one alignment centered on the street center line; and one alignment where the right hand side of the test vehicle was offset by one foot from the edge of pavement.

Figure 4-3
VERIFYING TRACK AREA
VEHICLE DETECTION
LOOP COVERAGE

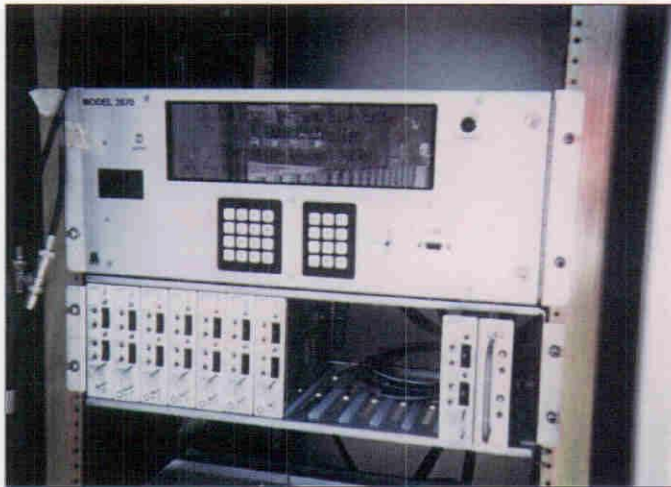
The detectors being used at the 124th Street crossing are Intersection Development Corporation (IDC) Detector Systems Model 262FCR detectors. These are rack-mounted NEMA Type 7T detectors that provide two channels, self tuning, nine sensitivity settings (for changes in inductance from 0.0025 percent to 0.64 percent), three operating frequencies (between 20 and 50 kHz), and a separate contact closure output to indicate that the loop circuit has failed with a short to ground or a break in the loop circuit. Loops operating on the two channels are scanned sequentially to eliminate, or minimize, crosstalk between the loops connected to these channels. Loops which are adjacent to each other but not connected to the same detector are operated on different frequencies to eliminate crosstalk. Crosstalk between adjacent track area loops was a major concern during system design and testing but was never a problem during the operation. Note that the vehicle detect relay is

- **System Controller.** The trapped highway vehicle detection system has been implemented on an open architecture VMEbus-based advanced transportation controller that meets the Caltrans 2070 specification. The 2070 controller hardware used at 124th Street was obtained from Eagle Traffic Control Systems. This controller hardware represents the latest generation of field computers or advanced transportation controllers that are being implemented throughout North America to support the traffic monitoring and processing requirements of intelligent transportation system applications.

Figure 4-5
FRONT VIEW OF SYSTEM
CONTROLLER AND LOOP
DETECTORS

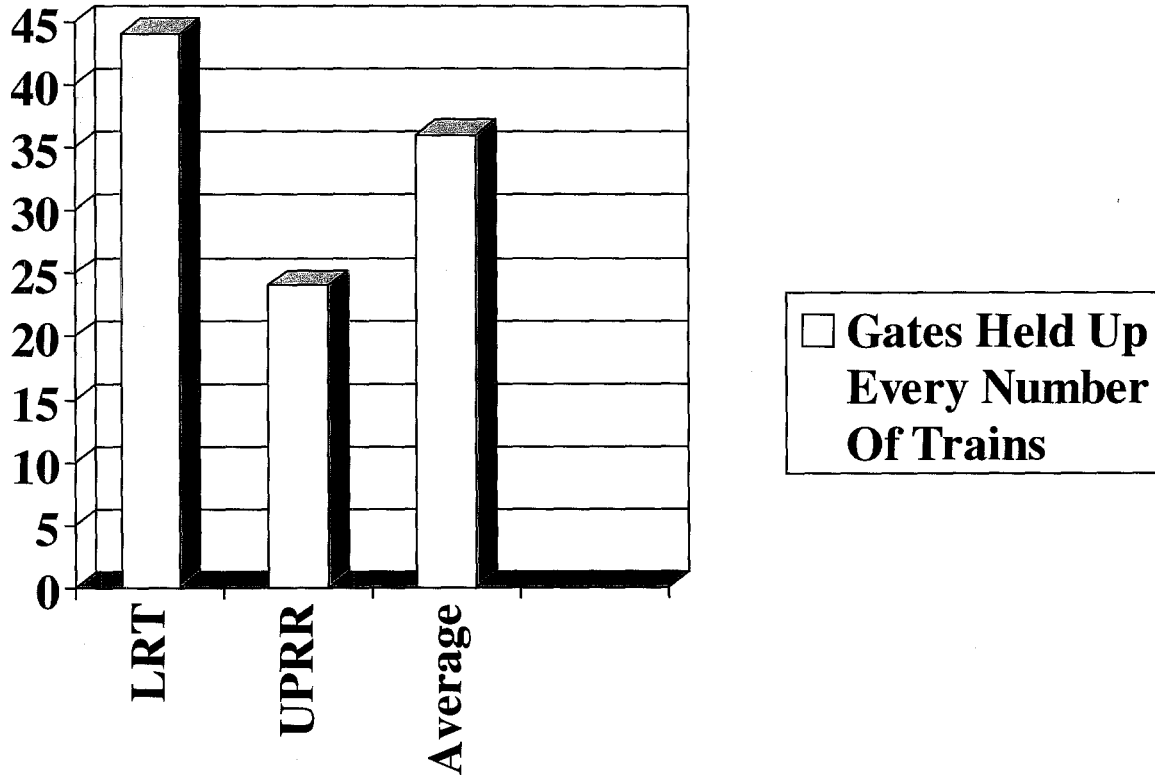
- The exit gates were held up 12 times for nine seconds or longer as the result of a highway vehicle being detected, 11 times for LRT gate down calls and one time for a UPRR gate down call. These instances were recorded as follows: one time for a motorist backing out from under the east entrance gate as it was being lowered; four times for a motorist backing out from under the west entrance gate as it was being lowered; two times as the result of the tail of an eastbound vehicle stopped and waiting to exit from the track area being detected; and four times caused by the tail of a westbound vehicle stopped and waiting to exit from the track area being detected.

Figure 6-1
FREQUENCY OF EXIT GATES BEING HELD UP

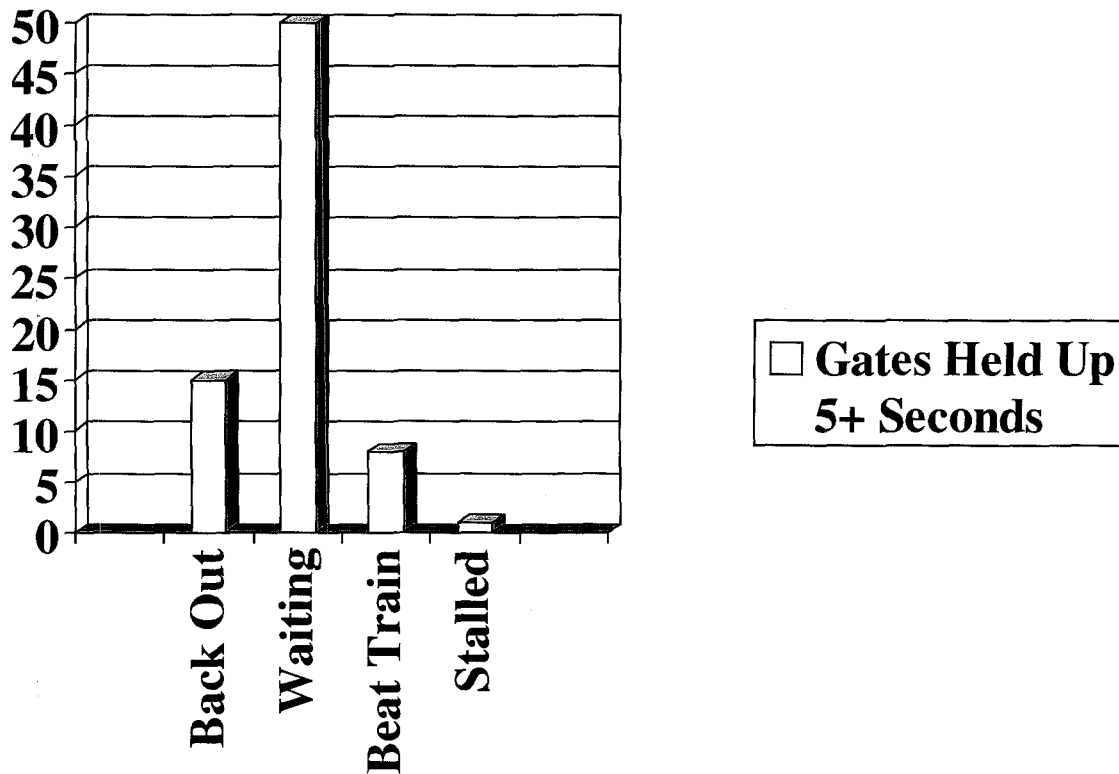
Figure 6-3
REASON FOR GATES BEING HELD UP MORE THAN FIVE SECONDS
