# **An Evaluation of Bus Bulbs on Transit, Traffic, and Pedestrian Operations**

**Transit Cooperative Research Program  
Transportation Research Board  
National Research Council**

**Kay Fitzpatrick  
Kevin Hall  
Stephen Farnsworth  
Melisa D. Finley  
Texas Transportation Institute  
College Station, Texas**

**August 2000**

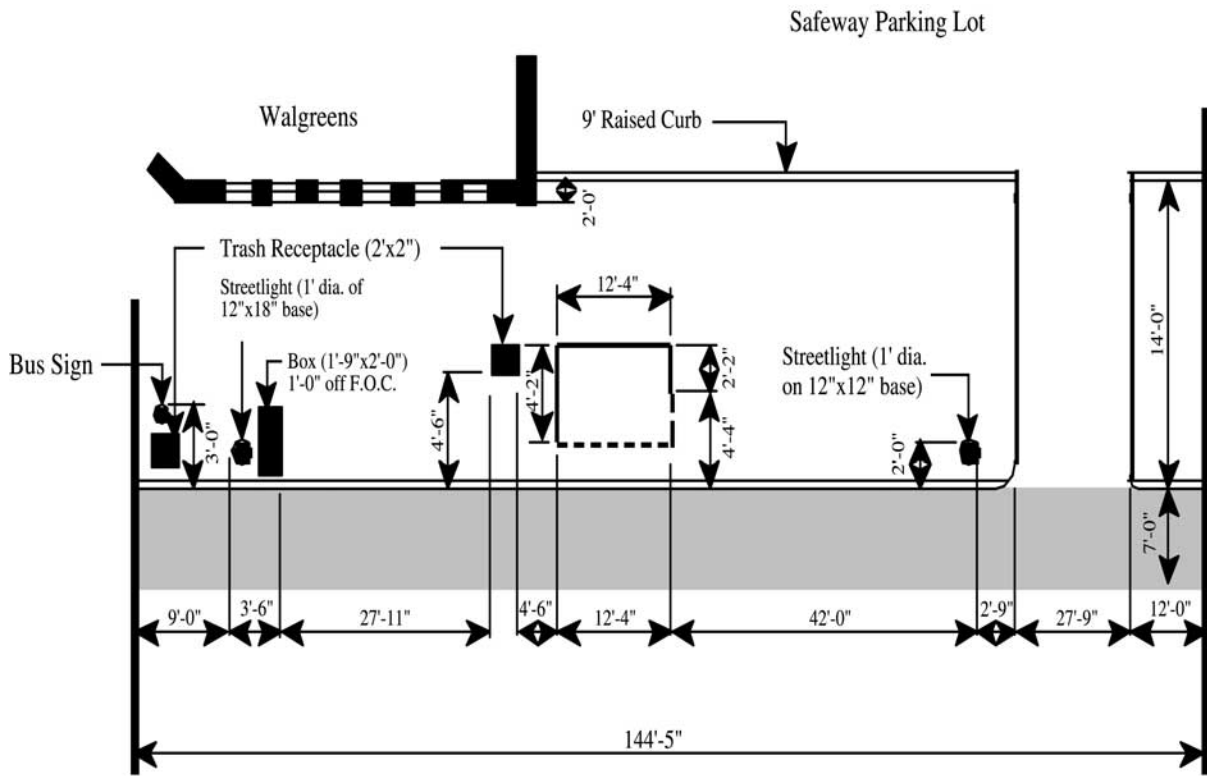
**Figure B-4. Mission @ 30<sup>th</sup> Street Bus Bay Dimensions.**

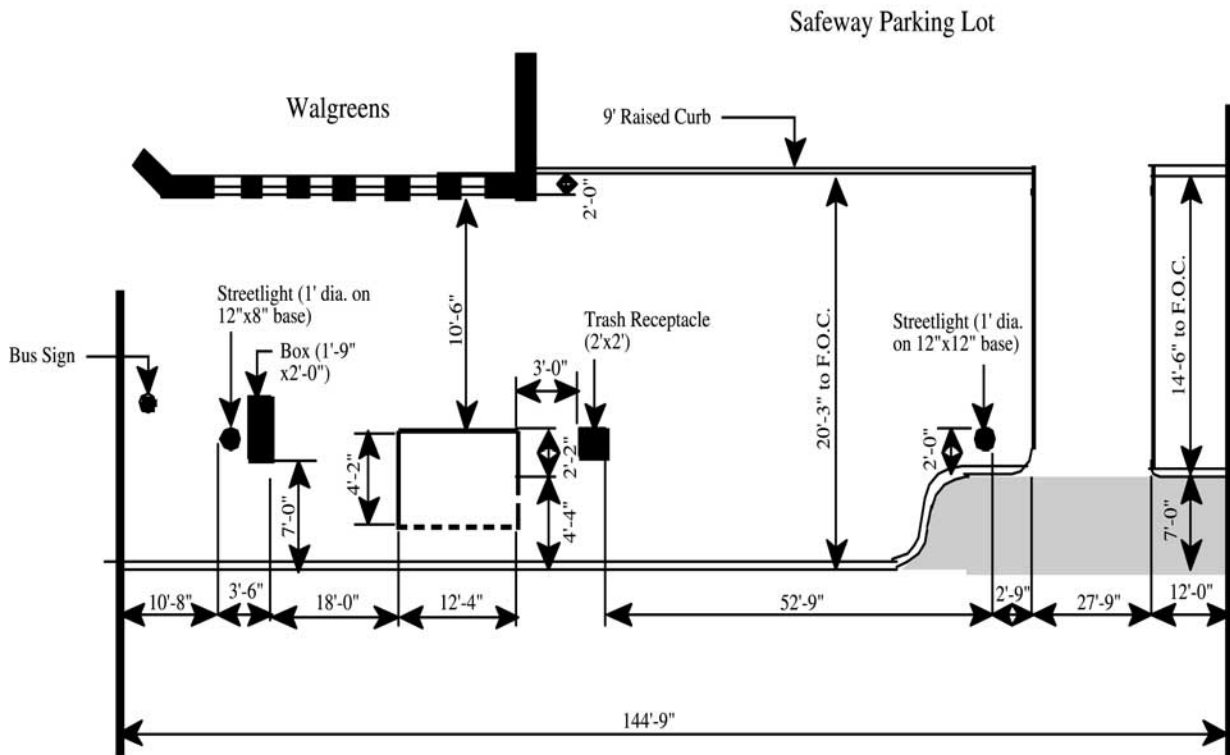
Figure B-5. Mission @ 30<sup>th</sup> Street Bus Bulb Dimensions.

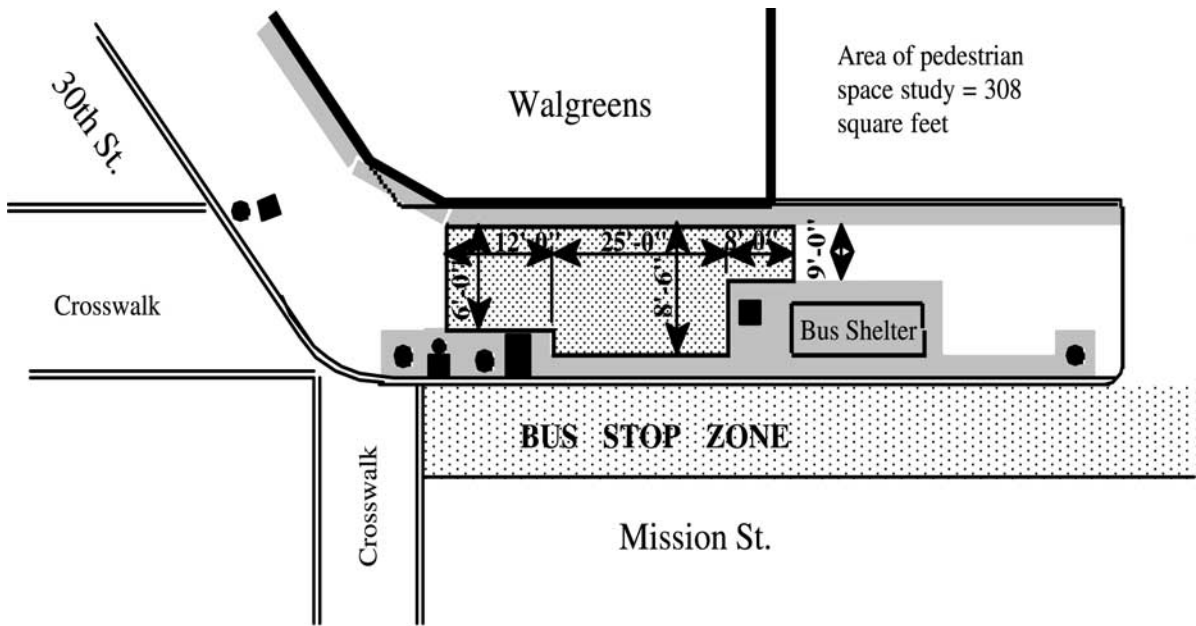
**Figure B-9. Walkway Space Study (Bus Bay Configuration).**

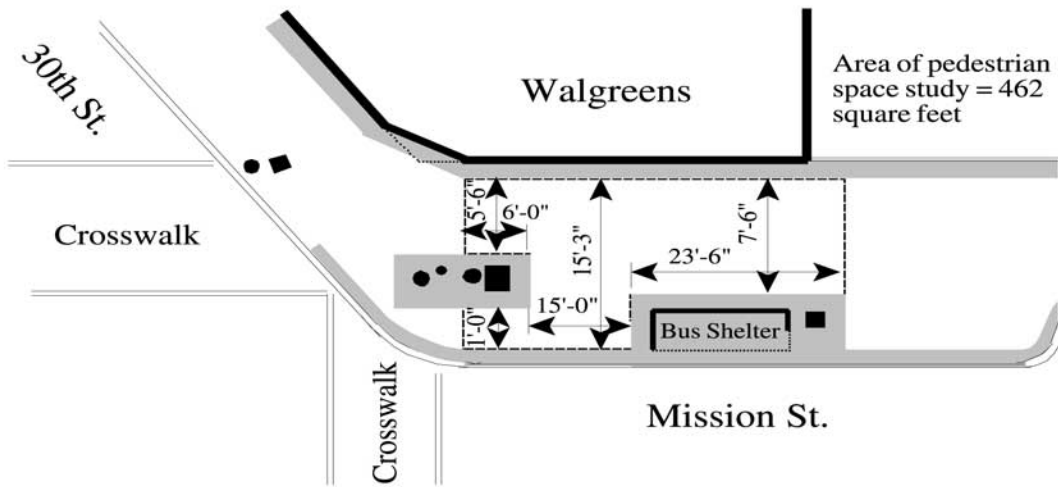
**Figure B-10. Walkway Space Study (Bus Bulb Configuration).**

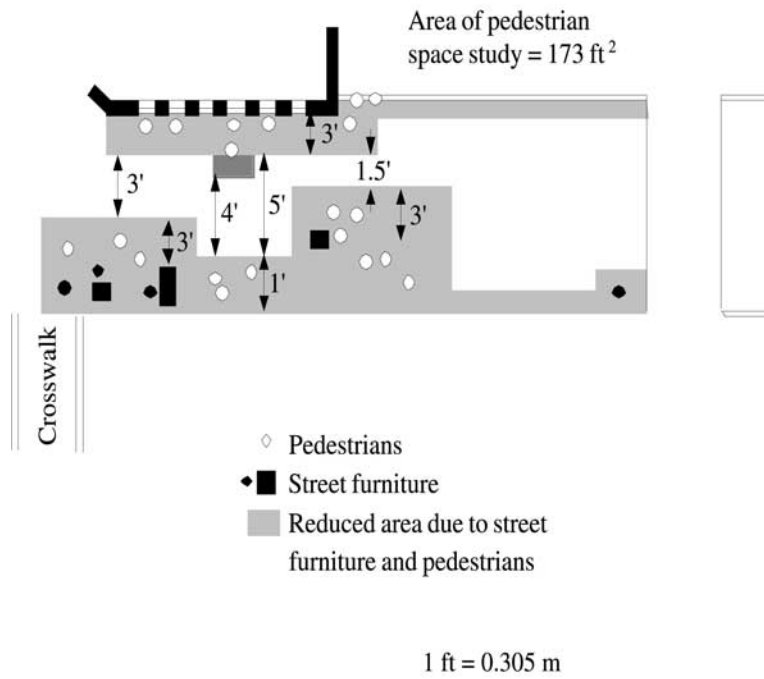
**Figure B-11. Common Pedestrian Waiting Areas at Bus Bay.**

Figure B–11 provides a graphical representation of the common waiting areas that were observed at the bus bay configuration. Dimensions of the reduced effective walkway width are also included in the figure. When waiting pedestrians/patrons are included in the space calculation, the available area in the bus bay is reduced from 308 to 173 sq ft (28.6 to 16.1 sq m). This is a fairly realistic inclusion since the bus stop zone is never completely void of waiting patrons, passing pedestrians, or people congregating in groups during the afternoon peak period.

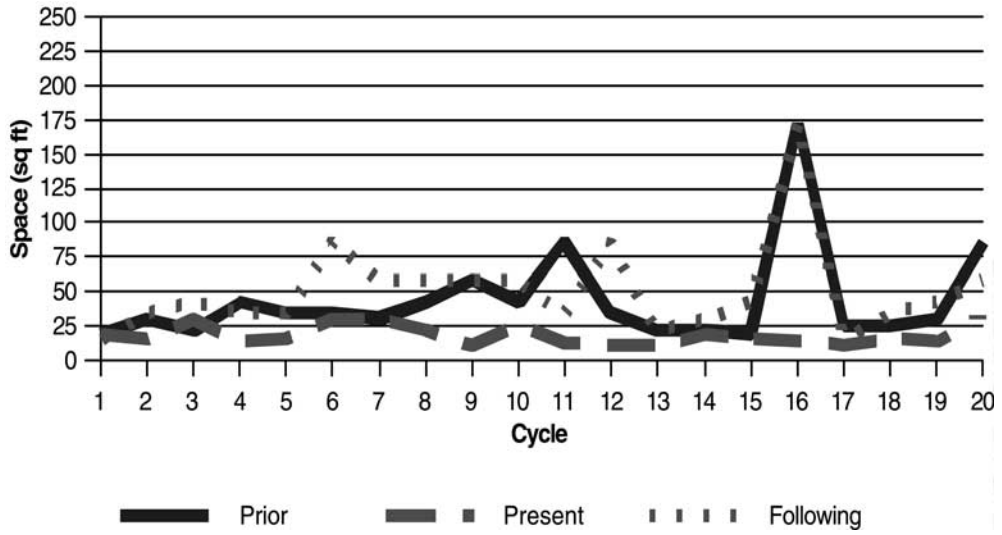
**Figure B-13. Pedestrian Space with Reduced Area at Bus Bay.**

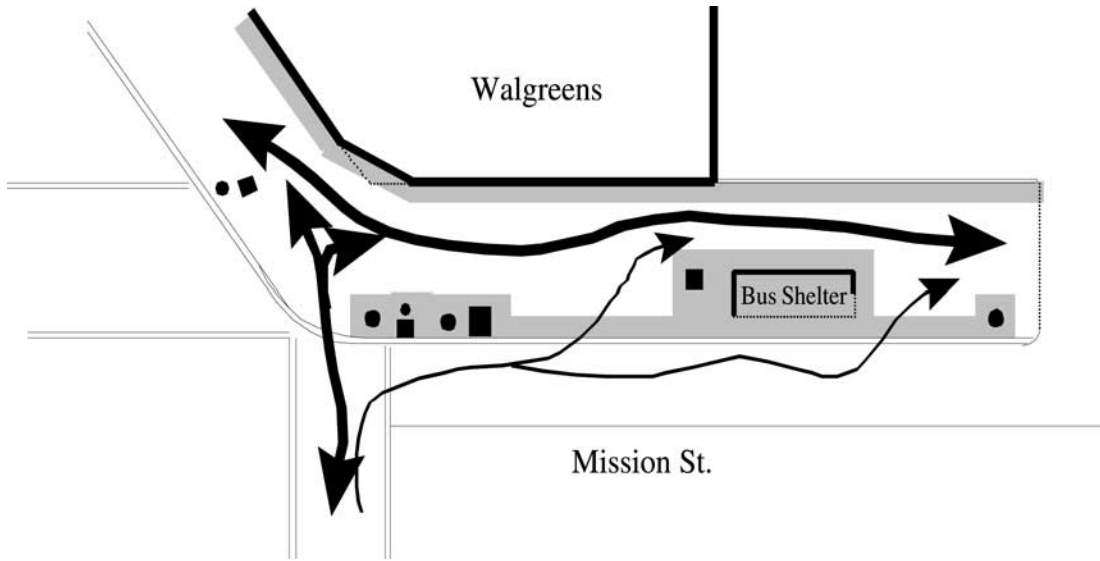
**Figure B-14. Common Walkway Paths Through the Bus Bay Zone.**

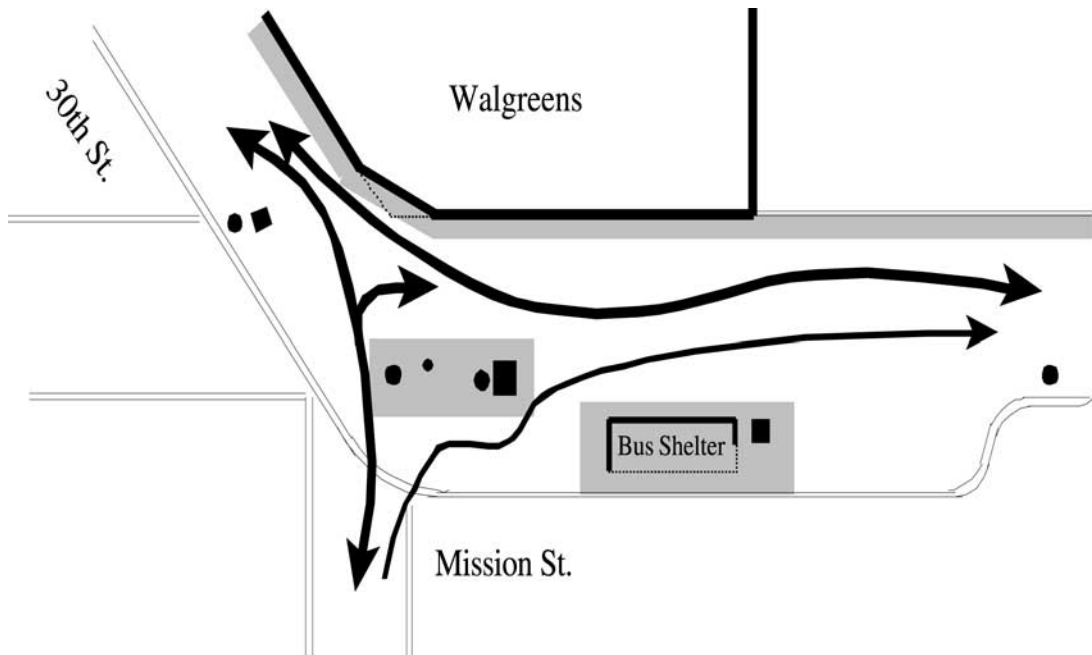
**Figure B-18. Common Walkway Paths (Bulb Configuration).**

walking in the street in front of the shelter. Figure B–18 illustrates common pedestrian walking paths observed during the after data collection trip. The reconfiguration of the site also produced other positive results, one of them being the noticeable improvement in the number of people that stay within the crosswalk boundaries when approaching the site. Previously, pedestrians would “cut the corner” and not completely cross the street within the lines.

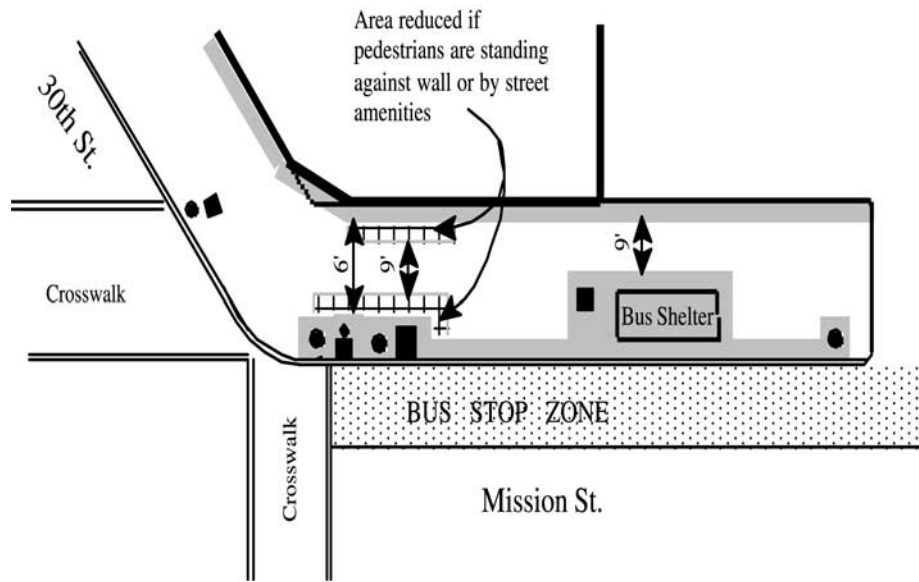
**Figure B-19. Sidewalk LOS Study Area of Bus Bay.**

The area between the corner of the Walgreens store and the light post at the far end of the bus stop zone was selected as the sidewalk LOS study area. This area represents the greatest level of pedestrian flow for the entire bus stop zone. As observed during the data collection trips, a majority of the boarding and alighting bus patrons typically used the sidewalk between the Walgreens store and the light post. The bus patrons are either moving from this bus stop to the adjacent bus stops (transfer point) on 30<sup>th</sup> Street or are going to the 30<sup>th</sup> Street or Mission Street crosswalks. A large number of school children with their book bags use the bus stop on Mission Street to go home in the evening. Pedestrians also utilize this space to move through the site. Most pedestrians are carrying shopping bags from the Safeway store and are usually traveling in groups (e.g., families and friends). Therefore bus patrons and pedestrians alike usually arrive and depart in groups and are a part of intermittent surges that place varying demands on this area to provide adequate space for unobstructed pedestrian movement.

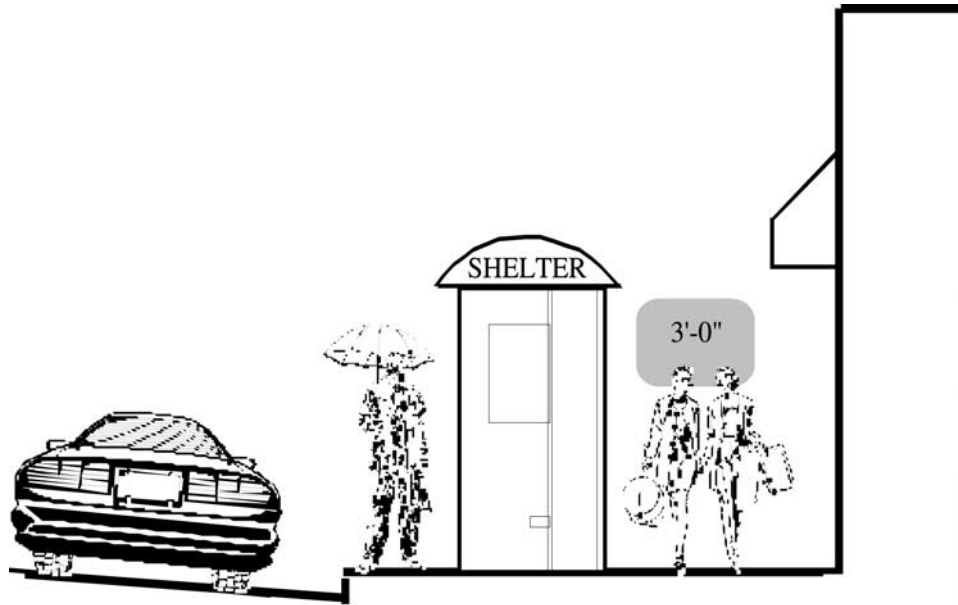
**Figure B-20. Cross-Section of Effective Walkway Width Between Bus Shelter and Walgreens (Bay Configuration).**

The effective walkway width is essentially the width of the sidewalk minus the width of any fixed features that cause pedestrians to avoid or move around them. Using only the effective walkway width provides one interpretation of the data. Another interpretation is to include common bus patron and pedestrian congregation areas in the calculation. These mobile features, while not fixed in a particular location, have a constant effect on the ability to comfortably travel on the sidewalk. For example, in Figure B–19 the effective walkway width of the empty curbside bus bay is 6 ft (1.8 m). However, if common waiting areas and congregation points are accounted for, the effective walkway width available for passage through the site is essentially reduced to 3 ft (0.92 m). Based on the research team’s observations of the frequency that this area contained waiting patrons, the most realistic conditions (with waiting patrons and congregating pedestrians) are presented in the findings.

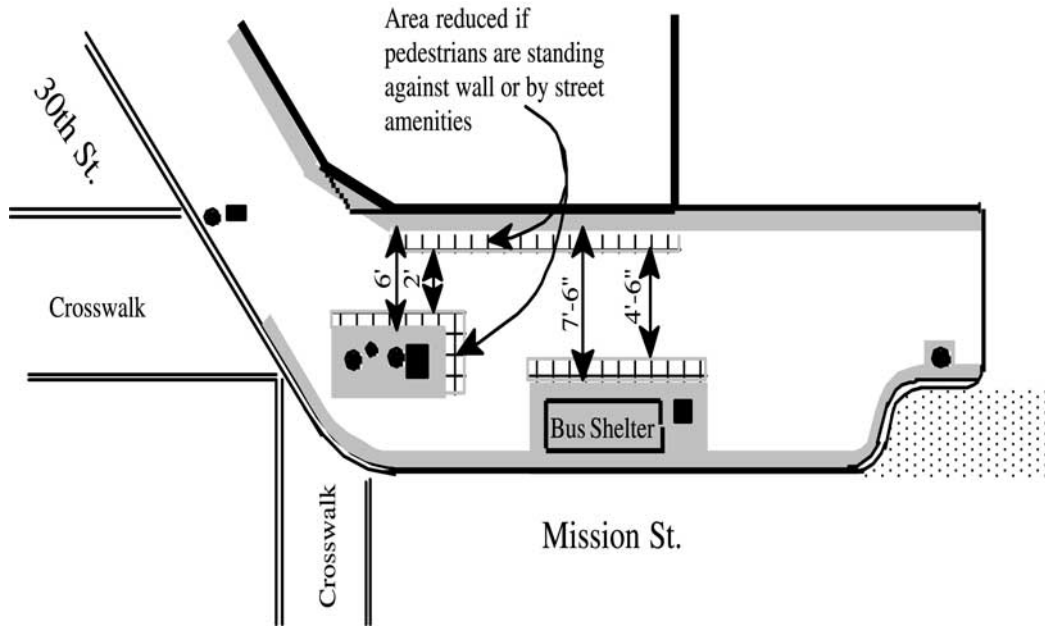
**Figure B-21. Sidewalk LOS Study Area of the Bus Bulb Configuration.**

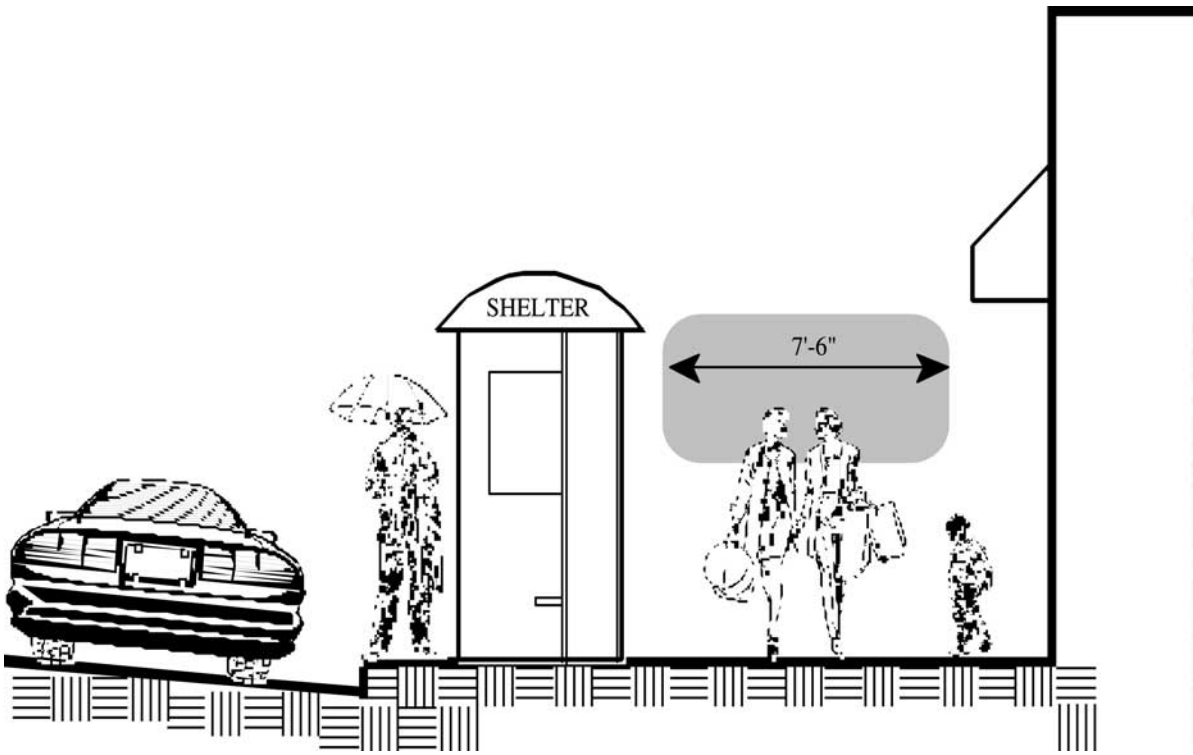
**Figure B-22. Cross-Section of Effective Walkway Width Between Bus Shelter and Walgreens (Bulb Configuration).**

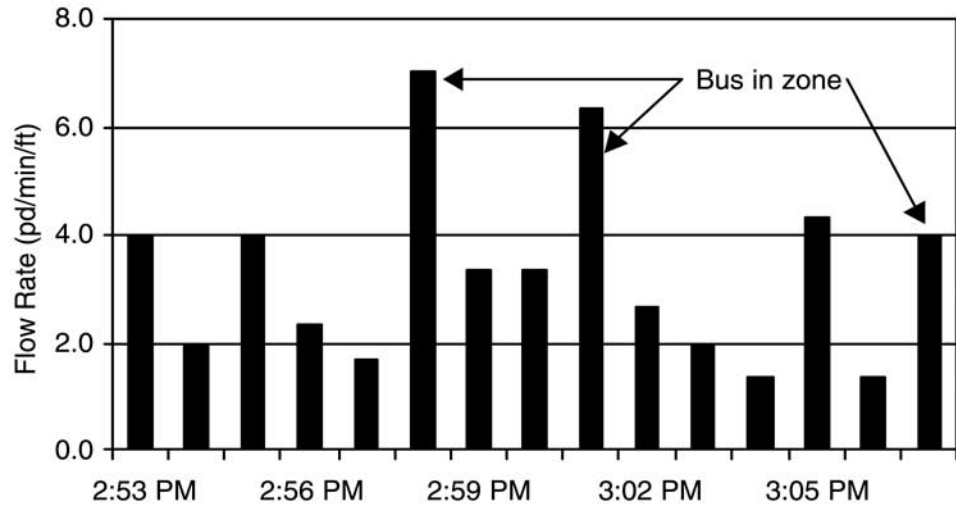
**Figure B-23. Summary of Peak 15-Minute Period Divided Into One-Minute Intervals.**

In addition to the 15-minute counts, the data were divided into one-minute increments. This was made possible by the time-stamps that were associated with the palmtop program developed for this data collection task. Having the data reduced into smaller segments provides a more complete view of the minute-by-minute conditions of the sidewalk. Using one-minute increments and an adjustment to the formula in the *Highway Capacity Manual*, the pedestrian flow rate and LOS were determined for all of the sidewalk LOS data that were collected. The modification of the formula used to calculate LOS in one-minute increments simply removes the factor of 15 used in the original formula and is as follows:

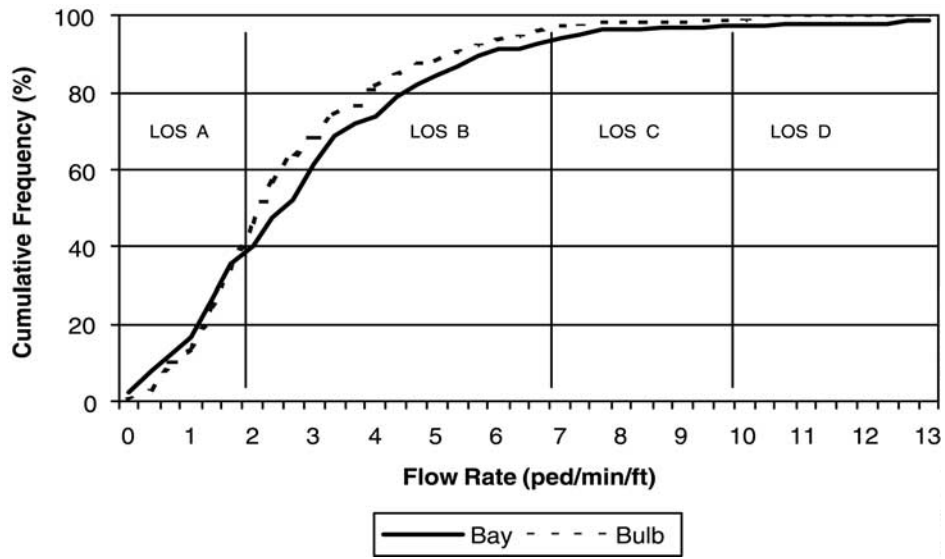
**Figure B-24. Pedestrian Flow Rates (Using Data Divided into One-Minute Segments).**

When the data are divided into one-minute increments to account for the presence of a bus at or not at the stop, similar results exist. The average flow rate on the sidewalk improved by 17 percent between the bay and bulb designs when the bus was not present at the bus stop boarding and alighting passengers. The average flow rate decreased from 2.8 to 2.4 ped/min/ft (9.2 to 7.9 ped/min/m). Intuitively, the conclusion from this data might suggest that the bulb is providing the necessary space for patrons to wait for their next bus off of the sidewalk, thereby, improving the conditions on the sidewalk. Contrary to this finding, the average flow rate increased with the bulb design when the bus was present boarding and alighting passengers. The rates changed from 4.0 ped/min/ft (13.1 ped/min/m) on the bay to 4.1 ped/min/ft (13.4 ped/min/m) on the bulb, which represents a degradation of only 2 percent. Once again, this finding may indicate that

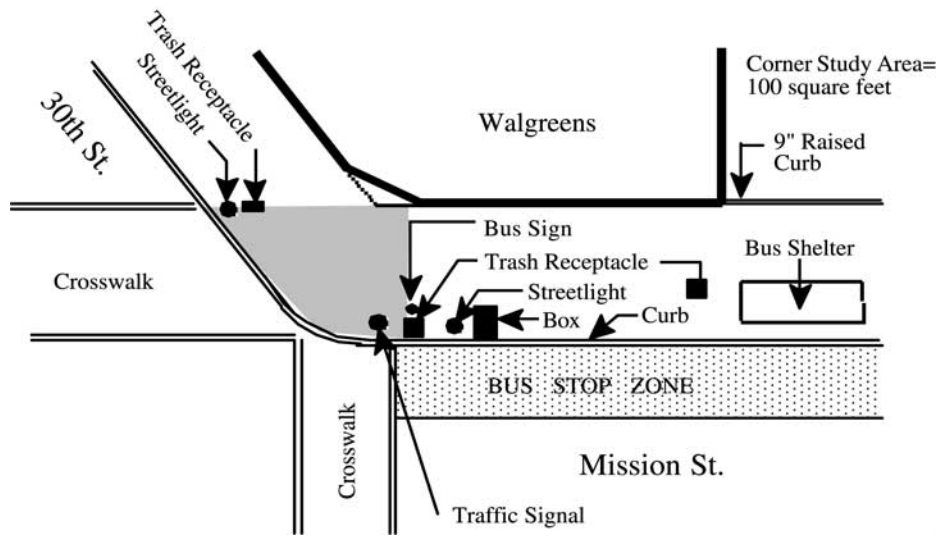
**Figure B-27. Corner LOS Study Area for Bus Bay.**

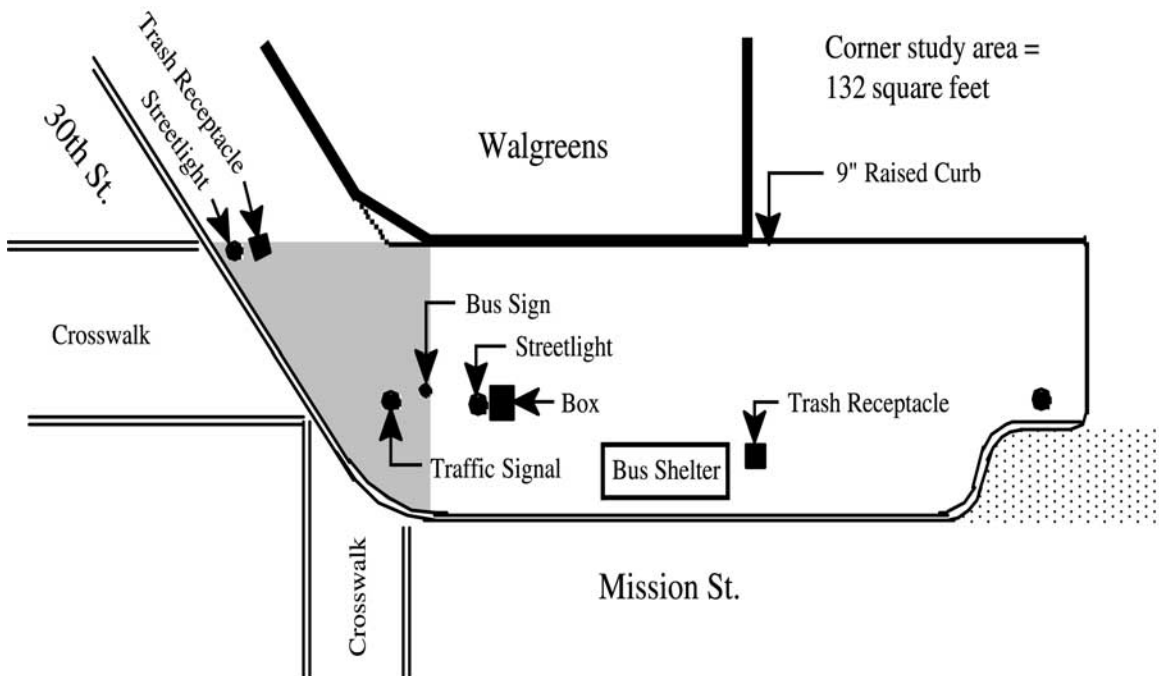
**Figure B-29. Corner LOS Study Area for Bus Bulb Configuration.**

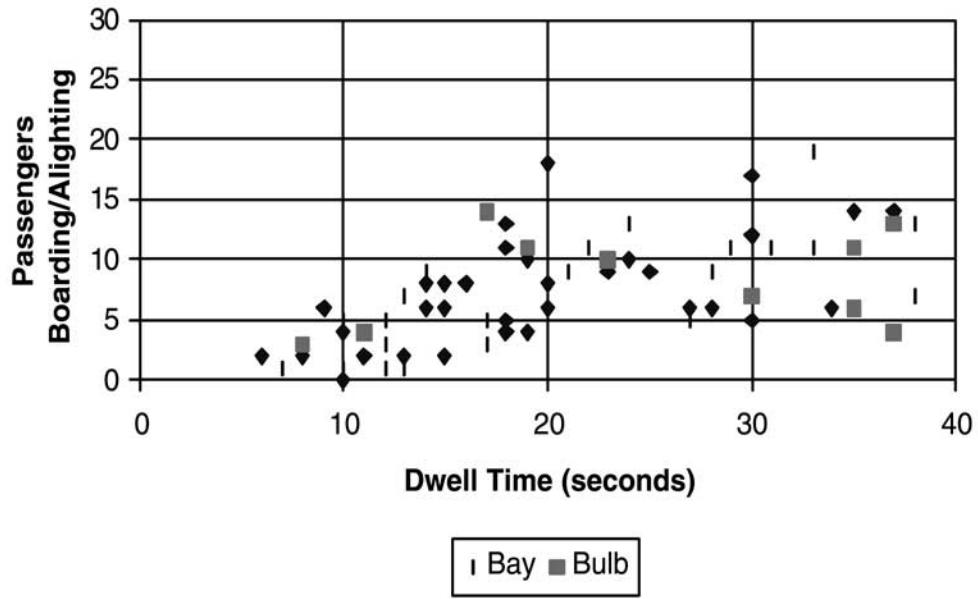
Figure B-31. Mission @ 30<sup>th</sup> Southbound Off-Peak Dwell Times.

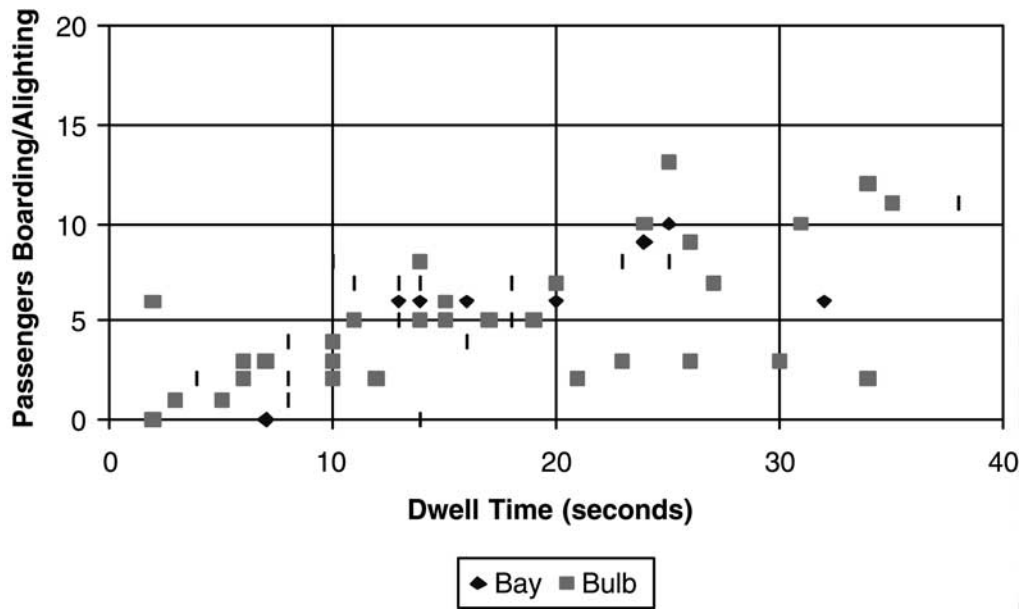
Figure B-32. Mission @ 30<sup>th</sup> Northbound Peak Bus Dwell Times.

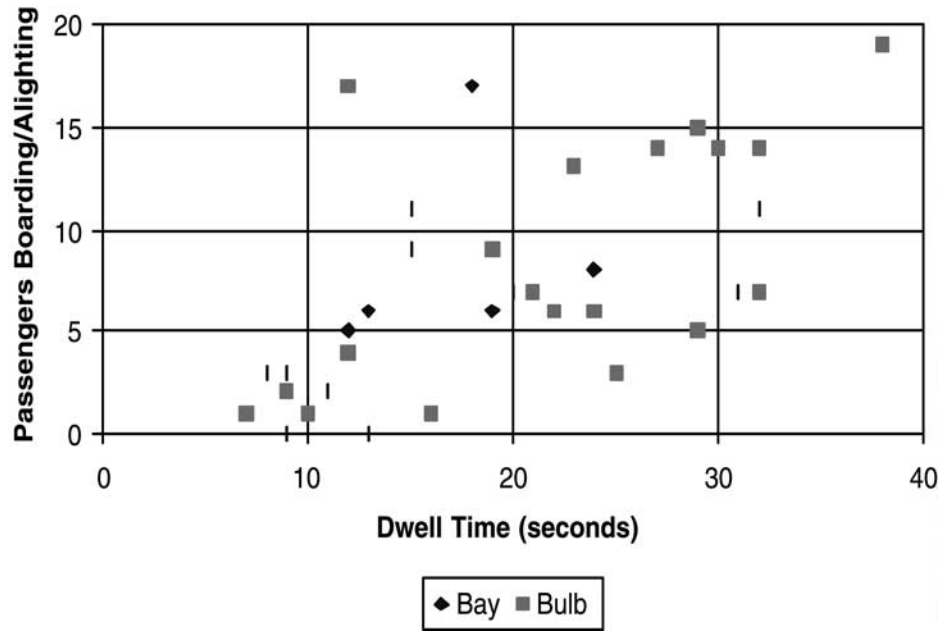
Figure B-33. Mission @ 30<sup>th</sup> Southbound Peak Bus Dwell Times.

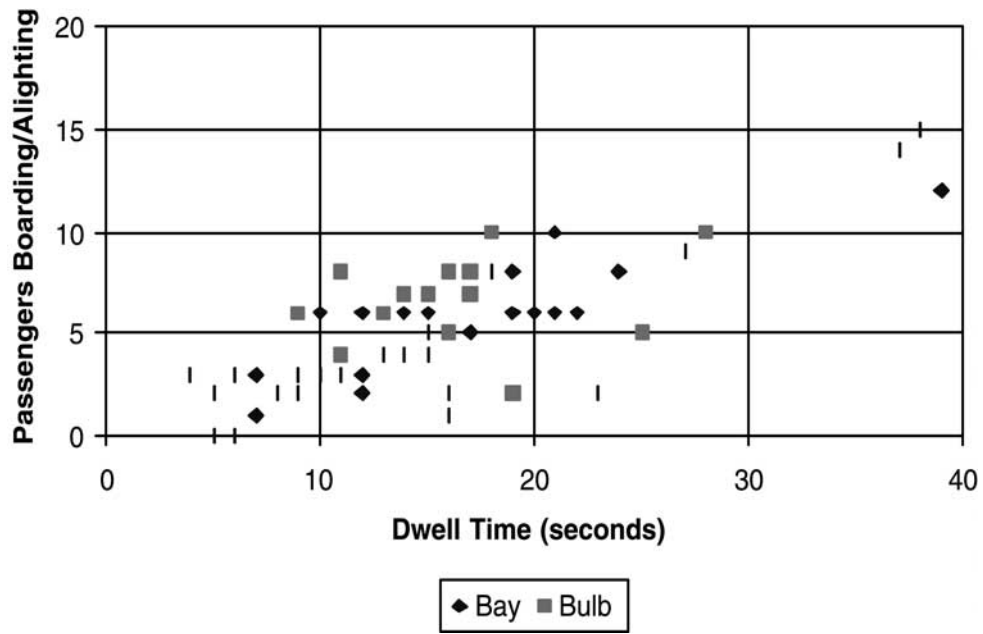
Figure B-34. Mission @ 30<sup>th</sup> Northbound Off-Peak Bus Dwell Times.

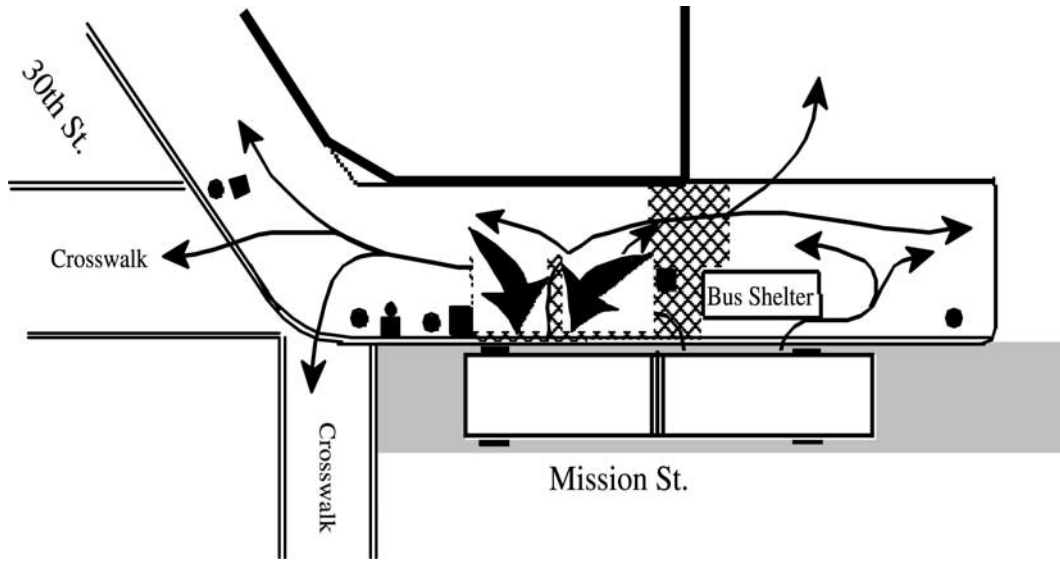
**Figure B-35. Pedestrian Walking Paths (Bay Configuration).**

Other observations made during the bus arrival departure study were the pedestrian behavior in the bus stop zone when buses were boarding and lighting. Figures B-35 and B-36 provide an overview of common walkway paths made by pedestrians during the boarding and alighting process. The figures show the alighting passengers and their subsequent paths as a solid black line. The boarding passengers are shown as thick gray arrows, and the area where high conflicts occurred are shown as cross-hatched boxes. In the after study, a noticeable improvement was observed at the front door of the bus where patrons alighted and boarded. In both the before and after data collection trips, high levels of congestion were noted in and around the front door of the bus. However, in the before configuration, the congested areas consumed a large portion on the sidewalk space. In the after configuration, the primary congestion occurred on the bus bulb. This allowed for less disruption on traffic on the sidewalk.

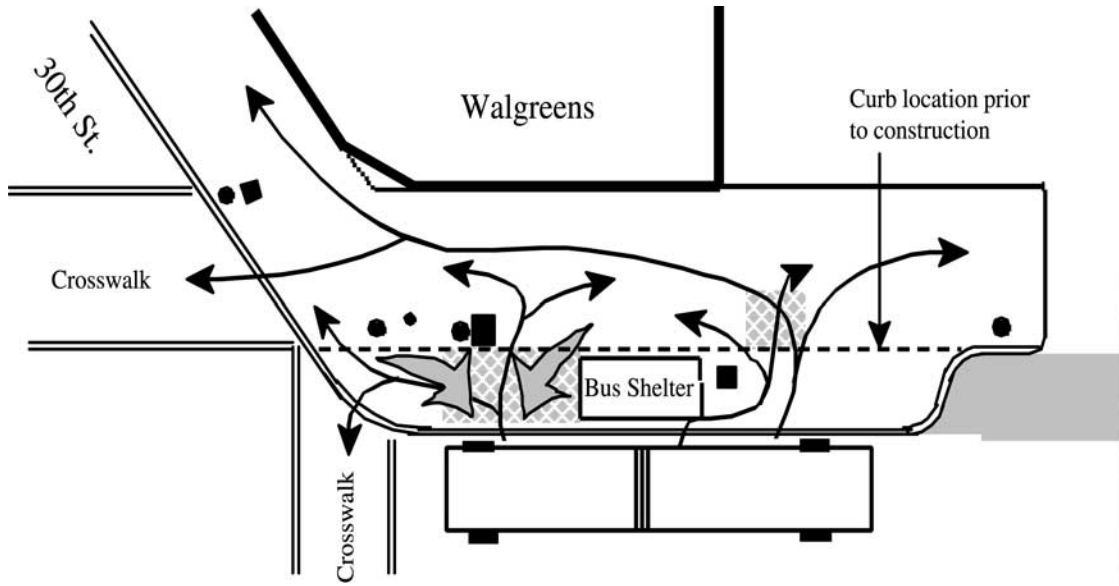
**Figure B-36. Pedestrian Walking Paths (Bulb Configuration).**

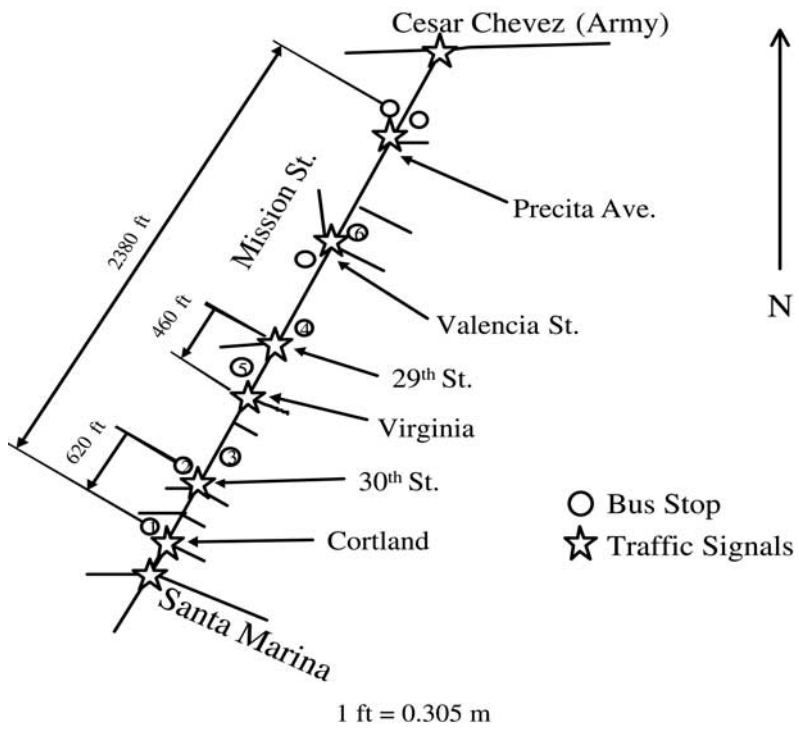
**Figure C-12. Travel Time Collection Locations.**

The travel time and speeds of vehicles and buses were recorded from Cortland Ave. to Precita St. (see Figure C–12). In this section of the corridor there were six intersections and seven bus stops, and the distance was approximately 2400 ft (732 m). The data were collected during a peak period. Speeds measured for a block may be heavily influenced by the operations at a traffic signal. Collecting travel time data for a longer distance should provide a better representation of the operating conditions along the entire corridor. A disadvantage to collecting travel time data for the longer distance, however, is that few vehicles travel the entire distance along the corridor. Less than 20 percent of the vehicles observed during the before-and-after

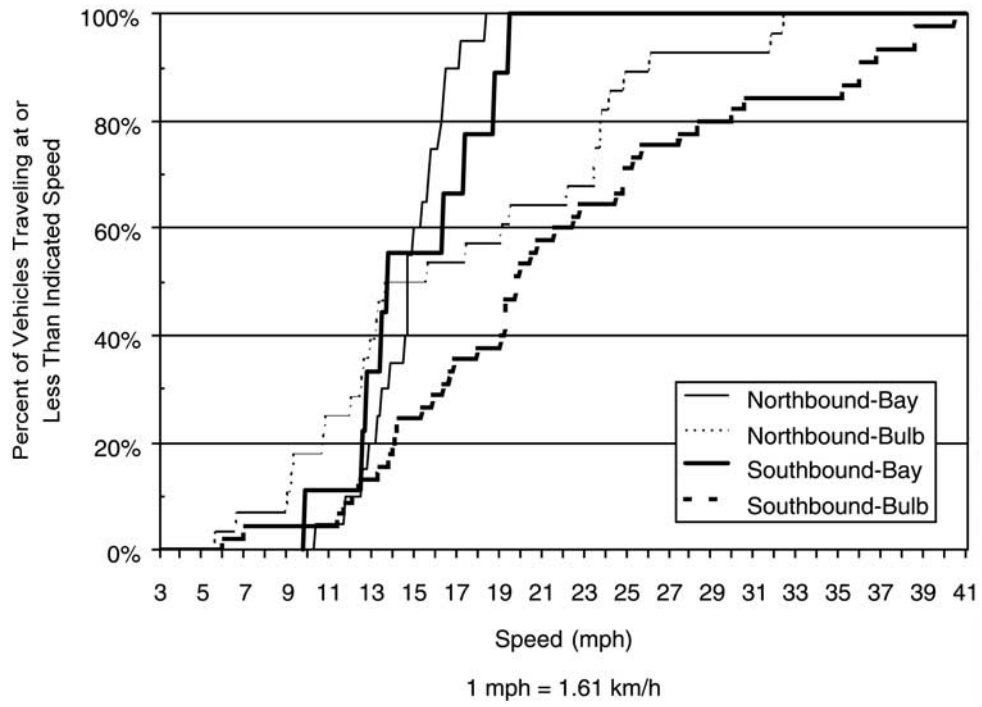
**Figure C-13. Vehicle Travel Speeds in Corridor.**

In the northbound and southbound directions the average speed for vehicles increased approximately 3 mph (4.8 km/h) and 7 mph (11.3 km/h), respectively. The increase in speed was statistically significant for the southbound direction. Figure C-13 is a plot of the individual vehicle speeds collected in both directions for both bus stop designs. It demonstrates that much higher speeds are present with the bulb design. Approximately 40 percent of the vehicles observed when the bulbs were present were driving at speeds greater than 19 mph (30.6 km/h), which was the highest speed measured in the before (bay) condition.

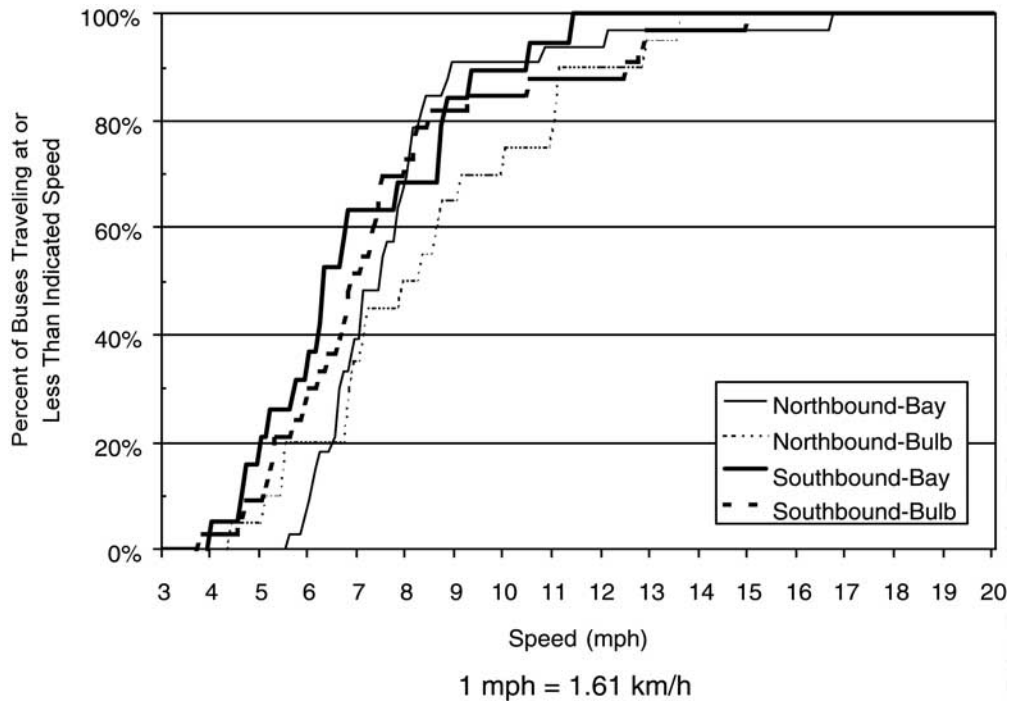
**Figure C-14. Bus Speeds in Corridor.**

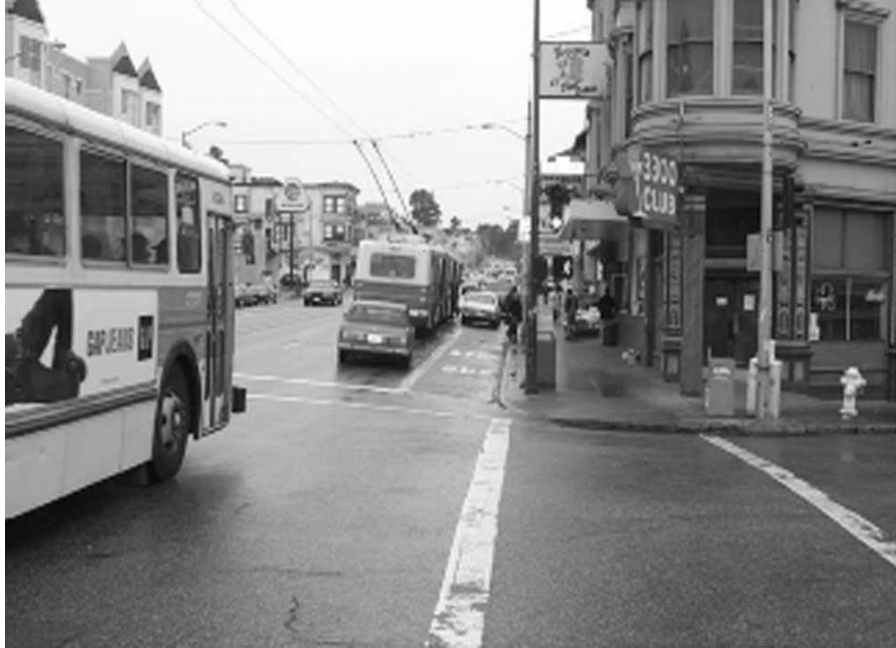
**(b) Bus Stop 5 with Bus Bay Design**

**Figure C-15. Examples of Vehicles Hindering  
Bus Operations (continued).**

- There were several observed near “sideswipes” between vehicles and buses when the bus tried to re-enter the traffic stream from a bus bay.
- Buses are sometimes caught in the queue created by a traffic signal before reaching the bus stop. This occurred on several occasions during the peak period especially at nearside stops (e.g. Mission at 30<sup>th</sup>, Southbound).
- Double-parked vehicles or illegally parked vehicles in the bus stop created difficulties for bus drivers with both the bus bay and bus bulb designs (see Figure C-15).

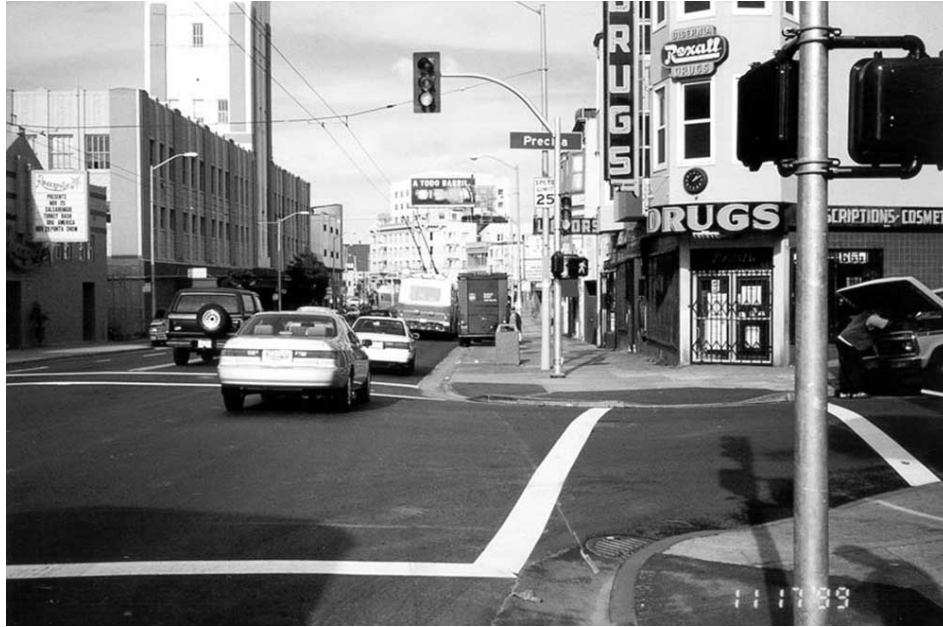
**(c) Bus Stop Northbound on Mission St. at Precita Ave.**

**Figure C-15. Examples of Vehicles Hindering Bus Operations (continued).**

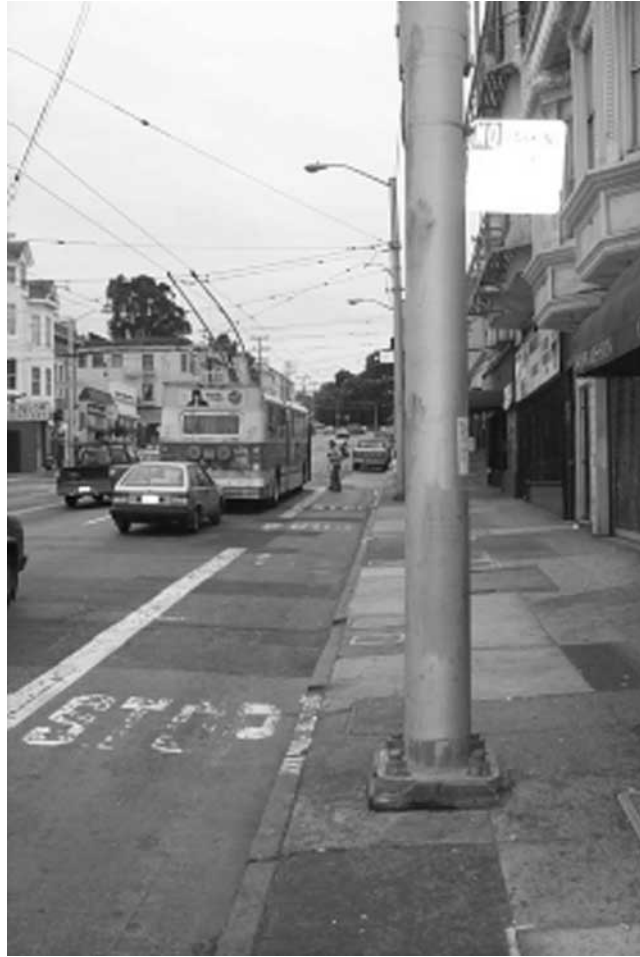
**Figure C-16. Bus Completely Stopped in Lane.**

During the before study, over 500 bus arrivals at the bus bay were observed. A majority of these buses completely or partially stopped in the outside lane instead of pulling into the bus bay (see Figures C-16 and C-17, respectively). At all of the sites studied except one, more than half of the buses stopped partially or fully in the travel lane (see Tables C-6 and C-7). Site 3 had the highest incident of buses stopping in the lane, with over 72 percent of the buses in the peak period stopping in the lane. Representatives of San Francisco MUNI acknowledged this observation and concluded this behavior is due to two events: bus drivers are wary of the bus re-entry problem and want to avoid this maneuver, and the overhead electrical wires had already been moved for the reconstruction of the bus stops, which can cause the catenary poles from the buses to dislodge from the electrical wire (the data collection team observed several of these events). However, bus patrons are asked to step off the curb and onto the street whenever this maneuver is practiced by bus drivers.

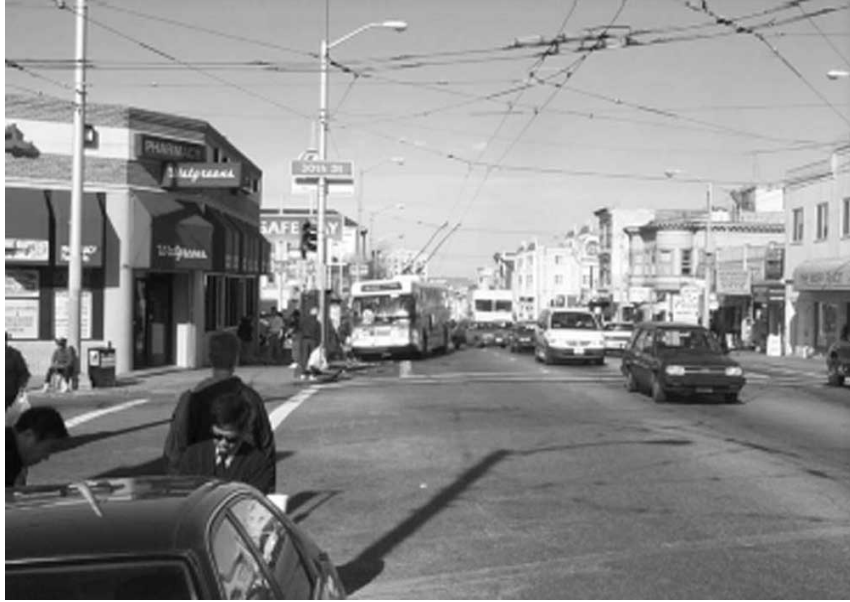
**Figure C-17. Bus Partially Stopped in Lane.**

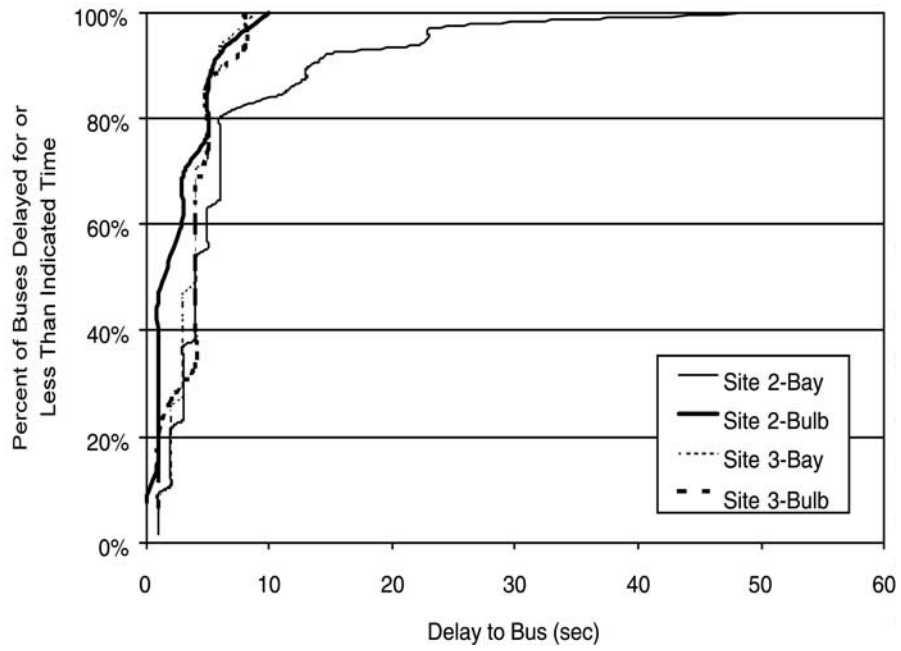
**Figure C-18. Non-Peak Bus Delay.**

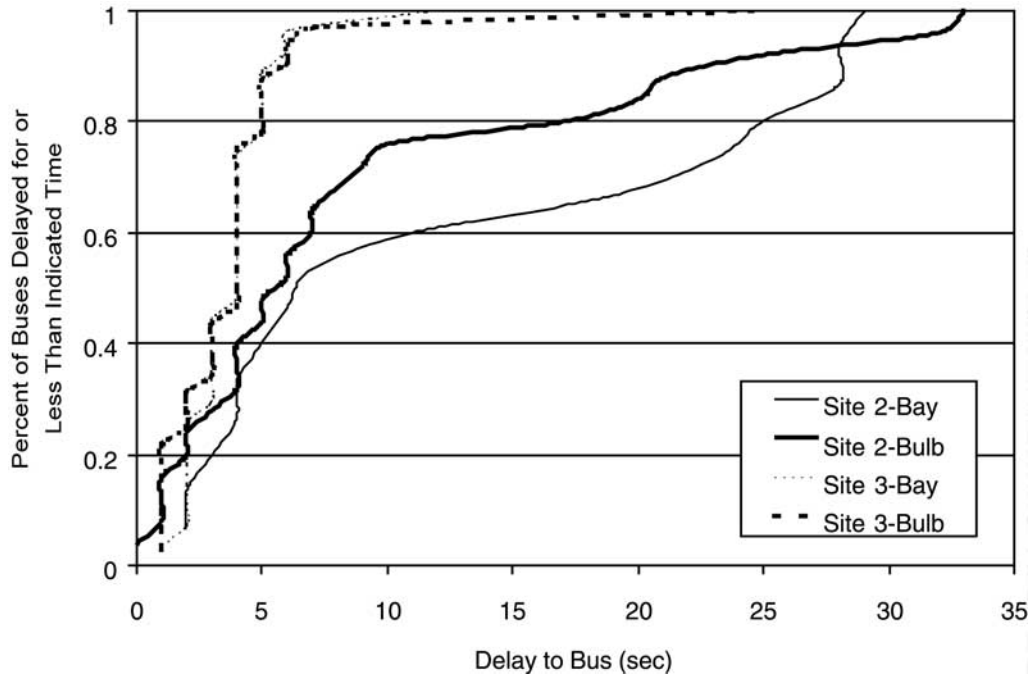
**Figure C-19. Peak Bus Delay.**
