# **An Evaluation of Bus Bulbs on Transit, Traffic, and Pedestrian Operations**

**Transit Cooperative Research Program  
Transportation Research Board  
National Research Council**

**Kay Fitzpatrick  
Kevin Hall  
Stephen Farnsworth  
Melisa D. Finley  
Texas Transportation Institute  
College Station, Texas**

**August 2000**

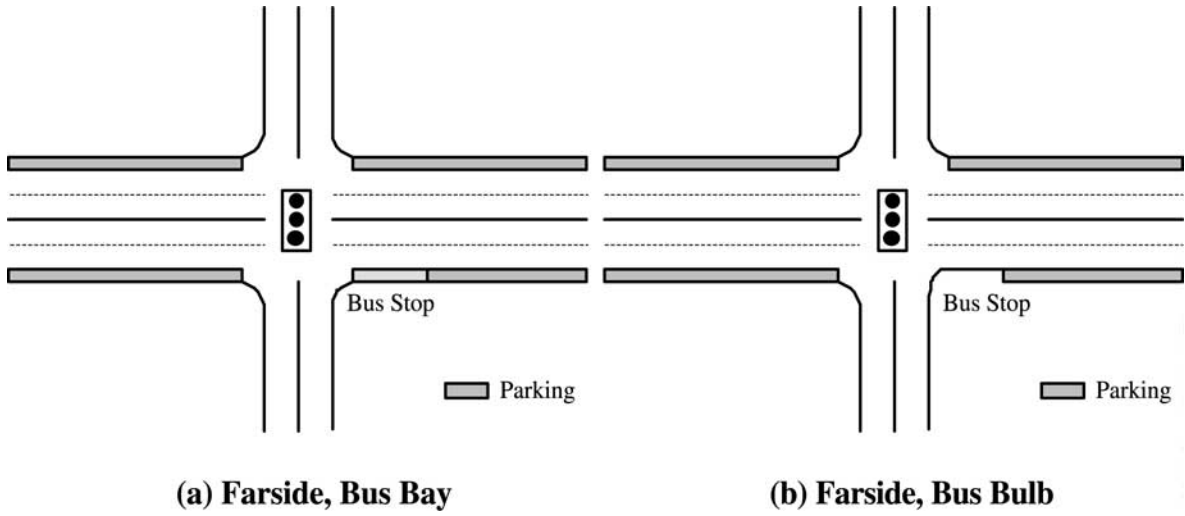
**Figure D-2. Farside Bus Stop**

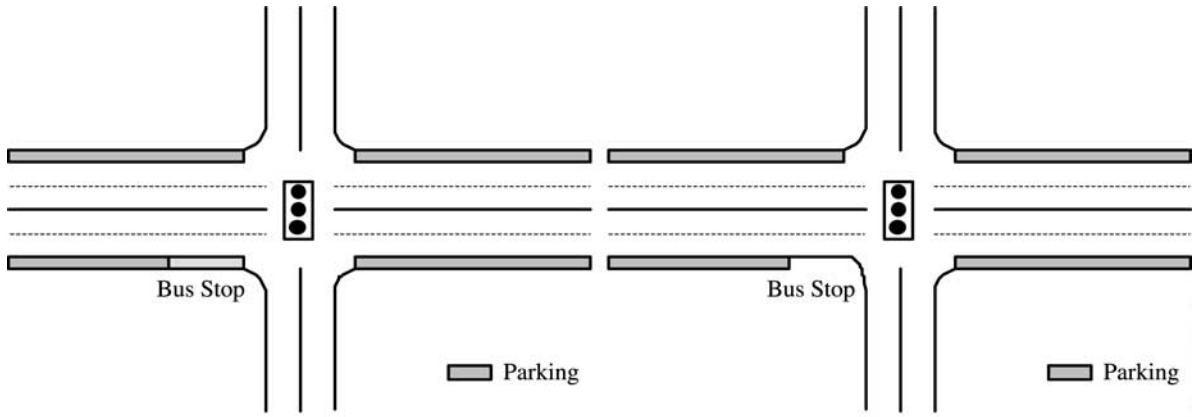
**(a) Nearside, Bus Bay**

**(b) Nearside, Bus Bulb**

**Figure D-3. Nearside bus Stop Designs.**

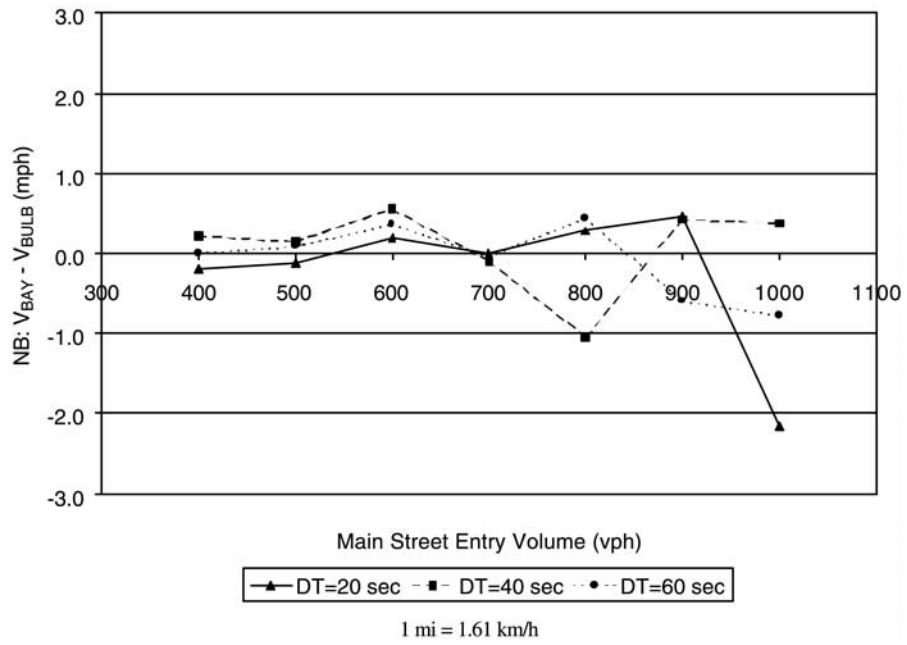
**Figure D-6. Northbound Average Vehicle Speed Difference Between Bus Bay and Bus Bulb Design.**

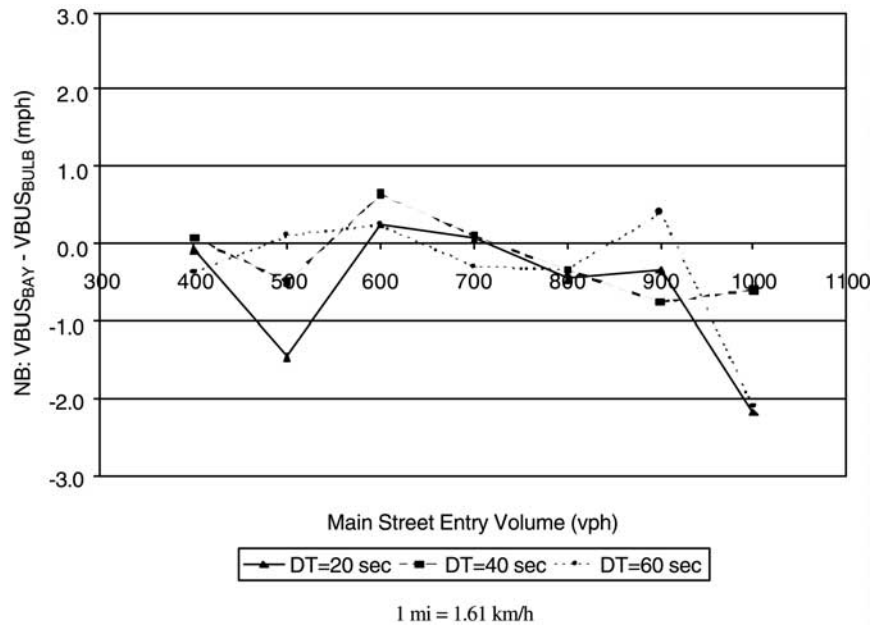
**Figure D-7. Northbound Average Bus Speed Difference Design Between Bus Bay and Bus Bulb.**

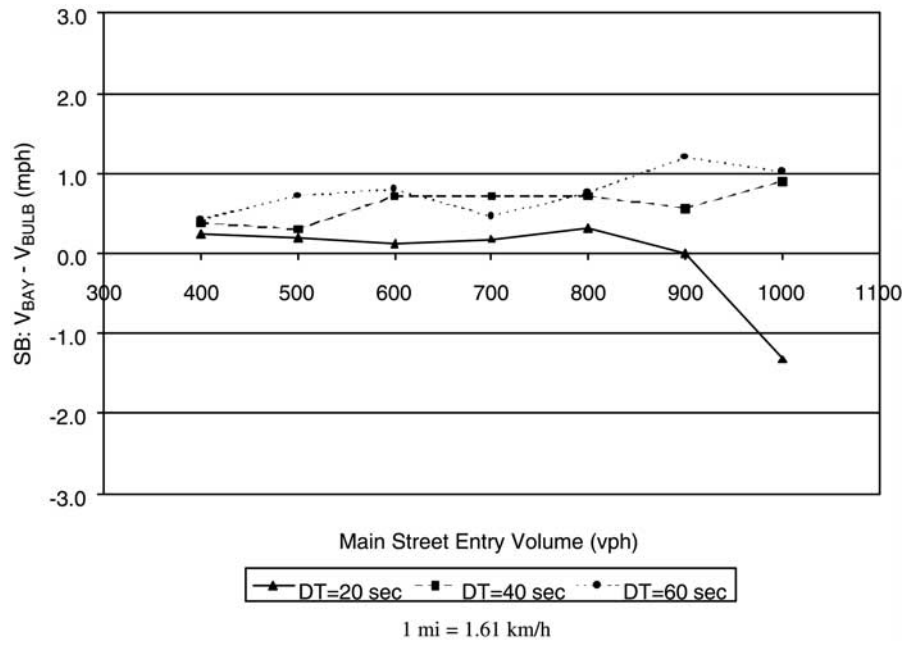
**Figure D-8. Southbound Average Vehicle Speed Difference Between Bus Bay and Bus Bulb Design.**

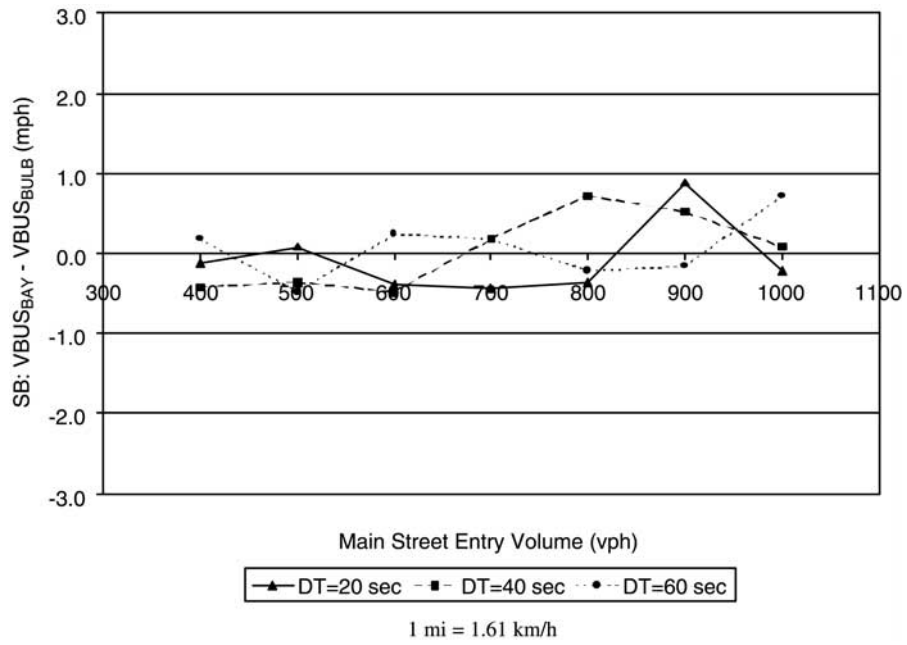
**Figure D-9. Southbound Average Bus Speed Difference Between Bus Bay and Bus Bulb Design.**

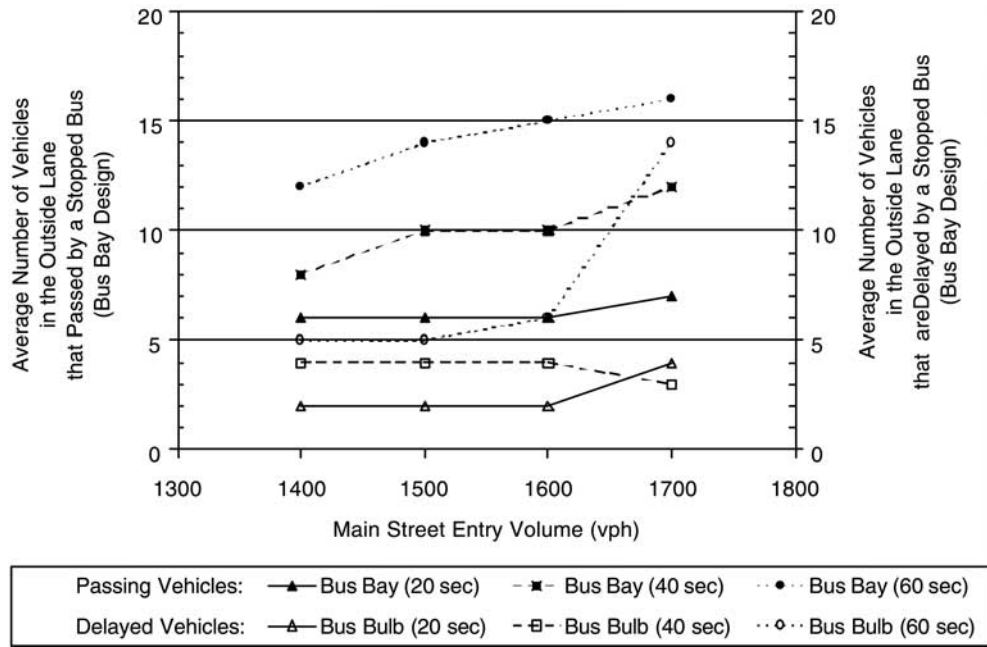
**Figure D-11. Relationship Between the Average Number of Vehicles that Passed by a Stopped Bus and the Average Number of Vehicles that Are Delayed by a Stopped Bus for a Farside Location.**

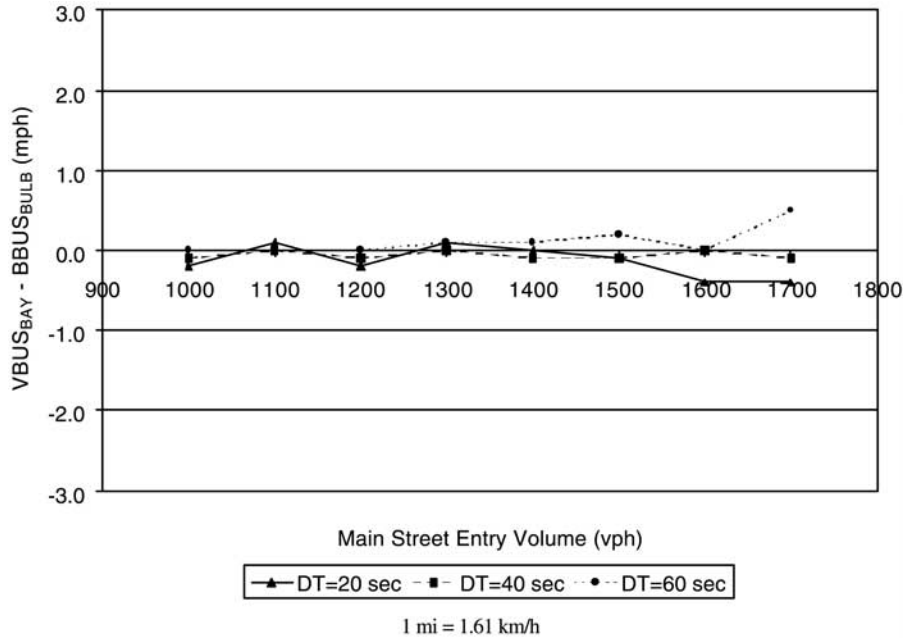
**Figure D-12. Average Bus Speed Difference Between Bus Bay and Bus Bulb Design For a Farside Location.**

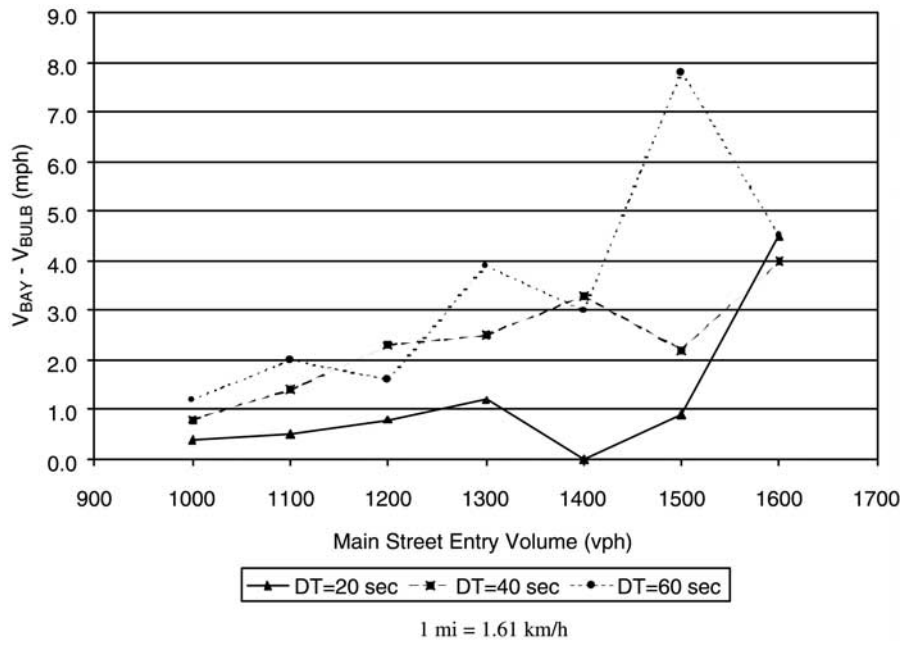
**Figure D-13. Average Vehicle Speed Difference Between Bus Bay and Bus Bulb Design for a Nearside Location.**

Based on the bus data, it was concluded that only at very high volumes is there a potential difference between the two designs when the bus stop is located on the nearside of the intersection. For most combinations of main street volumes and dwell times, the difference in average bus speed was less than 1 mph (1.6 km/h). The bus bay design had a 1 to 2 mph (1.6 to 3.2 km/h) speed advantage for buses with volumes greater than 1500 vph and a 20 sec dwell time.

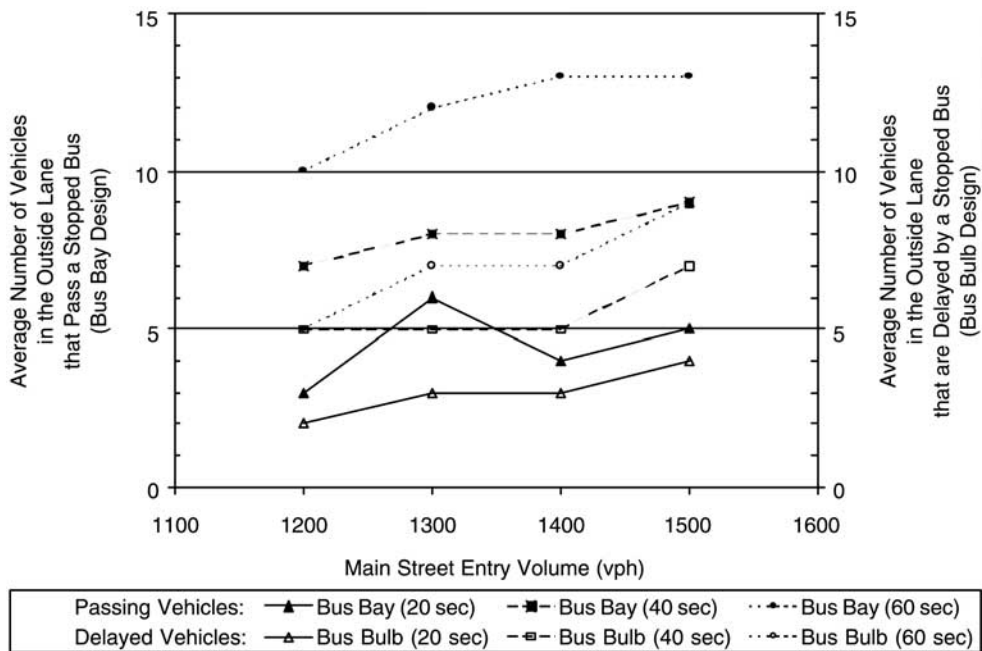
**Figure D-14. Relationship Between the Average Number of Vehicles that Pass a Stopped Bus and the Average Number of Vehicles that Are Delayed by a Stopped Bus for a Nearside Location.**

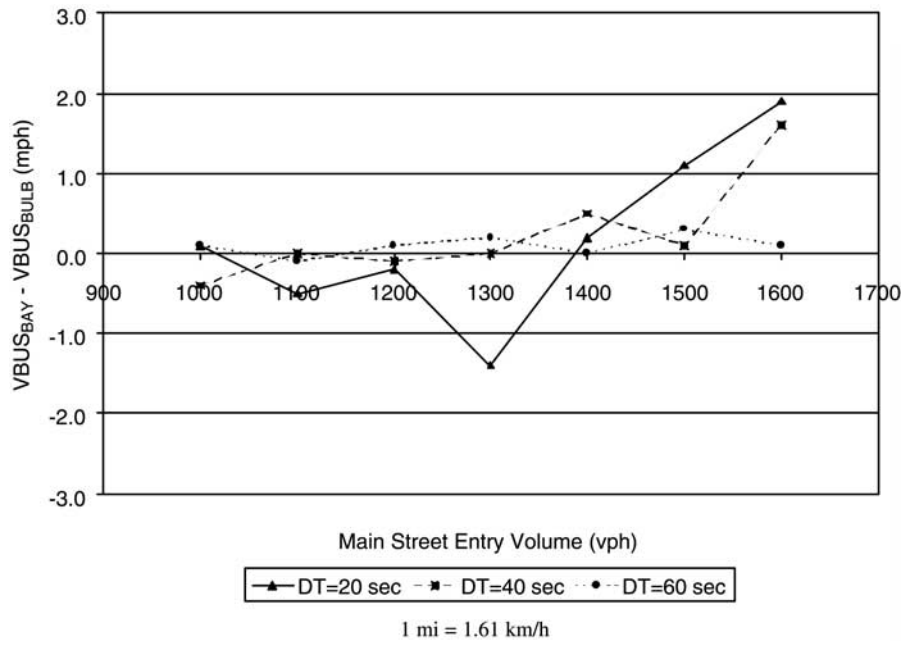
**Figure D-15. Average Bus Speed Difference Between Bus Bay and Bus Bulb Design for a Nearside Location.**
