CONFERENCE PROCEEDINGS 6

*Sixth International
Conference on*
Low-Volume Roads

Volume 2

Prevention of Salt Damage to Thin Bituminous Surfacing: Design Guidelines

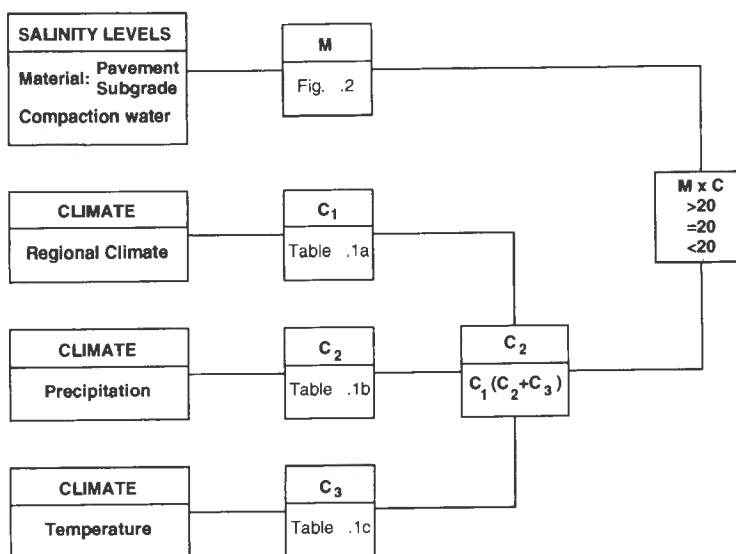
FIGURE 1 Risk analysis for salt damage to bituminous surfacings.

Salt damage risk evaluation is recommended whenever a thin bituminous surfacing is proposed for a pavement in a warm island or arid or semiarid inland region. Clearly, the damage process is dependent on a complex interaction of many variables, but the proposed design method is based on two significant parameters, salt content and climate, which can be measured relatively easily. Further design parameters can be added as other variables can be linked to the damage process in qualitative terms. The procedure (Figure 1) first allocates values to salt levels in the pavement and subgrade materials, compaction, and, in some situations, groundwater and then allocates values to climatic conditions. The values are combined to provide an overall rating that indicates the damage risk for bituminous surfacings.

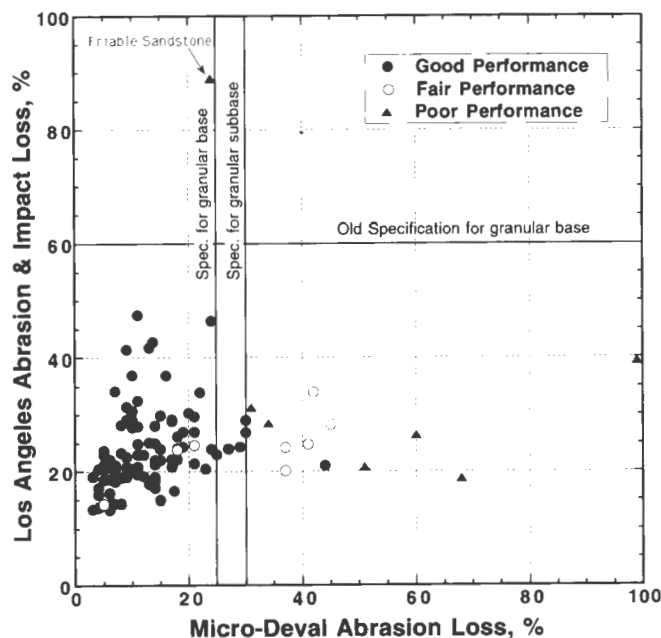
Figure 3 shows Los Angeles abrasion and impact loss against Micro-Deval abrasion loss. It can be seen that the Micro-Deval test is good at separating the majority

FIGURE 3 Los Angeles abrasion and impact loss value plotted against Micro-Deval abrasion loss value.
