**REPORT OF
PHASE I ENVIRONMENTAL SITE ASSESSMENT**

**ALAMEDA DISTRICT PLAN
LOS ANGELES, CALIFORNIA**

CORDOBA CORPORATION
Los Angeles, California

July 29, 1994

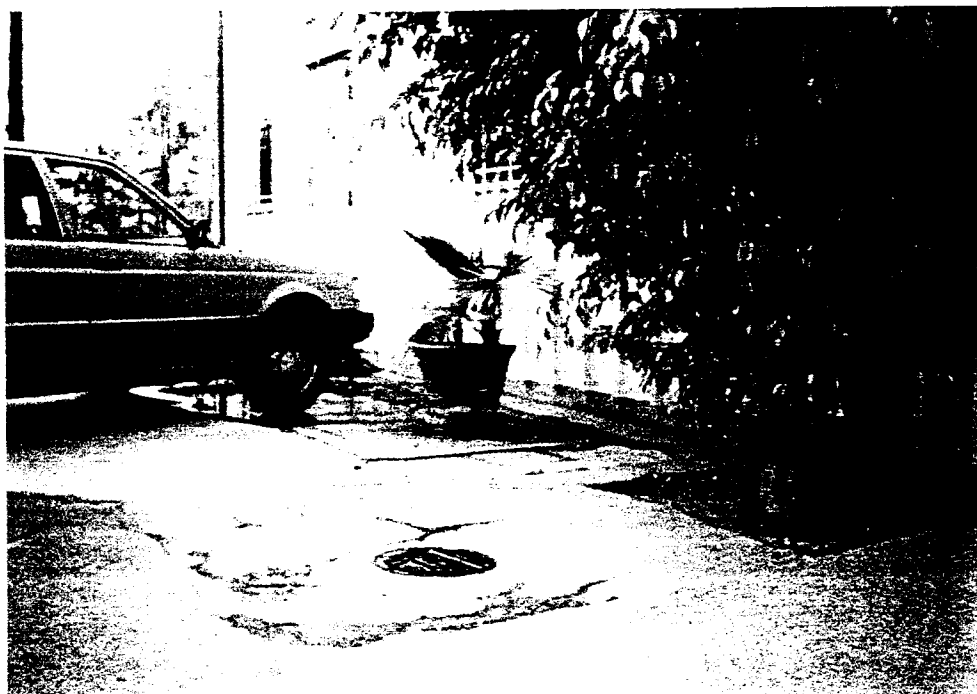
Photograph 5: View to east of the clarifier located near the AMTRAK office at the eastern boundary of the site. Groundwater monitoring well MW-10 is visible in the foreground.

In 1991, a groundwater monitoring well (MW-10) was installed adjacent to the outlet port of the clarifier (Figure 3). Analysis of soil samples collected during installation of groundwater monitoring well MW-10 indicated the presence of carbon disulfide (CS_2) and potentially methylene chloride at depths of up to 20 feet below ground surface (bgs). Methylene chloride was detected in the laboratory blank and may not represent soil conditions. Analysis of groundwater samples indicated the presence of acetone, dichloroethane (DCA), dichloroethylene (DCE), tetrachloroethylene (PCE), toluene, methylene chloride, and CS_2 (Levine-Fricke, 1991b). Methylene chloride and CS_2 were also detected in the laboratory blank and may not represent actual groundwater conditions.

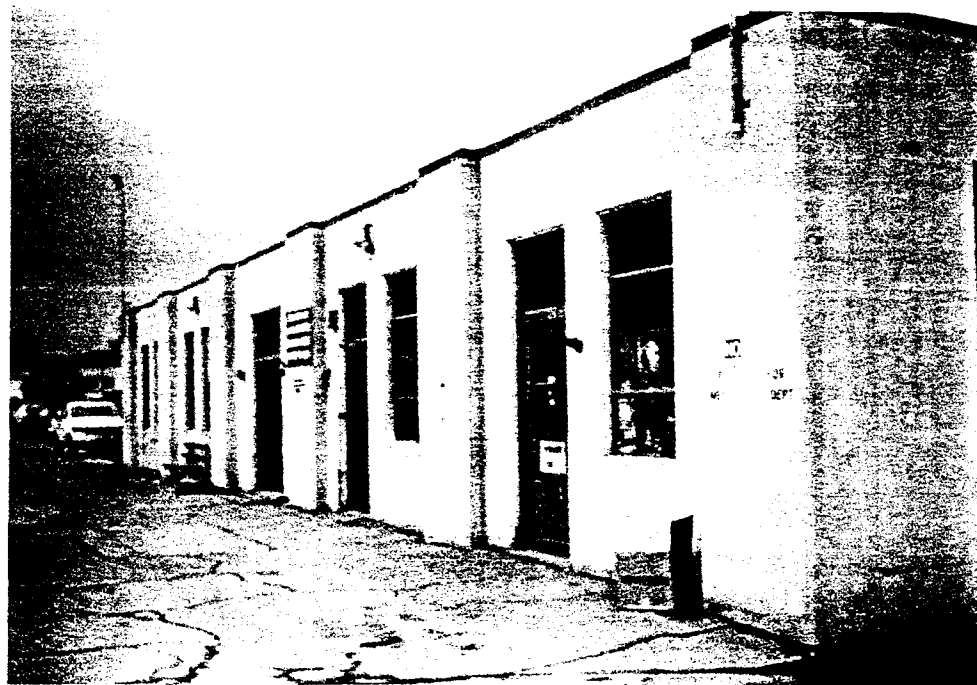
Photograph 6: View to the east of the AMTRAK maintenance garage located east of the railroad tracks in the elevated portion of the site.

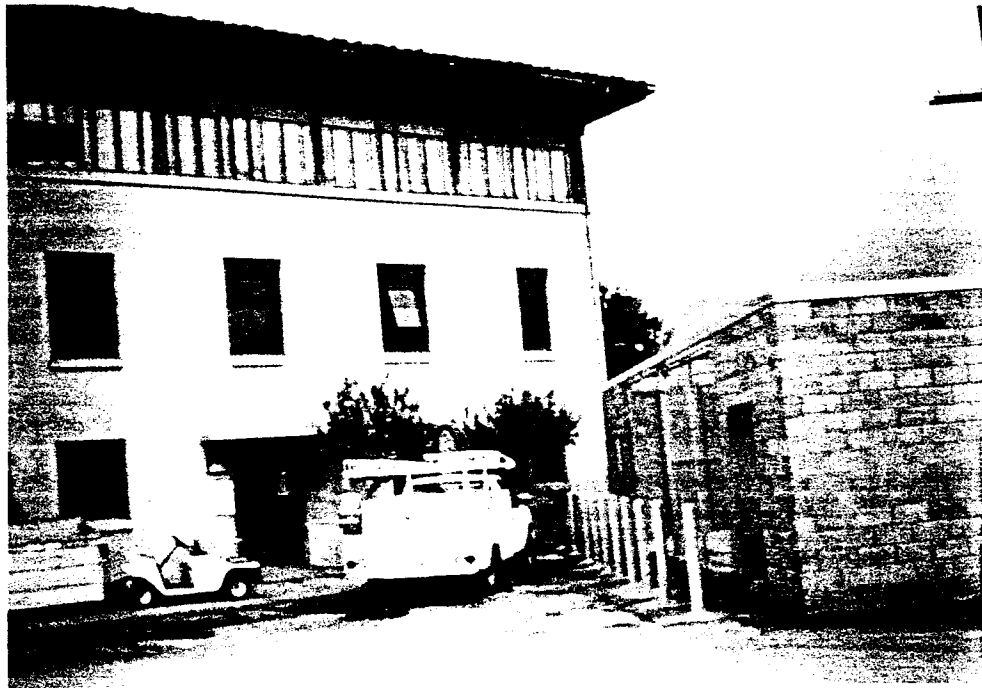
Photograph 7: View to the north of the AMTRAK switching tower and the new power enclosure currently under construction by the Metropolitan Transit Authority (MTA).

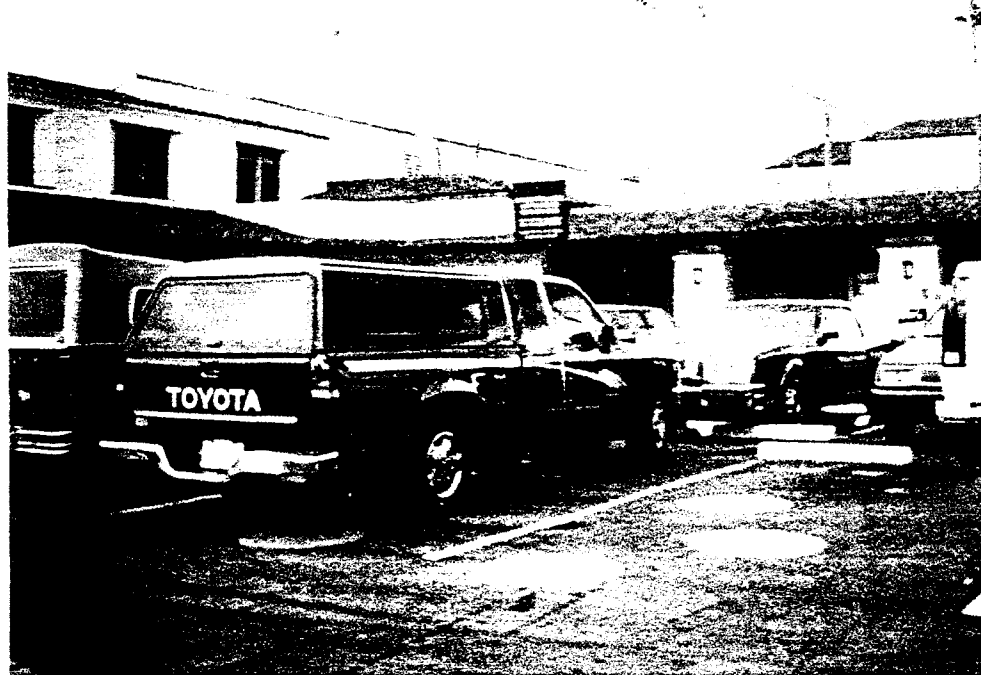
Photograph 9: View to the northwest of the concrete patches in Parking Lot D showing the location of the two underground tanks which were abandoned in place.

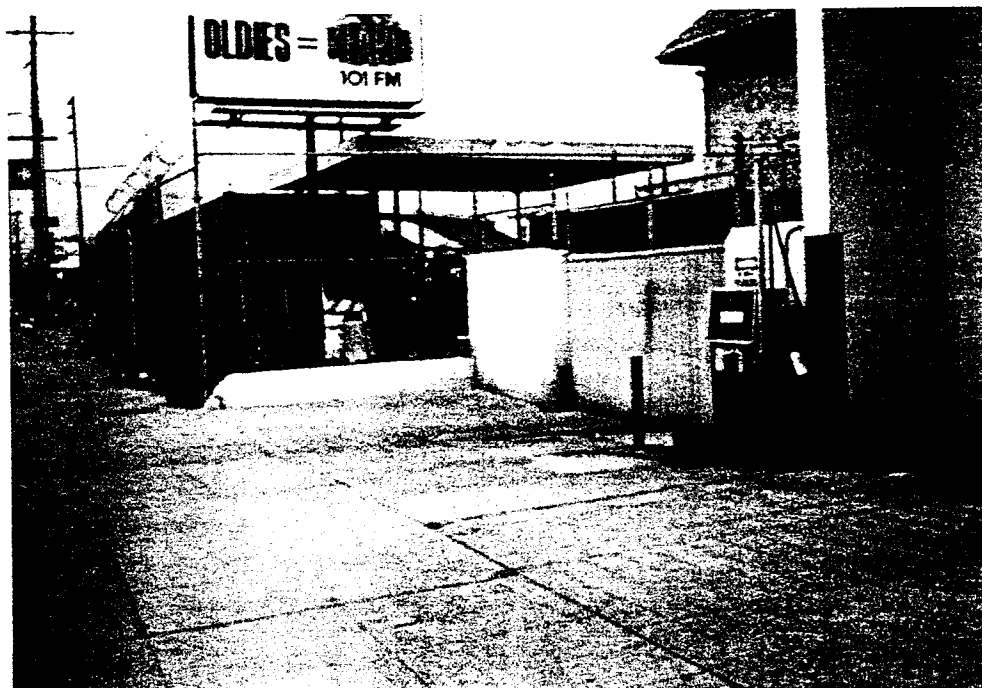
Photograph 12: View to the north of the fuel dispenser located in front of the City of Los Angeles Fire Station No. 4. To the north is the unidentified equipment yard located at the corner of Main and Vignes Streets.

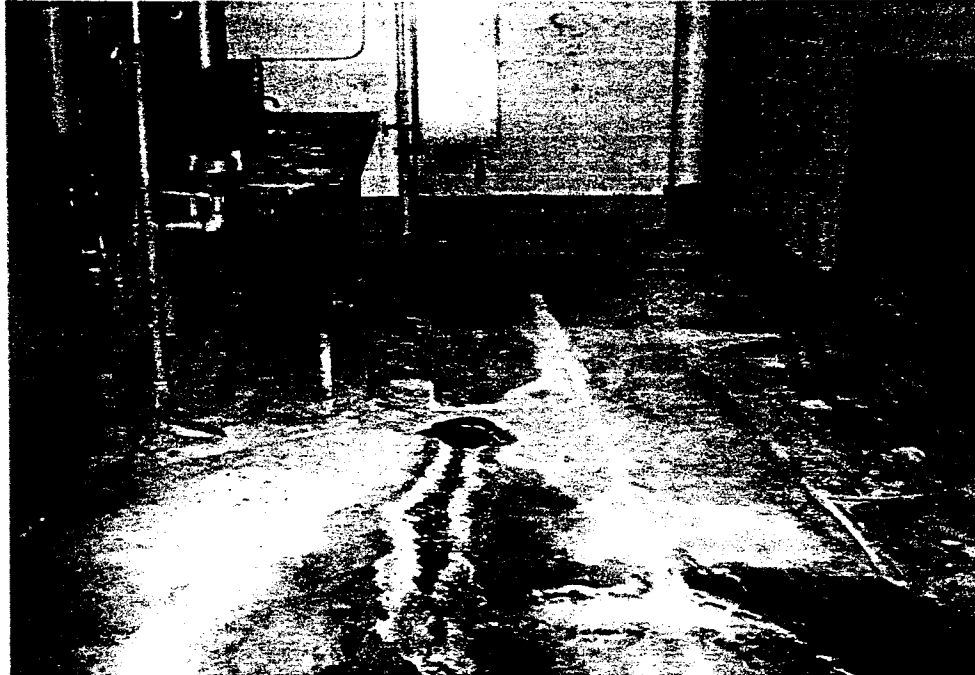
Photograph 15: View of one of the service bays within the interior of the VMF. Considerable staining and corrosion and a floor drain are visible.

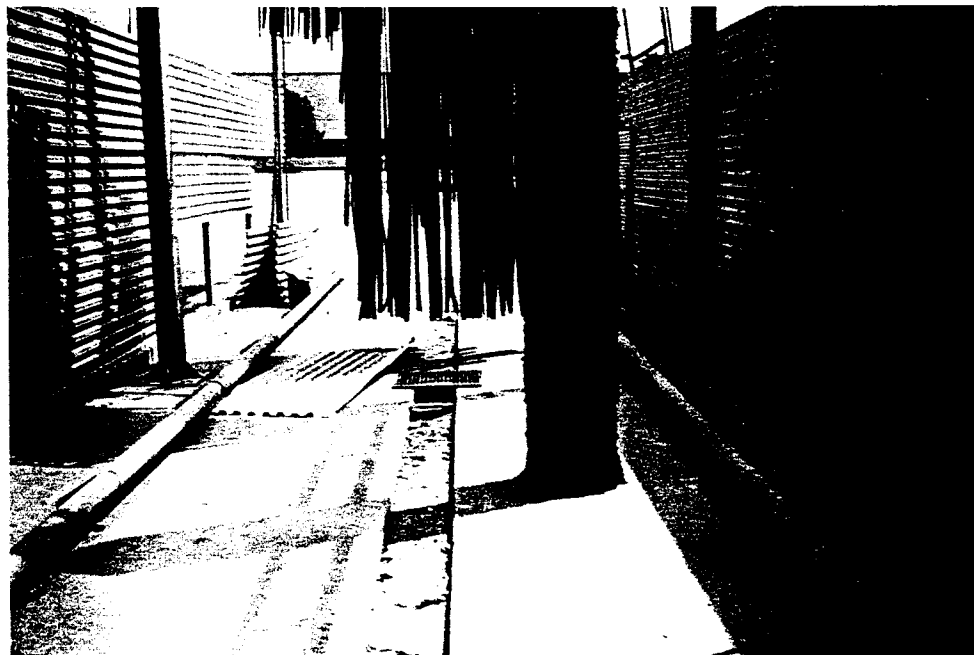
Photograph 16: View of the inoperative car wash located on the Terminal Annex property.
