Report No. FRA-OR&D 75-94

CONCRETE TUNNEL LINERS

STRUCTURAL TESTING OF CAST-IN-PLACE LINERS

6. Performing Organization Code	
7. Author(s) S. L. Paul and R. A. Ferrera-Boza				8. Performing Organization Report No. UILU ENG-75-2014	
9. Performing Organization Name and Address Department of Civil engineering University of Illinois at Urbana-Champaign Urbana, Illinois 61801				10. Work Unit No. (TRAIS)

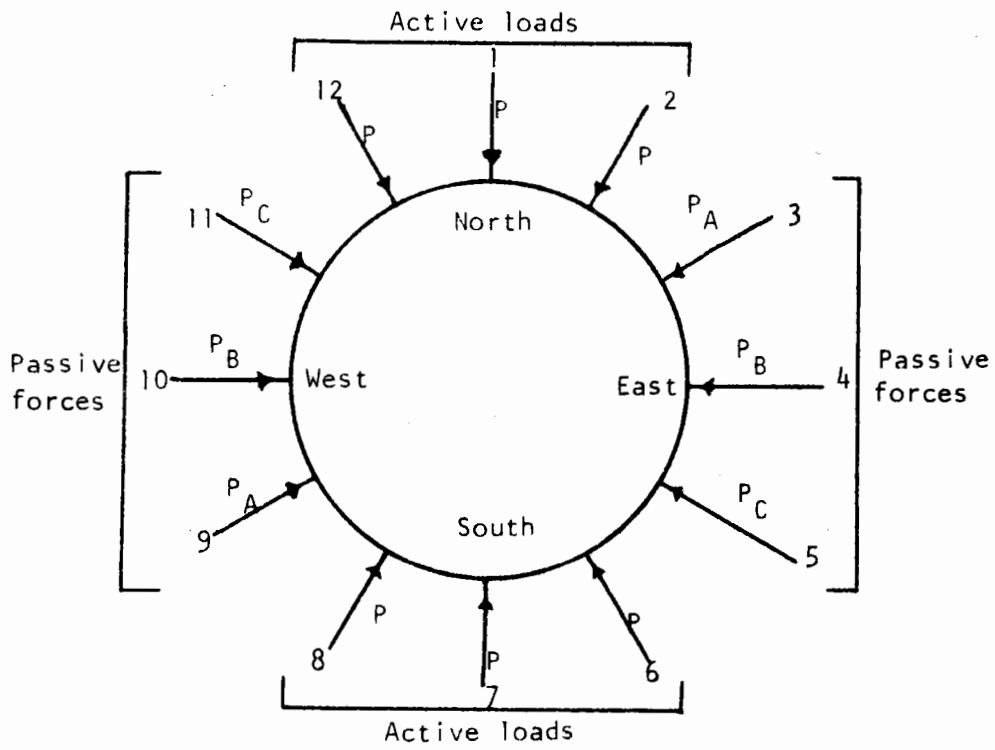
FIGURE 2.3 LOADING OF THE LINER SPECIMEN

The weight of the specimen rested on nests of rollers between steel plates located 90 deg apart at the cardinal directions and oriented

to roll in the radial direction. During previous tests the loading arrangement had a tendency to become unstable because of translational movement of the specimen. The loads were applied so that they were self equilibrating, but friction in the hydraulic rams caused slightly nonsymmetrical forces and the resulting movement accentuated the problem. Thus, brackets of the type shown in Fig. 2.5 were placed at the north, south, east and west sections to prevent the translation. Lateral rollers in the brackets reduced the frictional resistance to radial movement. The forces on the brackets, although small in magnitude, influence the internal forces in the liner as will be explained later.

Twelve external radial forces were applied to the liner specimens as shown in Fig. 2.3 and tangential forces were introduced at the north, south, east and west positions by the reactions of brackets preventing the specimens from rotating, as discussed in Section 2.3. The specimen thus loaded was statically indeterminate both externally and internally. There were 4 external unknown bracket forces (tangential forces) and three internal

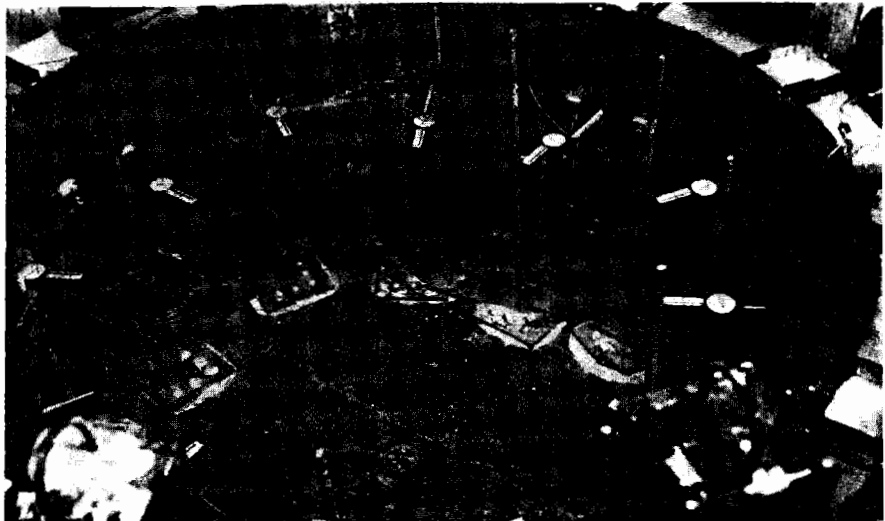
FIGURE 3.2 SPECIMEN C3 AFTER TESTING

(a) South portion

(b) North portion

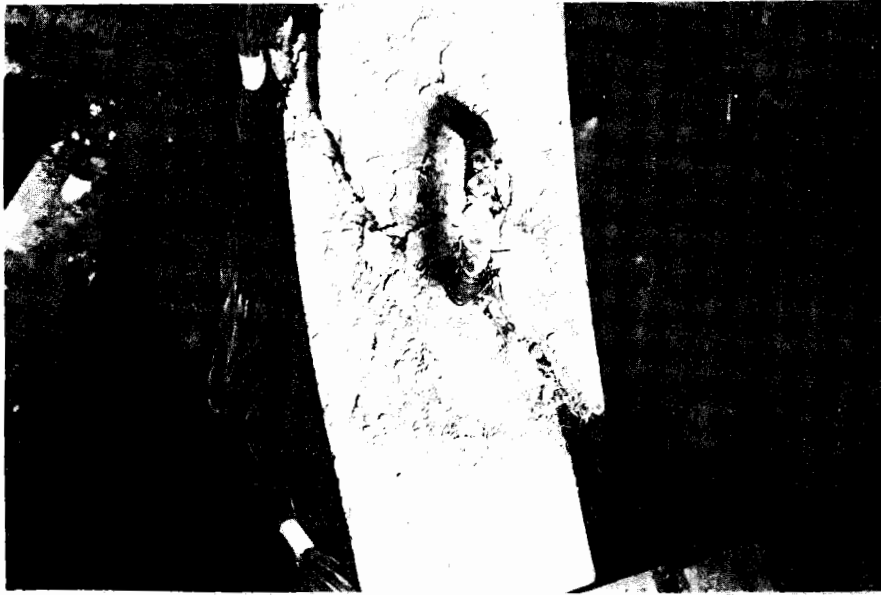
FIGURE 3.3 FAILURE REGION FOR SPECIMEN C3

(b) Top

(a) Inside south

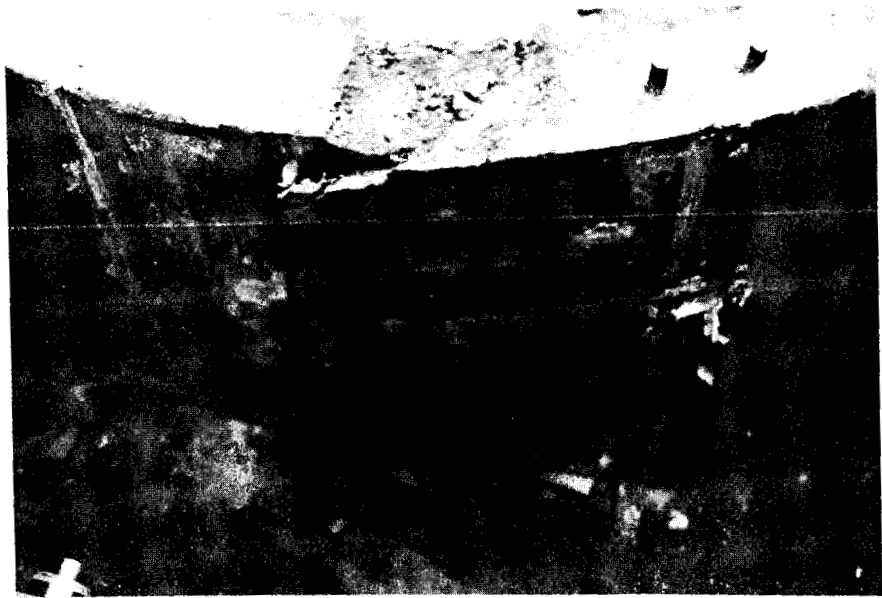
FIGURE 3.6 FAILURE SECTION OF SPECIMEN C6

Final failure occurred near the middle of the southwest quadrant; clearly visible tensile cracks appeared at the outside of the specimen rather suddenly at a load of 132.4 kips (592 kN). At the same load, corresponding to load increment 19, crushing was detected on the inside opposite these cracks. Final failure occurred during the application of the next load increment in a way similar to that described for C3, along a diagonal surface through the thickness, ending at the inside where the initial crushing was detected. Photographs of the failed section are shown in Fig. 3.6.

(a) Outside

(b) Top

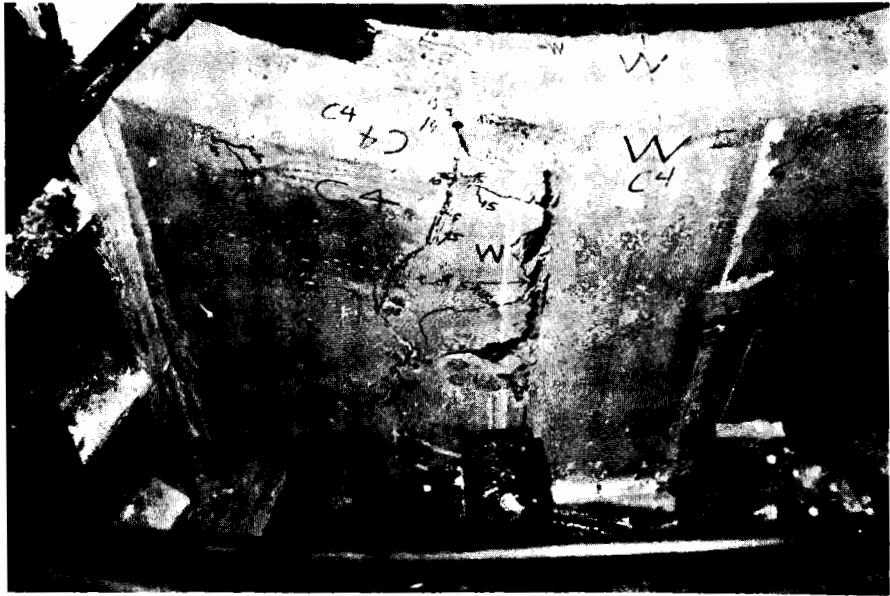
FIGURE 3.9 FAILURE SECTION OF SPECIMEN C4

Final failure occurred just north of the west load spread beam. First, a flexural crack appeared on the outside at a load P of 23.5 kips (105 kN), the cracks opened progressively and spalling occurred on the inside opposite the crack, at a load P of 94 kips (419 kN). At a load of 103.8 kips (461 kN) sudden crushing of the spalled zone on the inside was clearly observed, and the tensile crack closed. As a result of this, the surfaces of the original cracks came in contact and bearing developed. At increment 24, corresponding to an average active load of 115.1 kips (513 kN), the thrust across the crack caused crushing on the outside of the liner and the section failed during the application of the next increment of loading by spalling a wedge of concrete on the outside. Photographs of the failure section are shown in Fig. 3.9.

(a) Outside

(b) Top

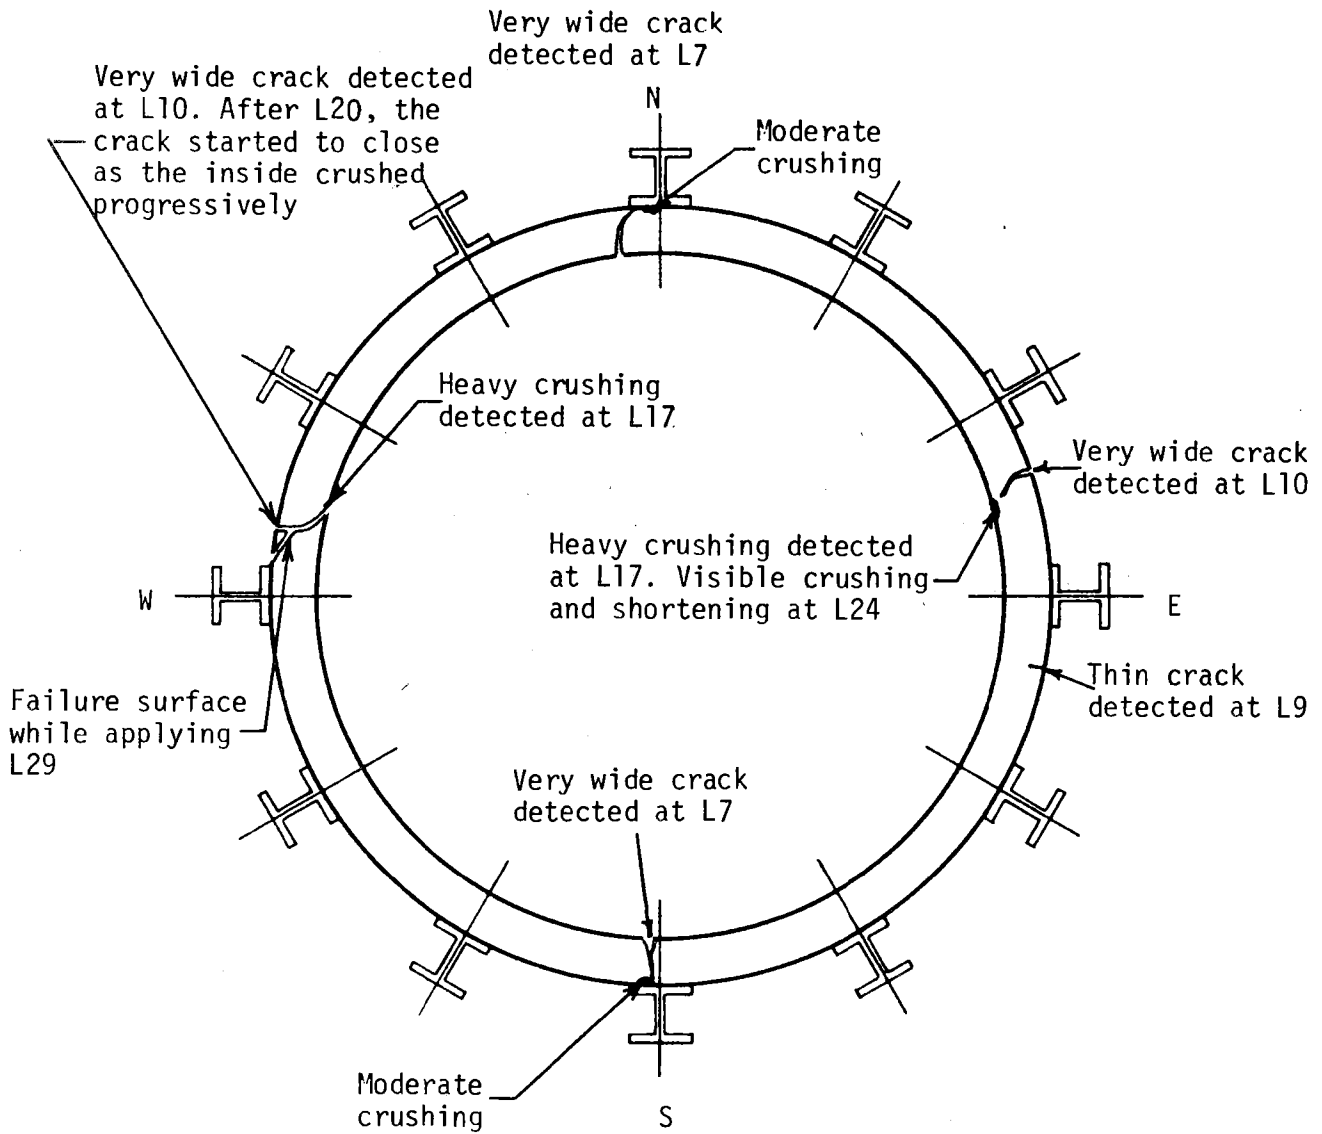
FIGURE 3.10 SPECIMEN C5 DAMAGE DURING TESTING

widening of the cracks, and spalling and crushing toward the end of the test. The extent and sequence of damage is shown in Fig. 3.10 and photographs in Fig. 3.11.

Tensile cracks were detected at the inside north and south, at a load of 9.4 kips (42 kN). These cracks progressively widened and penetrated deeply, reaching a width of more than a quarter of an inch. After the test was completed and the load spread beams removed, crushing was discovered hidden by the beams and opposite the tensile cracks at the north and south positions.

At loads of 21.6 and 27.7 kips (96.5 and 123.8 kN), tensile cracks appeared on the outside near the south and then at the north of the east load spread beam. The crack to the south of the east position never widened appreciably. The crack to the north of the east position opened progressively, while crushing appeared opposite it at a load of 78.3 kips (349 kN). This crushing also increased progressively, and at a load of 110.2 kips (493 kN) a sudden and large amount of crushing occurred and the tensile crack closed. However, final failure did not occur at this section.

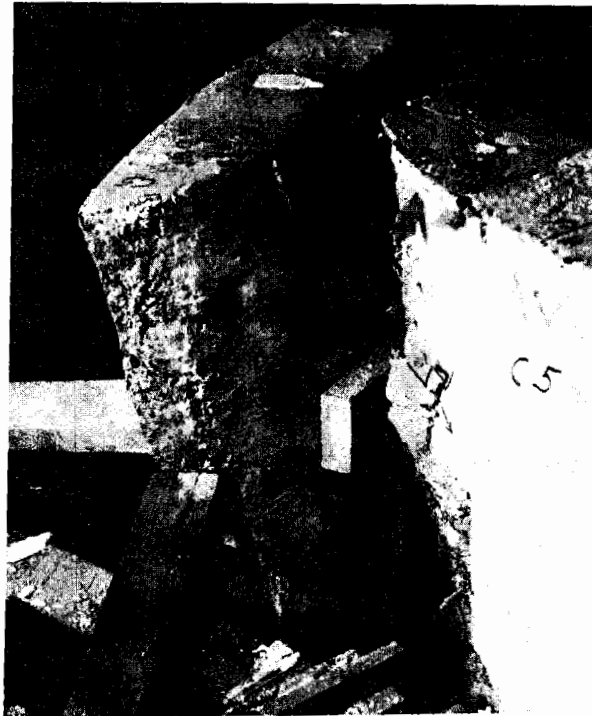
FIGURE 3.12 FAILURE SECTION OF SPECIMEN C5

Final failure occurred at a section north of the west load spread beam. A tensile crack was detected on the outside at a load of 27.7 kips (123 kN). One of these cracks opened progressively, while crushing appeared opposite it at a load of 78.3 kips (349 kN). This crushing also progressed and after a load of 84.2 kips (660 kN) closing of the tensile crack was observed. As a result of this, the surfaces of the crack came in contact, and bearing developed across it. During the beginning of increment 29 the section finally failed by spalling of a wedge of concrete on

(a) Top

(b) Outside

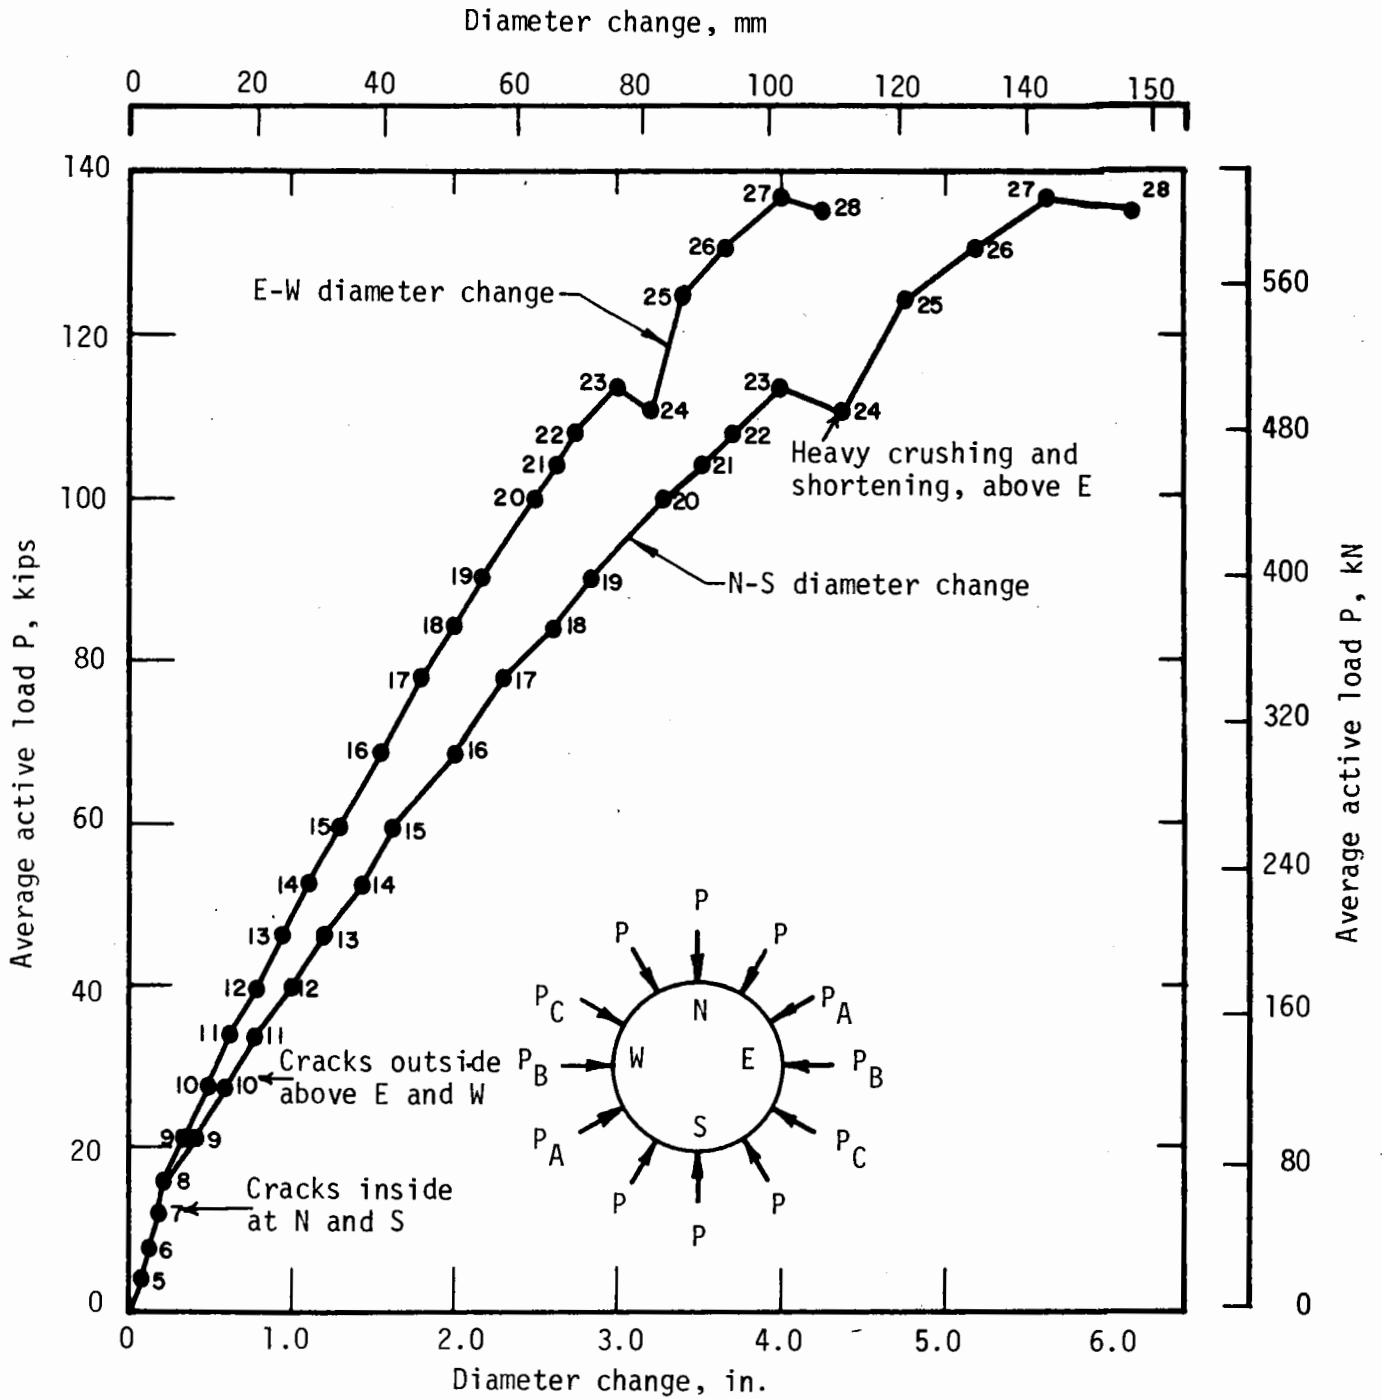
FIGURE 3.19 LOAD-DEFORMATION FOR TEST C4

FIGURE 3.20 LOAD-DEFORMATION FOR TEST C5

For the higher strength specimens, C4 and C5, both load-diameter change curves are rather smooth and nonlinear with the same general shape as the curves for the weak concrete specimens. The occurrence of events such as initiation of large flexural cracks, heavy crushing and spalling can be associated with sudden and well defined changes in slope in the path as shown in Figs. 3.19 and 3.20. During the application of load increment 21 for specimen C4 sudden crushing of the compression side at a flexural crack, followed by closing of the tension crack was observed but did not produce an irregularity in the curve because instrumentation readings were not taken at that load. During the testing of C5 this phenomenon was observed more carefully, and it occurred during application of load increment 24. Instrumentation readings were taken just after this occurred which indicate an abrupt drop in average active load P and an increase in deformation, as shown in Fig. 3.20. As in the low strength specimens, at high load levels, especially at the load increment preceding failure, the curves flatten considerably.
