# CONCRETE TUNNEL LINERS STRUCTURAL TESTING OF SEGMENTED LINERS

AUGUST 1975

FINAL REPORT

**Department of Transportation**  
**FEDERAL RAILROAD ADMINISTRATION**  
Washington, D.C. 20590

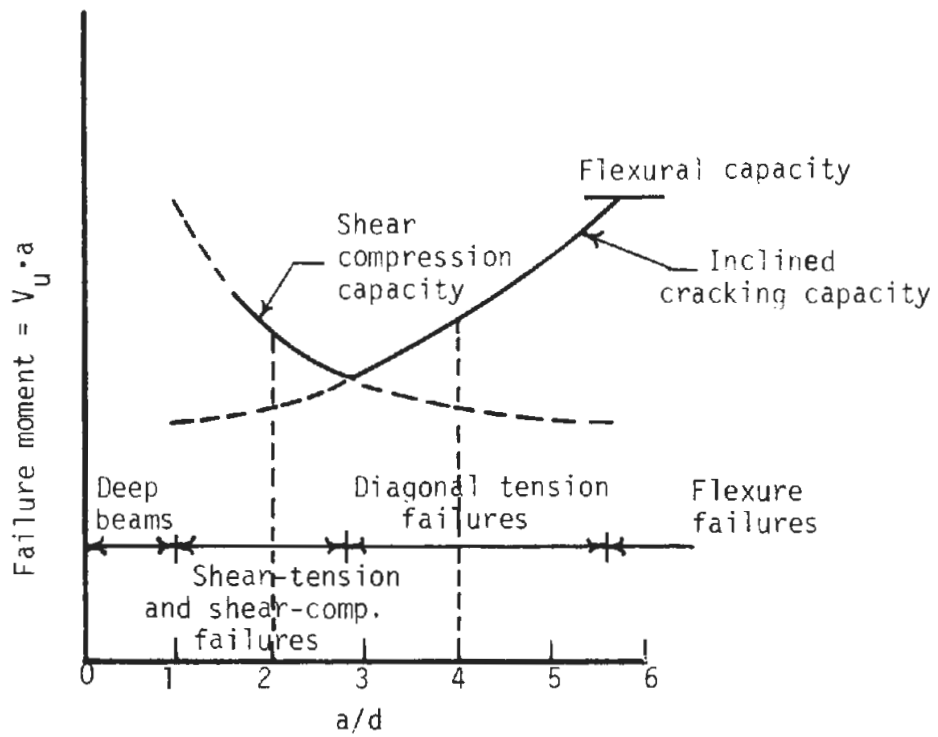
FIGURE 2.1 MODES OF FAILURE FOR NONFIBER BEAMS  
(Bresler and McGregor, 1967)

Inclined cracking may or may not cause collapse of the member. There are two mechanisms (at least) to resist the shear forces, and the tension stress across a potential inclined crack is one of them. Once the inclined crack develops, the shear force may be resisted by a shear force in the compression region of concrete above the neutral axis. If the shear capacity of the latter mechanism is larger than that which developed the inclined crack, the mechanism of resistance will be changed and more load can be added until the concrete in the compression region fails due to the combined forces, and a "shear-compression" failure is said to occur. If the shear capacity of the latter mechanism is smaller, collapse will occur immediately, and a diagonal tension failure is said to occur. This brief discussion is illustrated more completely in Fig. 2.1.

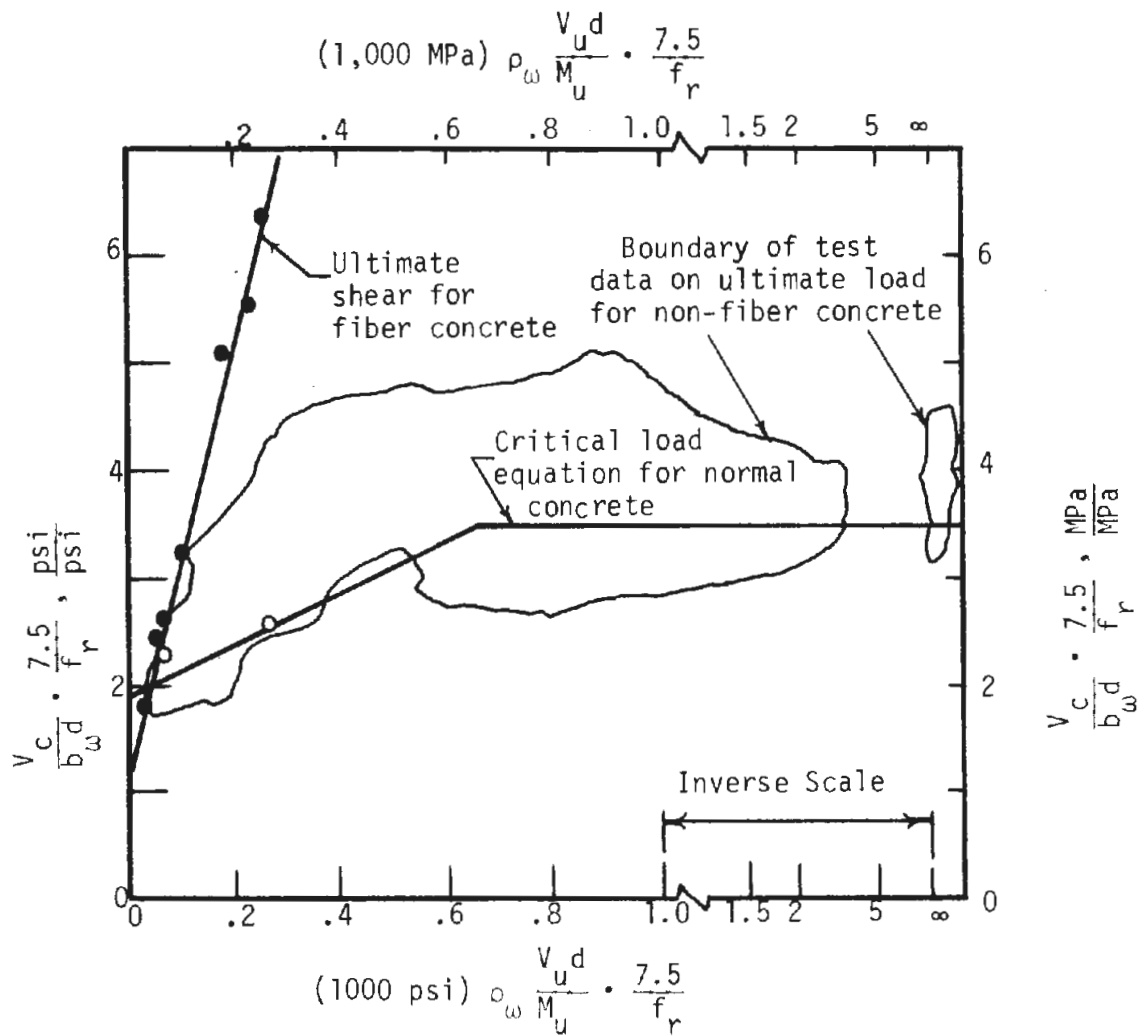
FIGURE 2.12 COMPARISON OF TEST DATA FOR FIBER CONCRETE WITH DATA FROM ACI-ASCE COMMITTEE 326 (1962)

At the capacity of the beam, the resisting shear on the left side of the equation ( $V_c$ ) is taken equal to the design shear on the right ( $V_u$ ). In Fig. 2.12, the dimensionless variable on the left of the equation which is a function of shear capacity is shown as the ordinate and the dimensionless variable on the right is shown as abscissa for nonfiber concrete beams. The equation applies over a part of the range of abscissa, after which the limit becomes active. The formula is based on a fit of data consisting of 194 beam tests (Journal of the ACI, 1962) of constant cross section and subjected to one or two concentrated loads in any one span (diagonal tension cracking occurs in a region of constant shear). The outline of points representing the data is shown in Fig. 2.12 also, where it can be compared with the formula. There is considerable scatter in the data and no distinction is made in the type of failure that occurred. The formula is near the

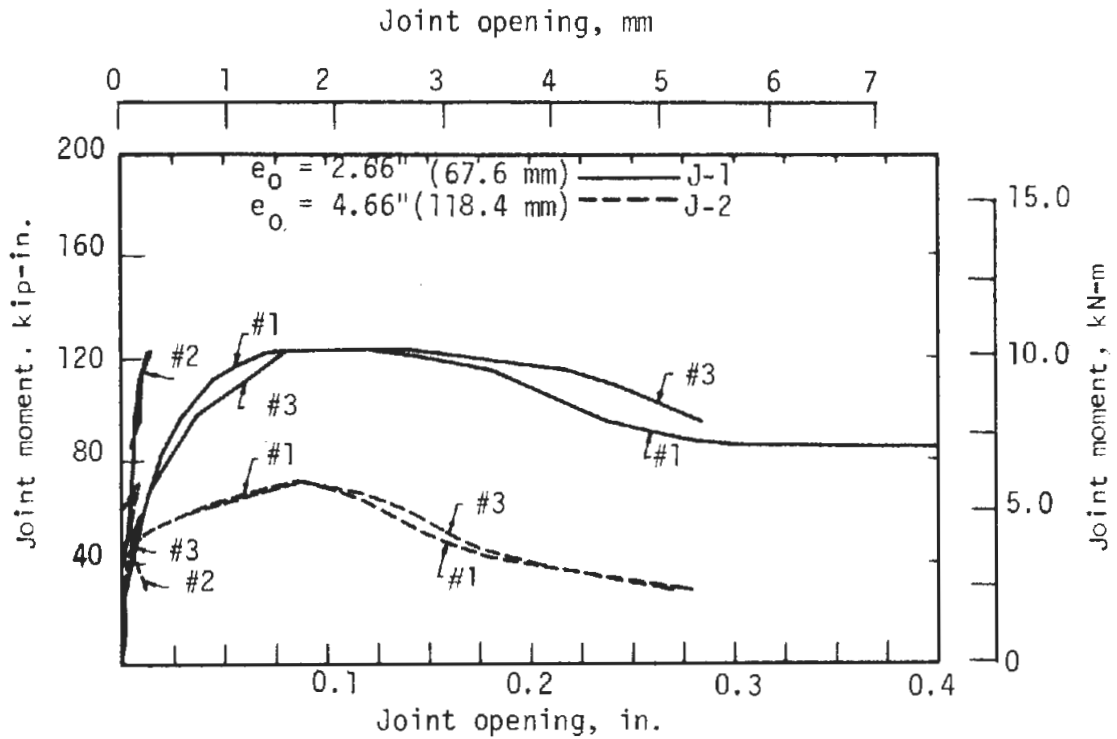
FIGURE 3.6 JOINT OPENING-MOMENT FOR TESTS J-1 AND J-2

Specimens J-1 and J-2 had initial positive eccentricities (shell in compression) of 2.66 in. and 4.66 in. (67.7 mm and 118.4 mm) respectively, measured from the calculated plastic centroid of the segment section with its longitudinal reinforcement as shown in Fig. 3.1(b). As the loading progressed and bending of the specimen occurred, the eccentricity changed slightly. This effect was considered by measuring the deformation and correcting the eccentricity when the moments were computed. Opening of the joint across the mating surface of the two specimens is shown in Fig. 3.6. Measurements made near the ends of the joints and at the center give a good indication of the behavior. The measurements show very little opening at the center (curve 2), while near the ends (curves 1 and 3) the joint continued to open throughout the loading history. The bolts held the end diaphragms of the segment together near the center, while the webs at

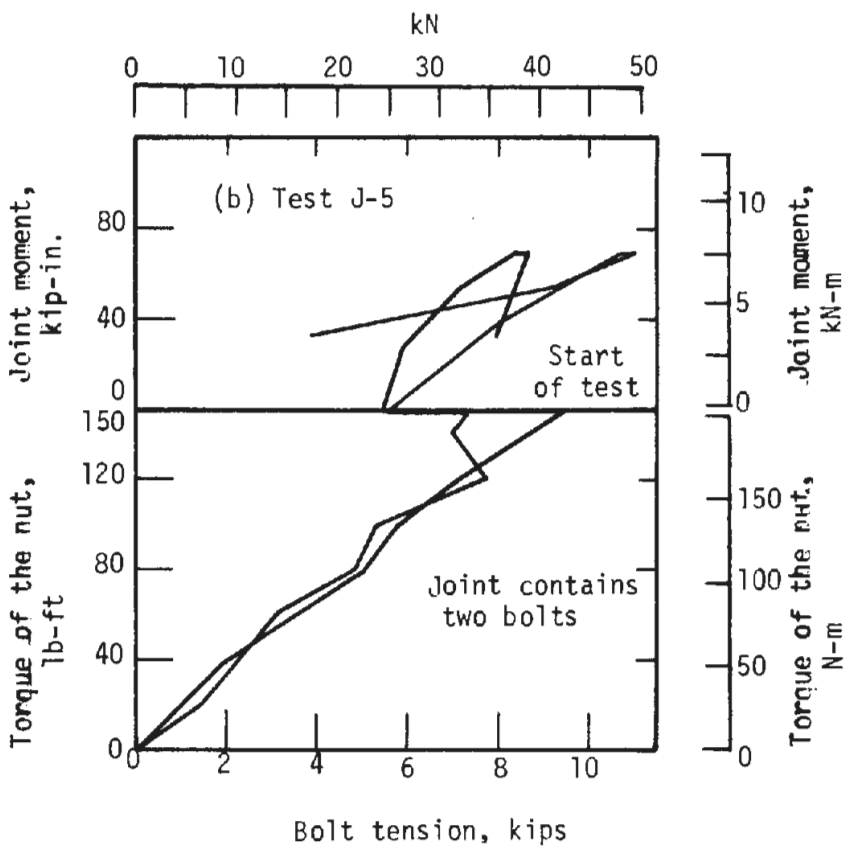
FIGURE 3.17 BOLT TENSION DURING INITIAL TORQUING AND DURING THE TEST

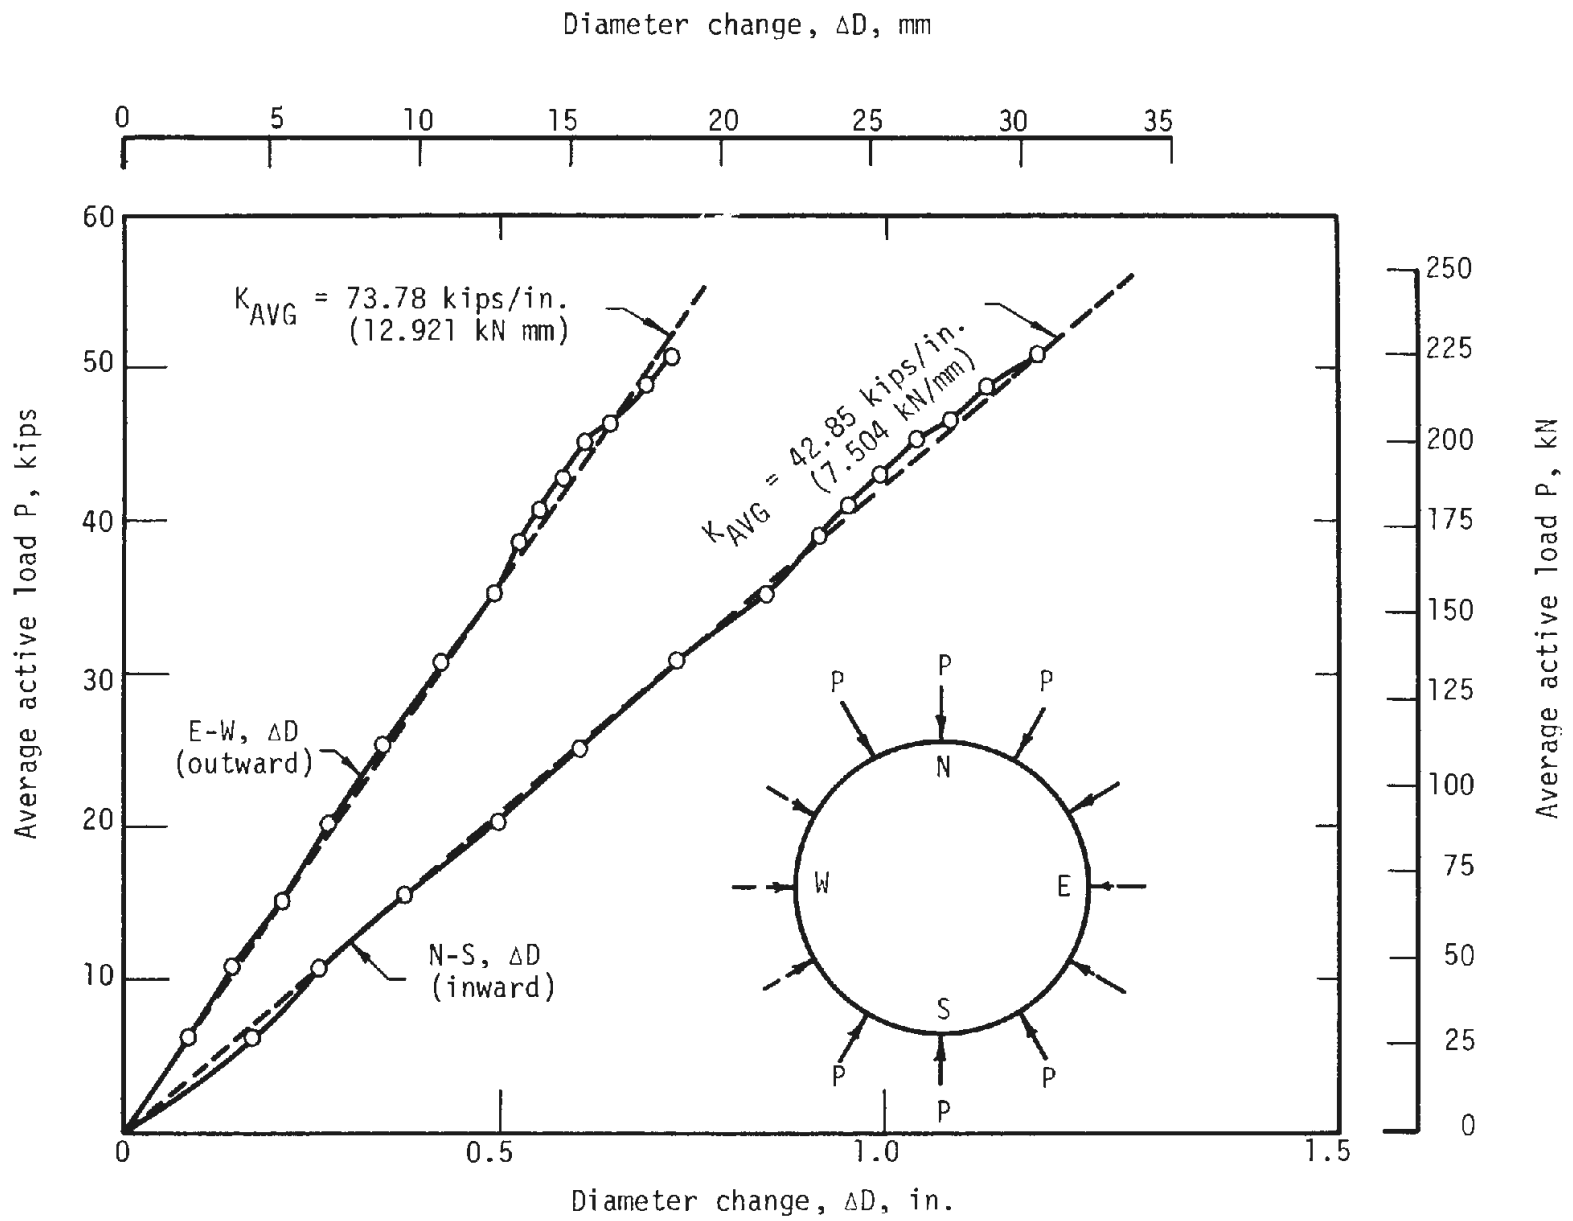
FIGURE 4.15 AVERAGE ACTIVE LOAD - DIAMETER CHANGE FOR TEST S2

Deformations associated with the application of active loads are a significant measure of overall structural response. Figures 4.14 to 4.16 show for each test the diameter change,  $\Delta D$ , in the north-south and east-west directions as the average active load  $P$  increased; the active stiffness is defined as  $P/\Delta l$ , as contrasted to the passive stiffness in Figs. 4.11 to 4.13 where the passive forces vs. one-half the corresponding diameter change are shown. Response up to failure was primarily linear, though in all cases there was some curvature of the north-south load-deformation curve near maximum load. This is most evident in test S3, though there

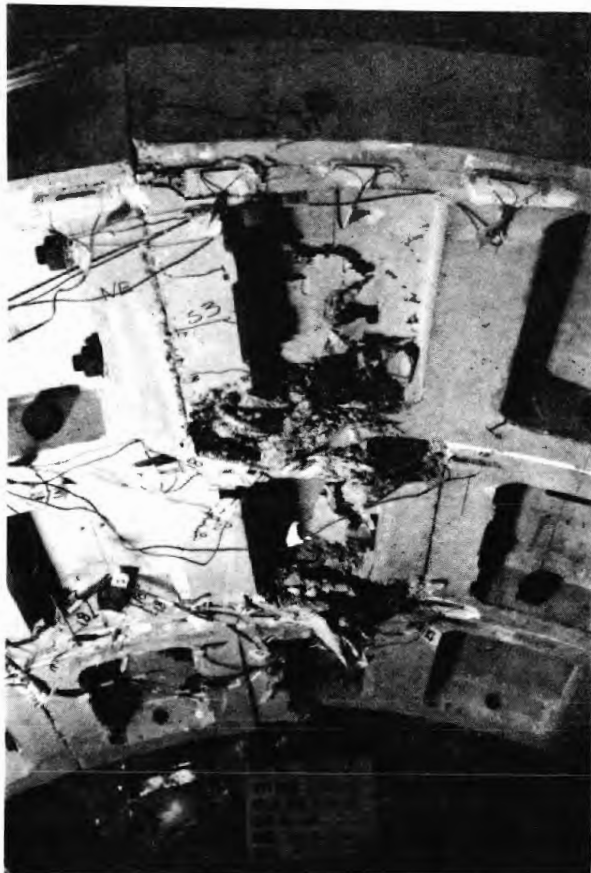
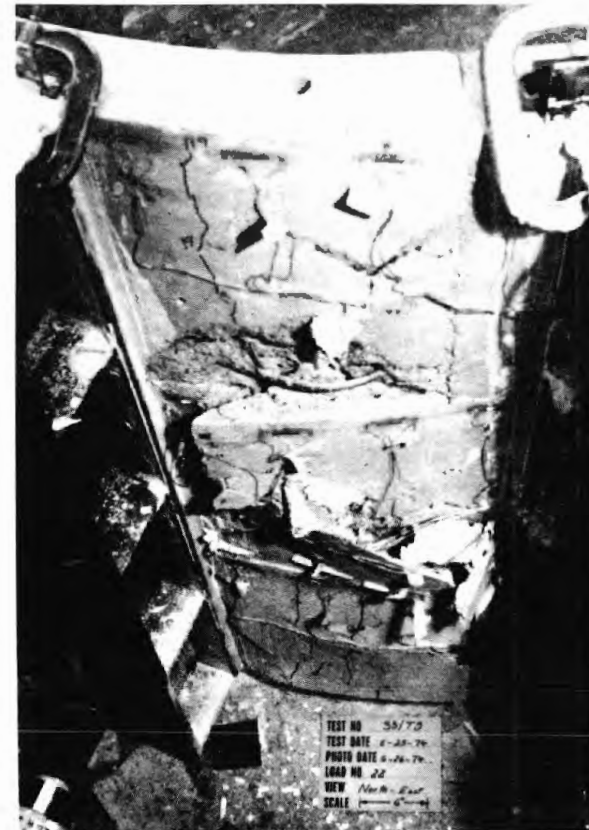
(a) View of failure from inside

(b) View of failure from outside

FIGURE 4.21 FAILURE REGION OF SPECIMEN S3

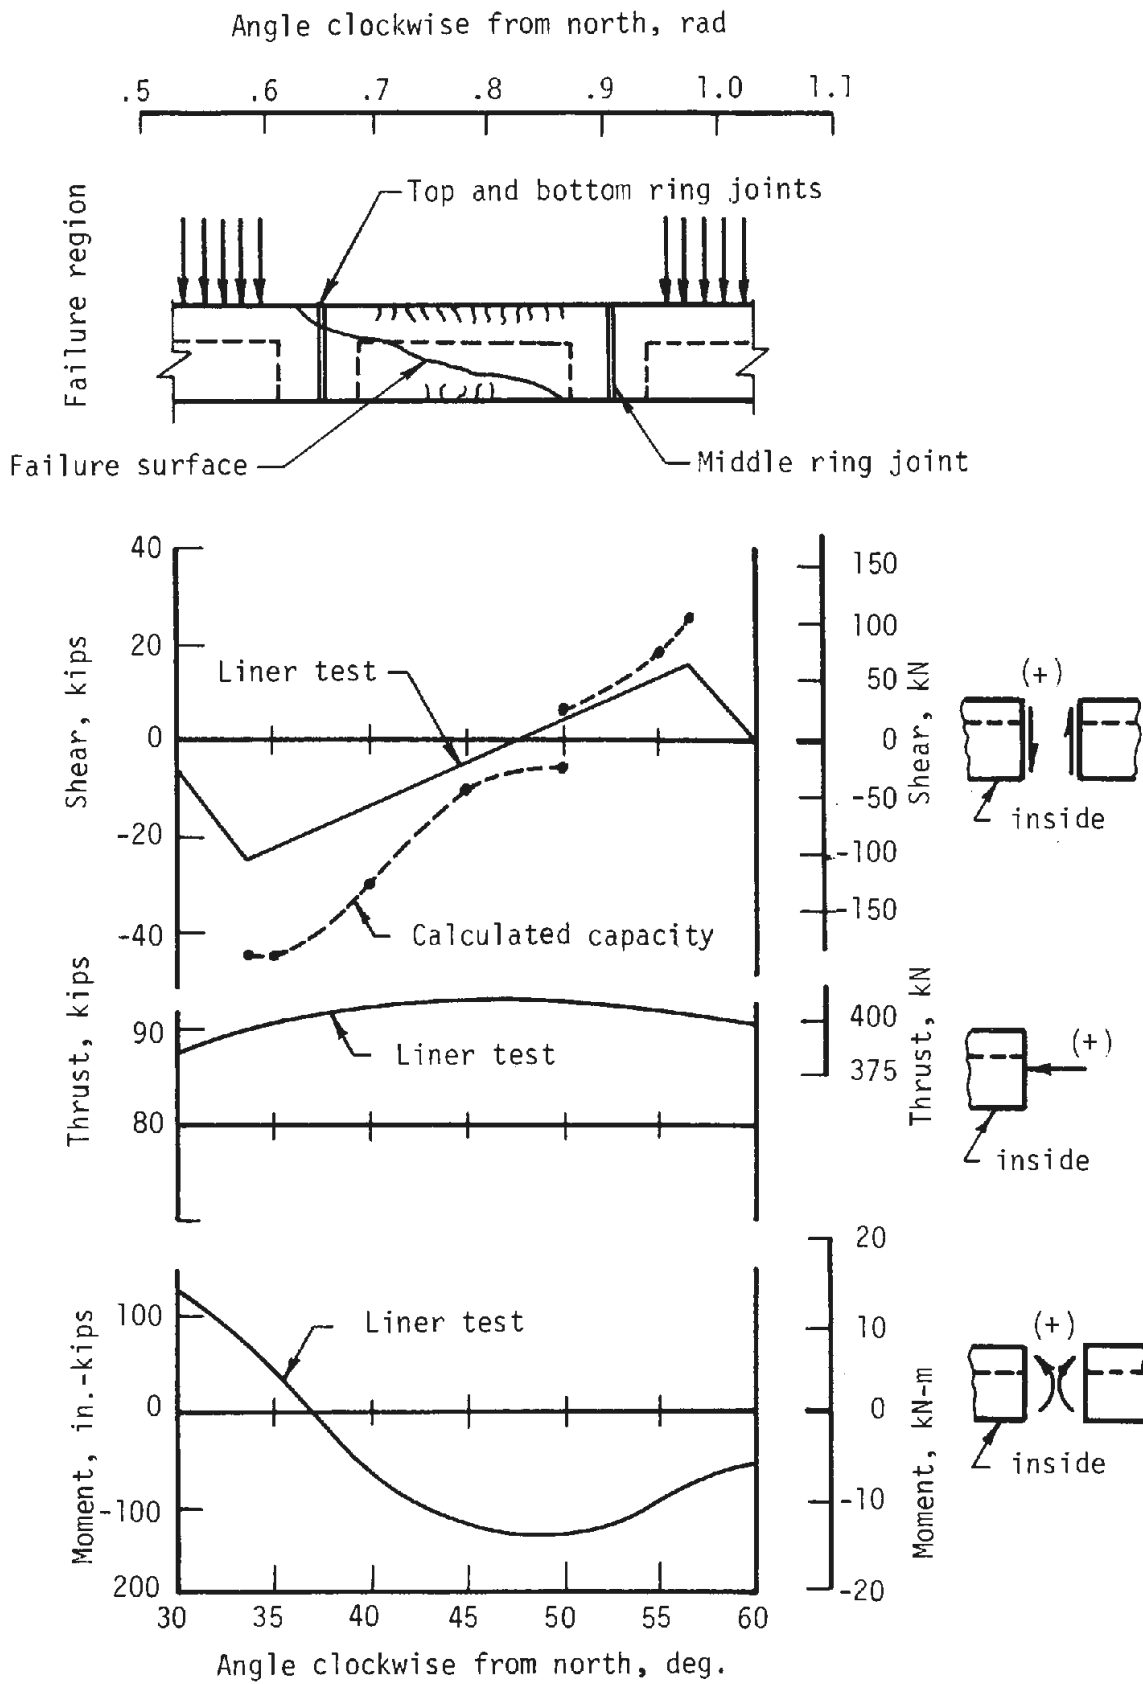
FIGURE 4.25 SHEAR, THRUST, AND MOMENT FOR THE FAILURE REGION AT MAXIMUM LOAD IN TEST S3

The internal thrust-moment paths for critical sections in specimens S2 and S3 are shown in Figs. 4.26 and 4.27. Also shown on these figures are the calculated failure envelopes for the segment section, and for the failure envelope from Chapter 3 for the joint when subjected to negative moment. For both tests the thrust-moment path is shown for the joint near the failure region and for the section of maximum moment shown on Figs. 4.24 and 4.25. These latter figures show the variation of the
