# SOAC

## STATE-OF-THE-ART CAR DEVELOPMENT PROGRAM

VOLUME 2:  
REPAIR, RE-TEST AND OPERATIONAL EVALUATION

**BOEING VERTOL COMPANY**  
(A Division of The Boeing Company)  
**Surface Transportation Systems**  
**Philadelphia, Pa. 19142**

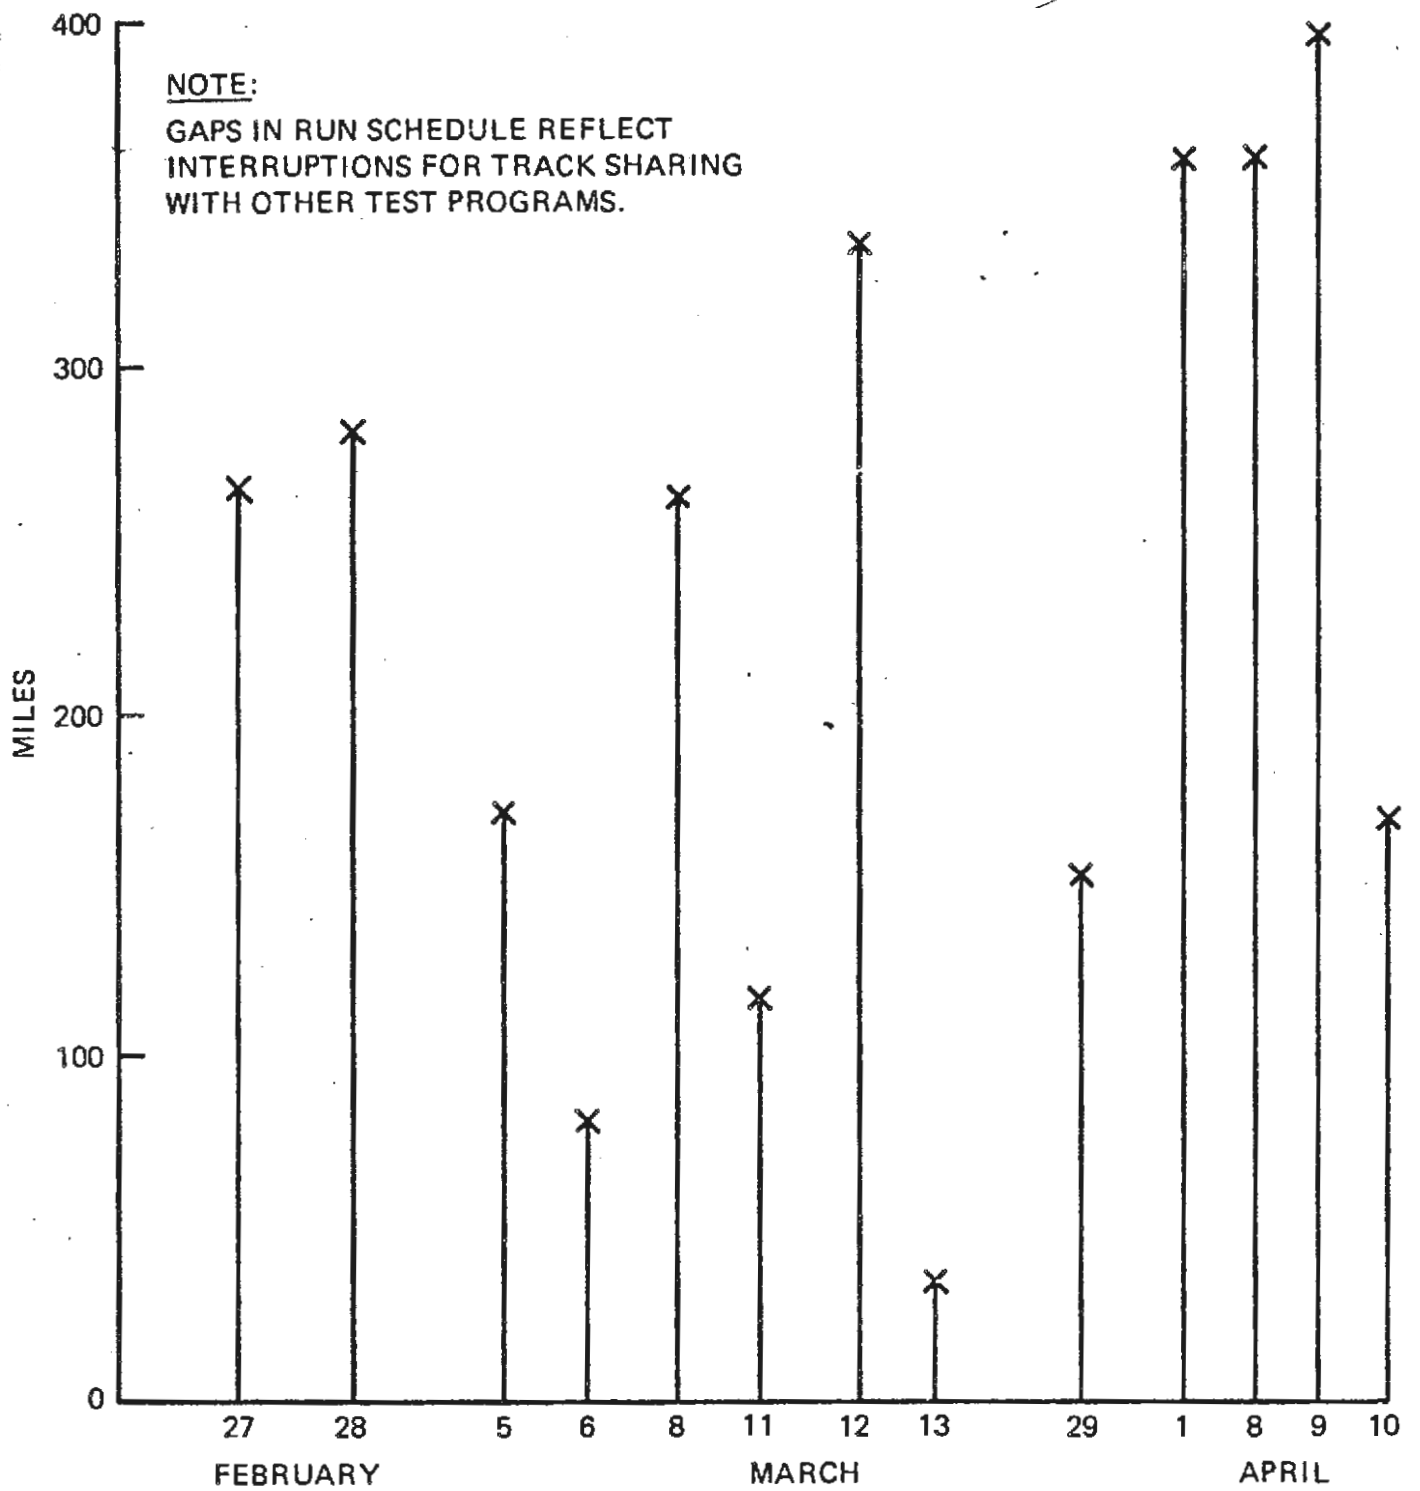
Figure 3-5. Daily Mileage Accumulation During Simulated Demonstration (February 27 to April 10, 1974)

The first phase of the simulated demonstration was conducted during the period between February 27 and March 13, 1974. Fifteen hundred and fifty-five (1555) miles were accumulated in eight days of testing (Figure 3-5). The only significant discrepancy encountered during this simulated revenue service testing was one case of high commutator bars causing broken brushes. This was corrected by grinding the commutator. Other discrepancies included replacement of one slip-slide circuit card, one B+ short to ground in the airflow sensor circuit, and one intermittent short in the P-wire cable. There was no measurable gearbox oil leakage.
