LORAN
AUTOMATIC VEHICLE MONITORING SYSTEM

PHASE I
FINAL REPORT

VOLUME I
TEST RESULTS

MARCH 1977

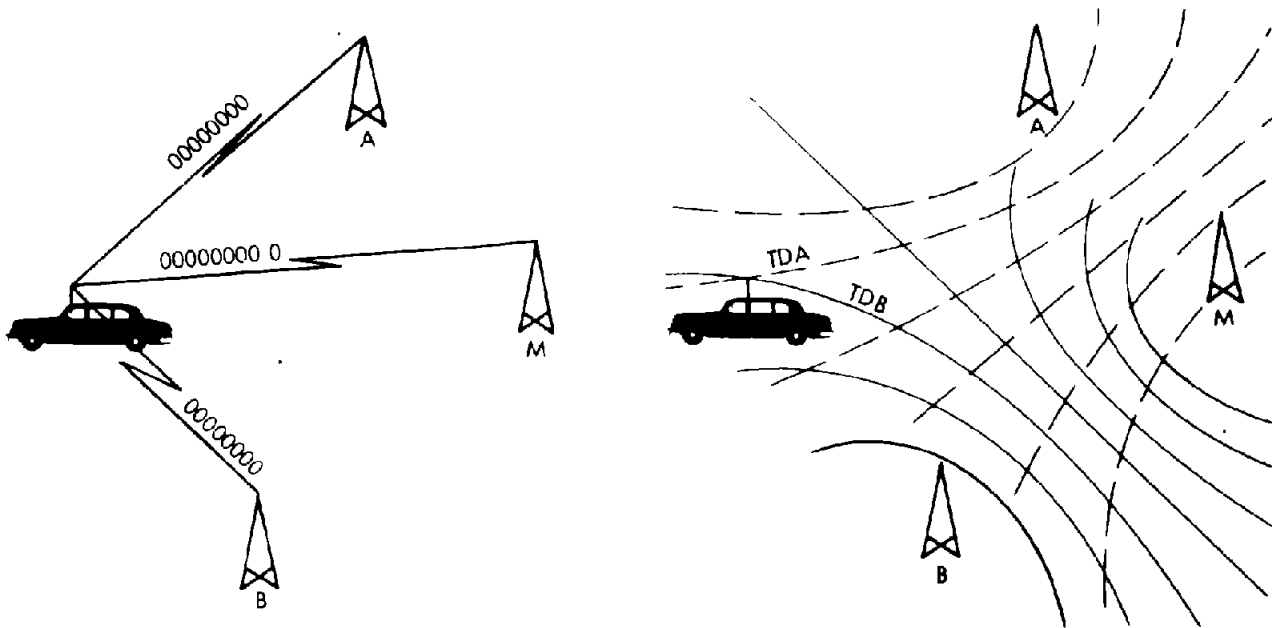
Figure 1-1. Hyperbolic Fix Geometry

These navigation systems operates on the principle that the difference in time of arrival of signals from two stations, observed at a point in the coverage area, is a measure of the difference in distance from the point of observation to each of the stations (See Figures 1-1 and 1-2). The locus of all points having the same observed difference in distance to a pair of stations is a hyperbola, called a line of position (LOP). The intersection of two or more LOP's defines the position of the observer. The accuracy of any hyperbolic navigation system depends on the observer's ability to measure the difference between the times of arrival of two signals (time difference, or TD), and his knowledge of the propagation conditions, so that the time difference can be converted to LOPs.

In identifying the proper frequency for a radio navigation system which will give wide coverage and high accuracy, various physical factors must be considered. The basic limitation on accuracy is the velocity of propagation of radio energy, approximately one foot per nanosecond (1 ft/nsec). Thus, for accuracies on the order of tens or hundreds of feet, measurements must be made to tens or hundreds

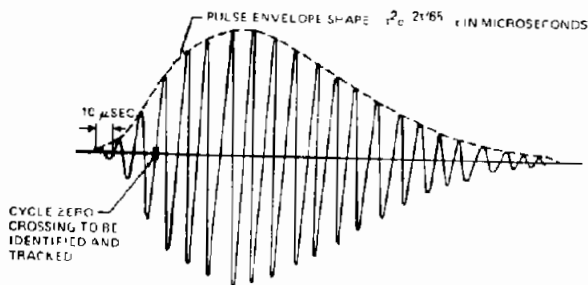
Figure 1-3. LORAN-C Pulse

The transmitting stations of a LORAN-C chain transmit groups of pulses at a specified group repetition interval (GRI). Each pulse has a 100 kHz carrier and is of the shape described in Figure 1-3. For each chain a minimum GRI is selected of sufficient length so that it contains time for transmission of the pulse group from each station (10,000 microseconds for the master and 8000 microseconds for each secondary) plus time between each pulse group so that signals from two

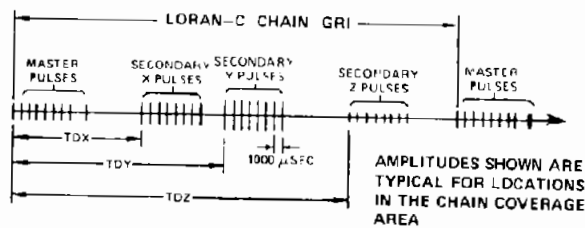
or more stations cannot overlap in time anywhere in the coverage area. (See Figure 1-4. Thus, with respect to the time of arrival of the master, a secondary station will delay its own transmissions for a specified time, called the secondary coding delay. The minimum GRI is therefore a direct function of the number of stations and the distance between them. A GRI for the chain is then selected so that adjacent chains do not cause mutual (cross-rate) interference. The GRI is defined to begin coincident with the start of the first pulse of the master group.

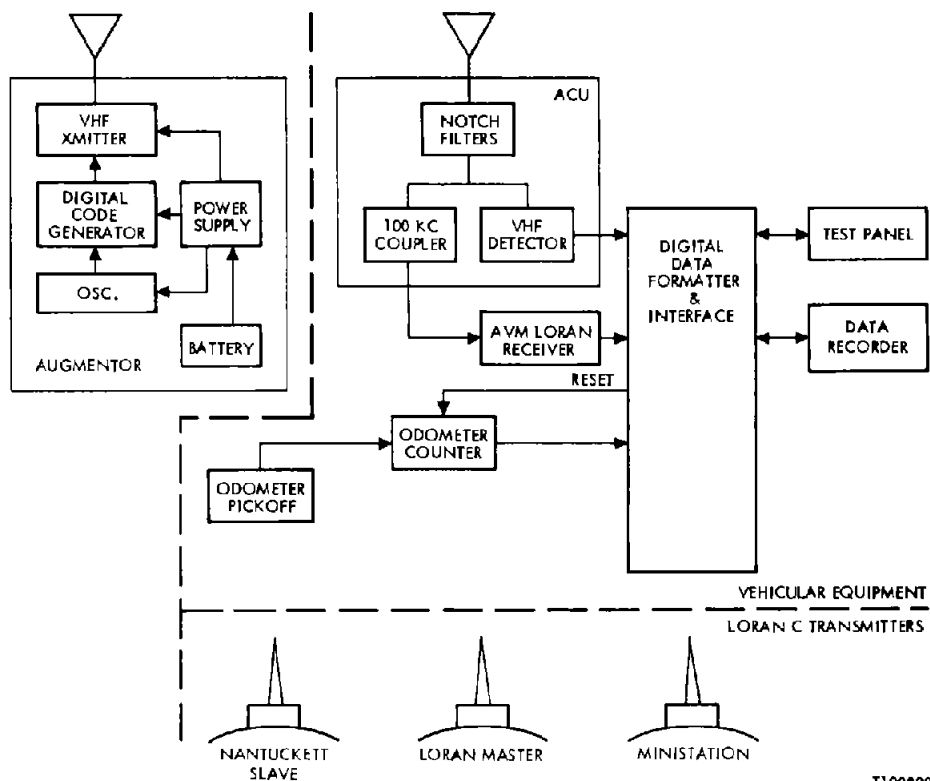
Figure 1-6. Location Subsystem

The LORAN AVM Location Subsystem consists of the vehicular and wayside equipment depicted in Figure 1-6. While there may be minor differences in some specific components as a function of the type of vehicle (for example, transit bus vs supervision auto), the rudiments of the location subsystem are identical in every instance. Augmentors were battery powered for Phase I.

The system is truly modular in that, to the basic LORAN location capability, it is possible to physically and functionally add auxiliary sensor components which enhance the overall system performance in direct proportion to their number. This feature also facilitates trouble-shooting, maintenance, and testing. The following detailed descriptions of each subsystem component is arranged in order of descending importance to location accuracy.

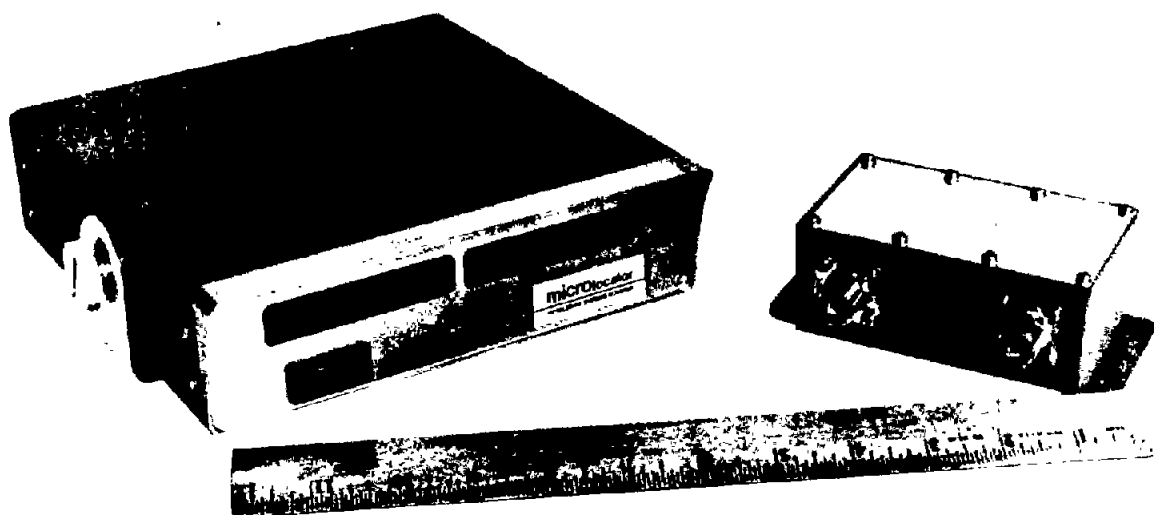
Figure 1-7. LORAN AVM Receiver

Indeed, careful consideration of the LORAN signal characteristics in urban areas has been maintained throughout the development program. Since AVM represents one of the largest volume applications of the new low cost receiver, the flexibility necessary to optimize receiver characteristics for AVM use has been built in. This has only been possible, of course, because of concurrent Teledyne AVM testing. Figure 1-7 is a photograph of the LORAN AVM receiver and the antenna coupler.

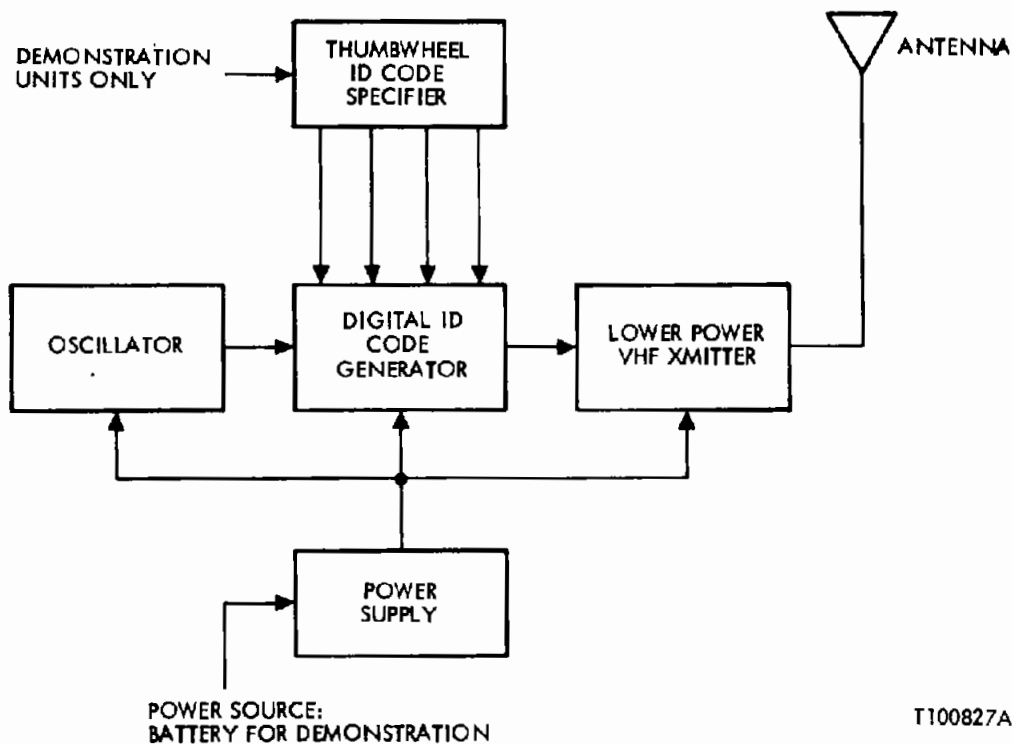
Figure 1-8. Block Diagram of Augmentor

1.3.1.3 Augmentor Device - The augmentor device which was demonstrated in Philadelphia was identical in function and operation to the production device for Phase II. A block diagram of the device is shown in Figure 1-8. The VHF transmitter is a low power, short range device. The remainder of the components are self explanatory except that the code specified in the code generator is in the

form of a time period between pulses instead of the more conventional binary or BCD number transmission. This simplifies the vehicle and augmentor device hardware and increases reliability. More detailed information on the LORAN C navigation system is included in Section 2.

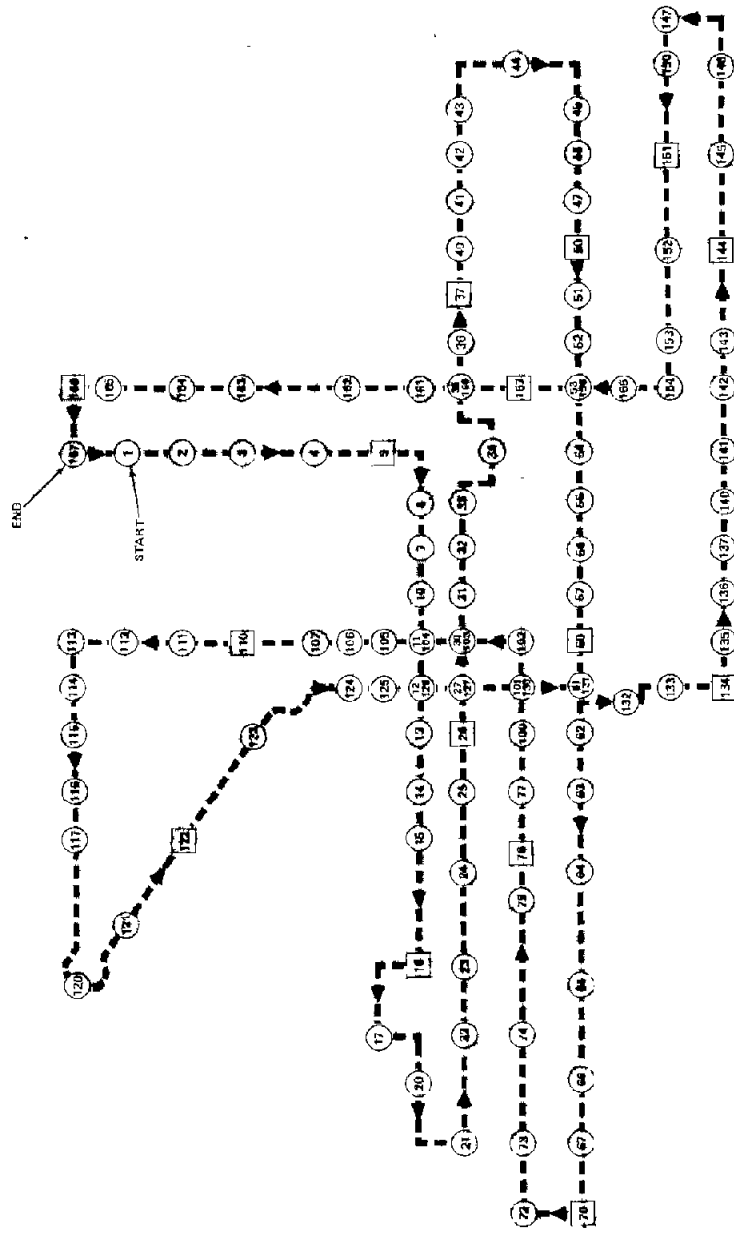
Figure 1-9. Revised Fixed Route Test

LEGEND
 □ TIMEPOINT
 ○ CHECKPOINT
 - - - PATH

Fixed route tests began on December 6, 1976. A route was laid out which traversed all types of urban environment from dense high rise to low rise residential. The original route contained 105 checkpoints and 12 time points. The test vehicle traversed the route with checkpoint or timepoint passage denoted by the operator pressing a test console button which in turn set a flag in the data marking the true vehicle location. Data was continuously recorded at one second intervals on magnetic tape. Each data record included LORAN time difference A & B, system odometer, 5th wheel odometer, checkpoint ID, test number, ID number of the last detected augmentor, various flags denoting checkpoint passage, LORAN signal quality, and augmentor detection.

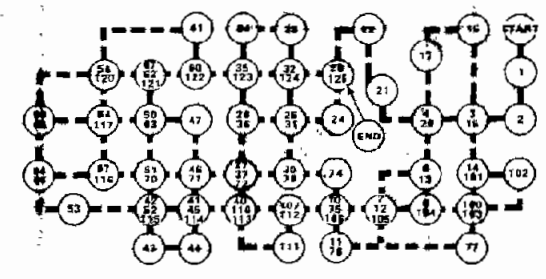
Figure 1-10. Random Route Test

LEGEND
○ CHECKPOINTS - SEQUENTIALLY NUMBERED (OCTAL)
- - - PATH

Random route tests were conducted on February 8. The test process was identical to the fixed route tests except there were no time points and the route was not known in advance. Figure 1-10 shows the random route tests.

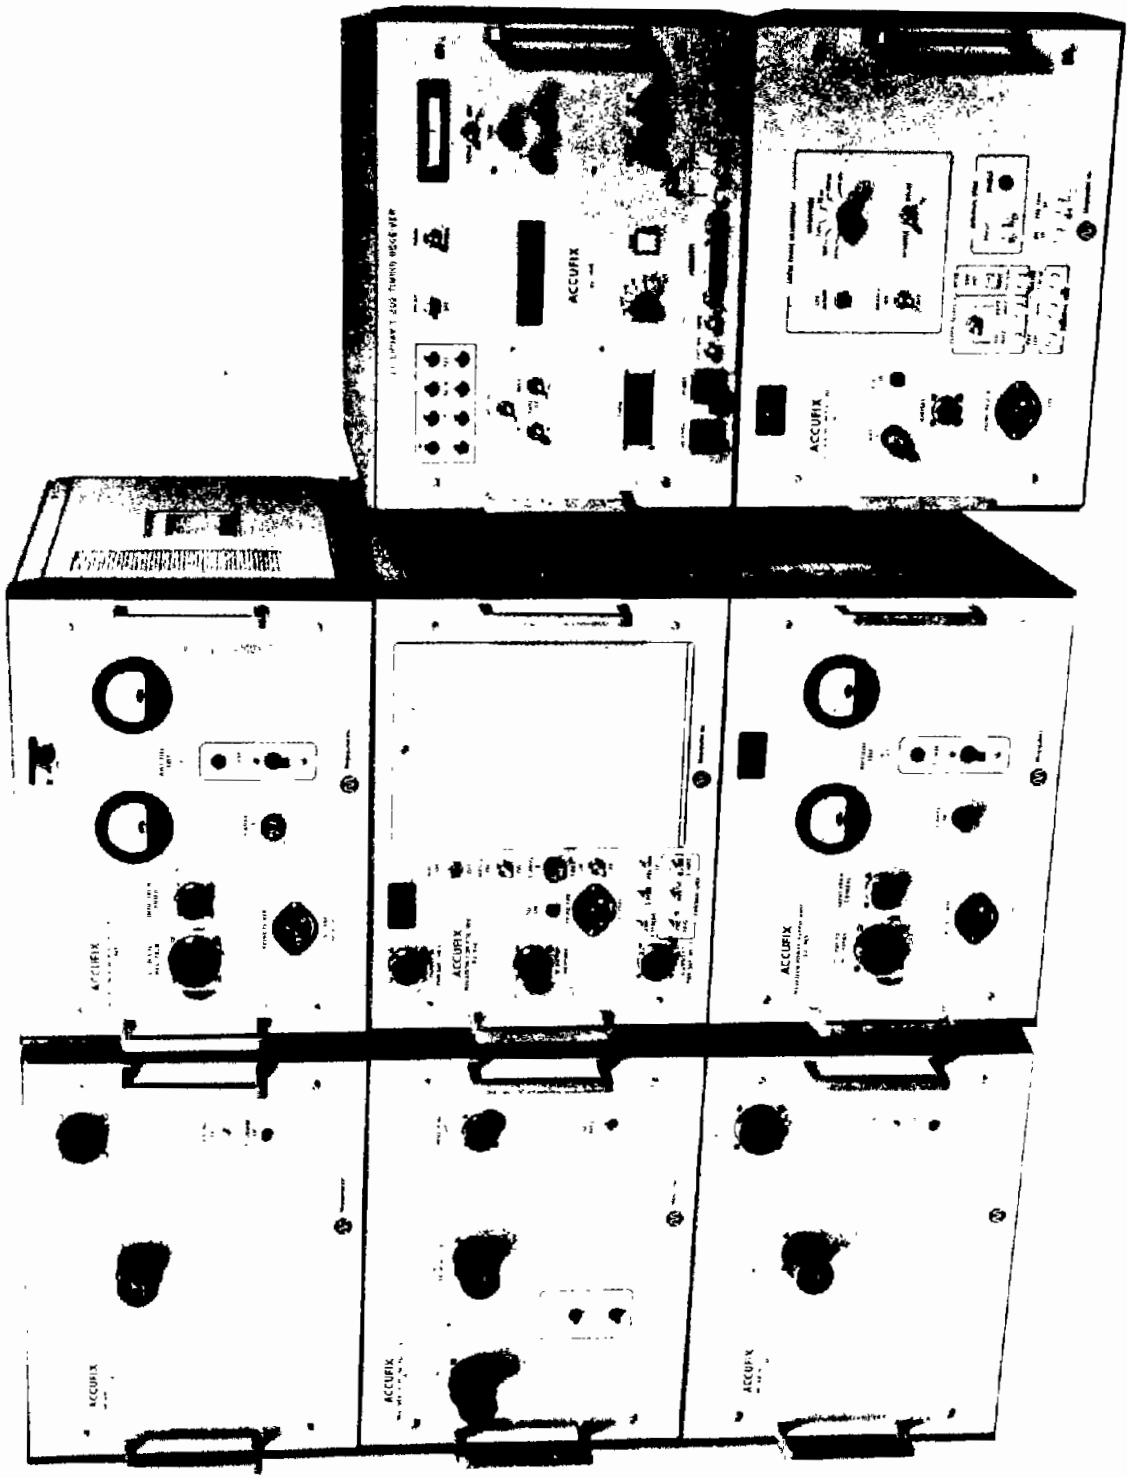
Figure 1-15. LORAN-C Mini Station

Support equipment consisted of a mini LORAN-C station installed in Limerick township and a monitor station installed in the Marriott Hotel. The ministation (shown in Figure 1-15) was used in conjunction with the East Coast LORAN-C chain to provide adequate LORAN signal coverage and the monitor station provides a hard copy strip chart recording of time difference stability during testing.

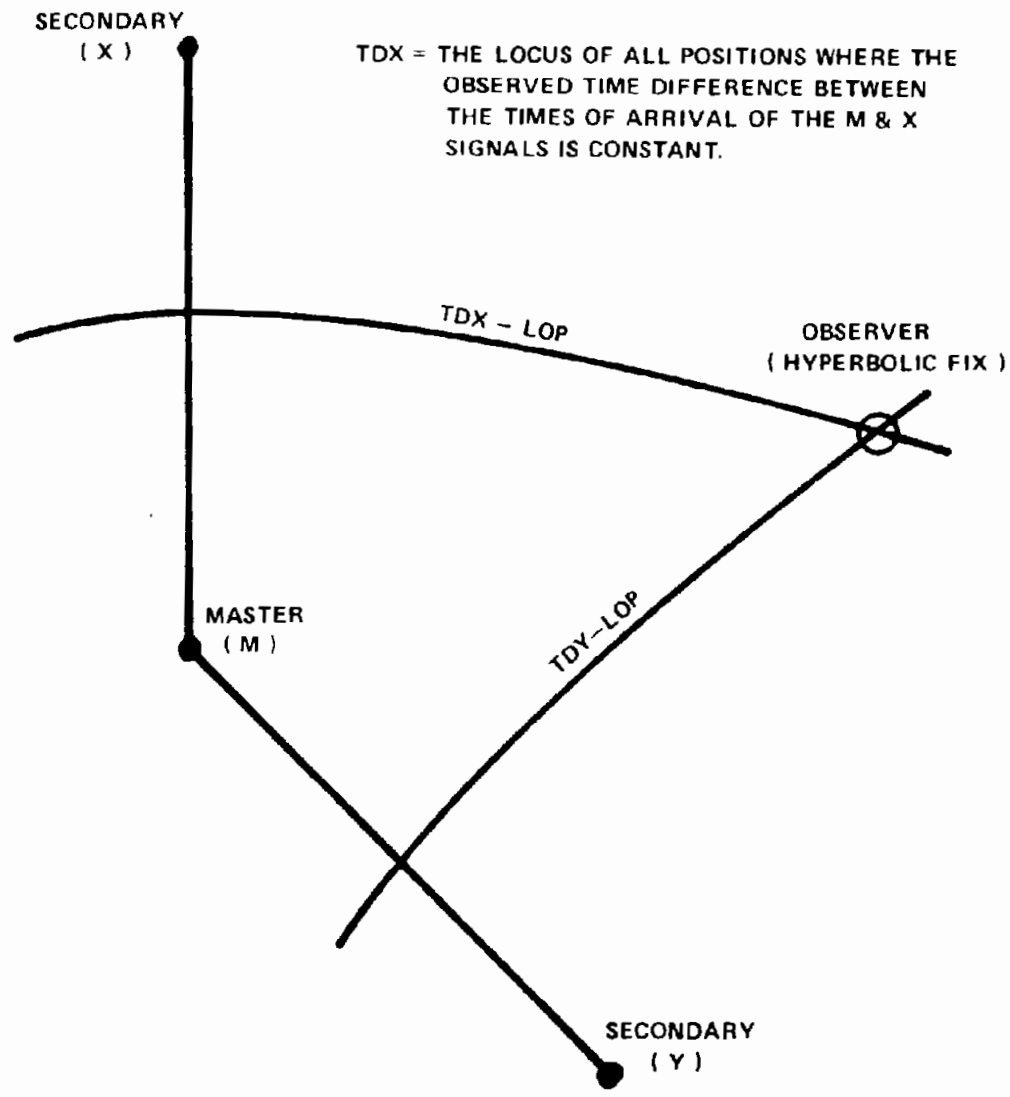
Figure 2-2. Hyperbolic Fix Geometry

Hyperbolic radio aids-to-navigation operate on the principle that the difference of time of arrival of signals from two stations, observed at a point in the coverage area, is a measure of the difference in distance from the point of observation to each of the stations (see Figure 2-2). The locus of all points having the same observed difference in distance to a pair of stations is a hyperbola and is a line of position (LOP). The intersection of two or more LOP's defines the position of the observer. The accuracy of hyperbolic radio aids-to-navigation depends on the observer's ability to measure the difference between the times of arrival of two signals (time difference or TD) and his knowledge of the propagation conditions so that the time differences can be converted to LOP's.

In identifying the proper frequency for a radio navigation system which will give wide coverage and high accuracy, various physical factors must be considered. The basic limitation on accuracy is the velocity of propagation of radio energy, approximately one foot per nanosecond (1 ft/ns). Thus for accuracies on the order of tens or hundreds of feet, measurements must be made to tens or hundreds of nanoseconds. Also the propagation conditions must be reliably predictable (mathematically or from survey) to tens or hundreds of nanoseconds.

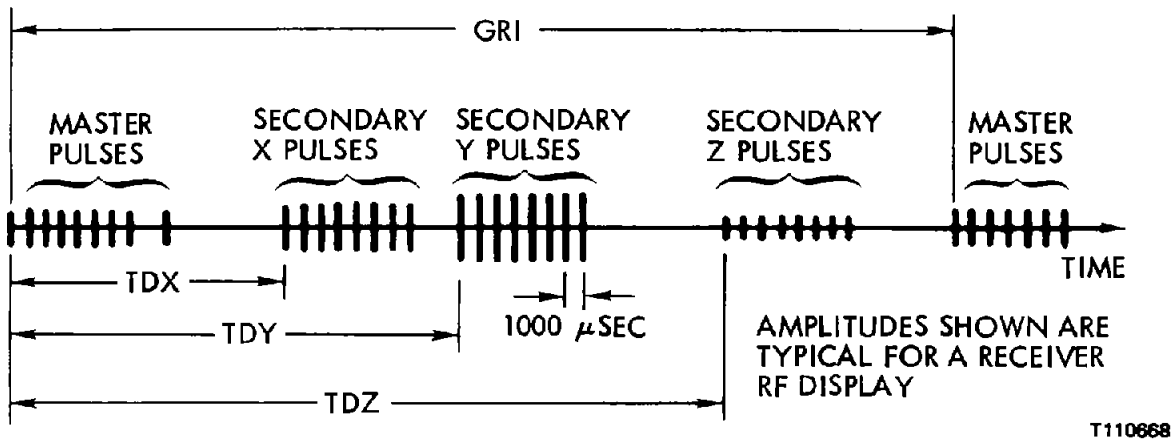
Figure 2-3a. Example of Received LORAN-C Signal

The transmitting stations of a LORAN-C chain transmit groups of pulses at a specified group repetition interval (GRI) (see Figure 2-3a). For each chain a minimum GRI is selected of sufficient length so that it contains time for transmission of the pulse group from each station (10 milliseconds for the master and 8 milliseconds for each secondary) plus time between each pulse group so that signals from 2 or more stations cannot overlap in time anywhere in the coverage area. The minimum GRI is therefore a direct function of the number of stations and the distance between them. A GRI for the chain is then selected so that adjacent chains do not cause mutual (cross-rate) interference. The GRI is defined to begin coincident with the start of the first pulse of the master group.

LORAN-C pulses and pulse groups: Each station transmits one pulse group per GRI. The master pulse group consists of eight pulses spaced 1000 microseconds apart, and a ninth pulse 2000 microseconds after the eighth. Secondary pulse

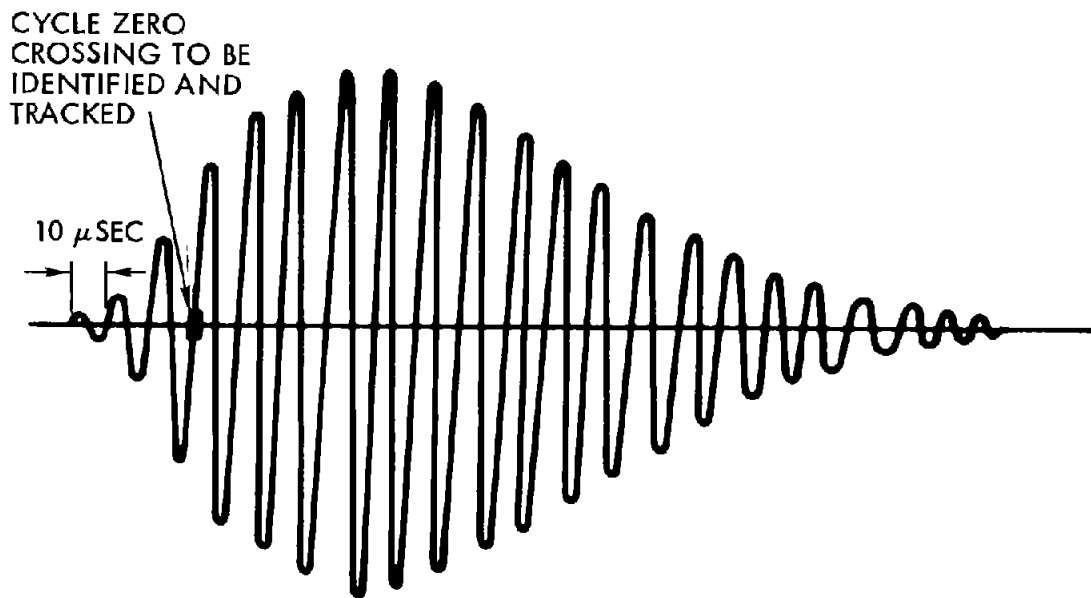
Figure 2-3b. LORAN-C Signal Format

groups contain eight pulses spaced 1000 microseconds apart. Eight pulses, rather than one, are used so that more signal energy is available at the receiver, improving significantly the signal to noise ratio without having to increase the peak transmitted power capability of the transmitters. The master's ninth pulse is used for visual identification of the master and for blink. Blink is accomplished by turning the ninth pulse on and off in a specified code. The secondary station of the unusable pair also blinks by turning its first two pulses on and off.

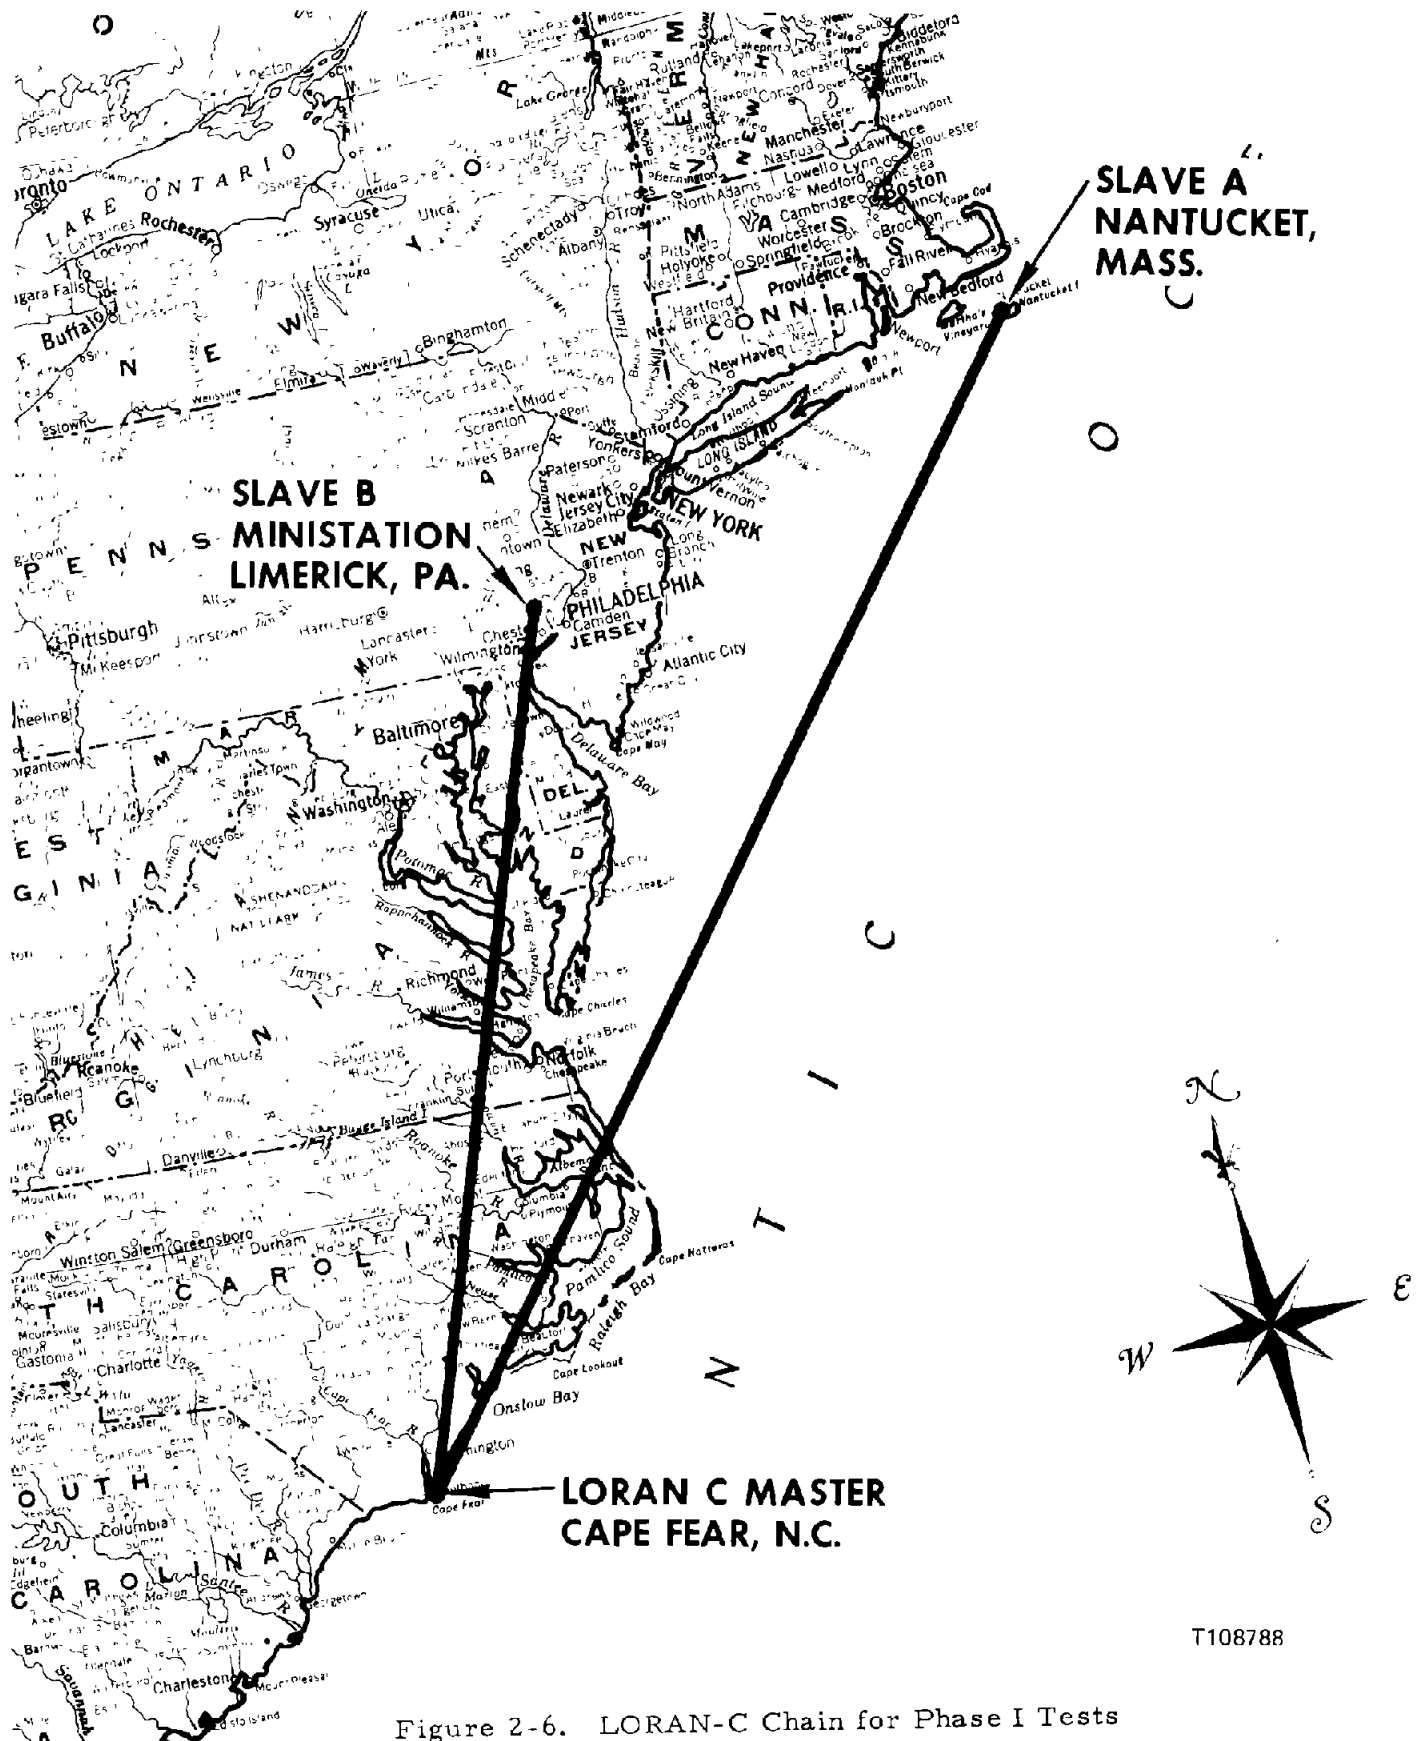
Figure 2-6. LORAN-C Chain for Phase I Tests

equipment is described in detail in Section 3. U.S. East Coast Stations used were the master at Cape Fear, North Carolina and the slave at Nantucket Island, Massachusetts. Figure 2-6 shows these stations and the chain geometry.

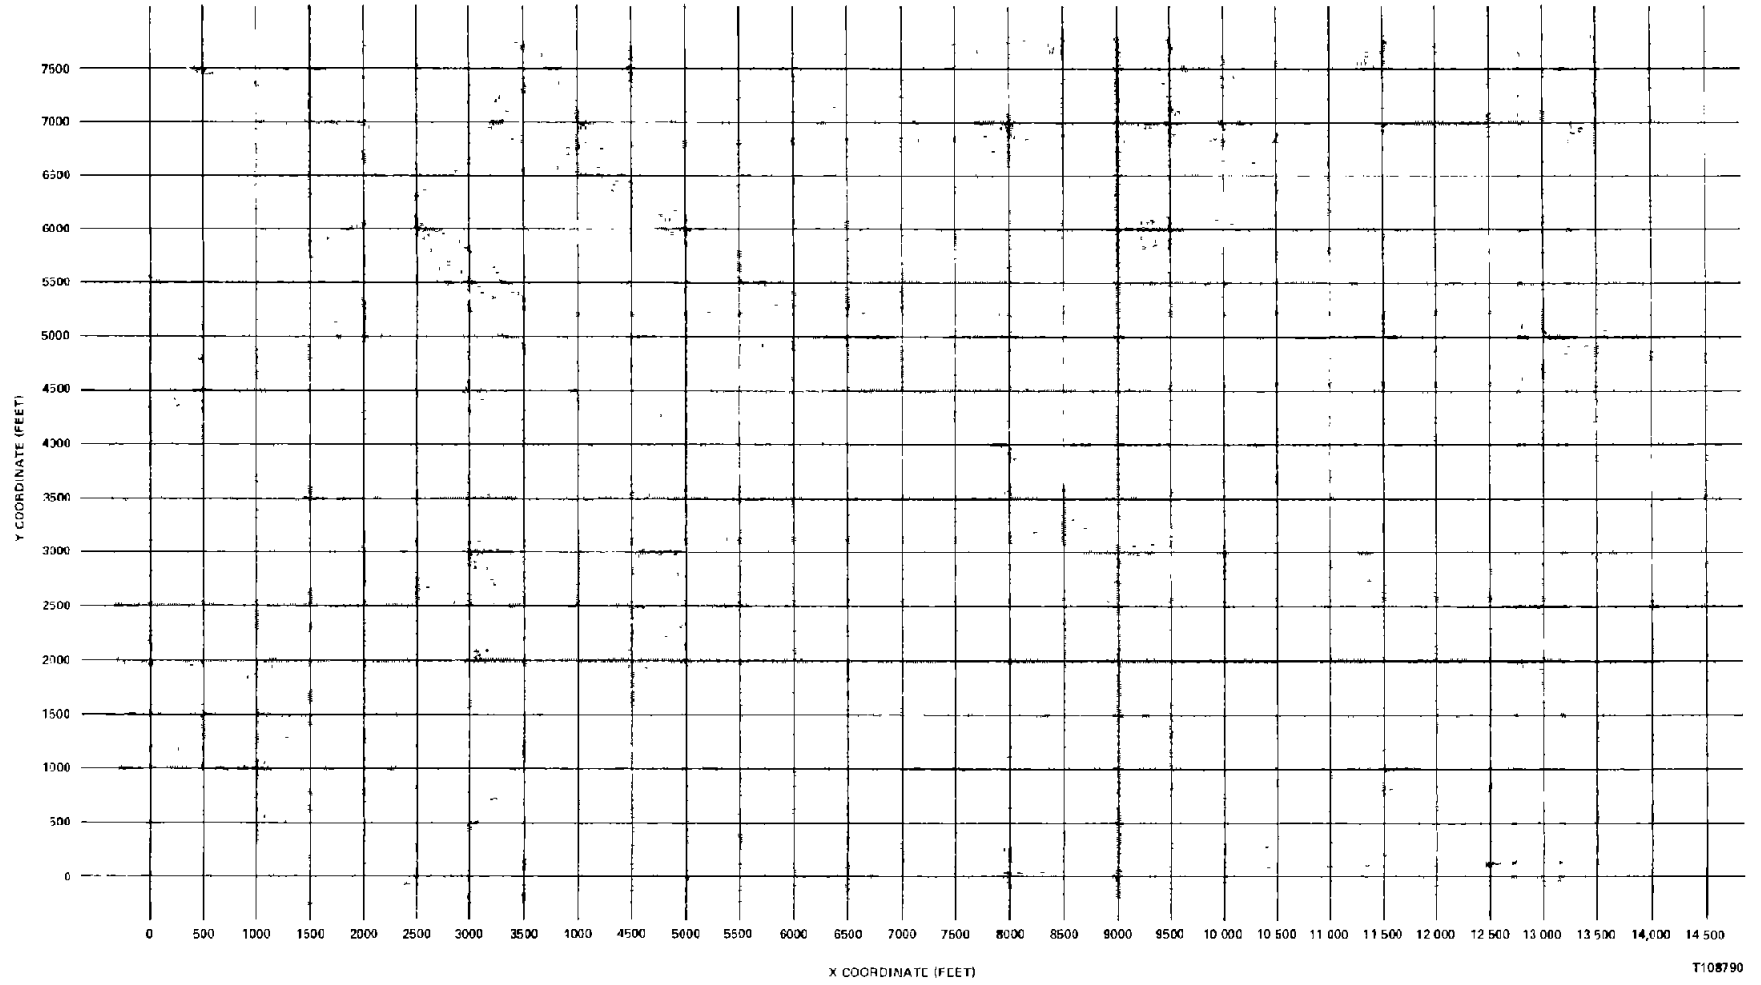
Figure 2-7. Philadelphia Test Area and X-Y Grid Overlays

To facilitate the location accuracy calculations, an X-Y grid overlay was used. Figure 2-7 shows the test area with the grid overlay. As can be seen, the grid was 7,500 feet by 14,500 feet. This grid provided a means of establishing true location coordinates for all calibration points, check points, and time points.

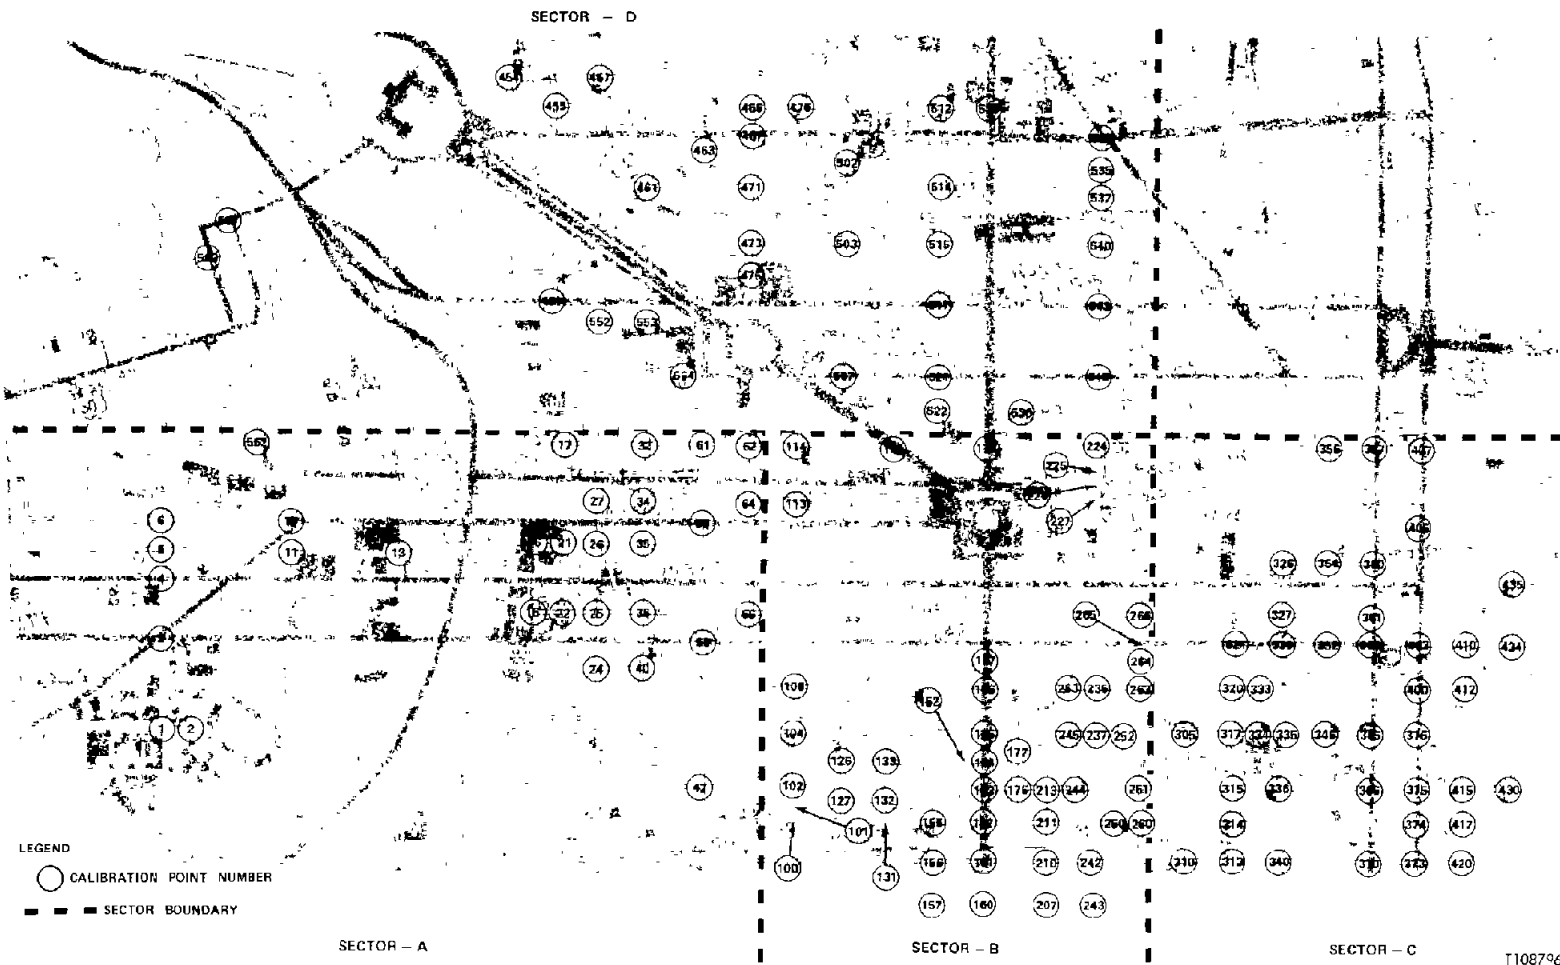
Figure 2-8. Test Area and Calibration Points

X-Y location computed, and a radial error calculated. In a perfect LORAN environment, four calibration points will suffice. Perfect LORAN implies a regular TD gradient over the entire test area which is seldom the case in urban locations. Anomalies or distortion of the LOP's require additional calibration points in and around the anomaly. In the Philadelphia area, anomalies are common and sometimes severe. To compensate for the distorted grid many times more calibration points are required. The calibration task is further complicated by the fact that TD anomalies are most prevalent in areas which suffer from high signal attenuation due to tall buildings and narrow streets. Often no LORAN measurements are possible in such areas. Those portions of the test area which cannot be adequately calibrated are abandoned in a LORAN sense. Augmentors are installed to provide 100% location coverage in and around the no LORAN coverage area. Fixed route tests lend themselves nicely to such straight forward augmentor deployment. Random route tests are more difficult, usually resulting in a larger quantity of augmentors.

The calibration data was recorded starting on October 12, 1976 and completed November 2, 1976. Over 395 locations were calibrated on 19 magnetic data tapes. Test numbers used on calibration tapes are shown in the table below:

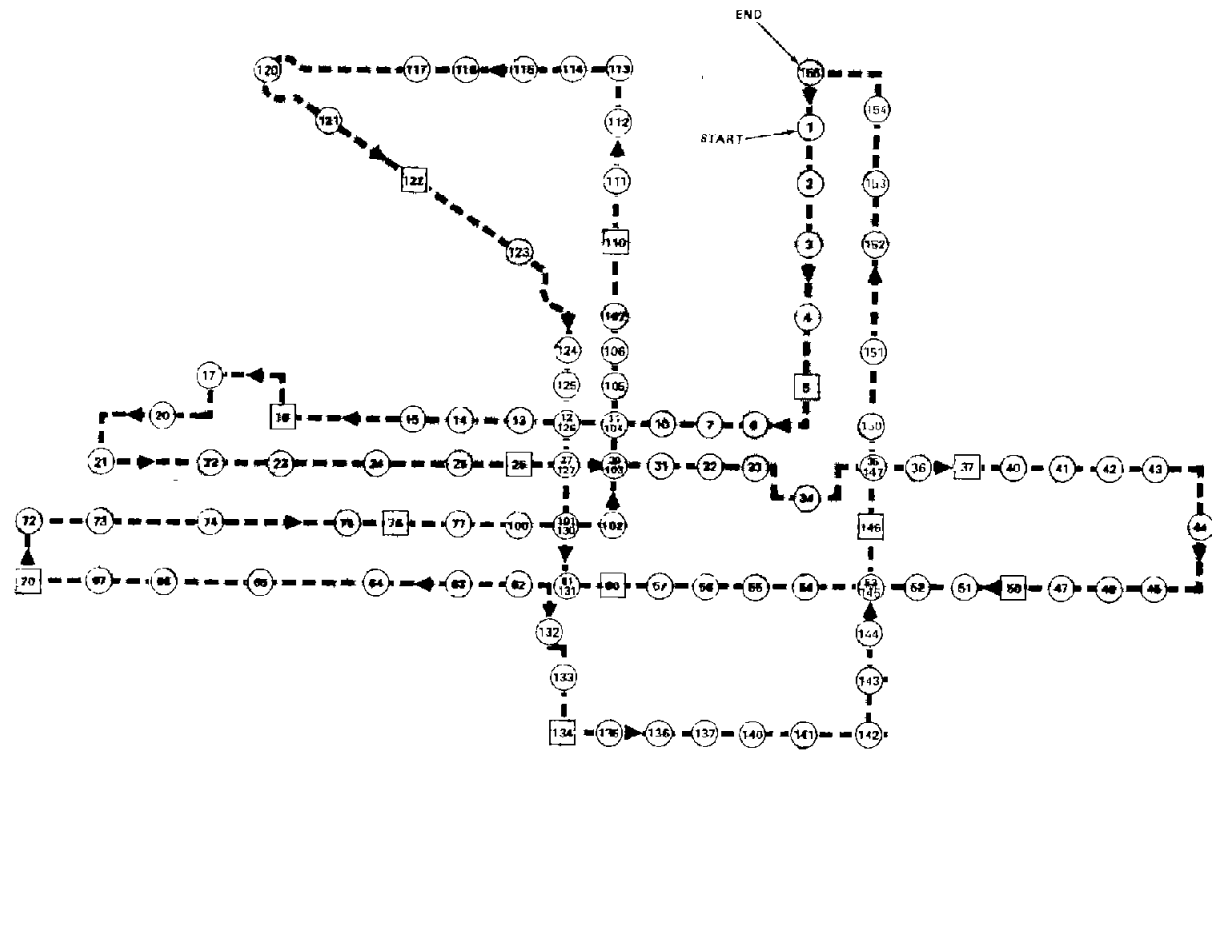
Figure 2-9. Fixed Route Test - Original

The fixed route (including checkpoints and timepoints) used for test numbers 10001 thru 10012 in December 1976 is shown in Figure 2-9. The extended fixed route used for test numbers 10012 to 10047 in February 1977 is shown in Figure 2-10. Likewise, Figure 2-11 shows the placement of augmentors for runs 10001 thru 10012, and Figure 2-12 shows those for runs 10012 thru 10047. Appendix C to the report contains the detailed coordinate locations at intersections for each augmentor used in the test.

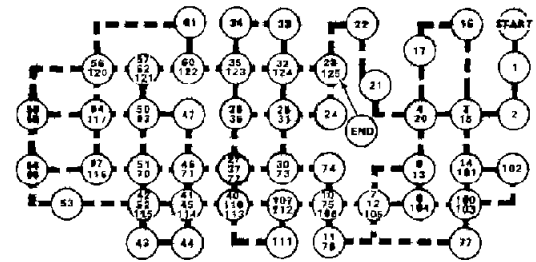
Figure 2-13. Random Route Test

The random route test was conducted in a manner very similar to the fixed route test with some exceptions: There were no time points and the route was not known in advance. At designated checkpoints the 'enter' button was pushed which set the data flag used by the software as the signal to process position. Figure 2-13 shows the random route test area with the route driven and checkpoints. Figure 2-14 shows the Augmentor locations in the Random Route Area.

LEGEND
○ CHECKPOINTS - SEQUENTIALLY NUMBERED (OCTAL)
--- PATH

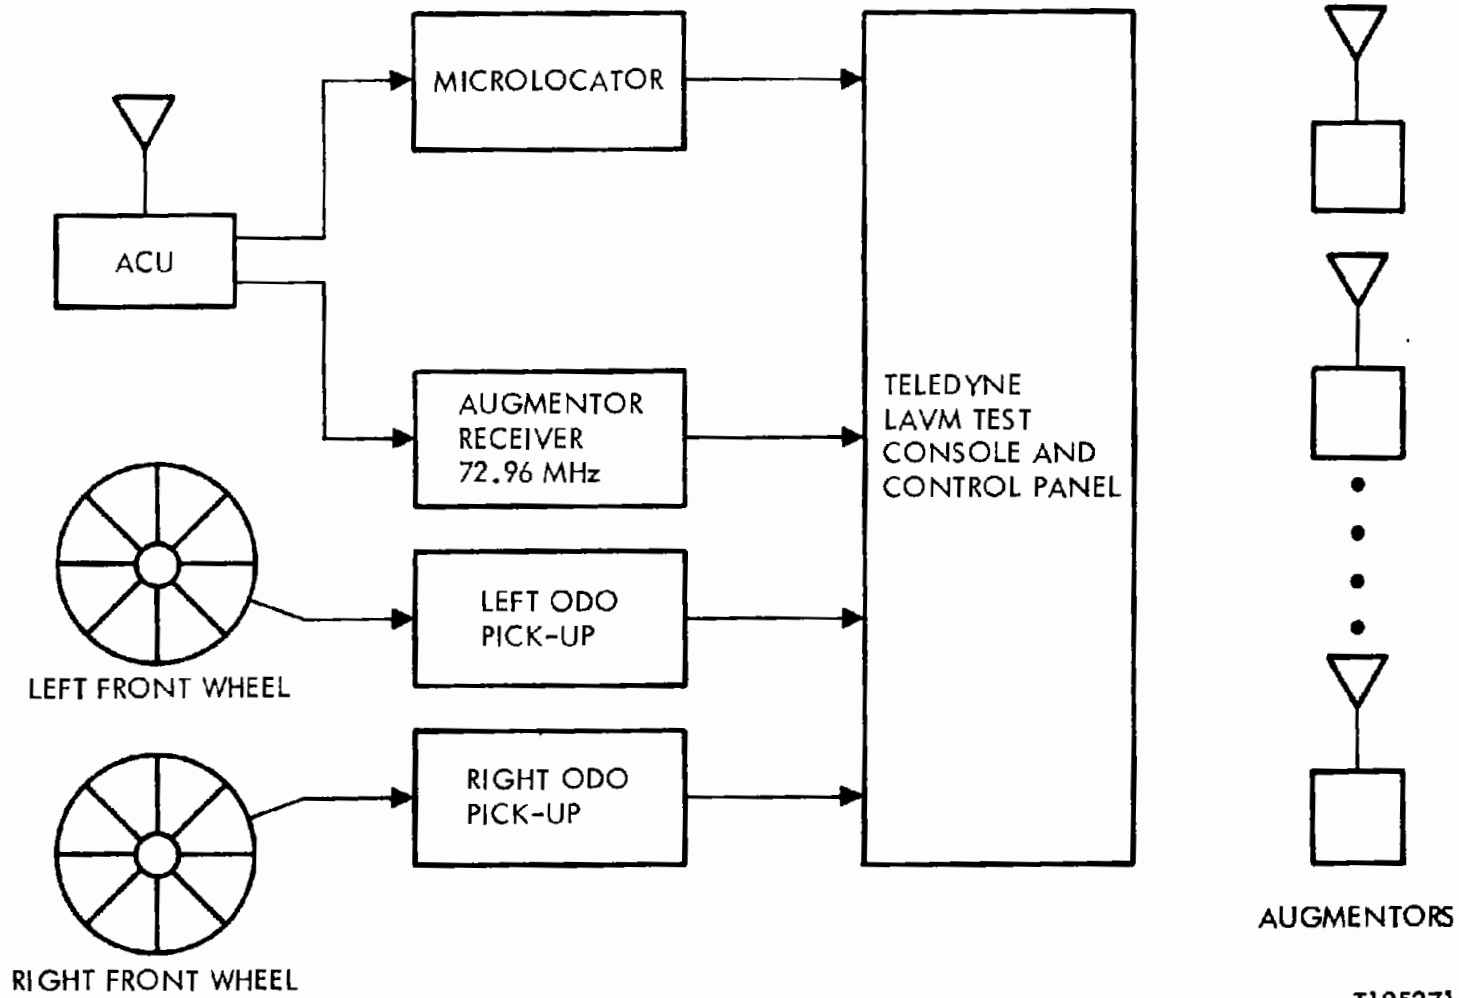
Figure 3-1. Block Diagram - LAVM Equipment

3.2.1.3 Left, Right Odometer Pickup - The odometers are hall effect proximity sensors permanently installed on the test vehicle. One device was installed near each front wheel. They sense proximity to 10 magnets which were installed on the inside of each wheel. Wheel rotation causes outputs which can be counted in the LAVM equipment and used to determine distance traveled.

3.2.1.4 Augmentor Receiver - The augmentor receiver is a circuit for detecting and demodulating the 72.96 MHz signal generated by the augmentor.

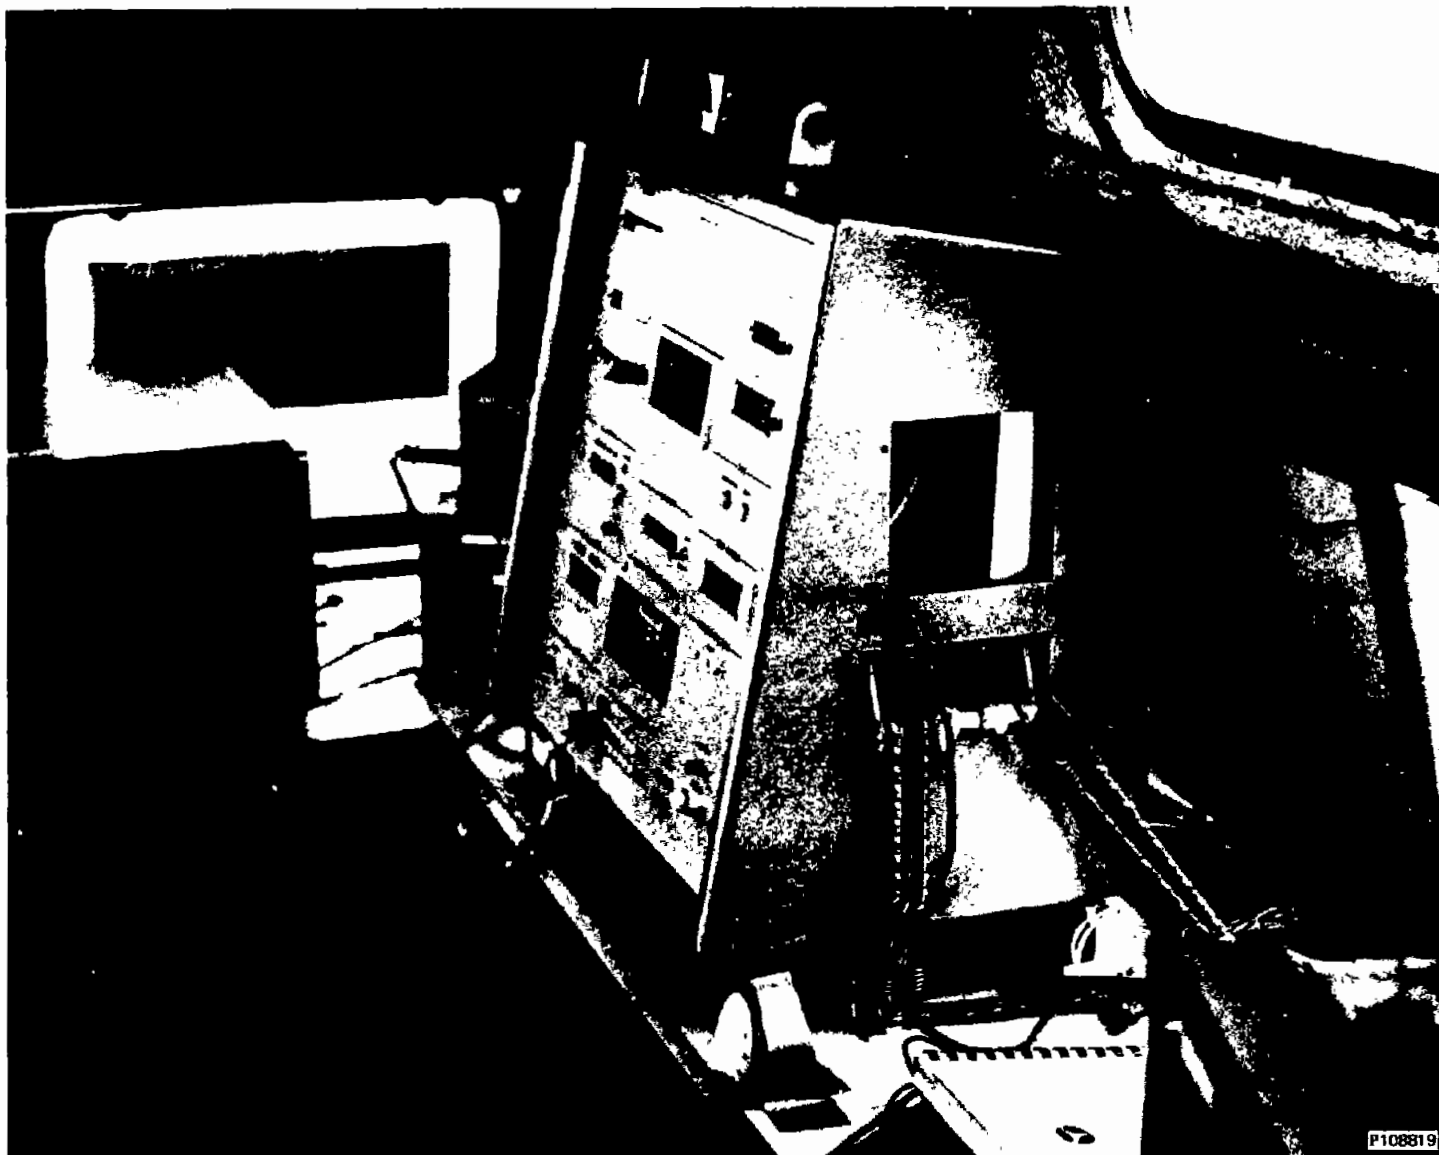
Figure 3-2. Micro-Locator LORAN Receiver and Test Console

3.2.1.1 Microlocator - The microlocator is the basic LORAN receiver which measures time-of-arrival of three (or more) LORAN C signals and outputs exact time differences used in the position location process. This receiver is the most modern available today and includes features specifically included to enhance its operation in the urban environment. Small size and low power have been achieved thru extensive application of the latest custom MOS/LSI integrated circuit and mini-processor technology. The Microlocator is shown atop the test console in Figure 3-2.

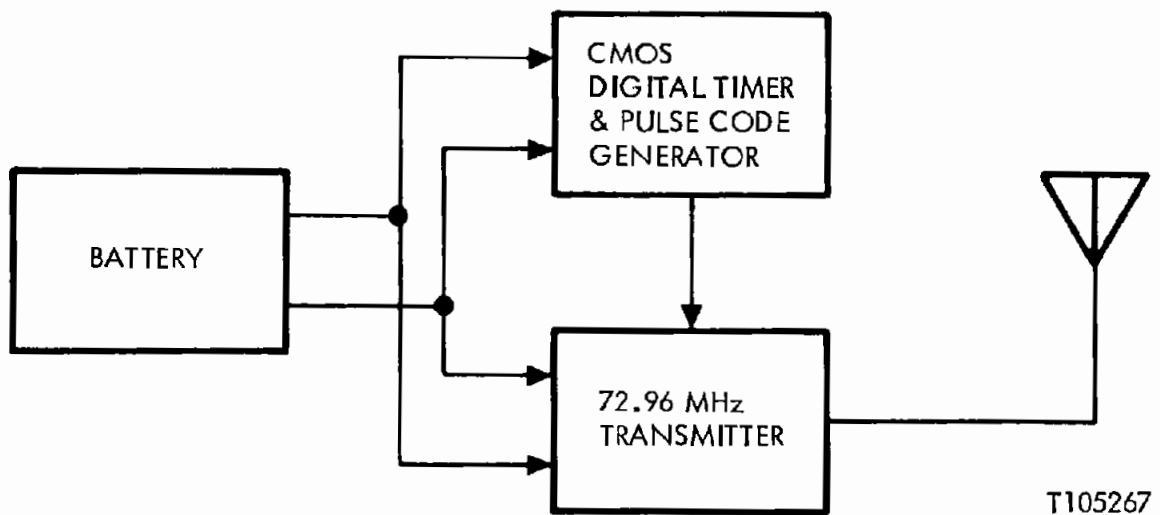
Figure 3-3. Block Diagram - Augmentor

3.2.1.5 Augmentors - Augmentors are wayside devices which emit a pulse-coded 72.96 MHz carrier with a range of from 50 to 75 feet. The devices tested in Philadelphia were battery powered. Figure 3-3 is a block diagram of a typical augmentor.
