LORAN
AUTOMATIC VEHICLE MONITORING SYSTEM

PHASE I
FINAL REPORT

VOLUME I
TEST RESULTS

MARCH 1977

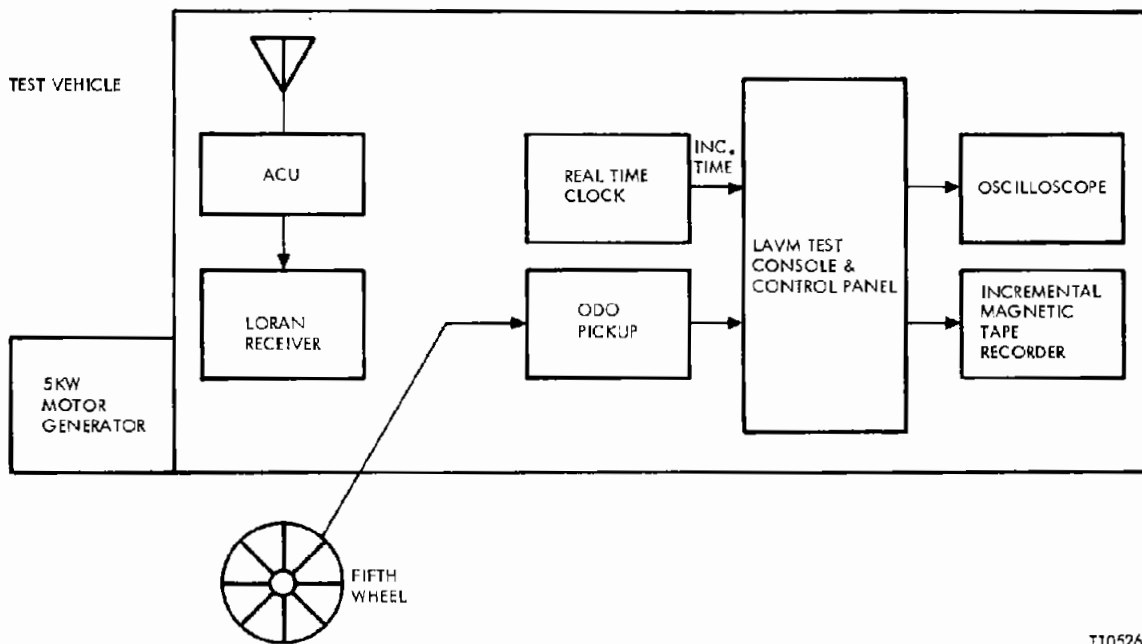
Figure 3-4. Test Instrumentation Equipment Block Diagram

Figure 3-4 is a block diagram of the test instrumentation equipment. A brief description of each element is presented here.

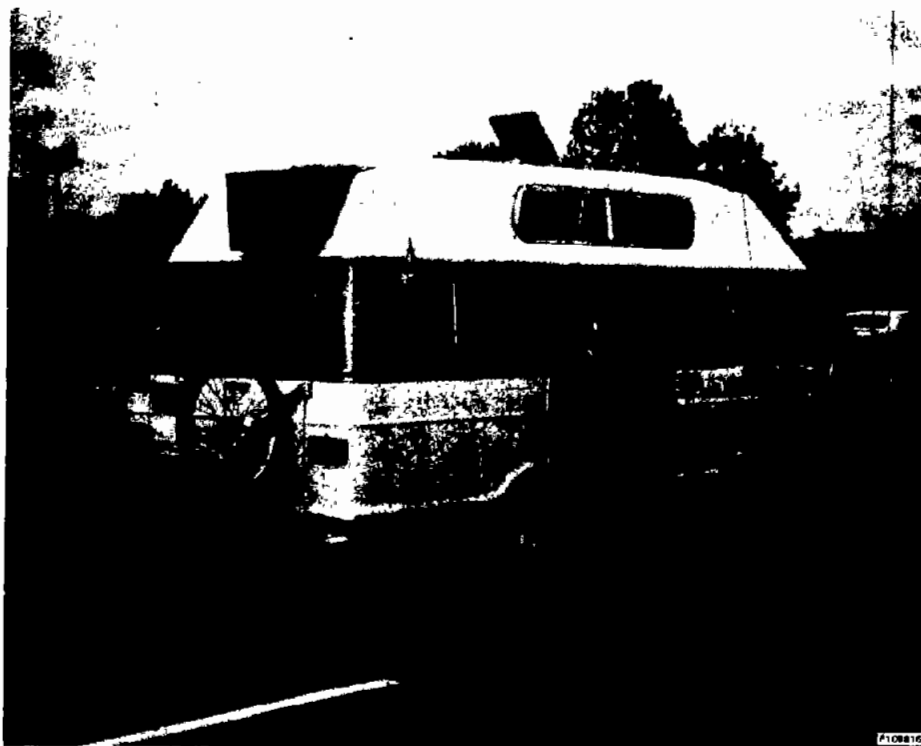
Figure 3-5. Test Vehicle, Generator & 5th Wheel

3.2.2.1 Test Vehicle and Motor-Generator - The test vehicle was a 1975 Dodge Maxi-van equipped with a 5 KW 115 VAC motor-generator. It contained all LAVM and test instrumentation equipment except augmentors. The power generated was used only for instrumentation equipment, however, since the LAVM equipment was powered by the vehicle's 12 VDC system. Figure 3-5 shows the van and generator.

3.2.2.2 Fifth Wheel - The fifth wheel was a high precision odometer used to determine exact distance traveled for error analysis. The device has a specified accuracy of 1% of distance traveled. The fifth wheel can be seen in Figure 3-5.

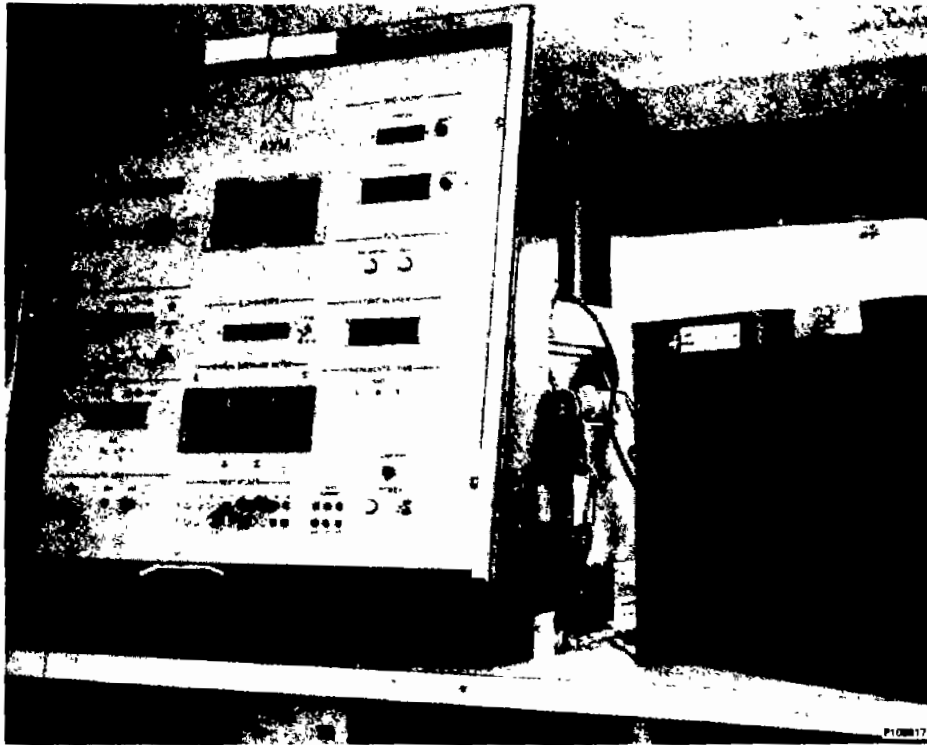
Figure 3-6. Magnetic Tape Recorder and Test Console

3.2.2.4 Magnetic Tape Recorder - The tape recorder was a 10 channel incremental write-only unit. All test and instrumentation data was written on this tape in the format described in Section 4. Figure 3-6 shows a partial view of the recorder on the right.

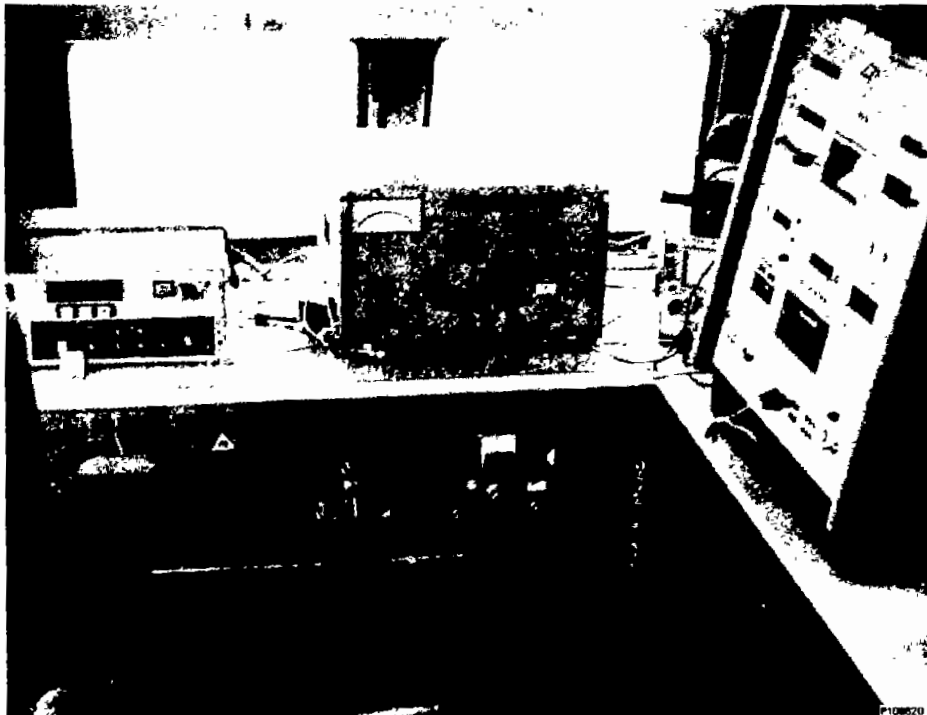
Figure 3-7. Test Equipment in Rear of Van

3.2.2.5 Oscilloscope - An oscilloscope was used to monitor the output of the bandpass filter in the microlocator for information only. It was not used in position location or test instrumentation. The oscilloscope and its position relative to the other test equipment in the vehicle can be seen in Figure 3-7 behind the test console at the rear of the van.

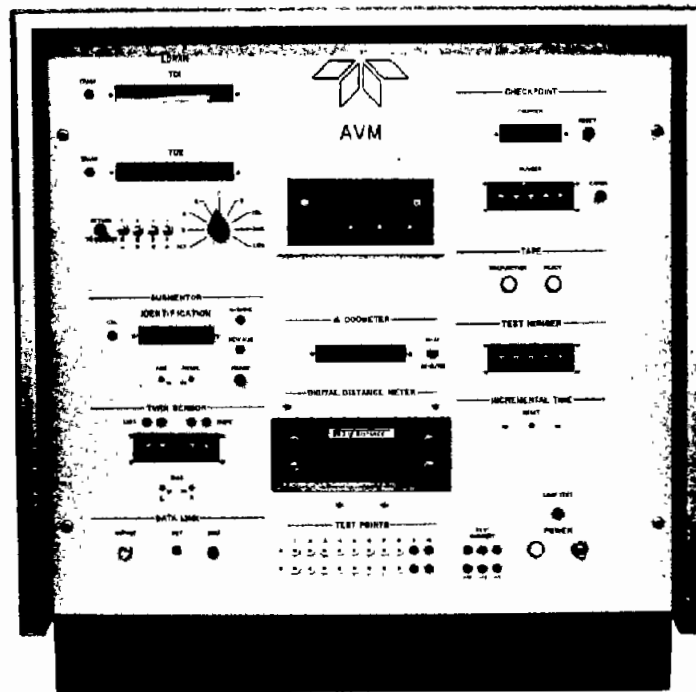
Figure 3-8. LAVM Test Console

3.2.2.6 Test Console and Control Panel - Figure 3-8 shows the front panel of the LAVM test console. This unit was permanently installed in the test vehicle. It served three functional needs:

- a. It allowed the test operator to input data such as checkpoint number, test number, and checkpoint arrive.
- b. It displayed all sensor outputs such as LORAN time difference, augmentor ID, and odometer.
- c. It collected all the sensor data, formatted it along with other relevant information such as equipment status and incremental time and presented it to the tape recorder along with the appropriate "write" commands. A brief description of its displays and controls follows. See Figure 3-9.
 - "TD1" and "TD2" are the two time difference displays. Each display presents the latest TD measurement from the Microlocator, in its entirety, i. e., 16,254.62 (microseconds). Note that this is essentially 'raw' TD data (not averaged) and slightly

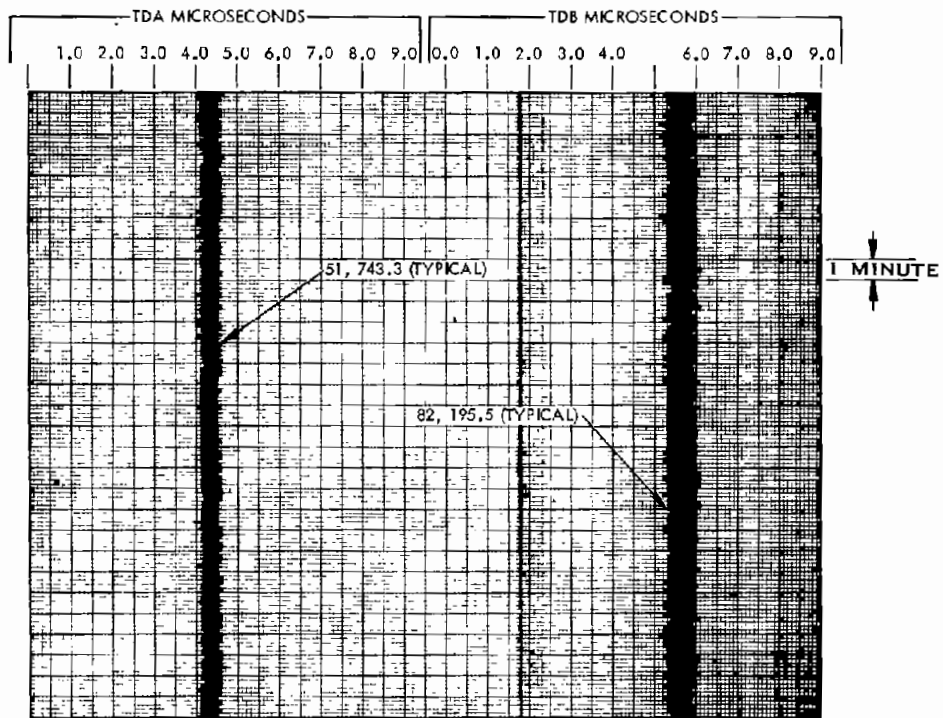
Figure 3-11A. Monitor Station TD Recording

The recorder was a two channel analog device. It recorded the 1 microsecond and 100 nanosecond number of each time difference being measured. For example, if TDA (Nantuckett) was 51,744.3 microseconds, the 4.3 part of the digital time difference was converted to an analog signal in the recorder interface (see Figure 3-10). The recorder was scaled so that each large division equals 1 microsecond and each small one 100 nanoseconds (see Figure 3-11A). The range of each channel is from 0.0 to 9.9 microseconds which is sufficient to record any timing variations. Figure 3-11B is a photograph of the monitor station.

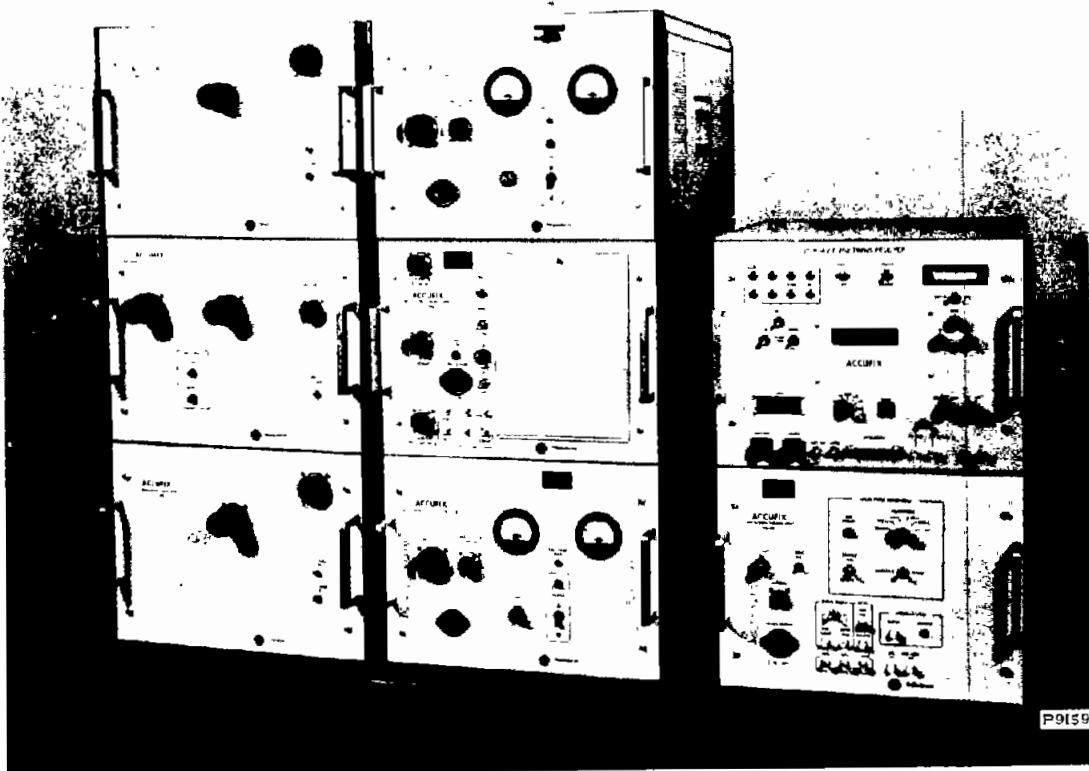
Figure 3-12. LORAN C Mini Station

- Frequency - 100 KHz
- Emission Designator - 20P2
- Radiated Power - 100 Watts @ Peak of Pulse
- Average Input Power From Final - 2 KW
- Peak Power @ Final Amp - 15 KW
- Spectrum - 99% of Energy within 80 KHz - 120 KHz Band
- Timing Stability - U.S. East Coast Master ± 25 nSec
- GRI - 9930 (SS7)
- Coding Delay - 82,002.5 microseconds

A LORAN C ministration was temporarily installed in Limerick Township, PA. for the duration of the Phase I Program. Standard LORAN C coverage in the Philadelphia area has been shown to be inadequate in view of the location accuracy required. In particular, the LORAN C Slave at Dana, Indiana does not provide the

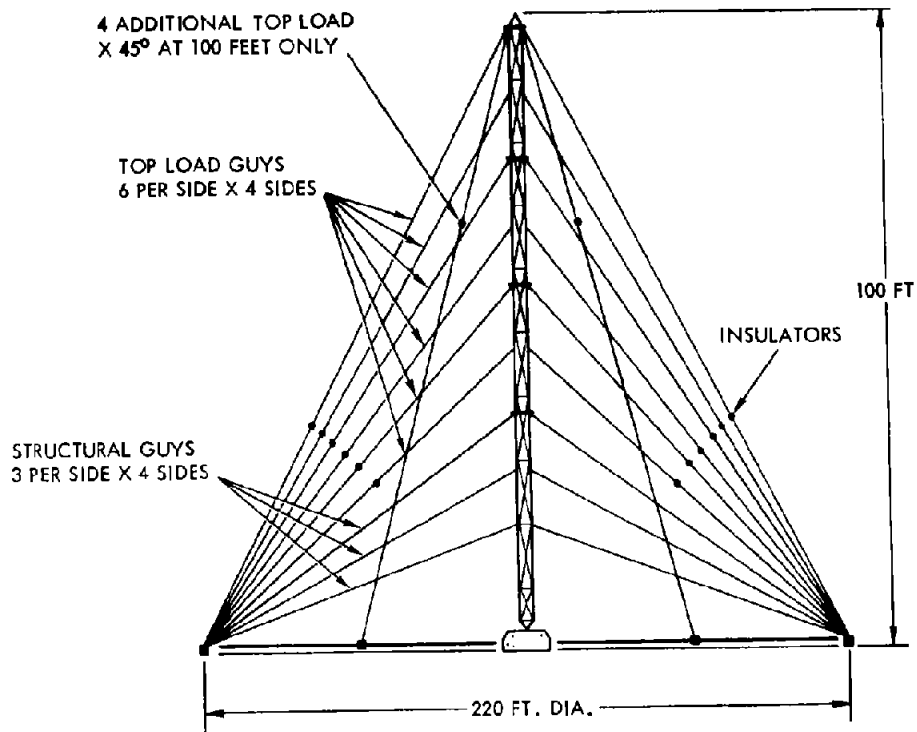
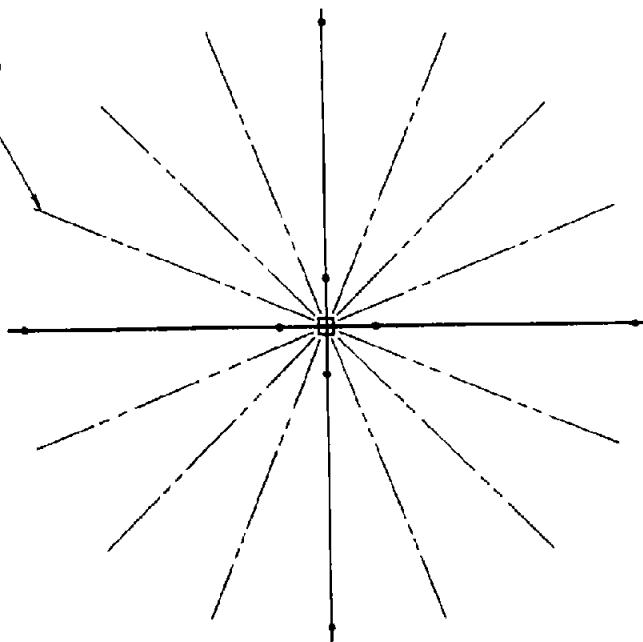
Figure 3-13. Transmitter Tower Diagram

The transmitting antenna was a 100 foot top loaded aluminum tower with sixteen 100 foot ground plane radials. Figure 3-13 is a diagram of the tower, Figure 3-14 is a photograph of the actual installation.

TOWER SECTION

100 FT
90 FT
80 FT
70 FT
60 FT
50 FT

94.3 FT (8 REQUIRED)
89.7 FT (4 REQUIRED)
85.3 FT (4 REQUIRED)
81.3 FT (4 REQUIRED)
77.7 FT (4 REQUIRED)
74.5 FT (4 REQUIRED)

GROUND PLANE 16
RADIAL WIRES
(100 FOOT RADIUS)

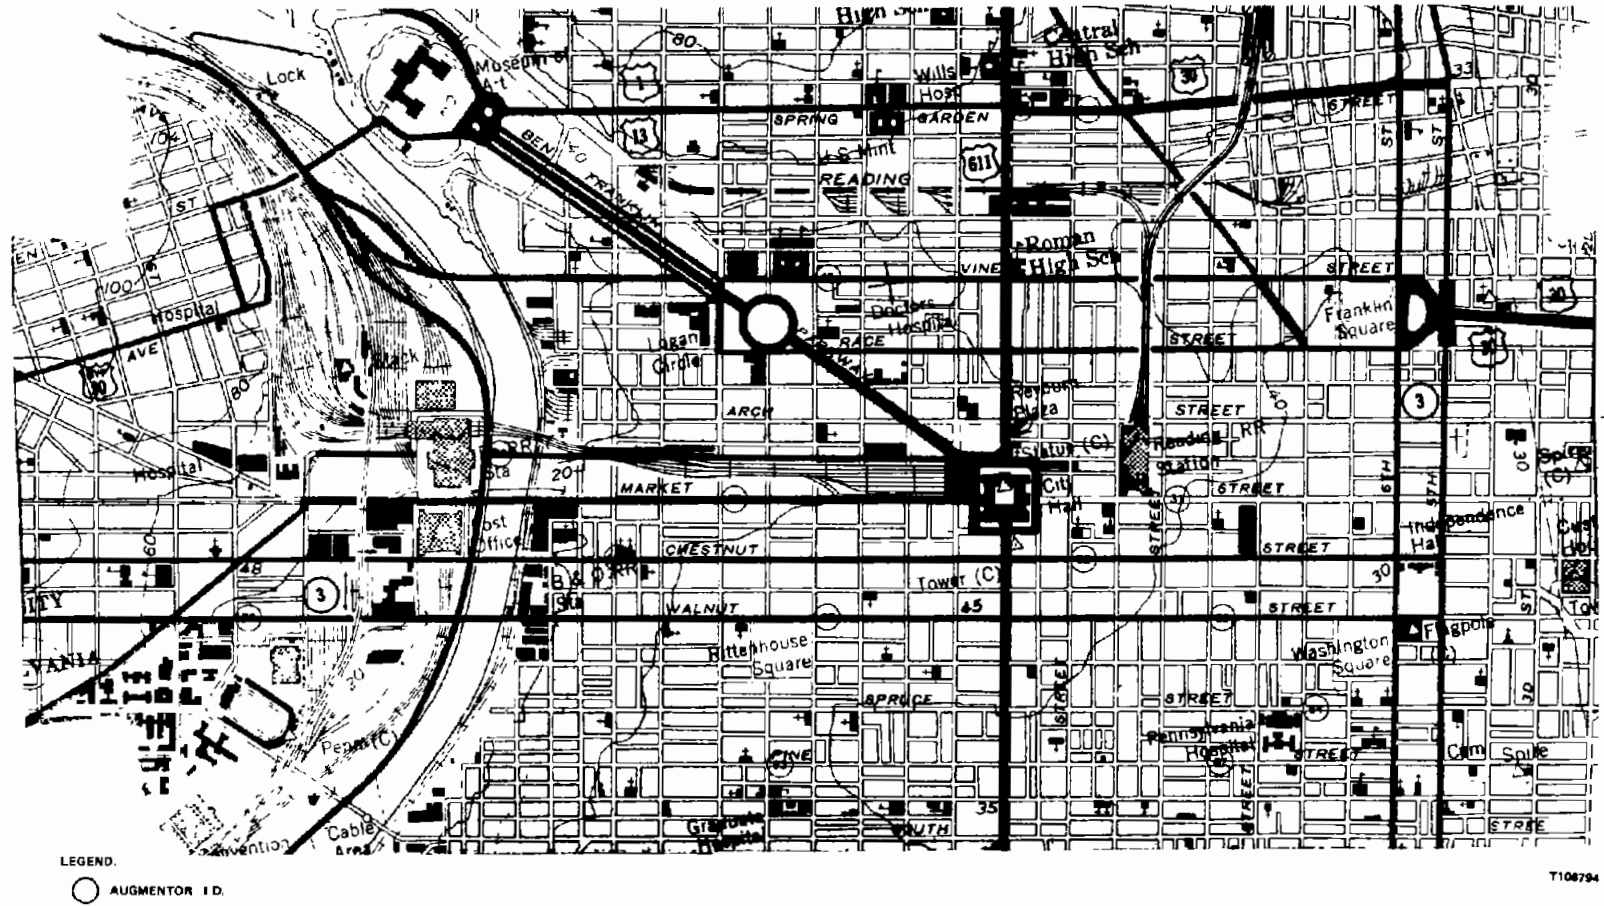
Figure 3-15. Fixed Route Augmentors

Fifty-three augmentors were deployed for Phase 1 tests. Except for time-points, augmentor deployment is a function of LORAN coverage. That is, augmentors were installed where the lack of adequate LORAN signal coverage indicates they were required. Deployment for the random route test was not the same as that for the fixed route test. This is because the random route test area had spotty LORAN coverage. Without a priori knowledge of the test route, a worst case situation was assumed. This would be a route which goes continually in and out of good LORAN coverage making very dense augmentor deployment mandatory. The fixed route, on the other hand, traverses sections of good LORAN coverage which resulted in augmentors only located at time points. Figure 3-15 shows final fixed route augmentor locations, and Figure 3-16 shows those used on the random route. Figure 3-17A, B, C show typical augmentor installations. The exact locations and coordinates of augmentors at specific intersections are given in Appendix C.

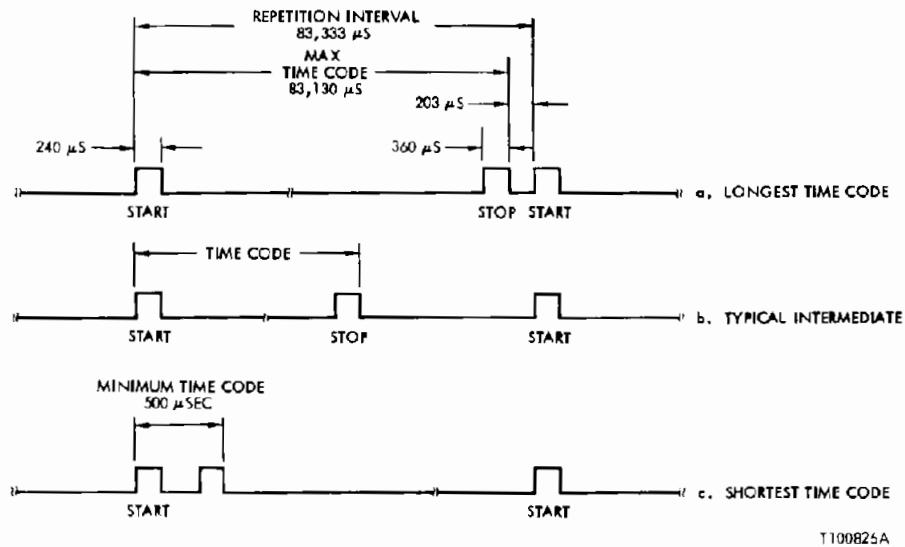
Figure 3-19. Augmentor Timing Code

The code specified in the code generation is in the form of a time period between pulses rather than the more conventional binary or BCD number transmission. This simplifies vehicle and augmentor hardware and increases reliability. Figure 3-19 is a timing diagram of the coding technique used. Detection of an augmentor signal consists of recognition of the 240 microsecond start pulse and the 360 microsecond stop pulse. The time between these pulses must be within a predetermined limit or no detection is made. Any combination of signals which meet this criteria will constitute an augmentor detection, while the time from

start pulse falling edge to stop pulse falling edge will uniquely identify an augmentor. Noise which occurs between pulses has no effect unless it occurs after the start pulse and causes the receiver to produce an artificial pulse exactly 360 microseconds long.

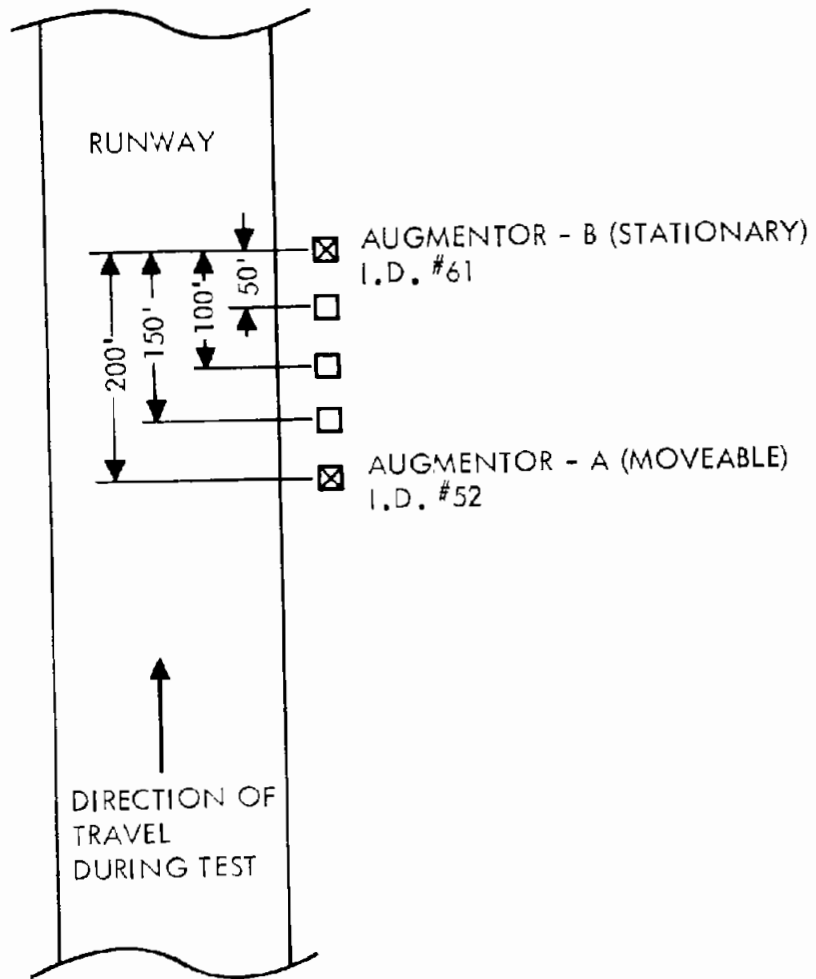
Figure 4-4. Augmentor Interference Test

Using the same driving procedure as in paragraph 4.5.1, the test vehicle made runs at 30 MPH and the detection or non-detection of the two augmentors was indicated on the data sheets. Detection was as defined in paragraph 4.5.1.

The augmentors were positioned as shown in Figure 4-4.

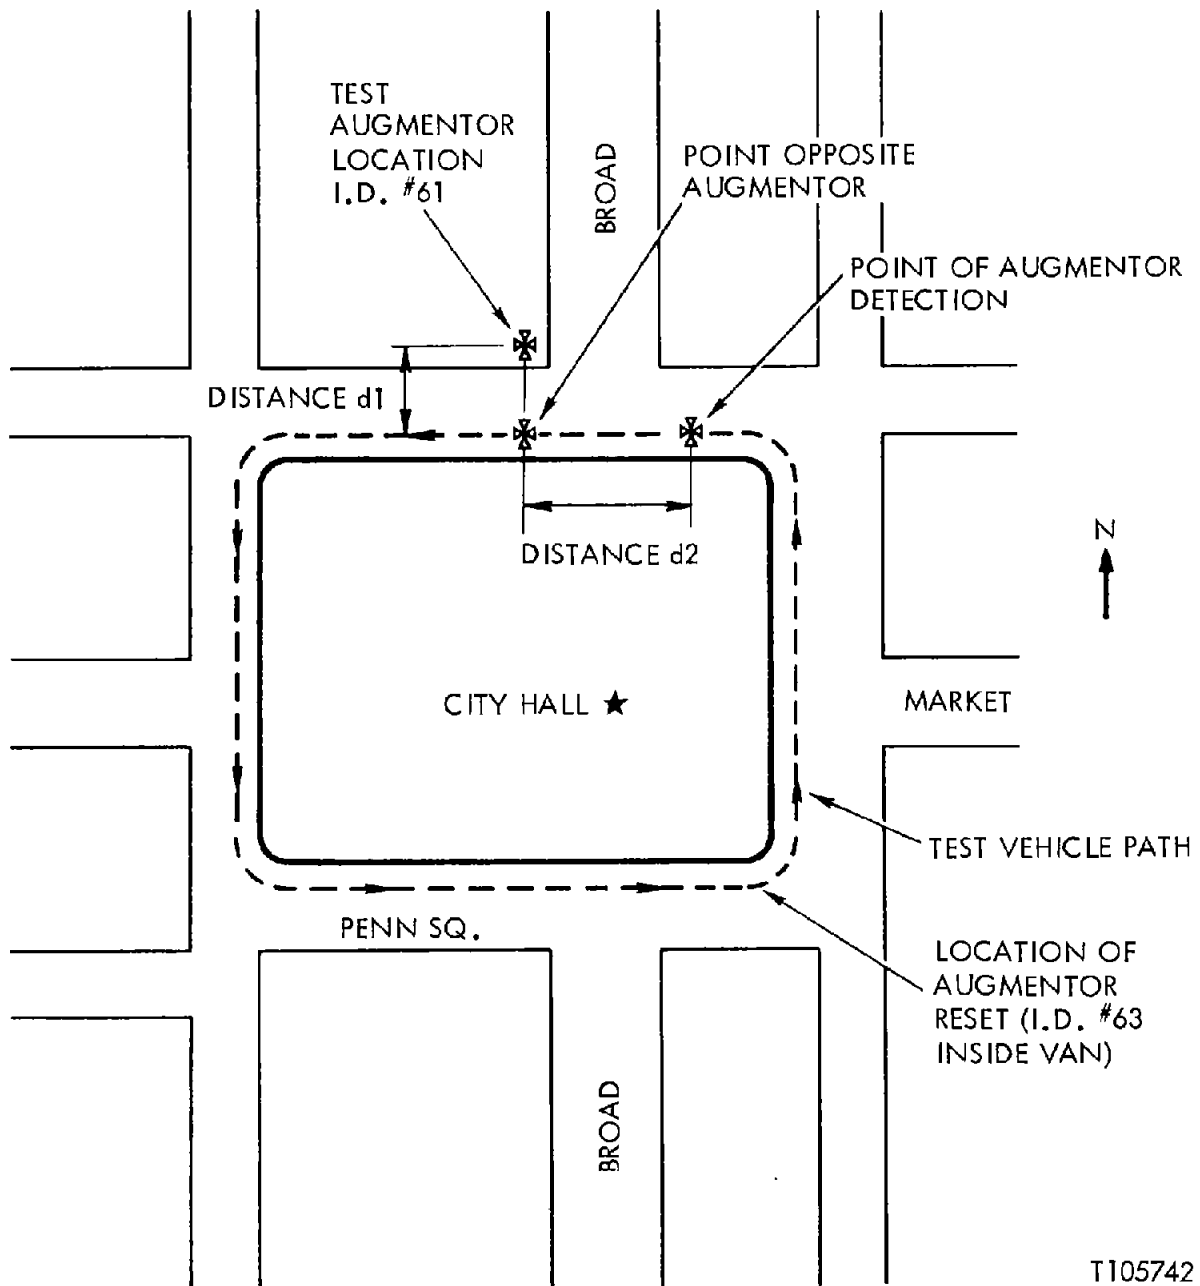
Figure 4-5A. Special Case Test Augmentor Coverage vs Traffic Conditions

An augmentor was positioned on a street light pole along the North side of JFK Boulevard as shown in Figures 4-5A, 4-5B, and 4-6. The detection distance and loss of signal distance (as defined in paragraph 4.5.1) and the elevation of the augmentor were measured (feet) and recorded on the data sheet while the van traveled in a counter clockwise path around city hall.

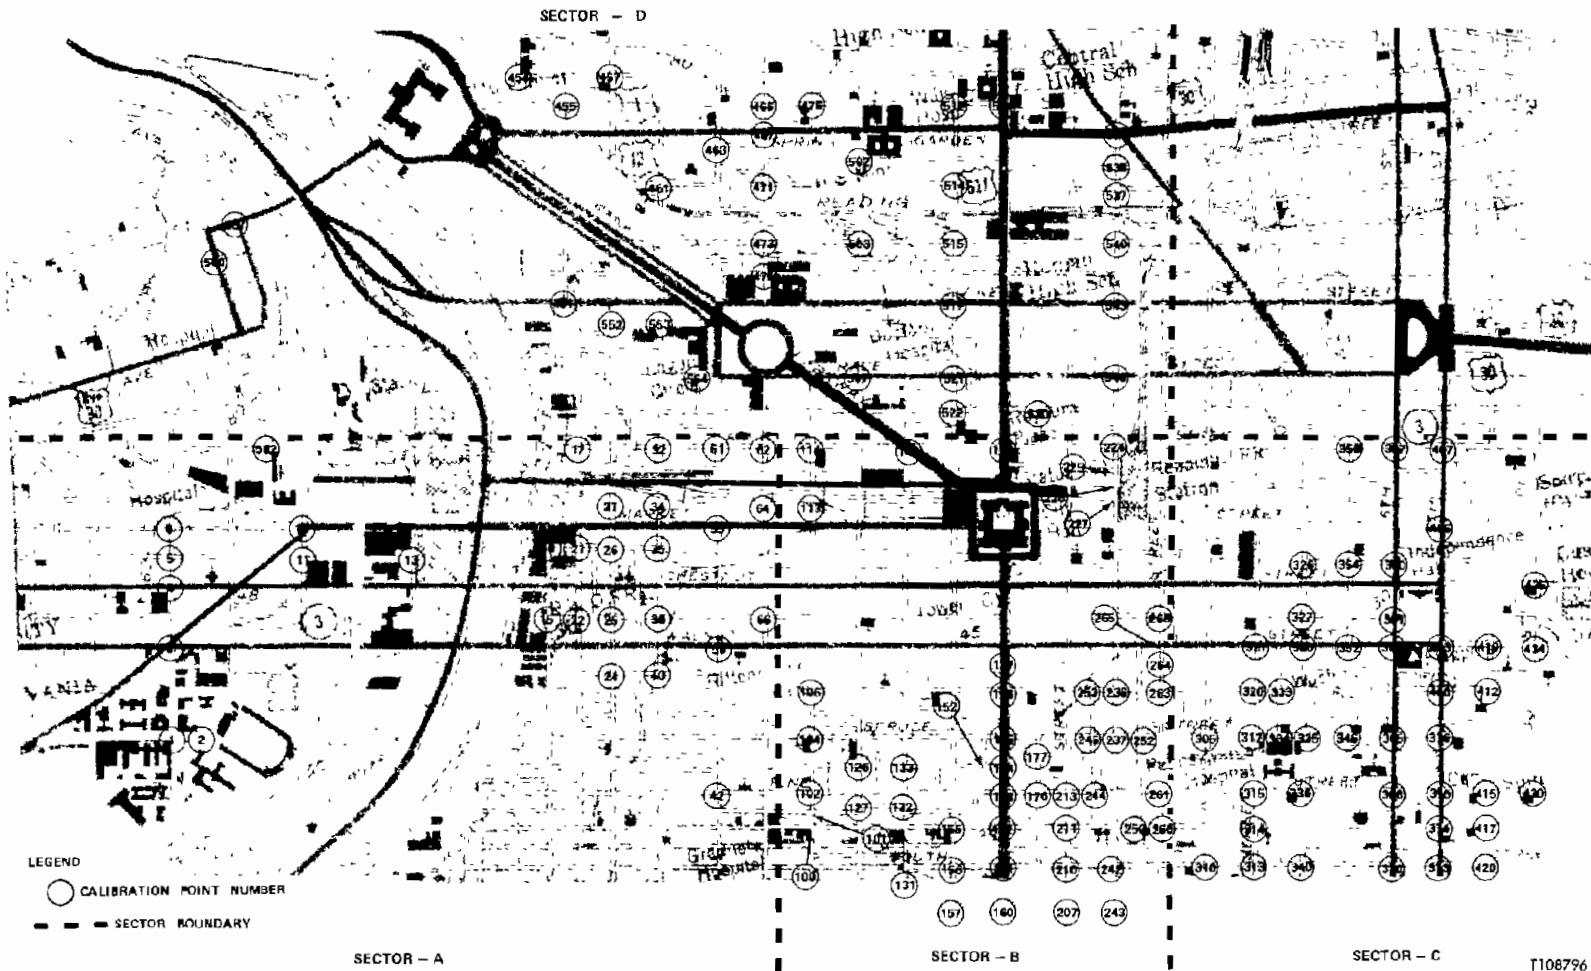
Figure 4-7. Calibration Area

Calibration data was taken for the fixed, random, LORAN only and Bridge route areas. Figure 4-7 shows the calibration points for the fixed and random route areas. All intersections within the LORAN only area were calibrated. The calibration points for the bridge run are shown in Appendix A.

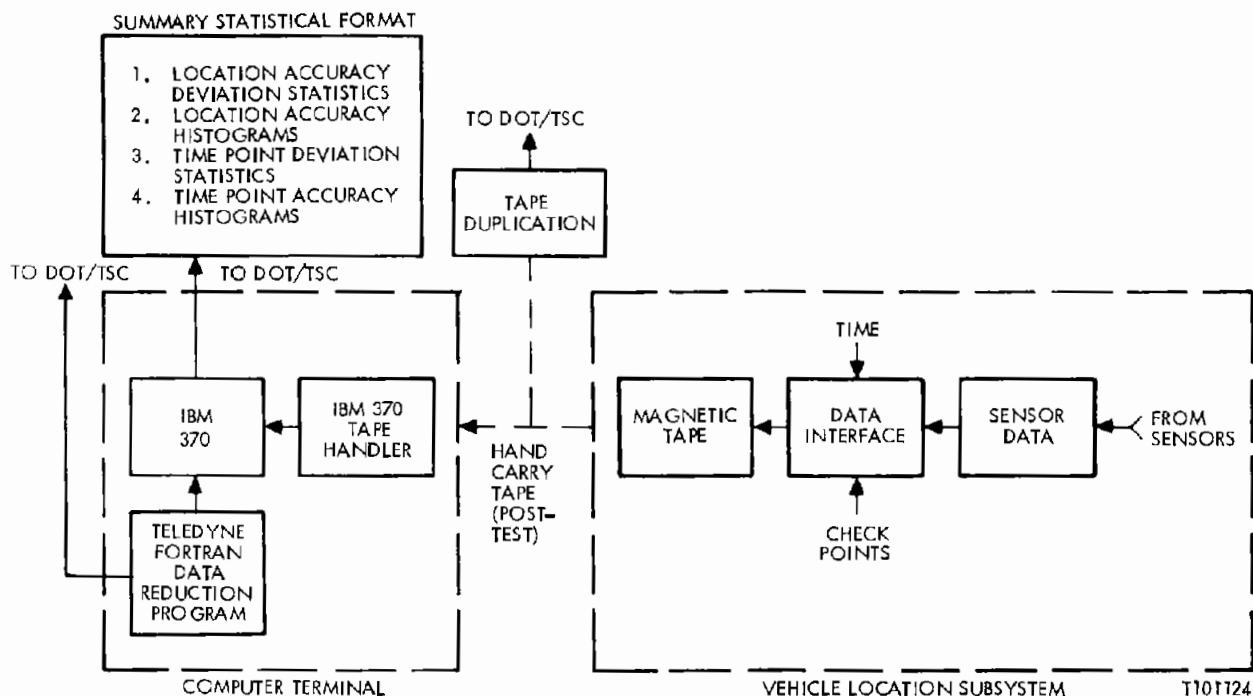
Figure 5-1. Data Handling Flow

Figure 5-1 shows the Overall Data Handling Flow described in this paragraph.

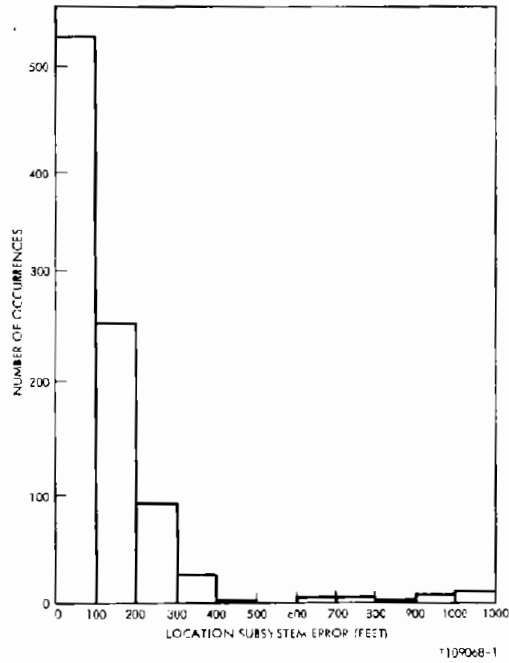
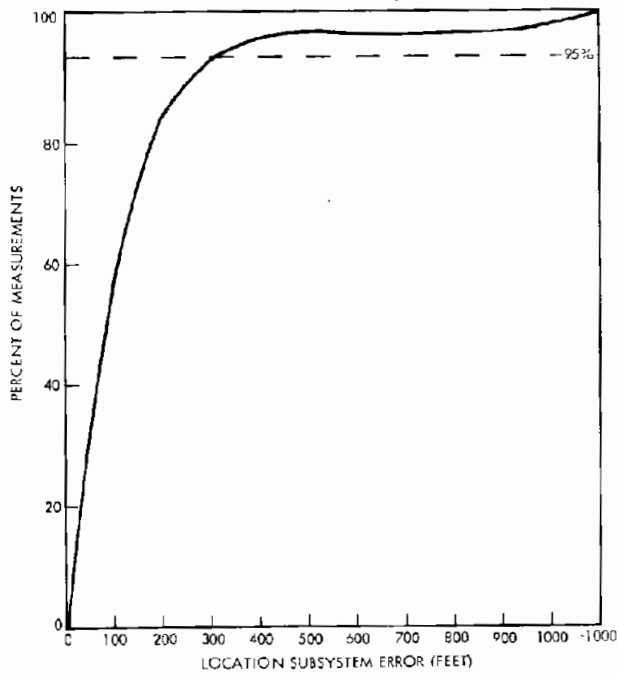
Figure 6-2A. Location Subsystem Histogram
 (Fixed Route Tests #10001 - 10012)
 December 1976

6.2.1.1 Location Subsystem - For the location subsystem the error at the 95th percentile was 318.66 feet. At the 99.5th percentile it was 1,457.62 feet. Figure 6-2 is a histogram and cumulative error curve for the location subsystem, runs 10001 through 10012.

The 99.5% number is not indicative of the system capability. It is the result of a problem in the augmentor transmitter circuit at low temperature which plagued this set of runs, ultimately resulting in the suspension of testing. When the augmentor transmitter malfunctioned, it resulted in one of two symptoms: no ID number at all was decoded as the test vehicle passed, or an incorrect number was decoded. The latter symptom was the more troublesome if the incorrectly decoded number happened to be the same as a legitimate ID at another time point on the route. In this unfortunate circumstance, the incorrect augmentor ID results in a new position update at an erroneous location which could be many thousands of feet away from the true location. This did happen with interesting results. On test 10010 as the vehicle passed augmentor ID 33 at 10th St. and Walnut, ID 32 was

decoded. It happens that 32 is the legitimate ID of an augmentor at 13th St. and Chestnut. At this point, the system located the test vehicle near 13th and Chestnut and, of course, produced large errors as the test vehicle continued along Walnut St. After three successive reports, the apparent LORAN errors were so large that the system declared the vehicle off the fixed route. In this mode, the vehicle is continually tracked using LORAN data only while the system continues to project the LORAN derived location onto the nearest segment of the fixed route. Since the vehicle had not actually left the route but only had been "spoofed" by a malfunctioning augmentor, it is of some interest to examine the run to see how long it took the system to determine the true location of the vehicle. The computer run shows that at the first checkpoint after declaring route departure (3 checkpoints after the false aug detection), the system error was 190.74 ft., which means that the raw LORAN location data put the vehicle within 200 feet of its true location. At the next two checkpoints the errors were 220.68 ft. and 318.66 ft. These were also based only on raw LORAN information. At the next checkpoint the conditions for declaring a return to the fixed route were satisfied. The system made the correct "returned to route" declaration and located the point at which the return was made with an error of only 112.85 ft.

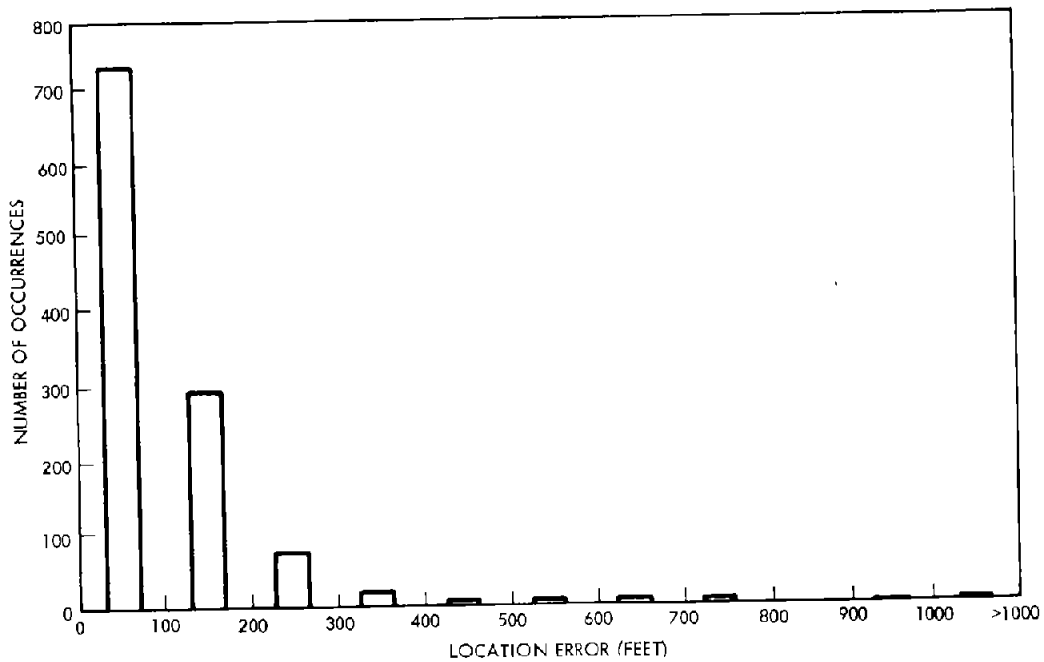
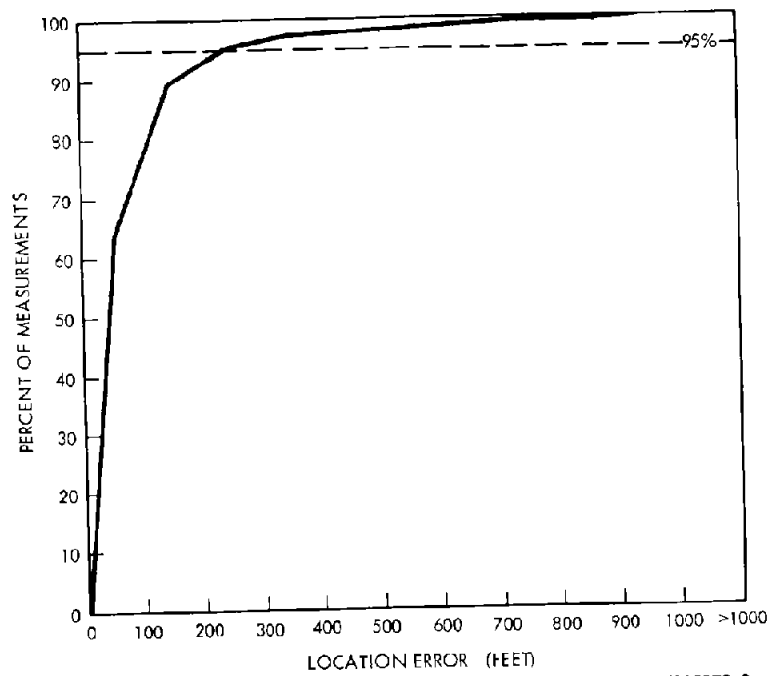
Figure 6-3A. Location Accuracy Histogram (System Simulation)
 (Fixed Route Tests #10001 - 10012)
 December 1976

6.2.1.2 System Simulation - The system simulation for runs 10001 through 10012 produced a location accuracy of 269.45 ft. at the 95th percentile and 787.37 ft. at the 99.5th percentile. A histogram and cumulative error plot is shown in Figure 6-3. As with the location subsystem runs, augmentor malfunctions had some effect on the 99.5%. This is primarily because the data rate of 32 seconds is higher than the average rate resulting from updates only at checkpoints. The higher data rate and nominally higher quality LORAN available at non-street-intersection sample points produces a markedly superior error distribution which can be seen through out the test results.

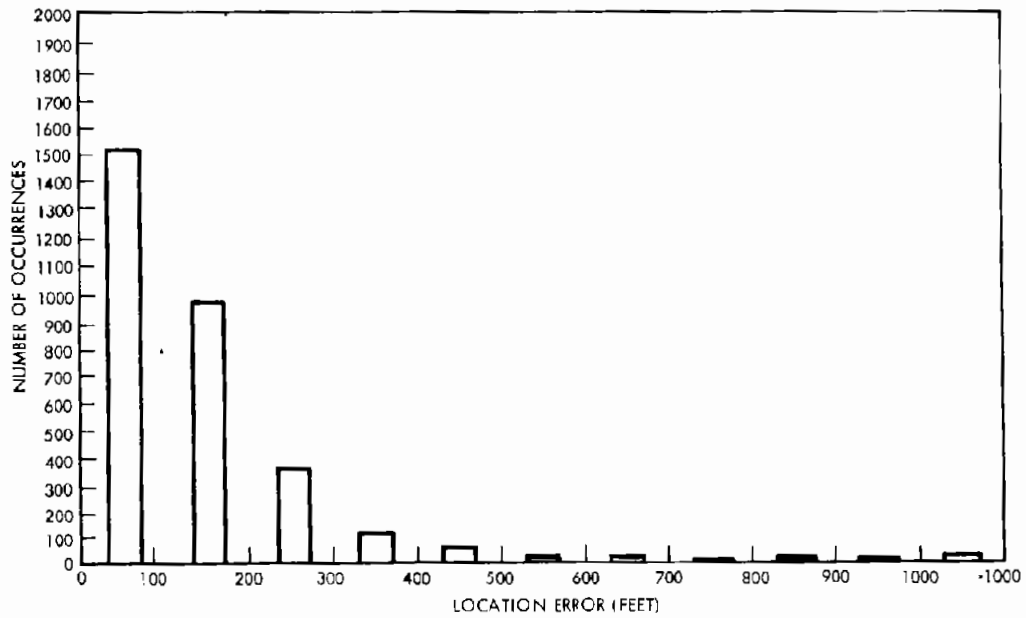
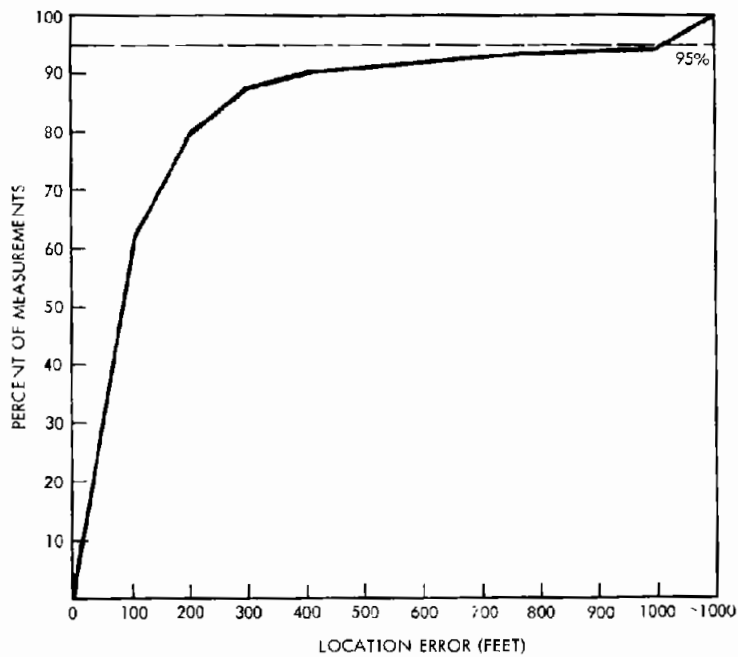
Figure 6-4A. Location Subsystem Histogram
(Fixed Route Tests (All) #10012 - 10047)

6.2.2.1 Location Subsystem - The error at the 95th percentile for all 30 runs was 1,269.16 feet for the location subsystem. At the 99.5th percentile the error was 4,914,435 ft due to the generator malfunction. Figure 6-4 shows the distribution of all errors for these tests.

These results are dominated by results of the early tests as will be shown later. The 99.5% error should be discussed. It is an artificial number which is the product of a computer software overflow in the position location routine. It results from test data inputs containing LORAN TDA and TDB numbers hundreds of microseconds away from the expected range of values in the Philadelphia area. The 4 million feet numbers are artificial in that a gross manual coordinate conversion shows that errors of about 50,000 feet would have resulted had the software been scaled to handle this large range of time difference values. It is highly likely that these time difference numbers were a result of the low voltage problems in the test console since this unit is powered by the motor generator. The numbers put on tape are the output of a time difference averaging circuit in the test console. In addition, this condition only occurred during the first tests. It did not occur after the electrical problem was corrected. Finally, time difference errors of this magnitude would certainly have attracted the attention of the test operator and witnesses since the LORAN receiver outputs are displayed. No notes or observation of improper time differences were made during any of the test runs.

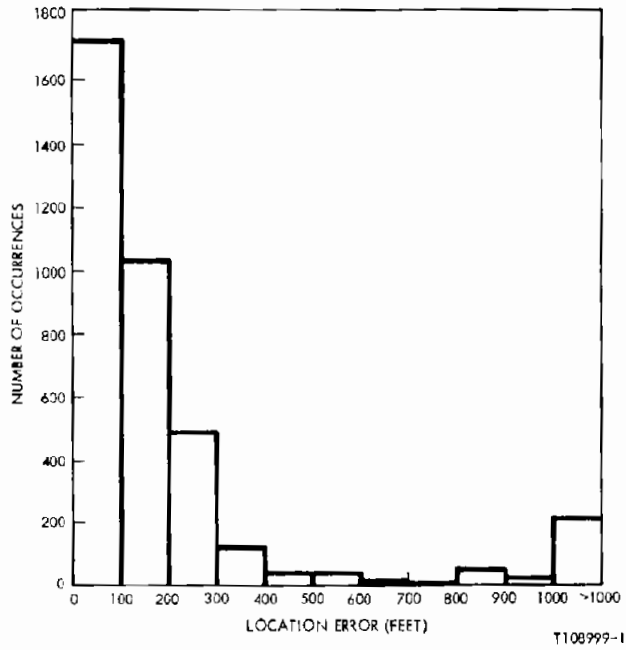
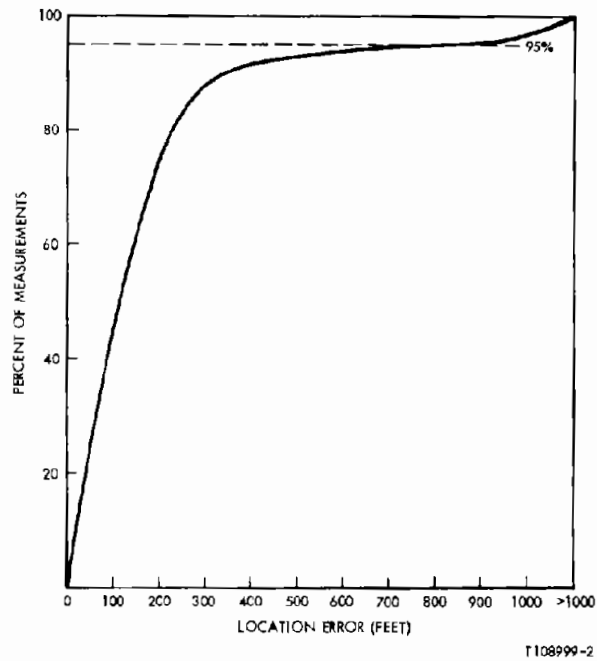
Figure 6-5A. Location Accuracy Histogram (System Simulation)
(Fixed Route Tests #10012 - 10047)

6.2.2.2 System Simulation - The results of the system simulation for all runs is also dominated by errors contained in the early tests. The error at the 95th percentile was 1,648.51 feet; at the 99.5th percentile the error was 5,087,946 feet. Figure 6-5 shows the distribution of these errors.

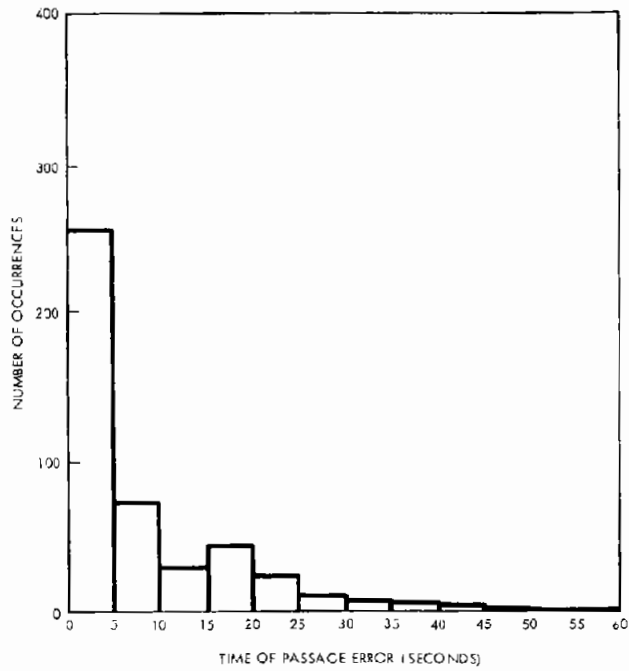
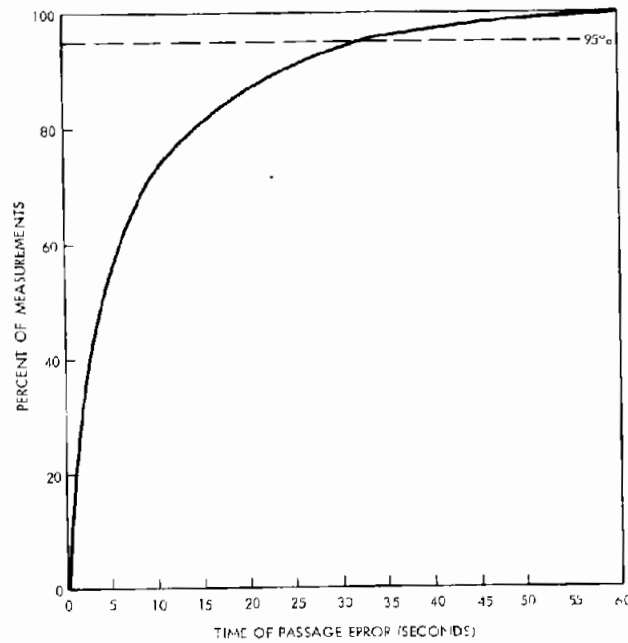
Figure 6-6A. Time of Passage Error Histogram
(Test 10012 - 10047)

The time of passage errors were not affected by the electrical problems to the same degree the location errors were. This is probably because the odometer, which was most vulnerable as previously discussed, is not as significant in the time of passage determination process. It is only used to measure a distance of 50 feet from initial augmentor detection. Erratic odometer data could only have a minimal effect at most. The error at the 95th percentile was 32 seconds; at the 99.5th it was 49 seconds. Figure 6-6 shows the error distribution. These results are indicative of the true system characteristics since they are relatively independent of any known extra-system problem. Results to be discussed later in this section tend to corroborate this. While 32 seconds - 95% is in excess of the specified requirement, post-test analysis has been completed showing that with some modifications and a door open-closed sensor, the 15 second 95% requirement can be met. A more detailed discussion of the error sources in the Phase I tests, plus a proposed mechanization for Phase II which is compliant, is presented in Section 7. Paragraph 6.2.6 describes an algorithm for determining time of passage at any point without benefit of an augmentor. A comparison of results is given in Table 6-4. Analytic error calculations for this algorithm are discussed along with the results of manual application of this algorithm to Phase I test data.

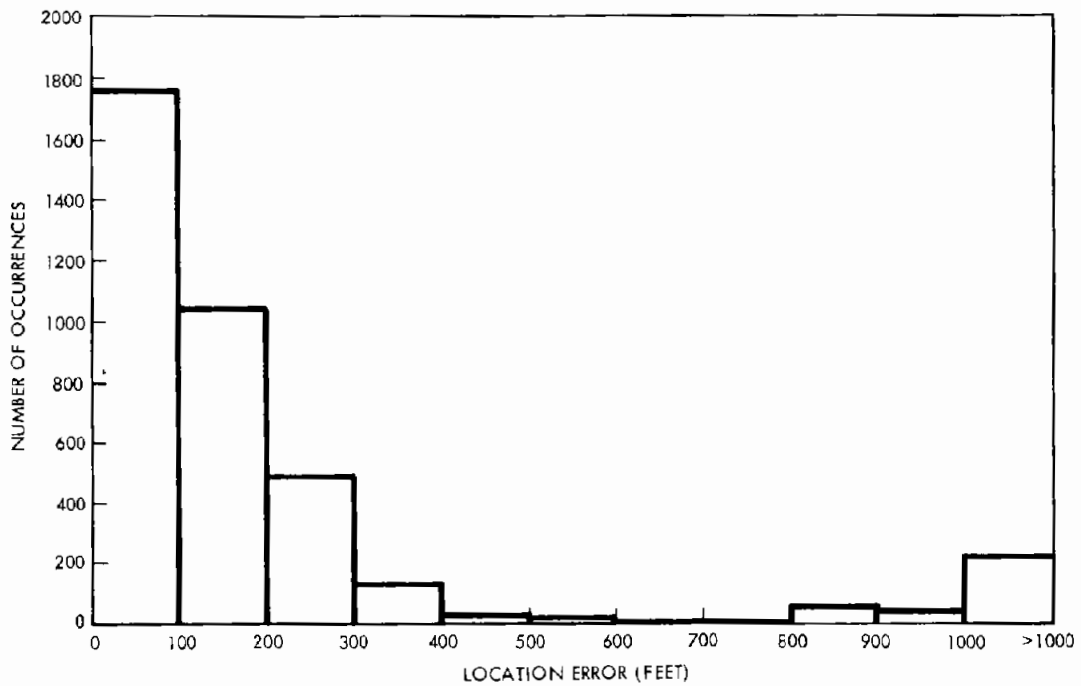
Figure 6-7A. Location Accuracy Histogram
 (System Simulation With 5% Missing Data)
 (Fixed Route Tests #10012 - 10047)

6.2.2.3 System Simulation with 5% Lost Data - The system simulation described in paragraph 6.2.2.2 was repeated for all 30 tests with a random 5% of all data deleted. This simulates the practical system operating conditions. Results do not significantly differ from the straight simulation. The error at the 95th percentile was 1,113 feet and 4,909,901 feet at the 99.5th percentile. Error distribution is shown in Figure 6-7.
