LORAN
AUTOMATIC VEHICLE MONITORING SYSTEM

PHASE I
FINAL REPORT

VOLUME I
TEST RESULTS

MARCH 1977

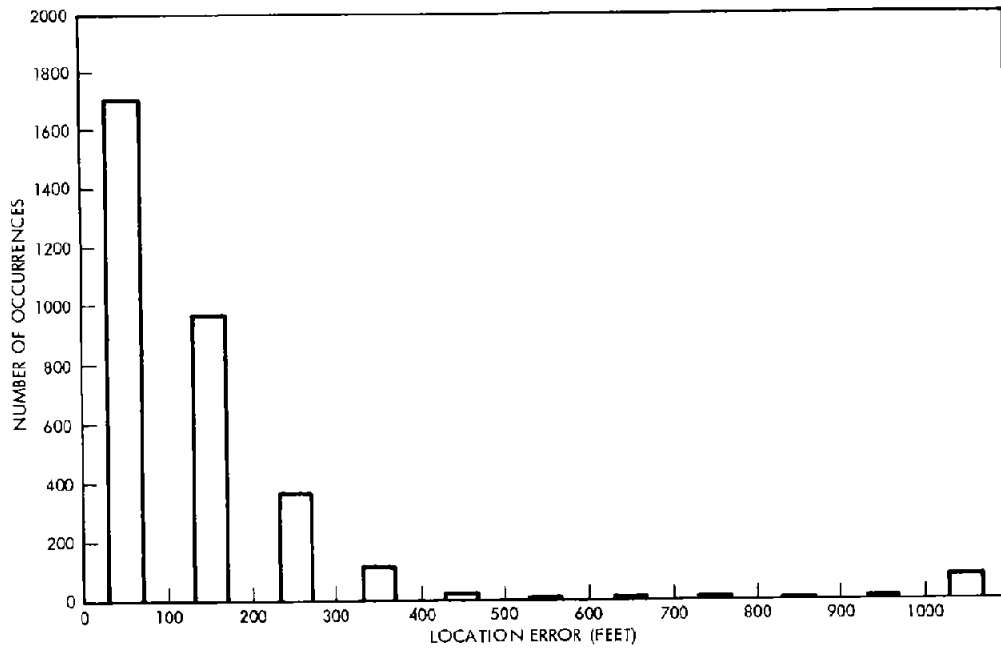
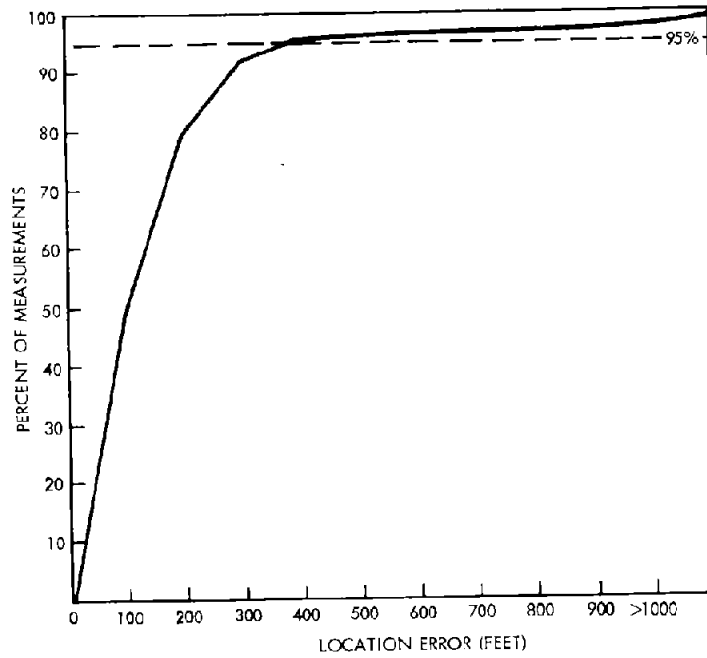
Figure 6-8A. Location Subsystem Histogram
(Fixed Route Tests (All) Less #10016 and 10017)

6.2.3.1 Location Subsystem - The location subsystem error at the 95th percentile was 352.79 feet. At the 99.5th percentile it was 4,914,435 feet. Error distribution for this data set is shown in Figure 6-8. Since severe and extensive electrical problems occurred during tests 10013 and 10024 which are included here, these results also are dominated by bad tests although not to the same extent as the previous set.

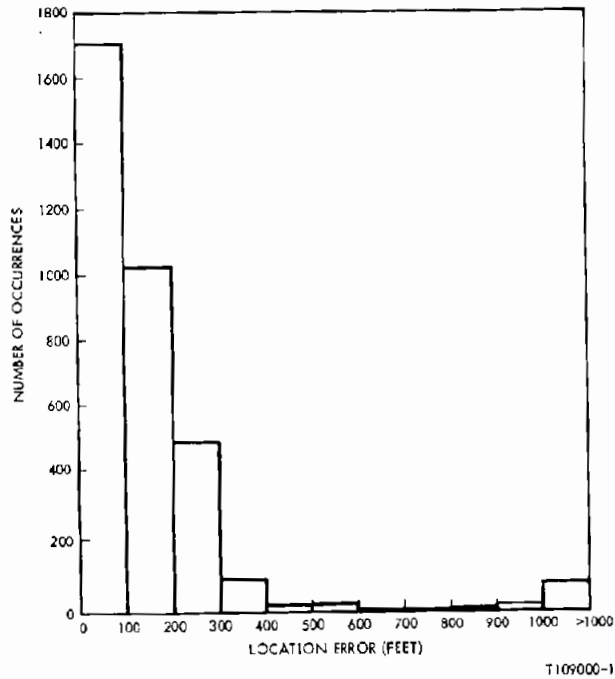
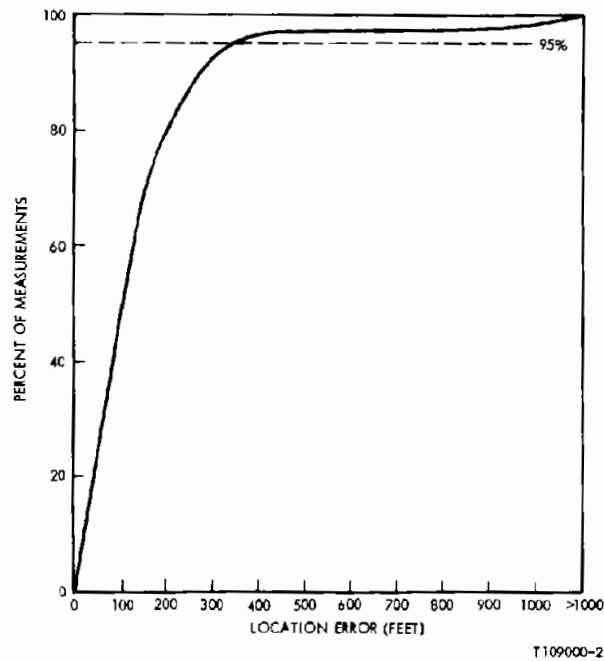
Figure 6-9A. Location Accuracy Histogram (System Simulation)
 (Fixed Route Tests (All) Less #10016 and 10017)

6.2.3.2 System Simulation - The system simulation for these tests produced an error at the 95th percentile of 320.56 feet and 4,909,913 feet at the 99.5th percentile. A histogram and cumulative error plot is given in Figure 6-9.

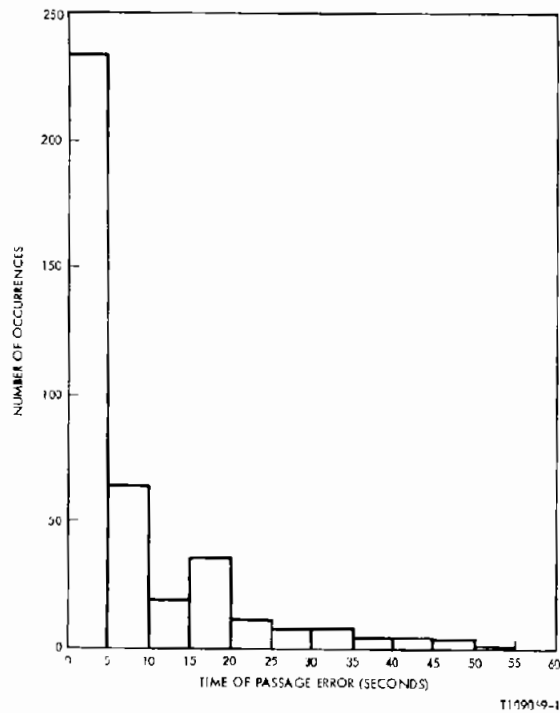
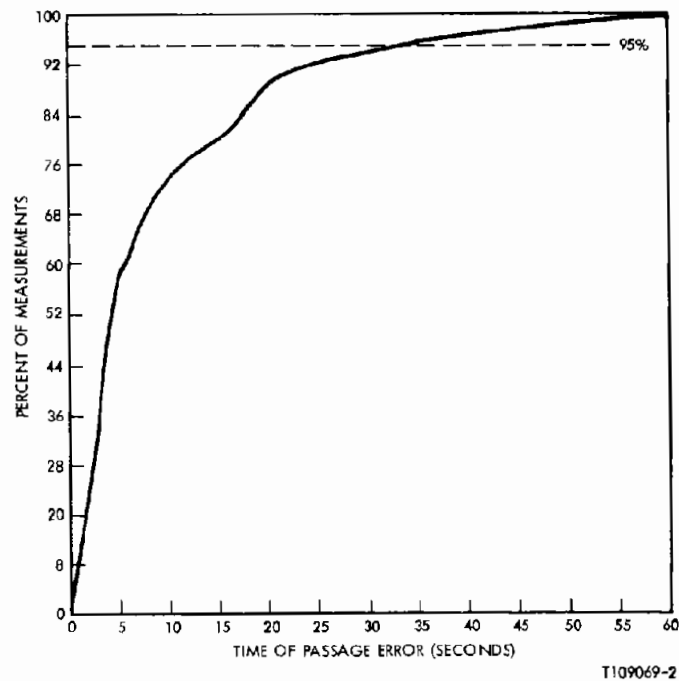
Figure 10A. Time of Passage Error Histogram
(Fixed Route Tests (All) Except #10016 and 10017)

The system simulation of time of passage showed an error of 33 seconds 95% and 47 seconds 99.5%. These results differ only slightly from those obtained for all 30 runs as would be expected. See Figure 6-10 for error distribution curves.

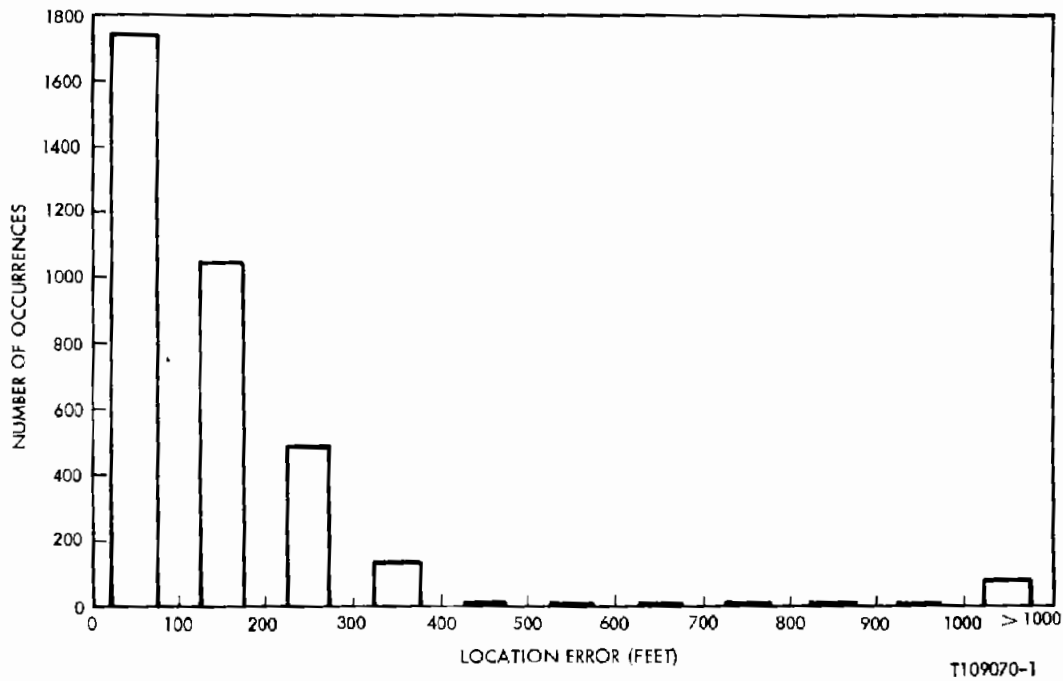
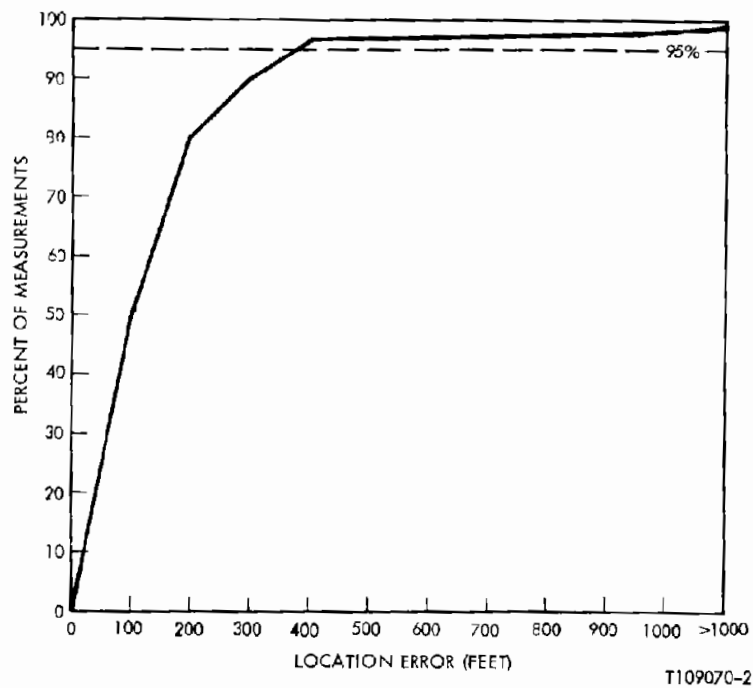
Figure 6-11A. Location Accuracy Histogram
 (System Simulation With 5% Missing Data)
 (Fixed Route Tests (All) Except #10016 and 10017)

6.2.3.3 System Simulation with 5% Missing Data - When the system simulation was repeated with a random 5% of the data deleted the error at the 95th percentile was 326 feet; at the 99.5th percentile it was 4,909,908 feet. A histogram and cumulative error curve is shown in Figure 6-11.

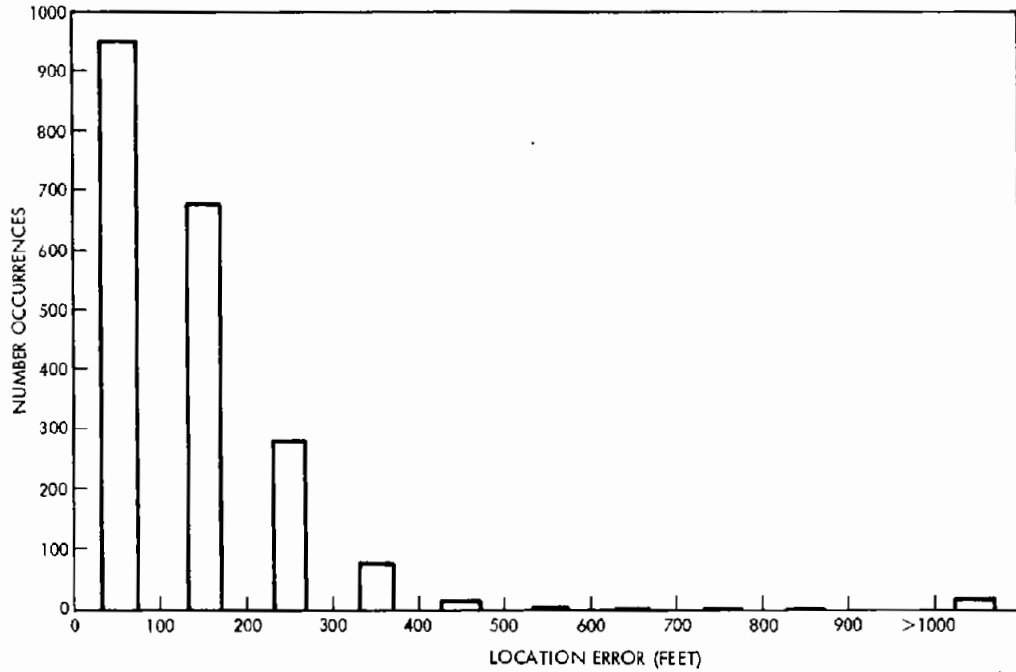
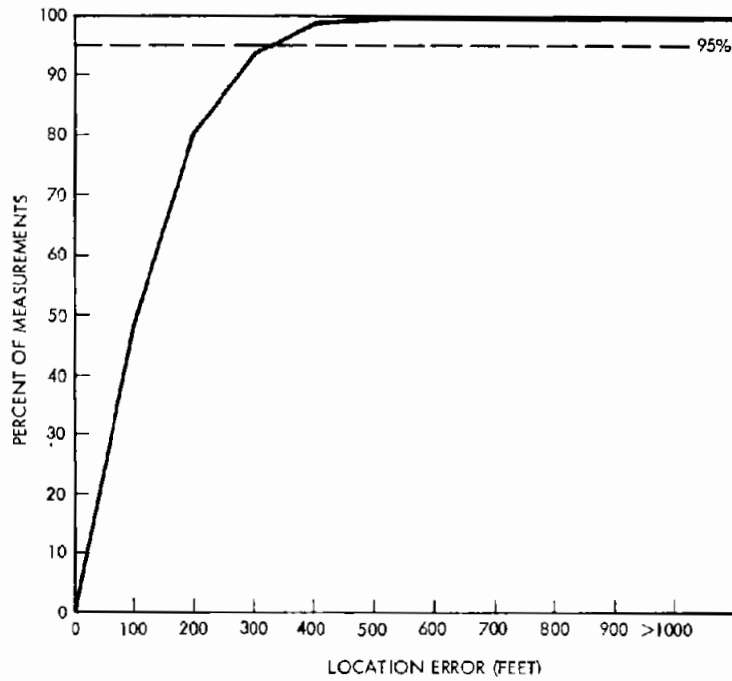
Figure 6-12A. Location Subsystem Error Histogram
(Fixed Route Tests #10026 - 10047)

6.2.4.1 Location Subsystem - The error at the 95th percentile for the Location Subsystem runs was 303.34 feet. At the 99.5th percentile the error was 5,186.65 feet. Error distribution curves are given in Figure 6-12. The 95% error is less than 4 feet greater than the required accuracy but the 99.5% figure should be explained. Of the 2,019 measurements made at checkpoints, 12 contained errors greater than 2,000 feet. These errors were the source of the 99.5% error figure. Examination reveals that 9 of the 12 occurred on Test 10030 and were the result of a LORAN cycle slip in time difference B. The cycle slip occurred just prior to checkpoing 151 at 8th and Spruce, probably the result of a temporary low SNR condition. The next few checkpoints are at checkpoints with consistently a poor SNR. Under these conditions, it is difficult or impossible for the LORAN receiver to make cycle corrections.

The electrical problem in the test support equipment was identified and corrected after Test 10025. This category of tests has no external forces acting on it and as such presents the most accurate portrayal of system accuracy capability. This test category covers 18 passes around the fixed route course covering a total of almost 250 miles. A total of over 2,000 checkpoints and 270 time points were passed. In itself this represents a very comprehensive test.

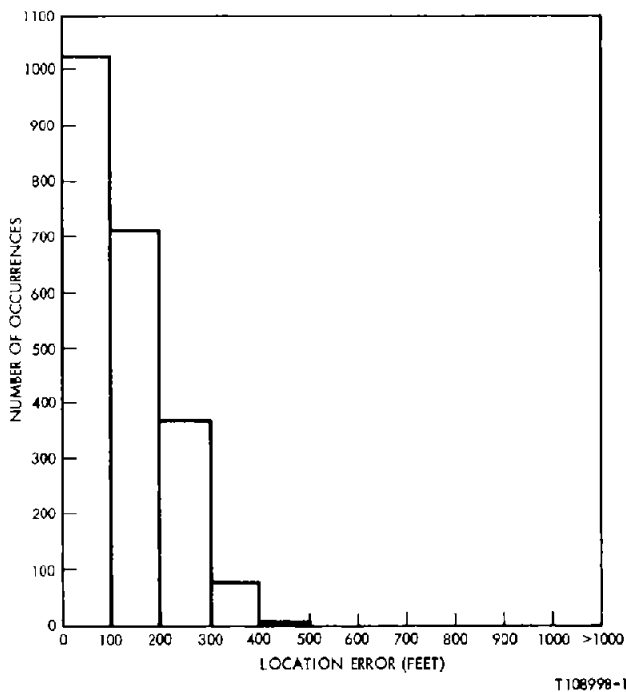
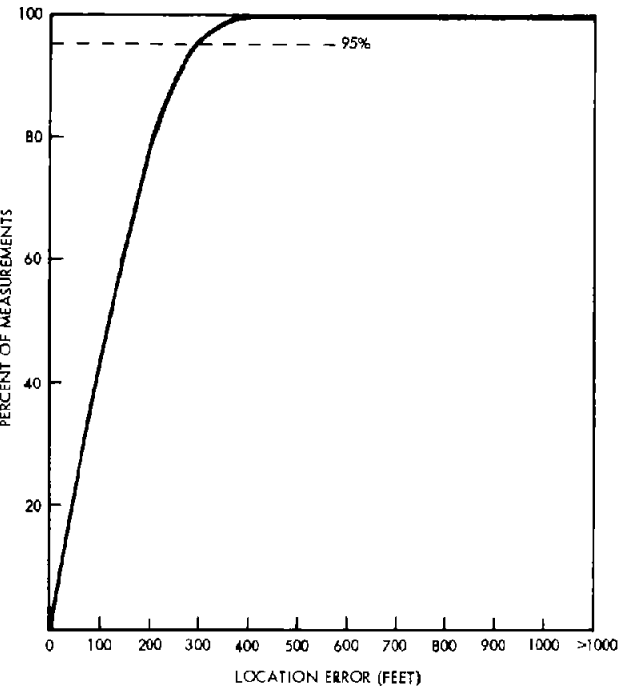
Figure 6-13A. Location Accuracy Histogram (System Simulation)
(Fixed Route Tests #10026 - 10047)

6.2.4.2 System Simulation - System simulation results for the 18 good runs show an error at the 95th percentile of 287.79 feet; at the 99.5th percentile the error was 369.60 feet. These are fully compatible with DOT requirements. Error distribution curves are given in Figure 6-13. These results speak for themselves. They are based on 2184 measurements made over three days and nights of testing. Of the over two thousand measurements, only 1 had an error larger than 500 feet and only 5 had an error larger than 400 feet.

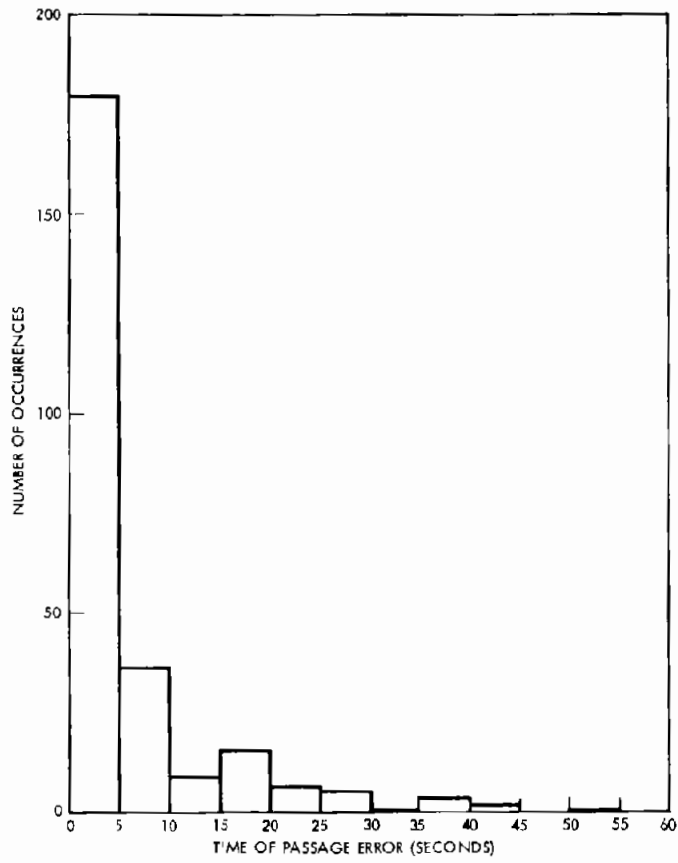
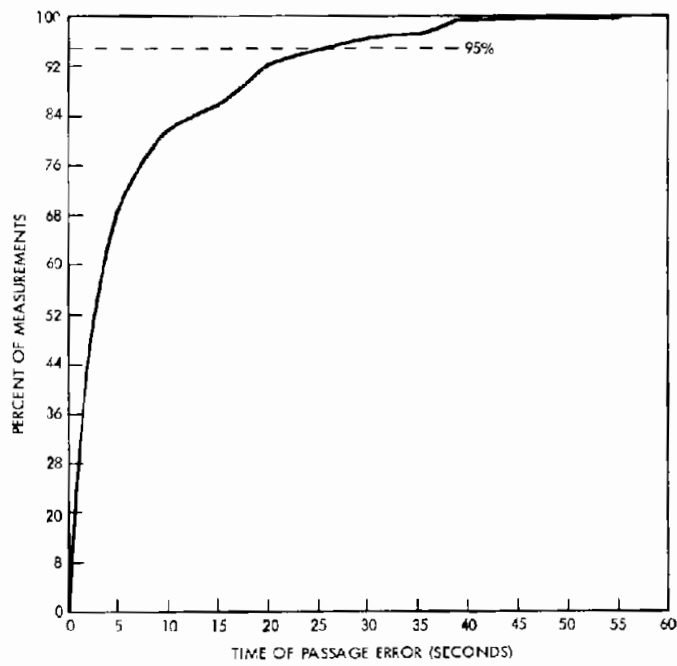
Figure 6-14A. Time of Passage Histogram
(Fixed Route Tests #10026 - 10047)

The time of passage errors for these runs were 26 seconds, 95%, and 42 seconds, 99.5%. Figure 6-14 shows these results. Some improvement is necessary to comply with the given requirements. Section 7 discusses a practical modification to the AVM System which will lower the time of passage errors to acceptable limits.

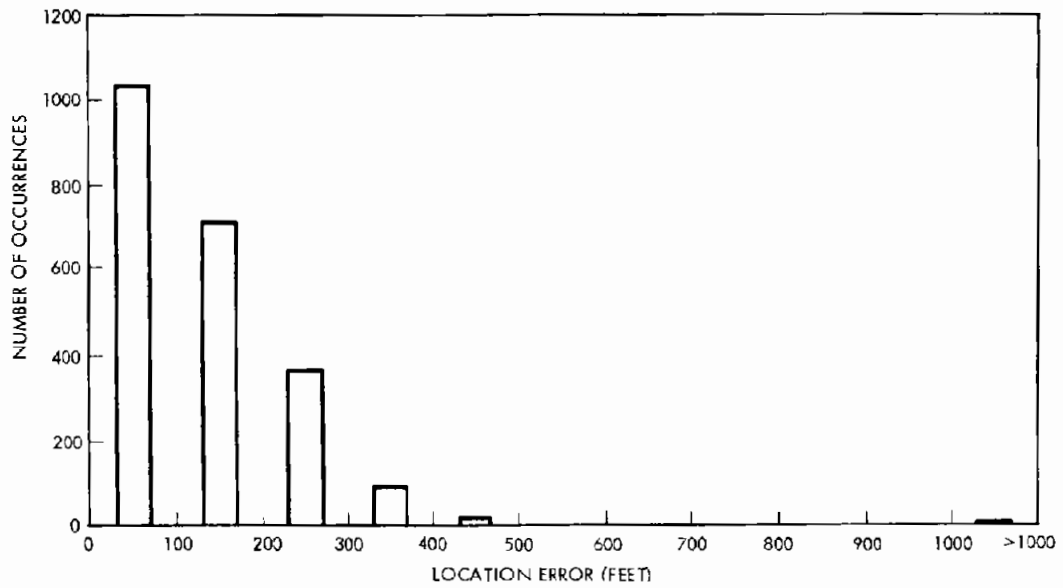
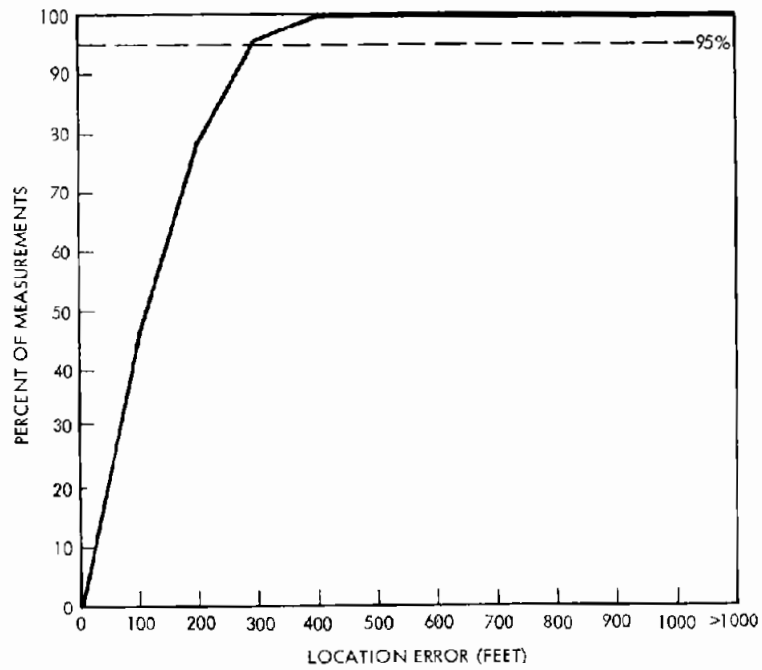
Figure 6-15A. Location Accuracy Histogram
 (System Simulation With 5% Missing Data)
 (Fixed Route Tests #10026 - 10047)

6.2.4.3 System Simulation With 5% Missing Data - These results are the most significant of the entire Phase I tests. Phase I was conducted to demonstrate the ability to perform in Phase II. The truest simulation of Phase II operation is the system simulation with missing data. Under conditions considerably less favorable than Los Angeles, the LORAN AVM System had an error of 291 feet at the 95th percentile and 383 feet at the 99.5th percentile. Both figures are under the stated requirements. Error distribution curves are presented in Figure 6-15.

Figure 6-15B. Cumulative Location Error
 (System Simulation With 5% Missing Data)
 (Fixed Route Tests #10026 - 10047)

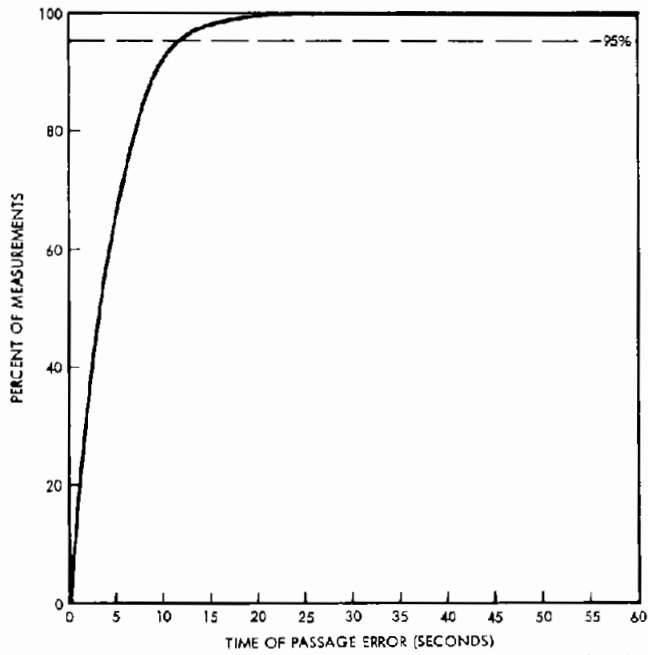
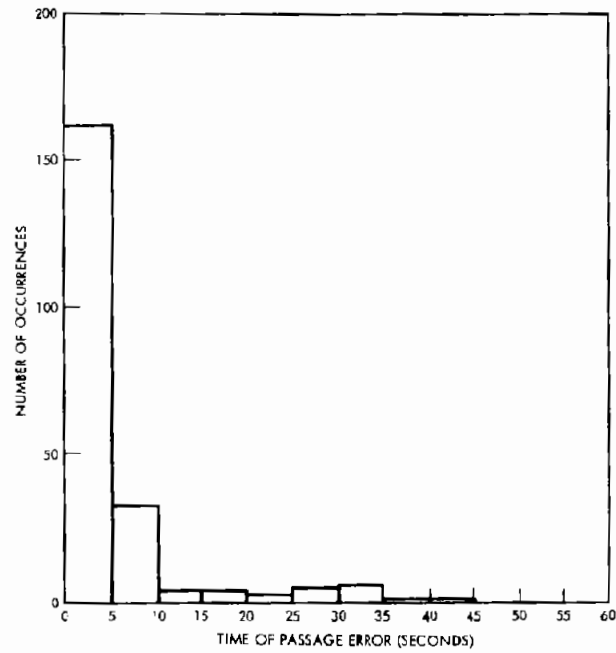
Figure 6-17A. Time of Passage Histogram
(All Points - Dead Time Removed)

Figure 6-17B. Time of Passage Cumulative Error
(All Points - Dead Time Removed)

Paragraph 7.2.1.2 in Section 7 explains how dead time may be removed from the TOP statistics. Figure 6-17 shows the systematic errors in the system with dead time removed. Figure 6-18 confirms the fact that dead time at stop time points caused excessive errors. The results in Figure 6-18 (no stop time

points) are not as good as the 'no dead time' results of Figure 6-17 because some time points were 'no stop' in name only.

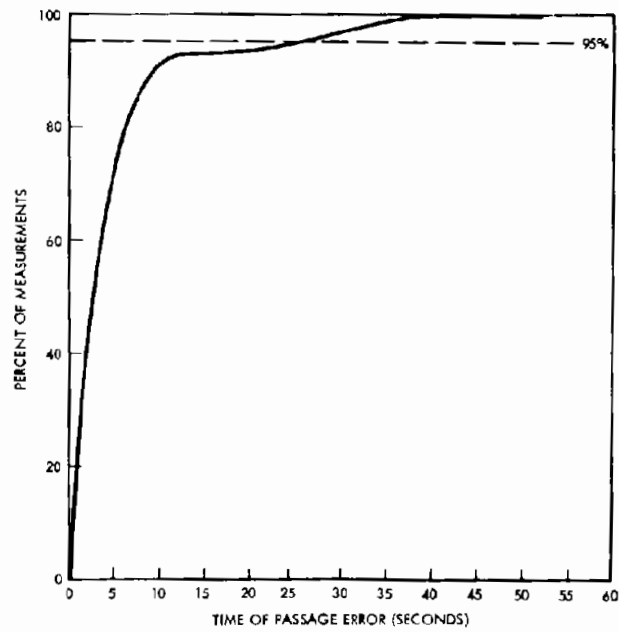
Figure 6-18A. Time of Passage Histogram
(No Stop Time Points)

Figure 6-18B. Time of Passage Cumulative Error
(No Stop Time Points)

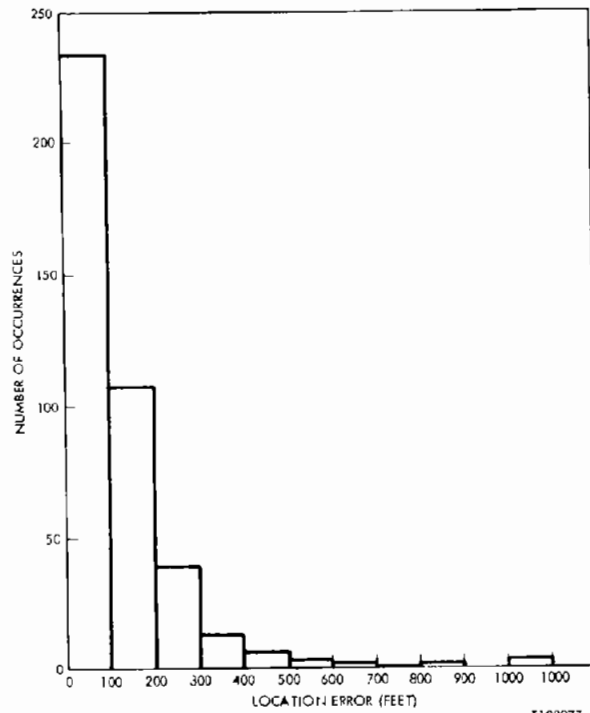
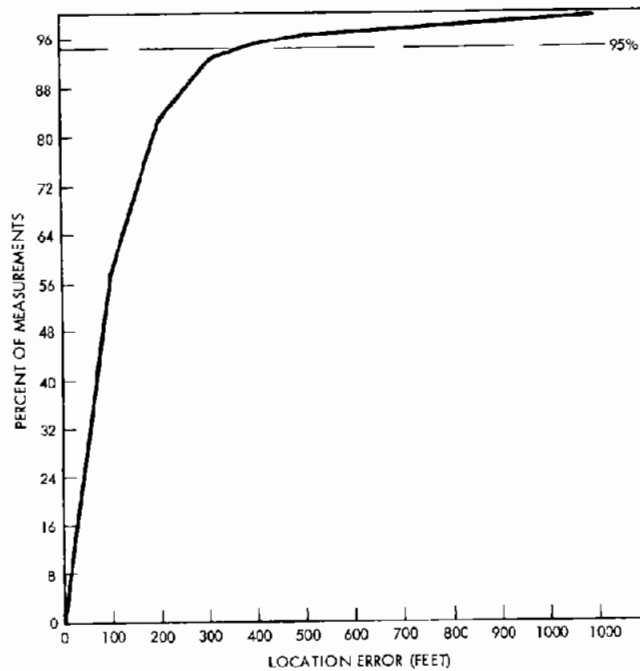
Figure 6-19A. Location Subsystem Histogram
(Random Route Tests #20001 - 20005)

Figure 6-19B. Location Subsystem Cumulative Error
(Random Route Tests #20001 - 20005)

The location subsystem error at the 95th percentile was 358.52 feet. At the 99.5th percentile it was 1,222.96 feet. Error distribution curves are shown in Figure 6-19. The 99.5% result is enough over the specified requirement to warrant a more detailed examination. The source of the 1,222.96 feet figure is found to be three measurements out of 406 with an error over 1,000 feet. As the histogram shows, 97.5% of all measurements had an error of less than 500 feet. While 1,222 feet, 99.5%, is by itself a disappointing statistic, realization that the 97.5% number is under 500 feet tends to put it in proper perspective.

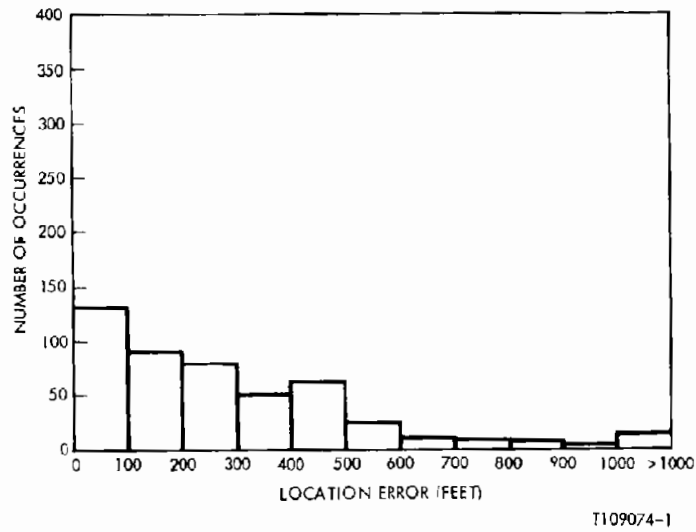
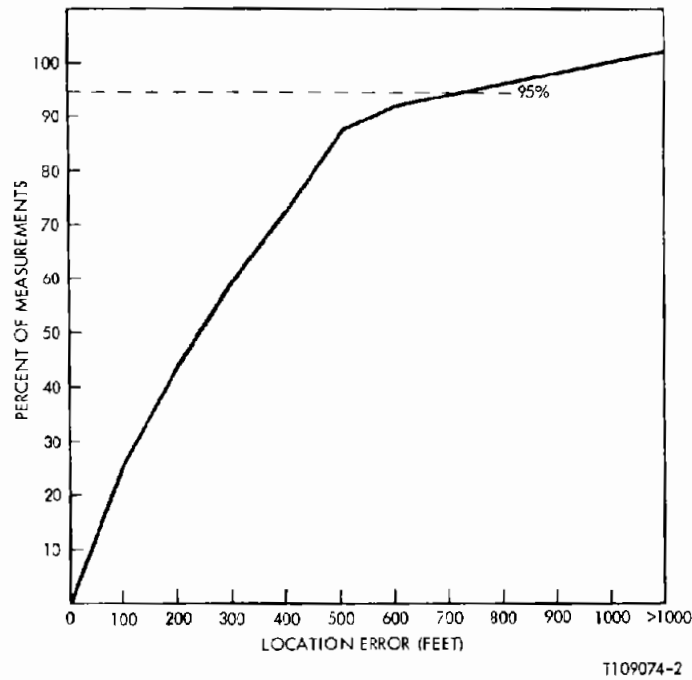
Figure 6-20A. Location Accuracy Histogram (System Simulation)
 (Random Route Tests #20001 - 20005)

Figure 6-20B. Cumulative Location Error (System Simulation)
 (Random Route Tests #20001 - 20005)

The system simulation of the random route tests gave a result at the 95th percentile of 691.16 feet and 819.17 feet at the 99.5 percentile. See Figure 6-20 for error distribution. These results are considerably in excess of the system requirements. Post-test examination of the random route location software revealed obvious means of improving accuracy. Two of the simpler improvements were implemented and the test data rerun. A marked improvement in system accuracy resulted. These results are shown previously in Table 6-1C under "improved software." As the table shows, the error at the 95th percentile was reduced to 475.89 feet and the 99.5% error came out 819.17 feet. See Figure 6-22 and 6-23 for the improved software error distribution. Obviously, additional improvement is needed. Time did not allow more elaborate software modifications to be evaluated for inclusion in this report. Some powerful software changes are discussed in Section 7, however, which have the potential of driving system errors below the specified values. In addition, some hardware modifications are discussed which could contribute a great deal to a more accurate random route system.

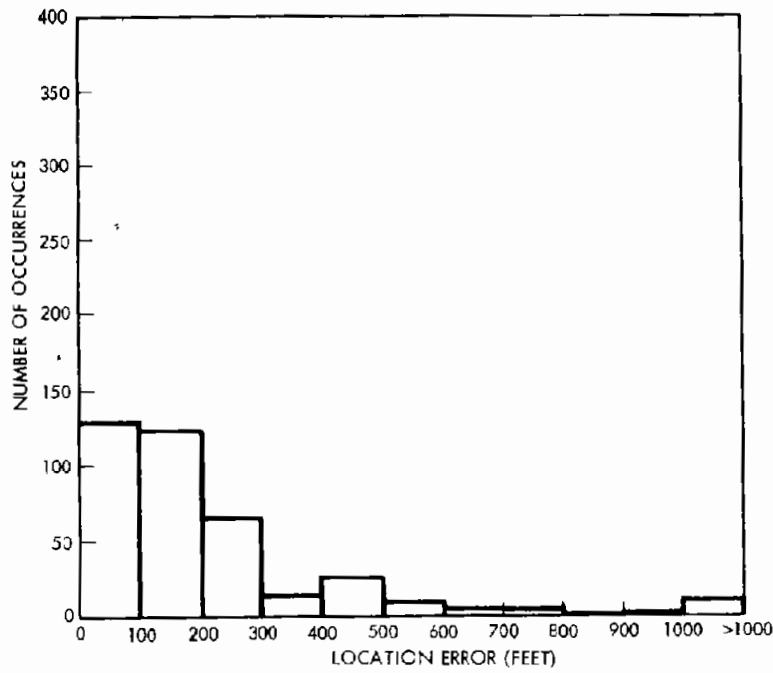
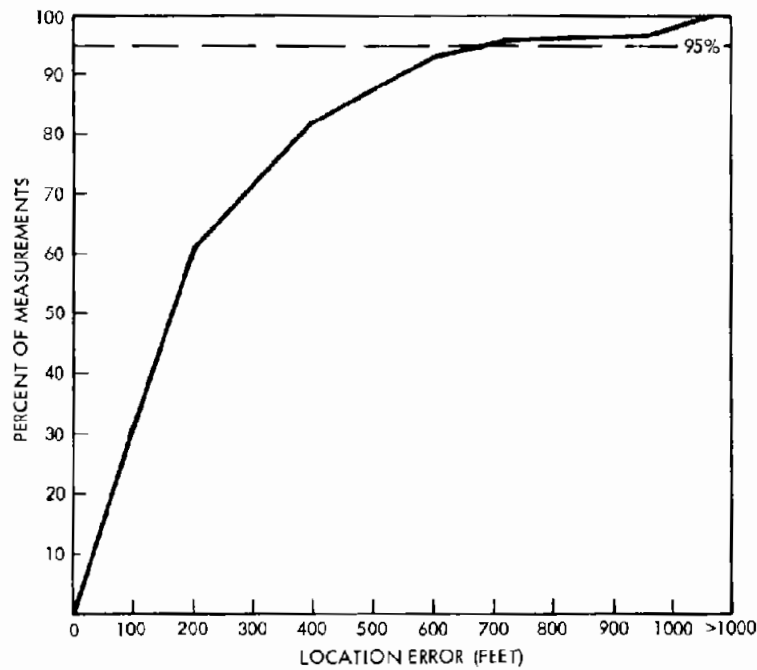
Figure 6-21A. Location Accuracy Histogram
(System Simulation With 5% Missing Data)
(Random Route Tests #20001 - 20005)

Figure 6-21B. Cumulative Location Error
(System Simulation With 5% Missing Data)
(Random Route Tests #20001 - 20005)

With 5% of the data removed the errors using the original software were slightly degraded; at the 95th percentile 752.55 feet and 1,293.11 feet at the 99.5 percentile. Using improved software they were 472.94 feet and 819.17 feet, respectively. As with the fixed route results, missing 5% of the data did not appreciably decrease accuracy. Improvement is required, however, as discussed in paragraph 6.3.2. See Figures 6-21 and 6-23 for error distributions of original and improved software, respectively.

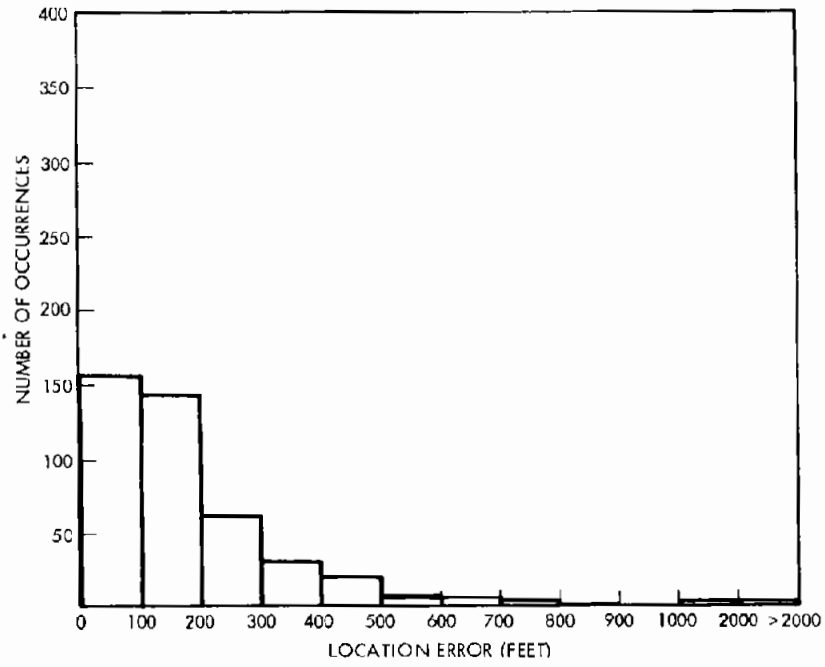
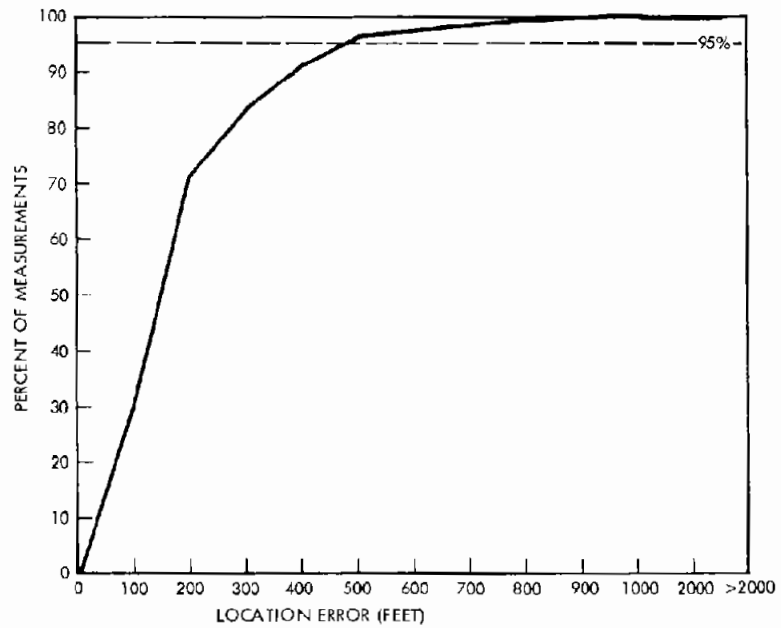
Figure 6-22A. Location Accuracy Histogram
 (System Simulation With 5% Missing Data and Improved Software)
 (Random Route Tests #20001 - 20005)

Figure 6-22B. Cumulative Location Error
 (System Simulation With 5% Missing Data and Improved Software)
 (Random Route Tests #20001 - 20005)

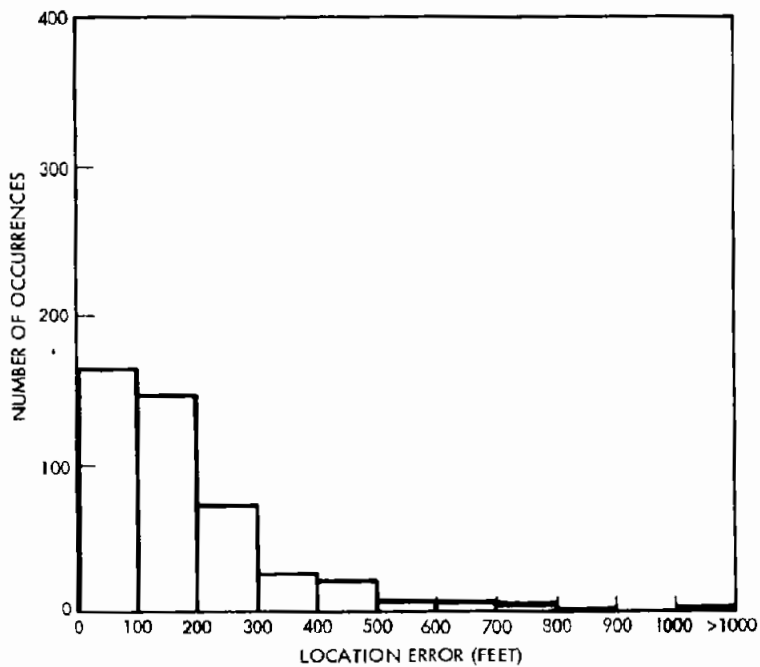
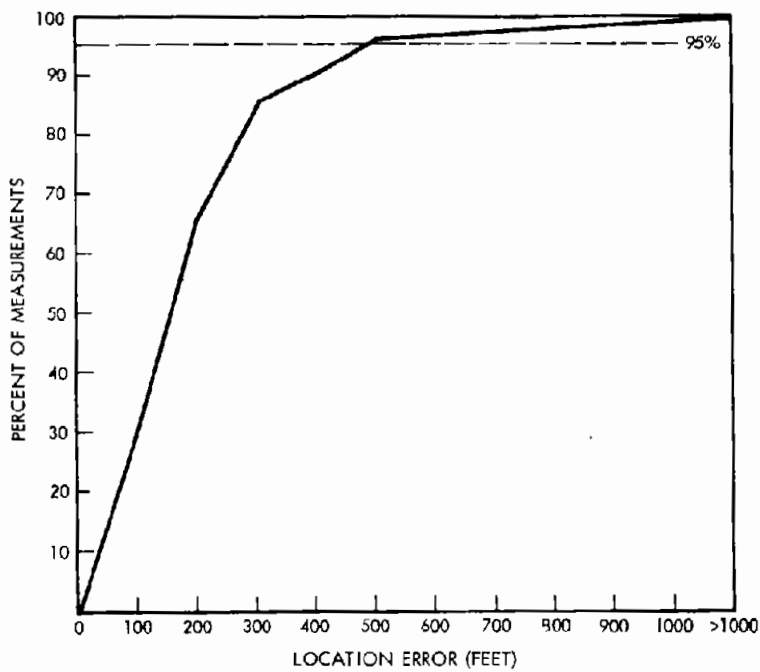
Figure 6-23A. Location Accuracy Histogram
(System Simulation and Improved Software)
(Random Route Tests #20001 - 20005)

Figure 6-23B. Cumulative Location Error
(System Simulation and Improved Software)
(Random Route Tests #20001 - 20005)

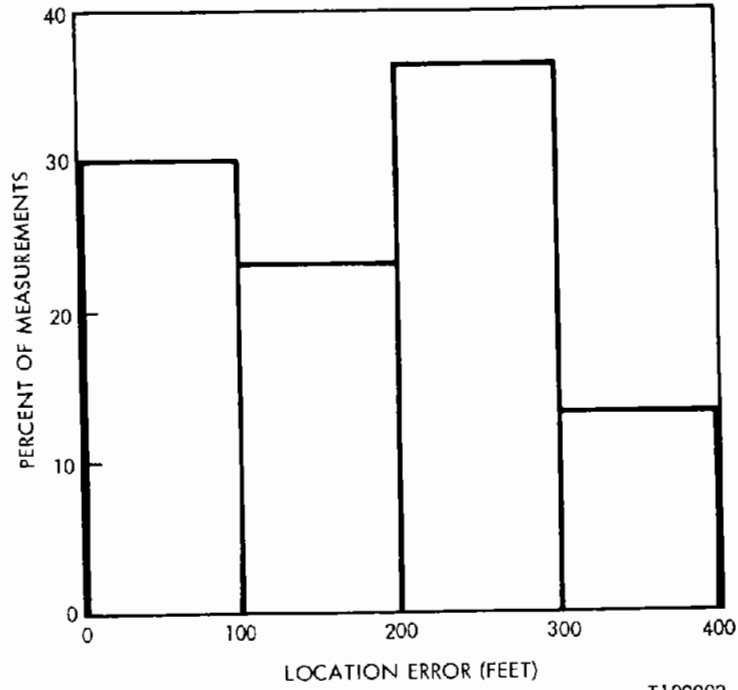
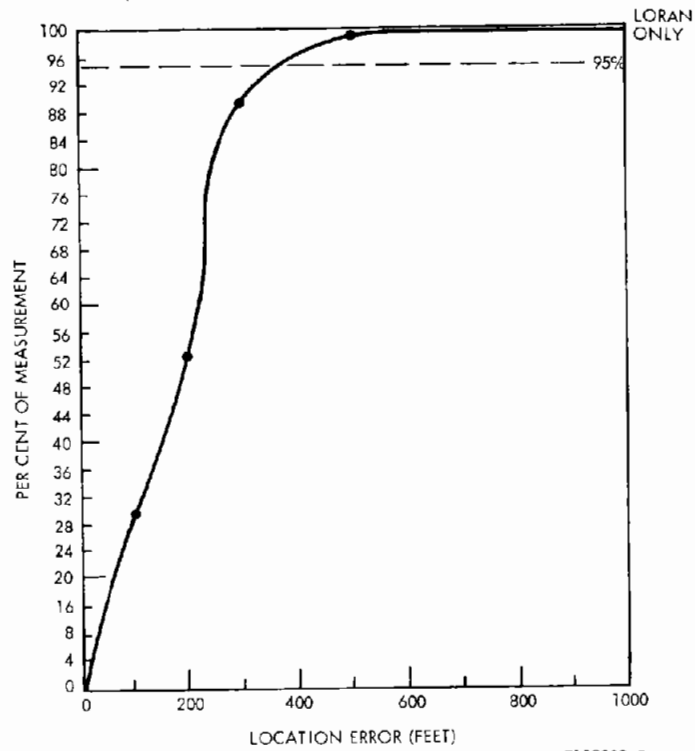
Figure 6-24A. LORAN Only Test - Location Accuracy Histogram (32 Second Fixed Polling)

Figure 6-24B. LORAN Only Test - Location Cumulative Error (32 Second Polling)

6.4.1.1 LORAN Only Test - The LORAN Only Test was run to demonstrate the location accuracy of the LORAN system component without benefit of any augmentor updates. The test was run in an area with good SNR although this was still poorer overall than the measured SNR in Los Angeles. The results show an error of 325.32 feet at the 95th percentile and 375.68 feet at the 99.5th percentile. A Phase II study should be made of a LORAN only system which derives location and time of passage solely from LORAN and odometer inputs. Some degradation in performance would be analyzed in a trade off with reduced costs of deleting all augmentors. Error distribution of the LORAN Only Test results is shown in Figure 6-24.

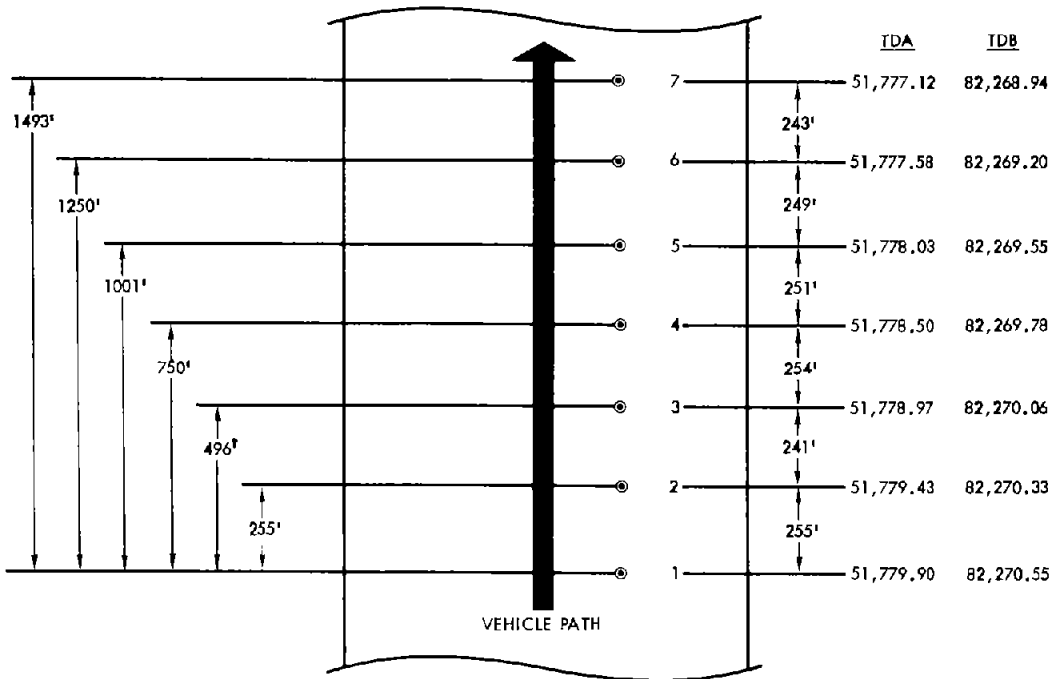
Figure 6-25. Runway Path and Checkpoint Diagram

6.4.1.2 LORAN Speed/Lag Test - The results of the LORAN Speed Tests are given in Tables 6-6 through 6-15 and Figure 6-26. Figure 6-25 depicts the path and important measurements for the interpretation of the data. Calibration information was taken just as for the random and fixed routes. The results of the calibration are shown in Table 6-6. The gradient along the path used was .00186 microsecond/foot for time difference "A" and .00107 microsecond/foot for time difference "B." The Root Sum Square (RSS) standard deviation for TDA and TDB calibration was 69.4 feet. Tables 6-8 through 6-15 show the results of the speed tests in terms of radial, TDA, and TDB errors in feet for 10, 20, 30 and 40 MPH, respectively.

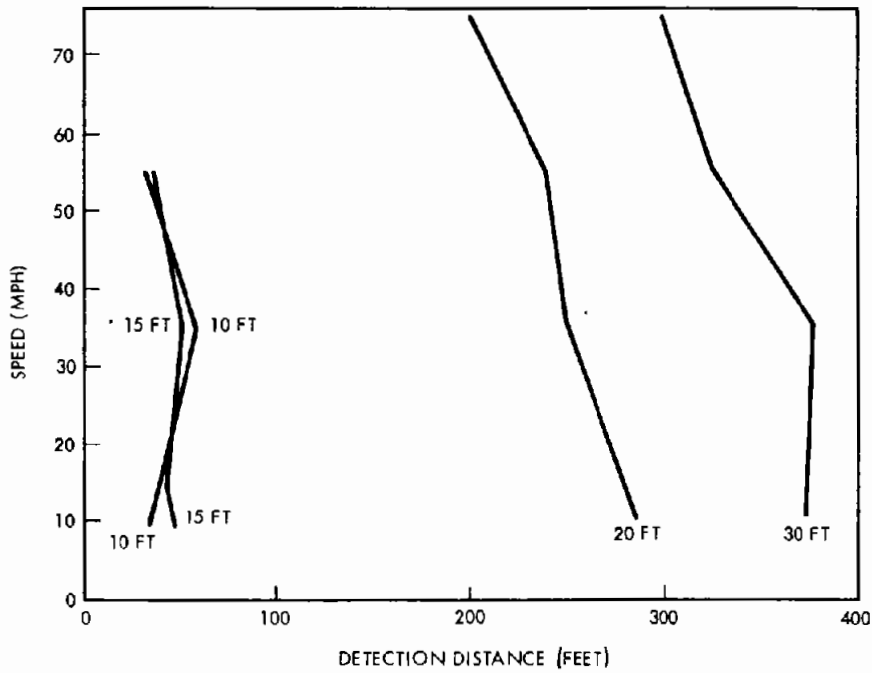
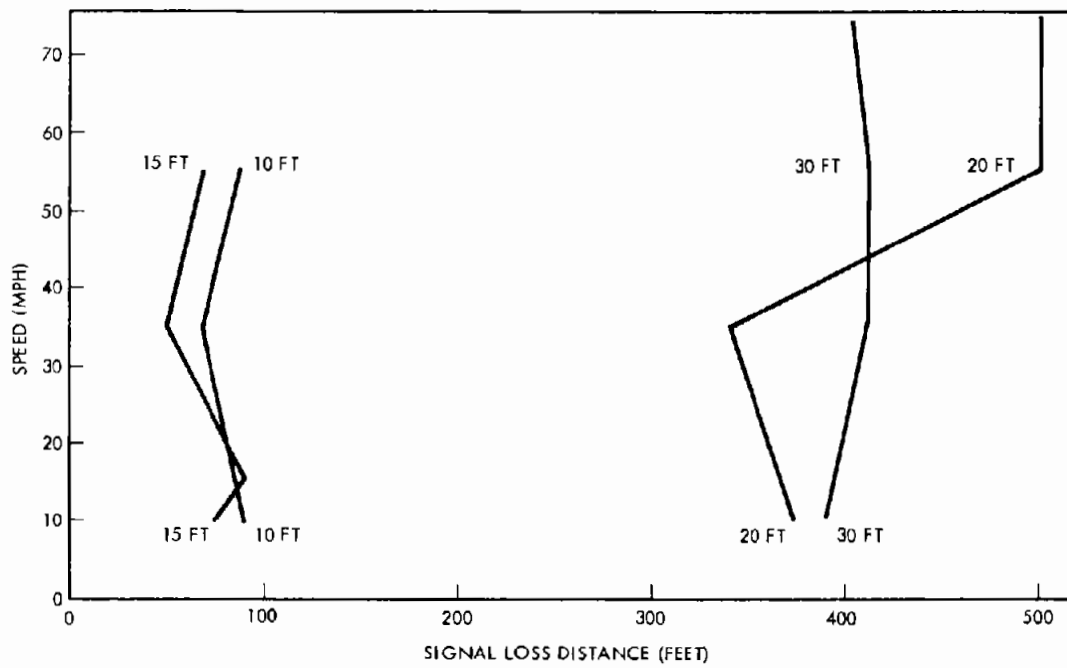
Figure 6-27A. Vehicle Speed Vs. Detection Distance

Figure 6-27B. Vehicle Speed Vs. Signal Loss Distance

6.4.2.1 Augmentor Coverage vs. Vehicle Speed - The results of the augmentor coverage versus vehicle speed tests are shown in Table 6-18 and Figure 6-27. As can be seen in Figure 6-27A, at low augmentor elevations of 10 feet and 15 feet, the speed of the vehicle (10 to 55 MPH) had little effect on the detection and signal loss distances. Detection distances ranged from 30 to 60 feet prior to reaching an augmentor, and loss distances ranged from 50 to 90 after passing an augmentor.

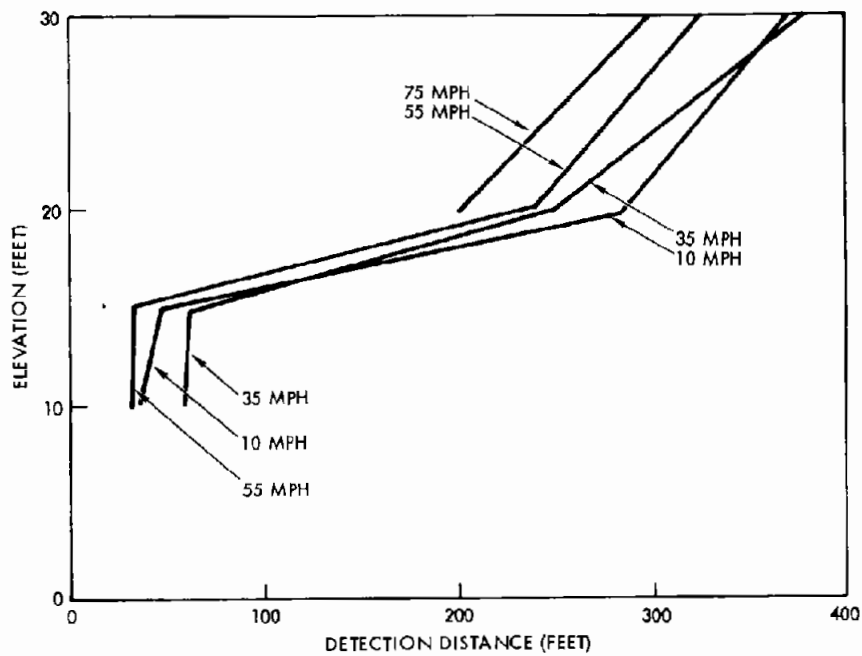
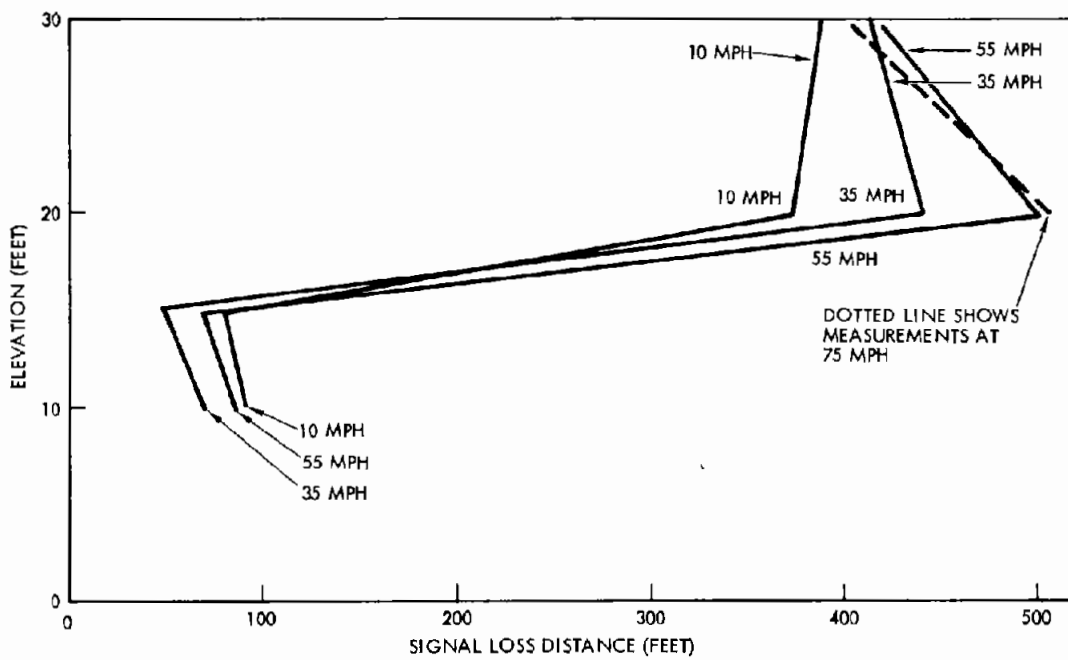
Figure 6-28A. Augmentor Elevation Vs. Detection Distance

Figure 6-28B. Elevation Vs. Loss Distance

6.4.2.2 Augmentor Coverage and Elevation - Figure 6-28 and Table 6-19 represent the results of the Augmentor Coverage versus Augmentor Elevation tests. At all vehicle speeds (10, 35, 55, and 75 MPH) the detection distance of the Augmentors increased with Augmentor Elevation. The increase followed the same pattern for 10, 35 and 55 MPH: there was virtually no increase in detection distance (15 Ft or less) as elevation increased from 10 to 15 feet. At this point a large increase in detection distance occurred: as elevation increased 5 more feet, an increase of from 200 to 240 feet was noted. Then as the elevation was further increased 10 more feet, a more gradual increase in detection distance of 85 to 130 feet occurred. At 75 MPH only two data points were plotted, and the results showed an increase of 100 feet in detection distance as elevation was raised 10 feet in going from 20 to a 30 foot height.

The curves plotted in Figure 6-28B to depict the effect of elevation on loss distance show that for vehicle speeds of 10, 35, and 55 MPH a small decrease in the loss distance of up to 20 feet took place in raising the elevation 5 feet from the 10 to 15 foot level. As the elevation was raised from the 15 to 20 foot height a large increase in loss distance of from 290 to 430 feet occurred. At this point, as the elevation was increased 10 feet to the 30 foot height, results varied with a small increase of 20 feet at 10 MPH to decreases of 30 and 80 feet at 35 and 55 MPH, respectively. Again at 75 MPH, only two data points were plotted, and these show a decrease in signal loss distance of 100 feet as elevation was raised from the 20 to 30 foot level.

In summary, these results show that as elevation increases the detection distance of an augmentor increases, and the effect is much more pronounced at heights above 15 feet. An increase of 10 to 17 feet in detection distance can be seen with each foot of increased elevation. Loss distances also increase with increases in elevation with the most pronounced increase at the 15 to 20 foot level; however, at lower elevations (below 15 feet) and higher elevations (above 20 feet) small decreases or increases in loss distance can occur.
