LORAN
AUTOMATIC VEHICLE MONITORING SYSTEM

PHASE I
FINAL REPORT

VOLUME I
TEST RESULTS

MARCH 1977

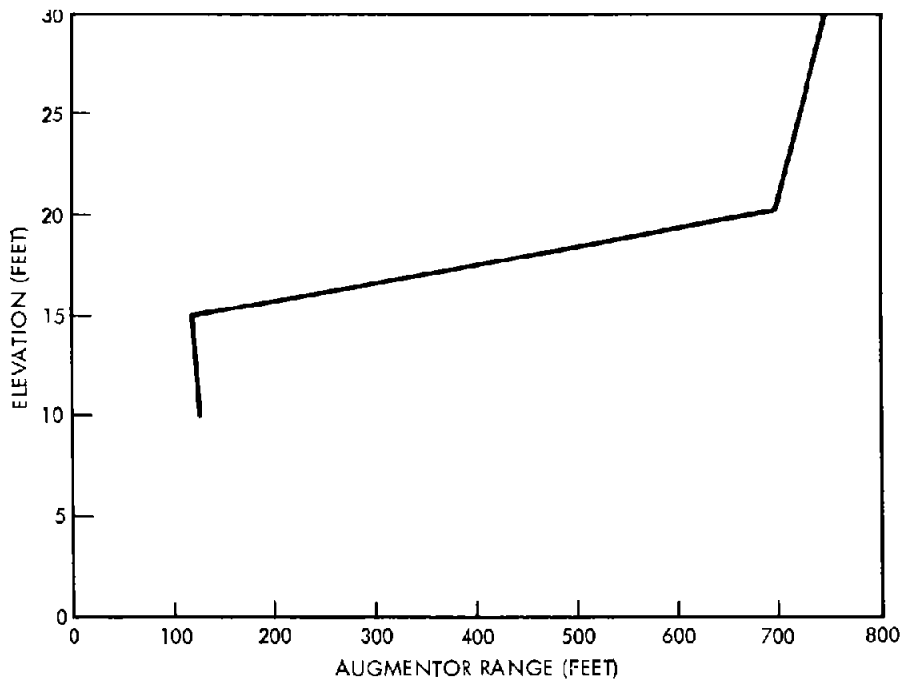
Figure 6-29. Augmentor Range Vs. Elevation

The mean ranges are plotted in Figure 6-29. As Augmentor Elevation increased from the 10 to 15 foot elevation, only a slight decrease of 10 foot of range occurred. In going from 15 to 20 foot elevation a large increase in range of 584 feet was observed. Finally, in going from the 20 to 30 foot height, an increase of 50 foot in range was noted.

In summary, these results indicate at low elevations of 10 to 15 feet, small Augmentor ranges of less than 125 feet occur. At higher elevations to 30 feet large ranges of up to 750 feet occur, and at these elevations above 15 feet, increases in elevation cause large increases in range.

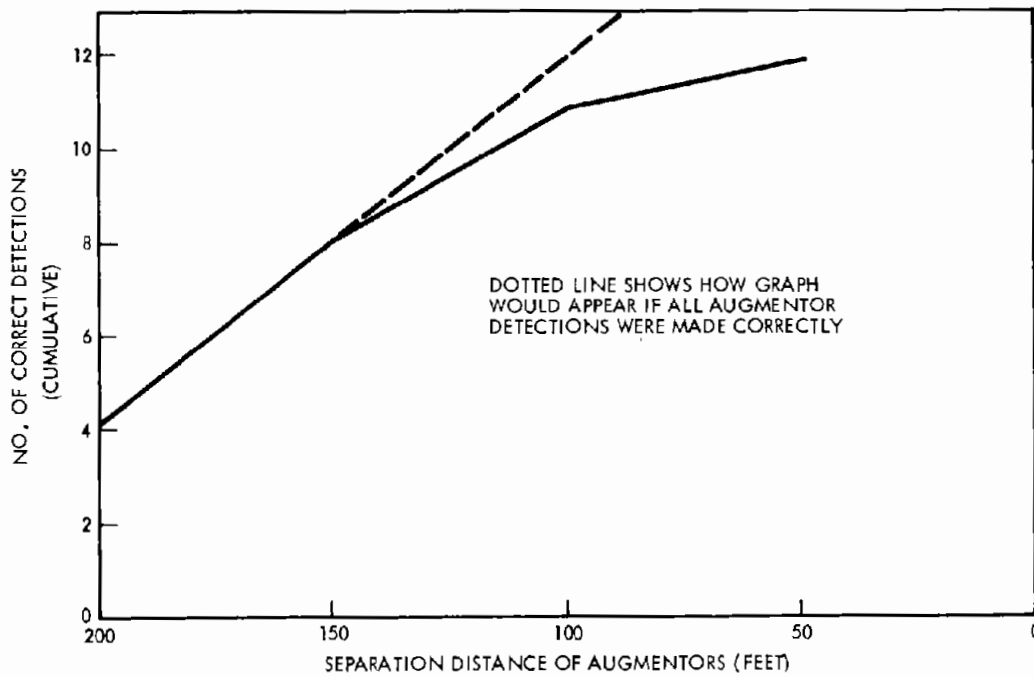
Figure 6-30. Augmentor Separation Distance vs. Number of Correct Detections (Cumulative)

6.4.2.4 Augmentor Interference Tests - The results of the Augmentor Interference tests are given in Table 6-21 and Figure 6-30. From the data analyzed, interference between augmentors which can cause erroneous detections or non-detections occurred as the separation between augmentors was reduced to 100 feet. The number of incorrect detections at this distance was one out of four attempts. This situation worsened as the distance was further reduced to 50 feet. The incorrect detections in this case were observed to be three out of four attempts.

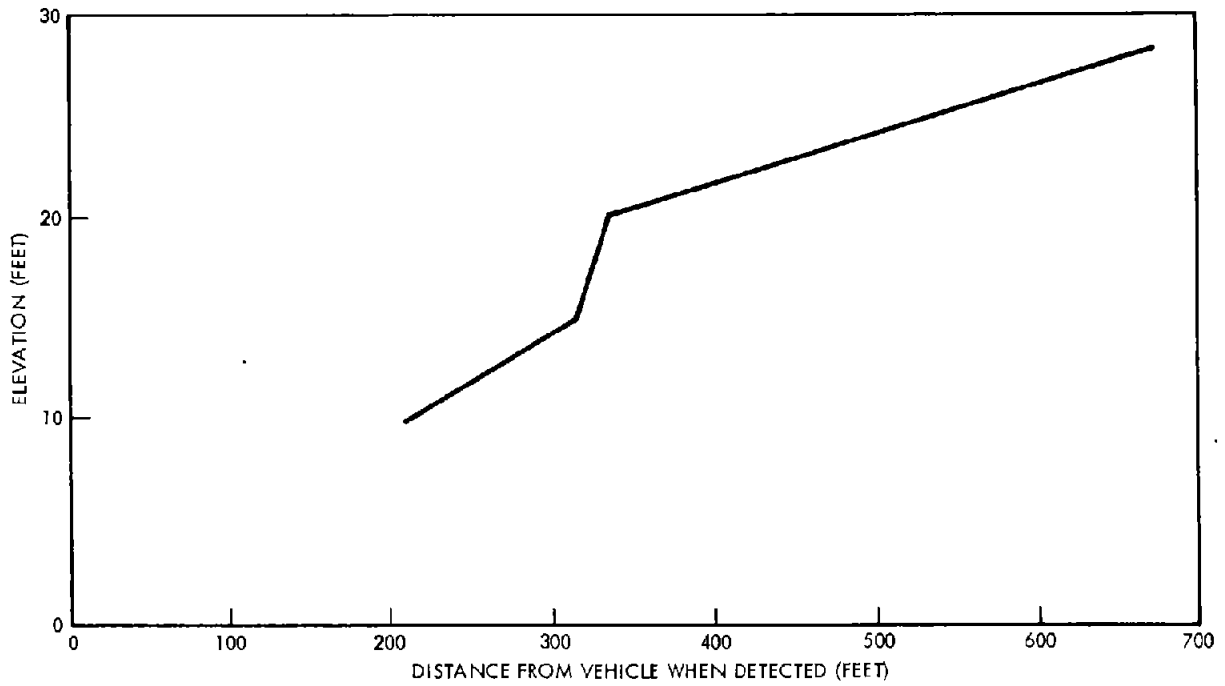
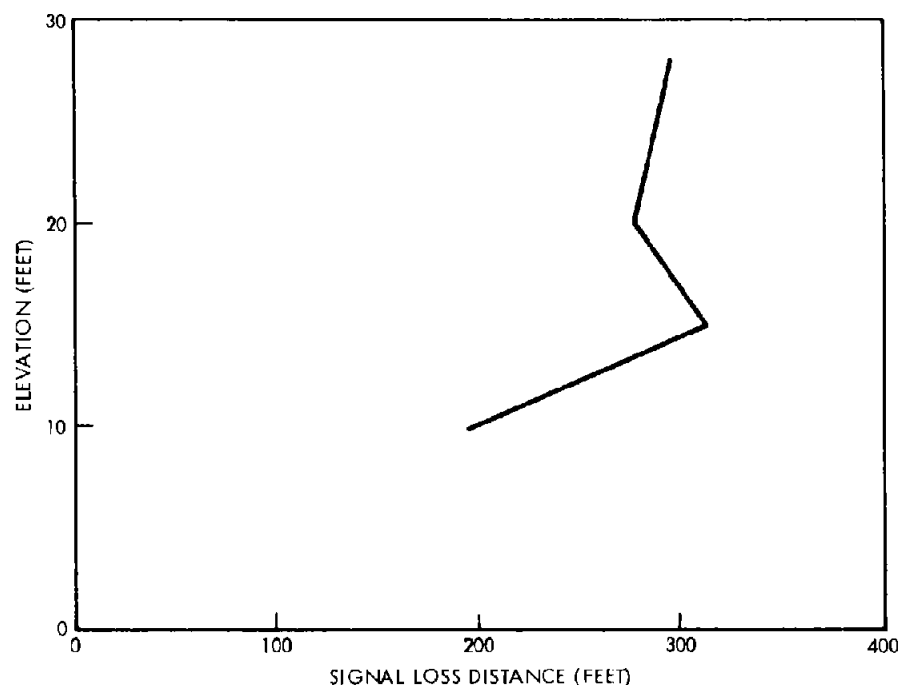
Figure 6-31A. Augmentor Detection Distance (In Traffic) Vs. Elevation

Figure 6-31B. Augmentor Signal Loss Distance (In Traffic) Vs. Elevation

6.4.2.5 Augmentor Detection in Traffic - In traffic the augmentor detection distance increased as the augmentor elevation increased. At a 10 foot elevation the detection distance was 205 feet and increased to 670 feet at a 28 foot elevation. Table 6-22 and Figures 6-31 show the results of the test.

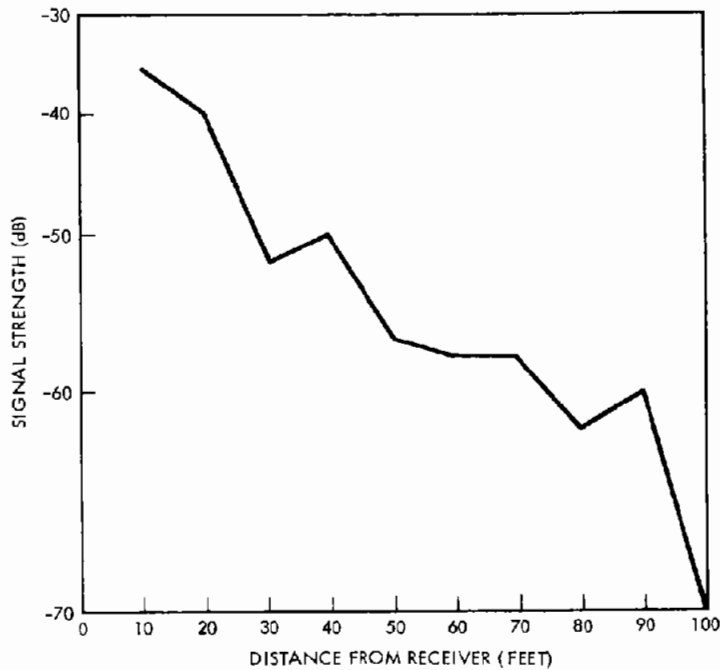
Figure 6-32. RFI Test - Augmentor Signal Strength versus Distance

6.4.2.6 Augmentor RFI Tests - The data from the Augmentor RFI tests is given in Table 6-23 and plotted in Figure 6-32. The 3 dB bandwidth (from data sheet) of the center frequency of 72.96 MHz was 350 Hz. Figure 6-32 shows the decrease in signal strength of the 72.96 MHz carrier as it was located farther and farther from the test vehicle. Signal loss occurred at 100 feet. The decrease in signal strength seemed to follow a curve of 0.25 dB/ft.

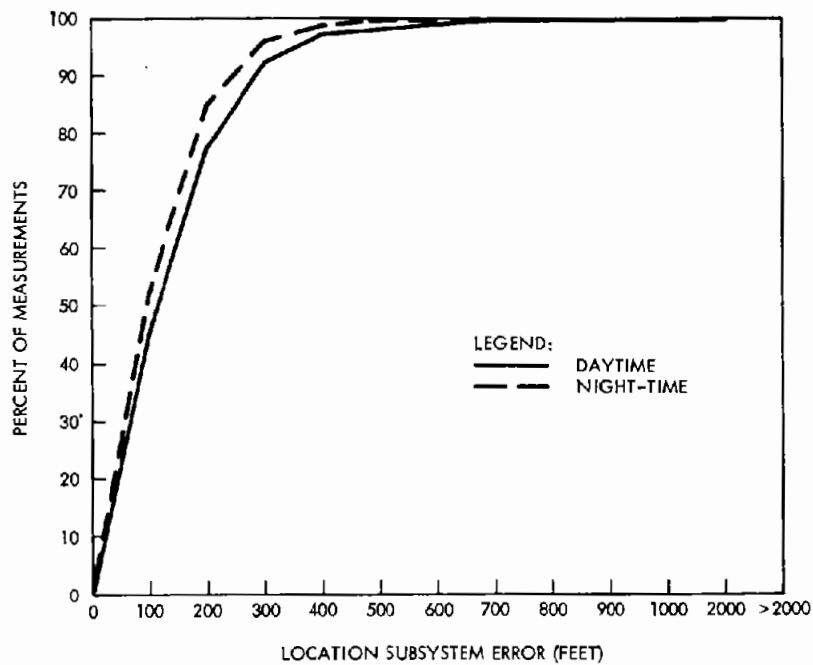
Figure 6-37. Fixed Route Cumulative Error By Time of Day

improvement in signal conditions in the 80 - 120 kHz band after sunset, a much more realistic explanation of the improvement is a decrease in local noise and interference sources as the activity in the city slows down at the end of the day. In band interference is a major source of LORAN errors because it contaminates the LORAN measurements without triggering low SNR indicators. After dark, many such interference sources such as business electrical equipment, spurious radio transmissions, and high voltage power transmission slow down or cease.

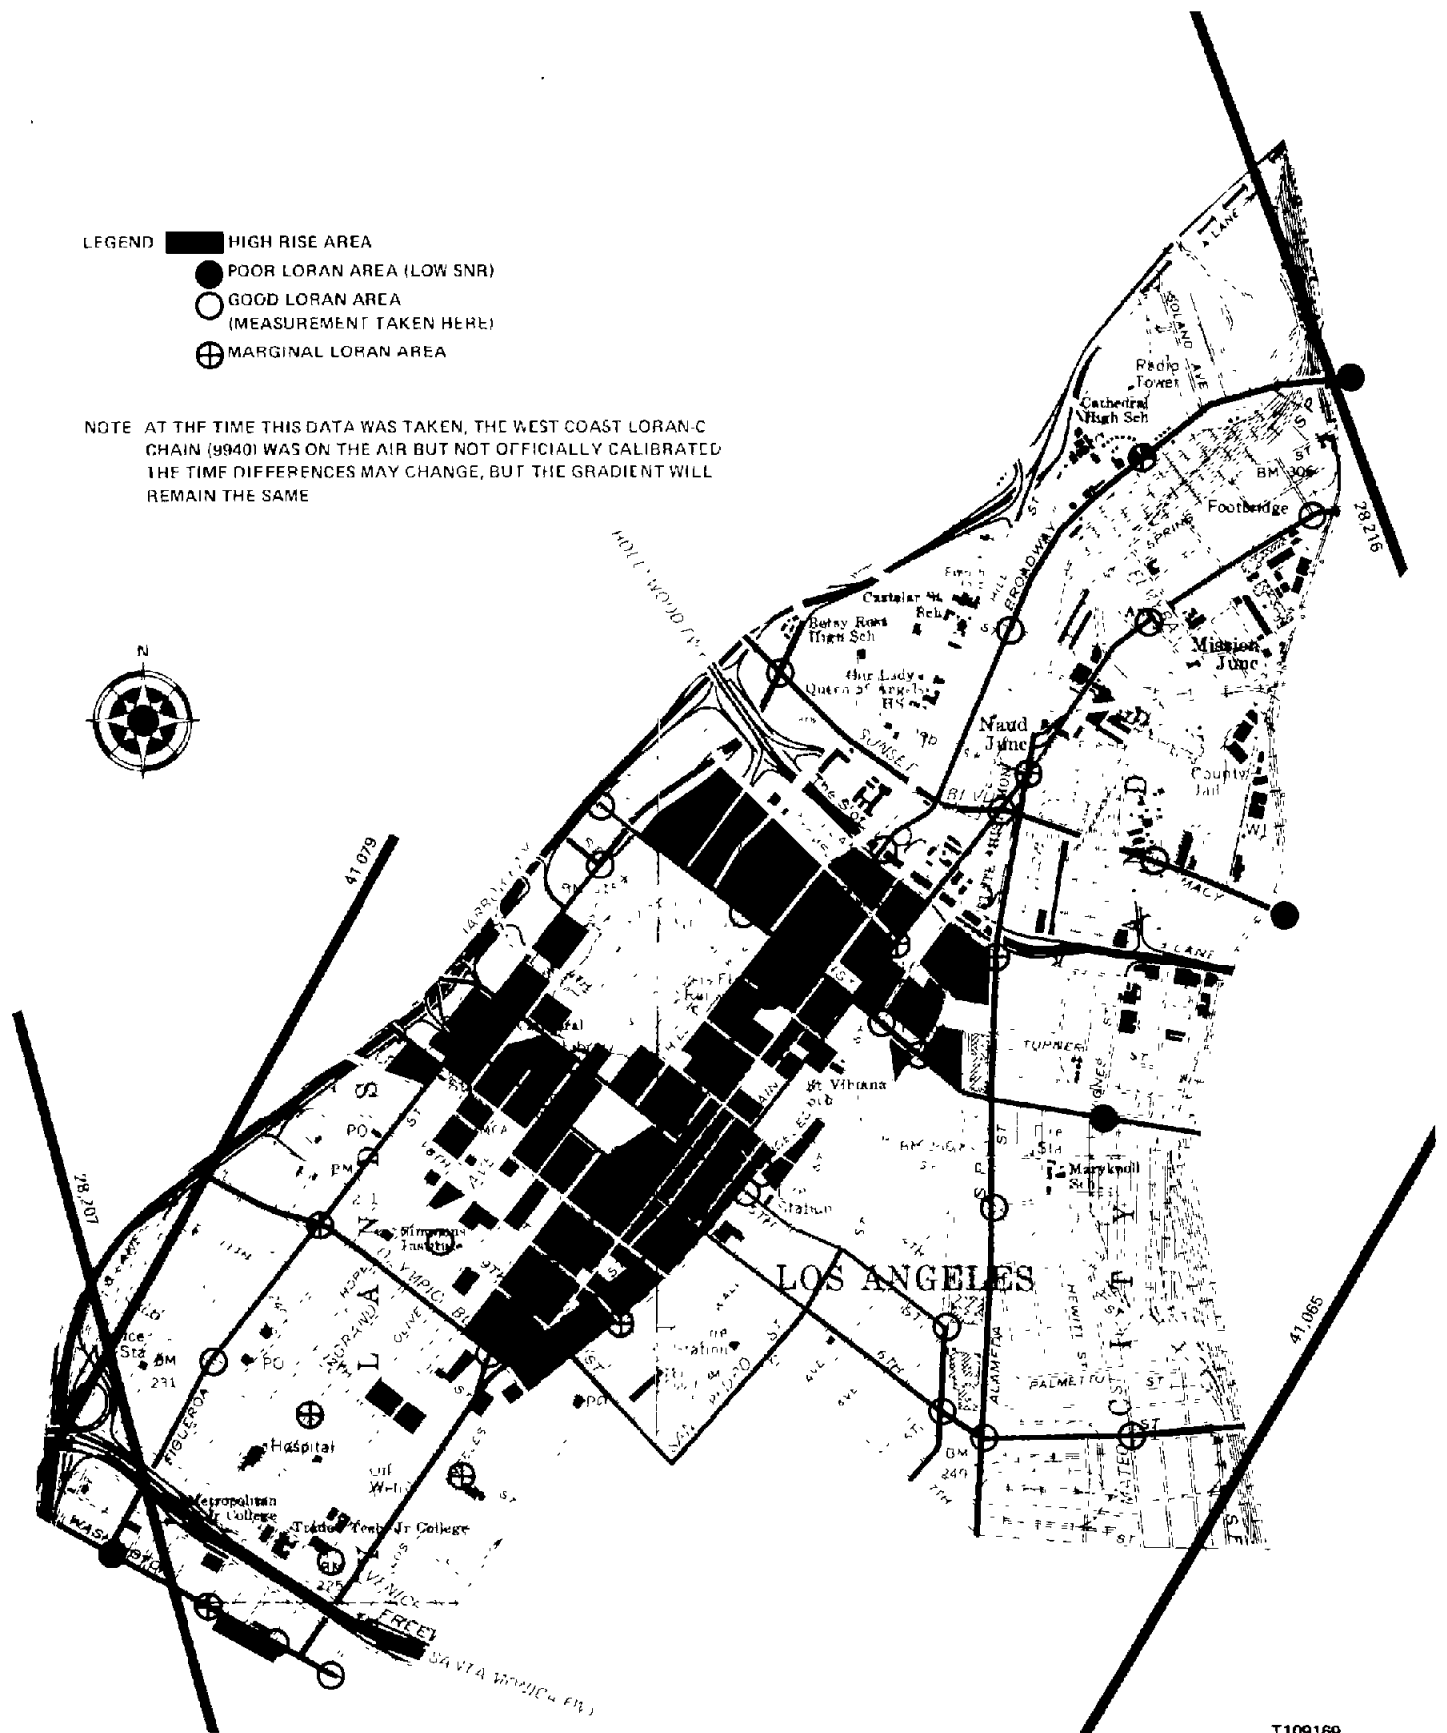
Figure 7-1. LORAN Coverage in the Phase II Random Route Area

Random route coverage to the stated accuracy of 300 feet 95% will still require some augmentors. Figure 7-1 shows 9 points within the random route area which do not have adequate LORAN. An additional 6 points are shown with an SNR in the range +6 db to +12 db. Conceding that not every possible street intersection was surveyed (as will be the case in Phase II), the points shown should be interpreted as indicative of conditions in the immediate (1 block radius) vicinity. Further conceding that an SNR of more than +12 db does not automatically guarantee a location determination to within 300 feet, the proposed Phase II augmentor figure is still an estimate. At the same time, however, the earlier estimate of 192 augmentors in addition to time points is clearly excessive. The current estimate of 31 augmentors in the random route area is based on present knowledge of conditions in the area. As more survey work is completed during Phase II it should be expected that the estimate of 31 augmentors will again be changed with the probability of decreasing requirements equal to that of increasing.

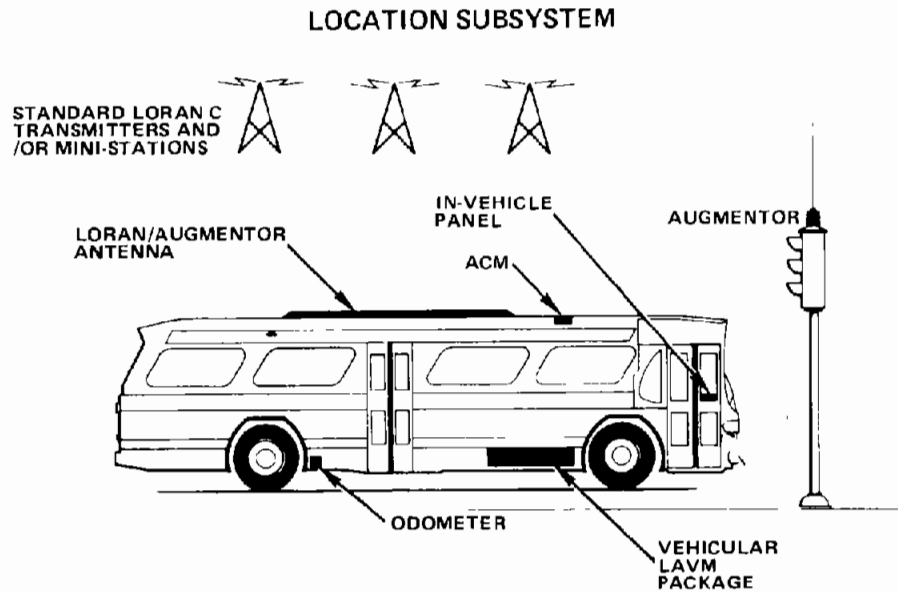
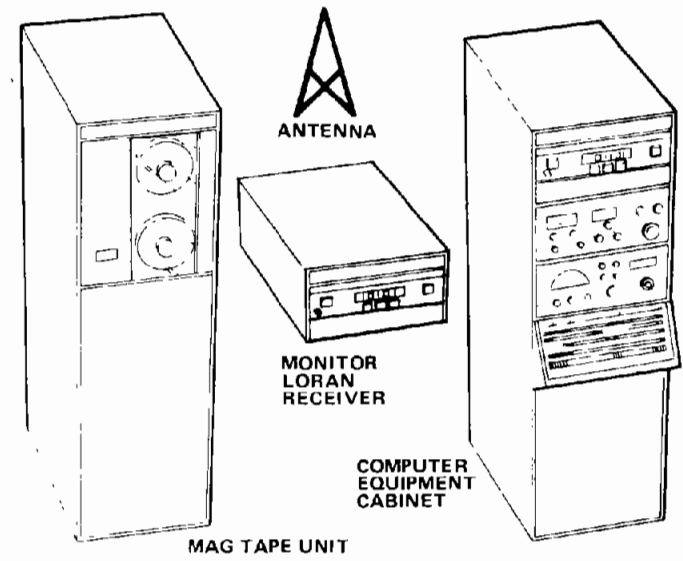
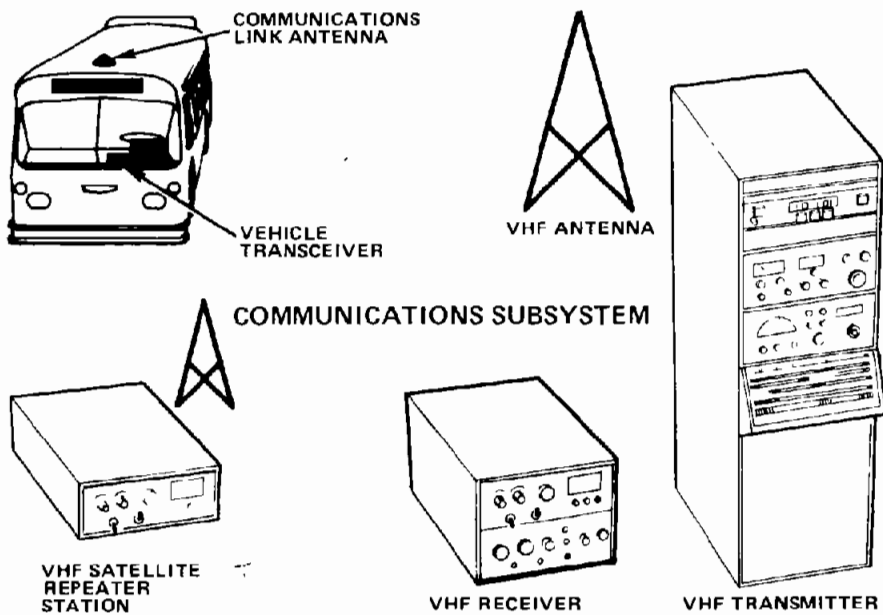
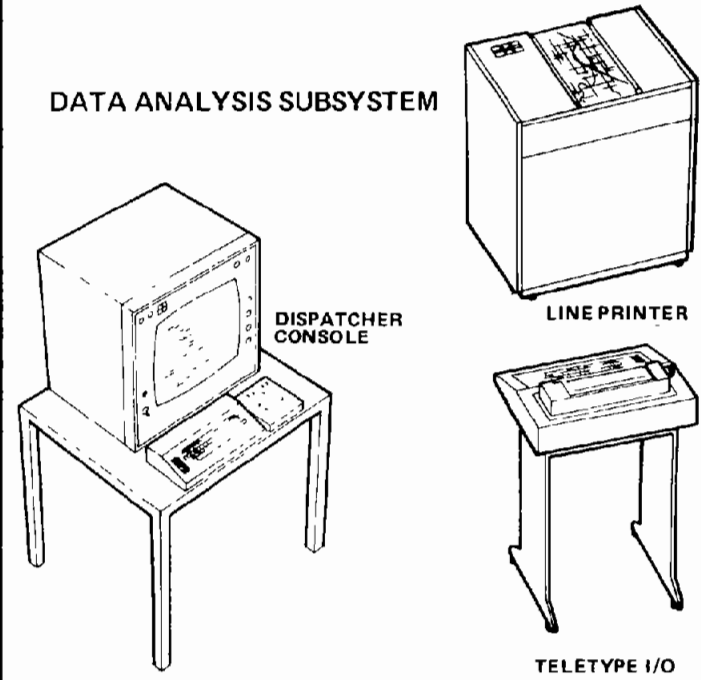
Figure 1-6. LAVM System

Figure 1-6 is the AVM Pictorial Diagram of the system and the associated signal flow block diagram is Figure 1-9.

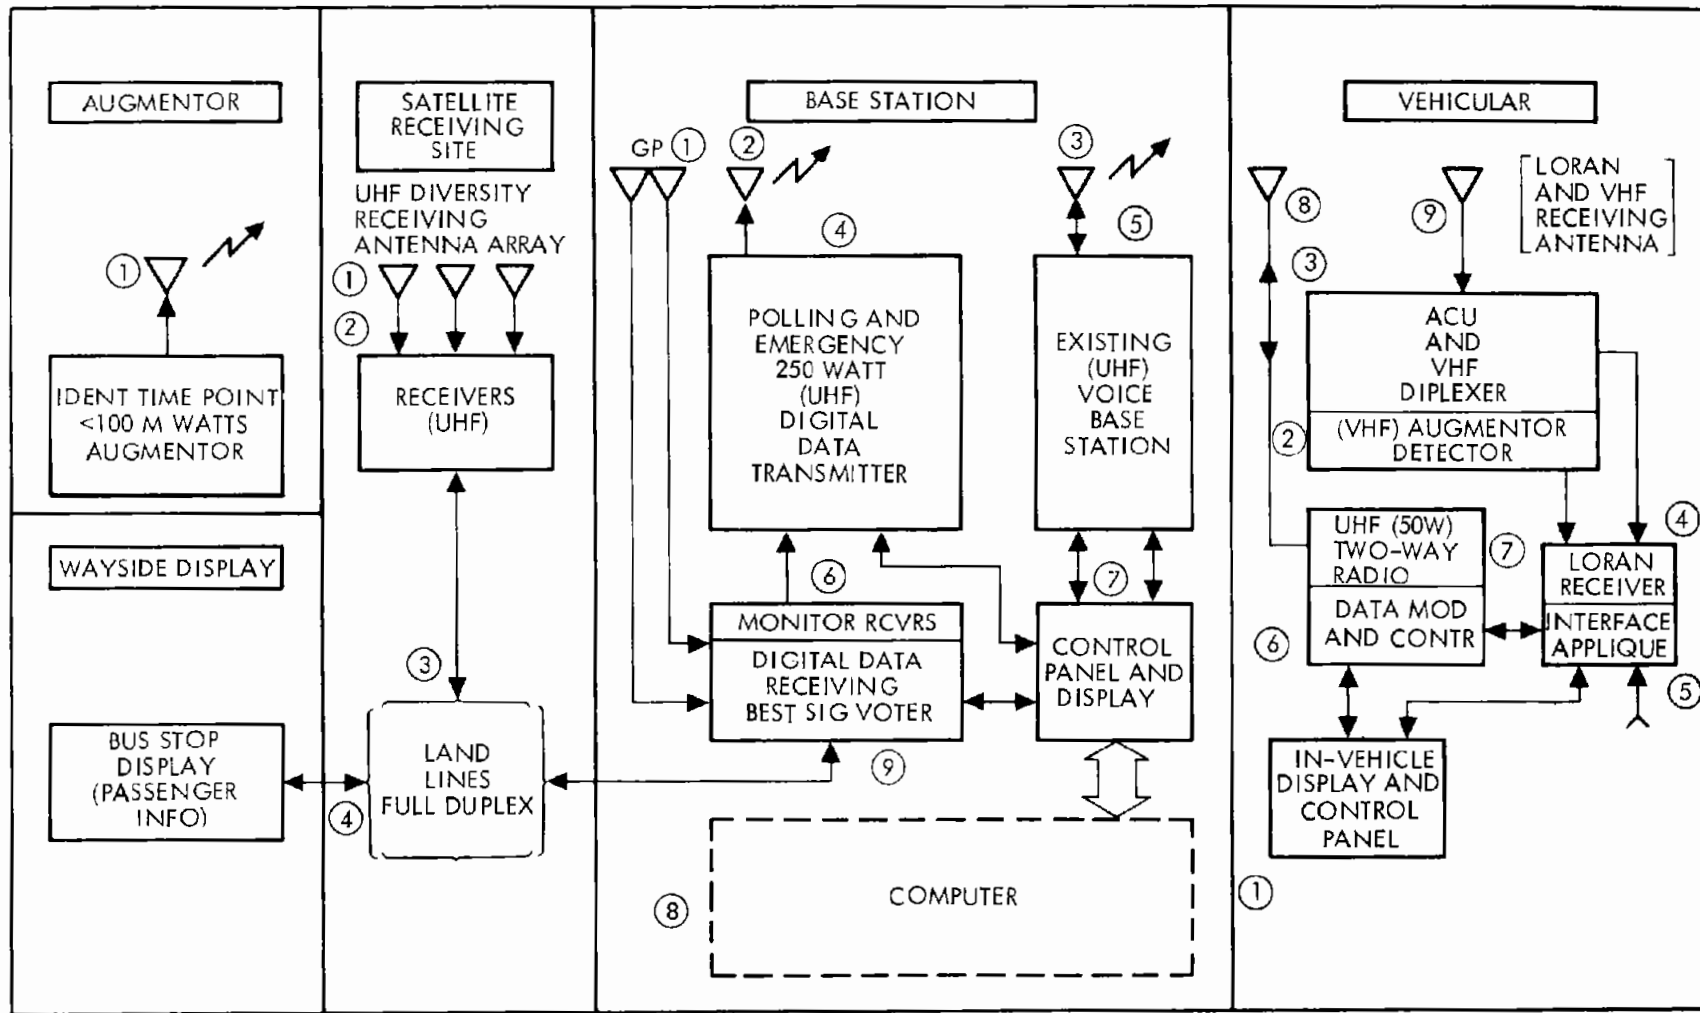
Figure 1-9. LAVM System Block Diagram

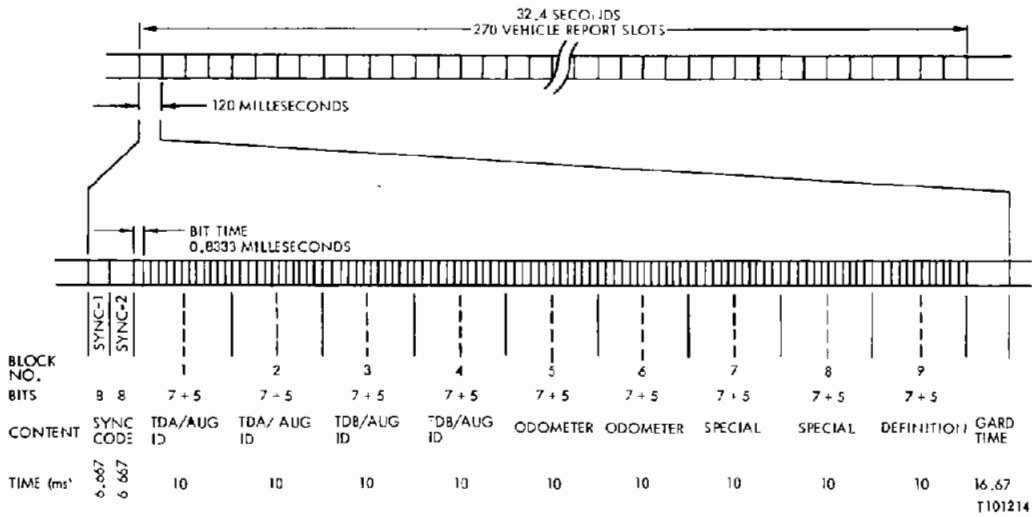
Figure 2-9. Vehicle Transmission Sequence

Vehicle to Base Information - Figure 2-9 shows the entire vehicle fleet data transmission sequence. The 32.4 second report cycle time is divided into 270 vehicle report slots corresponding to the 270 possible polls (18 x 15 = 270). Each vehicle when polled transmits 124 data bits in 120 milliseconds which includes 16.67 milliseconds of guard time for each vehicle transmission. This is done at a 1200 bits per second rate.

Note 3. Bit is sent once per 15 vehicle polling block. This is special poll designated "A" in Figure 2-9. All vehicles receive - all vehicles with unacknowledged alarm condition reply.

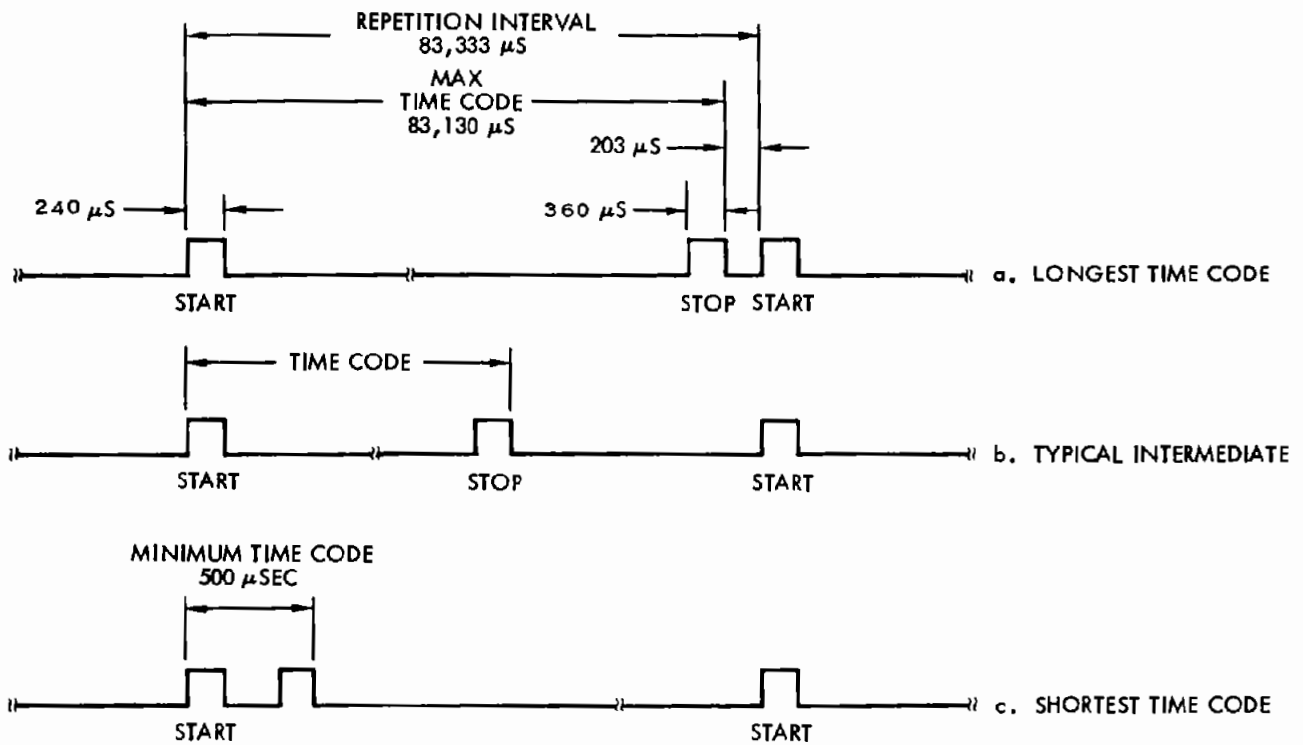
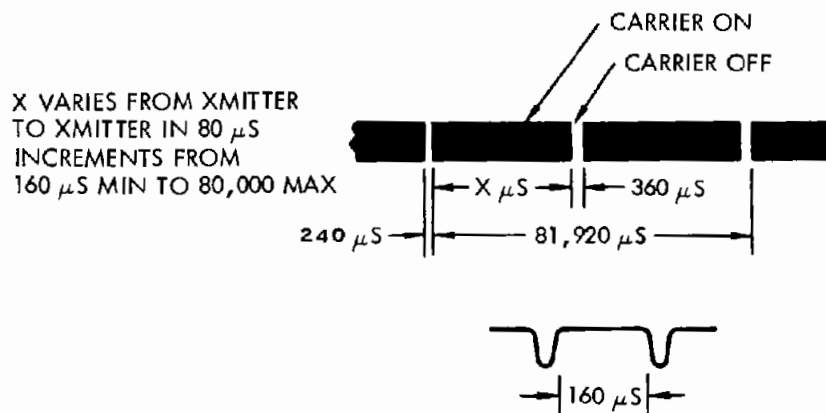
Figure 2-28. Augmentor Timing Code

MODULATION IS ON-OFF CARRIER KEYING. TRANSMISSION FORMAT:

ASSUME A 40 μ SEC RISE TIME $\left[f = \frac{1}{4} = \frac{1}{40 \times 10^{-6}} = \frac{10^6}{40} \right] = \frac{1}{4} 10^5 = 25 \text{ KHz}$

DOUBLE SIDEBAND AM

$\therefore \text{BW} = 8 \times \frac{1}{4} \times 10^5 = 2 \times 10^5 \text{ OR BW} = 200 \text{ KHz}$
