Special Study of Precast Concrete Tunnel Liner Demonstration

Lexington Market Tunnels Baltimore, Maryland

FINAL REPORT

Report No.
UMTA-MD-06-0039-81-1

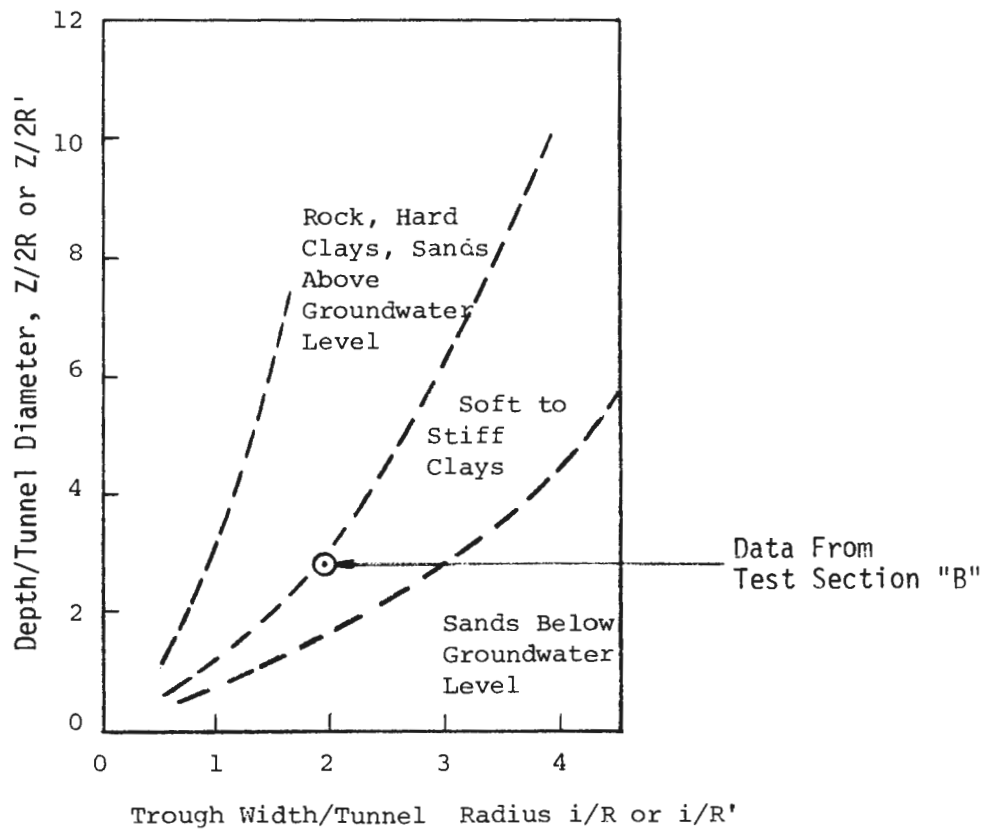
FIGURE 70. COMPARISON OF WIDTH OF SETTLEMENT TROUGH WITH PECK (1969)

In elastic ground, the volume of soil which is lost into a tunnel can be expected to cause a settlement trough of equal volume at the ground surface. This response has generally been noted to be true in tunnels driven in clay. However, in granular soils volume changes can develop. In dense granular soil, the soils above the shield can expand and become looser as they ravel into the voids created by the construction. The expansion of the soil causes the volume of the settlement trough at the ground surface to be less than the volume of ground lost into the tunnel. In loose granular soil, the opposite could be expected to occur whereby the soil would decrease in volume and become denser above the tunnel, creating a settlement trough whose volume is greater than the volume of soil lost

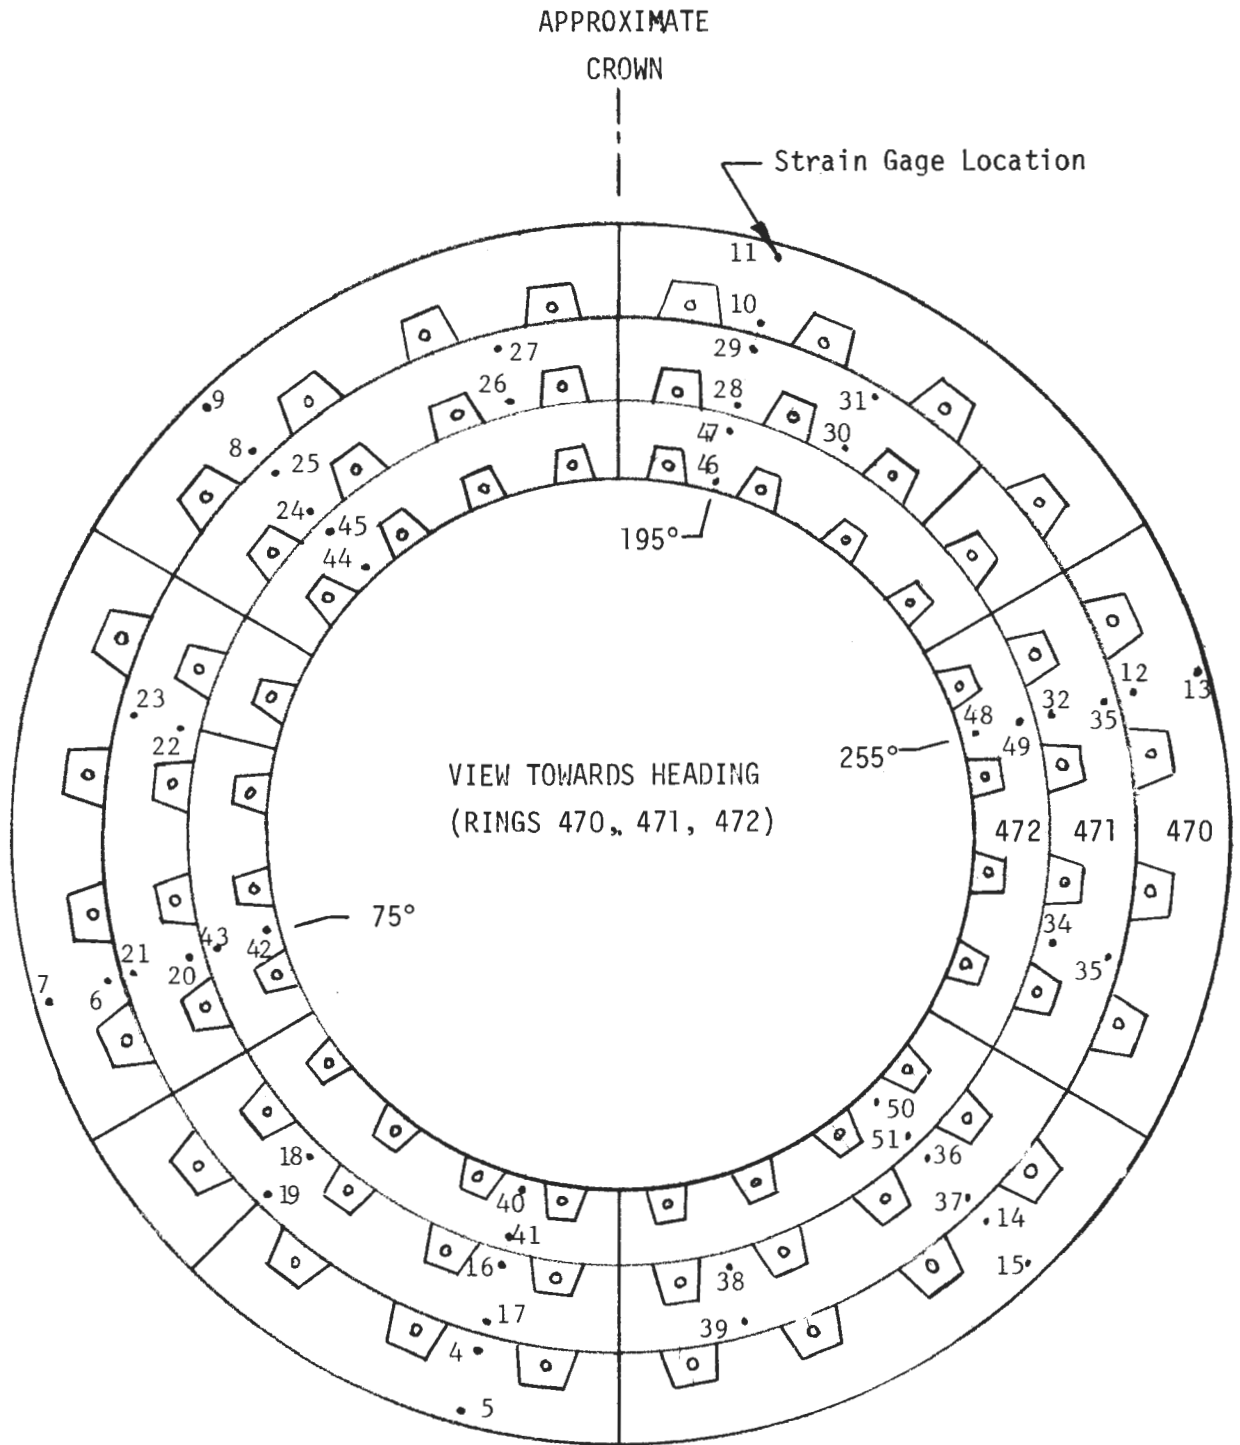
FIGURE 113. RING AND STRAIN GAGE CONFIGURATION AT TEST SECTION B.

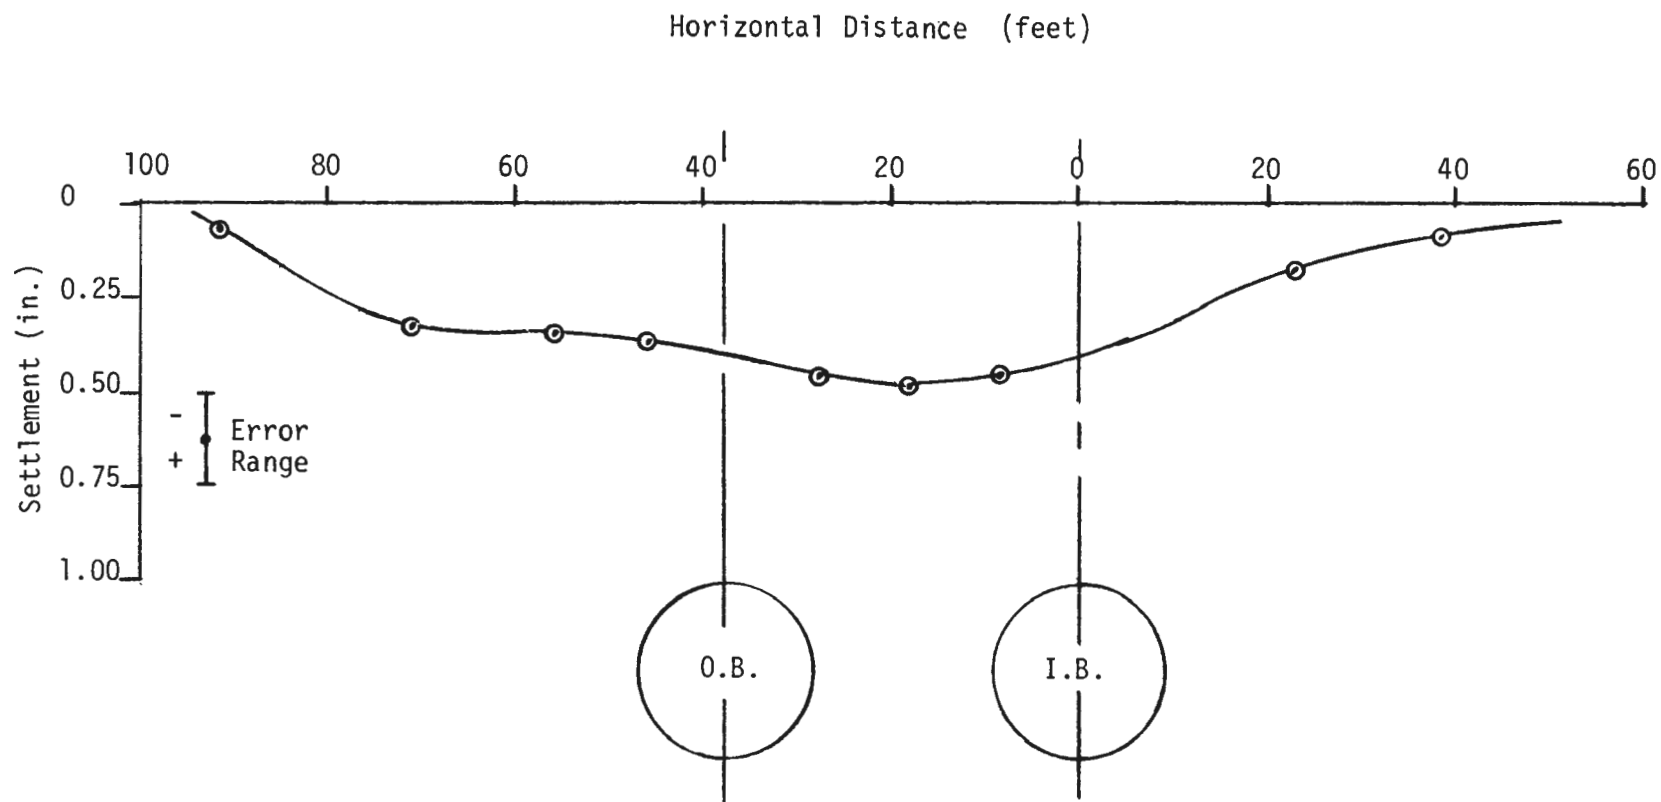
FIGURE 120. SURFACE SETTLEMENT OUTBOUND TUNNEL ONLY, TEST SECTION A

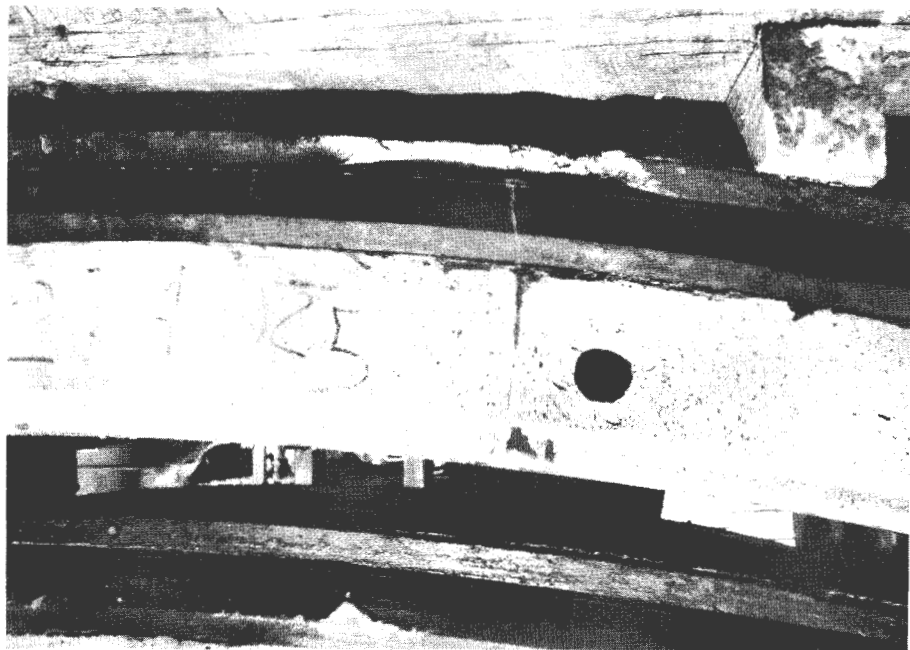
FIGURE 126. DAMAGE CAUSED BY FORKLIFT

During this time, they experienced damage (broken corners, gouges and spalled edges) due to impact against each other and to gouging by the forks of the forklift. Typical examples are shown in Figures 124, 125 and 126.

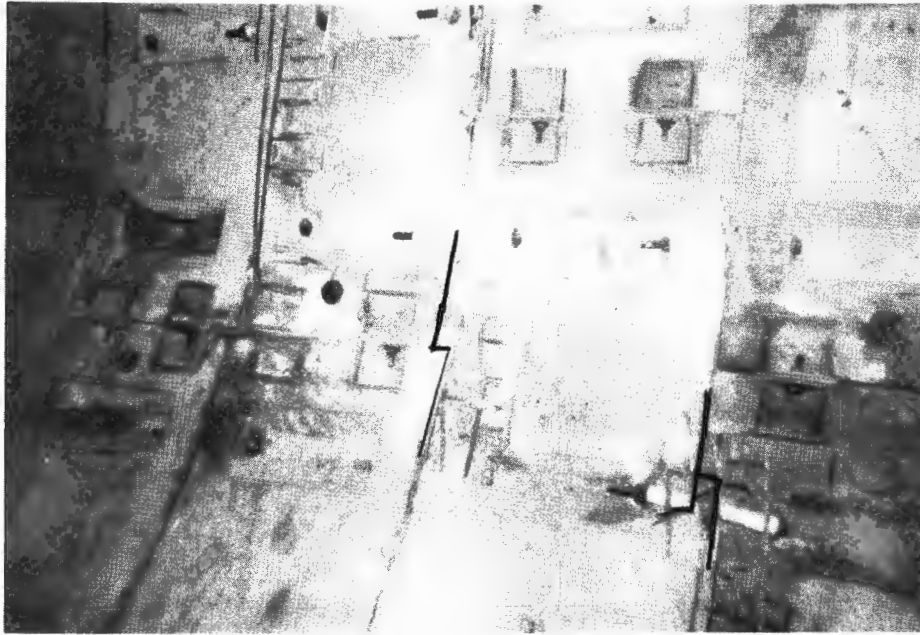
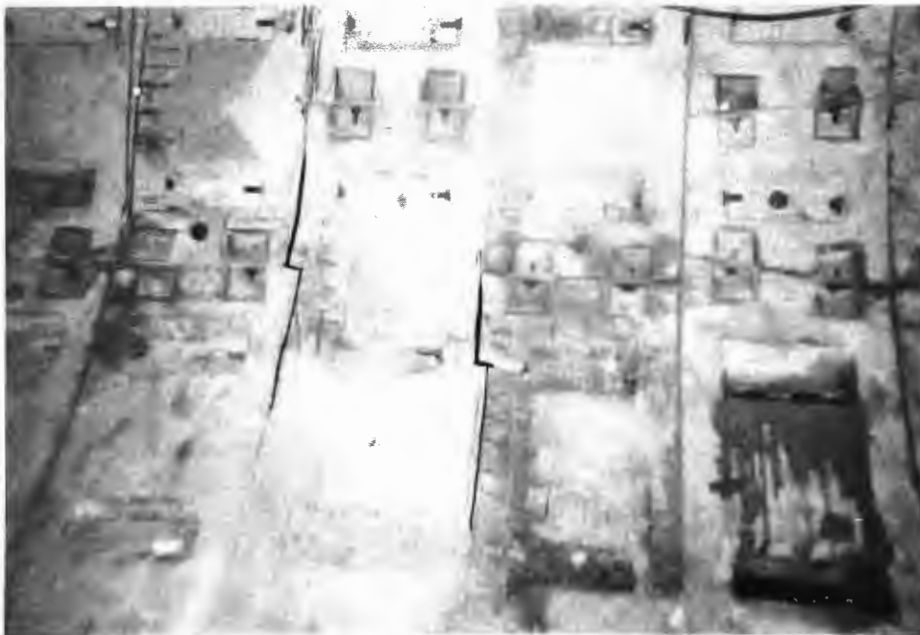
FIGURE 128. SEVERE RING FRACTURING AT RINGS #447-451

FIGURE 129. SEVERE RING FRACTURING AT RINGS #447-451.

No single, uncontestable explanation has been found for the observed failure, although several possibilities exist. One theory is that failure was initiated by an "ironbound" condition in the invert at ring #447, similar to that at ring #202 as explained above. The lack of full support in the localized area could then have caused the failure of the rings that followed. It is difficult

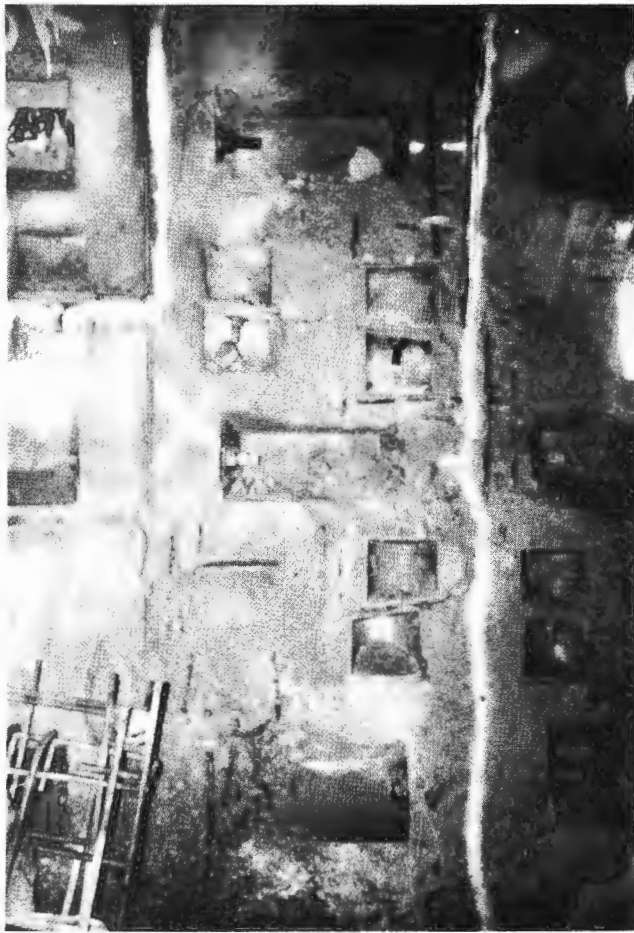
FIGURE 130. FRACTURE OF RING #449.

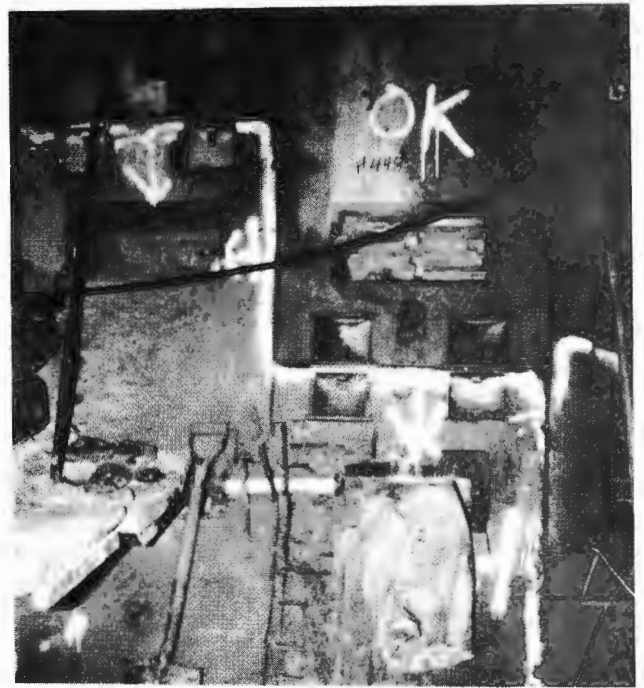
FIGURE 131. FRACTURE OF RING #448.

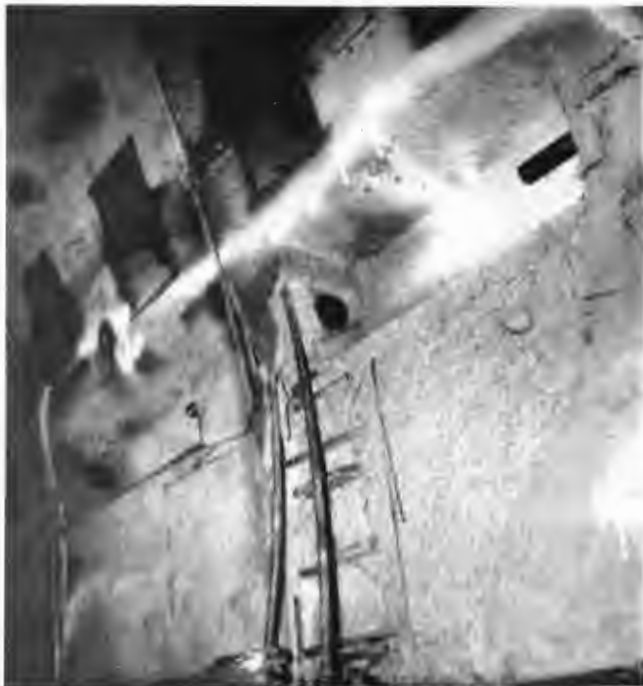
FIGURE 132. EXPOSED REBAR IN RING #450.

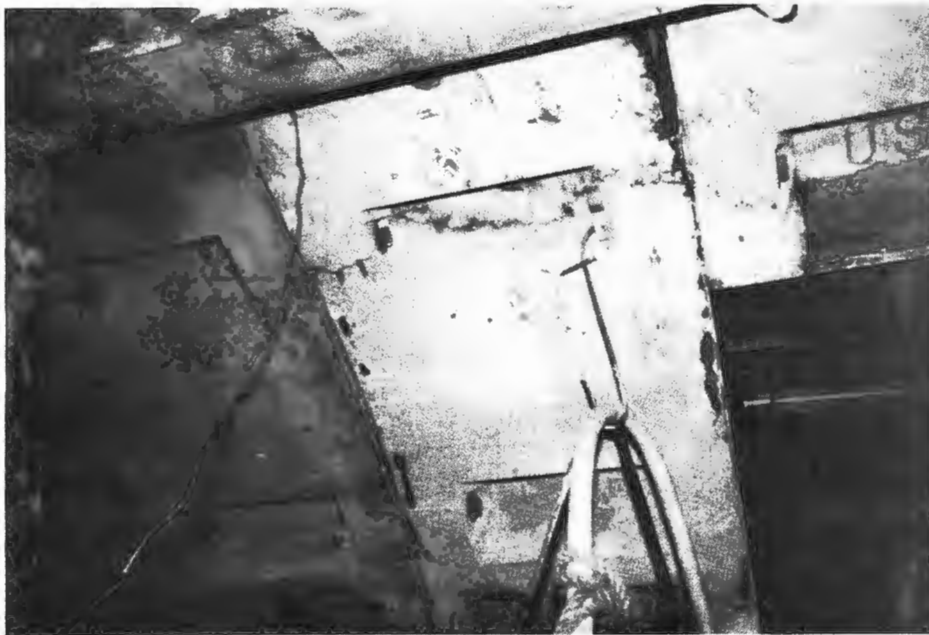
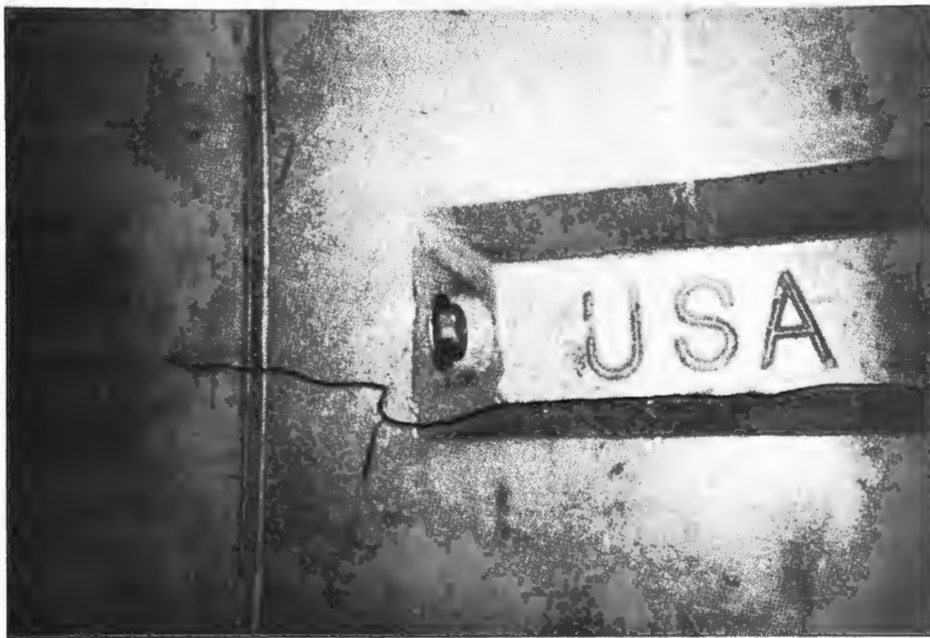
FIGURE 133. LONGITUDINAL SEGMENT CRACK

FIGURE 134. LONGITUDINAL SEGMENT CRACK.

Type III: A crack across the segment, parallel to the tunnel axis and always at a longitudinal bolt pocket location (see Figures 133 and 134).

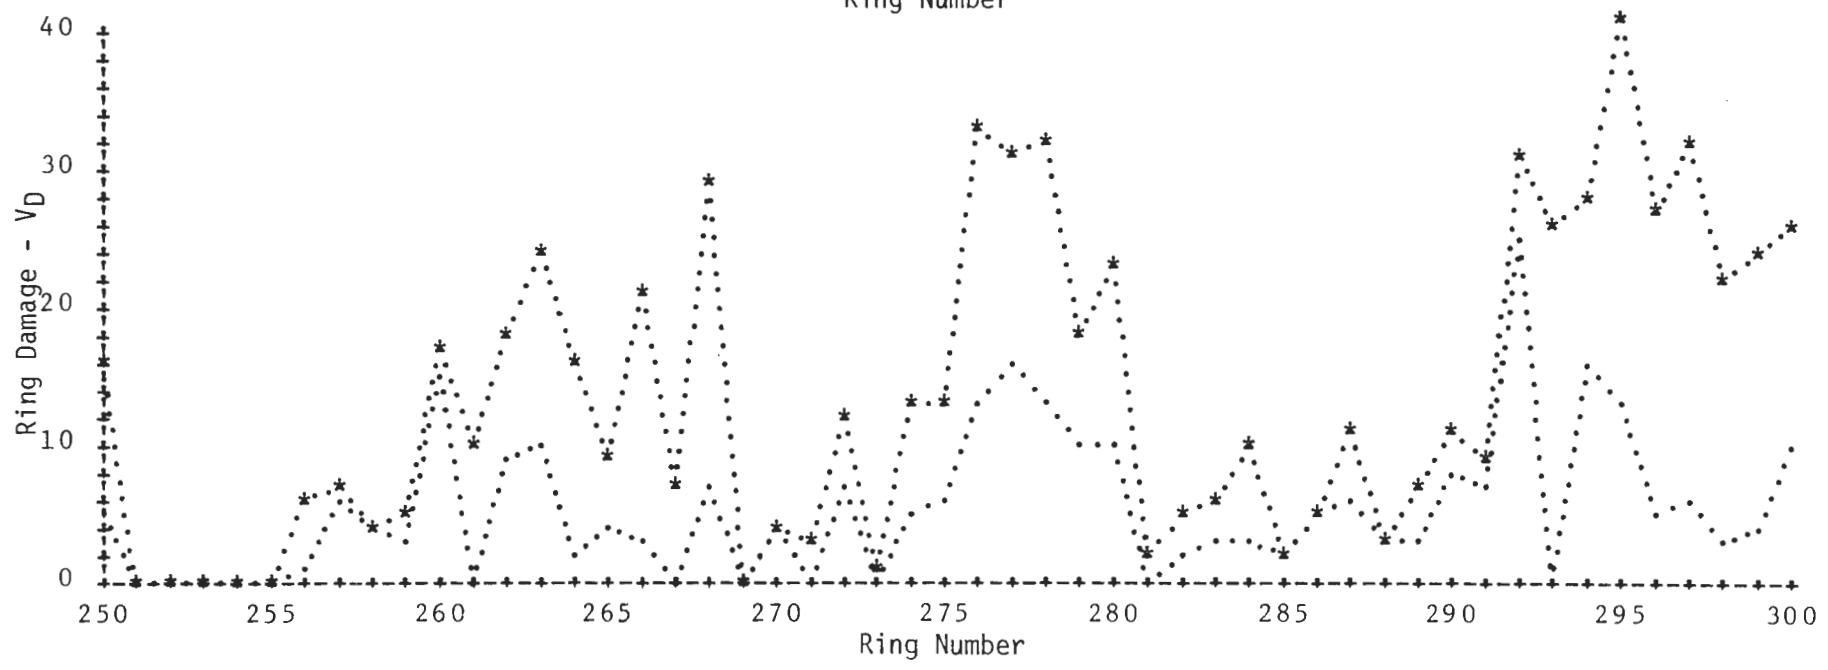
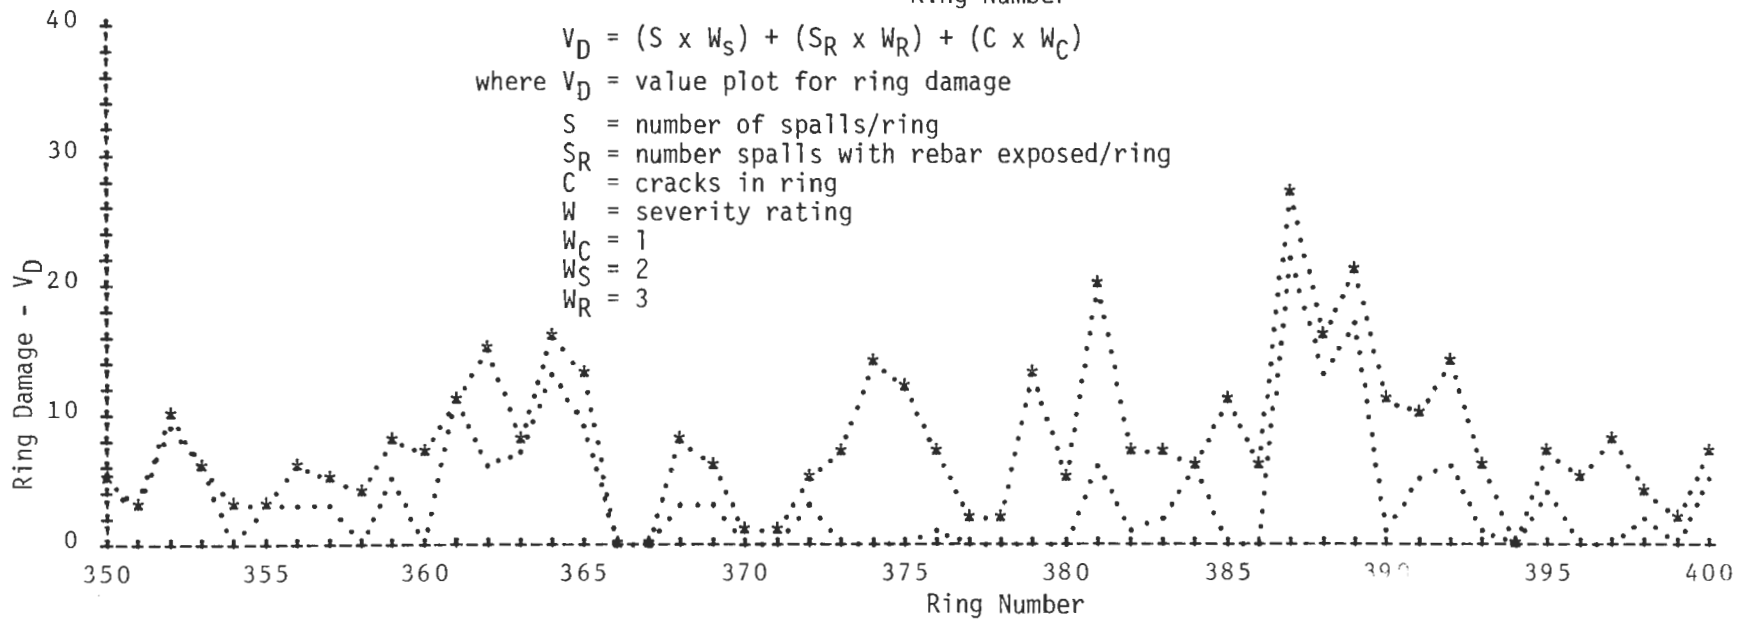
FIGURE 136(a). RING DAMAGE

FIGURE 136(b). RING DAMAGE

FIGURE 136(c). RING DAMAGE

$$V_D = (S \times W_S) + (S_R \times W_R) + (C \times W_C)$$
 where V_D = value plot for ring damage
 S = number of spalls/ring
 S_R = number spalls with rebar exposed/ring
 C = cracks in ring
 W = severity rating
 $W_C = 1$
 $W_S = 2$
 $W_R = 3$

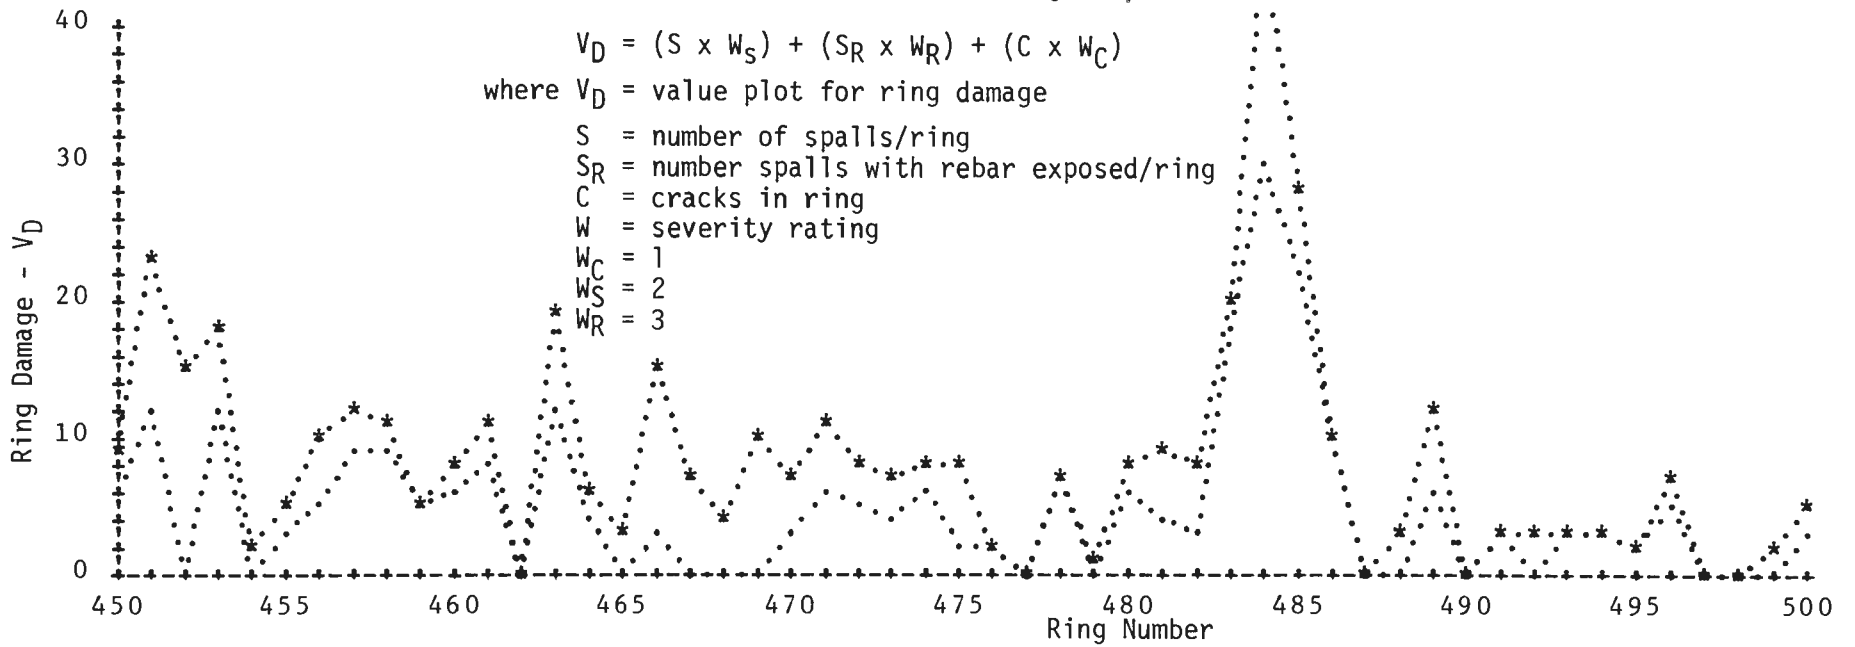
FIGURE 136(e). RING DAMAGE

$$V_D = (S \times W_S) + (S_R \times W_R) + (C \times W_C)$$
 where V_D = value plot for ring damage
 S = number of spalls/ring
 S_R = number spalls with rebar exposed/ring
 C = cracks in ring
 W = severity rating
 $W_C = 1$
 $W_S = 2$
 $W_R = 3$

FIGURE 136(f). RING DAMAGE

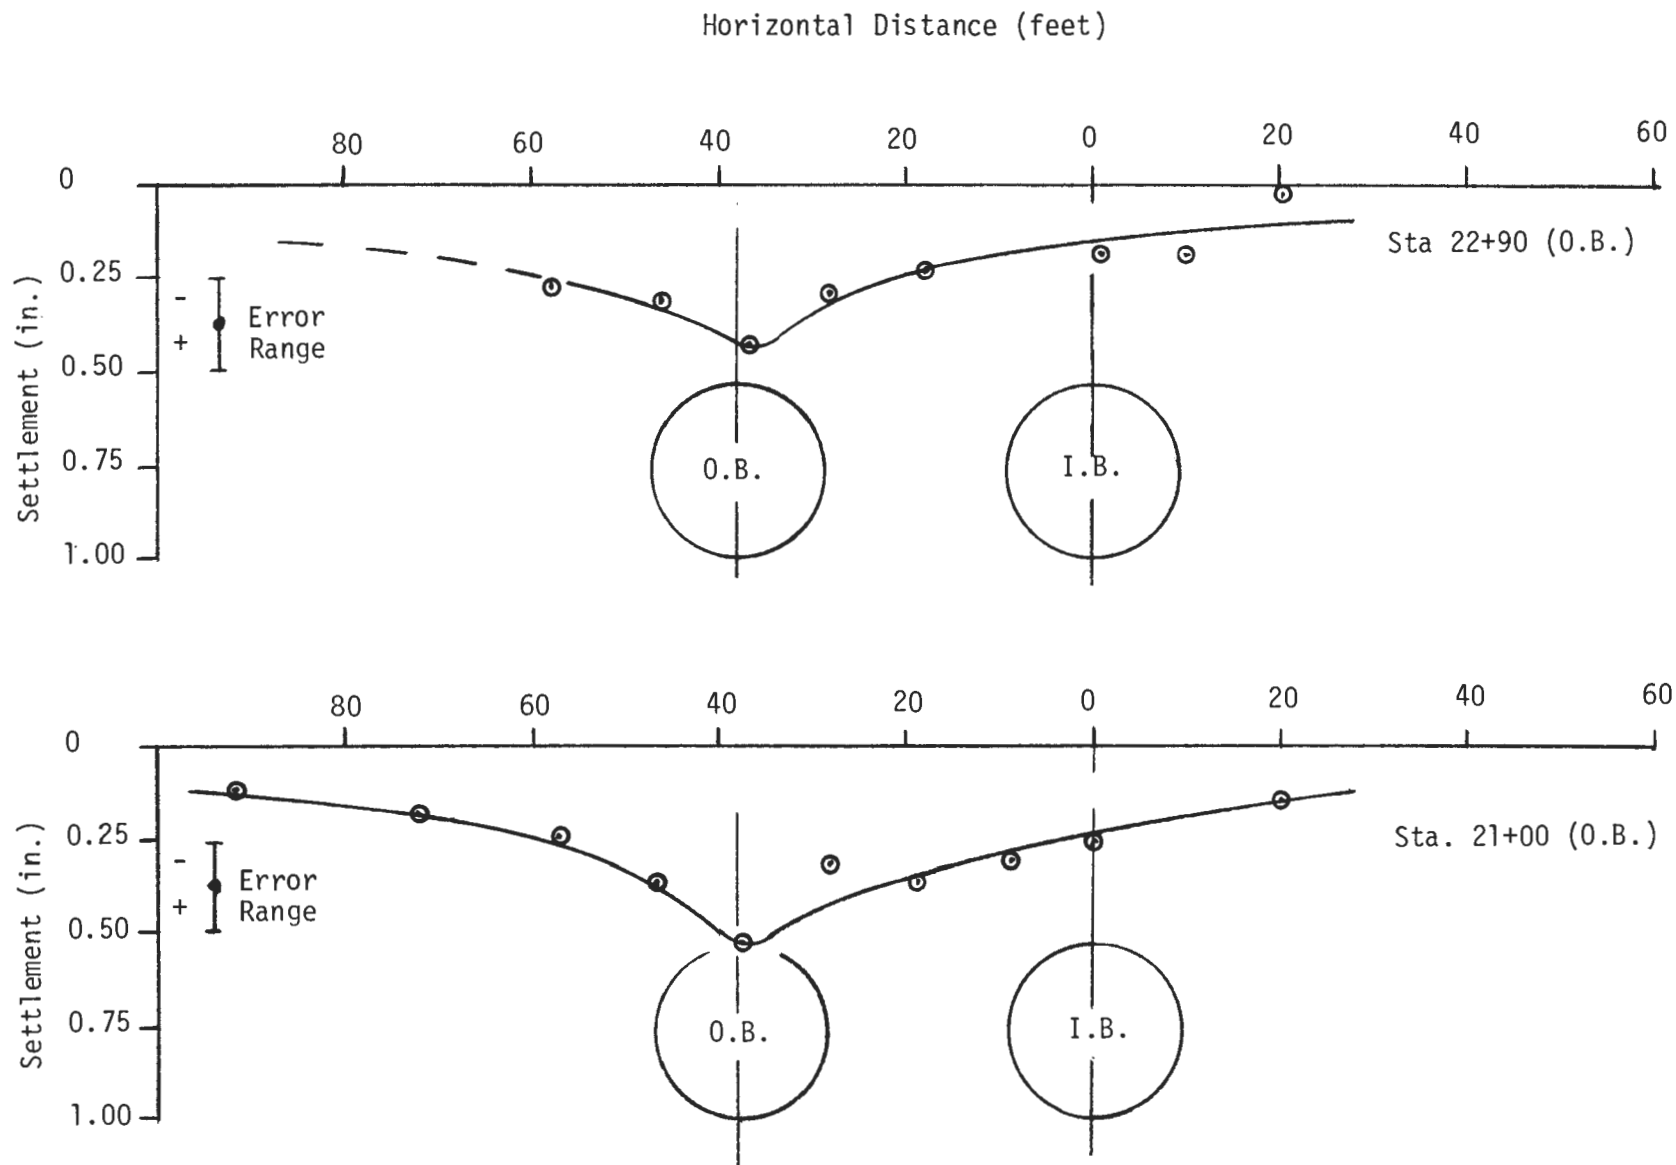
FIGURE 140. SURFACE SETTLEMENT TROUGHS, OUTBOUND TUNNEL ONLY

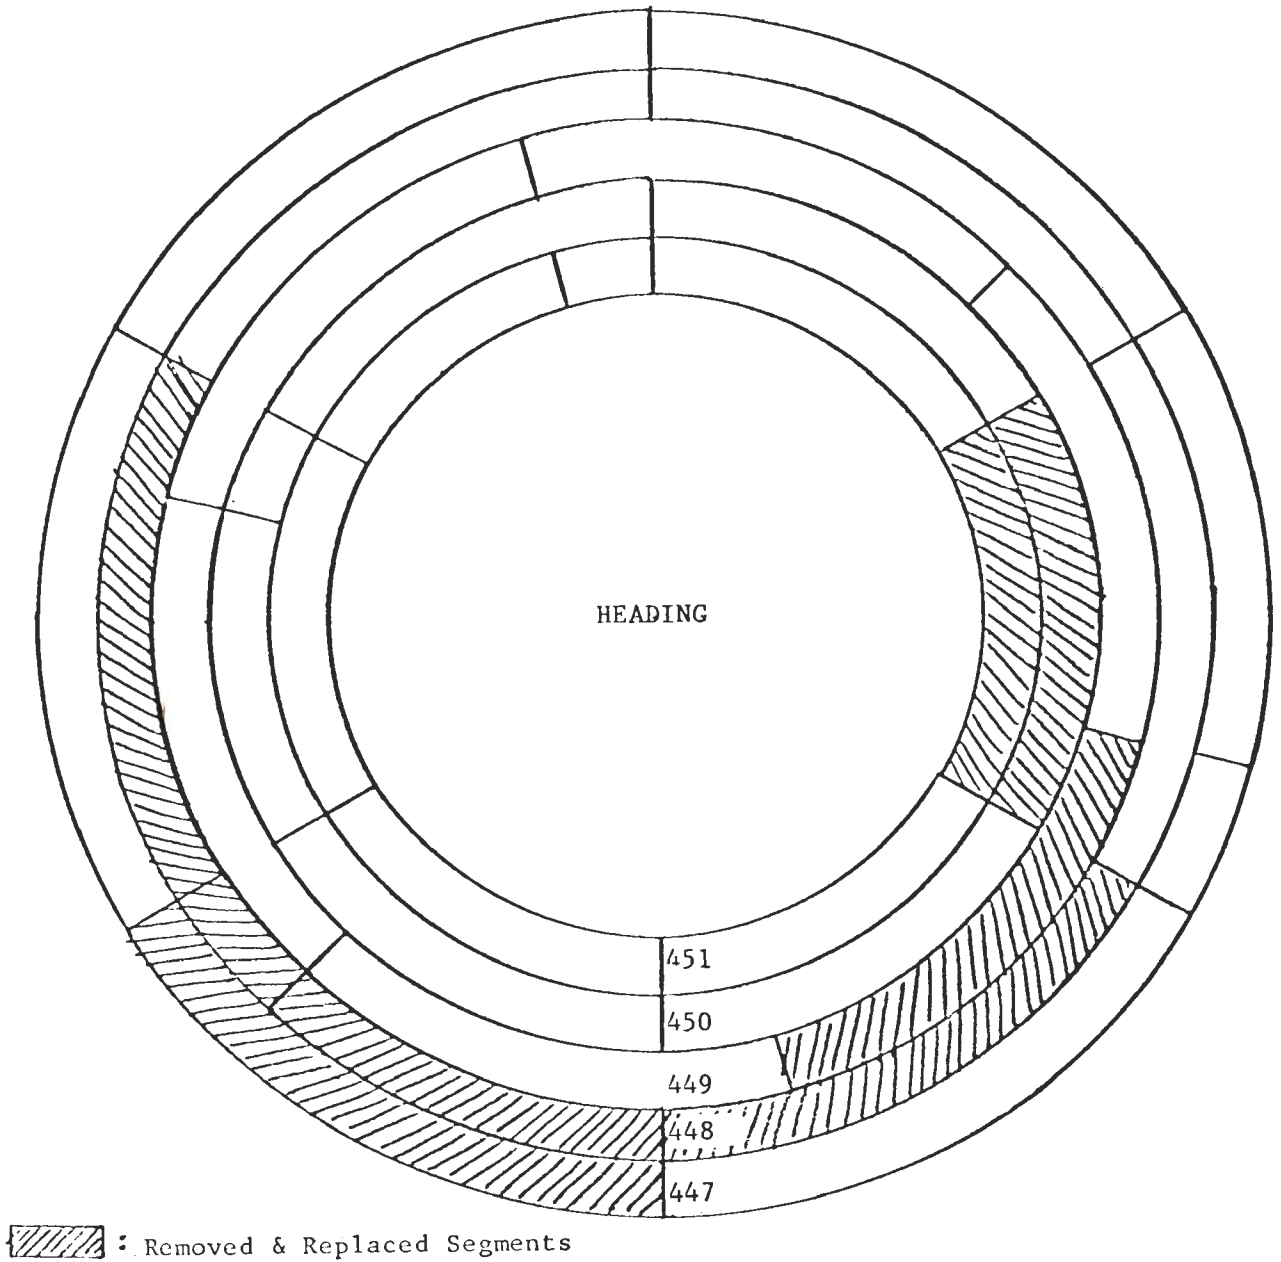
FIGURE 141. LOCATION OF REMOVED SEGMENTS
