# Wheelchair Securement On Bus and Paratransit Vehicles

Prepared for  
California Department  
of Transportation

July 1981

16. Abstract  <p>The performance of wheelchair securement systems is evaluated from 59 tests at various velocity and deceleration levels with a 50th percentile male dummy occupying the wheelchair. Manual and electric powered chairs were placed in forward or side facing orientations.</p> <p>This report gives the results of those tests. It also discusses many of the problems associated with providing securement for wheelchairs and their users, as well as with setting up dynamic tests for securement systems and evaluating the test results.</p> <p>Recommendations are made for the development and improvement of securement systems to ensure a safe and reliable mode of transportation for the confined wheelchair user.</p>

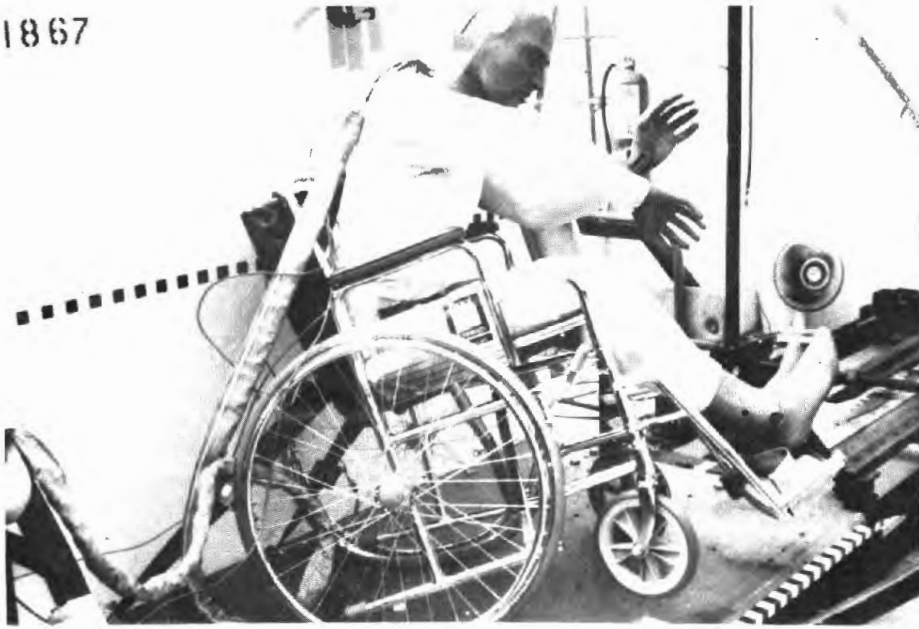
Figure A-8

Test 1867 Post-Test Conditions

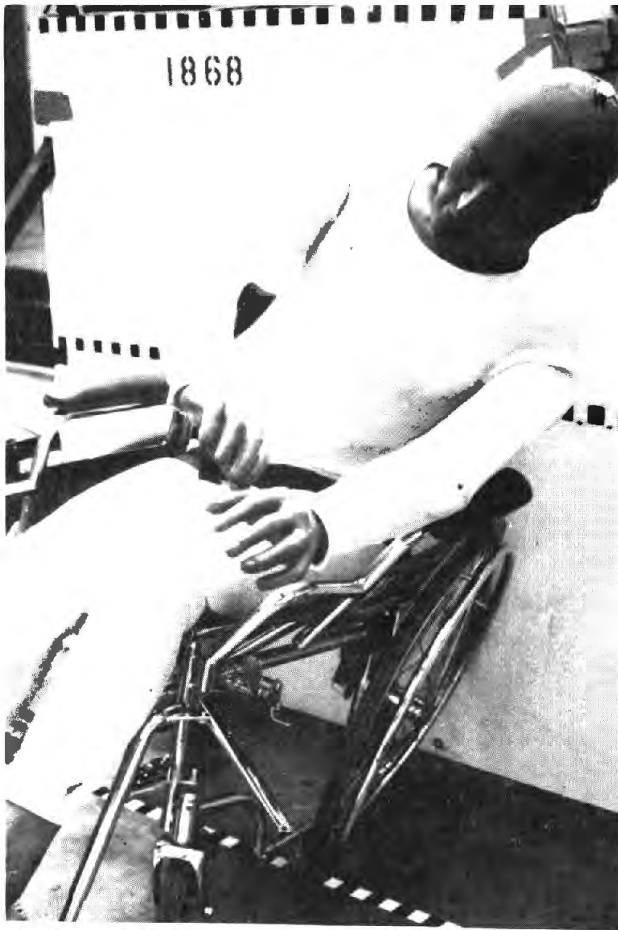
Figure A-11

Test 1868 Damage - Left Side

DUMMY: Both dummy acceleration measurements were low resulting in a HIC of 50 and a CSI of 34. The head excursion was 45 inches. The peak belt load was 300 pounds.

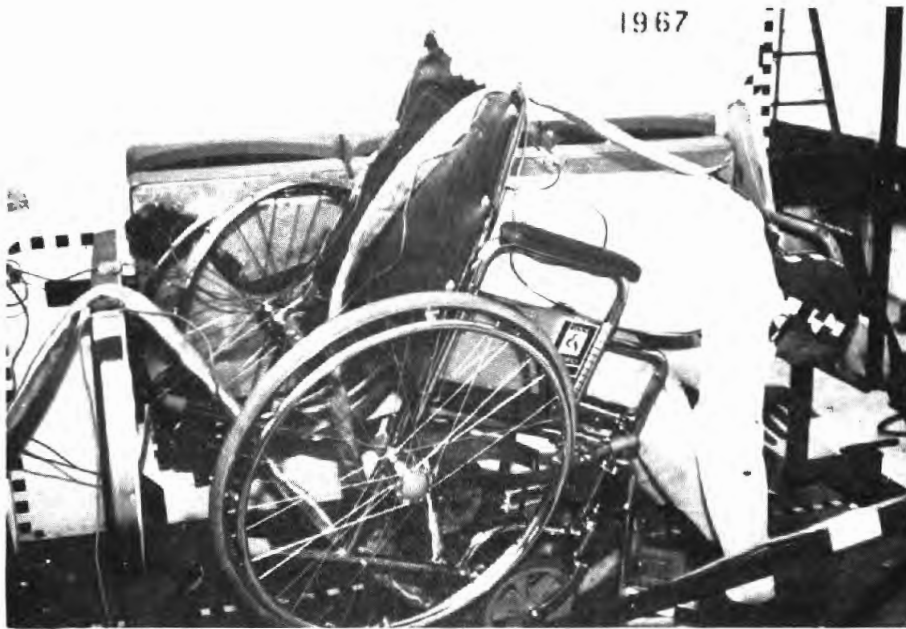
Test 1967 Post-Test Condition  
Figure A-25

DUMMY: The dummy suffered a shoulder strike. Although the test films show the shoulder strike to be quite severe, the head and chest accelerometers did not appear to be significantly affected by it. The HIC was 78 and the CSI was 62. The head excursion measured 52 inches. The peak belt load was 480 pounds.

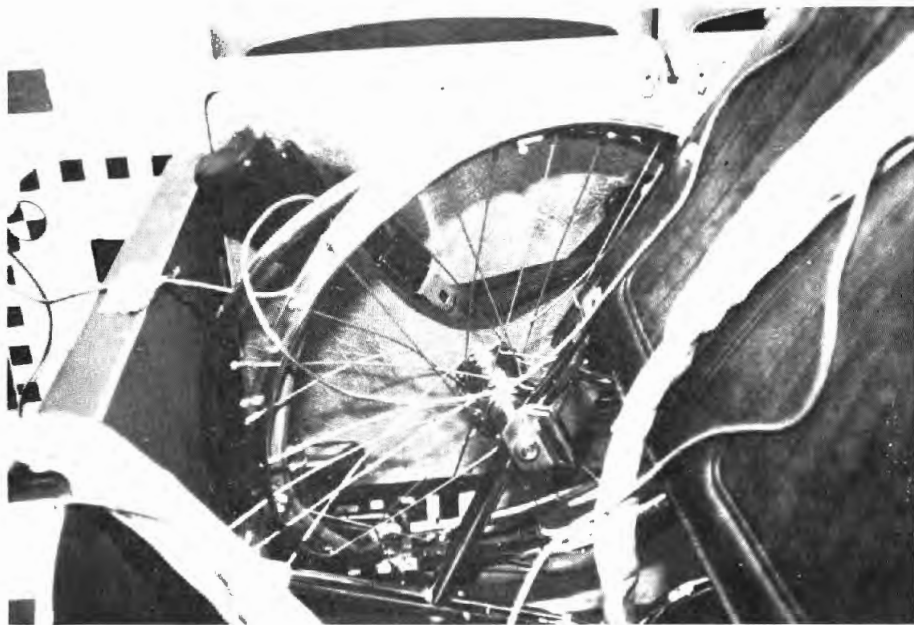
Test 1967 Left Wheel Damage  
Figure A-26

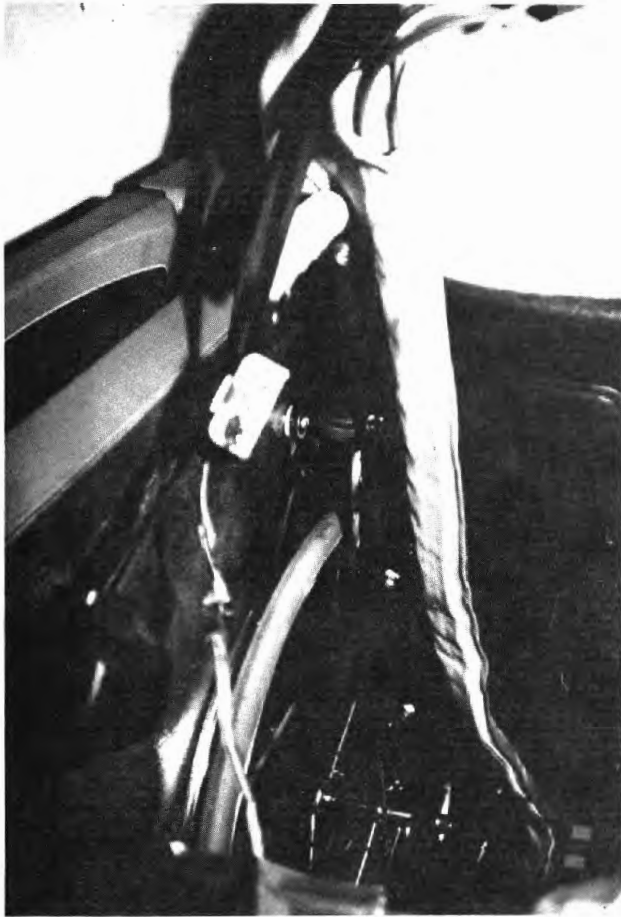
Figure A-30

Test 1966 Rear View of  
Upper Torso Belt

Test 1966 effectively demonstrates the value of an upper torso belt. If the backrest of the wheelchair can be adequately

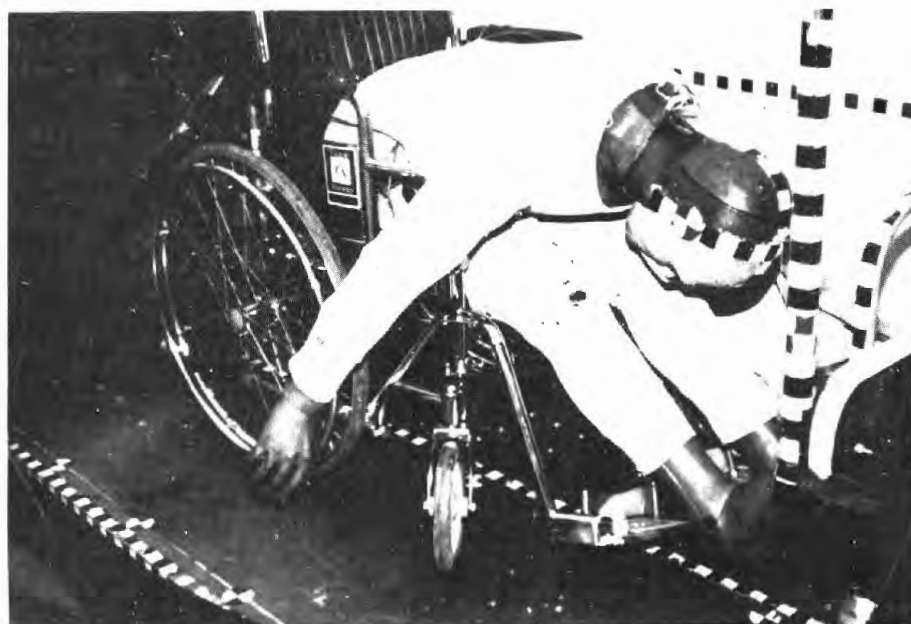
Test 1976 Post-Test Condition  
Figure A-52

DUMMY: The HIC was 1029 (very serious or fatal injury). The CSI was 140 and the peak belt load was 775 pounds. Head excursion was 27 inches.
