Accelerating Walkway Systems Phase III Summary Report

**The Port Authority of New York & New Jersey
Engineering Dept.**

December 1985

Final Report

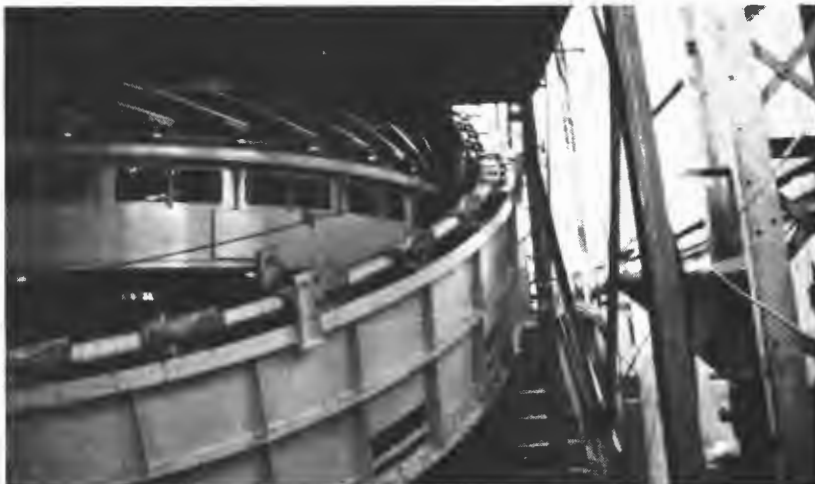
FIGURE 1.2

TRAX ACCELERATING WALKWAY SYSTEM

Upper - General view of ACB factory installation - Nantes, France

Lower - Turnaround section of loop, showing treadways in lift position, handrail bogies and chain.

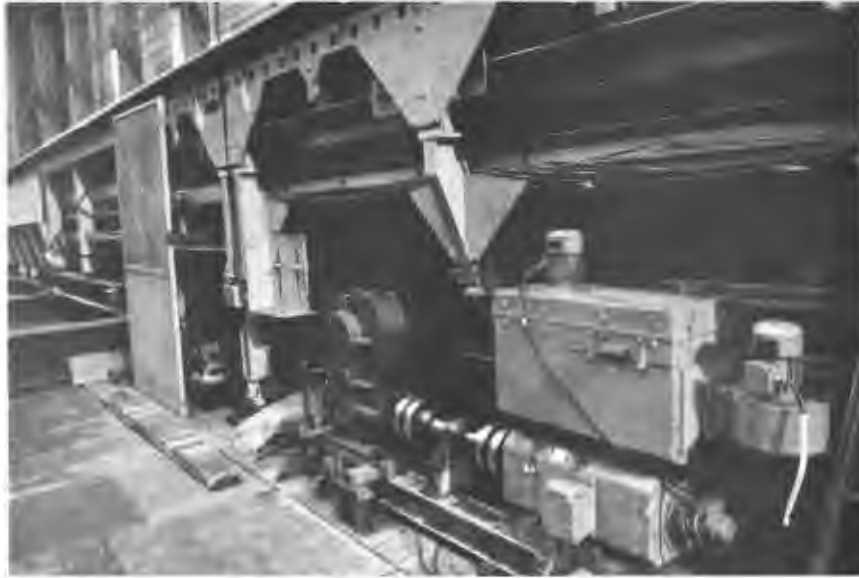
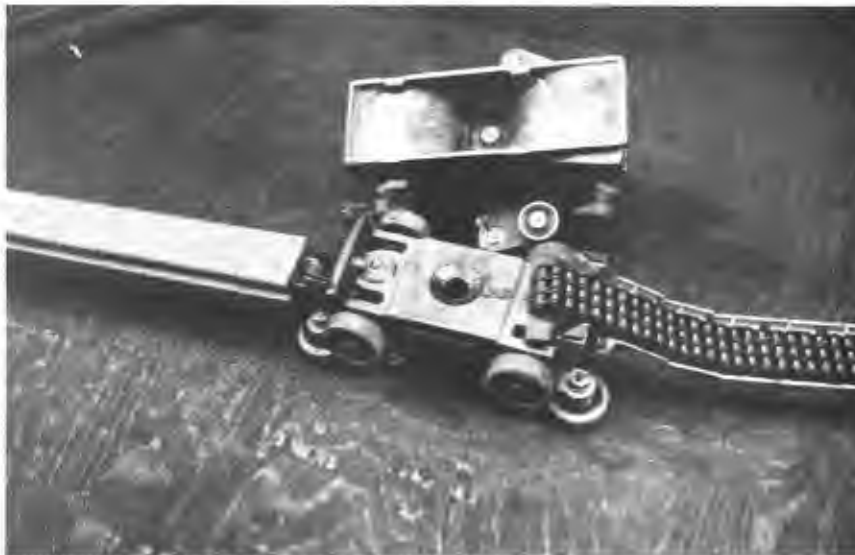
TRAX AWS - Upper - TRAX soft drive belt and rubber cleat "deltas", (horizontal line and rollers, top of photo).
Lower - Handrail failure, in this case due to sheared set pin and bolt. Other failures related to tension differentials causing sag of chains (at right) and collision of bogie (center) with balustrade support.

The operational failures that occurred during the March test program were virtually all attributable to the handrail and its propulsion system (see Figures 2.2 and 2.3 following). Several minor

- a. Quality Control - an initial system failure was traced to the shearing off of an anti-rotation set pin excessively tightened during fabrication of the handrail assembly.

- b. Variations in Chain Tensions - The drives located at the high speed zones caused differences in chain tensions and sagging of the handrail along sections of the handrail loop. In areas of low tension, the chain assembly and lower handrail assembly dropped below its normal running position and impacted balustrade spacers. The impact resulted in a failure of the handrail bogie and triggered an automatic system shut down. The breaking strength tests discussed in 2.1.1 showed that the ratio of handrail chain strength was much higher than handrail bogies, and this type of failure of the bogie before the drive chain, purposely designed into the system for safety reasons, was observed several times during actual system failures.

Since the treadway was more rugged and allowed for larger tolerances, the slack problem was effectively dealt with by removing one pallet in the loop. However the compounded slack in the handrail chains caused an excessive play and sag in the handrail which triggered a number of system failures. Among the problems encountered, the slack resulted in handgrasp bogies impacting the balustrade, causing a failure of the bogie and resulting in an automatic shut down of the system (see Figure 2.2).

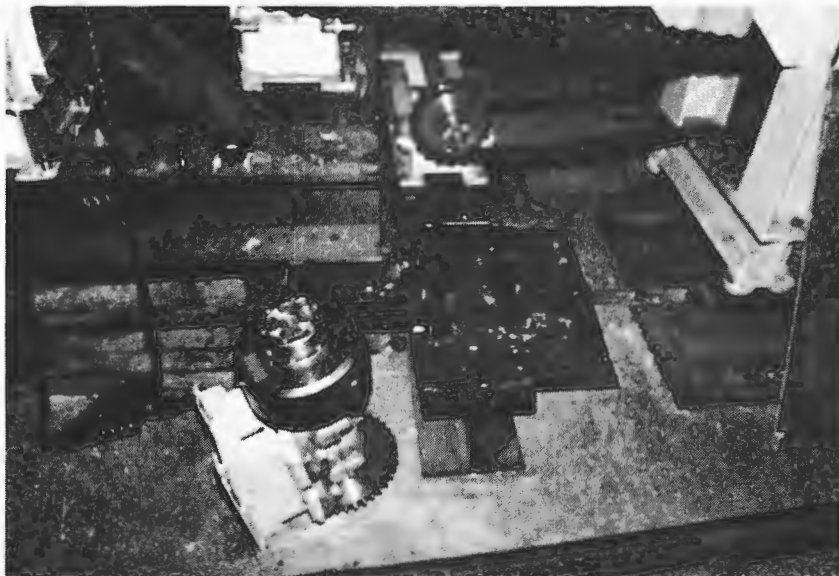
FIGURE 2.3

TRAX AWS - Upper - Treadway and handrail drive unit.
Lower - Torque limiter failure related to handrail chain problems. Collision of handrail bogie with balustrade overloaded drive unit and resulted in this failure. None of these failures would endanger passengers.

The driving cleats on each of the belts consists of approximately 20 triangular rubber teeth or "deltas", as they are called by ACB, which simultaneously intermesh with elements of the treadway and handrail to synchronously drive these systems (see Figure 2.4). The soft drive is purposely designed to slip and to cause an automatic system shut down in the event of an overload or jamming and loss of synchronization of the handrail or treadway. These rubber teeth proved to be too flexible and this was responsible for a number of system shut downs.

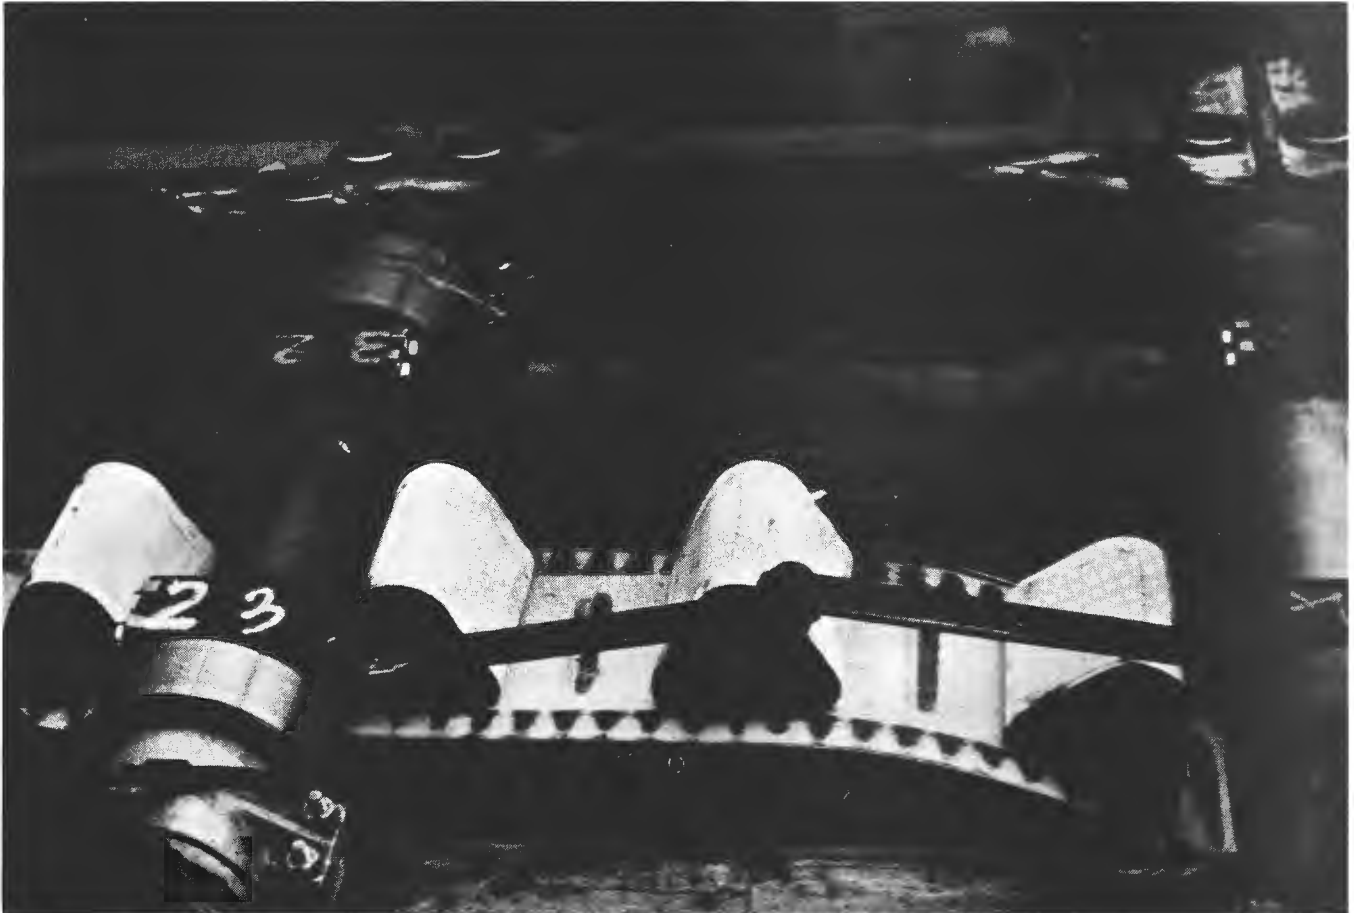
FIGURE 2.4

TRAX AWS - NANTES FACTORY UNIT
Close-up View of Delta Block
Treadway Propulsion Gear

The "delta-block" soft-drive propulsion utilized on the TRAX system has been devised to reduce noise and prevent potential high energy failures which, because of the forces involved, might endanger

passengers (see Figure 2.4). Examples could include a sudden parting of the treadway pallets, or sudden breaking of a handrail chain under high stress. With the soft-drive, excessive resistance in the treadway or handrail loops causes the delta-block's "gears" to slip, preventing the transmitting of large forces from the propulsion system to the chain and treadway loops. However, the dynamic tests showed that slippage of the delta drive was occurring too frequently, causing unnecessary automatic shutdowns.

The concept of the delta-blocks, that of avoiding excessive forces in equipment elements exposed to passengers, is a good one. However, a system less susceptible to slippage under normal variations in operating conditions is desirable to improve system reliability and availability.

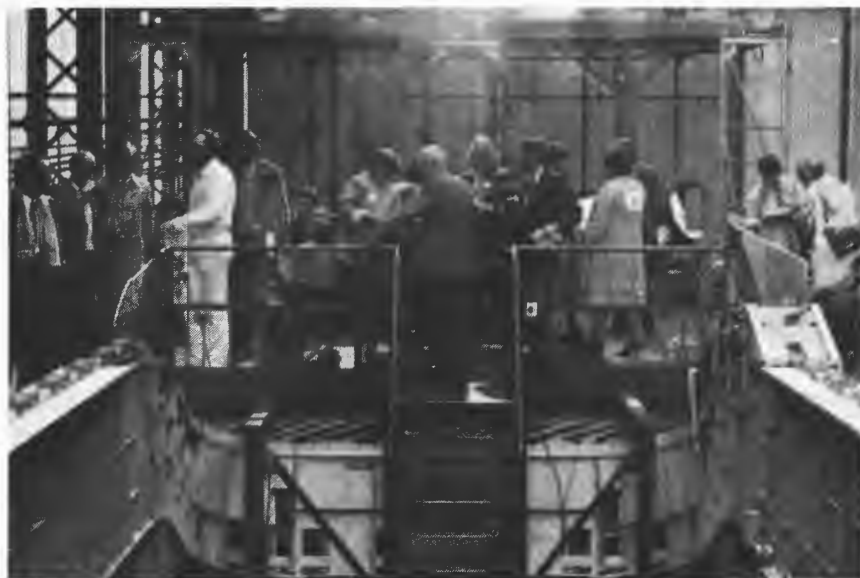
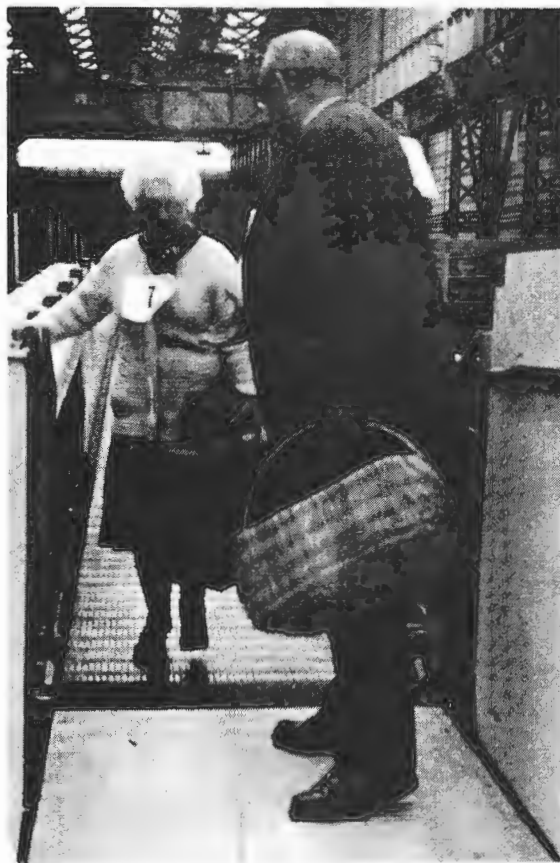
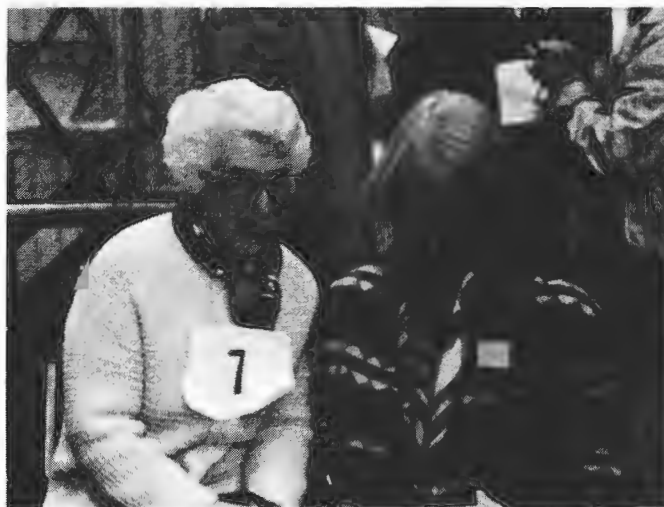
FIGURE 2.5

TRAX AWS - NANTES PASSENGER TESTS

Upper - Staging area for passengers at upper end of AWS loop.

Passenger rides were videotaped by 4 TV cameras located on platforms approximately 12 feet (3.7 m) above the two ends of the TRAX AWS. One camera was aligned with each entry and exit portal. The cameras were equipped with telephoto zoom lenses so that passengers could be tracked through a complete ride cycle. Figure 2.5 illustrates testing procedures.

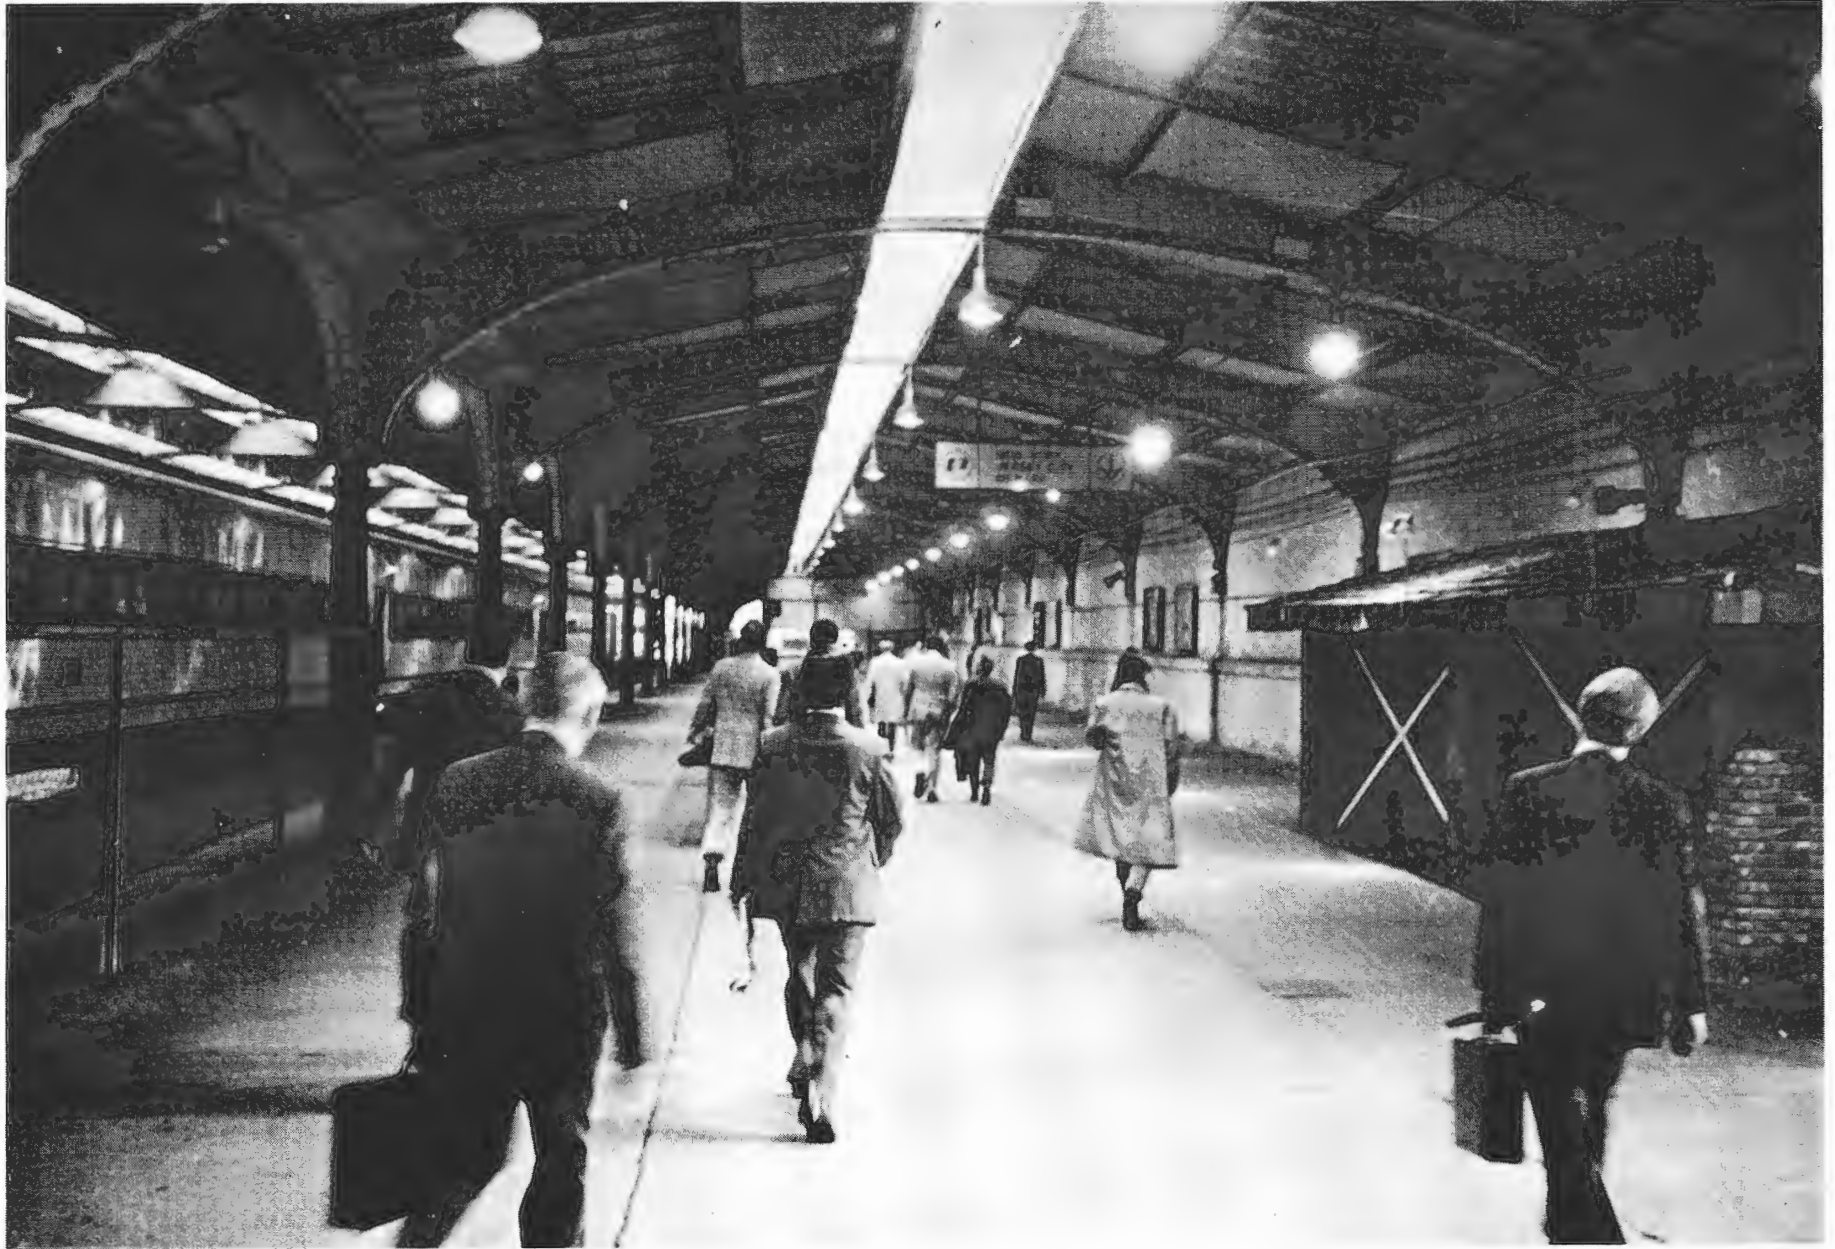
FIGURE 3.2

HOBOKEN RAIL TERMINAL - A.M. Passengers Approaching West Entrance to P.A.T.H.

Passengers transferring from NJ Transit trains to PATH may enter the PATH station from either the east or west end entrance. During the morning peak, passengers discharged from these trains form dense platoons heading toward the PATH entrances. This causes considerable crowding in the pedestrian passage at the east entrance and queues at PATH turnstiles. Passenger flows to the west end mezzanine entrance are less dense due to the smaller number of passengers choosing this alternative, and because of this, no queuing occurs at west entrance turnstiles. (See Figure 3.2.)

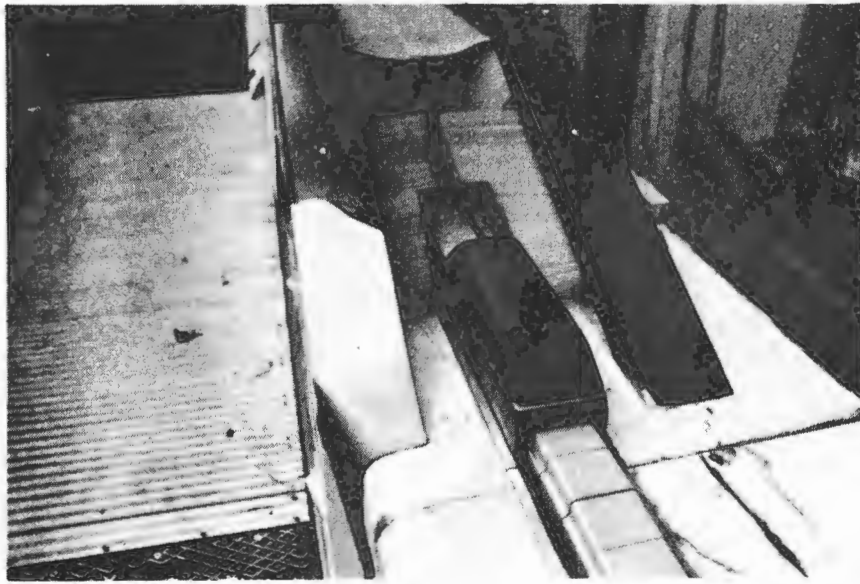
FIGURE 4.1

TRAX AWS - (Upper) Close up of handrail entry into balustrade enclosure.
(Lower) TRAX handrail slopes down at system ends and is returned on opposite side of loop.

4.4.5 Balustrade Configuration - The set-back of the handrail centerline from the treadway of 9 in. (229 mm) conforms with the ANSI code maximum of 10 in., but balustrade configurations shown in the code place the handrail closer to the balustrade edge than with TRAX. The common practice is to slope the balustrade wall in toward the handrail, or to set the wall back to provide more clearance for riders clothing and carried articles. Passengers riding TRAX were observed to be standing further away from the balustrade than with conventional

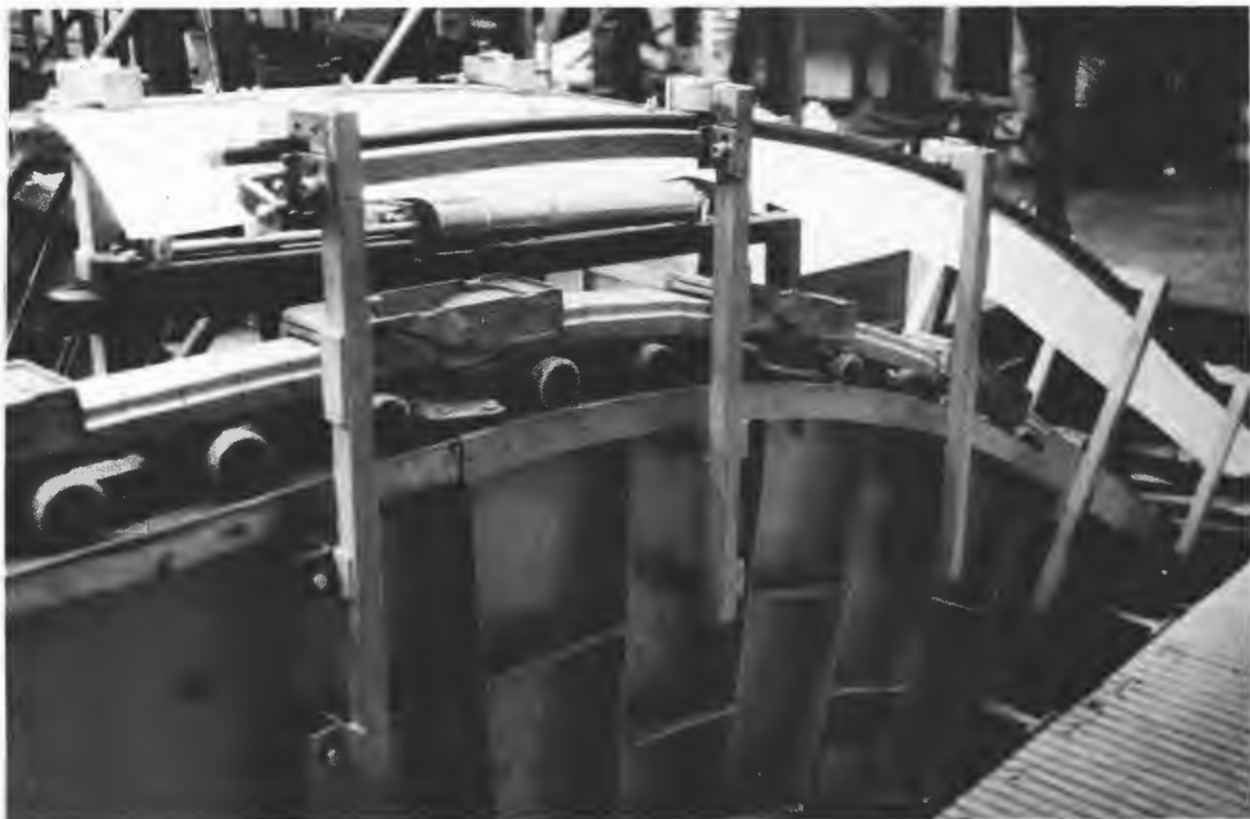
TRAX AWS - Photo of handrail entry with protective cover and balustrade removed. Cylinder and plunger is automatic shutdown device in event of entrapment.

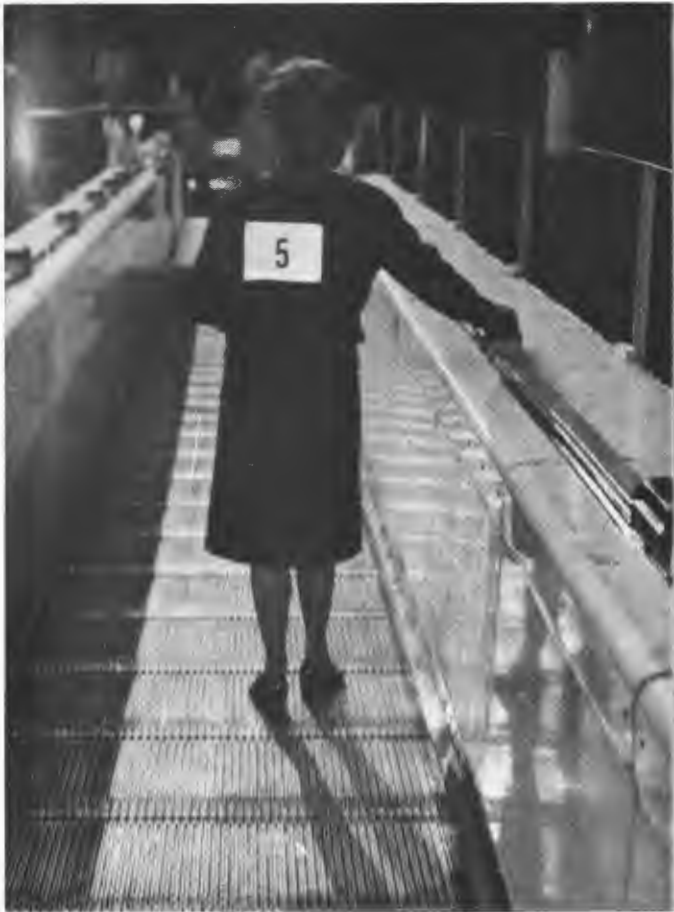
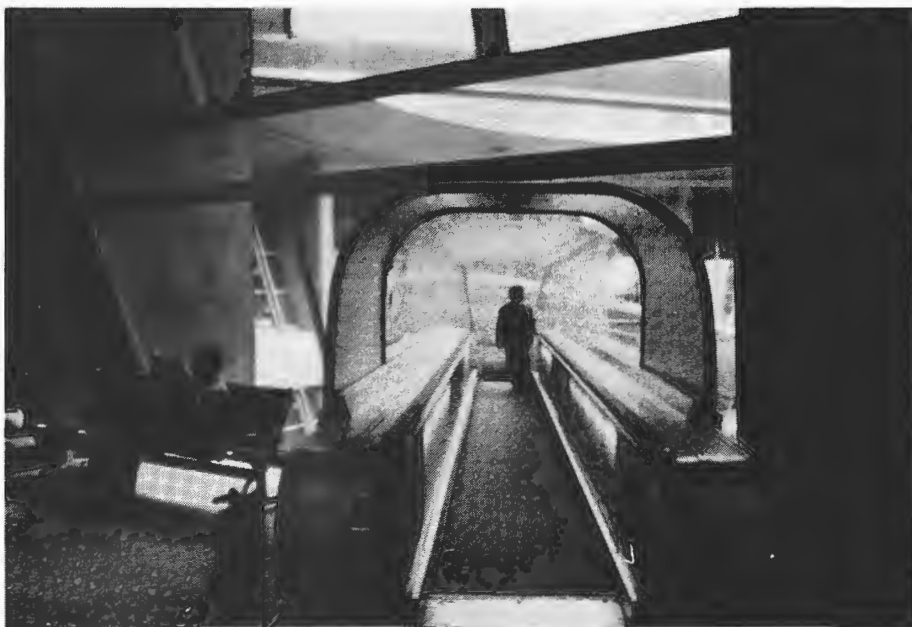
FIGURE 4.3

The TRAX handrail (right) is set back further from the balustrade edge than conventional walkways, (note below DeGaulle Airport). This causes greater arm extension than usual. The AWS handrail entry occurs on top of the balustrade near the plane of hand movement, instead of below it as in the conventional walkway shown in bottom photo. (See photos of TRAX AWS entry, other pages).

Conventional Single Speed Walkway - DeGaulle Airport, Paris

walkways to avoid brushing clothing against the balustrade (See Figure 4.3). A sloped or set-back balustrade wall is recommended for U.S. applications.

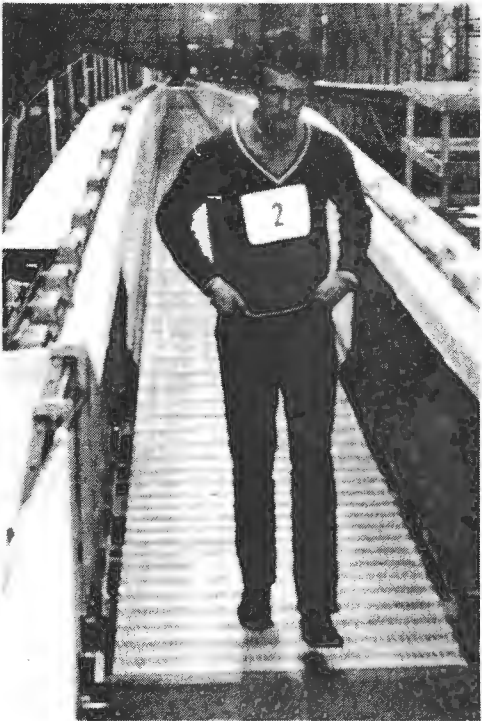
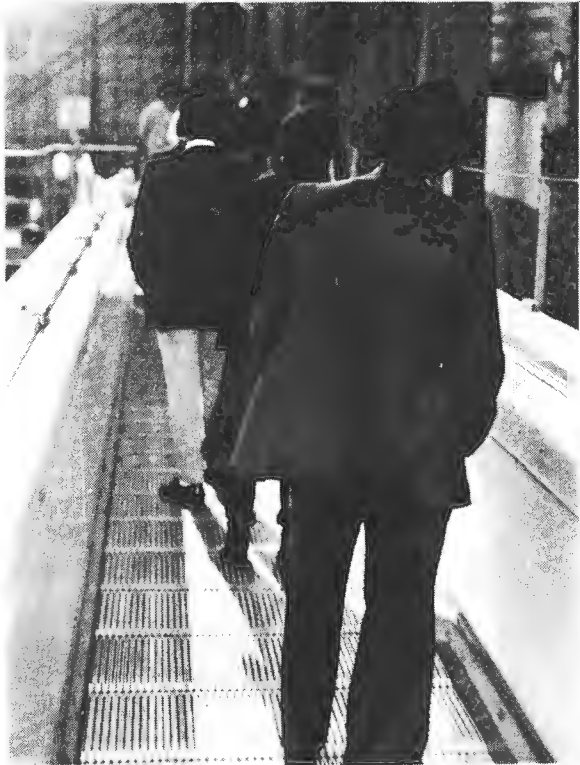
FIGURE 5.1

TRAX AWS PASSENGER TESTS NANTES,
FRANCE

Younger passengers readily adapted to accelerating walkway with minimal use of handrails at all speeds.

For the most part passengers appeared to adapt well to the motion characteristics of the TRAX AWS at all but the highest speed. Most younger passengers rode the system without using the handrails. (See Figure 5.1.) Handrail use was observed to increase with age and

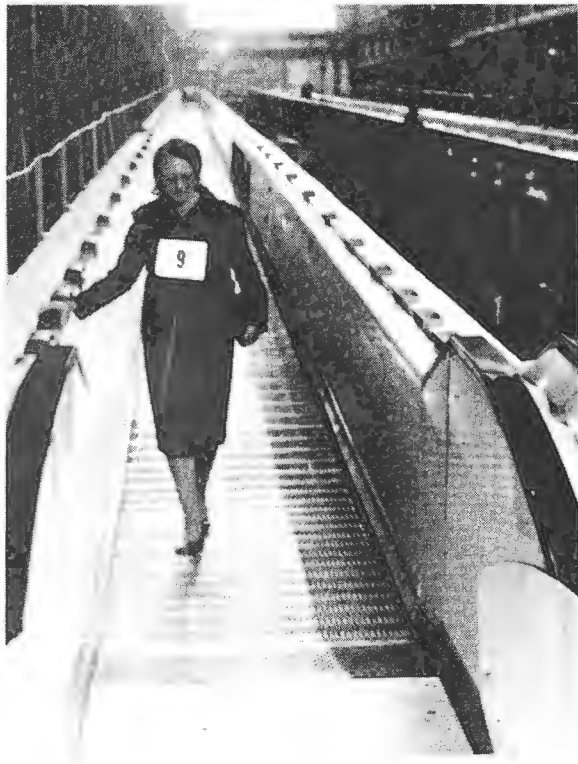
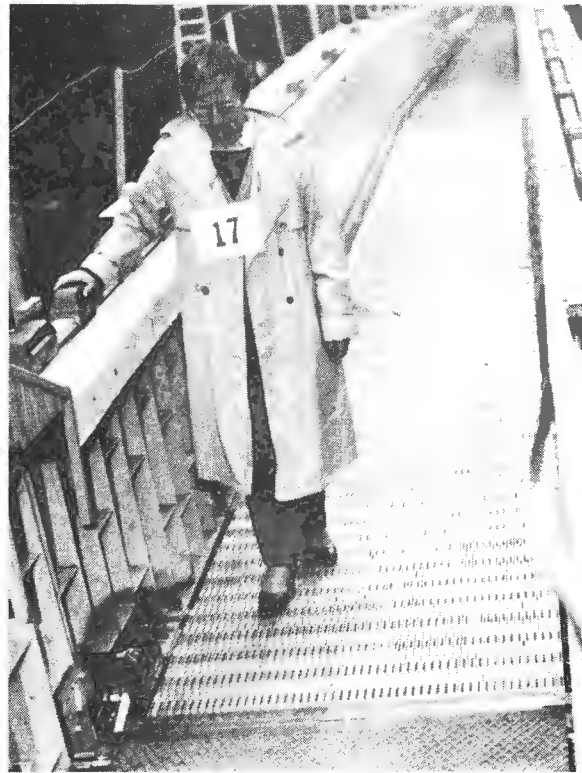
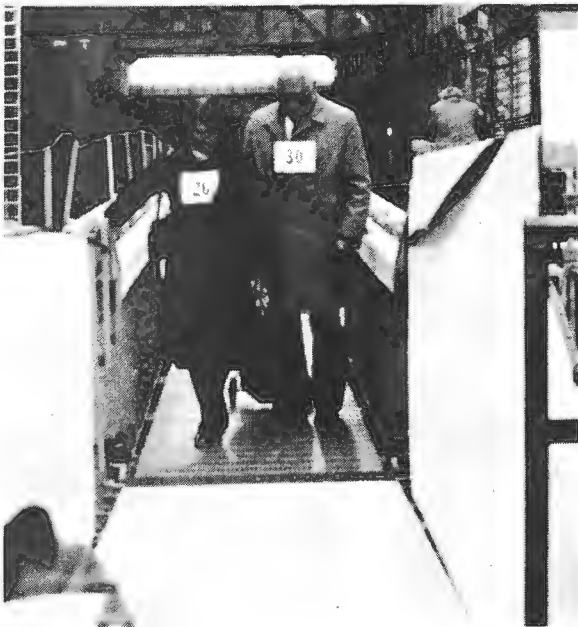
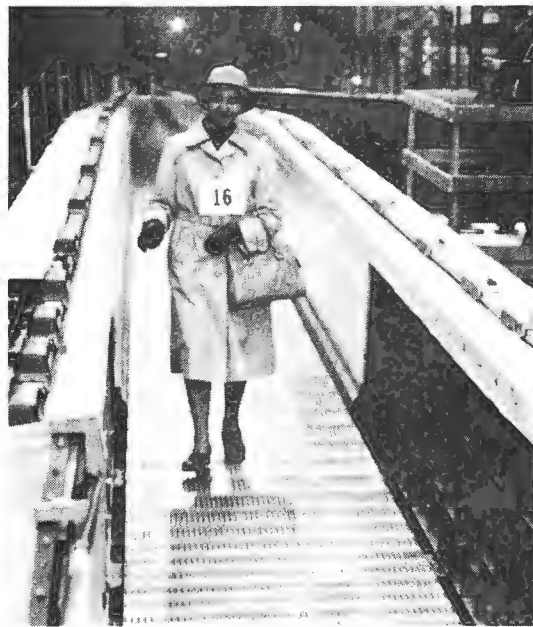
TRAX AWS PASSENGER TESTS NANTES, FRANCE

Greater use of handrails was noted with passengers that wore glasses, particularly at system portals.

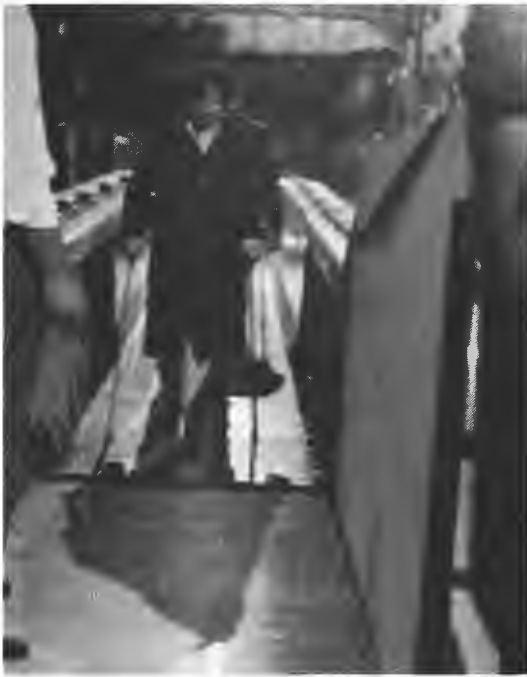
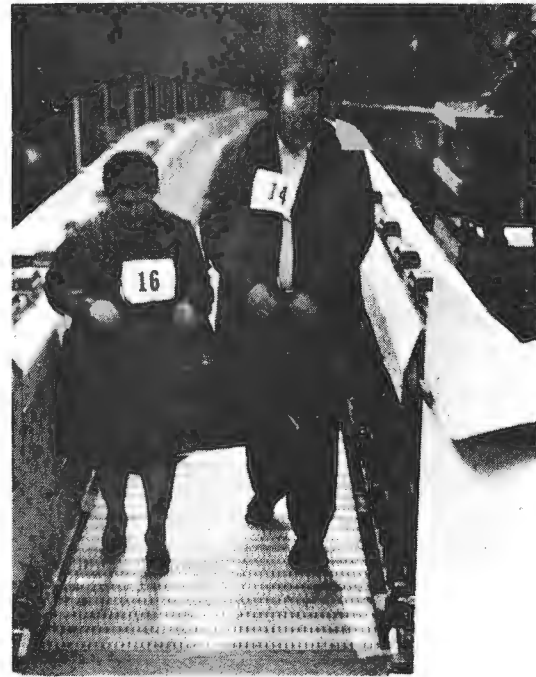
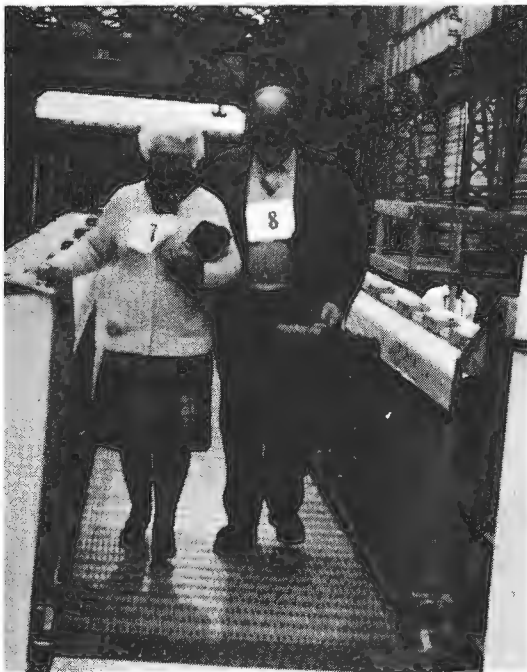
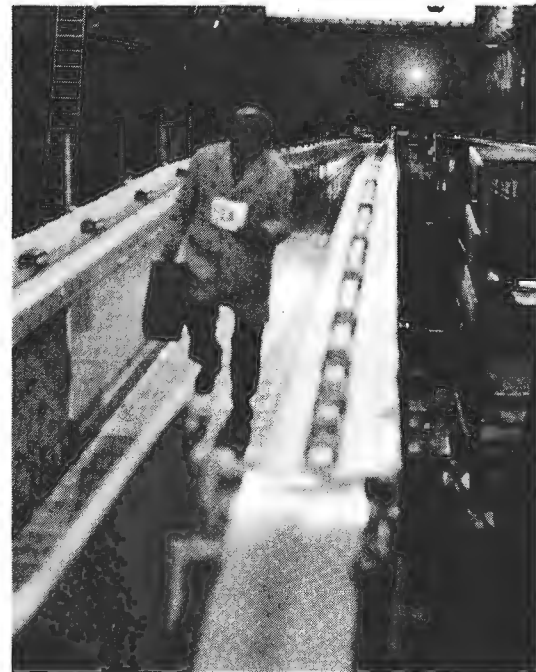
TRAX AWS PASSENGER TESTS NANTES, FRANCE

Elderly and ambulatory disabled adapted well to AWS at medium and lower speeds. (Lower right) - Sixty-two year old "commuter" rushing for train as joke.

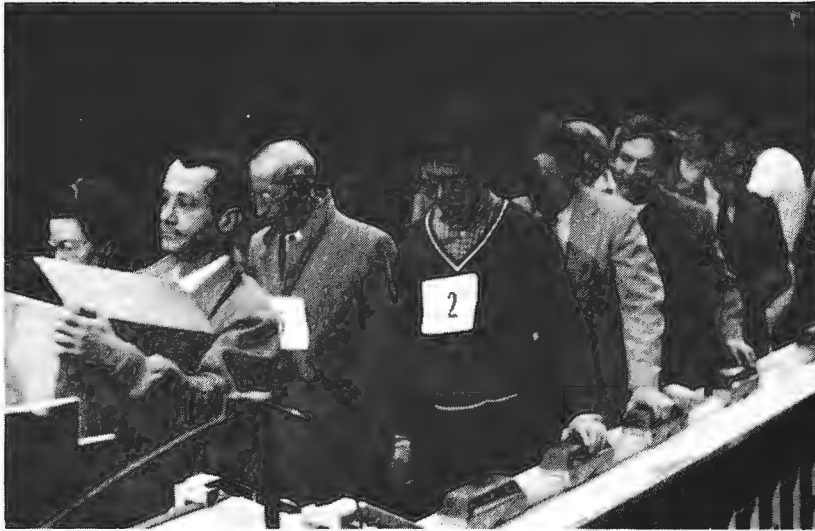
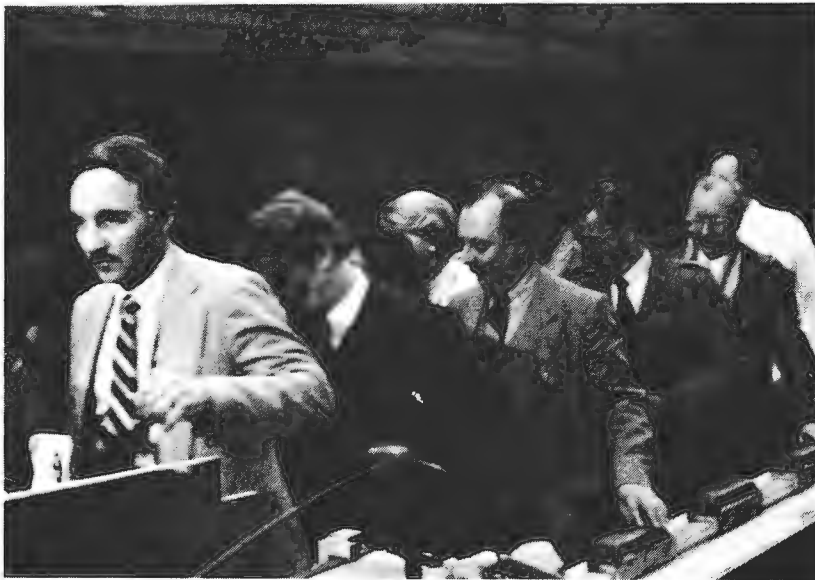
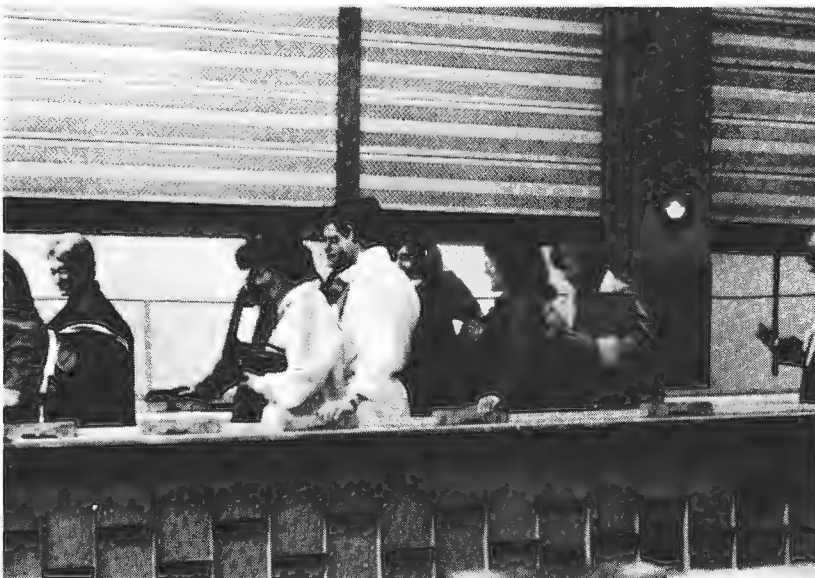
FIGURE 5.4

Bunching tests showed that this is a problem, but no serious difficulties noted. Signing needed to encourage use of handgrasps in deceleration zones.

the extreme conditions of the test, serious bunching conditions were in fact observed, but no falls occurred. It is unlikely that the level of pedestrian densities attained in the full-load test would occur in normal use. However, bunching remains as a recognized accident hazard with in-line accelerating walkway systems. Recommended preventative measures include flashing light signs and recorded announcements presented ahead of deceleration zones, advising passengers to hold handgrasps and avoid getting too close to other riders near the system exit.

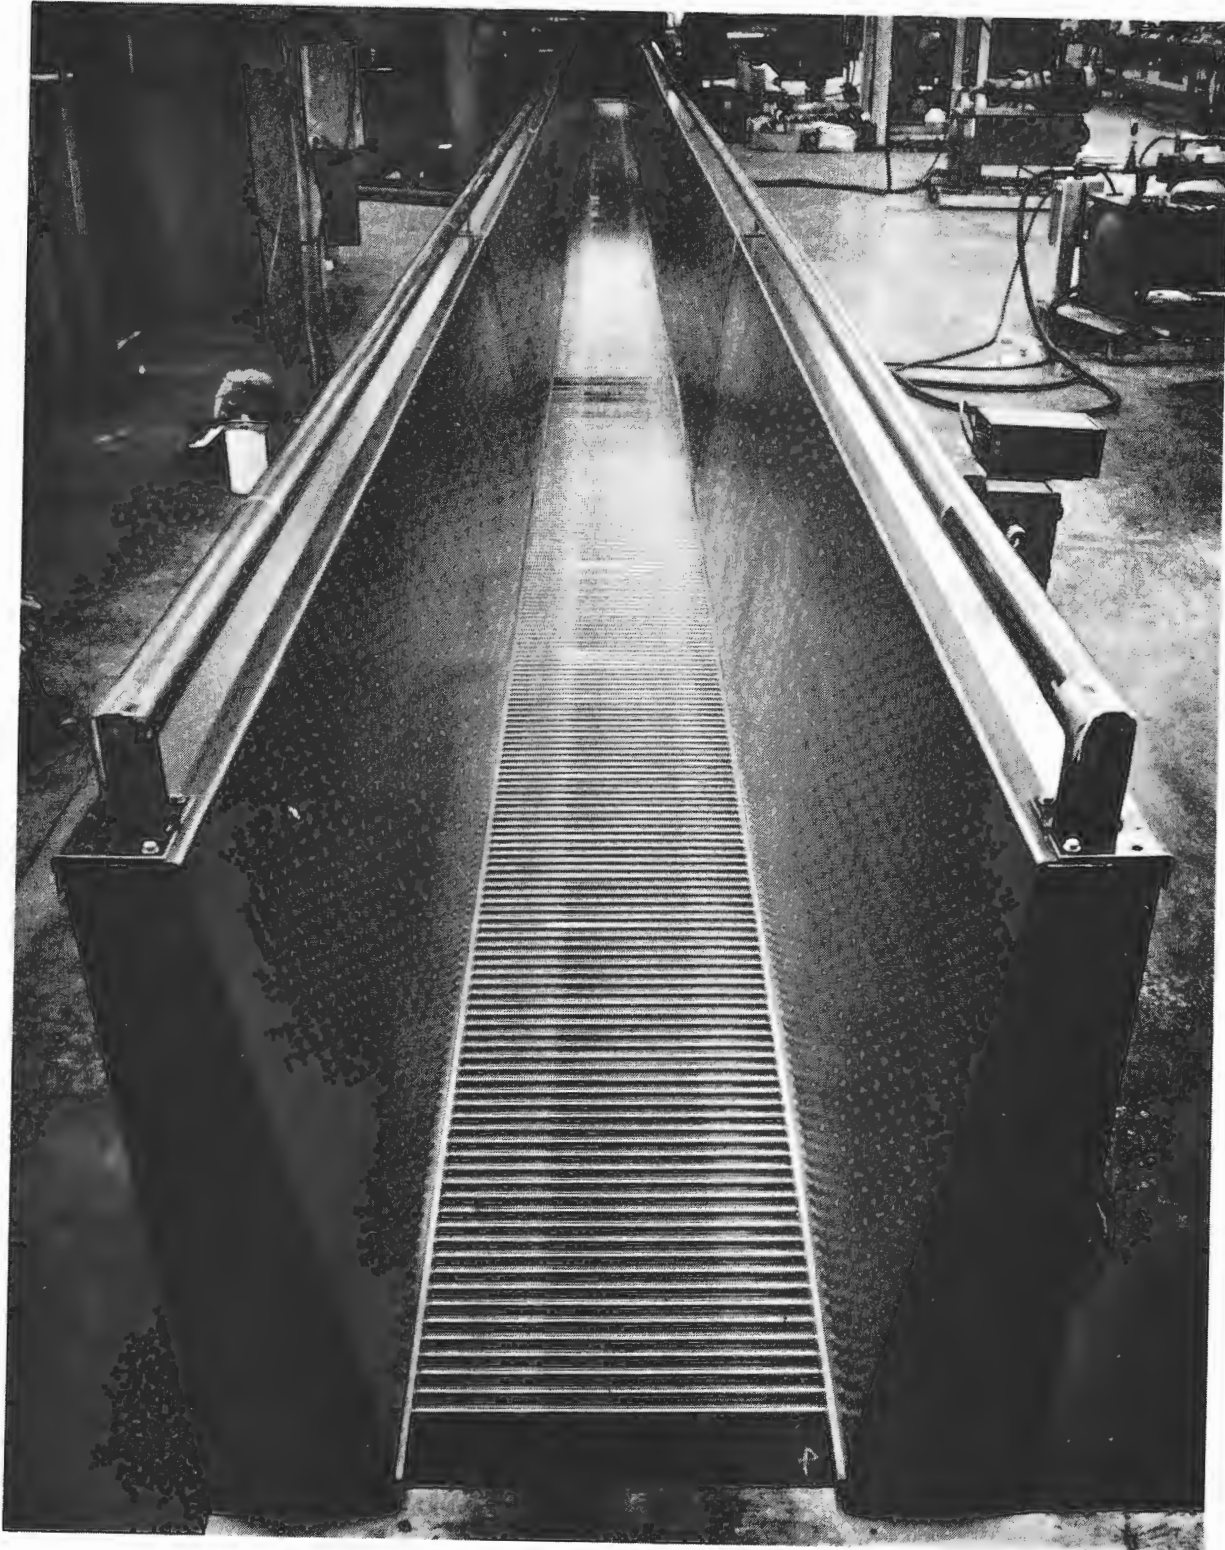
FIGURE A-3

DEAN RESEARCH AWS
60' PROTOTYPE
