Innovative Solutions for Disabled Transit Accessibility

Prepared by
Thomas J. McGean P.E.

Final Report
October 1991

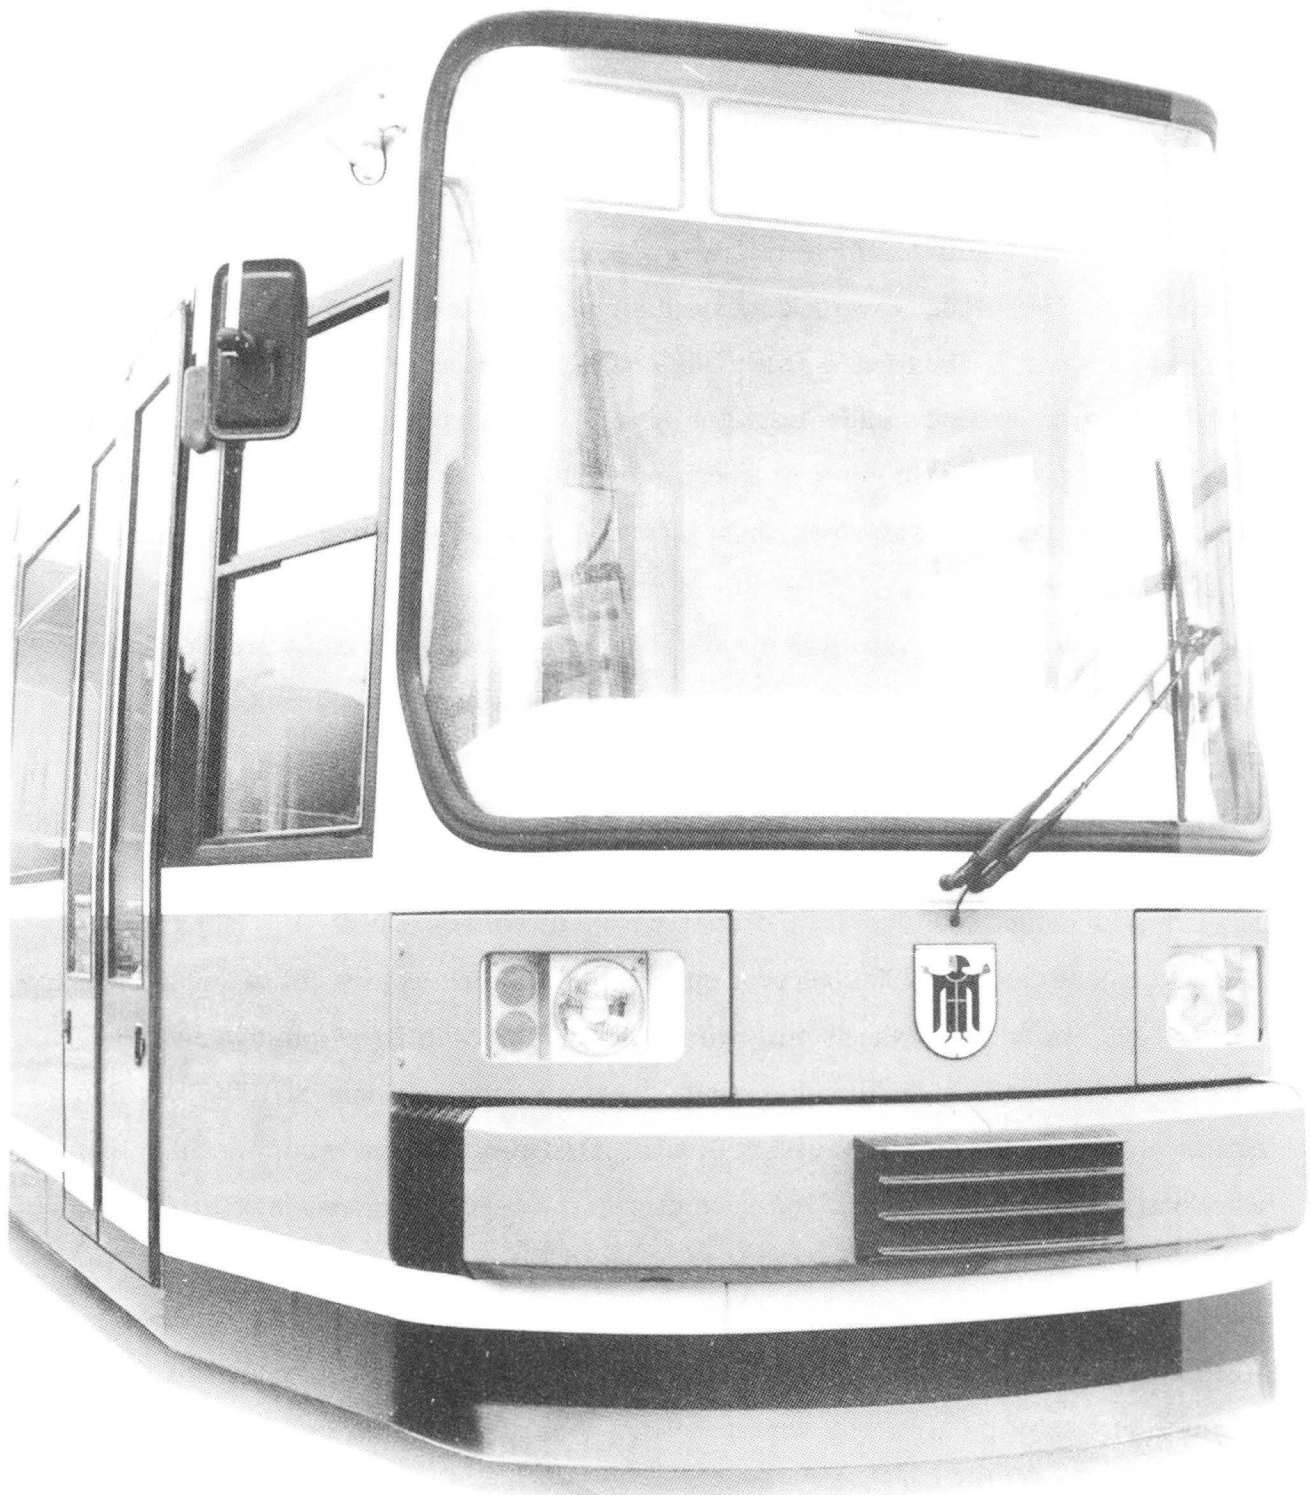
FIGURE 2-4. MAN-GHH GT6N

The GT6N LRV, developed by MAN GHH and marketed in the United States by AEG is the first articulated full length low floor light rail vehicle to be in revenue operation (Figure 2-9). The novel bogie has one pair of free wheels and one pair of torsionally stiff connected wheels. [22] The latter are driven by two spur gears interconnected by a low slung shaft, which causes these two wheels to act as though they were connected by an axle. Power is transmitted via a flexible cardan shaft from a single three phase A.C. motor mounted on the carbody. Motors are powered from inverters installed in the roof area. The

standard gauge vehicle has a maximum speed of 44 mph, an empty weight of 28 tons, and an overall length of 89 feet. The stainless steel cars hold 67 seated passengers and 103 standees at 4 persons per square meter. The floor is 14 inches above top of rail but slopes towards the entryway so that the door is only 12 inches above top of rail. A meter gauge version is under development.

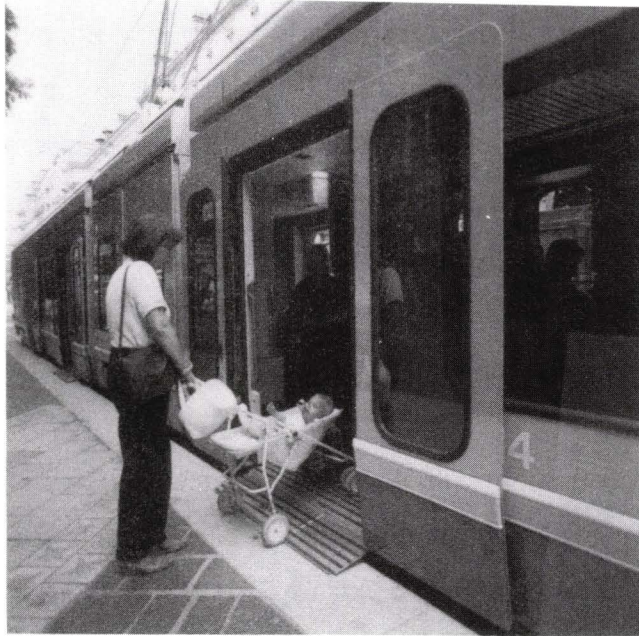
FIGURE 2-7. GRENOBLE BOARDING RAMP

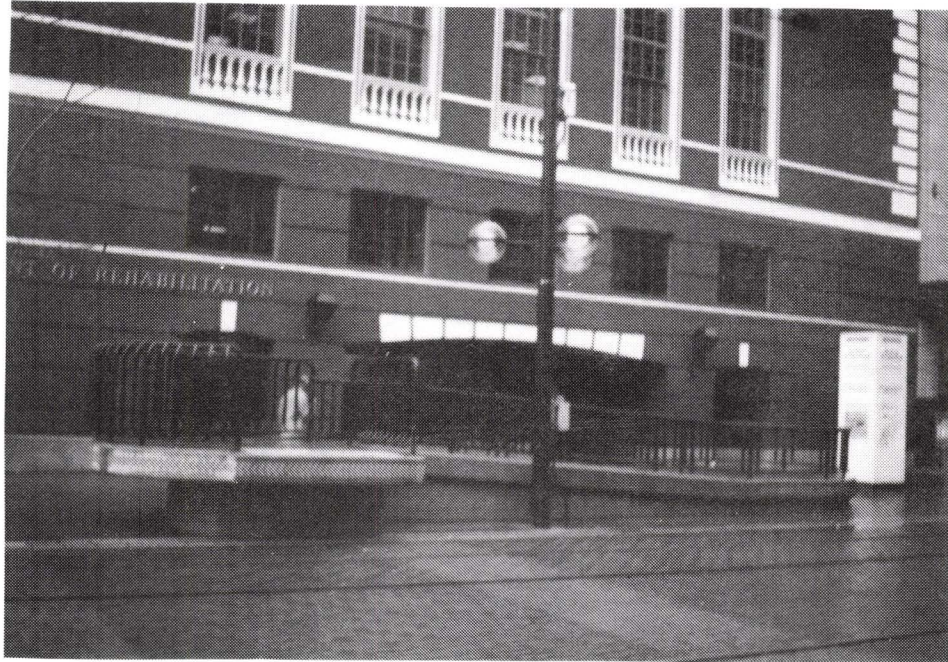
FIGURE 2-10. TYPICAL MINI-PLATFORM

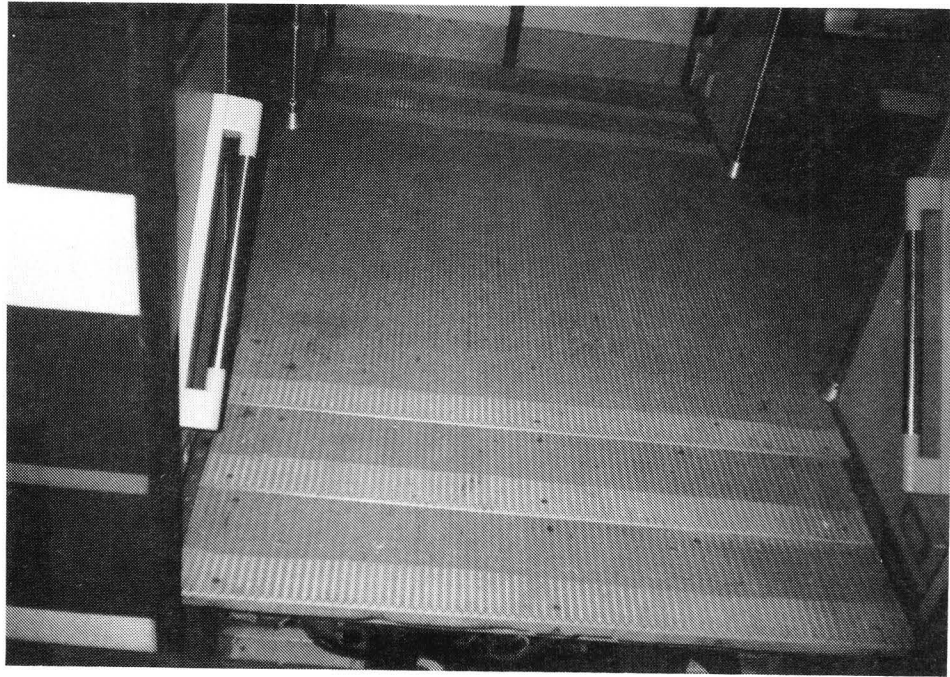
**FIGURE 2-12. MUNI STEP CONVERTED
FOR HIGH LEVEL BOARDING**

Mini-platforms are located at the far end of the station stop. MUNI trains normally stop short of the mini-platform, unless a handicapped person wishes to board or deboard. In this case two stops are required. The first stop is short of the mini-platform as would normally be the case (Figure 2-13). After regular passenger boarding and deboarding is accomplished, the operator then converts the stepwell at the forward center door of the lead car to high platform operation and pulls the train up to align that door with the mini-platform. After boarding or deboarding of the disabled passenger the steps must be returned to their low level position. This approach does not use a bridge plate to cover the gap between station platform and train. The horizontal gap is the same as for MUNI high platform subway stations, typically 4 - 4 1/2 inches. [37]

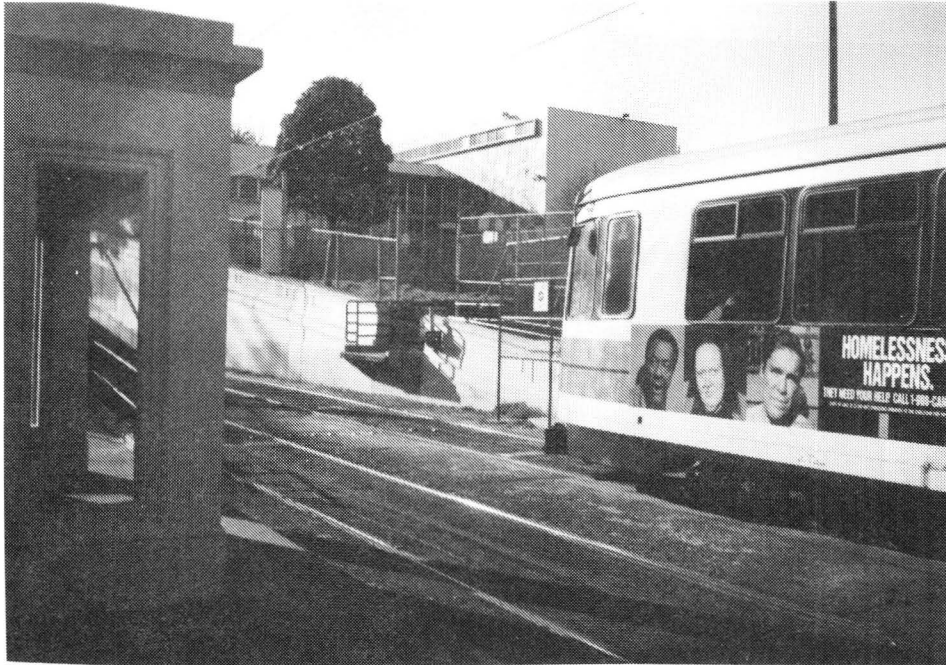
FIGURE 2-13. MUNI TRAIN MAKING NORMAL STOP SHORT OF MINI-PLATFORM

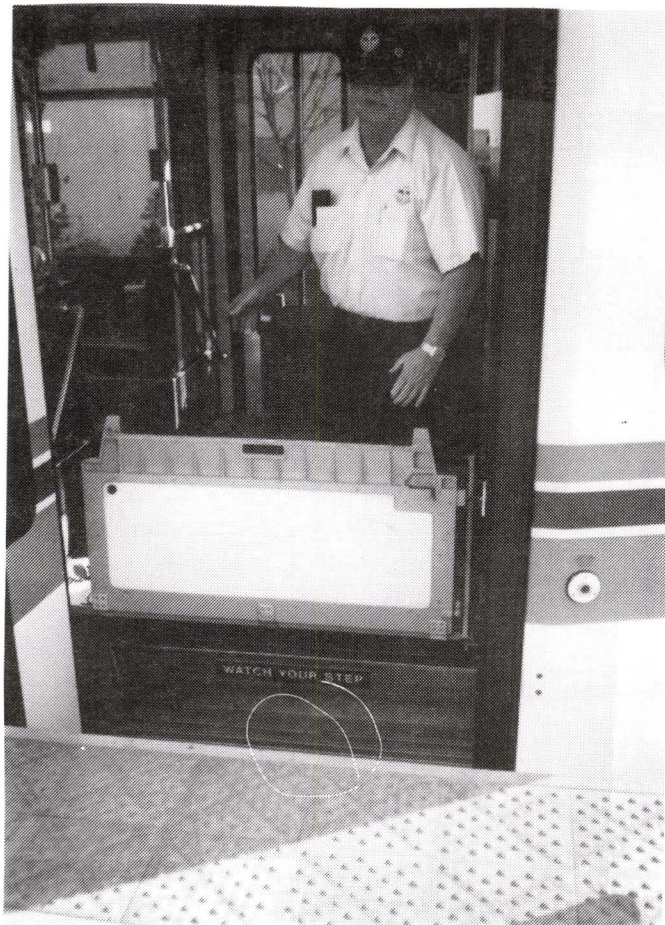
← **FIGURE 2-15**
OPERATOR DEPLOYING
BRIDGING DEVICE

FIGURE 2-16
FULLY STOWED POSITION OF →
SACRAMENTO BRIDGING DEVICE

In Sacramento bridging devices are provided for the front doors on both sides and at both ends of the reversible cars. These devices may be stowed in the rear wall of the operator's cab making the stepwell accessible for normal low level use (Figure 2-16). However, normal practice in Sacramento is to leave the bridge plate at both front doors covering the stairwell throughout the trip. It is then a simple matter for the operator to drop the bridge plate to cover the gap between car and platform using the handle visible in Figure 2-17. In Sacramento mini-platform use has been extended not just to the disabled, but to any persons desiring more convenient boarding. This includes the elderly as well as persons with strollers or packages. As a result, operators always stop at the mini-platforms. In Baltimore, it has not been decided whether or not trains will normally stop aligned with the mini-platform. Figure 2-18 is a sketch of the Baltimore mini-platform.

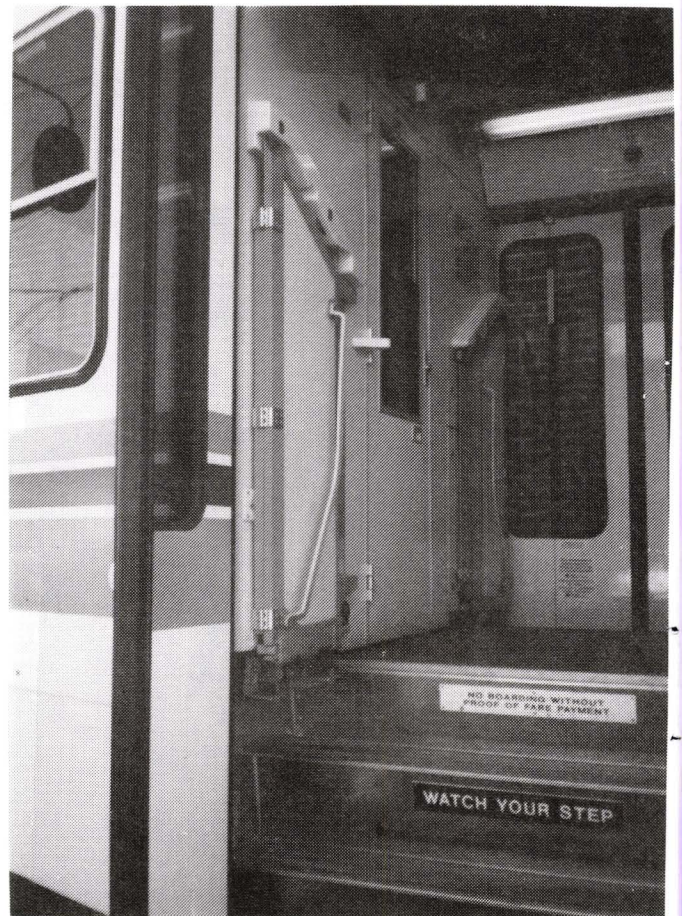
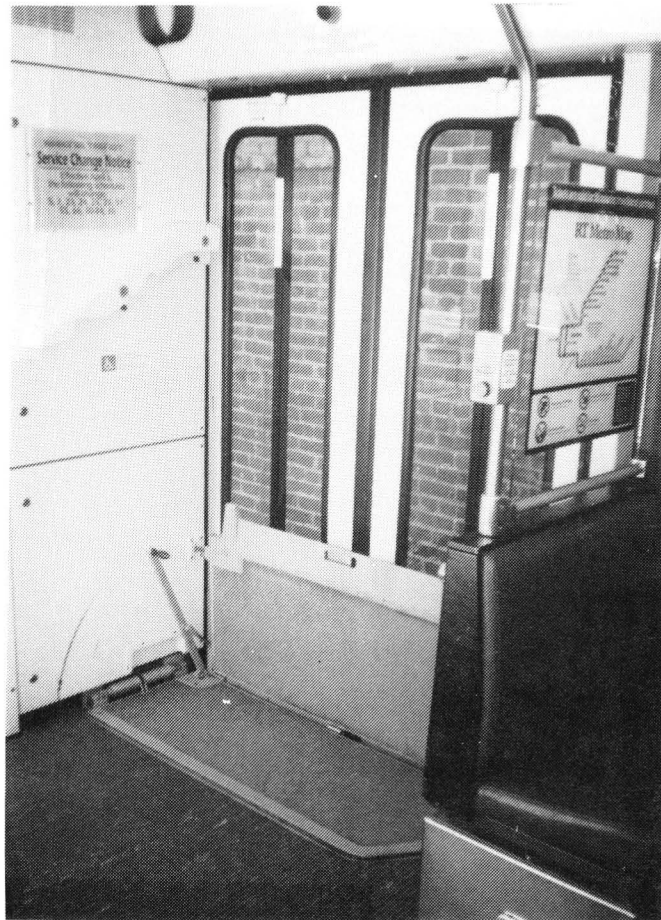
**FIGURE 2-17. PARTIALLY DEPLOYED POSITION OF
SACRAMENTO BRIDGING DEVICE
USED DURING NORMAL OPERATION**

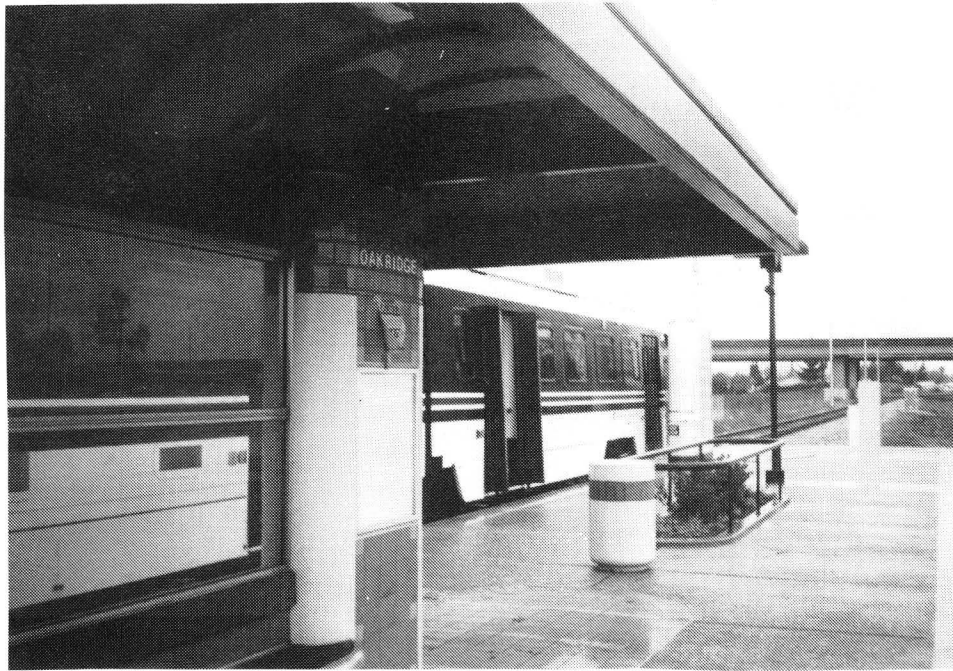
**FIGURE 2-19. SANTA CLARA
LIGHT RAIL CAR STOPPED AT LIFT**

The Santa Clara County Transit Agency operates a fleet of 50 articulated light rail cars built by UTDC operating on two routes. The original Guadeloupe route, opened in 1987-1988 is nine miles in length with 15 stations. The recently opened Santa Teresa route is eleven miles in length with 13 stations. All stations are equipped with wayside lifts provided by Mobility Unlimited Inc (Charles Williams Enterprises, Inc.). The custom lift, designed by Gregory Pachlan, is based on a Ricon R30 vehicle lift modified and provided with lift enclosures by C. E. Tolan (Figure 2-19). There are 36 lifts on the Guadeloupe line and 31 on the Santa Teresa line.

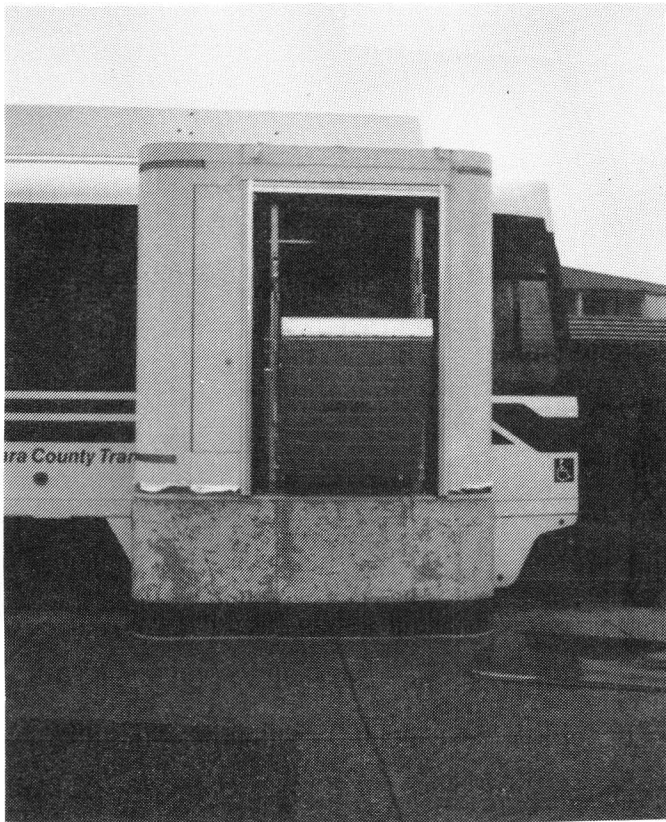
FIGURE 2-20
← **SANTA CLARA LIFT**

The SCCTA wayside lift combines a lift mechanism based upon the Ricon R30 vehicle borne lift and a bridging device. Both of these mechanisms are mounted on a concrete pedestal whose centerline is located 6 feet 9 3/4 inches to one side of the track centerline (Figure 2-20). The lift raises and lowers the disabled traveler to the level of the vehicle floor. The bridge plate spans the space between the pedestal and the light rail car doors, and also spans the vehicle stairwell providing level access to the car floor area. In their stored position, the bridge and lift mechanisms are protected by a rolltop sliding door which is locked when the lift is not in use (Figure 2-21).

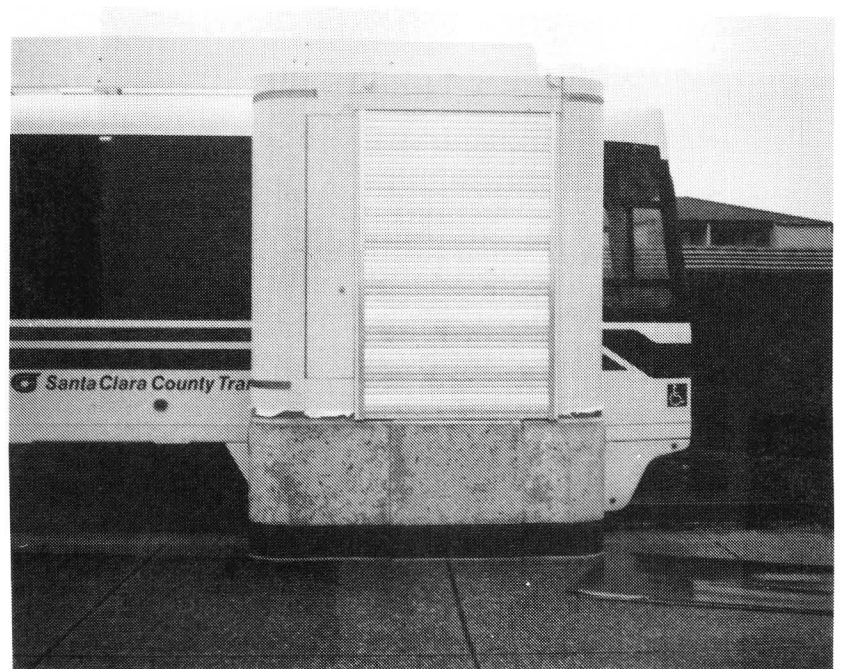
FIGURE 2-21
ROLLTOP SLIDING DOOR →
ON SANTA CLARA LIFT

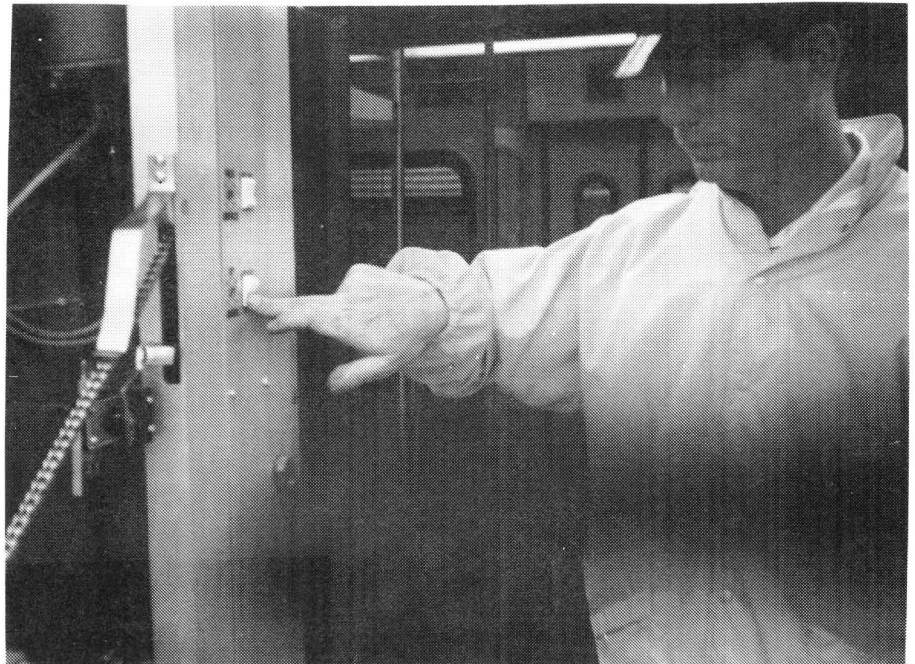
FIGURE 2-22
ROLLTOP DOOR
← ON SANTA CLARA LIFT
IN OPEN POSITION

FIGURE 2-23
OPERATOR PREPARING →
TO LOWER
SANTA CLARA LIFT

Once alignment has been verified, the operator opens all doors on the platform side and walks down the front car steps to the platform. [49] The control box located on the outside of the lift enclosure is unlocked and the operator throws a switch to raise the rolltop sliding doors to their fully open position (Figure 2-22). A pendant control unit is removed from the control box and the operator walks back into the train, standing clear of the area where the bridge plate will land. The operator then actuates the pendant controls to lower the bridge plate to cover the car stairwell and the gap between the train and the wayside lift pedestal. With the bridge plate in position, the operator walks across the bridge to access controls for the lift mechanism proper, which are located on the inside of the lift frame (Figure 2-23). These controls are used to first extend the lift mechanism and then to lower it to the ground (Figure 2-24). The disabled person then enters the lift platform area and the lift is moved to its raised position, where it aligns with the pedestal and bridge plate to provide a continuous level “gangplank” into the light rail car (Figure 2-25). The disabled passenger then moves across this “gangplank” into the car. With the passenger safely on board, the train operator still holding the pendant control walks across the “gangplank” into the train area. The pedant controls are actuated to fold the bridge plate and lift mechanism back into their stored position. The train operator then leaves the car to return the pendant control to the control box, lower and fully close the rolltop doors, and shut and lock the control box. With the lift properly secured, the operator returns to the cab and proceeds to continue his/her route. According to SCCTA records, the average delay or added station stop time required for the entire operation averages six minutes [50], most of which is involved with accurately aligning the car with the wayside lift pedestal.

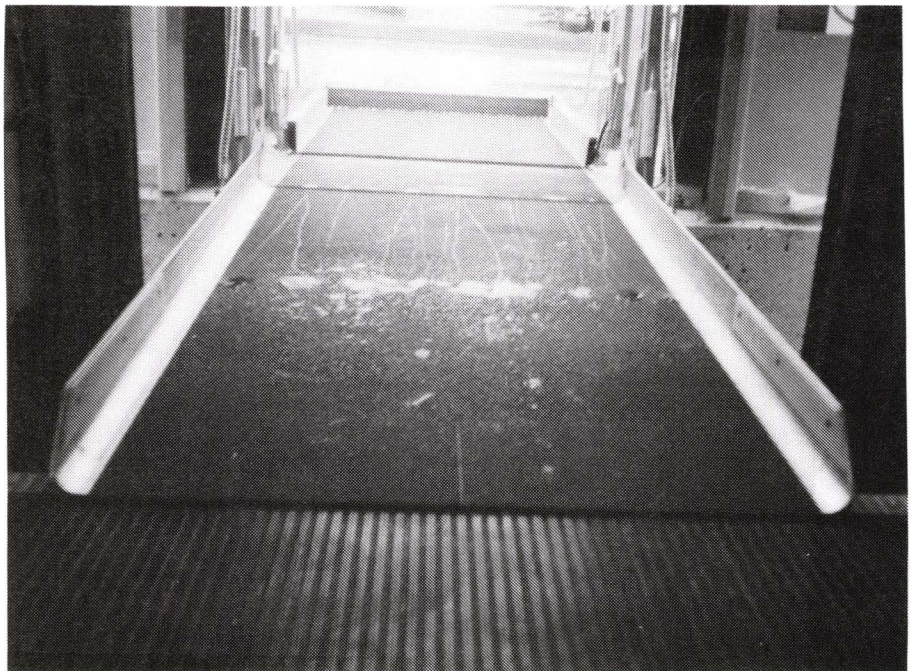
FIGURE 2-24
← **SANTA CLARA LIFT**
LOWERED TO GROUND LEVEL

FIGURE 2-25
FULLY DEPLOYED
SANTA CLARA LIFT
IN RAISED POSITION →
PROVIDES CONTINUOUS
“GANGPLANK” ONTO
LIGHT RAIL CAR

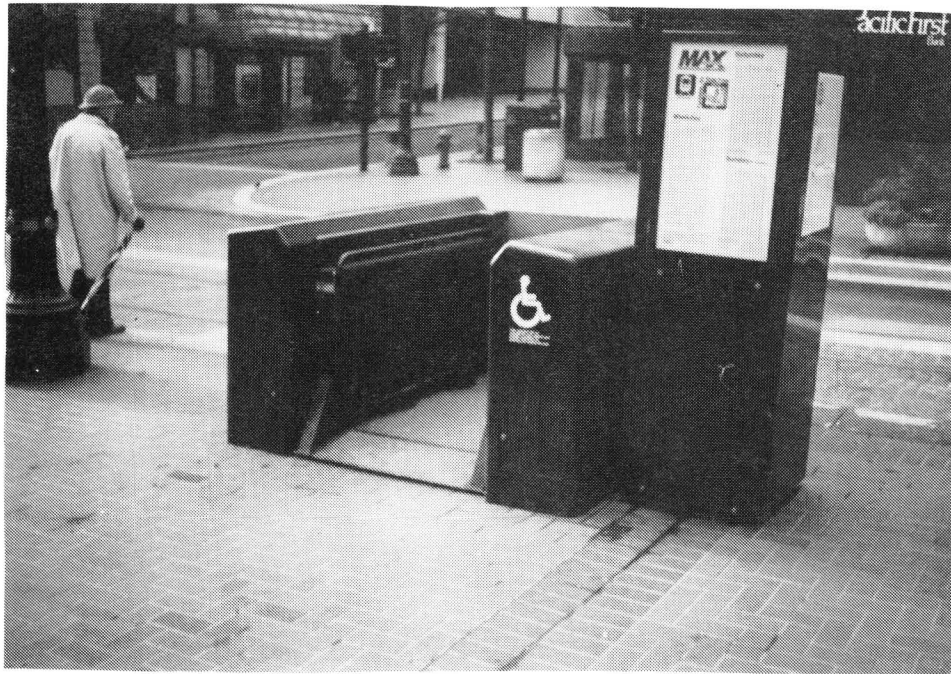
**FIGURE 2-27. PORTLAND WAYSIDE LIFT
(PIONEER SQUARE)**

The Tri-Met wayside lift is an electro-hydraulic mechanism designed to make the light rail vehicles accessible to disabled passengers (Figure 2-27). The major components are the lift platform, a bridging device, a ramp, and two frames which cradle the platform on each side. The left main frame contains virtually all the electrical and hydraulic components. Both frames have fiberglass covers with access doors for normal service and provision for manual operation in the event of an electrical failure.

Two 1-1/2 inch bore, 15 1/2 inch stroke hydraulic cylinders are used to raise and lower the platform a total distance of 29 1/2 inches. A system of eight stainless steel cables redundantly stabilize the platform in both lateral and longitudinal directions. Hydraulic cylinders are also used for lowering and raising the bridging device and ramp.

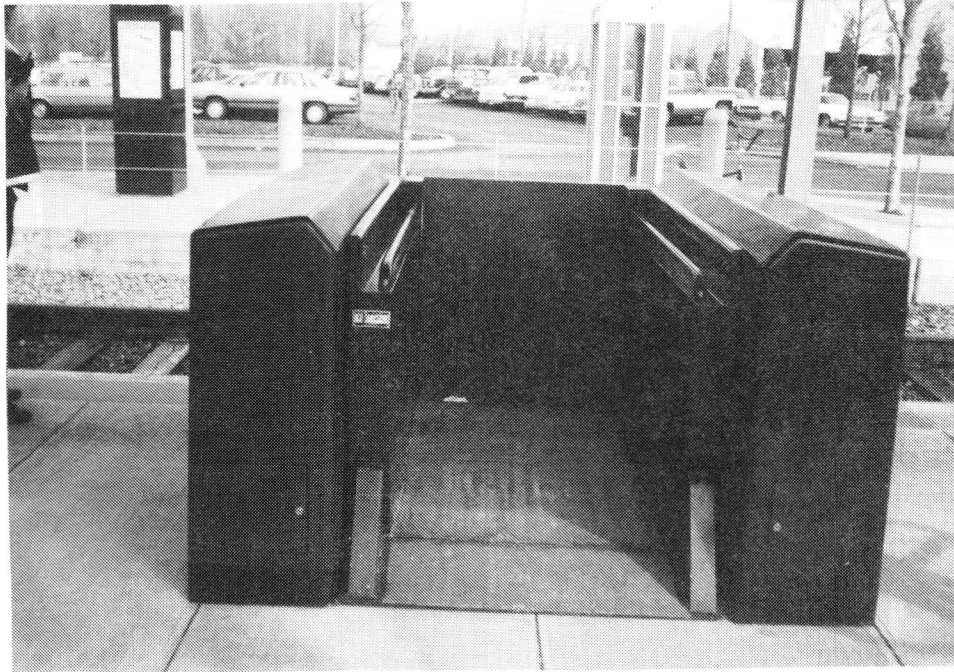
FIGURE 2-29. NORMAL LOWERED POSITION OF PORTLAND LIFT

The actual lift process is fairly simple. Normally, the platform is in its lowered position with the ramp deployed and the bridging device folded up (Figure 2-29). This makes it possible for the disabled passenger to position him or herself on the lift platform at leisure, prior to arrival of the light rail vehicle. Once the light rail car arrives and is properly aligned, the operator leaves the car and activates the system from a locked control box on the side of the lift. As the operator presses the "Up" button, the ramp folds up (Figure 2-30) and the platform raises to the level of the floor of the light rail car. It takes 2-4 seconds to fold up the ramp, and another 6-12 seconds to raise the platform to car floor level. [60] At the end of the "Up" cycle, the bridging device lowers to span the area between the platform and the floor of the light rail car (Figure 2-31). It takes between 4 and 7 seconds to deploy this bridge plate. With the bridge plate in position, the passenger maneuvers him or herself into the car and the operator then reverses the cycle to lower the lift to its normal down position. The entire process takes about a minute, plus whatever time was required to align the vehicle. Lift specifications are provided in Table 2-3.

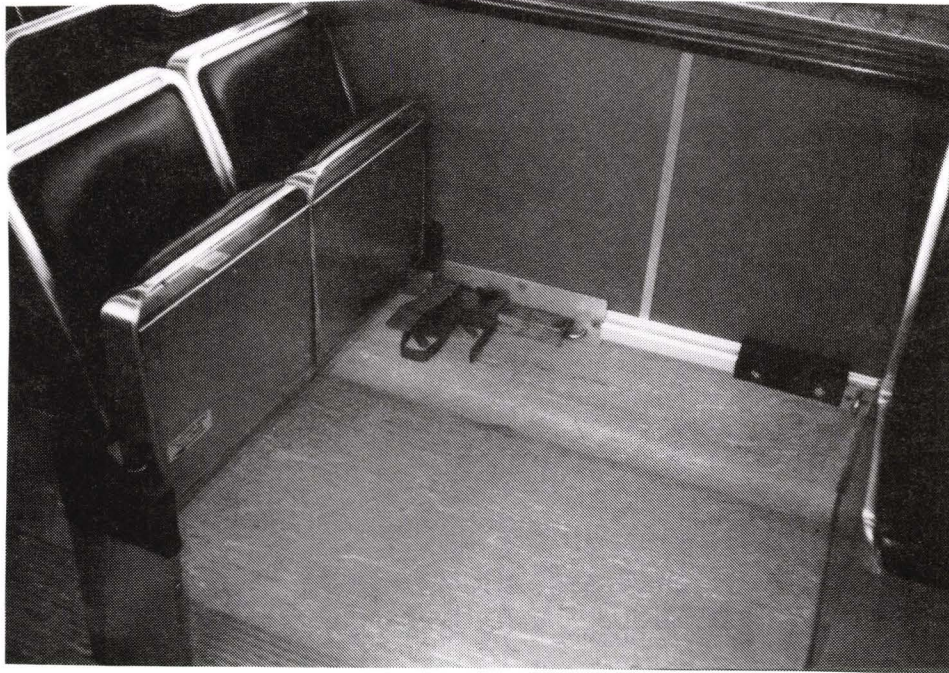
FIGURE 2-32. TRI-MET WHEELCHAIR SECUREMENT DEVICE

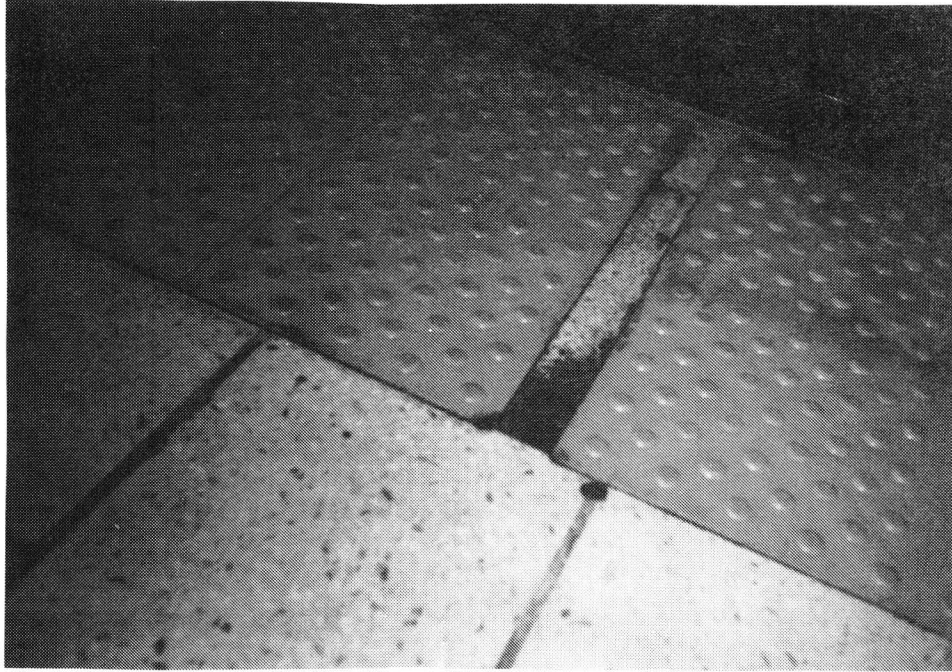
**FIGURE 3-2. TILE LIFT-OFF
LAKE MERRITT STATION**

Pathfinder tiles are of two distinct types. The original tile studied by Peck and Bentzen has now been installed at all transit platforms for San Francisco's BART, Sacramento's light rail, and Miami's rapid rail and people mover systems. It is a synthetic rubber tile with a pre-applied pliant polymer adhesive with release paper. The subsurface must be carefully cleaned and primed. The tile is then positioned in place and gently tapped with a mallet. Transit agencies using this tile have experienced problems with adhesive failures and liftoff, usually resulting in curling of the corners of the tile. This problem is aggravated by inadequate cleaning, defective installation including failure to maintain a small gap between adjacent tiles, and by hot and possibly cold weather. The tile expands on warm days, and possibly creeps with age. If an insufficient gap exists between tiles this can cause the tiles to buckle. Figures 3-2 and 3-3 show typical liftoff problems observed at the BART and Sacramento systems.

The Operations Support Manager for Sacramento Regional Transit estimates that 10-20 percent of the tiles have been replaced since 1987 due to failure of adhesion and liftoff. [5] At BART, a survey of the Bay Fair Station conducted by the System Safety Department showed a third of the tiles had failed after a year and a half of use. Other BART stations fared much better, with failures ranging from one to ten percent of the tiles. [6] Guidance Systems Incorporated estimates that on the average five percent of the tiles have failed. [7]

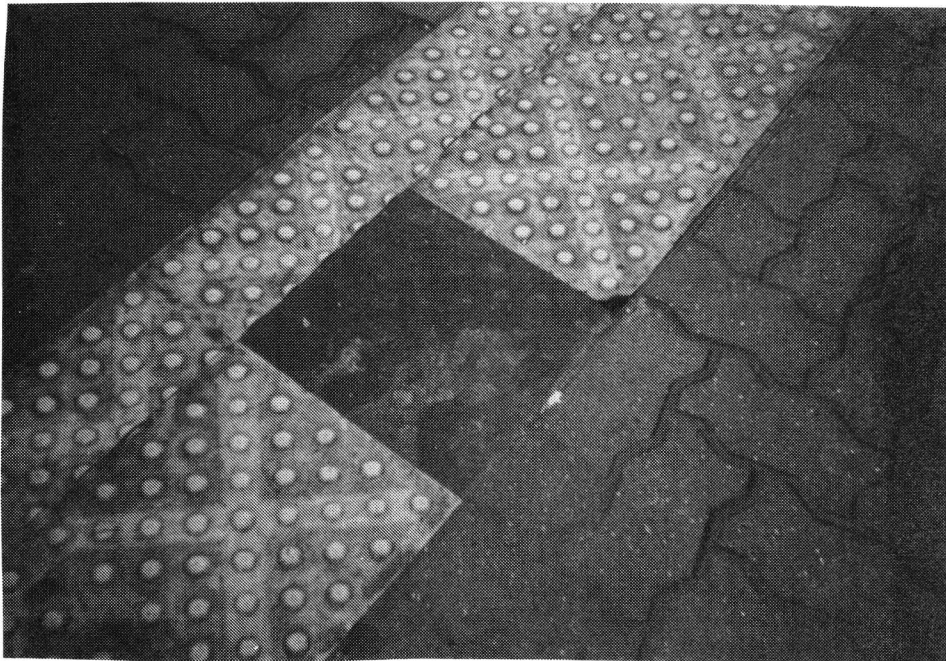
**FIGURE 3-3. TILE LIFT-OFF
SACRAMENTO MALL**

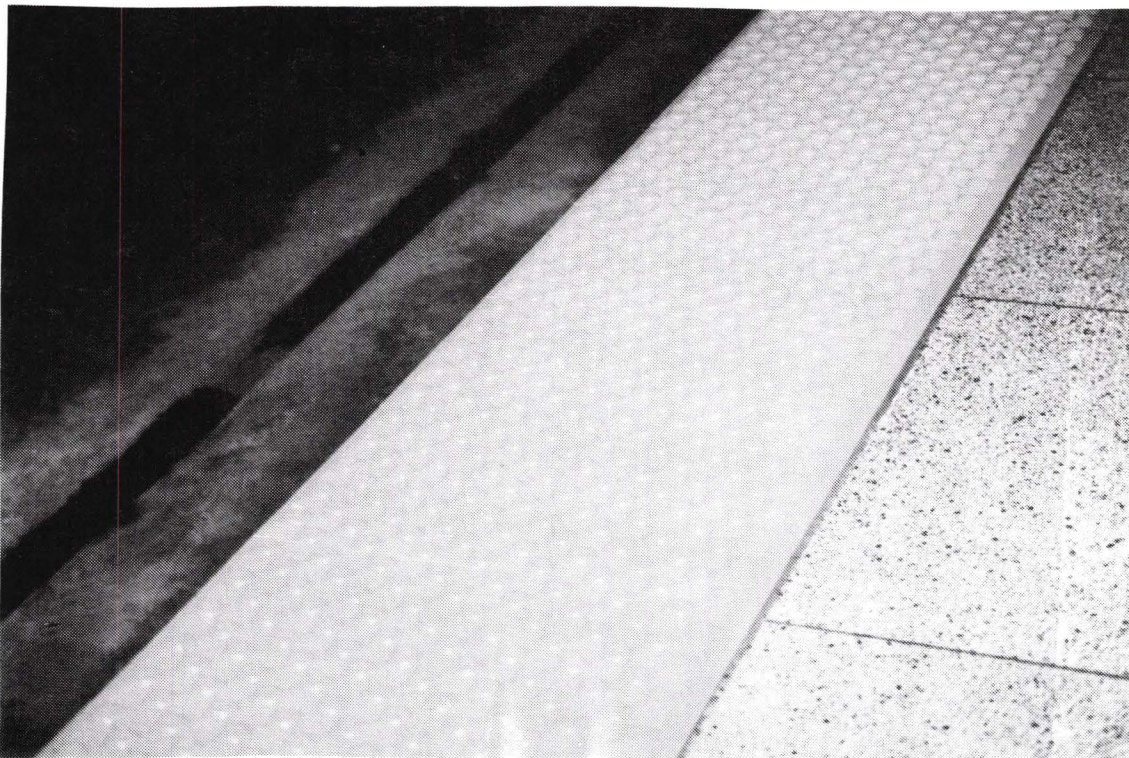
**FIGURE 3-8. "ARMOUR-TILE"
INSTALLED AT TRANSIT PLATFORM EDGE**

Epoxy adhesive is troweled to both floor and tile surface. The tile is placed in position and then either clamped or weighted to maintain pressure while the adhesive is curing. Epoxy adhesive is used to fill in the leading edge of the tile and lock it into the one inch deep groove. This careful installation process is intended to eliminate tile lifting and

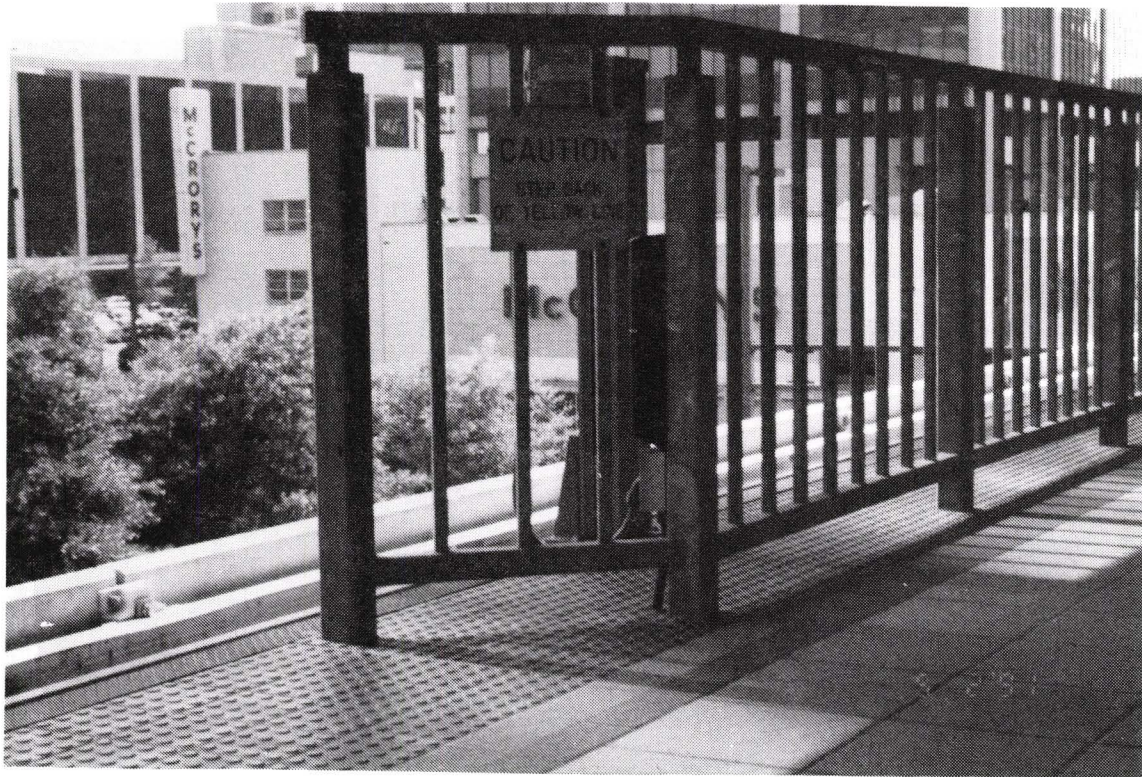
**FIGURE 3-14. AMERICAN OLEAN WARNING TILE
IN JACKSONVILLE, FLORIDA**

which opened for service in 1989, uses American Olean "Transit-Tile 191" at all platform edges. The ceramic tiles are six inch x six inch x 0.5 inch thick. Each tile has sixteen discs, 0.875 inch in diameter and 0.09 inches high. It can be installed using conventional mortar or epoxy mortar. A two foot wide strip of "Canyon Red" tiles is laid along the entire platform edge which is also protected by a railing (Figure 3-14). At the openings in the railing an additional six inch strip of warning tile finished "Safety Yellow" is added. In addition to Jacksonville, American Olean has also installed a similar tile at four stations on the Southeastern Pennsylvania Transportation Authority (SEPTA) Market-Frankford Line (the 19th, 30th, 34th and 38th Street Stations).

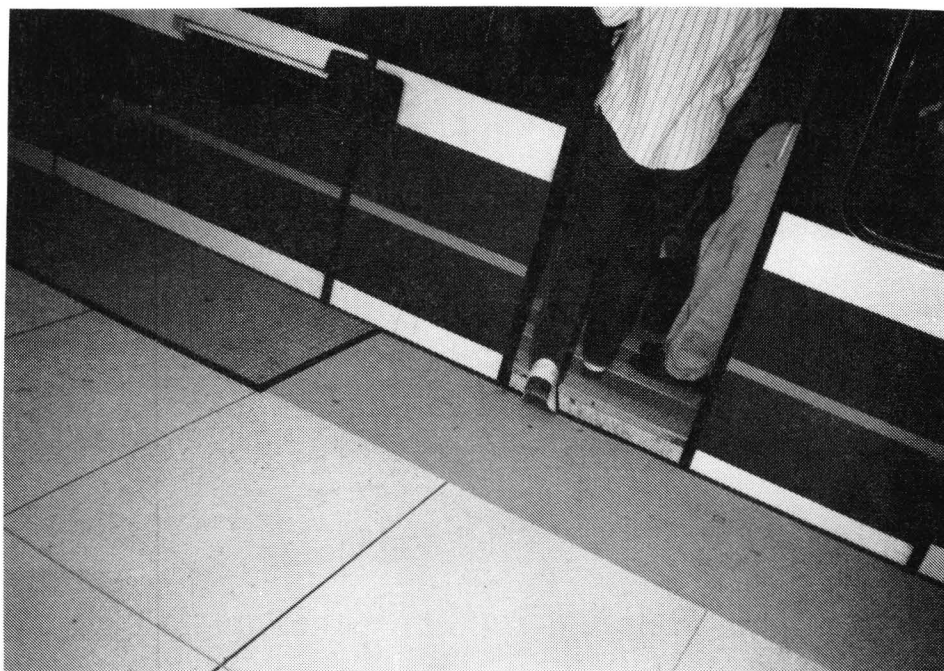
**FIGURE 3-16. SERVICE TEST OF
WAFFLE PATTERN RUBBER TILE (LEFT SIDE) AND
NON-SKID ALUMINUM OXIDE (RIGHT SIDE)
AT MUNI VAN NESS STATION**

Tests are now underway with 20 foot long by two foot wide warning strips of the non-skid aluminum oxide and waffle pattern rubber tile in the Van Ness Station of Muni (Figure 3-16). In addition, MUNI has arranged for the Department of Health to conduct flammability and toxicity tests on both of these materials as well as “Pathfinder” tile; results are not yet available. Neither of the two materials being considered by MUNI would meet Federal regulations for a detectable warning surface because they do not have the “bump” pattern.

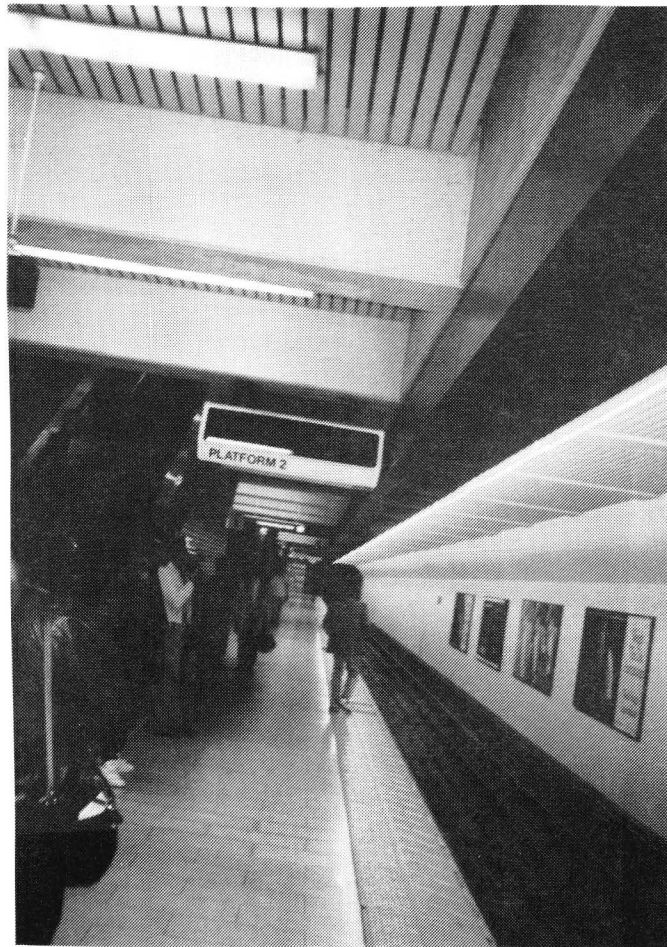
**FIGURE 3-17. PERSON USING
BART WARNING STRIP AS WALKWAY**

During study for the present report, passenger activities in the BART Embarcadero station during rush hour were videotaped. This station is equipped with a two foot wide warning strip using "Pathfinder" tile whose pattern and color meet Section 4.29.2. of the Architectural and Transportation Barriers Compliance Board guidelines. Inspection of the videotape showed this warning edge to be remarkably effective at keeping all patrons away from the platform edge; the vast majority of passengers stand away from the warning strip. However, even with the present two foot warning strip, occasional aggressive patrons can be seen using the two foot warning strip as a walkway to avoid the crowded platform (Figure 3-17). Two feet is generally considered inadequate for a walkway. If a three foot wide strip were used, as has been suggested at various times, the temptation for aggressive passengers to make use of the strip as a walkway could be expected to increase, with a possible adverse impact upon the success this warning edge has in reducing platform edge accidents, not only for the disabled, but for all passengers. In addition, center platform widths can be as narrow as 11 feet. With two detectable warning edges each three feet wide, over half the available platform area becomes prohibited to passengers. This would be expected to cause excessive crowding as all passengers would be restricted to only five feet of the eleven foot platform width. By comparison, a two foot wide warning strip is more realistic. In designing station platforms, it is standard to assume 18 inches of unused space at walls or platform edges. Thus use of a two foot wide warning strip on each side of a center platform will only reduce the effective width of the platform in terms of passenger staging capacity by one foot. For these reasons it appears that the present Federal requirement for a two foot wide warning strip is appropriate.

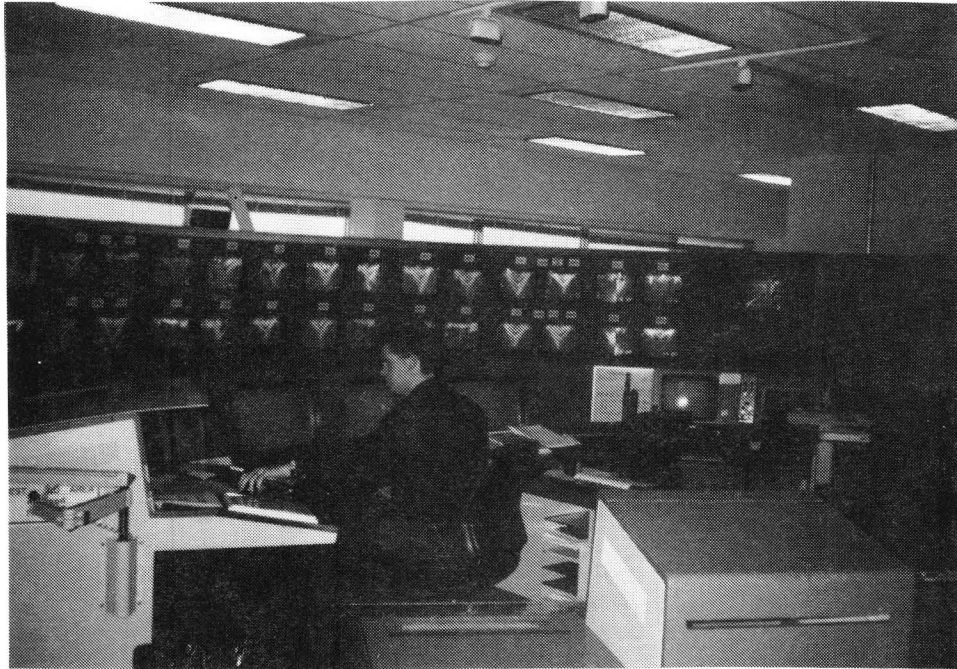
**FIGURE 3-19. CLOSED CIRCUIT TV SURVEILLANCE
(VANCOUVER SKYTRAIN)**

An alternative or adjunct to passive platform edge protection using tiles to provide a warning is the use of electronic surveillance techniques to detect intrusion of persons onto the guideway and stop approaching trains. It is common practice for automated transit systems as well as modern rapid transit systems to provide closed circuit television (CCTV) surveillance of the track area. Cameras, either fixed or panning in predetermined patterns are located on the station platforms. The image is transmitted to a central control area where it is displayed on a CRT (Figure 3-19). Small systems may provide a separate CRT for each camera. For larger systems it is more usual to sequence the images with one screen serving multiple stations. The images are monitored by central control personnel, who are able to hold the image in a particular station if a problem is observed. Videotape recording is available to provide a record. CCTV surveillance is well known in the industry and therefore will not be treated at length in this report.

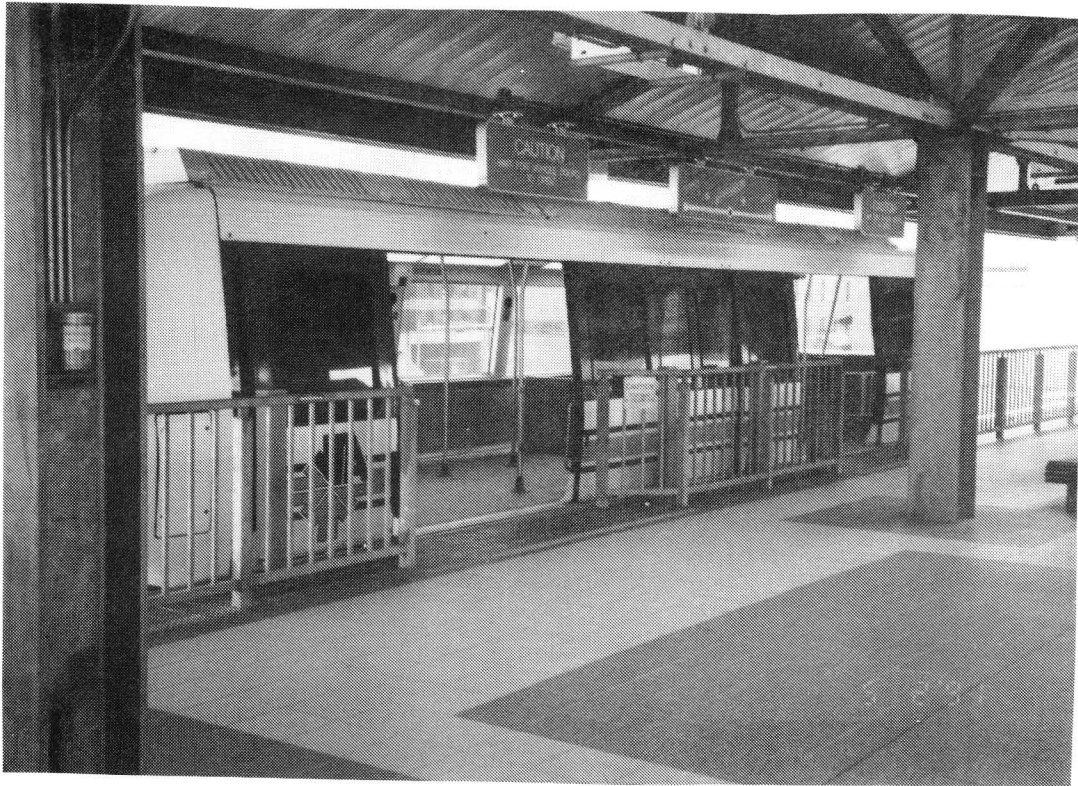
**FIGURE 3-26. JACKSONVILLE STATION
WITH RAILING SET BACK TWO FEET
FROM PLATFORM EDGE**

The platform area of the Automated Skyway Express system is protected by railings set two feet back from the edge of the platform. At loading areas, the railings are directed toward the edge of the platform at a forty-five degree angle, (Figure 3-26) so that an open gate area for passenger boarding is provided. The alarm warning system designed by JTA staff consists of two infrared beams across each loading gate area two feet back from the platform edge. In the event a potential guideway intruder interrupts the beams, a loud horn alarm is sounded at the loading gate area along with a flashing light. In addition, a buzzer and flashing light are activated in the central control room above the appropriate CCTV monitor.

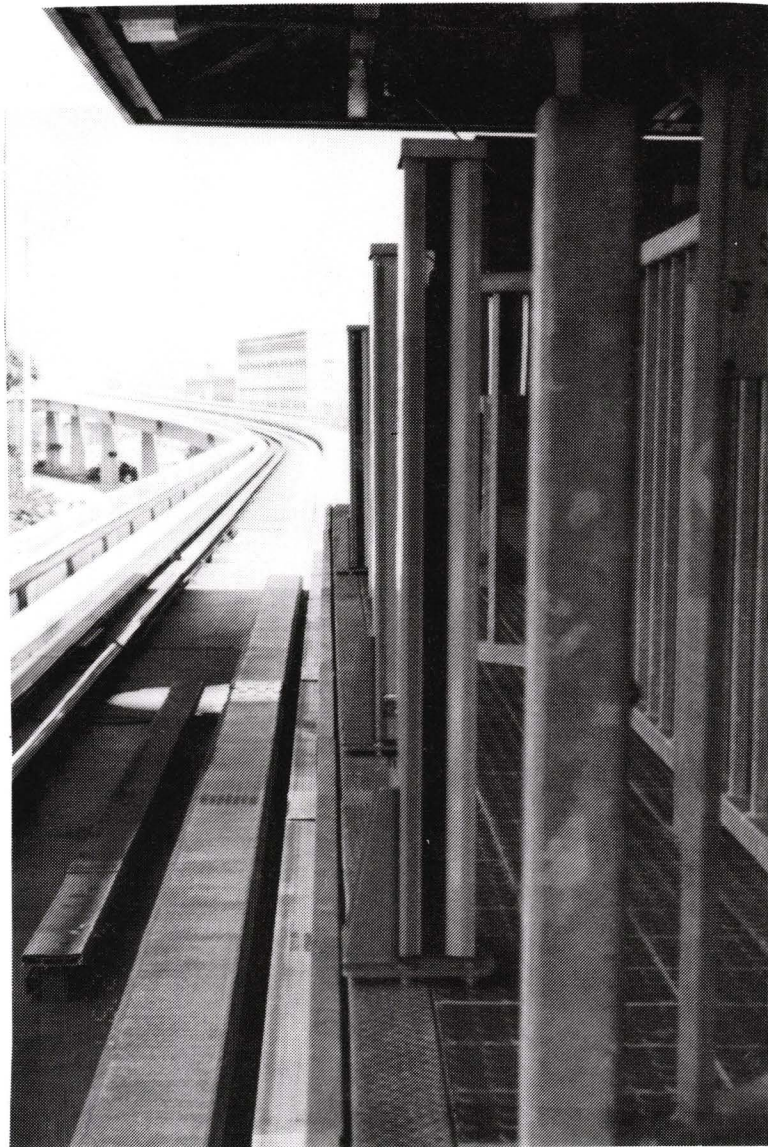
**FIGURE 3-27. PILLAR WITH ROW
OF FOUR INFRARED DETECTORS**

The early warning alarm system is backed up by an intrusion detection system supplied by Matra Transport. It consists of rows of four infrared beams recessed in a 3 1/2 foot high pillar installed to the side of the loading gate opening at the platform edge (Figure 3-27). [42] Instead of being located two feet away, these beams are only four inches from the edge of the platform. Each side of the platform has two sets of detectors, one for each
