Innovative Solutions for Disabled Transit Accessibility

Prepared by
Thomas J. McGean P.E.

Final Report
October 1991

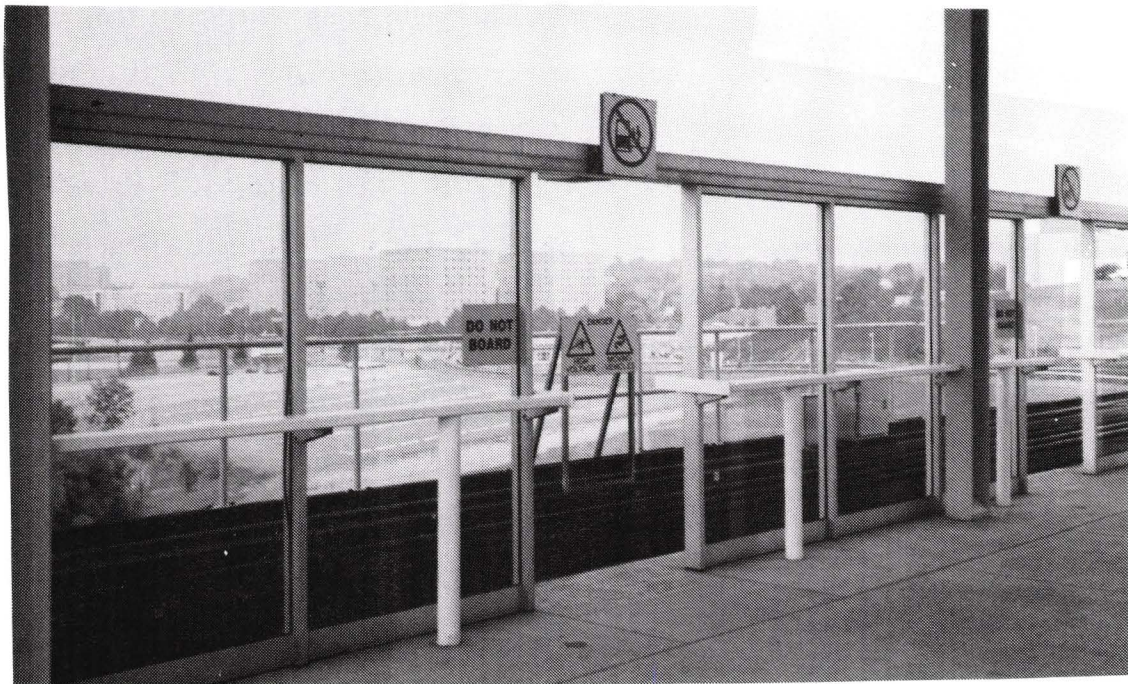
**FIGURE 3-30. WINDOW WALL PARTITIONS
FOR NEW MORGANTOWN PRT STATION**

Another unique feature of the Morgantown people mover is its use of platform barriers to separate the passenger platform area from the guideway. Morgantown uses two distinct types of platform barriers. Beechurst and Walnut stations have simple 3 1/2 foot high aluminum railings with openings aligned with the stopped vehicle doors (Figure 3-29). The other three stations at Medical Center, Towers and Engineering have seven foot high window walls of tempered glass with tubular aluminum framing (Figure 3-30). Closed circuit video cameras monitor the openings but no other intrusion detection is provided. It should be noted that PRT cars are normally kept parked at the boarding gate in the offline stations so that access to the guideway is not possible most of the time. Unloading areas are less frequently occupied by vehicles, but are not areas where passengers normally congregate. Transit systems with online stations would not have cars parked in the stations so that passenger intrusion onto the guideway could be a greater problem than at Morgantown.

and adding a 15% contingency plus 25% for professional services, the cost for a 3 1/2 foot high railing would run approximately \$30 per linear foot installed [52]. A seven foot high window wall, using the same assumptions, would cost about \$220 per linear foot installed. [53] Operating and maintenance costs are limited to painting the railing and costs for cleaning and replacing the glass. By using a vandal-proof finish in place of glass, partition maintenance costs could be made negligible. A major advantage of this approach is that it adds no moving parts or electronics, so there is no impact on system reliability or maintenance costs.

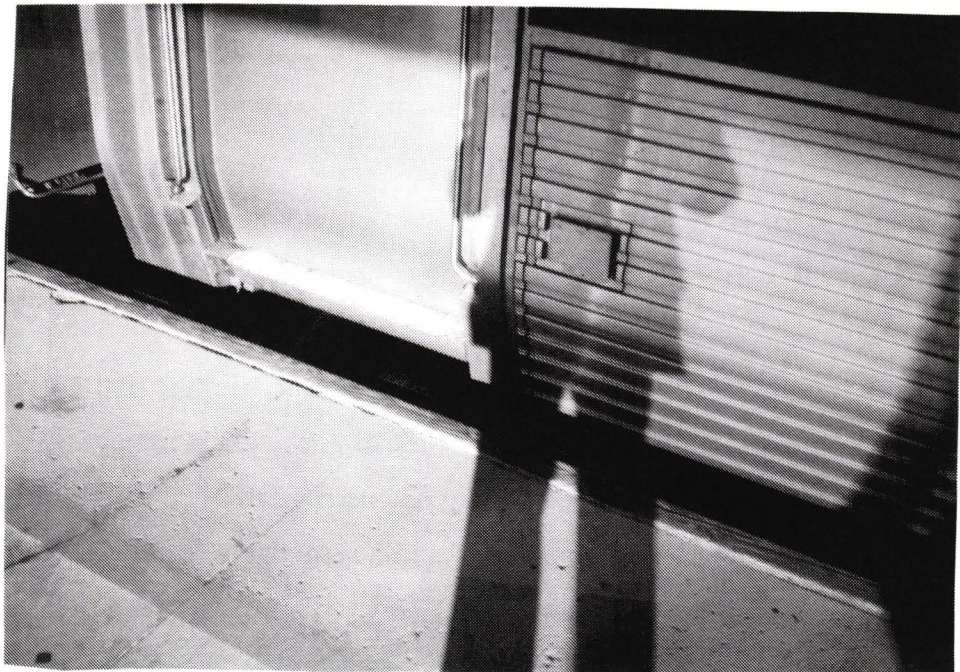
**FIGURE 4-1. AMTRAK HIGH PLATFORM
AT NEW CARROLTON STATION**

The Long Island Rail Road also has high level platforms at most stations on its electrified routes. Bridgeplates are not being used. Instead crews assist in getting wheelchair users across the gap. A training program has been established which includes disabled persons. [6] The Metro-North Commuter Railroad Company operates commuter lines formerly run by the New York Central and New Haven Railroads. Most platforms are high level. Horizontal gaps range from 4 to 6 inches and according to company officials normally cause "no real problem." However, the more modern M-3 and M-4 cars are equipped to carry bridgeplates. [7] Amtrak operations in the northeast corridor (Washington-New Haven) have high level platforms for boarding (Figure 4-1). Bridgeplates are not used in high platform territory.

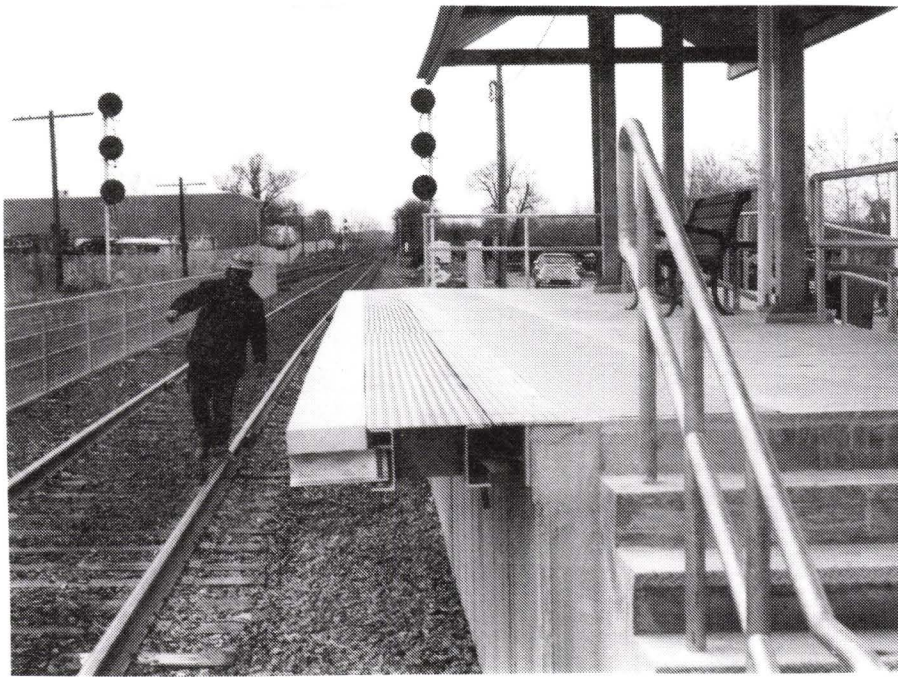
**FIGURE 4-2
FRANGIBLE
← PLATFORM EDGE
AT MBTA
MISHAWUM STATION
(DEPLOYED)**

The Massachusetts Bay Transportation Authority has made a policy decision to use either high platforms or mini-platforms to make all "key" commuter rail stations accessible. All rehabilitated stations will have 45 foot long mini-platforms. New stations will have full 730 foot long platforms. The design target for horizontal gap on MBTA commuter lines is five inches but freight clearances on some lines require a greater amount. [10] To handle these situations, the MBTA has developed a unique frangible platform edge shown installed at the Mishawum station. Figure 4-2 shows the edge in the deployed position, while Figure 4-3 shows it retracted. The outer edge consists of a two foot wide hinged aluminum structure which can be rotated to a vertical (retracted) position to provide increased clearance. The normal or deployed position permits high level boarding of passenger cars. Because relatively few special "wide" freight loads are carried, the MBTA has arranged that it receive prior notification from the carrier. Maintenance staff then go out and retract the platform edge. To protect against failure to retract the edge, the outer nine inches of the edge consists of polyurethane foam supported by individual hinged aluminum channels on 12 inch centers. If the edge is struck, the channels swing out of the way and the frangible foam is harmlessly scattered upon impact. [11]

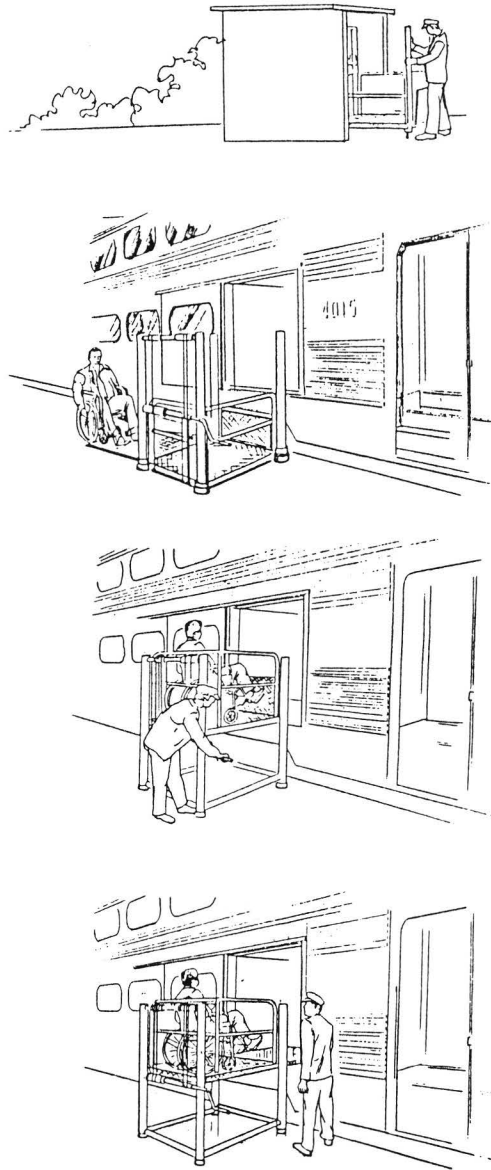
FIGURE 4-4. OPERATION OF PORTABLE LIFT

Amtrak and VIA Rail Canada both use a mechanically assisted (crank and gear) mobile lift inside a portable framework (Figure 4-4). The mobile lift is a moveable device, normally stored out of the way in a locked shed or room. It is moved into position in front of the door after the train has stopped. The wheelchair passenger maneuvers onto the lift which is then hand cranked up to the floor level of the car. A bridge plate on the wheelchair lift platform is then manually folded down to traverse the stairwell and provide access to the train. A lift of this type, the "AMPLE" lift, is manufactured by Adaptive Engineering, Ltd. of Calgary, Alberta. [18] The lift includes a braking and stabilizing system; the brakes are locked by default unless released to roll the lift around the station. Amtrak uses this lift for access to Amfleet and Heritage equipment operating from low level platforms. Mobile lifts provide a simple solution. However a manual operator is required. If job descriptions and union agreements do not permit station agents or train crew members to operate the mobile lift, then an additional class of station agent would be required, making the mobile lift extremely expensive. The other key concern with mobile lifts is the time required to access the lift, move it into position, and hand crank it up and down. The mobile lift is the most time consuming solution and therefore only suitable where the demand for wheelchair service is not very high.

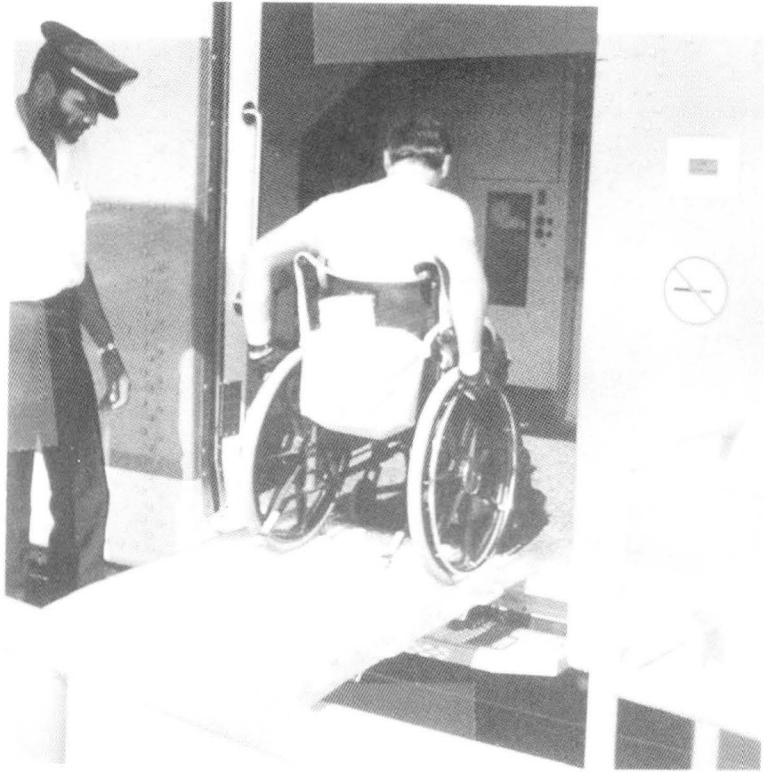
**FIGURE 4-5. RAMP BOARDING OF TRI-COUNTY
BI-LEVEL CARS IN SOUTH FLORIDA**

UTDC has built 18 bi-level commuter rail cars for the Tri-County Commuter Rail Authority of South Florida for use between West Palm Beach and Miami. [21] The cars entered service on the 60 mile route in 1989. The car, a derivative of the GO Transit cars used in Toronto, utilizes short manual ramps similar to those on Amtrak Superliners to permit access from a slightly raised platform (Figure 4-5).

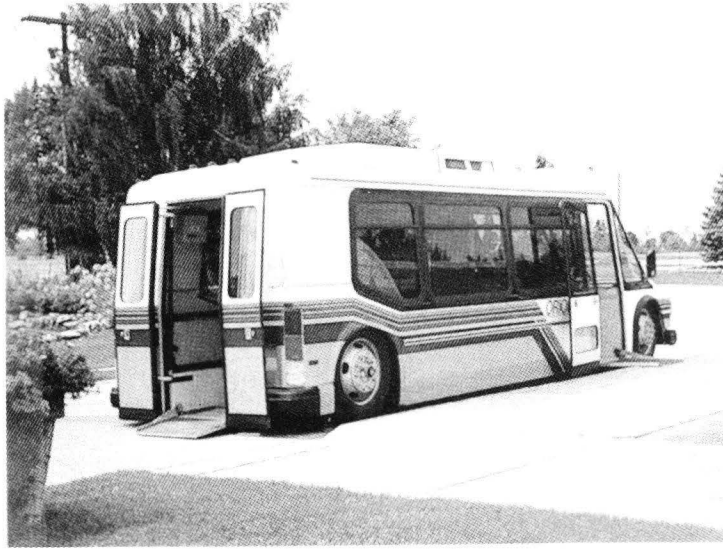
FIGURE 5-1. ORION II BUS

The Orion II (Figure 5-1), built in Canada by Ontario Bus Industries and in the United States by Bus Industries of America, is offered in two models. The 22 foot model has seats for 18 persons while the 25 foot model seats 25 persons. The diesel powered buses have a stainless steel structure with removable aluminum, fiberglass and stainless steel

panels. An unusual feature which facilitates the low floor height is front wheel drive. This feature also makes it possible to pull the whole power train out of the bus to permit servicing. Floor height is 12 inches throughout with no steps or ramps inside the vehicle. The buses have air bag suspension and a kneeling feature which can drop the floor to 8 inches from the ground in the front and only 3.6 inches from the ground in the rear, so that a simple ramp suffices for wheelchair boarding. [8]

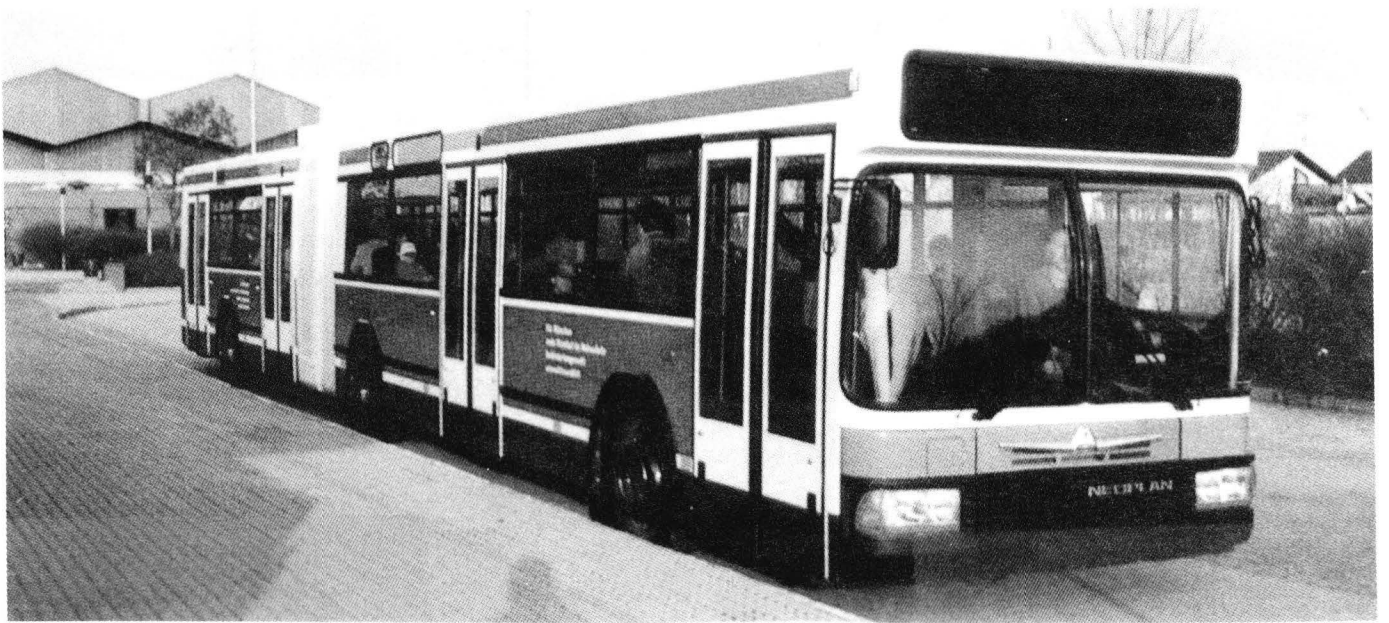
FIGURE 5-3. NEOPLAN LOW FLOOR ARTICULATED BUS

In 1979 the Neoplan Telebus was demonstrated at the International Transport Exhibition in Hamburg. The floor of this small bus was only nine inches high and could be further dropped to only six inches during boarding. In 1987, Neoplan developed the N 4021 NF, the first low-floor articulated vehicle, for the Munich Transport Corporation (Figure 5-3). Six of these buses are now operating in Munich, another 35 in Bremen and five in Cologne. Neoplan now offers a complete line of low floor vehicles with a floor height of 13

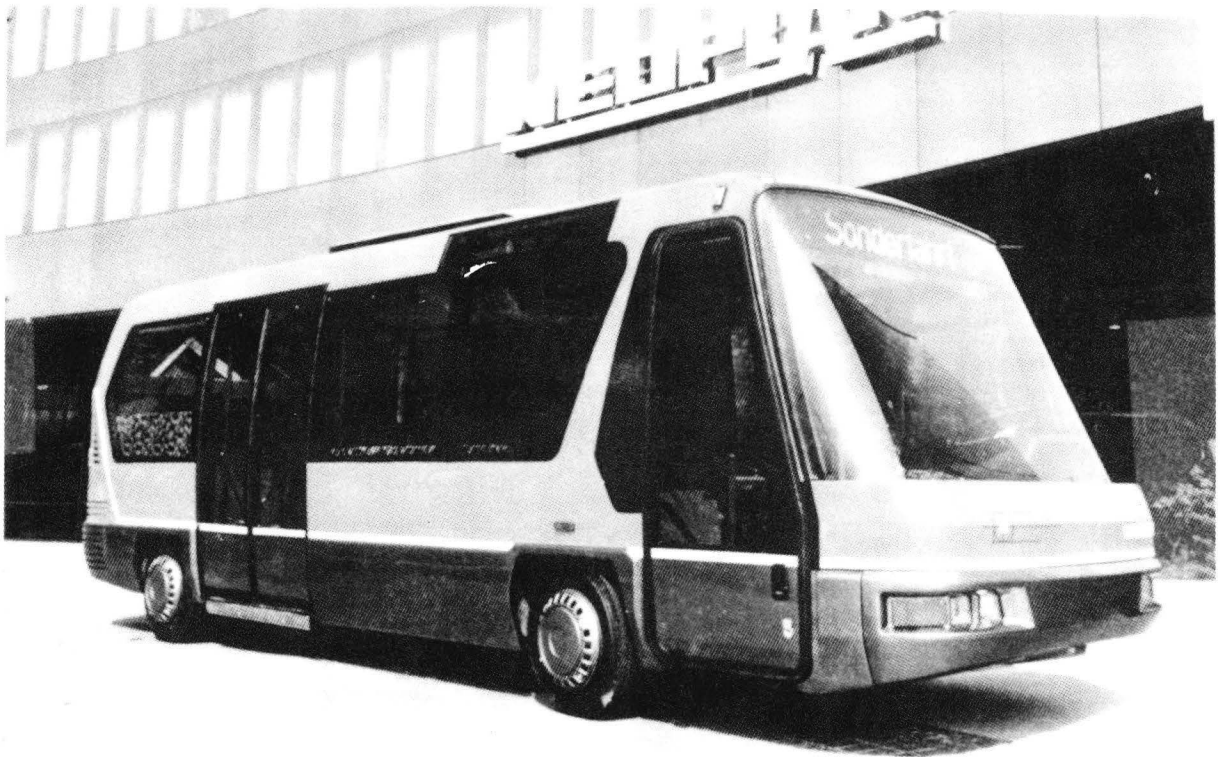
FIGURE 5-6. NEOPLAN "METROLINER"

Neoplan has an even more modern set of low floor buses under development and testing. These vehicles, known as "Metroliners", are composed of lightweight carbon fiber shells joined vertically without metal reinforcement (Figure 5-6). Weight is a third less than comparable models in use today. [19] The first Metroliner in regularly scheduled service began operating in Berlin in 1988. Metroliners are also in service in Stuttgart where Neoplan world headquarters are located and also in Herten, Cologne and Bochum. Neoplan is offering the Metroliner in a 26 foot model seating 22 passengers with 23 standees, a 35 foot model seating 43 passengers with 36 standees and a forty foot model with a total capacity of 106 passengers. [20] The Metroliner low floor extends to just in front of the rear axle where it ramps up to provide needed clearance.

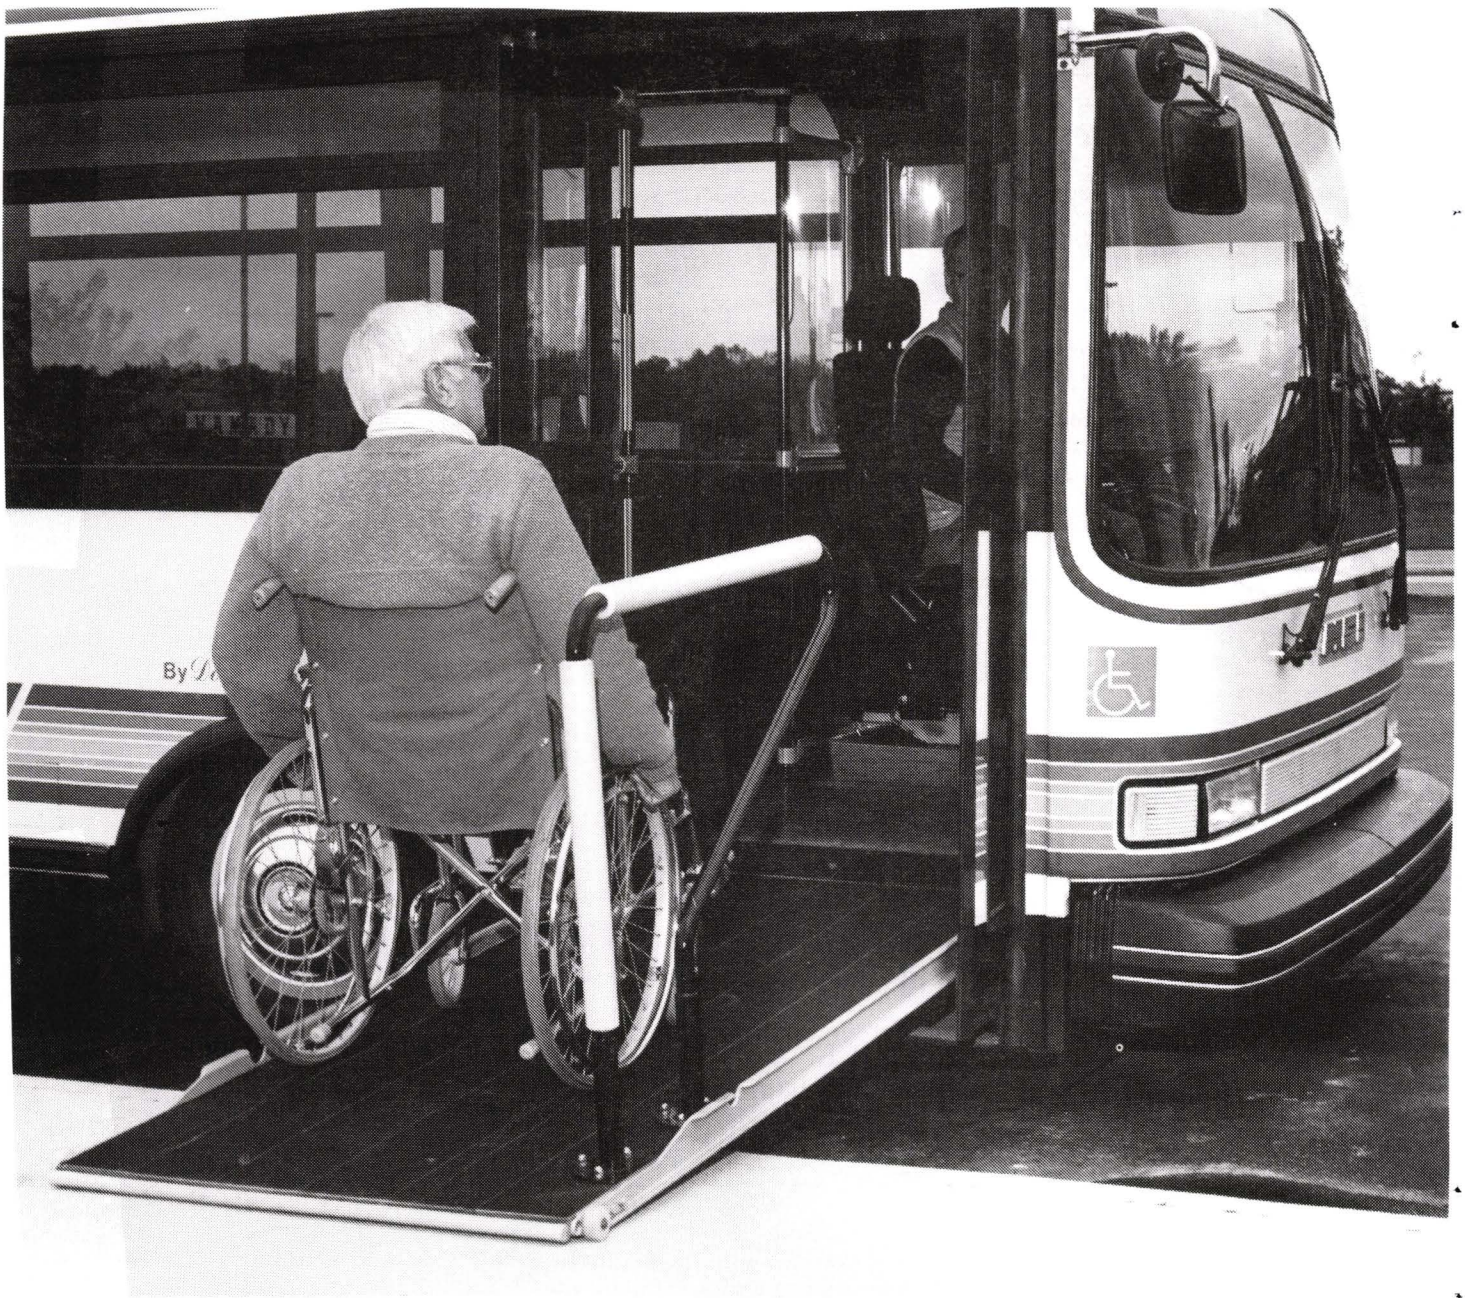
FIGURE 5-7. RAMP ACCESS TO DON MANNING BUS

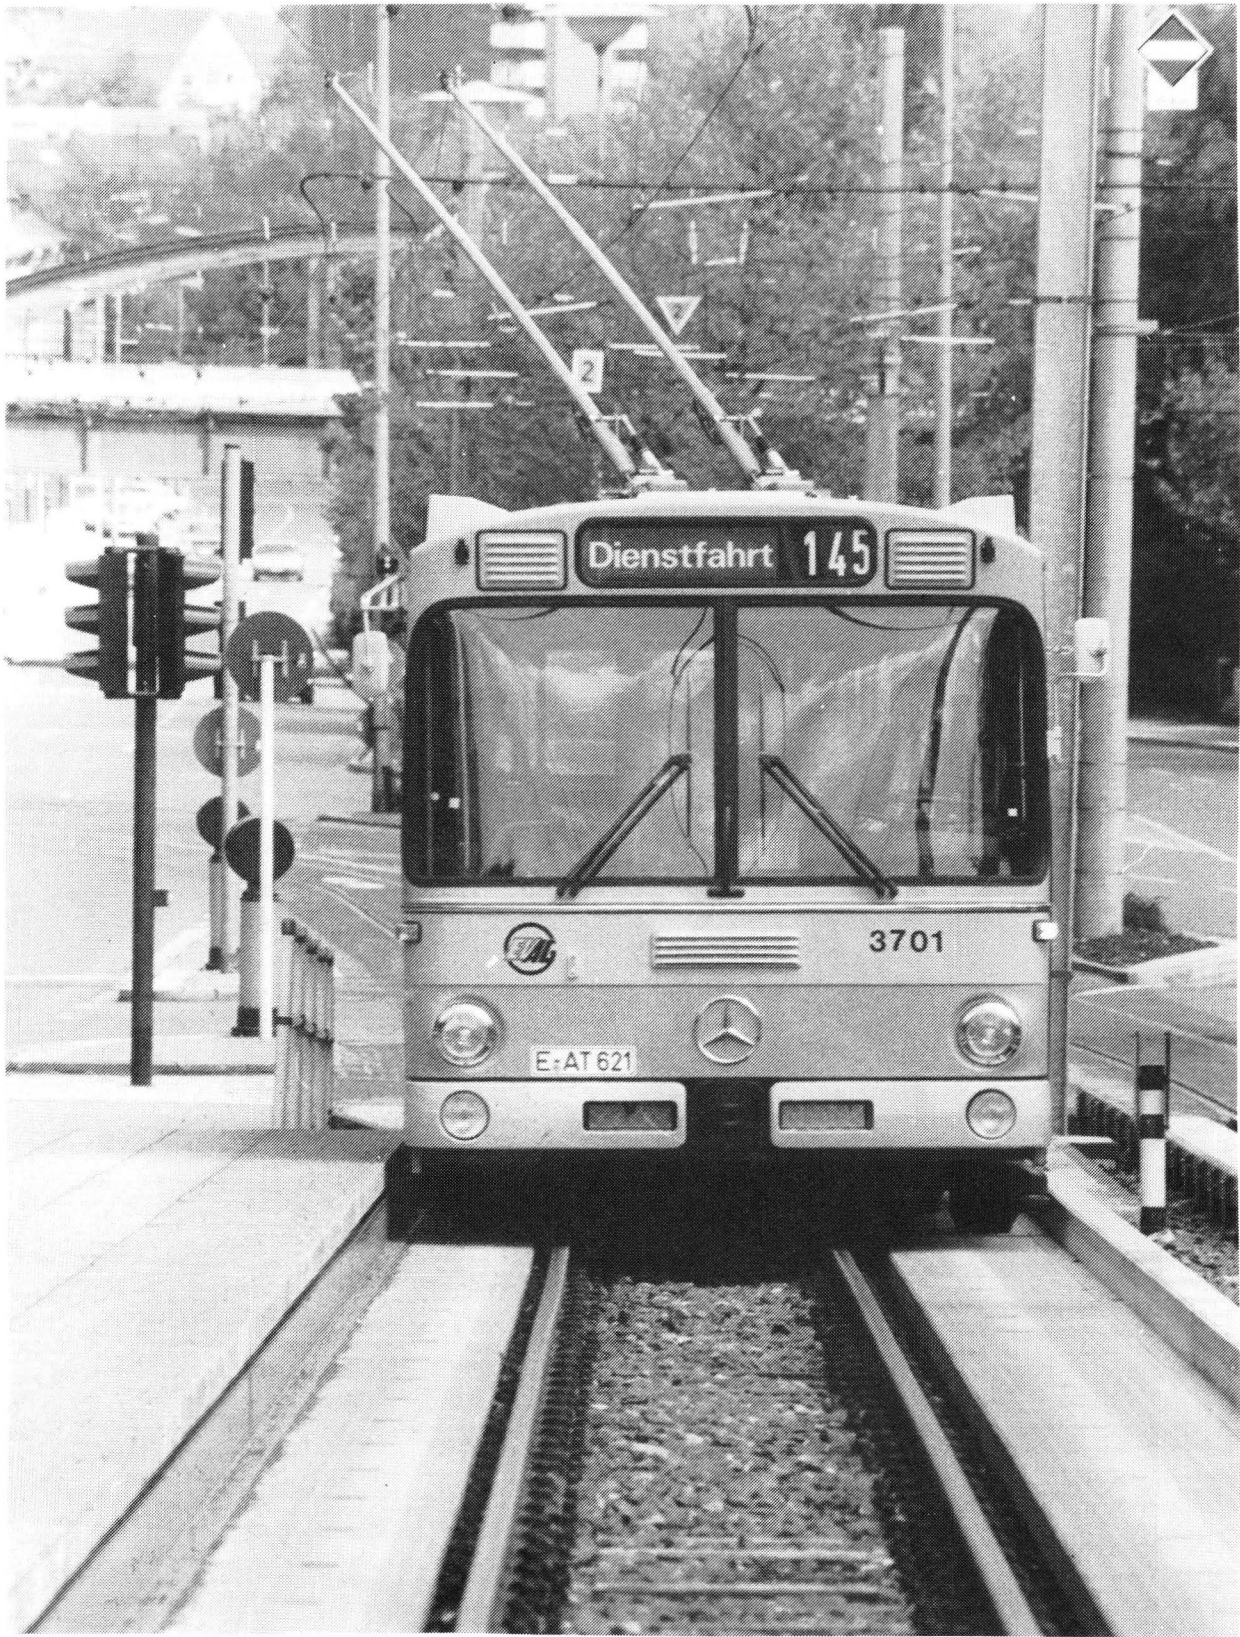
FIGURE 5-8. GUIDED BUS IN ESSEN, GERMANY

Mechanical guidance has been tested using both conventional buses and dual propulsion trolleybuses on routes in Essen Germany (Figure 5-8). German work on guided buses began at test tracks in the early seventies under the auspices of the Federal Ministry for Research & Technology. Both the MAN guided bus test track in Munich and the Daimler Benz test track near Stuttgart were provided with station platforms of various heights including full high level platform boarding (Figure 5-9). Development was moved to Essen in 1980. Mechanically guided equipment now operating in Essen includes 29 articulated Mercedes buses, 18 standard two-axle Mercedes buses, and 18 articulated "dual propulsion" Mercedes buses which have both diesel and electric trolley propulsion. [30] In addition, a single dual propulsion prototype built by MAN was also operated in Essen. The mechanical track guidance equipment allows the vehicle to be steered without any action being taken by the driver. Automatic steering is effected by rubber guide rollers mounted on arms rigidly bolted to the steering knuckle on each side of the bus. These guidewheels run against guiderails installed on either side of the guideway and are directly connected to the stub axles of the front wheels (Figures 5-10 and 5-11). If the bus moves away from the nominal track determined by the guiderails, the deviation is immediately corrected via the guide roller, guide arm and stub axle. Small rollers are also attached to the rear axles of the bus to act as safety rollers to prevent the shoulders of the rear tires from contacting the guiderails in sharp curves. The existing steering system of the bus remains unchanged and normal manual steering is still possible when operating on the street network. The two guiderails are 7 inches in height and spaced 8 1/2 feet apart (Bus width is four inches less). In Essen more than 1.5 million miles have been traversed on the guided busway. [31]

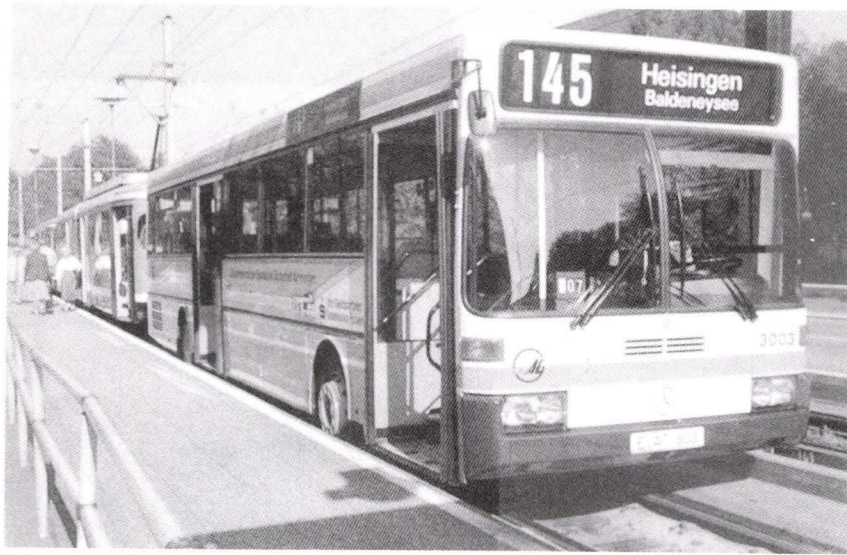
**FIGURE 5-12. ESSEN PLATFORM IS LEVEL WITH
FIRST STEP OF GUIDED BUS**

At the Essen demonstration, bus stop platforms are normally 12 inches above the running surface which puts them in line with the first step of the bus (Figure 5-12). However, there is a half mile tunnel section with high level island platforms where passengers load directly into the dual propulsion buses at floor level through doors on the left hand side. [33]
